NOTIFICATION OF ENVIRONMENTAL CONCERN (NOEC) INVESTIGATION REPORT

NOTIFICATION NUMBER 021221-NH-0845	NDEQ ID / Program ID 84069
---------------------------------------	-------------------------------

INSPECTION DATE 2-12-2021	TIME/ARRIVAL 1:00pm	TIME/DEPARTURE 5:00pm	WEATHER Cloudy, snow	TEMP 2F
------------------------------	------------------------	--------------------------	-------------------------	------------

BUSINESS NAME
AltEn, LLC

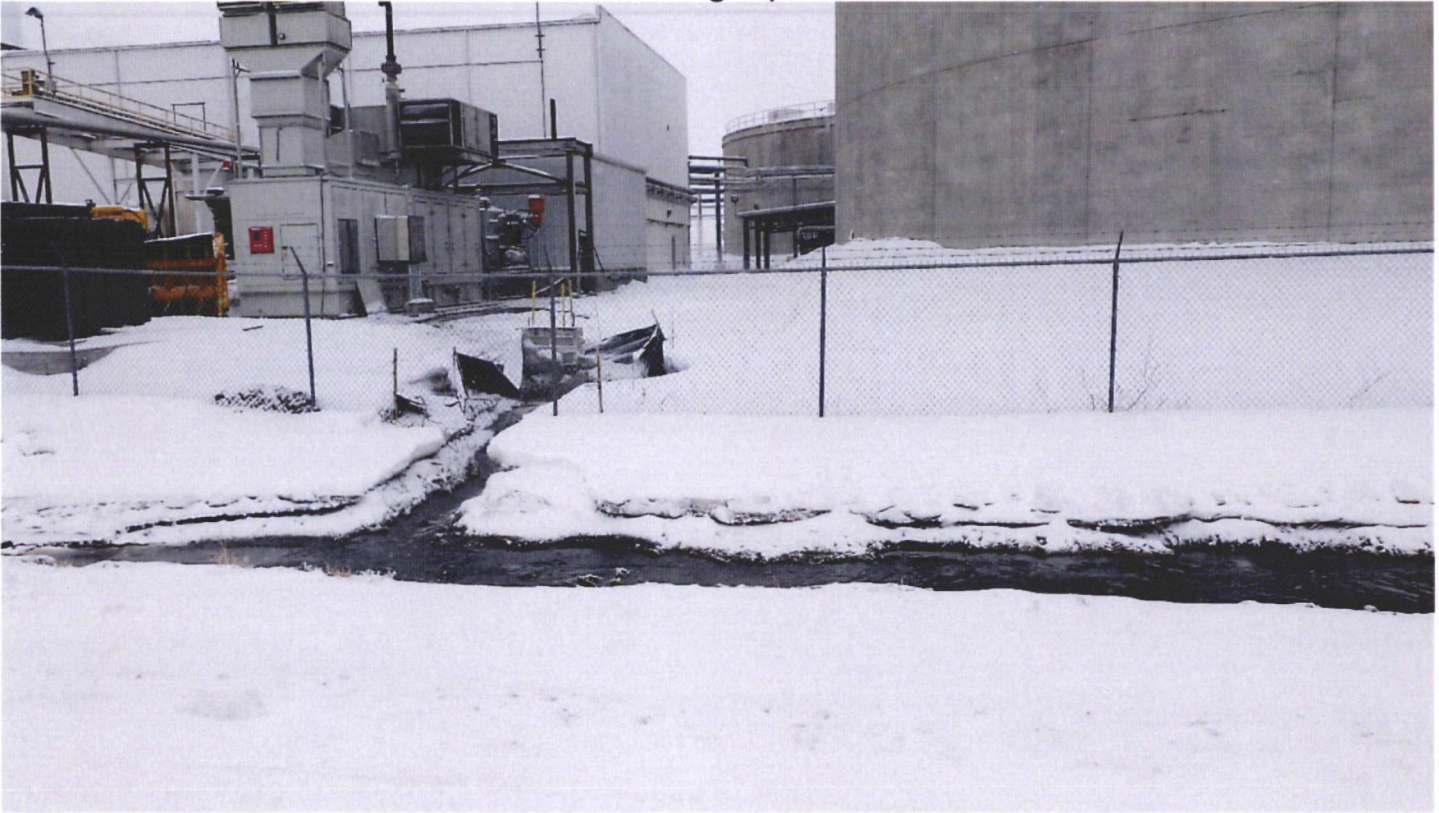
Photo 1

Mr. Peterson drove me to the digester. Upon arrival I observed wastewater conveying from the southwest side of the digester, photo 1. I asked Mr. Peterson if the break is located on the southwest side. Mr. Peterson stated no and drove to the southeast corner. There is heavy flow cascading over the hill into the adjacent ditch, photos 2 and 3. We then exited the truck and walked to the digester. The ruptured pipe is located on the east side splashing and spraying against the digester, photo 4. The surrounding area east, west and north are filled with wastewater, photos 5 and 6. I asked Mr. Peterson if the tank was full. Mr. Peterson confirmed the tank contained four million gallons. I asked what containment activities have been employed. Mr. Peterson stated the break is below ground. The water pressure and break area are making management difficult. Mr. Peterson stated they installed two trash pumps, photos 7 and 8.

Location: Southwest corner of the digester

Description: This photo depicts water flow from the storm water conveyance system. Water is entering the ditch flowing east along the south side of the digester.

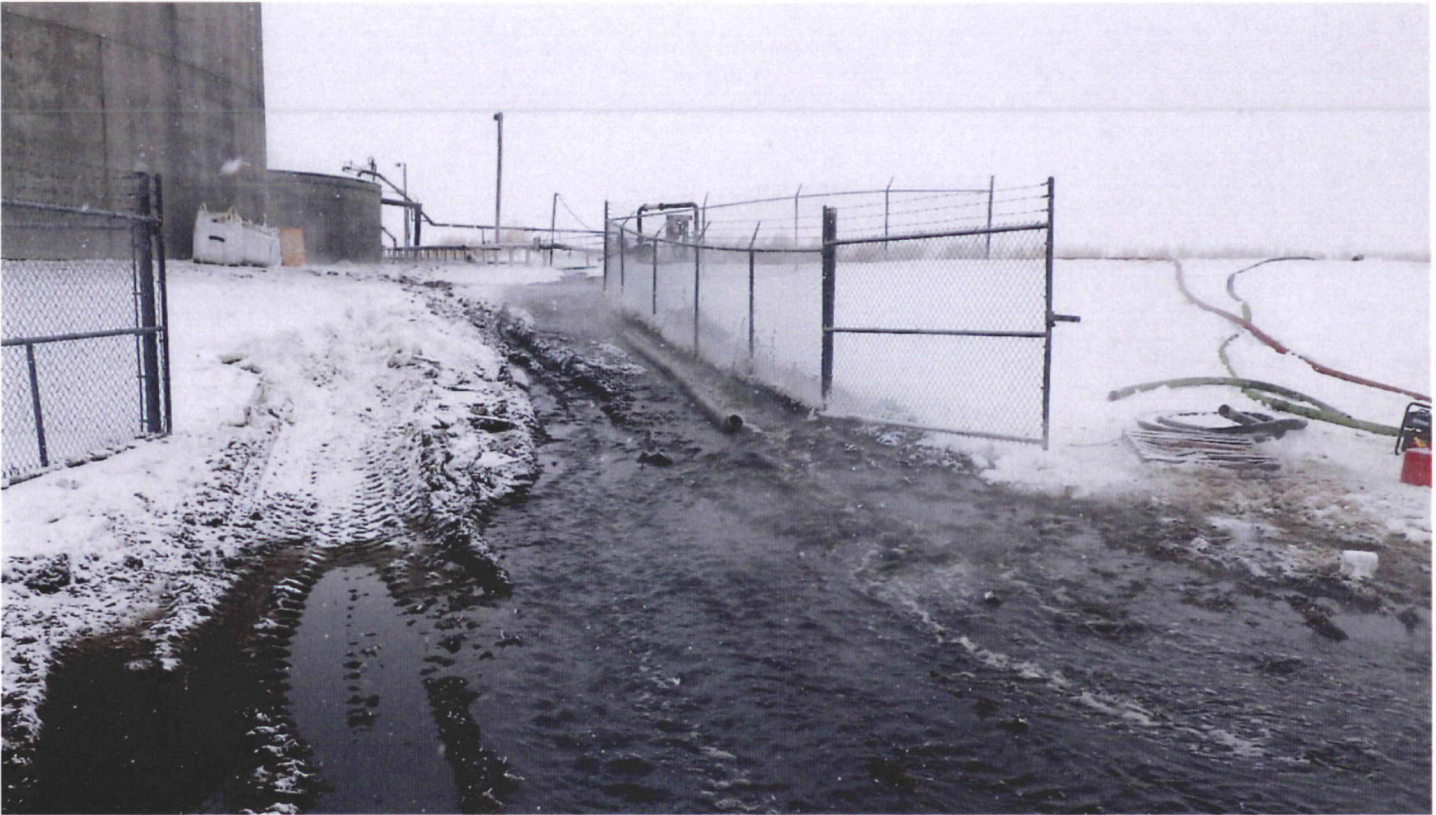
Photo 2

Location: Southeast side of the digester

Description: This photo depicts cascading water exiting the southeast side of the digester.

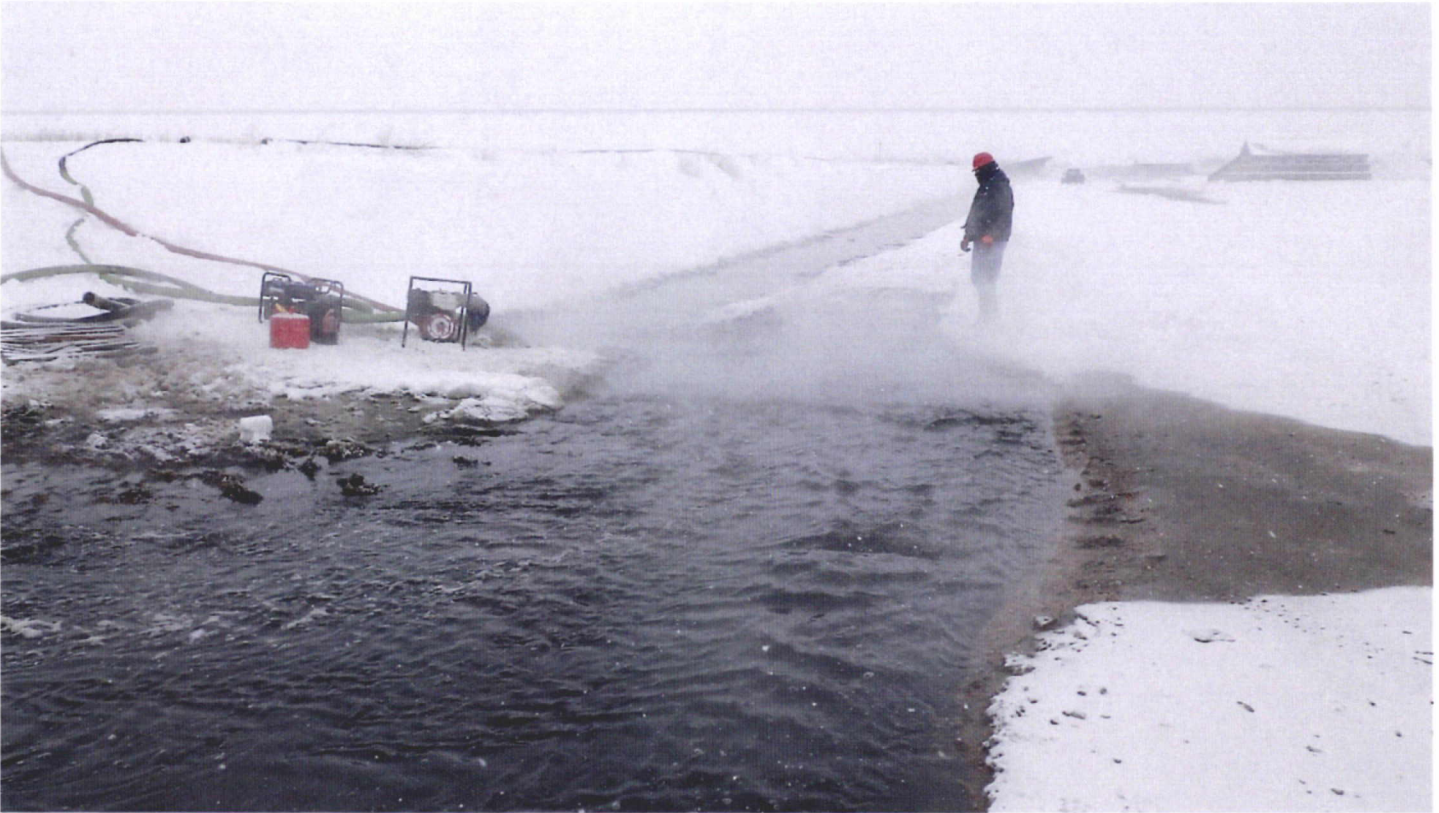
Photo 3

Location: Southeast side of the digester

Description: This photo depicts water entering the ditch and flowing along the emergency lagoons. Also depicted is the trash pumps installed to transport water into the emergency lagoon.

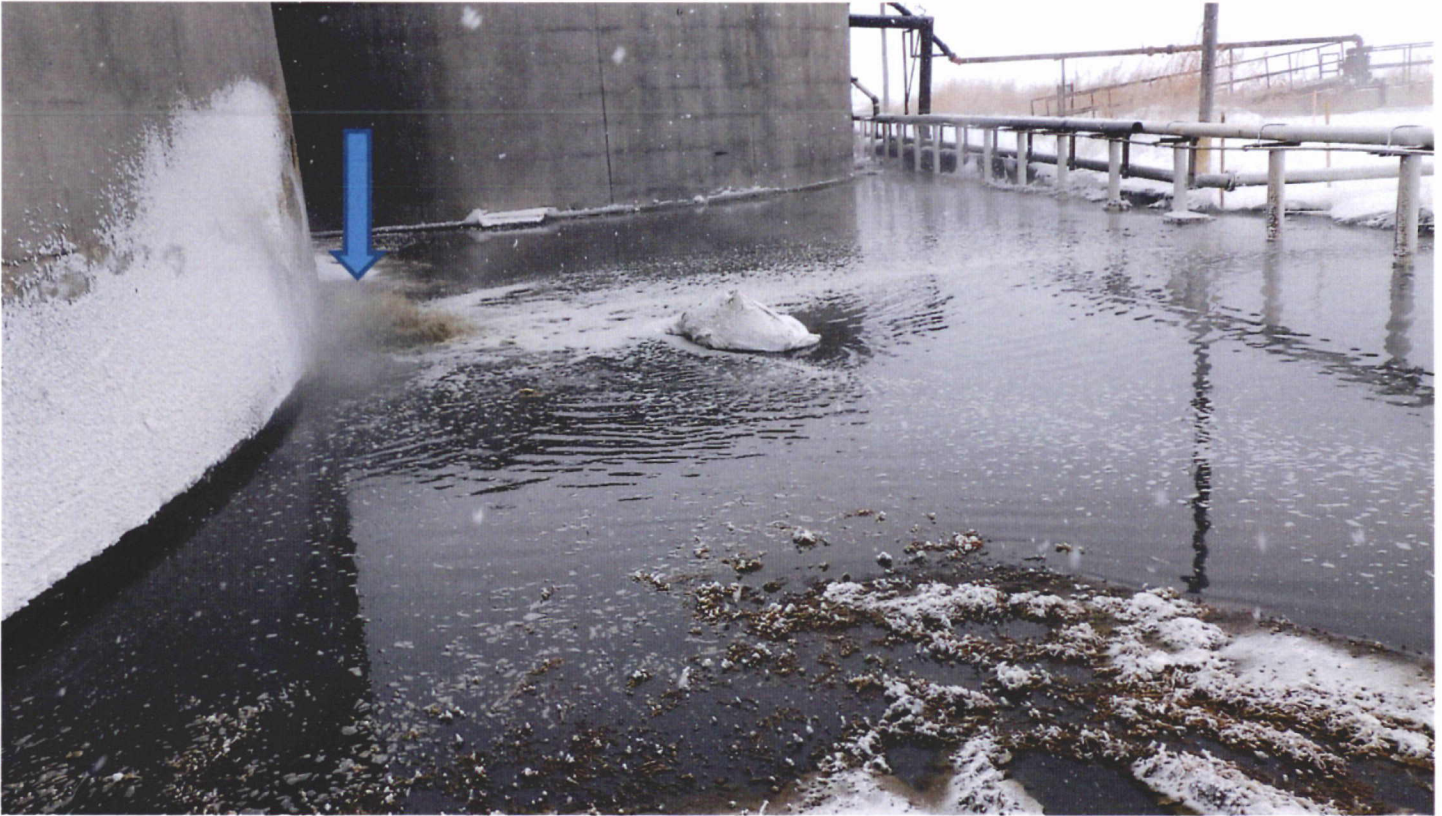
Photo 4

The south digester containing thin stillage and manure suffered a pipe break reportedly due to freezing conditions. An estimated four million gallons of liquid was released onto surface water. The spill flowed into a storm water ditch adjacent to the digester onto neighboring UNL property. AltEn had attempted to contain the spill by constructing a dam made of biochar supersacks, which was ineffective. The facility also installed trash pumps along the ditch attempting to pump into the neighboring emergency lagoon. A dam was also constructed at a culvert located on the southeast side of the property. The NDEE will determine if additional actions are needed.

Location: Southeast side of the digester

Description: This photo depicts the damaged area (arrow). Water is quickly exiting the digester creating ponding and discharge.

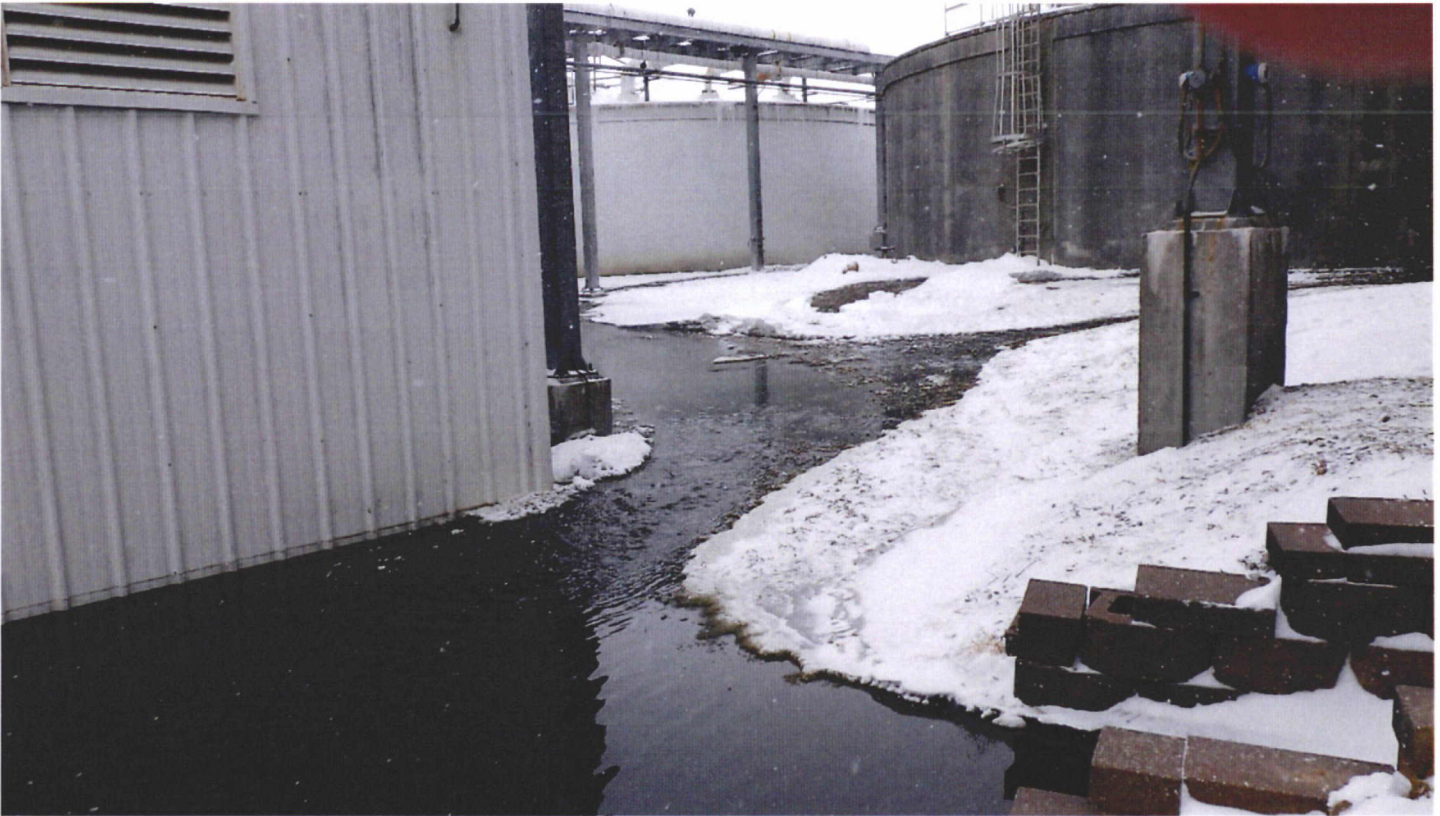
Photo 5

Location: Southwest side of the digester

Description: This photo water flowing behind the digester. Wastewater is flowing behind the digester (arrow). Flow continued southwest and into the conveyance system depicted in photo 1.

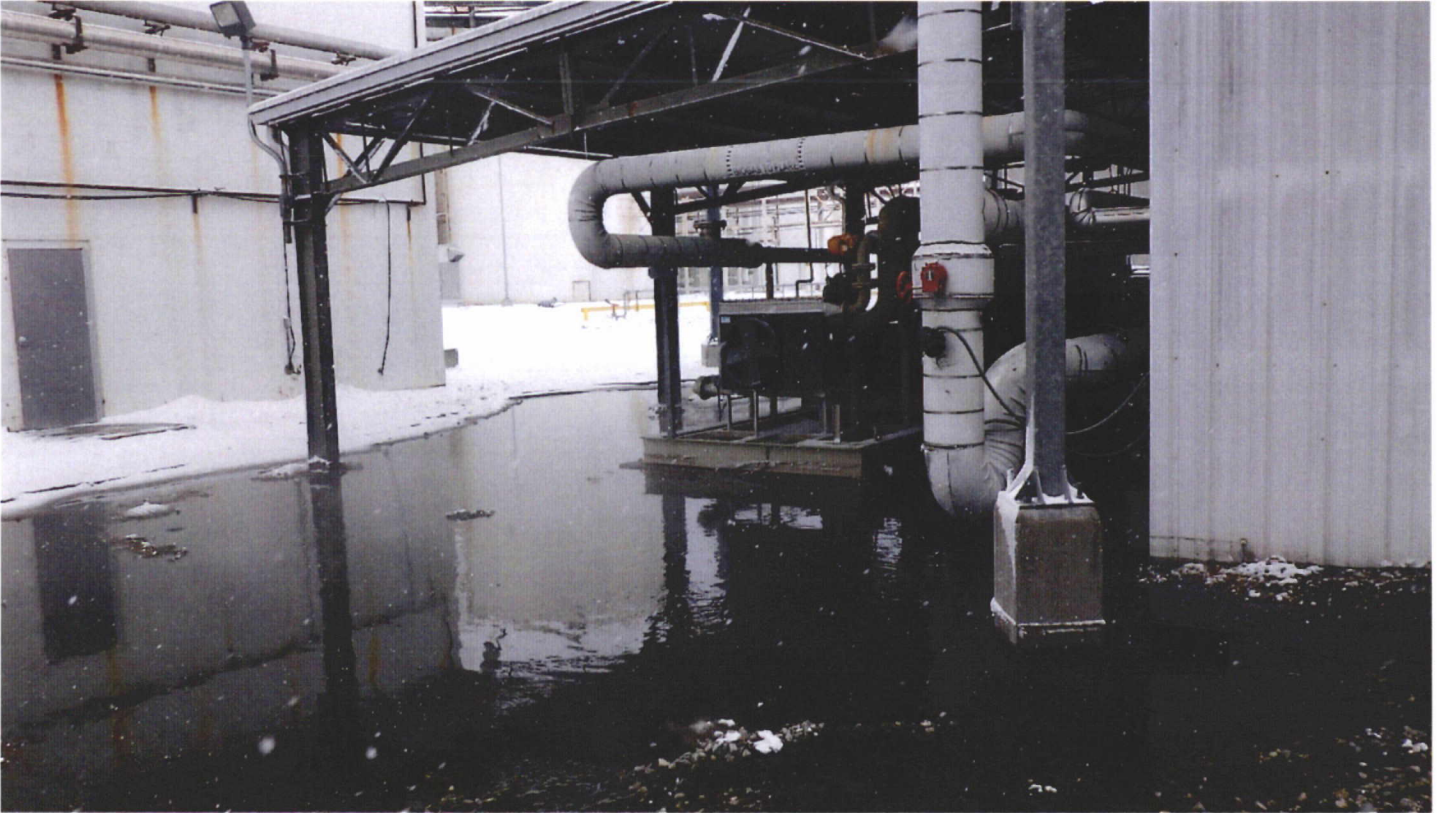
Photo 6
NOEC Inspection Report
Date Taken: 2-12-2021
Photographer: Mark Pomajzl
Facility Name/ Project Name: AltEn
Facility IIS number / Project identifier: IIS: 84069
Location: Southwest side of the digester
Direction Facing: Northeast
Description: This photo is pooled water west of the digester.

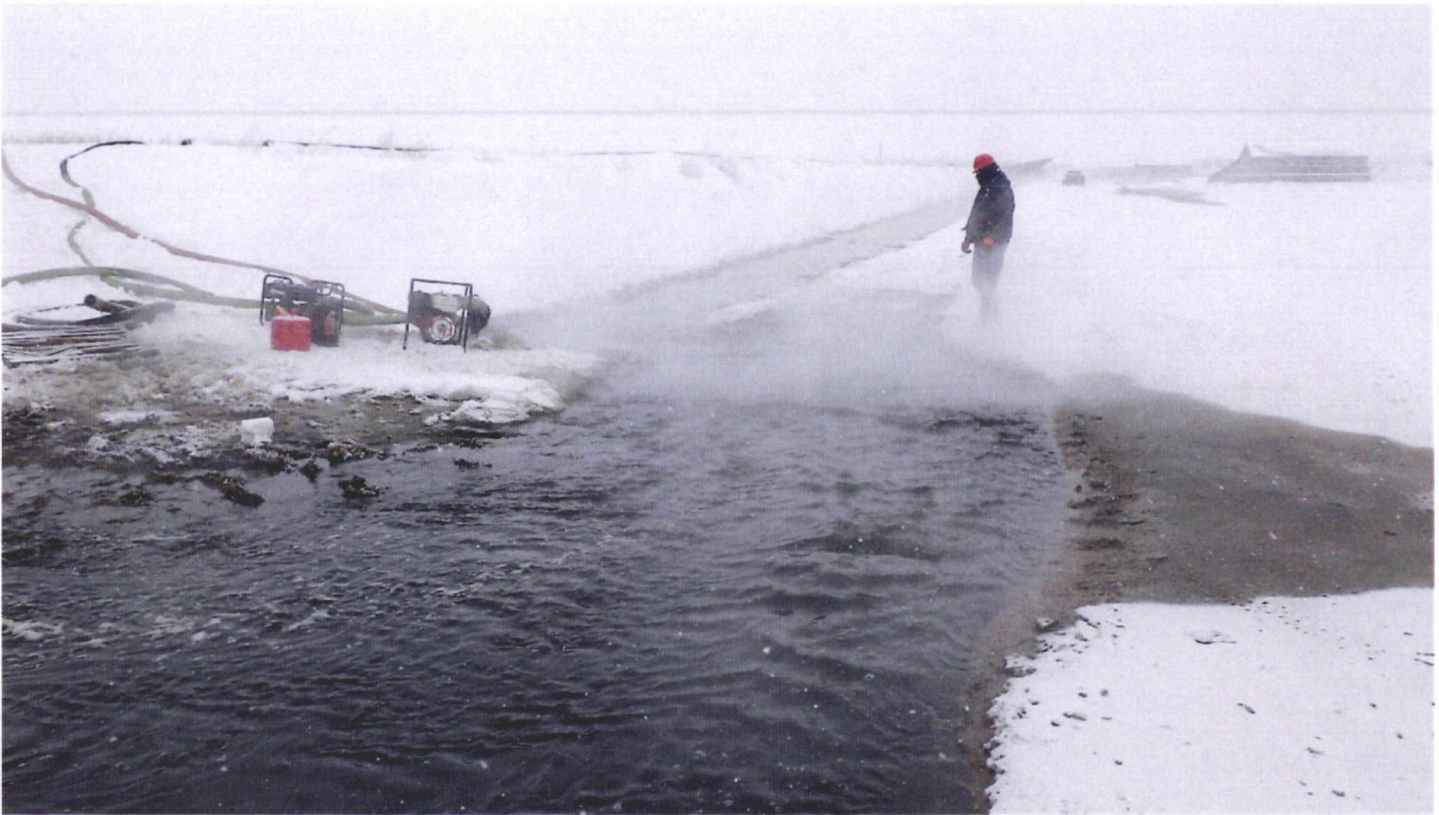
Photo 7

Location: Southwest side of the digester

Description: This photo depicts the trash pumps used to transport water into the emergency lagoon.

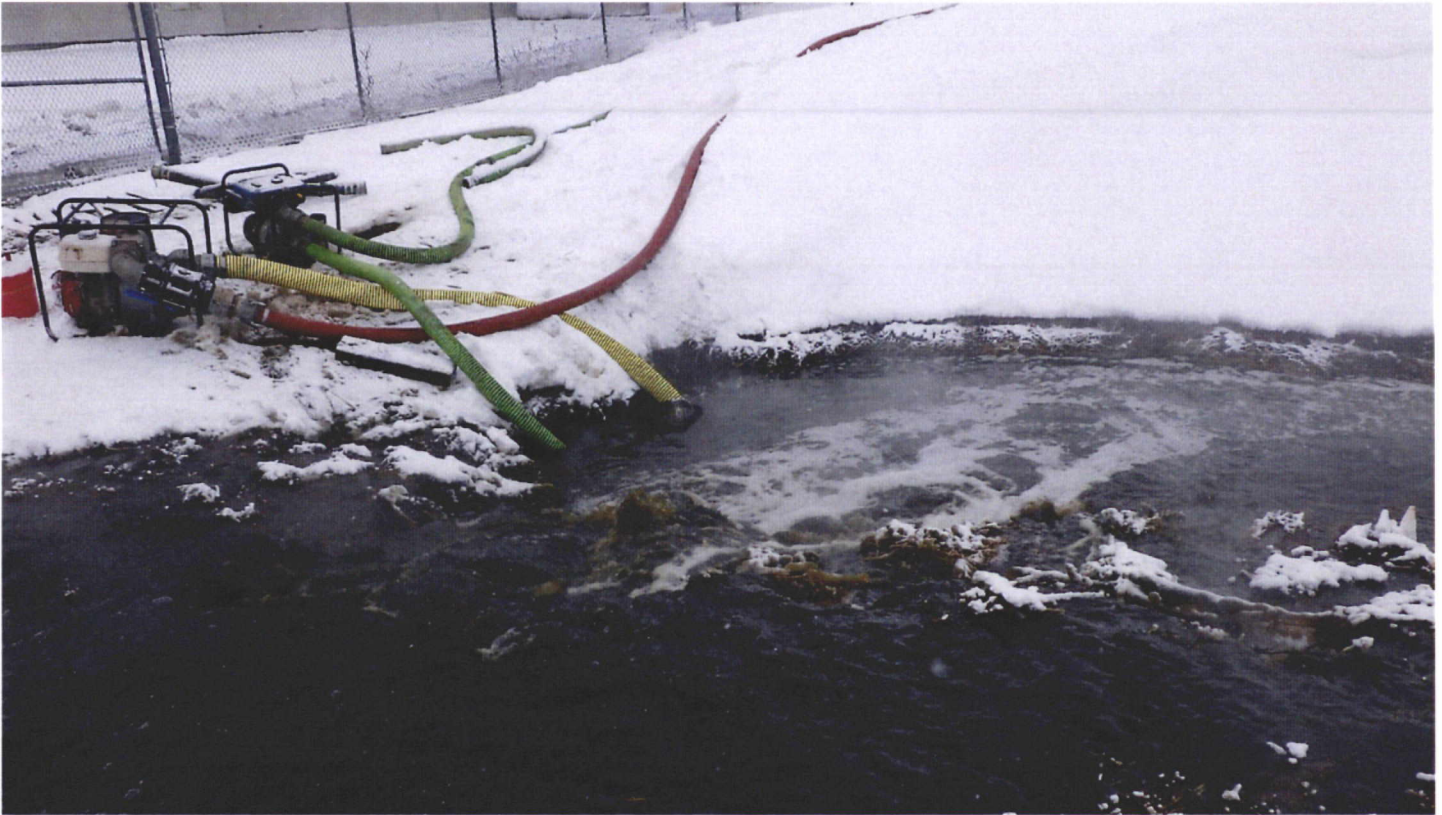
Photo 8

Location: Southwest side of the digester

Description: This photo depicts the trash pumps used to transport water into the emergency lagoon.

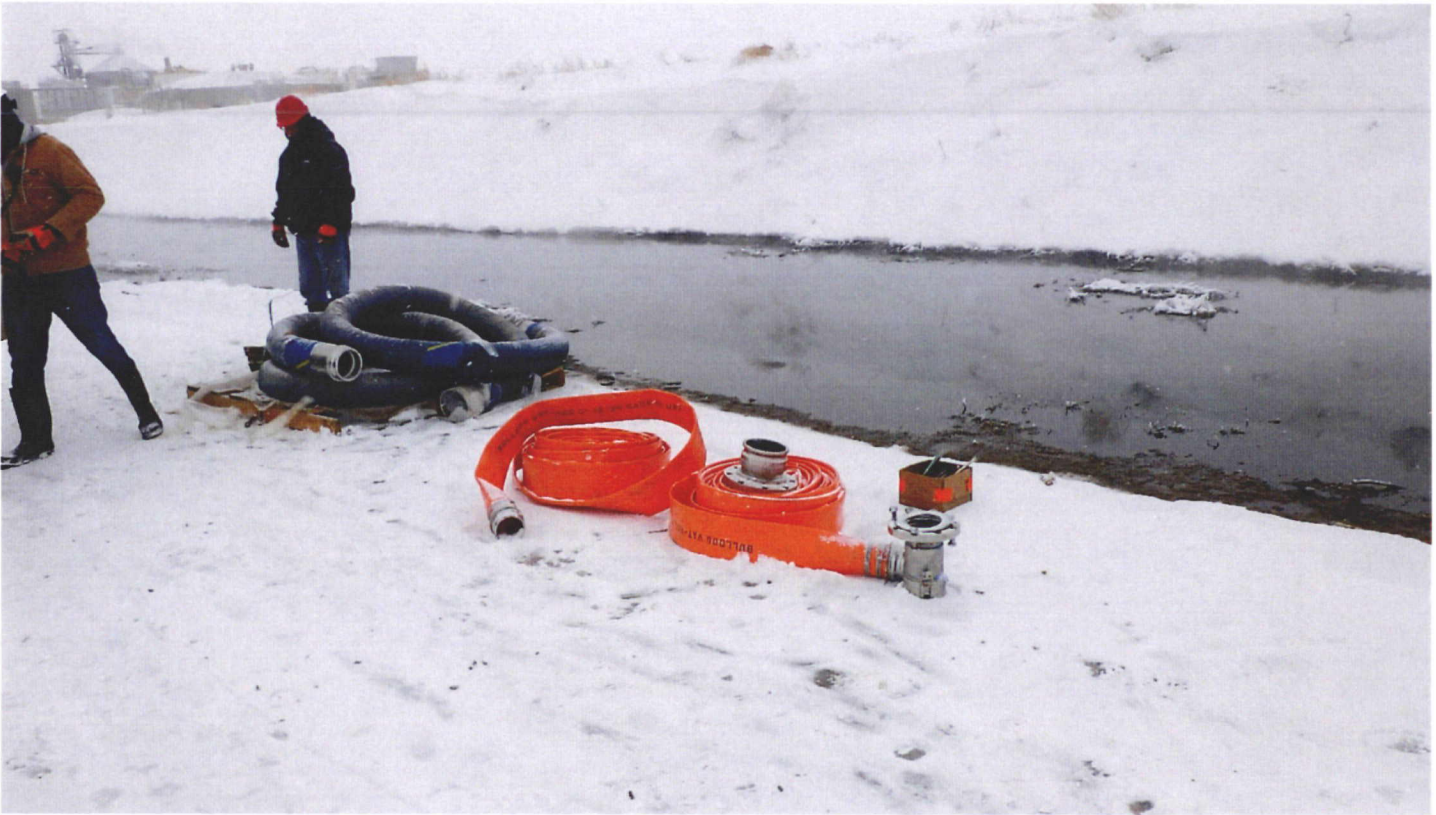
Photo 9

Location: East of the spill site along the emergency lagoon

Description: This photo depicts AltEn personnel working to install an additional trash pump. The pump is being installed approximately 100 yards east of the pumps depicted in photo 8.

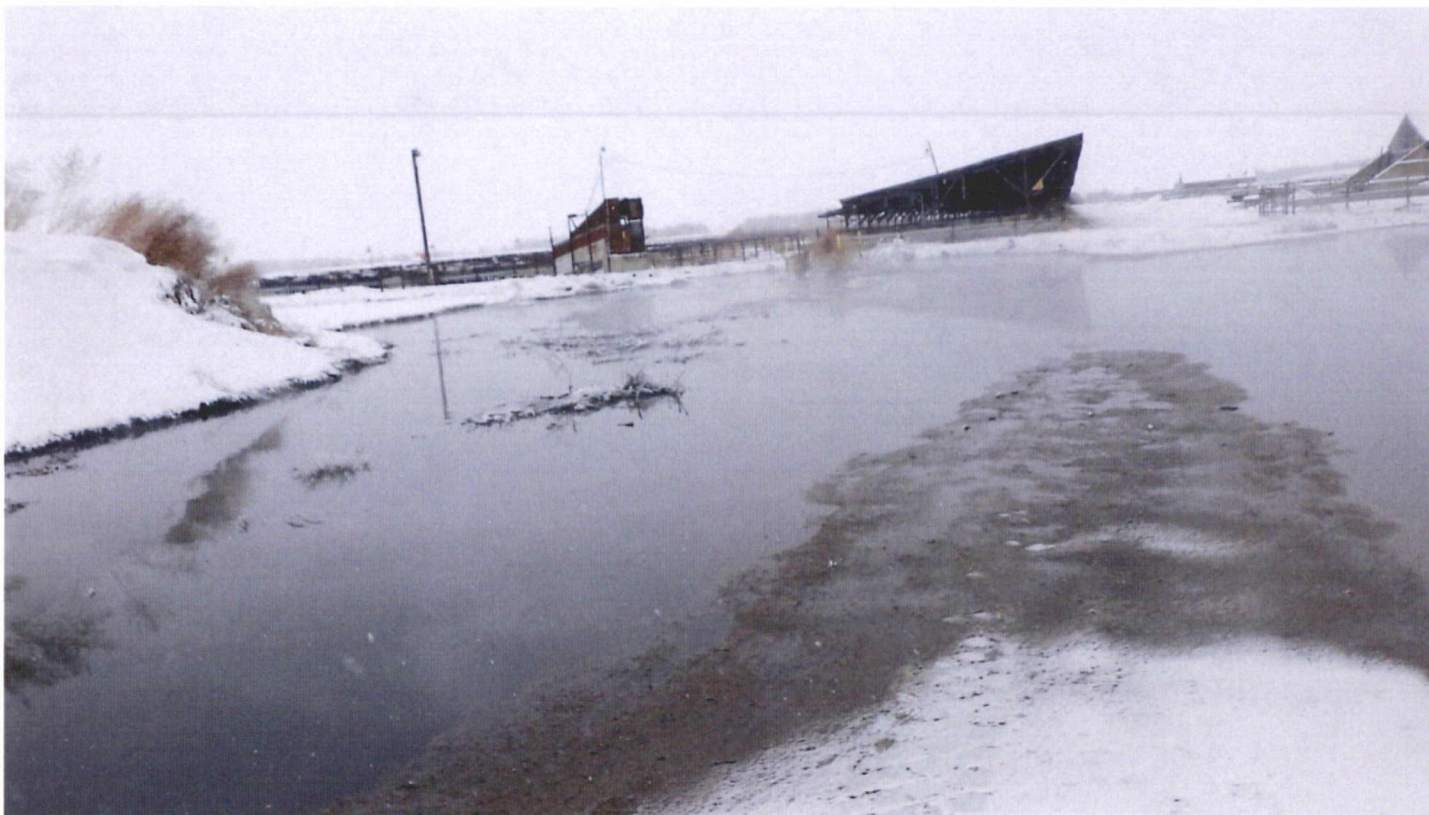
Photo 10

Mr. Peterson stated they are in process of adding an additional larger pump downstream, photo 9. Mr. Peterson did not know how much water had been pumped into the emergency lagoon. The storm water ditch meanders around the emergency lagoon and has overwhelmed the ditch creating a lake adjacent to the west side of Mead Cattle and east of the biochar process, photos 10 and 11.

Location: East of the spill site along the emergency lagoon

Description: This photo depicts the creek flooding the road entering Mead Cattle.

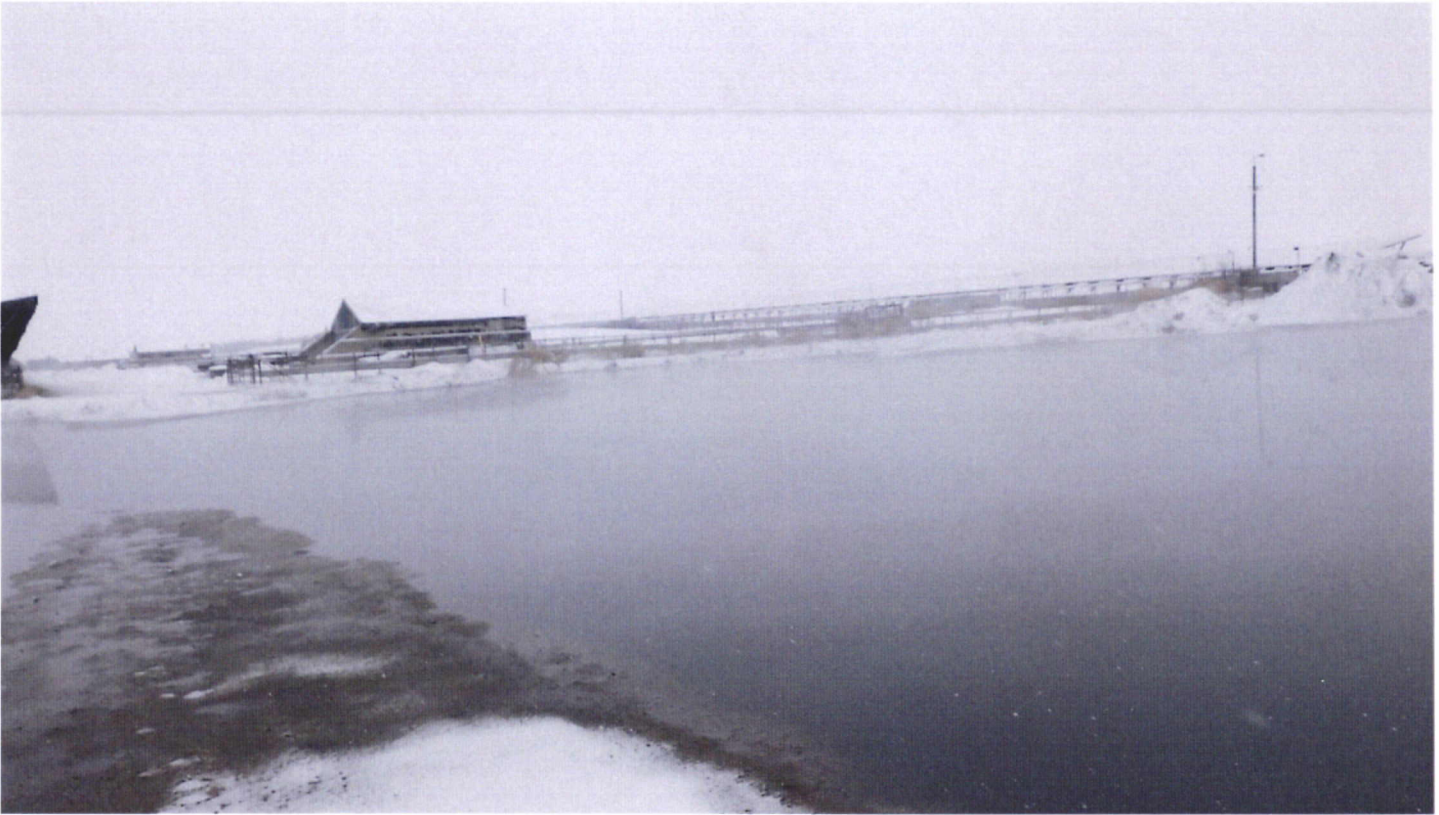
Photo 11

Location: West of Mead Cattle

Description: This photo depicts water flooding the road and ponding on the south side.

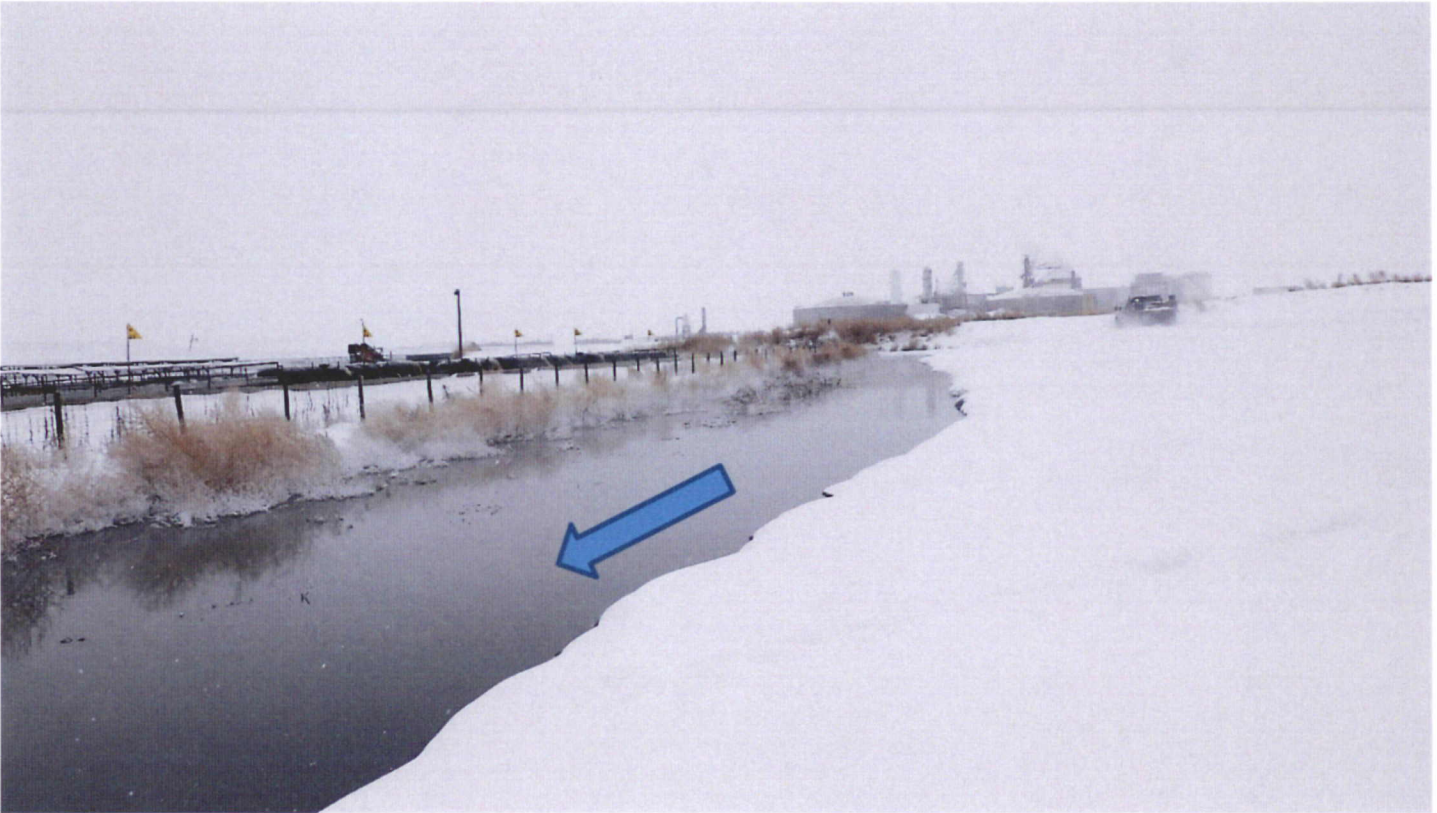
Photo 12

Location: North of Mead Cattle

Description: This photo depicts wastewater flowing east along Mead Cattle. The arrow depicts flow direction.

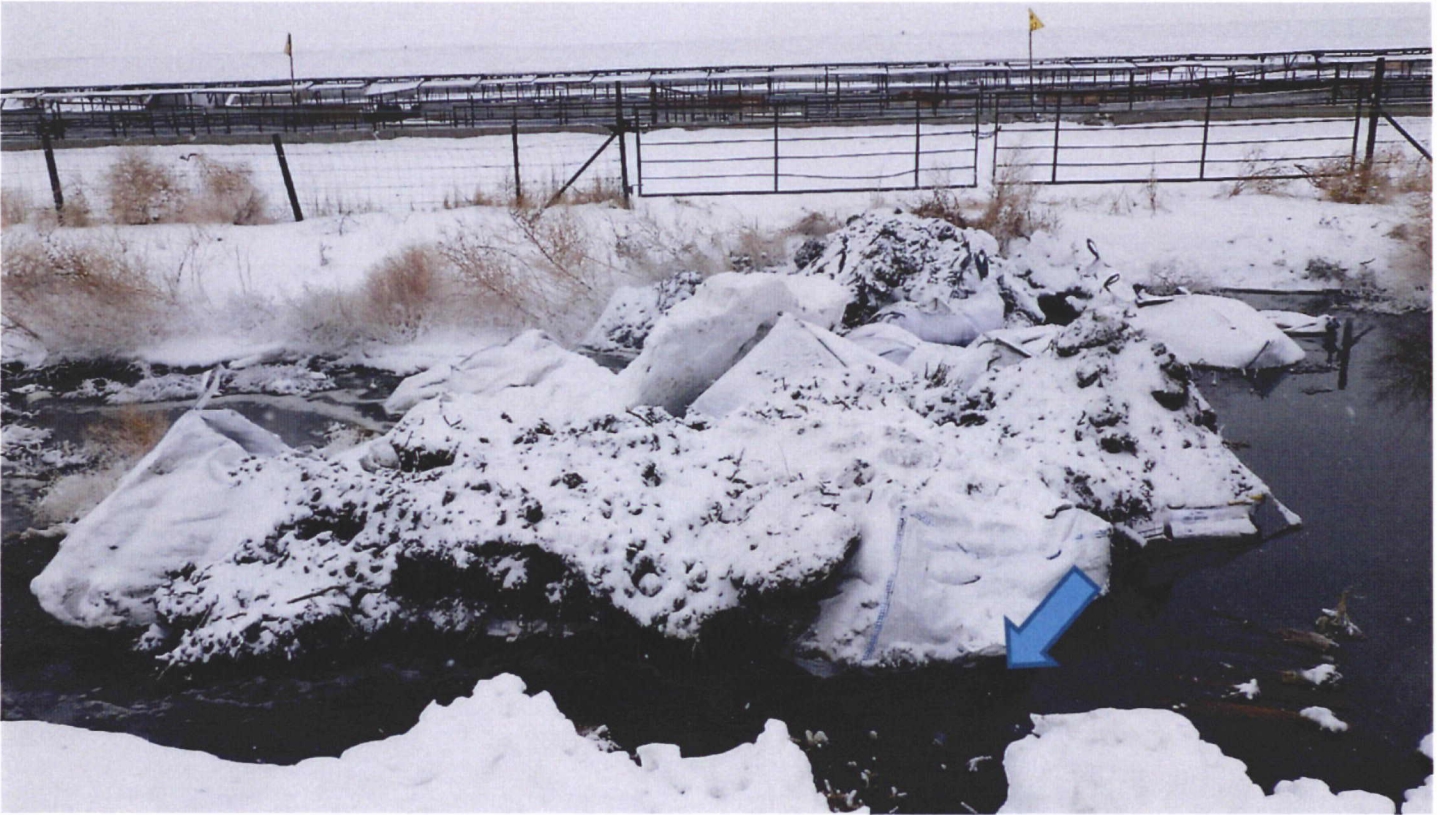
Photo 13

Mr. Peterson then showed me their makeshift dam made of biochar supersacks. Early during the spill, the facility dumped sacks of biochar into the ditch. Wastewater has meandered around the east side of the emergency lagoon and is flowing east on the north side of Mead Cattle. Mr. Peterson stated that the dam did slow the flow but eventually breached, photo 12 and 13.

Location: North of Mead Cattle

Description: This photo depicts a makeshift dam made of biochar supersacks. This photo also depicts the breach that occurred on the north side (arrow)

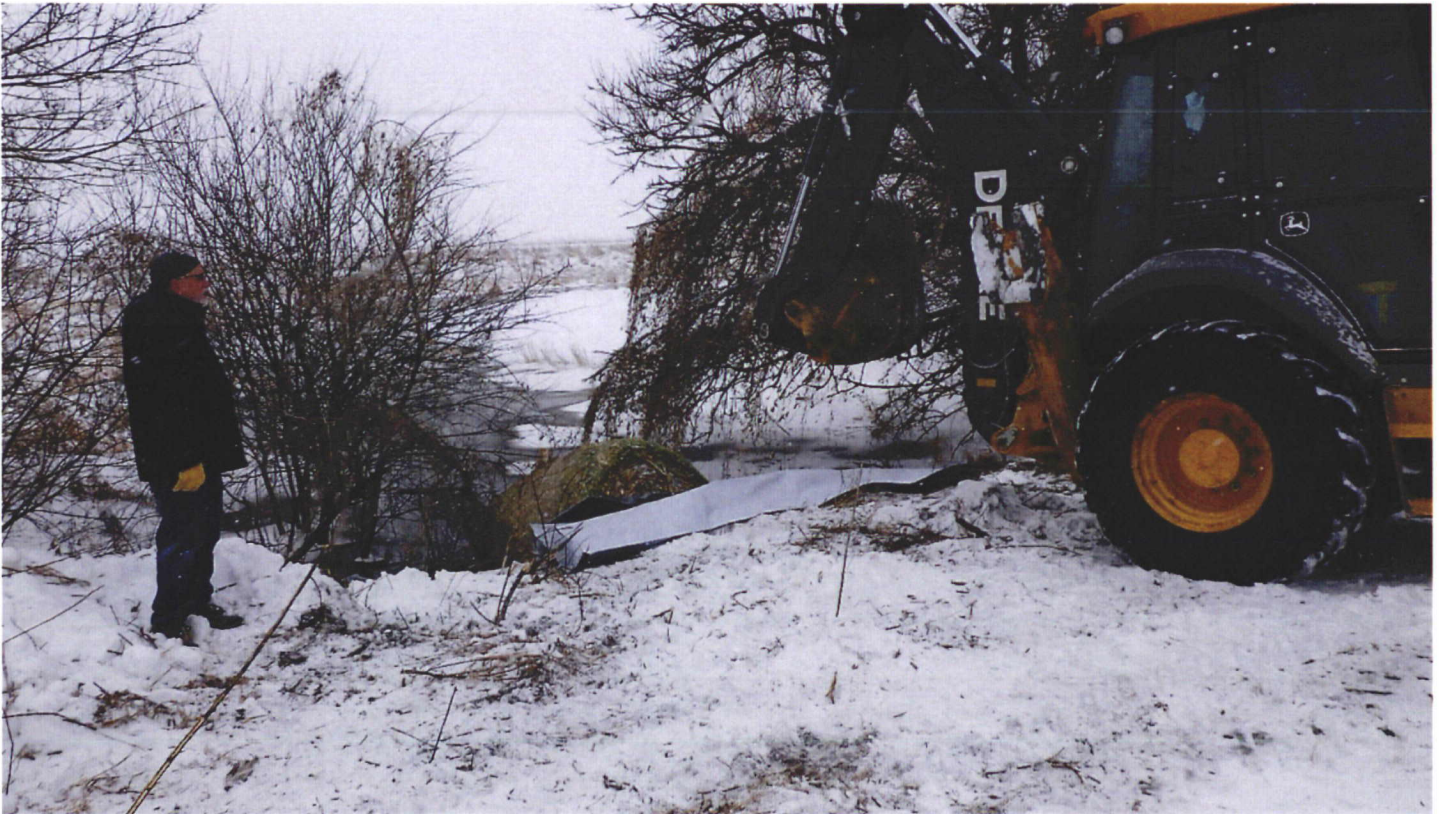
Photo 14

I then drove to the culvert that exits the facility. The culvert is located on the southeast side of the property. When I arrived, I met representatives from the University of Nebraska – Lincoln (UNL). I observed UNL installing plastic, bales and cement (rip-rap) in attempt to hold back the flow, photos 14 and 15.

Location: County Road J and 9

Description: This photo depicts UNL personal installing plastic and bales to dam the culvert.

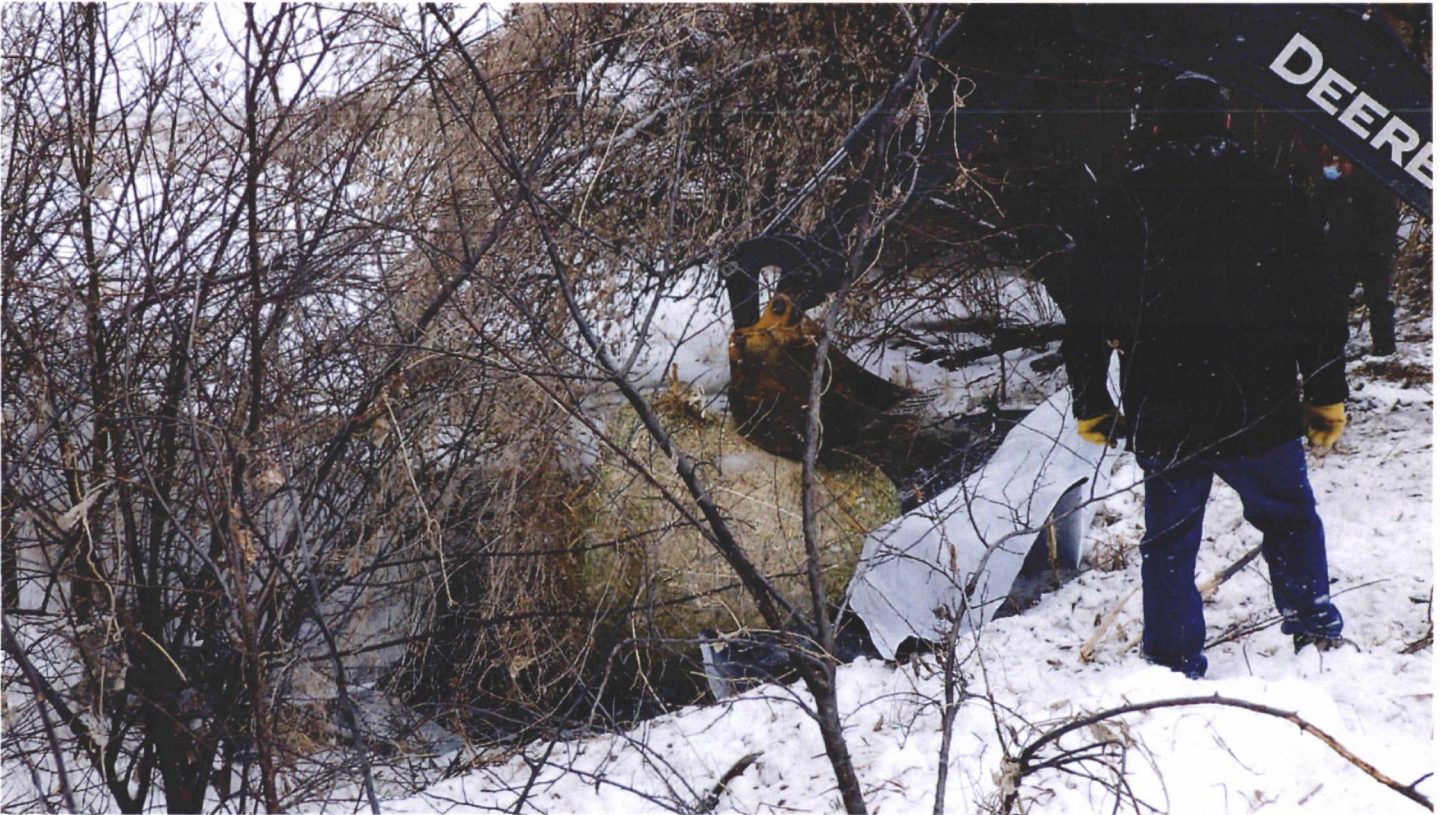
Photo 15

Location: County Road J and 9

Description: This photo depicts UNL using a backhoe to push a bale and plastic into place.

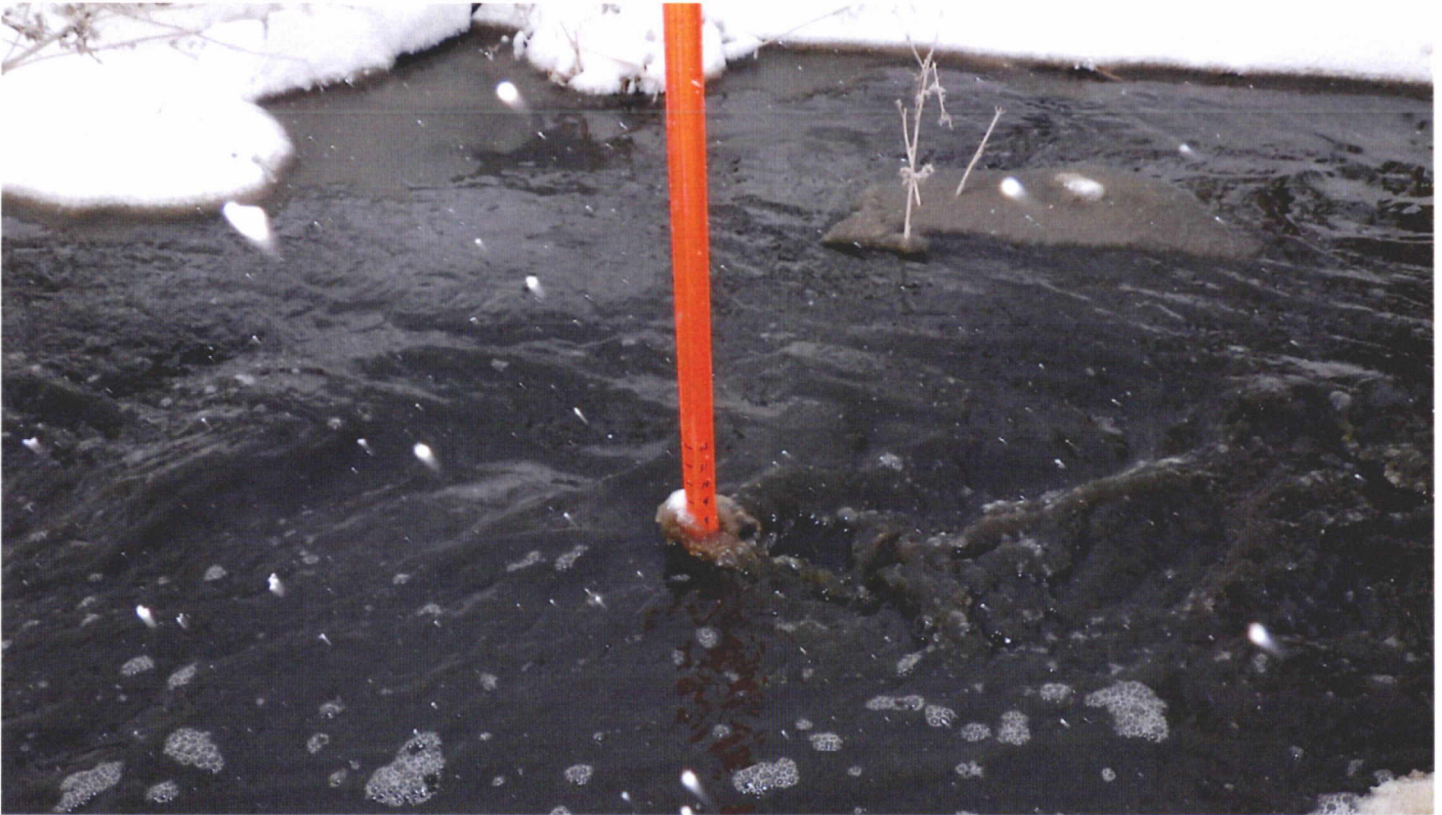
Photo 16

Location: UNL property

Description: This photo depicts UNL property adjacent county road 9. This photo is a depth finder that UNL installed to measure flow. Mr. Brummel (UNL) stated that water depth had been rising 2 inches per hour.

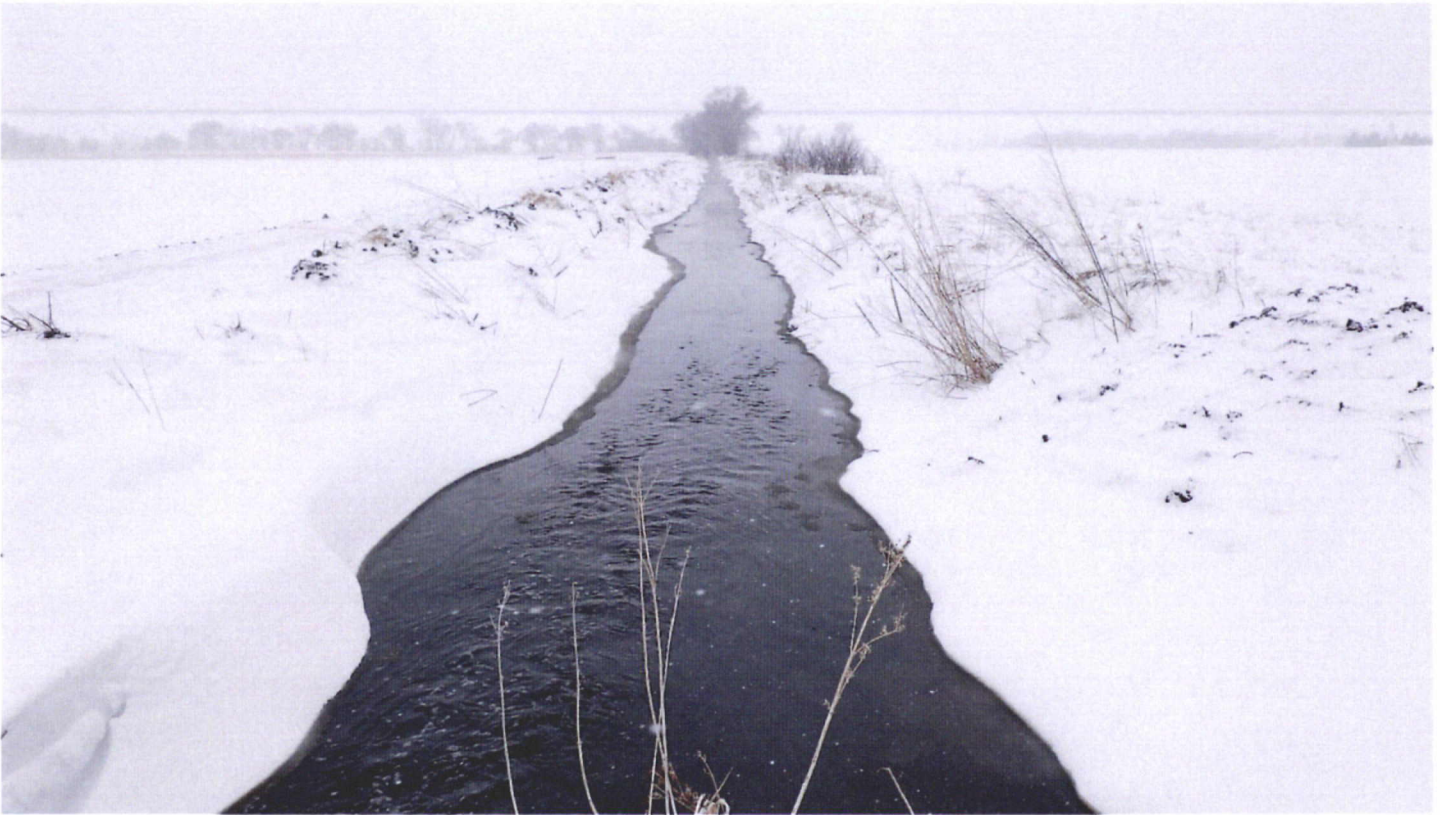
Photo 17

The flow continued through the culvert and then entered UNL property. Prior to investigating UNL property, I met with Sheldon Brummel (UNL). Mr. Brummel agreed to escort me to various locations to document flow. Mr. Brummel provide access to the first culvert site. I observed dark colored water and odor near a depth finder. Mr. Brummel stated that they have sampled the location all day and the depth has steadily increased, photo 16. I took photos from this area documenting the flow and dark colored water, photo 17.

Location: UNL property

Description: This photo is from the same area as the above photo. This photo is facing south from onto the culvert. I observed dark water and odor at this location.

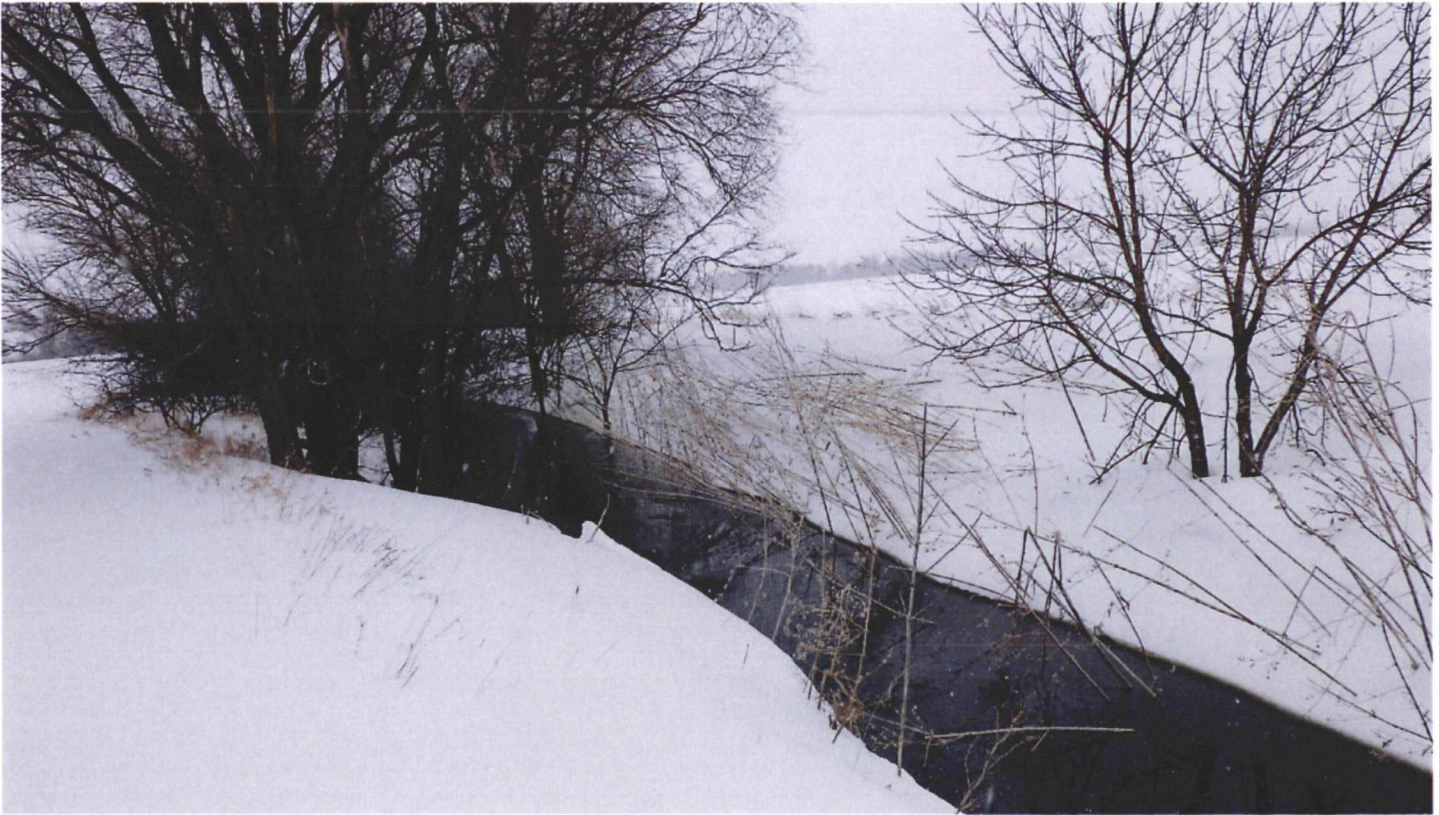
Photo 18

Mr. Brummel drove farther downstream. I again observed flow, dark colored water and noted odor, photo 18.

Location: UNL property

Description: This photo depicts an area deep into UNL property. I observed flow, dark water and odor.
