NPDES Inspection Report

Date: February 1, 2019

RE: AltEn, LLC, compliant investigation

Notice of Environmental Concern (NOEC): 013119-KM-1630

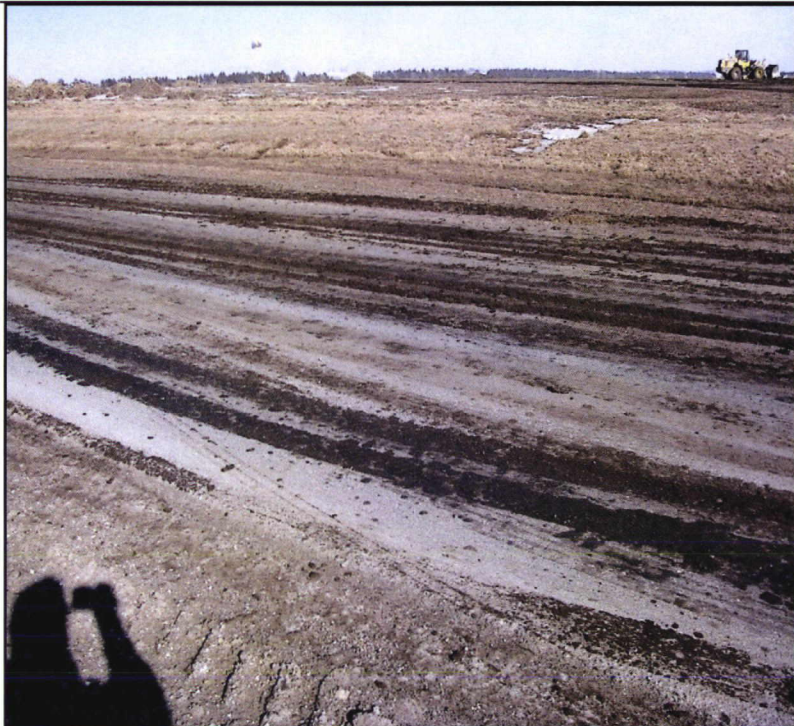
Photograph # 1
Date: 2/1/2019
Photographer: Dan LeMaistre
Camera: Sony Cyber-shot (DSC-W370)
Facility Name/ Project Name: AltEn LLC
Facility IIS number / Program ID:
IIS# 84069, NE0137634
Observation Point #: 1
Direction Facing: Northeast
Description: Track out heading north toward Mead.

I wrote the exit summary form, which states to add rock in the entrance to help control track out, and to clean up the roadway. I also requested that they provide the Department with photos of the cleanup.

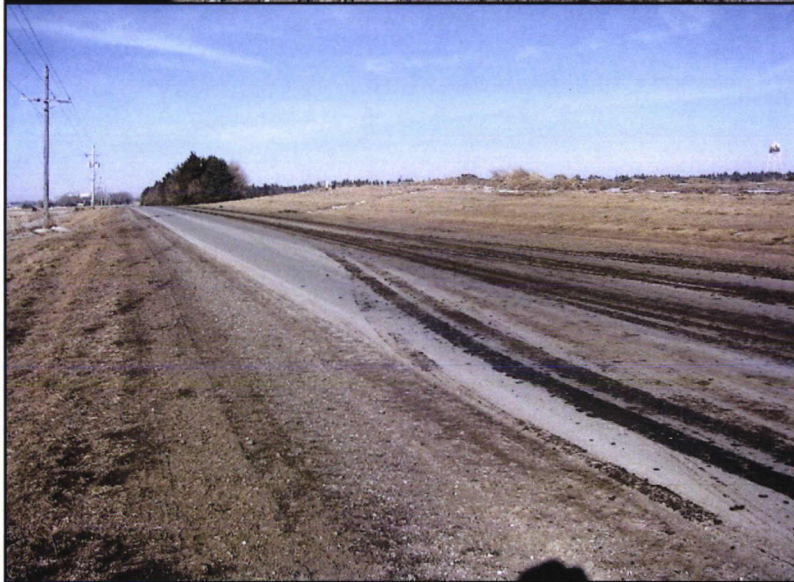
Photograph # 2
Date: 2/1/2019
Photographer: Dan LeMaistre
Camera: Sony Cyber-shot (DSC-W370)
Facility Name/ Project Name: AltEn LLC
Facility IIS number / Program ID:
IIS# 84069, NE0137634
Observation Point #: 2
Direction Facing: Northeast
Description: This is a photo of the track out heading north bound.

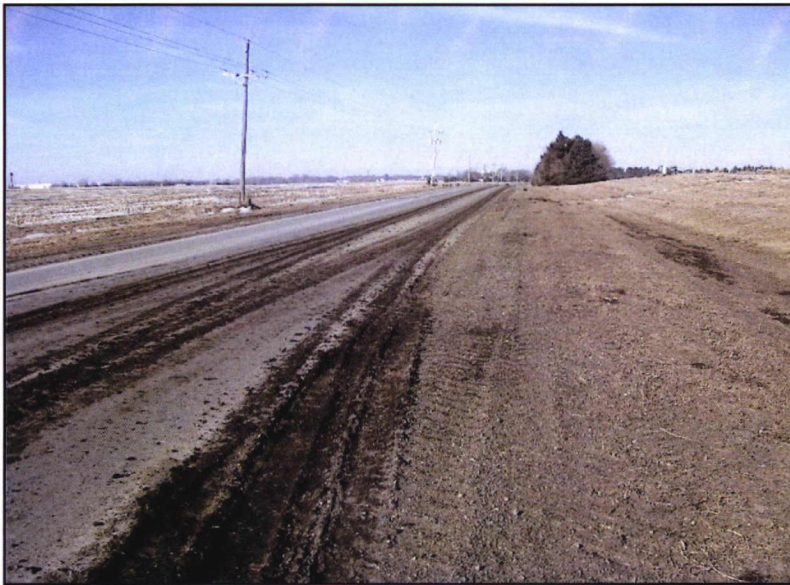
Photograph # 3
 Date: 2/1/2019
 Photographer: Mark Pomajzl
 Camera: Sony Cyber-shot (DSC-W370)
 Facility Name/ Project Name: AltEn LLC
 Facility IIS number / Program ID:
 IIS# 84069, NE0137634
 Observation Point #: 3
 Direction Facing: North
 Description: This looking directly north of
 the site along country road 10.

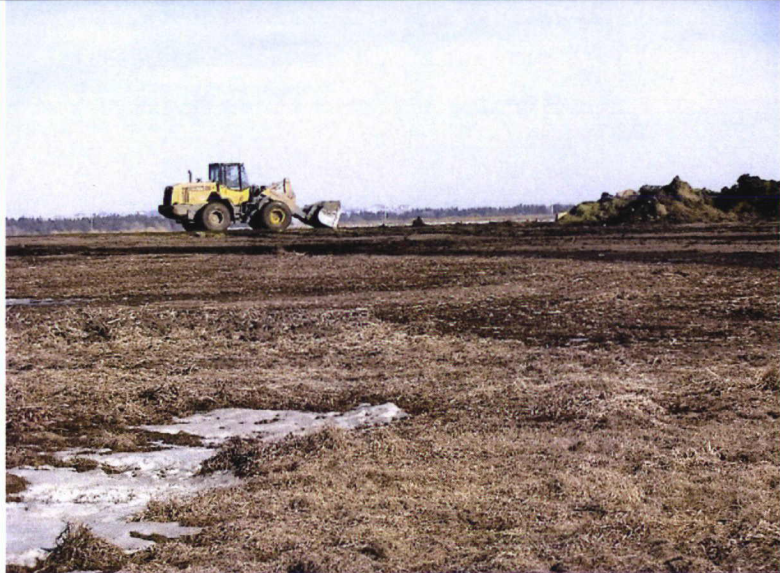
Photograph # 4
 Date: 2/1/2019
 Photographer: Mark Pomajzl
 Camera: Sony Cyber-shot (DSC-W370)
 Facility Name/ Project Name: AltEn LLC
 Facility IIS number / Program ID:
 IIS# 84069, NE0137634
 Observation Point #: 4
 Direction Facing: Northeast
 Description: Facility loading wet cake.

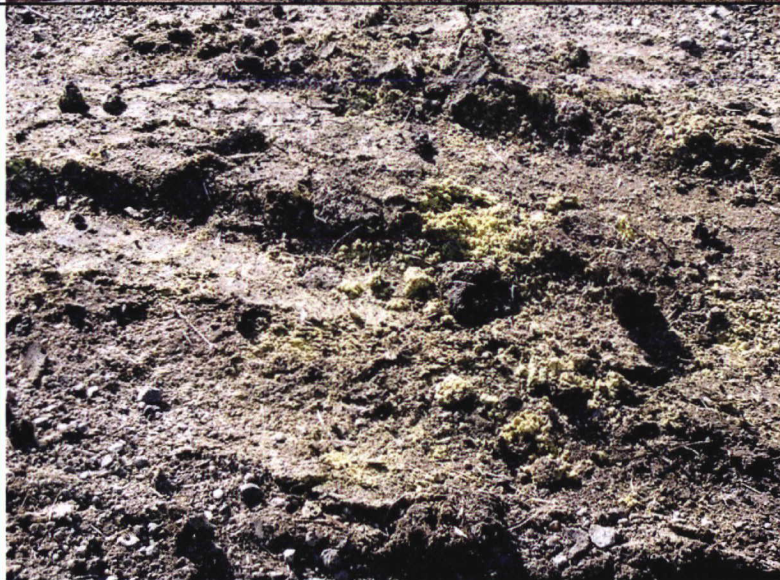
Photograph # 5
 Date: 2/1/2019
 Photographer: Mark Pomajzl
 Camera: Sony Cyber-shot (DSC-W370)
 Facility Name/ Project Name: AltEn LLC
 Facility IIS number / Program ID:
 IIS# 84069, NE0137634
 Observation Point #: 5
 Direction Facing: Northeast
 Description: Wet cake spilled onto the
 roadway.

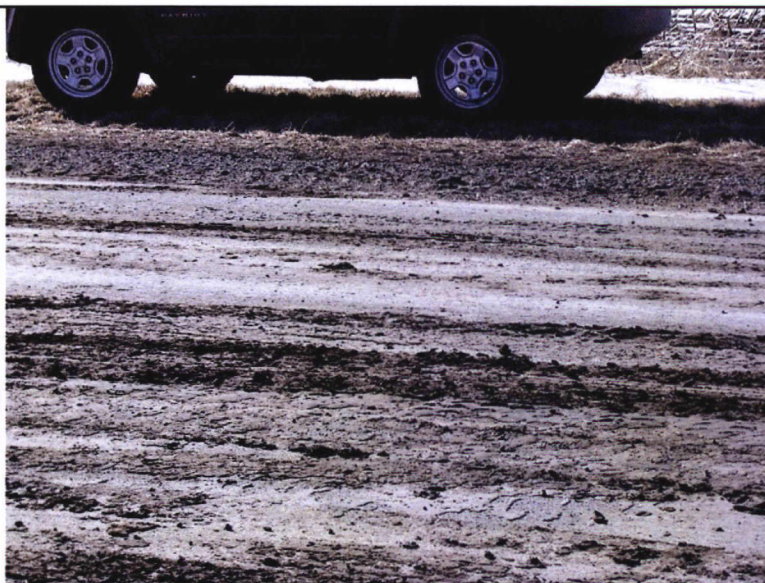
Photograph # 6
 Date: 2/1/2019
 Photographer: Mark Pomajzl
 Camera: Sony Cyber-shot (DSC-W370)
 Facility Name/ Project Name: AltEn LLC
 Facility IIS number / Program ID:
 IIS# 84069, NE0137634
 Observation Point #: 6
 Direction Facing: Northeast
 Description: This photo is facing west across the roadway. Mud and wet cake is matted right outside the entrance to the wet cake area.

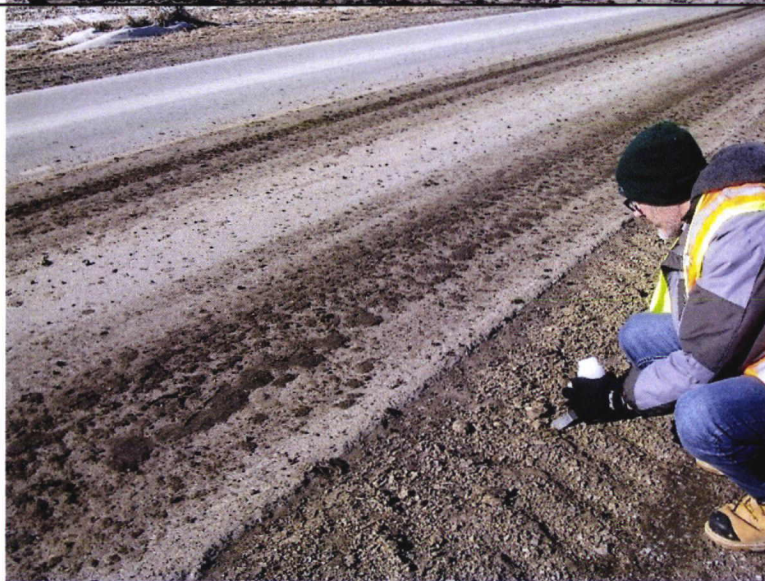
Photograph # 7
 Date: 2/1/2019
 Photographer: Mark Pomajzl
 Camera: Sony Cyber-shot (DSC-W370)
 Facility Name/ Project Name: AltEn LLC
 Facility IIS number / Program ID:
 IIS# 84069, NE0137634
 Observation Point #: 7
 Direction Facing: North
 Description: This is one of the samples collected along the roadway.

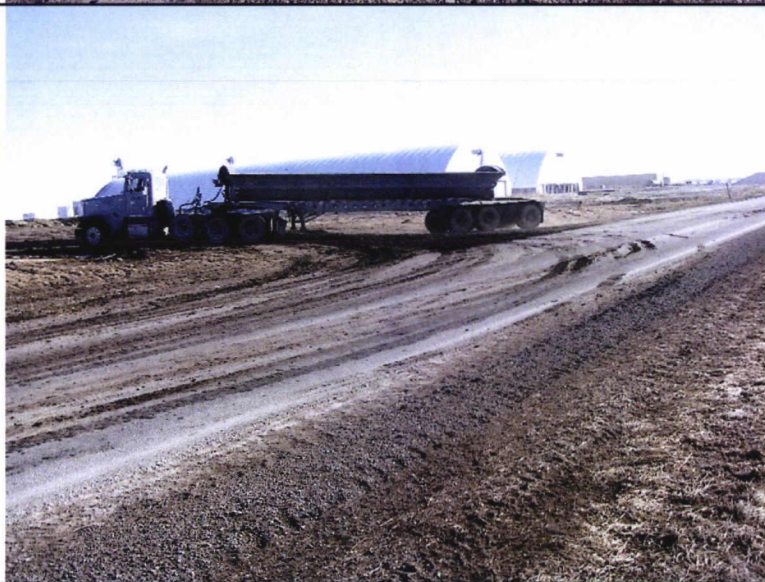
Photograph # 7
 Date: 2/1/2019
 Photographer: Mark Pomajzl
 Camera: Sony Cyber-shot (DSC-W370)
 Facility Name/ Project Name: AltEn LLC
 Facility IIS number / Program ID:
 IIS# 84069, NE0137634
 Observation Point #: 7
 Direction Facing: South
 Description: Side dumper trucks entering the facility.

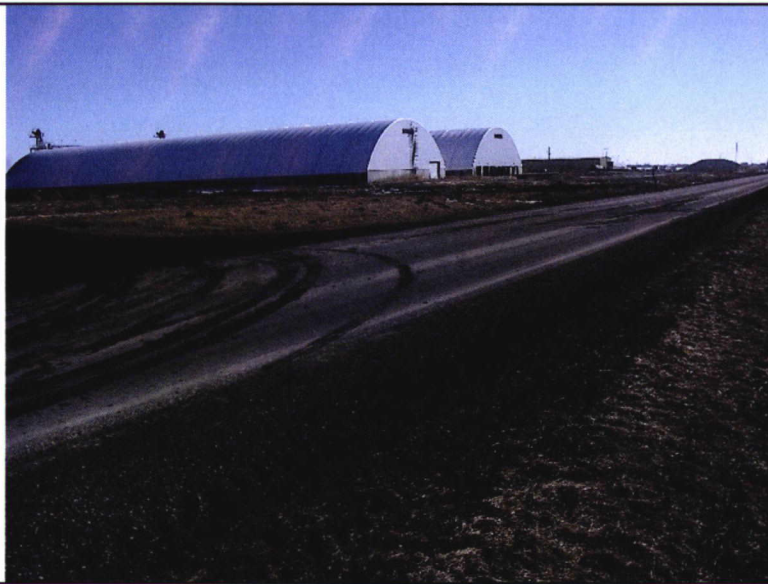
Photograph # 8
Date: 2/1/2019
Photographer: Mark Pomajzl
Camera: Sony Cyber-shot (DSC-W370)
Facility Name/ Project Name: AltEn LLC
Facility IIS number / Program ID:
IIS# 84069, NE0137634
Observation Point #: 8
Direction Facing: South
Description: More evidence of track out.

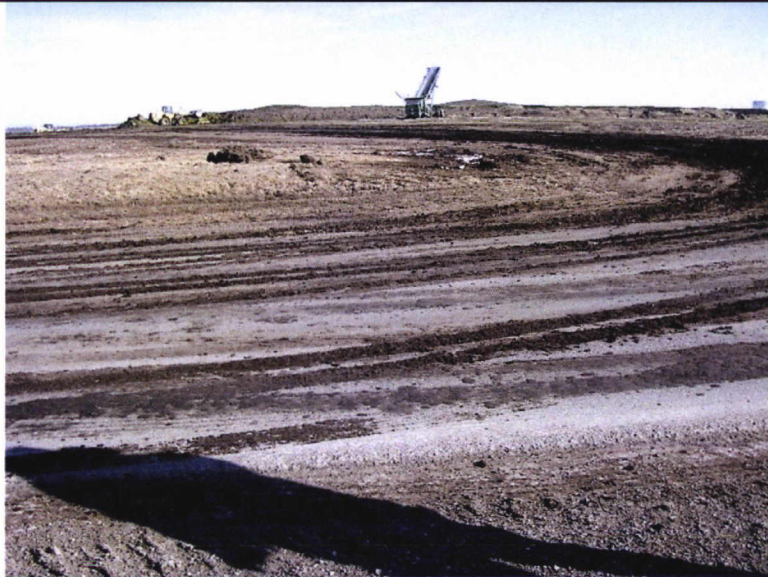
Photograph # 9
Date: 2/1/2019
Photographer: Mark Pomajzl
Camera: Sony Cyber-shot (DSC-W370)
Facility Name/ Project Name: AltEn LLC
Facility IIS number / Program ID:
IIS# 84069, NE0137634
Observation Point #: 9
Direction Facing: Southeast
Description: This photo documents the magnitude of the track out.
