INVESTIGATION REPORT

Report Date: 2/16/2021

Re: AltEn LLC-Mead

Topic: Release of Thin Stillage and Manure from Digester

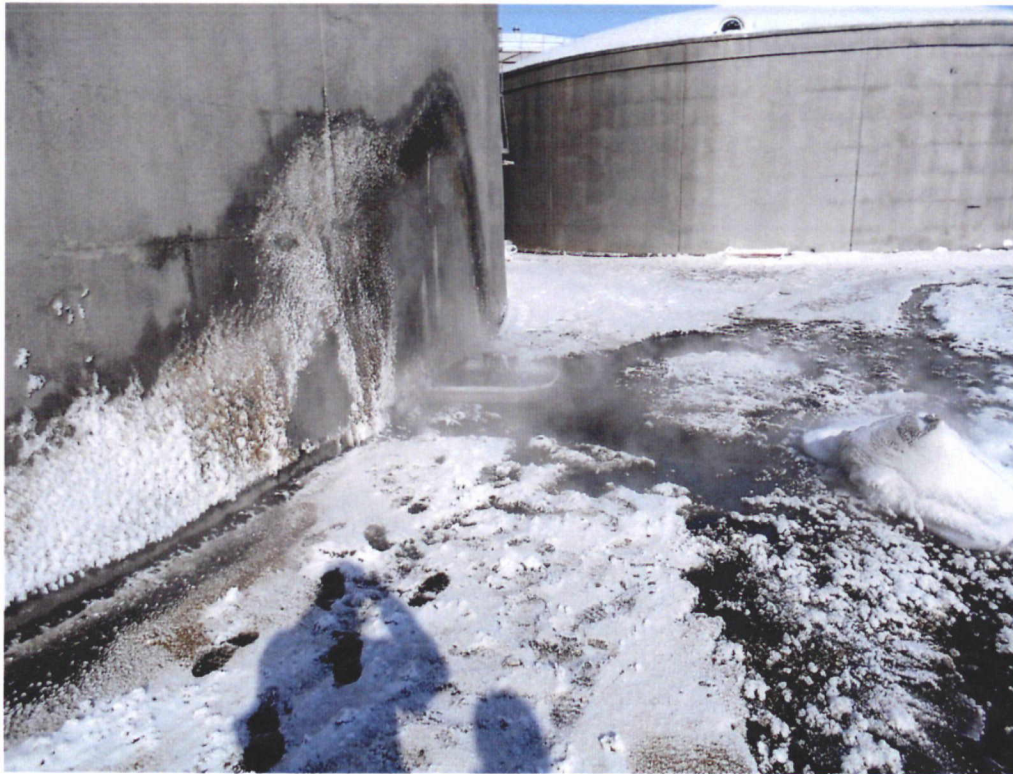
A digester containing thin stillage and cattle manure suffered a catastrophic failure due to a pipe connected to the floor of the digester bursting; reportedly due to freezing weather. An estimated

View north of piping vault where leak occurred

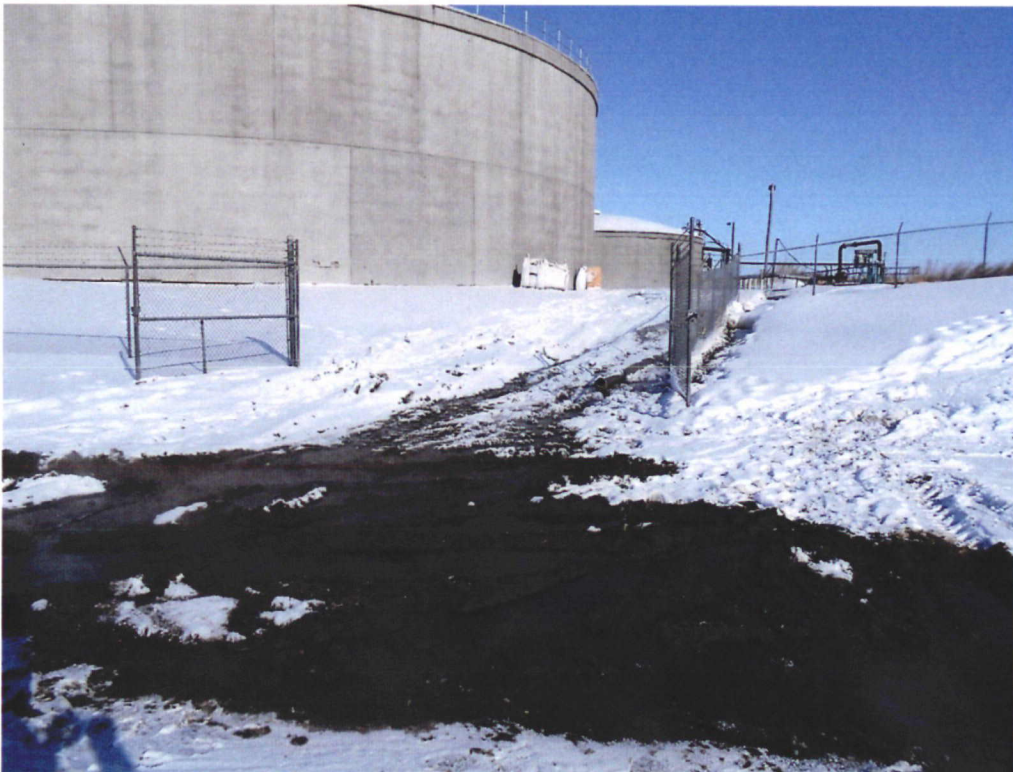
View north of digester where leak occurred

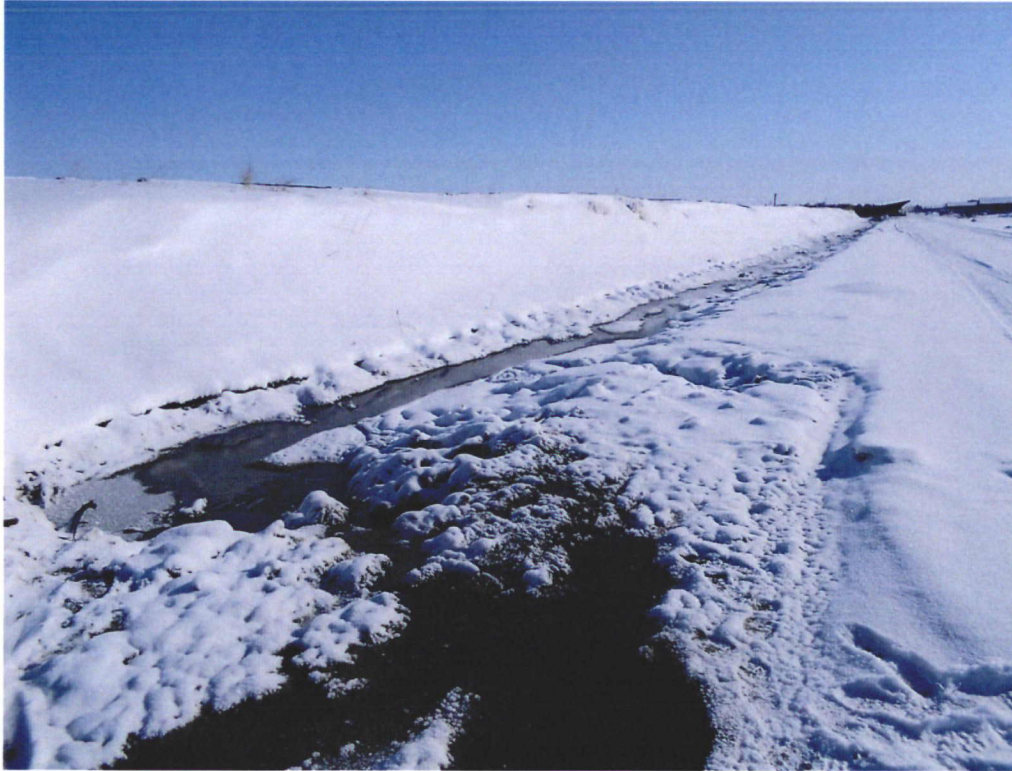
View east from near digester toward road ditch

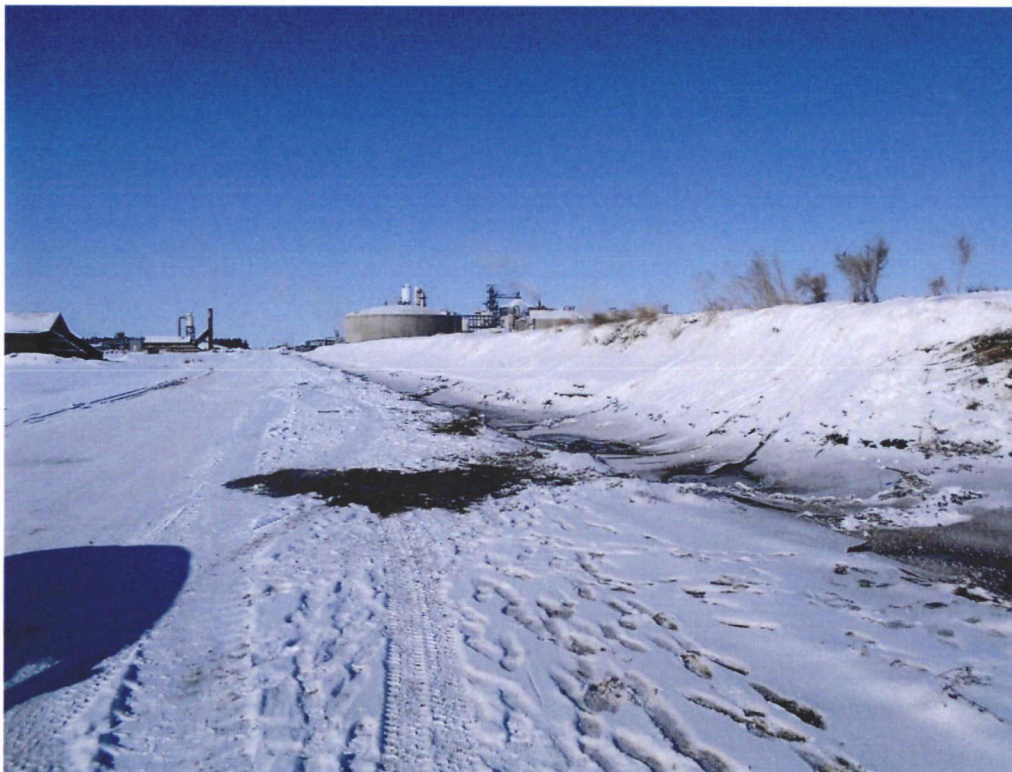
View west of road ditch with digester in background

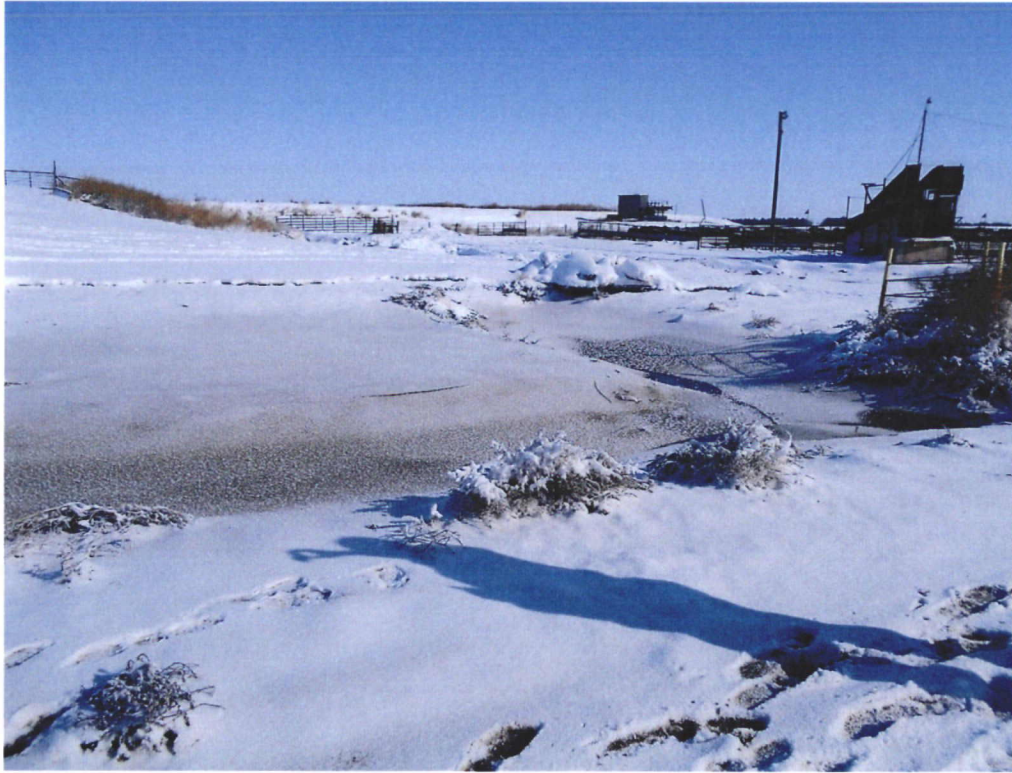
Mark and I drove east to a tee intersection at/adjacent to the Mead Cattle Company. Mark said the area had been inundated with liquid spilled from the digester during his visit on Friday. Mark said pumping equipment had been present at this location on Friday, however, none was present at this time. Fresh snowfall made it difficult to discern areas now covered with liquid spilled from the digester, but, Mark said it appeared that the liquid levels were lower compared to yesterday.

View NE of ditch near Mead Cattle Company

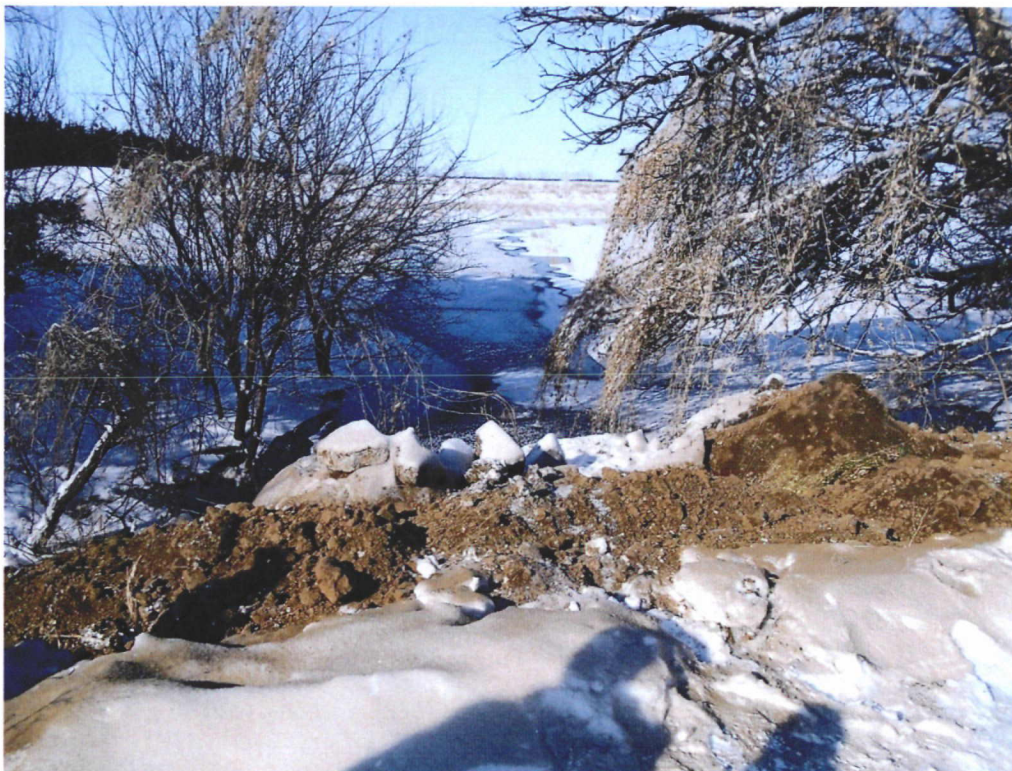
Mark and I proceeded to the area depicted as culvert A on the attached Google Earth image. We encountered two AltEn staff, including Mr. Egr, in a pickup truck at that location. Mr. Egr informed us that AltEn was attempting to seal an improvised dam, constructed on Friday, with earth. The dam, built on the upstream side of a culvert under the roadway, appeared to be built with plastic

sheeting, large round hay bales, concrete rip-rap, and earth. Mr. Egr said a contractor was en route from Kansas with pumps/piping that would capture and transmit the spilled liquid from upstream of this dam back to the AltEn lagoon. Significant flow of liquid was apparent on the downstream side of the culvert. A payload arrived a short while later with a load of dirt and placed the dirt on the dam. We asked Mr. Egr if the digester that had leaked liquid was empty. Mr. Egr estimated only about 1 foot of liquid remained in the digester. We asked Mr. Egr if the second digester (similar in capacity to the one that suffered a release) contained liquid. Mr. Egr said it did. We asked what, if any, precautions had AltEn taken to protect the piping on the second digester at the facility from suffering a similar release. Mr. Egr said insulation had been placed over the subgrade vault where the vulnerable piping is located. Mr. Egr said a heat lamp had been placed in the vault under the insulation to prevent freezing of the piping. Mark informed Mr. Egr of our plan to inspect the spill area and provided to him an Inspection and Assistance Exit Summary (copy attached).

four million gallons of liquid was released to the land surface. The spilled liquid flowed into a ditch and travelled approximately three miles from the source at the time of our response. A dam constructed some time Friday, was ineffective at stopping the flow of spilled liquid. It is not known if the lack of effectiveness of the dam was due to poor construction or failure of the dam due to build-up of hydrostatic pressure.

View WNW of dam upstream of culvert A

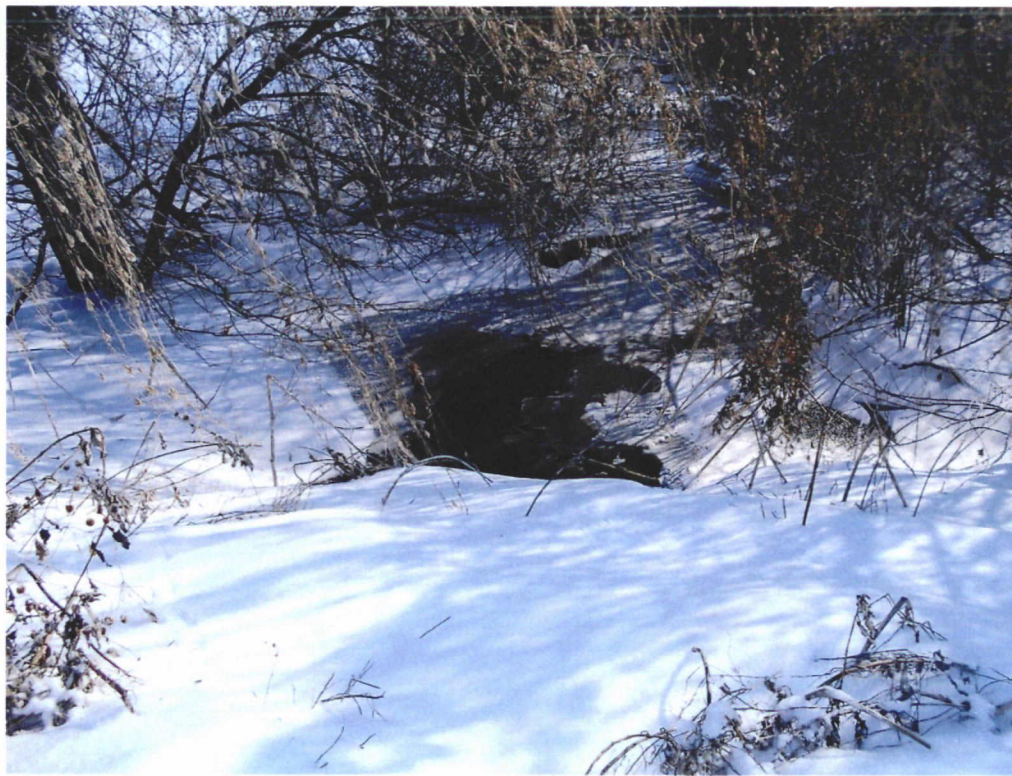
View east of ditch downstream from culvert A

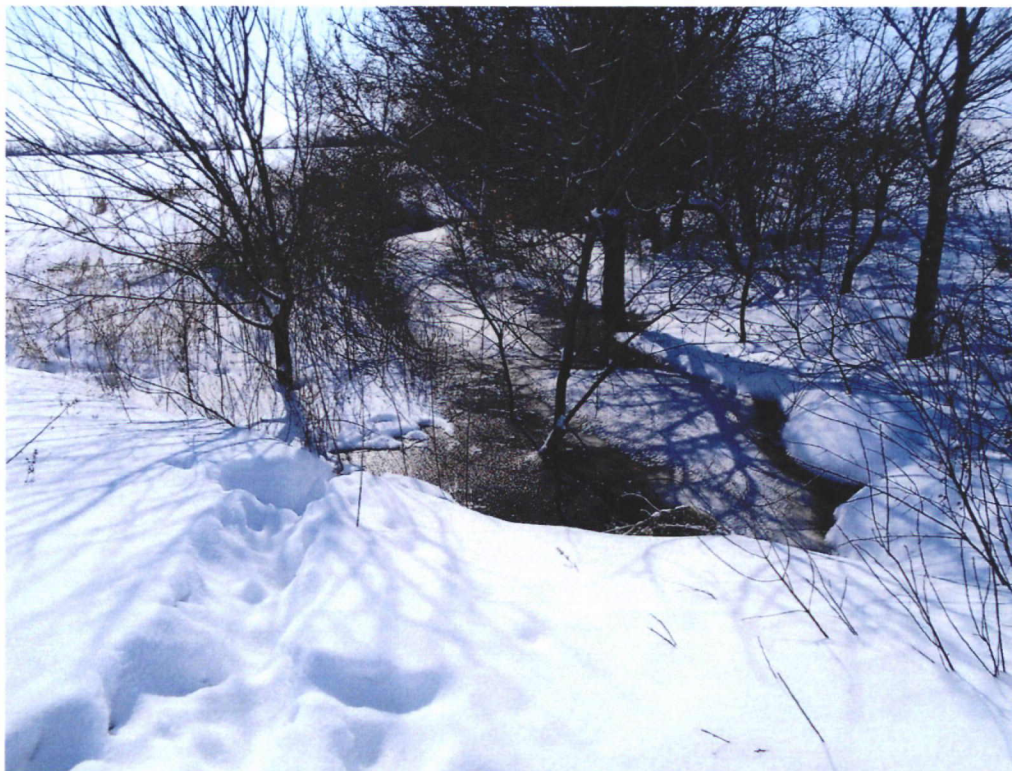
Mark and I proceeded to the next downstream location, depicted as culvert B on the attached Google Earth image, where the ditch intersected with a roadway. We observed liquid flowing through the culvert (see attached photos). Based upon the cold temperatures that we presume would have frozen any pre-existing water and the odor associated with the flowing liquid we observed, that the flowing liquid was likely what had spilled from the digester.

View north of ditch upstream from culvert B

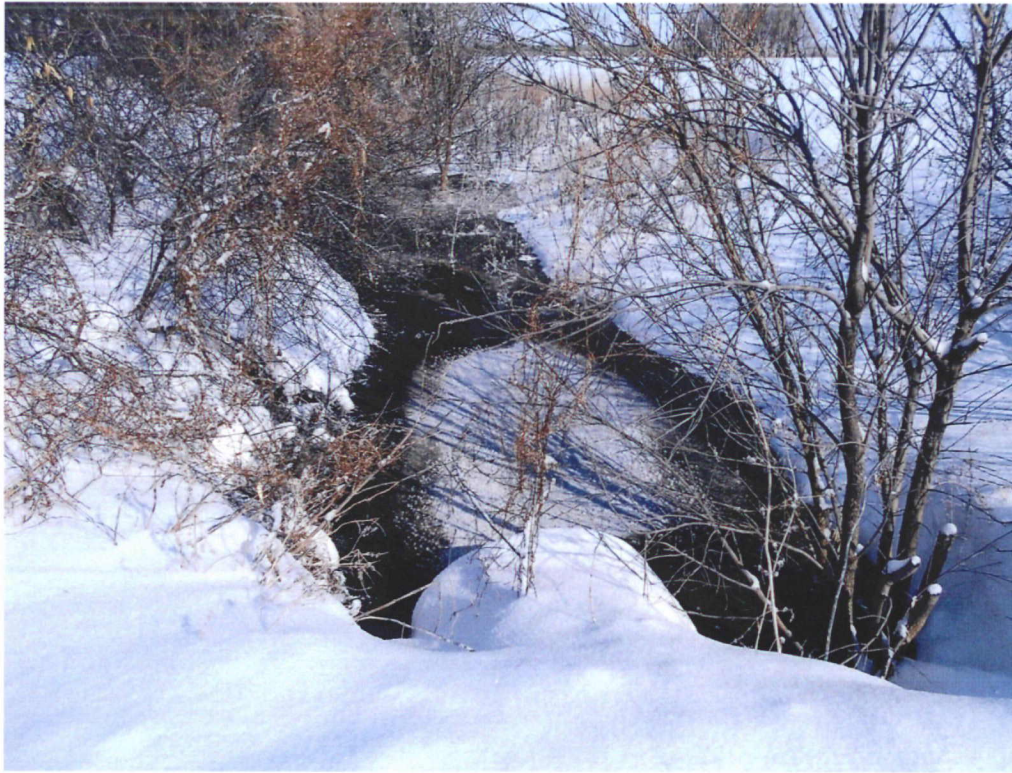
View south of ditch downstream of culvert B

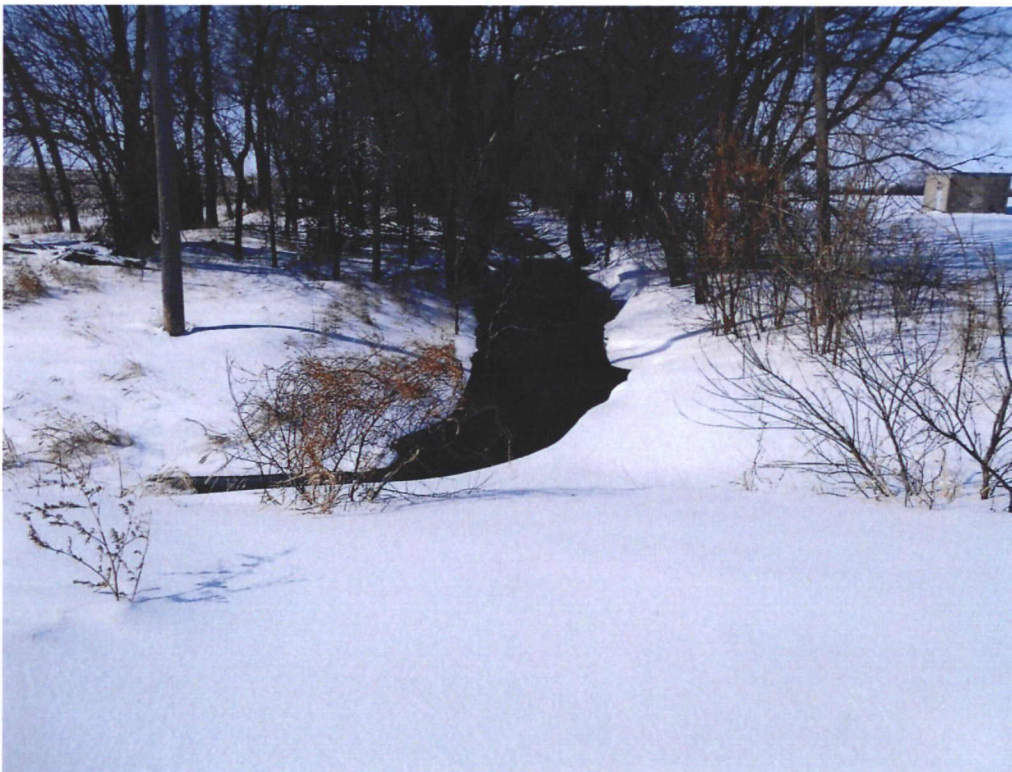
Mark and I proceeded to the location depicted as culvert C on the attached Google Earth image. We observed liquid flowing through the culvert (see attached photos). We proceeded to the location depicted as culvert D on the attached Google Earth image. We observed an inch or two of liquid on top of existing ice and within the snow cover (see attached photos). There was no obvious flow of this liquid. The liquid did exhibit an odor similar to the liquid spilled from the digester.

View north of ditch upstream from culvert C

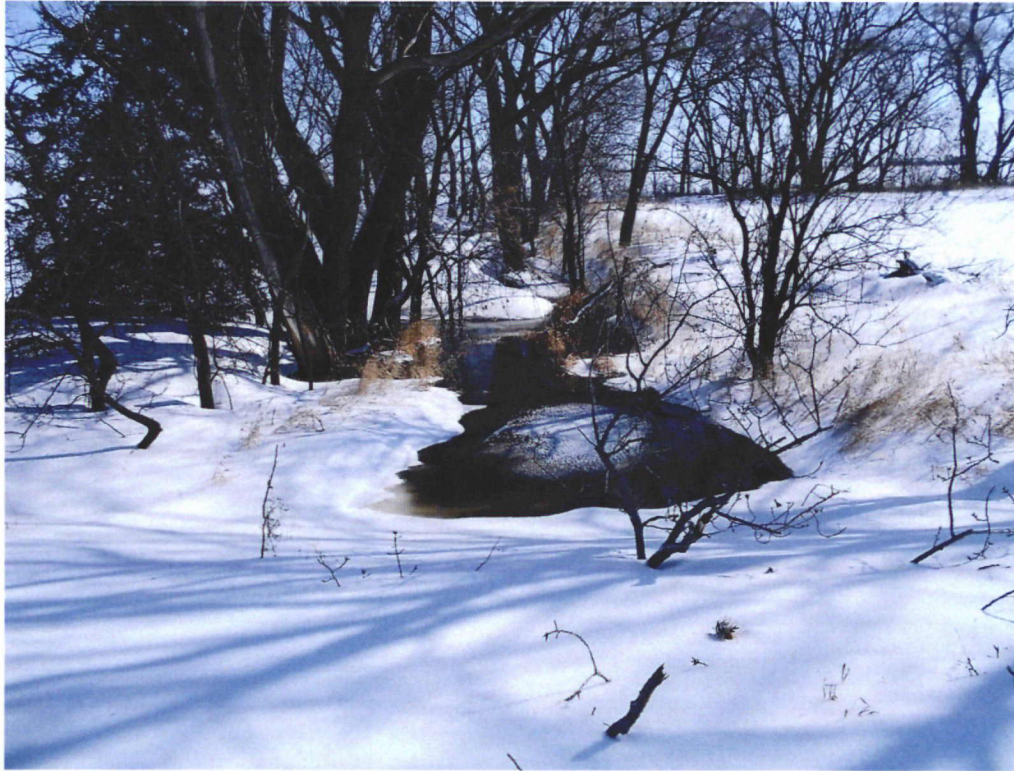
View south of ditch downstream from culvert C

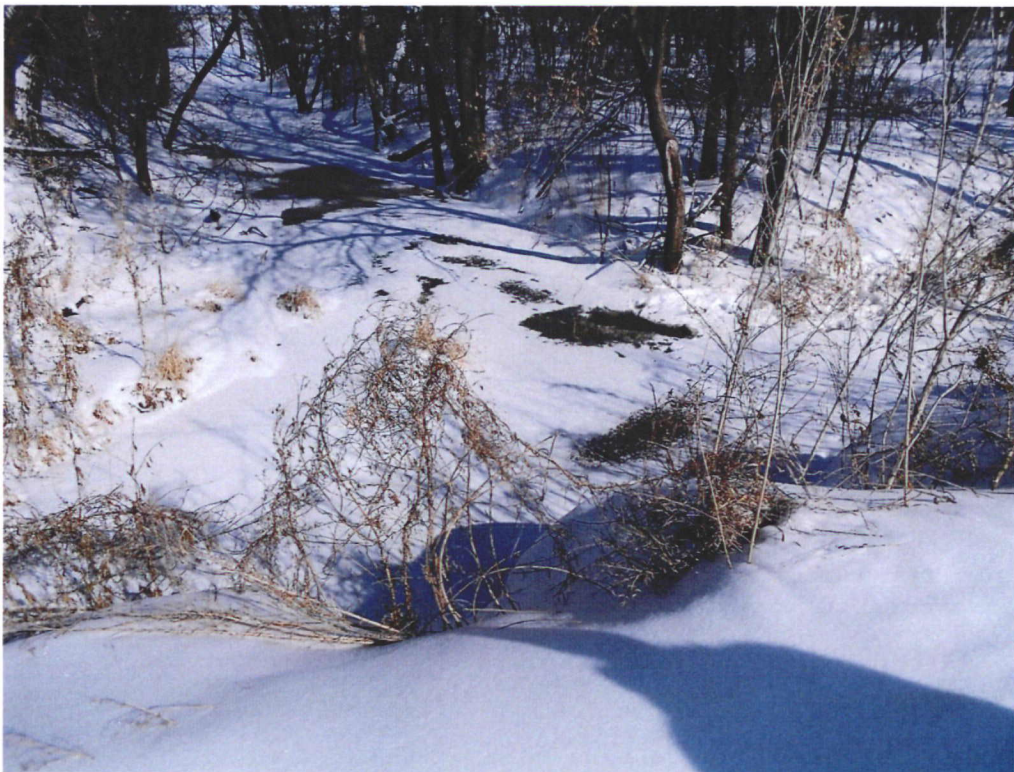
View north of ditch upstream from culvert D

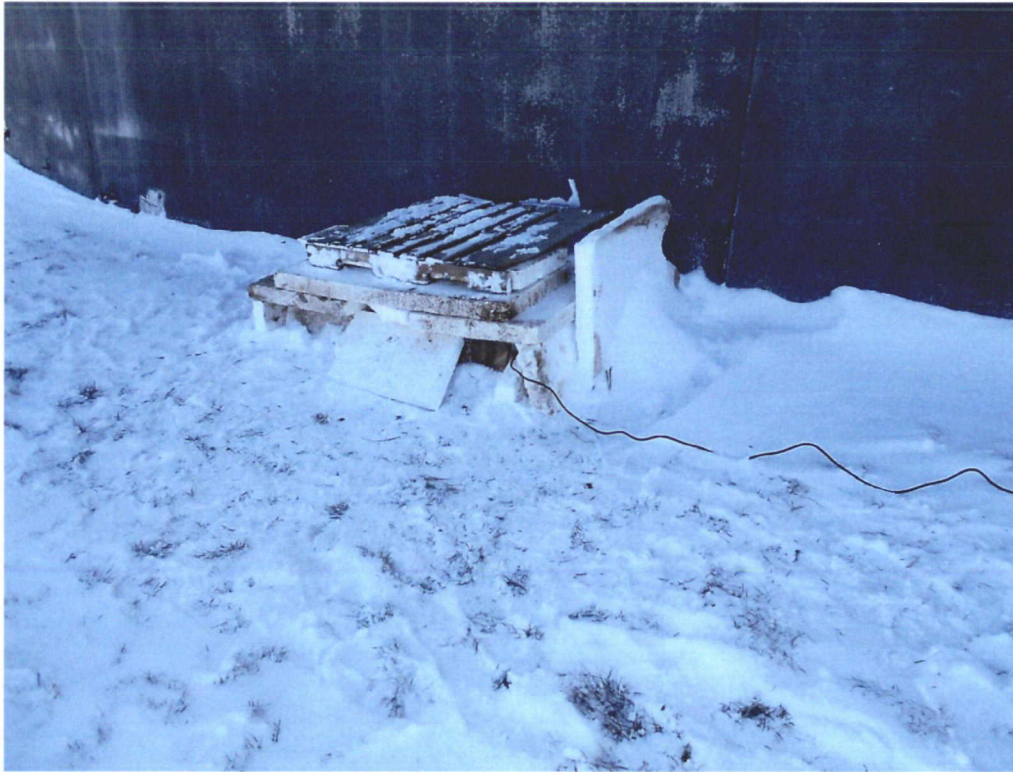
We returned to the AltEn facility to examine the digester that had not suffered a release. We observed a pile of Styrofoam insulation panels we presumed were covering the piping vault (see attached photo). We observed electrical wiring leading under the pile of insulation and presumed that to be for the heat lamp mentioned by Mr. Egr. We observed on the south side of the digester that had not suffered a leak a column of ice surrounded by caution tape (see attached photo). We could see a fitting above the column of ice actively releasing a liquid (which appeared to be freezing and creating the column of ice). We presumed this liquid was thin stillage and manure being released from the full or nearly full digester.

Insulation over piping vault on digester without leak

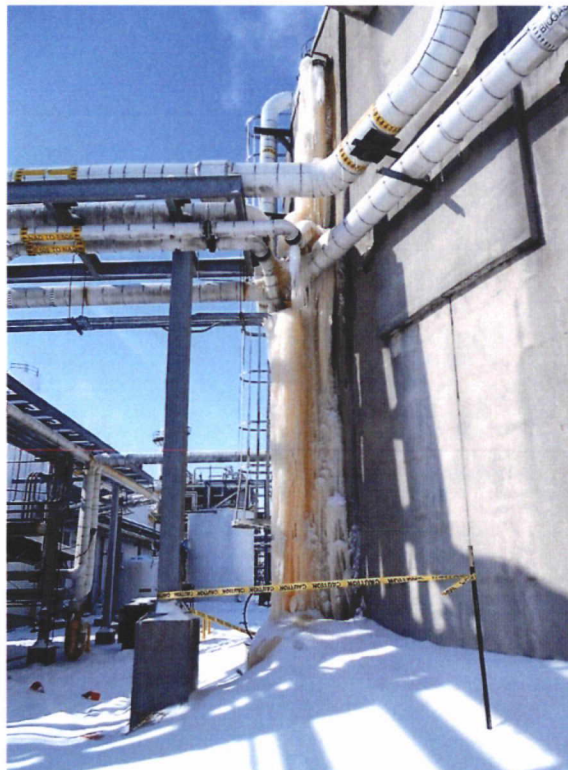
Spilling and leaking liquid from digester without leak
