INVESTIGATION REPORT

Report Date: 2/17/2021

Re: AltEn LLC-Mead

Topic: Release of Thin Stillage and Manure from Digester

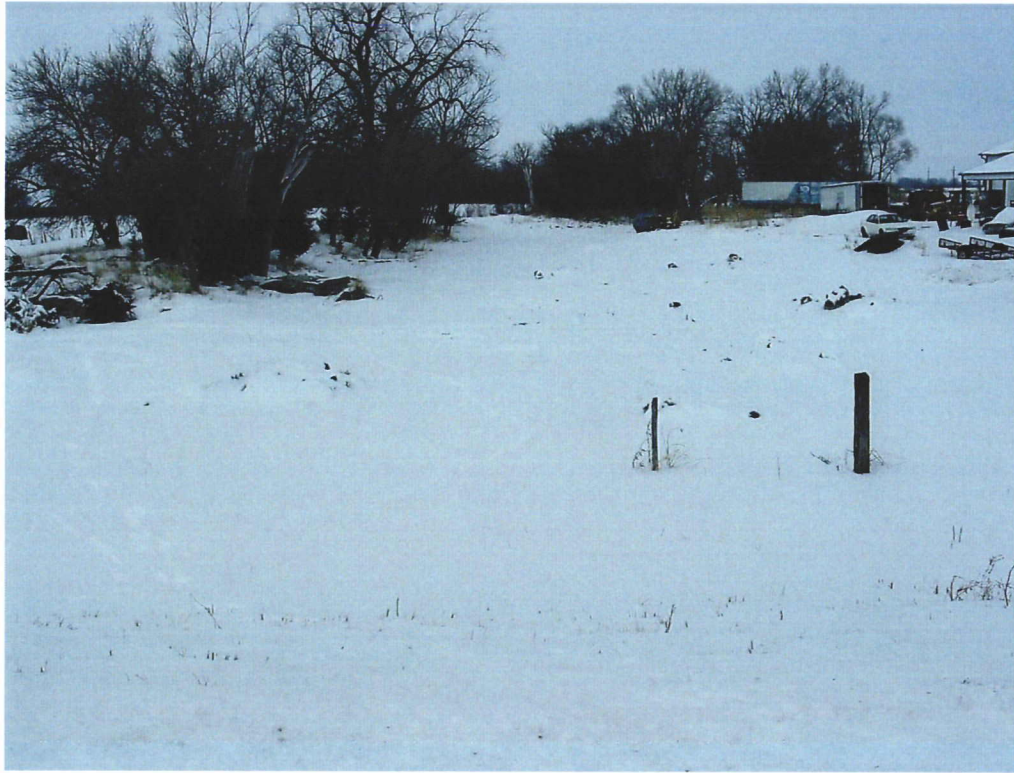
NDEE representative Kirk Morrow had provided to me a map with six pre-determined locations I was to visit (see attached Google Earth images with locations). I arrived at Stop #1 at about 1449 hours. Stop #1 is along a paved road just east of the Ashland Gun Club. I did not observe any obvious evidence such as free-flowing liquid, brown-colored ice, melted snow, or odor that would suggest the material spilled from the digester at AltEn had reached this location (see attached photo).

View north of ditch upstream from Stop #1

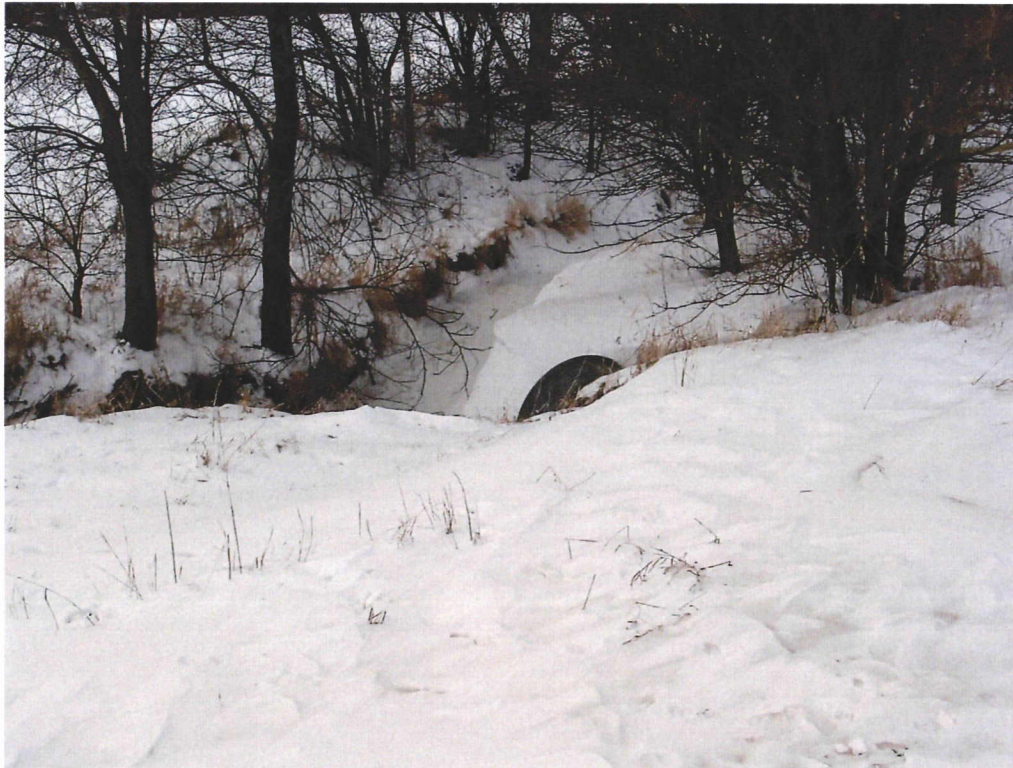
I proceeded to Stop #2. Stop #2 is located a short distance north of the intersection of road 6 and road F. I did not see any evidence that the spilled material had reached this location (see attached photos). All liquid in the ditch appeared frozen and there was no flow through the culvert.

View west of ditch upstream from Stop #2

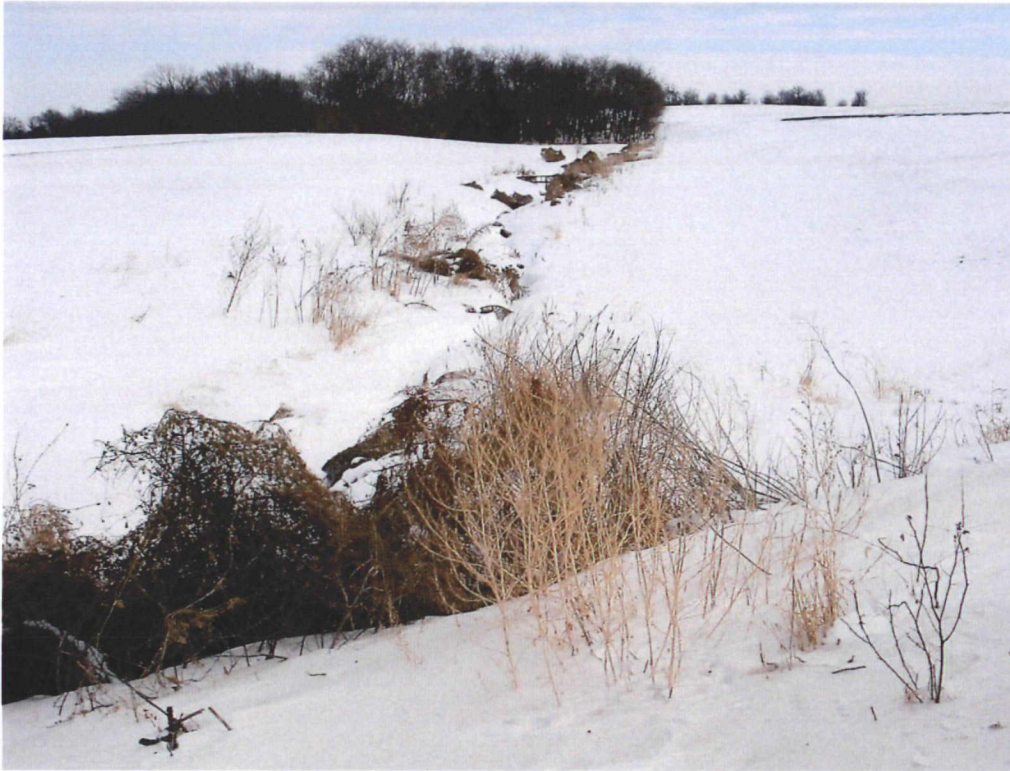
View east of ditch downstream from Stop #2

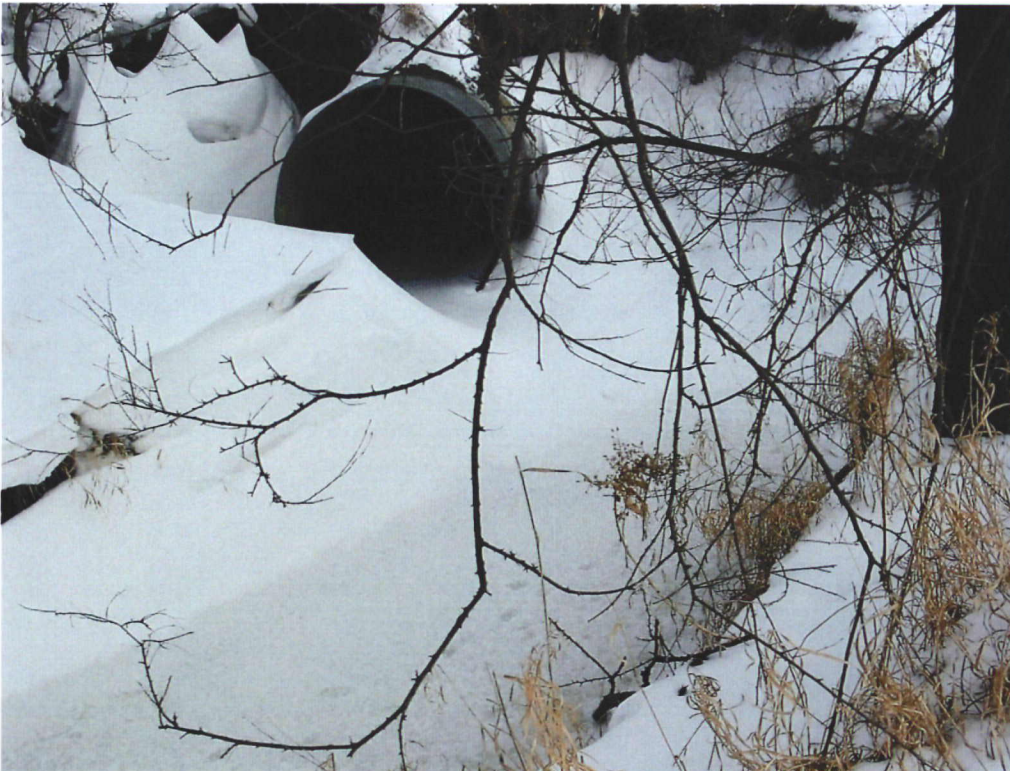
View east of upstream culvert inlet at Stop #2

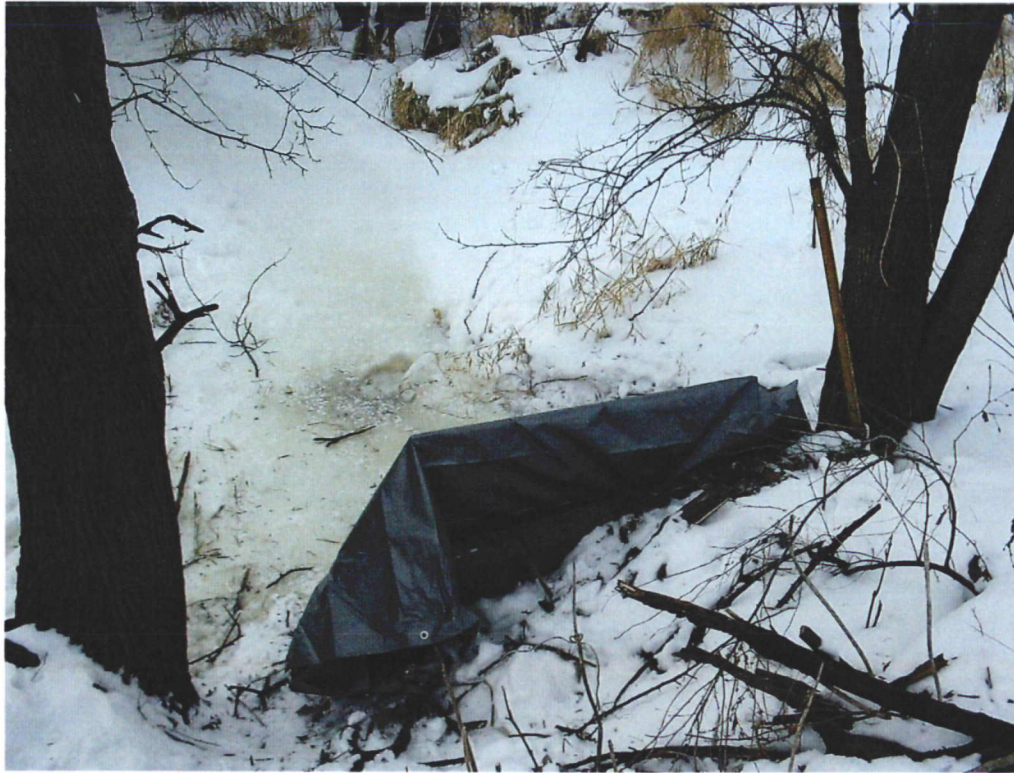
I proceeded to Stop #3. Stop #3 is located on road 7 about 1/2 mile north of road F. The surface of the liquid in the ditch at Stop #3 was frozen. I did not attempt to break through the ice to determine if there was unfrozen liquid below the ice. The ice had slight yellow/tan coloration. I observed plywood (or similar) wrapped with a tarp covering the inlet of the culvert. There were several sandbags placed at the base of the plywood/tarp to hold it in place (see attached photos). I dug through the snow at the downstream outlet of the culvert and found only ice. I did not attempt to break through the ice at the culvert outlet to look for unfrozen liquid.

View west of ditch upstream from Stop #3

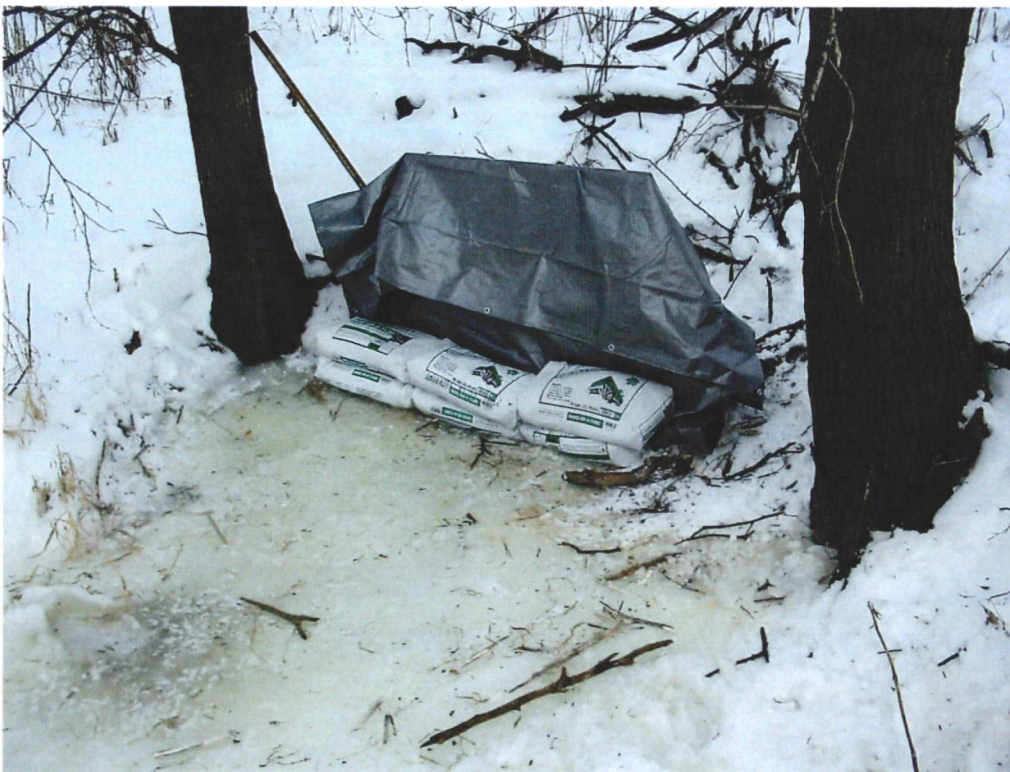
Containment structure in culvert inlet at Stop #3

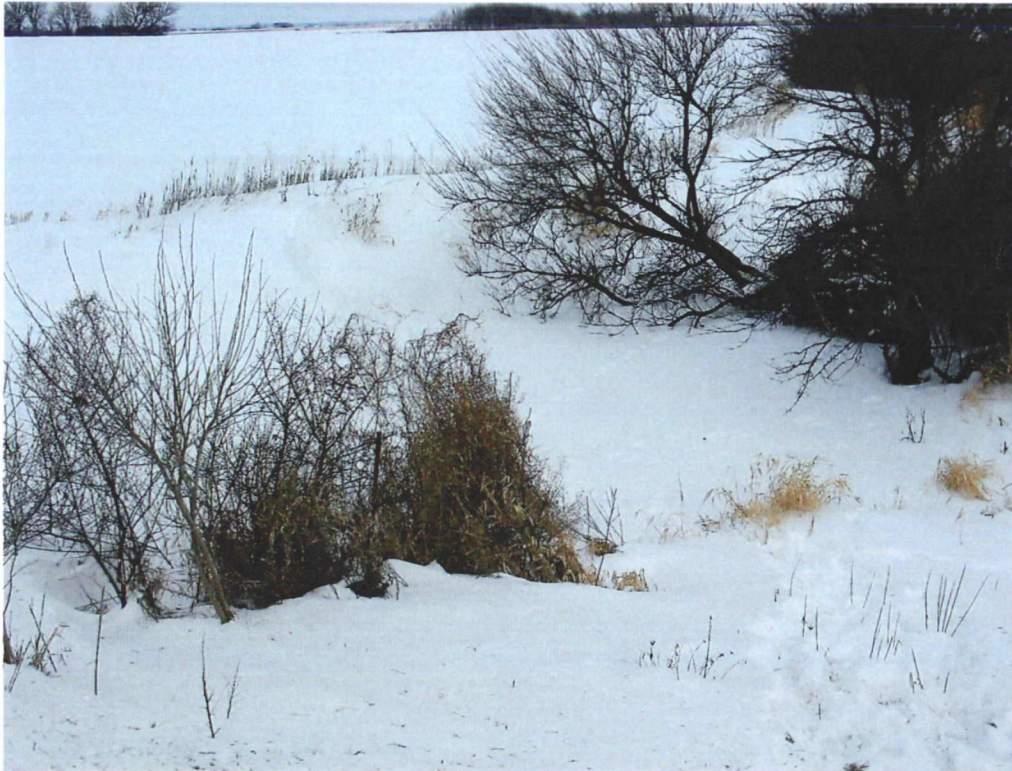
View east of ditch downstream from Stop #3

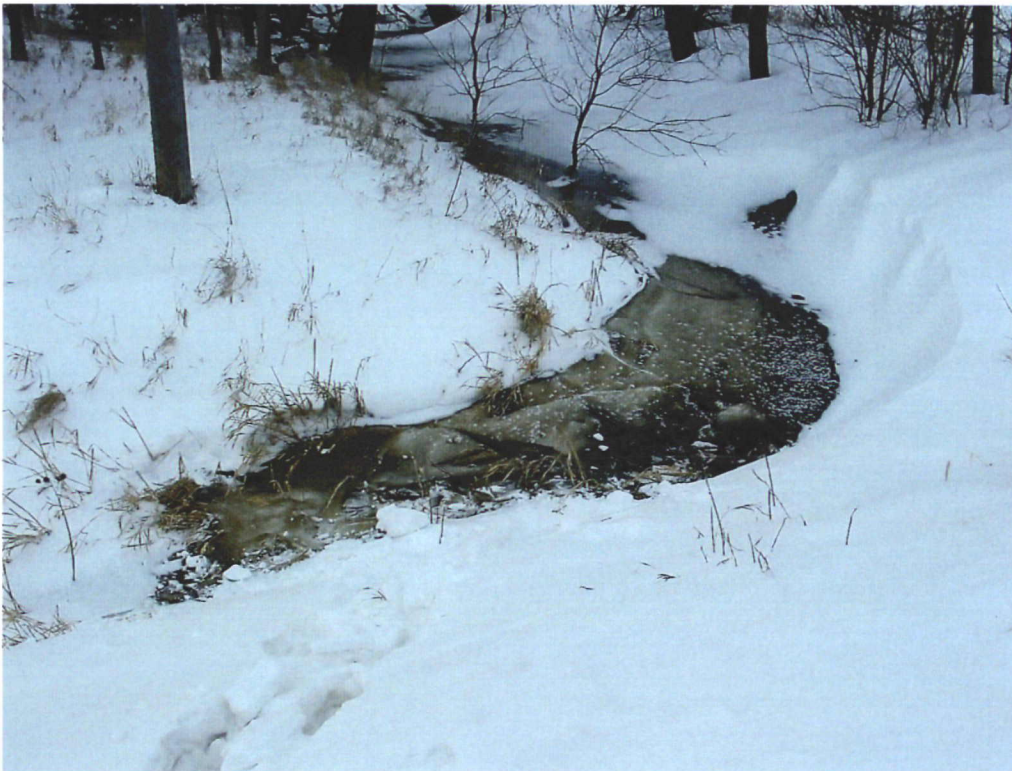
I proceeded to Stop #4. Stop #4 is located on road 8 about 1/2 mile north of road H. I observed brown-colored ice both upstream and downstream from Stop #4. Upstream from Stop #4, the ice was broken in many pieces as if it froze and the liquid below drained away (see attached photos).

View west of ditch upstream from Stop #4

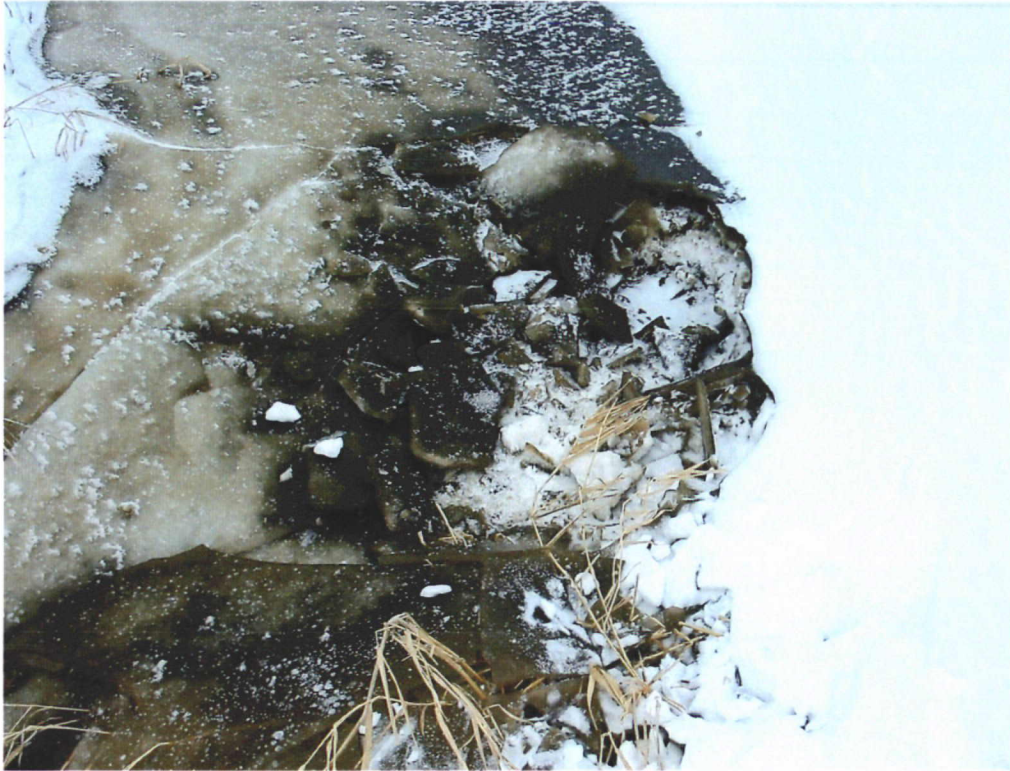
Broken crust of ice at culvert inlet at Stop #4

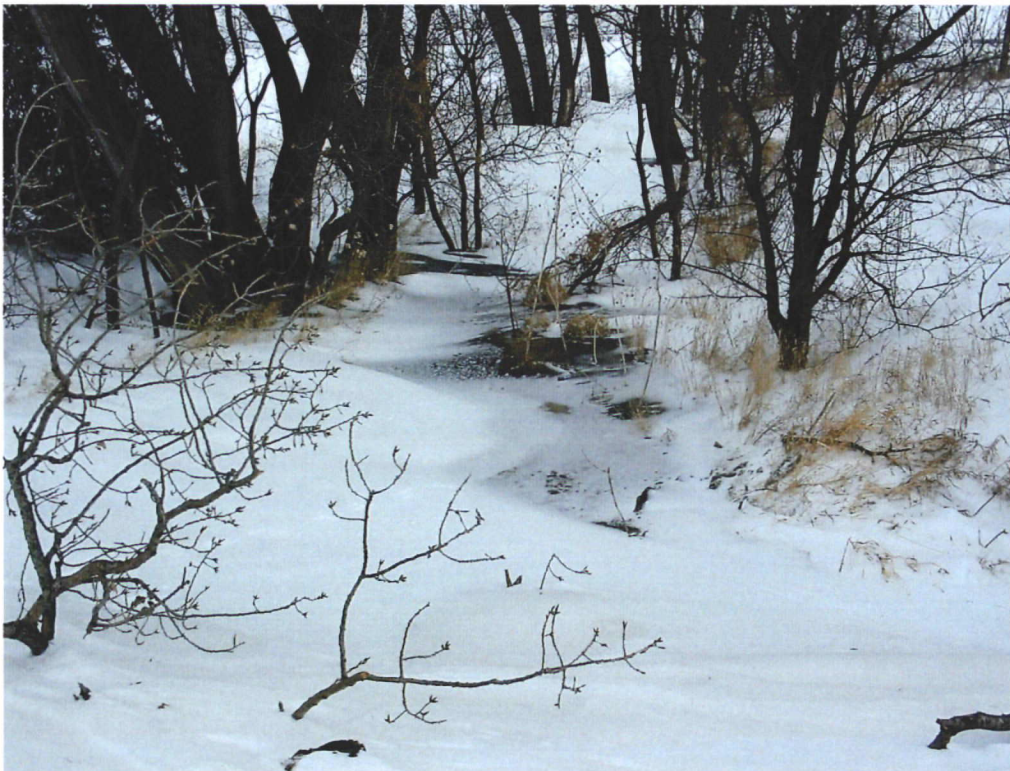
View east of ditch downstream from Stop #4

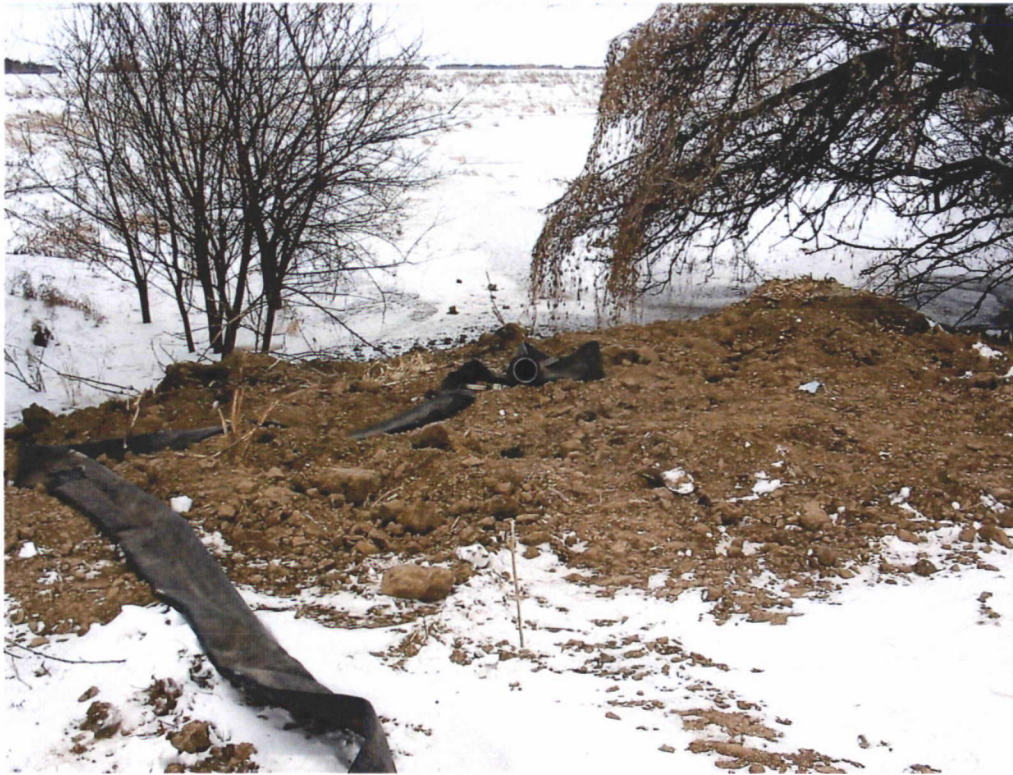
I proceeded to Stop #5. Stop #5 is located on a closed road (road 9) a short distance north of road J. I observed an earthen dam upstream from Stop #5. I did not see the hay bales or concrete rip-

rap I had observed at this location on February 13th. It is unknown if the bales and concrete were removed, or simply covered with earth. The volume of earth present was significantly greater than the volume of earth I had observed on the 13th. I observed brown ice both upstream and downstream of Stop #5. I made no attempt to break through the ice to determine if flowing liquid was present below the ice. I observed flexible piping laid out near Stop #5 and extending some distance to the north (see attached photos).

View west of dam upstream of Stop #5

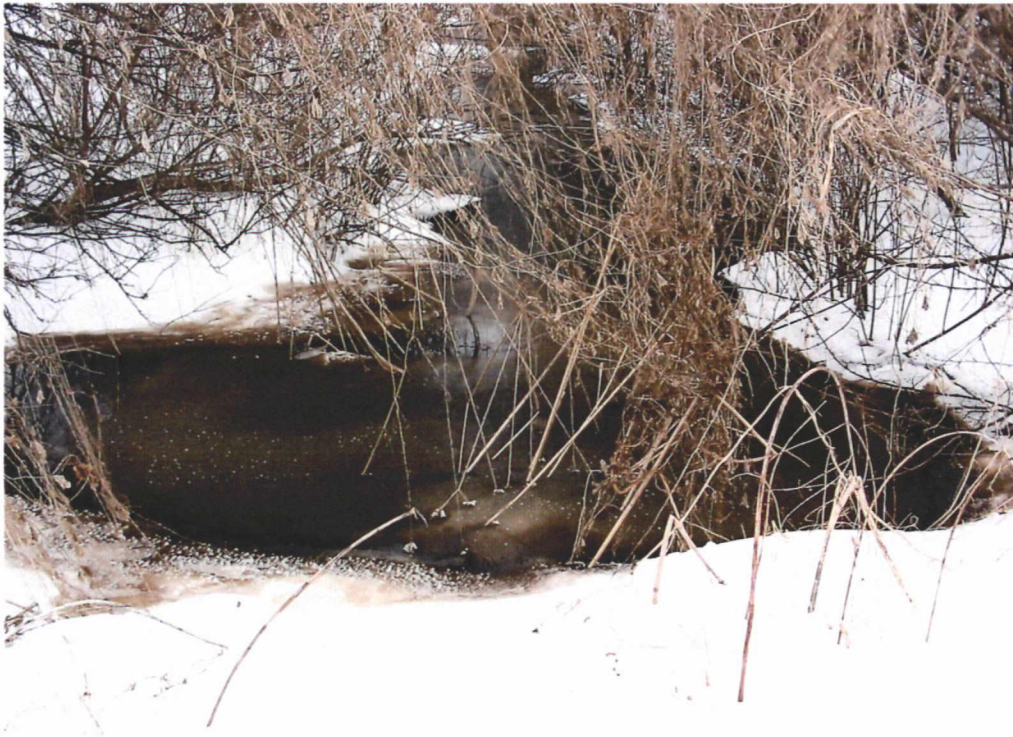
View east of ditch downstream from Stop #5

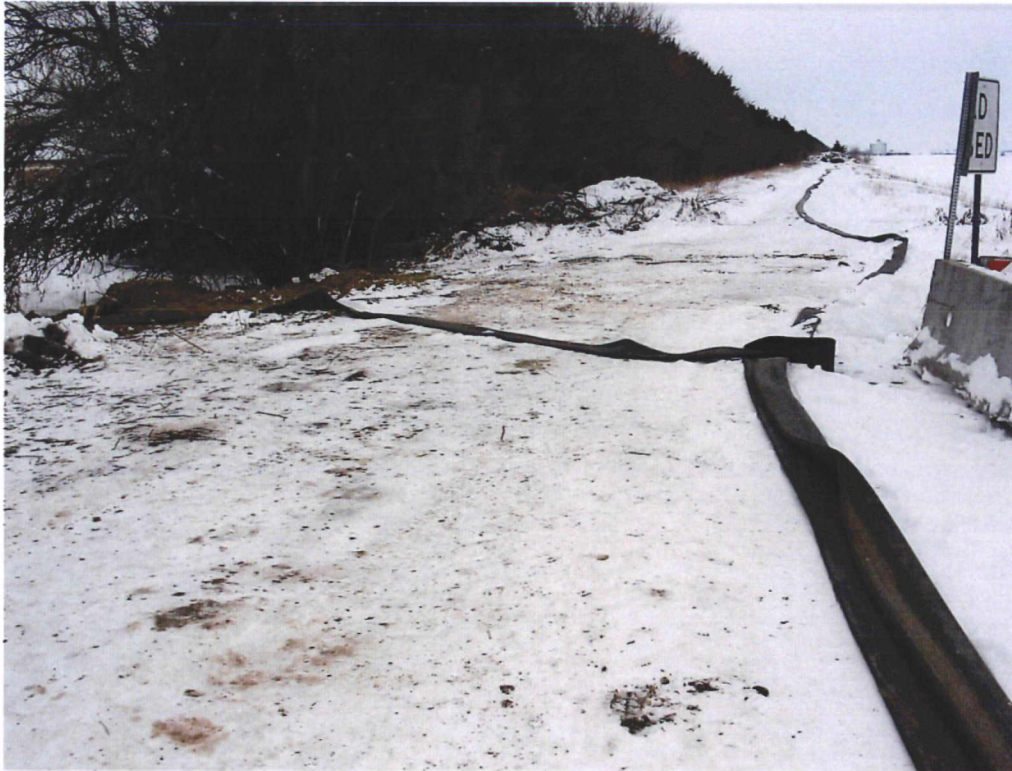
View north of piping laid out at Stop #5

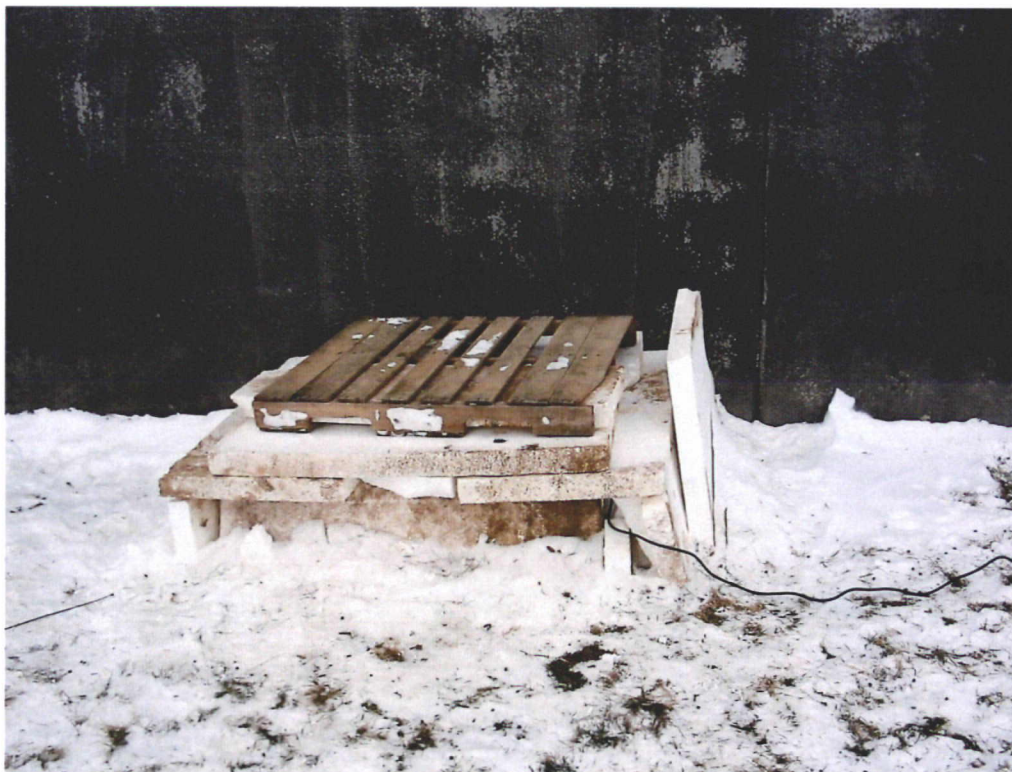
I proceeded to the AltEn administrative office to request permission to visit Stop #6; the AltEn digester which had not suffered a release. Mr. Ken Peterson, Plant Manager, greeted me at the office and accompanied me to the digester. I did not attempt to view the digester that had already suffered a release as it is my understanding the complete contents of the digester had already been lost. I only viewed the digester that had not yet suffered a release. I saw no evidence of a release from this digester. Mr. Peterson showed me the insulation placed over the piping vault on this digester. Mr. Peterson said a trouble light with a 75 watt bulb was placed in the vault below the insulation to provide warmth to the piping. Mr. Peterson said AltEn employees inspect the digester hourly to ensure no leak occurs.

Insulation over piping well on digester w/out leak
