NOTIFICATION OF ENVIRONMENTAL CONCERN (NOEC) INVESTIGATION REPORT

NOTIFICATION NUMBER 021221-NH-0845				NDEQ ID / Program ID 84069	
INSPECTOR Mark Pomajzl					
INSPECTION DATE 2-14-2021	TIME/ARRIVAL 10:00am	TIME/DEPARTURE 10:30am	WEATHER Clear		TEMP 2F
PROBLEM LOCATION			<input checked="" type="checkbox"/> Same as NEC Problem Location		
NAME Scott Tingelhoff				PROGRAM ID # 84069	
POSITION/TITLE General Manager					
BUSINESS NAME AltEn, LLC					
ADDRESS 1344 County Road 10		CITY Mead	COUNTY Saunders	STATE NE	ZIP CODE 68041
QUARTER N1/2, SW1/4	SECTION 12	TOWNSHIP N 14		RANGE E 8	
DIRECTIONS TO SITE From Airport, Highway 92/77 (Rd M) -3E, Rd 13-0.75, W Side		LATITUDE 41.19714		LONGITUDE -96.48081	
RESPONSIBLE PARTY			<input checked="" type="checkbox"/> Same as NEC Responsible Party		
NAME Scott Tingelhoff				PROGRAM ID # 84069	
POSITION/TITLE General Manager					
BUSINESS NAME AltEn, LLC					
ADDRESS 1344 County Road 10		CITY Mead	COUNTY Saunders	STATE NE	ZIP CODE 68041

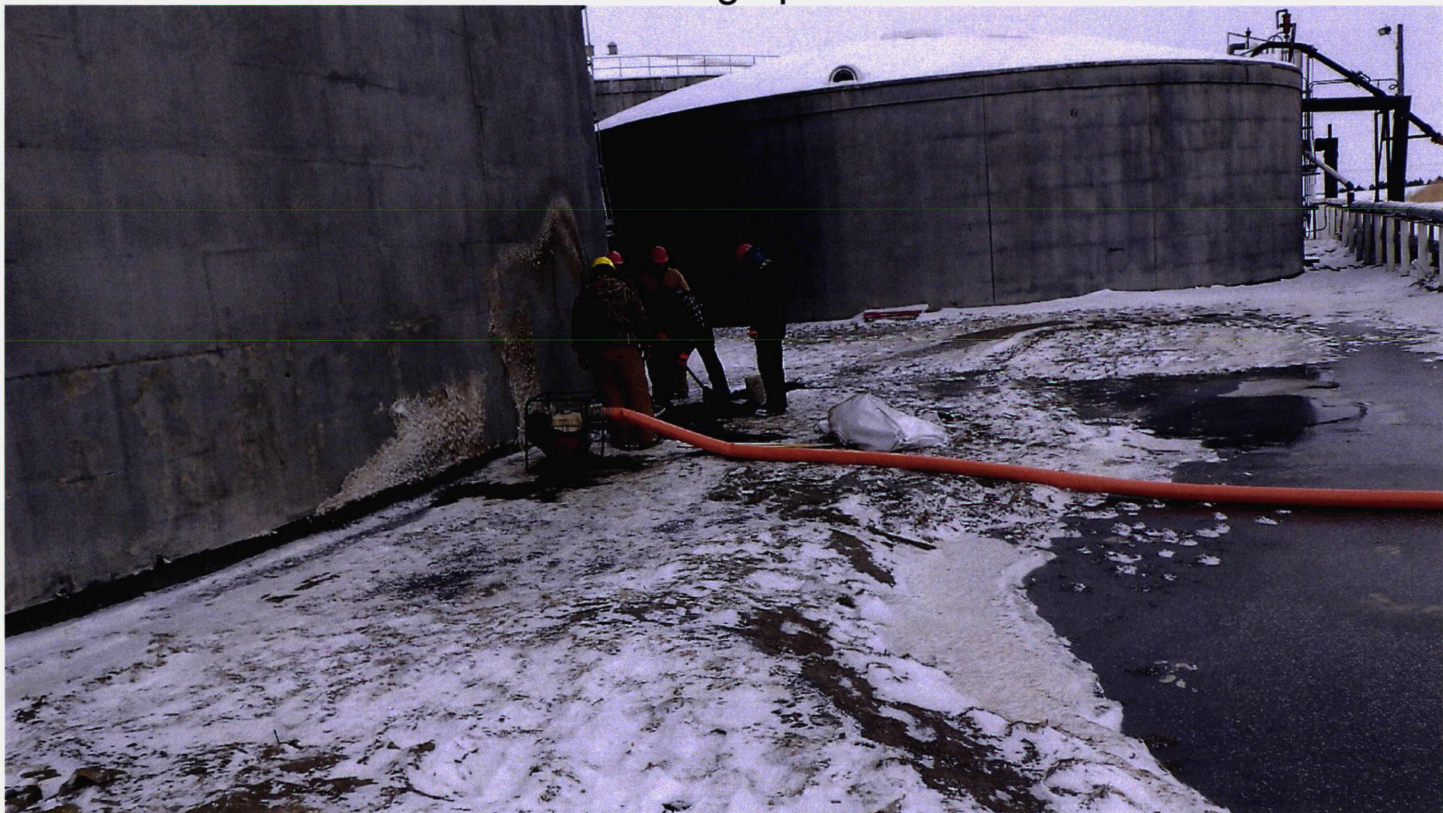
Photo 1

Upon arrival, I noted that the area east of the digester was significantly lower than before. I briefly spoke to Mr. Peterson who was about to leave. I stated I was just there to document the digester. Mr. Peterson granted me access and then went to buy supplies. I was able to walk to the broken pipe, photo 1. There was no one onsite to confirm, but it appears the digester is empty. The facility has not installed storm water controls or spill response measures to mitigate the spill. I then walked around the digester and noted the north digester had developed a large icicle, photo 2. The icicle covers the valve and piping system. I did email Mr. Tingelhoff of the icicle for information purposes. AltEn installed caution tape below the icicle. Mr. Egr stated Saturday that the north digester pipes are now protected by heat lamp, heat tape and foam insulation.

Location: South digester

Description: The photo depicts workers making repairs. The facility is pumping wastewater into the emergency lagoon.

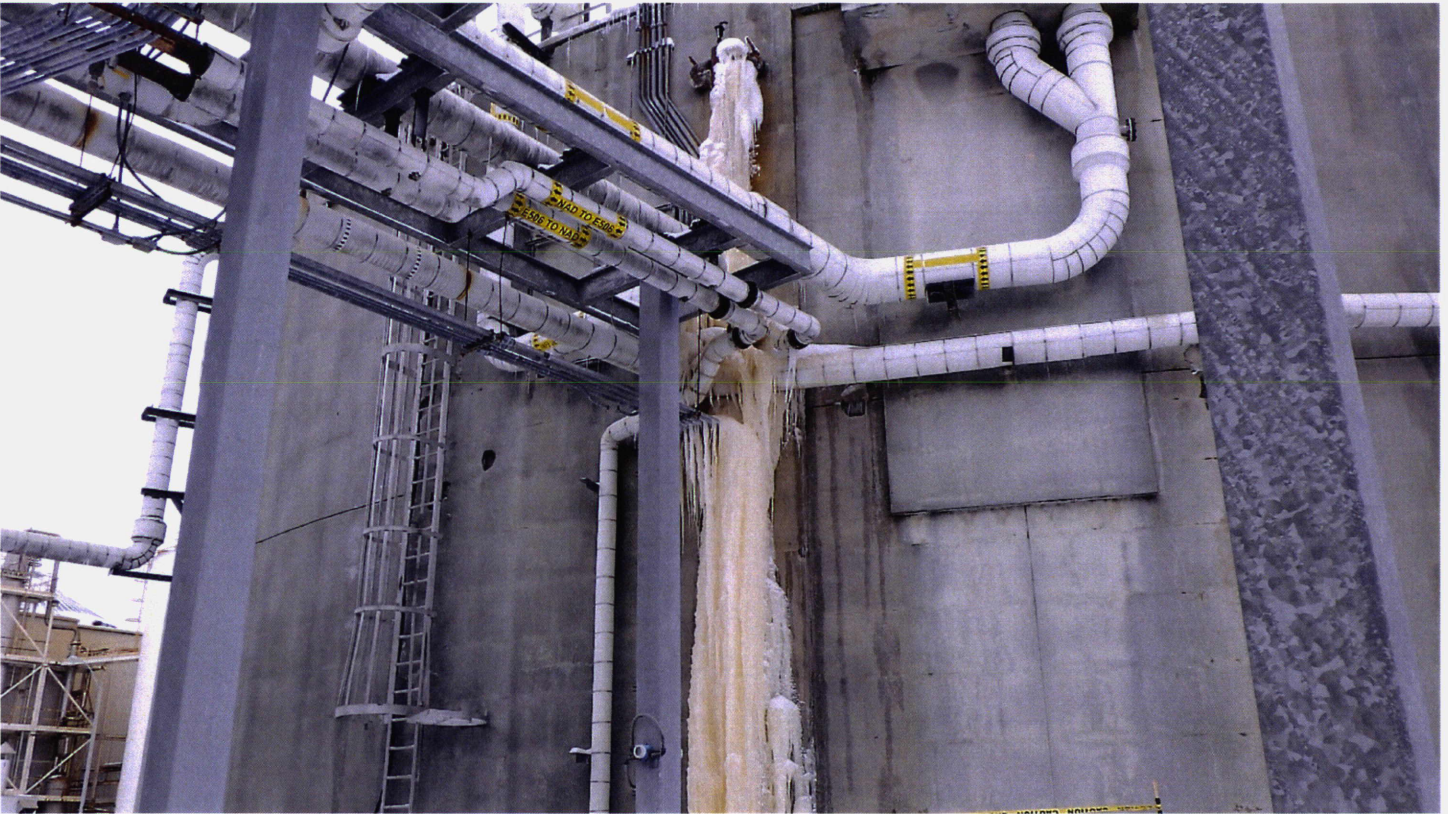
Photo 2

Location: North digester

Description: The photo depicts a leak forming a large icicle on the north digester. AltEn is aware that it is there.

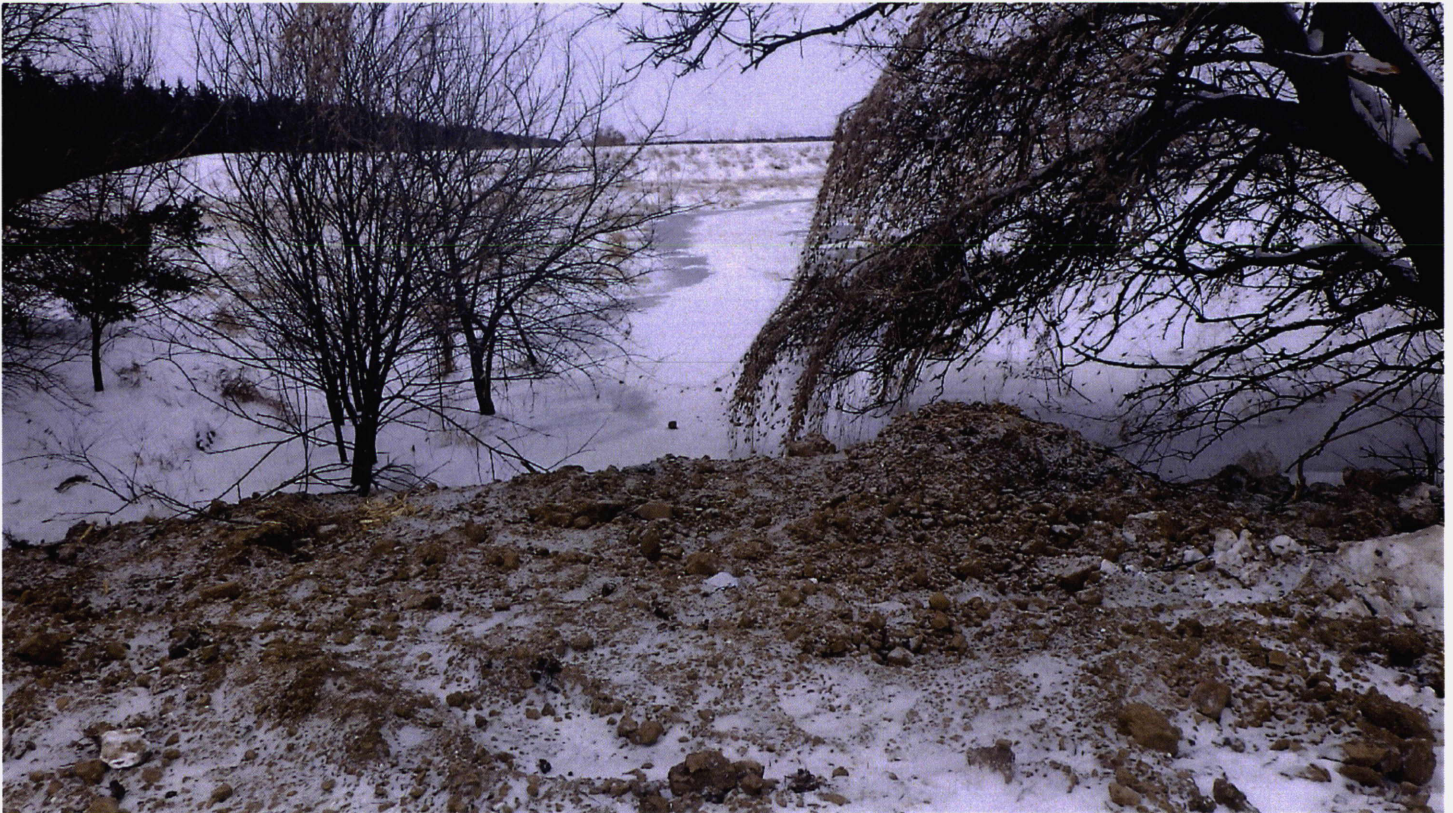
Photo 3

I then investigated the southeast culvert/outfall 001, photo 3. There was no one onsite so I inspected the structure. I observed that water continues to flow through the makeshift dam, photo 4. I did not inspect the spill on University of Nebraska – Lincoln UNL property.

Location: Southeast culvert

Description: The photo depicts the makeshift dam. The dam is larger than observed on Saturday.

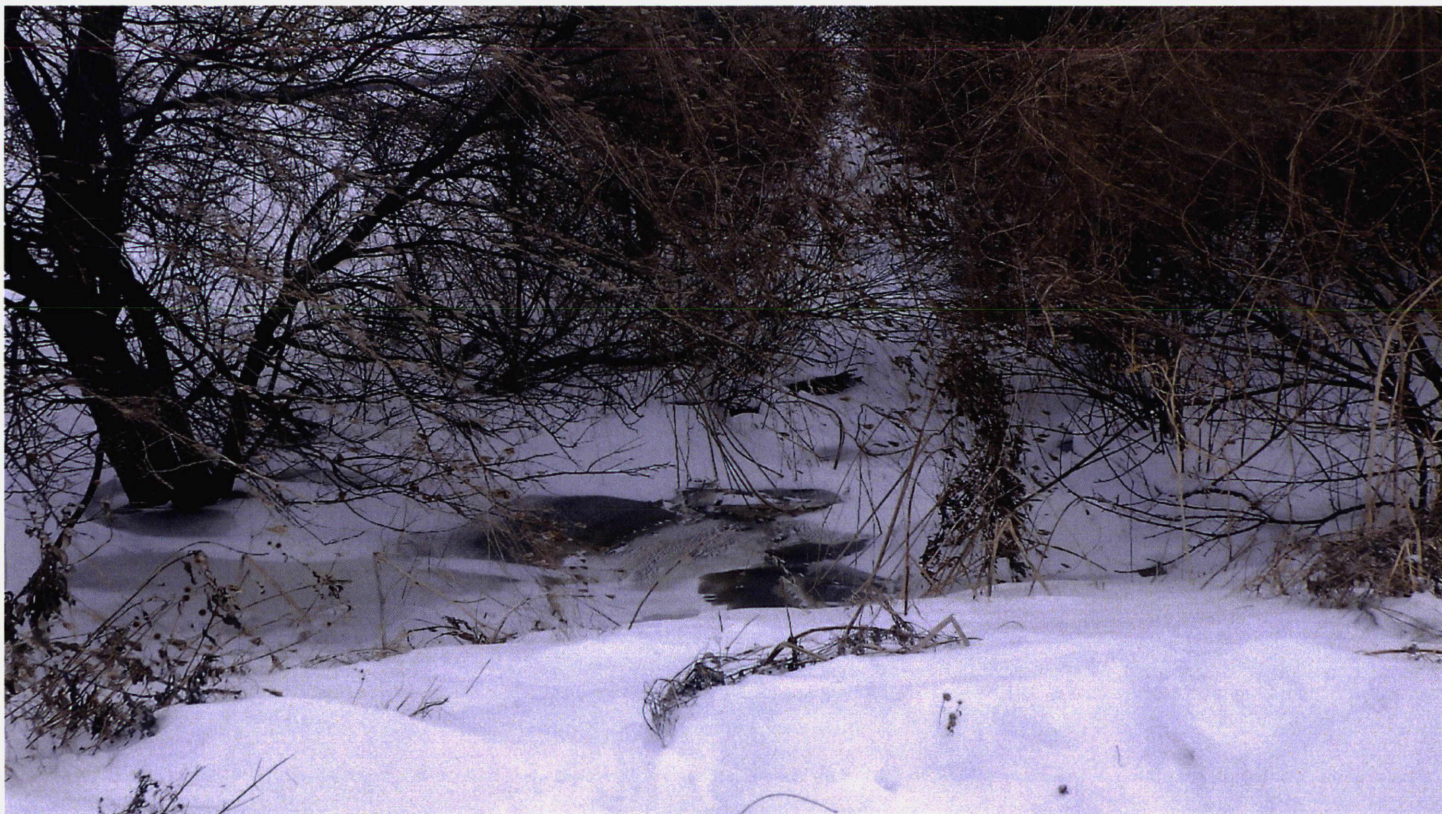
Photo 4

Location: Southeast culvert

Description: The photo depicts flow exiting the east side of the culvert.

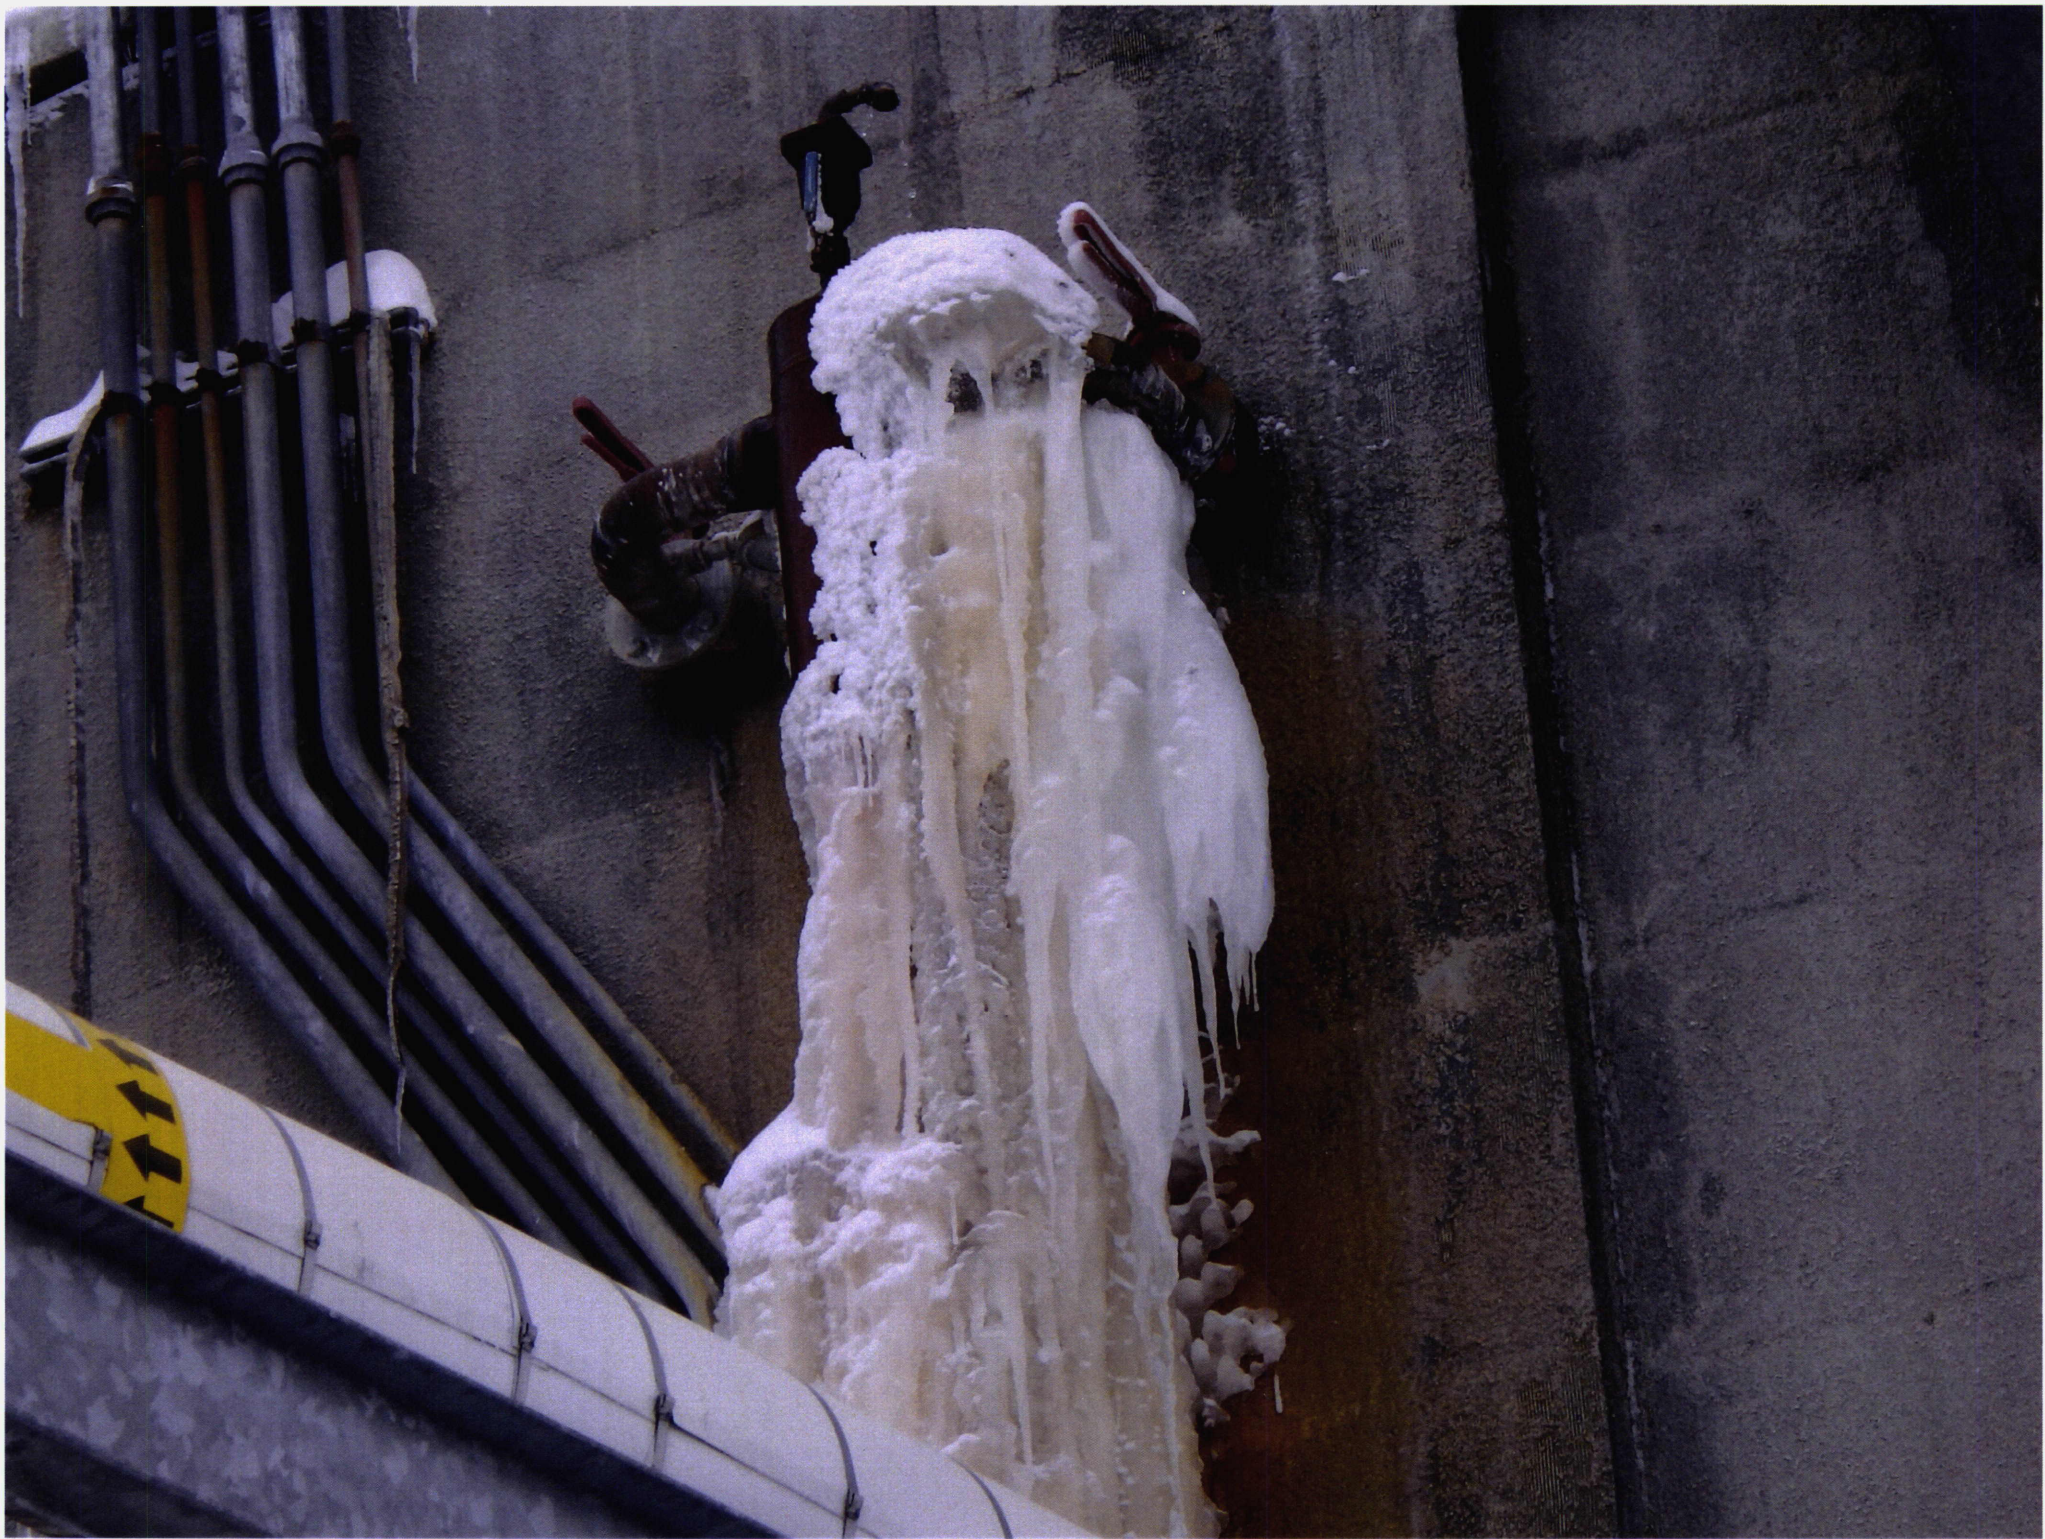
I was onsite Saturday and today (Sunday). Both days I noticed a small but consistent water leak from the north digester. I know you and your team are aware of the icicle it has formed since it is blocked off with tape, see photo. The question is, could this cause valve or piping failure? I was just concerned of the way it looked this morning and wanted to give you a heads up. It would be a good idea to investigate that leak especially during this extreme cold temperatures.
