BEFORE THE NEBRASKA DEPARTMENT OF ENVIRONMENT AND ENERGY

IN THE MATTER OF	)	
AltEn, LLC,	)	CASE NO. 3546
	)	
FID # 84069	)	EMERGENCY COMPLAINT
	)	AND ORDER
Respondent.	)

Release of Thin Stillage and Cattle Manure from Digester at AltEn LLC, IIS #84069, RA  
#021221-NH-0845

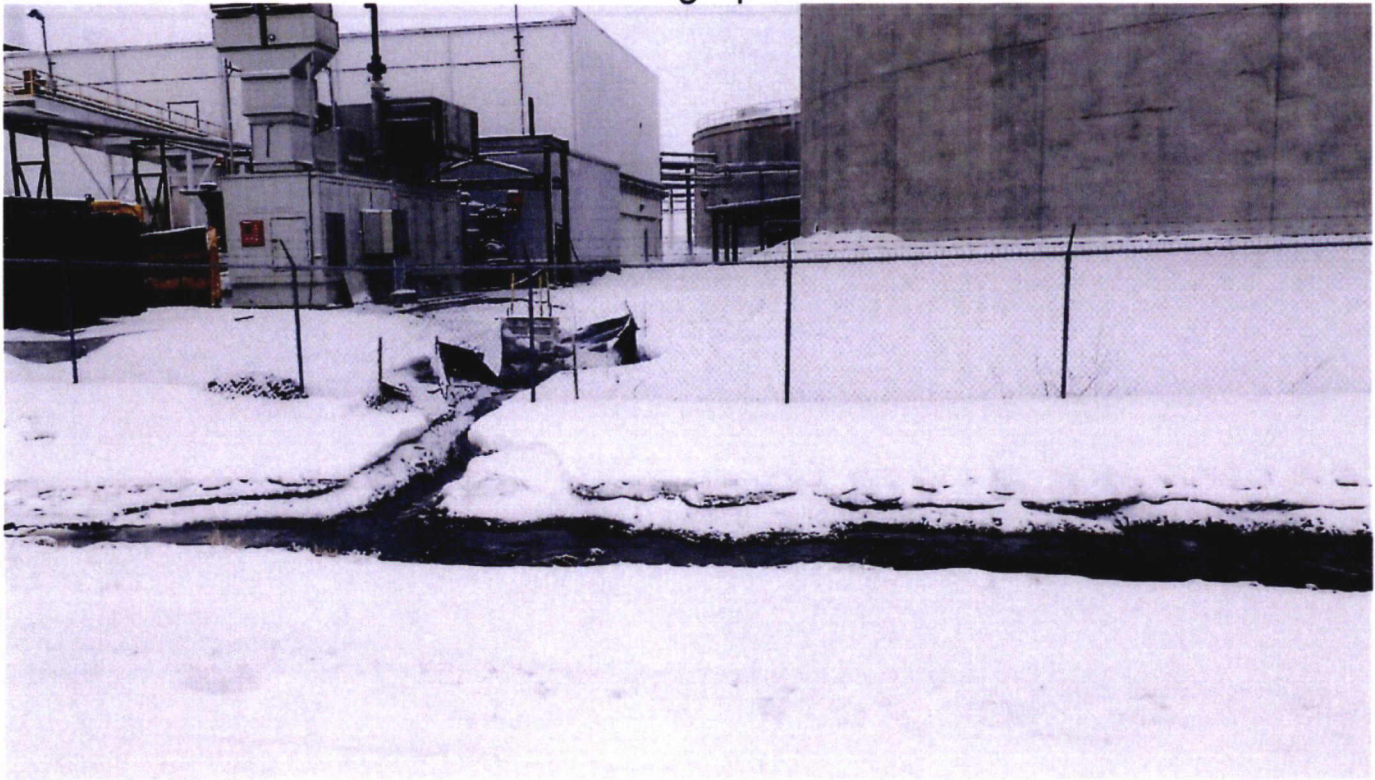
Photo 1

Description: This photo depicts water flow from the storm water conveyance system. Water is entering the ditch flowing east along the south side of the digester.

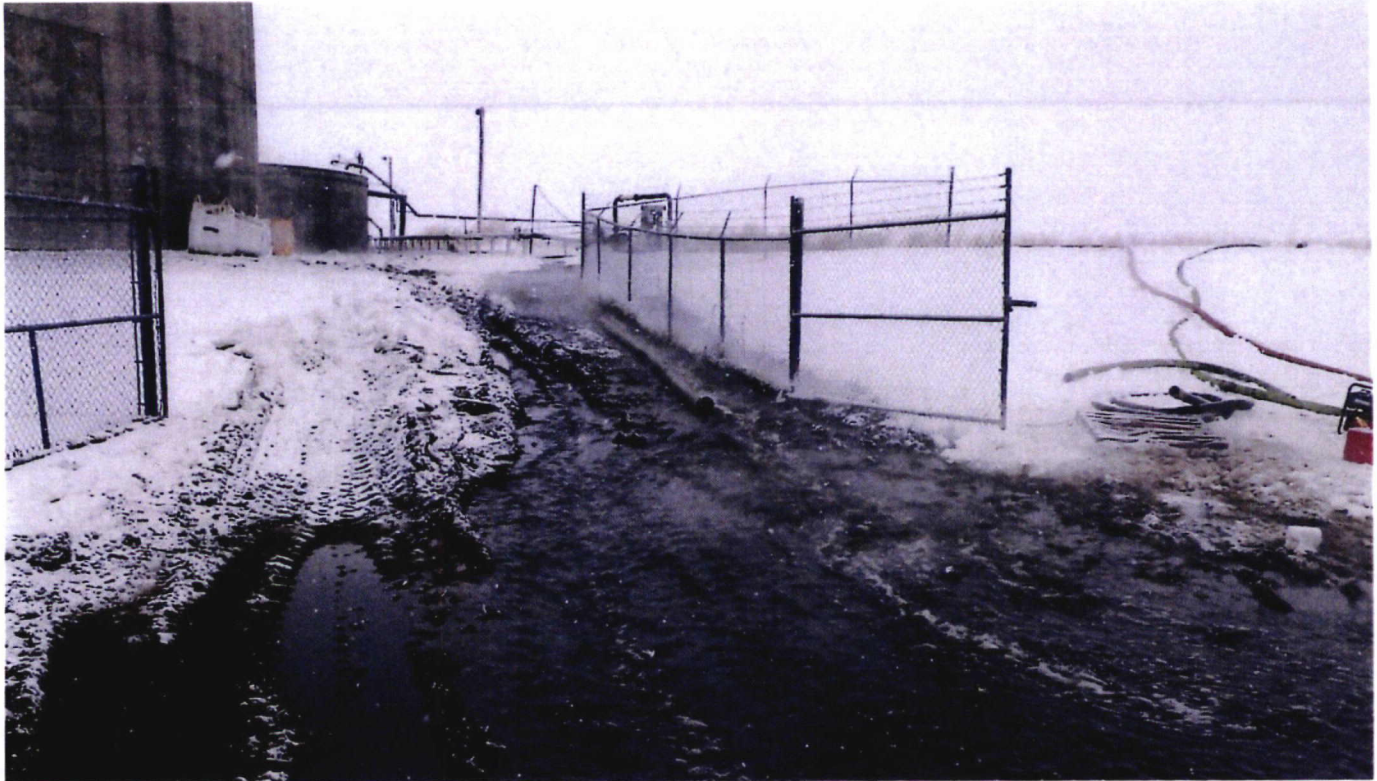
Photo 2

Description: This photo depicts cascading water exiting the southeast side of the digester.

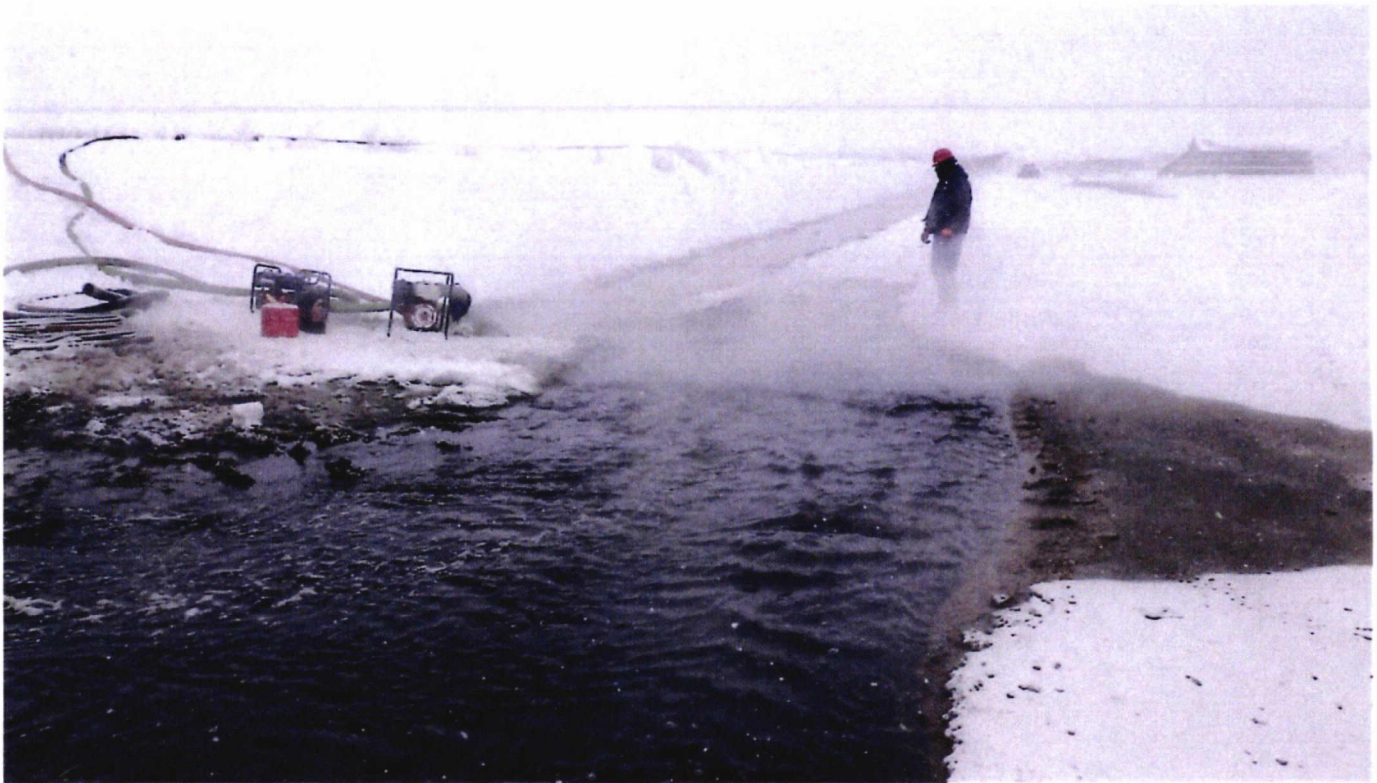
Photo 3

Description: This photo depicts water entering the ditch and flowing along the emergency lagoons. Also depicted is the trash pumps installed to transport water into the emergency lagoon.

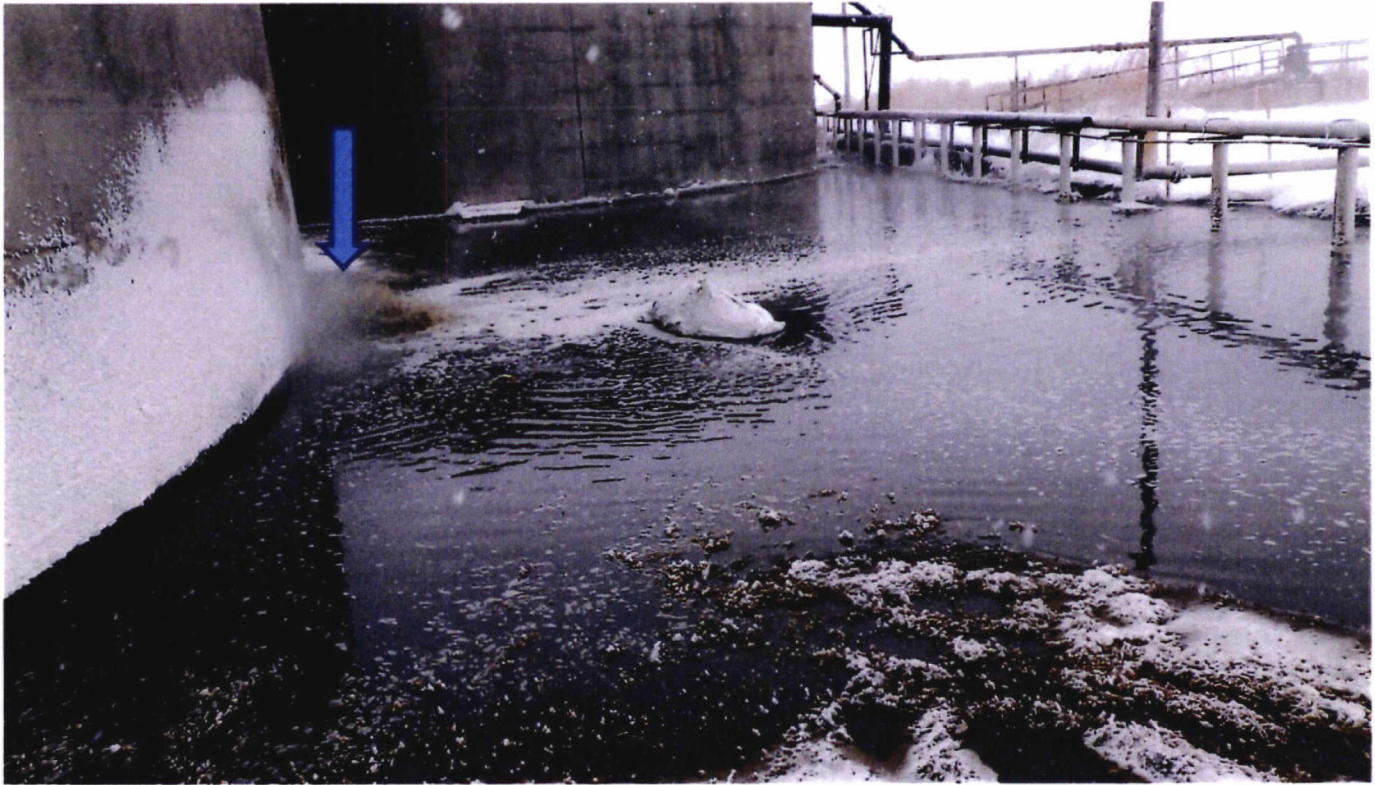
Photo 4

Description: This photo depicts the damaged area (arrow). Water is quickly exiting the digester creating ponding and discharge.

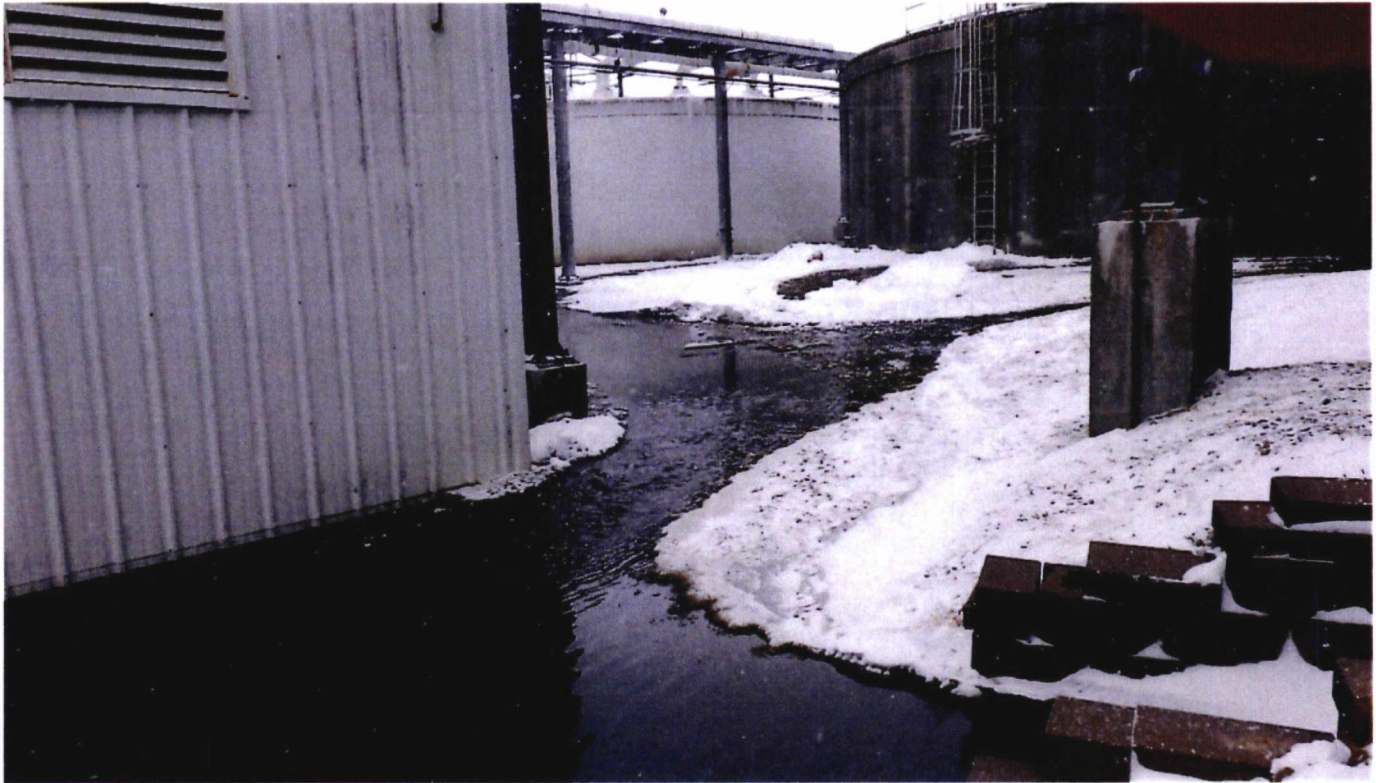
Photo 5

Description: This photo water flowing behind the digester. Wastewater is flowing behind the digester (arrow). Flow continued southwest and into the conveyance system depicted in photo 1.

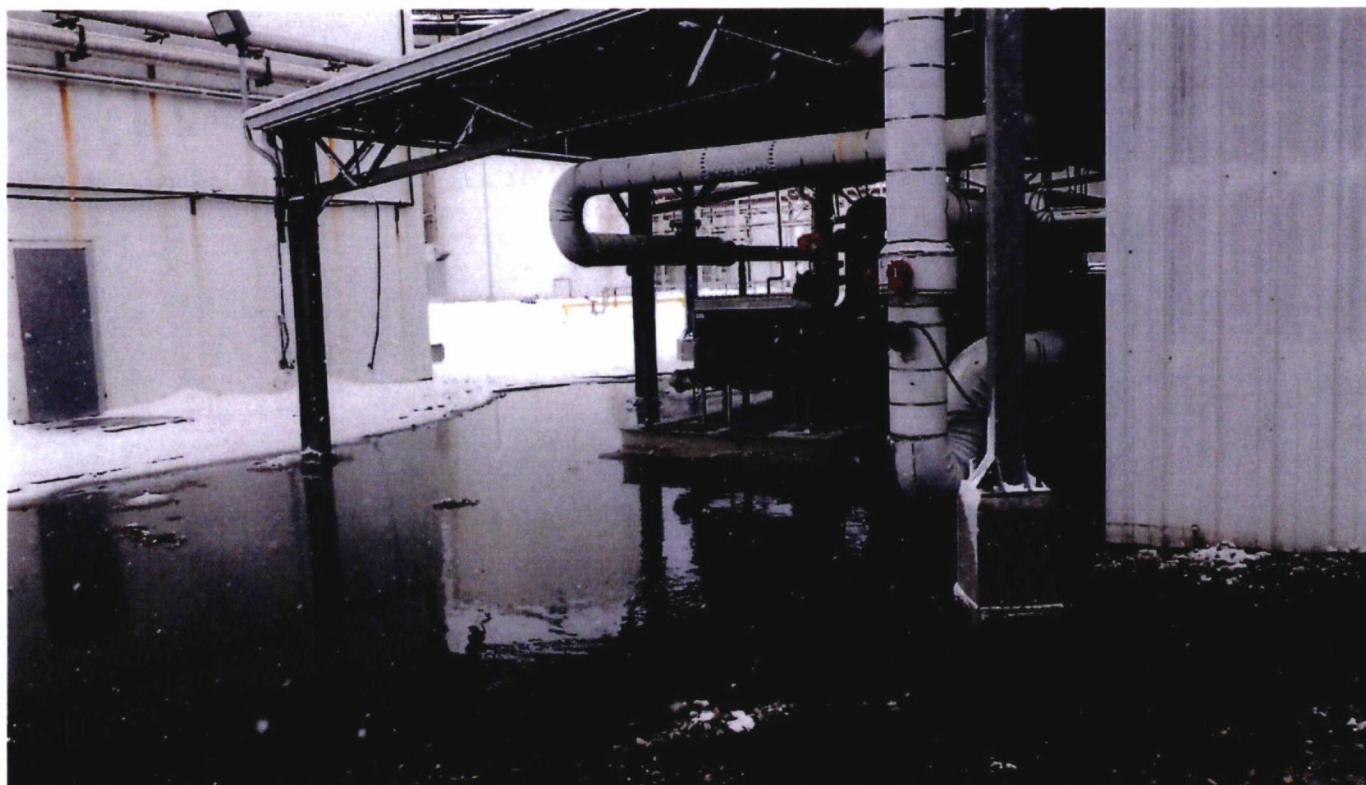
Photo 6

Description: This photo is pooled water west of the digester.

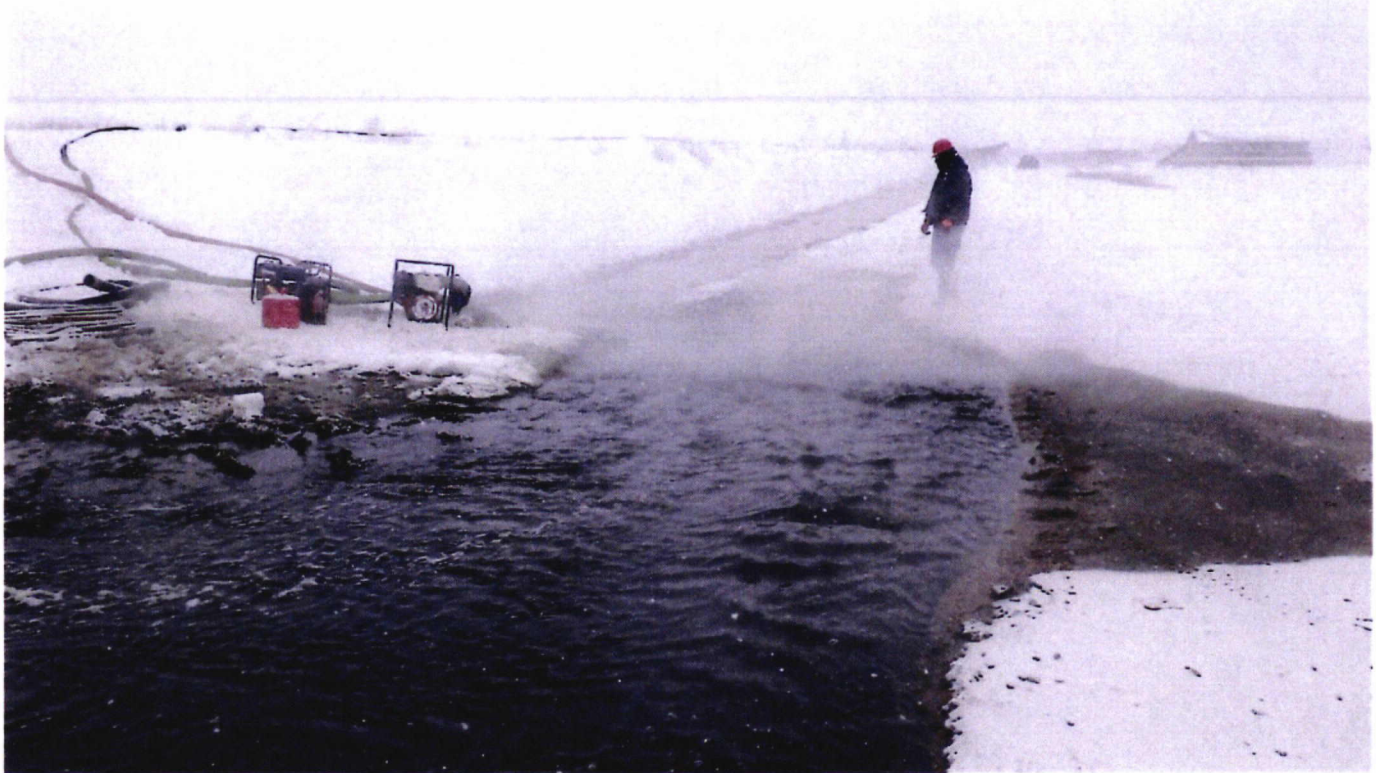
Photo 7

Description: This photo depicts the trash pumps used to transport water into the emergency lagoon.

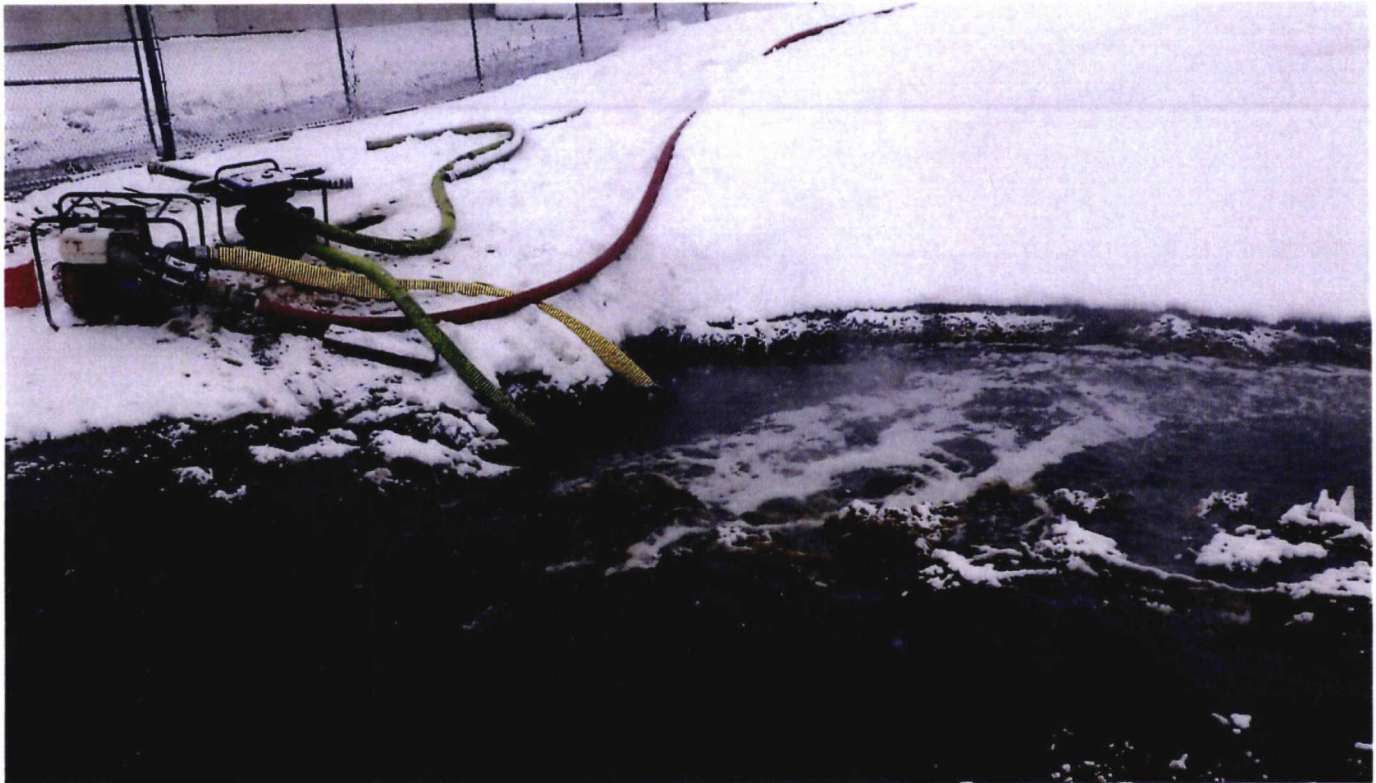
Photo 8

Description: This photo depicts the trash pumps used to transport water into the emergency lagoon.

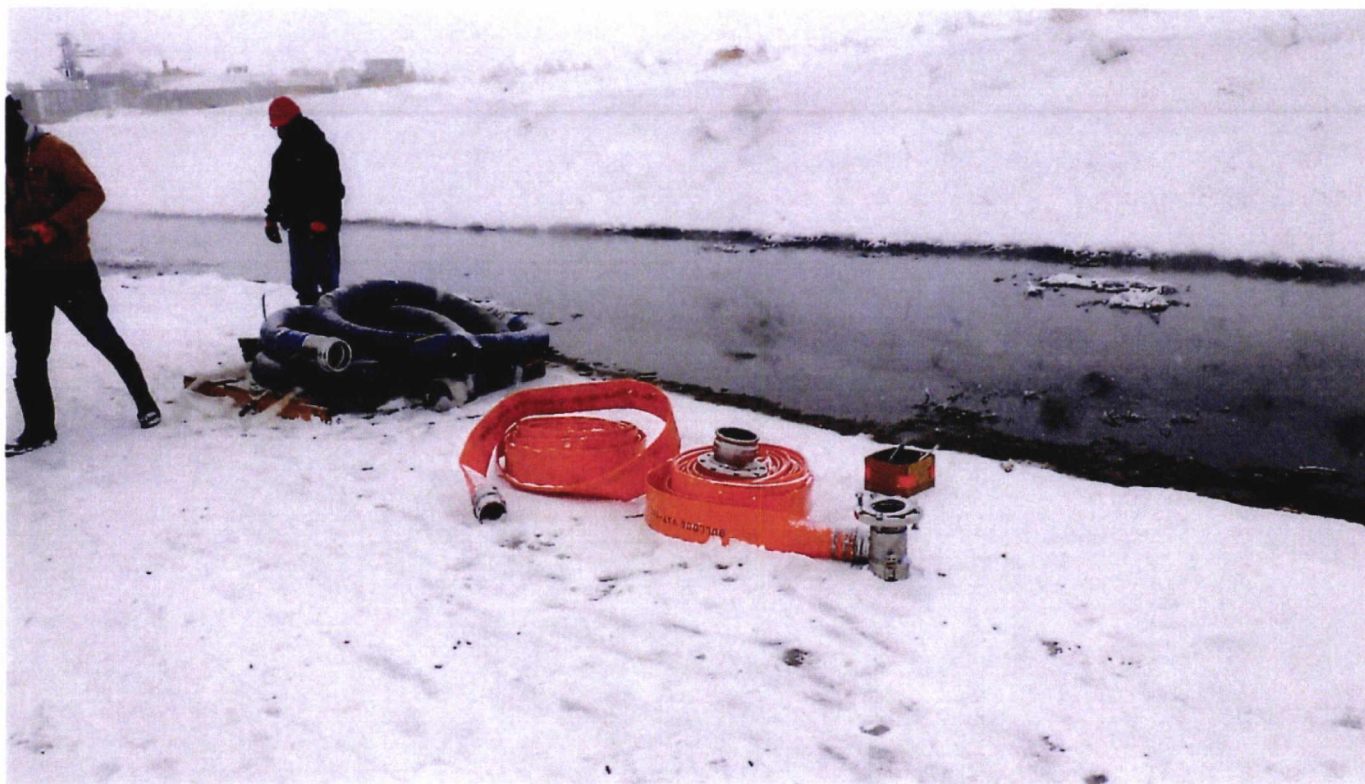
Photo 9

Description: This photo depicts AltEn personnel working to install an additional trash pump. The pump is being installed approximately 100 yards east of the pumps depicted in photo 8.

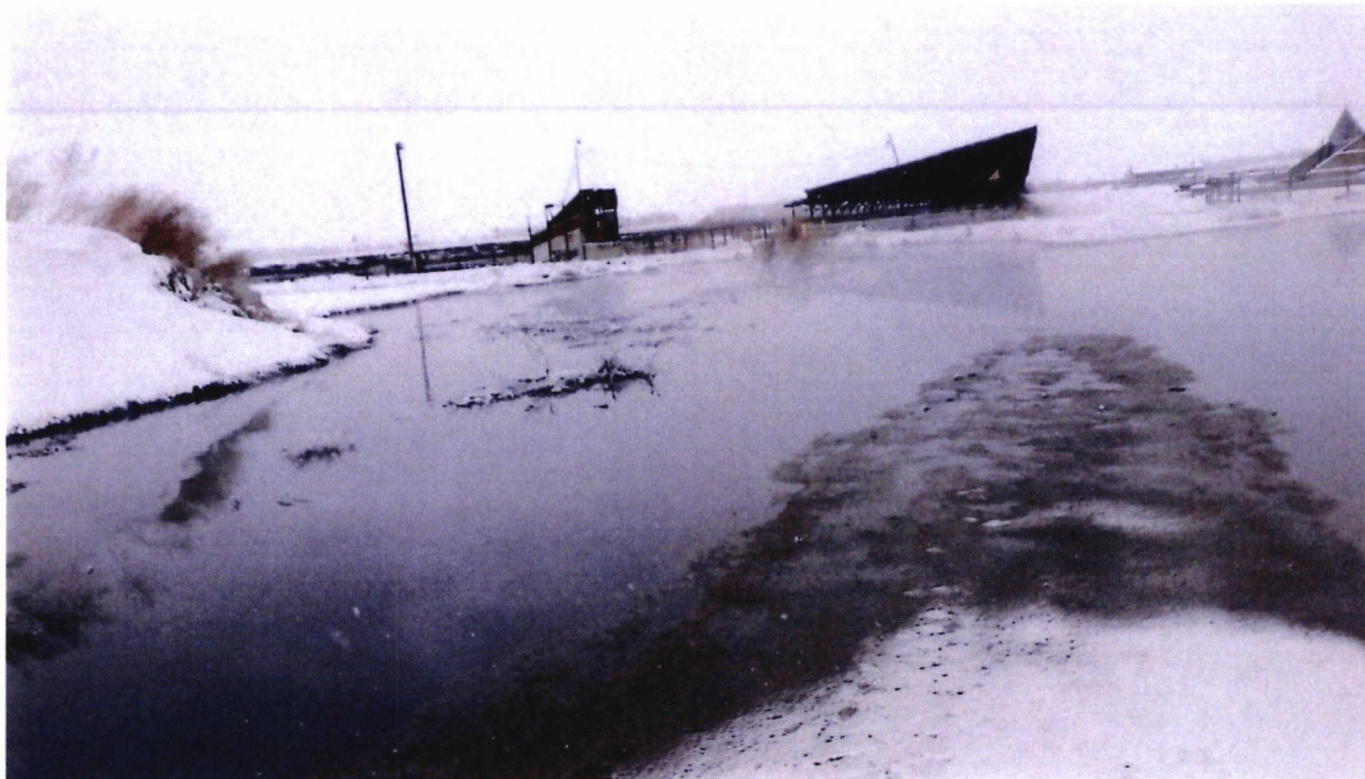
Photo 10

Description: This photo depicts the creek flooding the road entering Mead Cattle.

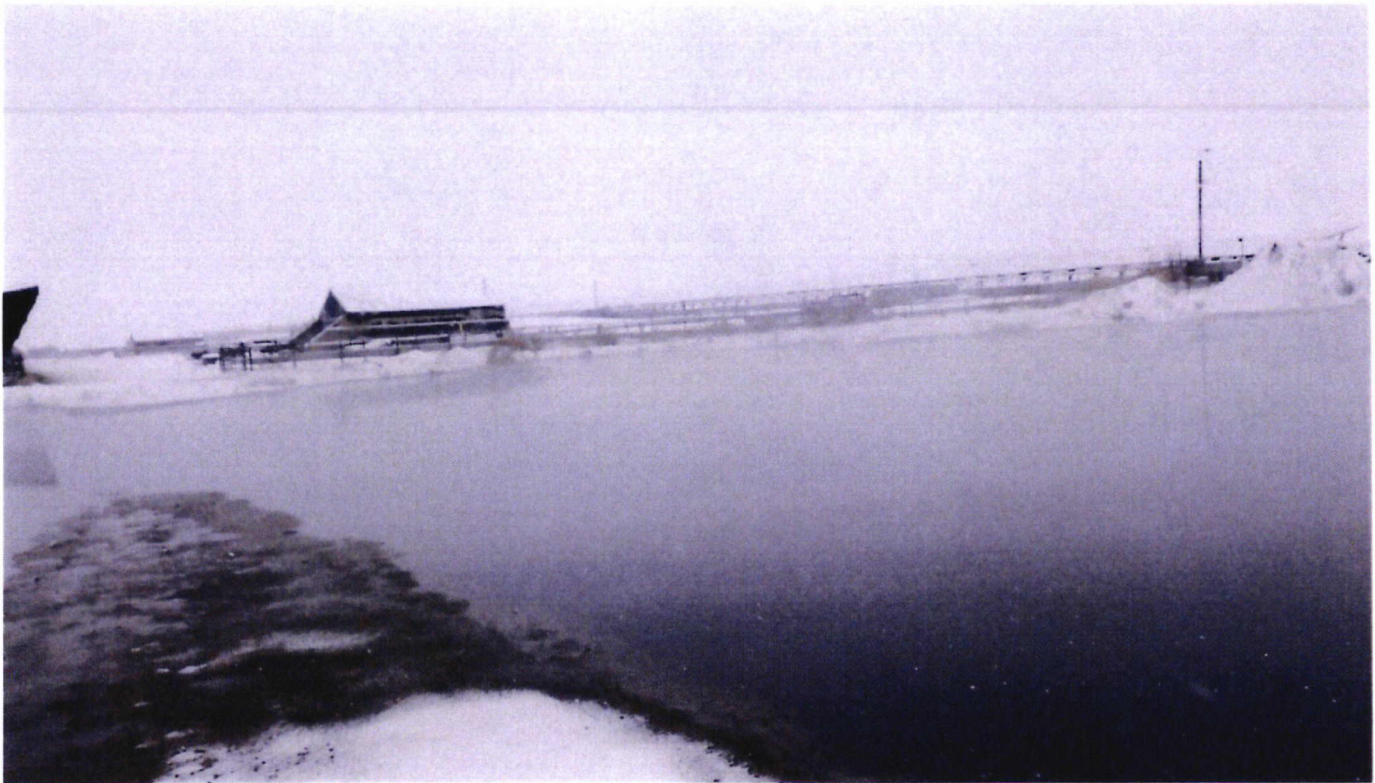
Photo 11

Description: This photo depicts water flooding the road and ponding on the south side.

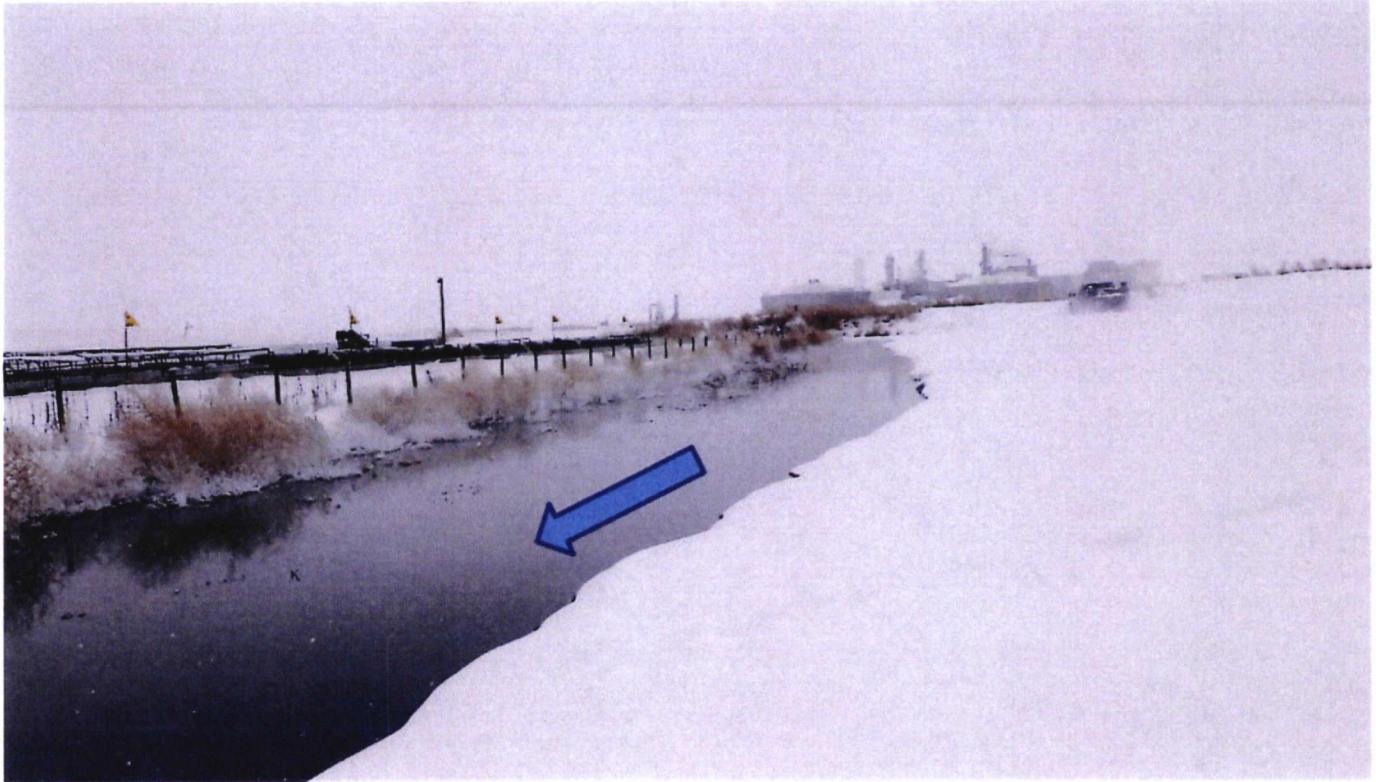
Photo 12

Description: This photo depicts wastewater flowing east along Mead Cattle. The arrow depicts flow direction.

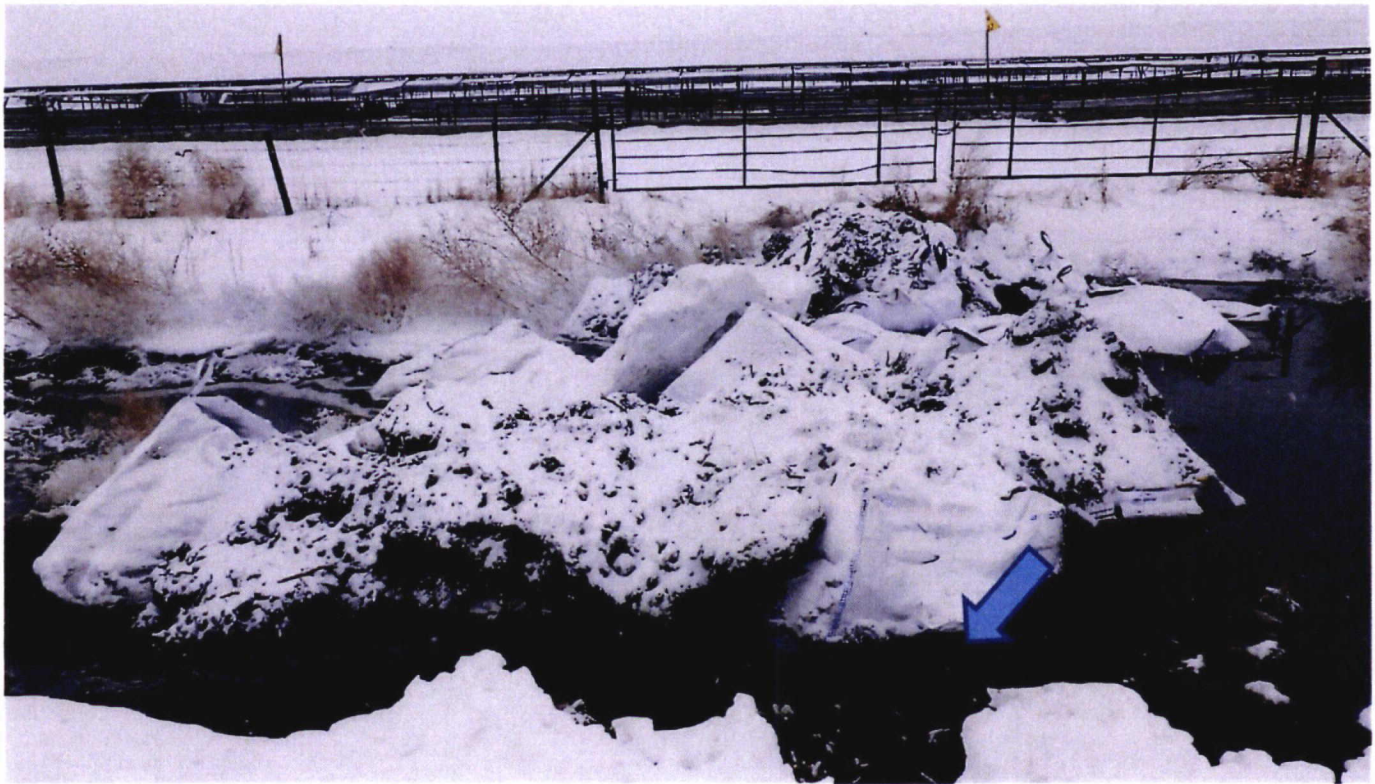
Photo 13

Description: This photo depicts a makeshift dam made of biochar supersacks. This photo also depicts the breach that occurred on the north side (arrow)

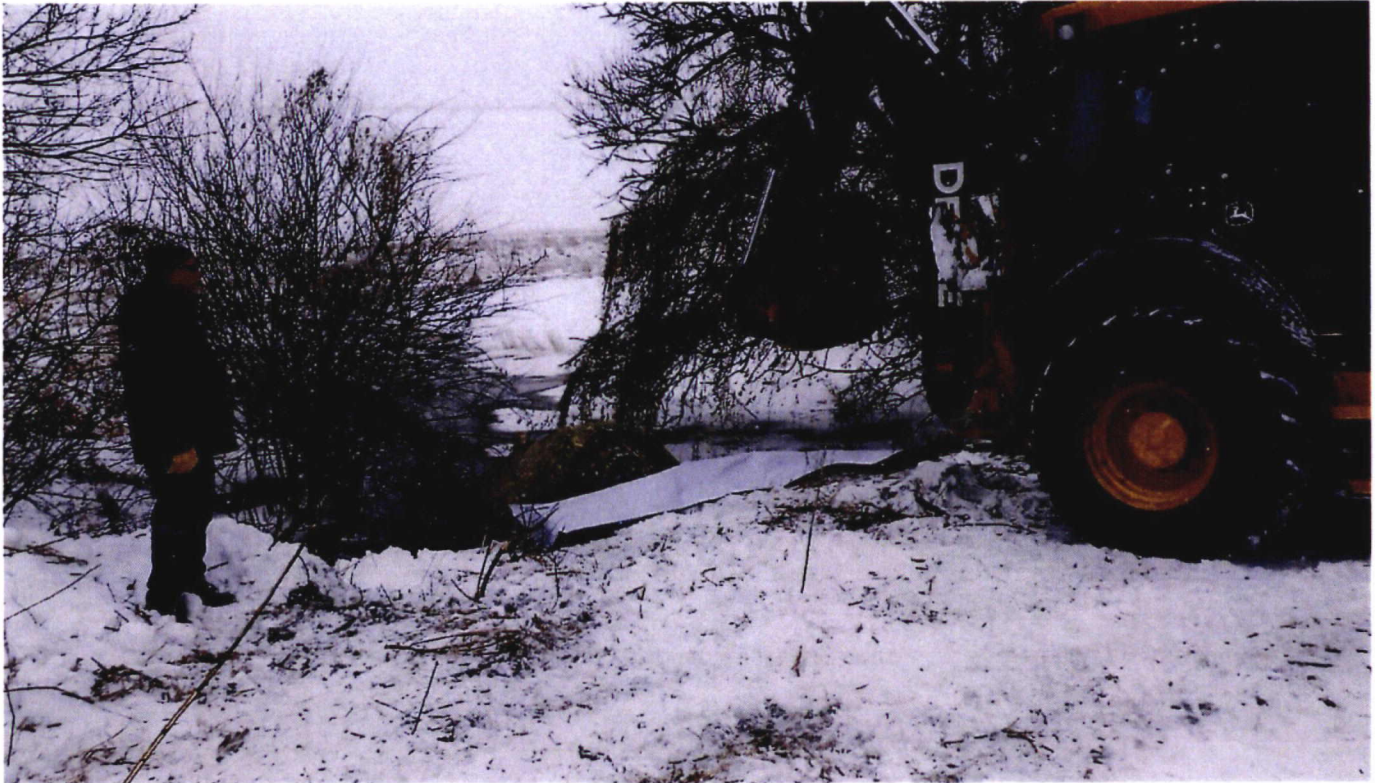
Photo 14

Description: This photo depicts UNL personal installing plastic and bales to dam the culvert.

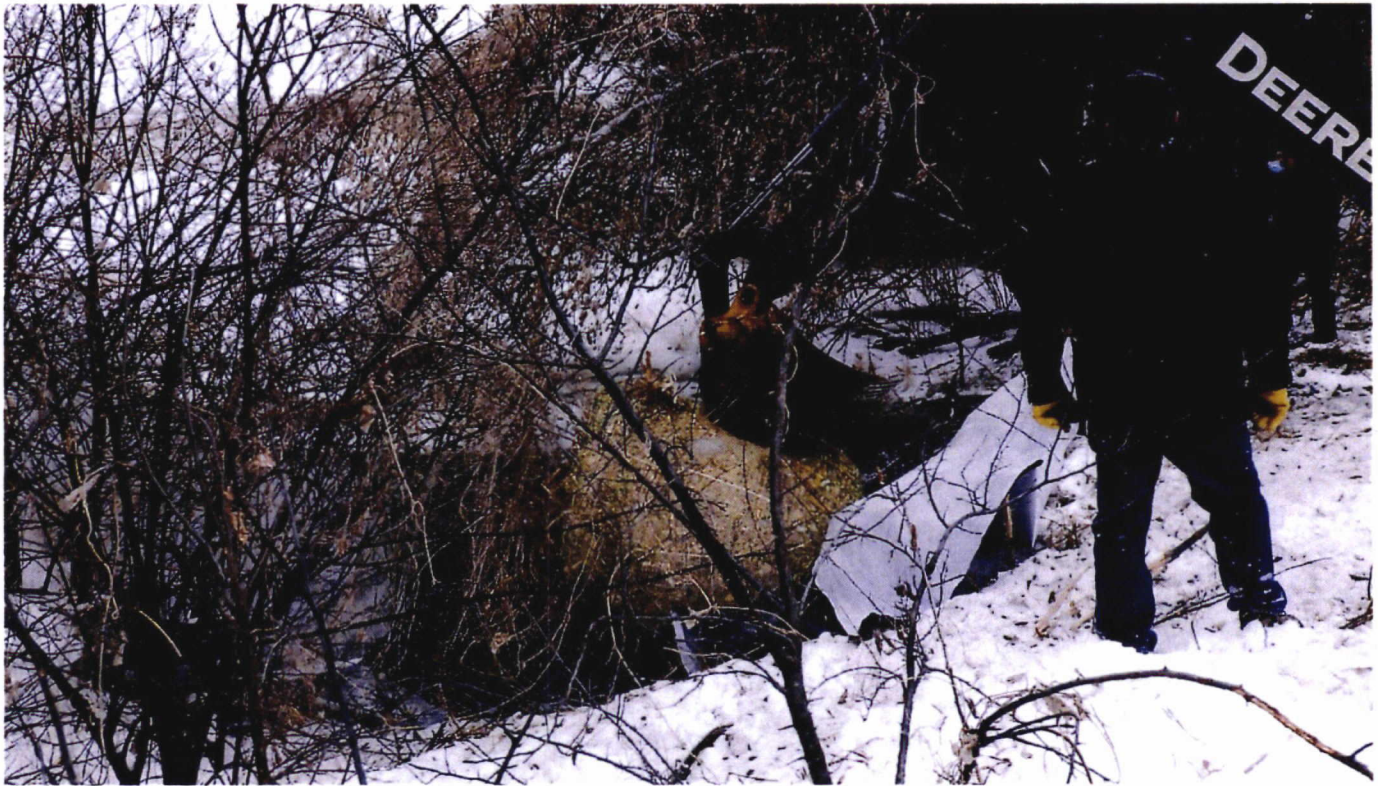
Photo 15

Description: This photo depicts UNL using a backhoe to push a bale and plastic into place.

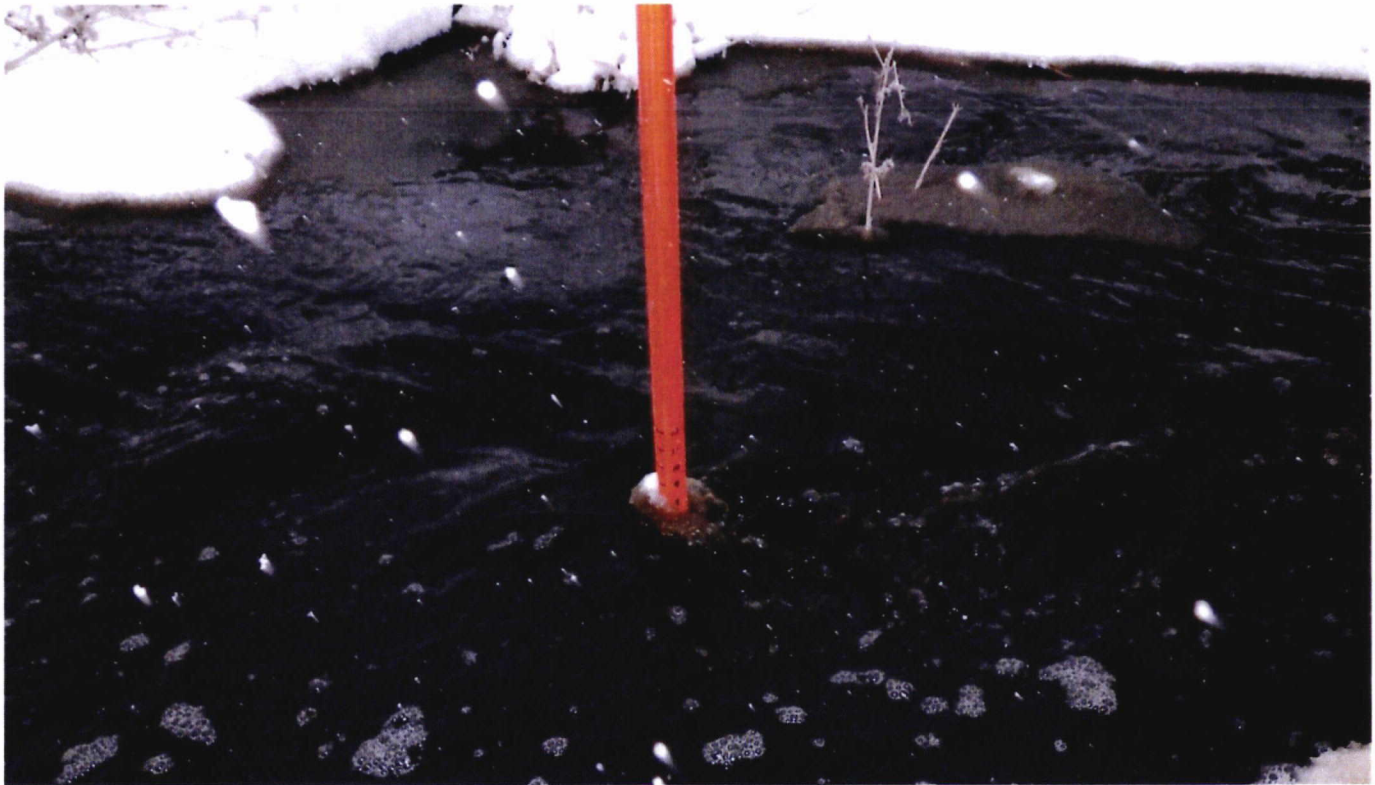
Photo 16

Description: This photo depicts UNL property adjacent county road 9. This photo is a depth finder that UNL installed to measure flow. Mr. Brummel (UNL) stated that water depth had been rising 2 inches per hour.

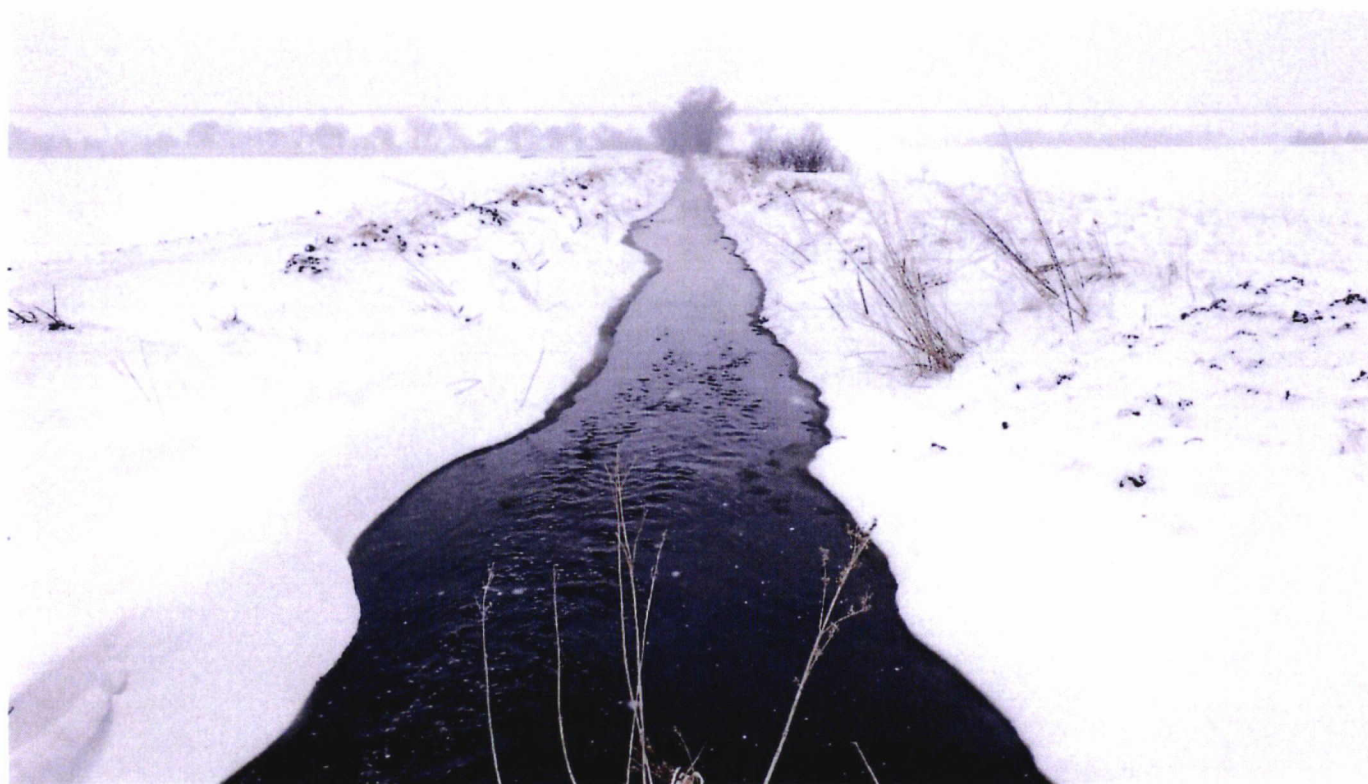
Photo 17

Description: This photo is from the same area as the above photo. This photo is facing south from onto the culvert. I observed dark water and odor at this location.

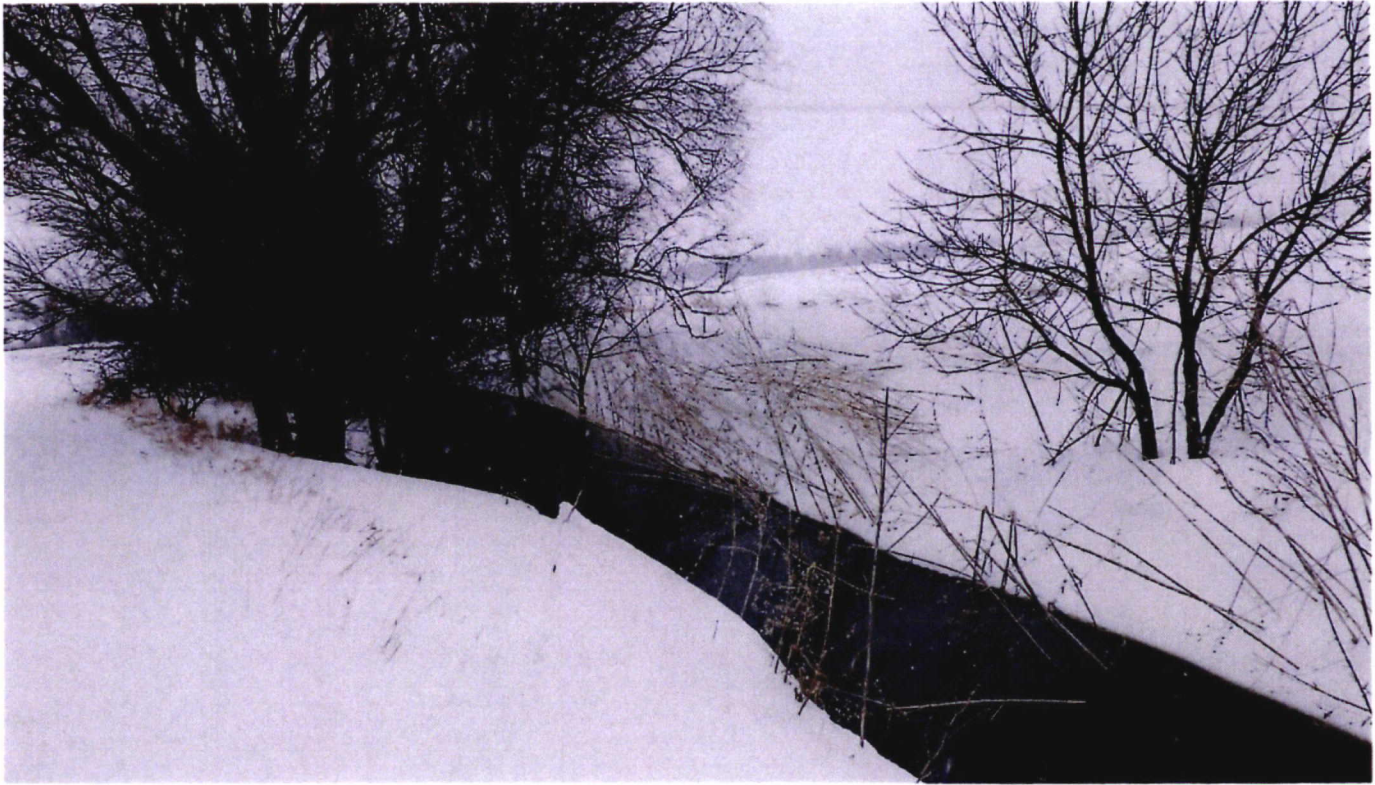
Photo 18

Description: This photo depicts an area deep into UNL property. I observed flow, dark water and odor.

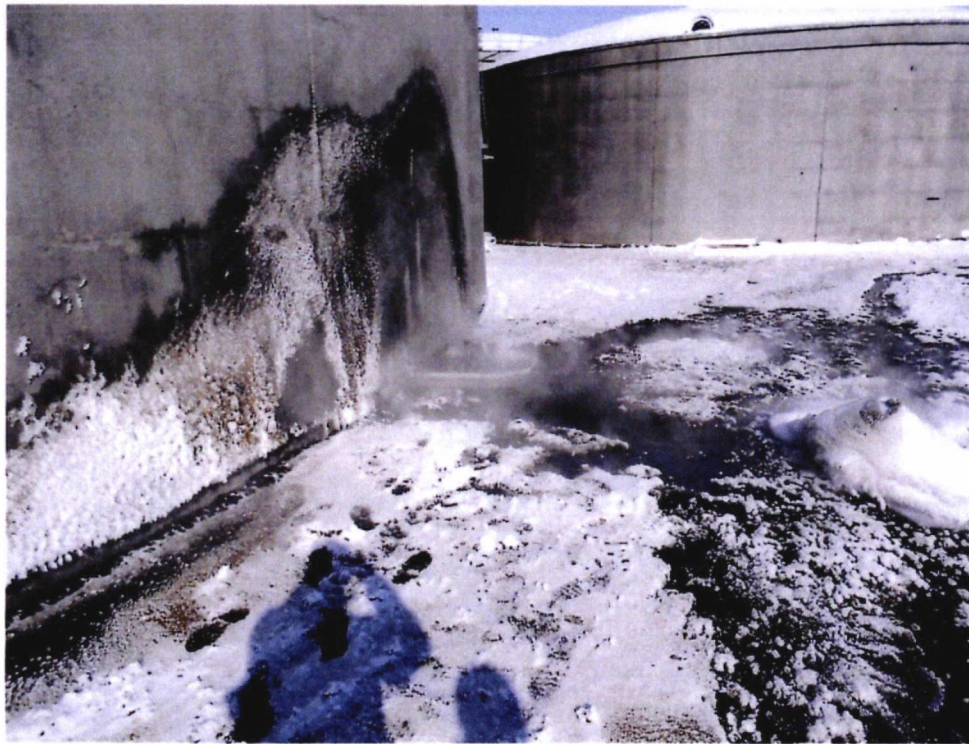
View north of piping vault where leak occurred

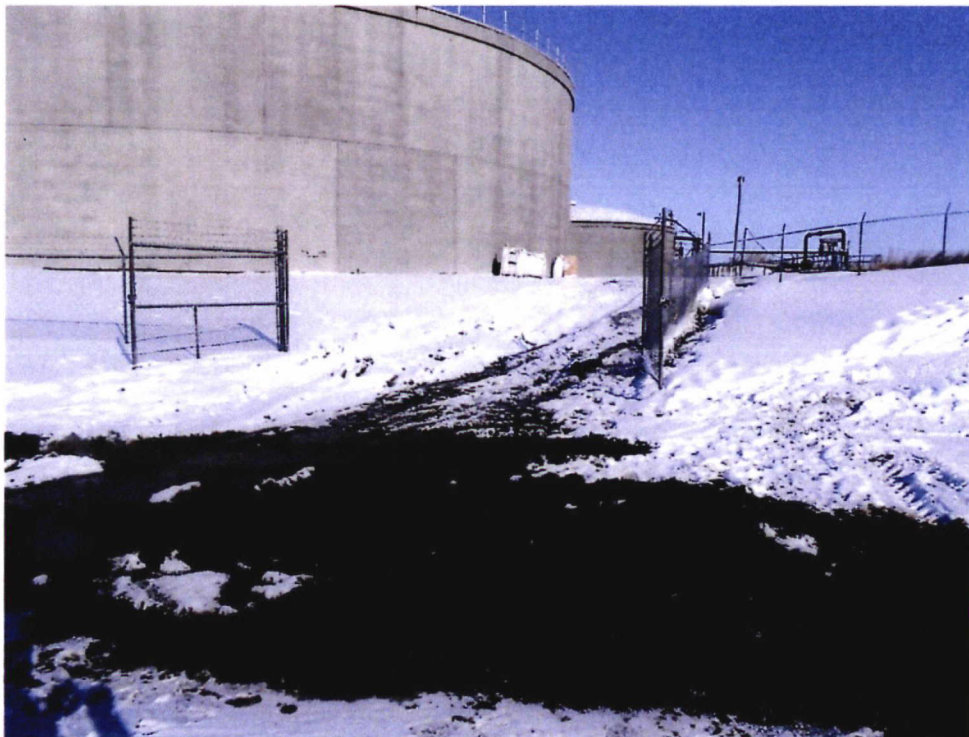
View north of digester where leak occurred

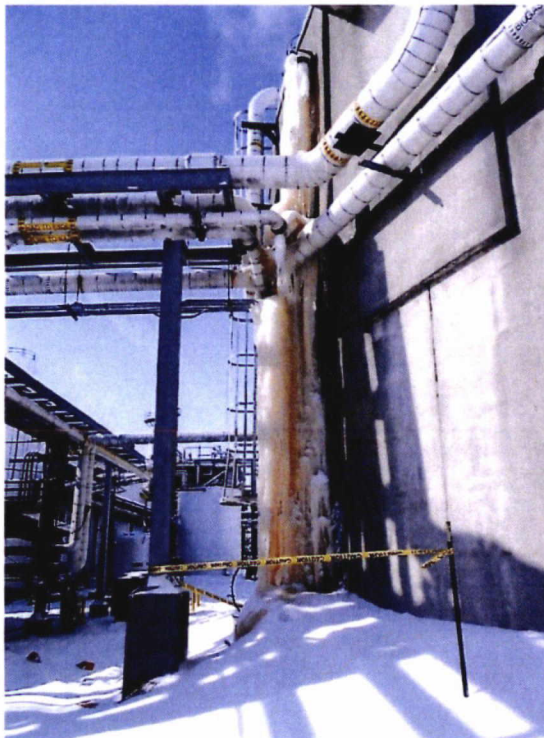
Spilling and leaking liquid from digester without leak

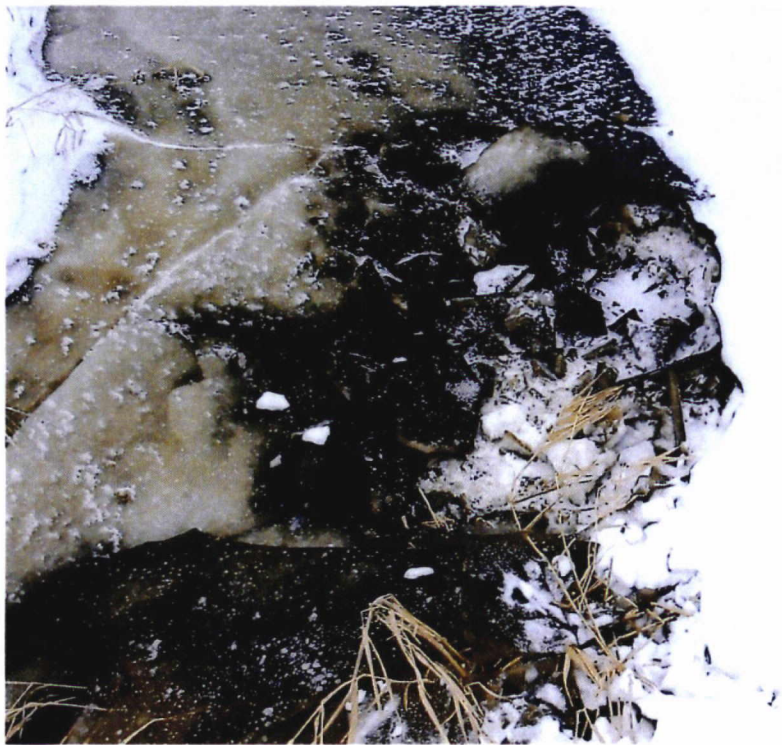
Broken crust of ice at culvert inlet at Stop #4

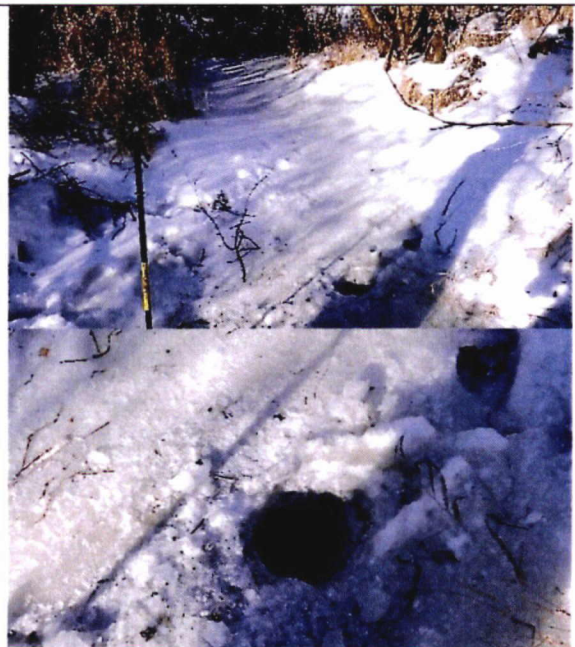
**STOP 3 – Road 7/Highway 66**

I found no evidence of the AltEn LLC thin stillage discharge reaching this location. I chopped a hole in the ice (~12 inches thick) to the channel's substrate. It was completely frozen, with no water below the ice. Photos were taken looking west/northwest (upstream).

The berm/dam located here made up of a tarp and sand bags appears to have constructed on top of the channel's ice surface in front the culvert. It would seem prudent to chip the ice away and lower the entire structure.
