BEFORE THE NEBRASKA DEPARTMENT OF ENVIRONMENT AND ENERGY

IN THE MATTER OF	)	
AltEn, LLC,	)	CASE NO. 3546
	)	
FID # 84069	)	EMERGENCY COMPLAINT
	)	AND ORDER
Respondent.	)

Release of Thin Stillage and Cattle Manure from Digester at AltEn LLC, IIS #84069, RA  
#021221-NH-0845

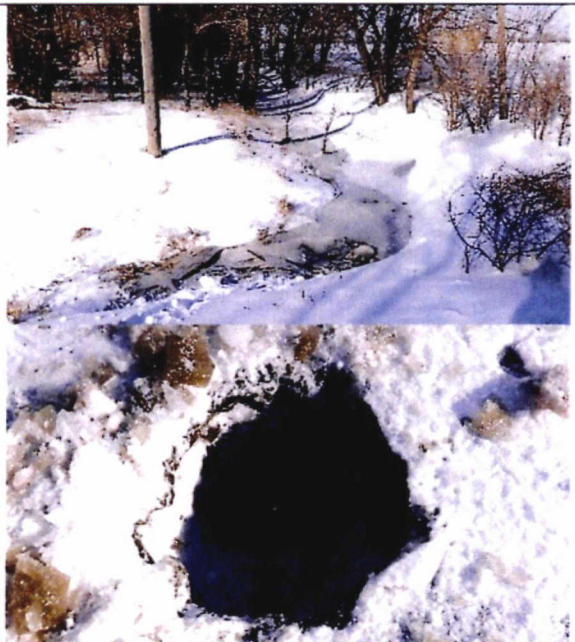
**STOP 4 – County Road 8, North of Road H**

The AltEn LLC thin stillage discharge water remains as a frozen layer on top of the original ice layer that existed prior to the thin stillage release. The frozen waste water ice is much darker in appearance than the snow and original ice in the channel. The darker, frozen top layer was easily broken by walking on it. I did chop a hole through the channel's original ice layer (~12 inches thick) and found water underneath at this location. I do not believe the water to be the thin stillage waste, as there was no pressure from below that filled the hole I had opened. However, I did not have a meter with me to confirm to be true.

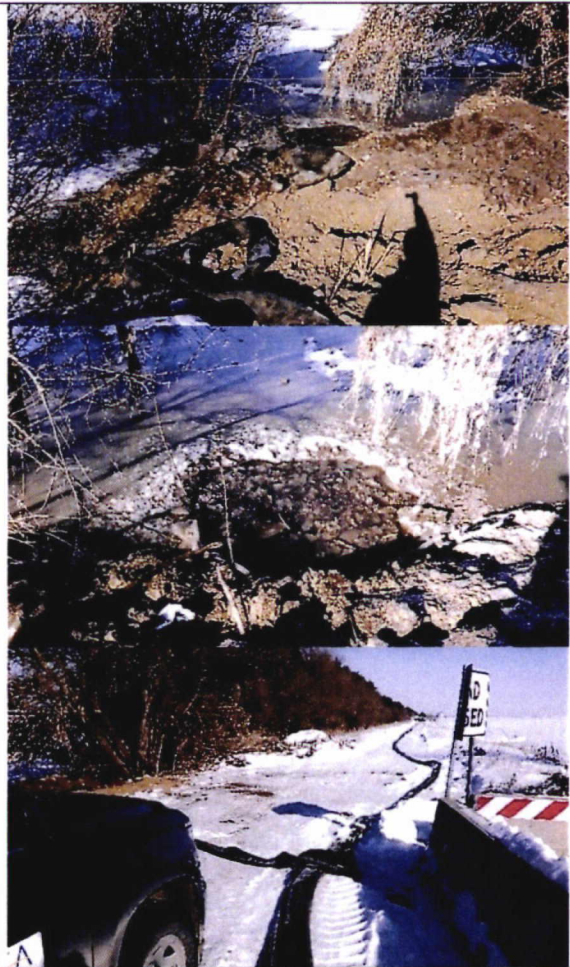
**STOP 5 – UN-L Eastern Extension – North of County Roads 9 & J**

The AltEn LLC thin stillage discharge water remains as a large pooled area behind the make-shift dam constructed on the upstream (west) side at this location. Ken Peterson (AltEn Plant Manager) showed up while I was at this location. He told me they had placed additional earthen material here to stop the seepage through the culverts. He also said they planned to start pumping the liquid from this location back into a lagoon yet today. A hose was stretched out in this area, but no pump was in place when I was there.

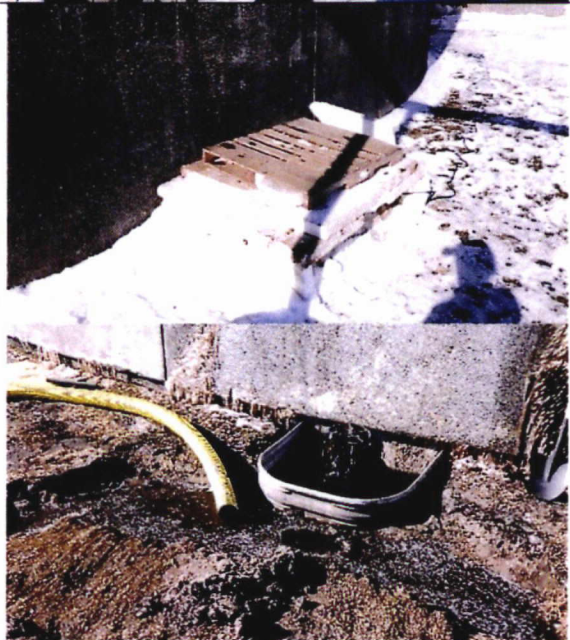
**STOP 6 – ALTEN LLC FACILITY DIGESTERS**

Ken Peterson (AltEn Plant Manager) led me to the digesters and gave me a quick tour. I did not observe any discharges from either the north or south stillage tank. The top photo is the covered pipe/valve housing on the north tank and the bottom photo is of the one that failed on the south tank.

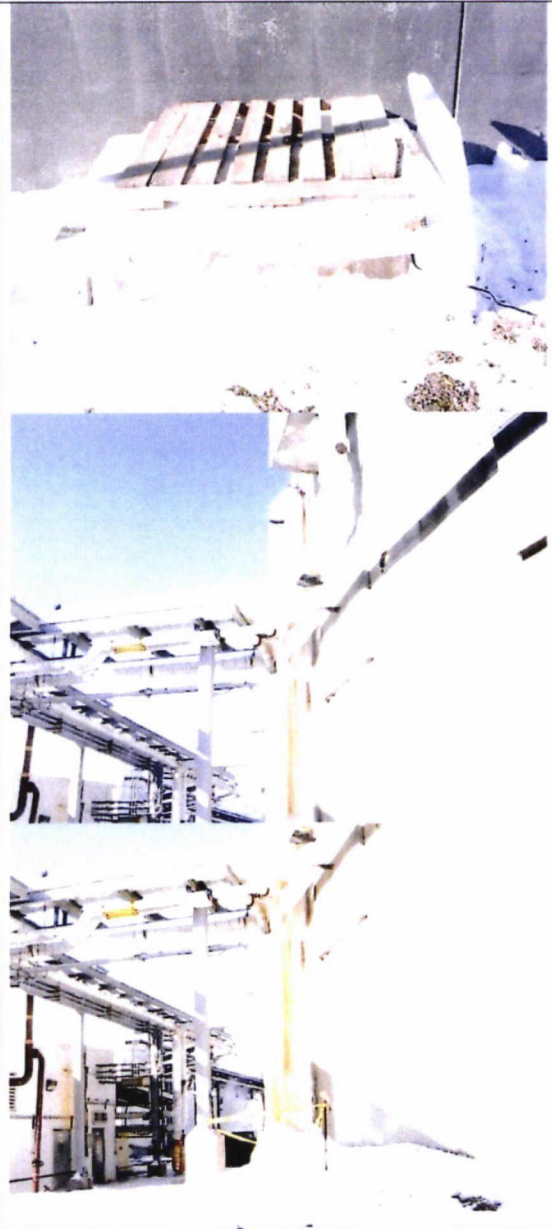
**STOP 6 – ALTEN LLC FACILITY  
DIGESTERS – 0932 hrs.**

Same observed by Greg Michl 2-18-21.

Top photo. Looking at piping well associated with north digester. Chord on right side leading into well is associated with heating lamp for piping.

Bottom two photos. Looking at ice accumulation on side of north digester.
