AltEn: Samples at Pond below Site 2,  
March 26, 2021  
Dave Bubb, NDEE

On March 26, 2021 I collected water samples from a pond, owned by Stan Keiser, approximately 0.5 miles below, or east of, Site 2 on the unnamed tributary to Clear Creek.

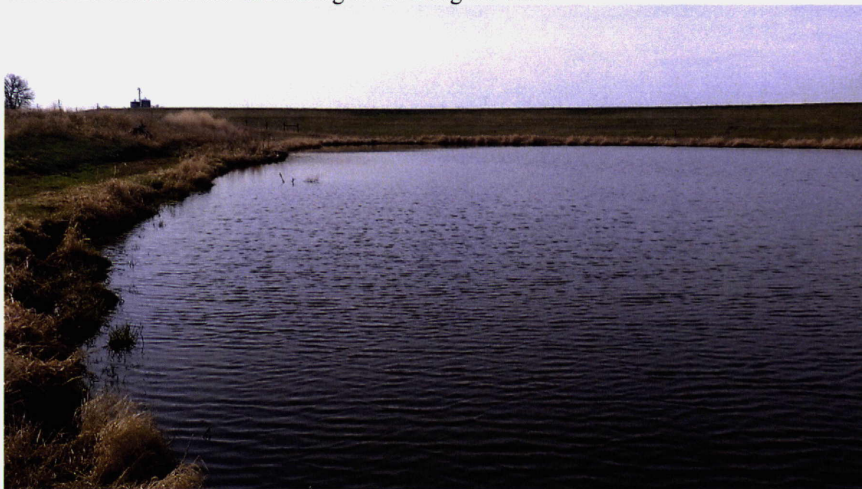
On the north side of the dam facing south along the dam.

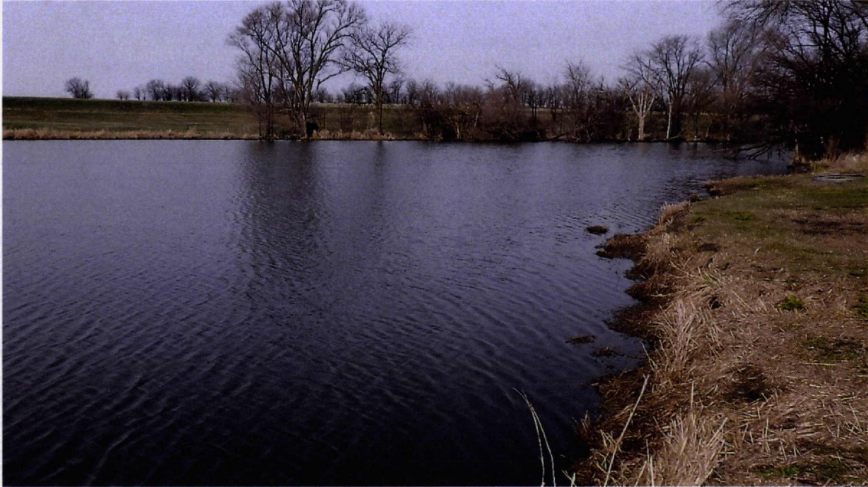
On the north side of the dam facing west/northwest

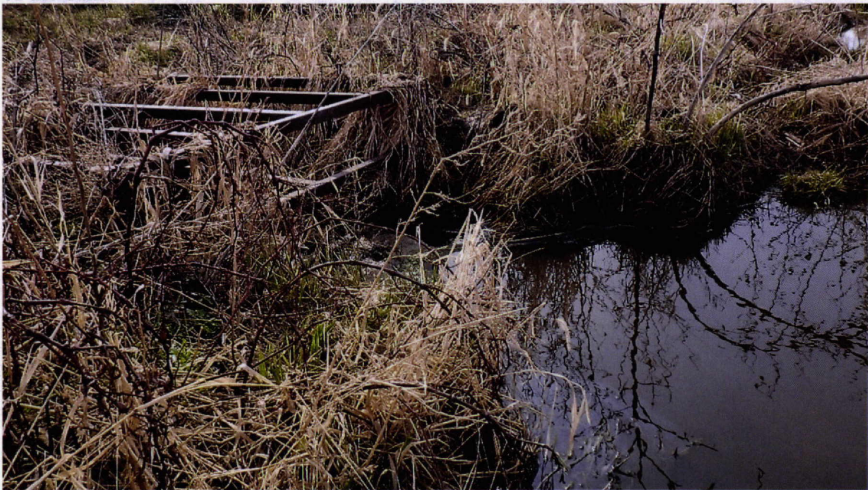
Photo is facing south/southeast and is of the outfall structure at approximately the middle of the dam.

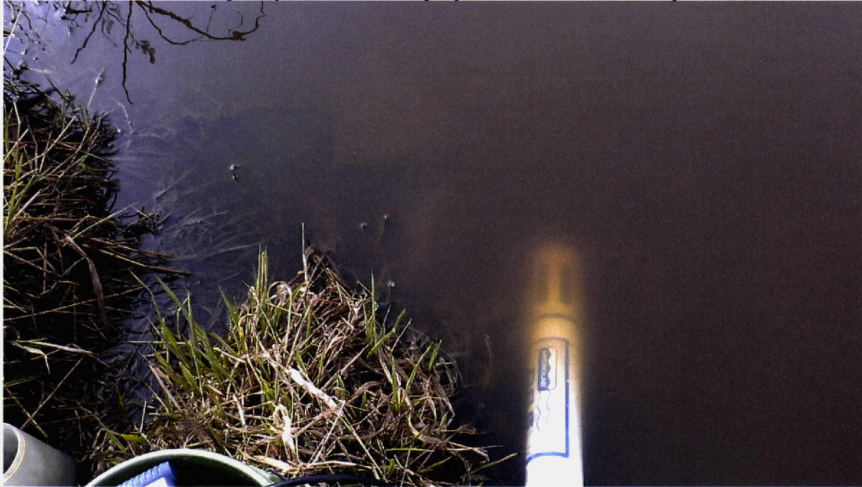
Photo taken at approximate center of dam just to the north of the outfall structure and is of the Hydrolab water quality instrument deployed to determine field parameters.

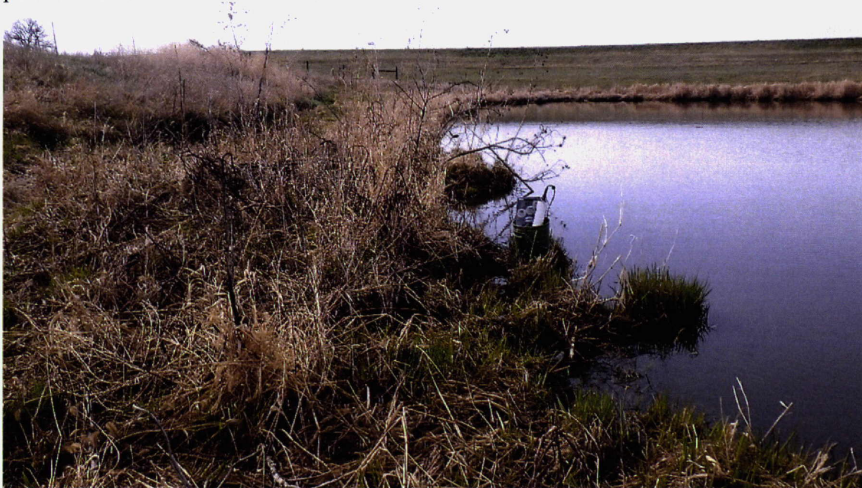
Facing south at approximate center of dam. Photo is of the green bucket which contains the Hydrolab water quality instrument and is at the site where field parameters and water samples were collected. The outfall structure is to the left of the bucket. Water temperature: 8.4 degrees C, Dissolved oxygen: 0.4 mg/l, pH: 6.7 St.Units, Conductivity: 483 Umhos/cm, Turbidity: 36.1 NTU's, Dissolved oxygen (percent saturation) 2.6 percent. Collections time was 10:20.

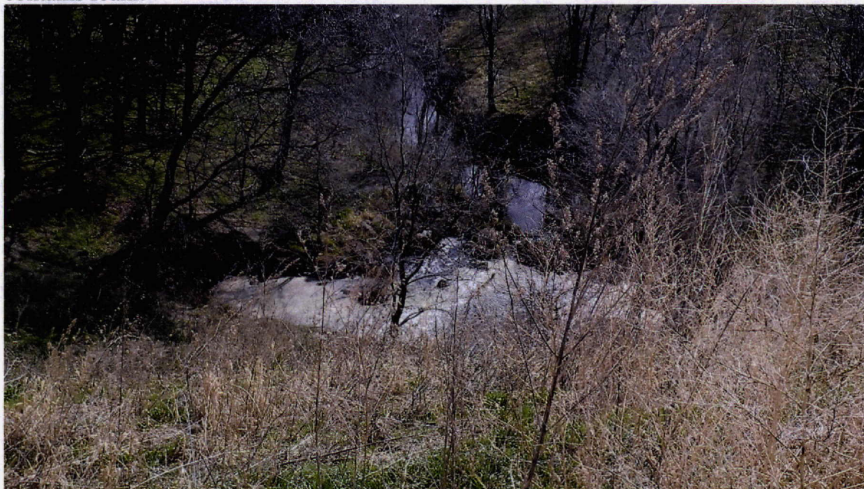
Facing east from the east side of the dam. Photo shows discharge below the dam. Water contains foam.

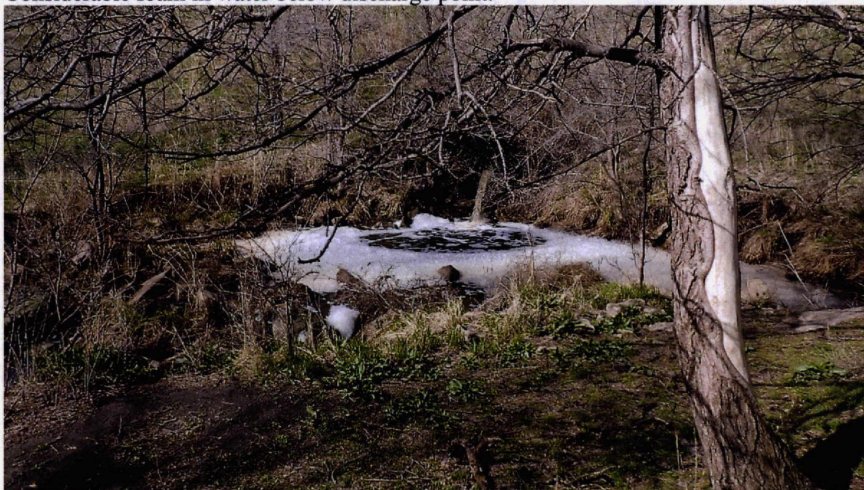
Below dam and facing west towards dam. Center of photo is discharge from pond. Considerable foam in water below discharge point.

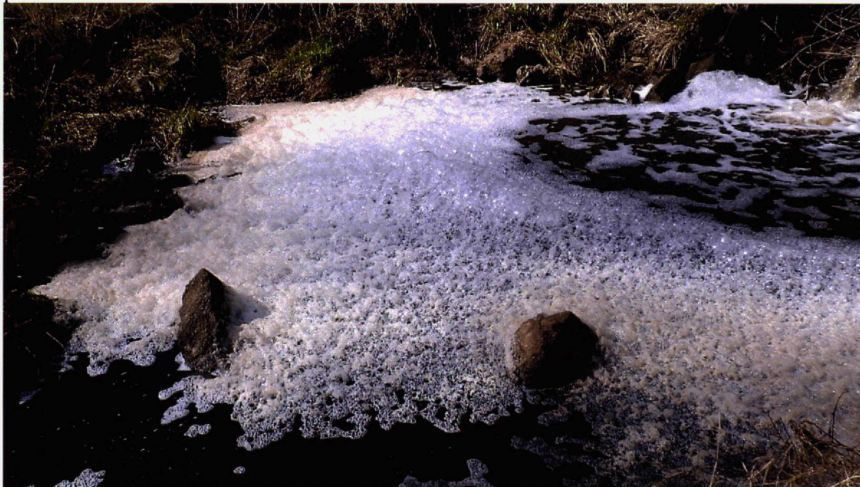
Close-up of foam from discharge below dam. Discharge point is on the right side of the photo.

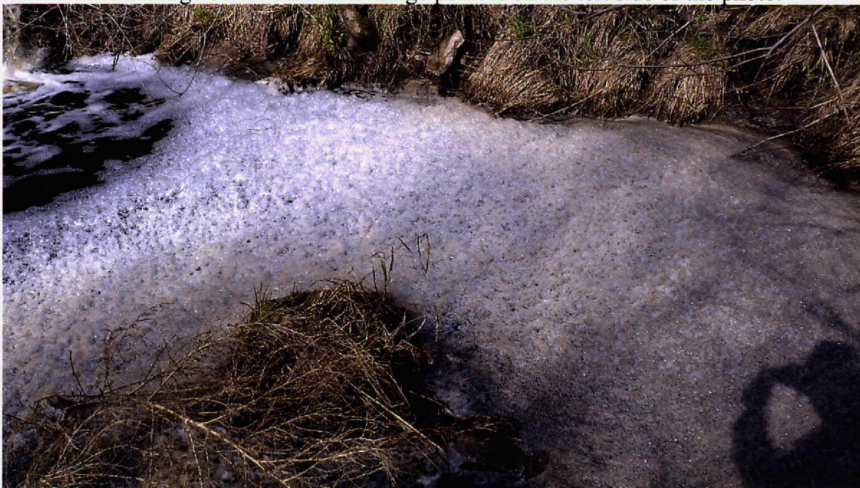
Foam near discharge below dam. Discharge point is on the left side of the photo.
