Facility: AltEn
IIS: 84069
PCS: NE0137634

Site Visit Check list

AltEn LLC - Storm Water Temporary BMP Check Map

Site Visit Report

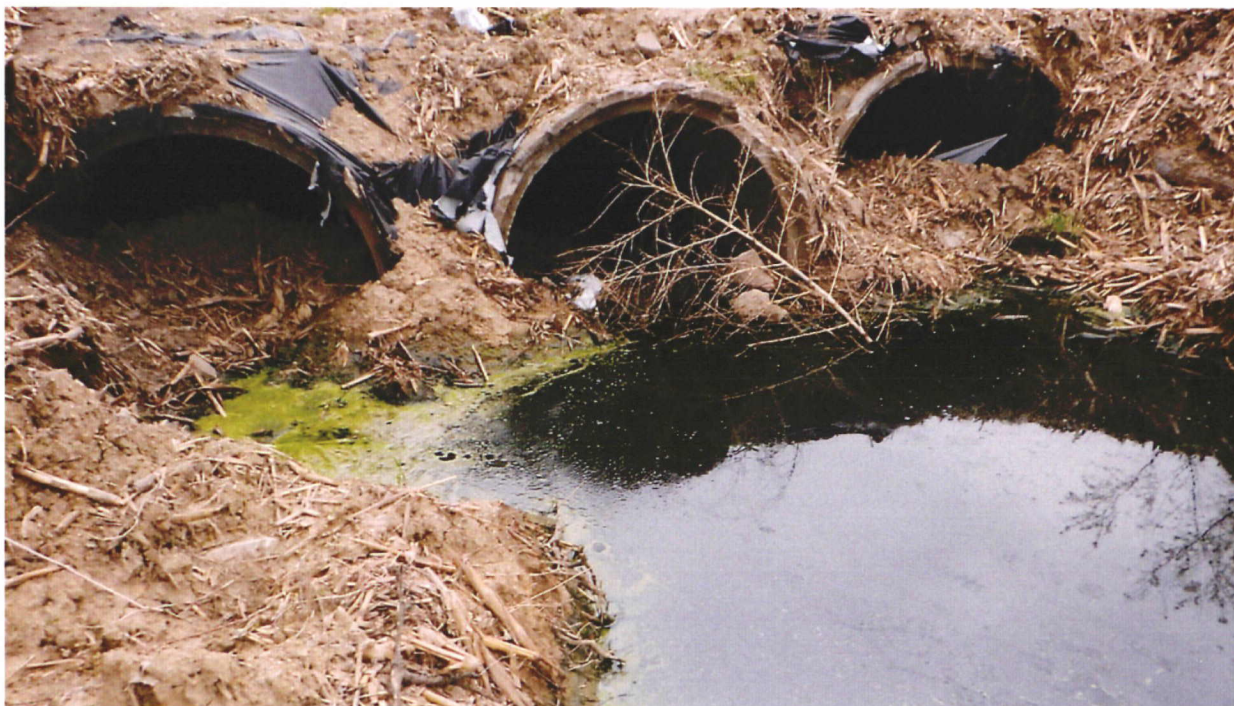
Photos: 1

Description: Culverts still partially plugged and water beginning to clear up with the addition of algae.

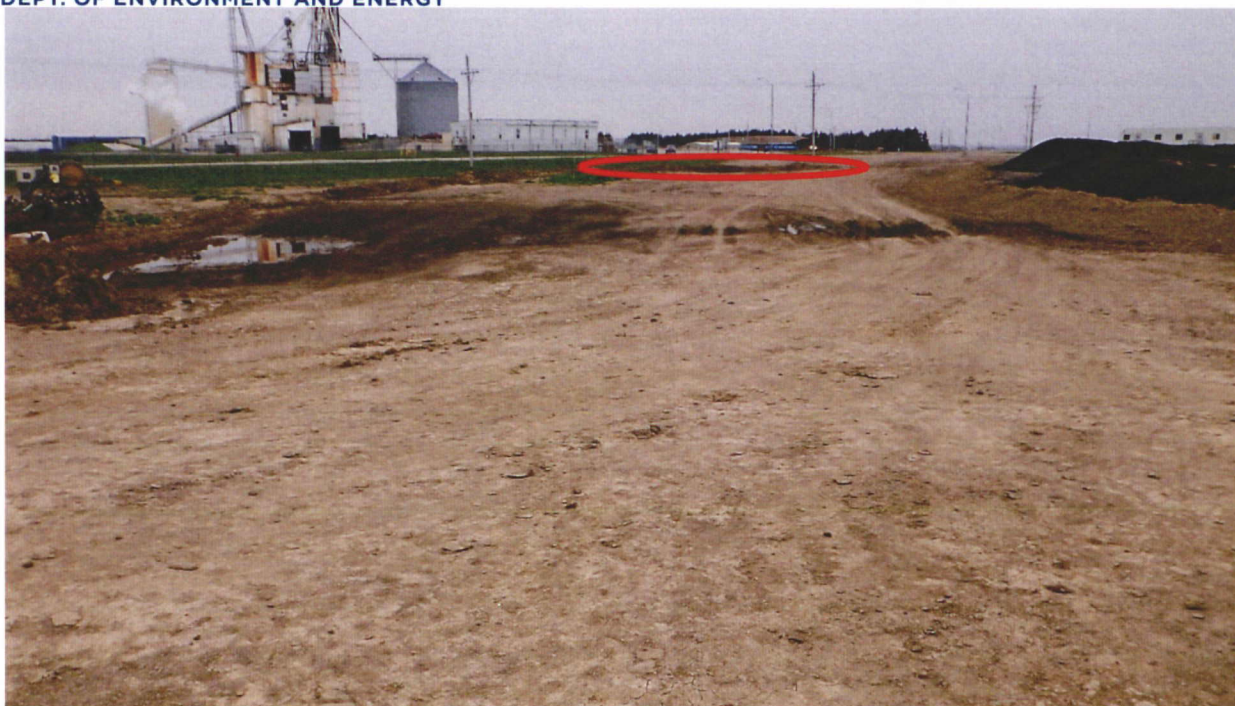
Photos: 2

Description: An additional berm was added to divert runoff from the parking lot to separate from wetcake area runoff.

Area - 1 - Berm in good condition & second berm added to reflect water from parking lot

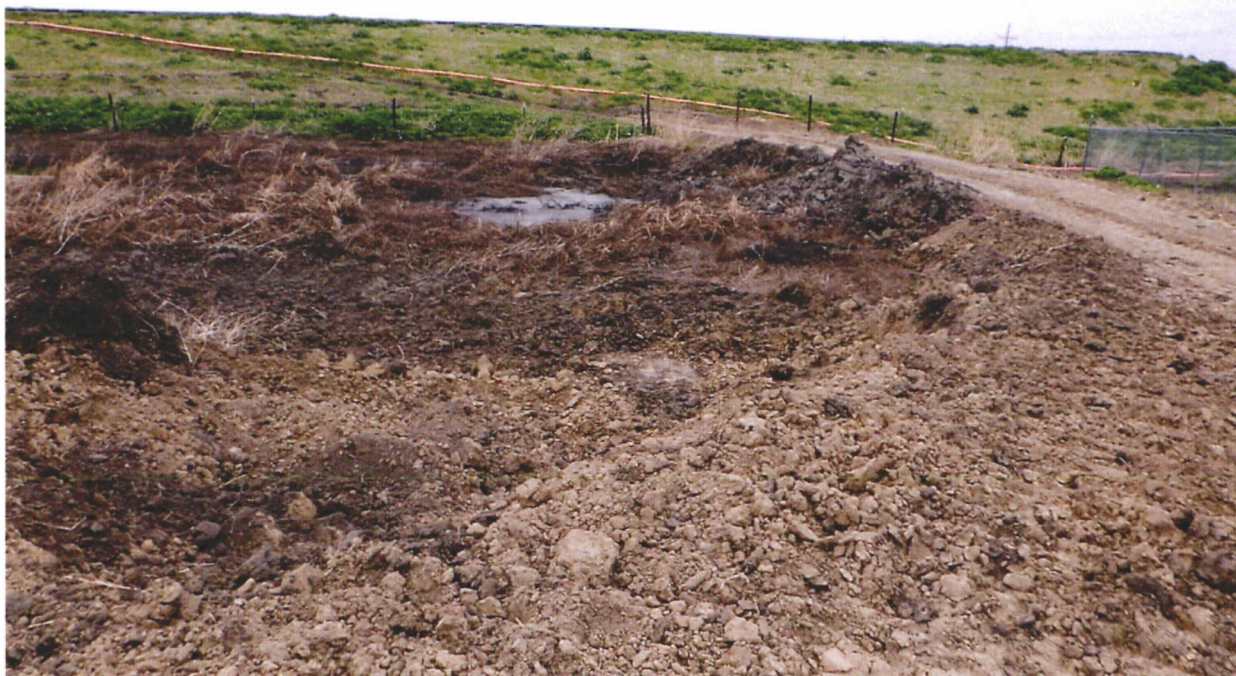
Photos: 3

Description: Berm is holding and was pumped down earlier this week.

2 - Raised earlier this week & completed. berm in good condition

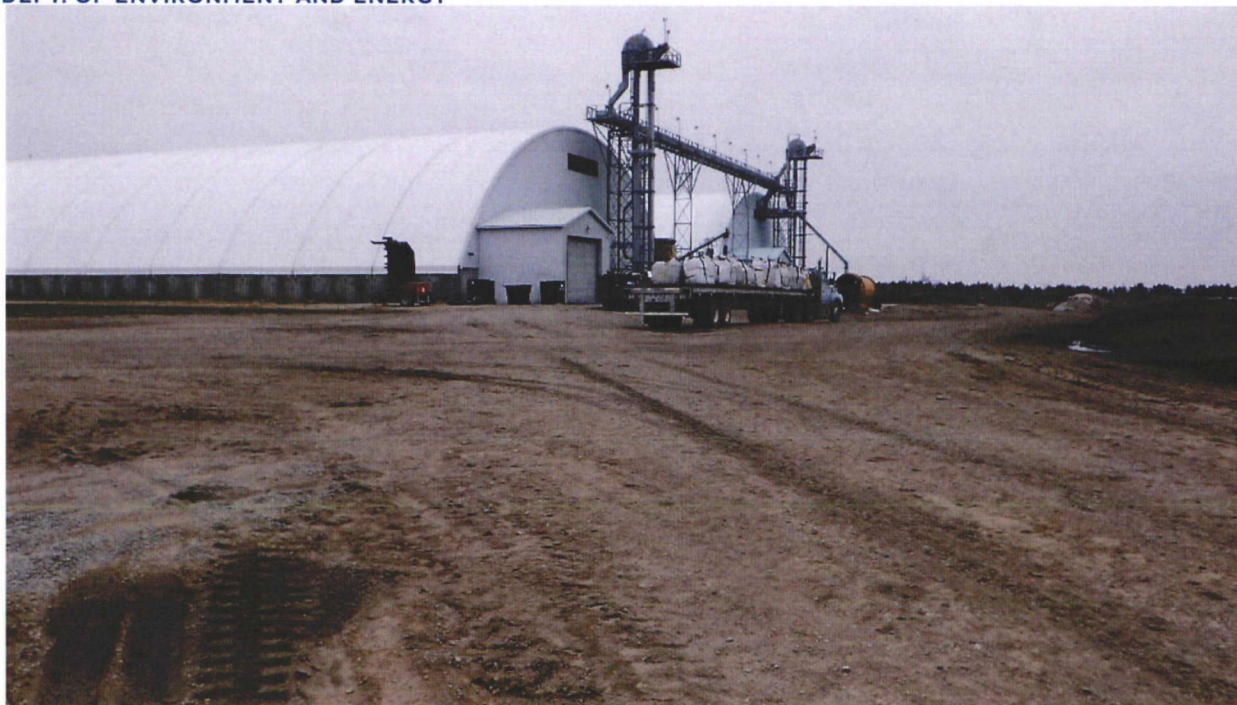
Photos: 4

- Biochar bags have been removed from the ground around the Biochar unit but were observed still on the flatbed truck east of the hoop buildings.
- The tractor used for pumping being serviced offsite and is unknown when this will be completed. The pumping of runoff in area 6 is dependent upon the repair of this tractor to power the PTO for the vacuum pump liquid manure spreader.

Description: Flatbed truck with 20 bags of Biochar waiting to be unloaded.

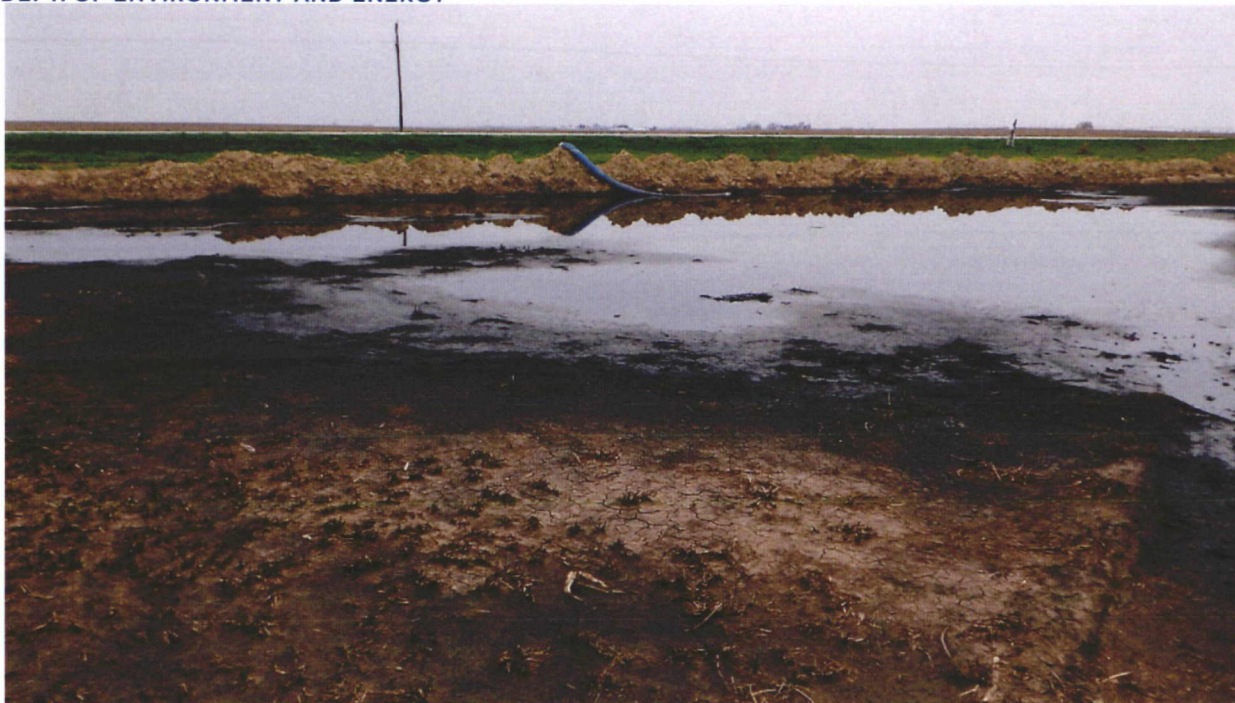
Photos: 5

Description: Berm continues to hold and majority of runoff drains to the east.

5 - Berm in good condition

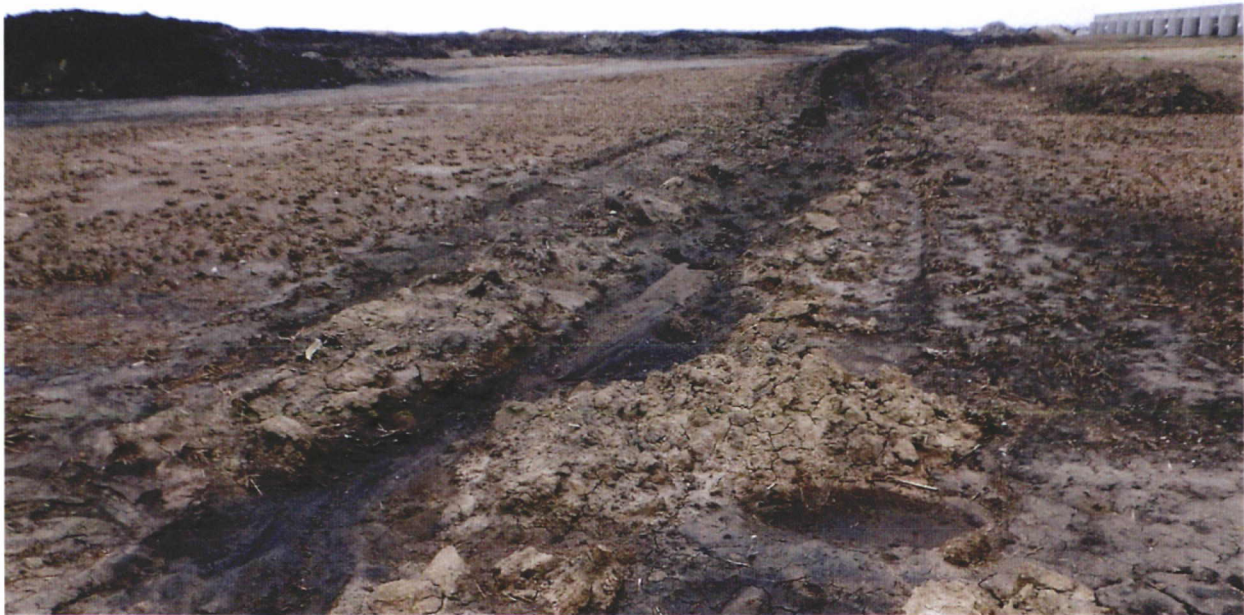
Photos: 6

Description: The trench excavated to drain area 5 to area 2.

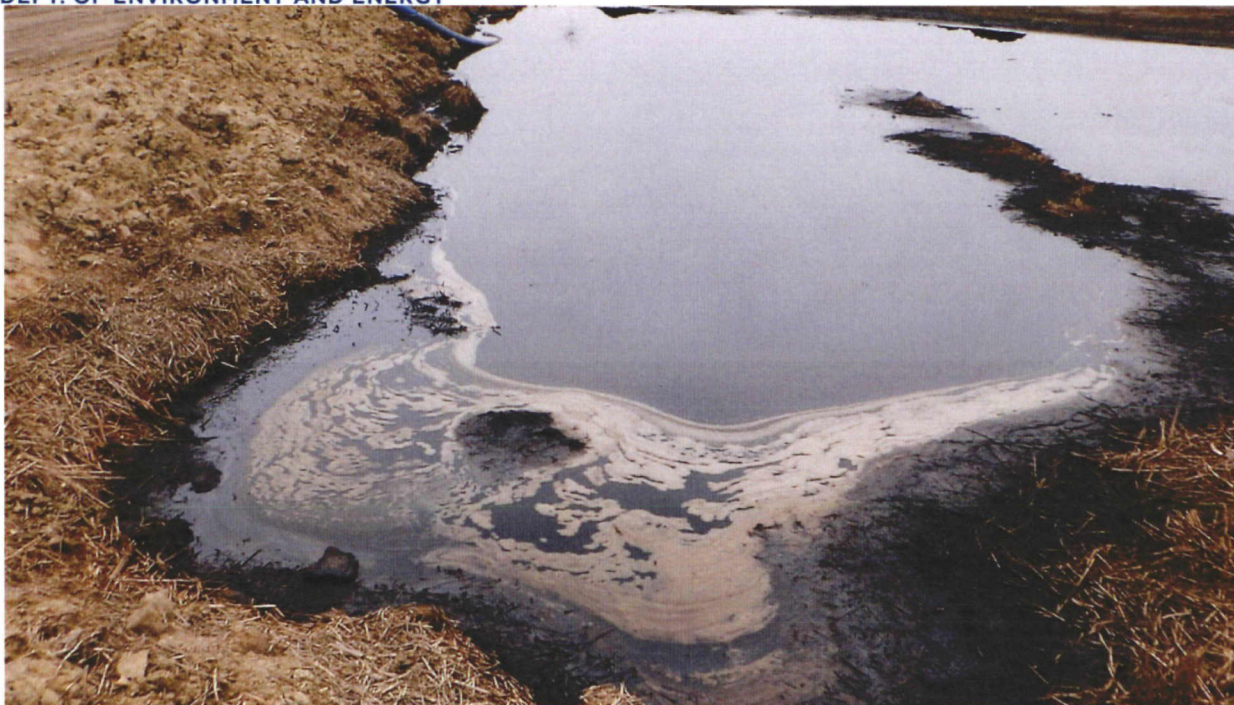
Photos: 7

Description: Wetcake runoff retained behind berm at area 5.

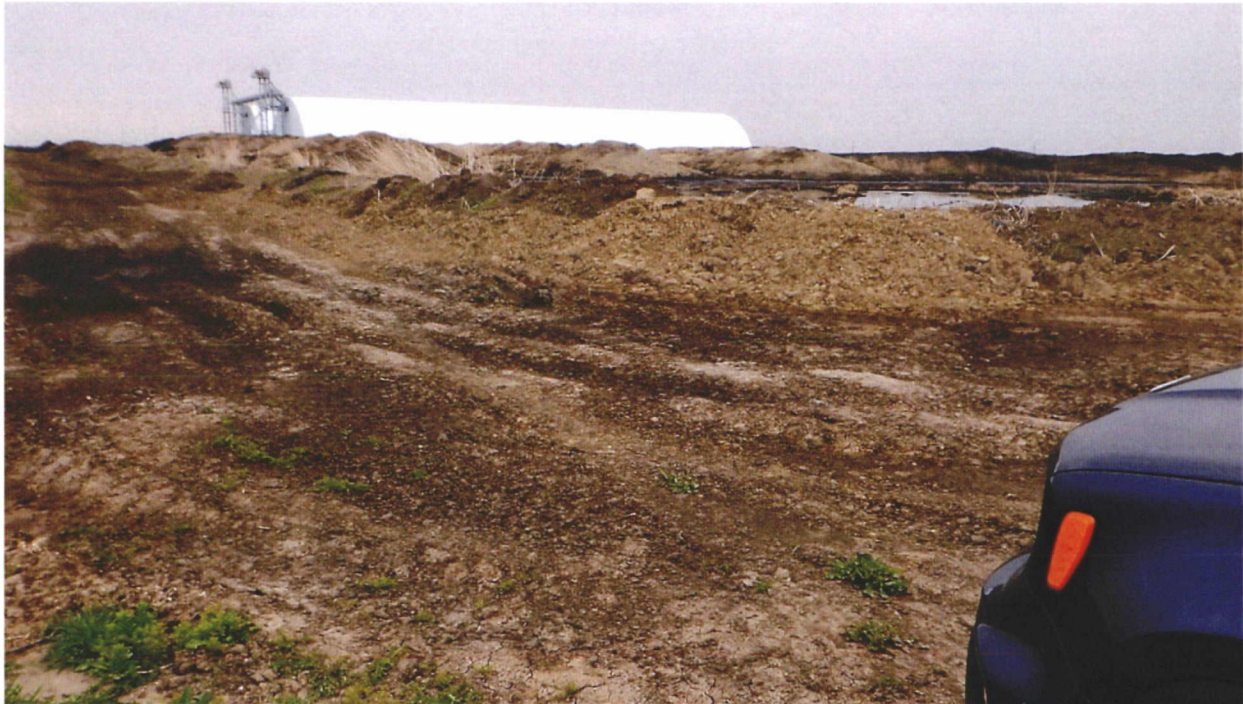
Photos: 8

Description: Berms are holding and do not show any signs of seepage.

3 - Berm in good condition & stable

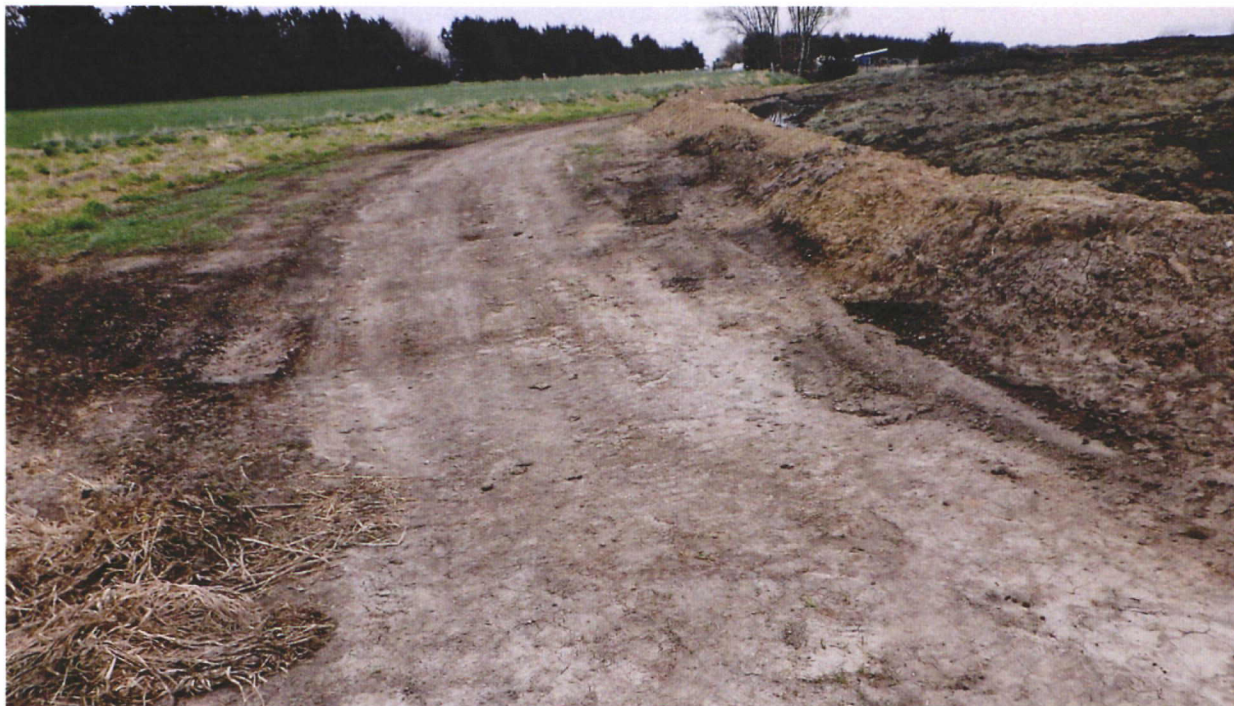
Photos: 9

Description: Seepage has slowed down on the north side of the east berm.

6 - Pump as soon as possible & stabilize berm

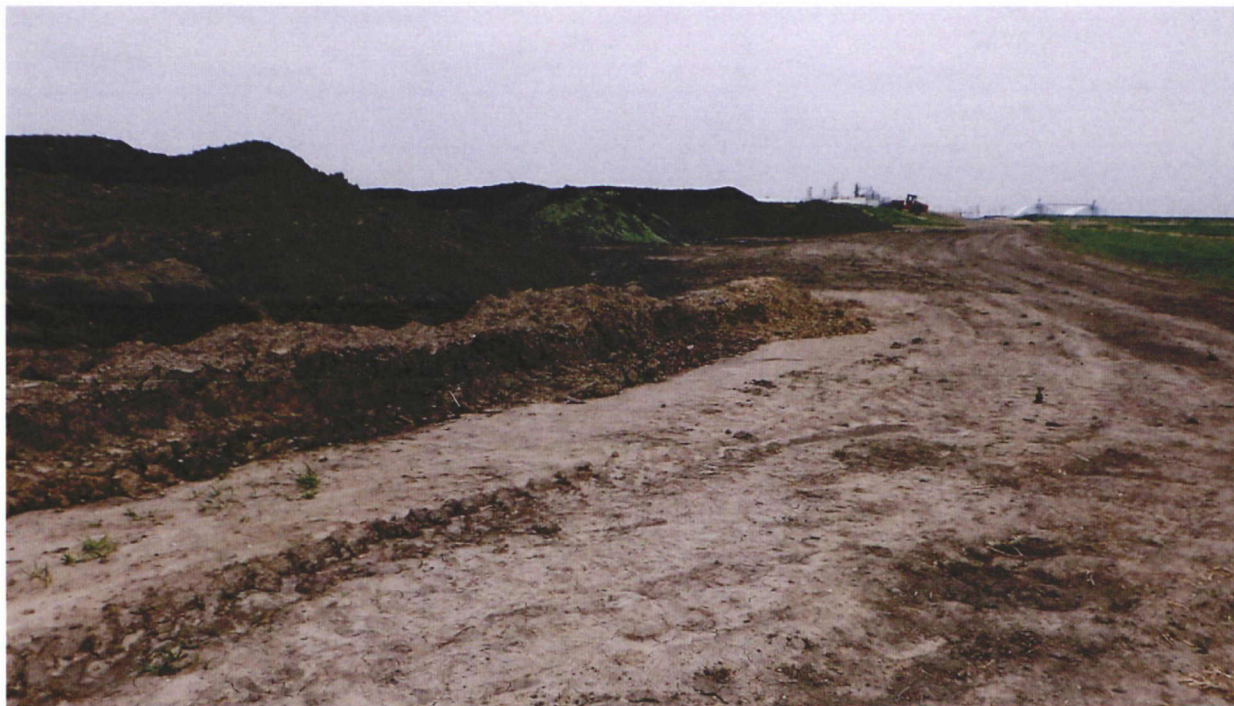
Photos: 10

Description: North side of east wetcake area.

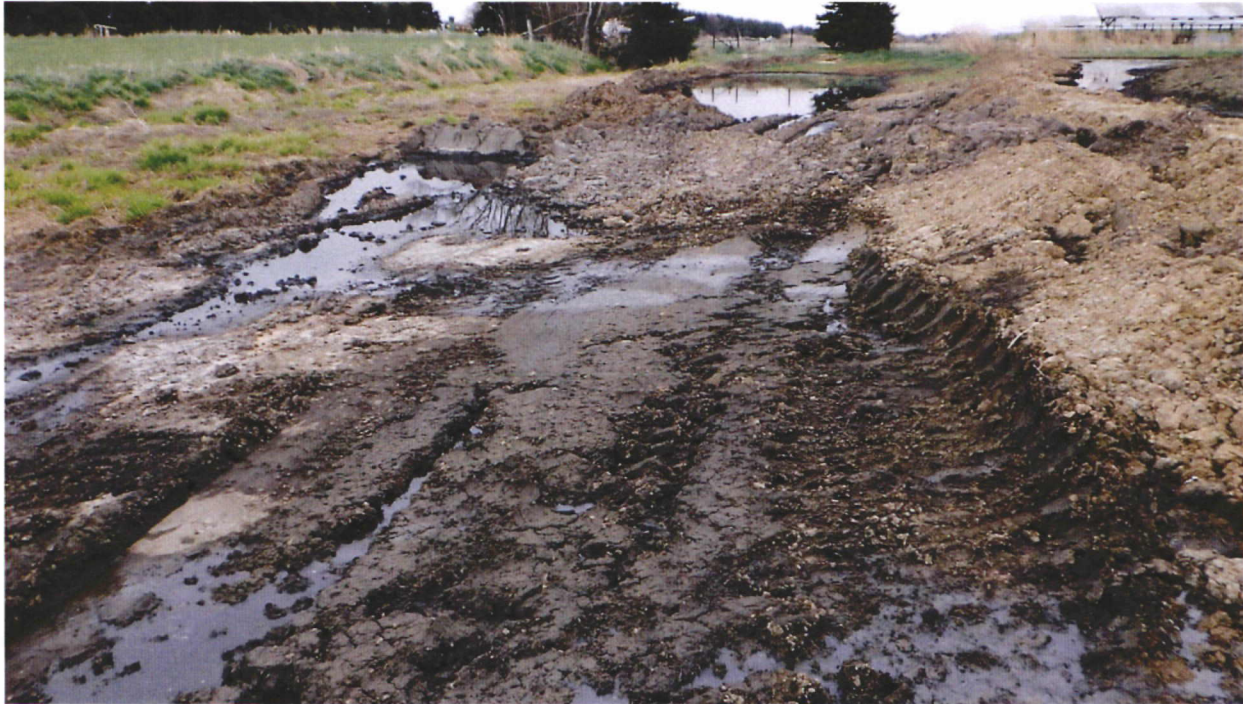
Photos: 11

Description: Center section of the east berm continues to seep and collect past the berm. AltEn will remove the seepage material this weekend or early next week.

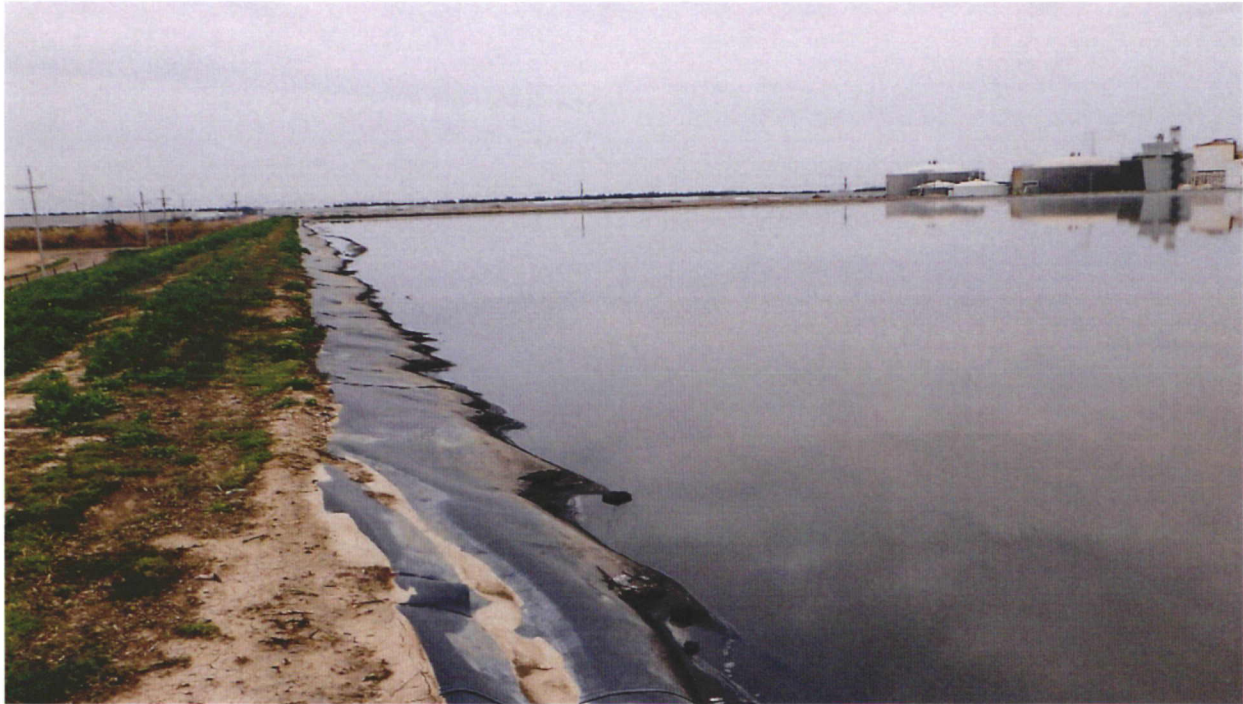
Photos: 12

Description: Lagoon has black solids collecting on all the edges of the lagoon.

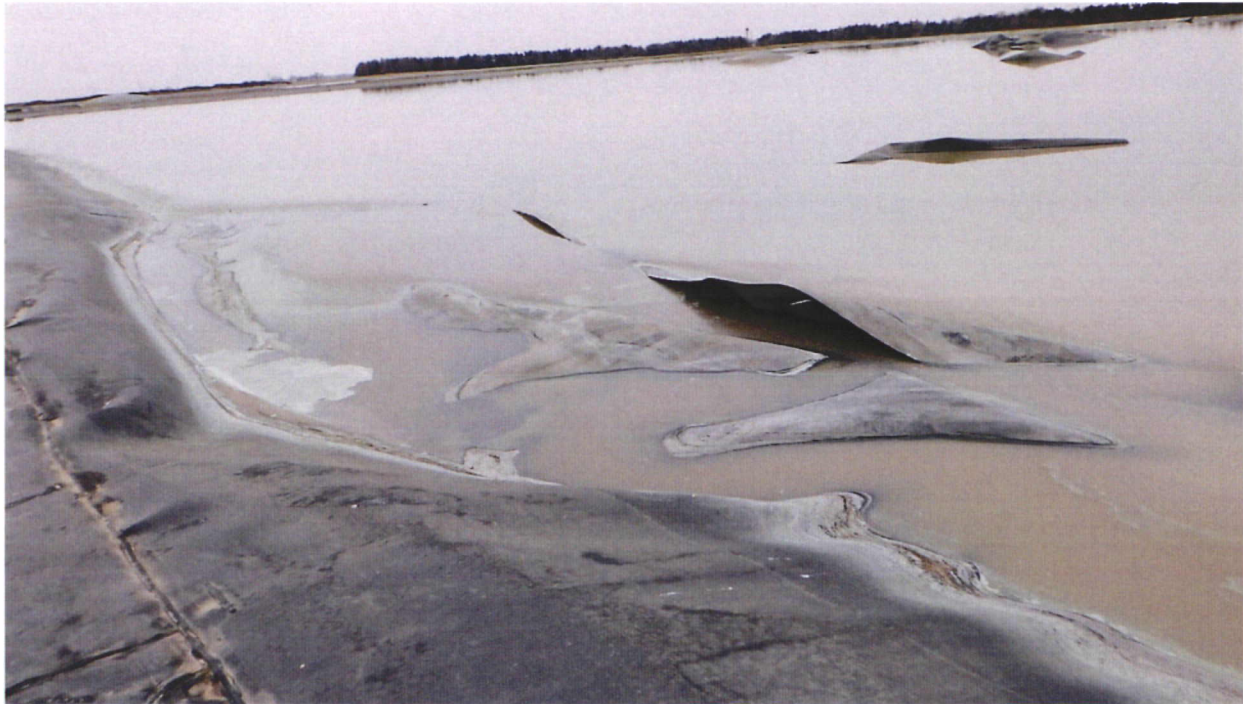
Photos: 13

Description: Green sludge beginning to surface and collect in areas that have excessive tears/rips.

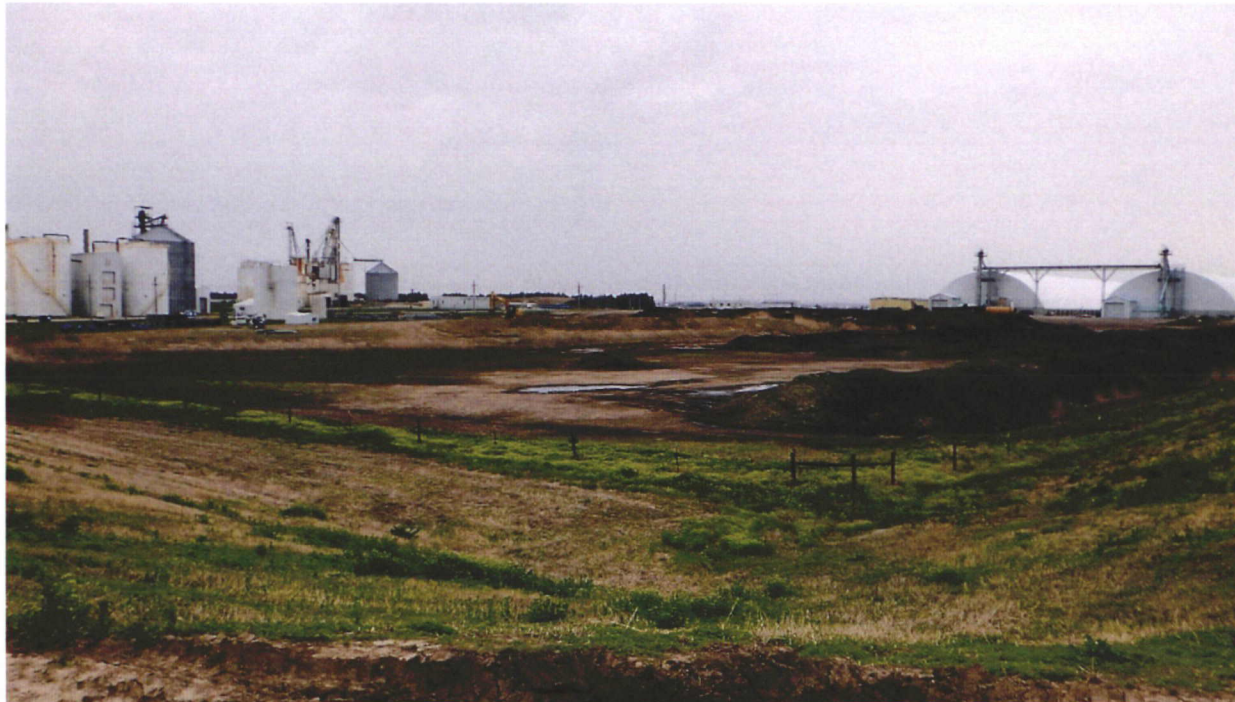
Photos: 14

Description: Area draining to area two beginning to dry out.

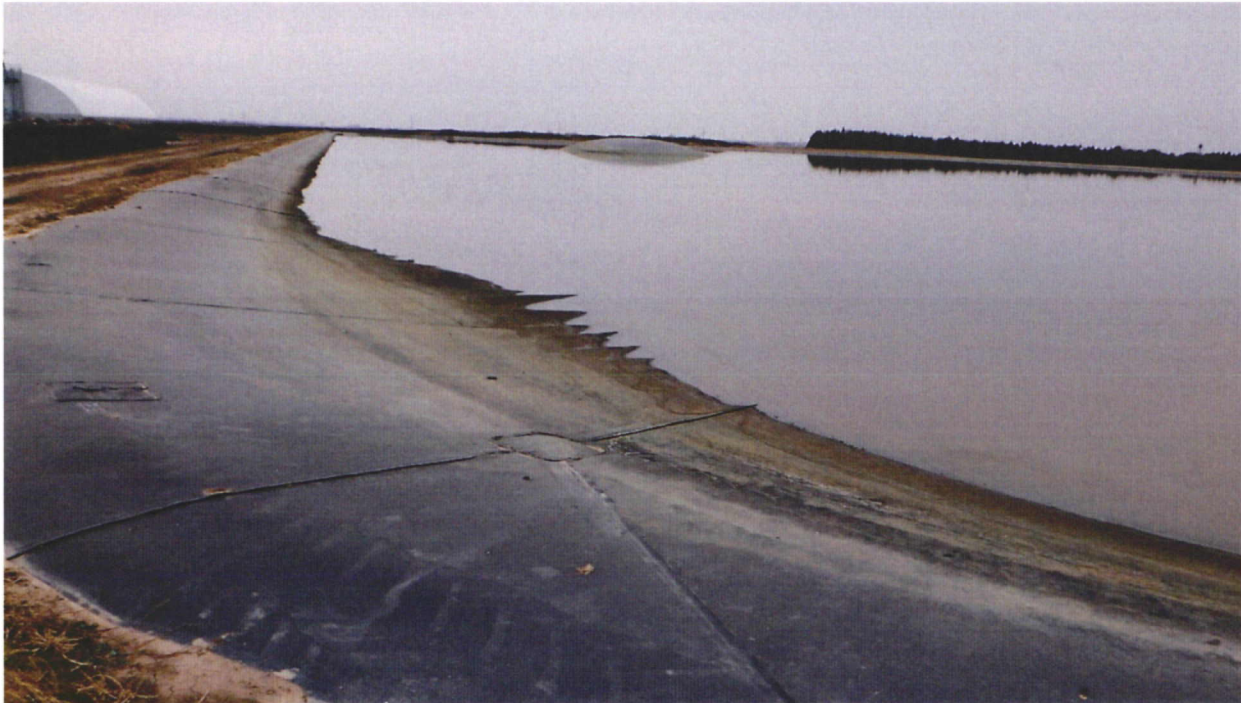
Photos: 15

Description: Sludge collecting along the lagoon edges and water line showing lagoon level dropping.

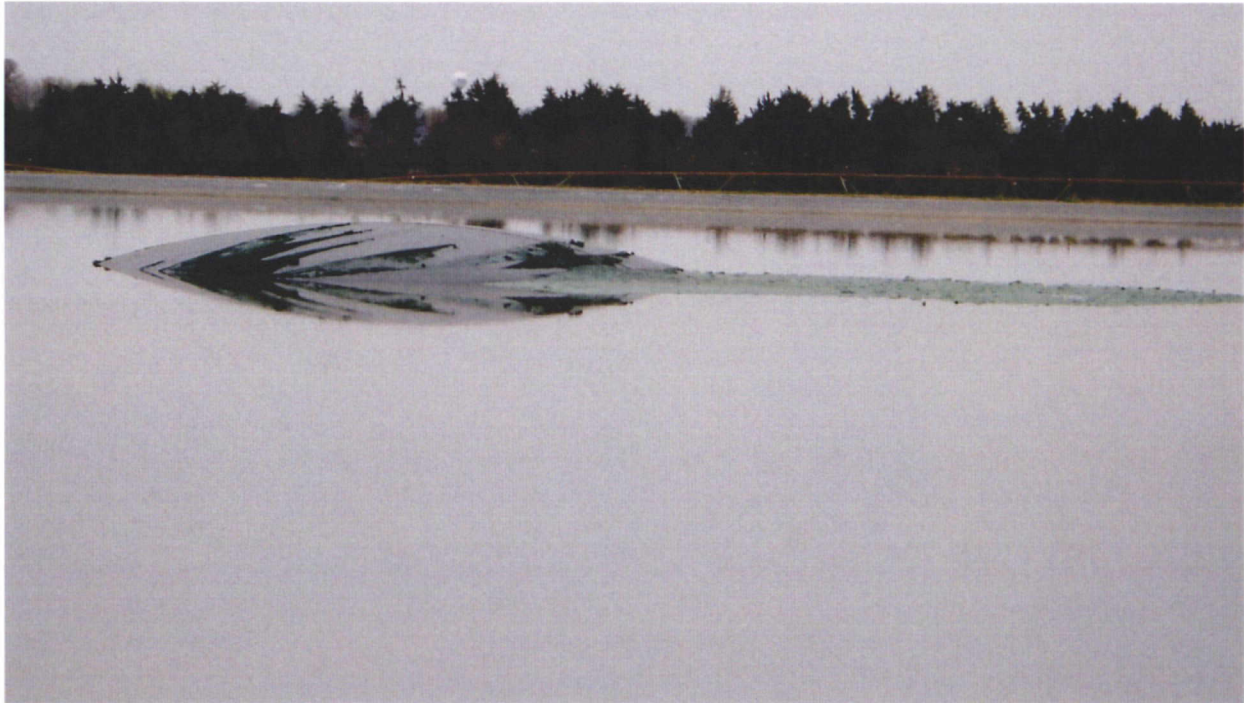
Photos: 16

Description: Thick bright green sludge surfacing around the east whale. Sludge lines on the whale indicate there may be movement of the whale toward the east edge of the lagoon.

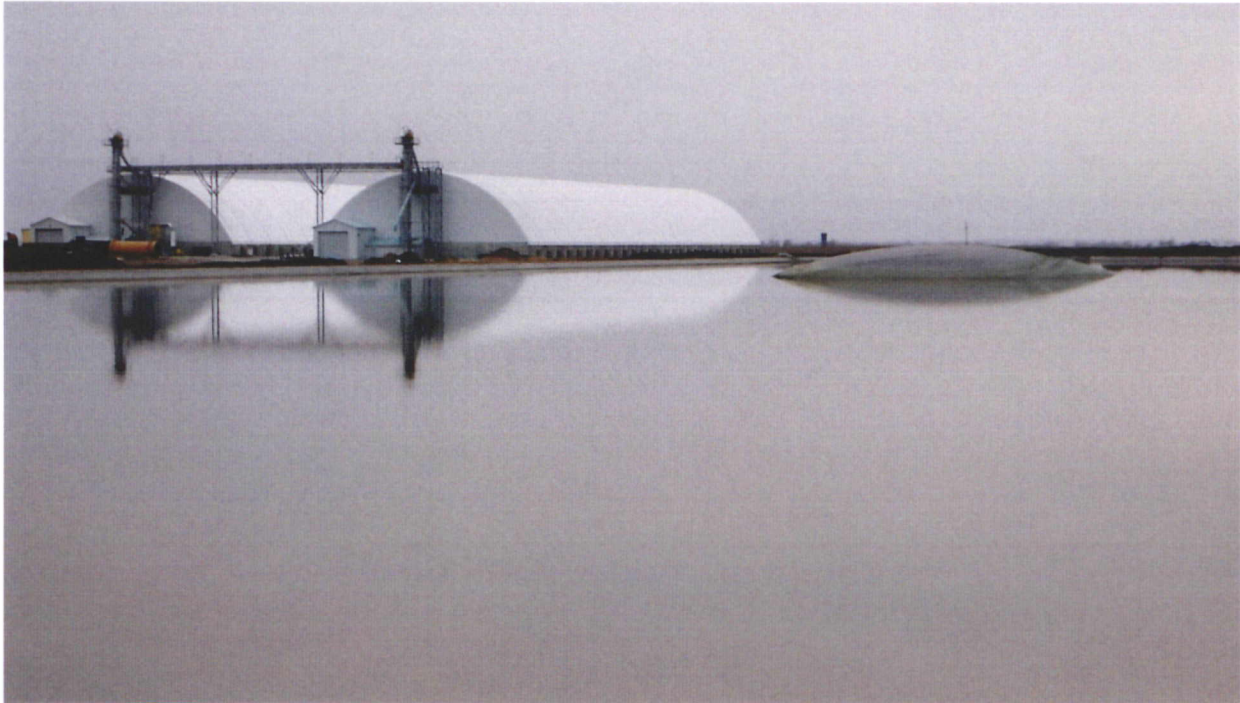
Photos: 17

Description: First whale present in the lagoon on the right of the photo and hoop barns in the background.

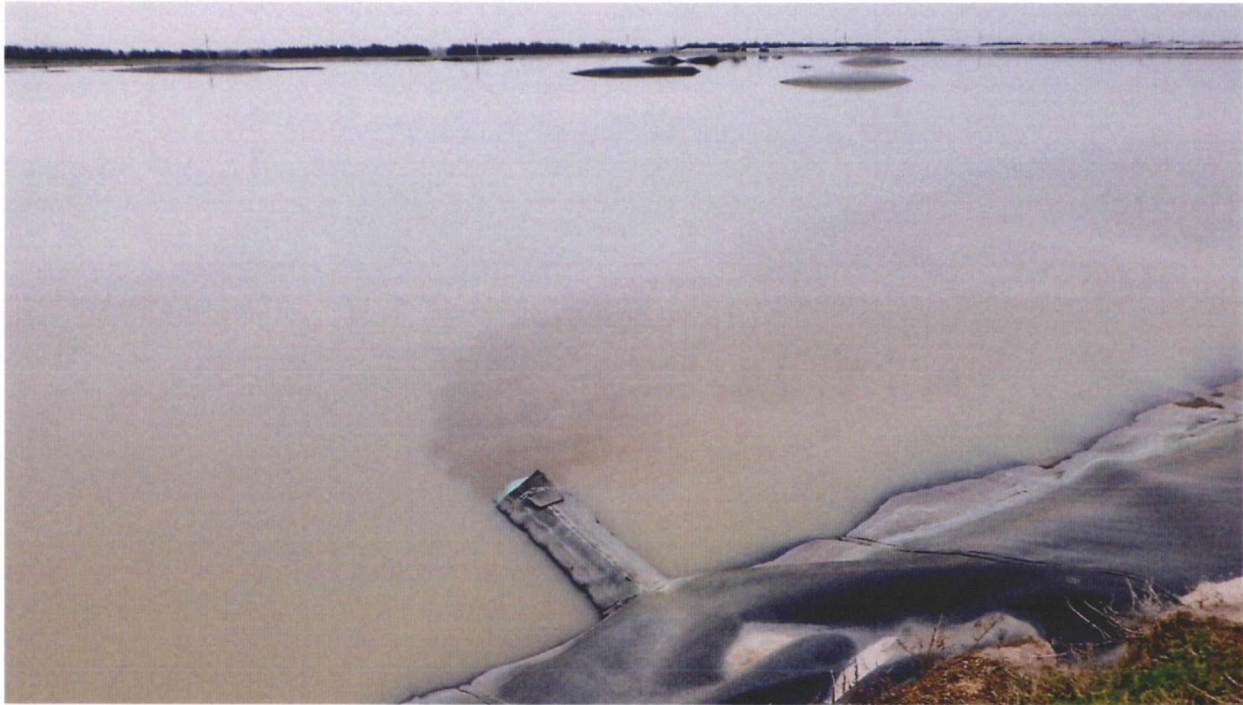
Photos: 18

Description: Equalization pipe showing flow from west to east.

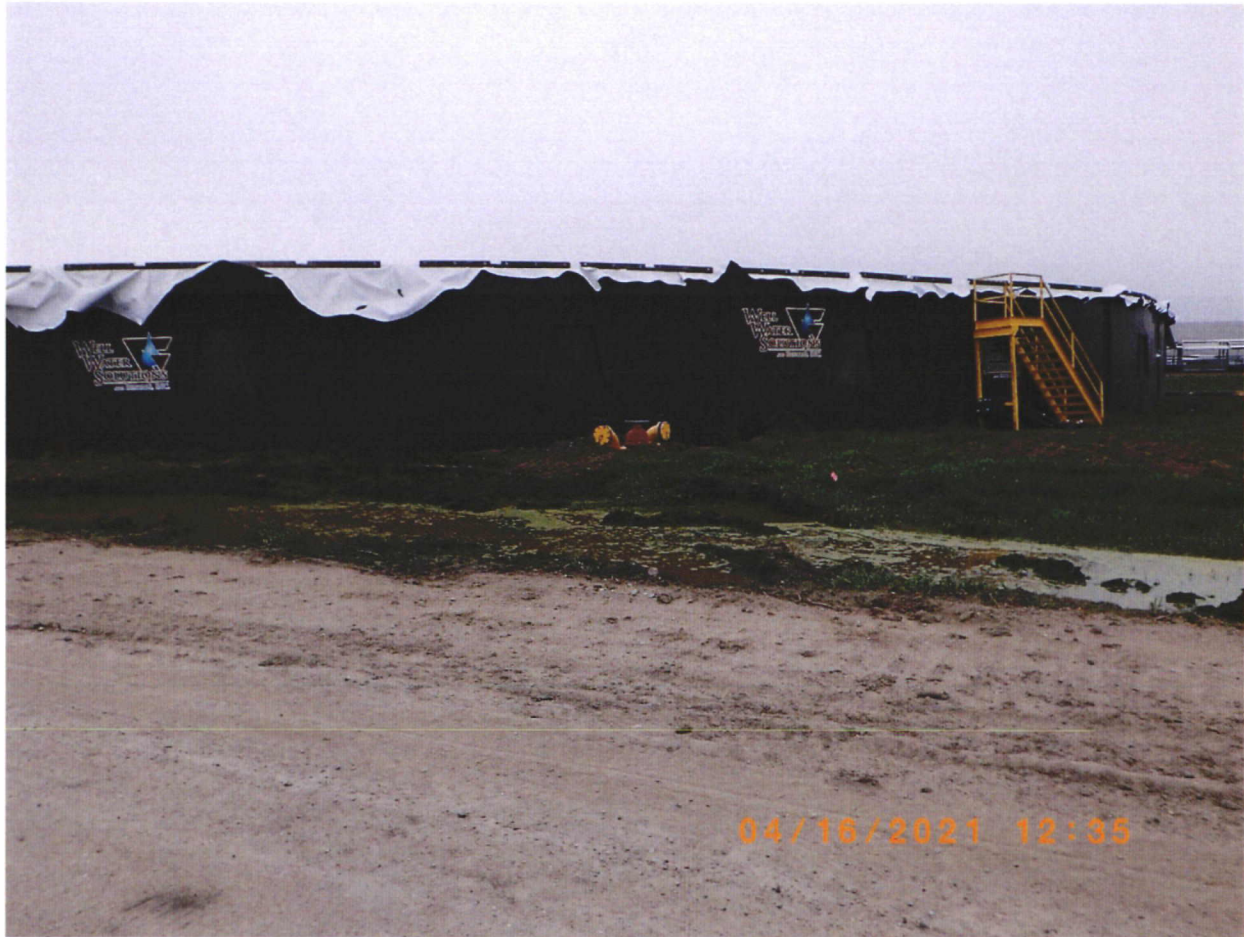
Photos: 19

Description: Tank has piping to the tank but has not been plumbed for discharge piping currently.

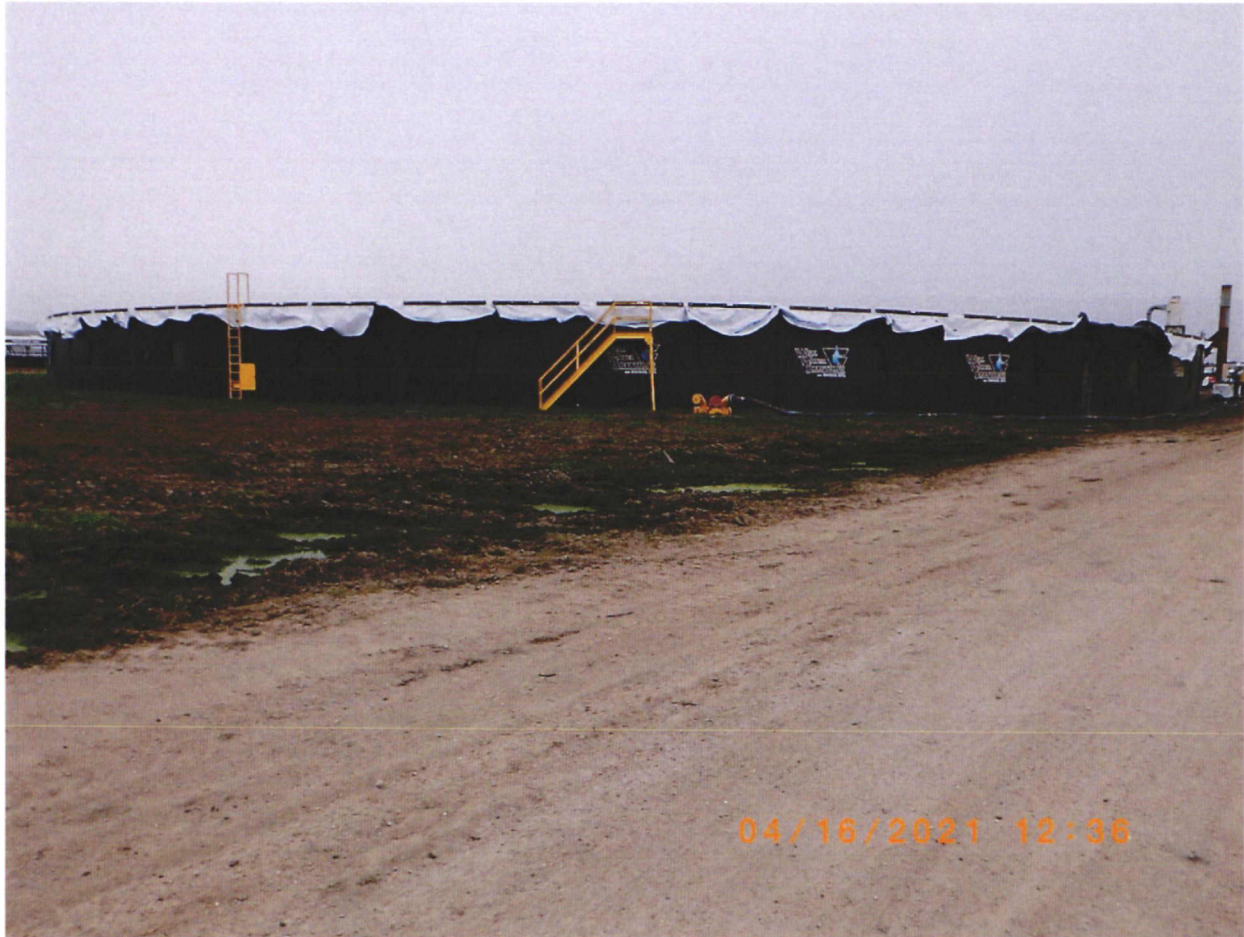
Photos: 20
Site Visit Report
Date Taken: 4-16-2021
Photographer: Jason Windhorst
Facility Name/ Project Name: AltEn LLC
Facility IIS number / Project identifier: IIS: 84069 / NE0137634
Location: Center Poseidon tank.
Direction Facing: Southwest
Description: Tank has been plumbed for inflow and outflow.

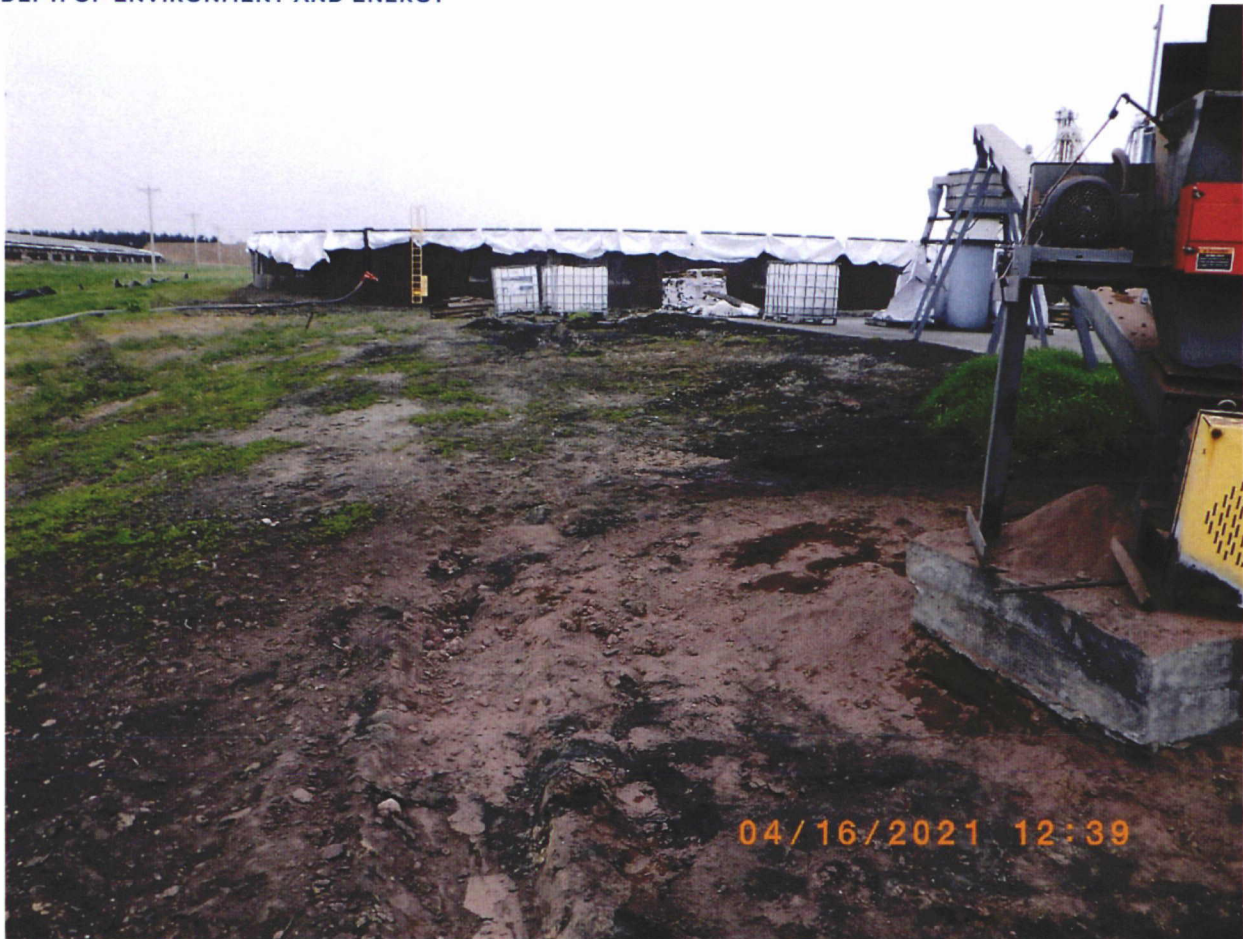
Photos: 21

Description: Debris/Biochar material covering the ground with west Poseidon in the background. All bags of Biochar have been removed, but material from bagging operation continues to cover the ground with red material removed from inside Biochar unit.

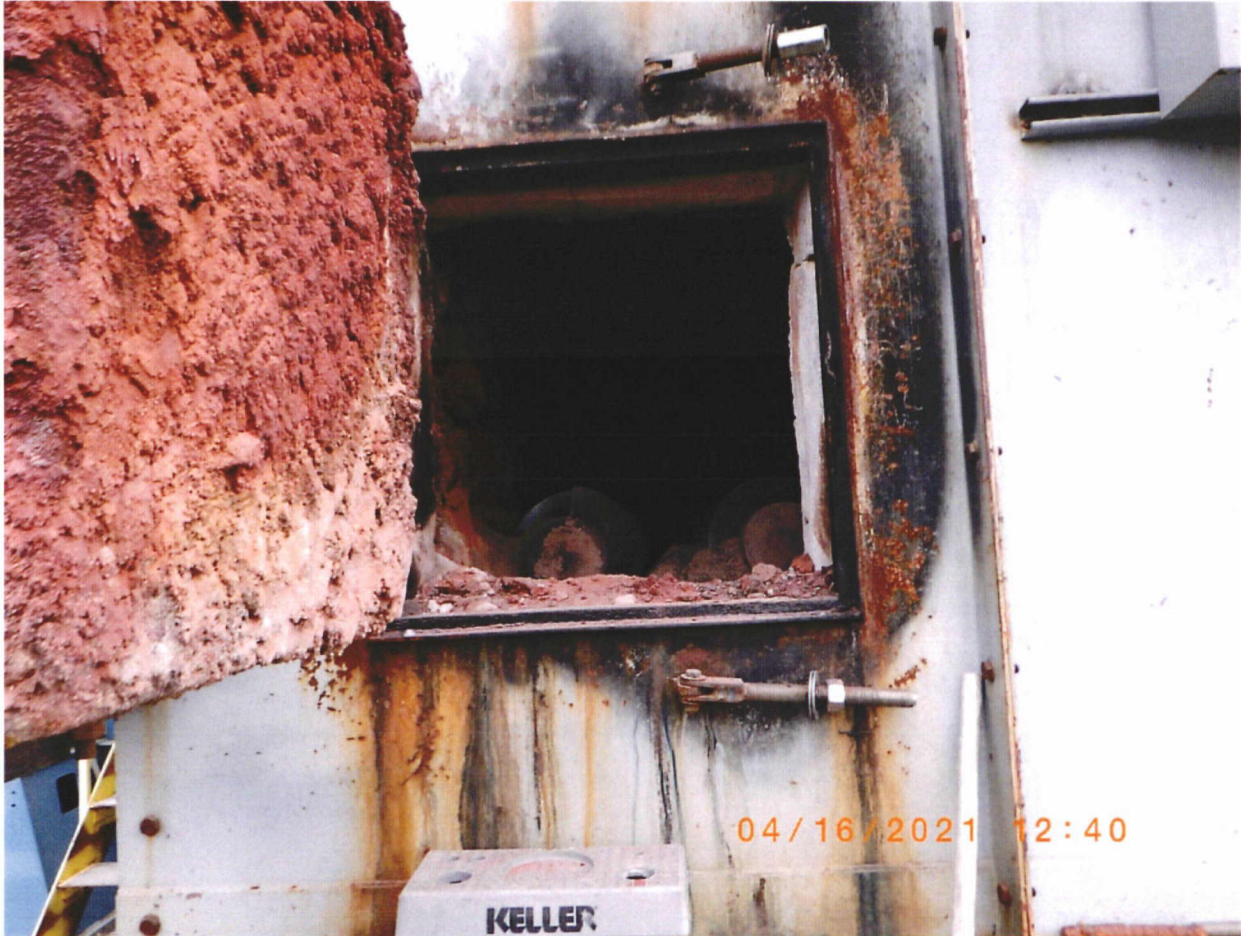
Photos: 22

Description: Inside Biochar internal auger system
