Facility: AltEn
IIS: 84069
PCS: NE0137634

Jason Windhorst
4-12-2021

Site Visit Check list

AltEn LLC - Storm Water Temporary BMP Check Map

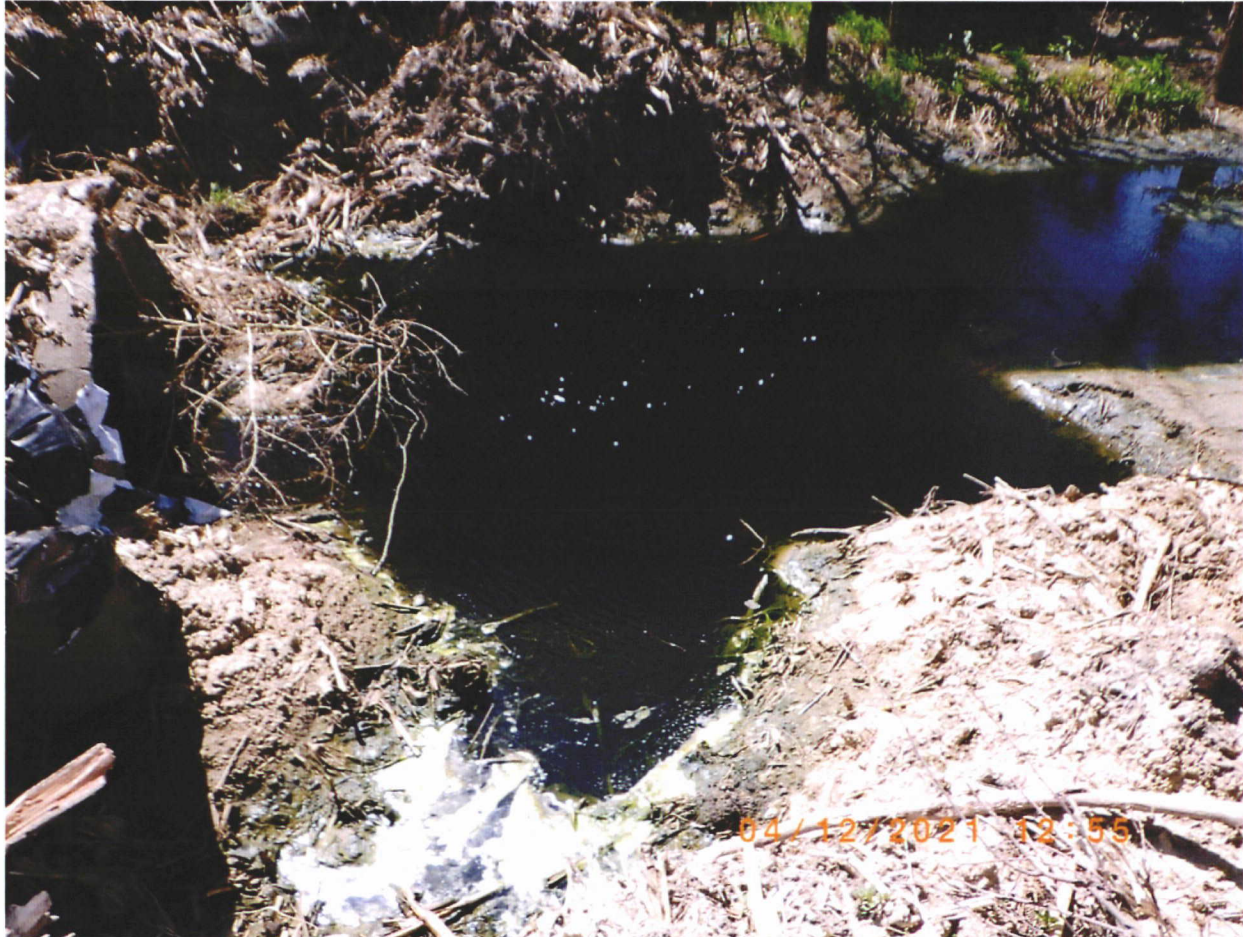
Photos: 1

Description: West side of CR 9 showing water in drainage way is slowly becoming less dark colored with each rain event.

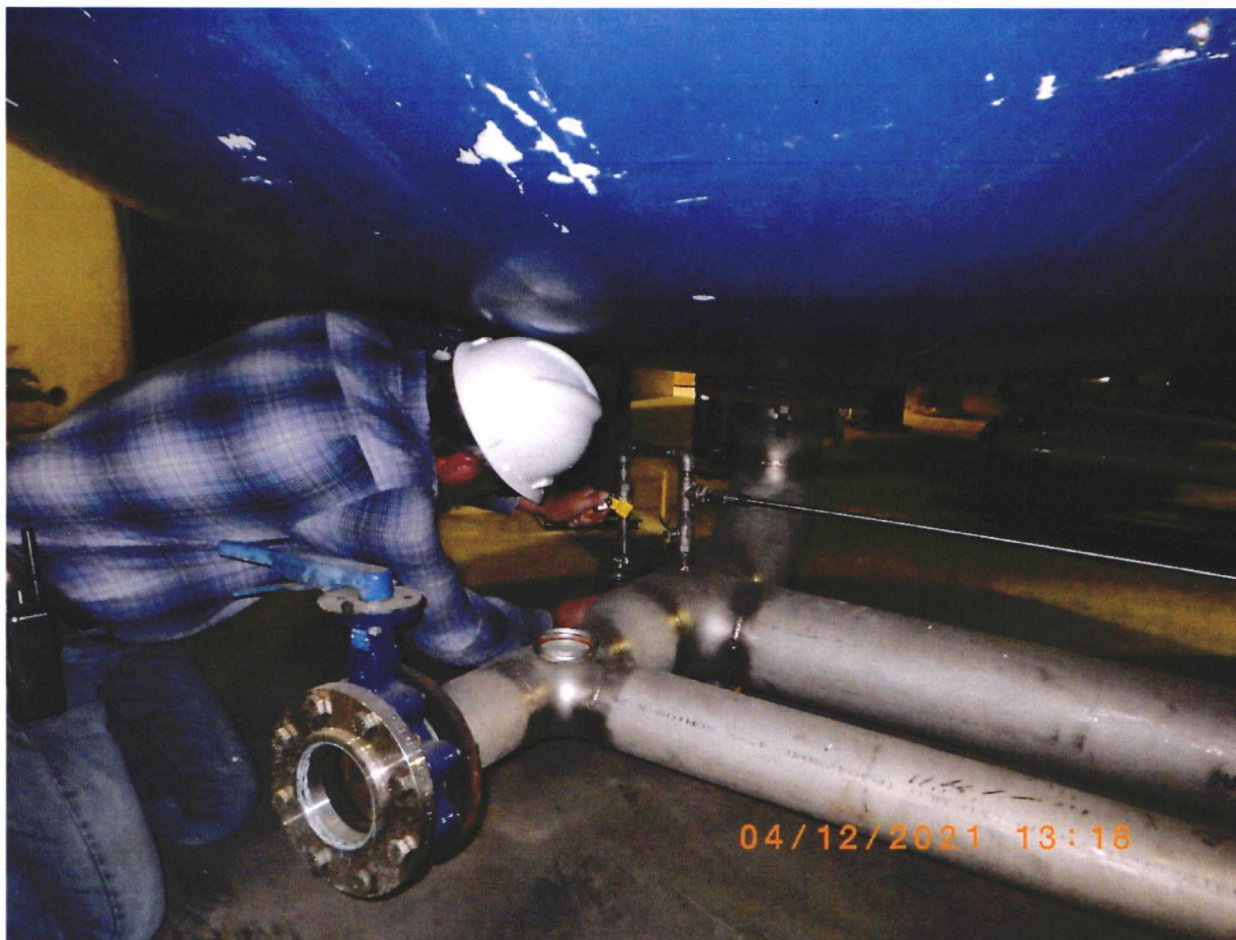
Photos: 2

Description: Staff sampling effluent from carbon filter tank.

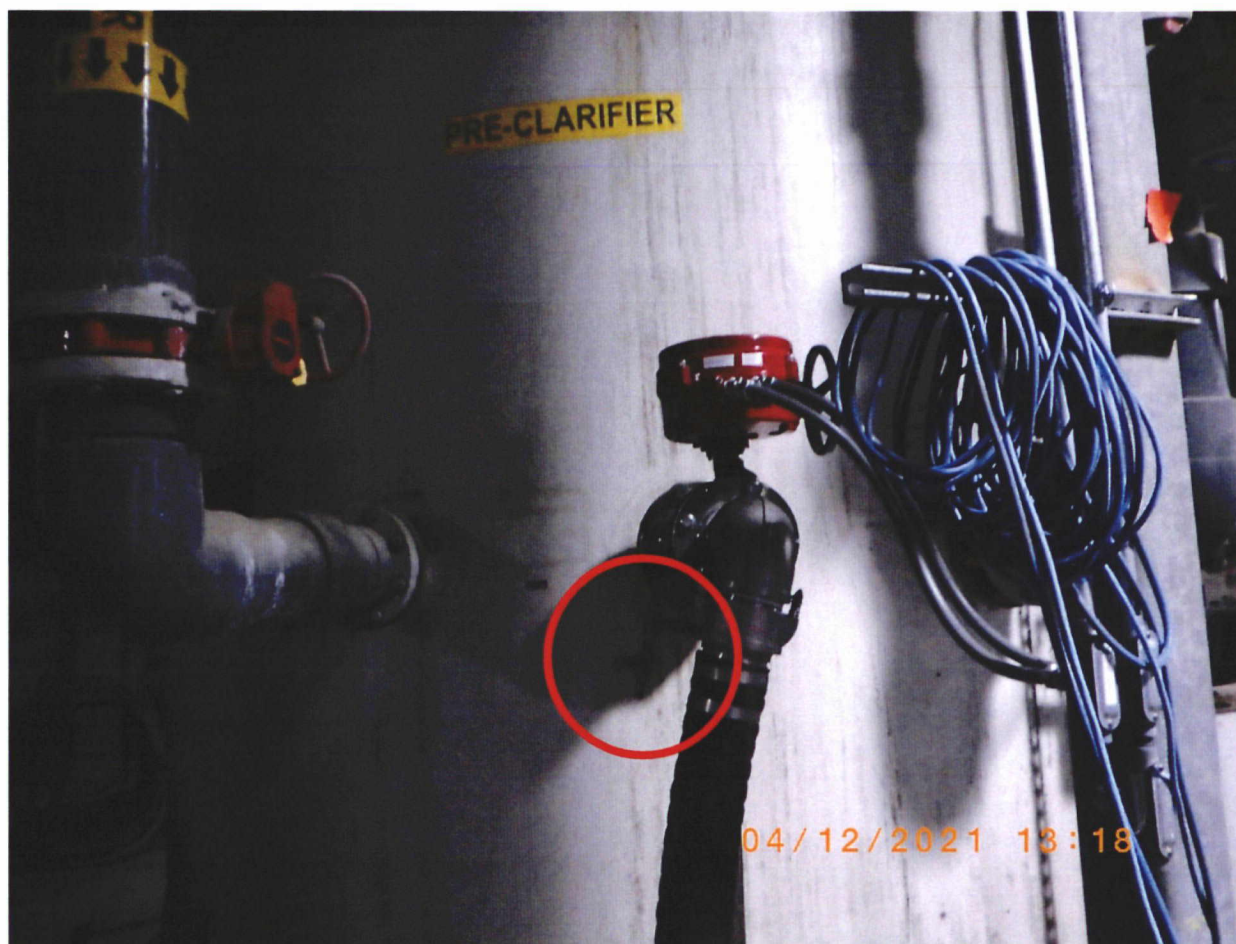
Photos: 3

Description: Influent sample location for water pumped from the southeast lagoon.

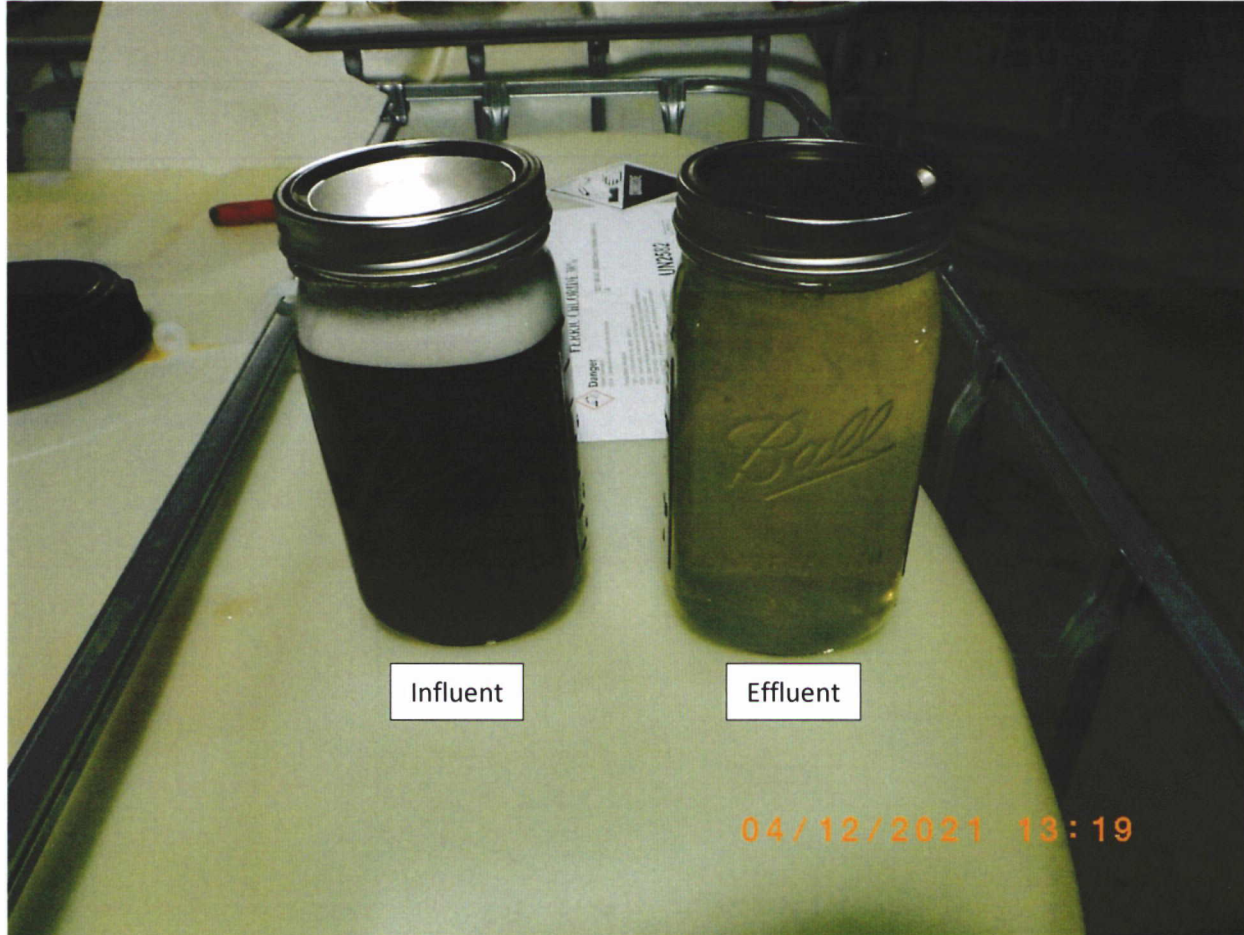
Photos: 4

Description: Influent and effluent samples taken.

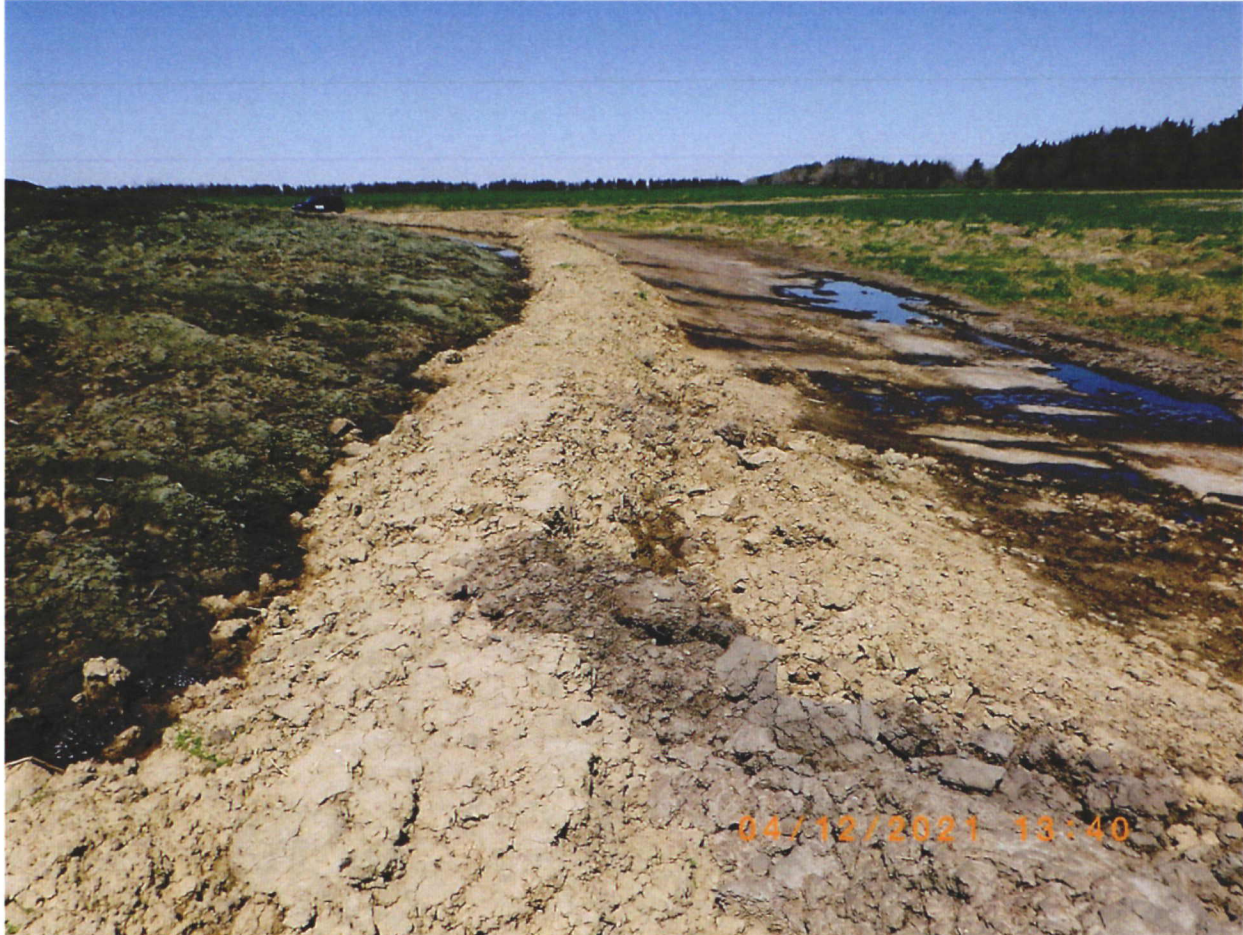
Photos: 5

Description: Seepage along upper berm on the east side of the east wetcake storage area.

Area 1 - Pumping to area 2 currently, berm holding
- 2 - Pumping to emergency lagoon, berm holding
- 3 - Berm holding some water, not enough to pump
- 4 - ~~berm~~ berm holding & no runoff
- 5 - Berm holding some runoff, most drained to area 2
- 6 - Berm has a lot of seepage & should be pumped
before berms completely fail

Pump out area 6 (east wet area) & fix
berms.

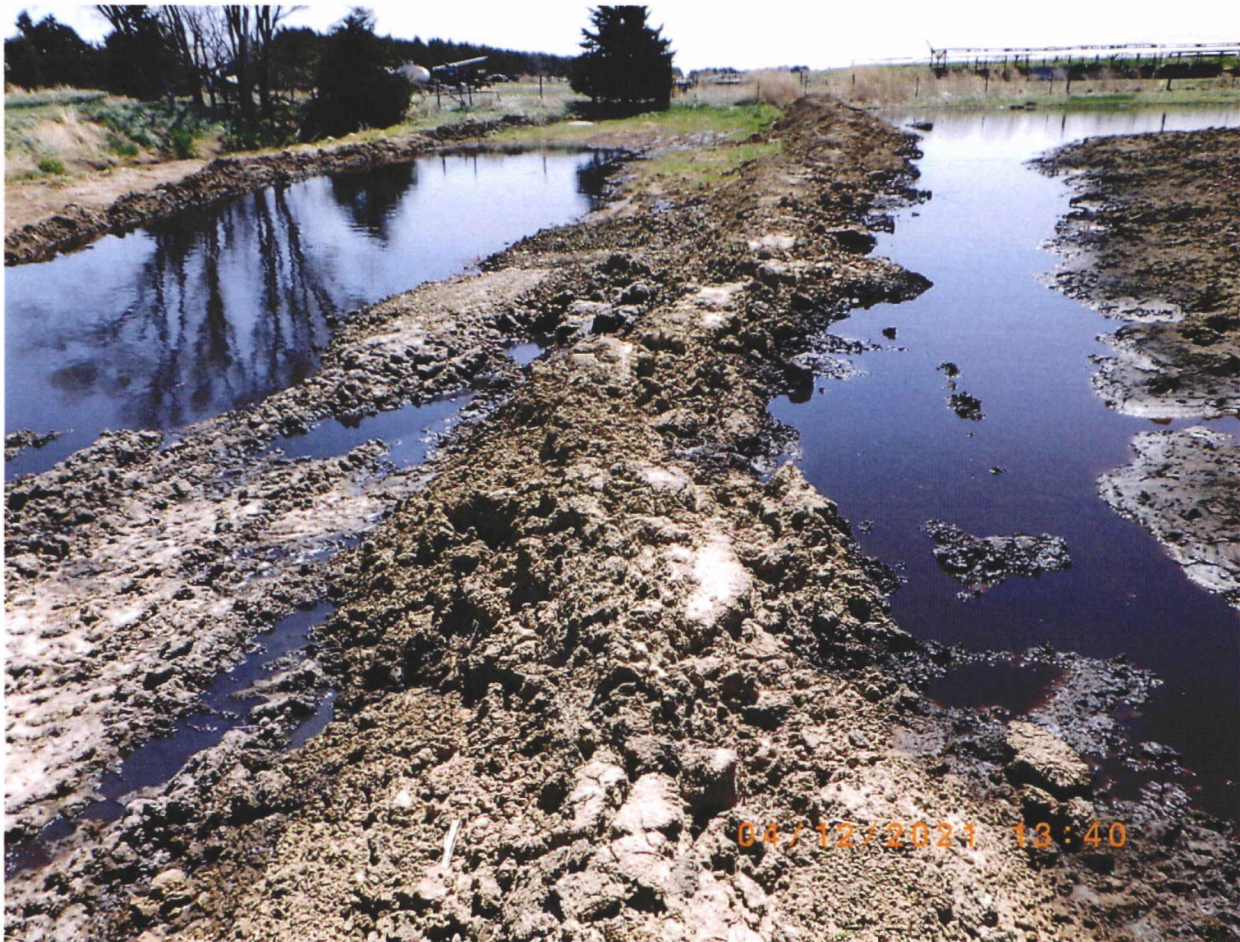
Photos: 6

Description: Multiple seepage points from the upper berm is filling the secondary berm area more daily. The area should be pumped as soon as possible, and berms repaired.

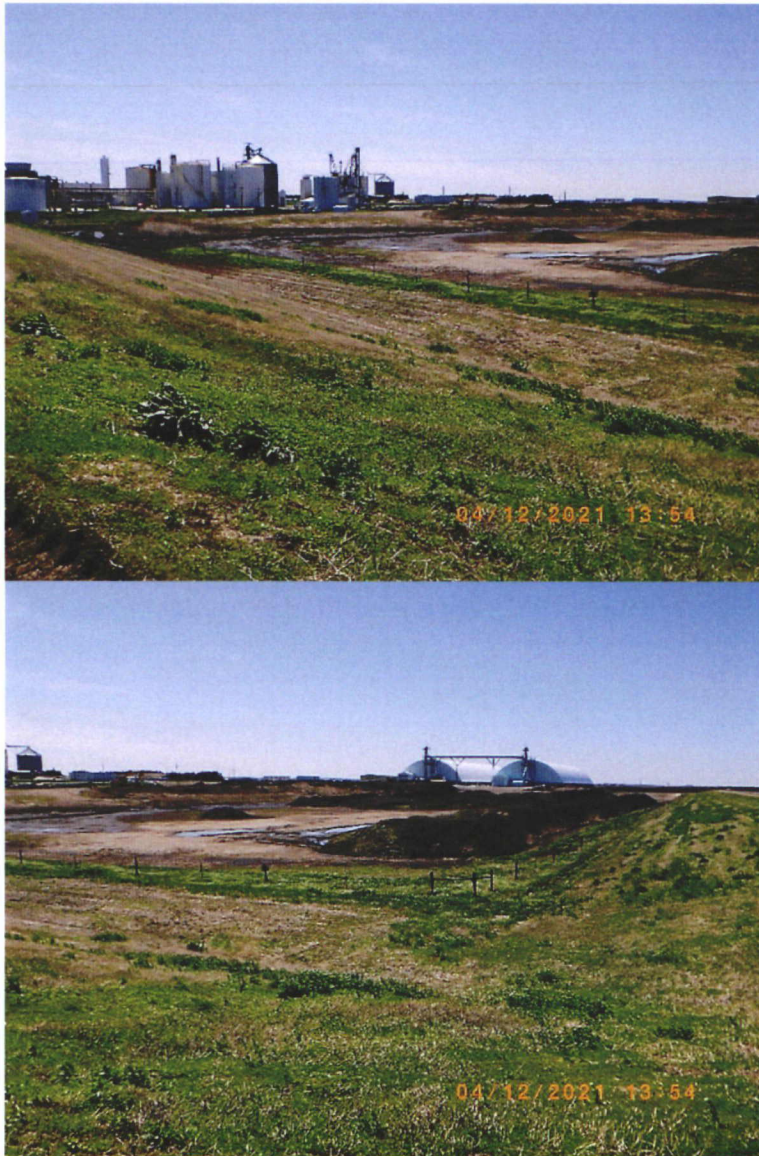
Photos: 7

Description: Area 2 on the site is in the top photo and both show the area south of the northwest lagoon.

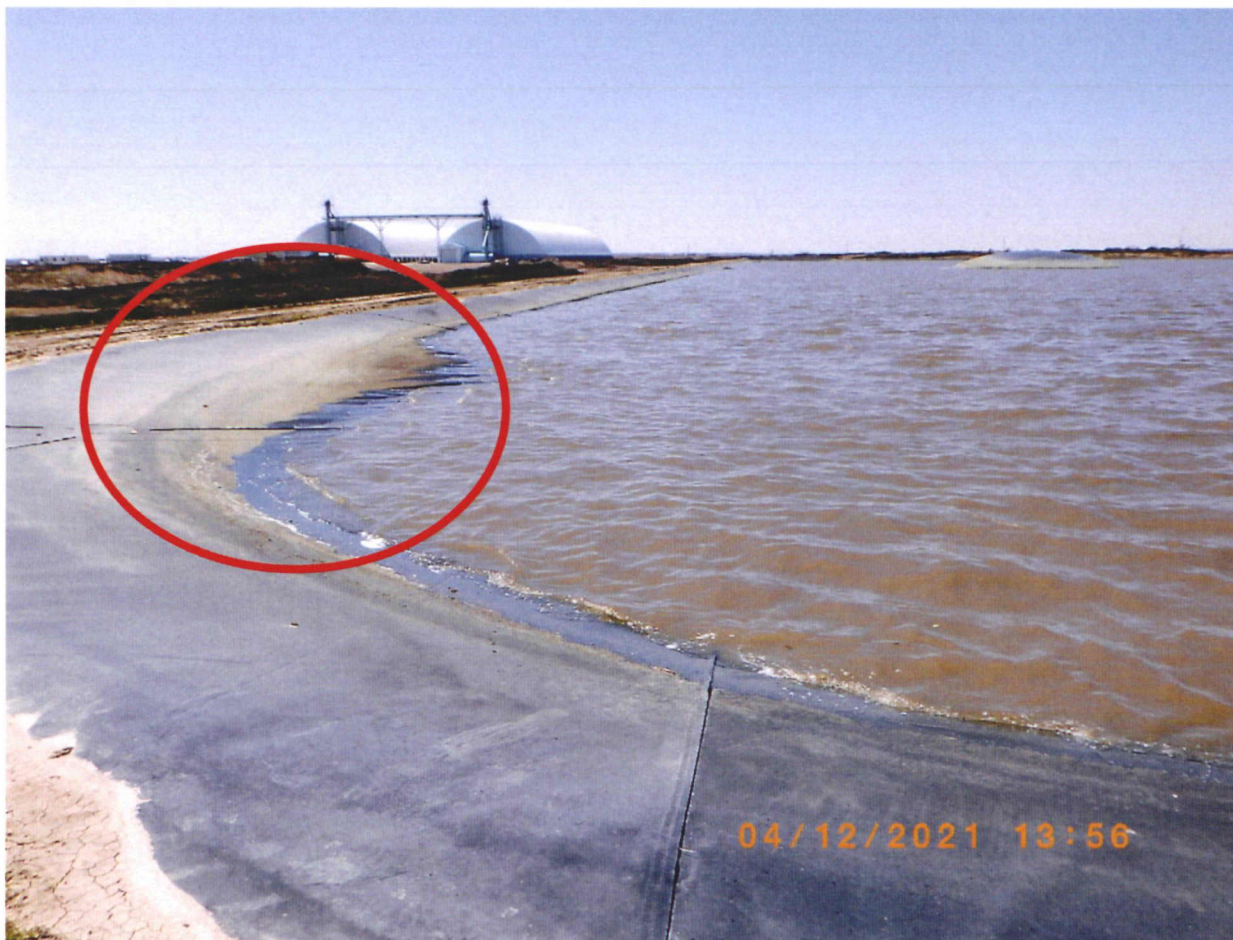
Photos: 8

- Northeast lagoon
 - No change in liner condition observed.
- Northwest lagoon
 - Two of the whales have disappeared and liner sections along the east and south side are exhibiting movement under moderate winds.
- South lagoon
 - No change in liner condition observed.

Description: Area where liner was moving up and down (8"-10") with the wind. This was also observed on the east side of this lagoon.

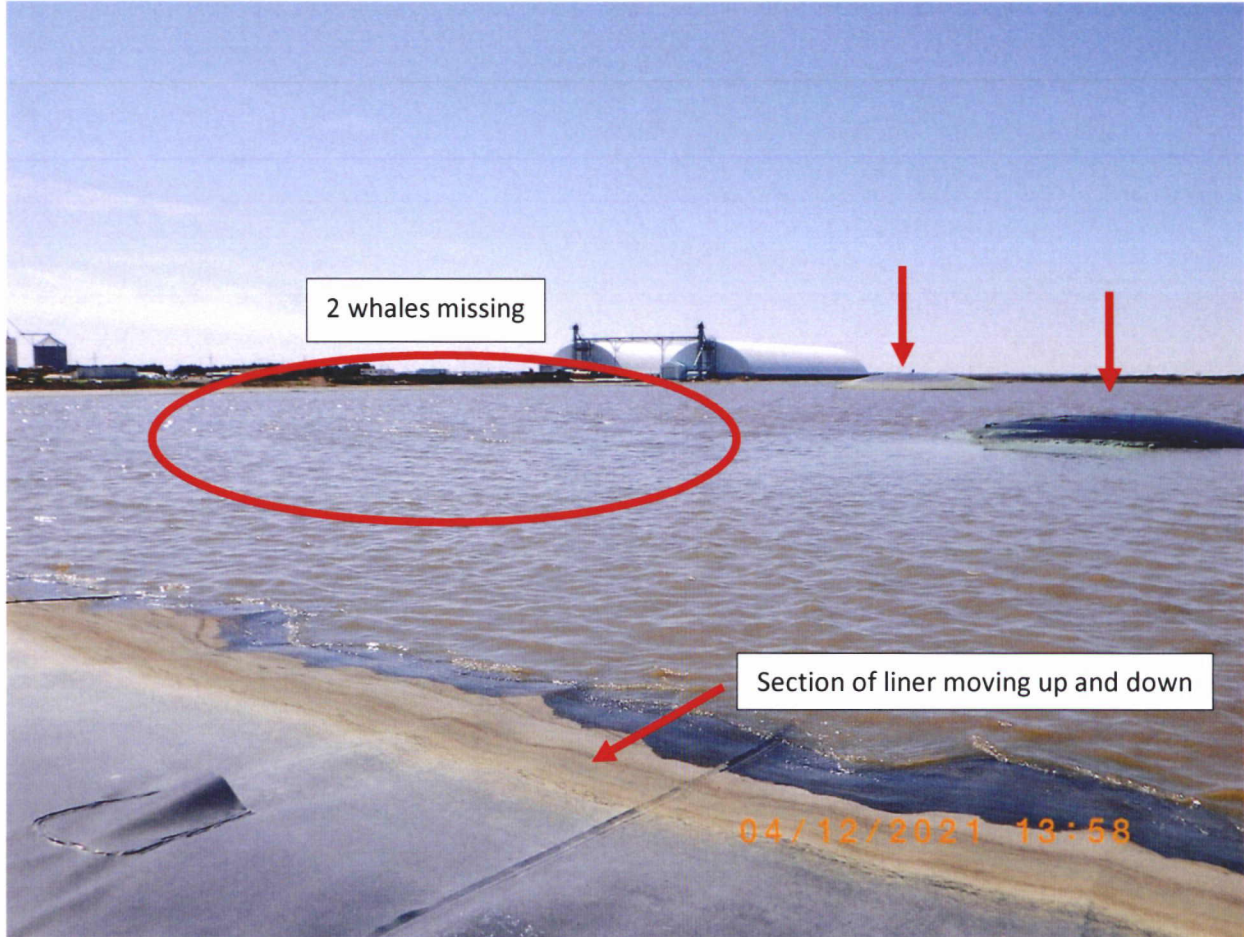
Photos: 9

Description: Whales missing in northwest lagoon and section of liner impacted by wind on east side of the lagoon.

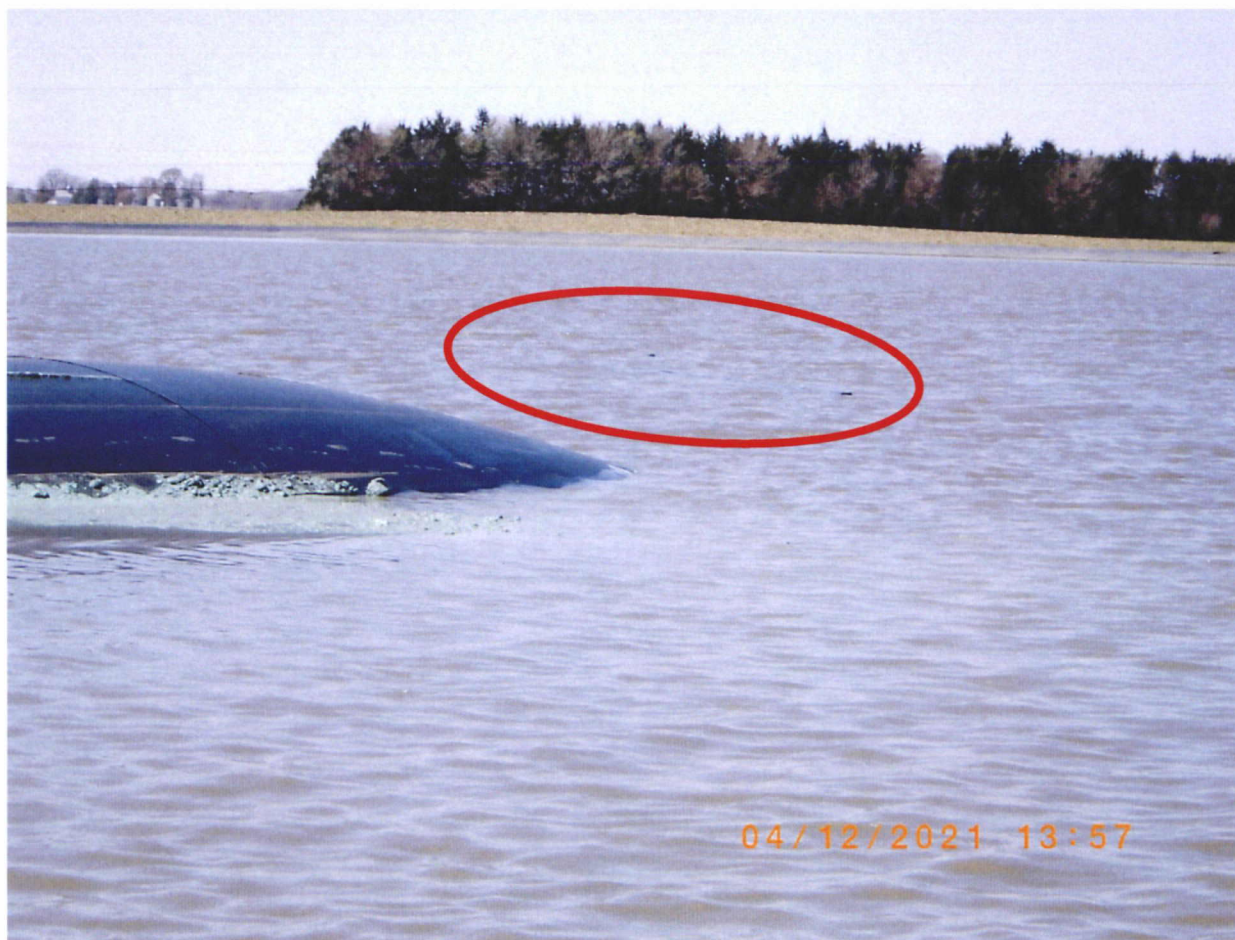
Photos: 10

Description: Whale midway north from the southeast corner of the northwest lagoon and segment of liner moving with wave action.

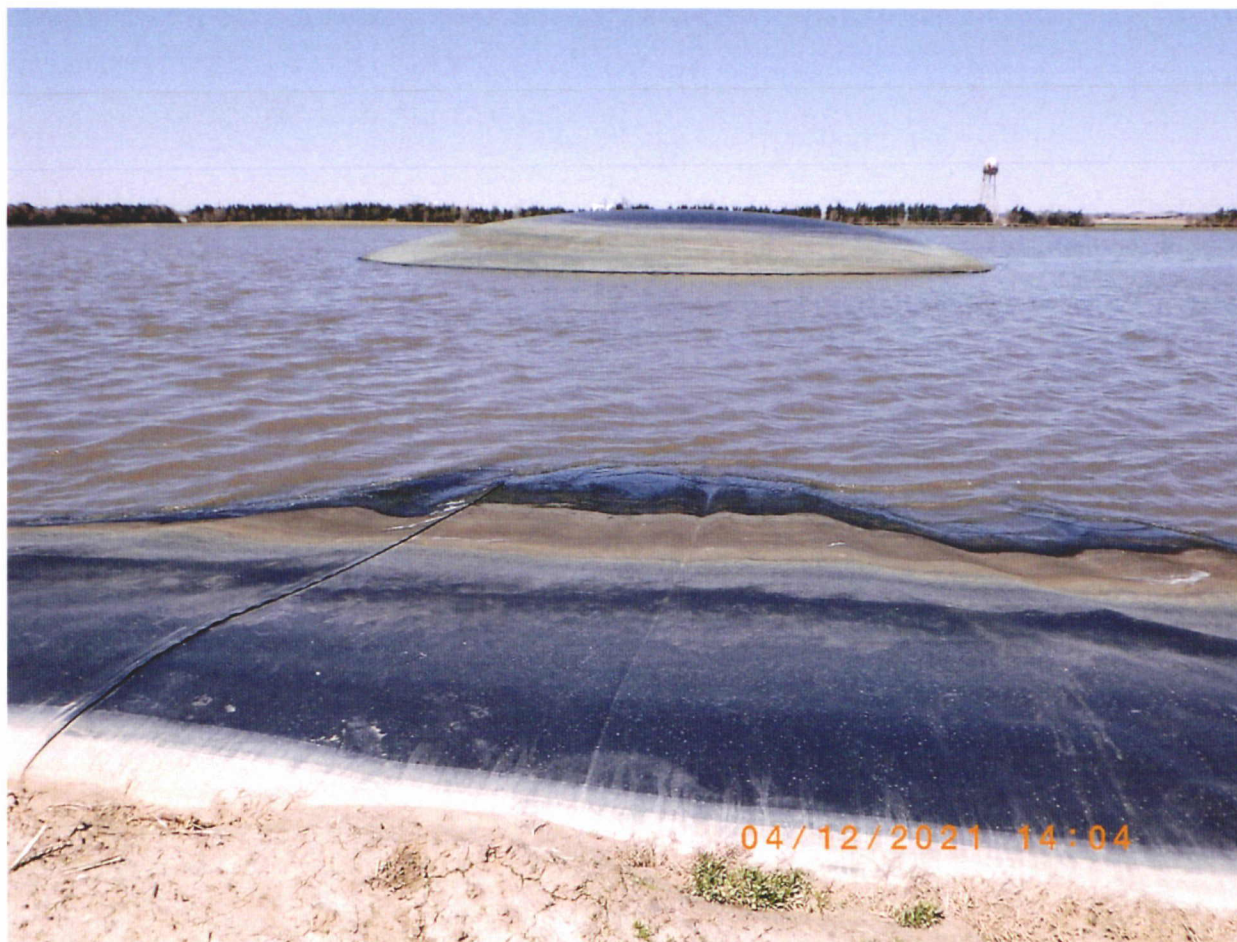
Photos: 11

Description: Section of the liner along the edge of the lagoon could be seen moving up and down with the wind.

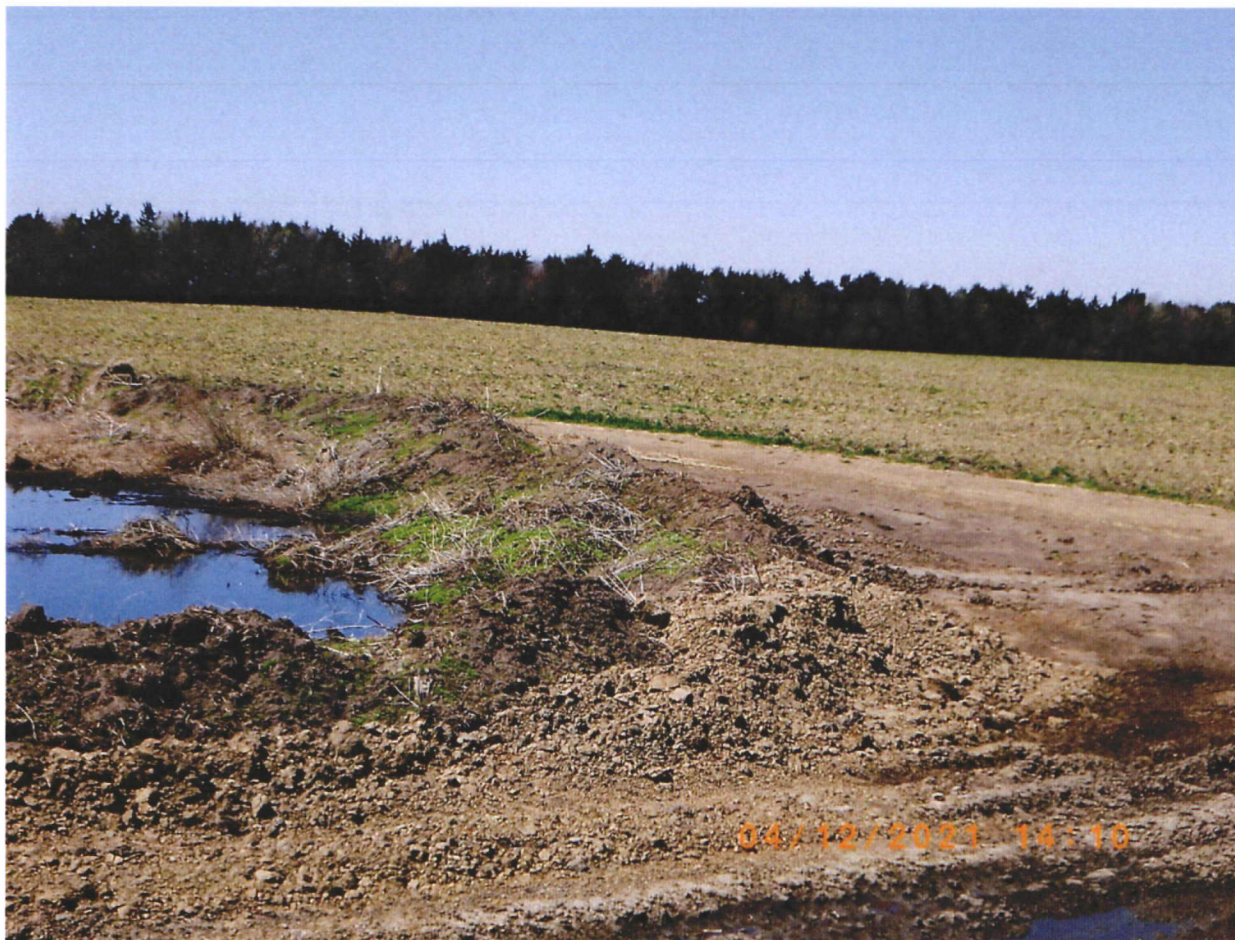
Photos: 12

Description: Berm is holding now that it was reinforced.

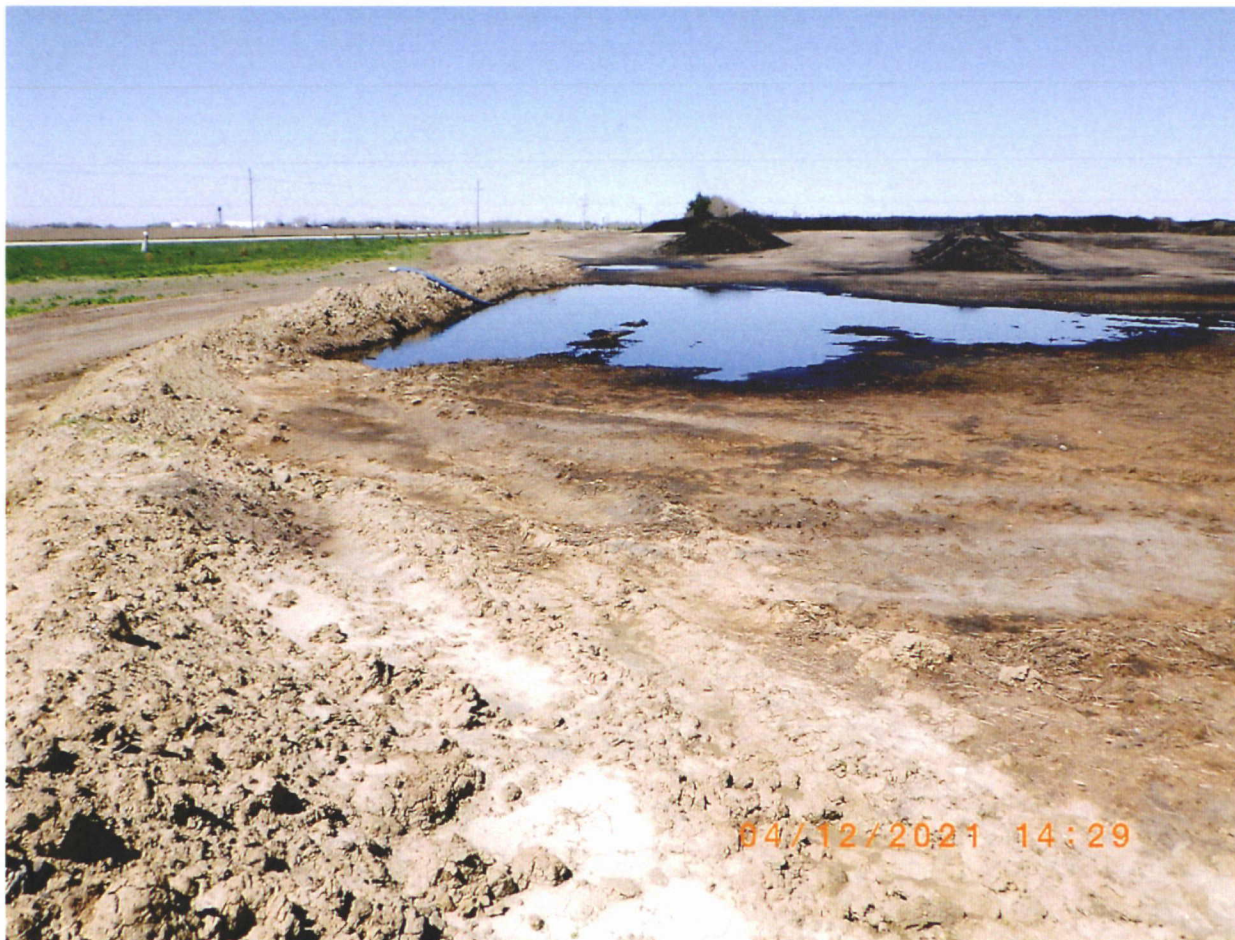
Photos: 13

Description: Berm is holding and most of runoff has drained to area 2 along the trench.

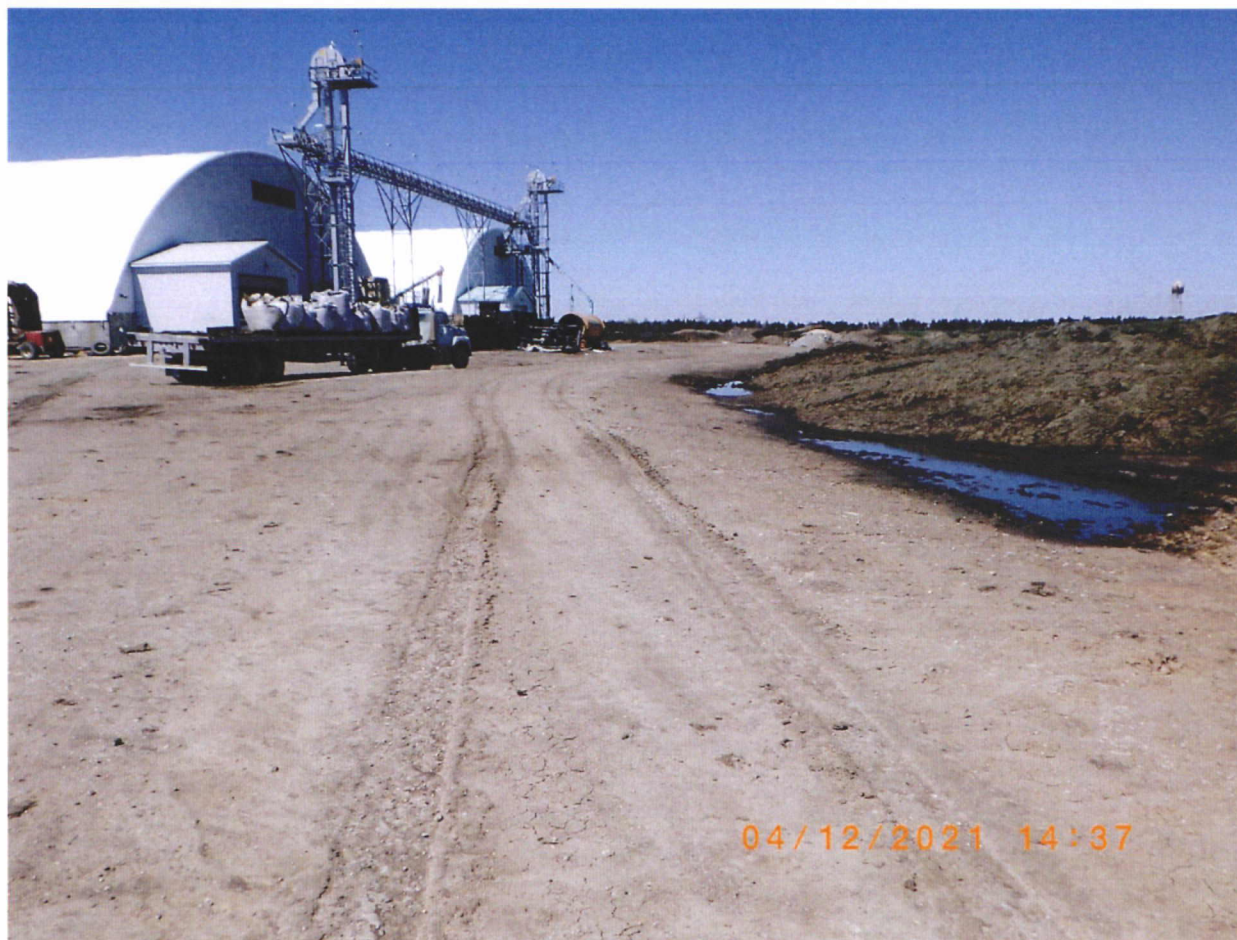
Photos: 14

Description: Staff unloading the Biochar bags from the flatbed truck to the south hoop building.

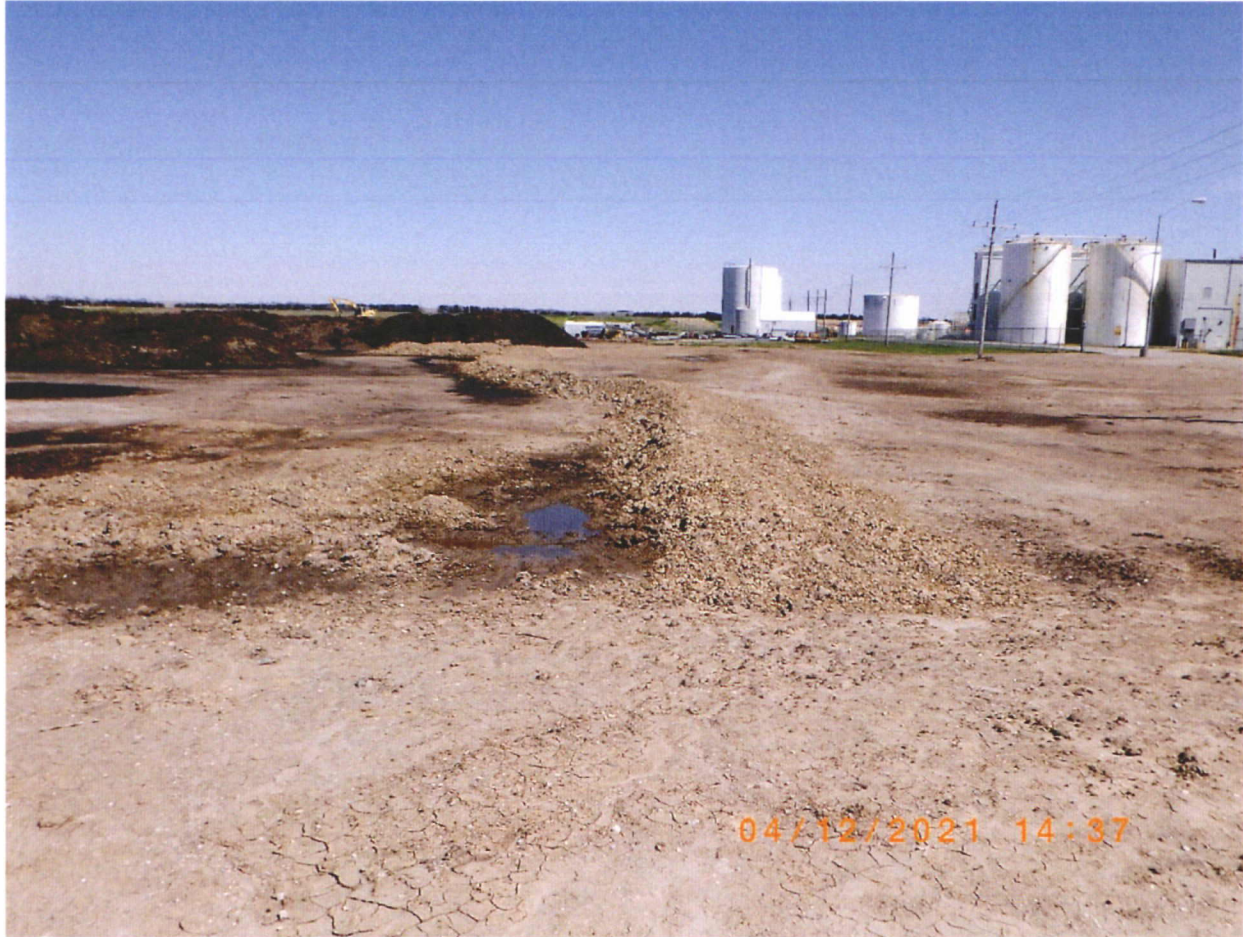
Photos: 15

Description: New berm constructed along wetcake preventing run-on from parking lot and access road runoff.

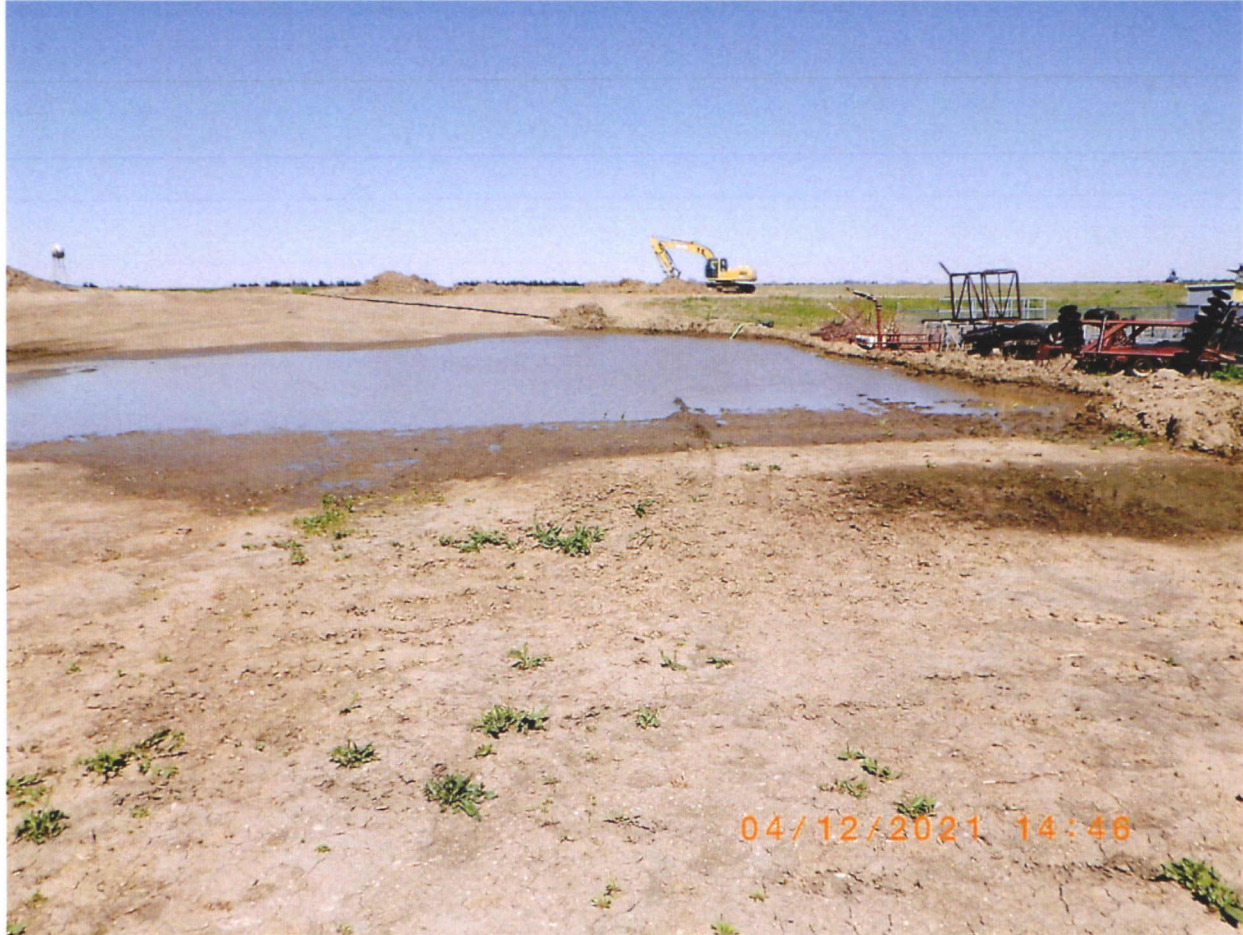
Photos: 16

Description: Berm holding runoff from parking area and access road being pumped over to area that drains to area 2 on the site map.

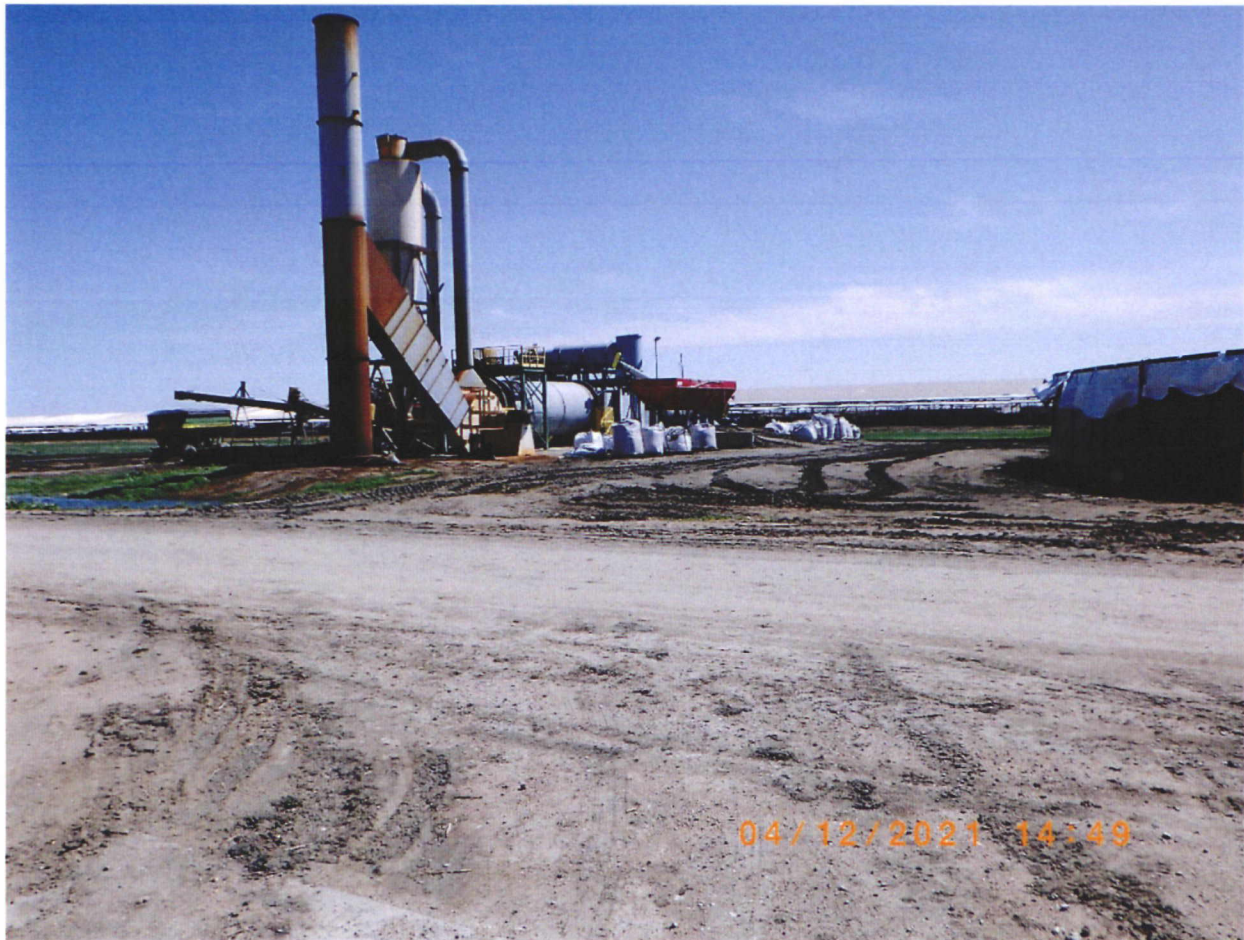
Photos: 17

Description: Bags of Biochar on the ground west of the Biochar unit. Once all the bags are removed the Biochar material scattered on the ground around the area will also need to be cleaned up.

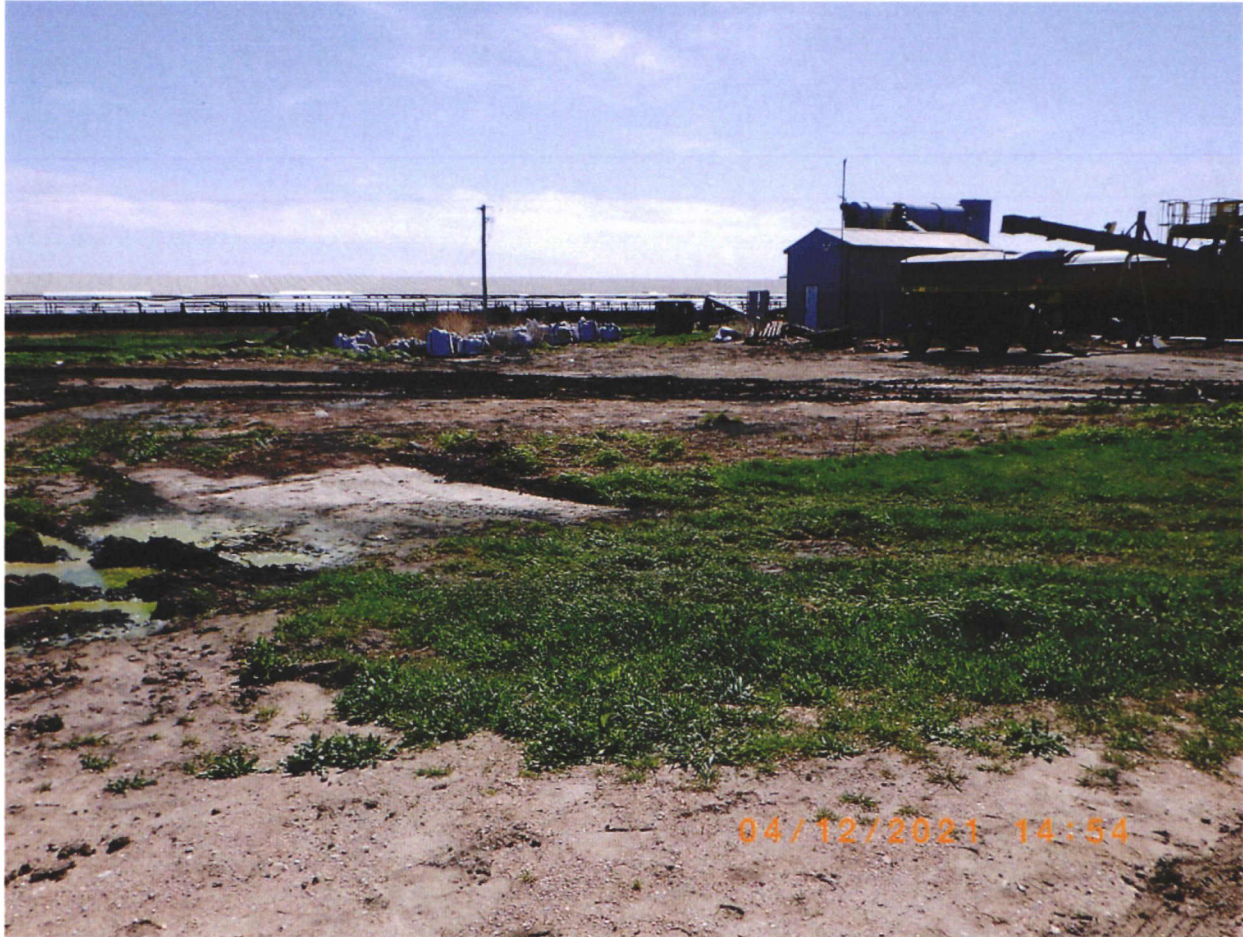
Photos: 18

Description: More bags of Biochar on the east side of the area.

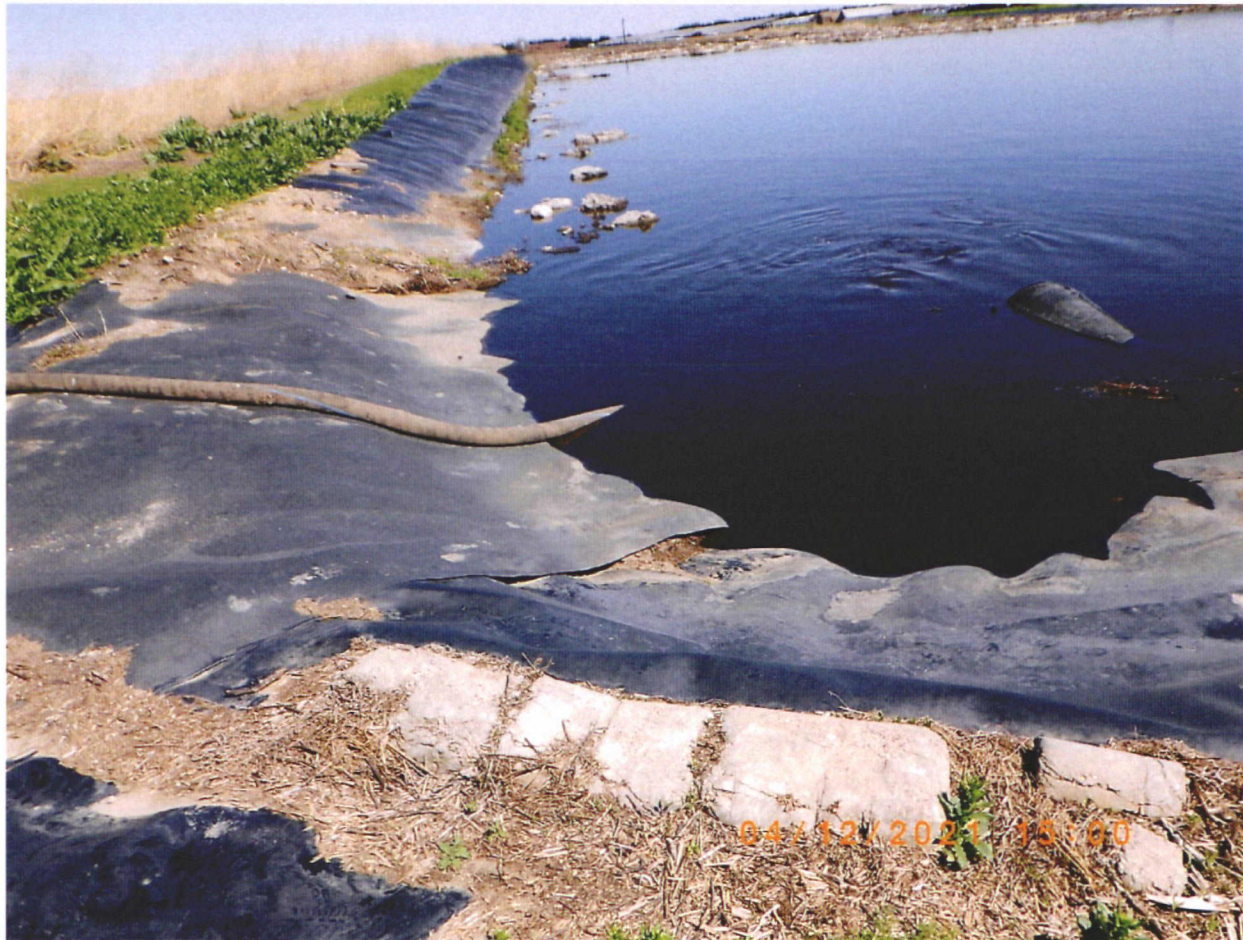
Photos: 19

Description: Runoff from behind the berm in area 2 of the site map being pumped to this location.
