Facility: AltEn
IIS: 84069
PCS: NE0137634

Jason Windhorst
4-12-2021

Site Visit Check list

AltEn LLC - Storm Water Temporary BMP Check Map

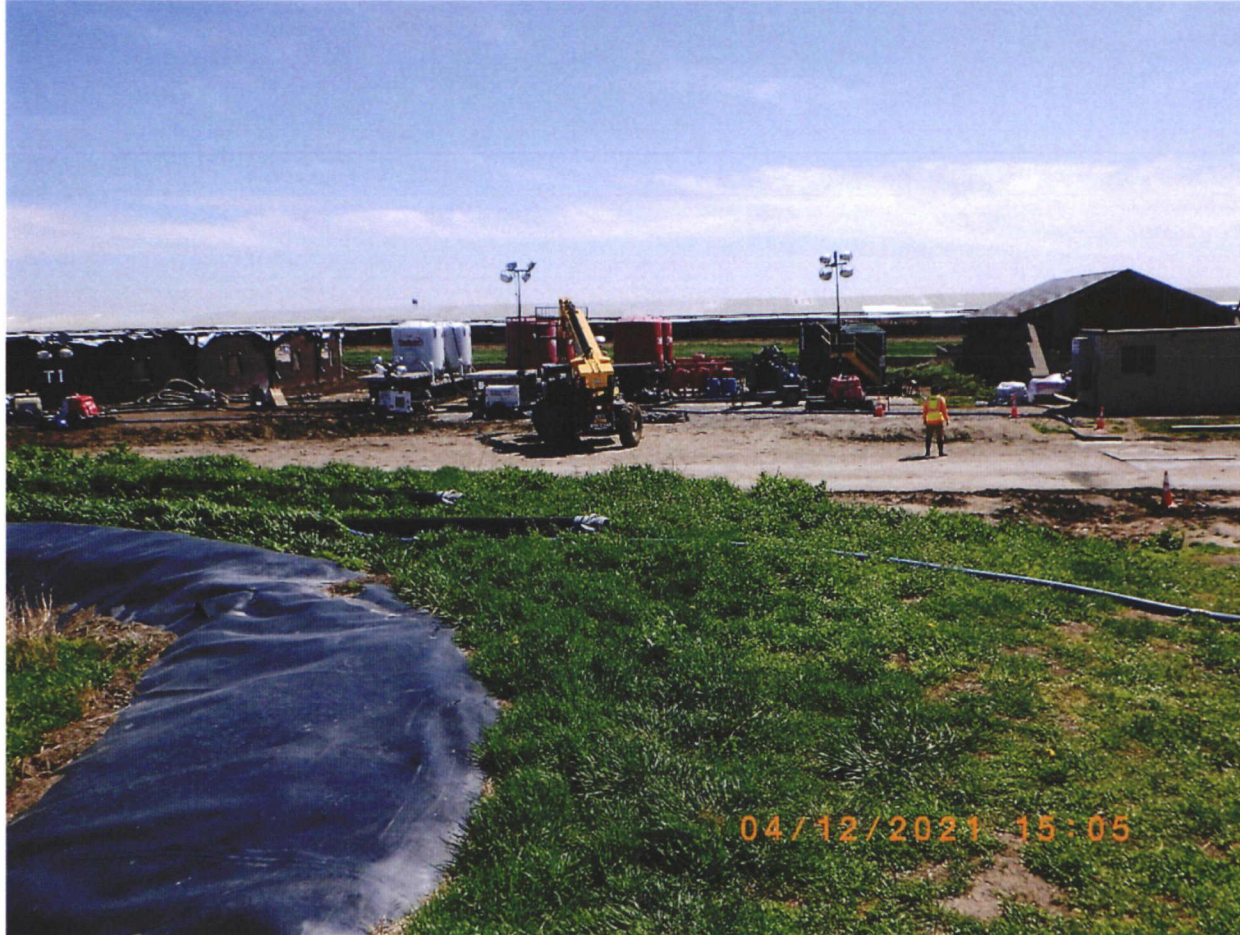
Photos: 20

Description: Clean Harbors staging area with staff continuing to set up equipment to begin treating the effluent from the AltEn treatment system.
