Facility: AltEn
IIS: 84069
PCS: NE0137634

Mark Pomajzl
4/19/2021

Site Visit Check list

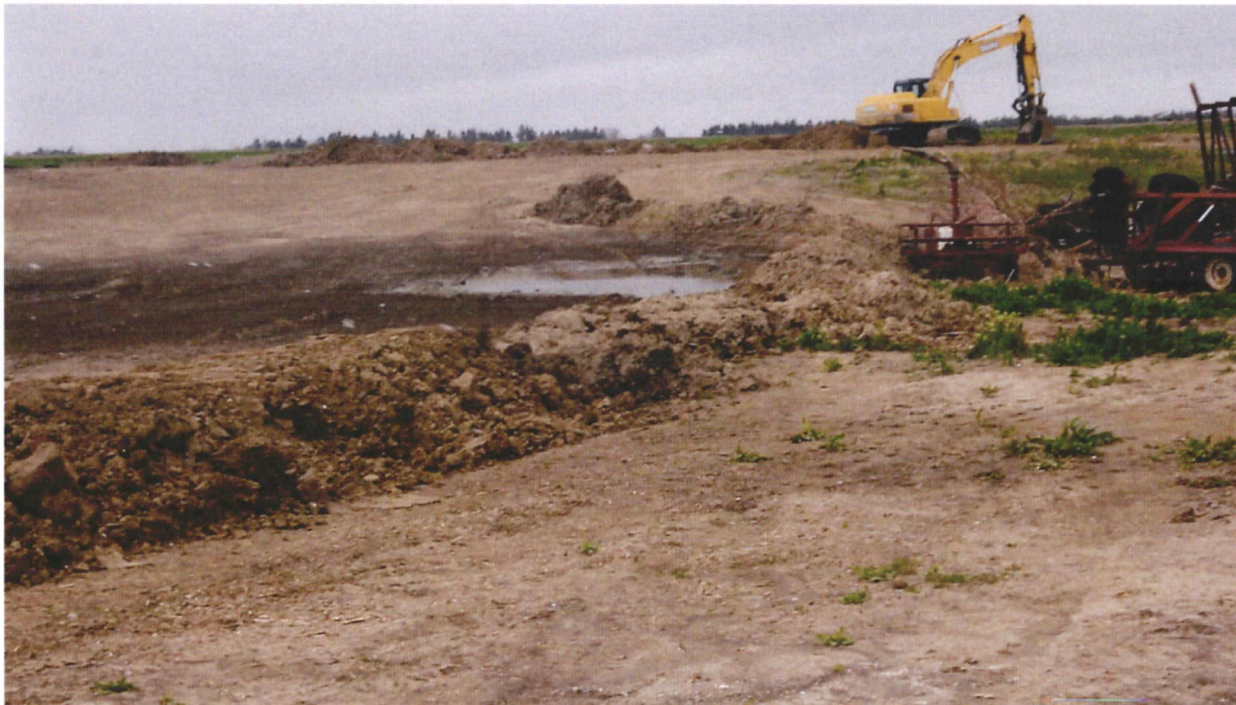
Photo: 1

Description: This photo depicts Area 1.

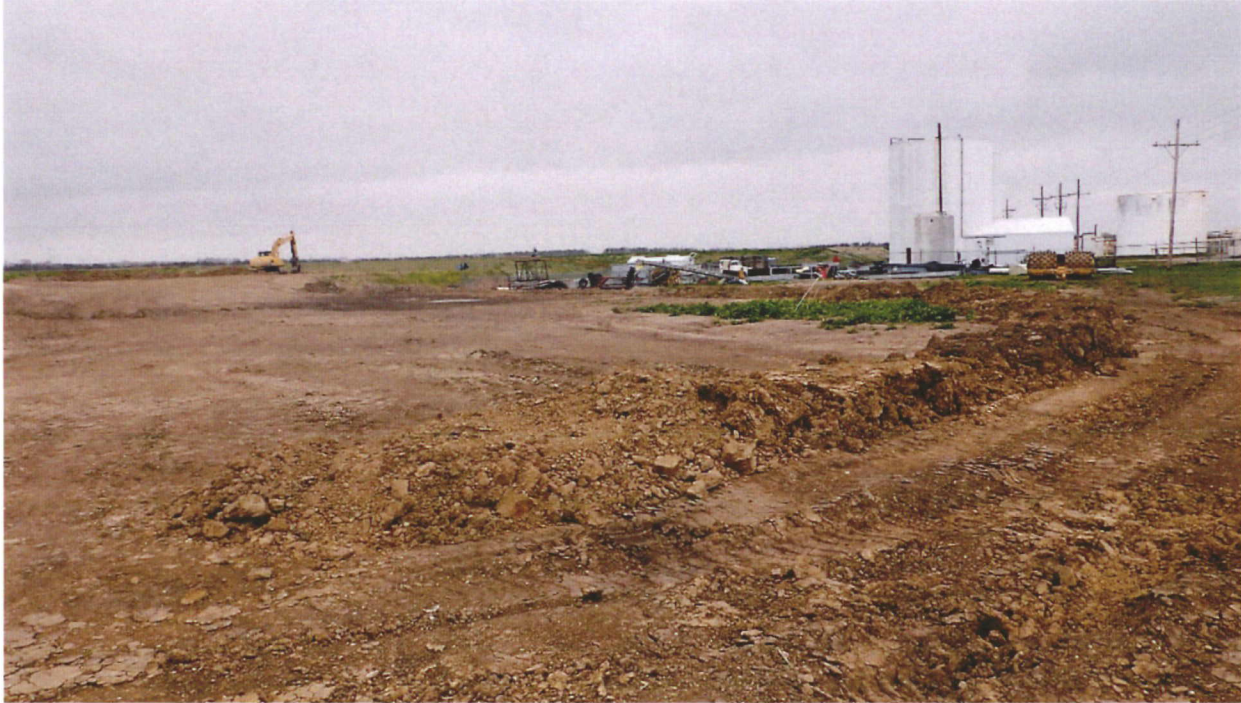
Photo: 2

Description: The facility expanded the berm to the southwest to prevent storm water from the parking lot from entering.

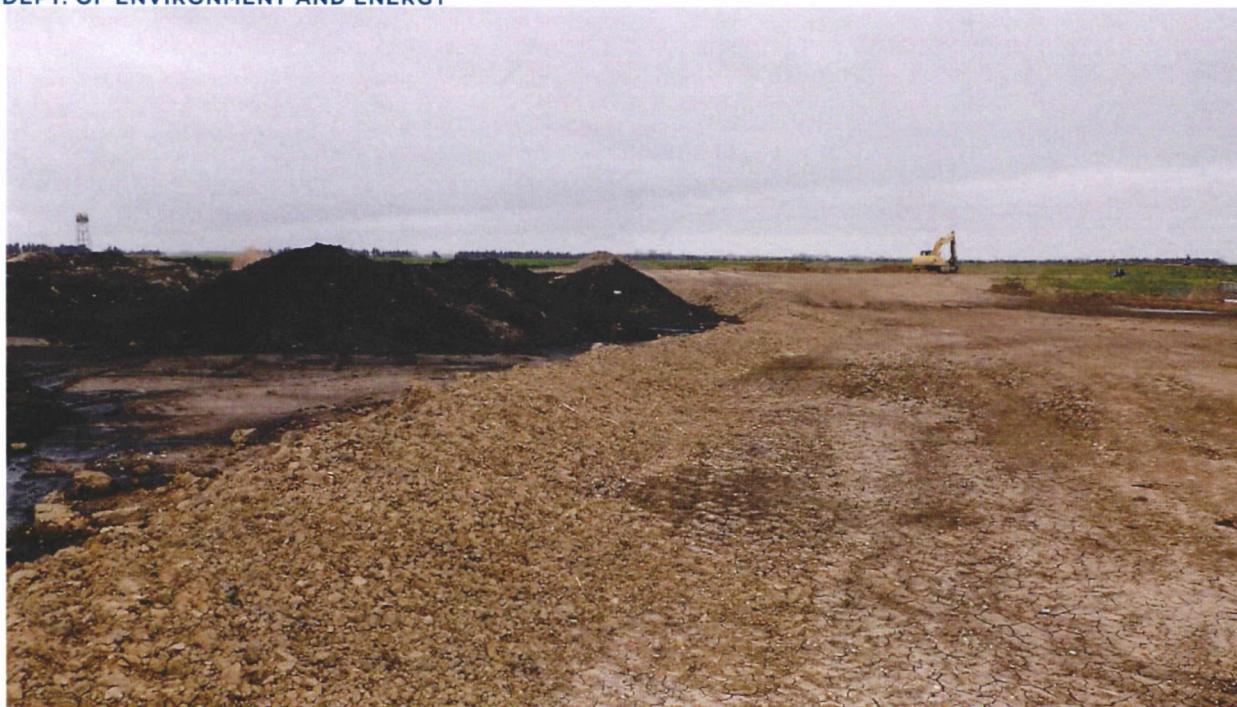
Photo: 3

Description: This photo depicts the west berm of area 1. This berm expands and surrounds the southwest pile.

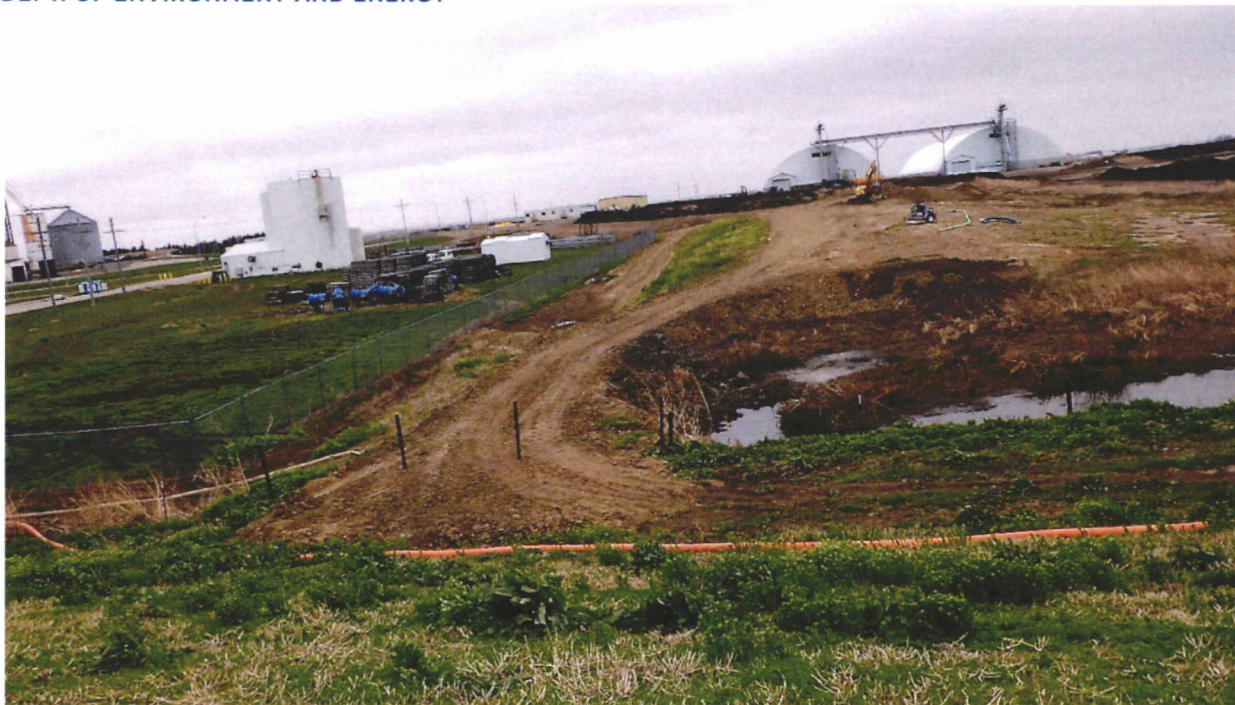
Photo: 4

Description: This facility has recently reinforced area 2. The facility has added material and fence along the southwest corner of the south lagoon. No seepage was observed.

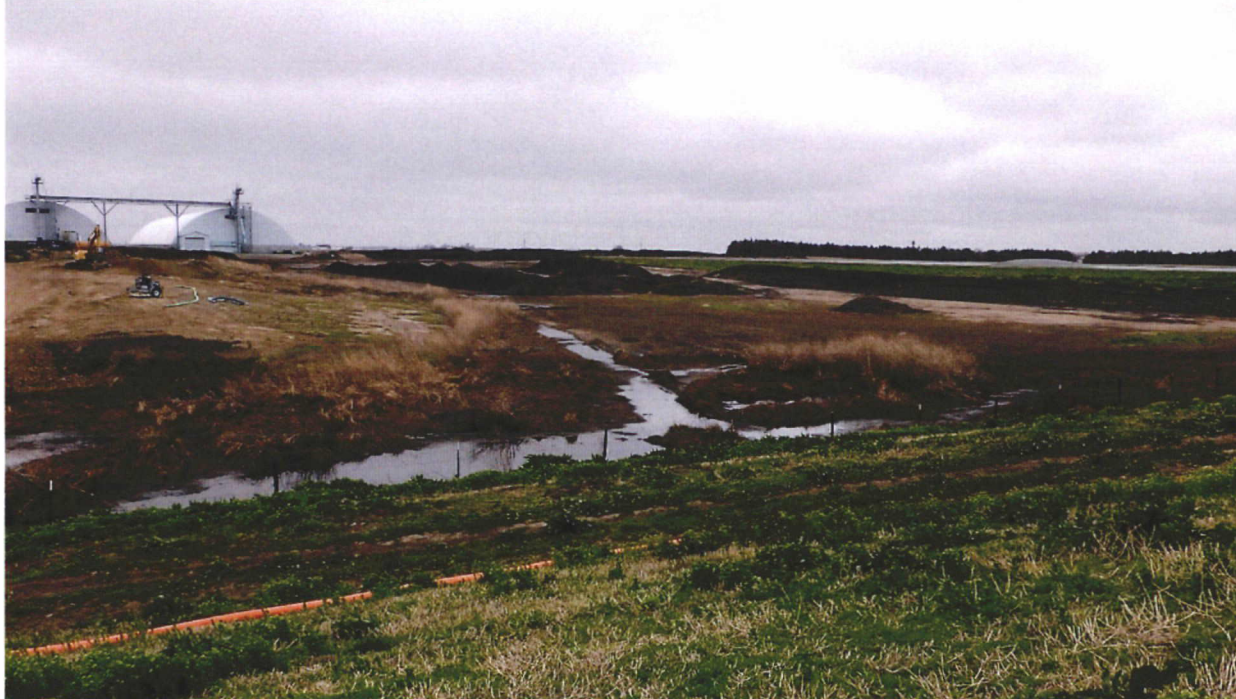
Photo: 5

Description: This photo depicts accumulated water behind the area 2 berm.

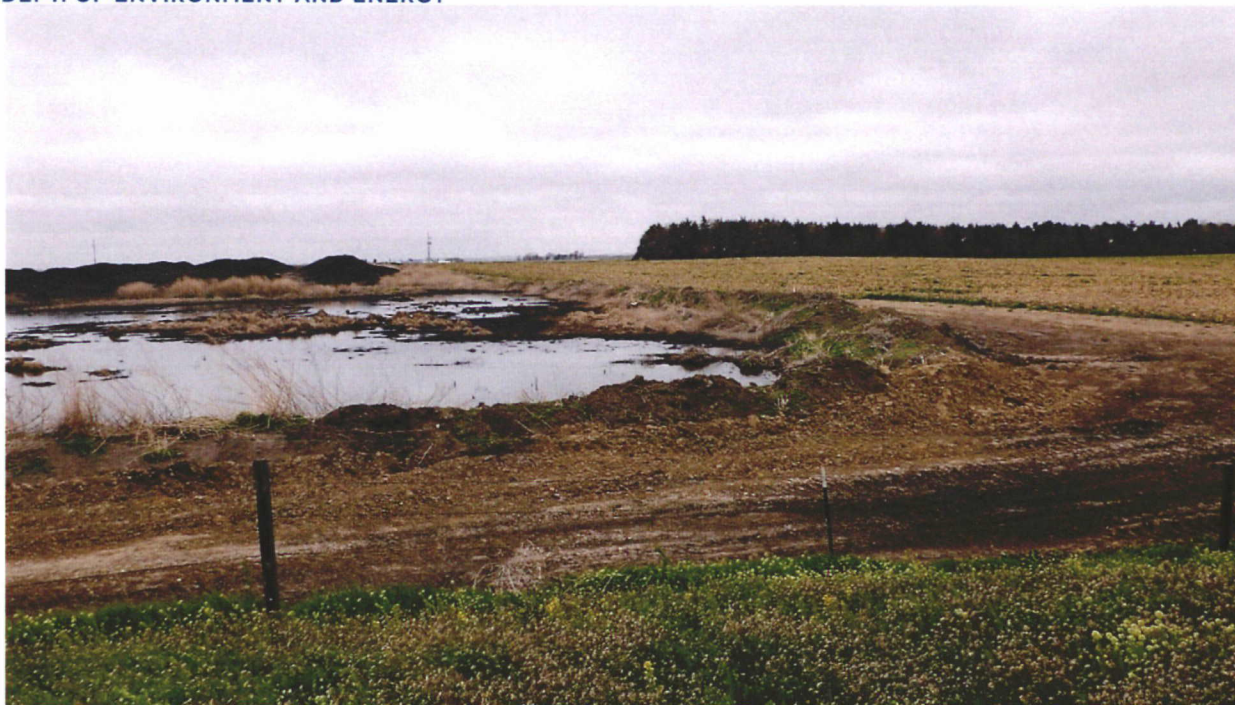
Photo: 6

Description: This photo depicts the area 3 berm. The berm is not seeping at this time.

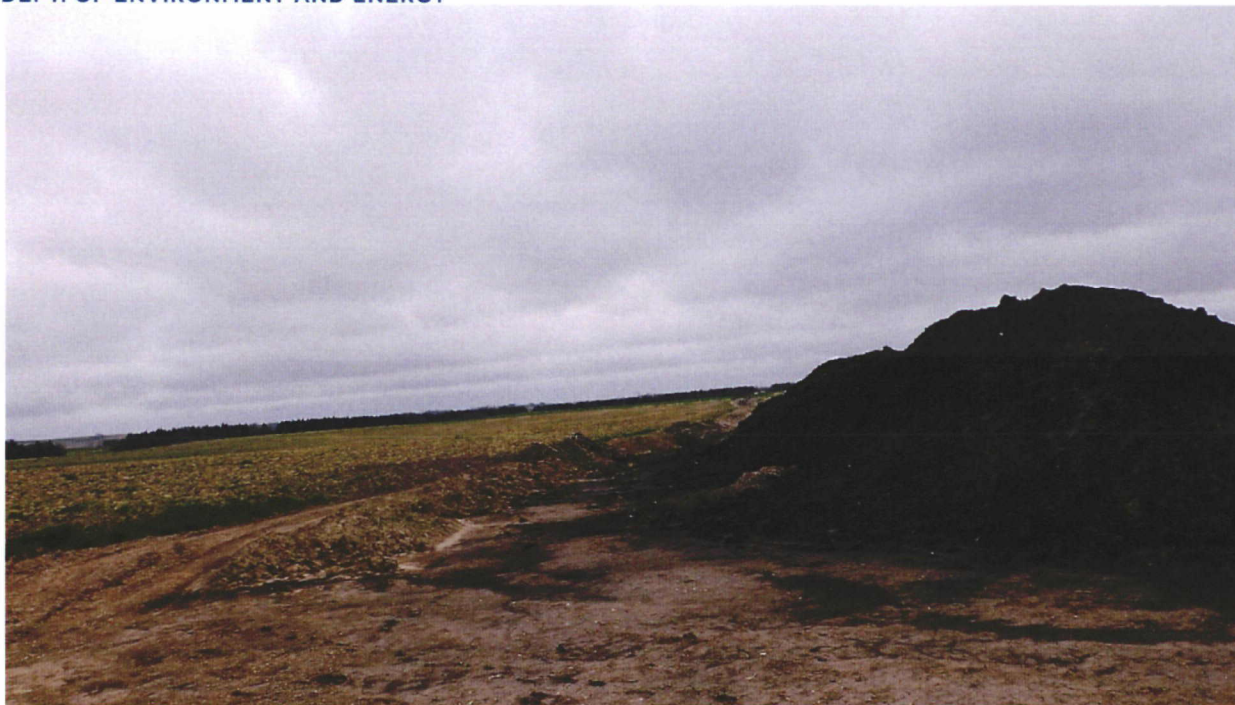
Photo: 7

Description: This photo depicts area 4. There is no water accumulation or seepage observed.

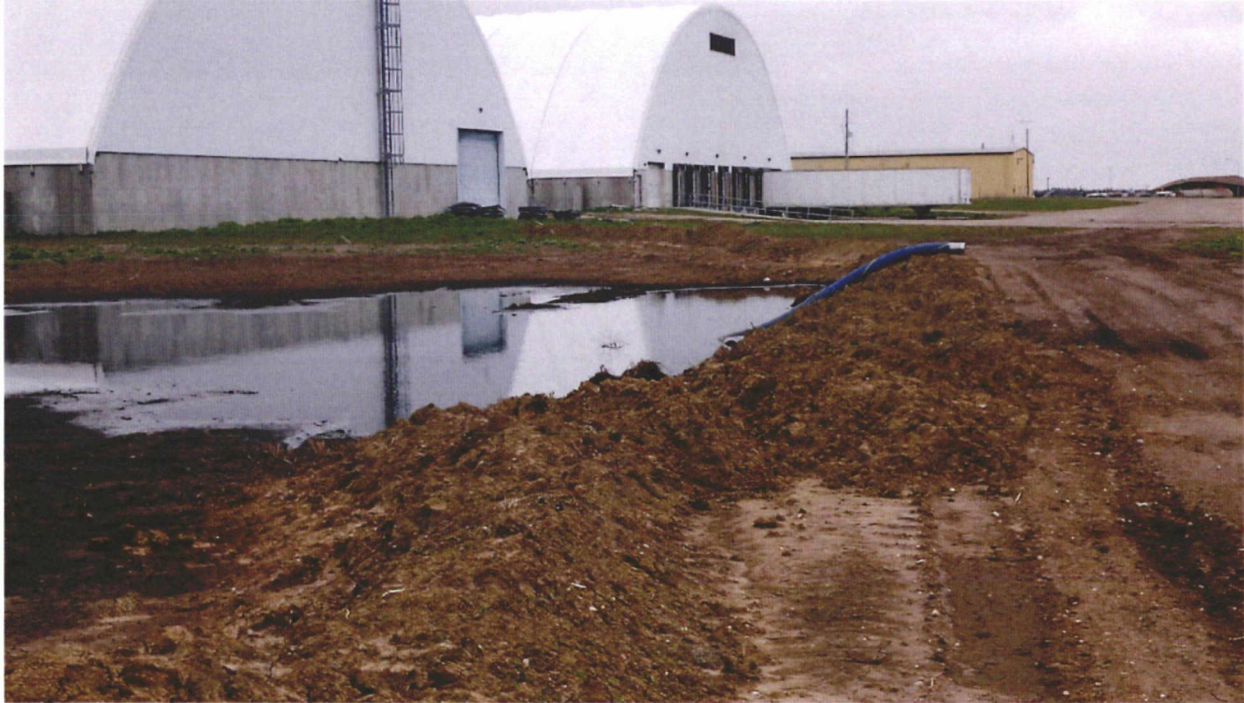
Photo: 9

Description: This is the berm that surrounds the west pile. There is only some water accumulation. The blue hose is used to transfer water when needed. There is no seepage or leaking observed.

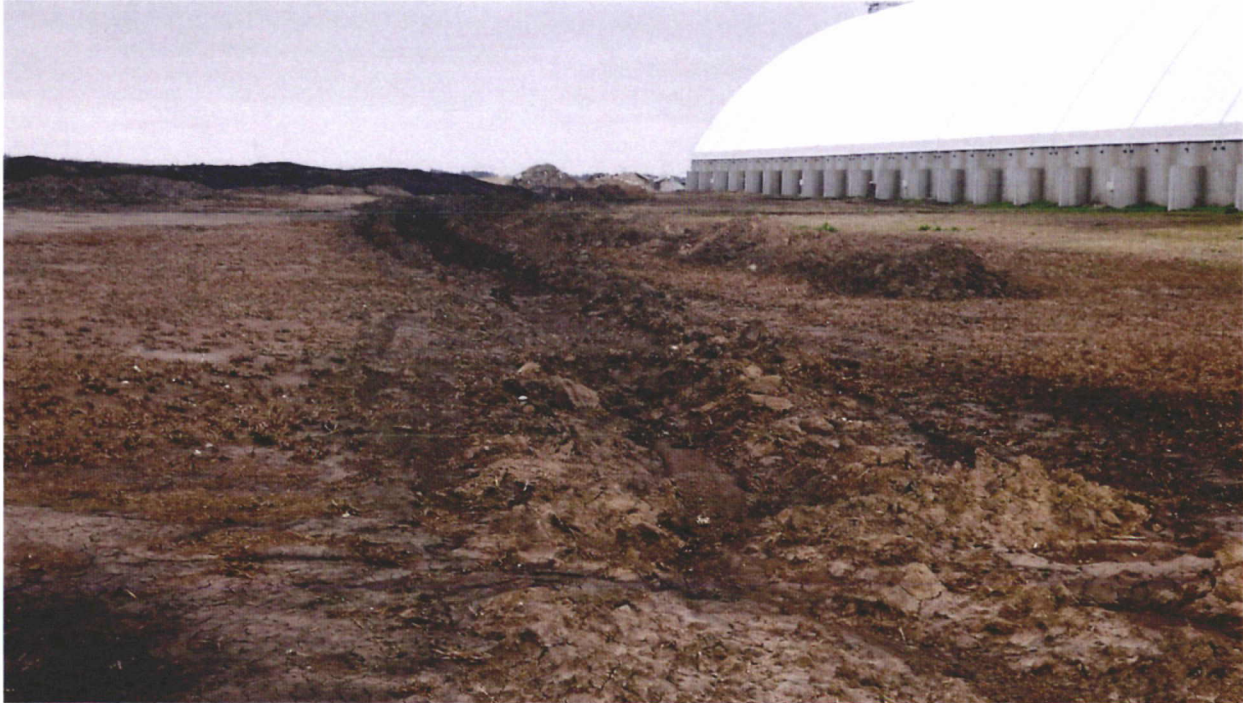
Photo: 10

Description: This is a trench that facility recently dug to transfer water from area 5 to area 2. Water from area 2 is then transferred to the emergency lagoon.

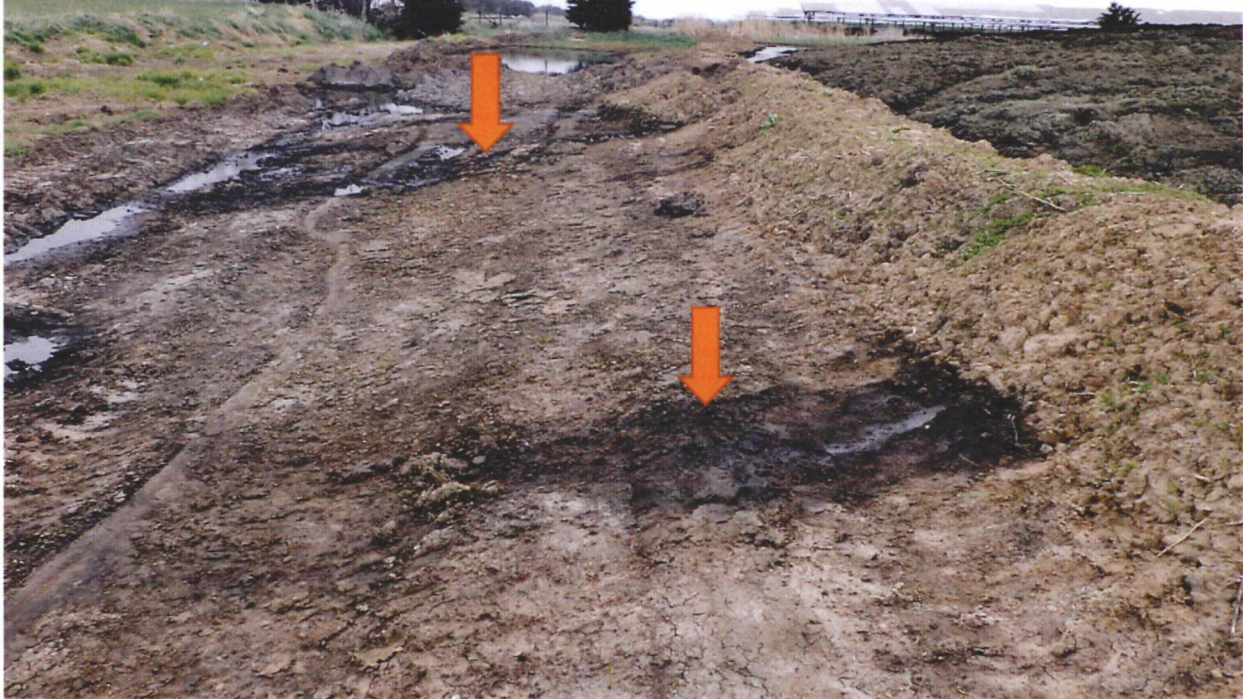
Photo: 11

- Area 1 contains two berms. The east berm has been expanded to prevent parking lot water from entering the berm area. The west berm surrounds the wetcake pile. There is no seepage observed.
- Areas 2, 3, 4 and 5 show no seepage.
- Area 6 shows signs of seepage. The facility explained that they are pumping water from the berm with dryer wetcake. The facility then transfers the wetcake to the west storage area. Mr. Peterson stated they will be working on the berm today.

Description: This photo depicts various areas of seepage (arrows).

- Fix Area - 6 - seepage problem
- Clean up Biochar process area (Housekeeping).

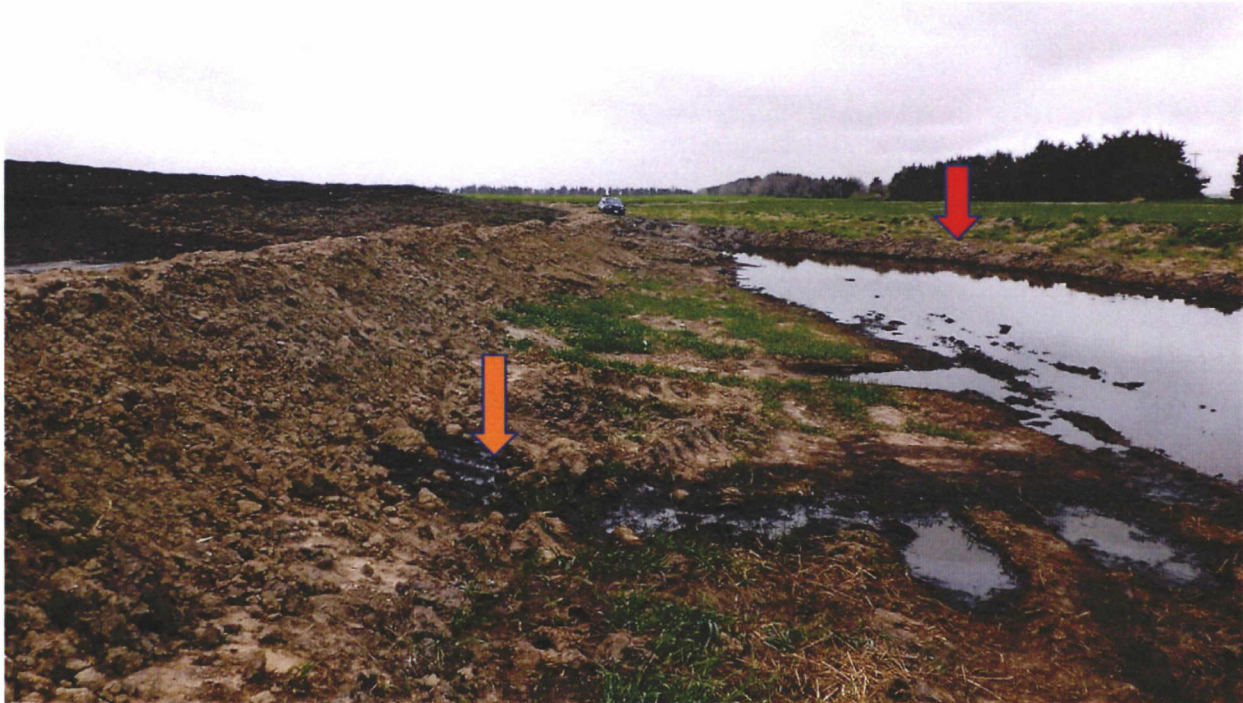
Photo: 12

Description: This photo is taken on the south end of the berm. There is seepage observed (orange arrow). The secondary berm (red arrow) is holding water.

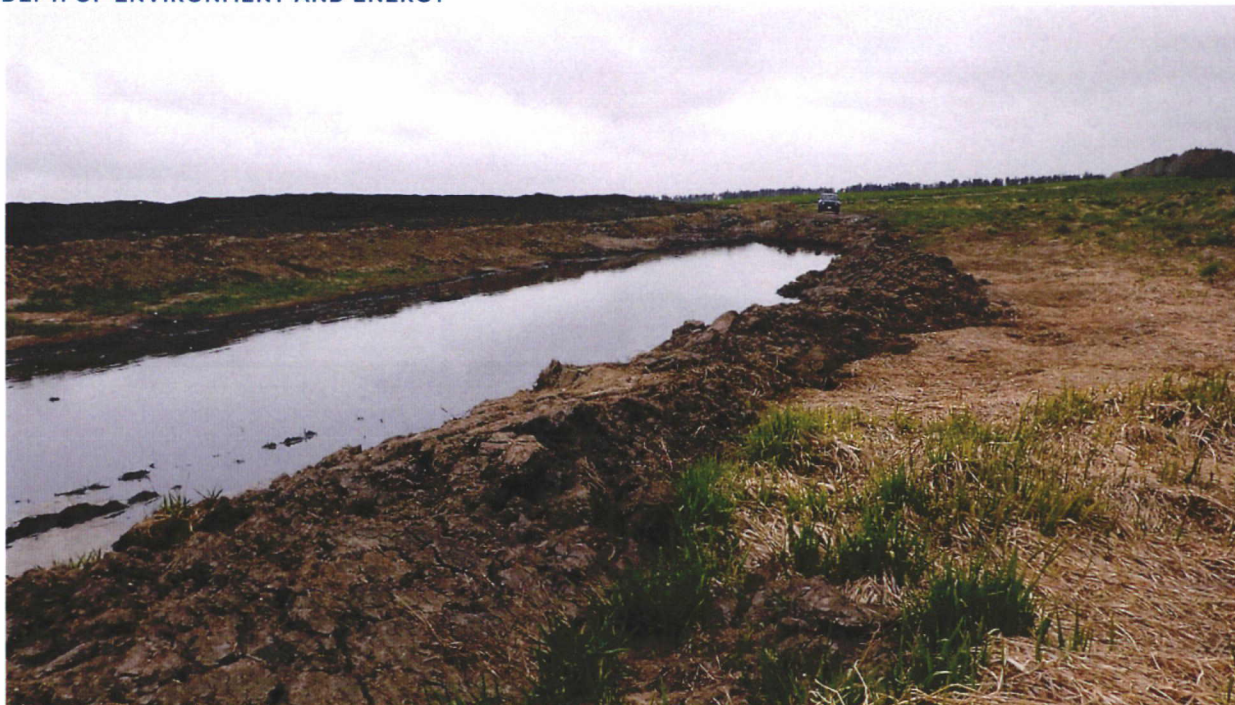
Photo: 13

Description: This photo is taken on the south end of the berm system. The secondary berm is pictured here. It is hard to determine if the berm is leaking with the heavy vegetation.

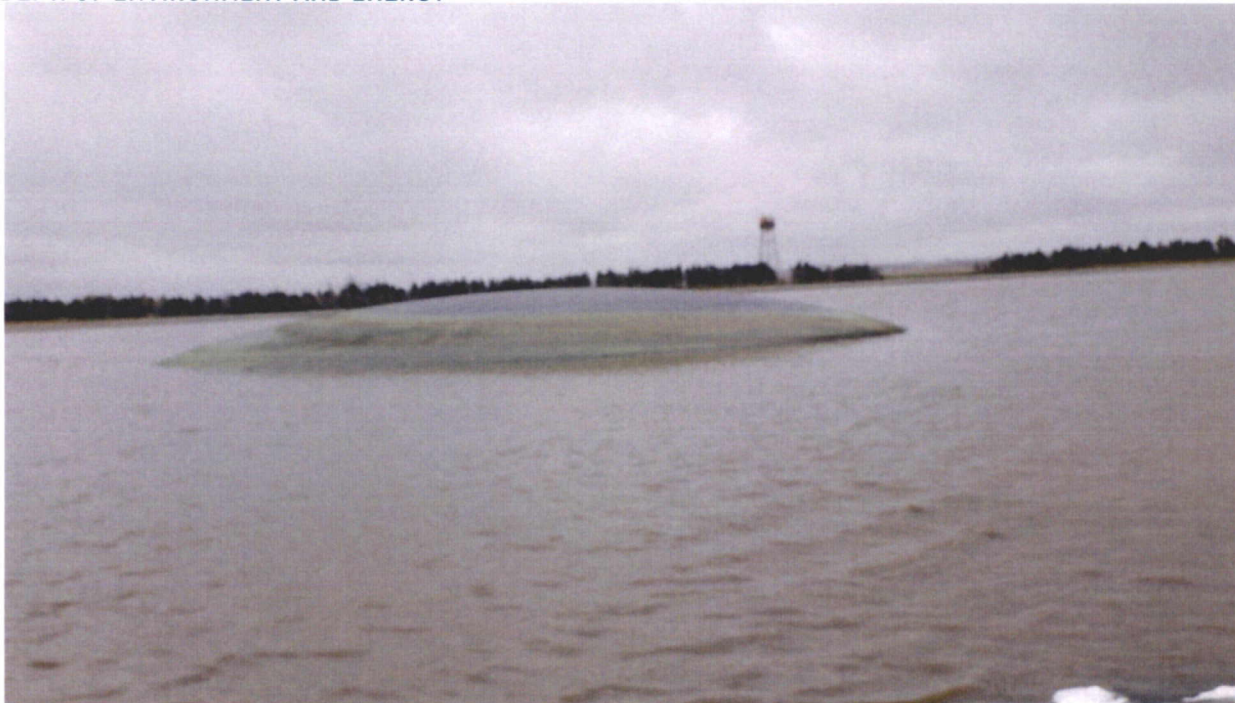
Photo: 17

Description: Large floating liner.

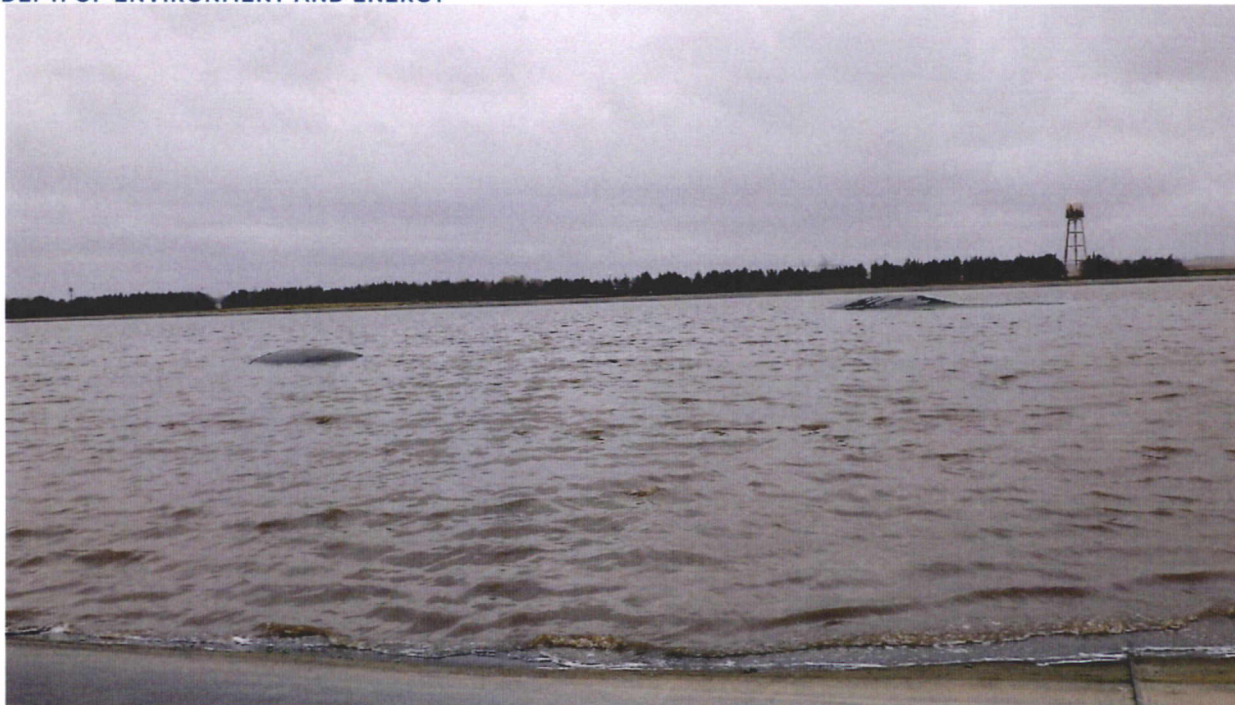
Photo: 18

Description: Two smaller floating liners.

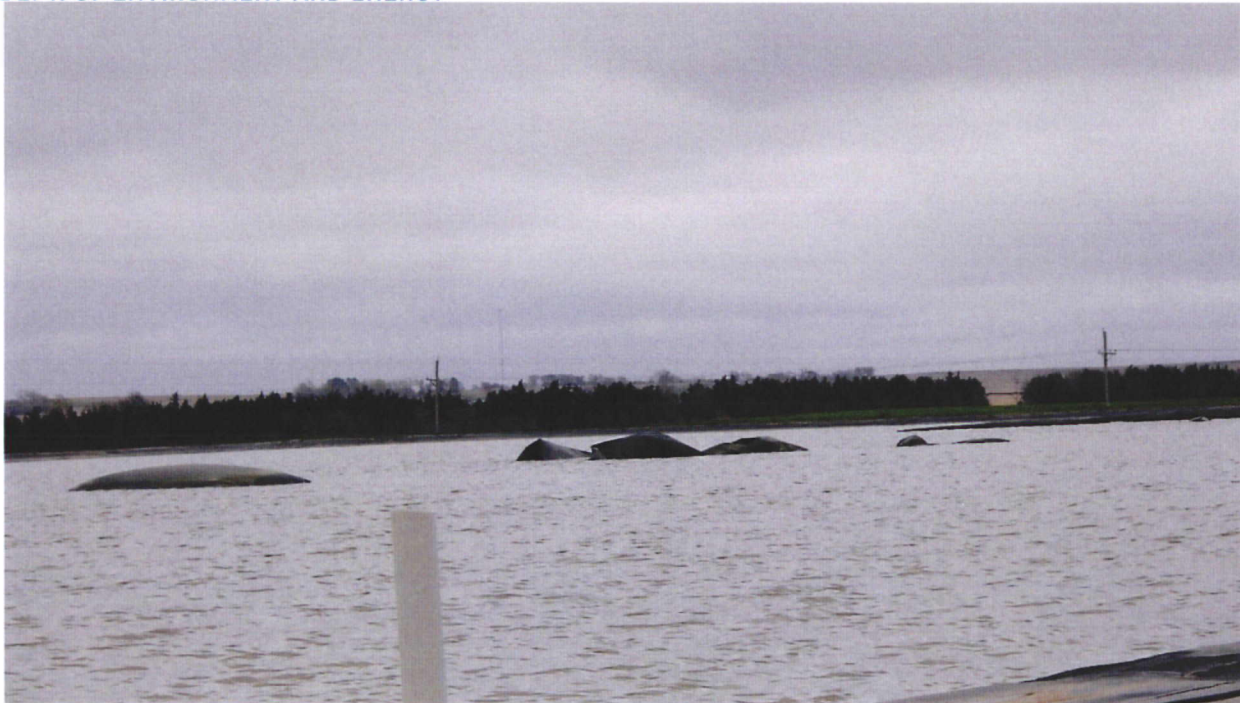
Photo: 19

Description: Damaged liners

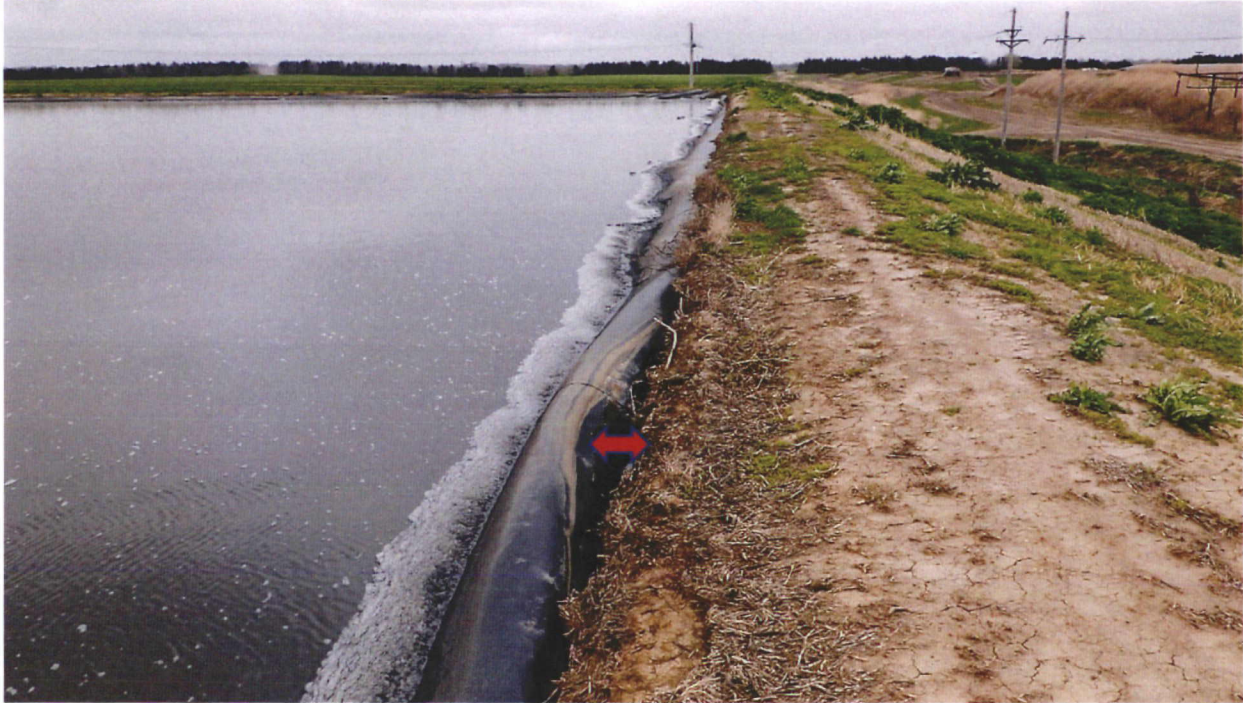
Photo: 21

- Northeast lagoon
 - No change
- Northwest lagoon
 - No change
- South lagoon
 - The fence has been mended.
 - The facility is pumping from the south lagoon to the treatment system.
 - The liner appears to be separating from the south dike (photo).
 - Liner torn on the south dike (photo).

Description: This photo depicts the south liner potentially pulling away from the dike (arrow).

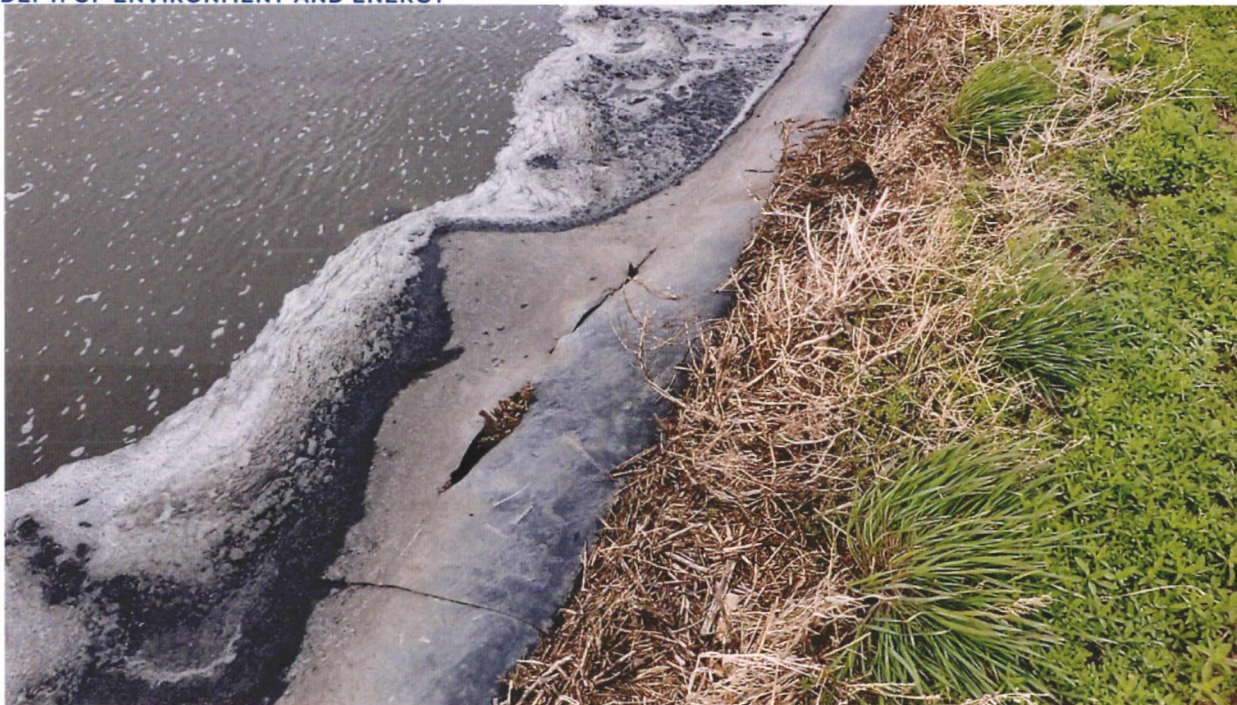
Photo: 22

Description: Tears observed on the south liner.

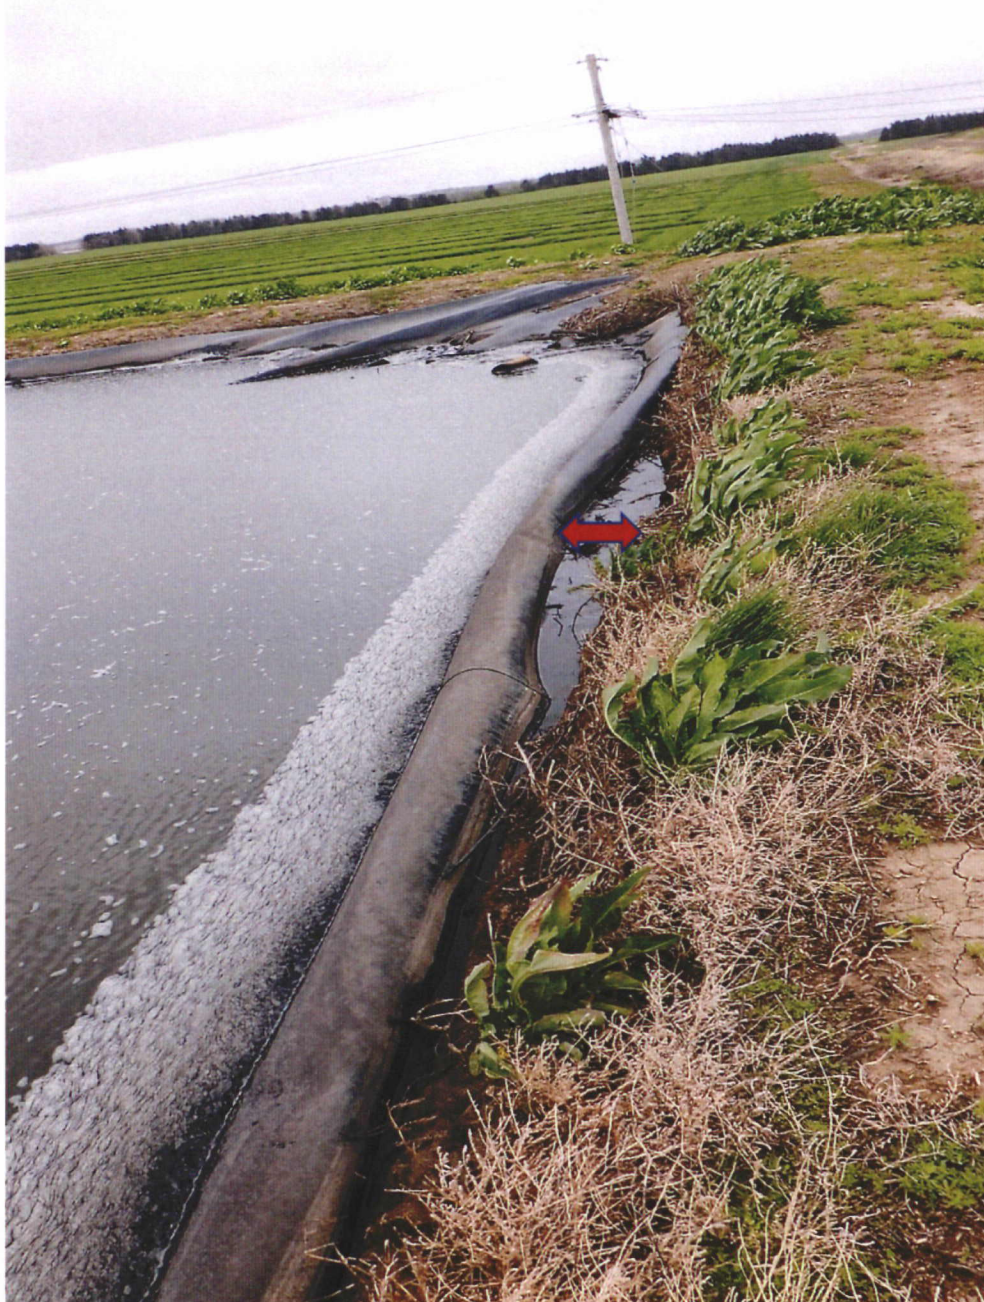
Photo: 23

Description: This photo depicts that the liner appears to be separating from the lagoon dike.

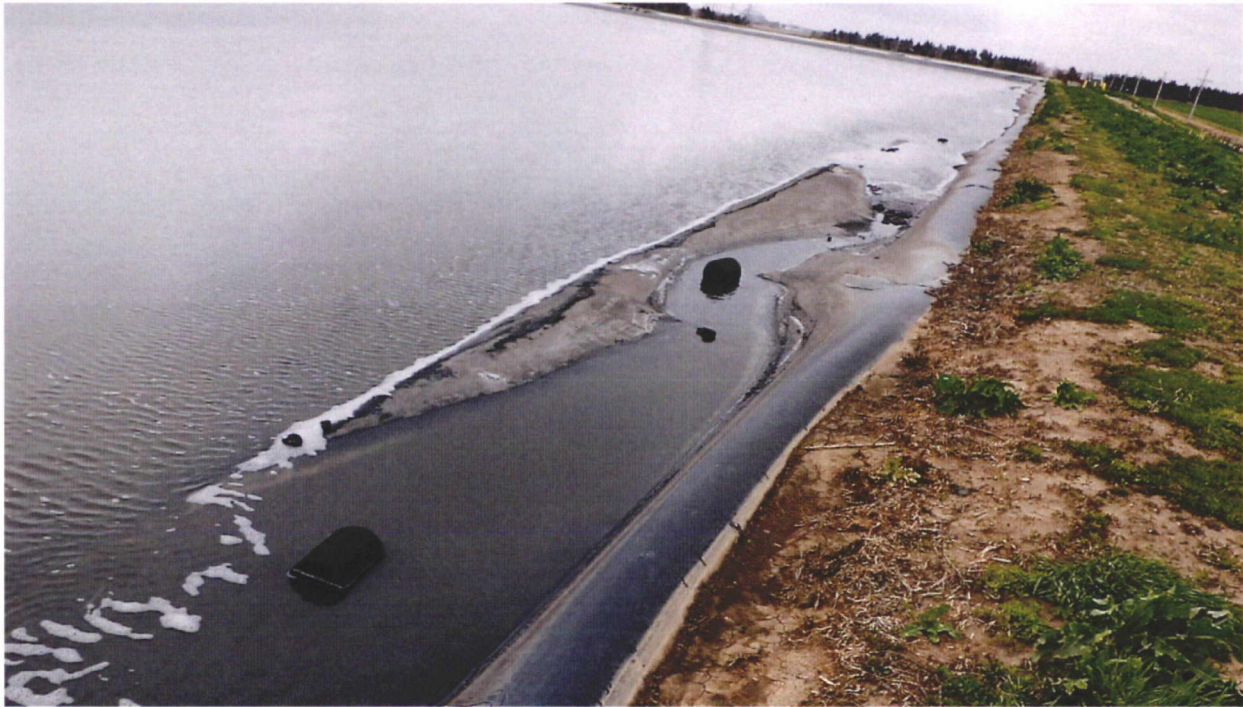
Photo: 24

Description: This photo depicts floating liner on the east side of the south lagoon.

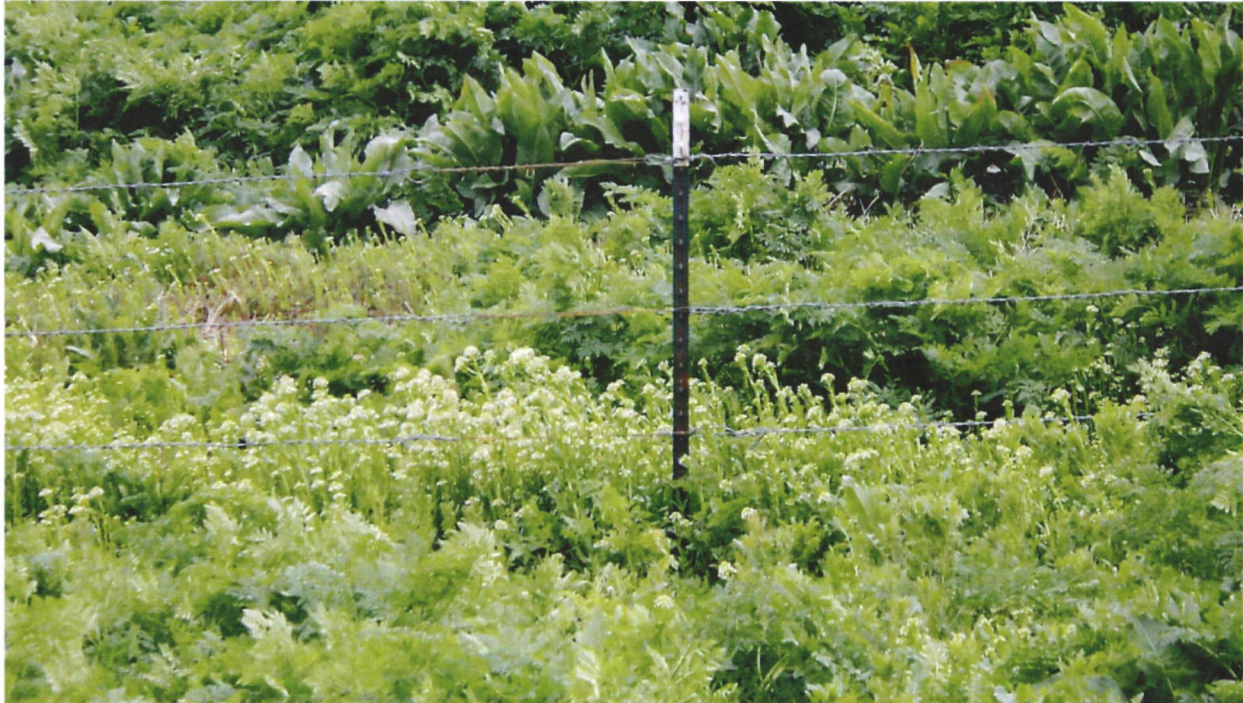
Photo: 28

Description: This photo depicts that the fence is mended.

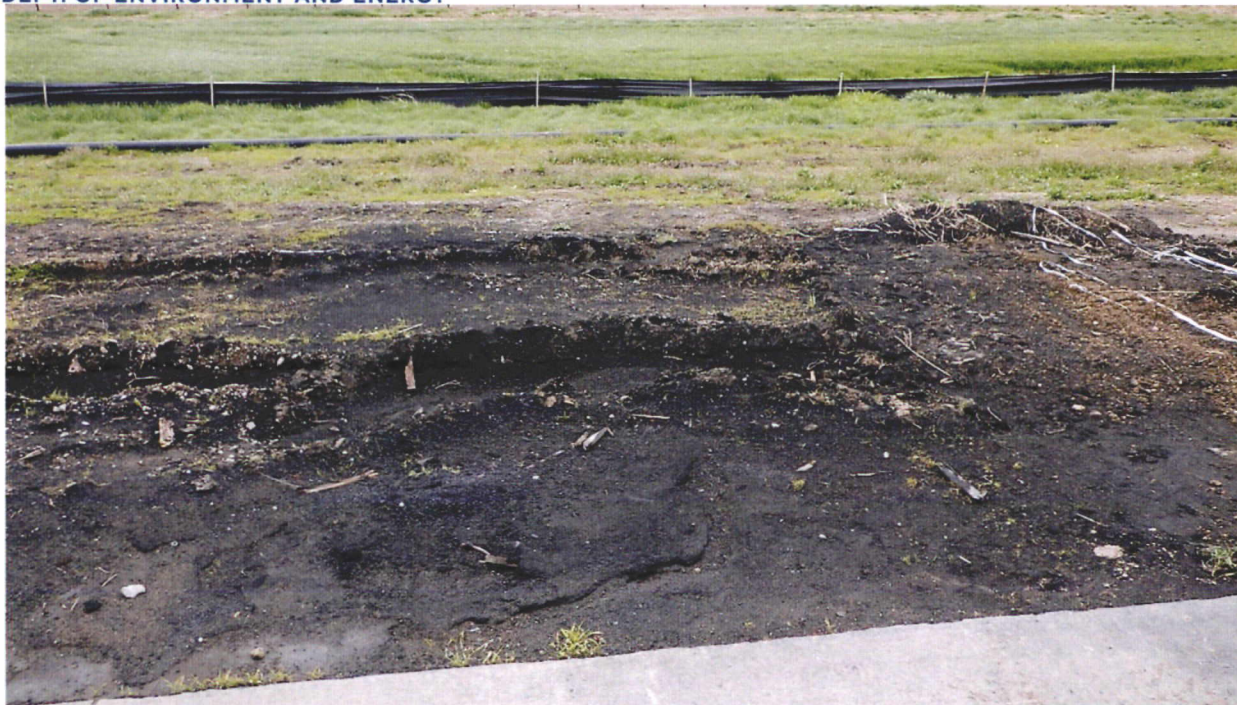
Photo: 29

Description: This photo depicts biochar spilled of the south side.

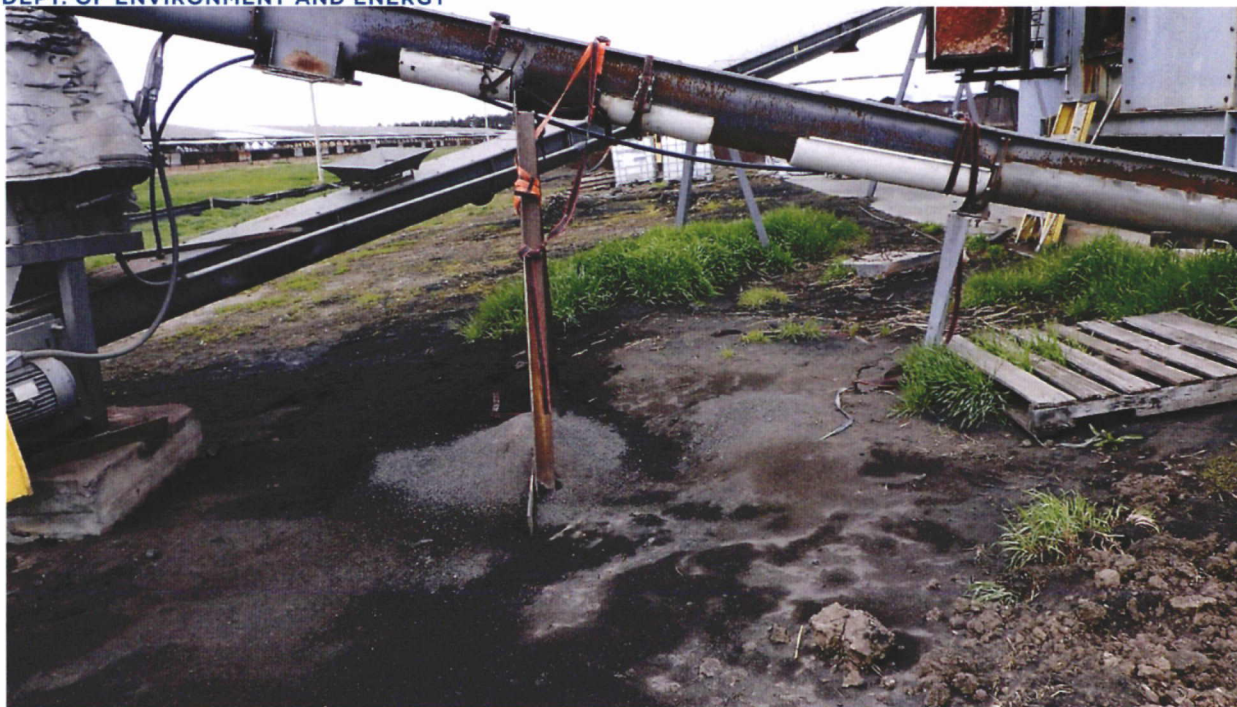
Photo: 30

Description: This photo residual biochar. There is no containment or best management practice to control this runoff.

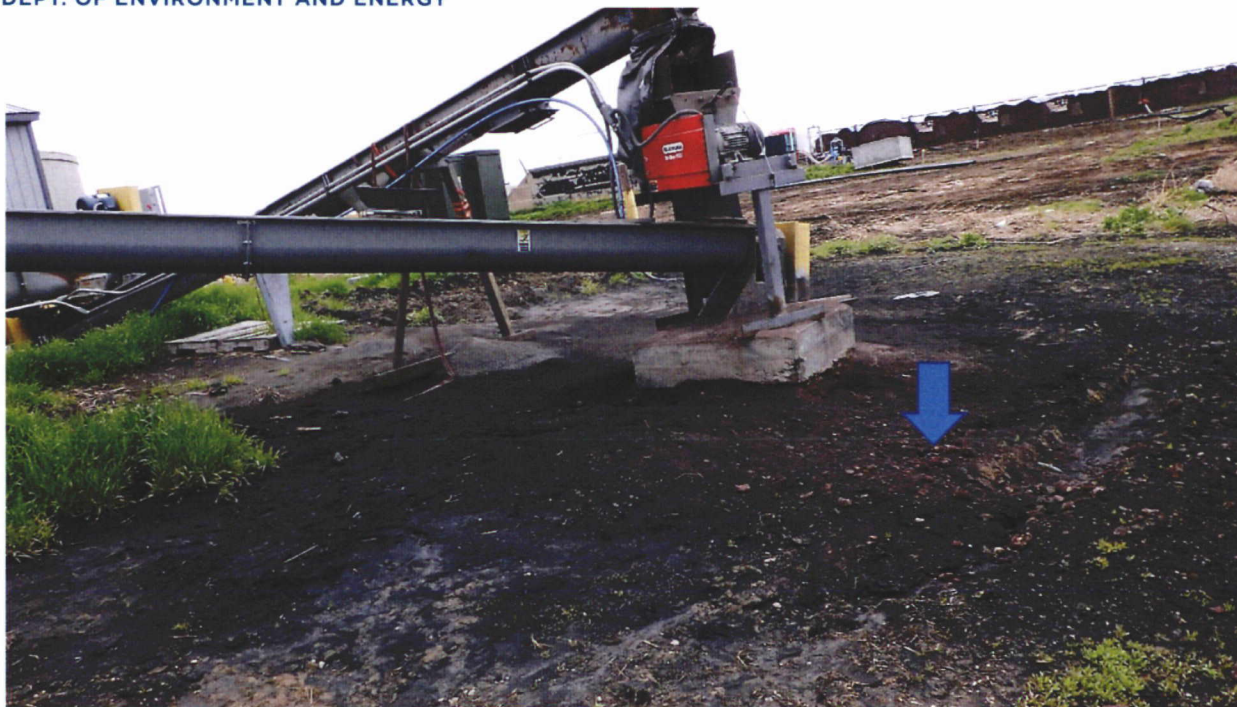
Photo: 31

Description: This photo residual biochar and red material (arrow).

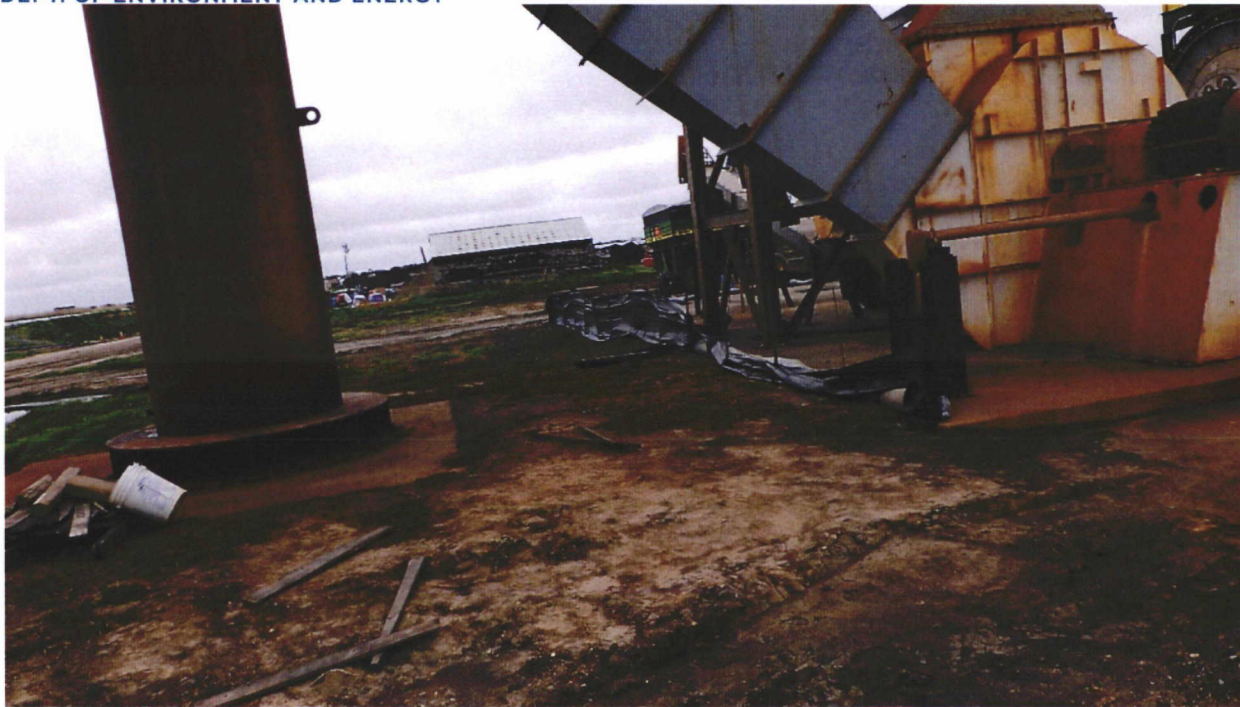
Photo: 32

Description: This photo is taken on the north side of the biochar. There is a red colored material on the ground. The material is not in containment.

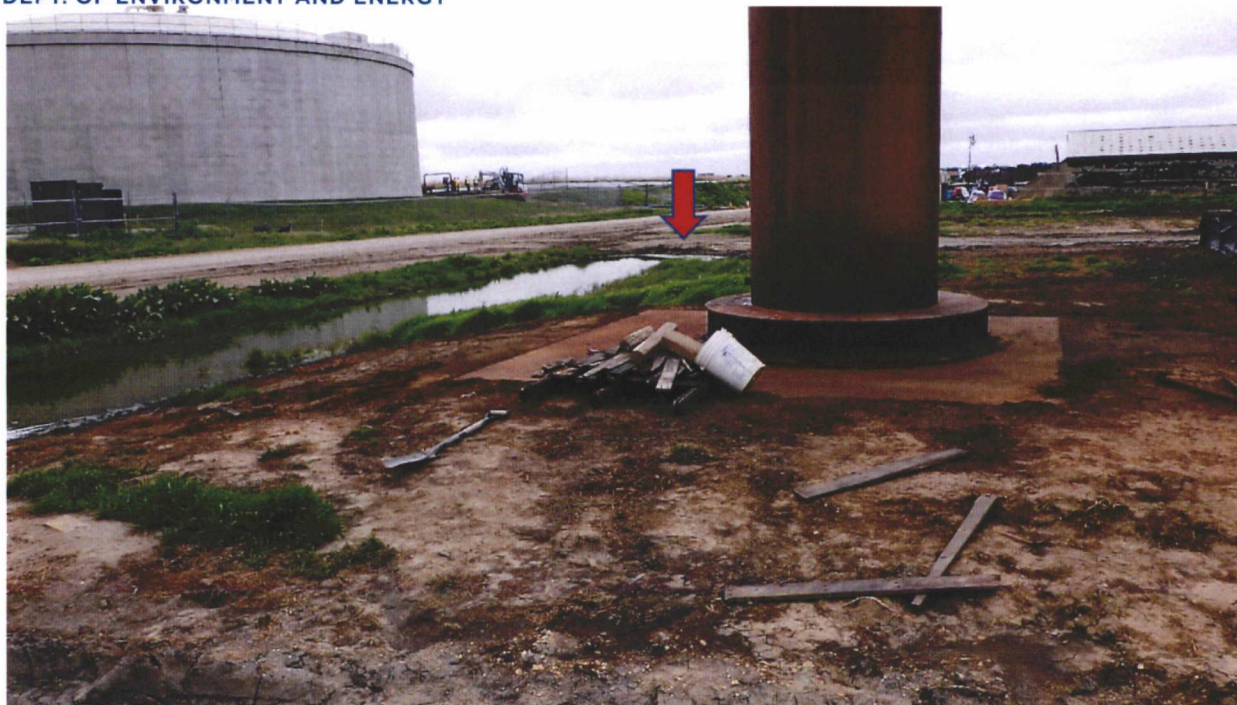
Photo: 33

Description: This photo is a little north of photo 29. The material depicted in the photo can wash into the drainage ditch. The facility has plugged the culvert on the east side (arrow).
