Facility: AltEn
IIS: 84069
PCS: NE0137634

Site Visit Check list

AltEn LLC - Storm Water Temporary BMP Check Map

Site Visit Report

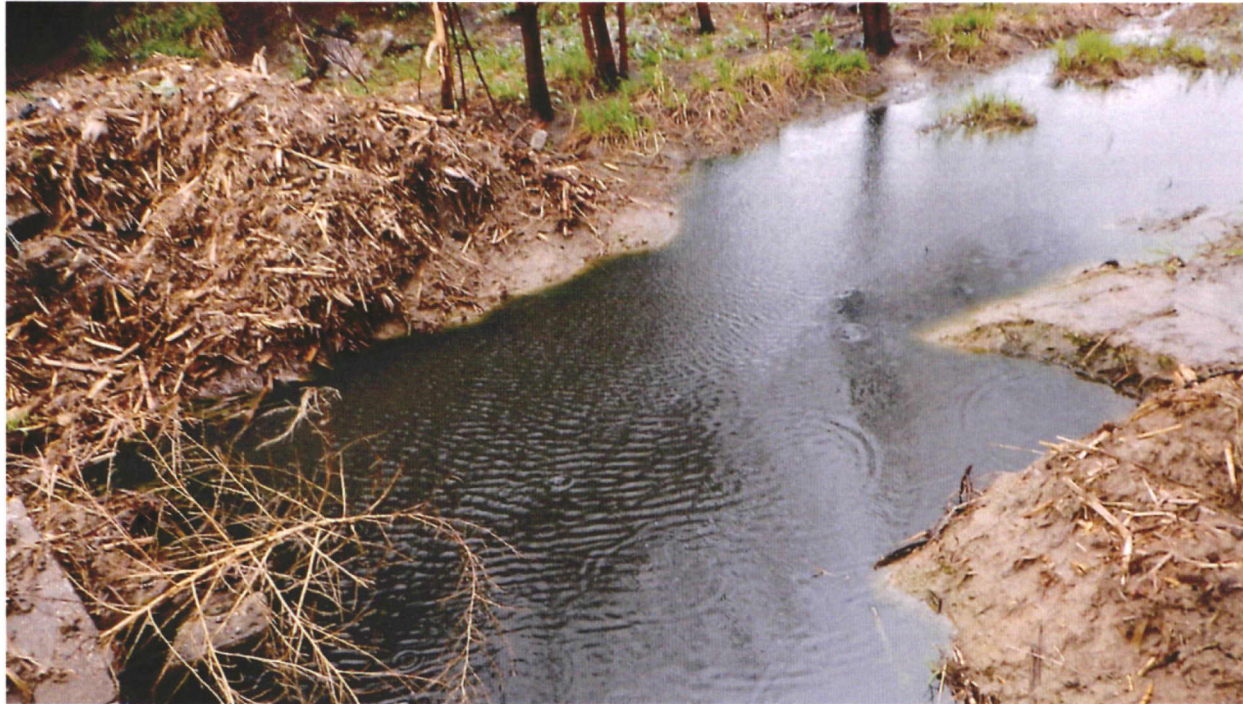
Photos: 1

Description: East side of CR 9 showing dark colored water with and algae growth along the edges of the drainage way.

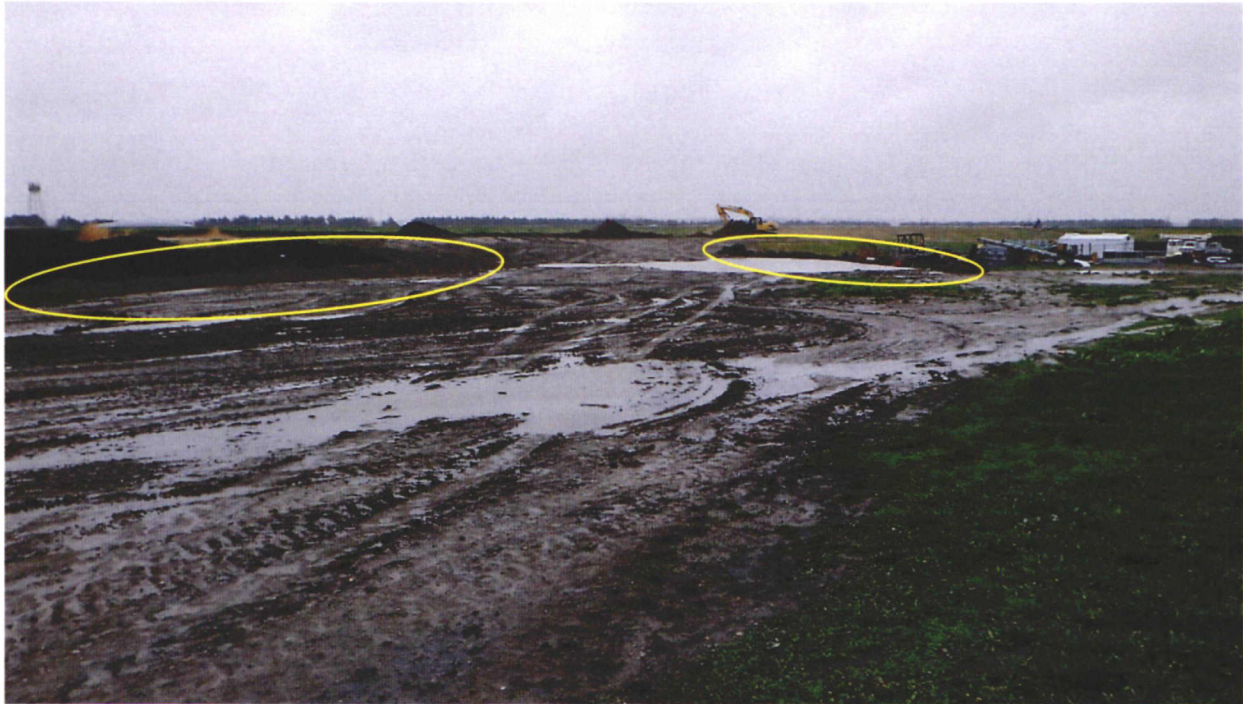
Photos: 2

Description: Berm on left and berm in right of photo. The berm on the right needs to be pumped as soon as possible and the berm on the left is slowly filling up from runoff from wetcake area adjacent.

- Pump out berm areas ASAP before potential breach or failure of berm.
- Provide process diagram & description of treatment system used for water. Primarily method using ethanol plant system.
- Provide information on fluid being discharged from distillation area.

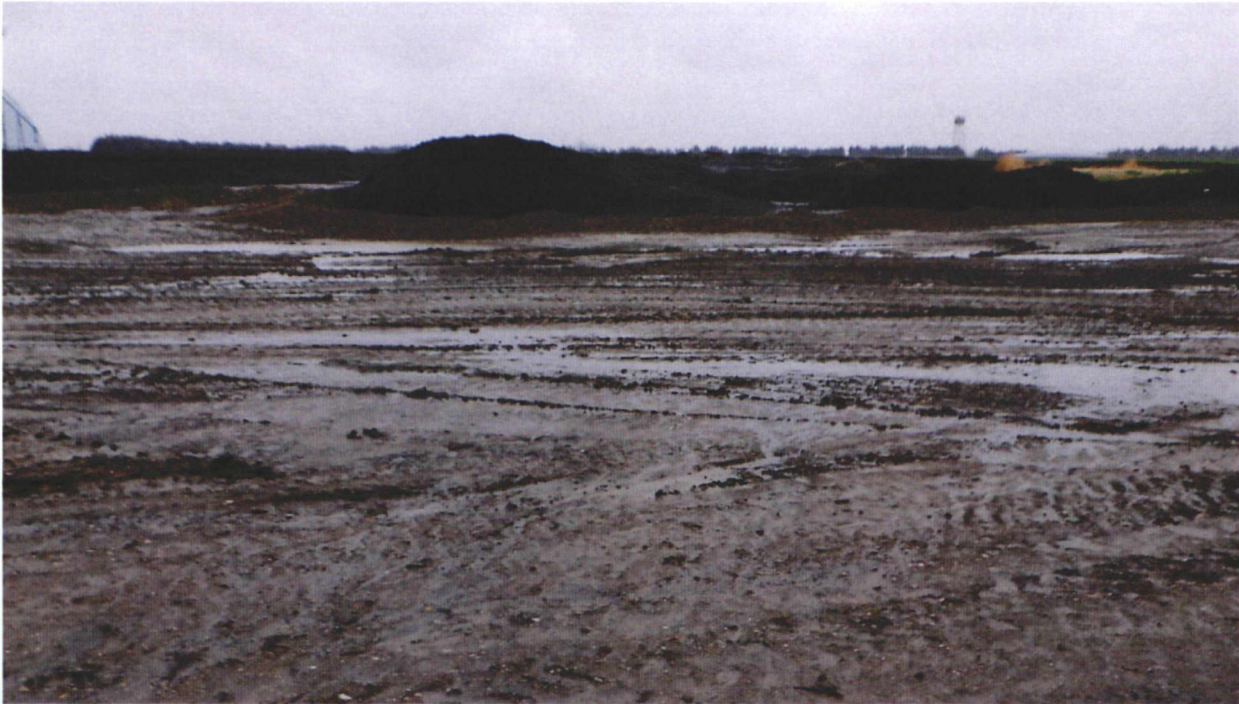
Photos: 3

Description: Small berms placed around wetcake preventing outside runoff in and attempting to contain runoff from the wetcake from discharging offsite.

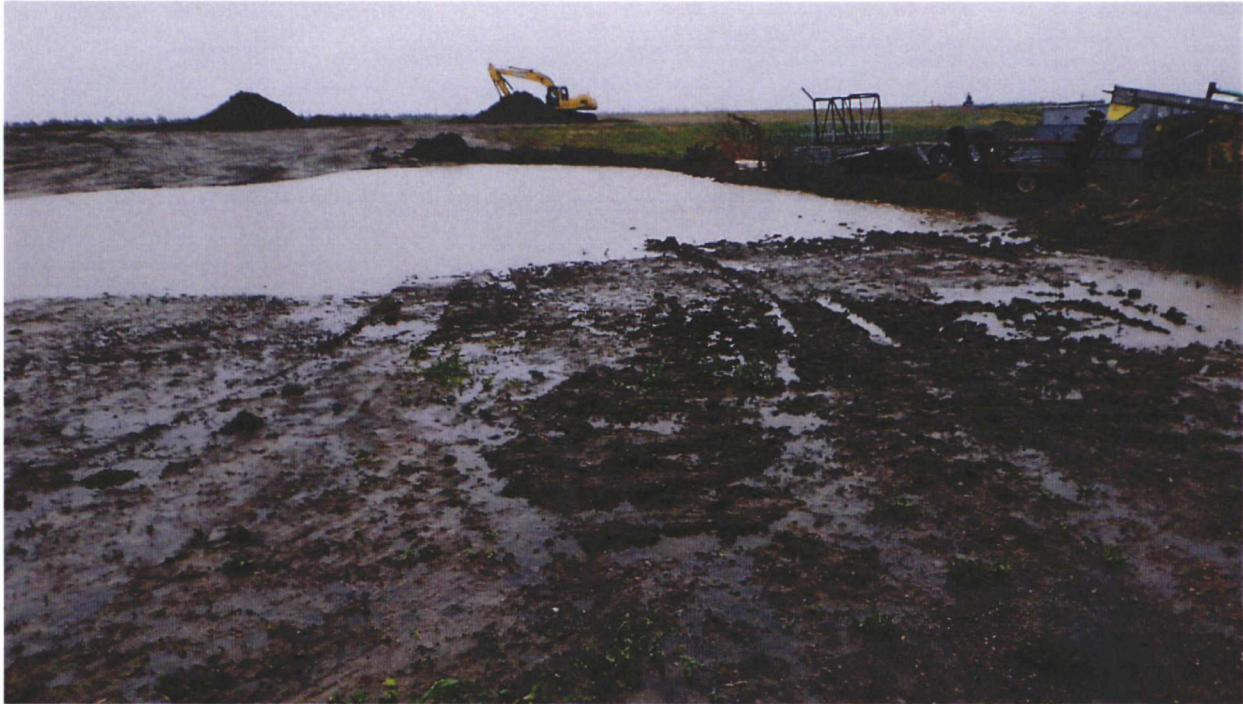
Photos: 4

Description: Close up of berm holding storm water from roadway and parking area to the west of the admin building.

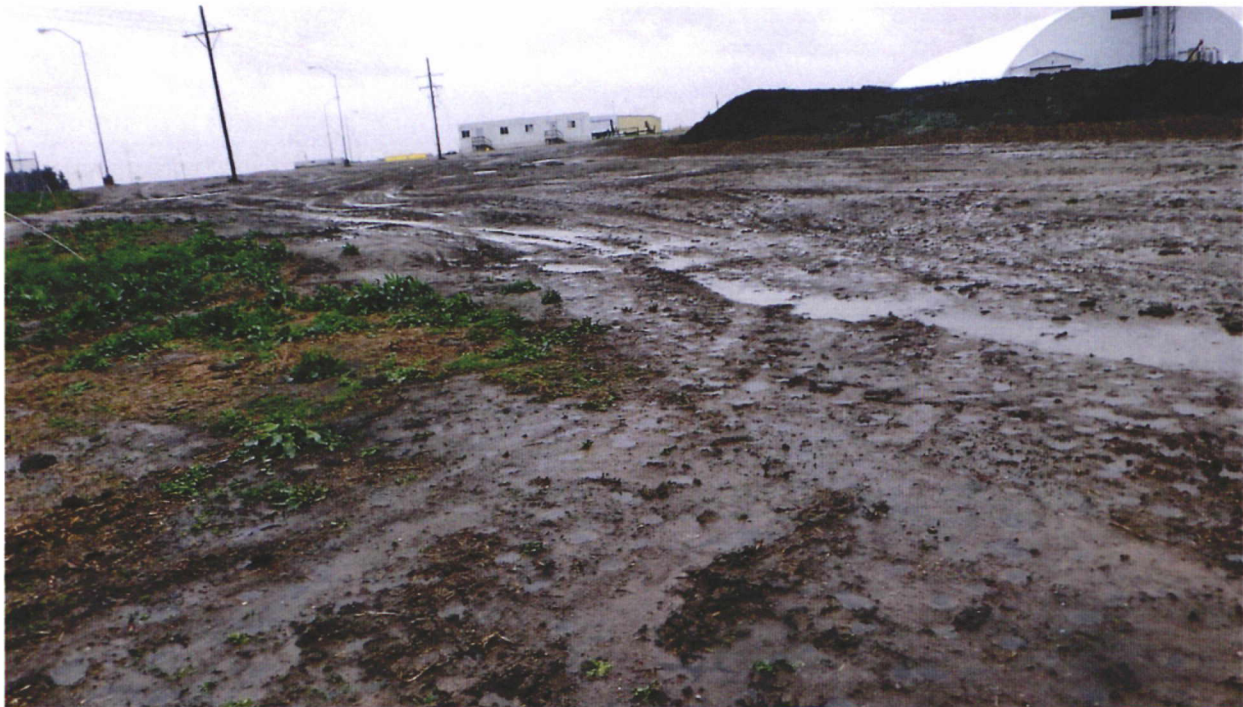
Photos: 5

Description: Drainage area collected at berm shown in photo 4.

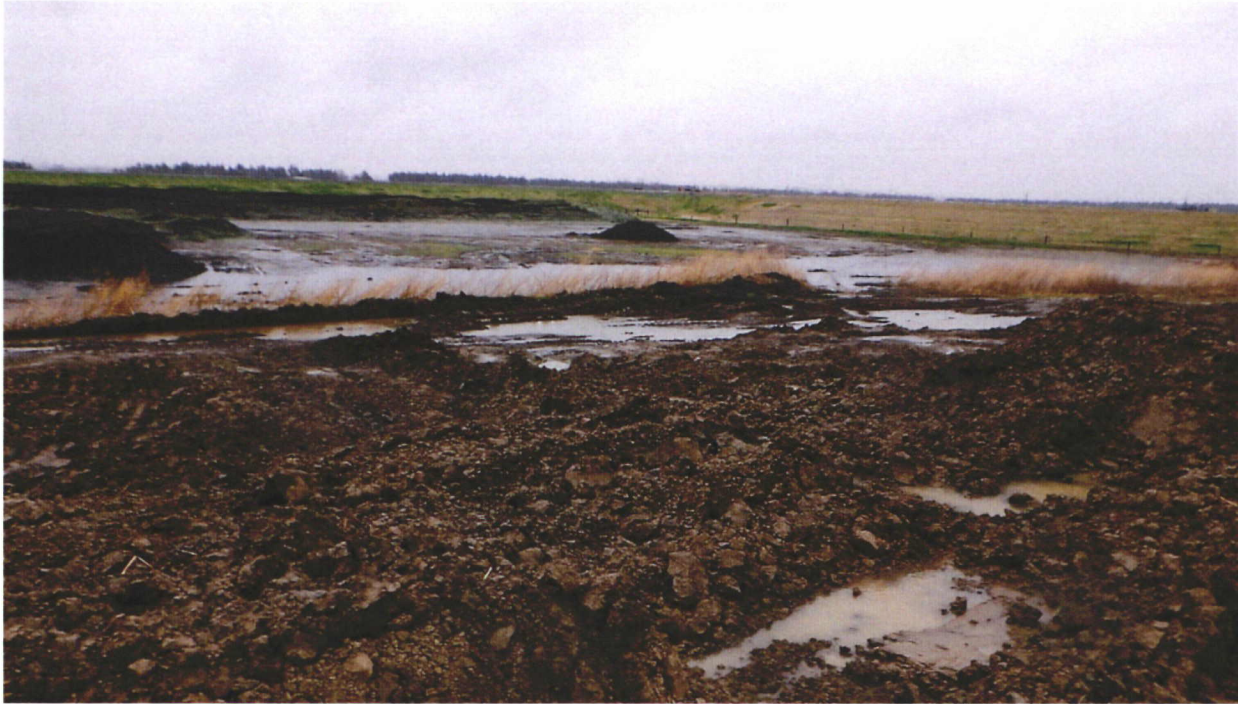
Photos: 6

Description: Central drainage from the main wetcake area to the north and west that collects in area 2 on the site map. Photo taken from high area where soil excavated from the northwest lagoon was stored. The area was previously covered with vegetation, but is now being used as soil borrow material for berm construction.

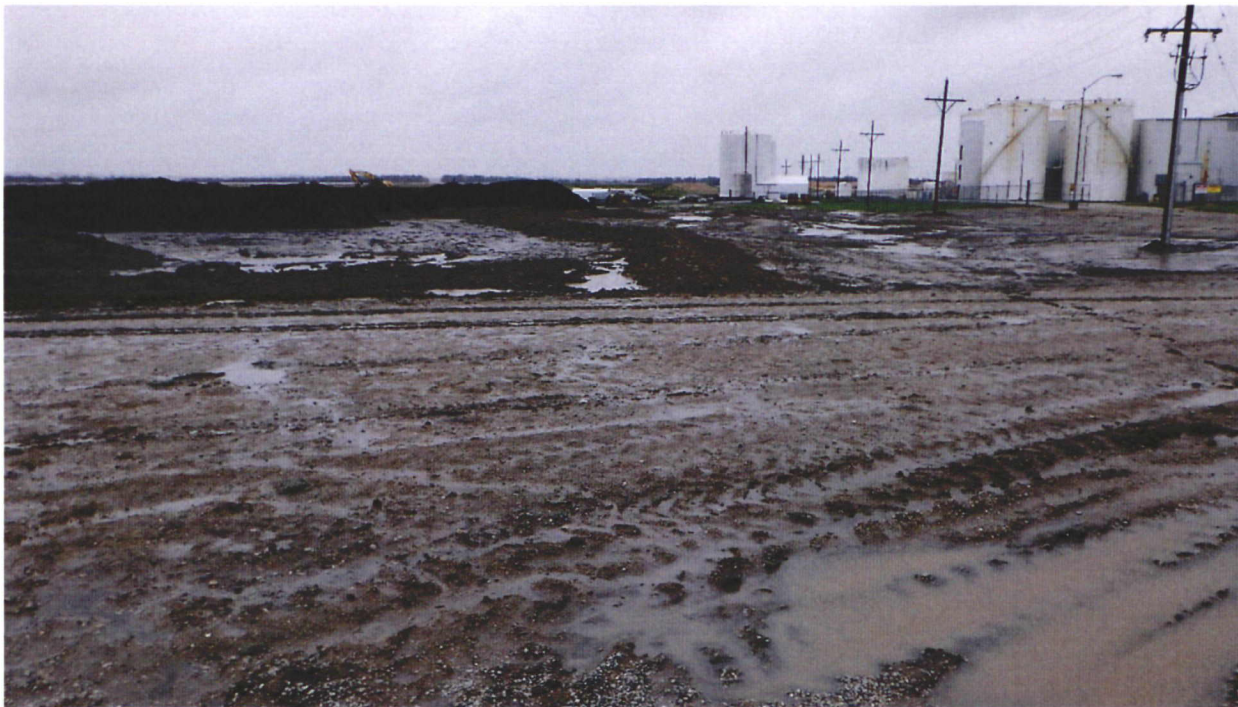
Photos: 7

Description: Showing extent of berm to access road.

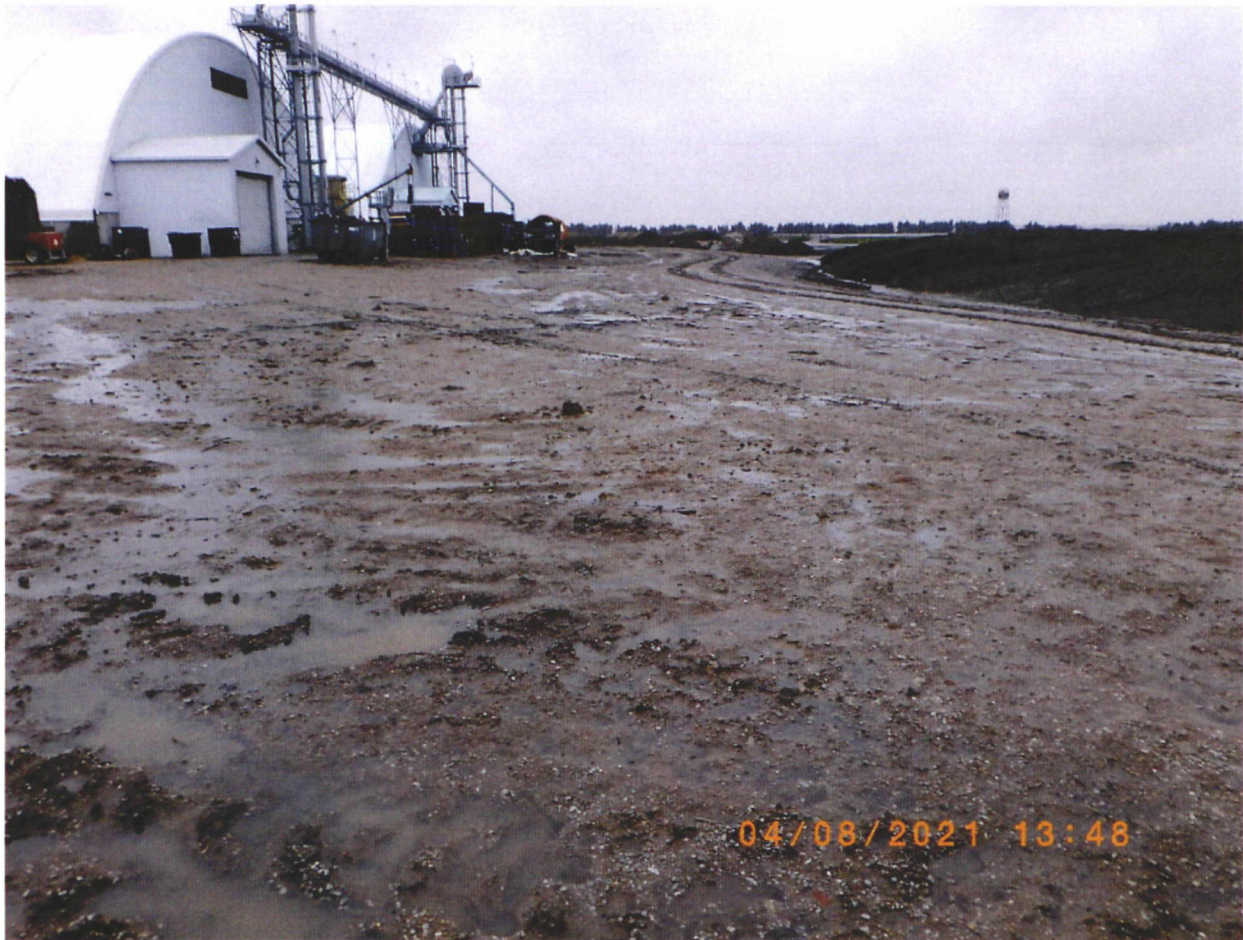
Photos: 8

Description: Access road east of the hoop buildings.

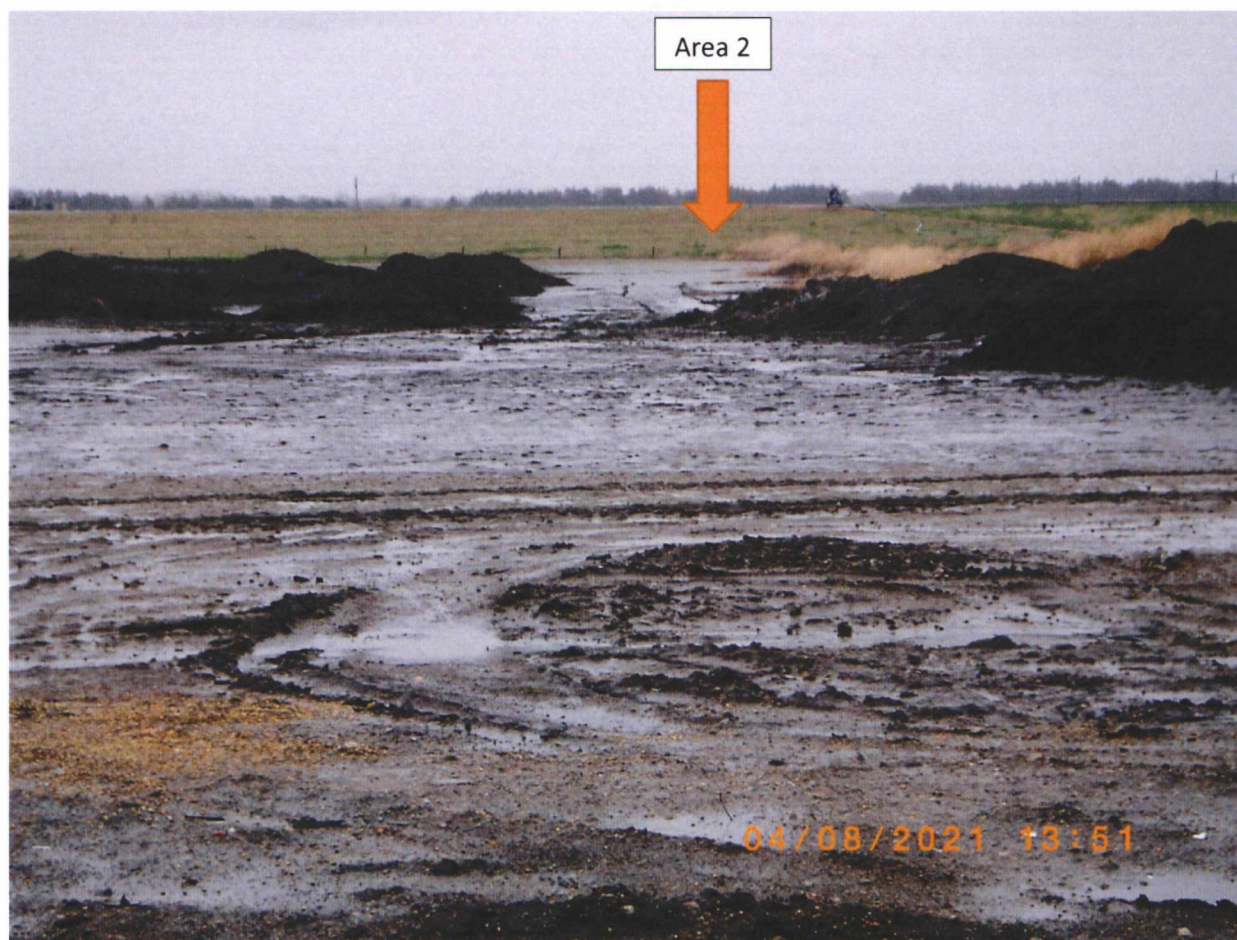
Photos: 9

Description: Main drainage path to area 2 from west wetcake area.

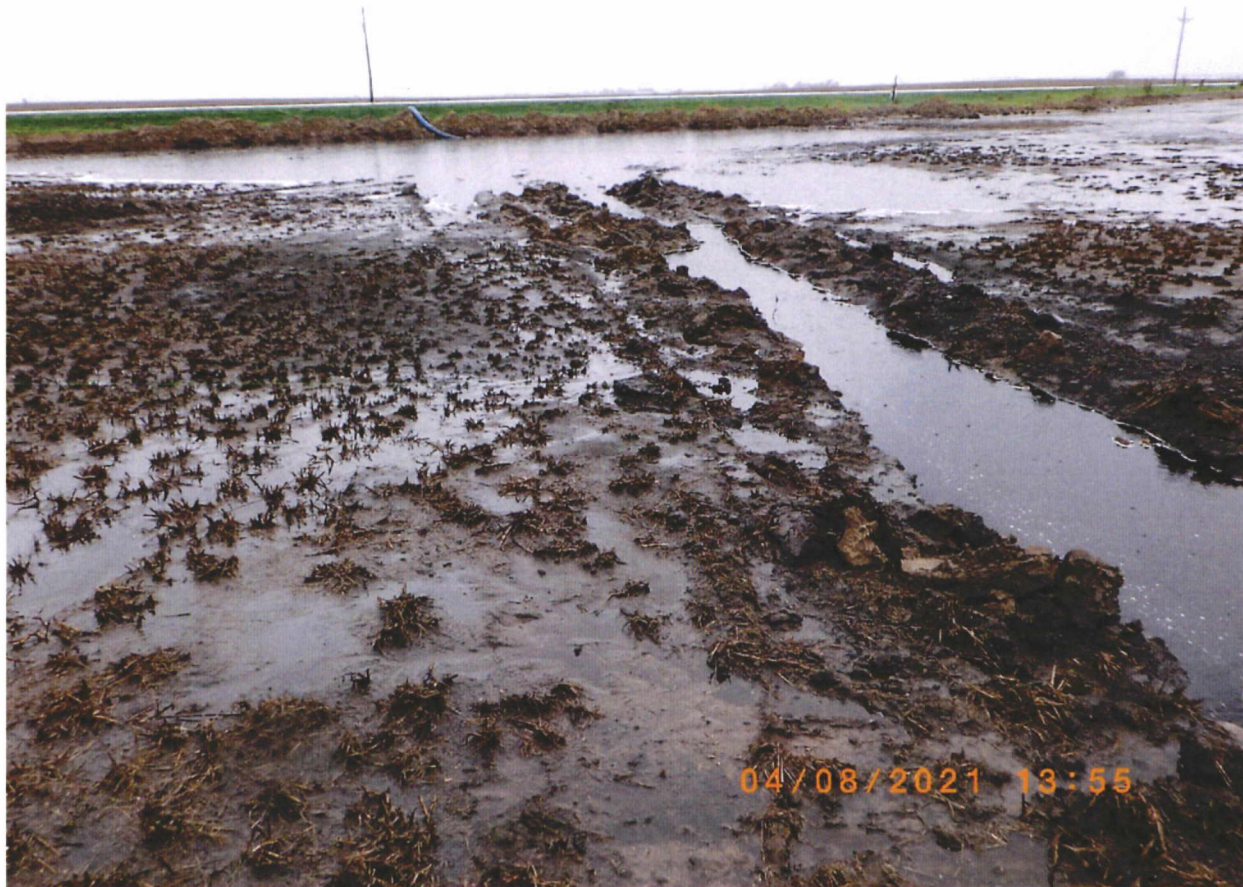
Photos: 10

Description: Stabilized berm with trench draining opposite direction to area 2 on other side of hoop buildings.

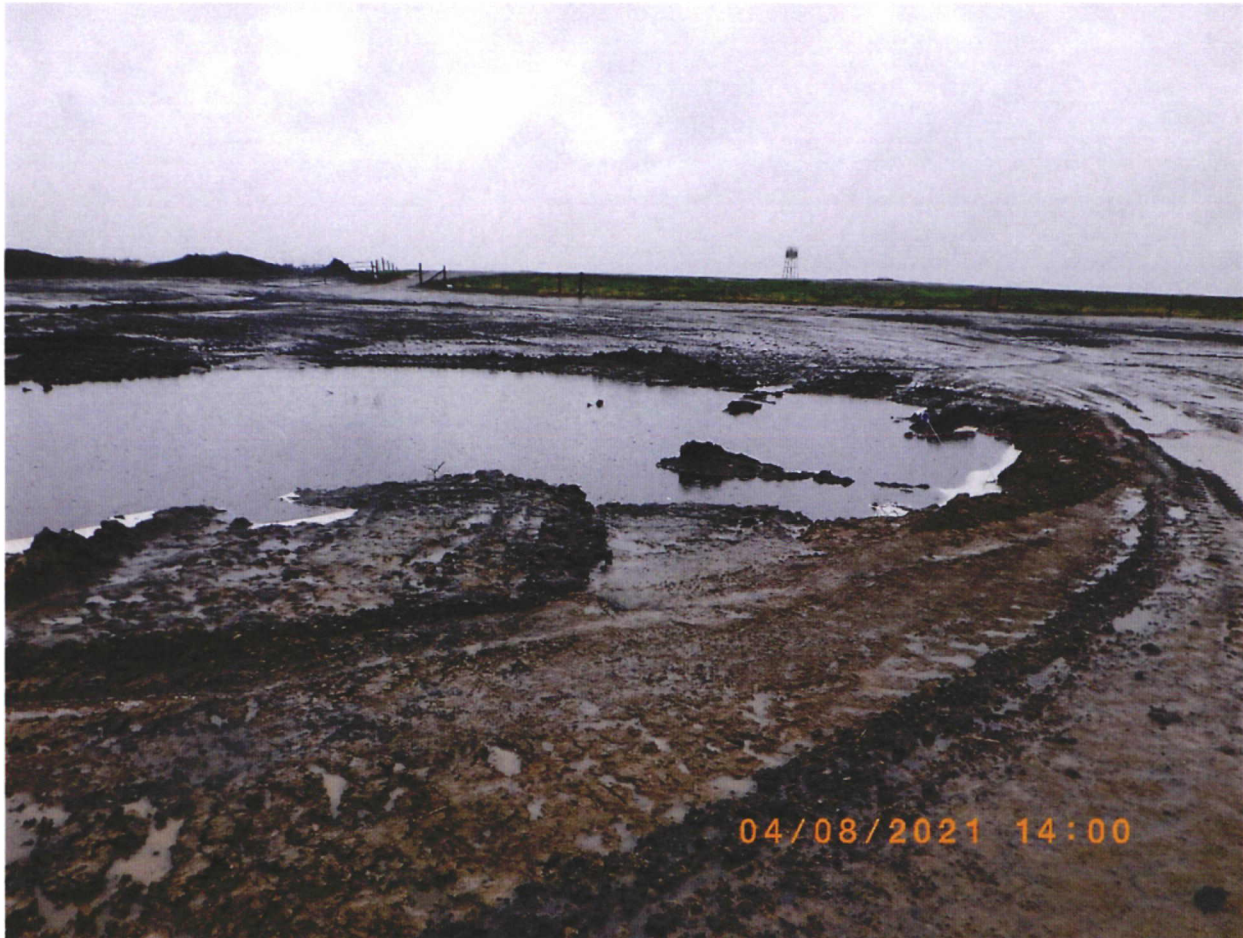
Photos: 11

Description: Runoff from wetcake draining to area 2 from the NW. The access road on the right of the photos acts as a berm during rain events and is drained by a small pipe on the backside (SE side of road).

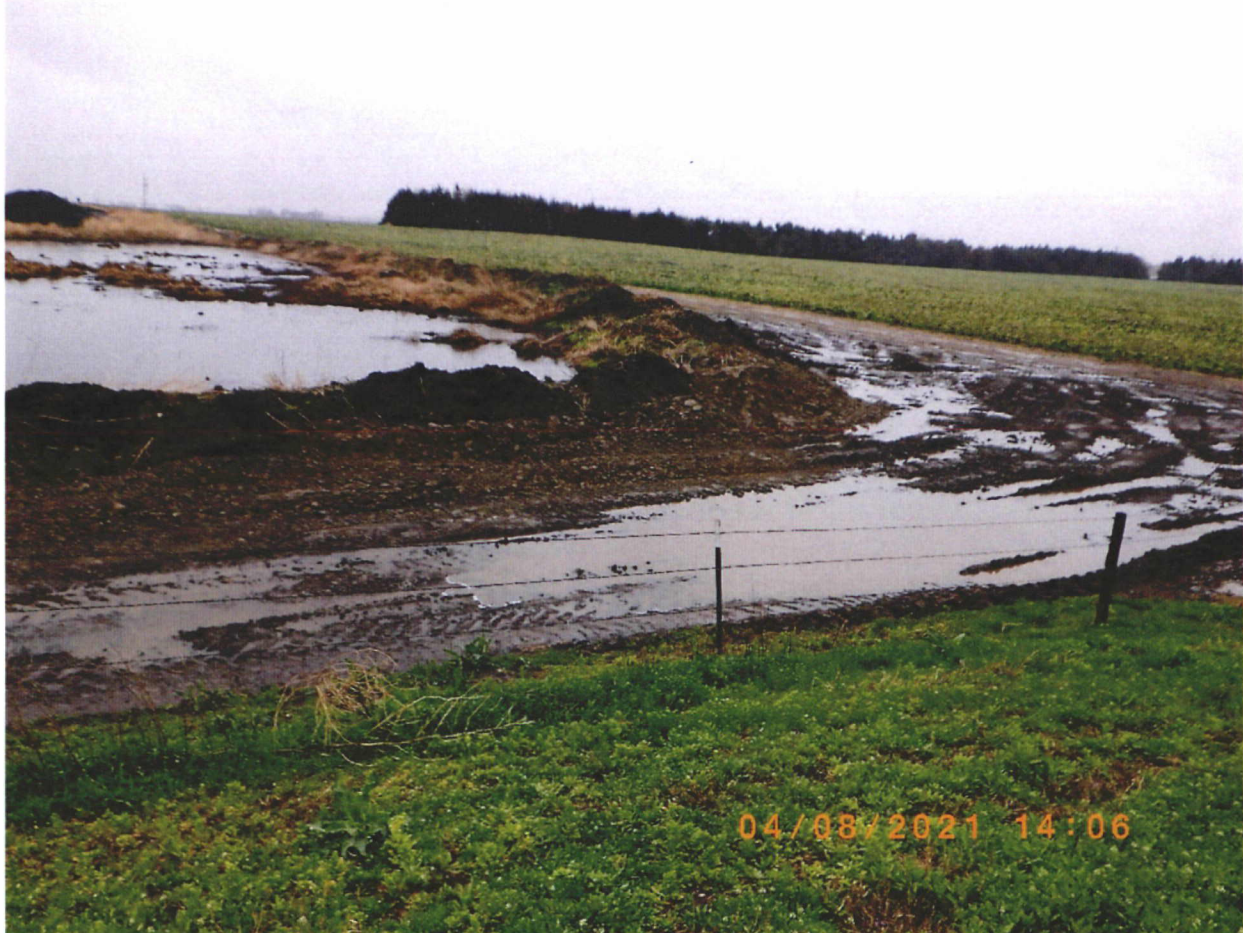
Photos: 12

Description: Berm is holding now that it was reinforced. Water outside of berm is runoff from the access road and adjacent field.

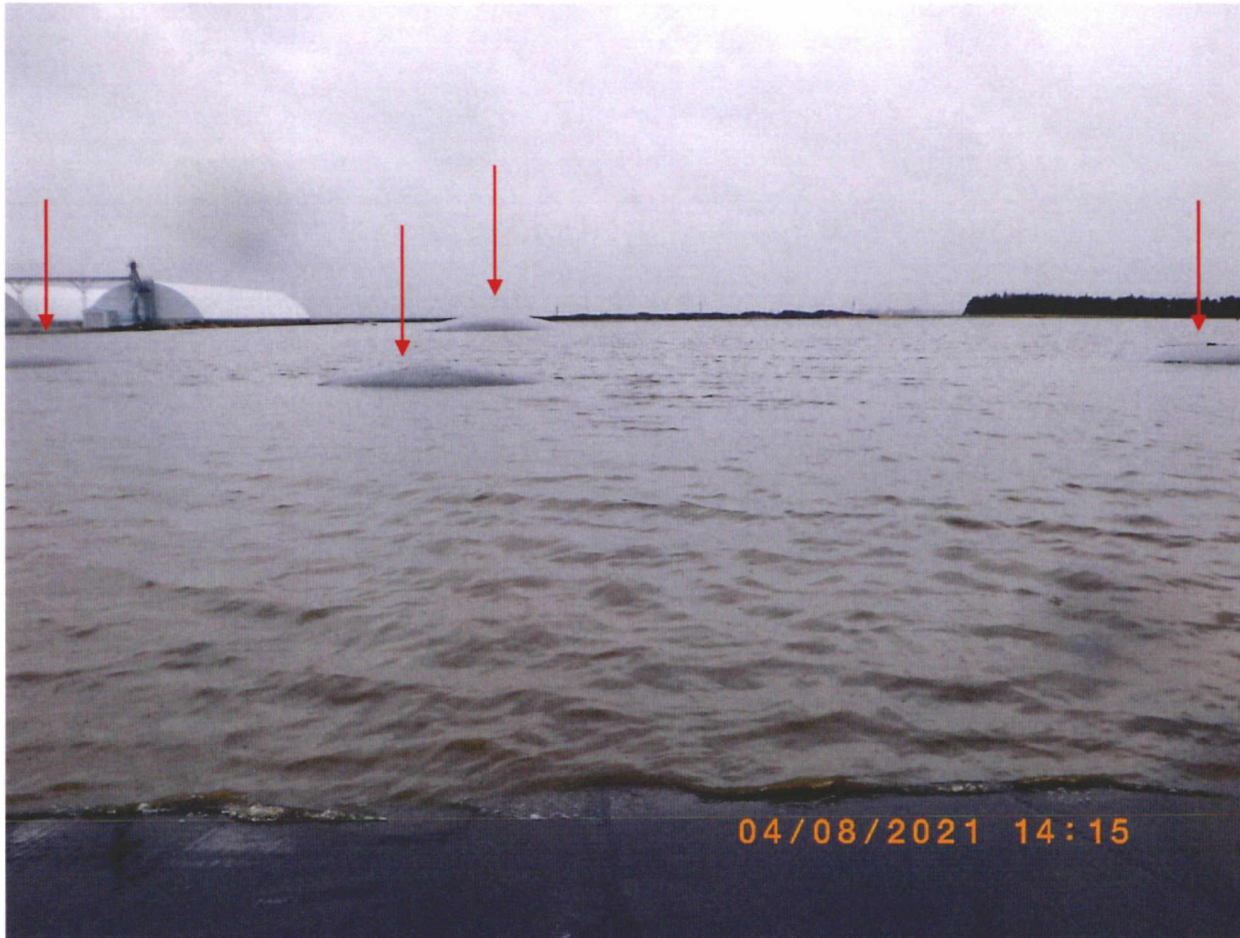
Photos: 13

Description: Photo depicts 4 whales present in the northwest lagoon.

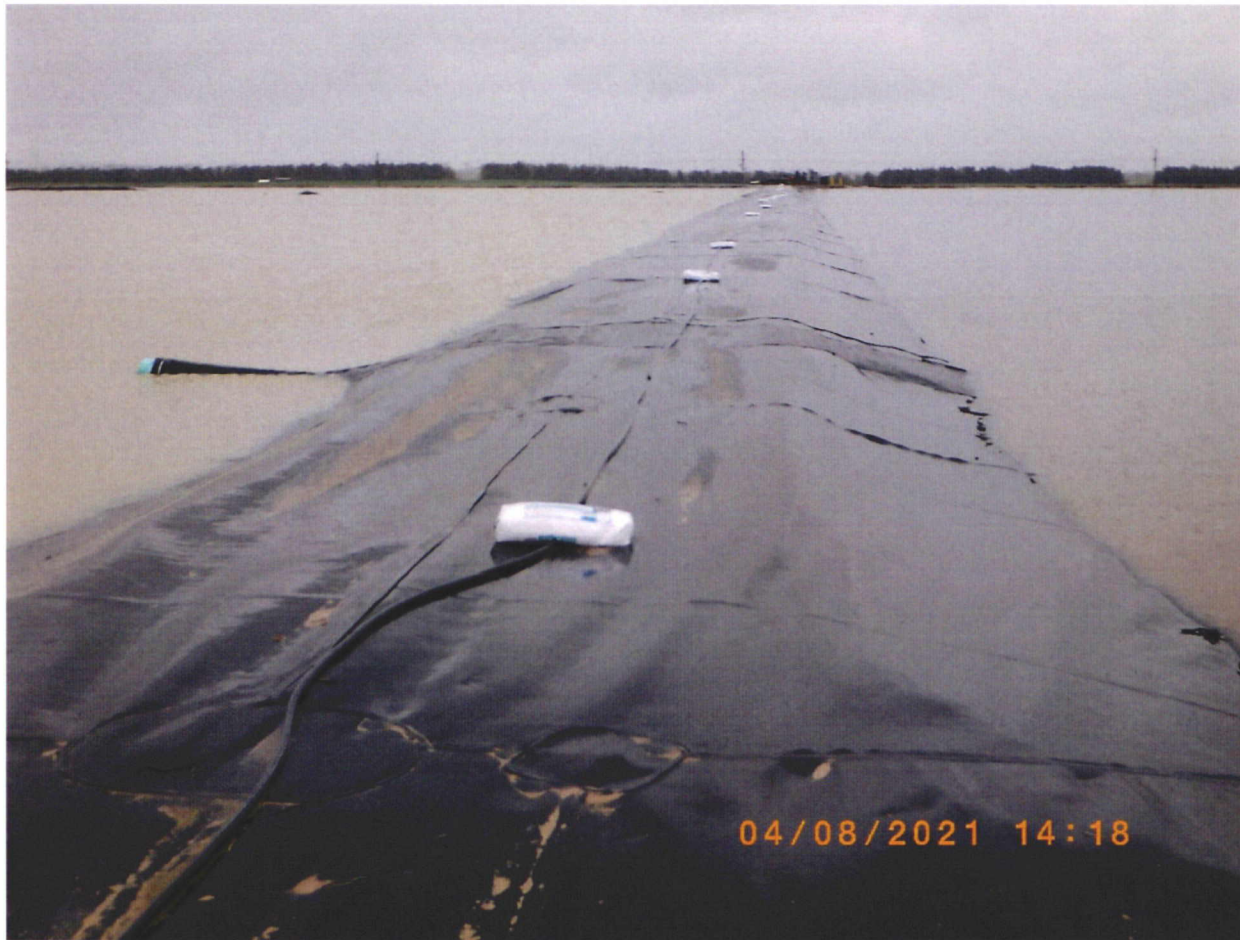
Photos: 14

Description: Photo showing the NE lagoon on the left and the SE lagoon on the right.

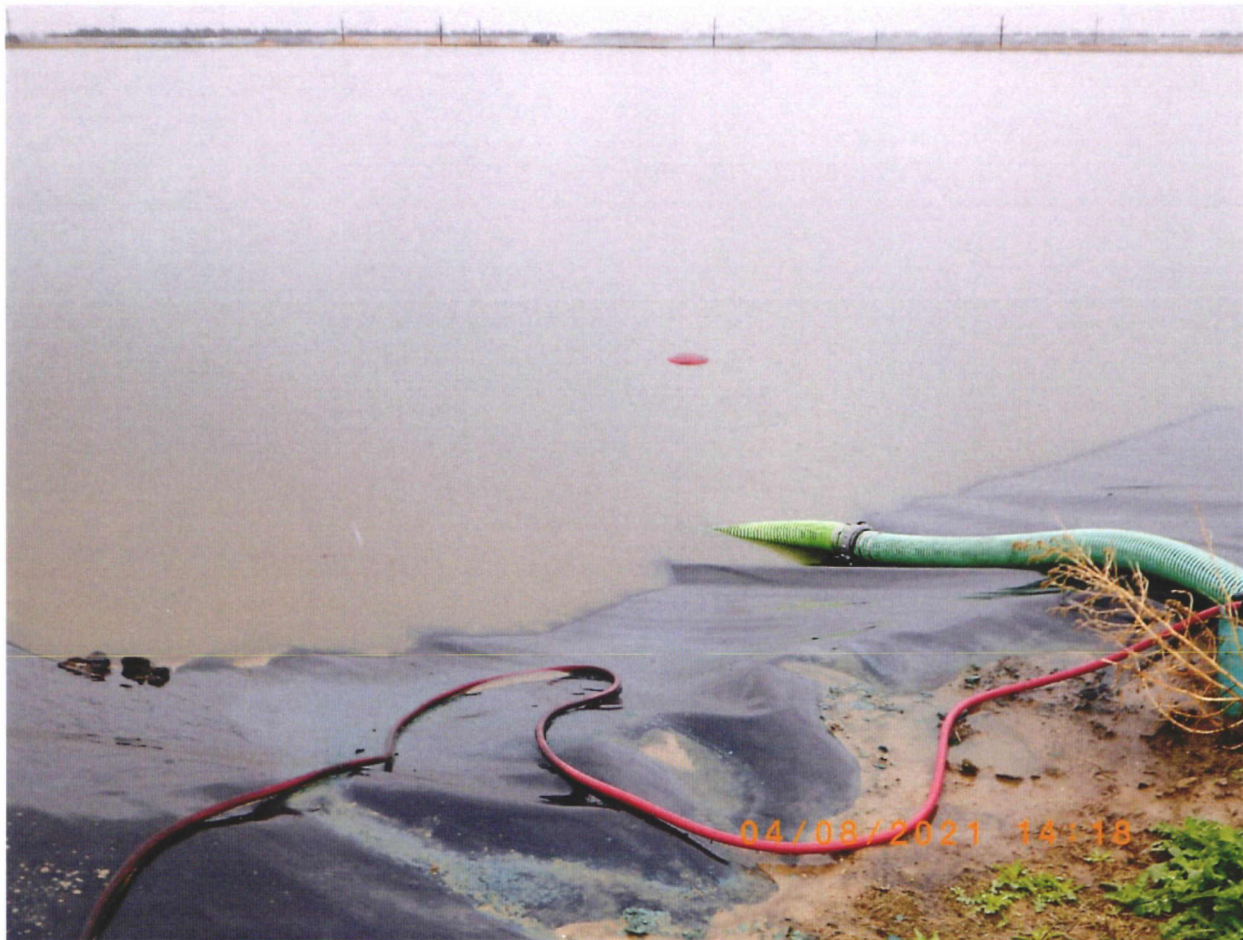
Photos: 15

Description: Pump/hose system used to pull water from the southeast lagoon.

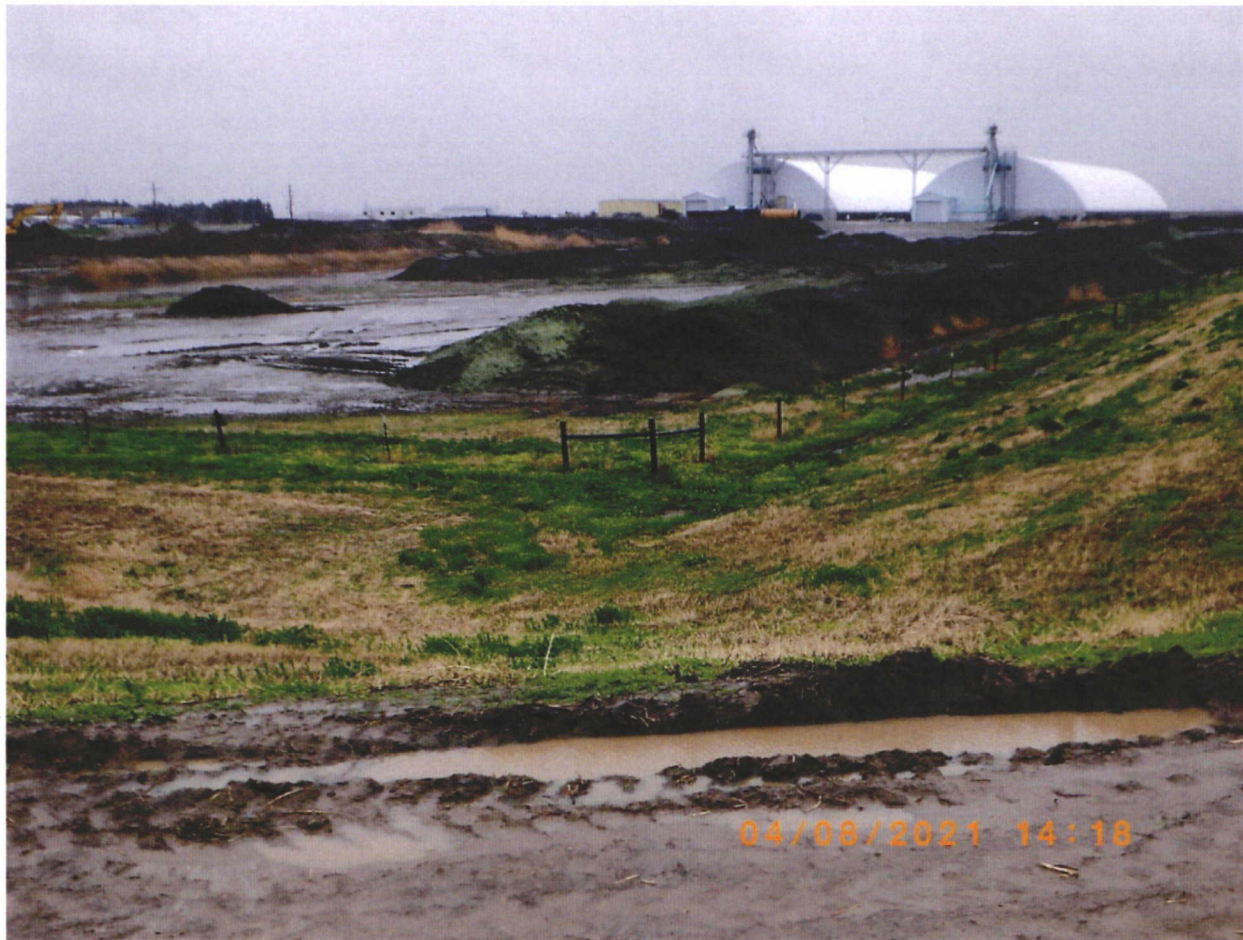
Photos: 16

Description: North side of the drainage area to area 2 south of the northwest lagoon.

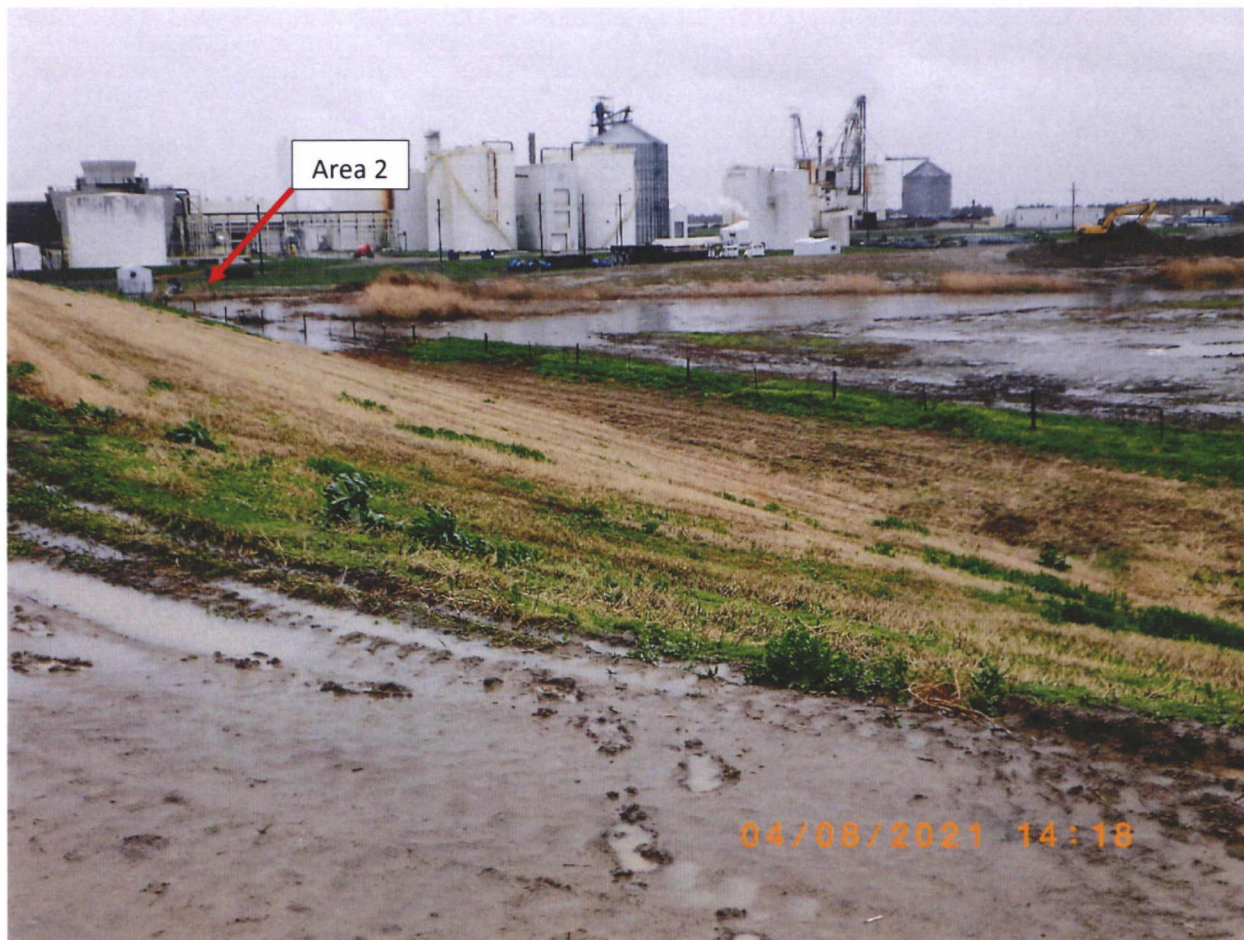
Photos: 17

Description: Runoff accumulating in area 2 from wetcake storage areas west and north.

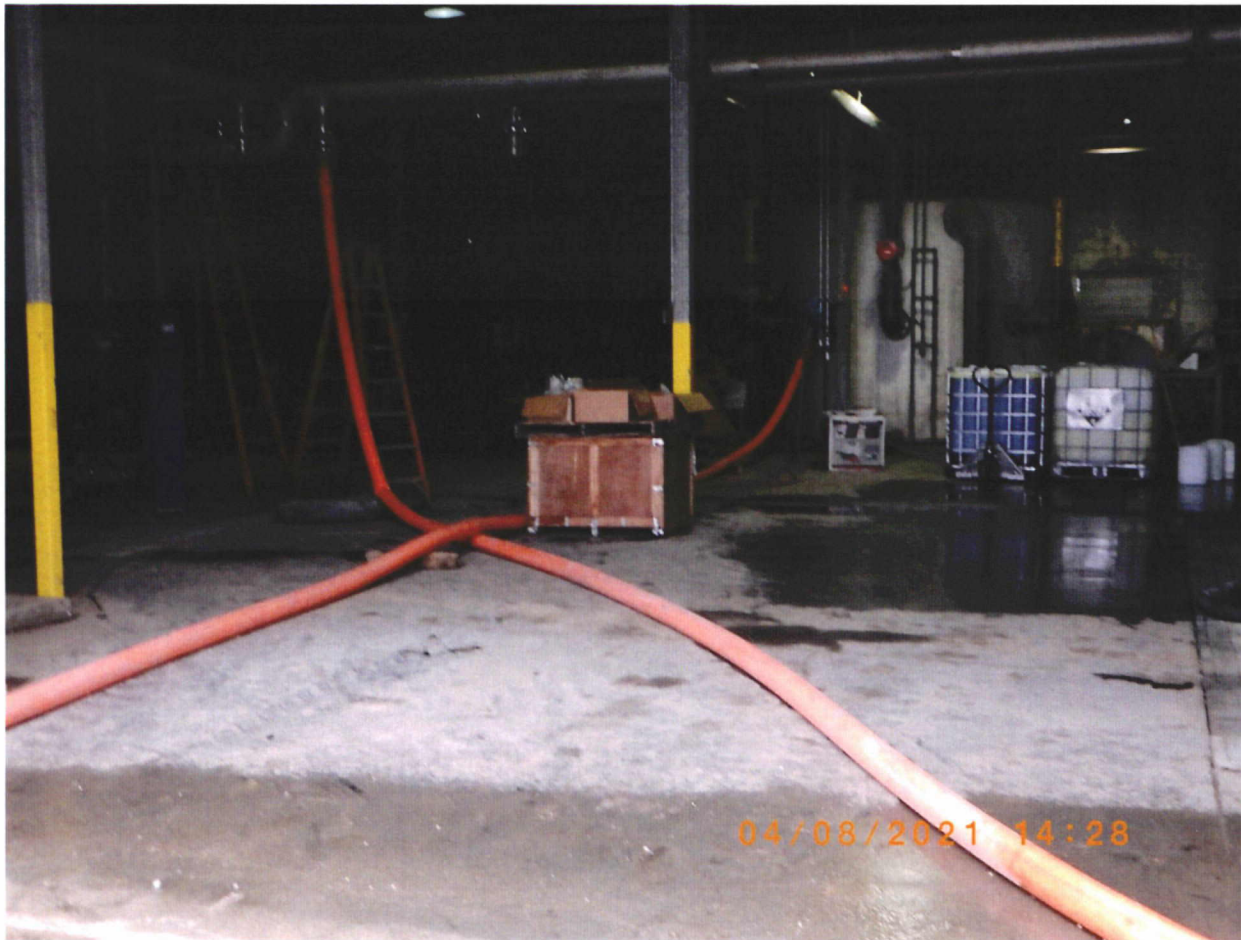
Photos: 18

Description: Building where cleanup of lagoon water is being filtered and clarified.

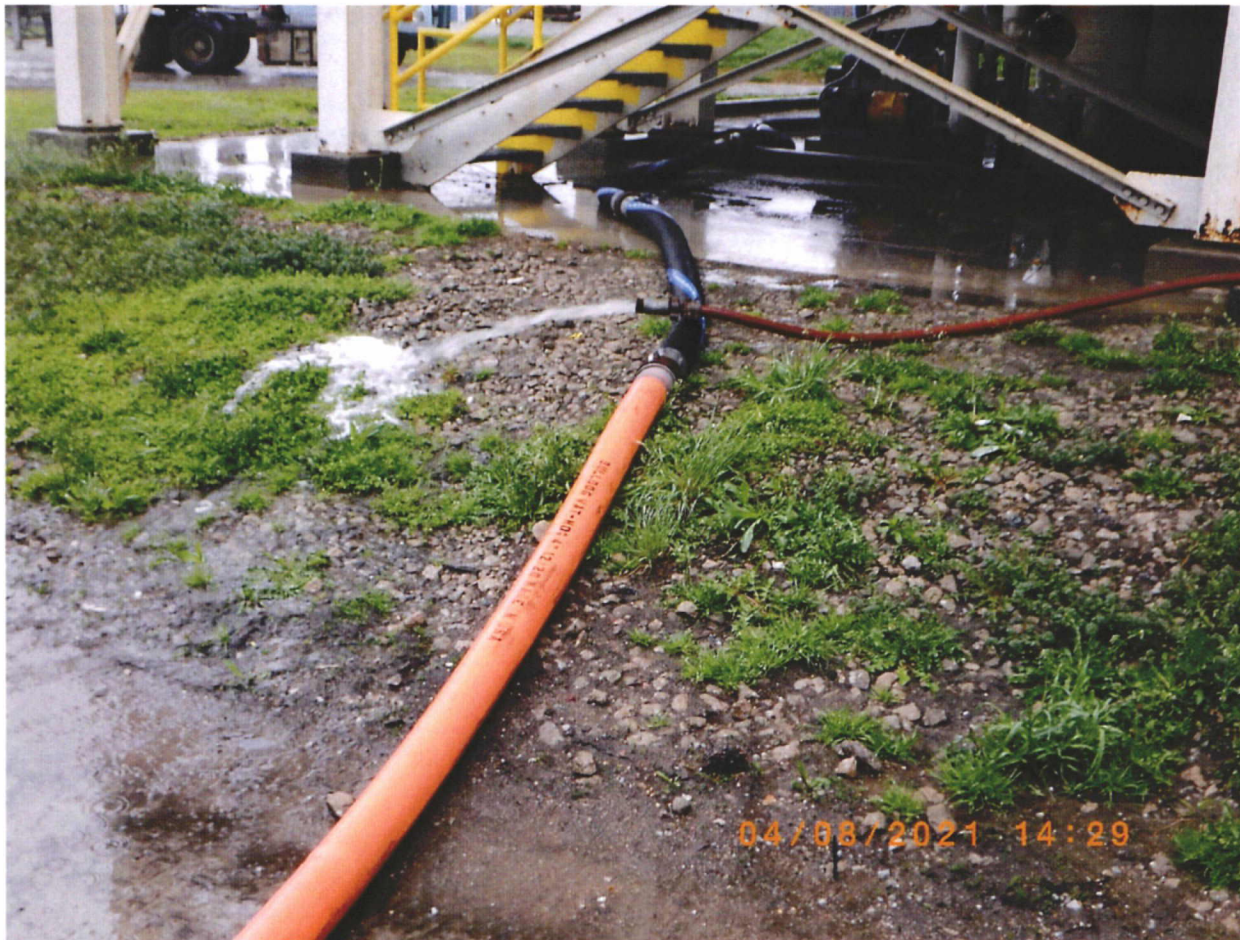
Photos: 19

Description: Orange hose coming from the cleanup building and small hose is water discharge from the sump pit under distillation.

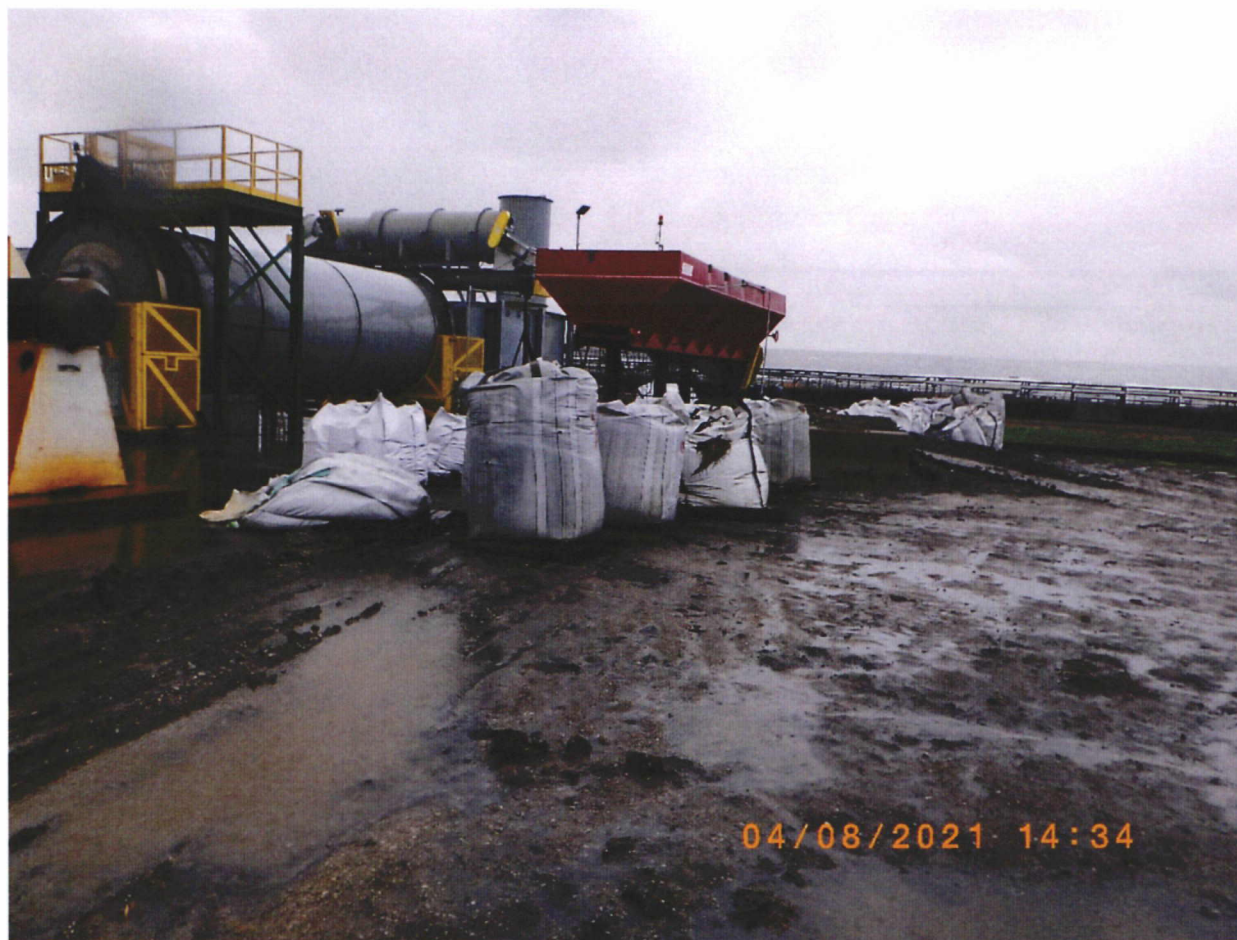
Photos: 20

Description: Bags of Biochar stored on the west side of the Biochar unit.

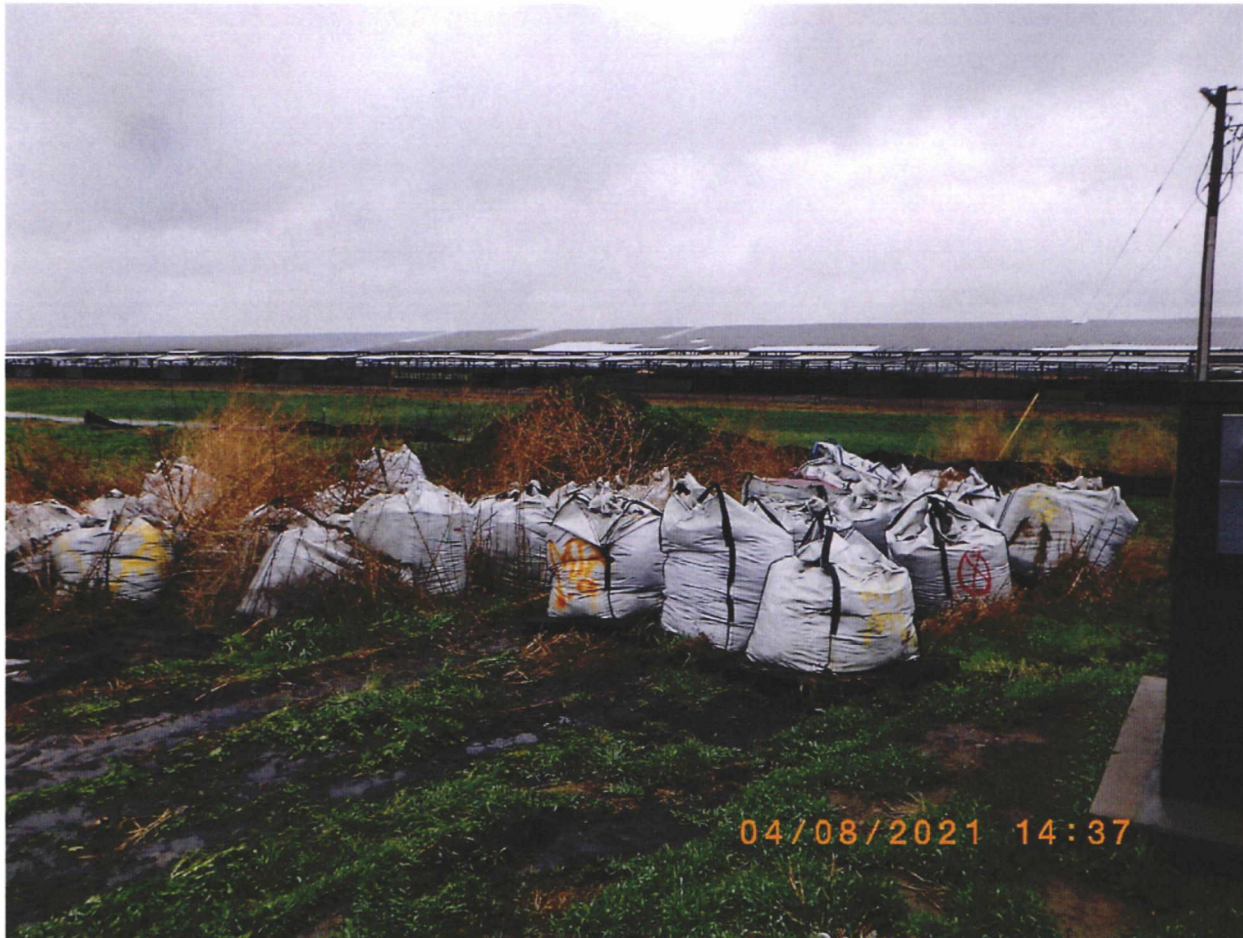
Photos: 21

Description: Biochar stored on the east side of the Biochar unit.
