Facility: AltEn
IIS: 84069
PCS: NE0137634

Site Visit Check list

AltEn LLC - Storm Water Temporary BMP Check Map

Site Visit Report

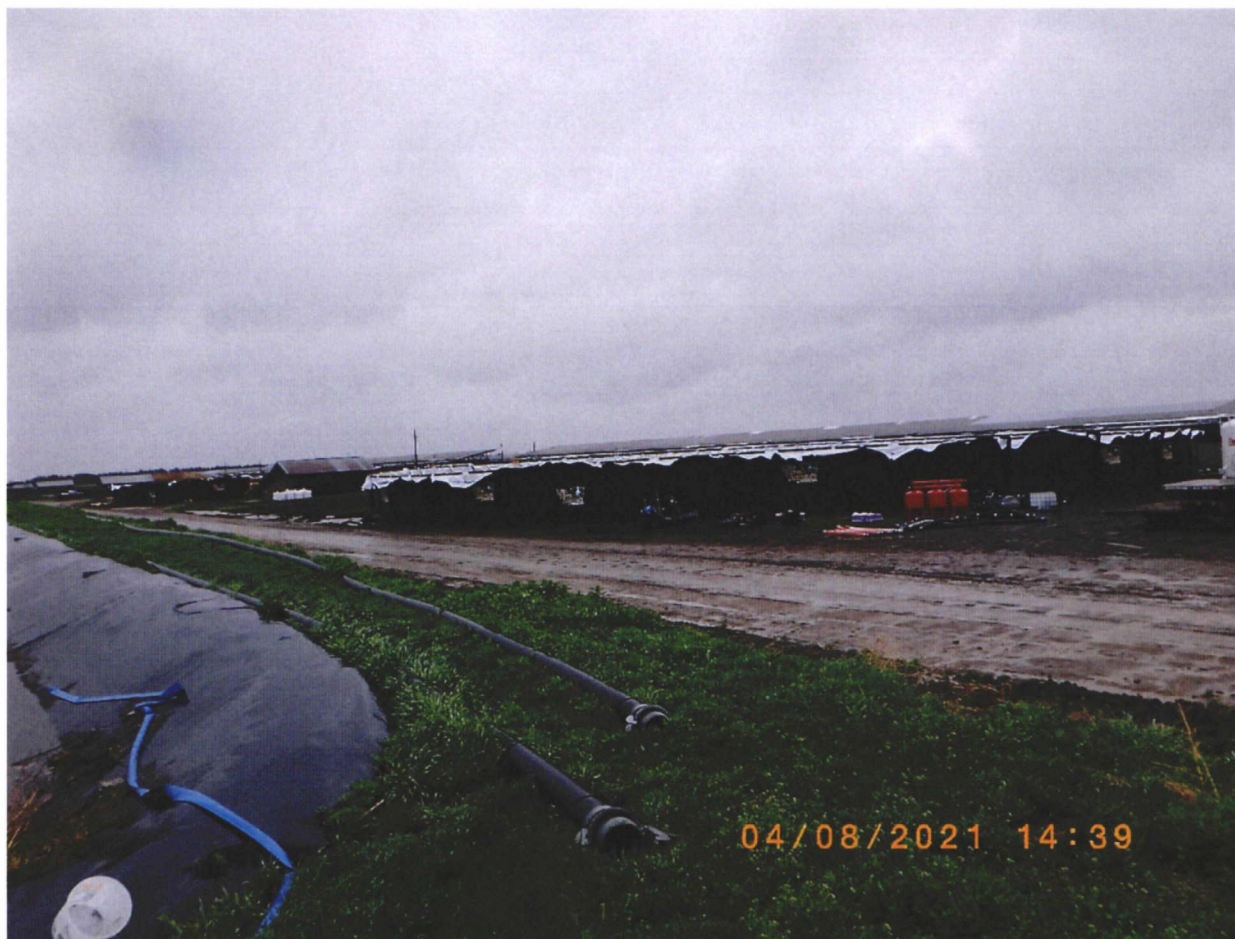
Photos: 22

Description: The east and center Poseidon tanks south of the emergency lagoon.

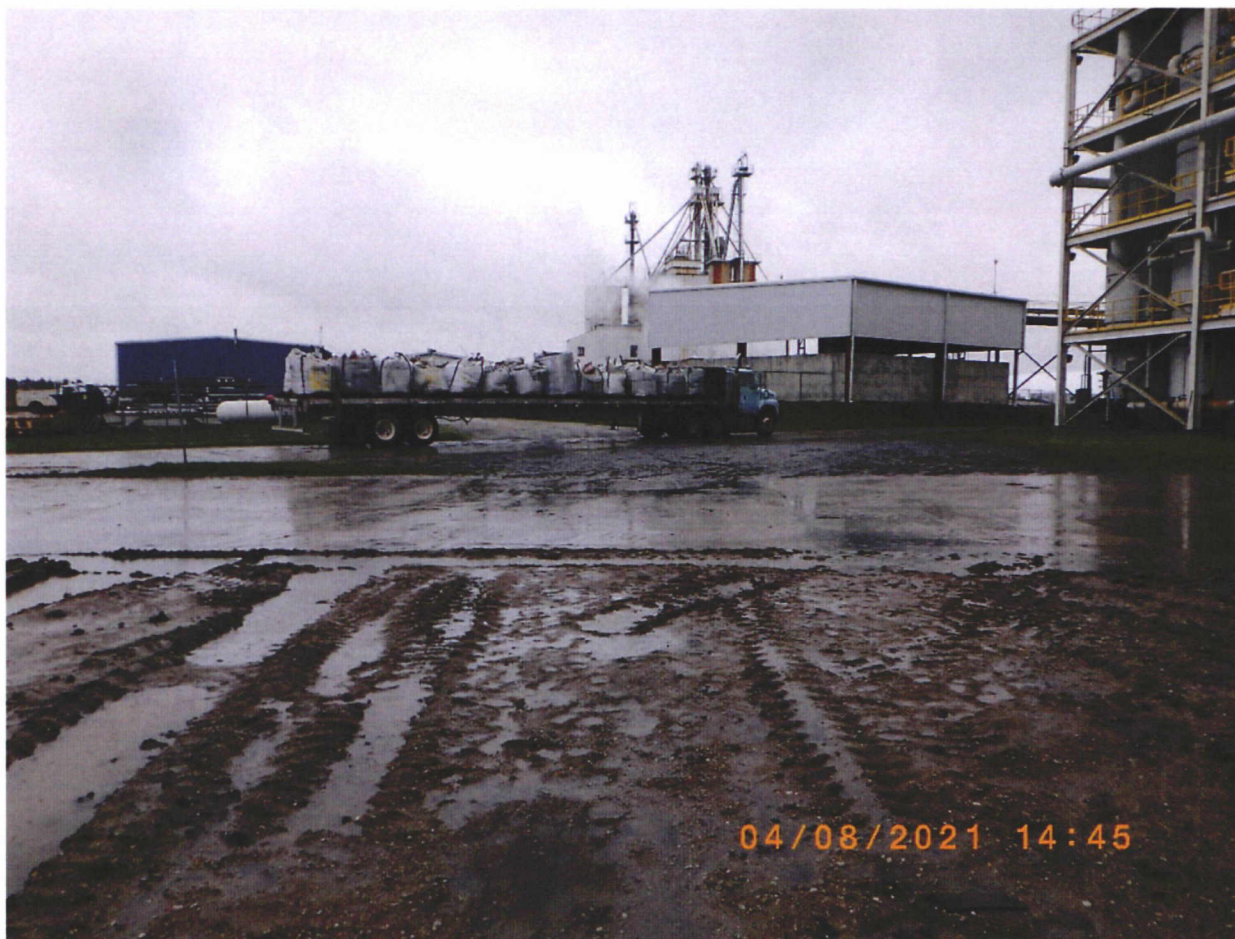
Photos: 23

Description: Biochar loaded on flatbed truck waiting to move to the south hoop building.

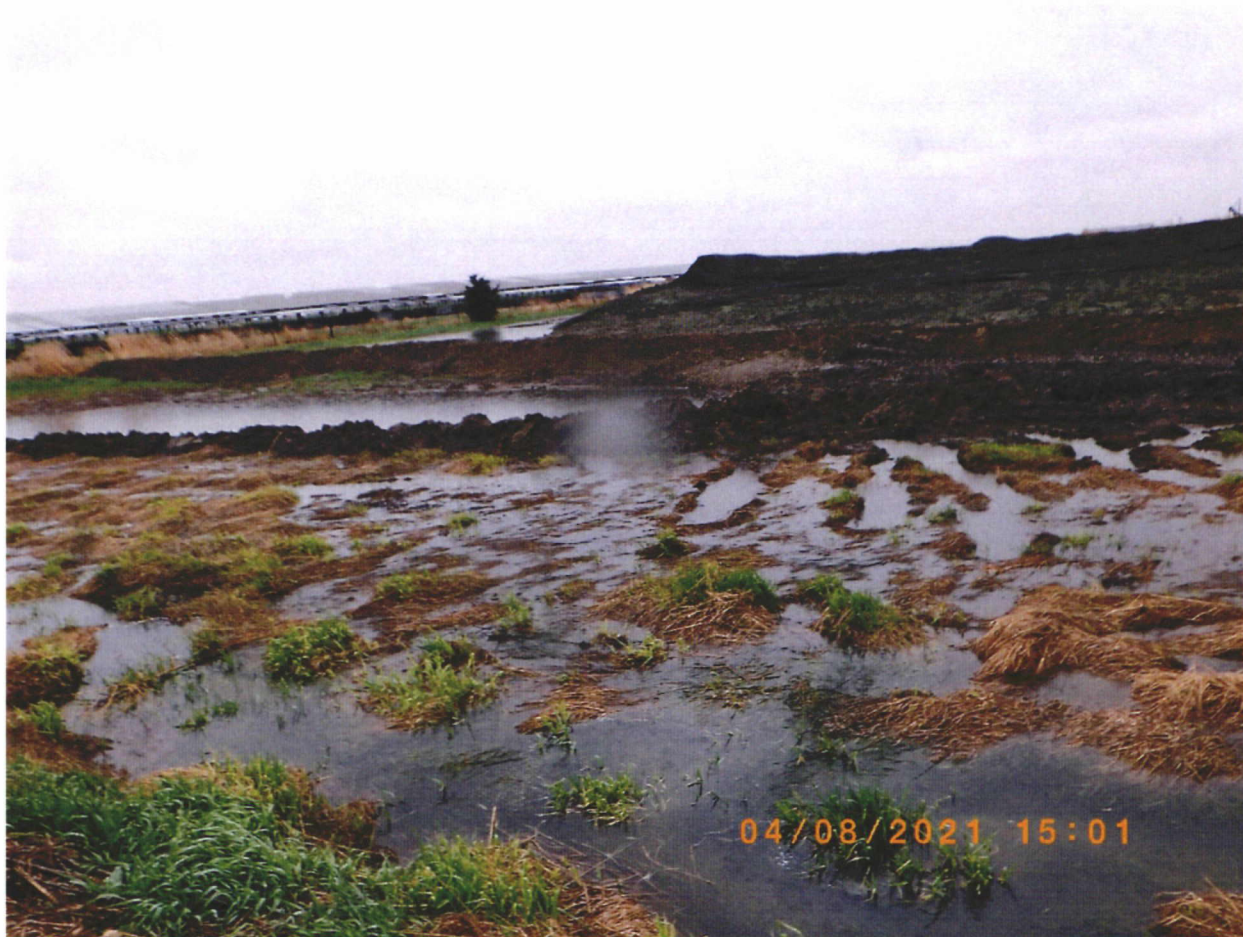
Photos: 24

Description: Drainage way beginning to fill up and is separated by the lower berm east of the wetcake storage.
