Facility: AltEn
IIS: 84069
PCS: NE0137634

Site Visit Check list

AltEn LLC - Storm Water Temporary BMP Check Map

Site Visit Report

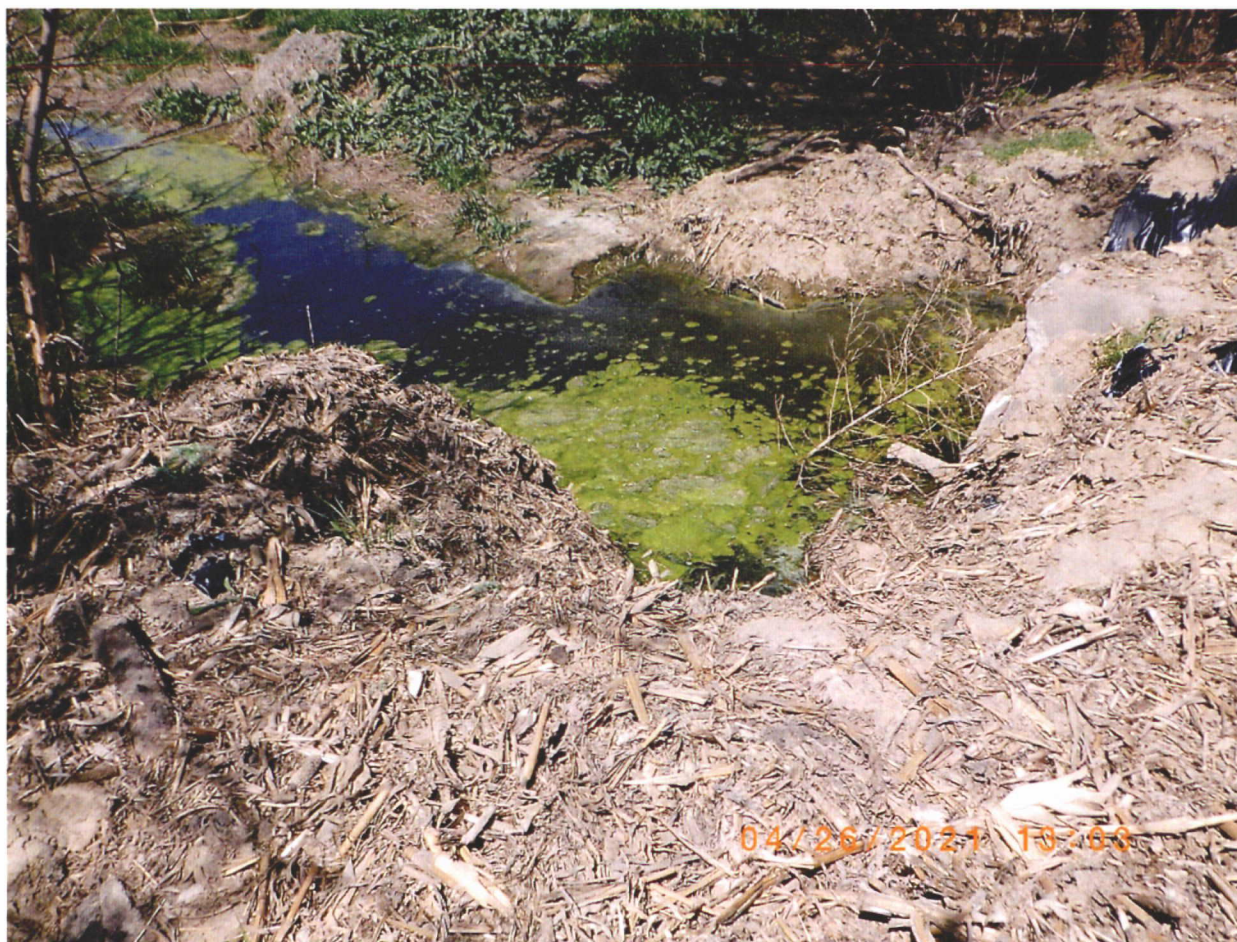
Photos: 1

Location: Culverts at CR 9 & J

Description: The water in the ditch is becoming cloudy with algae growth on the surface.

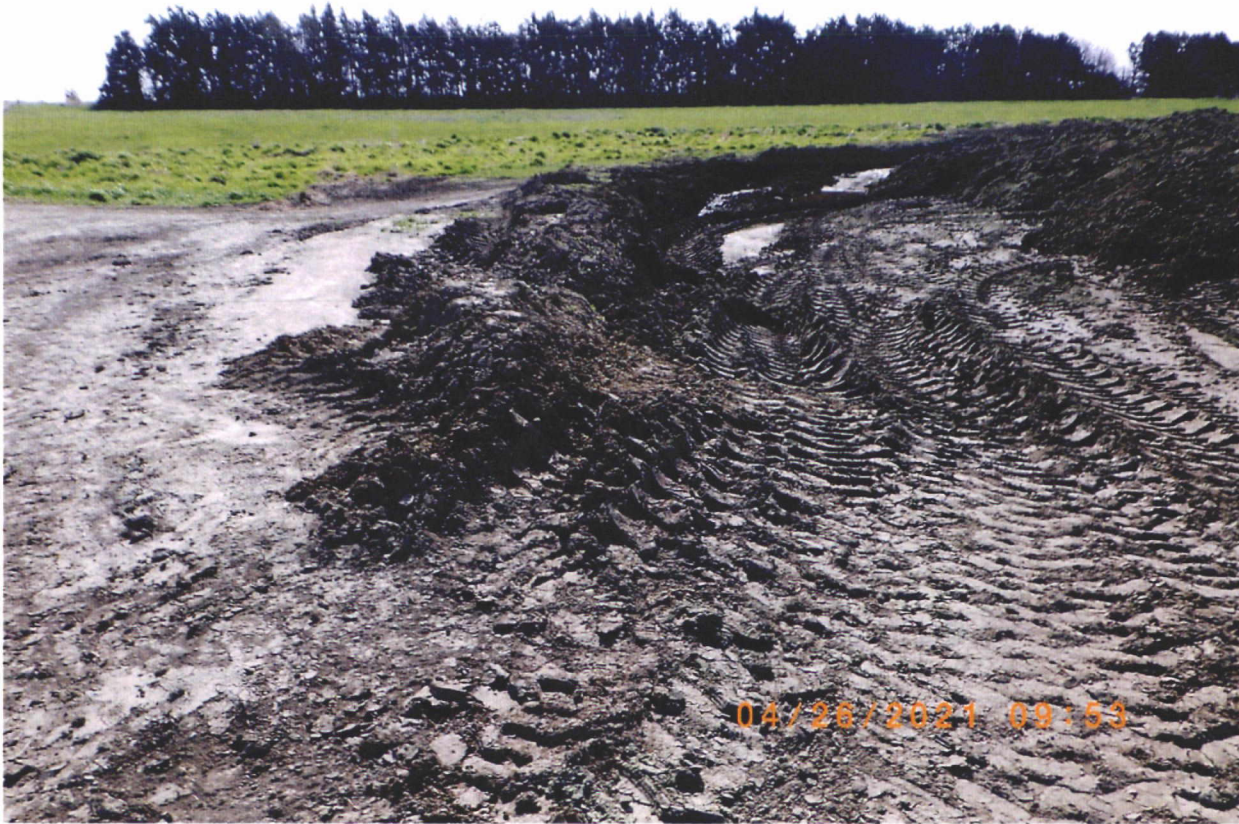
Photos: 2

Location: Area 6 on the site map

Description: Northeast side of area 6 showing additional space for runoff from relocation of wetcake to north of area 1.

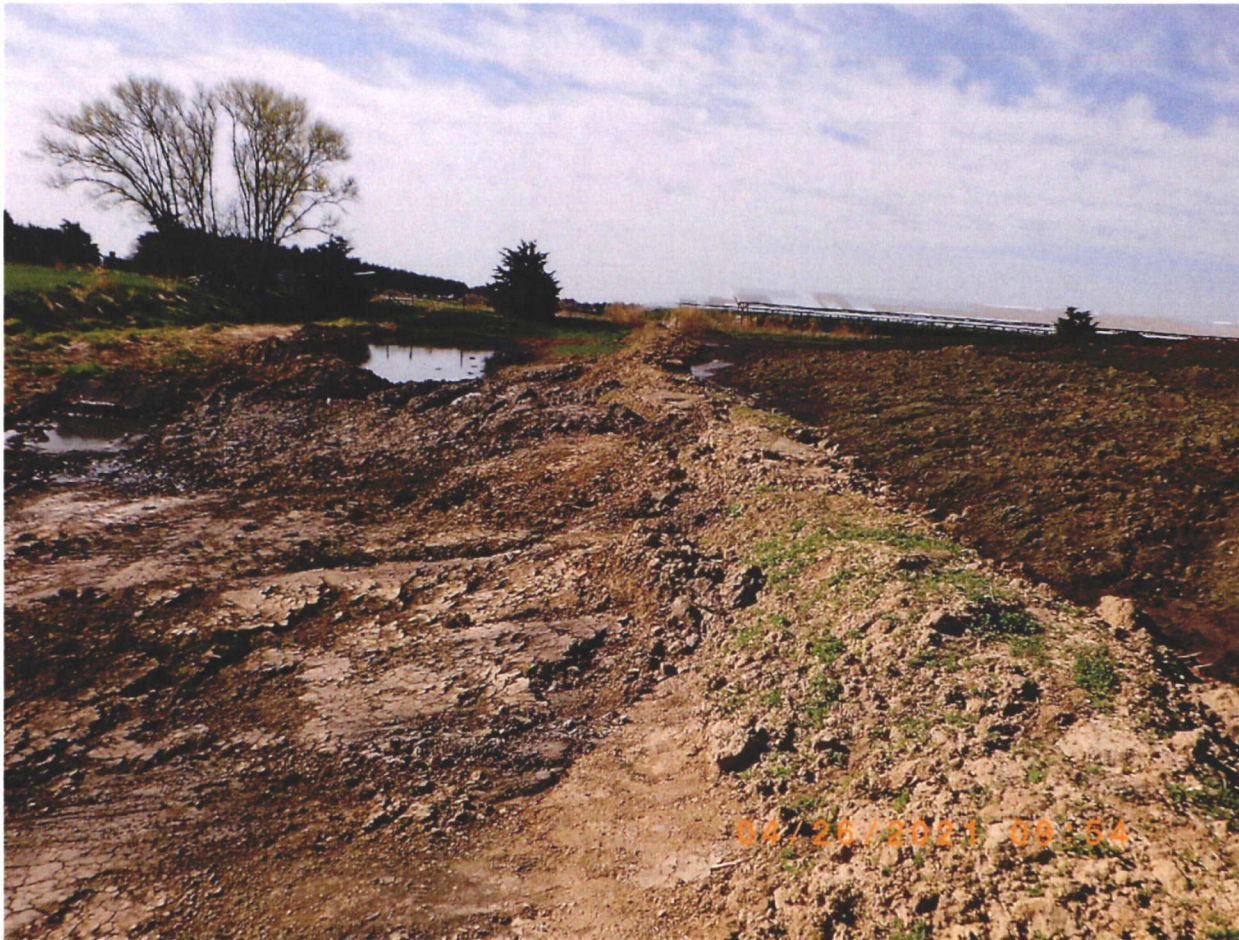
Photos: 3

Location: Area 6 on the site map.

Description: Upper berm has had most of the runoff mixed with wetcake and relocated to the west area but the lower berm is still very full and shows visual indication of seepage.

6 - Berm still has seepage, but most of runoff removed behind upper berm. Lower berm area is full

Pump out berm at CAS, wet cake area
to treatment system

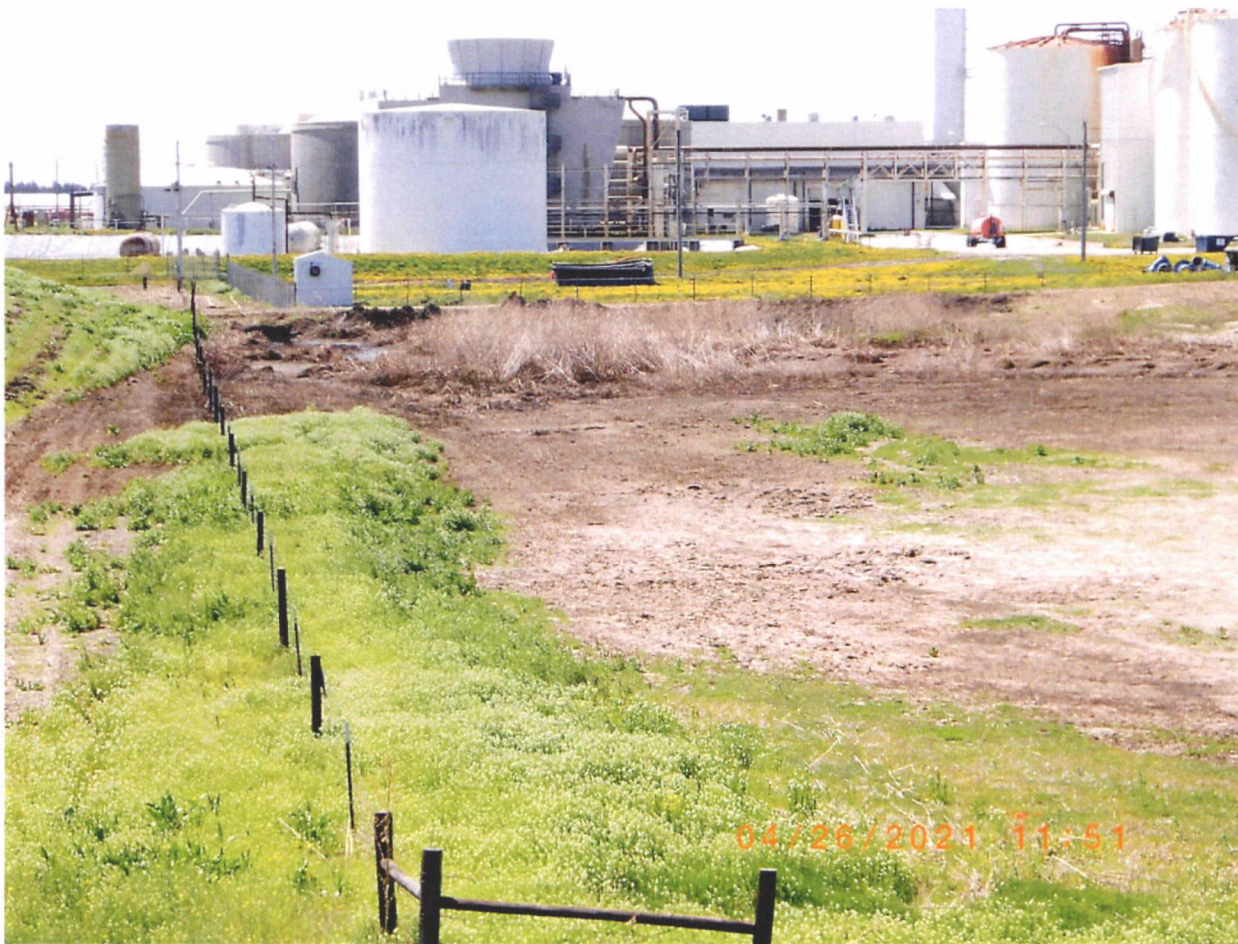
Photos: 4

Location: South of the southeast corner of the northwest lagoon.

Description: No change to the berm and no new runoff present.

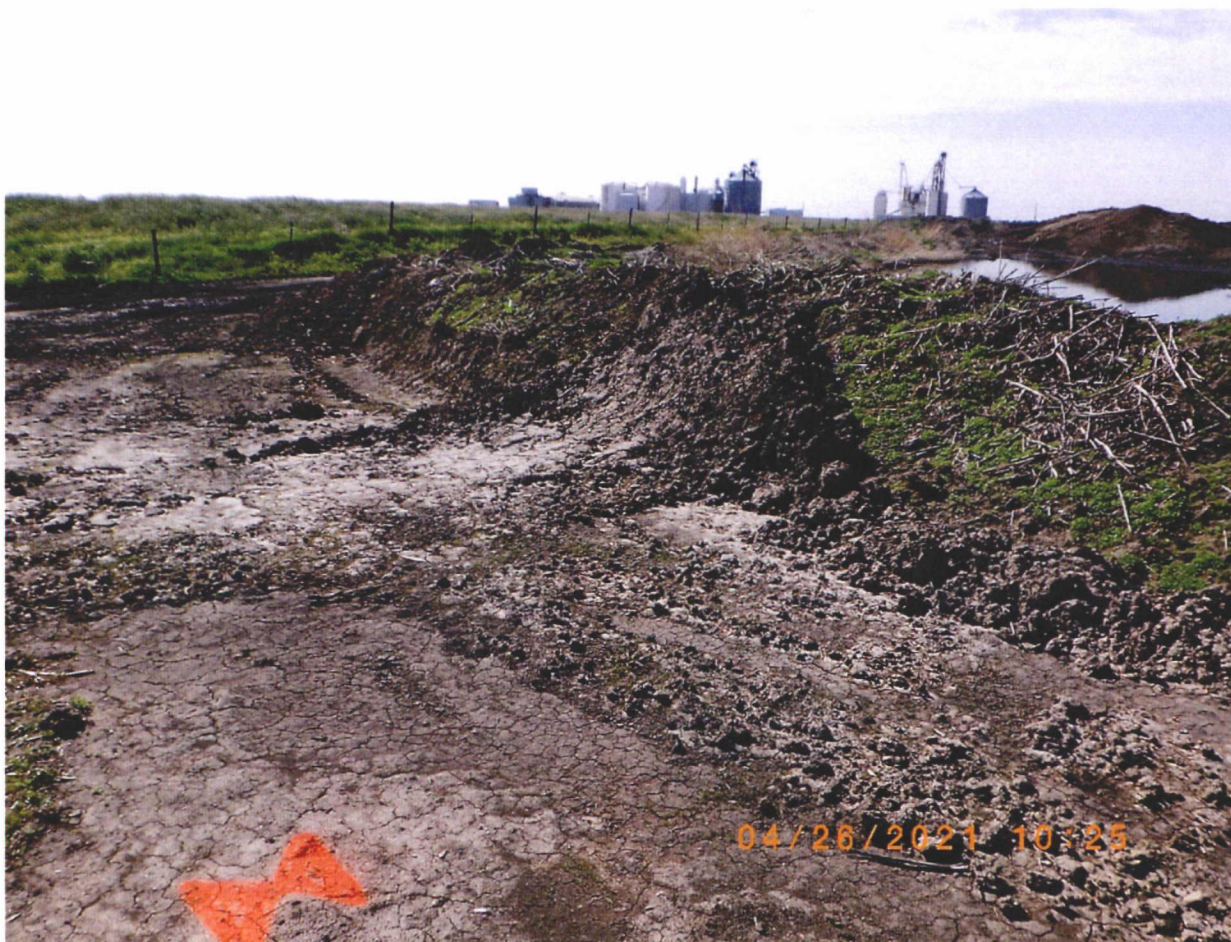
Photos: 5

Location: Area 3 on the site map

Description: Berm is holding and no sign of seepage.

3 - Berm holding & could be pumped. No seepage

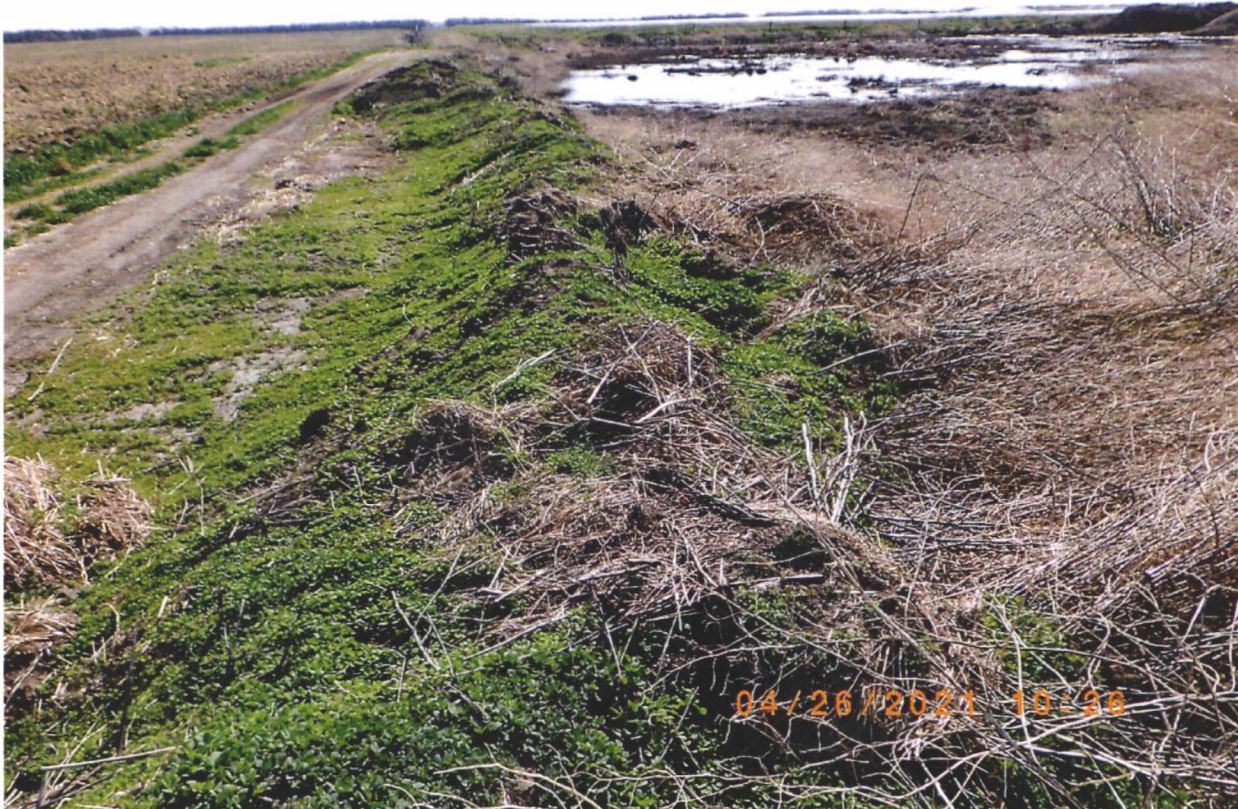
Photos: 6

Location: Area 4 on the site map.

Description: This section does not hold runoff but was an area of concern in the past where wetcake had been pushed up to the top of the berm and was a potential source of wetcake runoff. There are no concerns for this area anymore.

4 - No concern

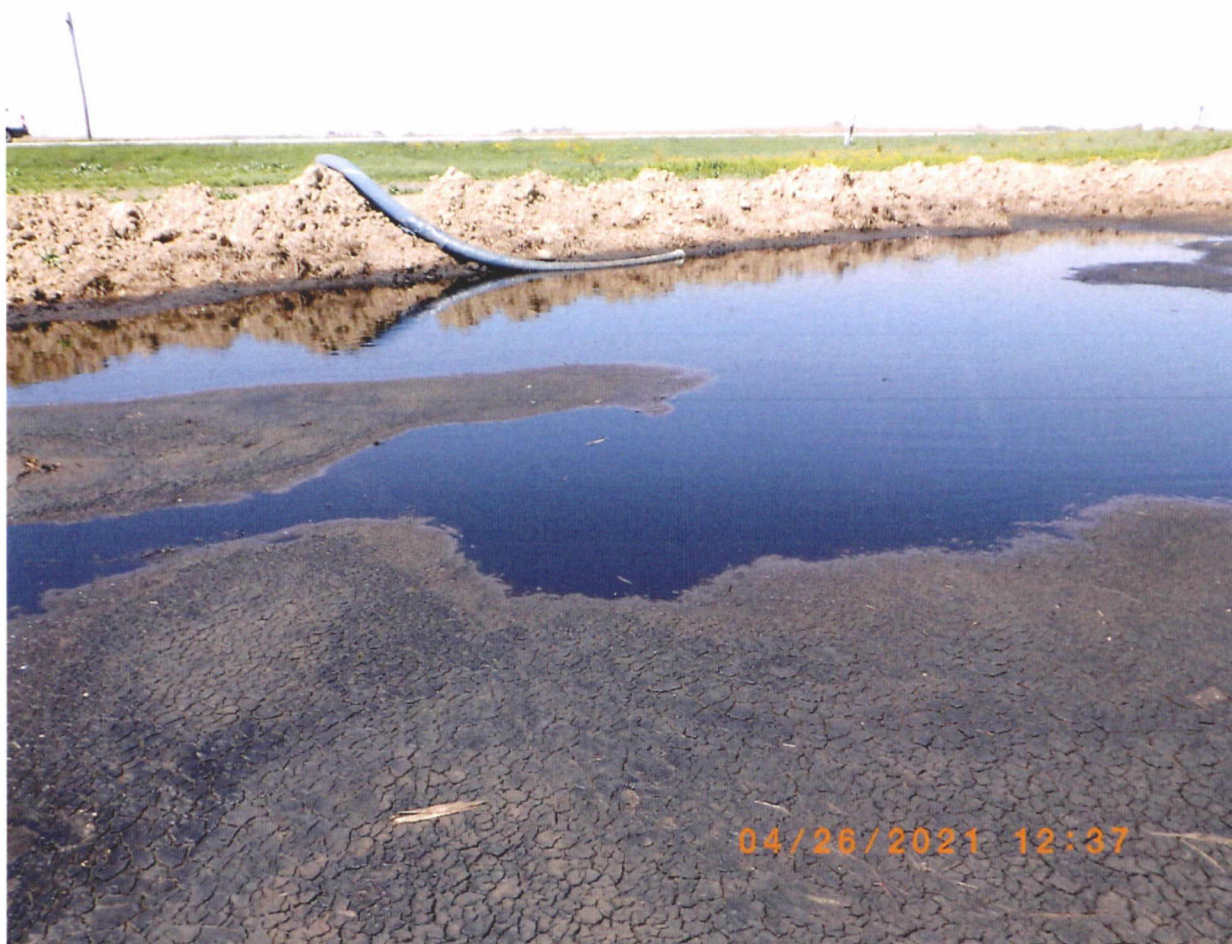
Photos: 7

Location: Area 5 on the site map

Description: Runoff still present at this area and continues to bubble and have a strong odor.

5 - Berm holding & continues to have runoff, but majoring in ground

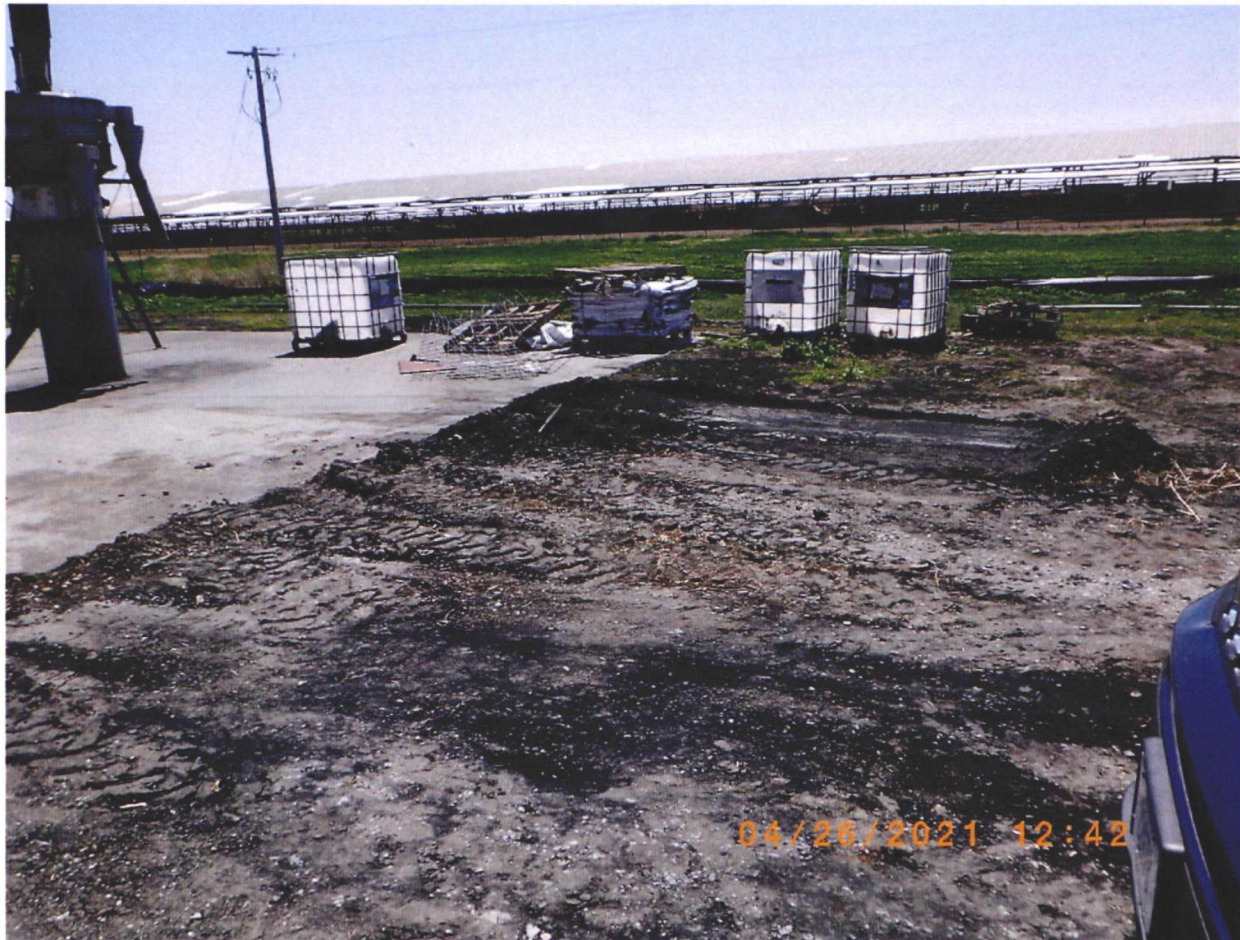
Photos: 8

Location: North side of Biochar.

Description: Attempts at Biochar cleanup appear to have begun but are incomplete. There continues to be a large volume (2"-3" thick in areas) of Biochar on the ground to the south of the area.

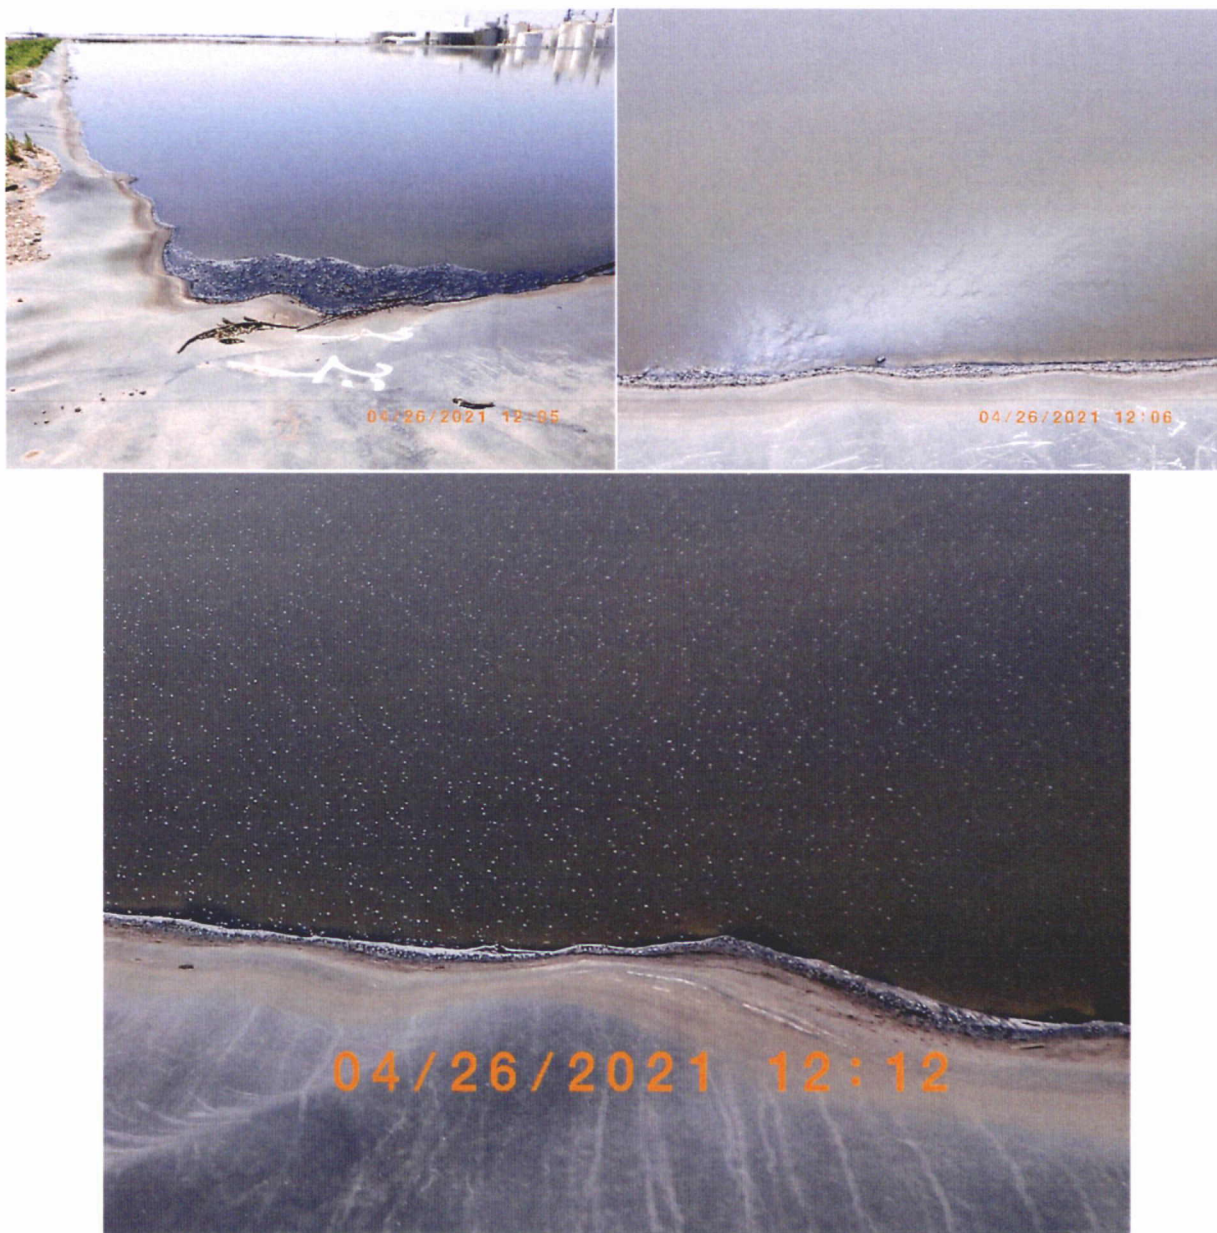
Photos: 9

Location: Northeast corner of the southeast lagoon.

Description: Black sludge and an oily substance with bubbling was the only new observation that was notable.

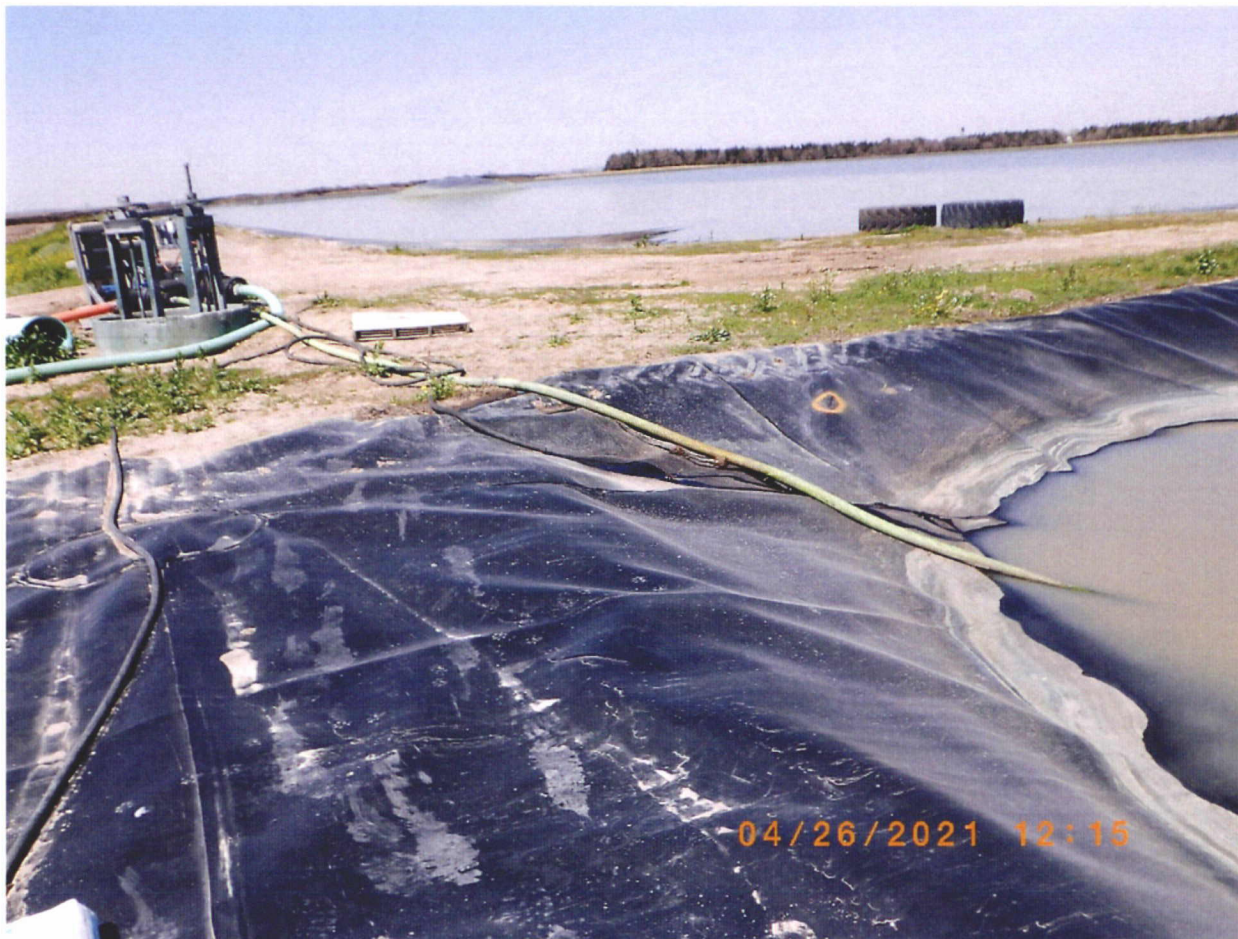
Photos: 10

Location: Southwest corner of the northeast lagoon

Description: Pumping now out of the northeast lagoon as well as the southeast lagoon.

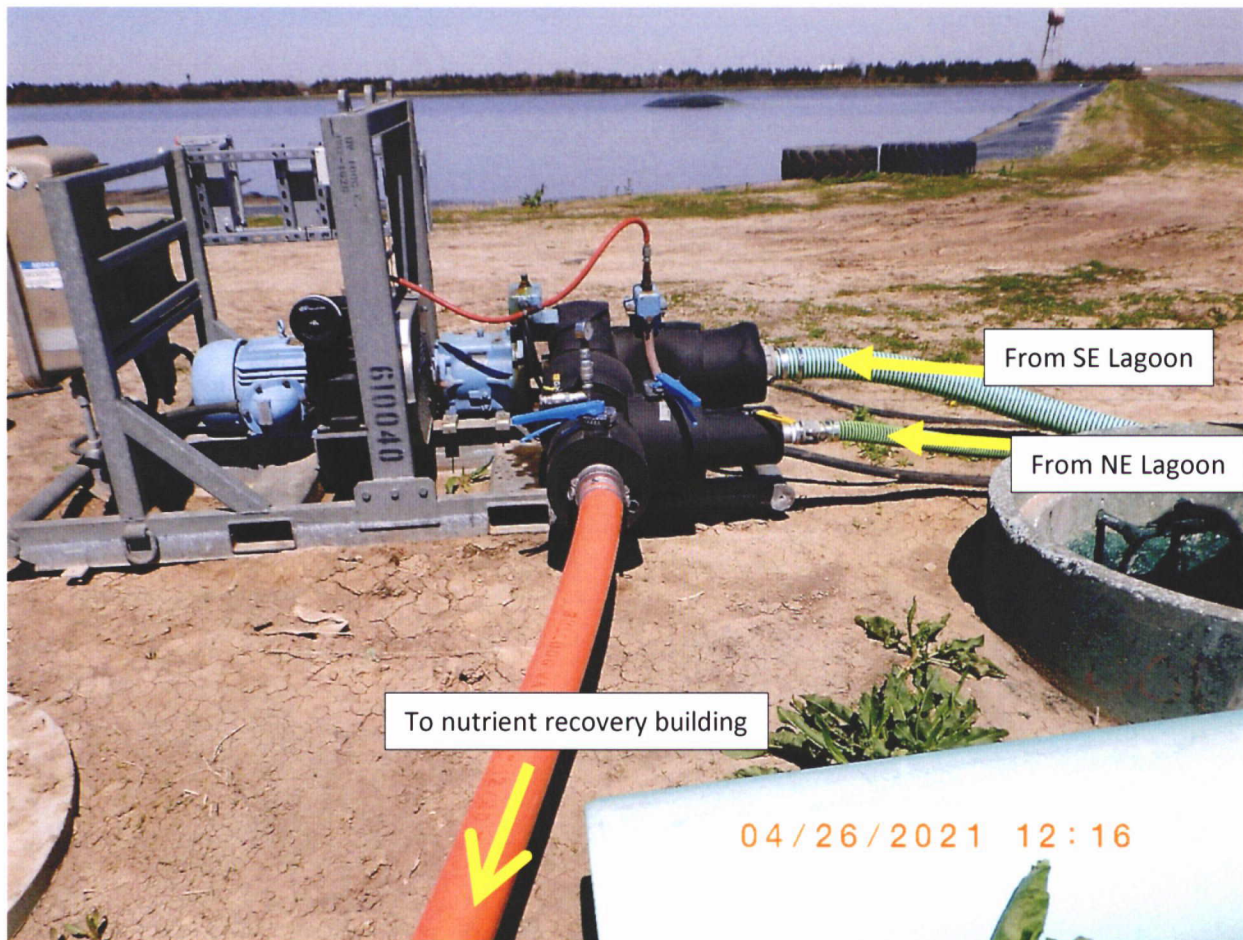
Photos: 11

Location: West of the northwest corner of the southeast lagoon.

Description: Pump station moving lagoon water to the NR building for filtration.

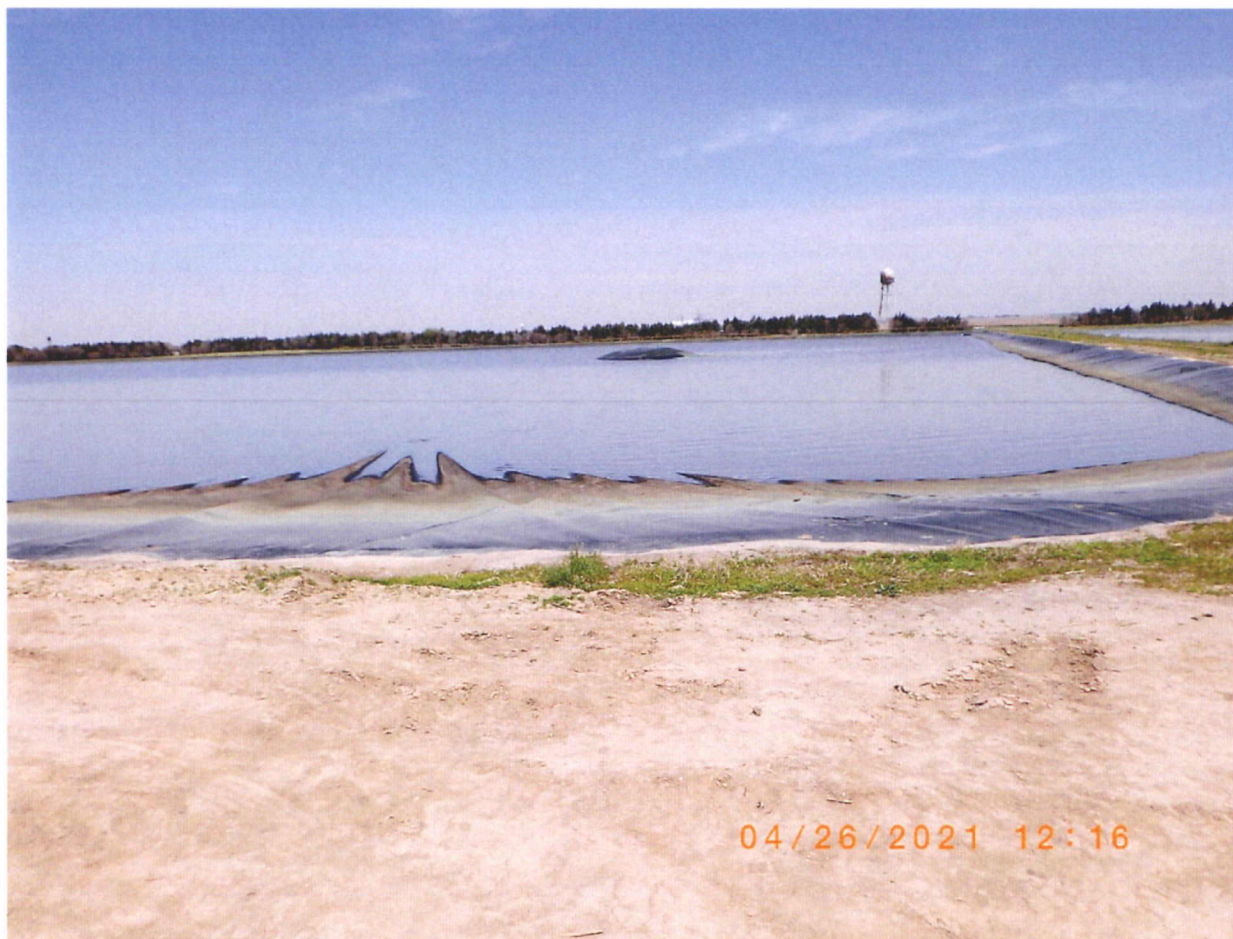
Photos: 12

Location: Southeast corner of the northwest lagoon.

Description: Liner section in this corner continues to pull outward while the section along the east edge has subsided.

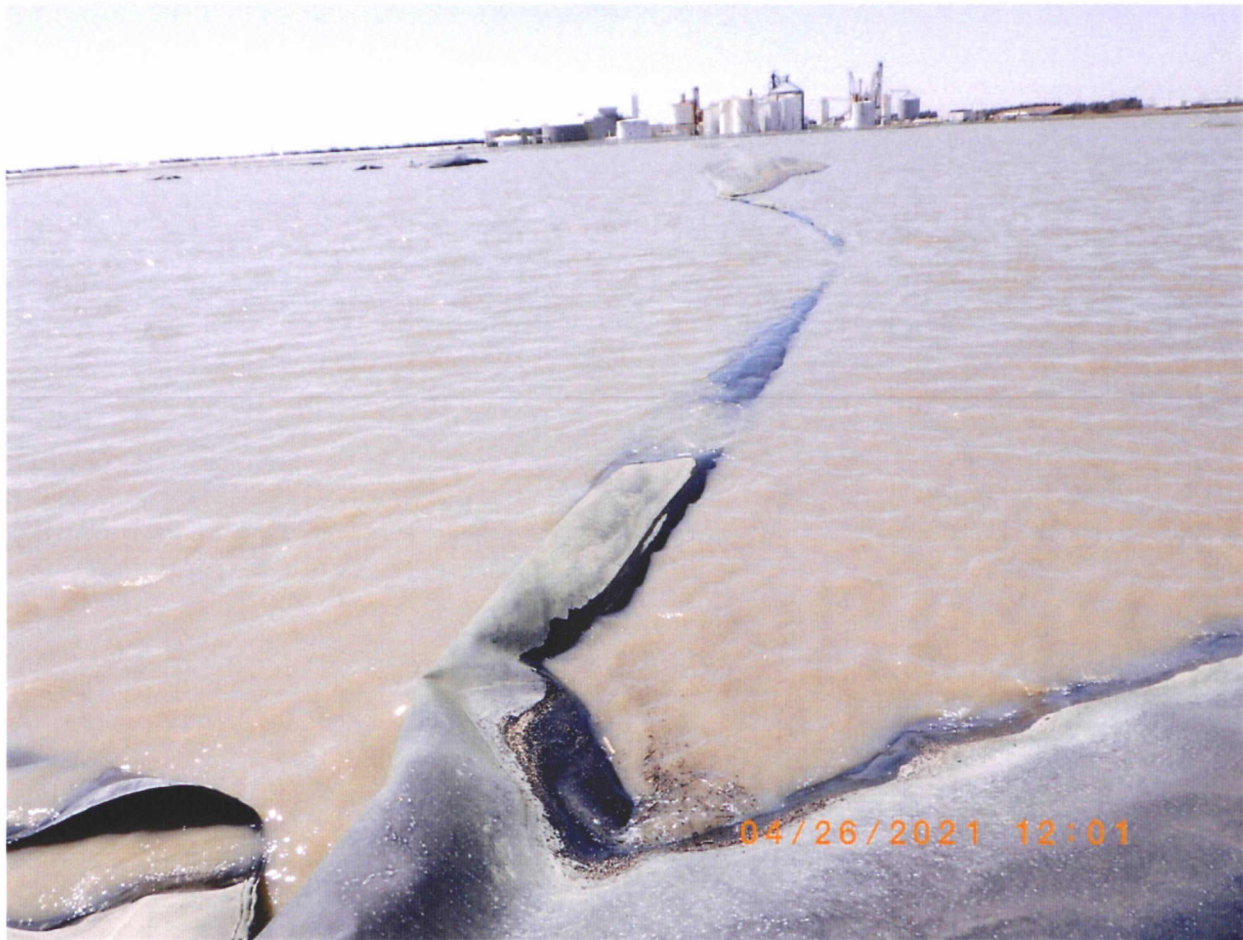
Photos: 13

Location: Midway along the north side of the northeast lagoon.

Description: Section of liner connecting to whale.

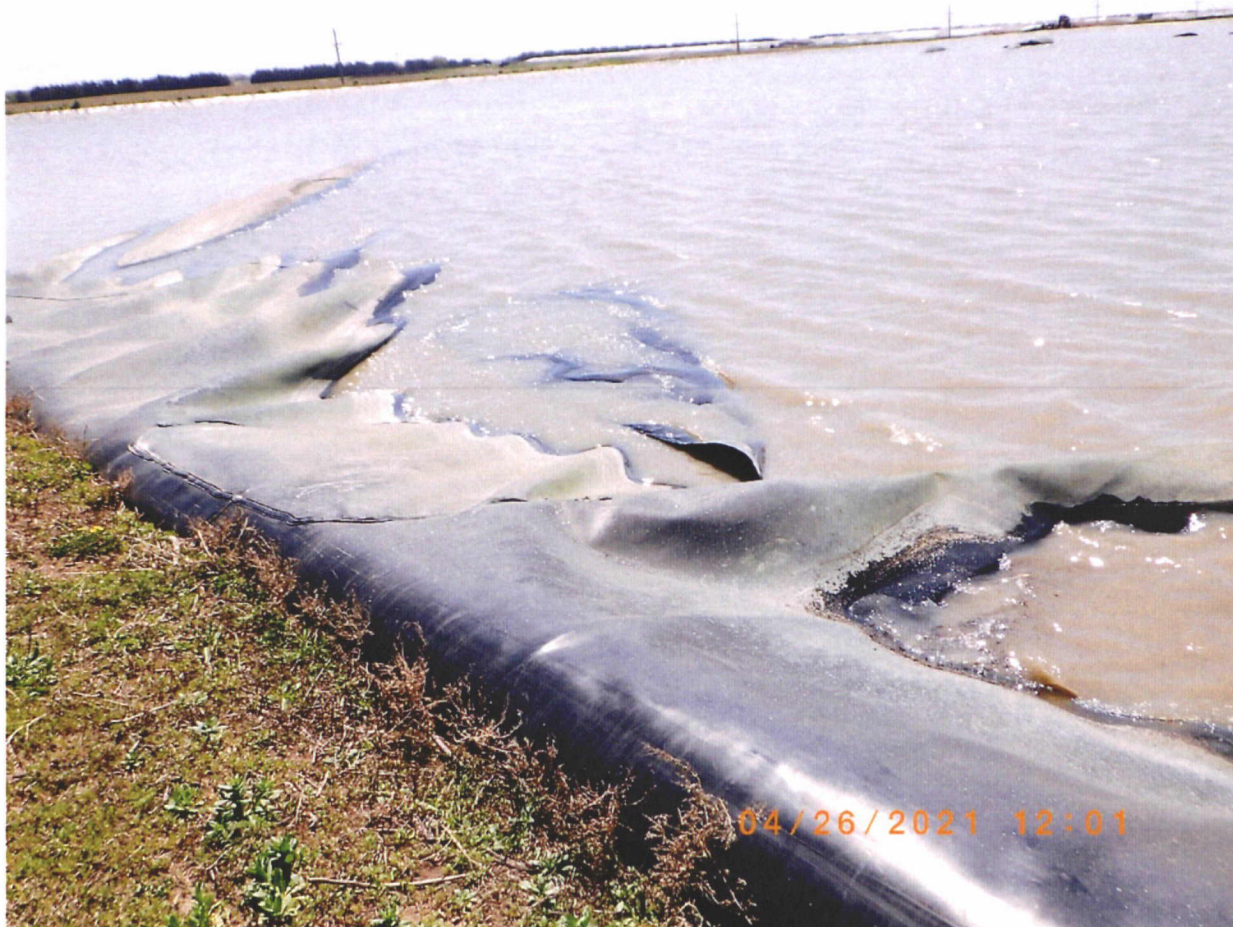
Photos: 14

Location: same as photo 13.

Description: Section of torn liner continuing to tear under high winds.

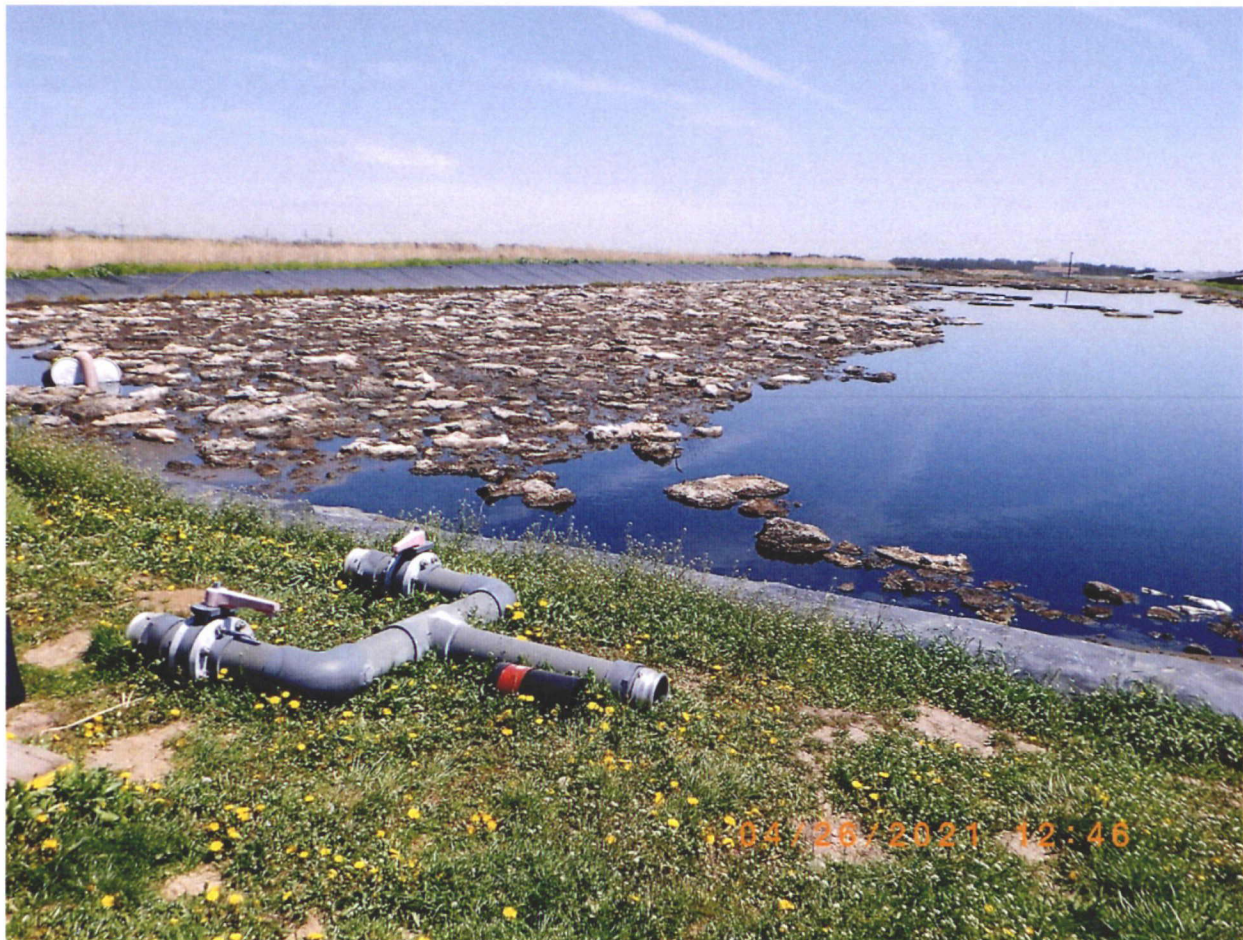
Photos: 15

Location: West side of the emergency lagoon

Description: There is no pumping to this lagoon today and no significant changes are present in the lagoon level.

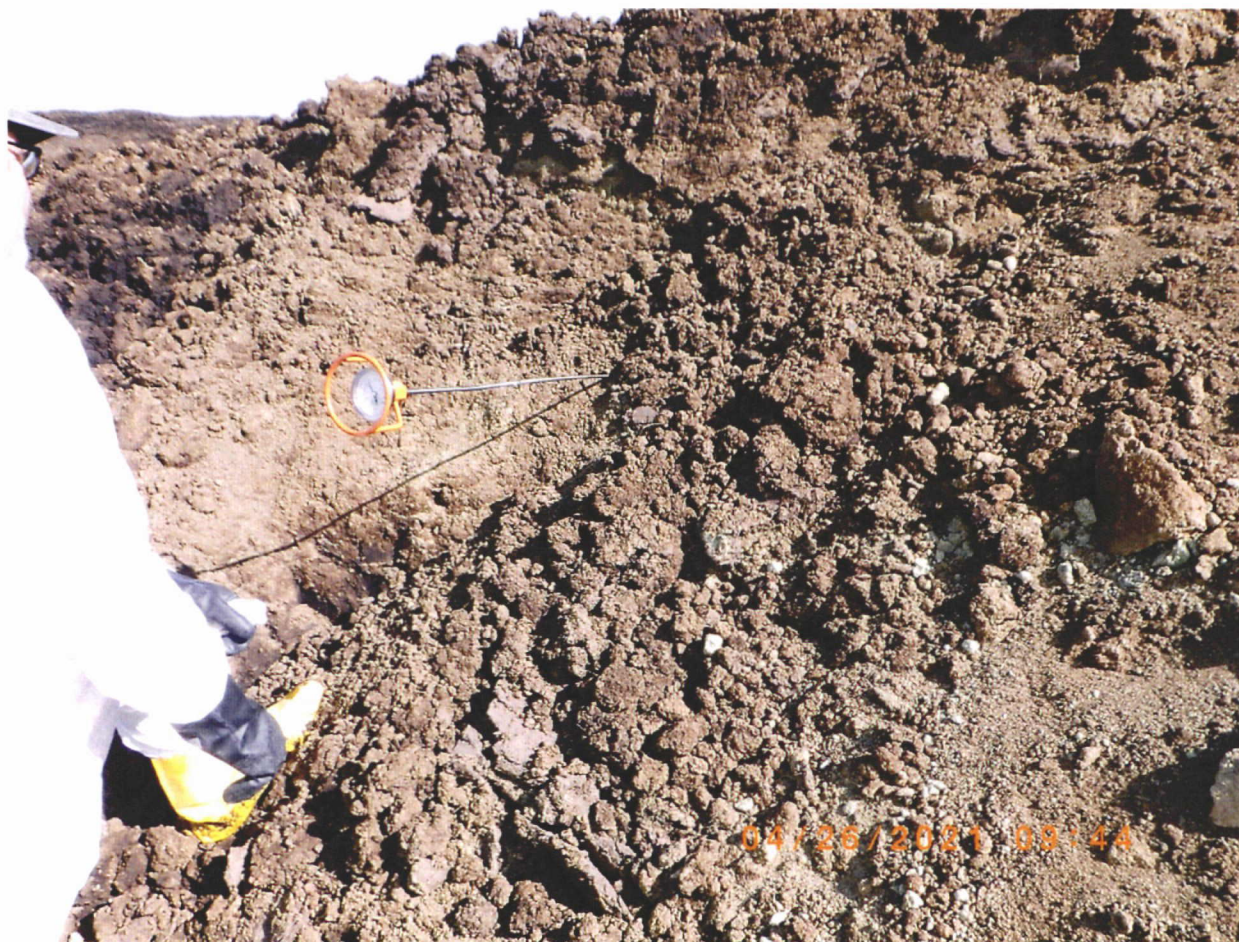
Photos: 16

Location: Area 6 on the site map.

Description: Temperature monitoring of the wetcake on the north side of the east wetcake area.

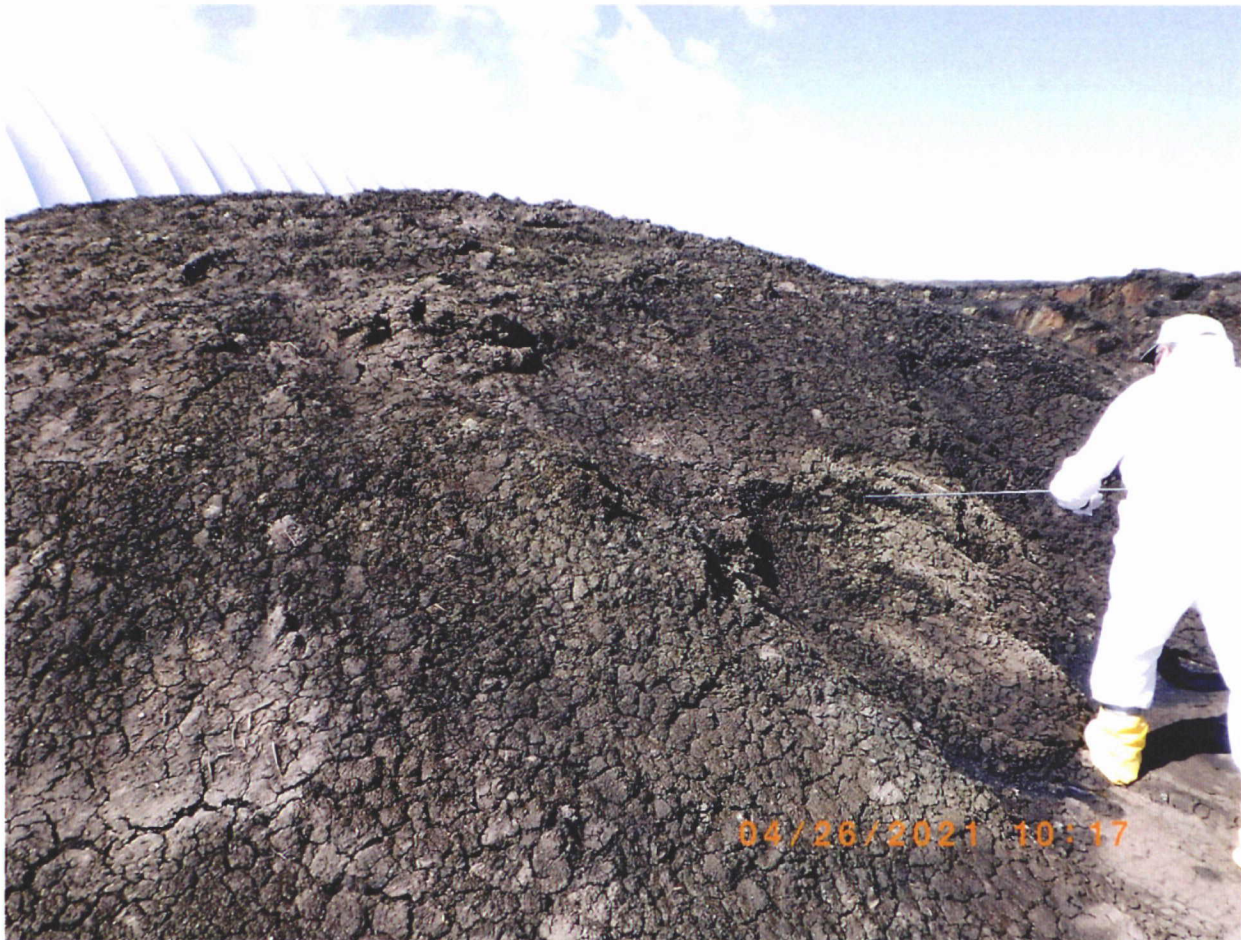
Photos: 17

Location: Northeast of the north hoop building.

Description: Temperature monitoring of wetcake in the west area showing much of the older wetcake having higher resistance to the temperature probe. Sample refusal was encountered at several locations.
