Facility: AltEn
IIS: 84069
PCS: NE0137634

Site Visit Check list

AltEn LLC - Storm Water Temporary BMP Check Map

Site Visit Report

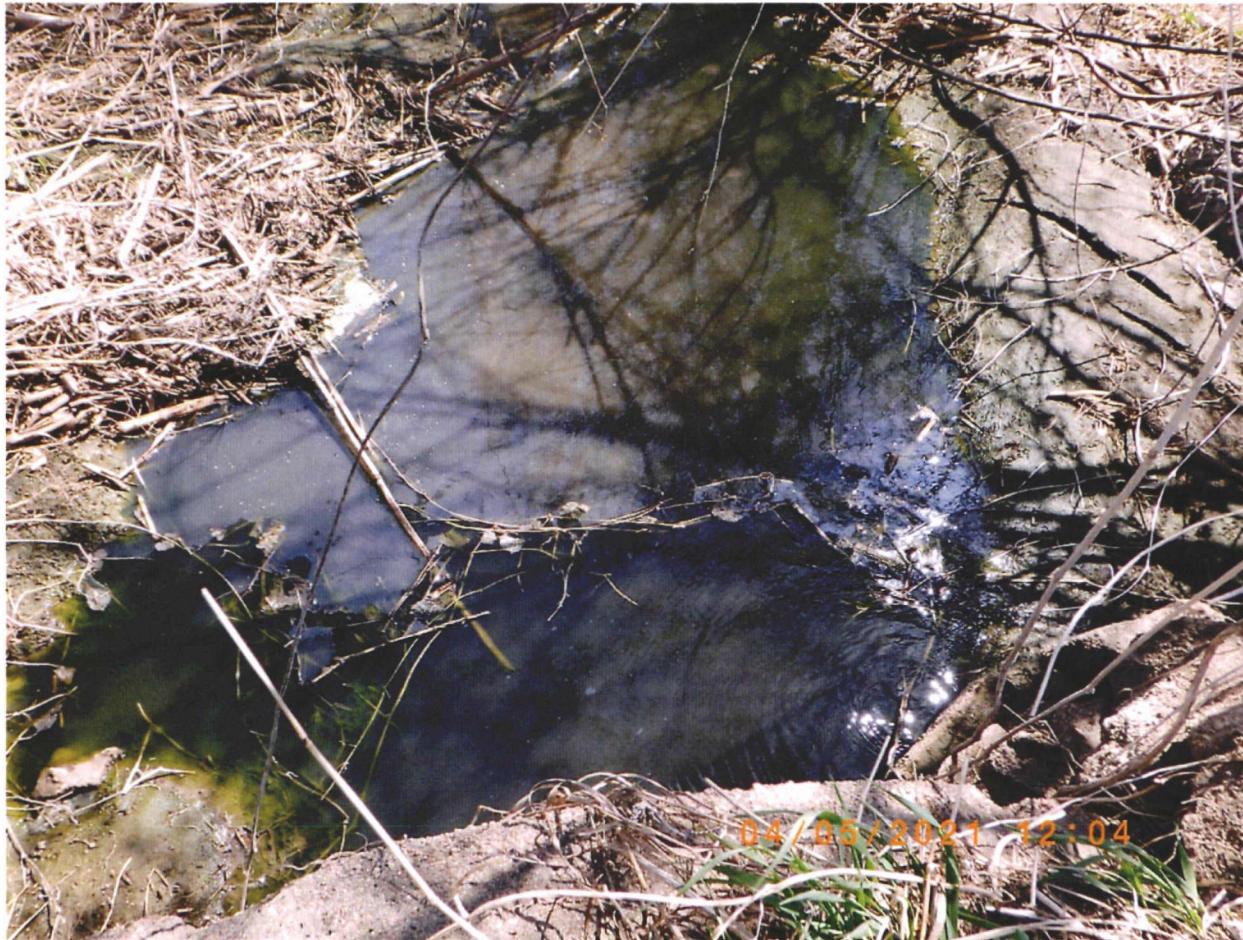
Photos: 1

Location: Culvert north of CR 9 & J

Description: East side of CR 9 showing dark colored water with film on top in drainage way from AltEn.

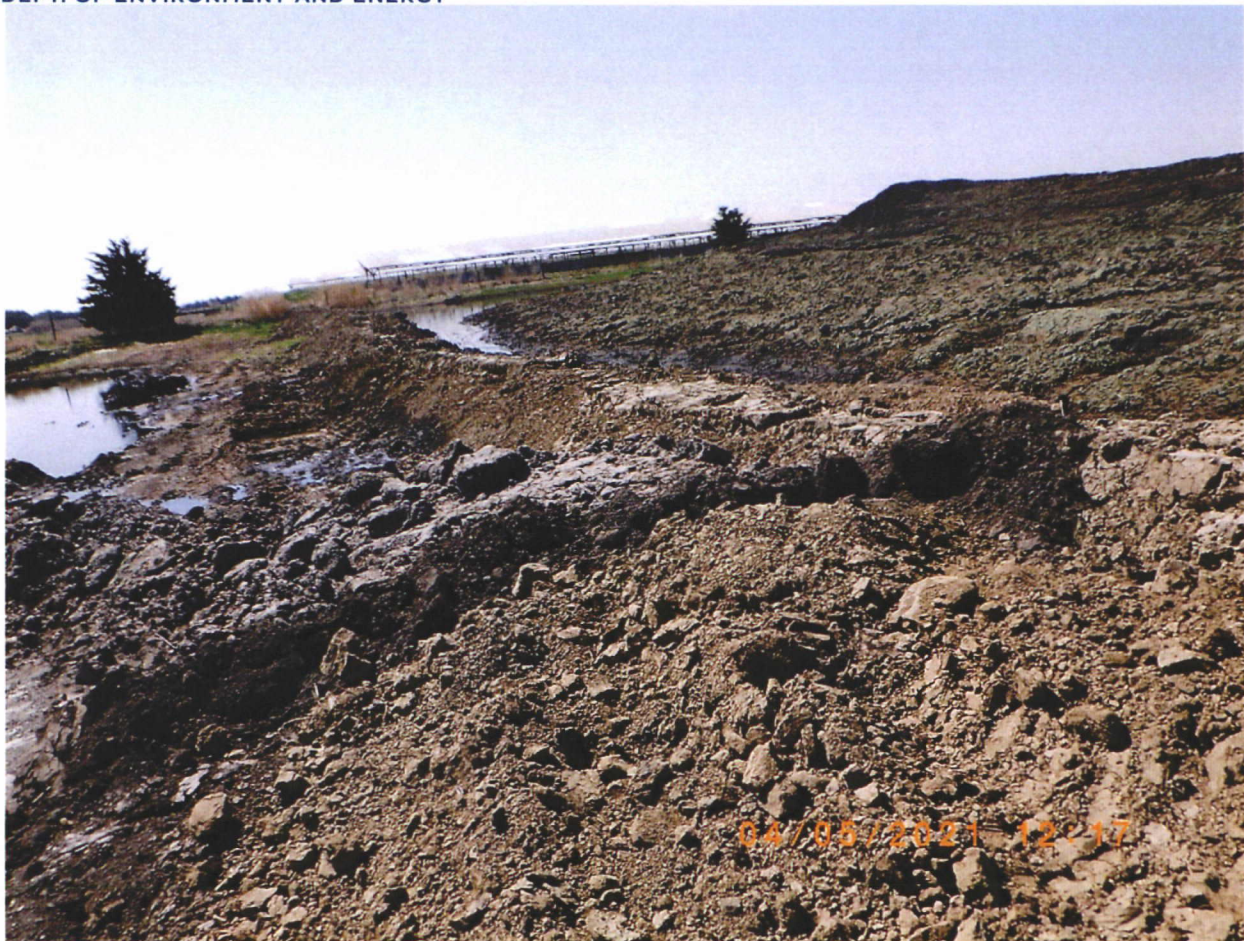
Photos: 2

Location: Area 6 on site map

Description: Two berms used to contain runoff from the east wetcake storage area.

6 - slight seepage & holding water behind berm

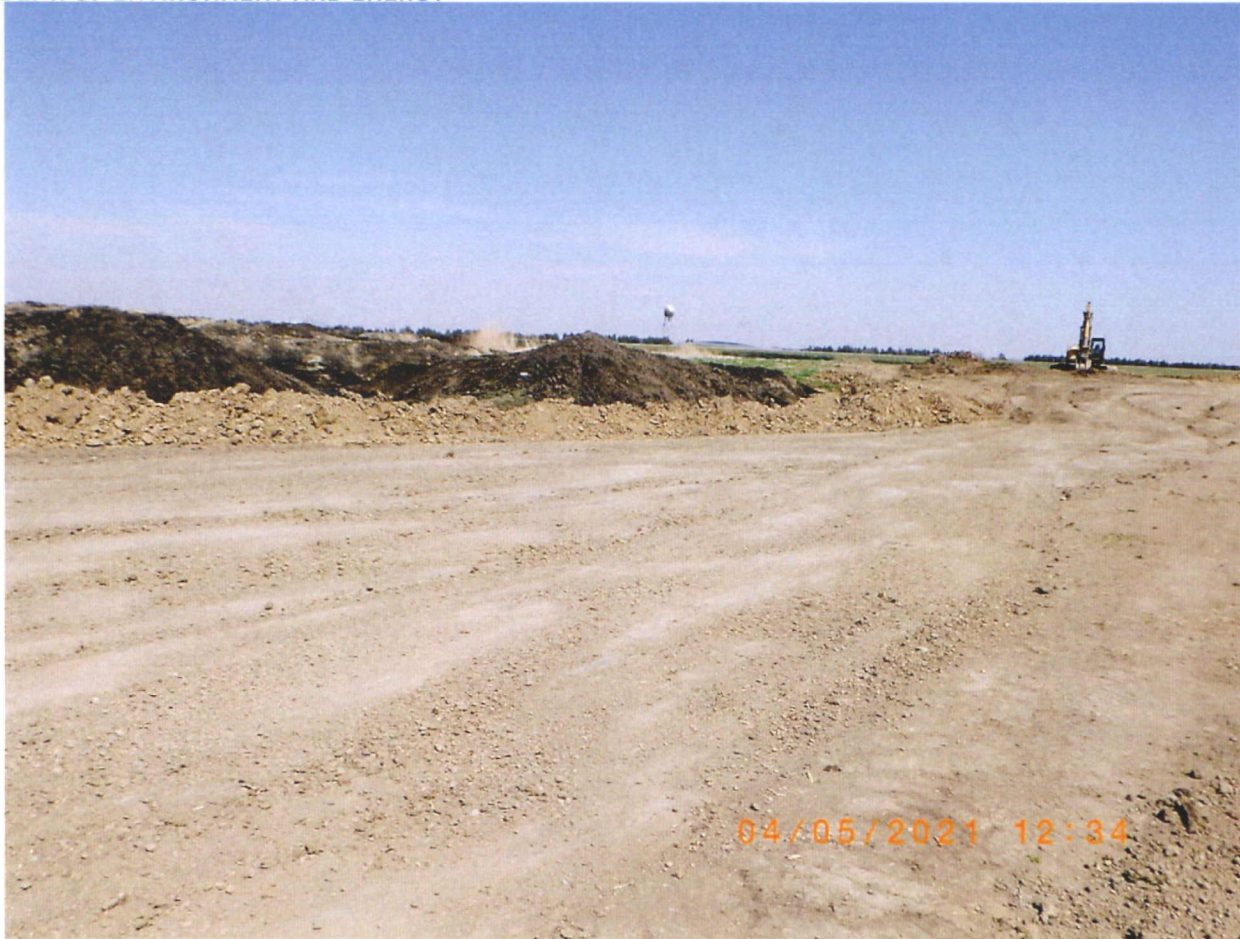
Photos: 3

Location: Area 1 on site map

Description: Regraded area west of area 1 showing new berm constructed.

Area - 1 Muddy near center of berm but berm good condition

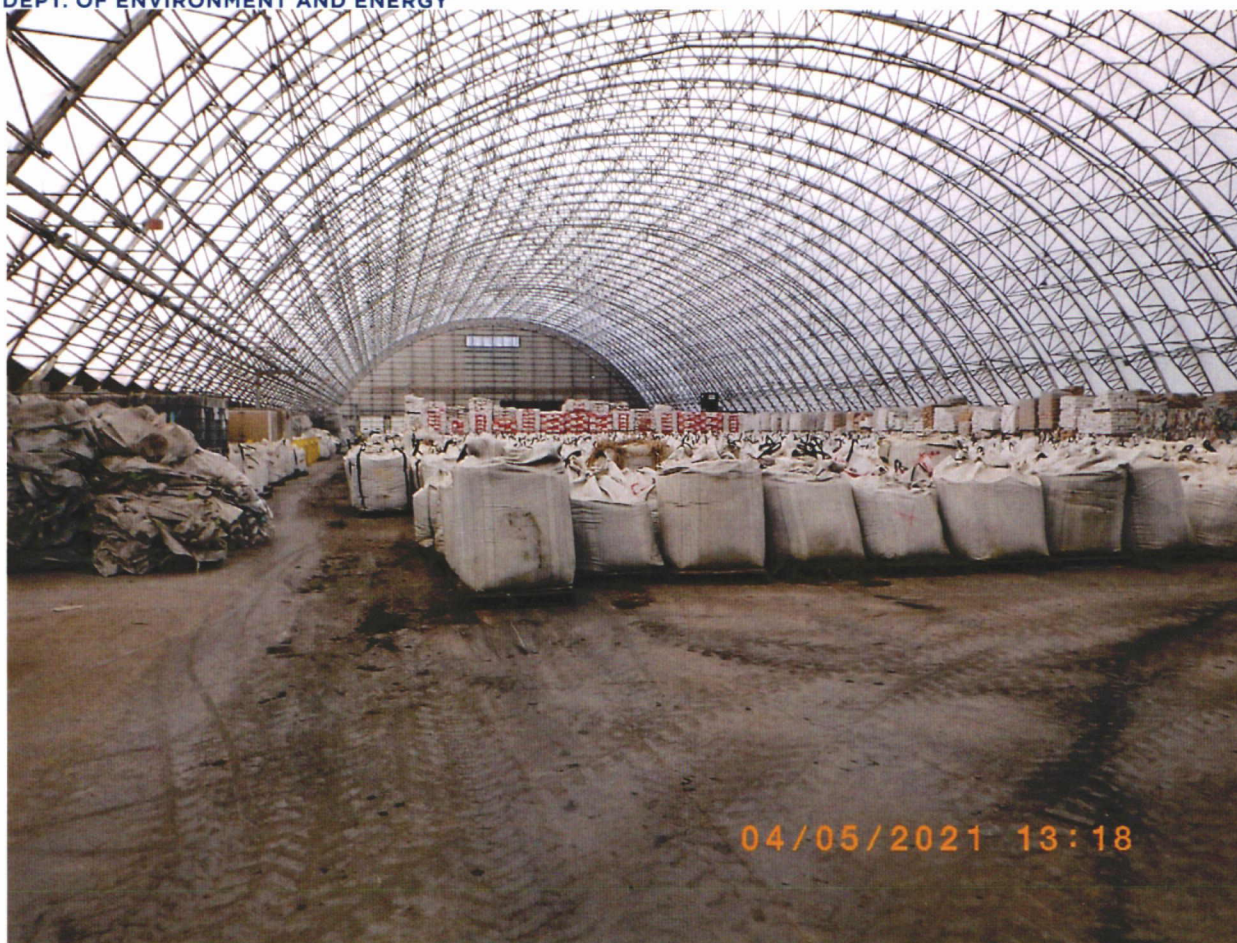
Photos: 4

Location: South hoop building

Description: Updated photo of Biochar being stored in south hoop building.

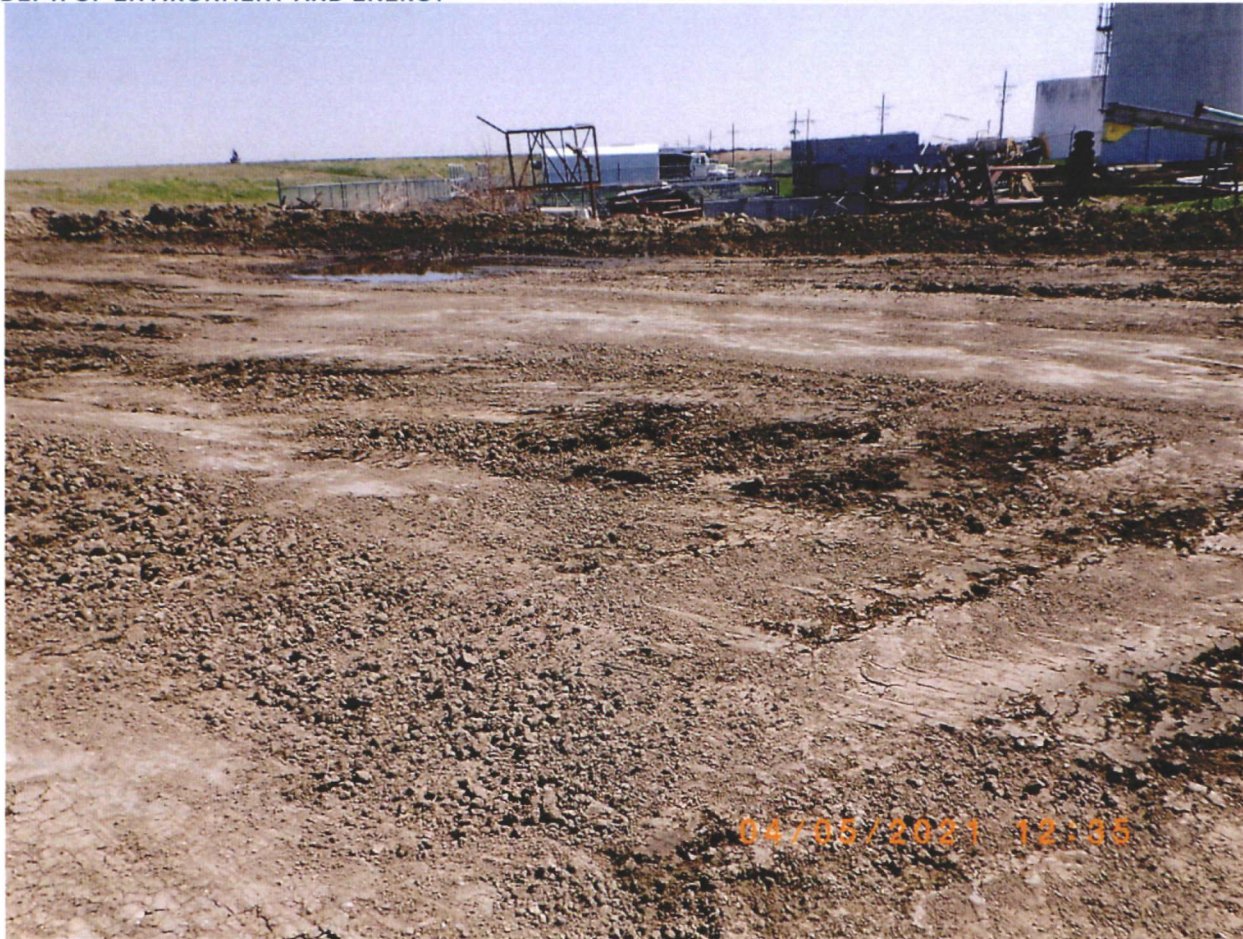
Photos: 5

Location: Berm between area 1 and 2 on the site map

Description: This area has been pumped except for a small amount of runoff. Staff will maintain this berm until permission is given to remove it.

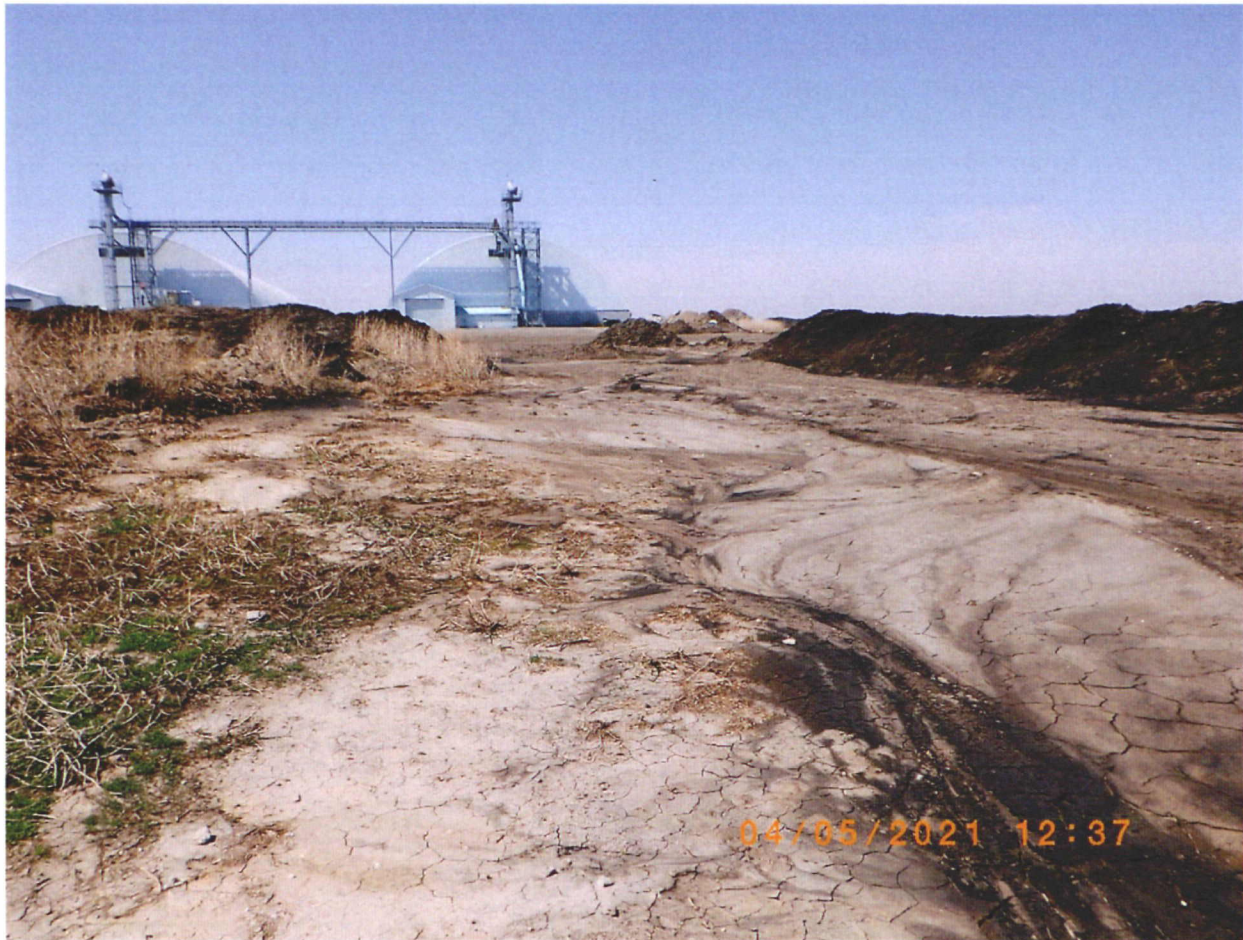
Photos: 6

Location: North of area 1 and east of the hoop buildings

Description: Central drainage from the main wetcake area to the north and west that collects in area 2 on the site map.

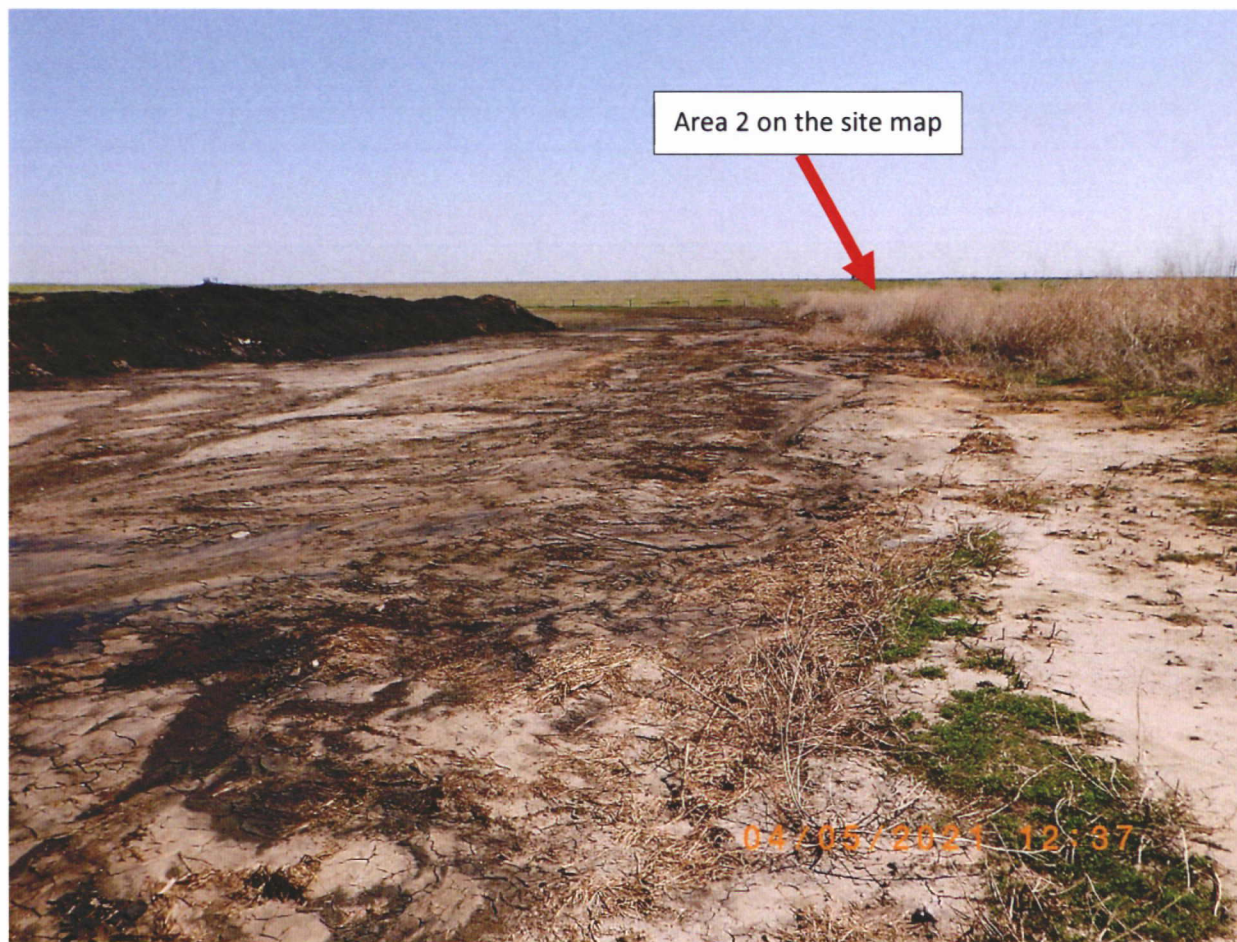
Photos: 7

Location: Same as photo 6

Description: Flow path of wet cake runoff to area 2 on the site map.

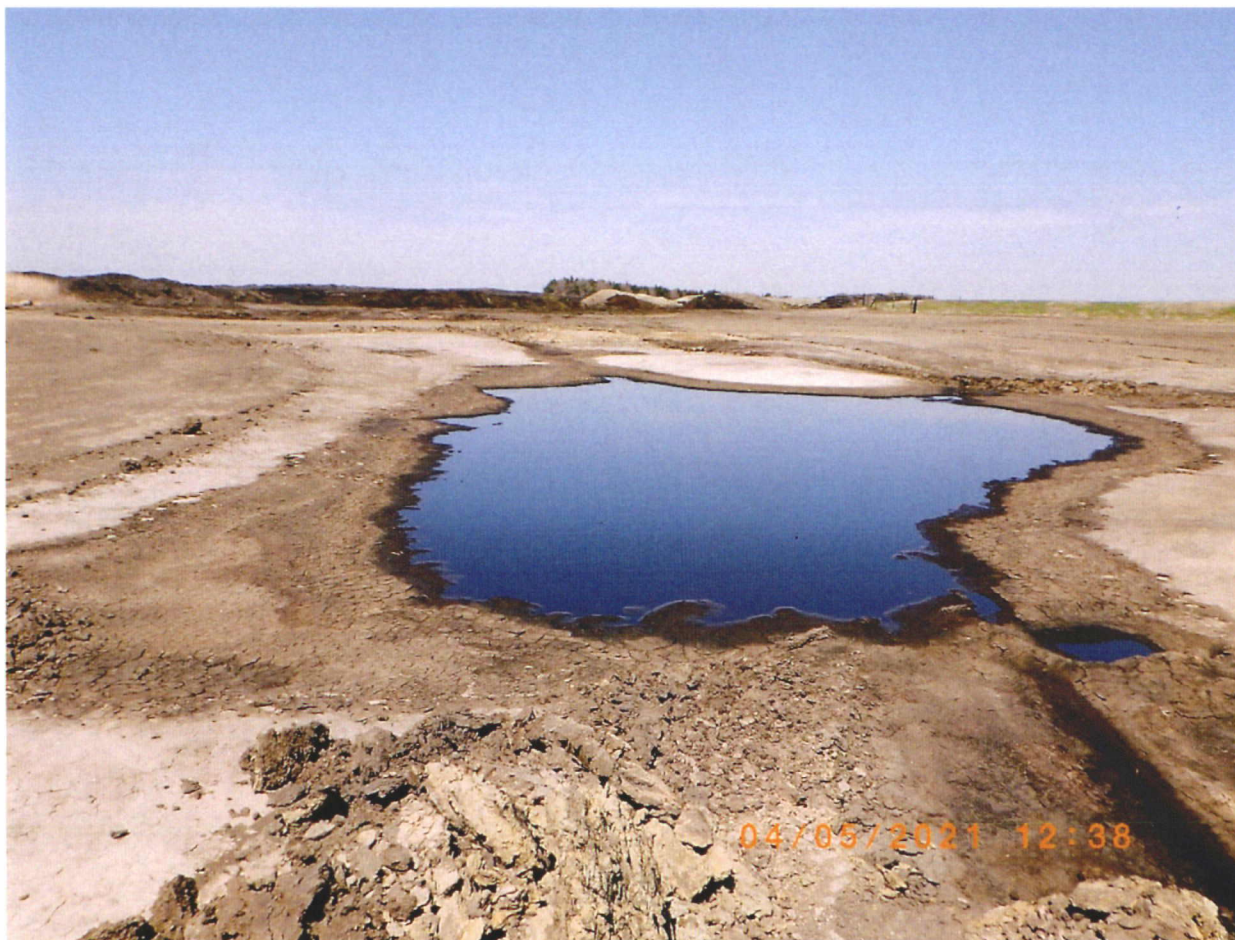
Photos: 8

Location: Approximately 200' east of the north hoop building

Description: Poned runoff north of temporary access road south of the northwest lagoon.

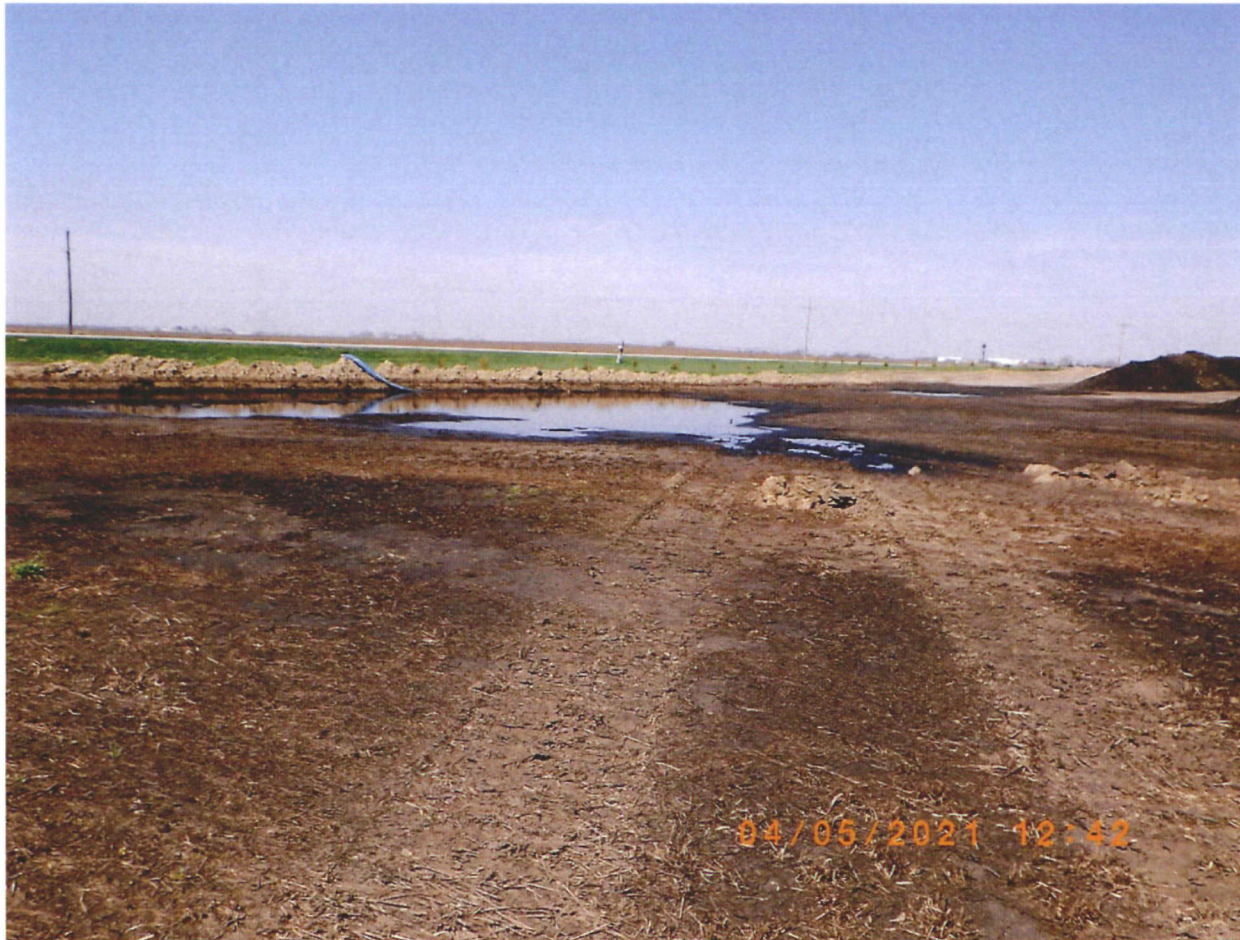
Photos: 9

Location: Area 5

Description: Small amount of ponded runoff left behind berm in area 5. The majority of this runoff is now diverted to the east and drains to area 2 on the site map.

5 - Berm holding water diverted east

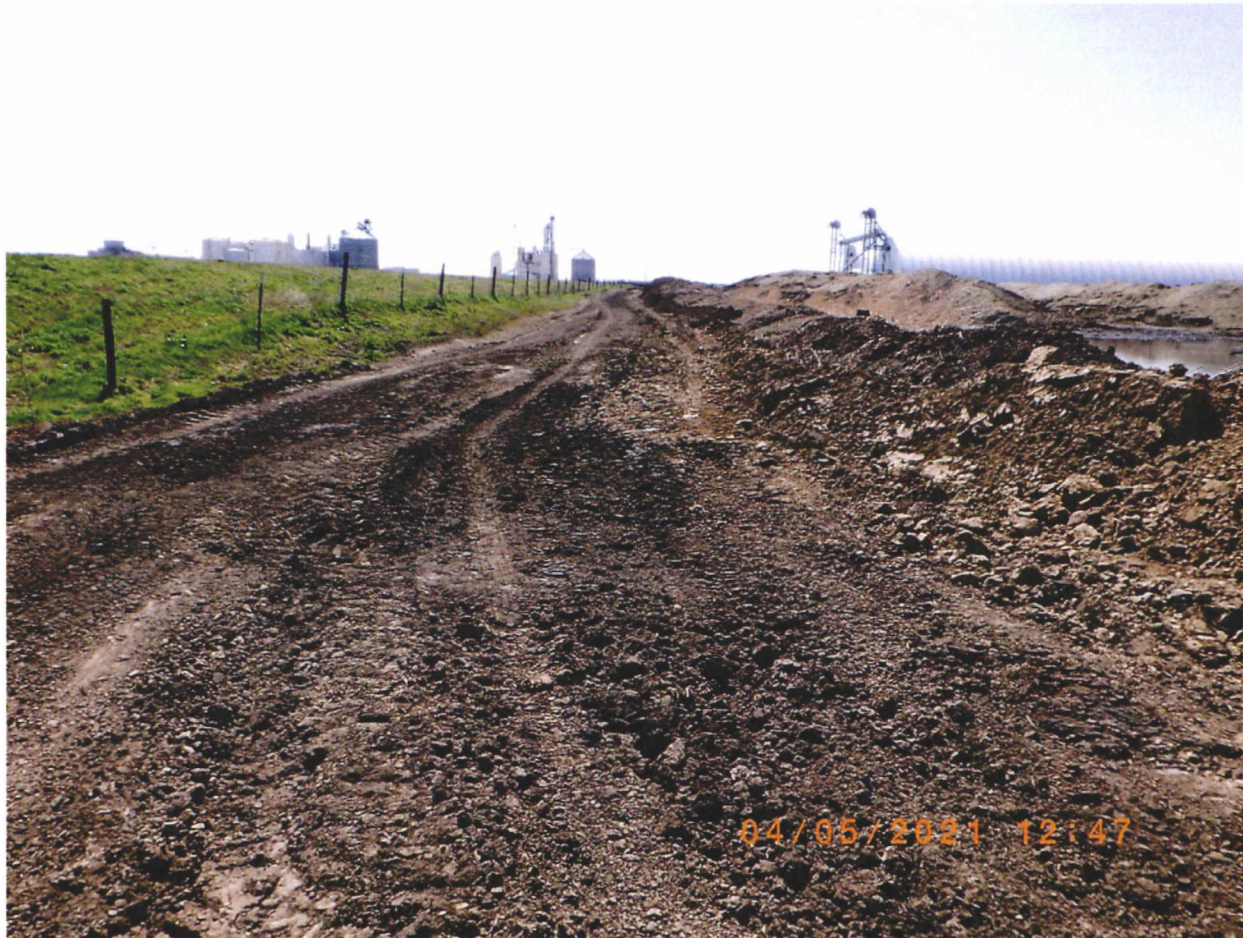
Photos: 10

Location: Area 3 on the site map

Description: Stabilized berm and access road at area 5, no seepage observed.

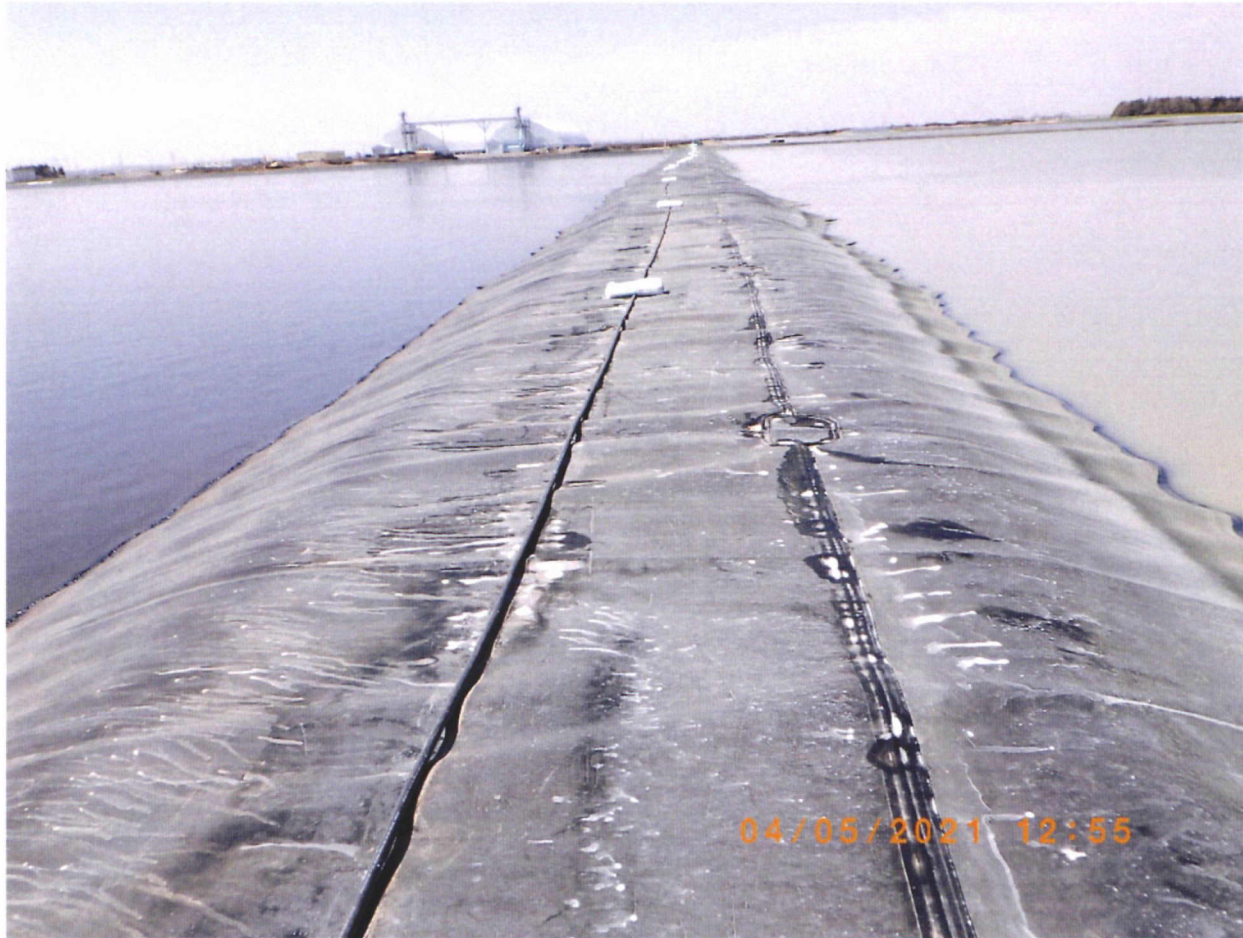
Photos: 11

Location: Northeast corner of the southeast lagoon

Description: Lagoon levels are slowly dropping and previous water levels can be observed in the northeast lagoon on the right side of the photo.

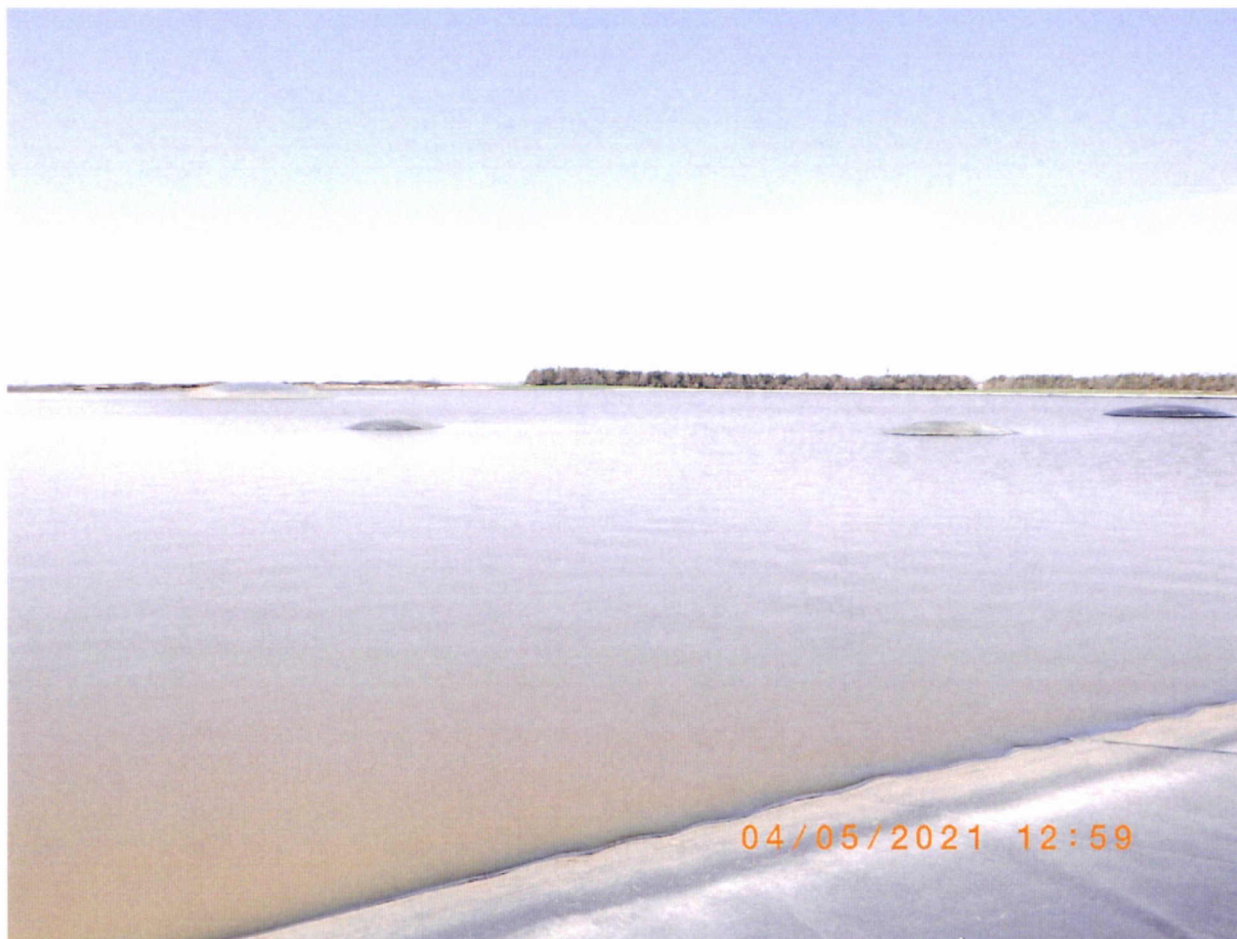
Photos: 12

Location: Southeast corner of the northwest lagoon

Description: 4 whales visible in the northwest lagoon.

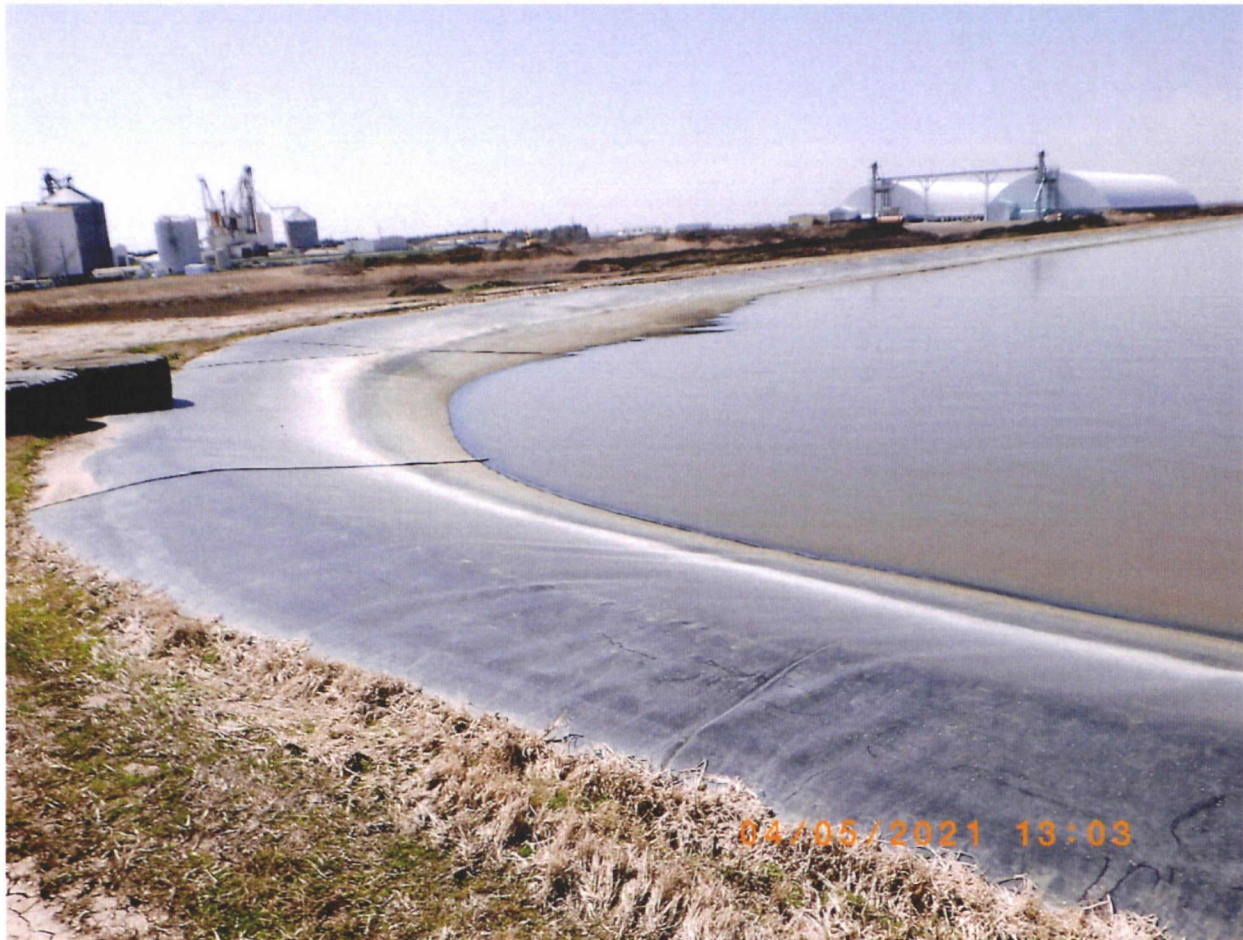
Photos: 13

Location: Same as photo 12

Description: Southeast corner of the northwest lagoon showing water level staining indicating water level is dropping.

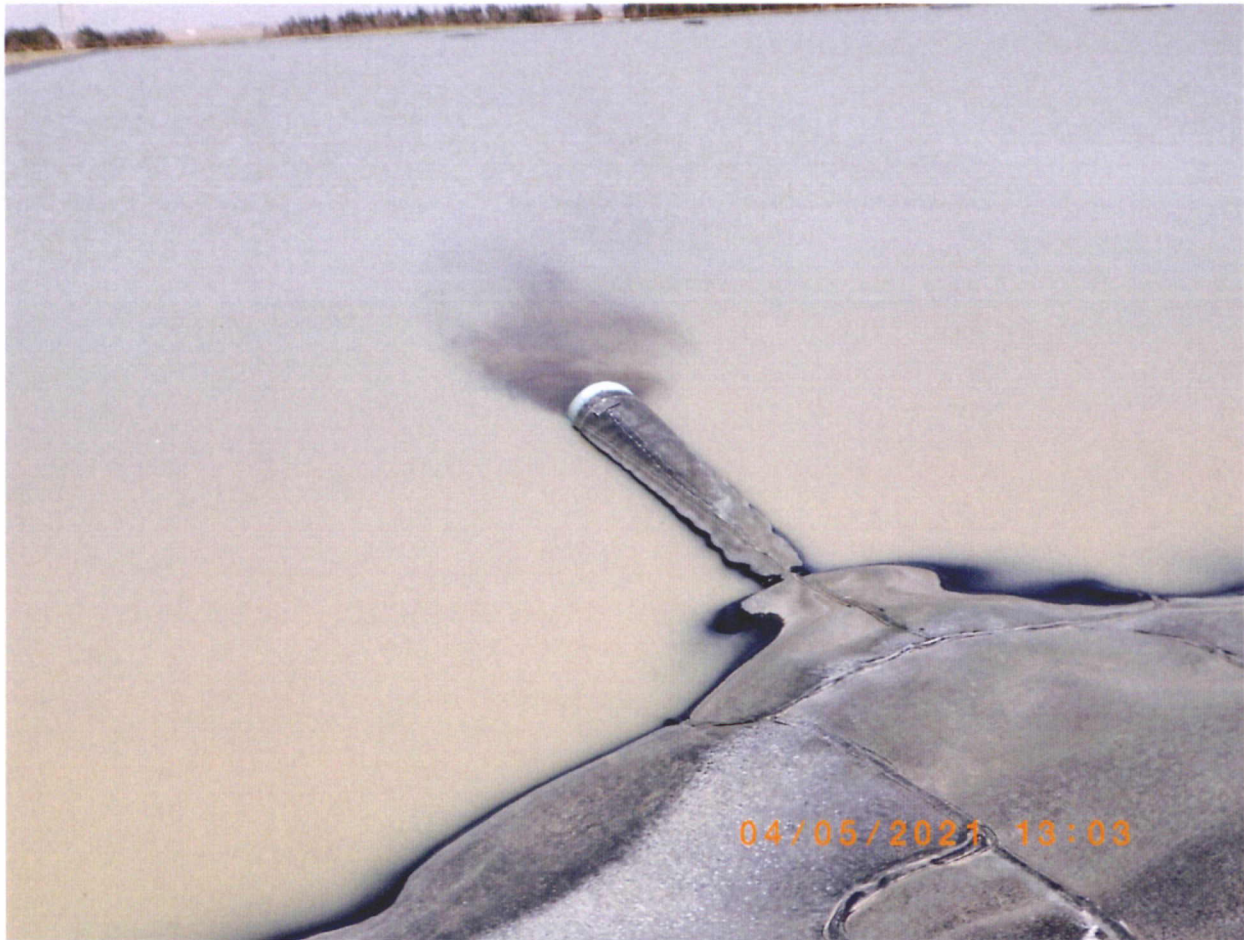
Photos: 14

Location: Southwest corner of the northeast lagoon

Description: Water from the southeast lagoon was observed flowing back to the northeast lagoon via the equalization pipe.

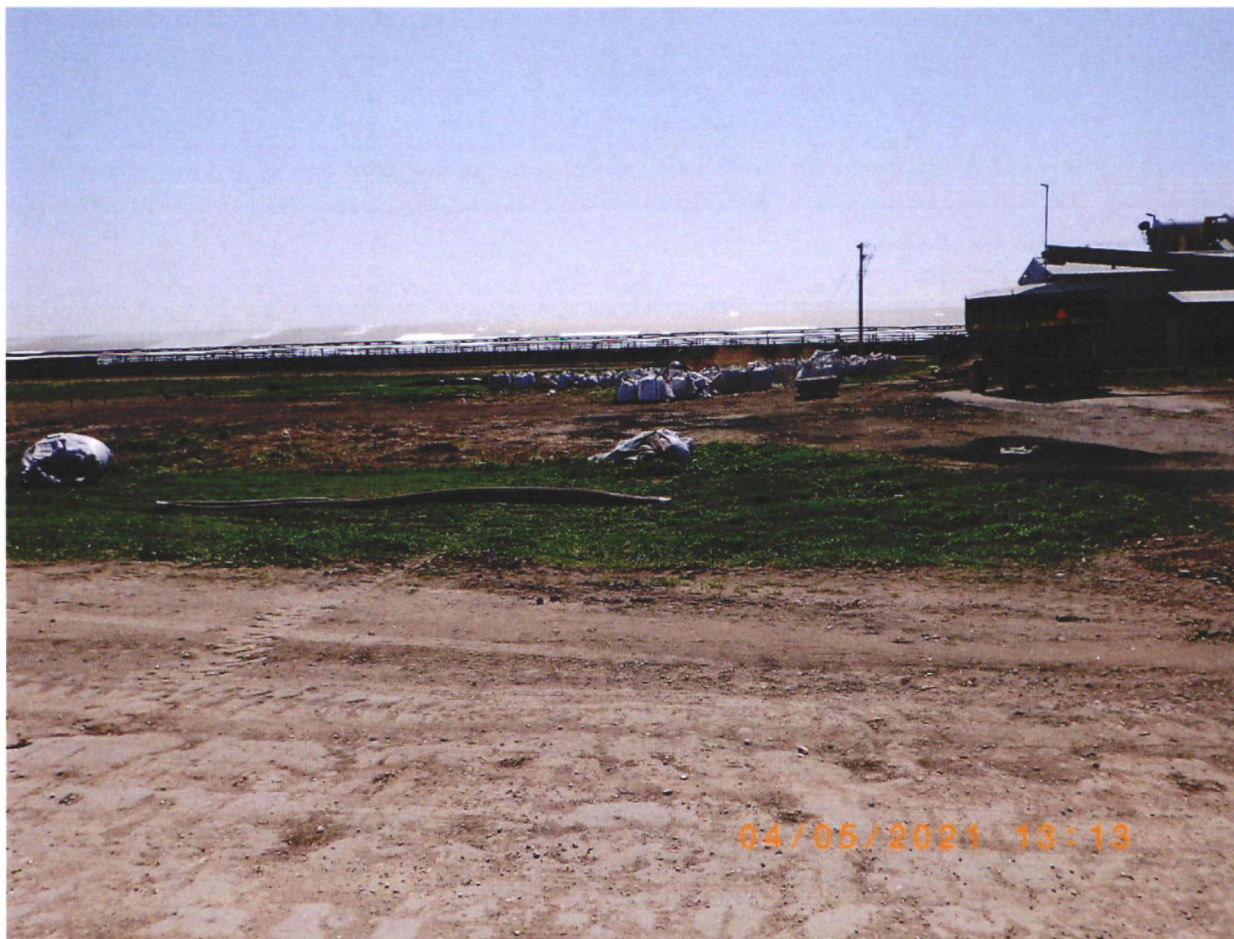
Photos: 15

Location: North of the Biochar operation

Description: Last of Biochar bags stored on east side of Biochar operation.

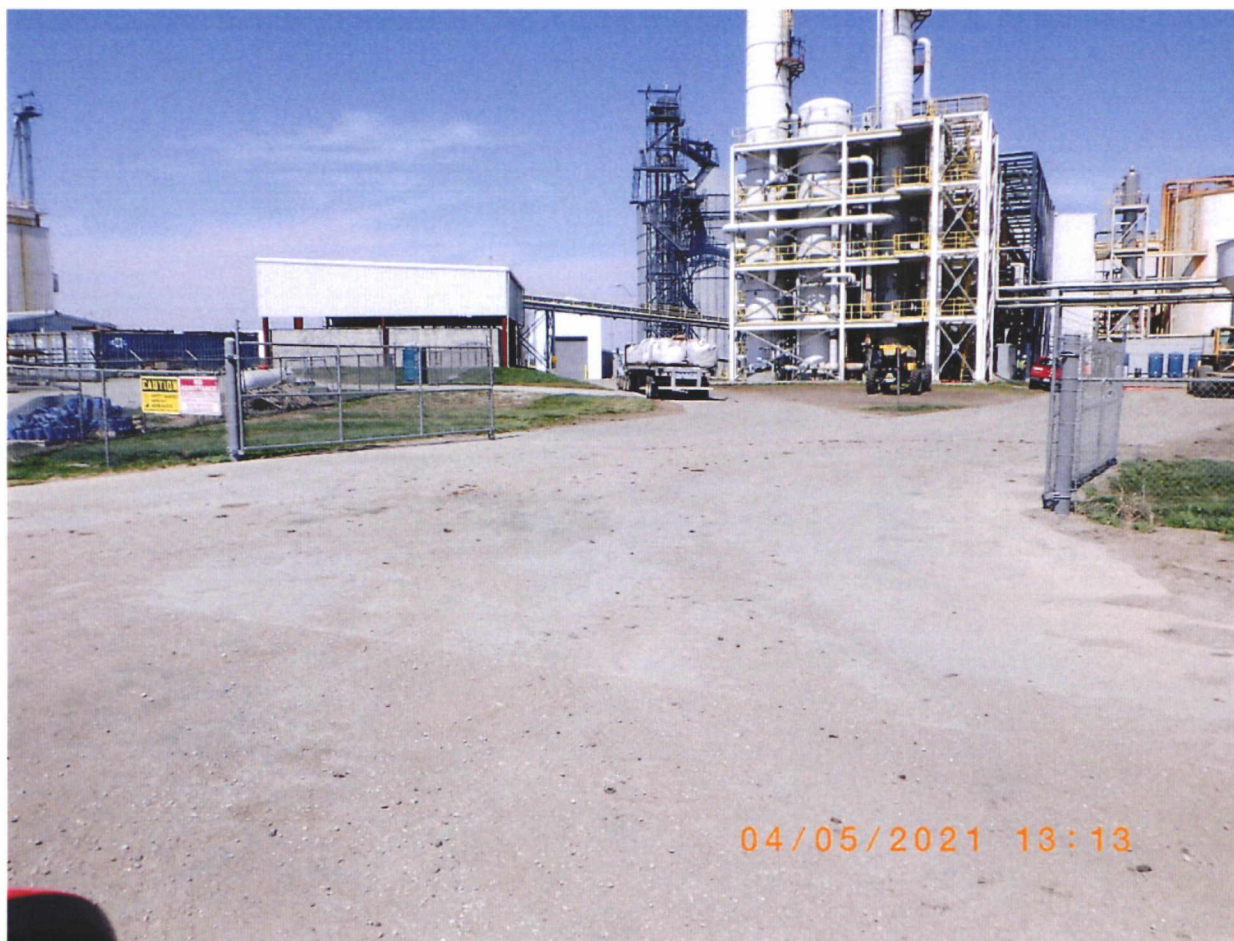
Photos: 16

Location: North of the Biochar operation.

Description: Flatbed in center of photo being loaded with Biochar bags to take to the south hoop building.

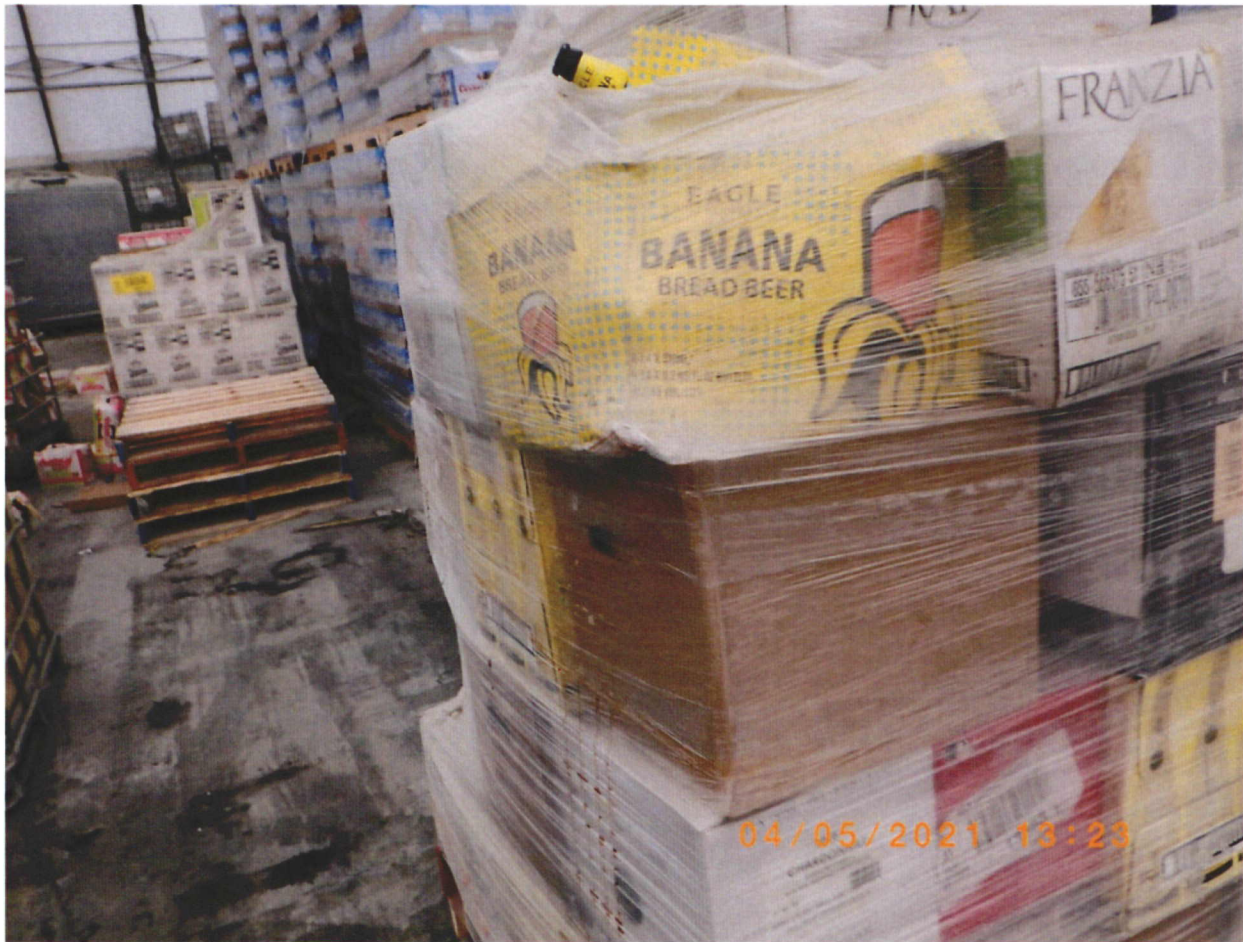
Photos: 17

Location: South hoop building

Description: Leftover waste material used in the ethanol production process.
