Facility: AltEn
IIS: 84069
PCS: NE0137634

Site Visit Check list

AltEn LLC - Storm Water Temporary BMP Check Map

Site Visit Report

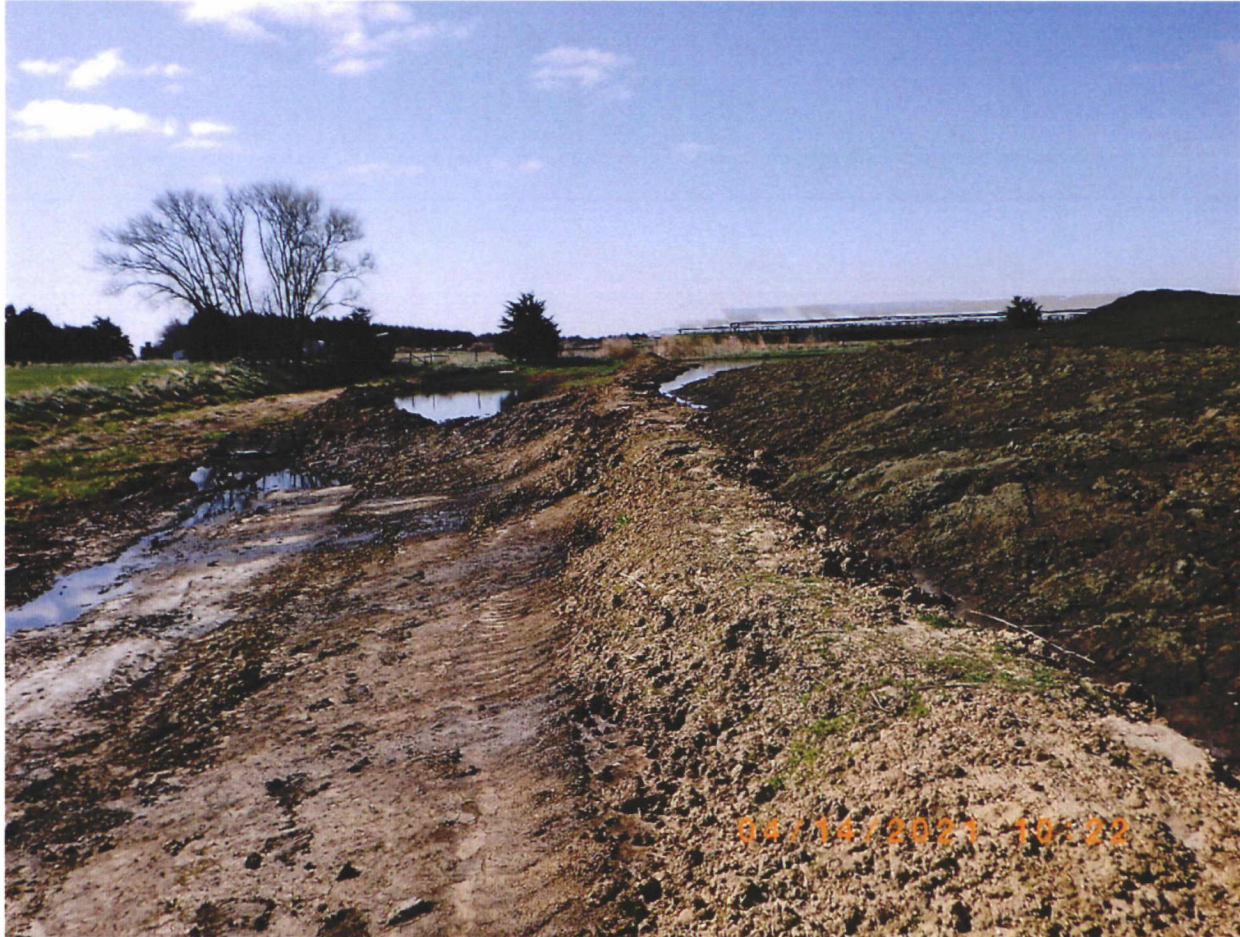
Photos: 1

- The berm in area 2 was raised to gain more storage capacity.
- The tractor used for pumping being serviced offsite and is unknown when this will be completed. The pumping of runoff in area 6 is dependent upon the repair of this tractor to power the PTO for the vacuum pump liquid manure spreader.
- Biochar continues to be removed and placed in the south hoop building. The material on the ground south of the Biochar pad is several inches thick while to the north and south it is less visible.
- Camera did not save photo from drainage ditch from CR 9 & J

Location: Area 6 on the site map

Description: Berm along the east side of the east wetcake area has multiple seep locations and is beginning to pool outside of the second berm.

Area 1 - Berm in good condition & pumped
2 - Berm raised & compacted & pumped most of water
3 - Berm in good condition not pumped
4 - No concerns
5 - Berm in good condition not pumped but diking East
6 - Berms seeping & need to be pumped

- Pump out Area 6 berms & repair berms
- Finish moving Biochar to hoop building

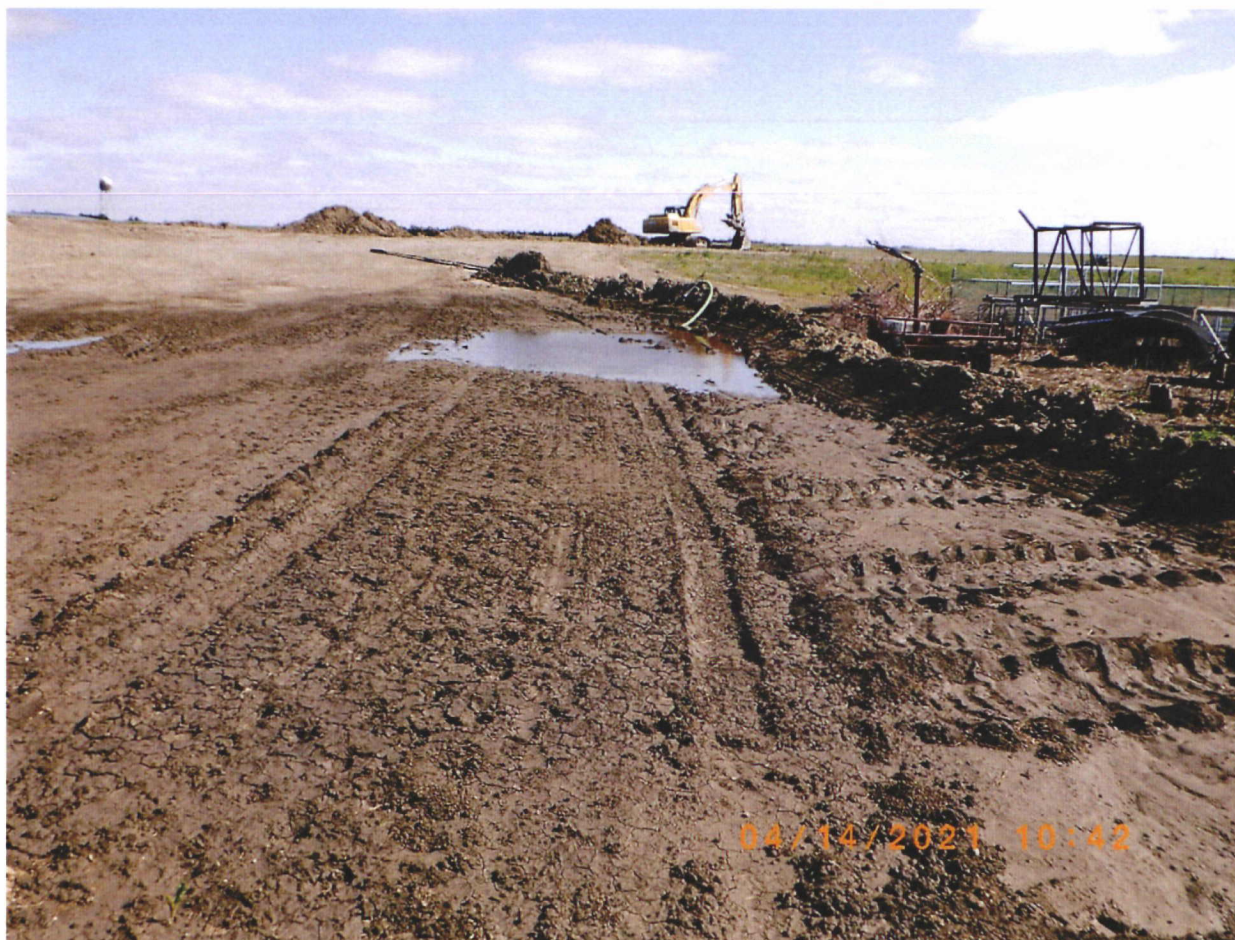
Photos: 2

Location: Area 1 on the site map

Description: Berm pumped out to the area north over the small hill to the area draining to area 2.

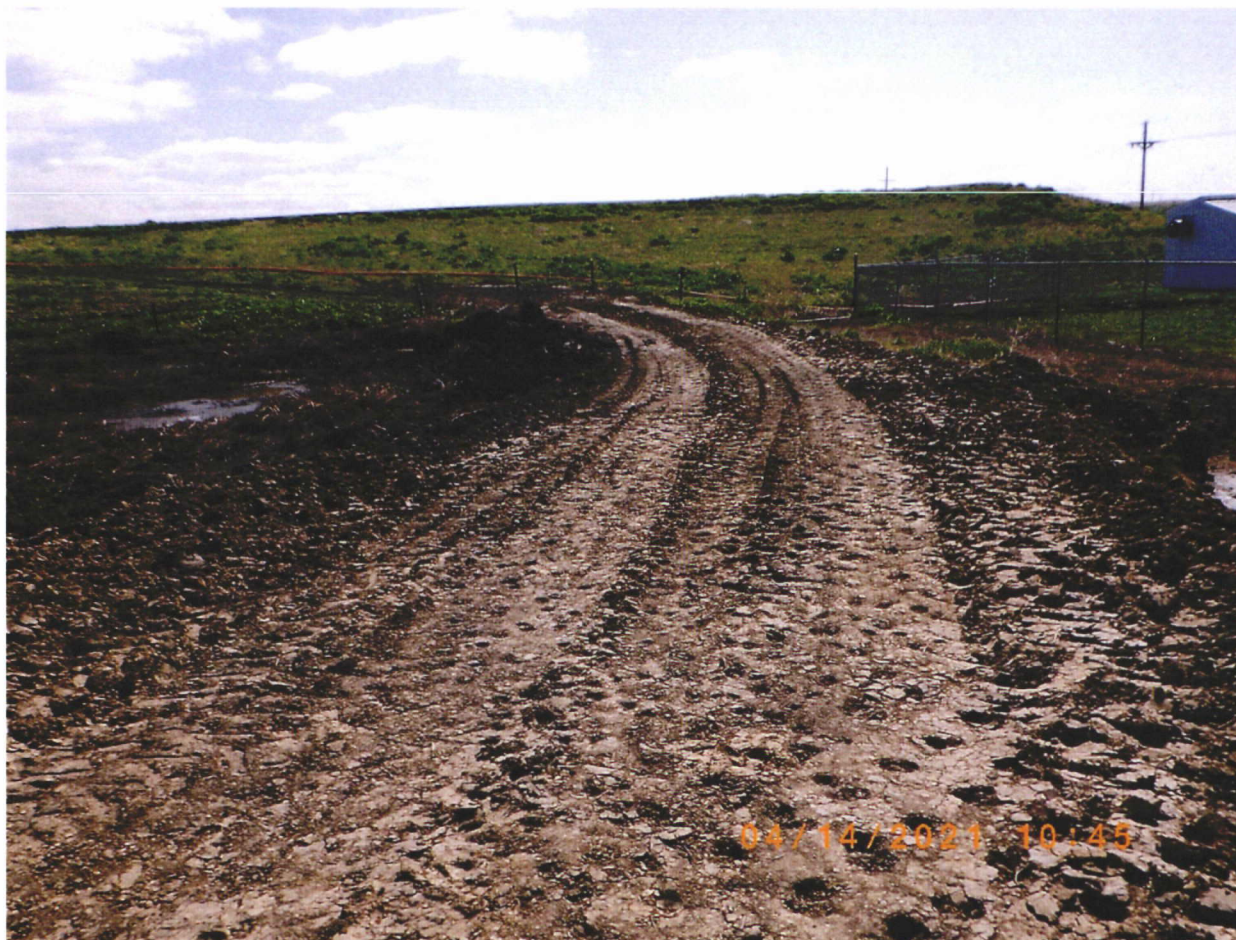
Photos: 3

Location: Area 2 on the site map.

Description: Berm in this area has been raised by approximately 1' and has been compacted using a pull behind sheepsfoot drum roller.

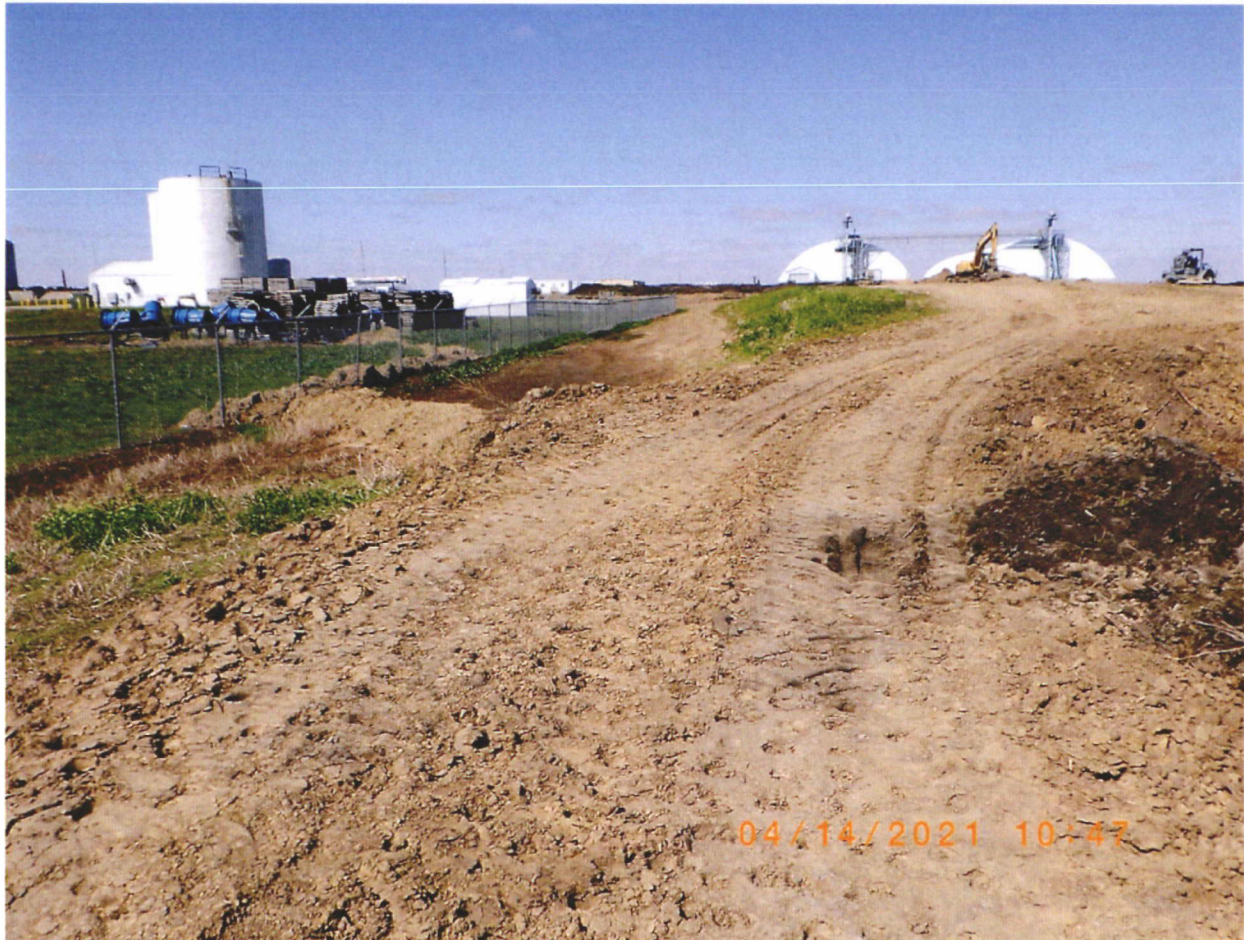
Photos: 4

Description: Compacted berm has been extended to the west to connect with the hill north of the admin building.

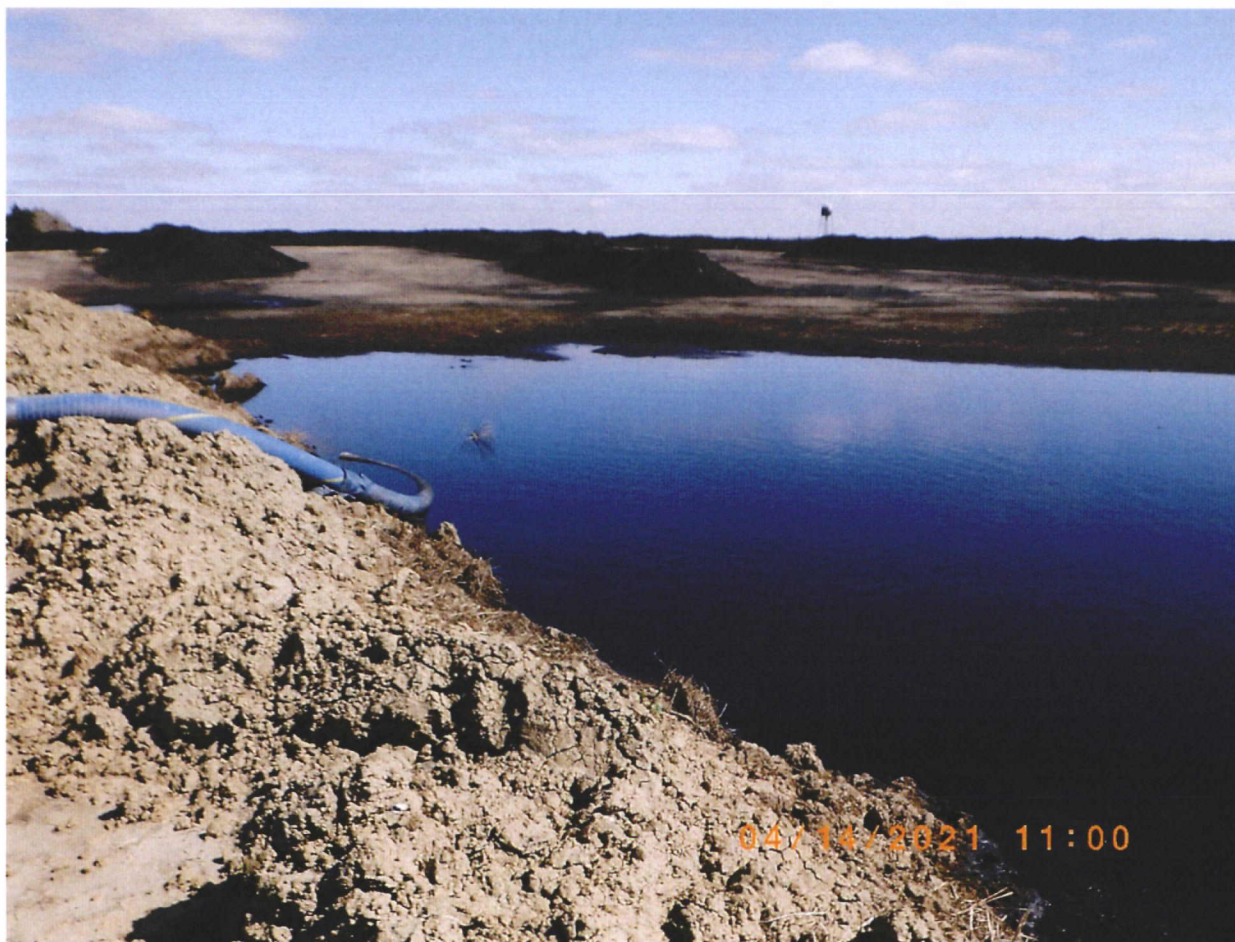
Photos: 5

Location: Area 5 on site map

Description: Berm continues to hold and majority of runoff drains to the east.

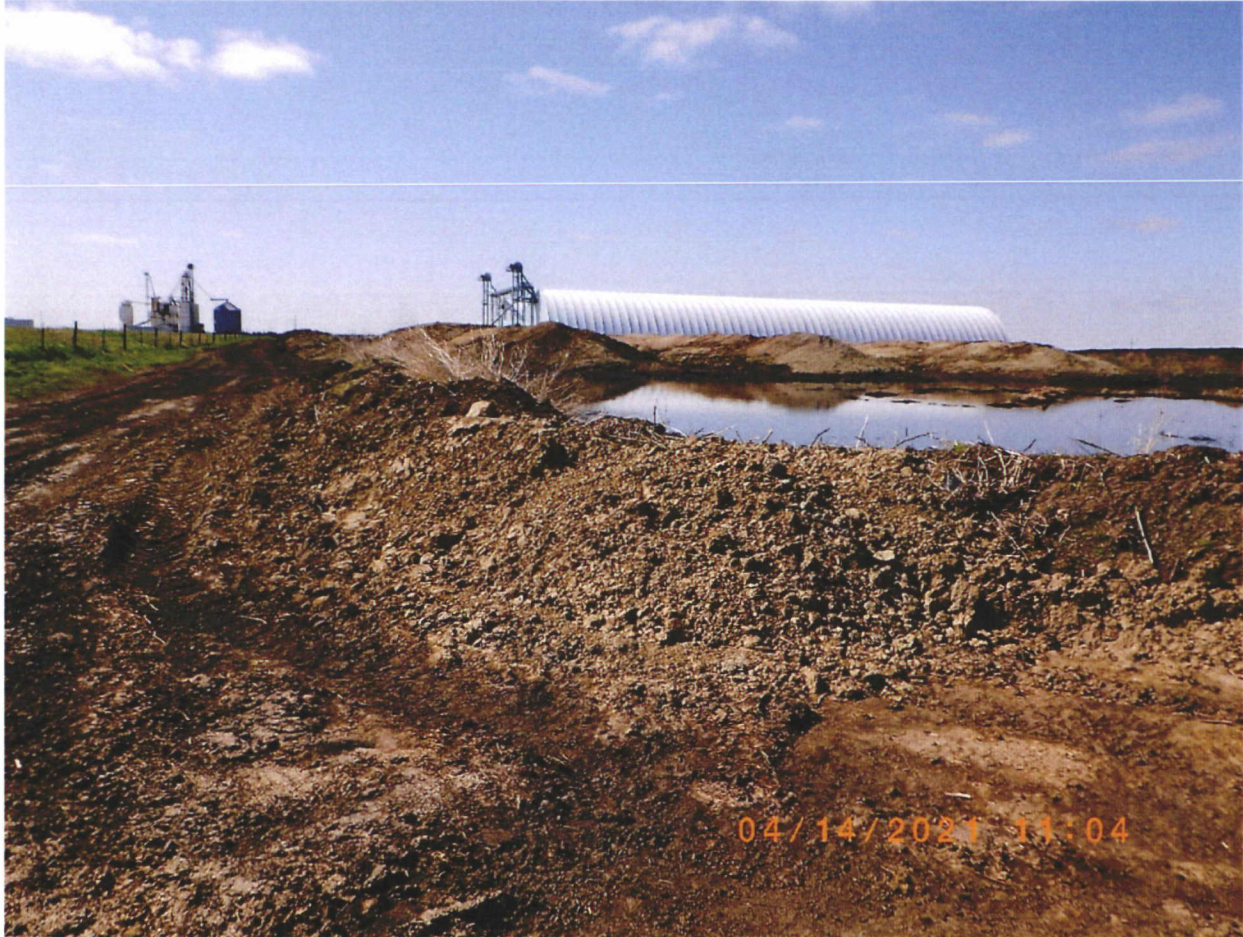
Photos: 6

Location: Area 3 on the site map.

Description: The recent reinforcement of the section berm in this area is holding and shows no sign of seepage.

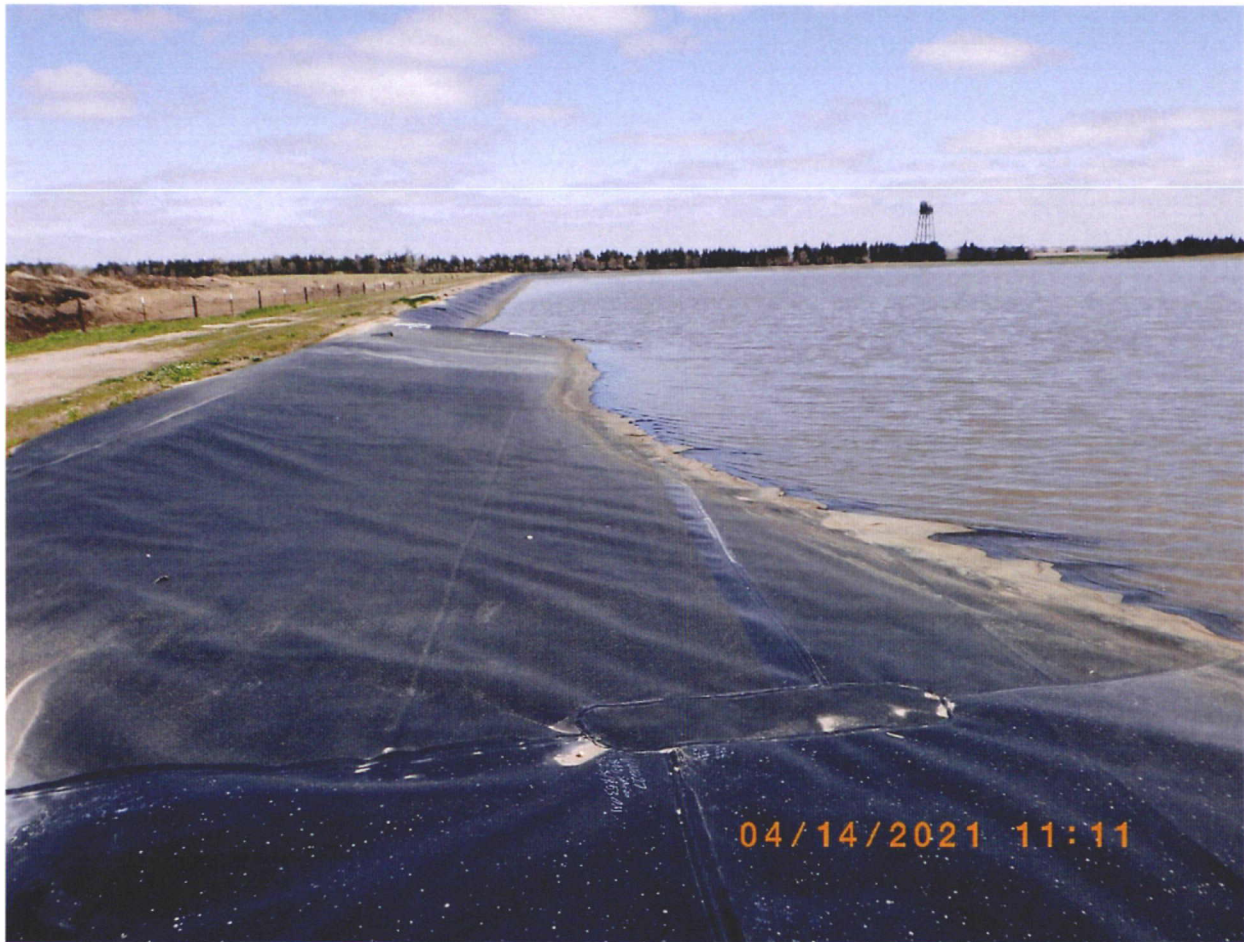
Photos: 7

Description: Depth indicator marking on southwest corner of the northwest lagoon showing lagoon level is less than 19'.

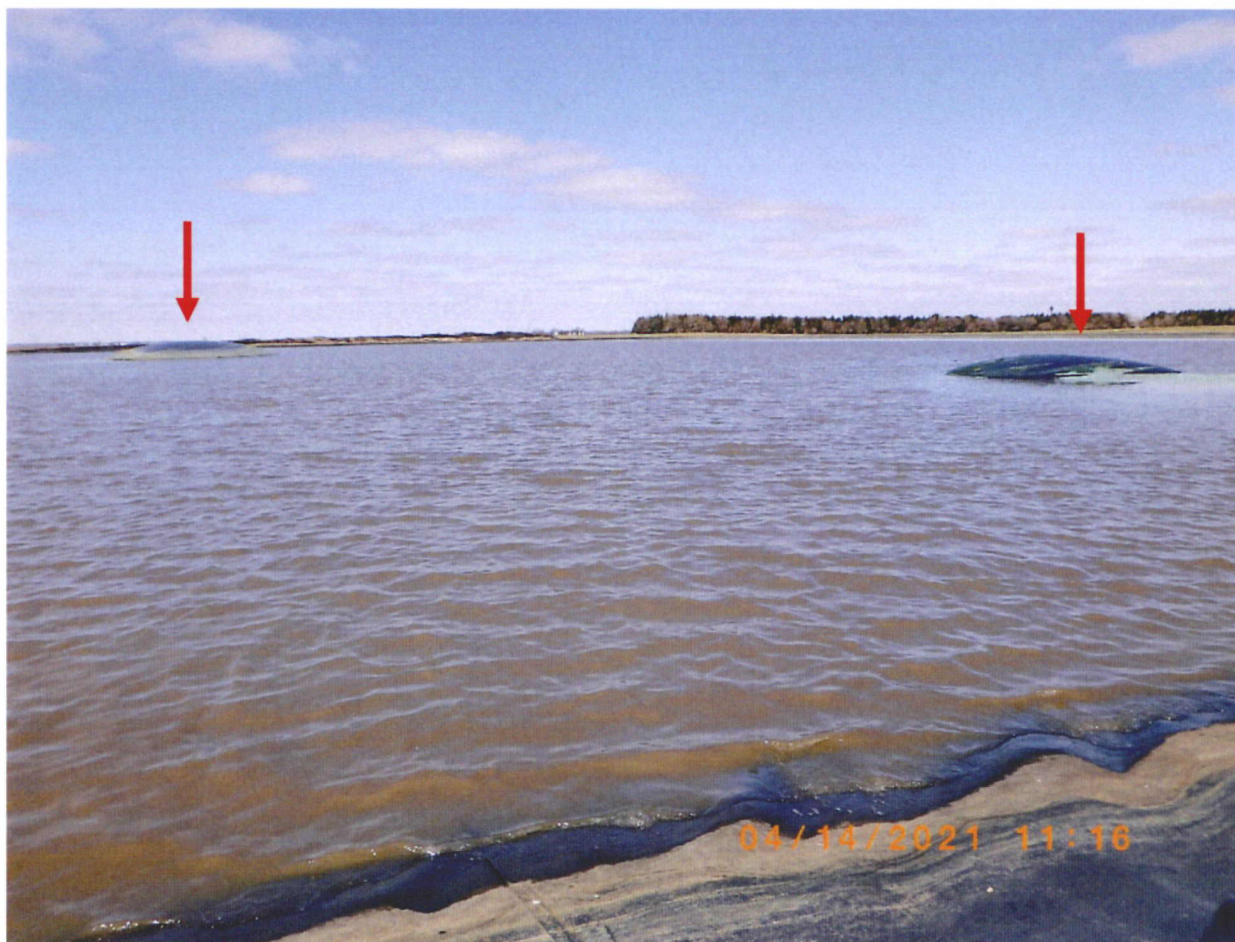
Photos: 8

Description: Photos shows the two remaining whales in the northwest lagoon and thick green material accumulating around the east whale. The green material is increasing daily and only found around the east whale.

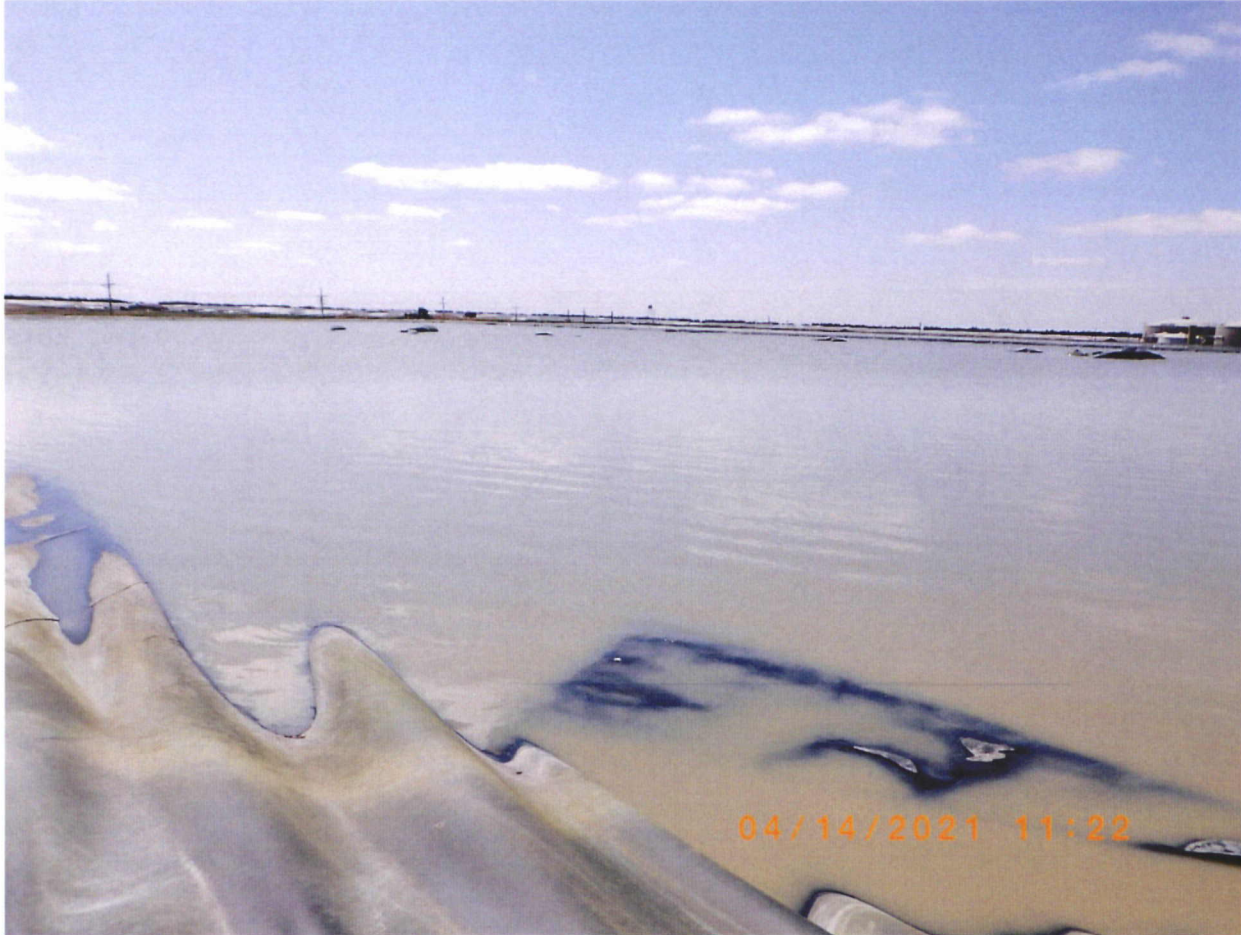
Photos: 9

Description: Whales and torn sections of the lagoon.

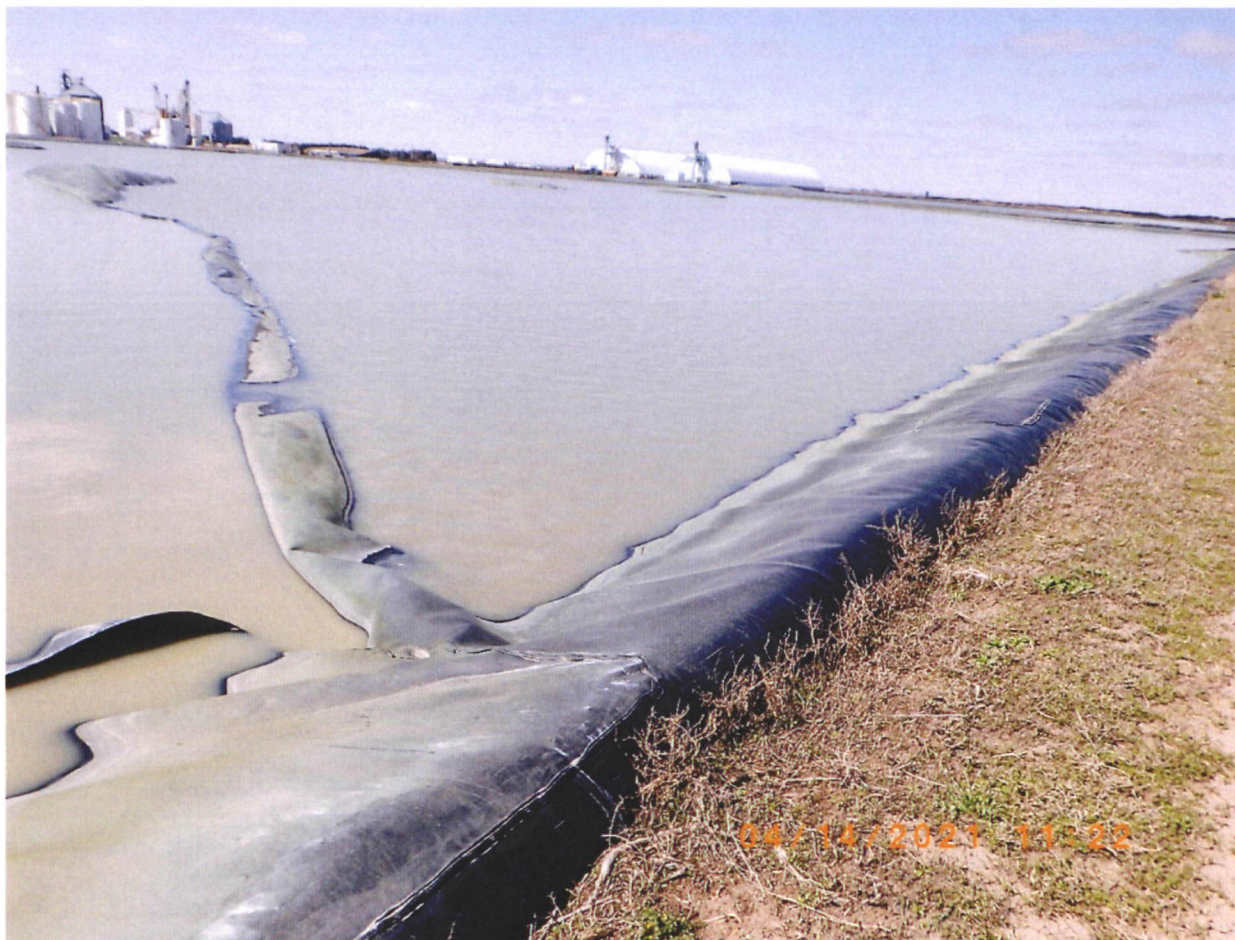
Photos: 10

Description: Whales and torn sections of the lagoon.

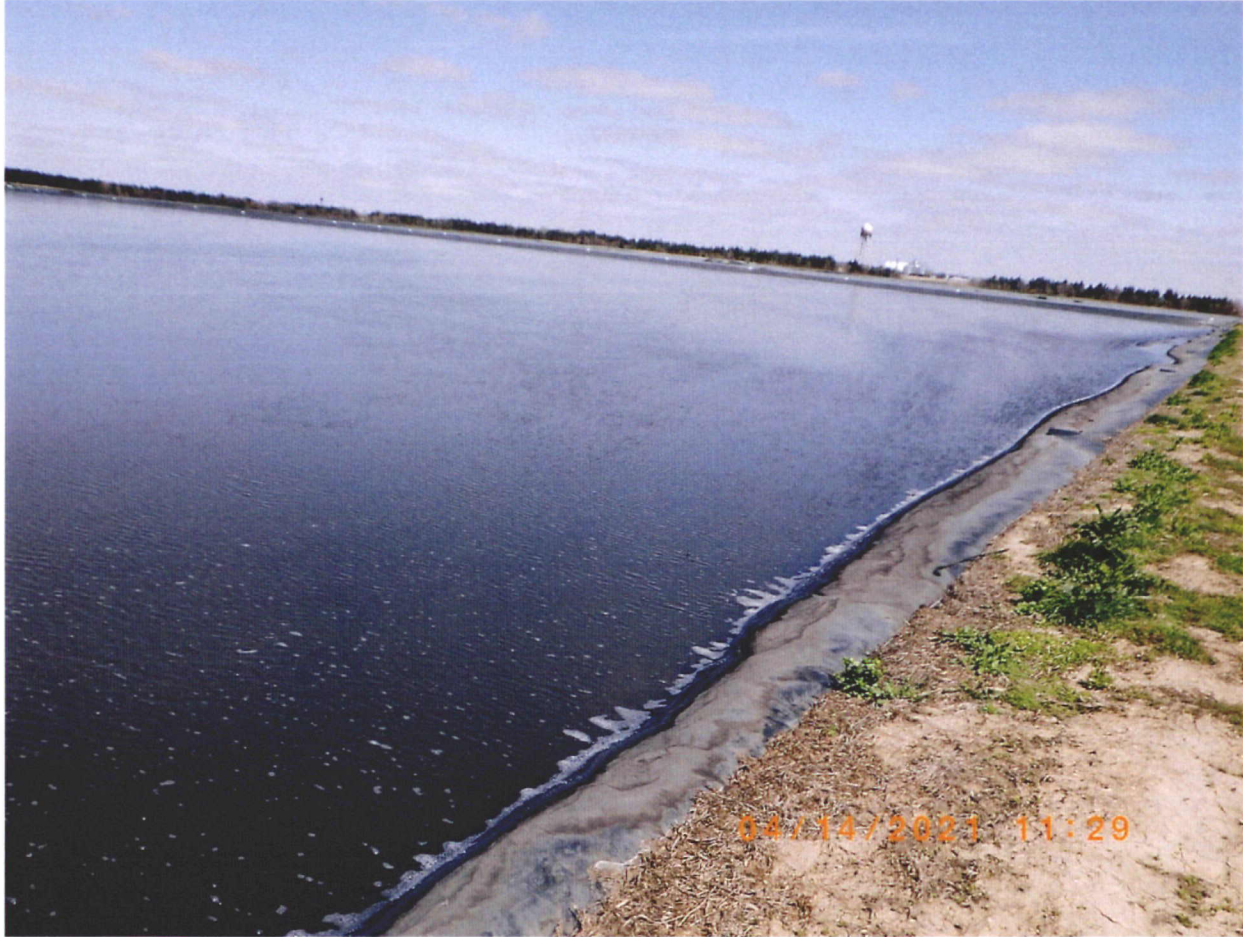
Photos: 11

Description: The lagoon is beginning to exhibit bubbling and foaming with a very strong septic odor.

Solids are beginning to float to the top along south edge.

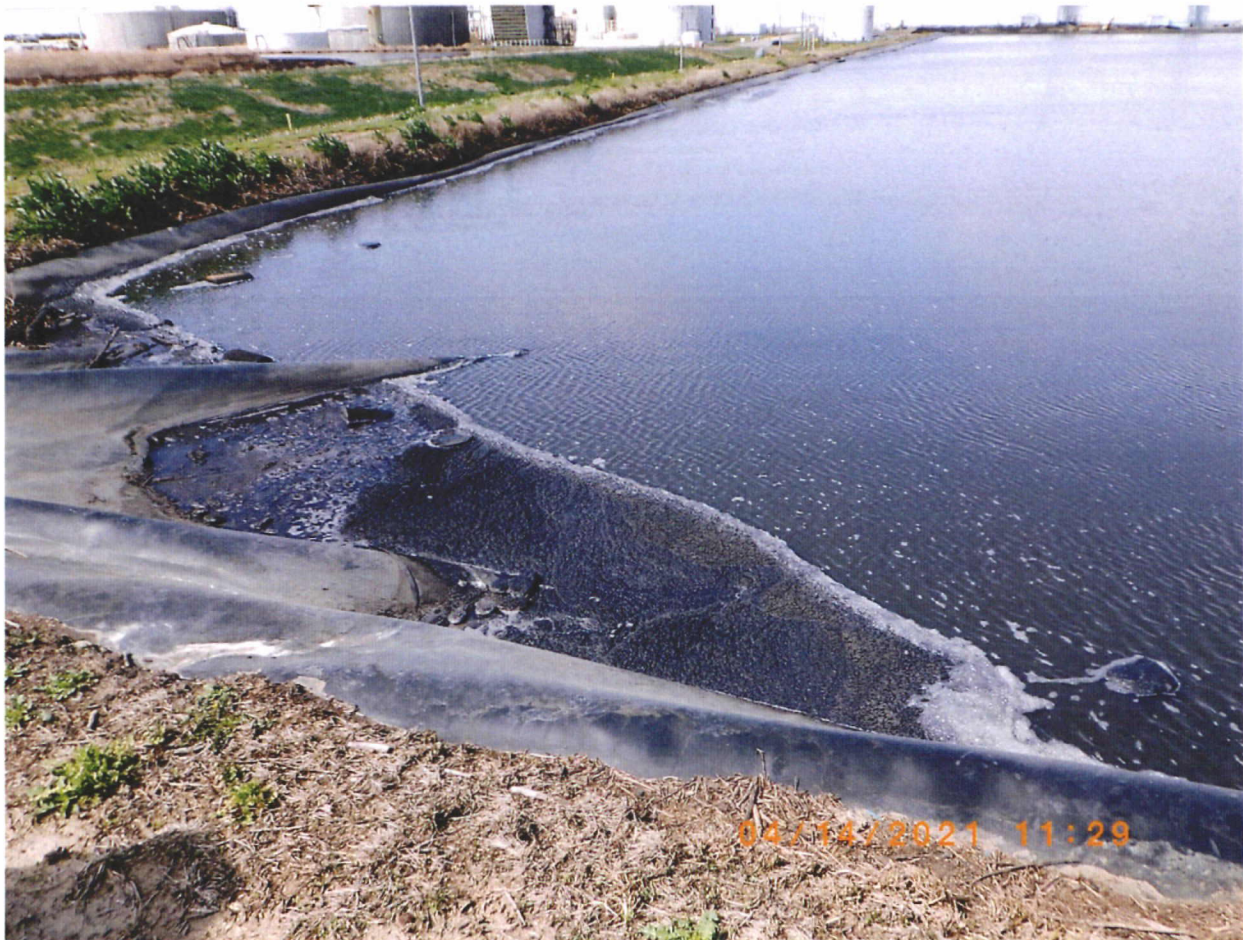
Photos: 12

Description: Solids and debris collecting in the corner of the lagoon.

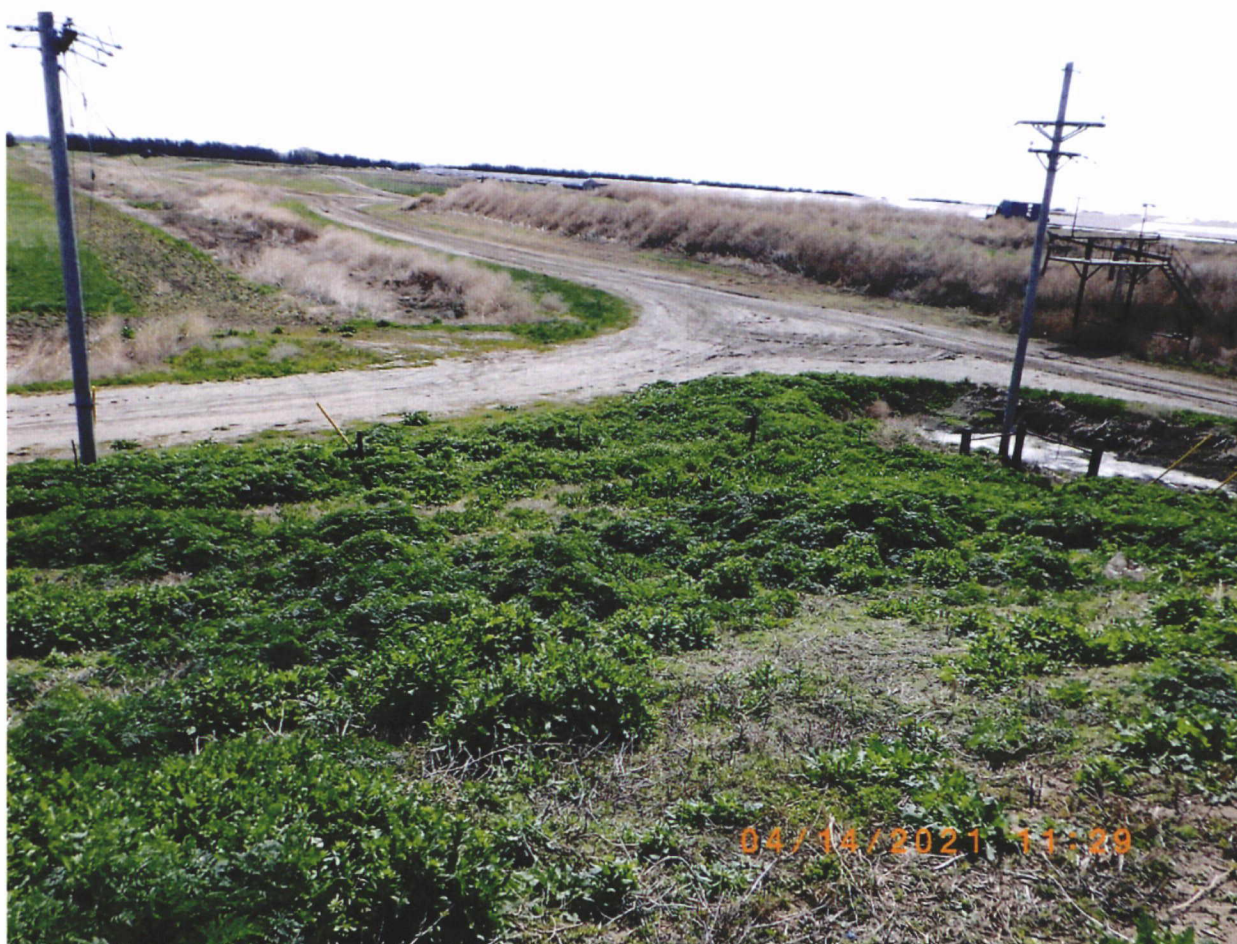
Photos: 13

Description: Repaired fence that was cut to allow access when the facility was pumping in February.

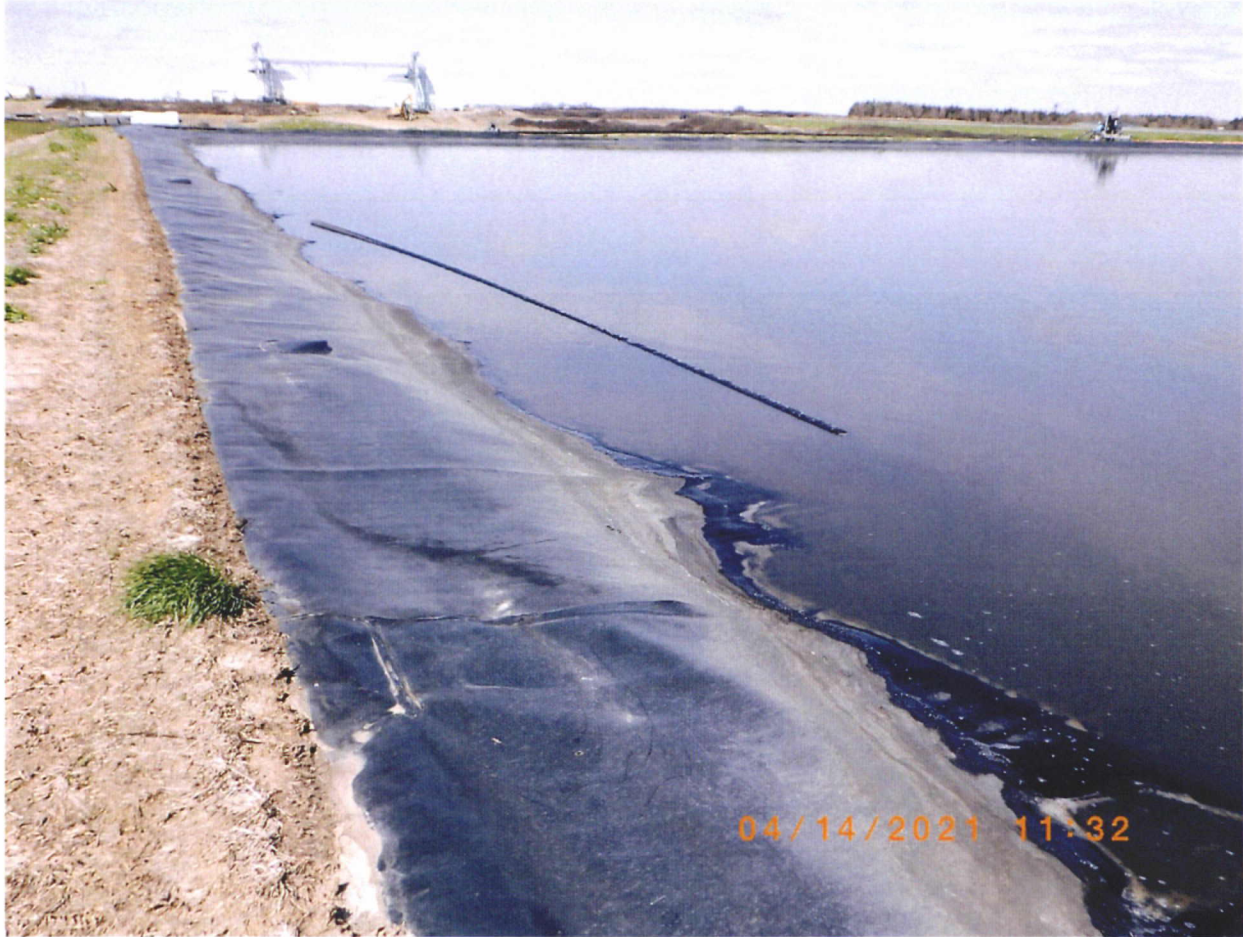
Photos: 14

Description: Pipe floating along the south edge of the lagoon. Pipe possibly blew into the lagoon sometime in the last week.

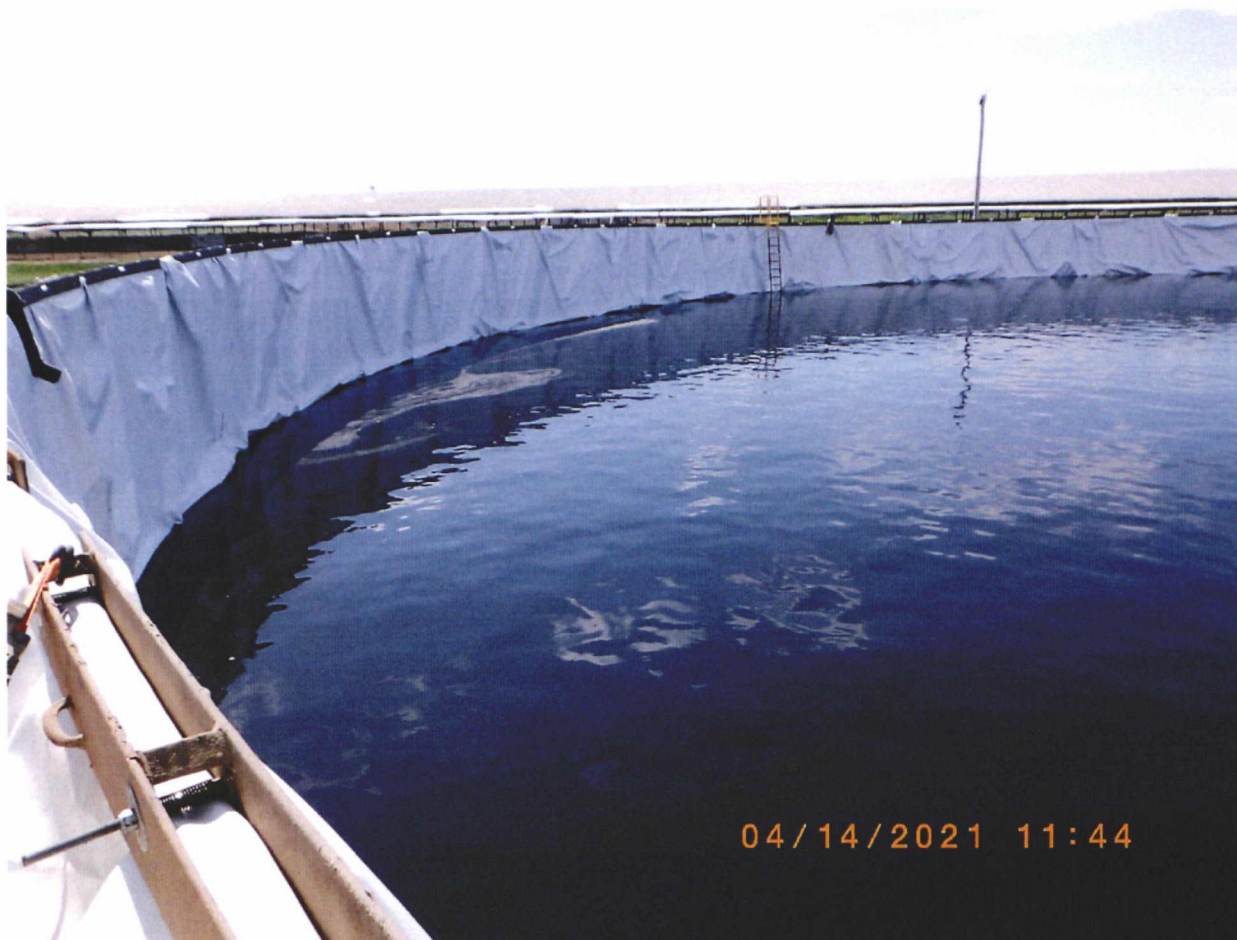
Photos: 15

Description: Approximately 3' of liquid in the tank. Liquid inside the tank appeared black with a strong septic odor.

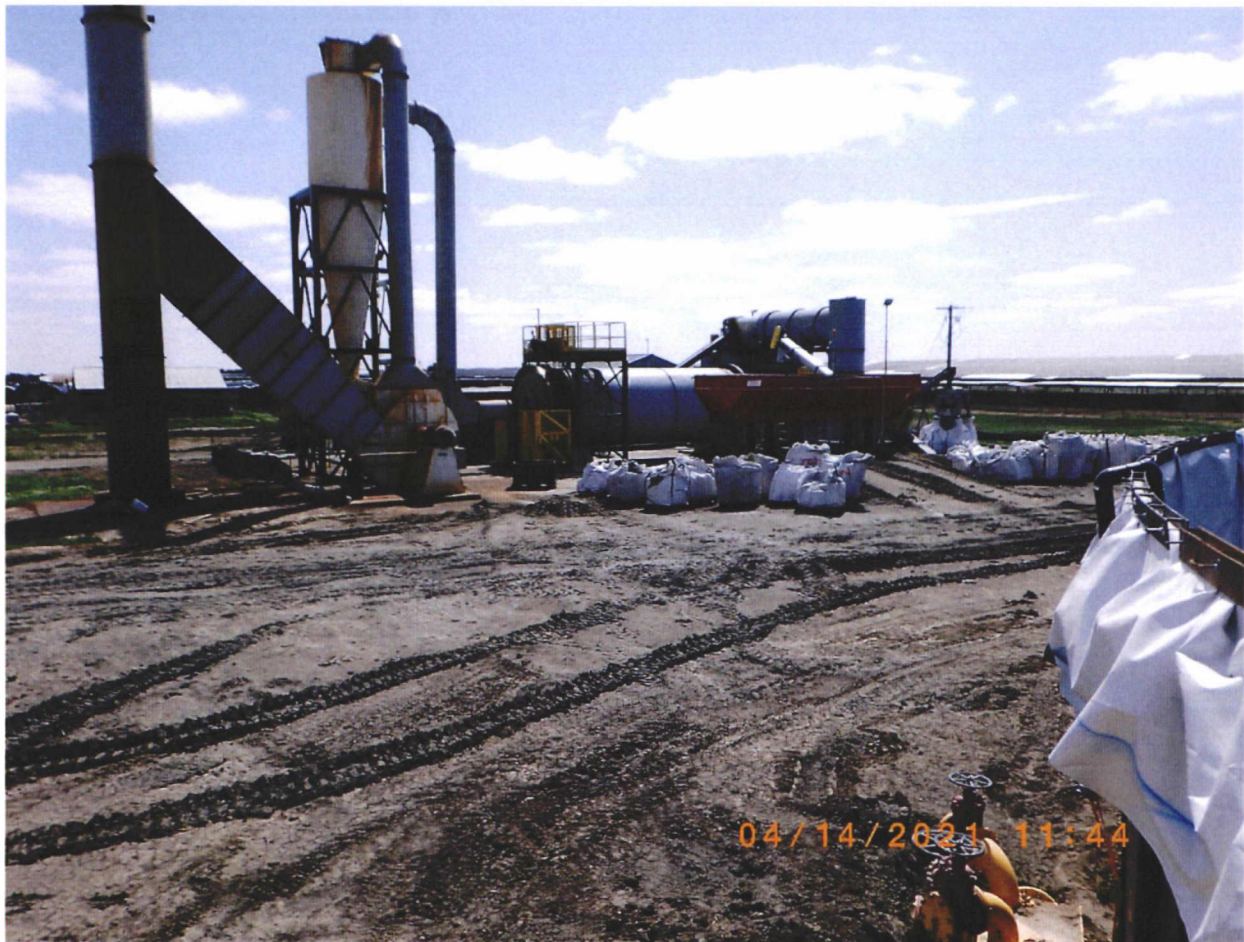
Photos: 16

Description: Remaining bags of Biochar on the ground. Muddy conditions have slowed the progress of relocating the Biochar bags in previous days but AltEn should now be able to complete this within the next day or two.

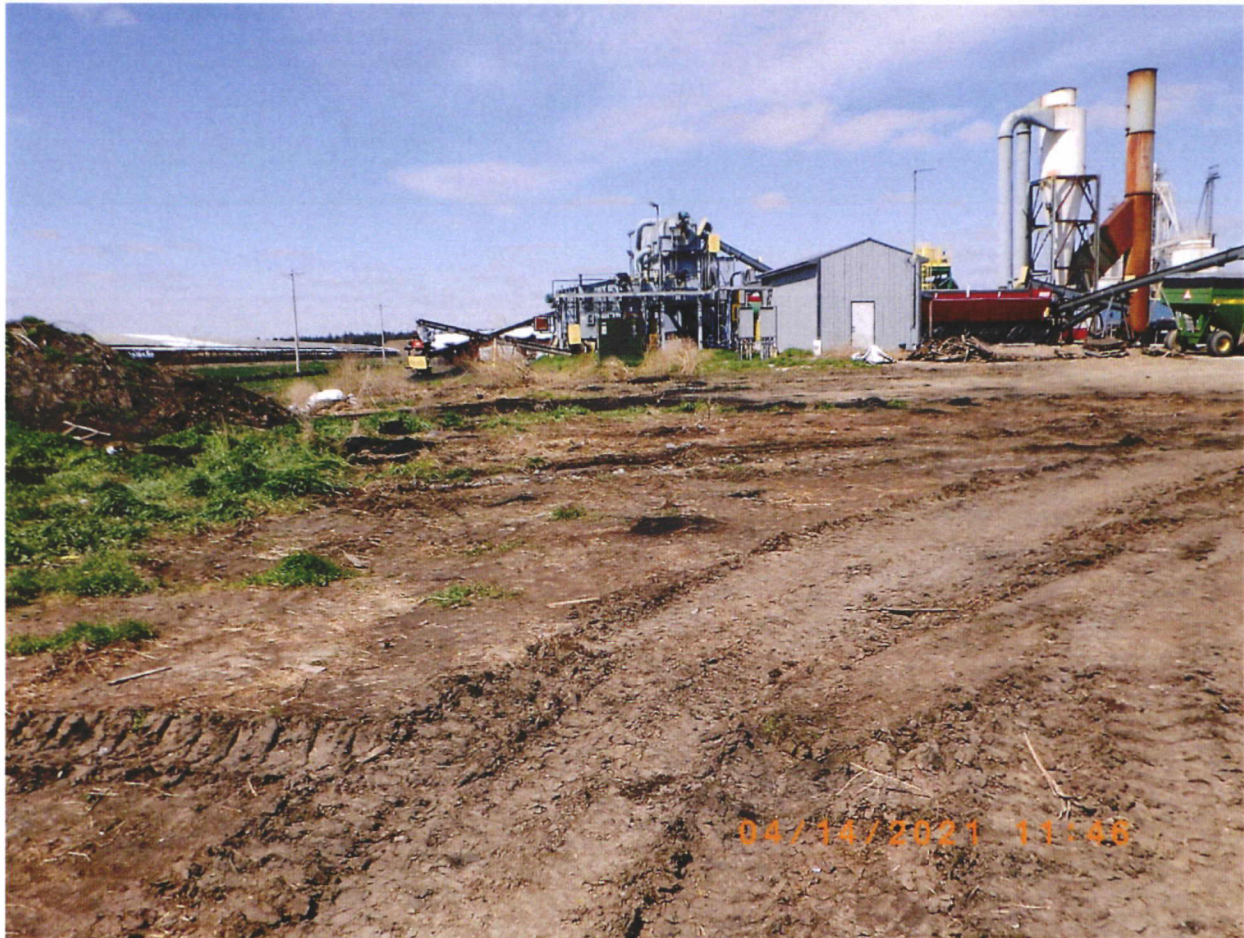
Photos: 17

Description: Bags of Biochar are now removed from the east side of the Biochar area but do show excessive amounts of material on the ground.

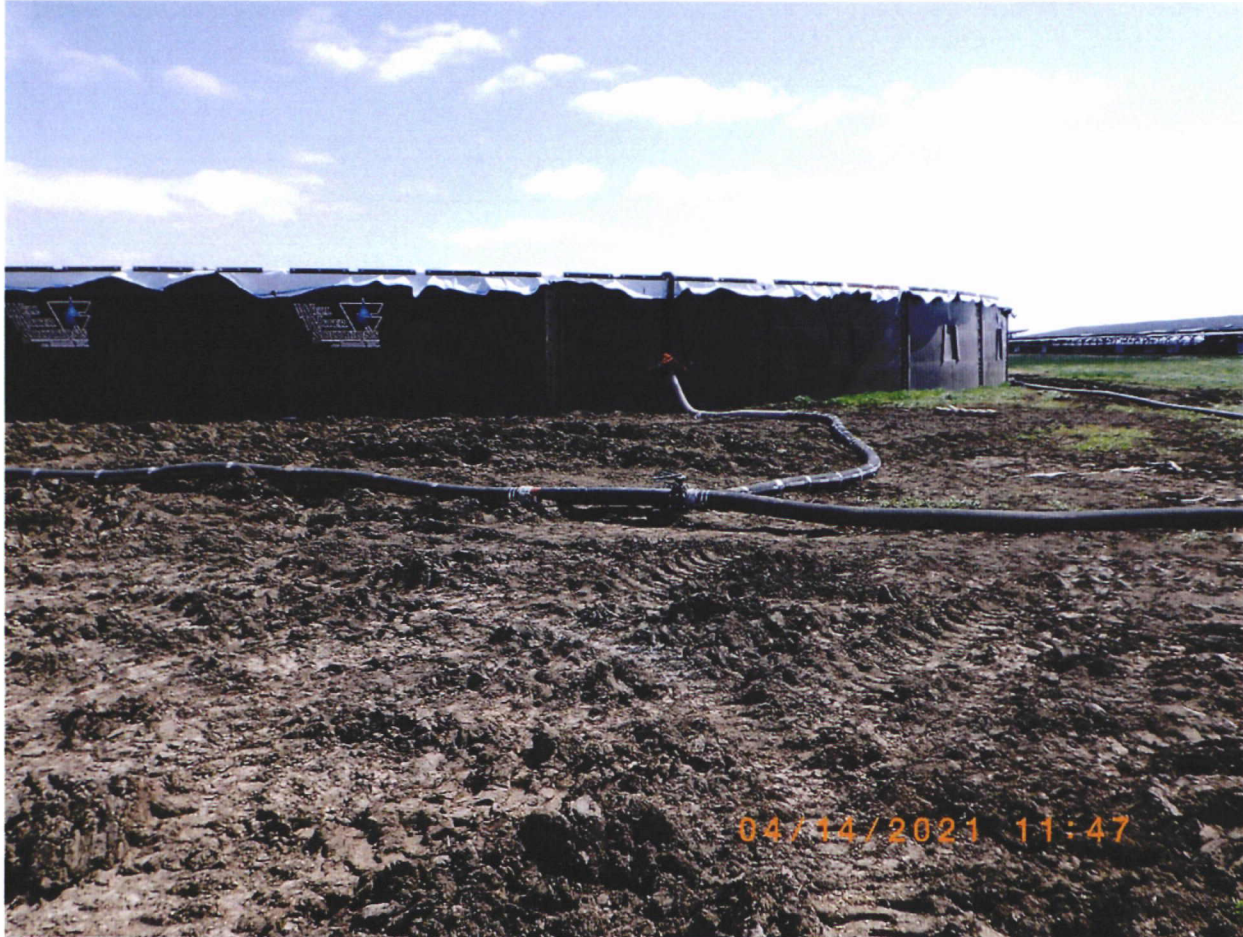
Photos: 18

Description: Most of the piping has been connected between all three Poseidon tanks and Clean Harbors treatment system.

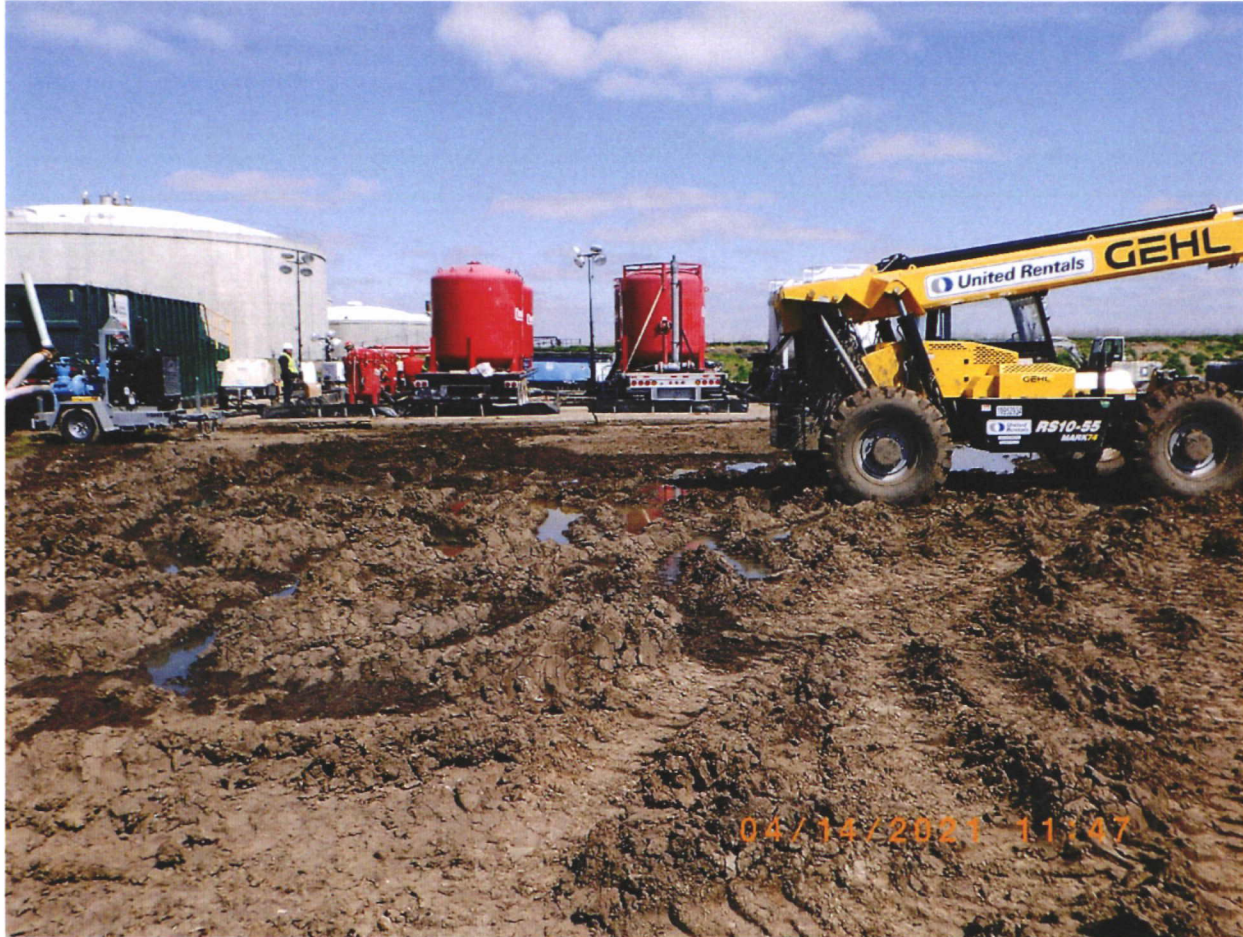
Photos: 19

Description: Clean Harbors treatment/cleanup .
