Facility: AltEn
IIS: 84069
PCS: NE0137634

Site Visit Check list

AltEn LLC - Storm Water Temporary BMP Check Map

Site Visit Report

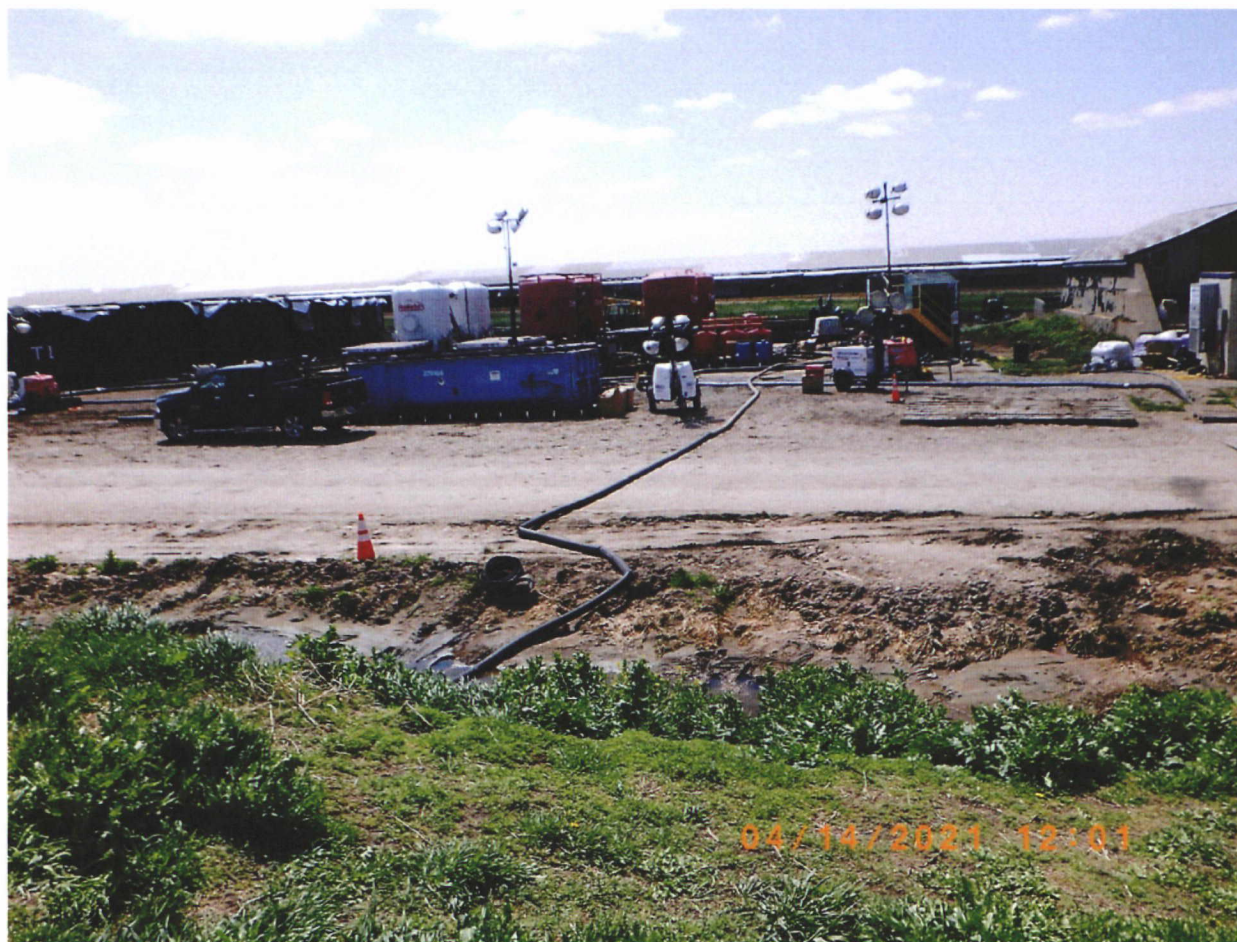
Photos: 20

Description: Clean Harbors staging area with staff continuing to set up equipment to begin treating the effluent from the AltEn treatment system.
