Facility: AltEn
IIS: 84069
PCS: NE0137634

Jason Windhorst
4-2-2021

Site Visit Check list

Site Visit Report

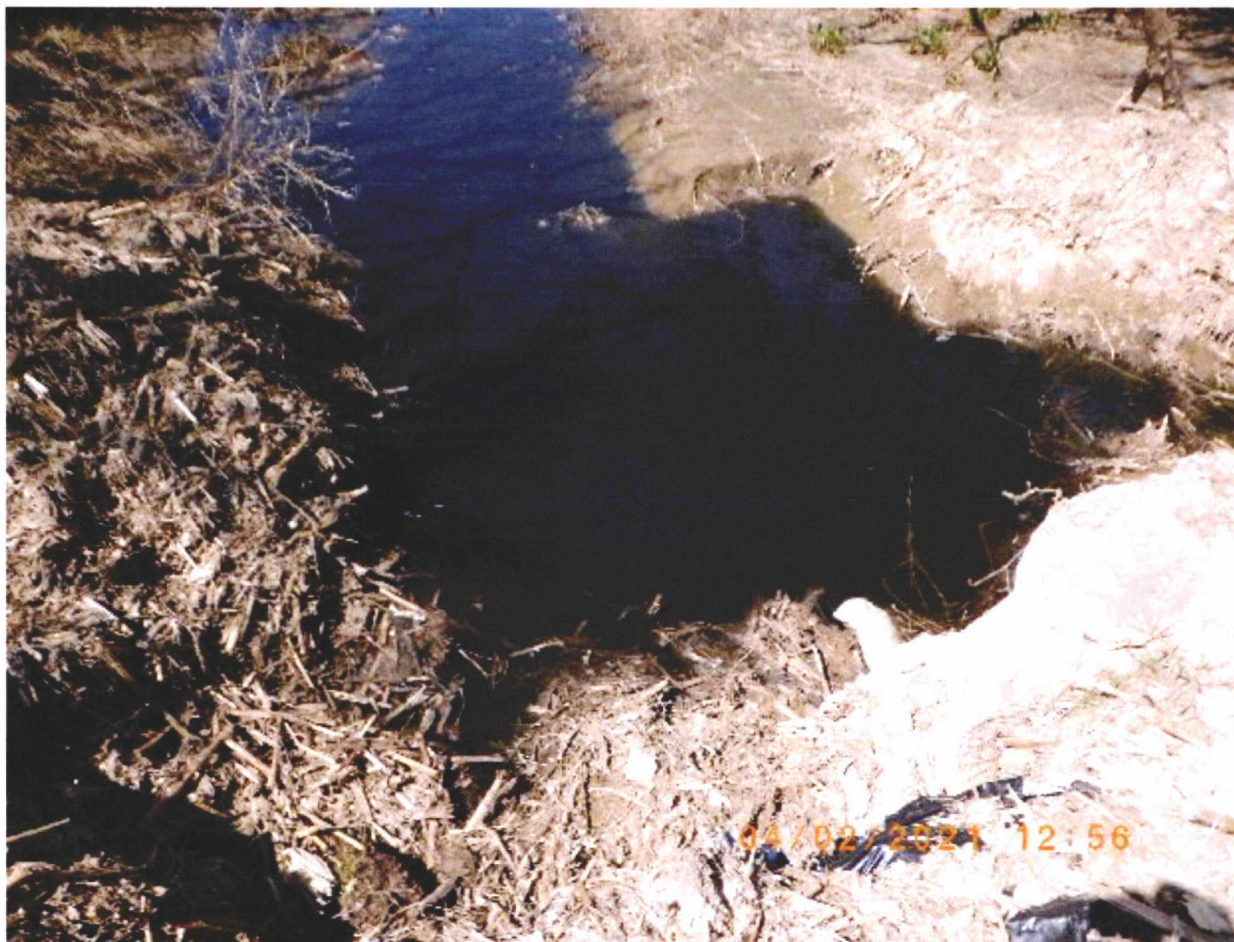
Photos: 1

Location: Culvert north of CR 9 & J

Description: Dark colored water in drainage way from AltEn.

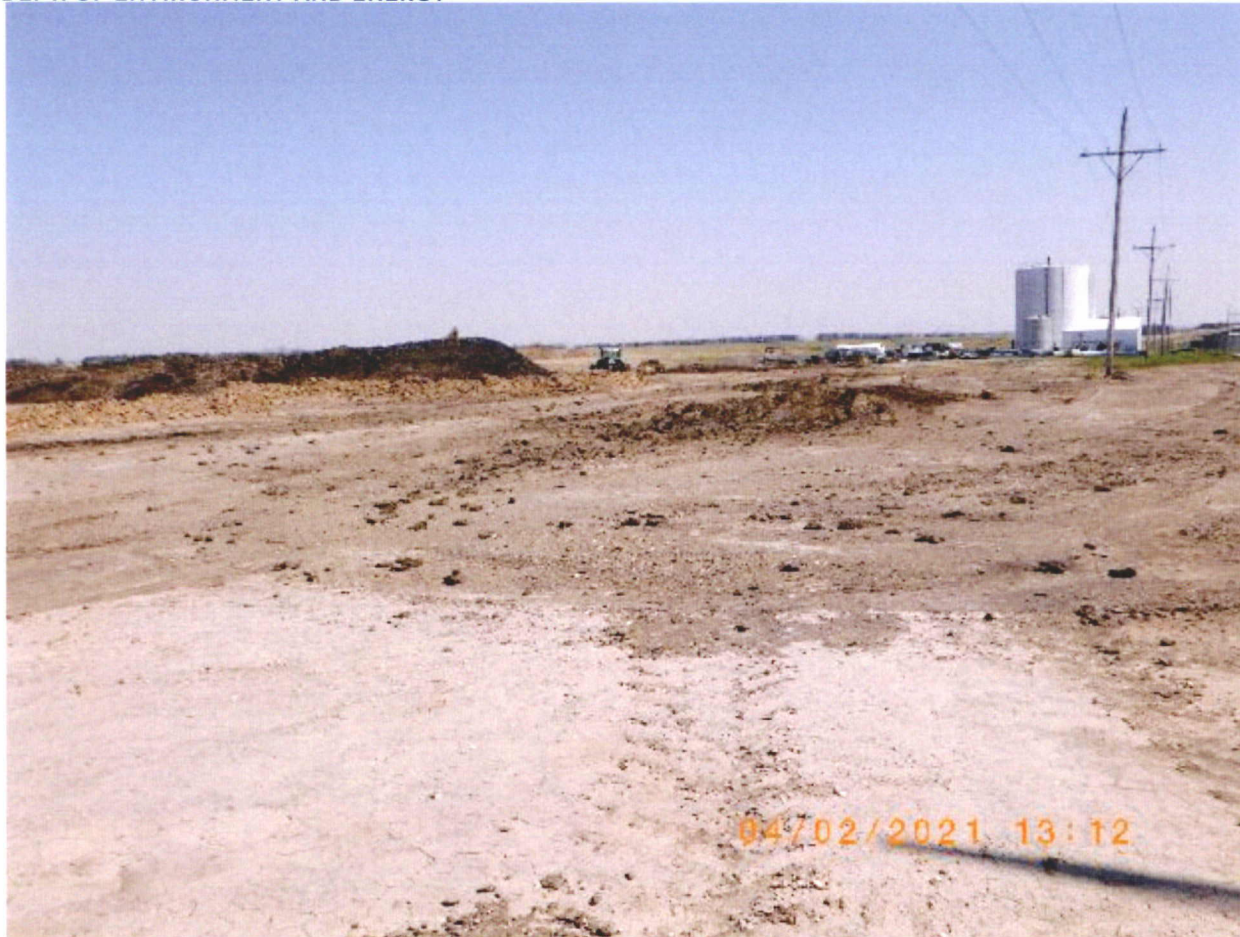
Photos: 2

Location: Area 1 on site map

Description: Area cleared of wetcake from drainage way from parking area and roadway.

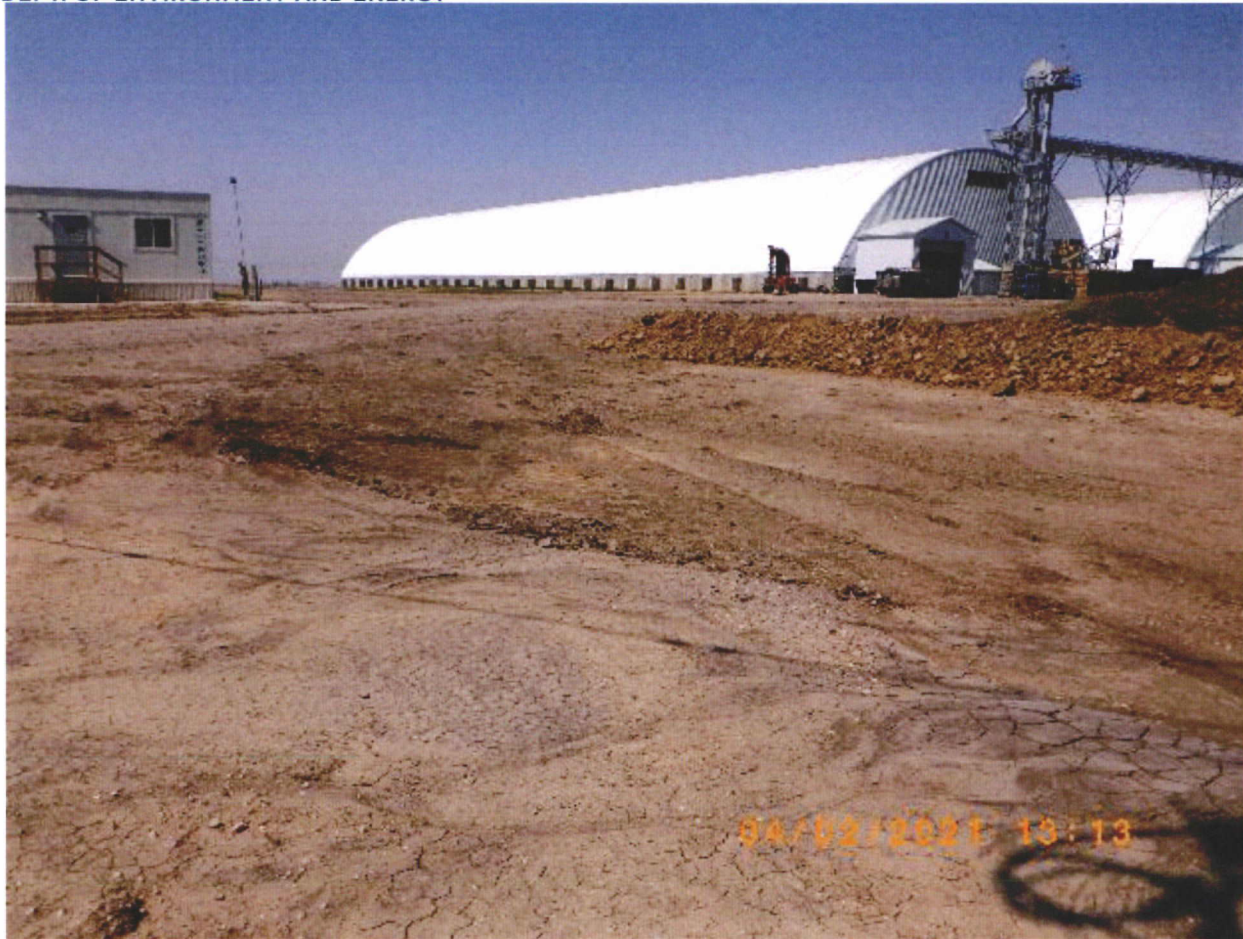
Photos: 3

Description: Cleared area west of area 1 showing western extent of new berm constructed.

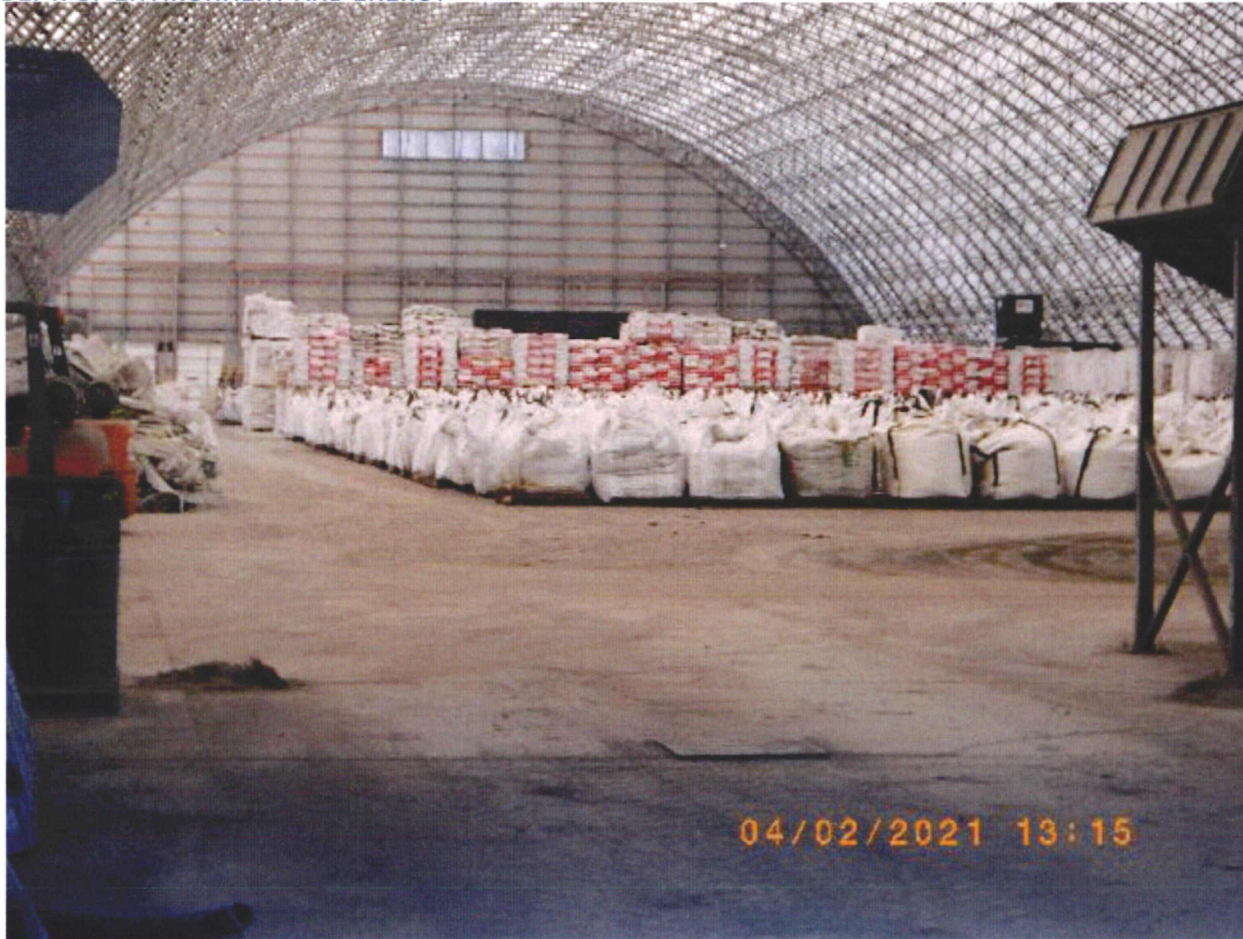
Photos: 4

Description: Biochar being stored in south hoop building.

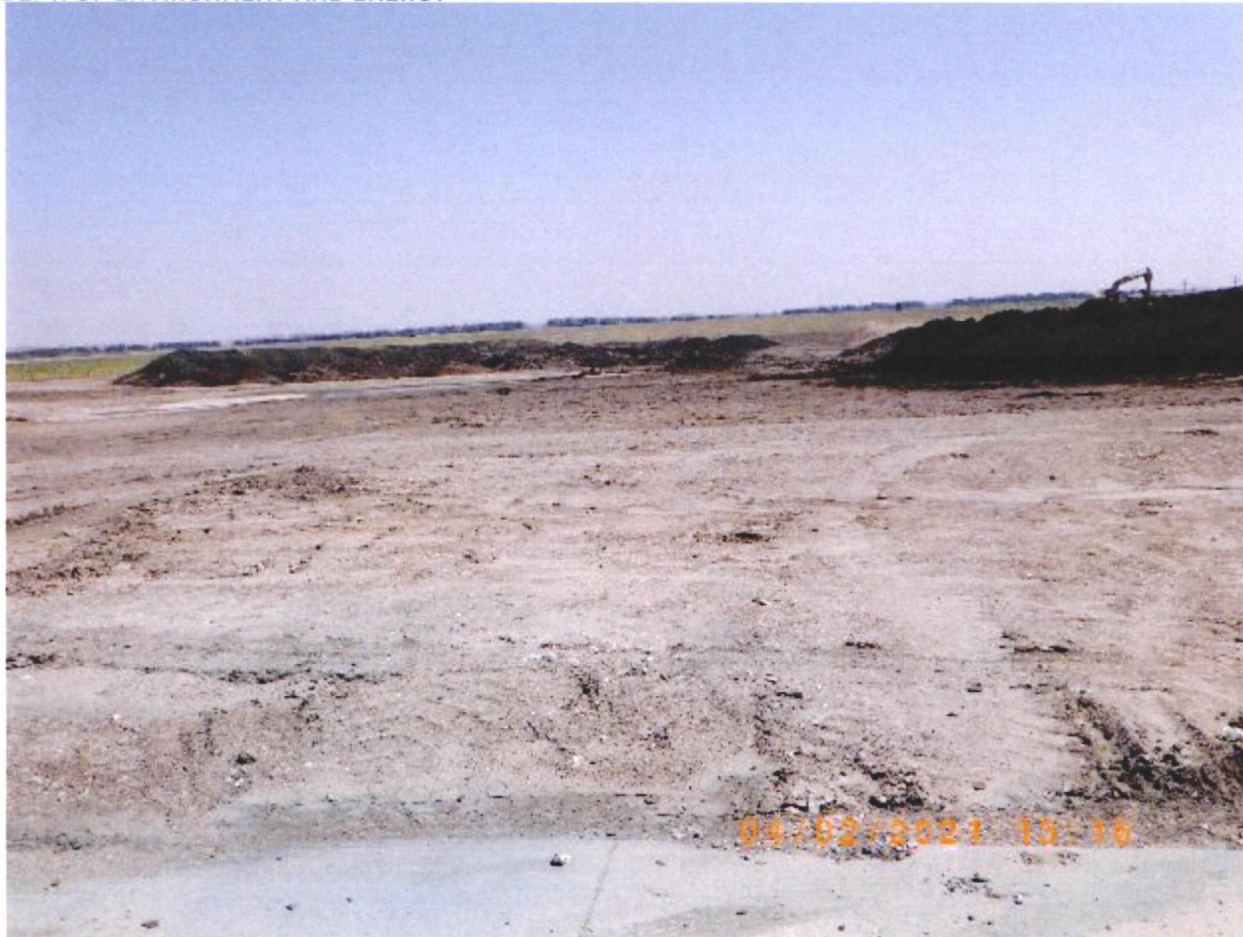
Photos: 5

Description: Open area east of the hoop buildings showing wetcake being consolidated.

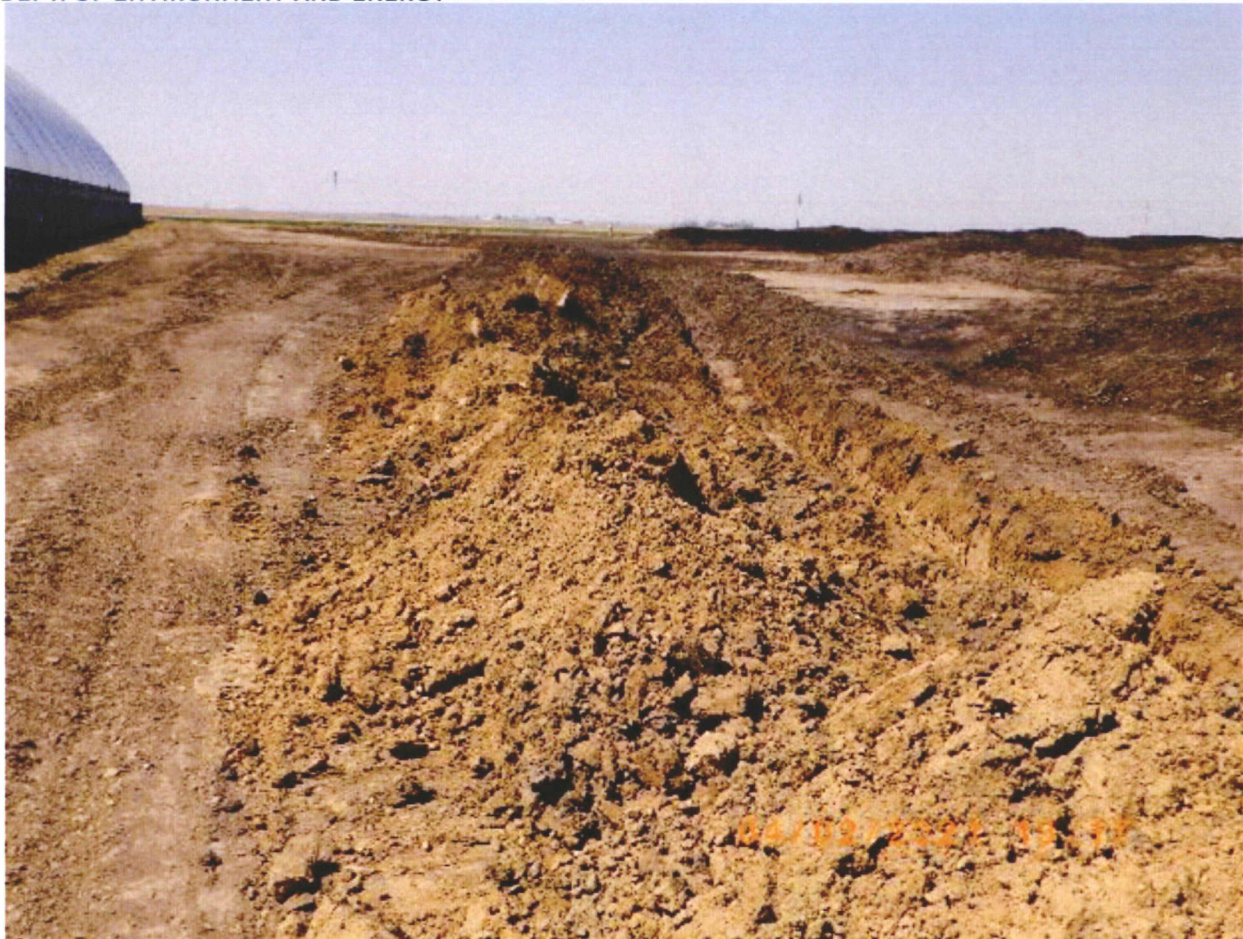
Photos: 6

Description: Trench cut from area 5 on the site map to drain ponded water to the east.

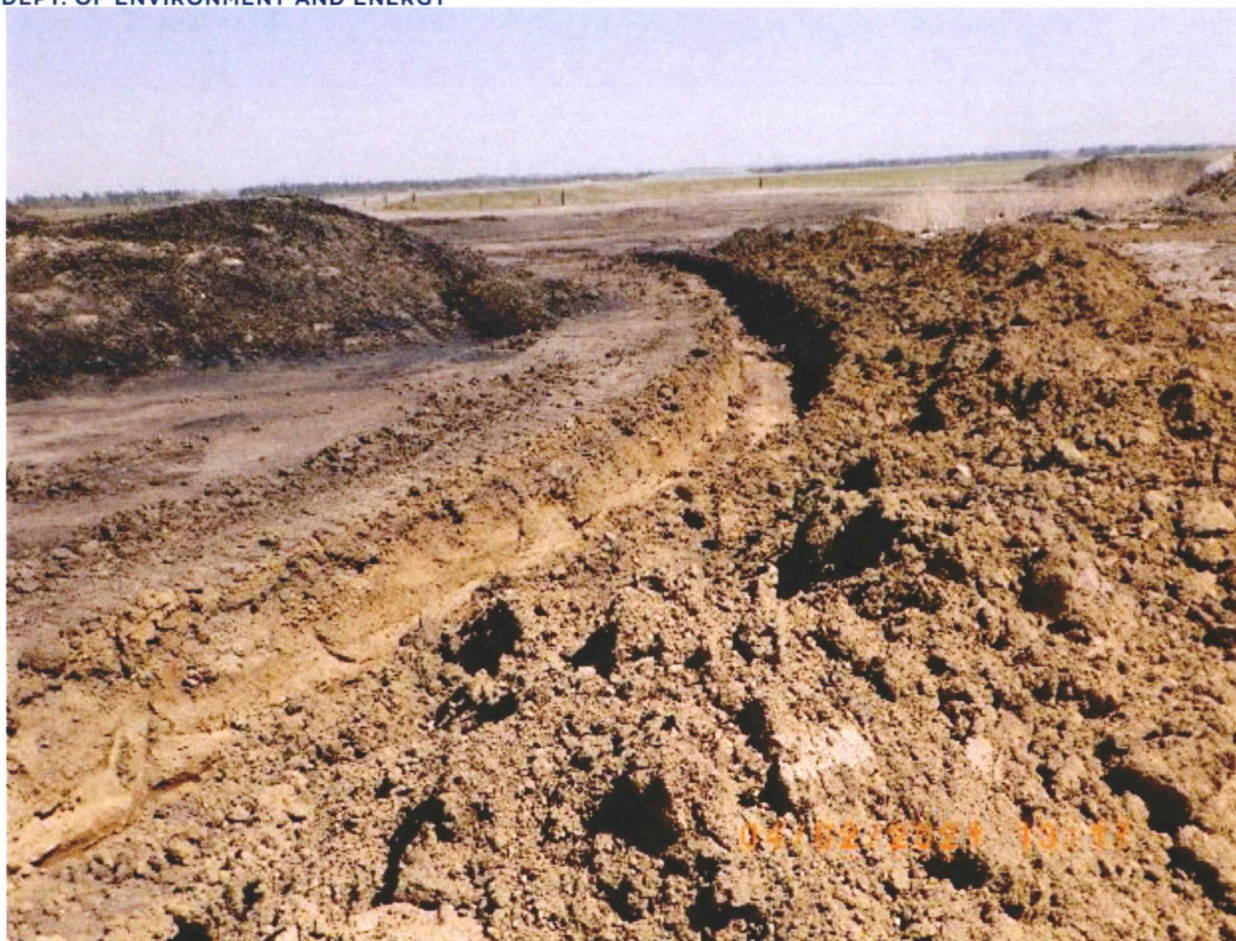
Photos: 7

Description: Trench to drain area 5.

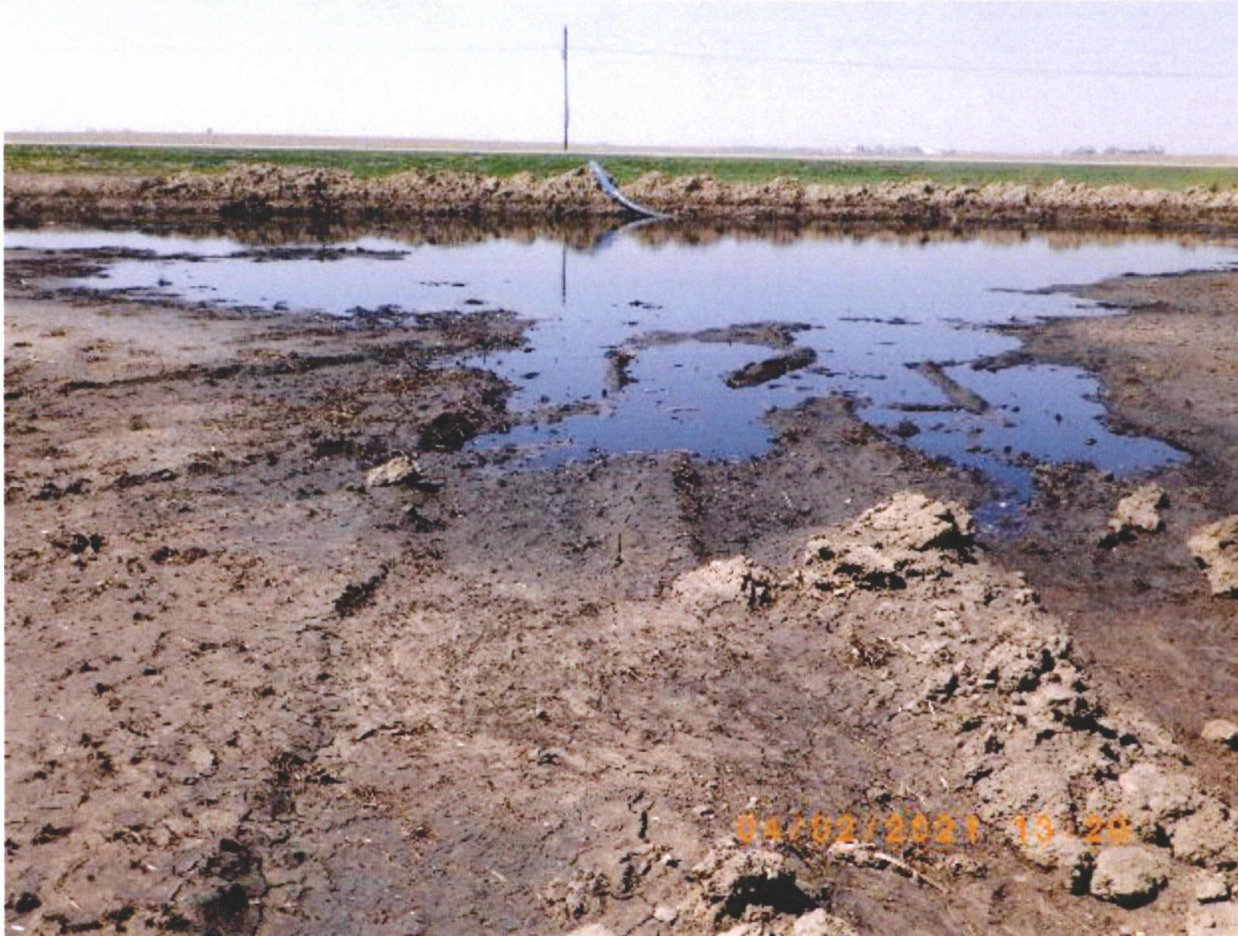
Photos: 8

Description: Small amount of runoff ponded against the berm in area 5. This area will eventually be pumped out.

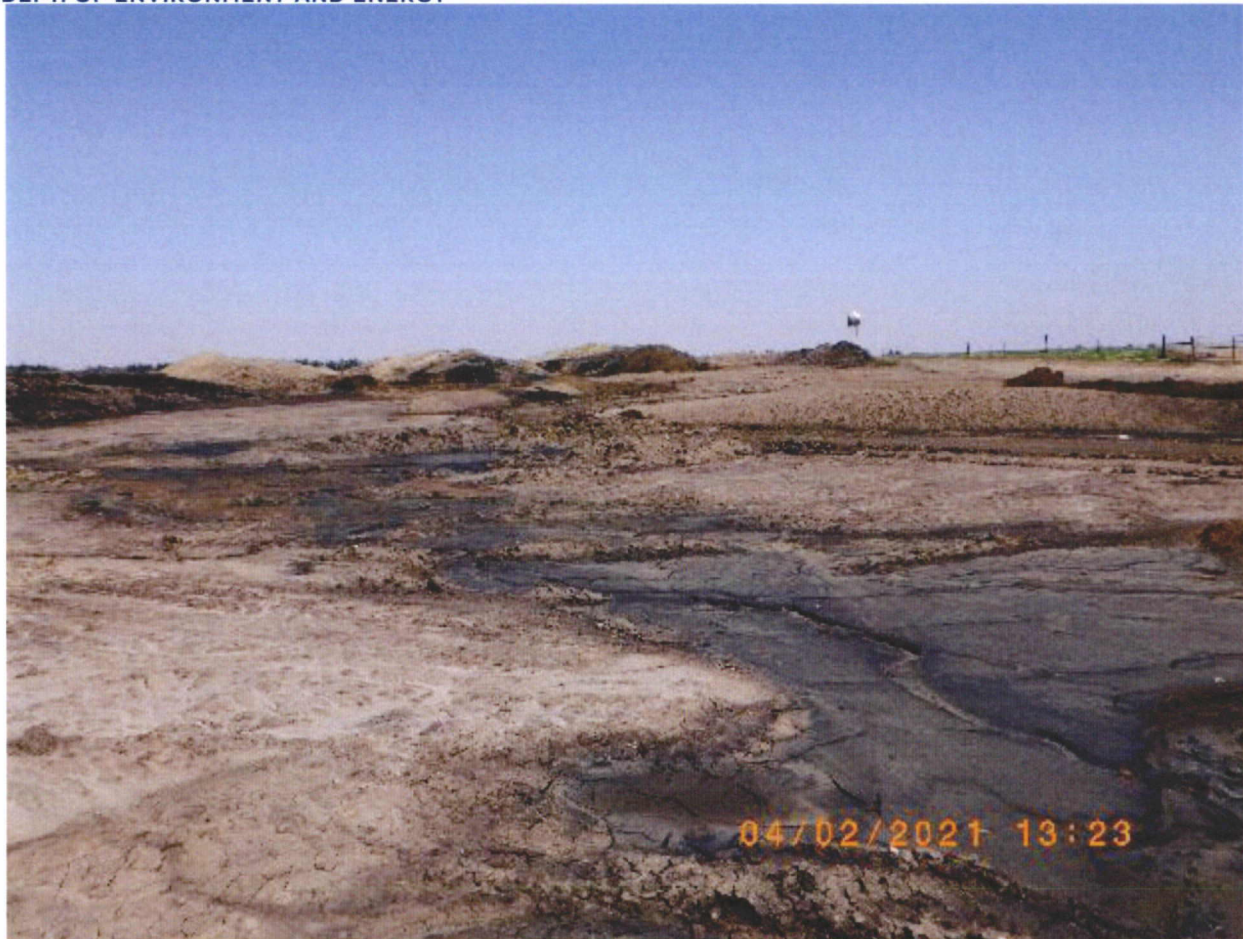
Photos: 9

Description: Open area where wetcake was stored and then consolidated to the north.

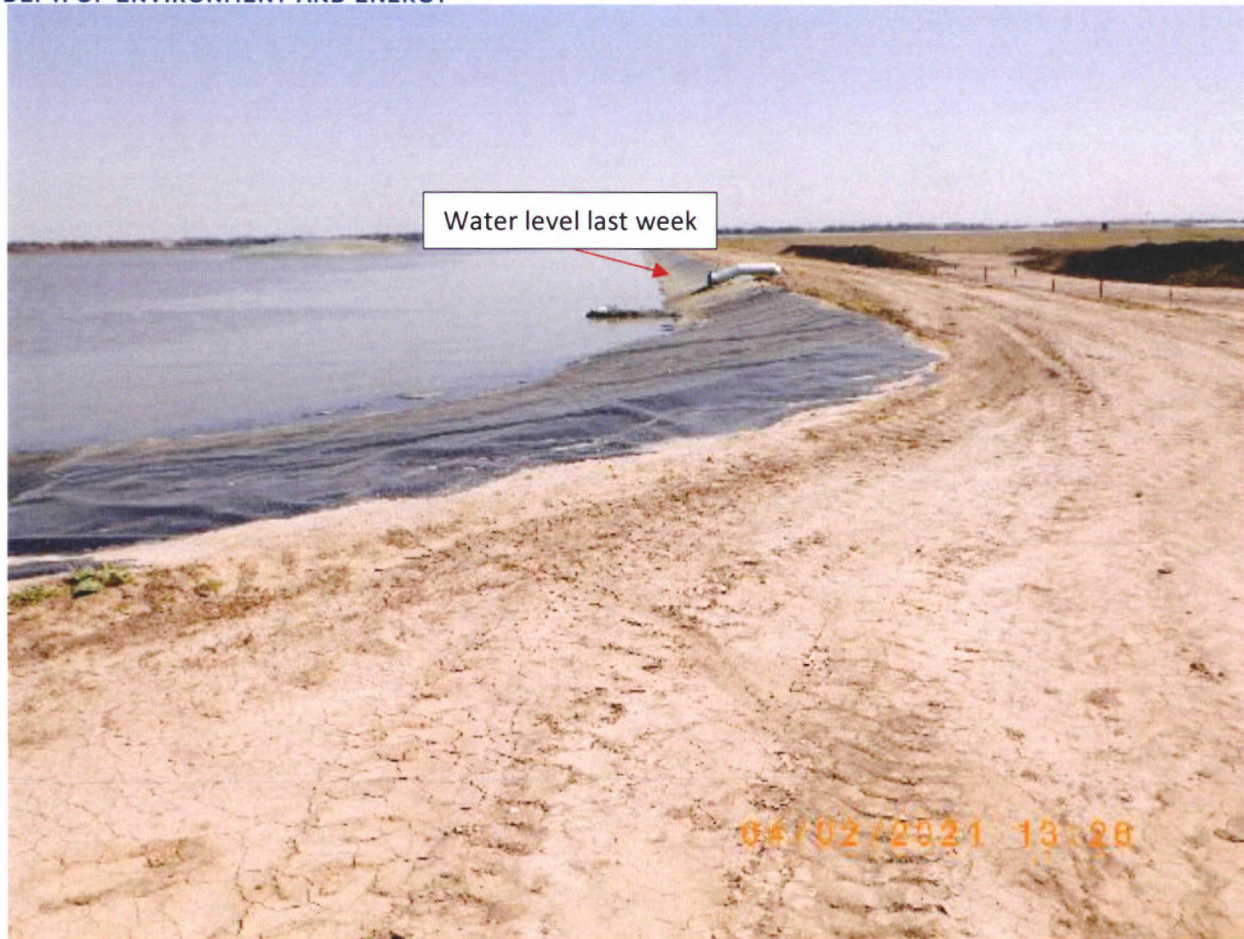
Photos: 10

Description: Lagoon showing evidence of water levels dropping.

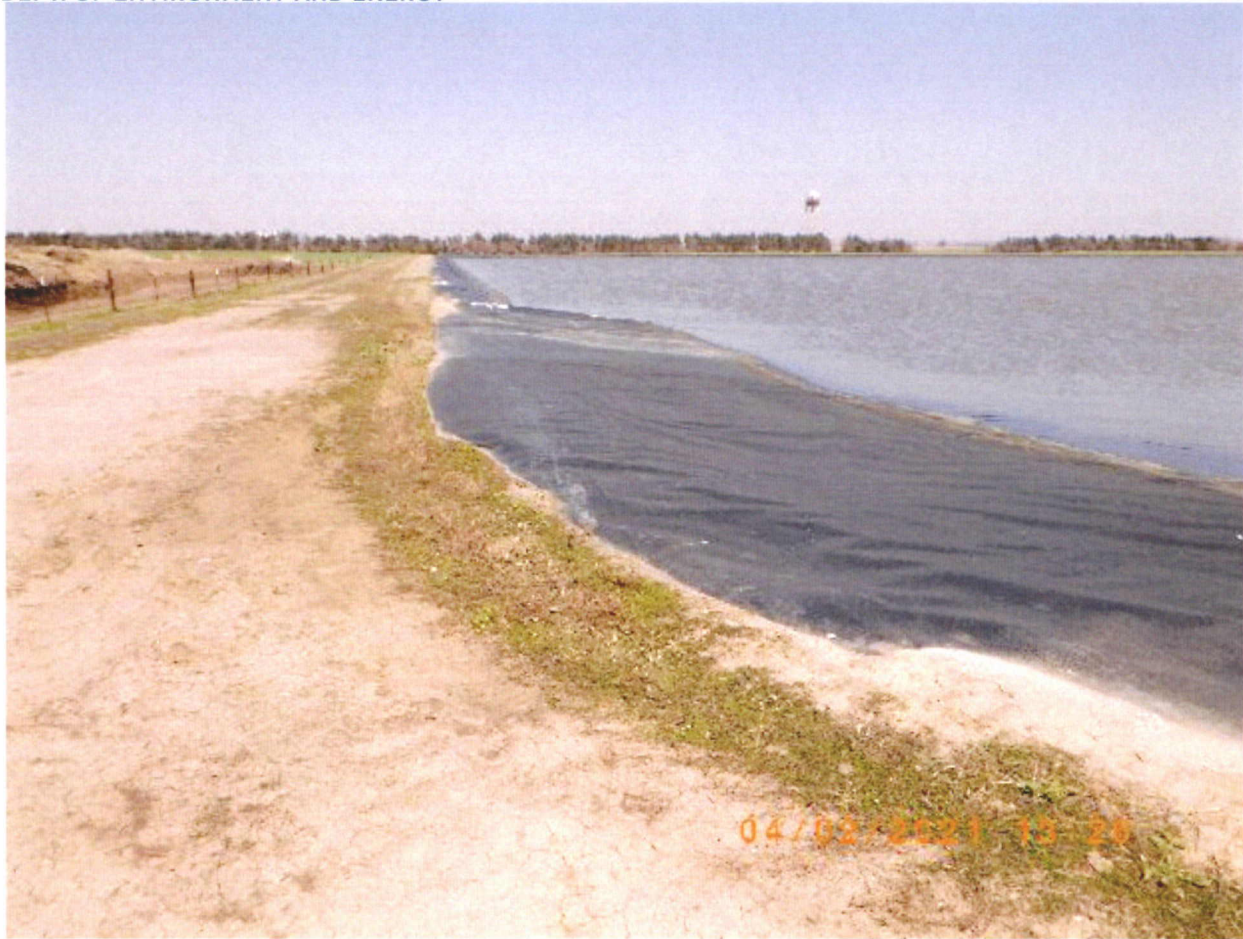
Photos: 11

Description: Same as photo 10

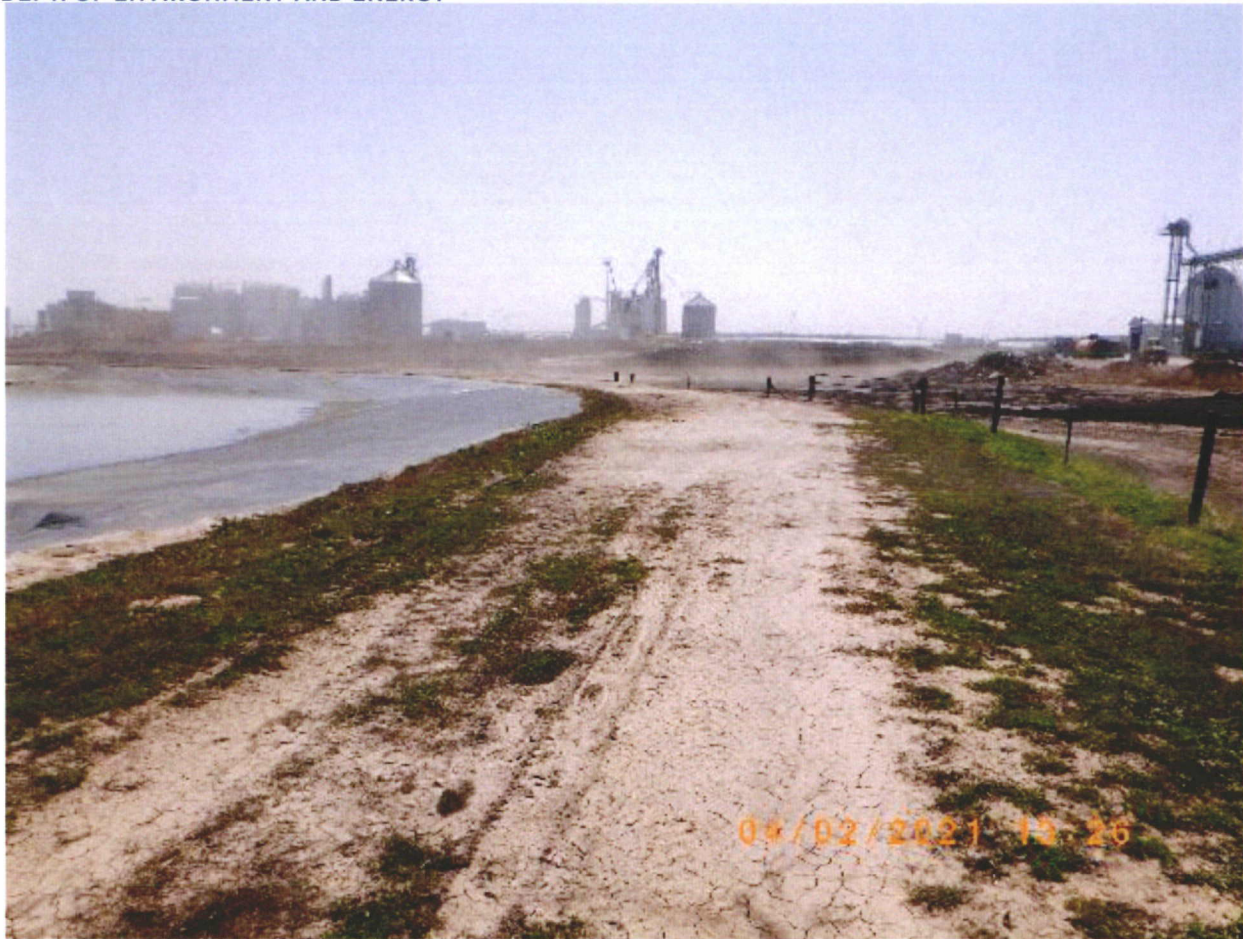
Photos: 12

Description: High winds blowing dust around when trucks are dropping wetcake retrieved from fields offsite.

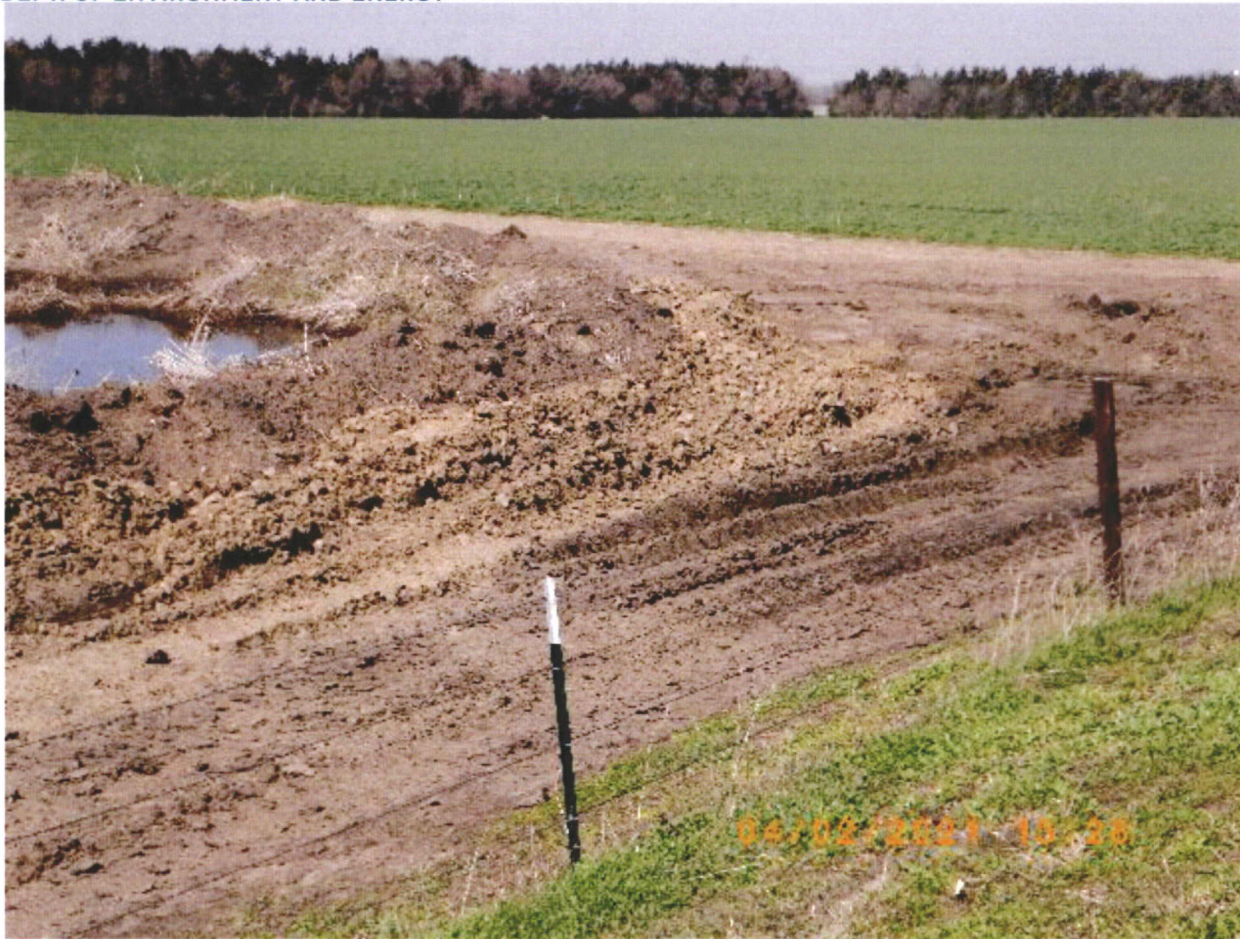
Photos: 13

Description: Berm repaired and reinforced. Soil outside of the berm area is still wet and rutted easily from loader traffic.

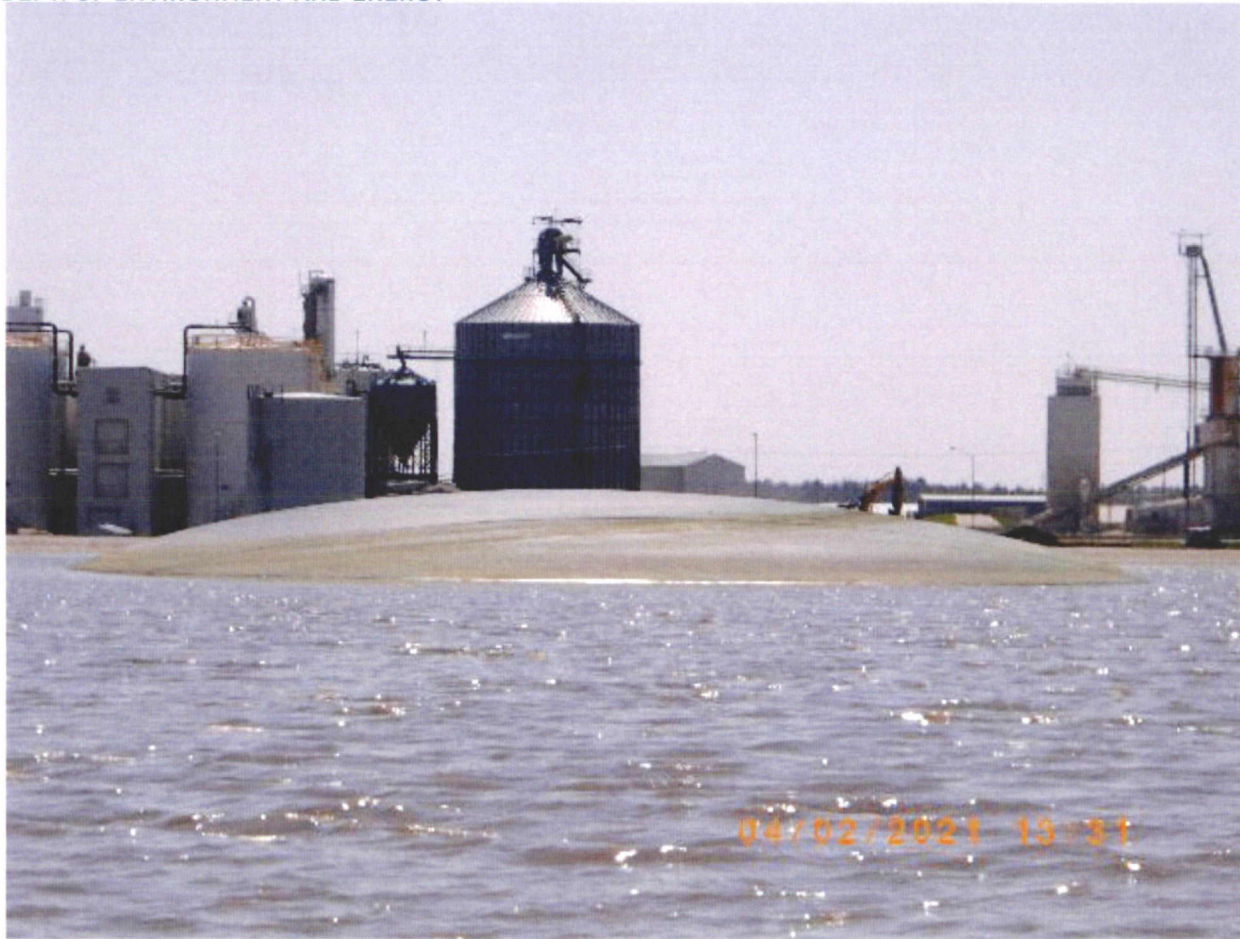
Photos: 14

Description: Large whale along the southside of the lagoon.

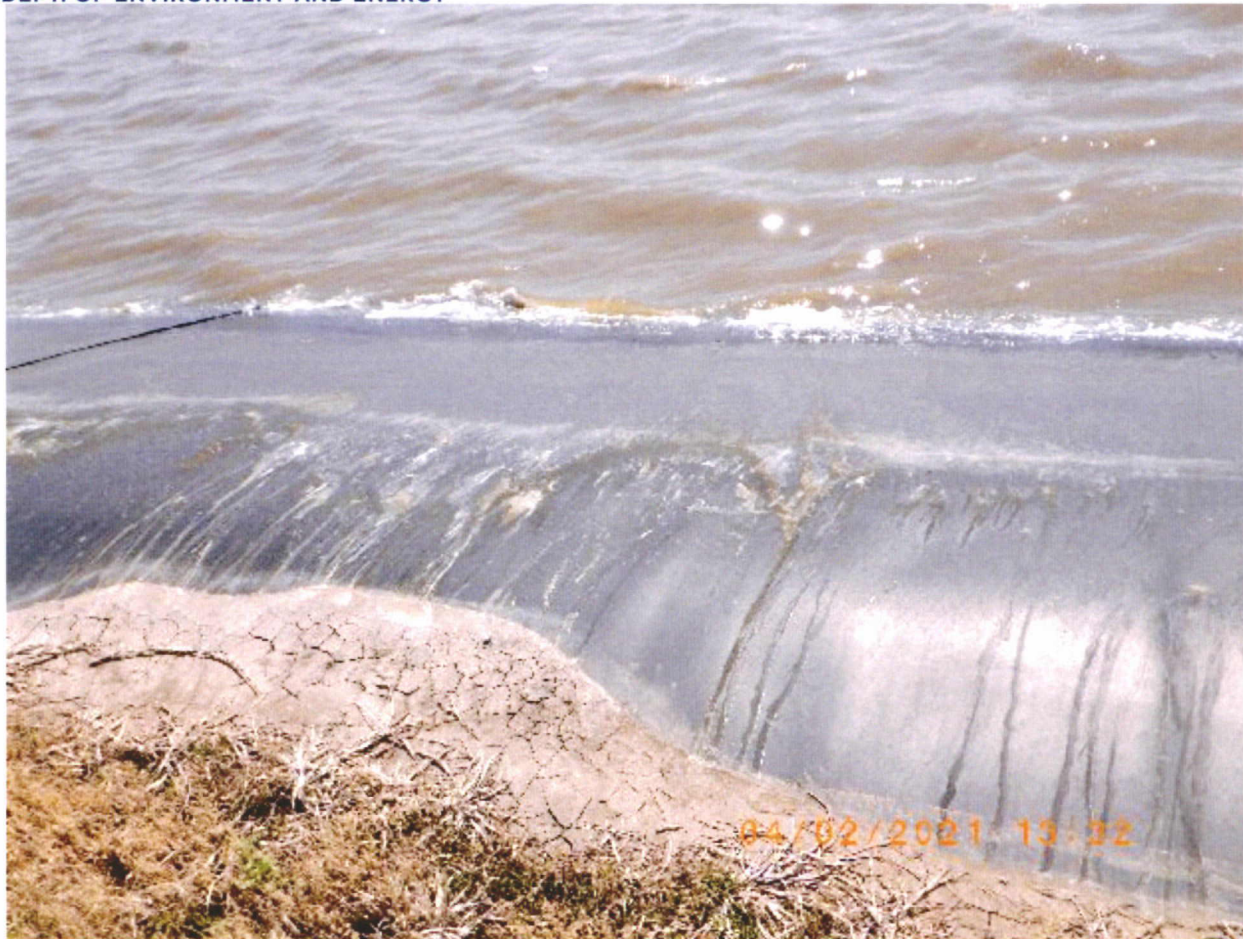
Photos: 15

Description: Residue from waves splashing up on the edge of the lagoon.

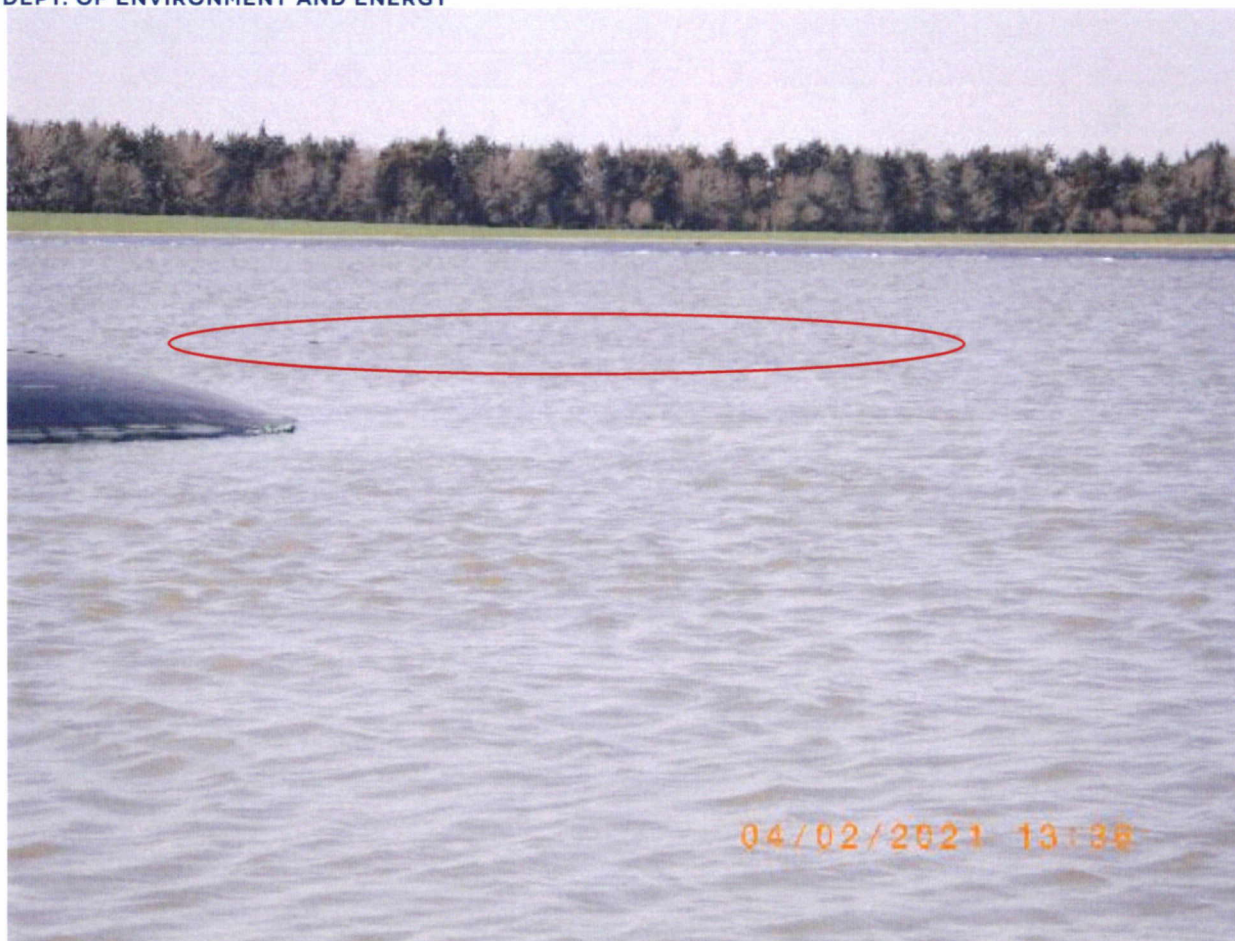
Photos: 16

- Northeast lagoon
 - No change in liner condition observed.
- Northwest lagoon
 - Only 3 whales present today, but a new section of liner was observed floating next to the northern most whale.
- South lagoon
 - No change

Description: Section of liner appeared recently and was observed moving with the high winds. The photo does not provide clear evidence but was easily viewed as waves moved it around.

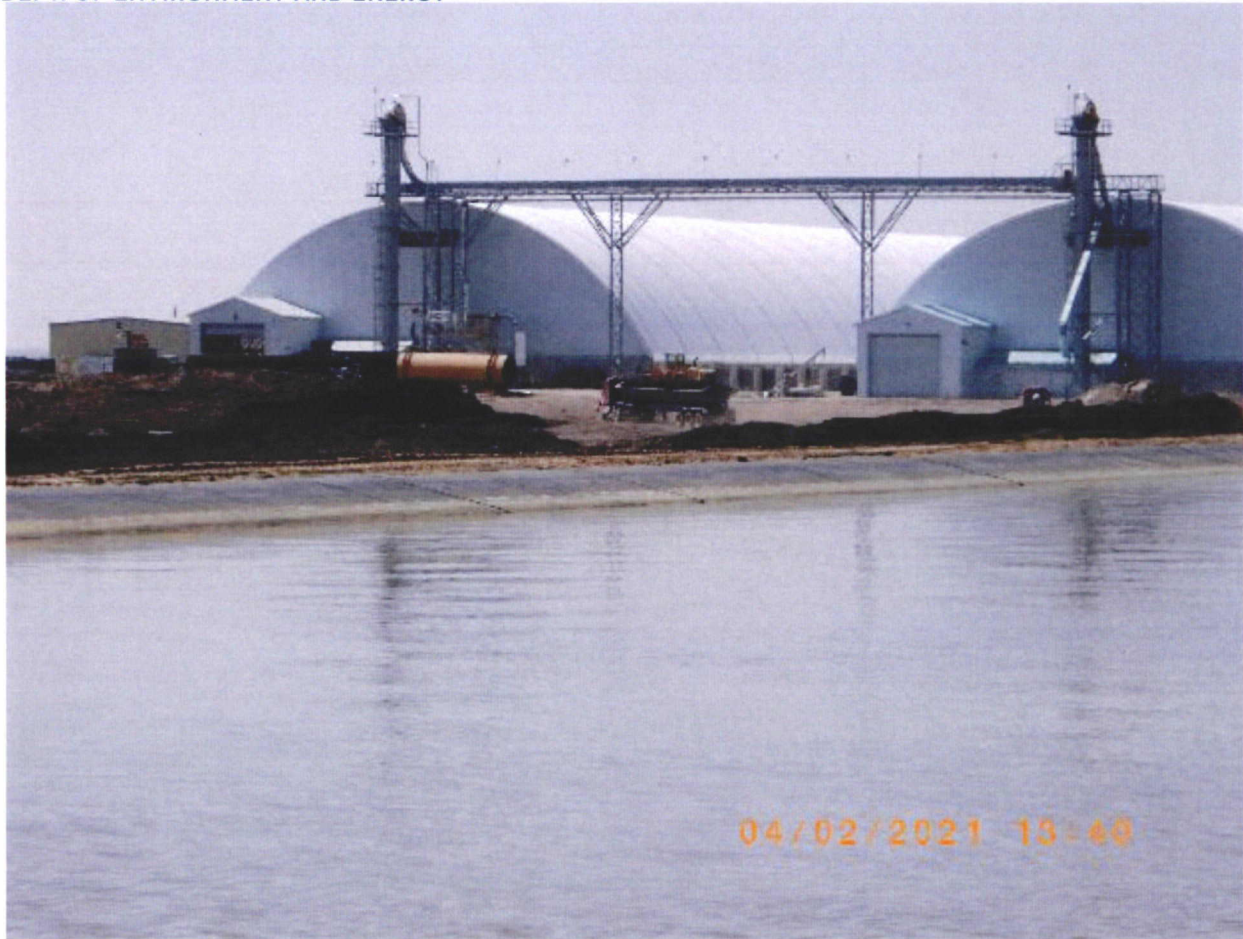
Photos: 17
Site Visit Report
Date Taken: 4-2-2021
Photographer: Jason Windhorst
Facility Name/ Project Name: AltEn LLC
Facility IIS number / Project identifier: IIS: 84069 / NE0137634
Location: Southeast corner of the northwest lagoon
Direction Facing: Southwest
Description: Load of wetcake being brought back from fields.

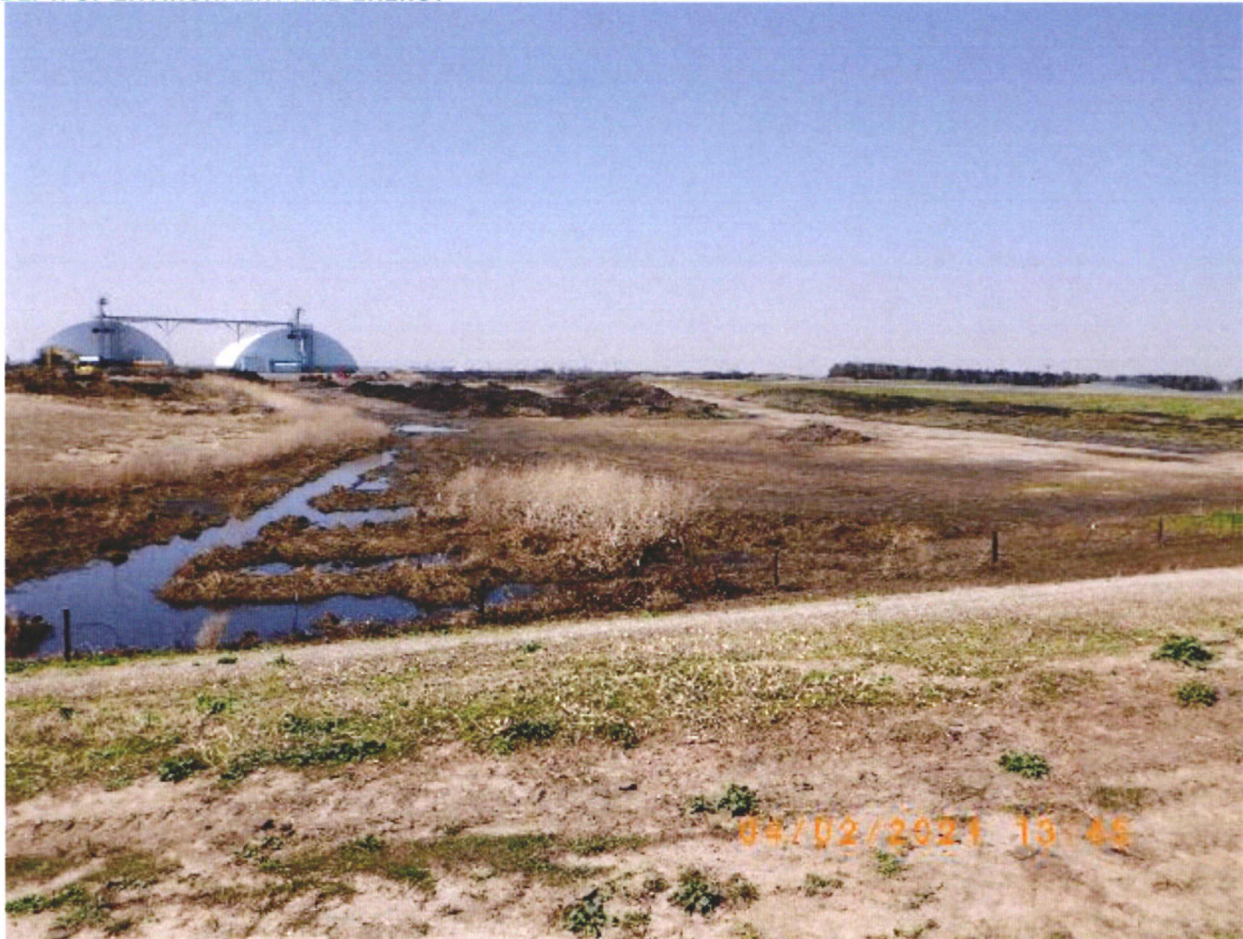
Photos: 18

Description: Area 2 on the site map showing ponded runoff. Berm is holding and no seepage was visible.

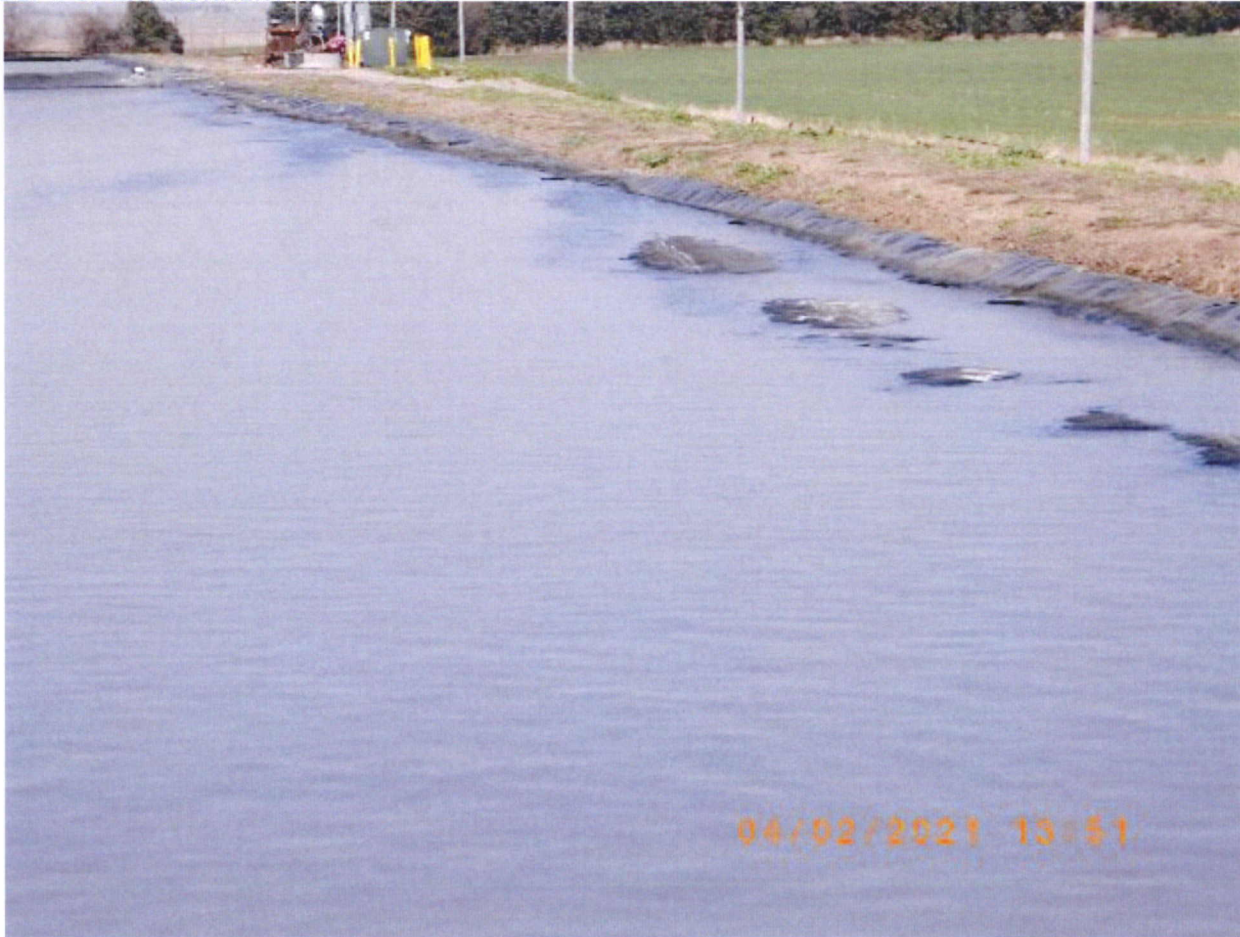
Photos: 19

Description: Wastewater level and liner sections of the southeast lagoon.
