Facility: AltEn
IIS: 84069
PCS: NE0137634

Jason Windhorst
4-2-2021

Site Visit Check list

Site Visit Report

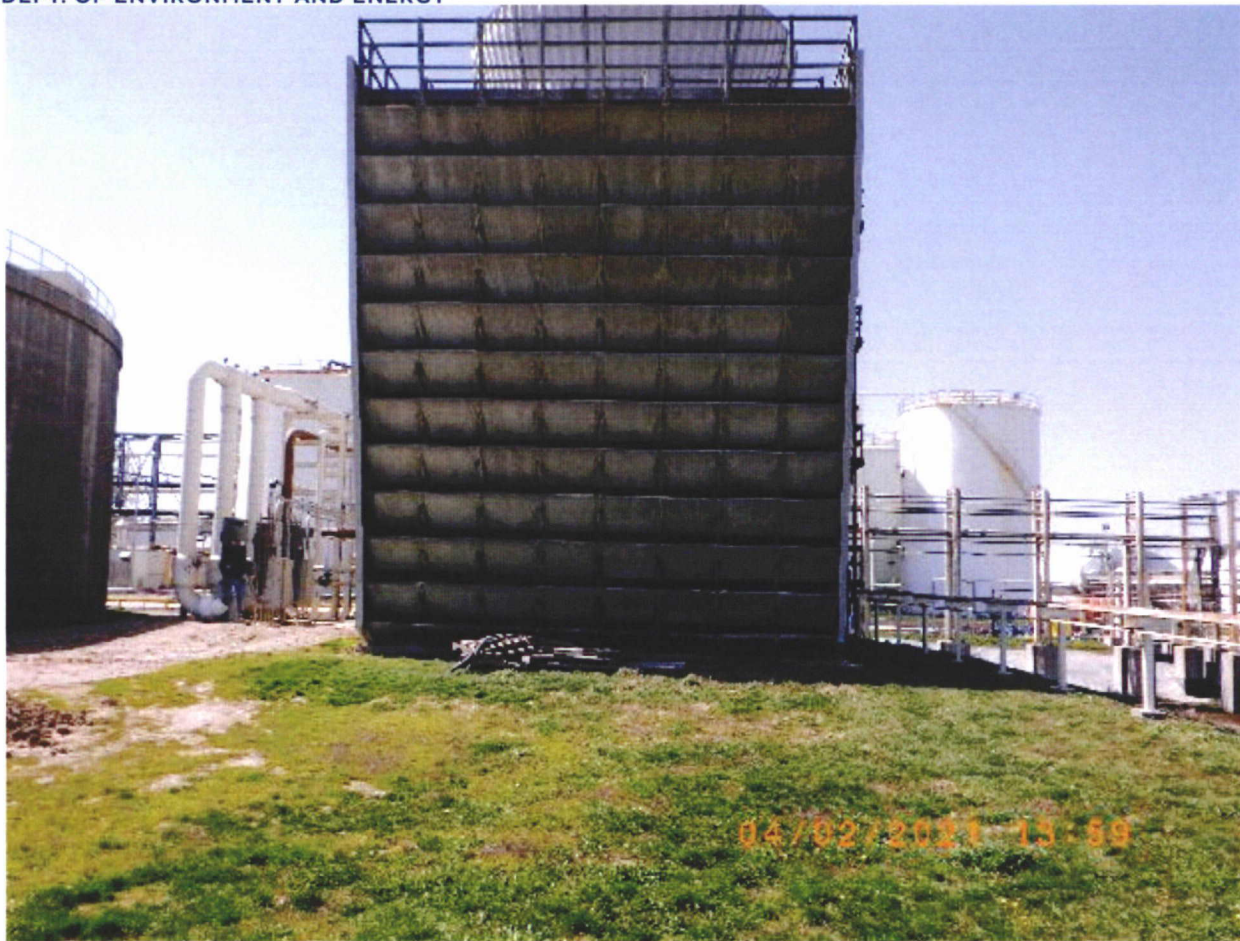
Photos: 20

Description: Cooling tower in use to cool pumps in main plant.

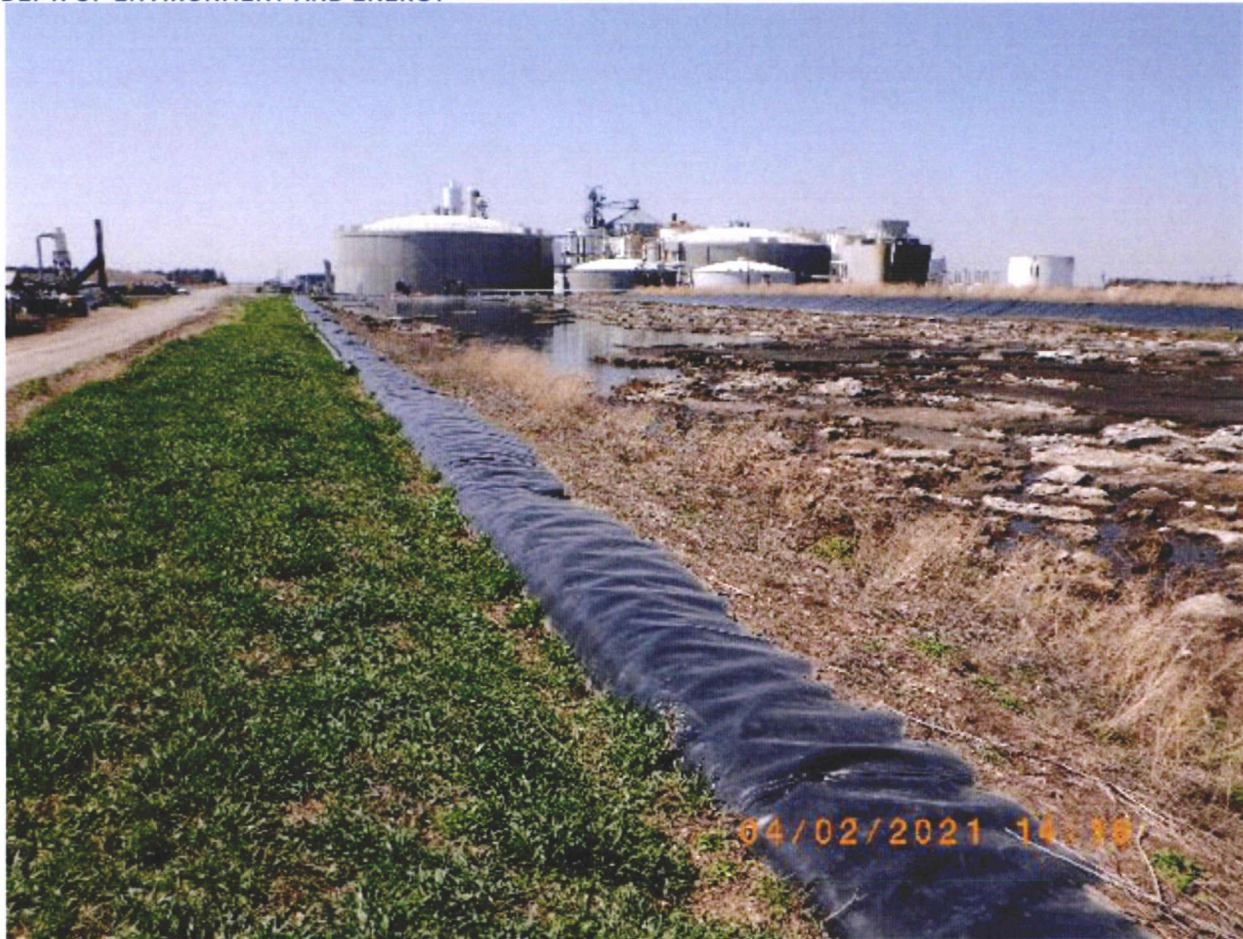
Photos: 21

Description: Showing water level of the lagoon and solids present. The lagoon was drawn down a small amount to add to the east and west Poseidon tanks to hold the liners down.

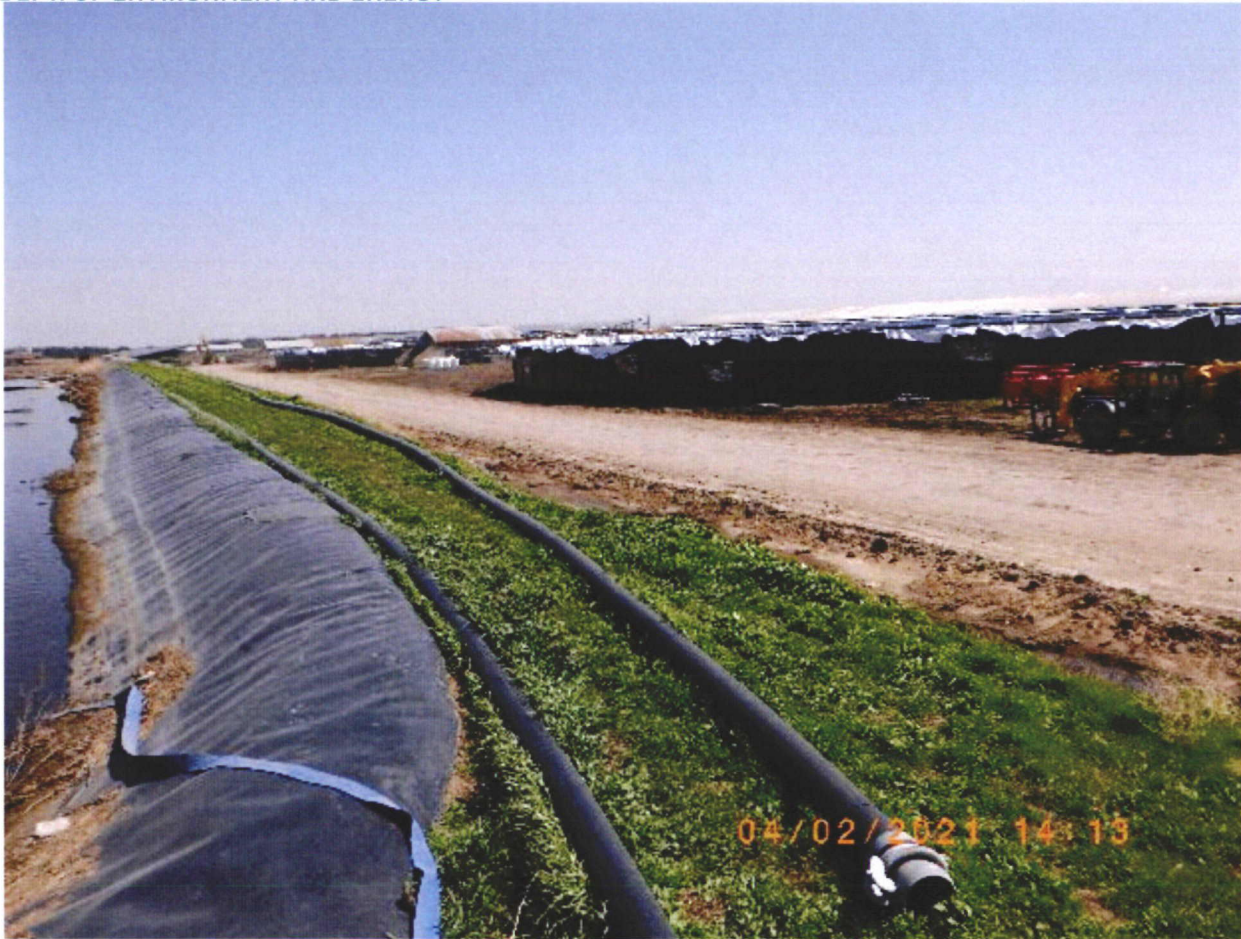
Photos: 22

Description: South edge of the lagoon and the east Poseidon tank completed.

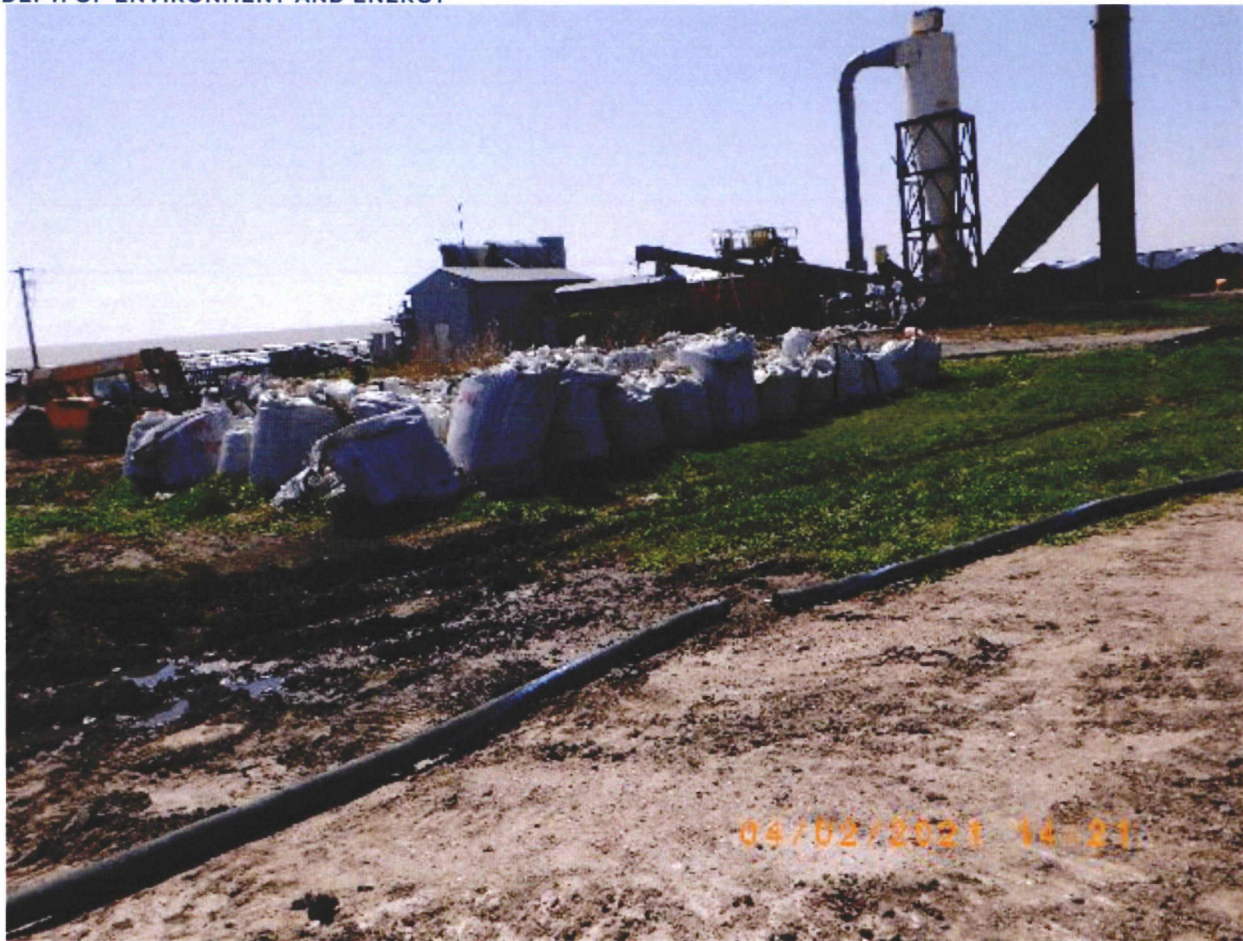
Photos: 23

Description: Biochar bags stored on the ground surrounding the Biochar unit. There is more stored to the south of this area and to the west.

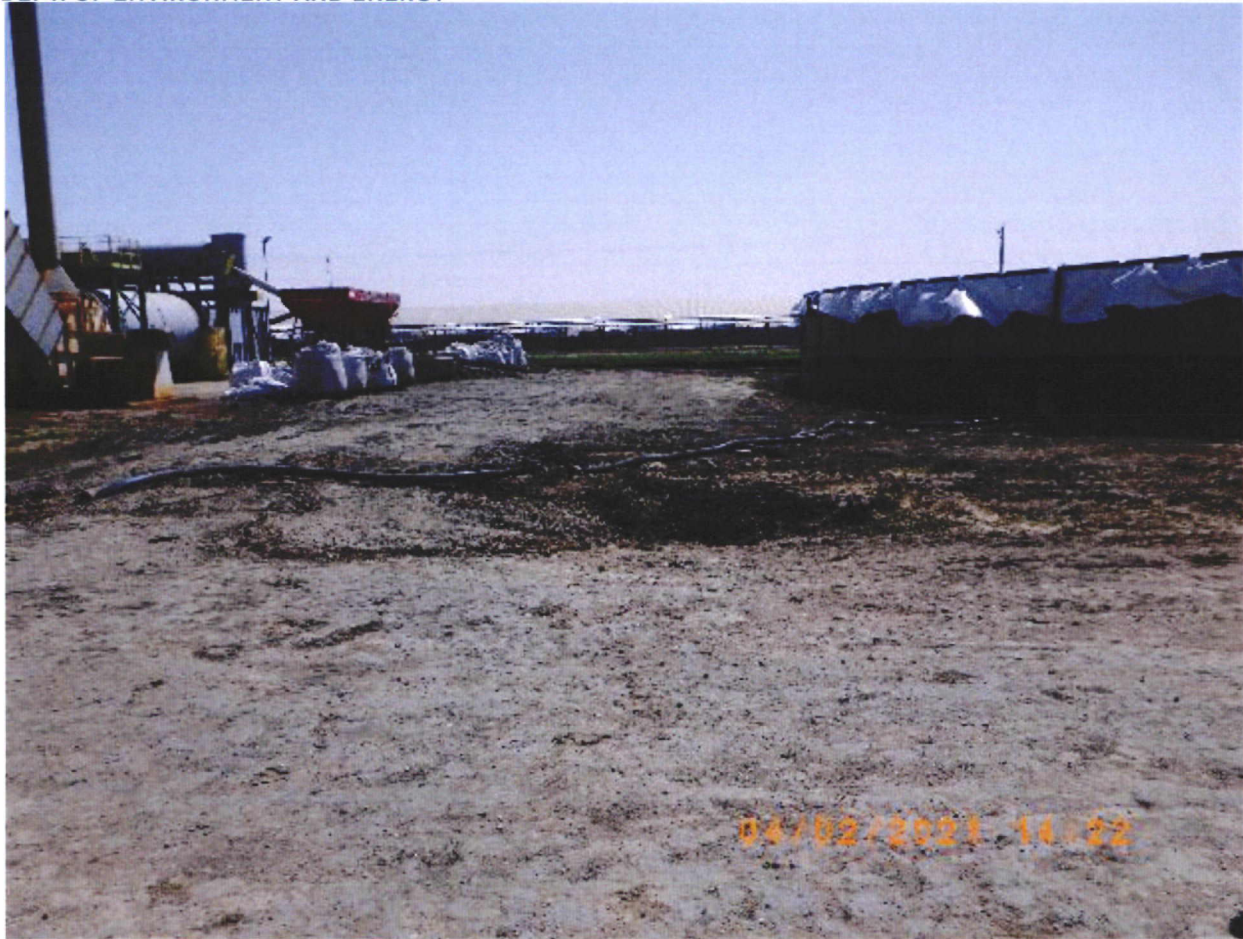
Photos: 24

Description: Biochar on the left side of the photo with bags stored next to it and the west Poseidon tank.

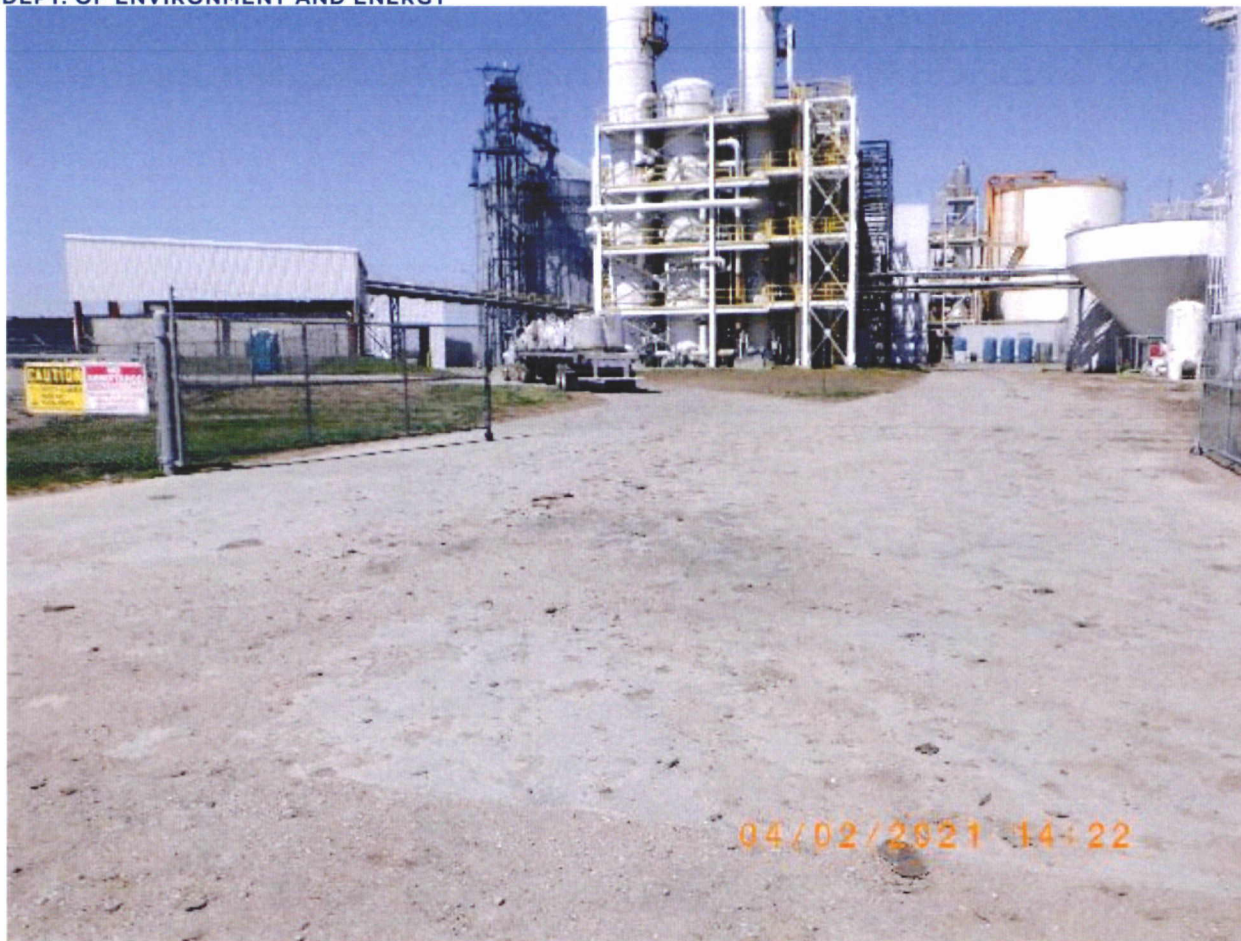
Photos: 25

Description: Flatbed truck with bags of Biochar being loaded to haul to the south hoop building.

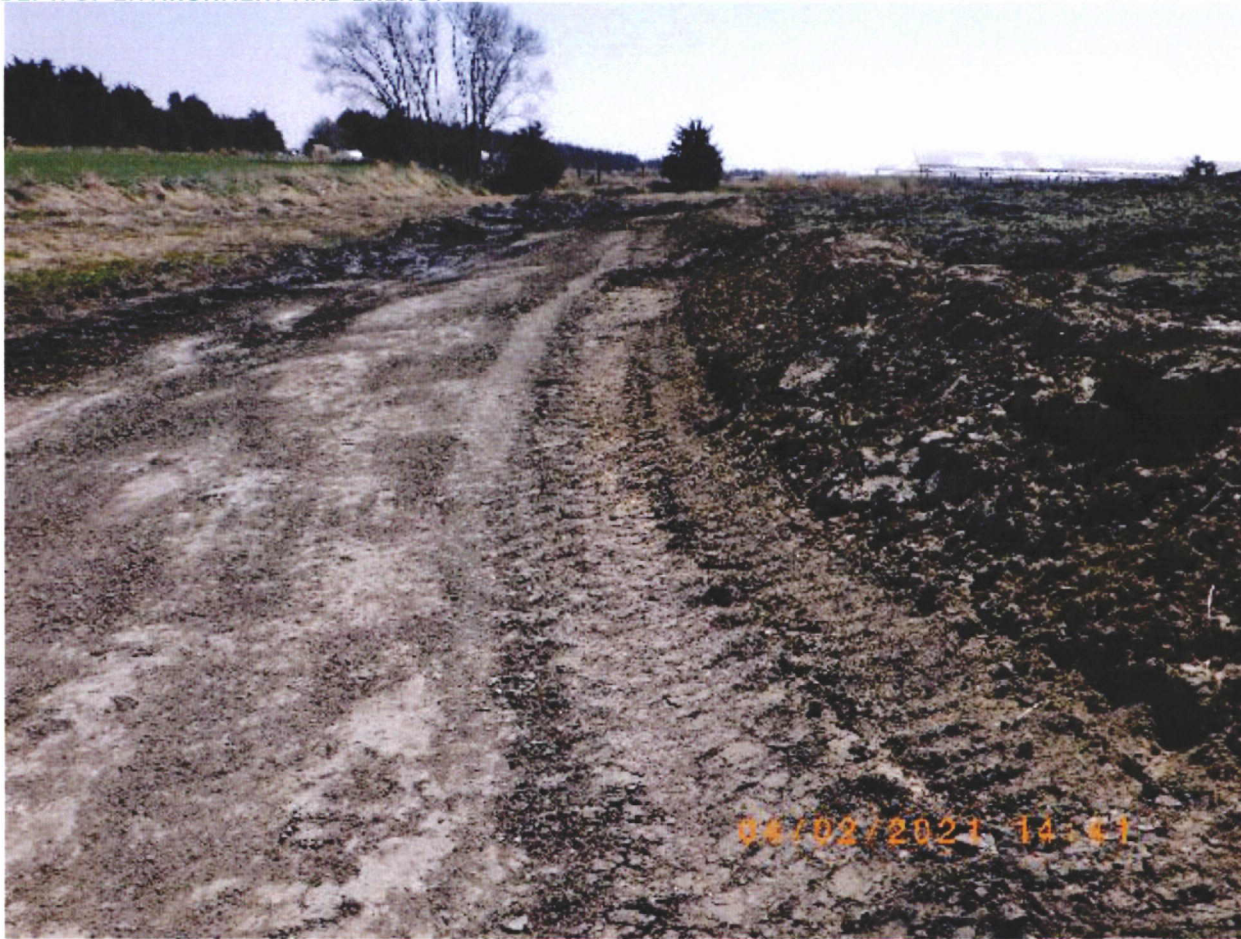
Photos: 26

Description: Berm reinforced along the north side of the east wetcake area.

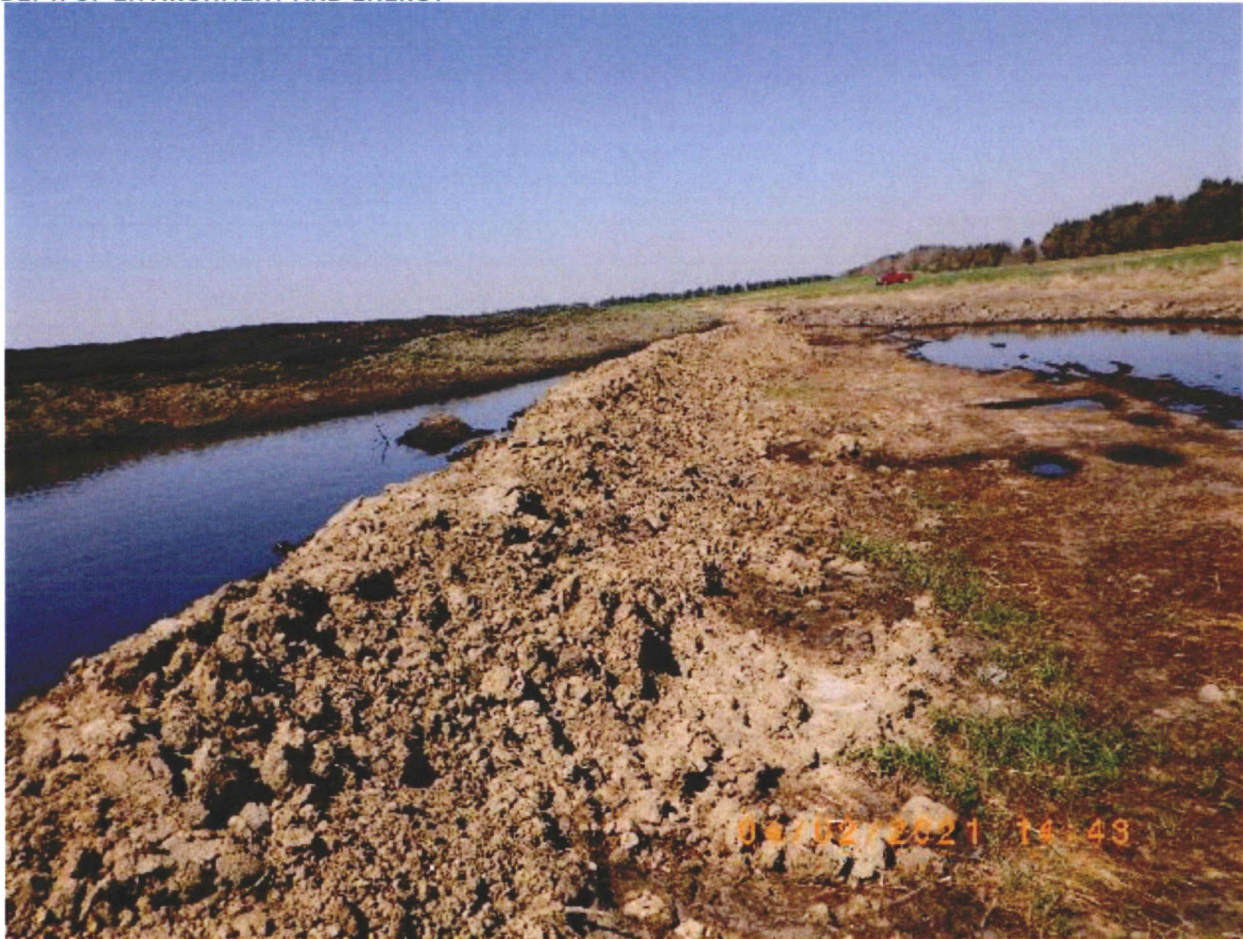
Photos: 27

Description: Bermed runoff retained behind both berms. This area should be pumped out very soon.

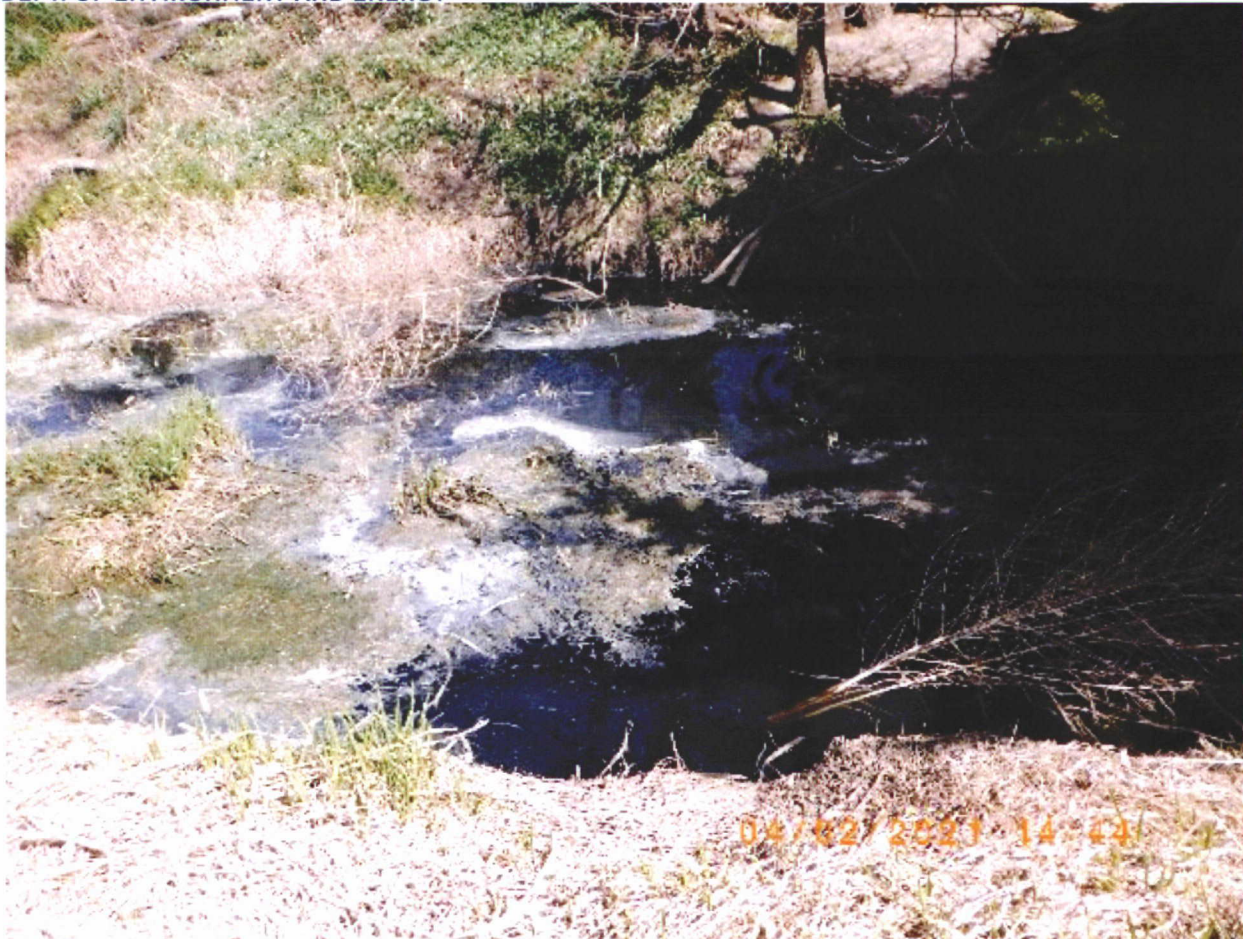
Photos: 28

Description: Dark water with white filamentous bacteria accumulating on the surface and on vegetation.
