Facility: AltEn
IIS: 84069
PCS: NE0137634

Site Visit Check list

Site Visit Report

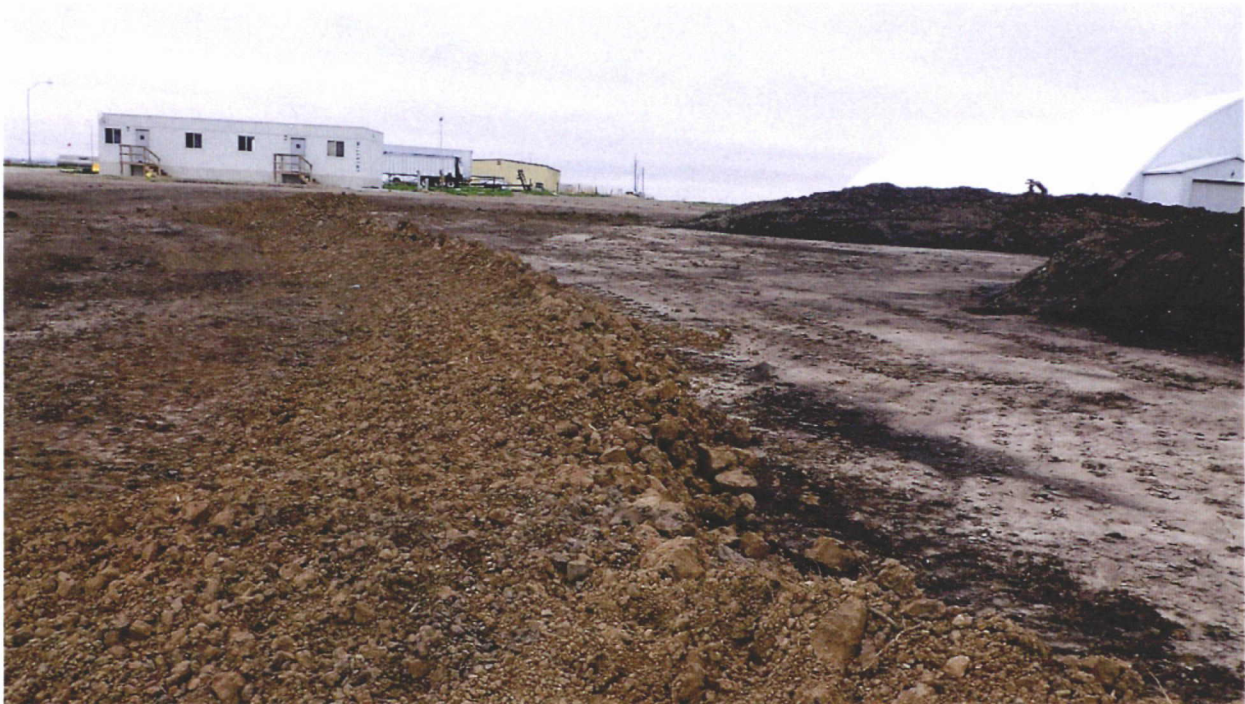
Photos: 1

Description: This photo depicts a newly constructed berm. The berm appears to have some compaction.

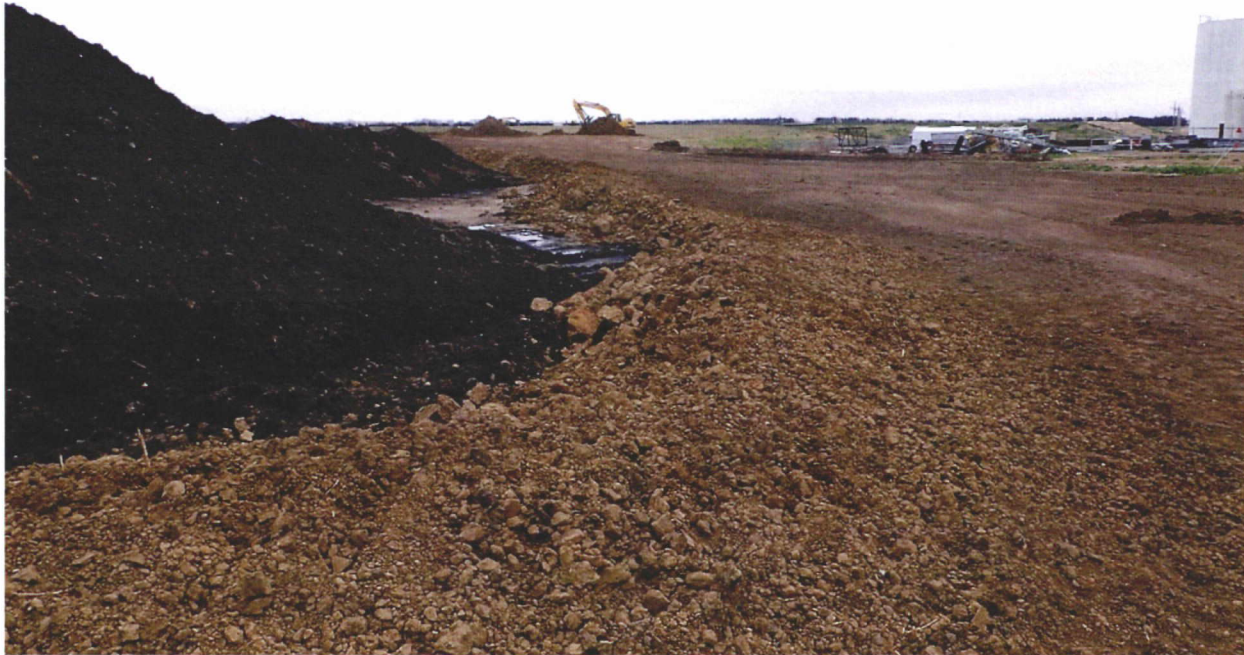
Photos: 2

Description: This the same berm depicted above just facing east.

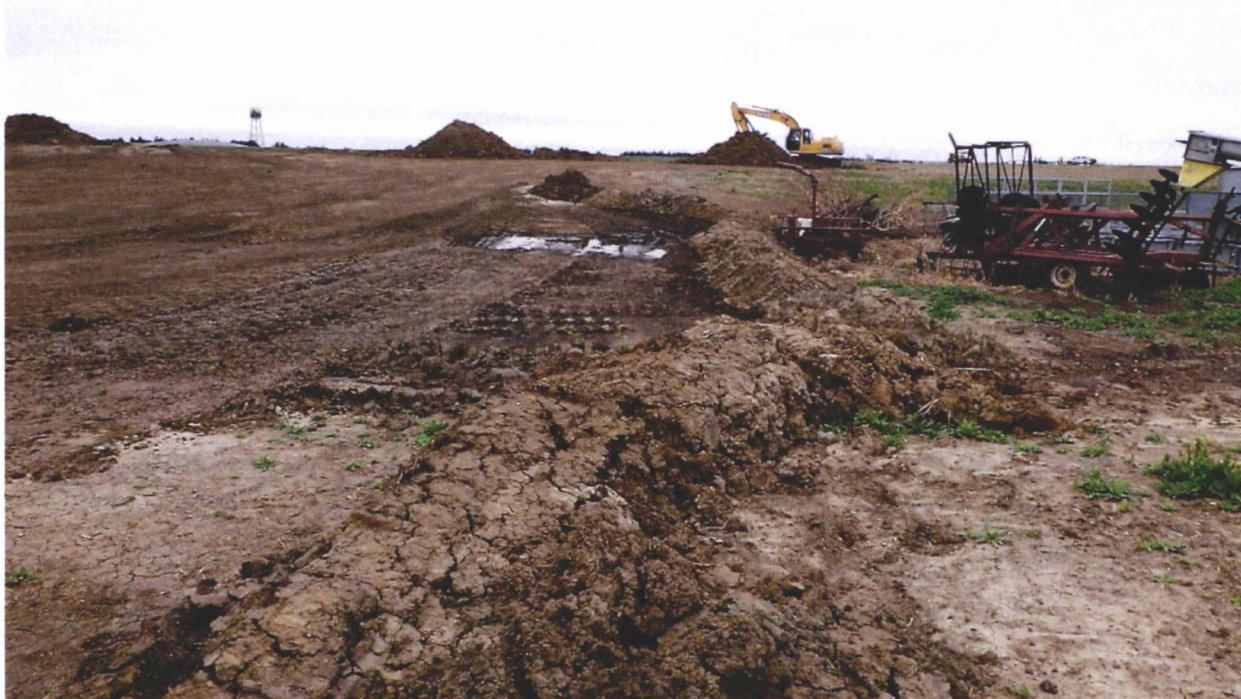
Photos: 3

Description: This is the original berm constructed for Area 1. Nothing of concern observed.

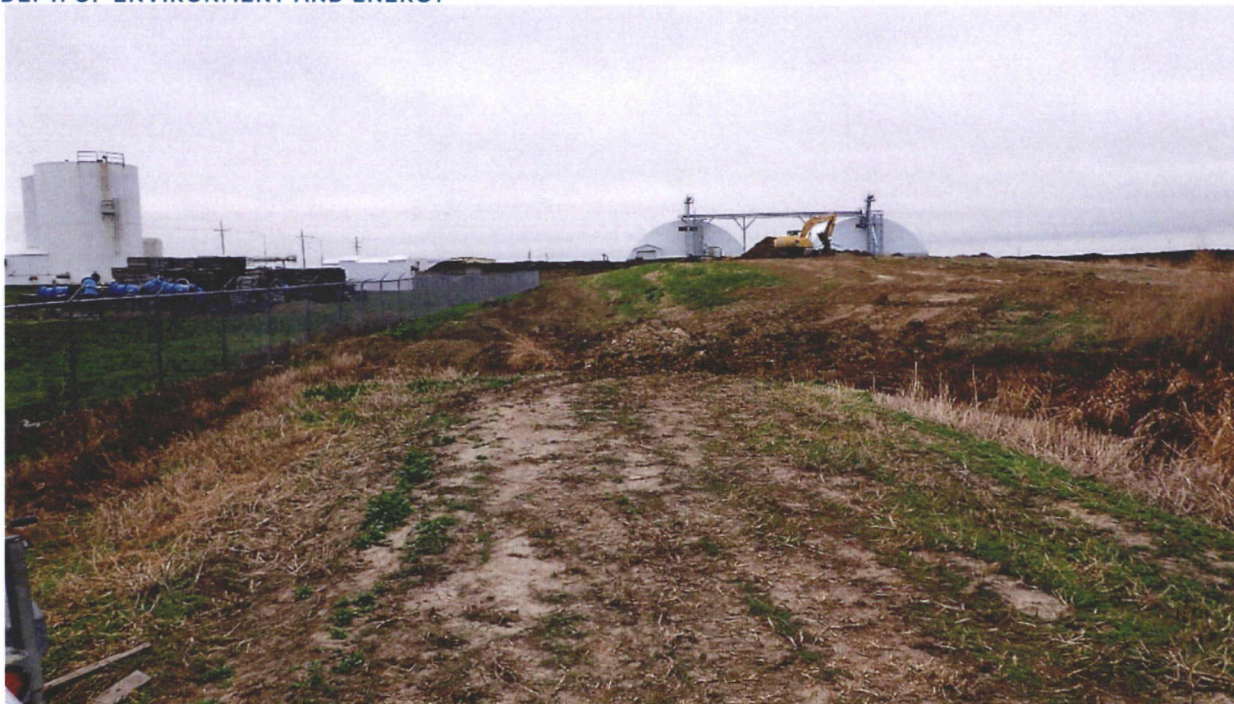
Photos: 4

Description: This berm is located southeast corner of the south lagoon. The facility has reinforced the berm with additional soil.

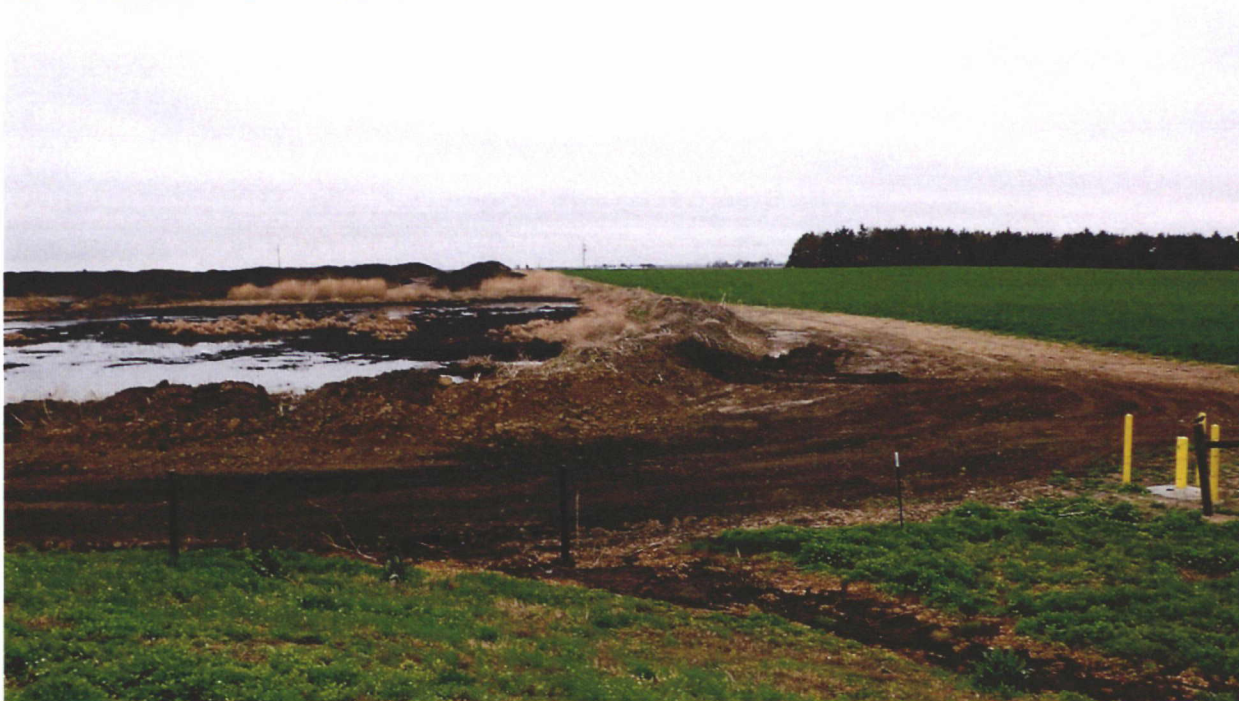
Photos: 5

Description: The facility has recently reinforced this berm with additional material. There is no evidence of seepage or leakage.

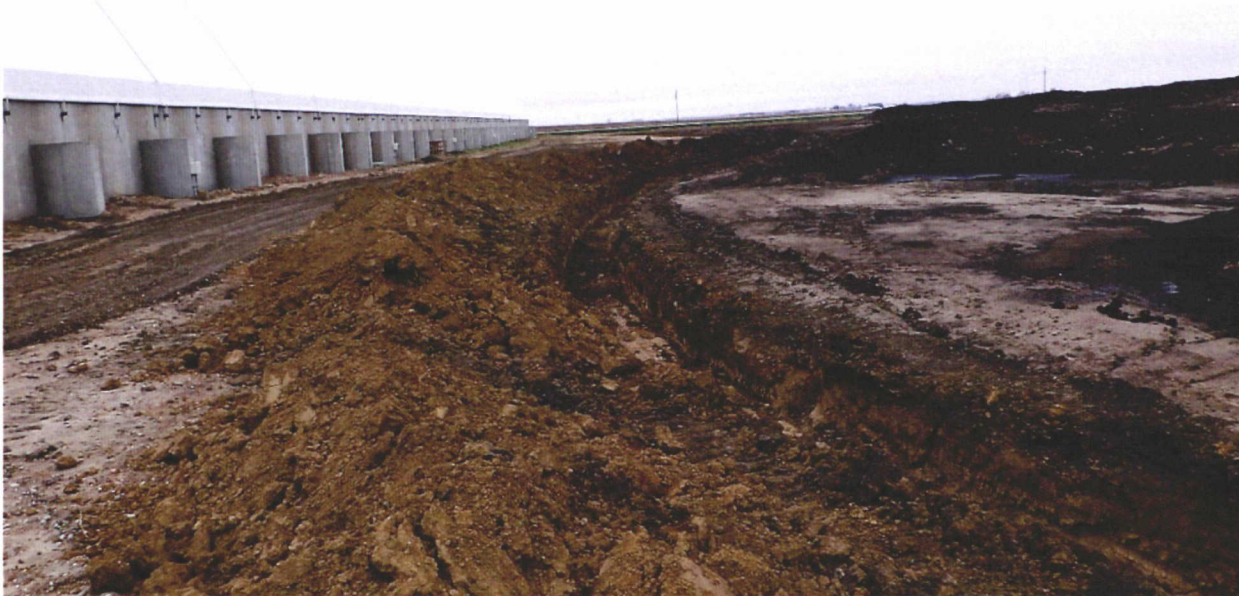
Photos: 6

Description: The facility has installed this trench. Mr. Peterson stated it is used to help transfer water from area 5 to area 2. Area 2 is then transferred to the emergency lagoon.

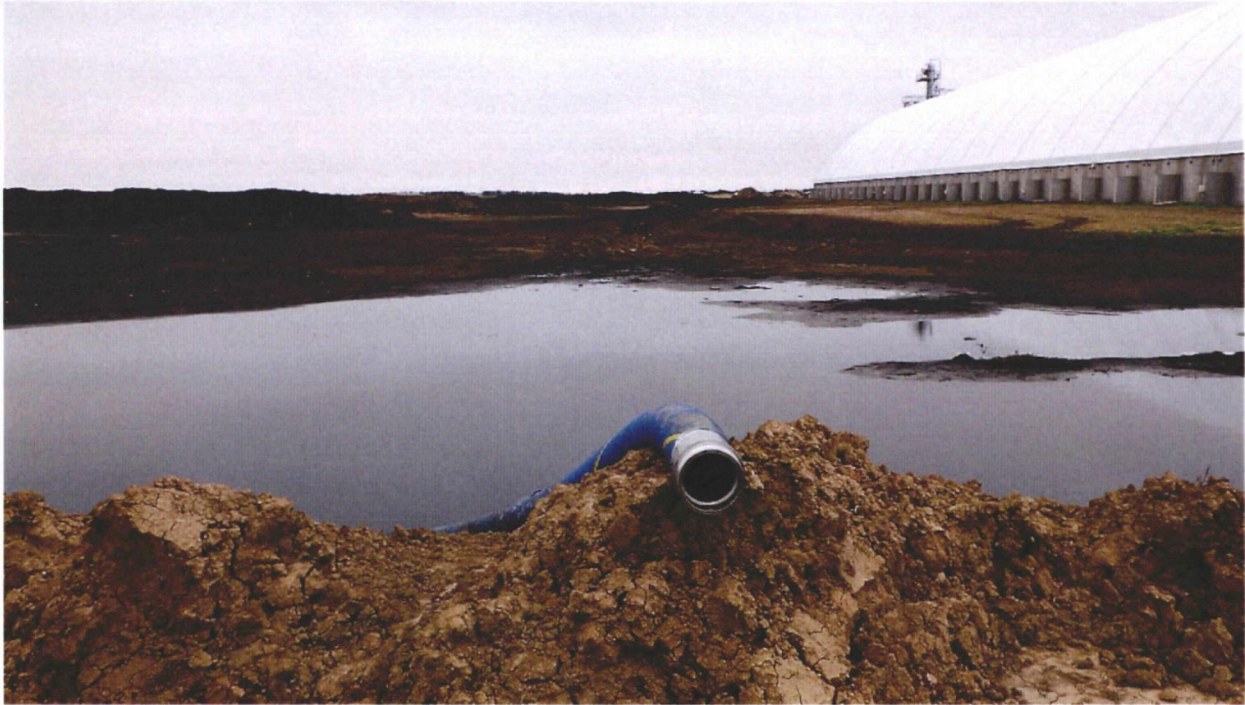
Photos: 7

Description: This photo depicts the hose used to connect to the transfer pump. The hose is then placed in the trench depicted in the above photo. There is some water accumulation but no seepage or leaking observed.

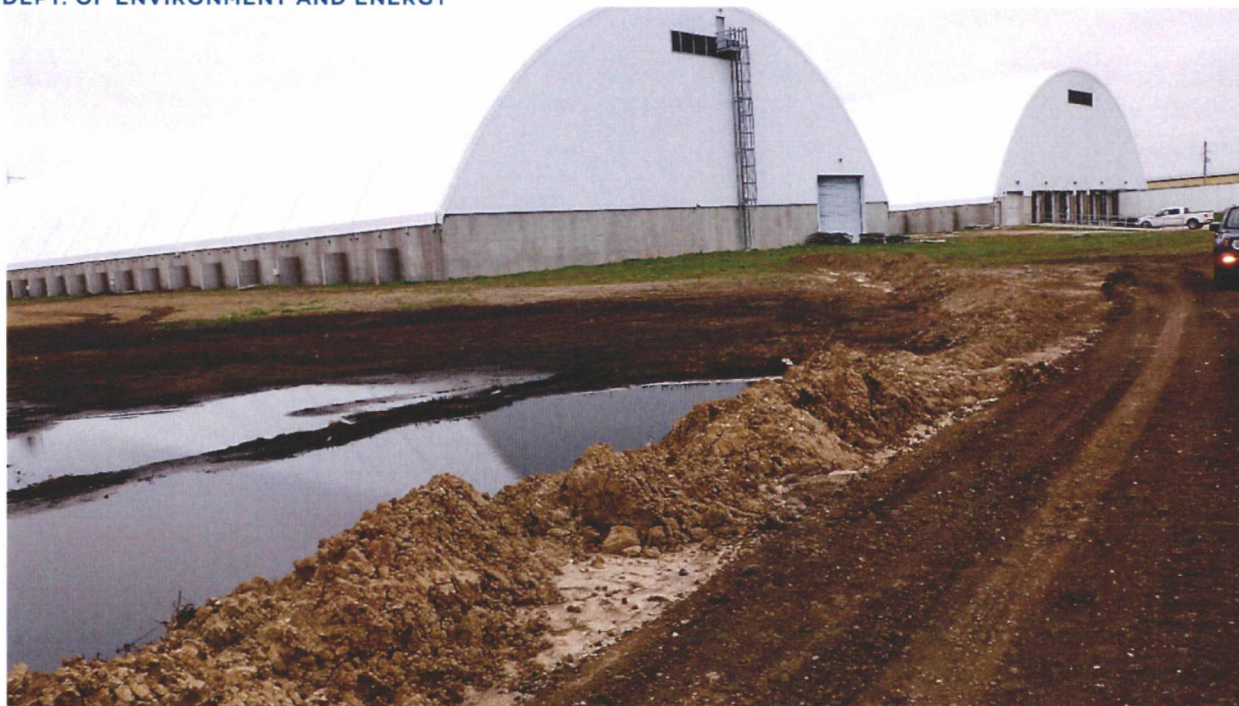
Photos: 8

Description: This photo depicts area 5 facing southeast. There is some water accumulation but I did not observe seepage or leakage.

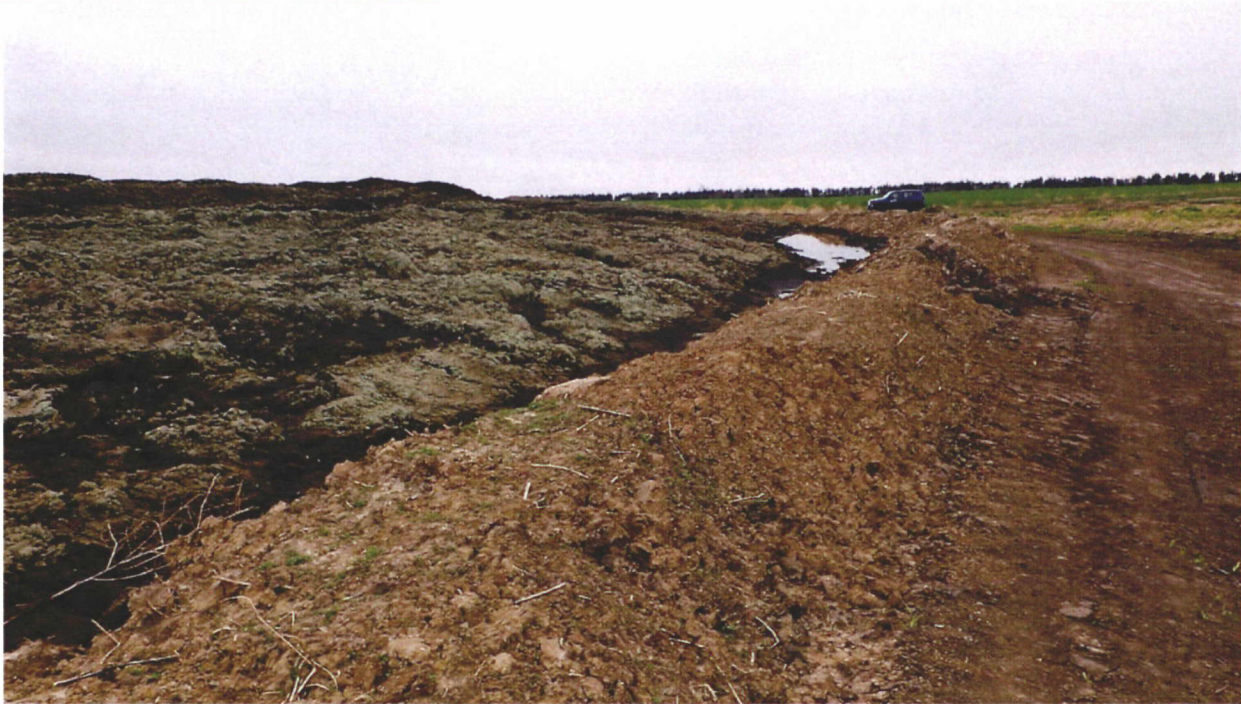
Photos: 9

Description: This photo depicts area 6 facing north. The facility has reinforced the berm with additional material.

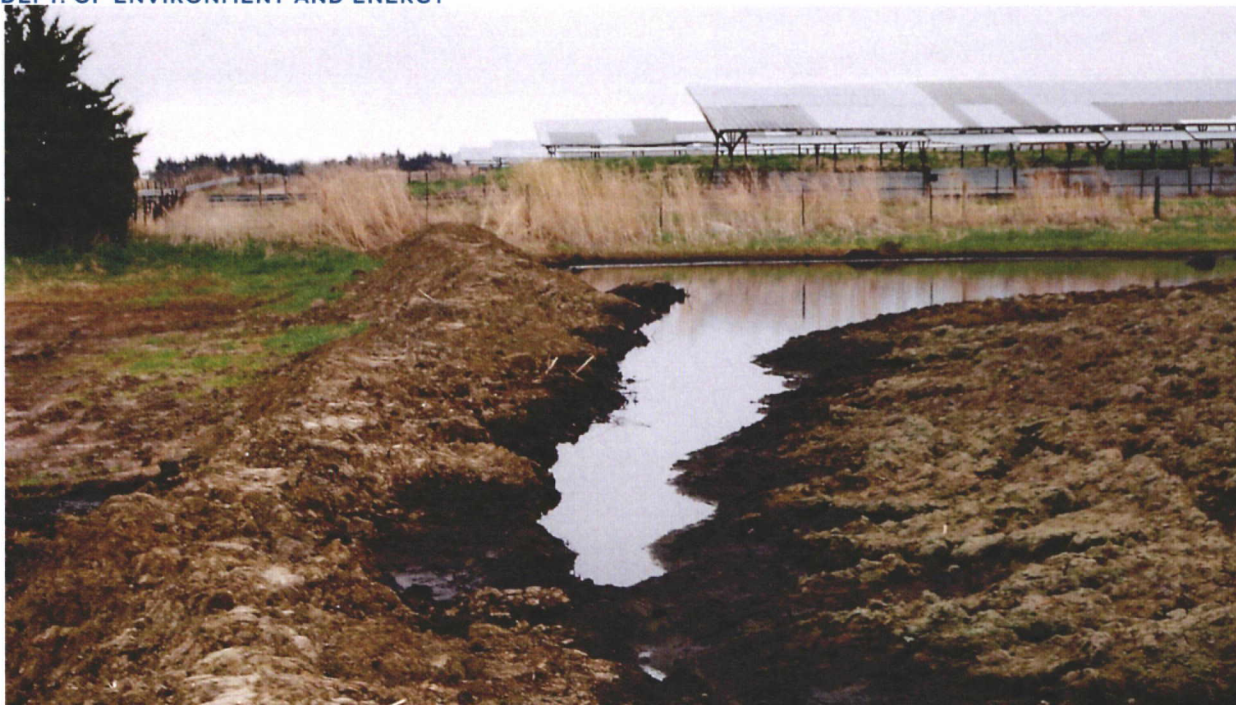
Photo: 11

- The facility completed the berms north of the Area 1.
- Area 6 is seeping in two places. The facility needs to pump down this berm.
- The facility has dug a trench from area 5 to the northeast side of the south hoop building. The facility pumps contained water from area 5 through the trench to area 2. The facility then transfers water from area 2 to the emergency lagoon.
- Area 4 was not photographed.

Description: This photo depicts water accumulation behind the berm.

Inspection Date: 4/19/21 Start Time: 10:00 End Time: 11:08a☐ No concerns observed☐ Further agency discussion needed to determine compliance☒ Concerns observed:- Area 1 - ok2 - ok3 - ok4 - ok5 - ok6 - Seepage notedLegions - ok☒ Actions to be performed immediately or as soon as reasonably practical:Fix Seepage problem at EAST Basin.**Please notify the Inspector when the above actions are completed.**

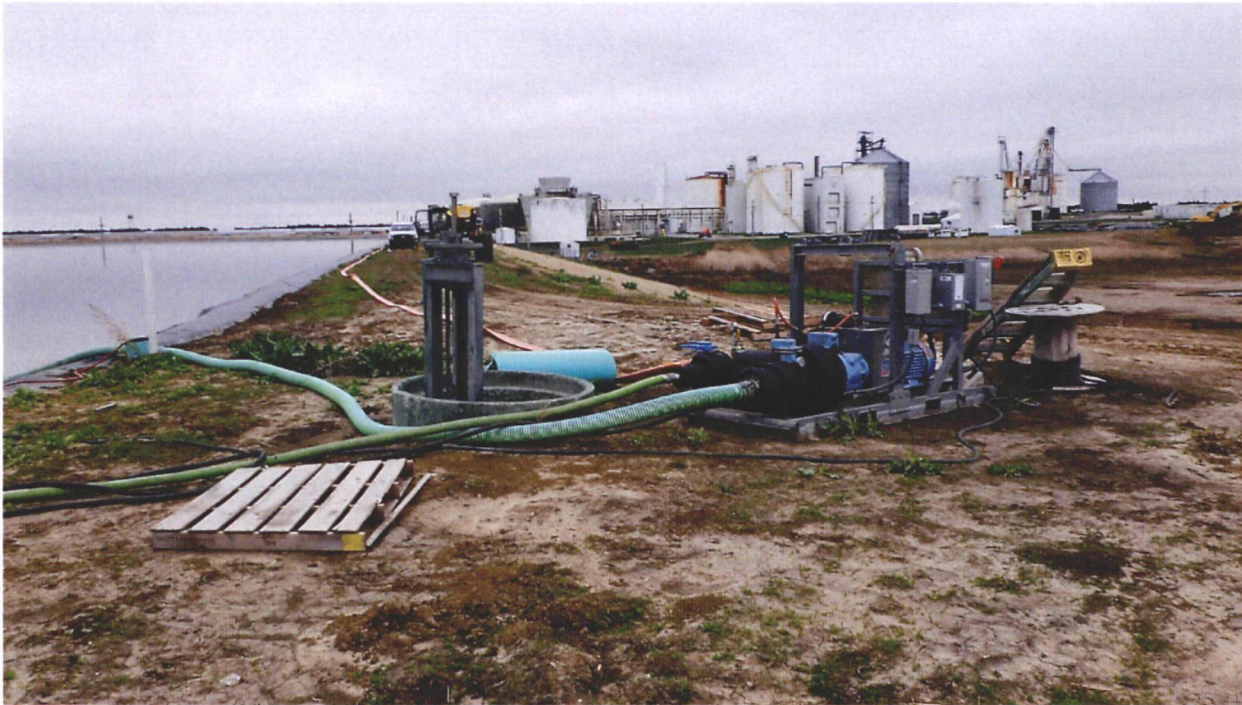
Photo: 12

Description: This photo depicts the treatment pumping station.

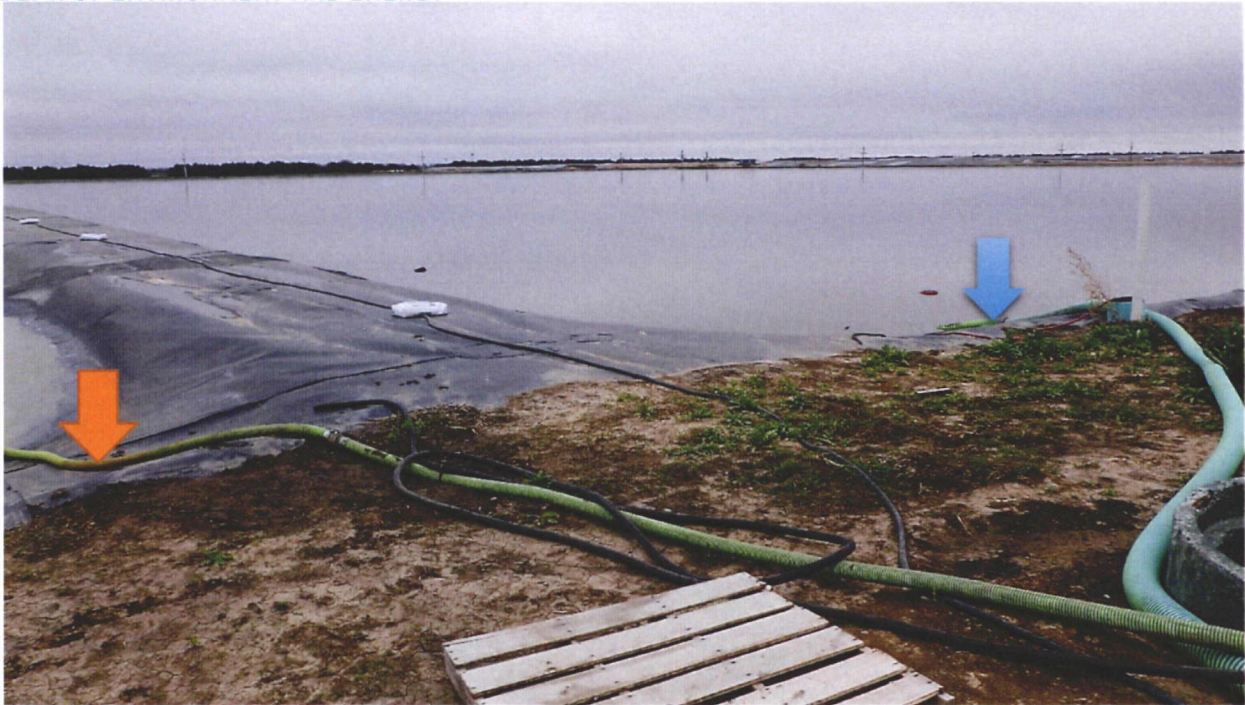
Photo: 13

Description: This photo depicts hoses entering the south (blue arrow) and northeast lagoon (orange arrow).

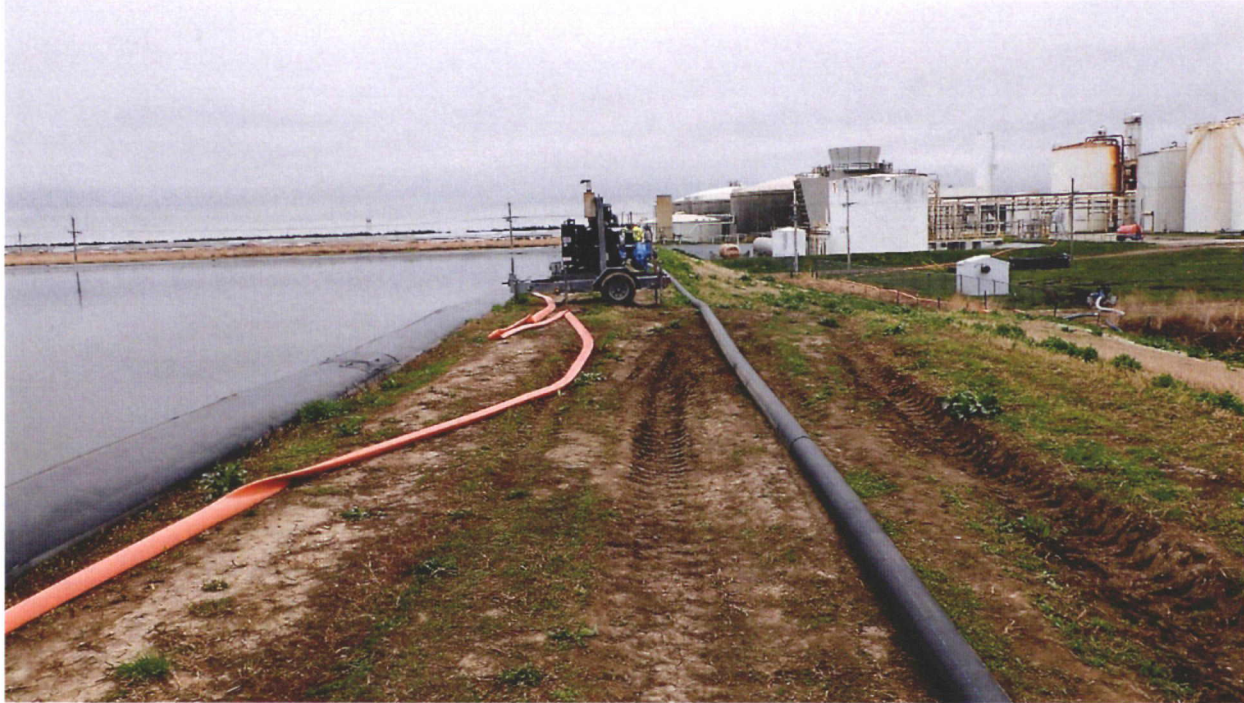
Photo: 14

Description: This photo depicts an additional pumping station along the west dike of the south lagoon.

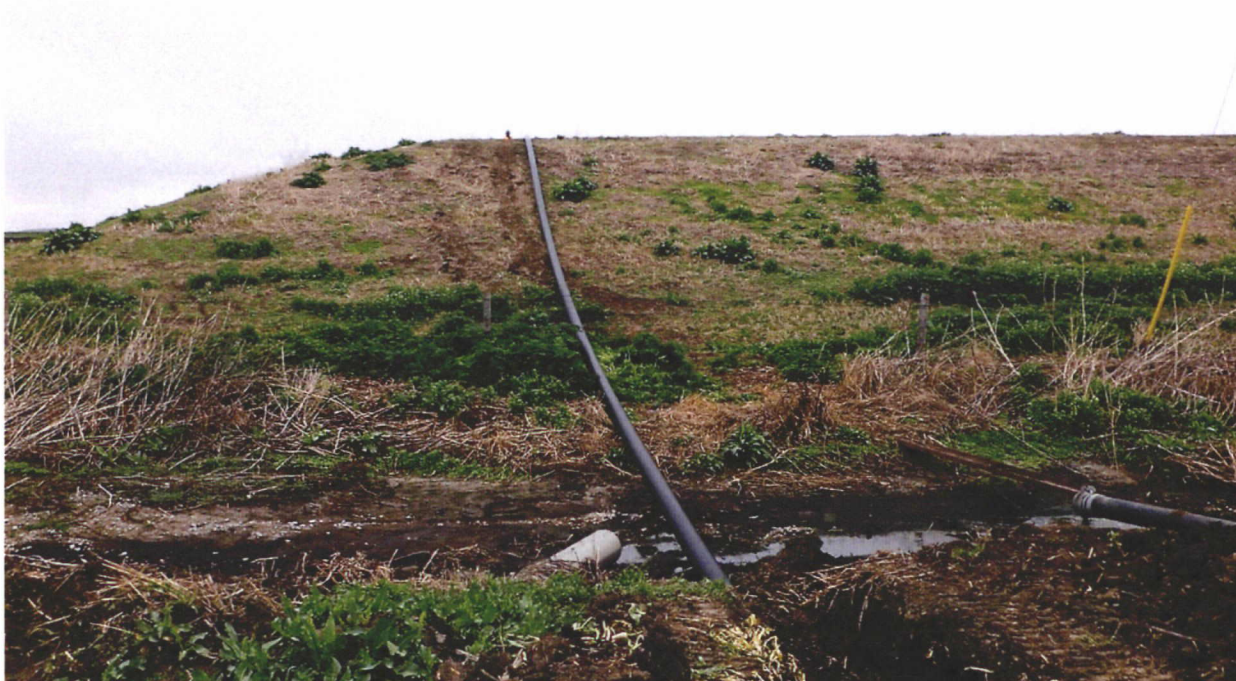
Photo: 14

Description: This photo depicts workers pulling hose over the south lagoon through a trench. The hose continues over the road and over the next lagoon dike. This is depicted in the next photo.

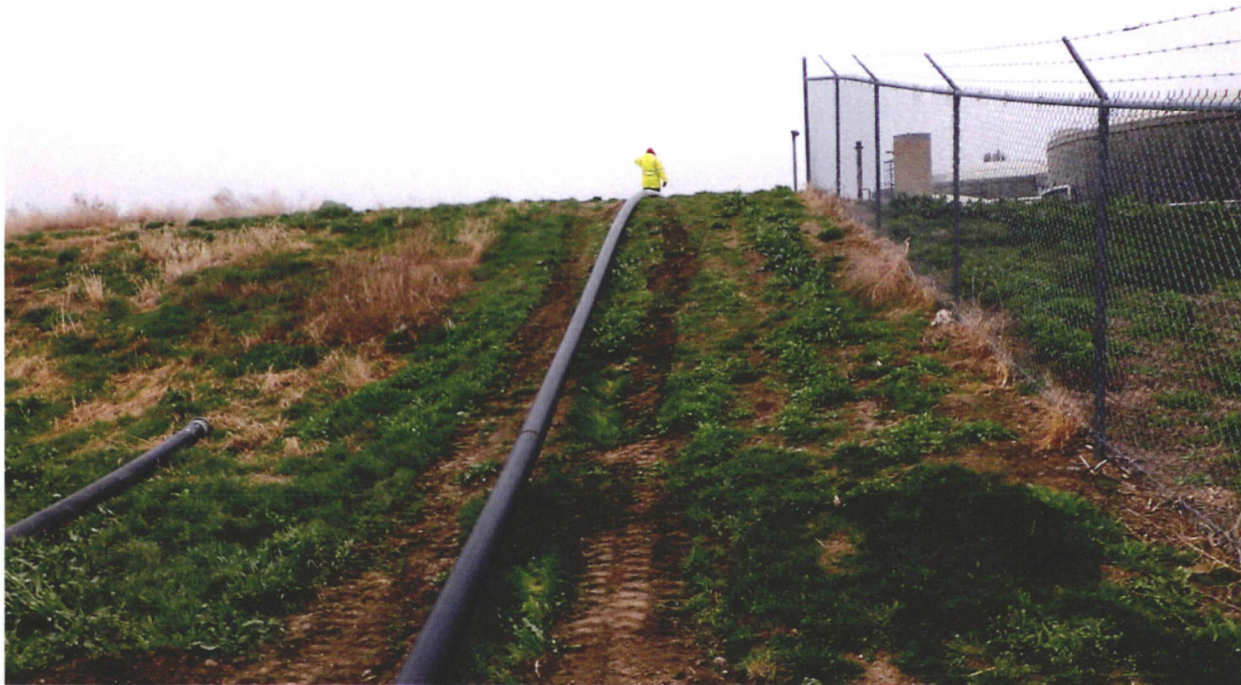
Photo: 15

Description: This photo depicts a worker pulling hose over a lagoon dike to eventually connect to the treatment system.

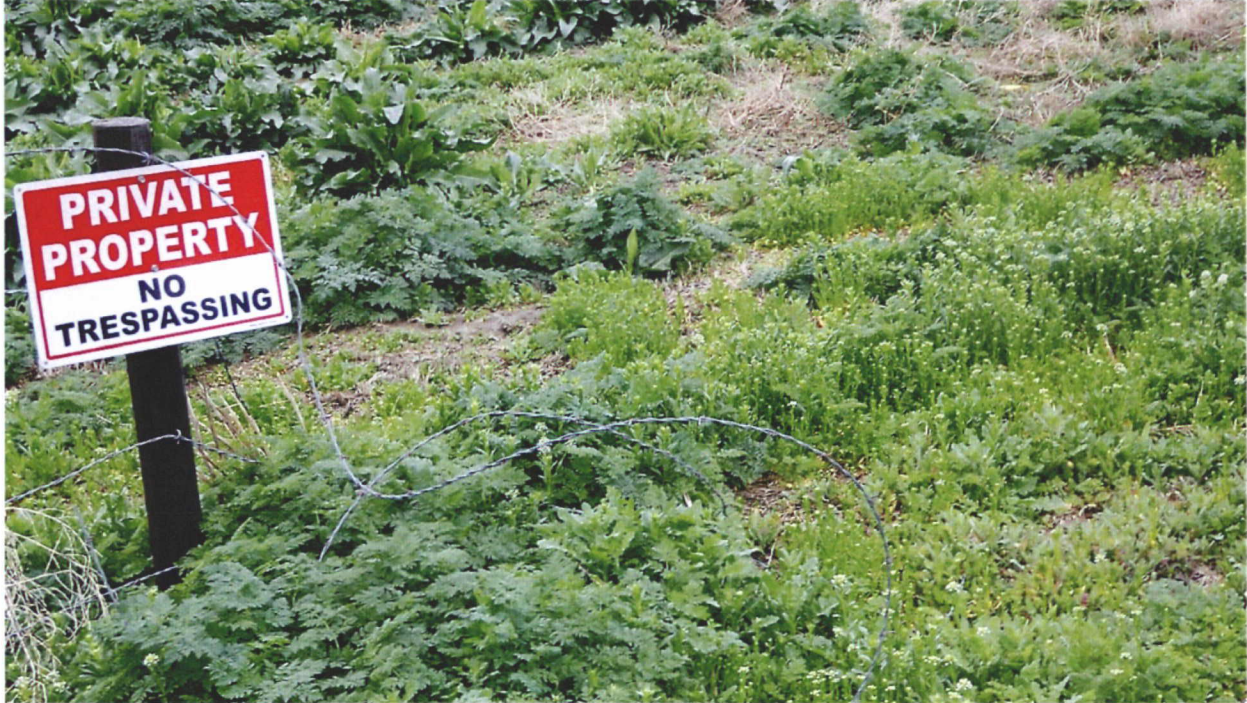
Photo: 16

Description: This photo depicts cut wires. The fence on the southwest corner of the south lagoon.

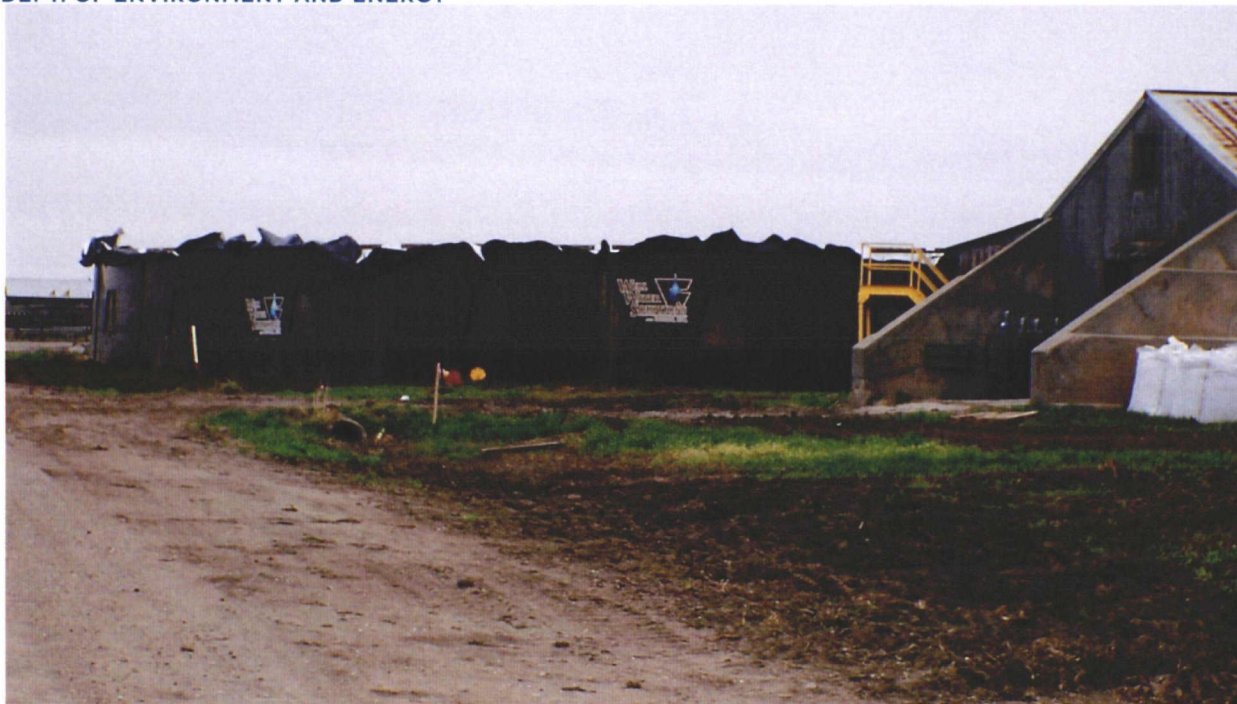
Photo: 17

Description: This photo depicts the east Poseidon tank.

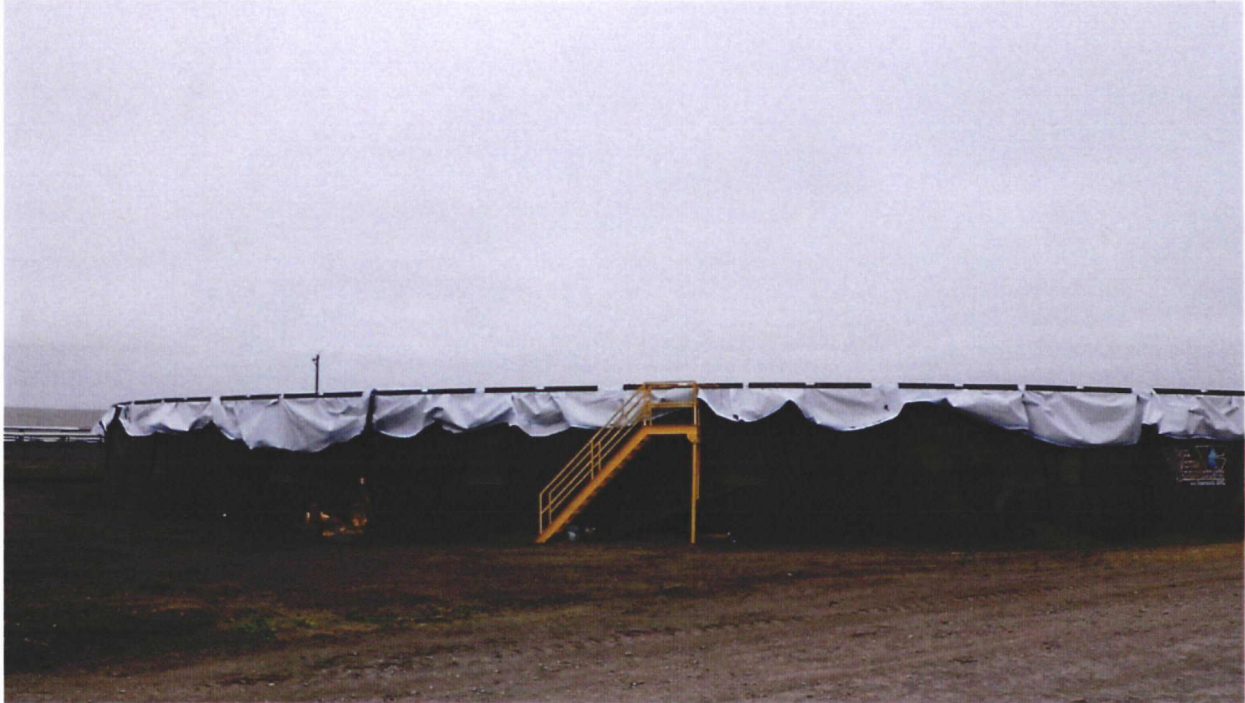
Photo: 18

Description: This photo depicts the west Poseidon tank.

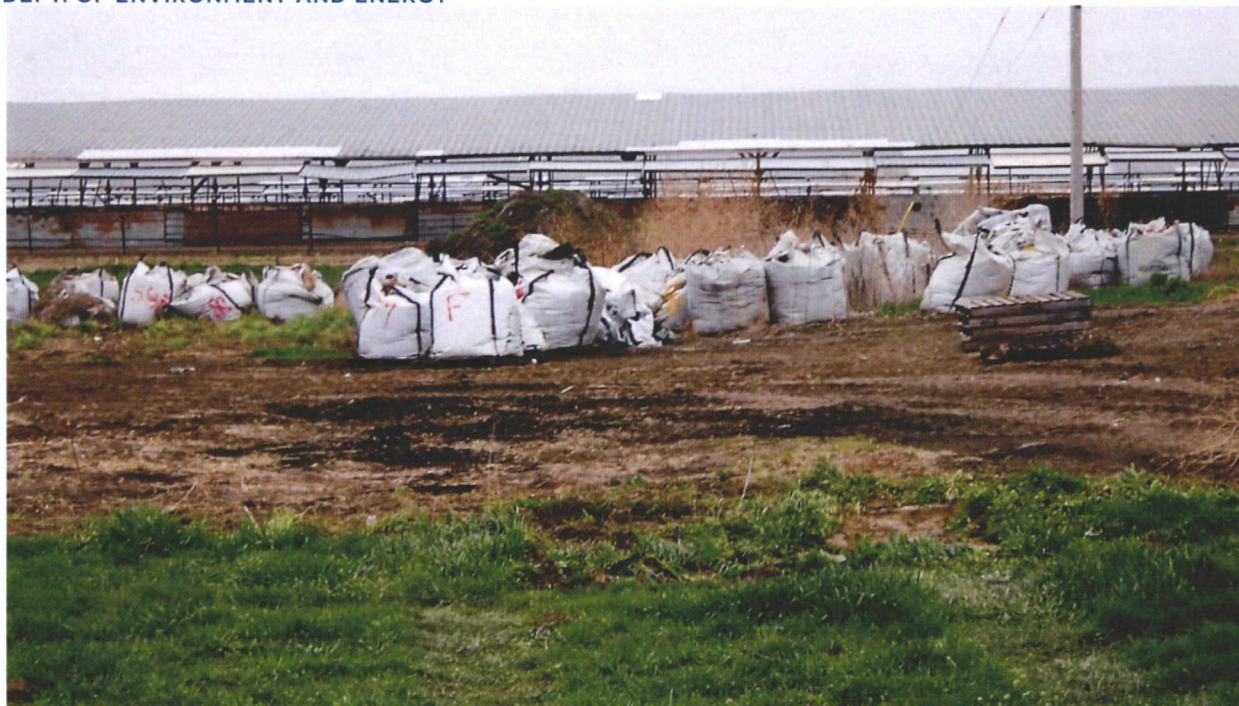
Photo: 19

Description: There are some supersacks located east of the biochar. Most have been moved to the south hoop building.

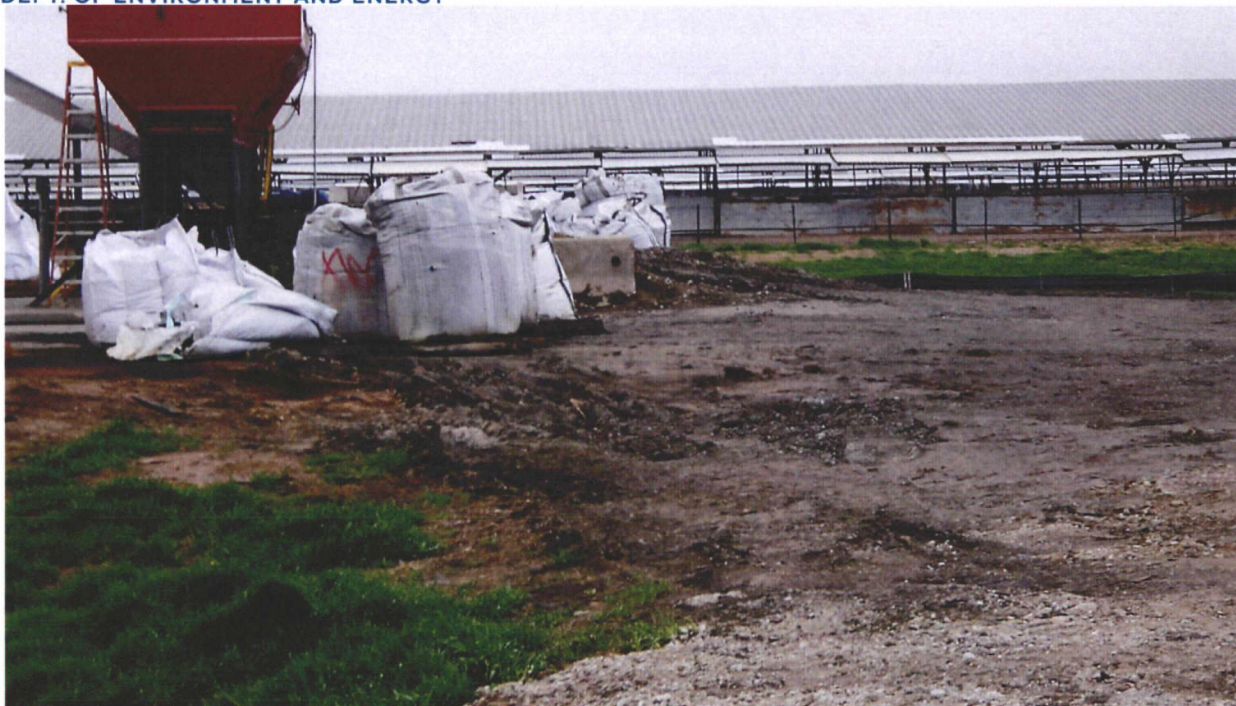
Photo: 20

Description: There are some supersacks located west of the biochar. Most have been moved to the south hoop building.

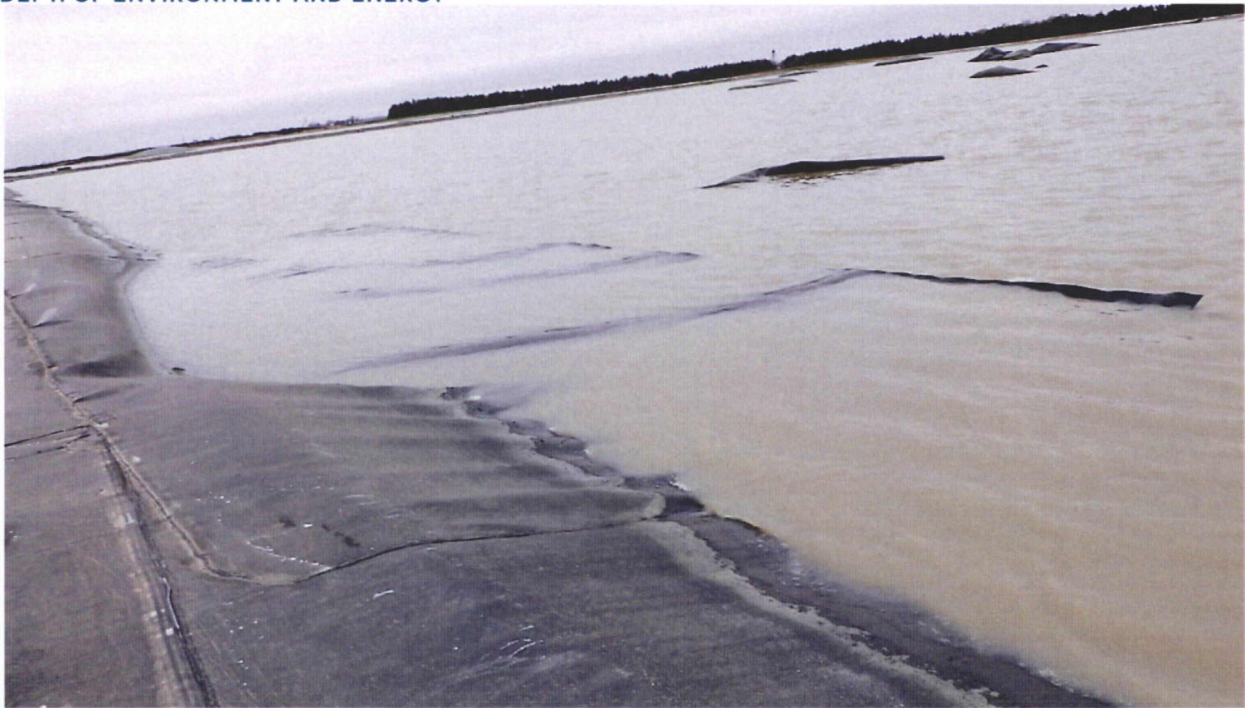
Photo: 22

- The water surface appears to be lower.
- I observed a gas release and floating liner (see photo log).

Description: This photo depicts floating liners along the south dike.

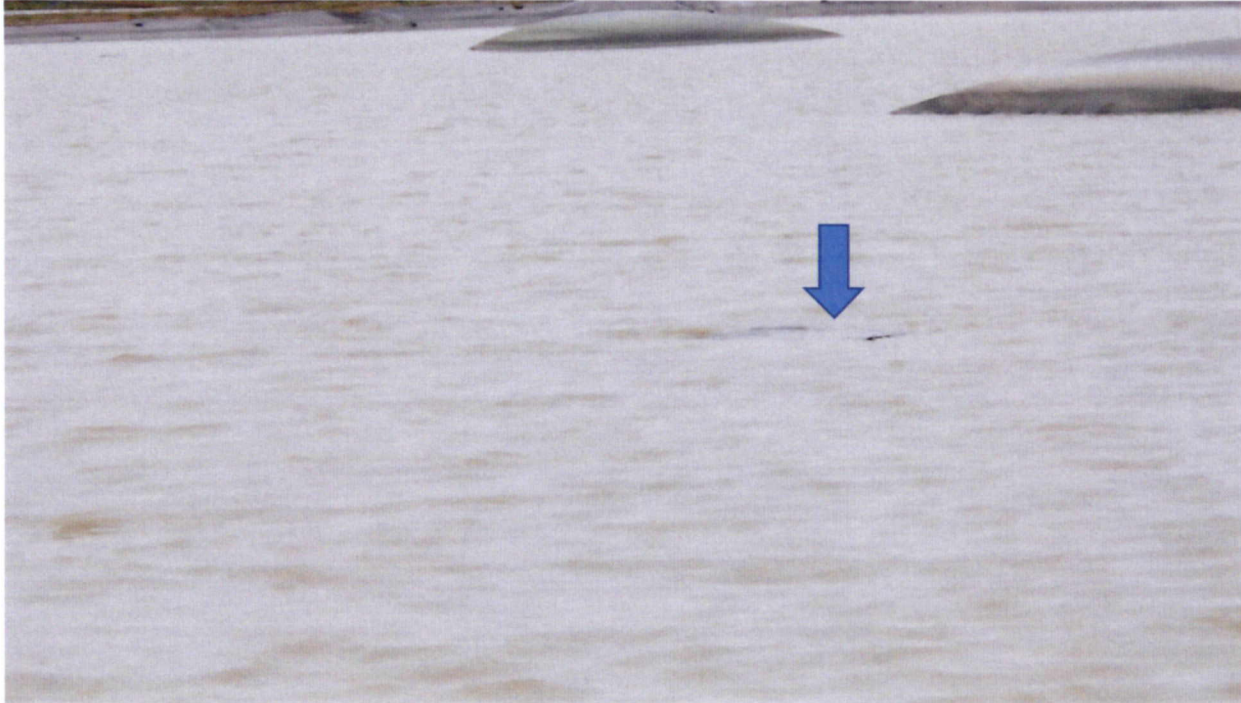
Photo: 23

Description: The arrow depicts floating liner. Prior to this photograph, I heard a popping sound. I then observed water rushing upwards. This liner was observed after the incident (arrow).
