Facility: AltEn  
IIS: 84069  
PCS: NE0137634

Mark Pomajzl  
4/9/2021

## Site Visit Check list

Site Visit Report

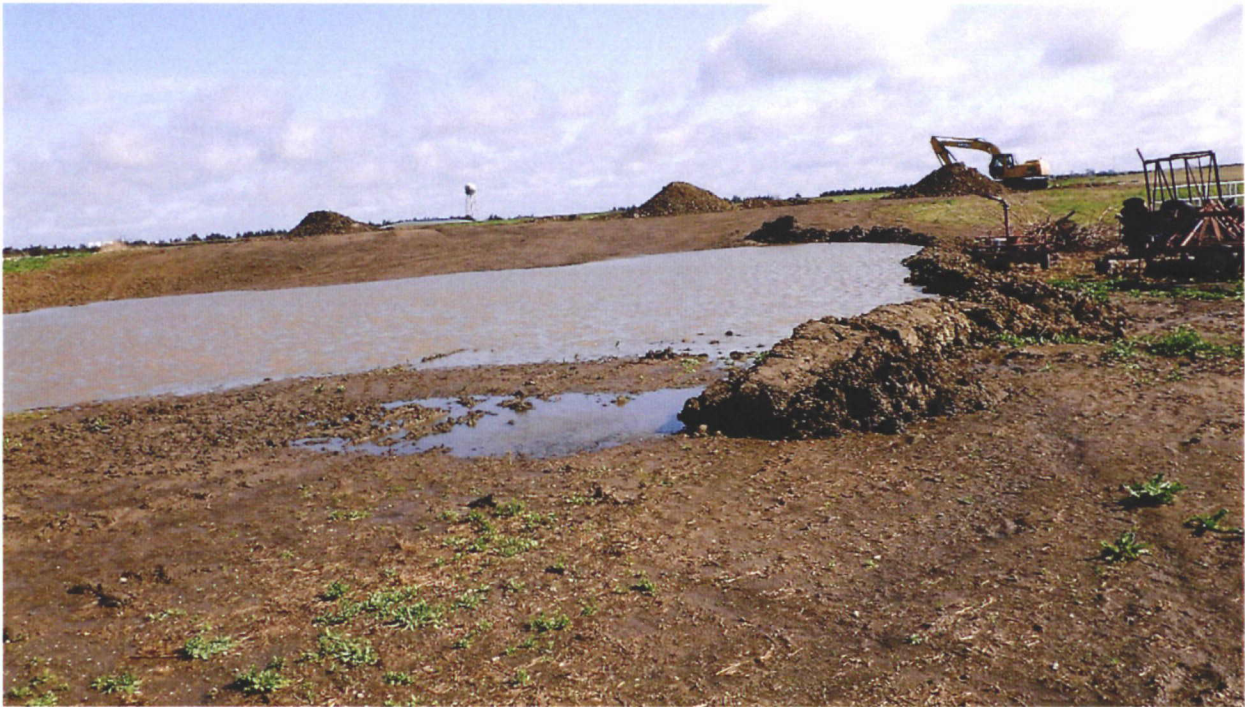
Photos: 1

Description: This photo depicts Area 1 north of the administration building. The berm is holding storm water at this time.

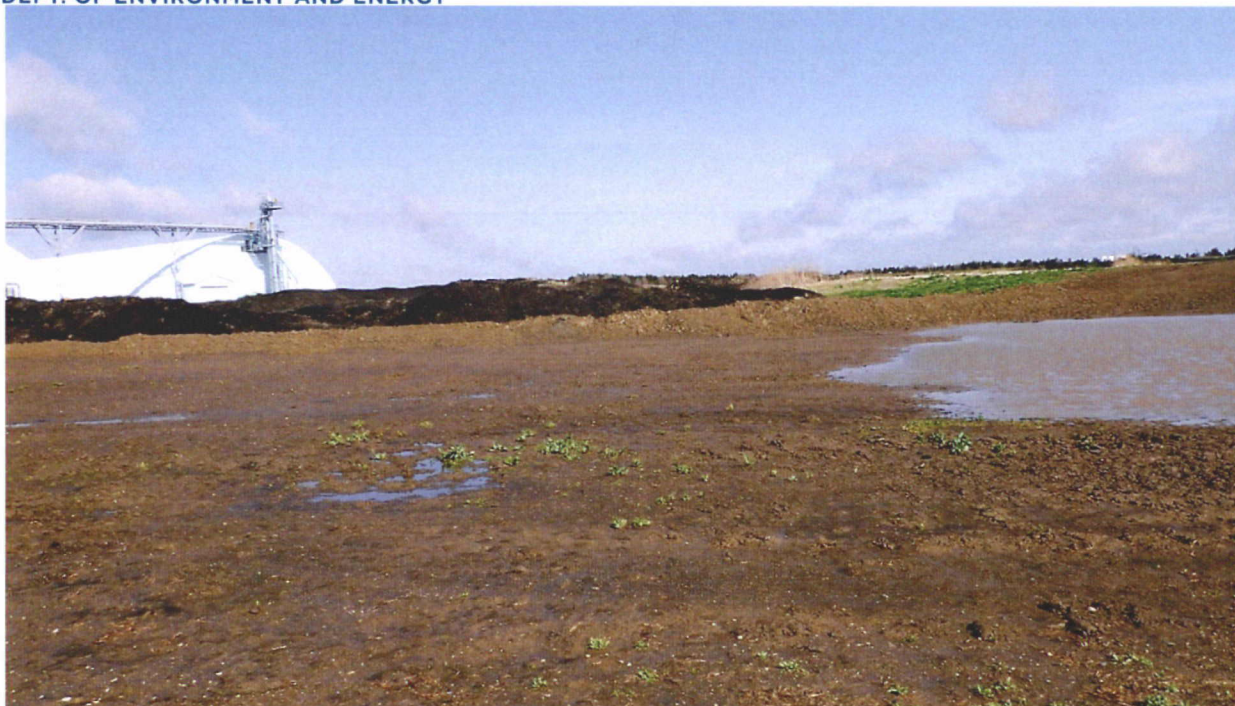
Photos: 2

Description: This photo depicts Area 1. This photo is facing west depicting the new constructed berm. This berm surrounds the south wet cake pile. The berm is only minimally compacted.

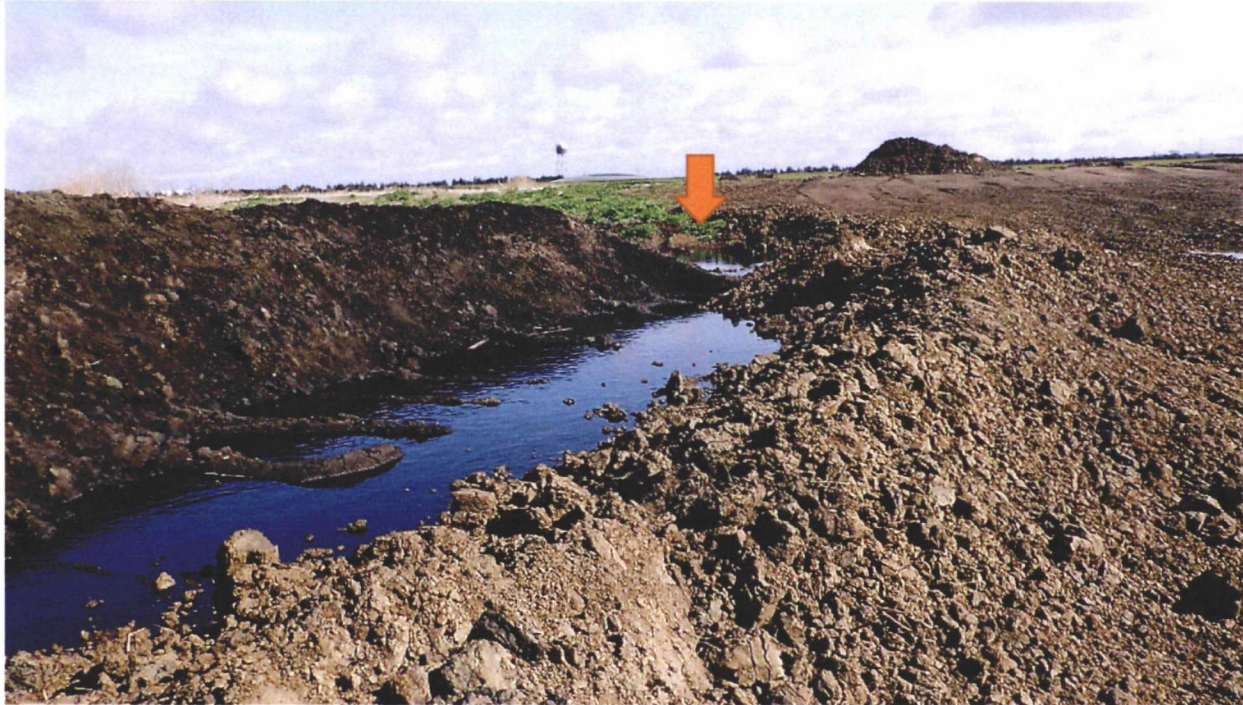
Photo: 3

Description: This photo is a close up of photo 2. The berm is containing water but is over half full. The arrow depicts the berm cannot drain.

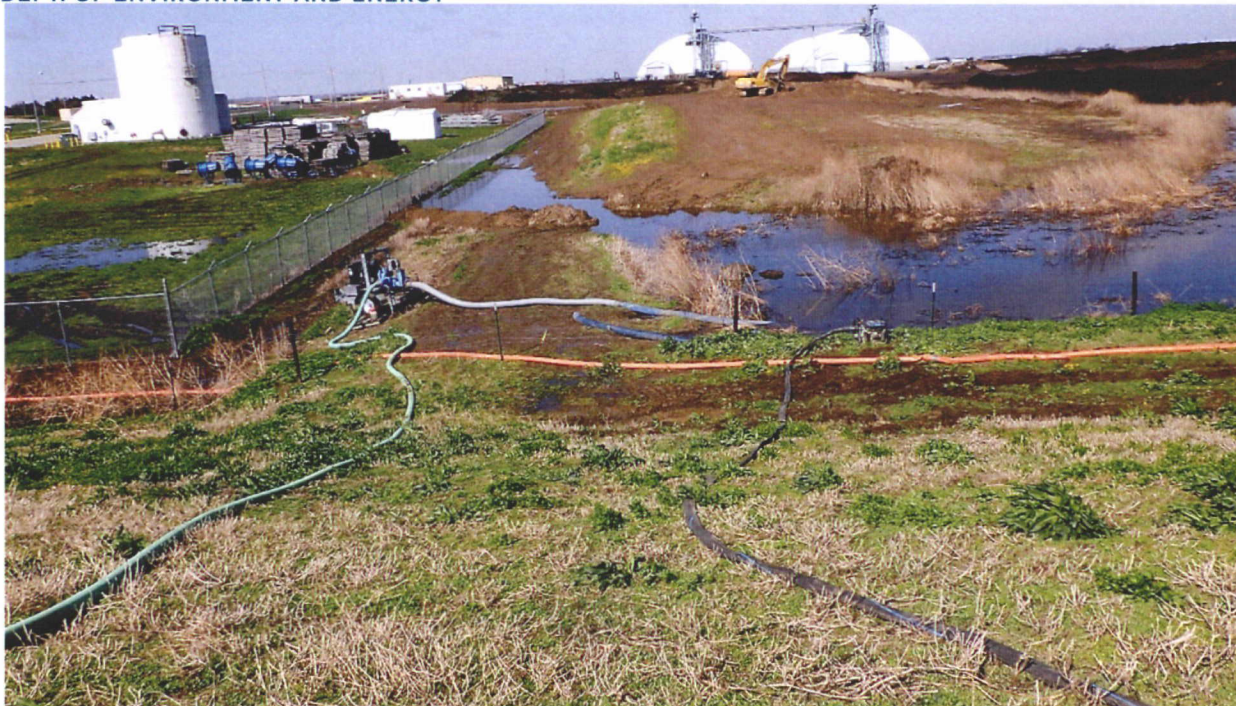
Photo: 5

Description: This photo was taken on the southwest corner of the south lagoon. The facility began pumping the contained water into the south lagoon while onsite. I requested that they stop pumping until they heard from the Department. The facility shut down the pump before I finished the inspection.

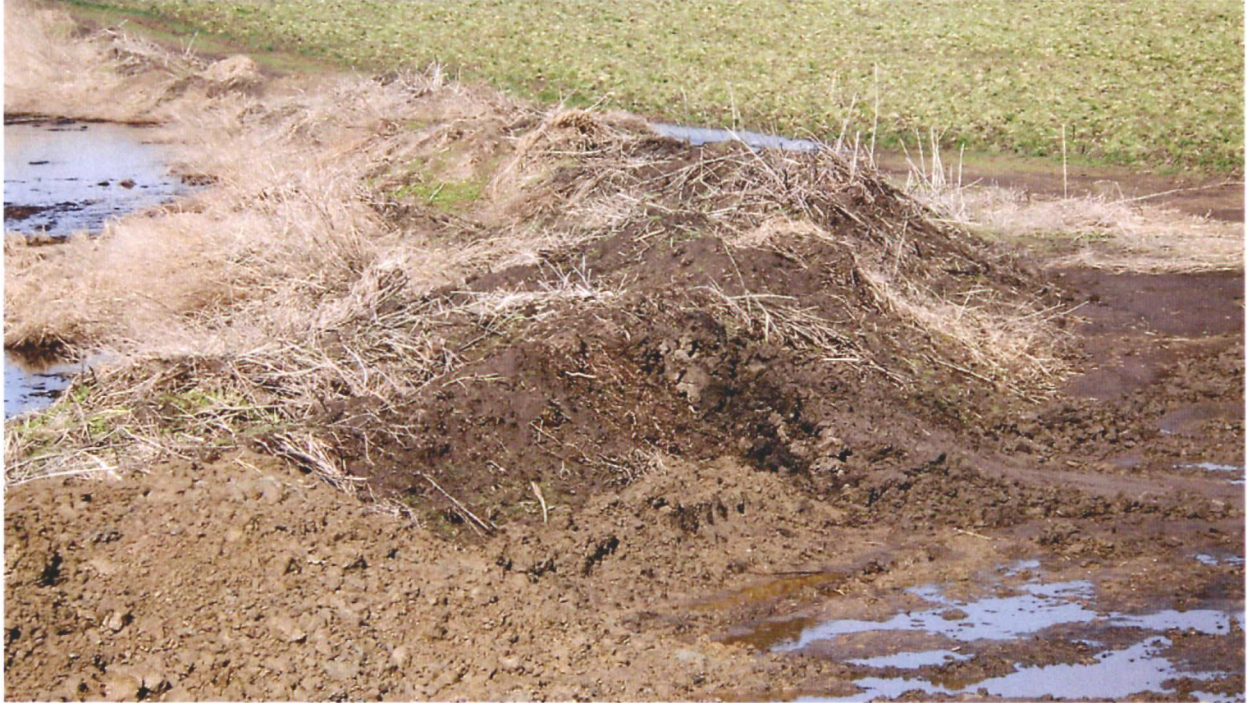
Photo: 6

Description: This photo depicts the berm on the northwest corner of the north lagoon. The water on the forefront appears to be accumulated rainwater from outside the berm.

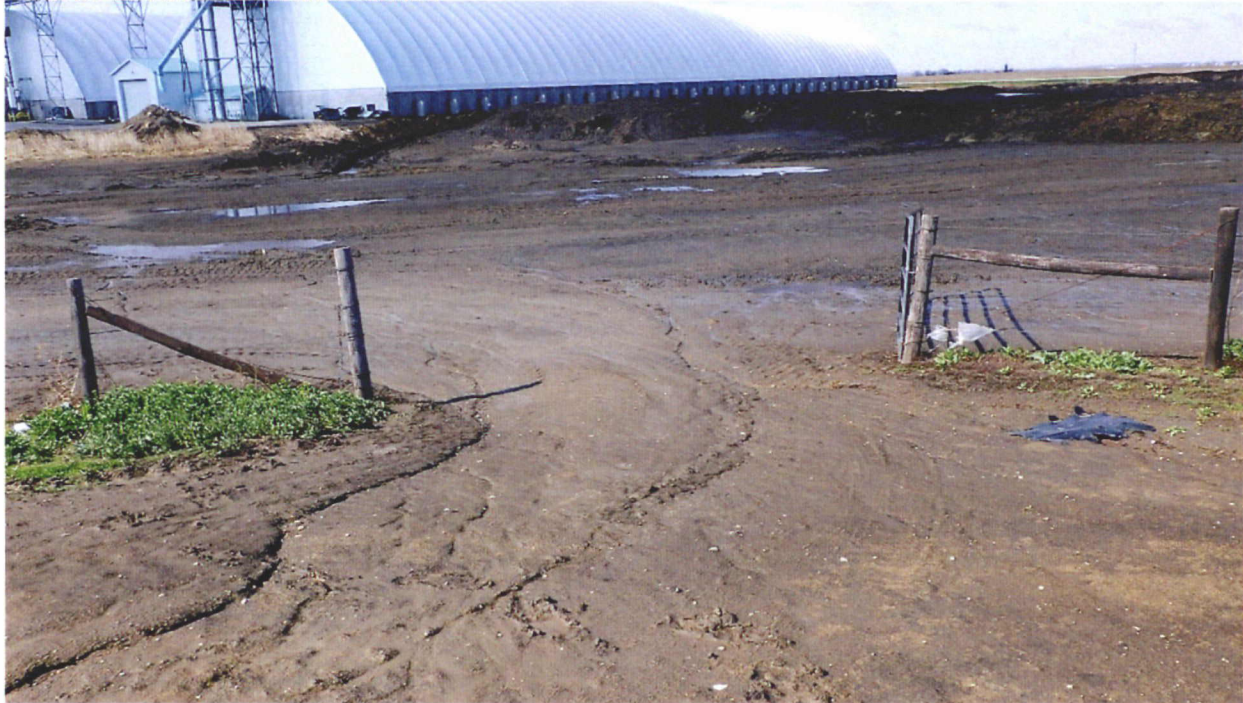
Photo: 8

Description: This photo depicts an open gate. There is nobody working in the lagoon at this time.

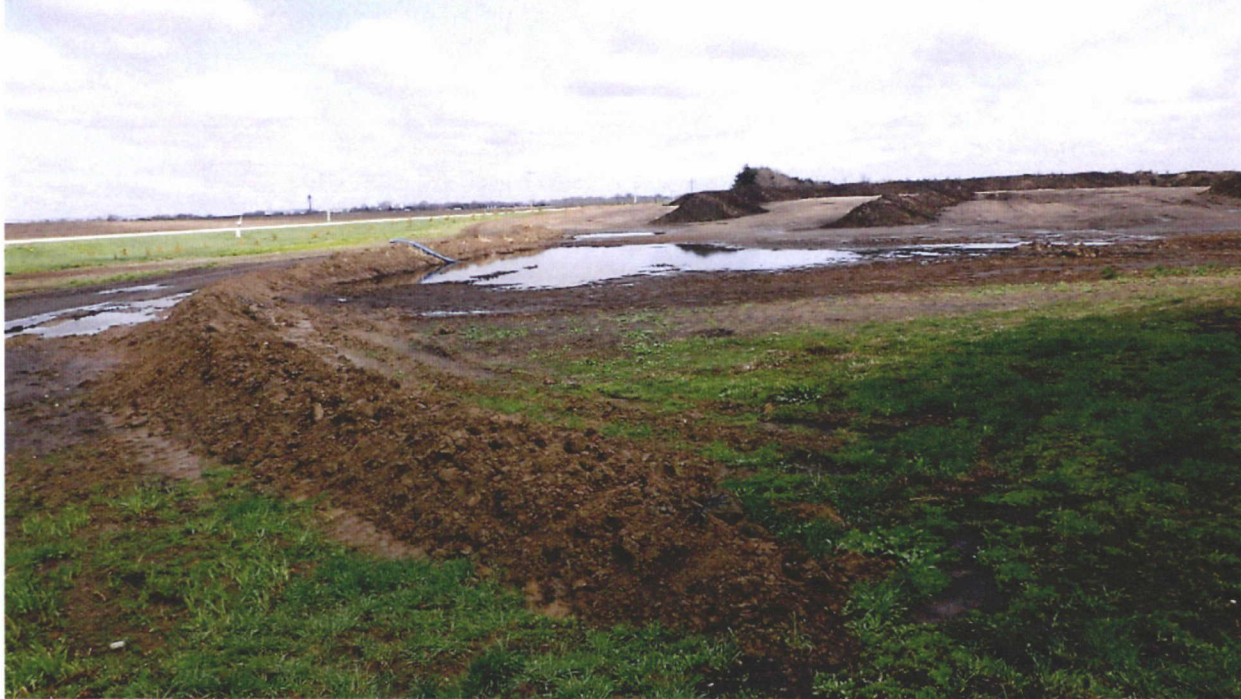
Photo: 10

Description: This photo depicts water contained behind the area 5 berm. The facility has trenched a drainage system from area 5 to area 2 (to the right of this photo). The system appears to drain the area well.

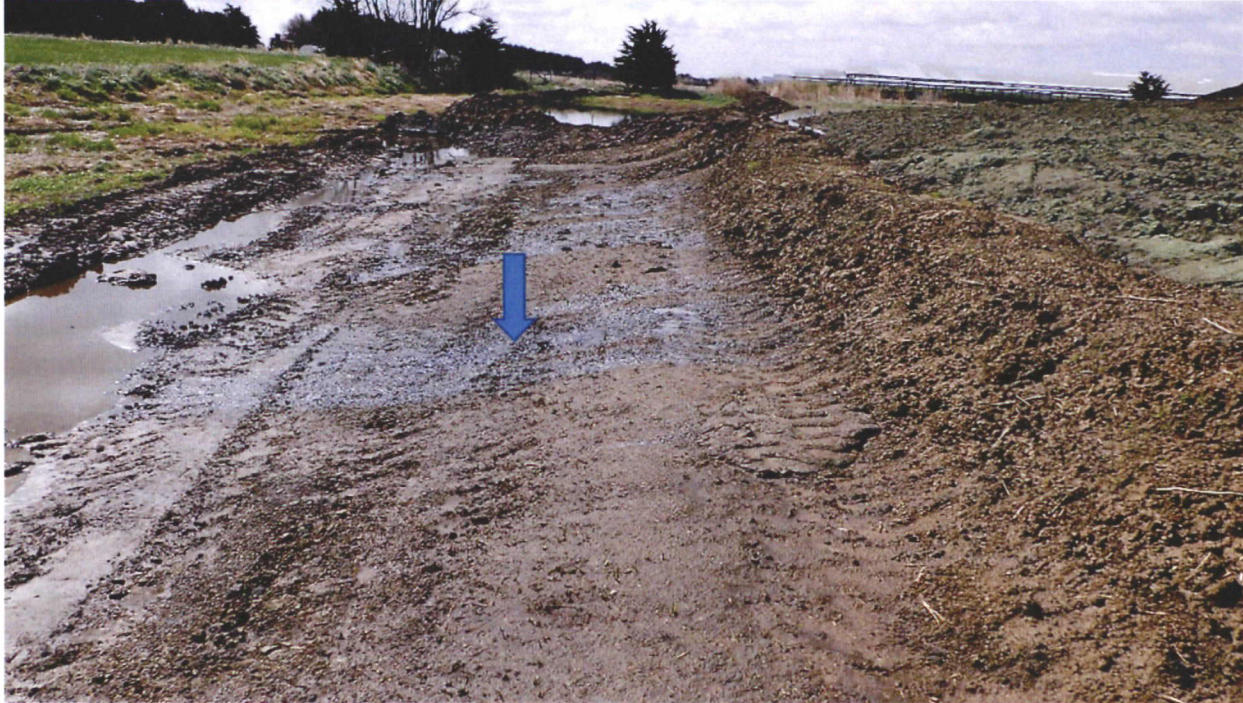
Photo: 11

Description: This photo depicts seepage (arrow).

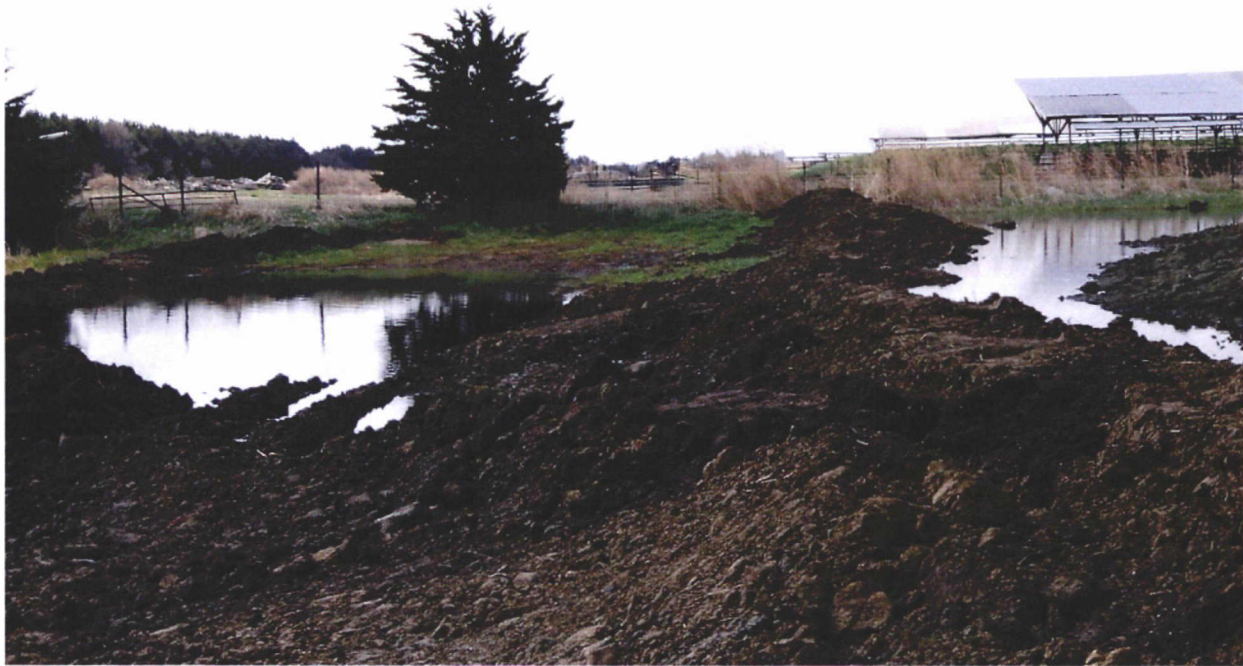
Photo: 12

Description: This photo depicts that berm 1 and 2 are containing water.

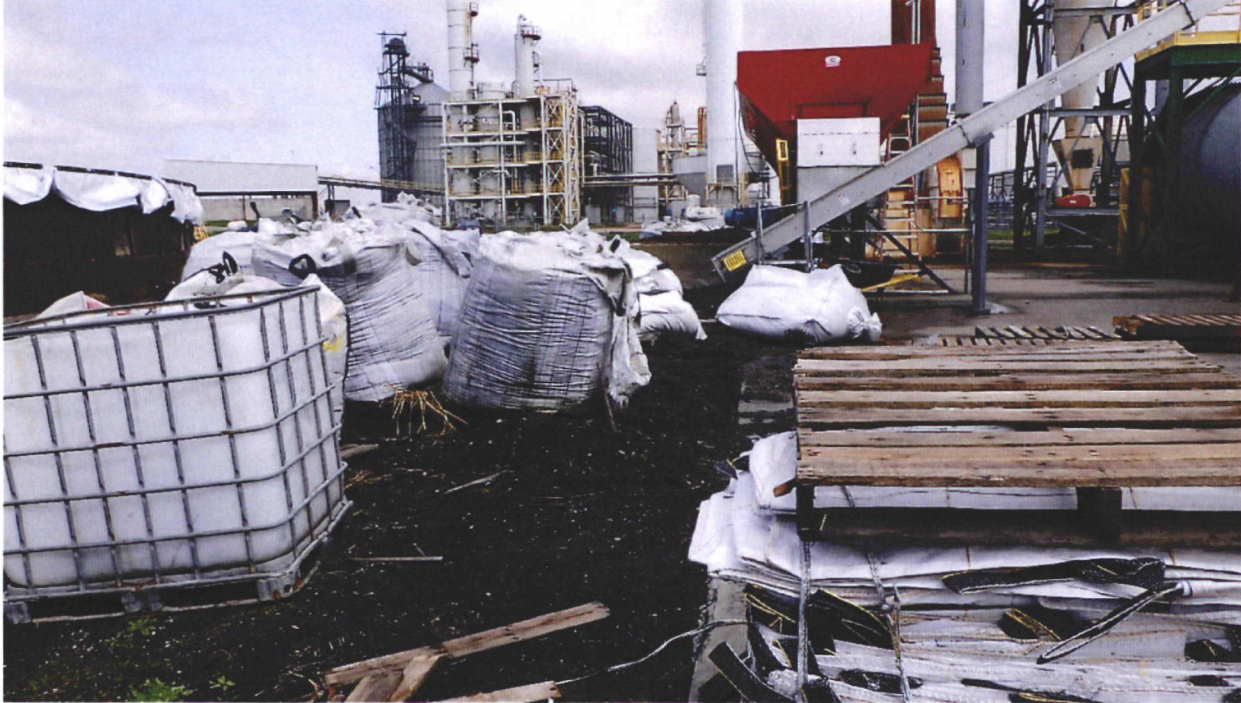
Photo: 13

Description: This photo depicts old bags of biochar.

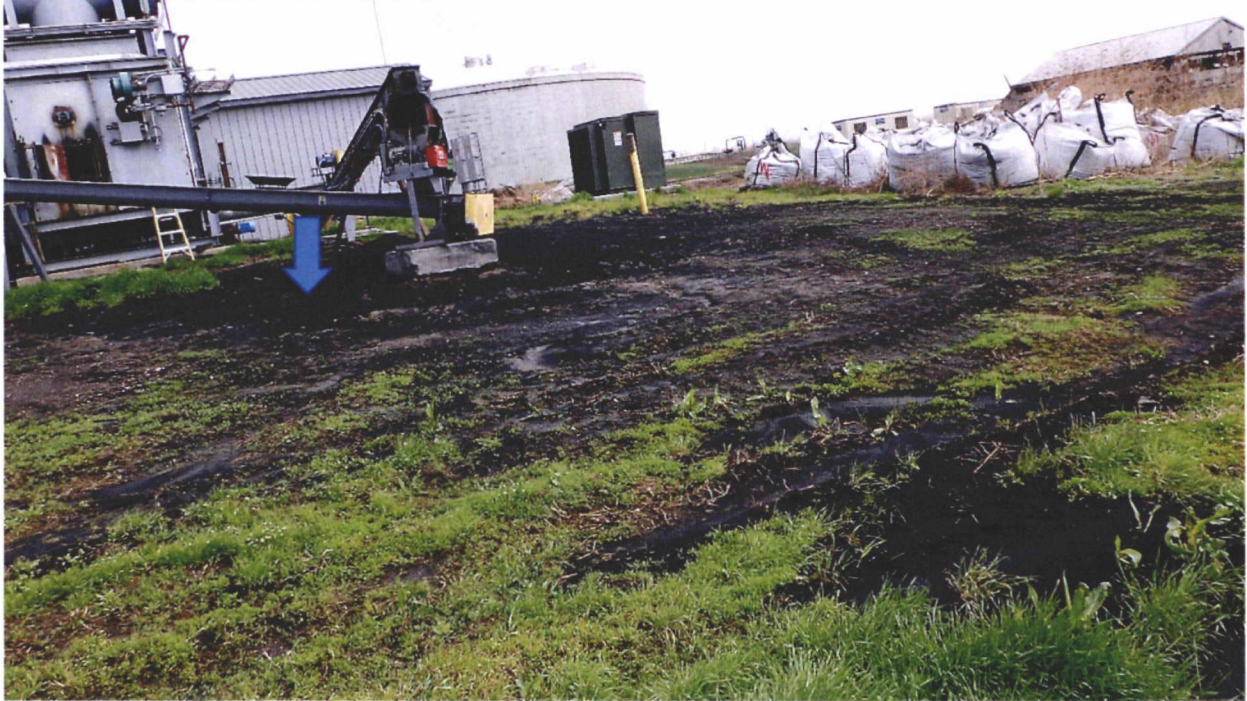
Photo: 14

Description: This photo depicts the area where biochar is bagged. There is spilled biochar around the auger system (arrow).

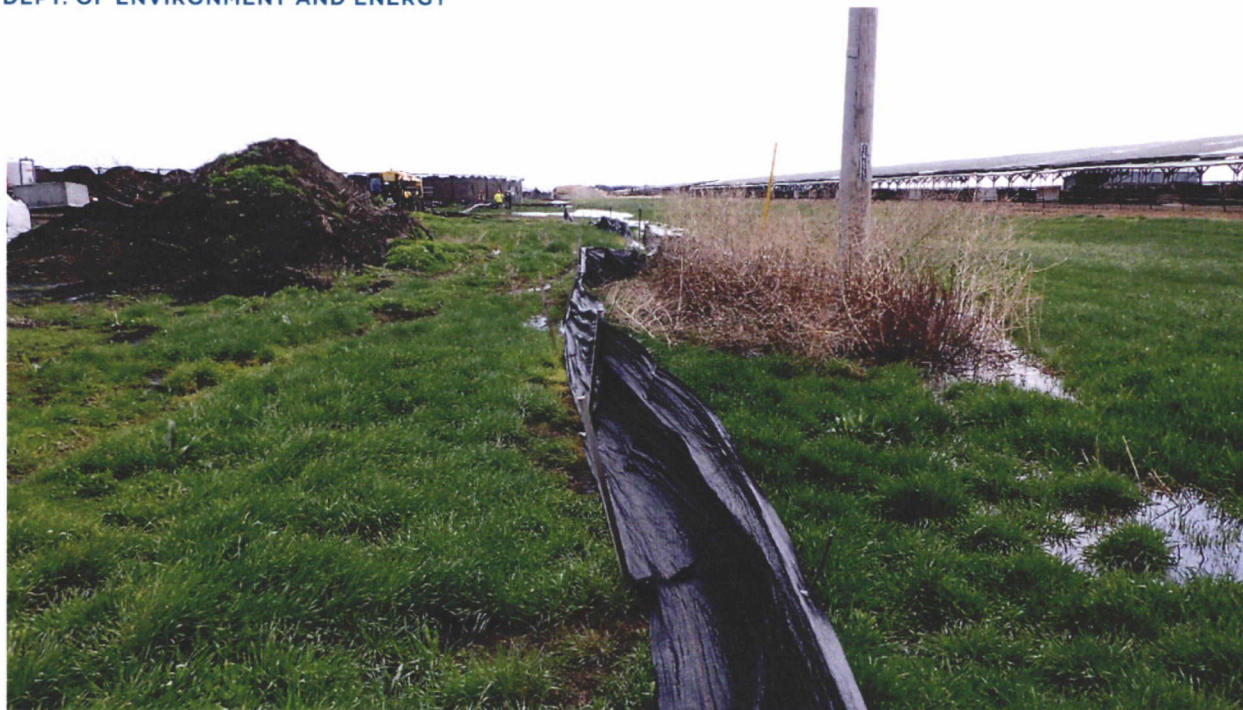
Photo: 14

Description: This photo depicts the silt fence south of the biochar process. The silt fence is not knifed in.

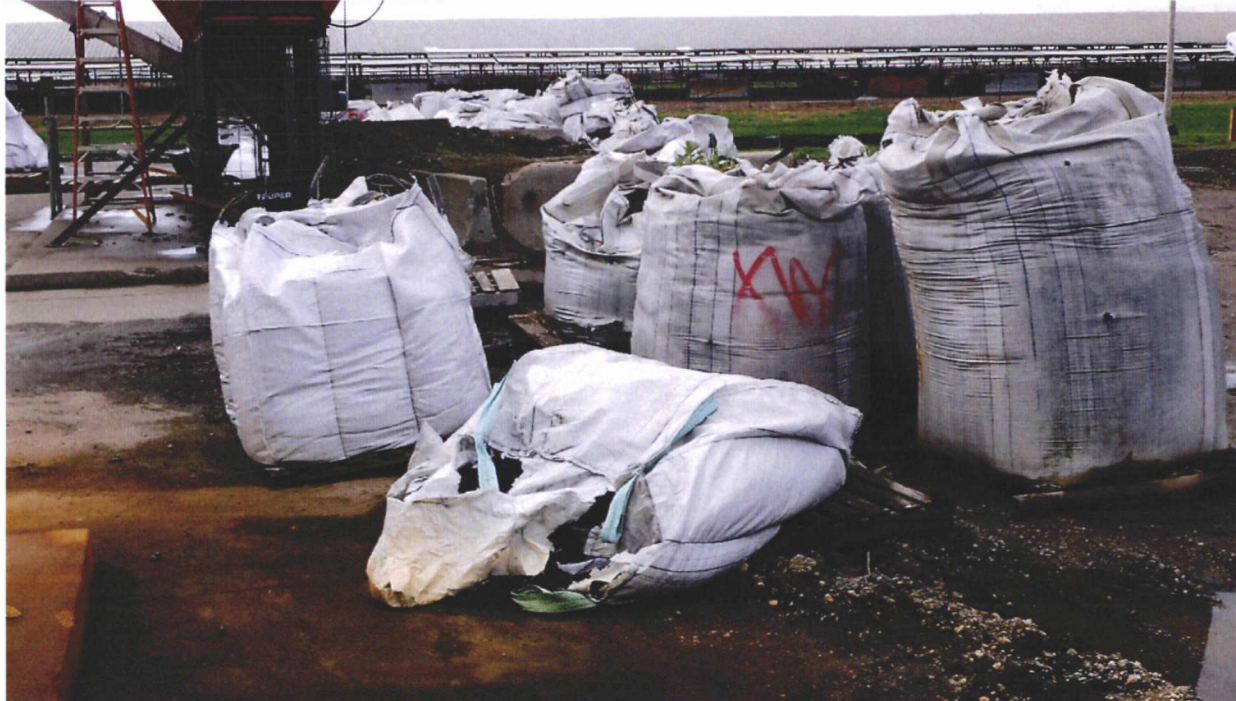
Photo: 15

Description: This photo depicts torn and spilled bags of biochar.

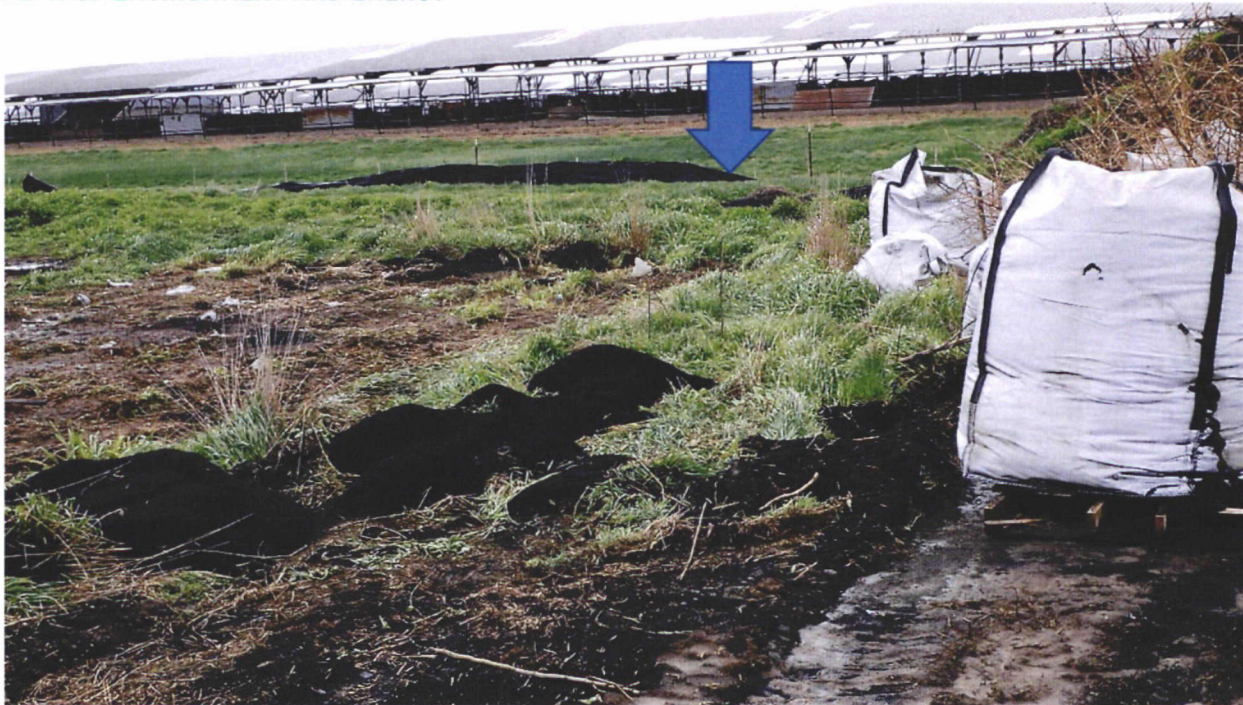
Photo: 16

Description: This photo spilled biochar. Noted the silt fence is not being maintained (arrow).

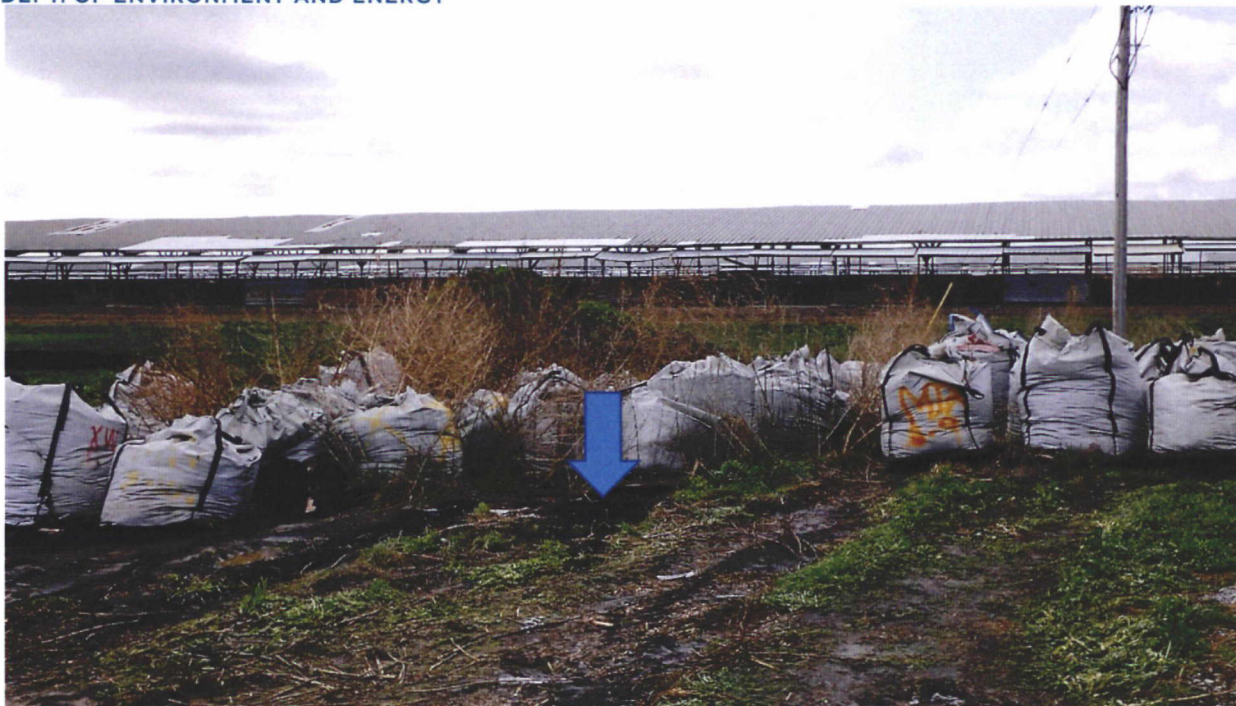
Photo: 17

Description: This photo depicts old biochar supersacks. The facility continues to haul supersacks to the south hoop building. There is also spilled biochar (arrow).

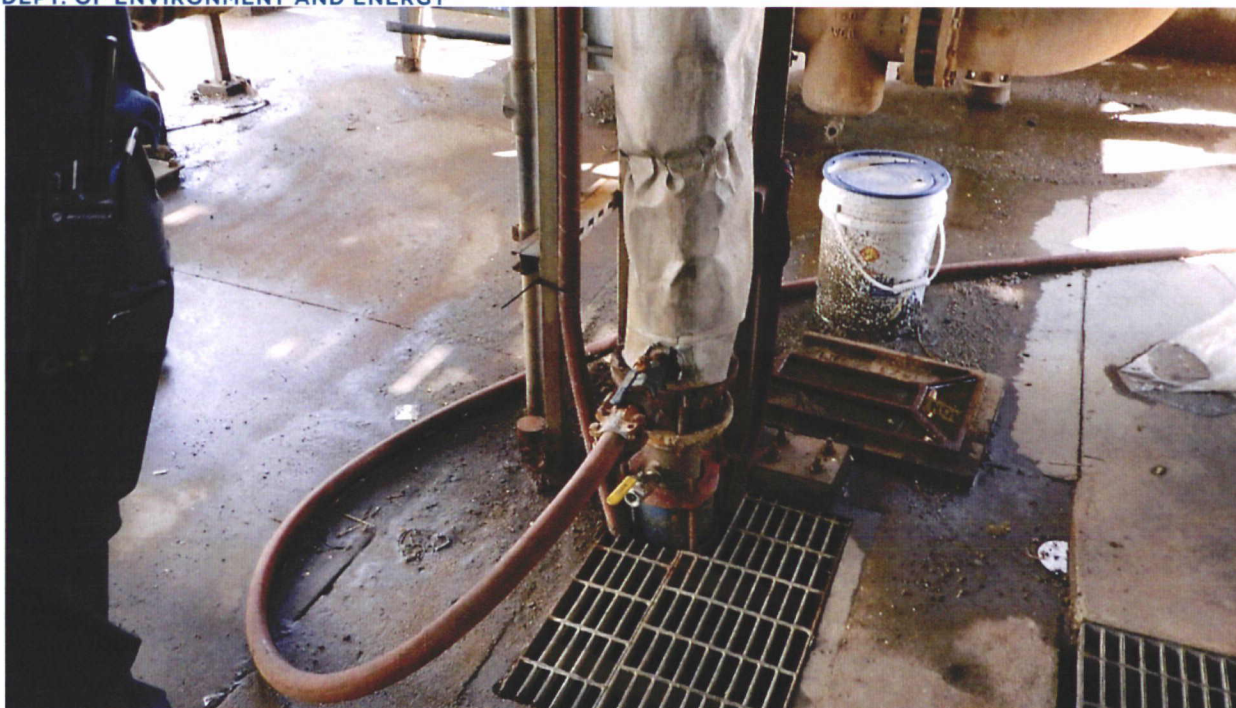
Photo: 20

Description: This photo depicts a sump pump. The site visit on February 5 documented a discharge from this sump. I documented today the sump pump manually pumps storm water.

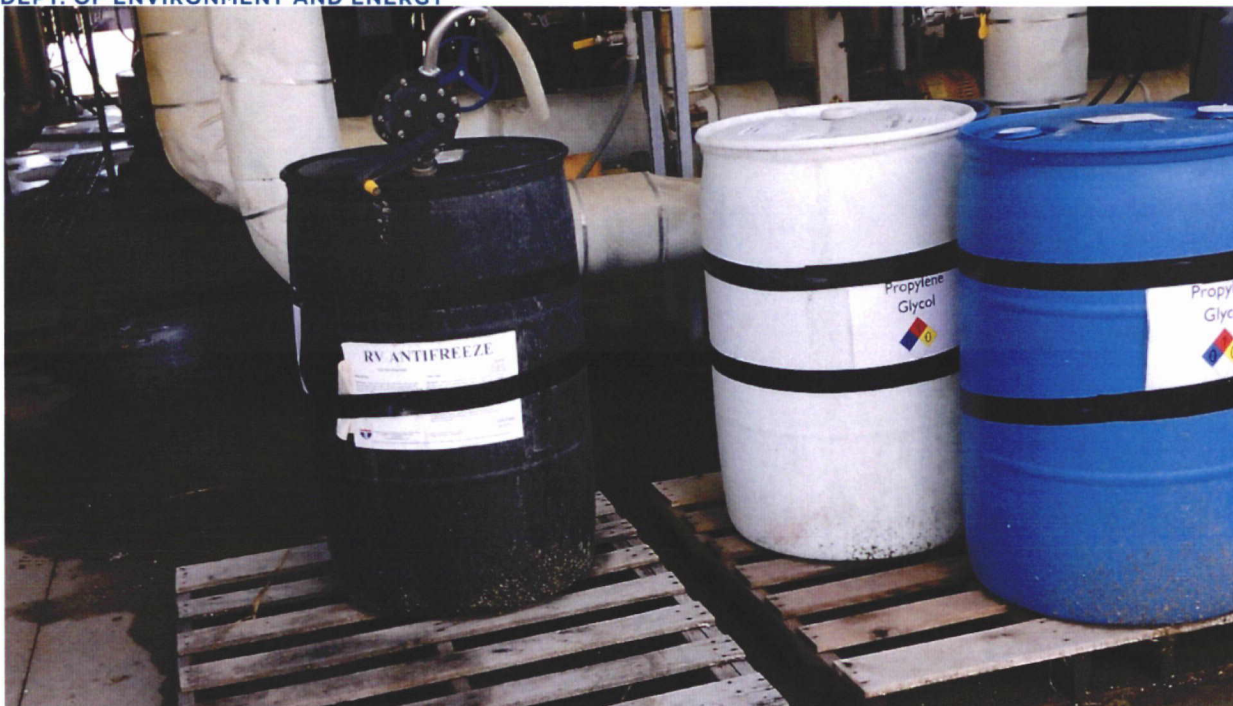
Photo: 21

Description: There are chemical totes stored near the sump pumping area. This photo depicts antifreeze and Propylene Glycol.

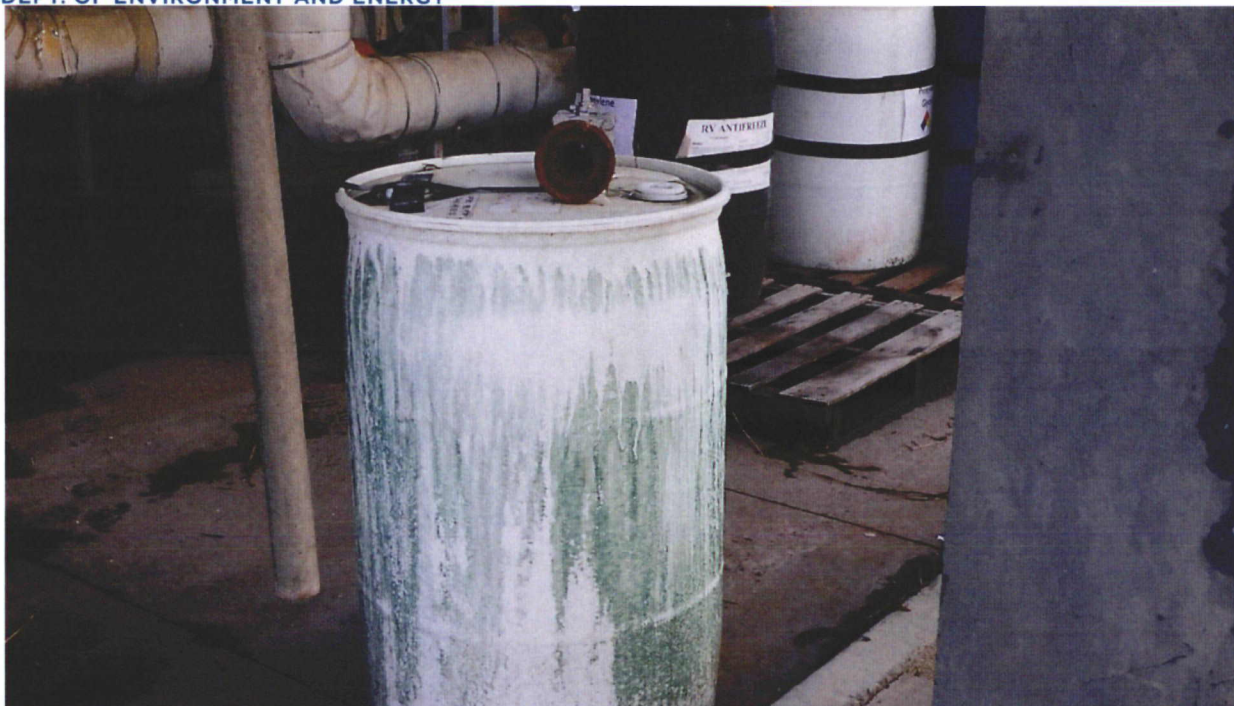
Photo: 22

Description: This an unknown chemical tote. The tote contains residual chemical.

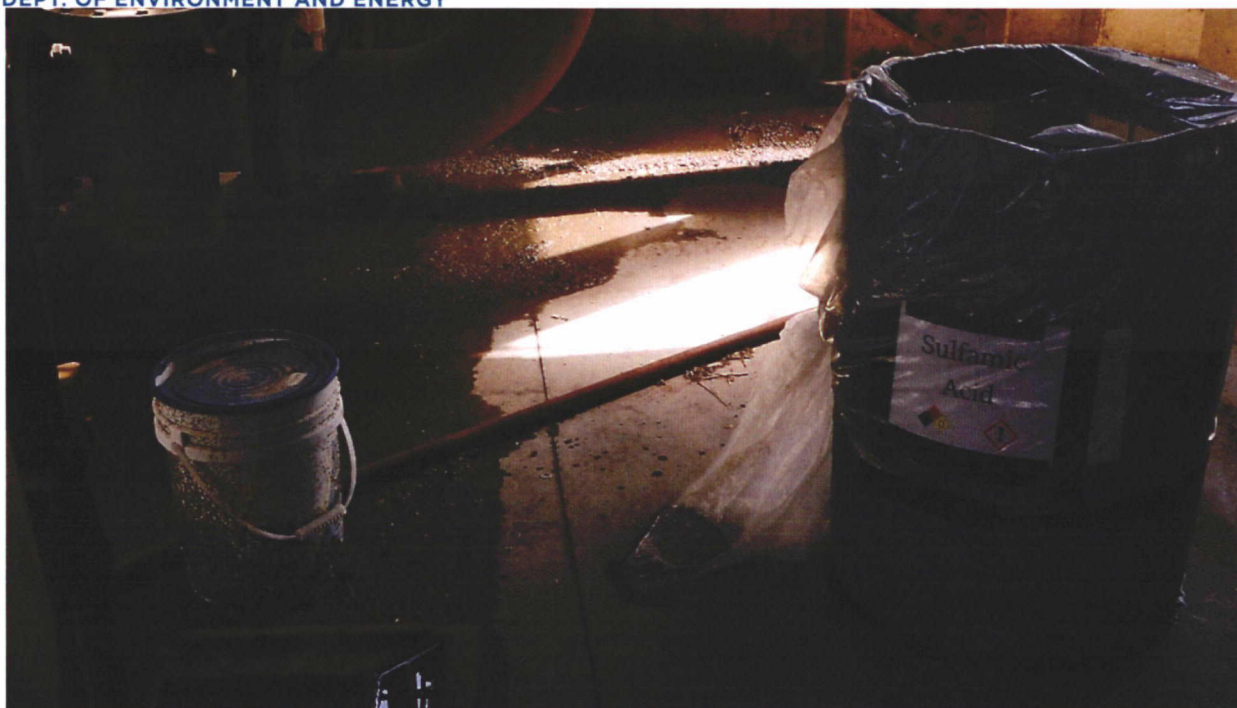
Photo: 23

Description: This photo depicts oil and grease (arrow) and a tote of Sulfamic Acid.

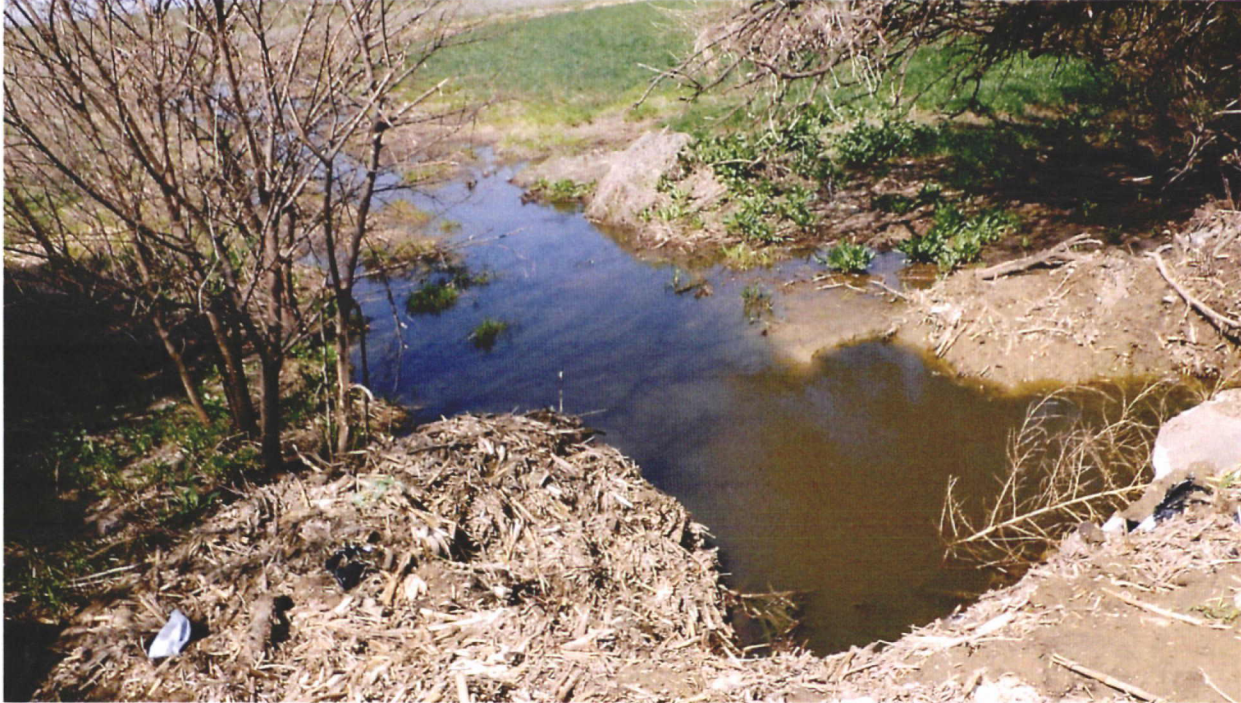
Photo: 24

Description: This photo depicts the culvert at County Road 9 and J. The flow appears to be lighter color today.

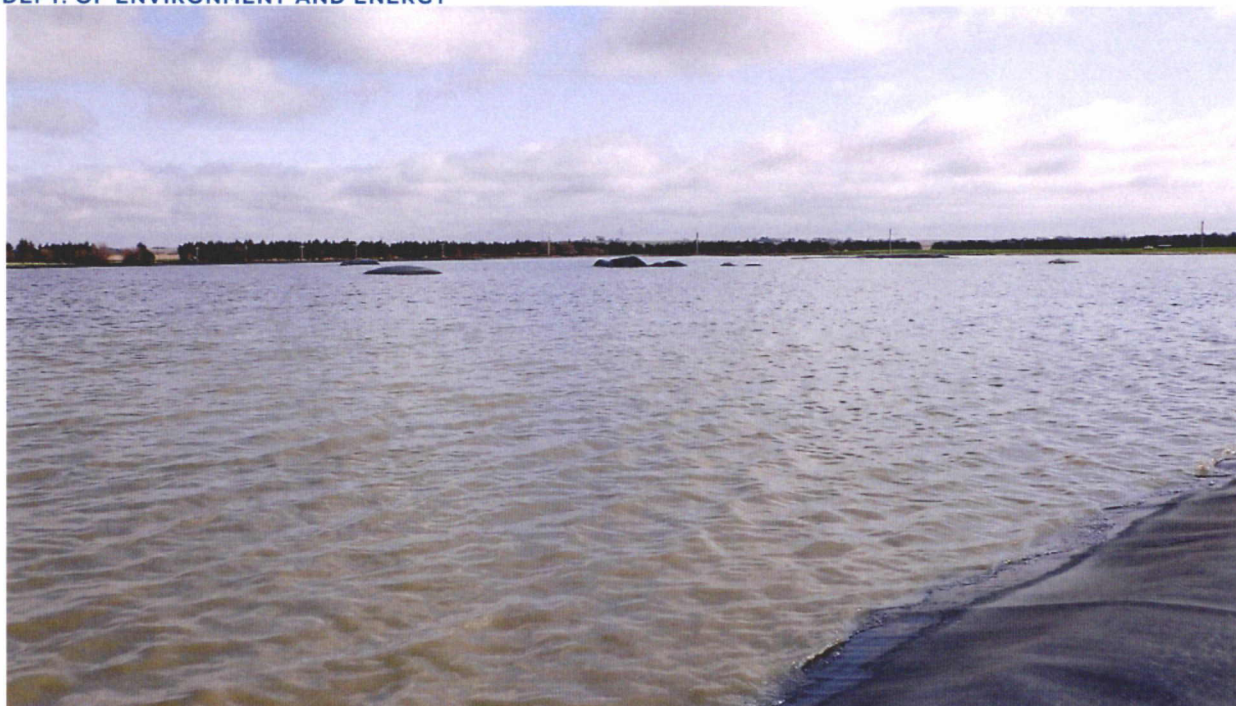
Photo: 26

Description: This photo depicts floating liners in the northeast lagoon.
