Facility: AltEn
IIS: 84069
PCS: NE0137634

Mark Pomajzl
4/23/2021

Site Visit Check list

Site Visit Report

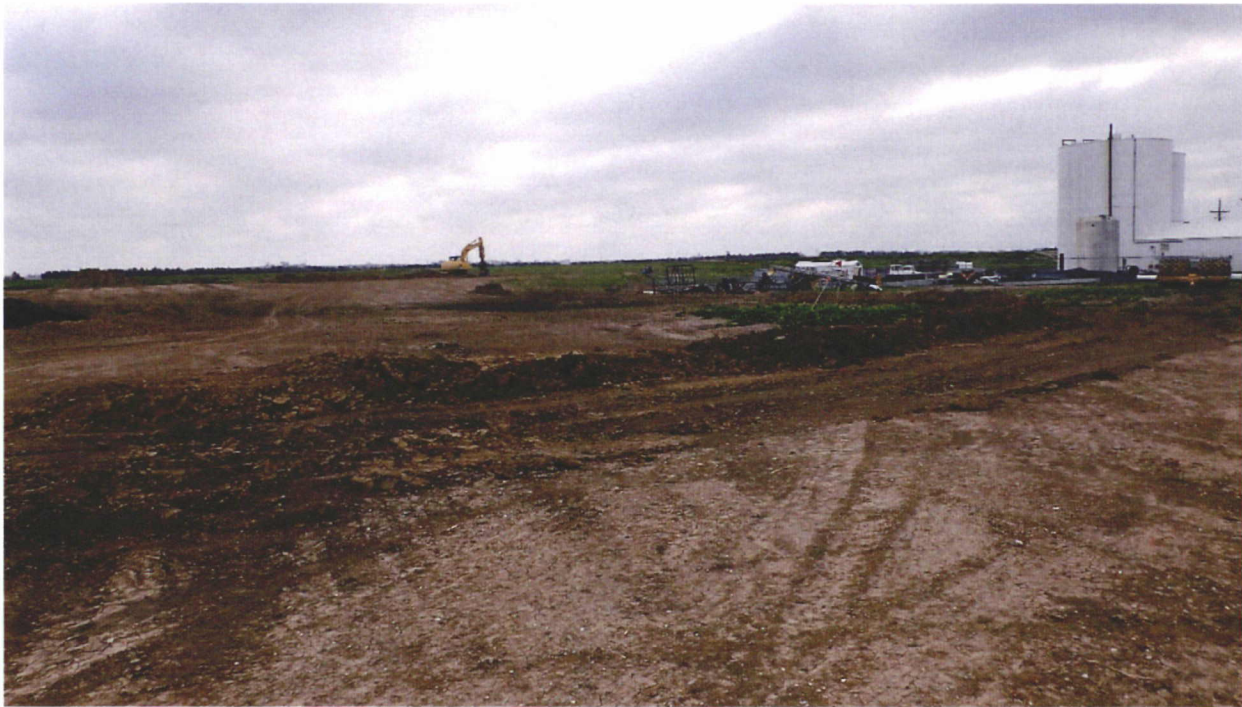
Photo: 1

Description: This photo depicts Area 1. This is the east berm. The berm has been extended south to reduce the amount of storm water from entering the berm.

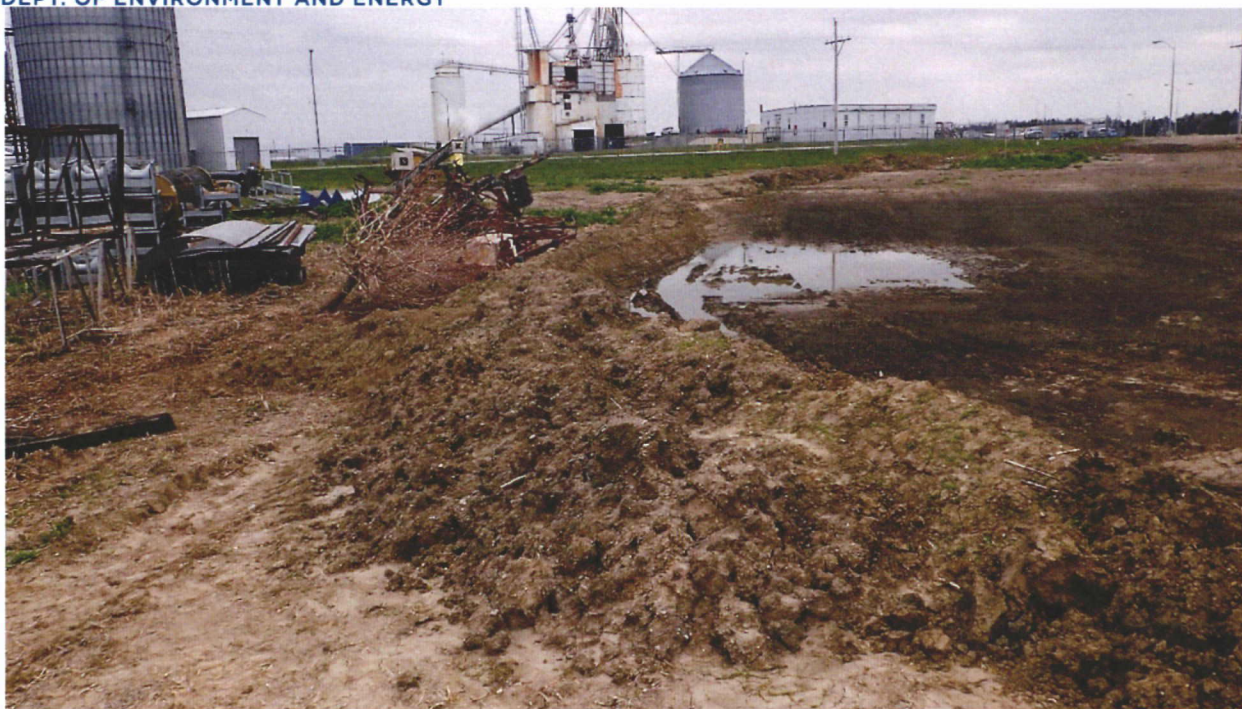
Description: This photo depicts the east berm on Area 1. There is only minimal water accumulation.

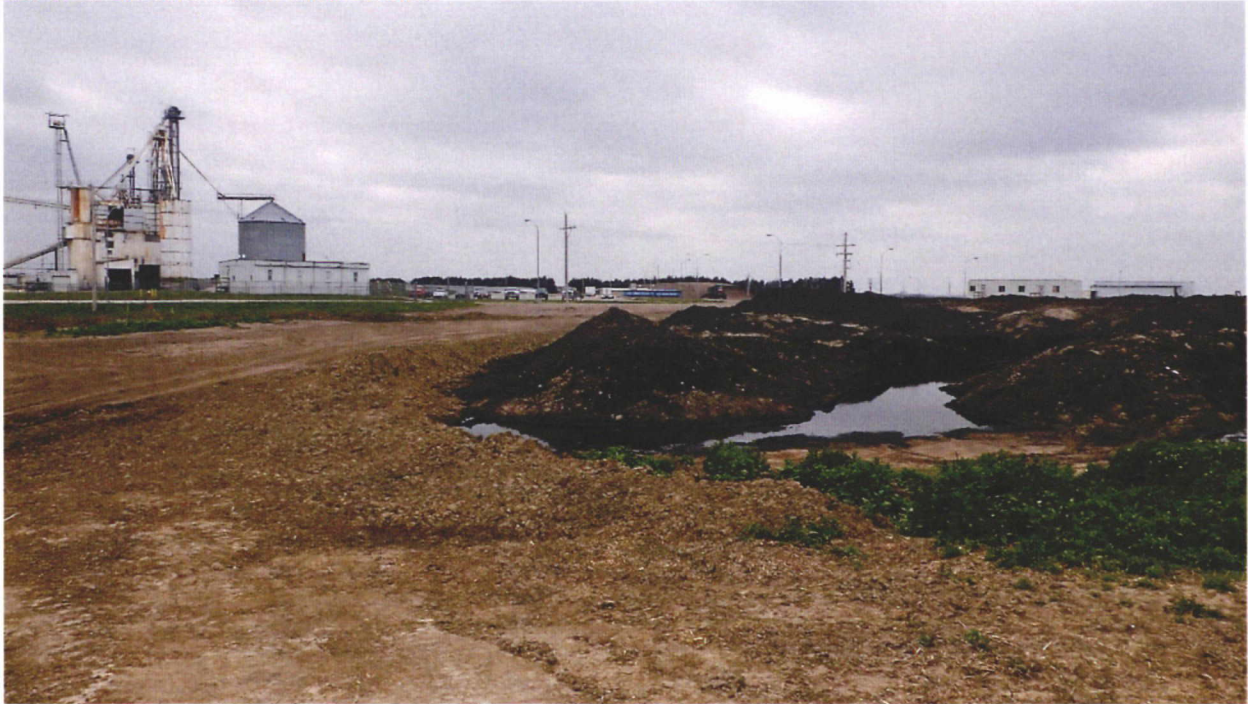
Photo: 3

Description: This photo is the west berm. This berm contains the south wet cake pile. There is minor accumulation and no seepage observed.

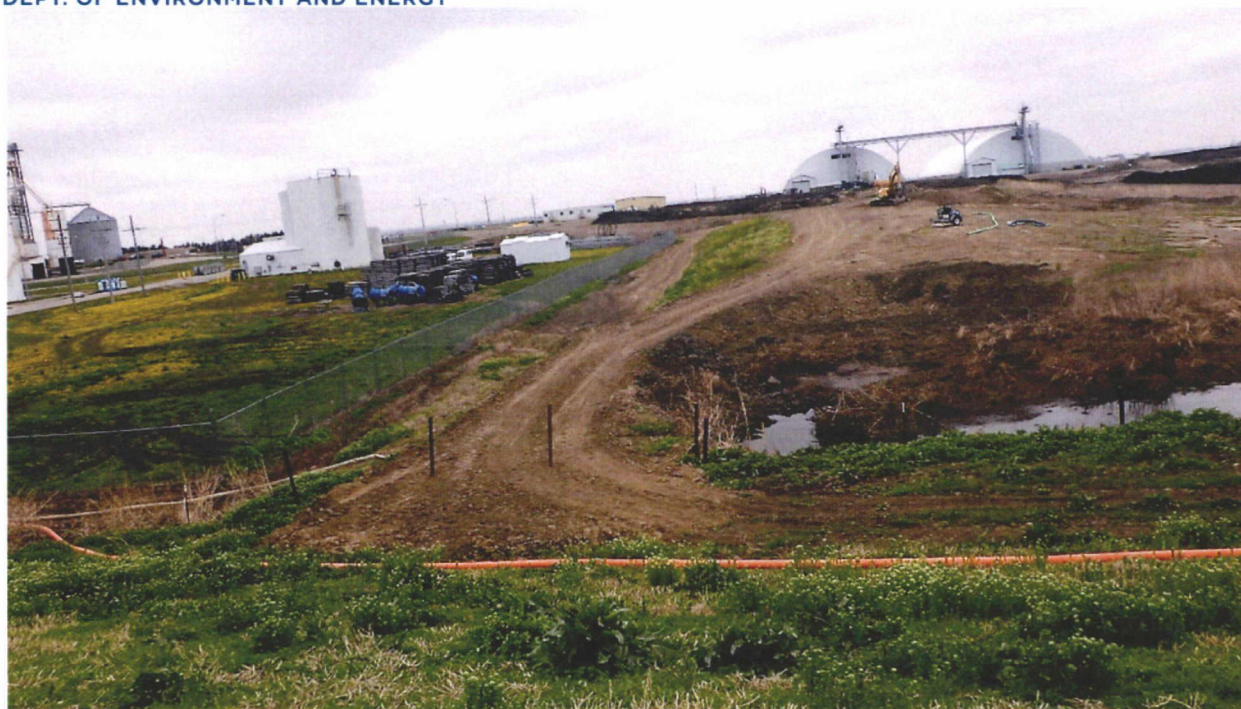
Photo: 4

Description: This photo is the southwest side of the south lagoon. The facility has recompacted the area and installed a gate.

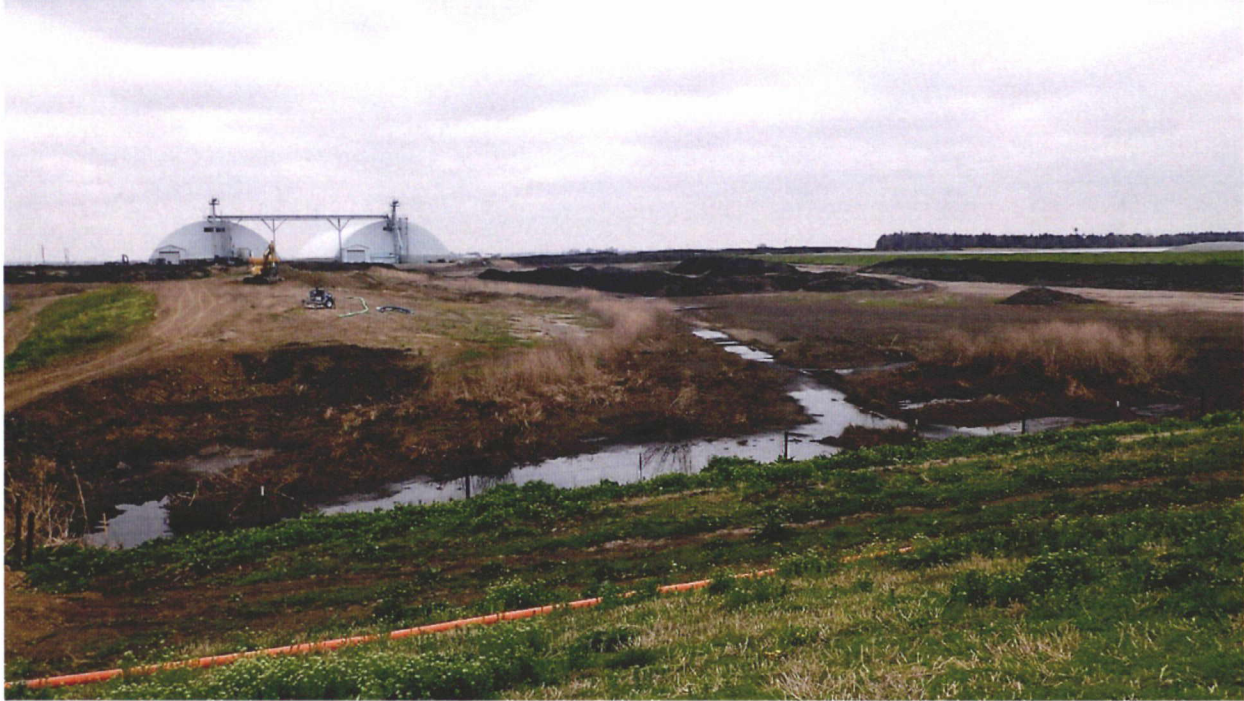
Photo: 5

Description: This photo is the southwest side of the south lagoon. There is some water accumulation and no seepage observed.

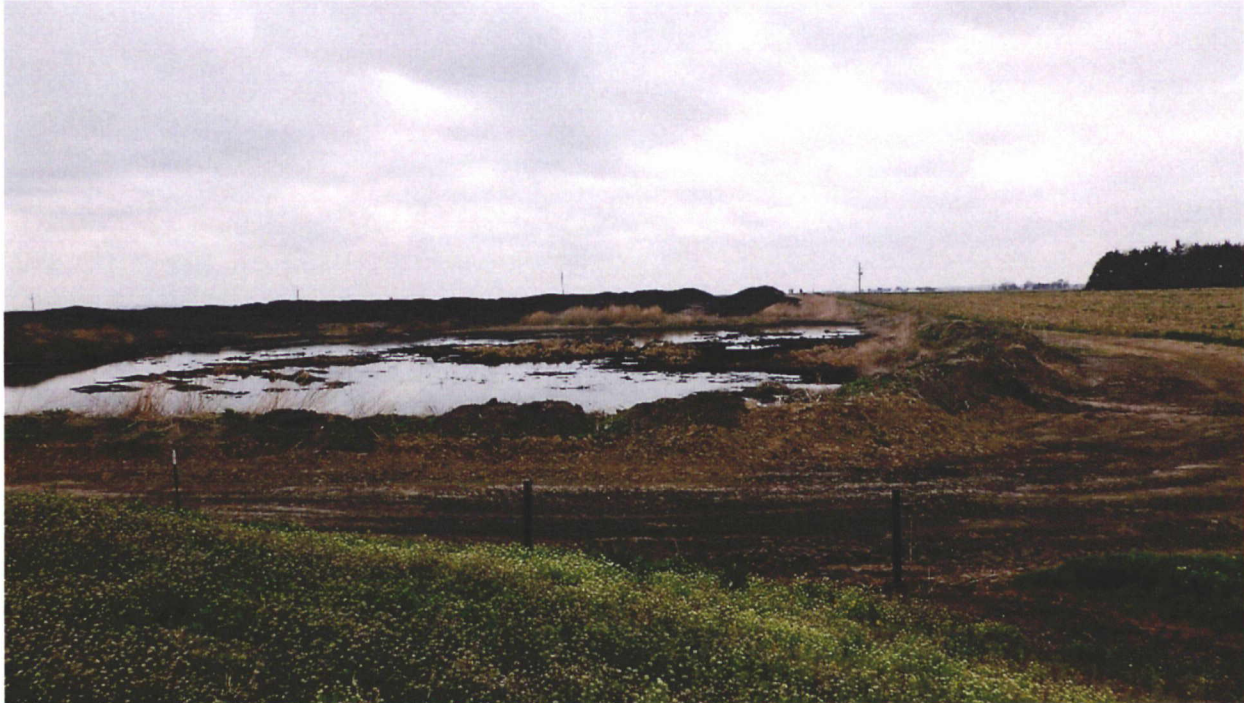
Photo: 6

Description: This photo depicts water accumulation. There are no signs of seepage.

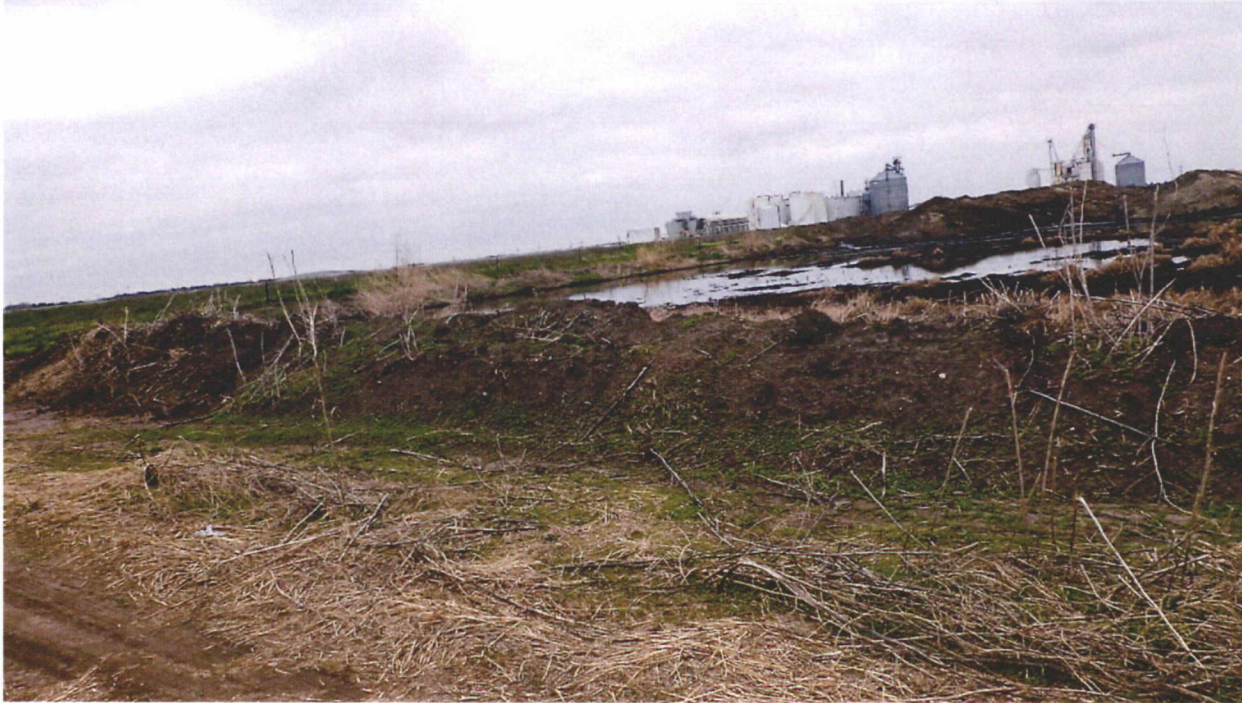
Photo: 7

Description: This photo depicts the north side of the Area 3 berm. There is no seepage observed.

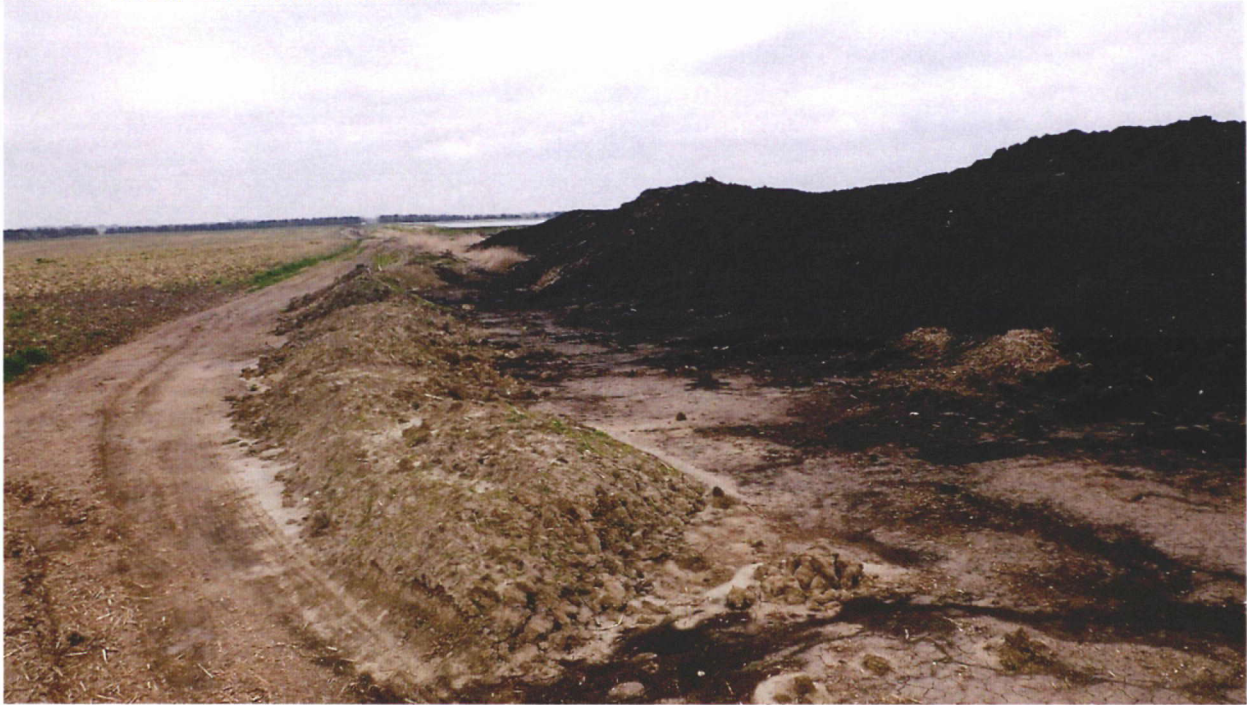
Photo: 8

Description: There is no water accumulation observed.

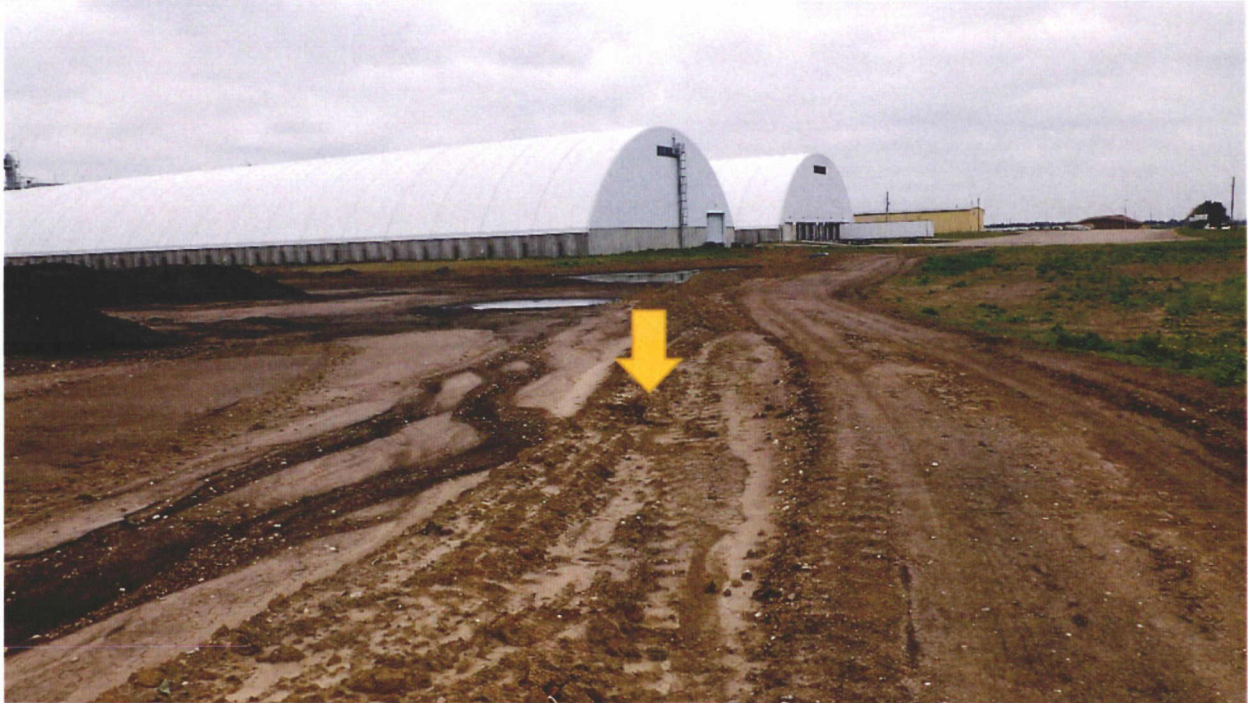
Photo: 9

Description: This is the north side of the Area 5. The berm needs to be reinforced (arrow).

Inspection Date: 4-23-21 Start Time: 10:05 End Time: 12:02☐ No concerns observed☐ Further agency discussion needed to determine compliance☒ Concerns observed:Area 1 - OK *MEAD Cattle Washout - DischargingArea 2 - OK, new gate (closed) to ALLEN propertyArea 3 - OKArea 4 - OKArea 5 - OK (Needs to be reinforced)Area 6 -> Some Seepage observed *MT. Egr remains Some wet cake*South Lagoon - ~~Some~~ OK *Northwest - Two Whales - no change*Northeast Lagoon - OK *Buchan ^{area} needs to be cleared☒ Actions to be performed immediately or as soon as reasonably practical:- Clean Buchan Area (Housekeeping)- Monitor Seepage at Area 6- Recompact portions of Area 5 - North side of Containment

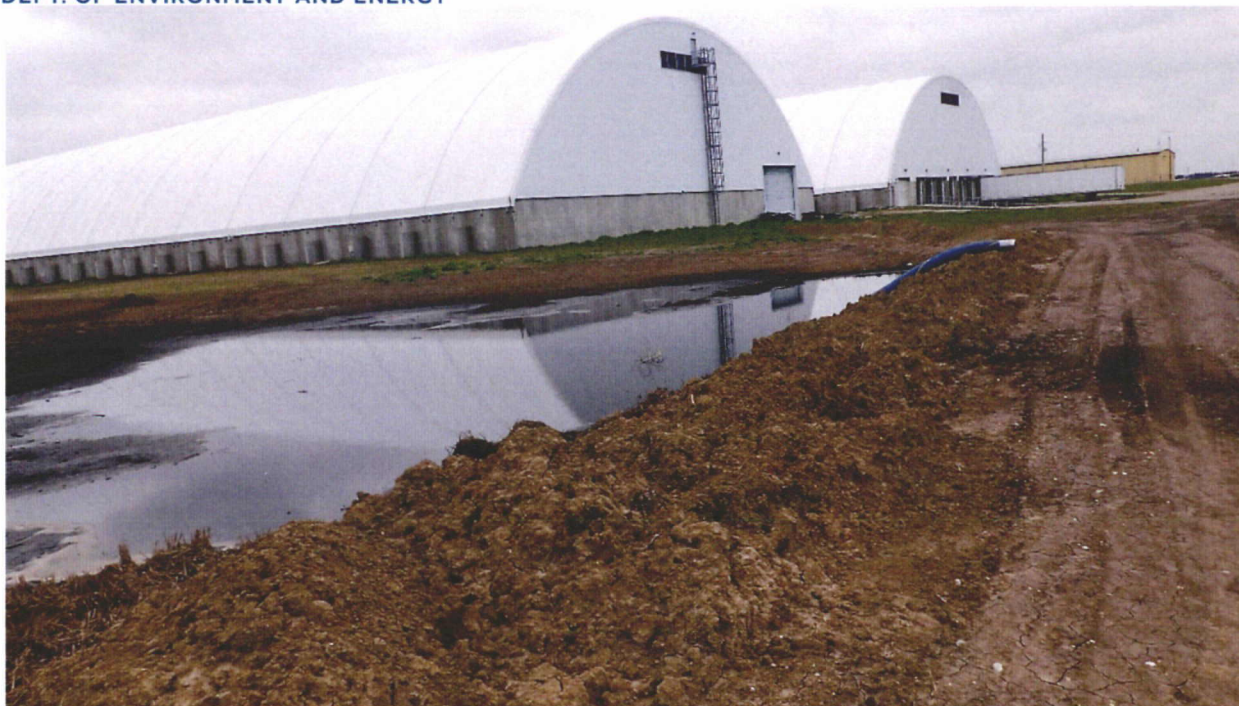
Photo: 10

Description: There is some water accumulation from the previous rain event. There is no seepage observed.

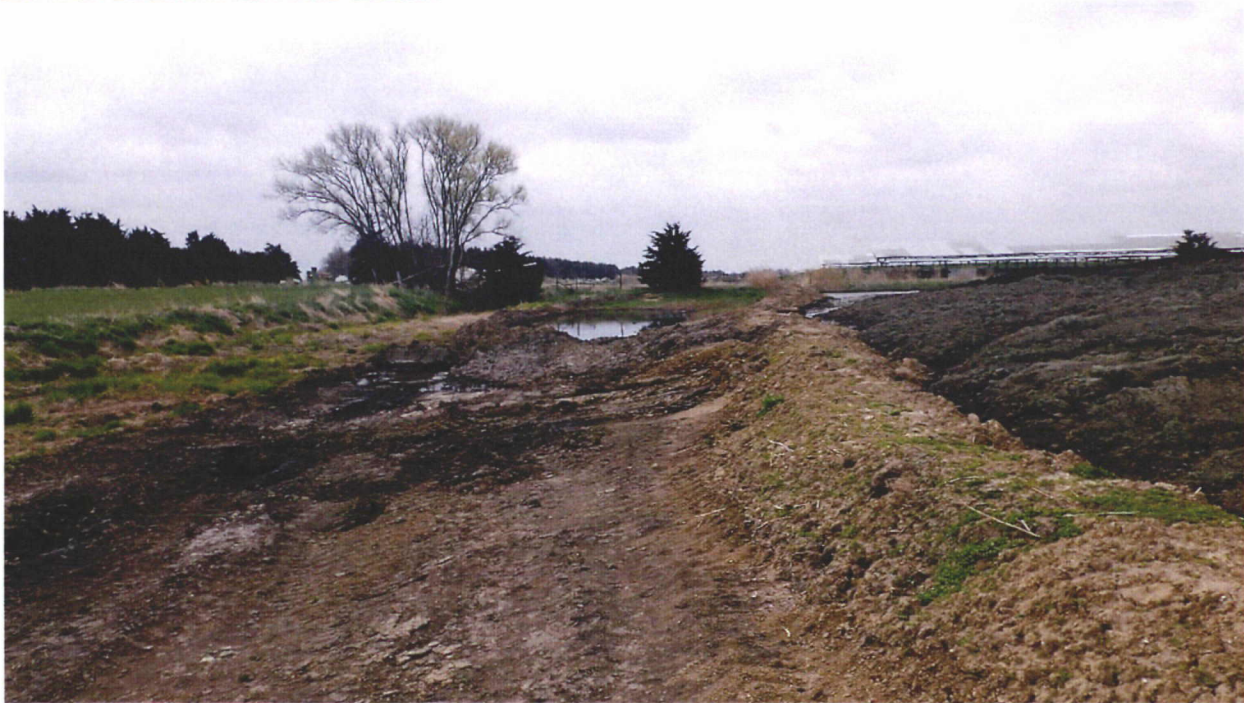
Photo: 11

Description: There is minor signs of seepage. The facility is mixing accumulated water with wet and then hauling to the west storage area.

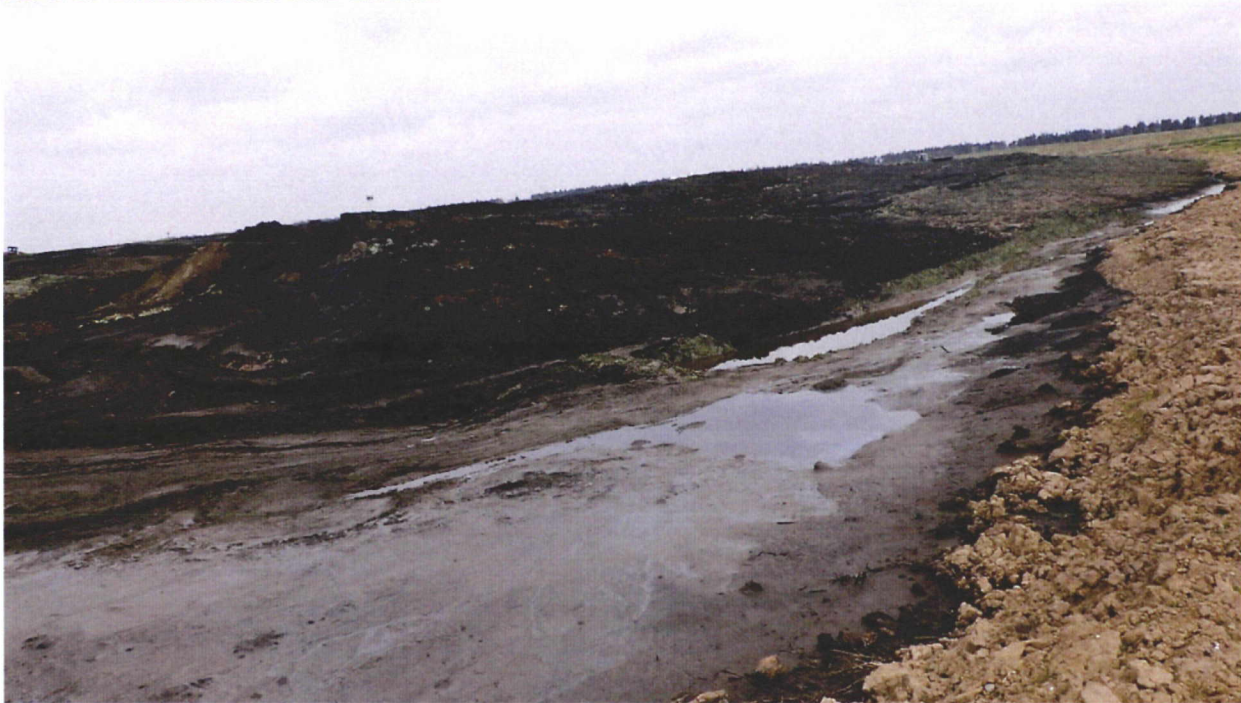
Photo: 12

Description: The facility is mixing accumulated water with wet cake and hauling to the west storage area. This photo depicts that the water levels are beginning to recede.

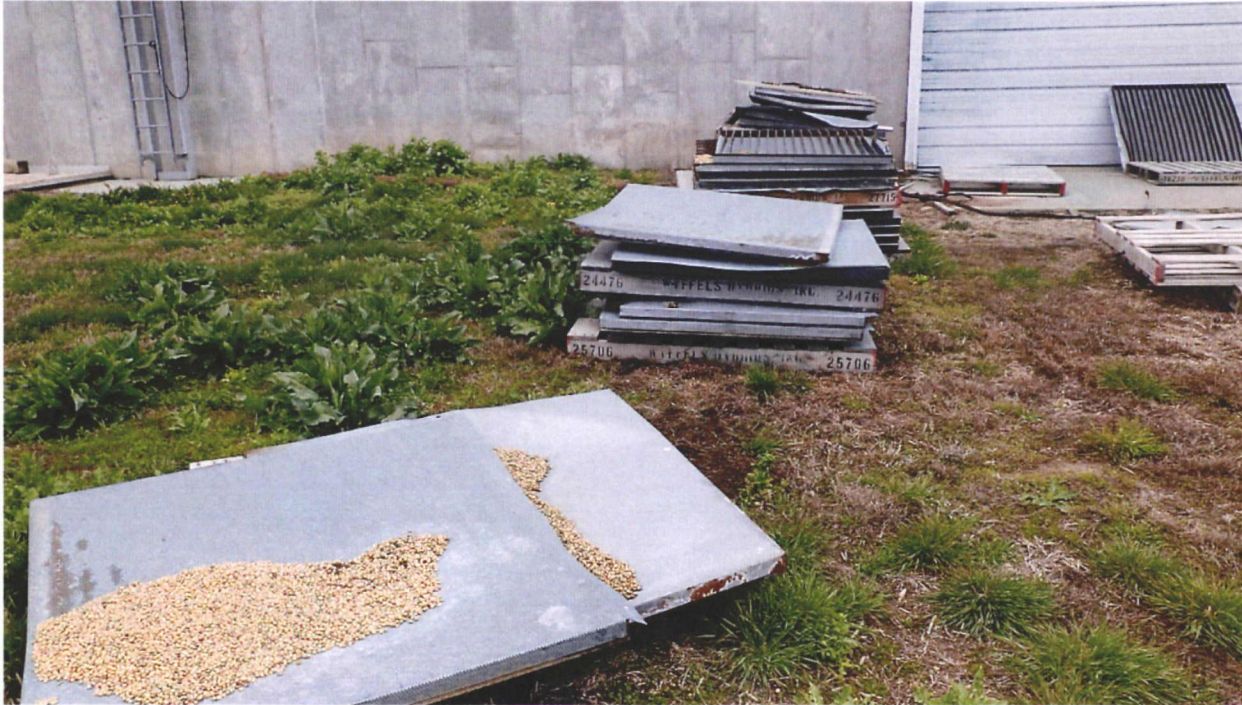
Photo: 13

Description: This photo depicts filter/sieves? There is residual grain dust and grain on these items.

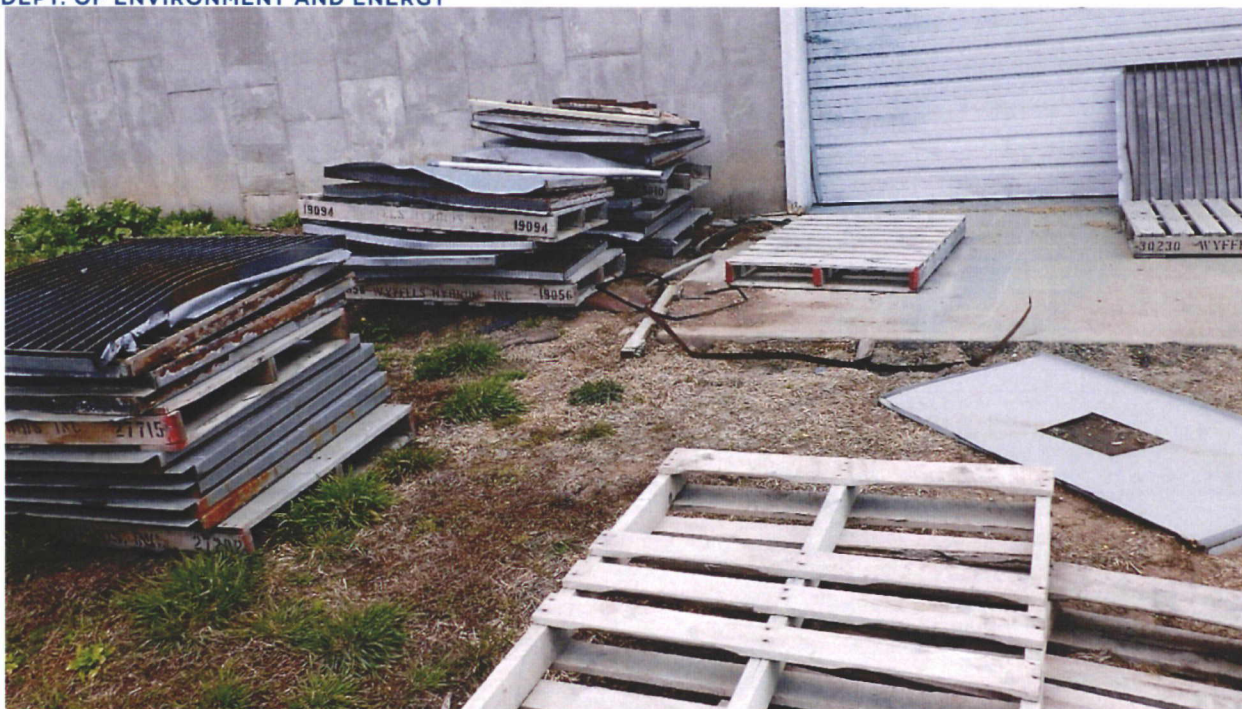
Photo: 14

Description: This photo depicts filter/sieves? There is residual grain dust and grain on these items.

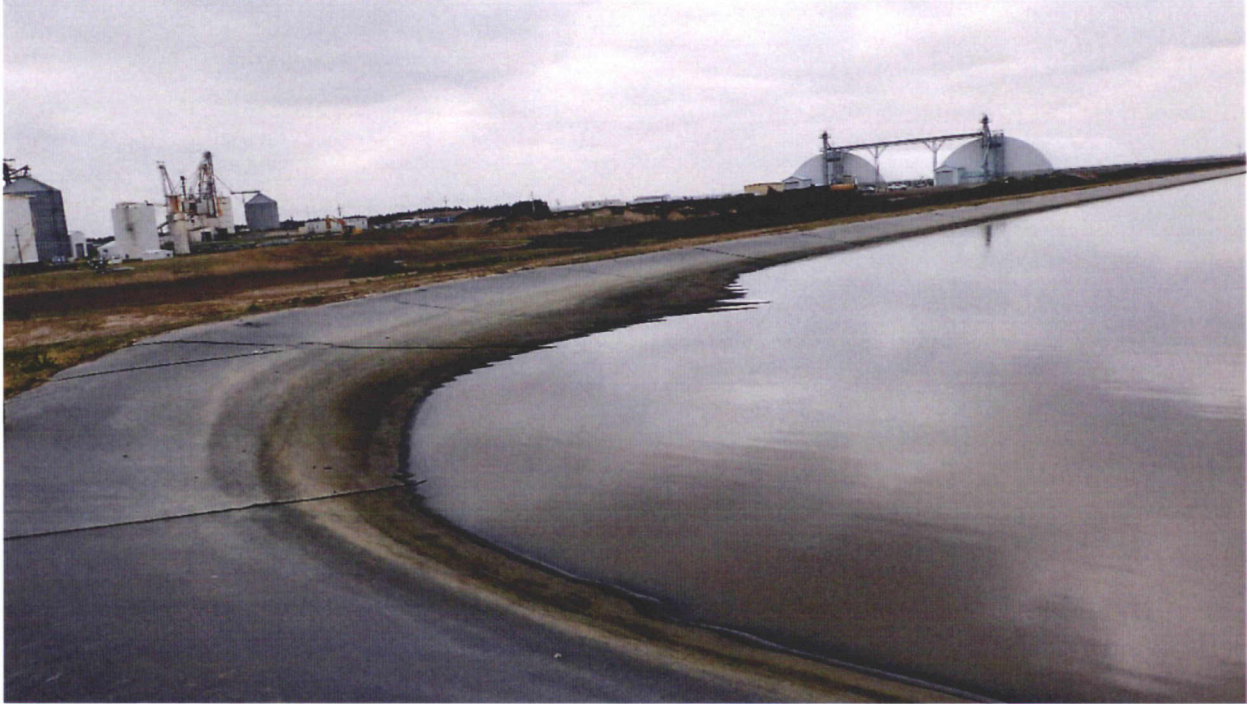
Photo: 15

Description: This photo depicts that the lagoon level continues to lower.

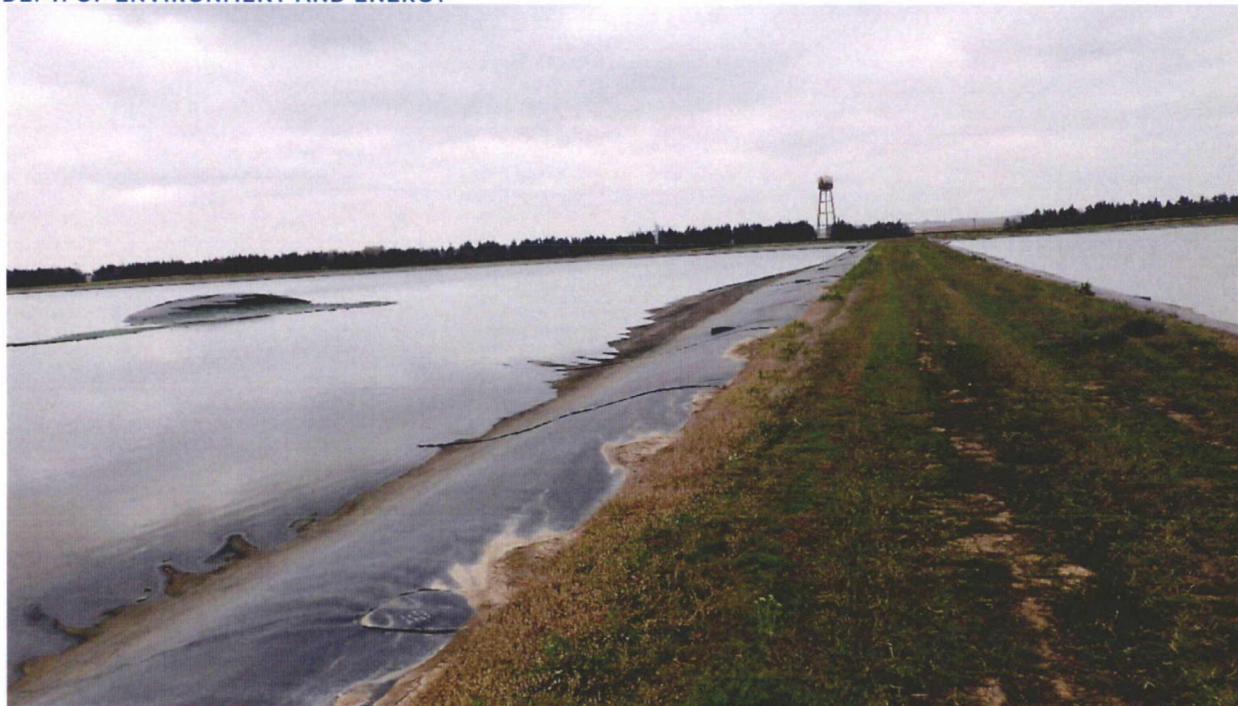
Photo: 16

Description: This photo depicts lowering levels.

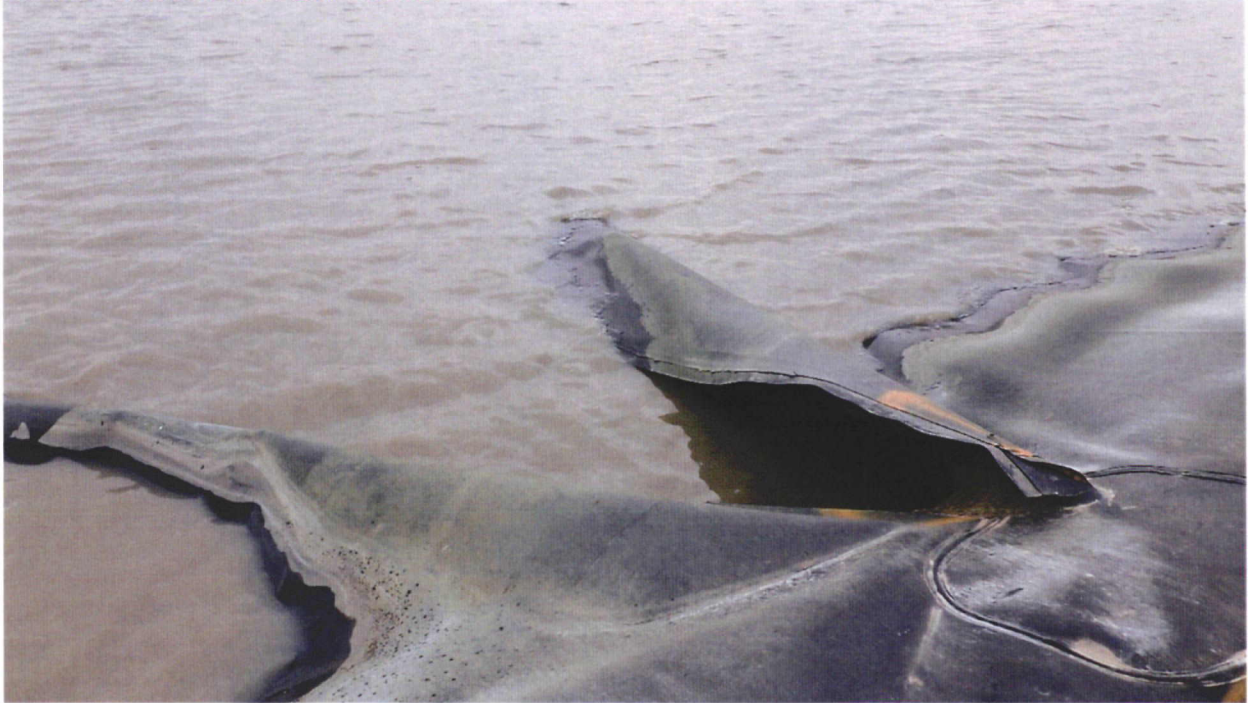
Photo: 17

Description: This photo depicts are tear in the liner. **Please see next photo.**

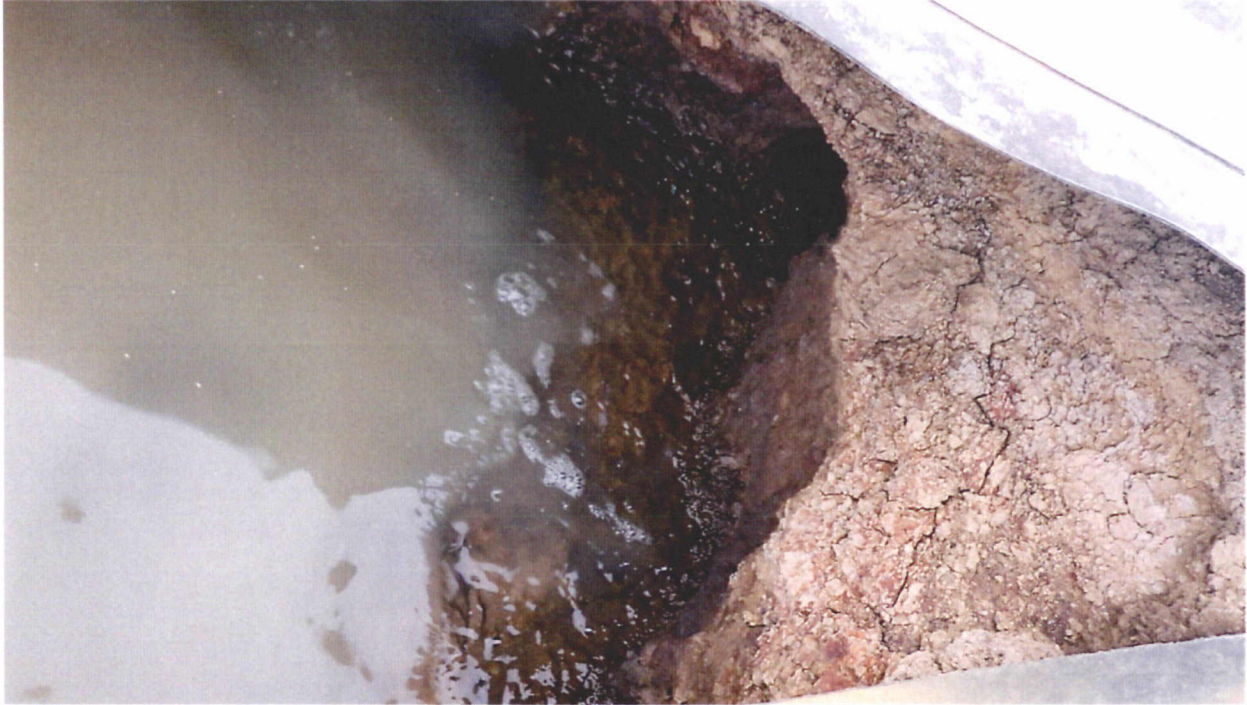
Photo: 18

- The water level continues to lower. There is erosion observed behind torn liner on the north dike of the northeast lagoon (see photo log).

Description: This photo depicts behind the torn liner. There is an area of erosion observed.

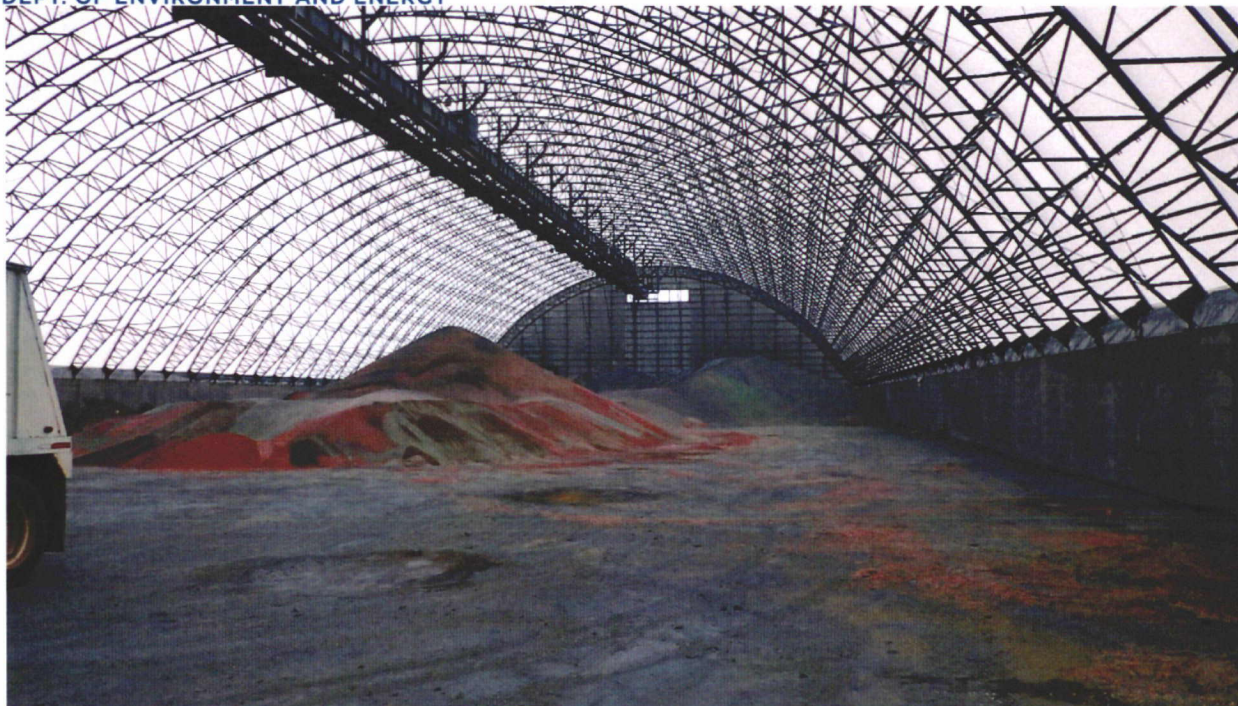
Photo: 22

Description: This is a photo of a left-over pile of seed corn inside the north hoop building.

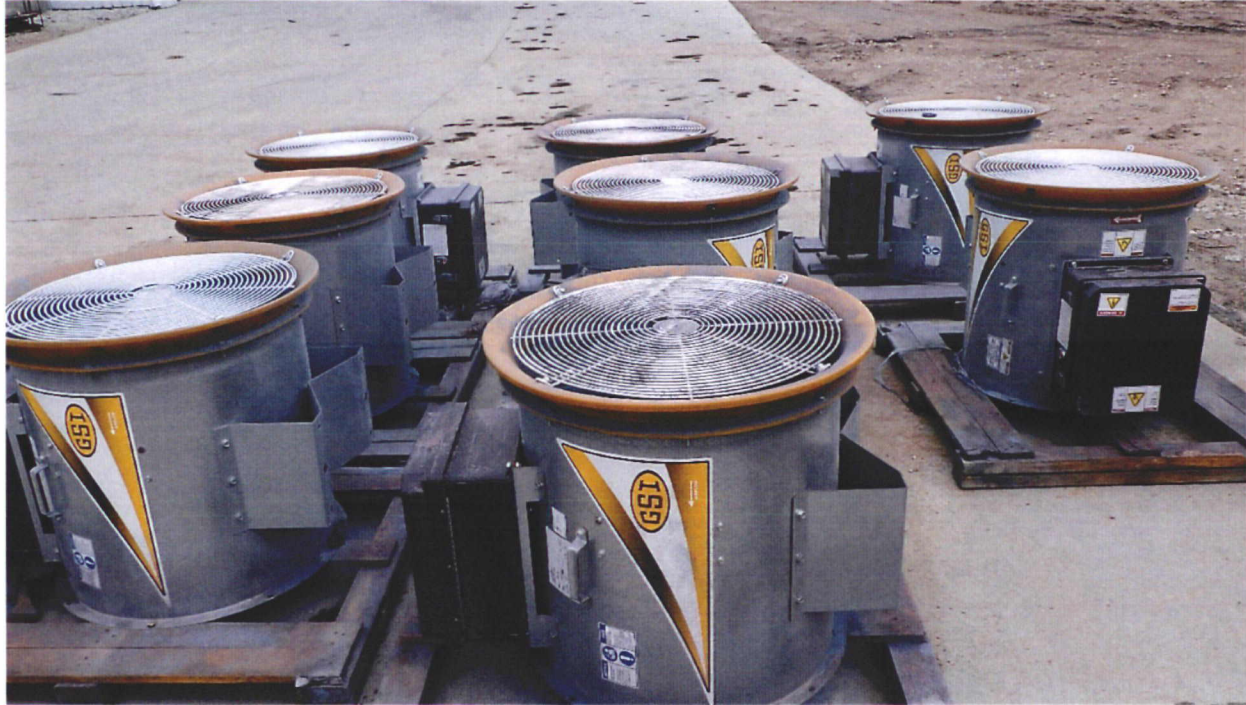
Photo: 24

Description: These are fans that according to Mr. Peterson had never been installed. Mr. Peterson stated that the facility is going to be selling them.

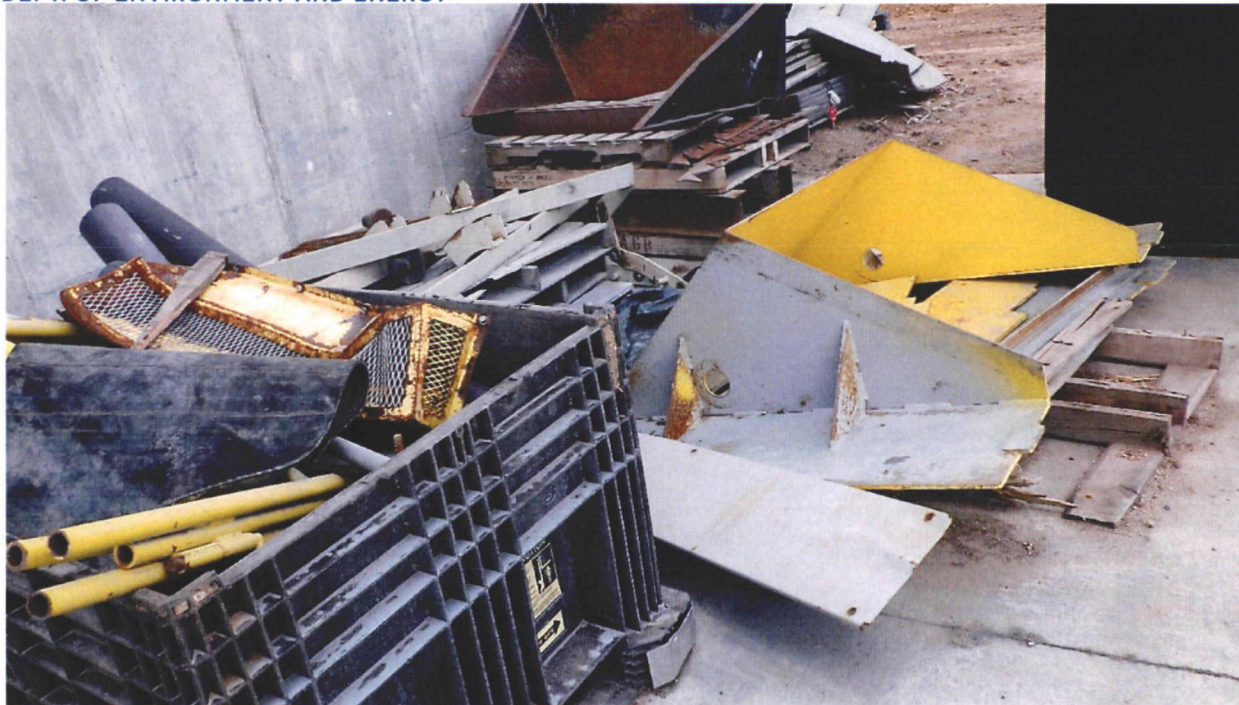
Photo: 25

Description: Trash and debris outside the hoop building.

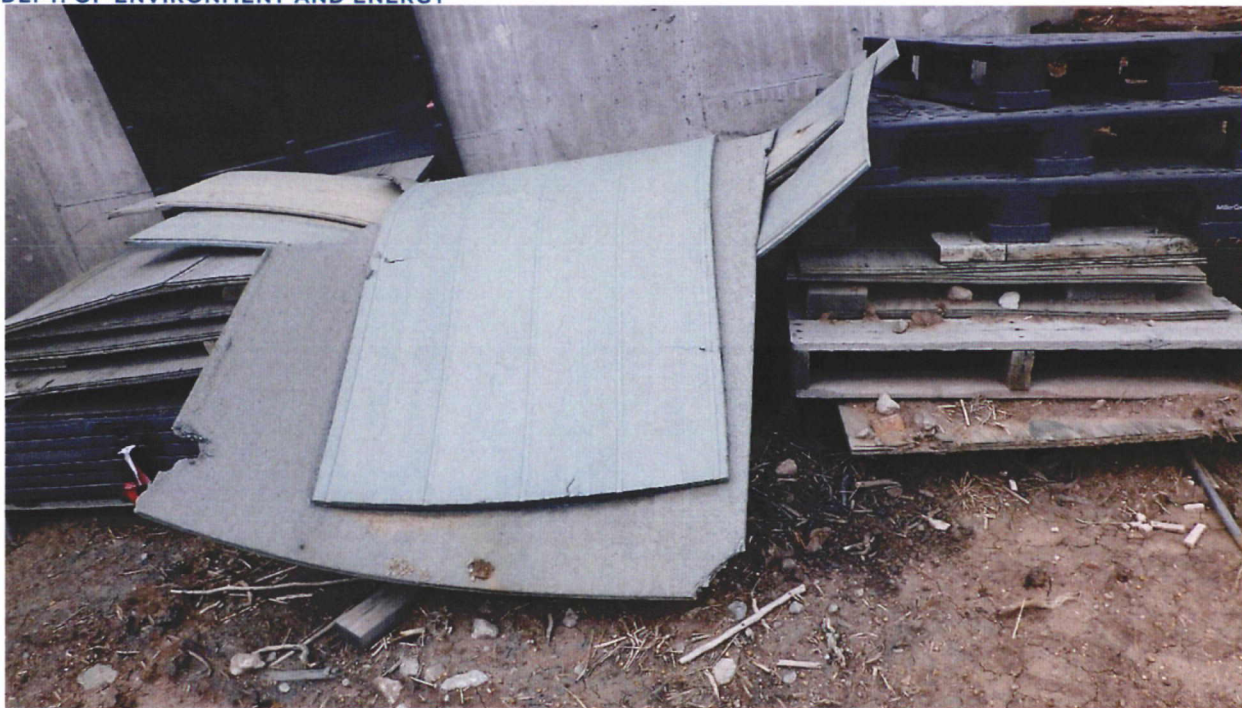
Photo: 26

Description: Trash and debris outside the hoop building.

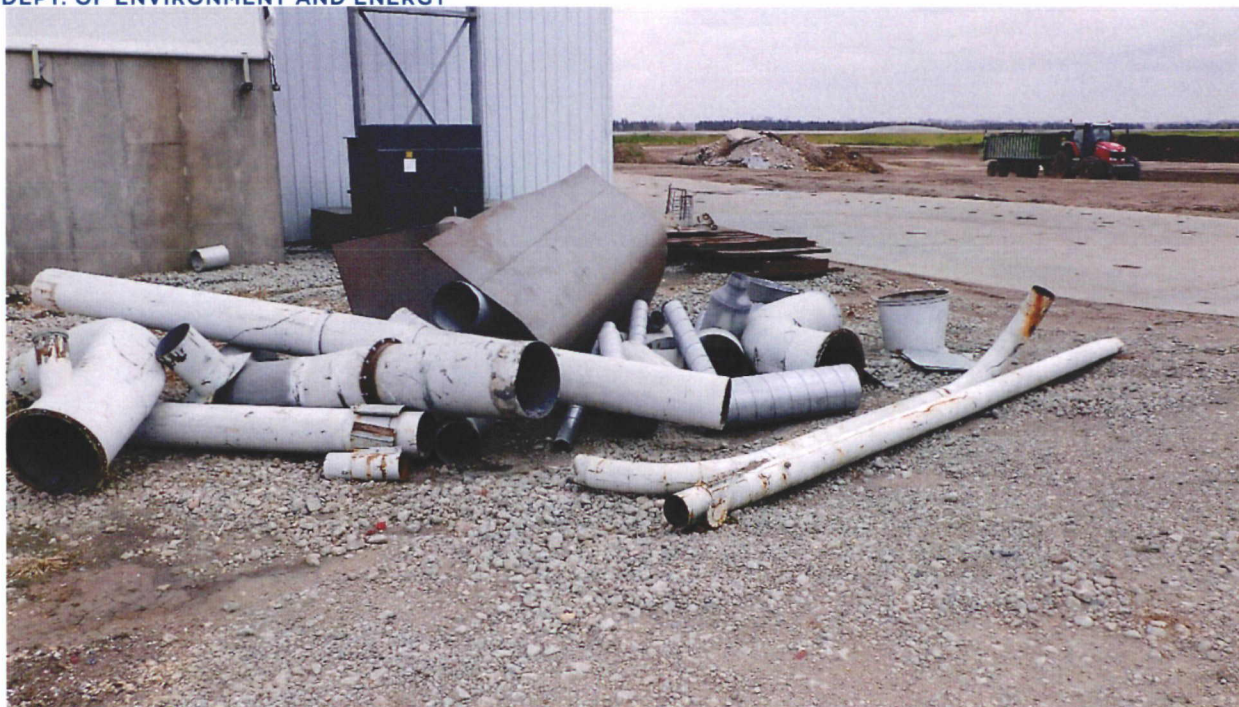
Photo: 27

Description: Tubing and trash outside the hoop building.

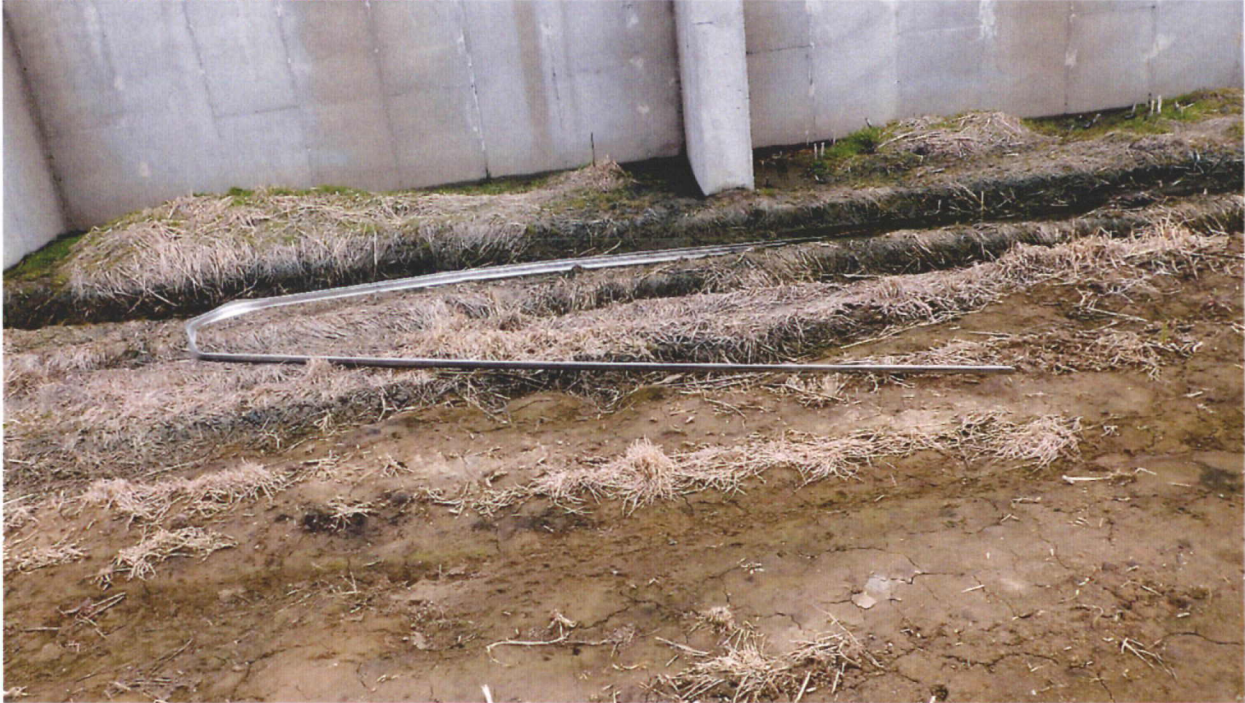
Photo: 28

Description: This is a piece of flashing. I looked at the roof prove that it came from the hoop building roof. Mr. Peterson stated he would investigate.

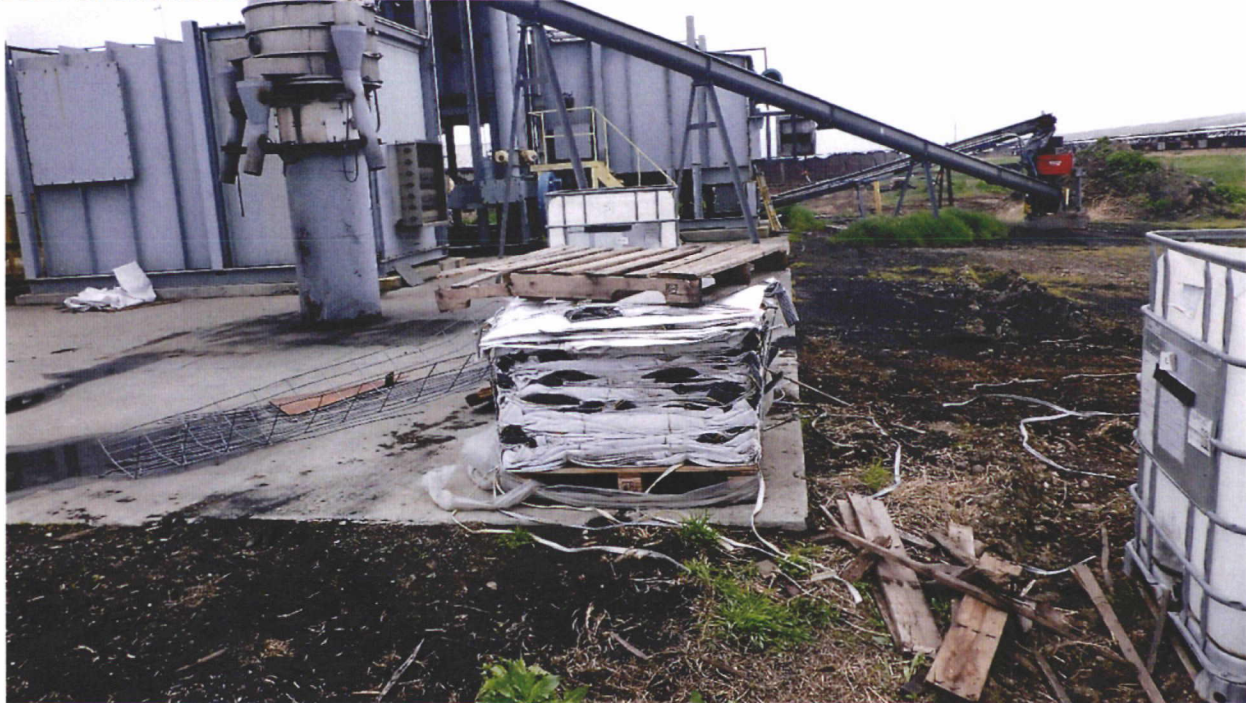
Photo: 29

Description: This photo depicts trash and debris south of the Biochar unit.
