Facility: AltEn
IIS: 84069
PCS: NE0137634

Mark Pomajzl
4/23/2021

Site Visit Check list

Site Visit Report

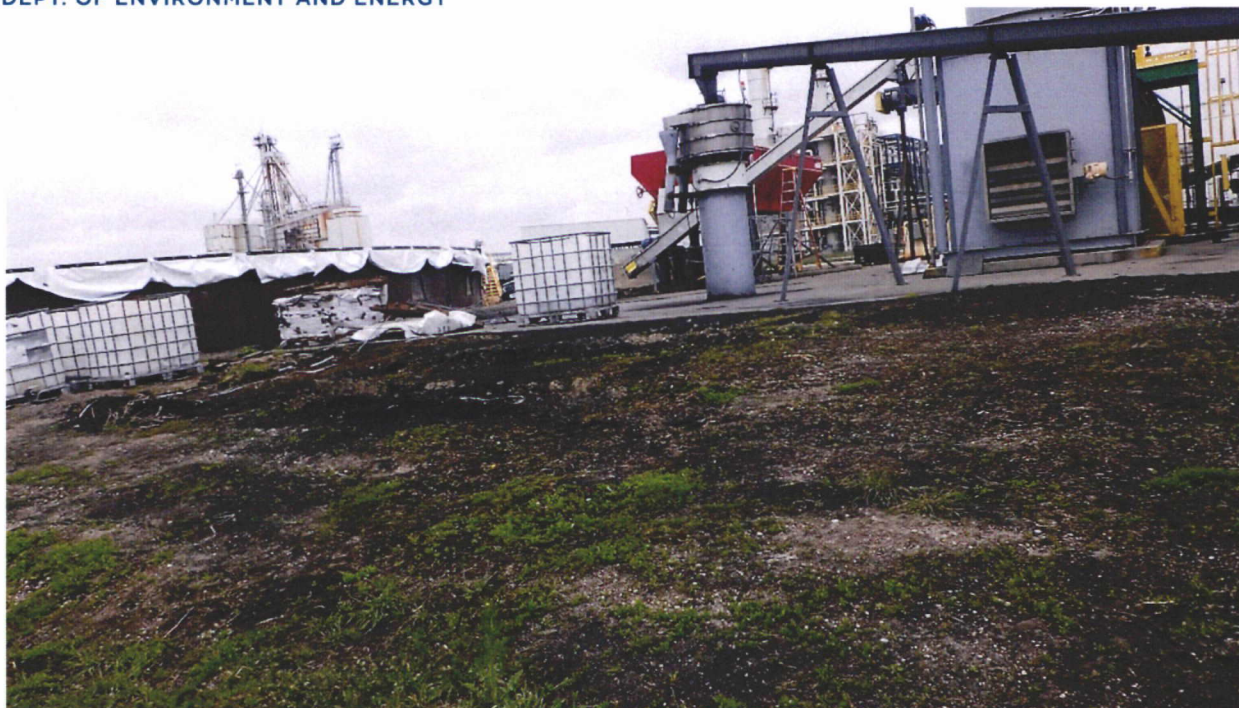
Photo: 30

Description: This photo depicts spilled biochar (arrow).

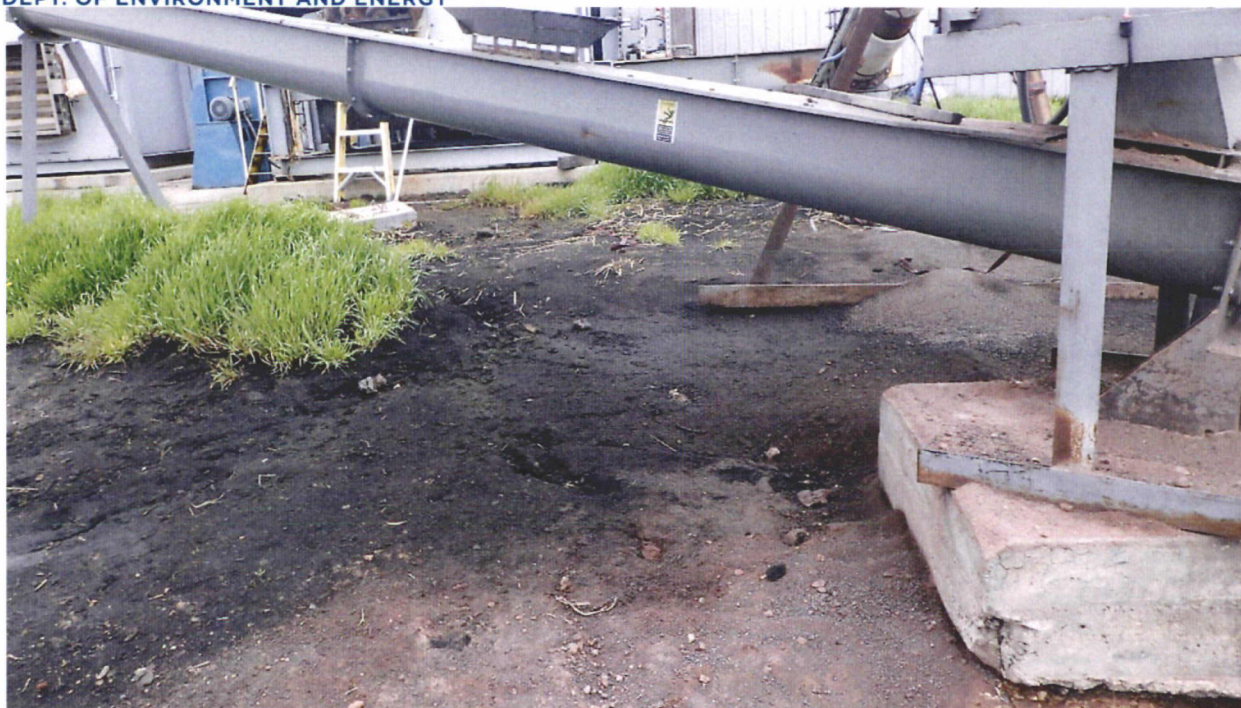
Photo: 31

Description: This photo depicts spilled biochar south of the biochar unit.

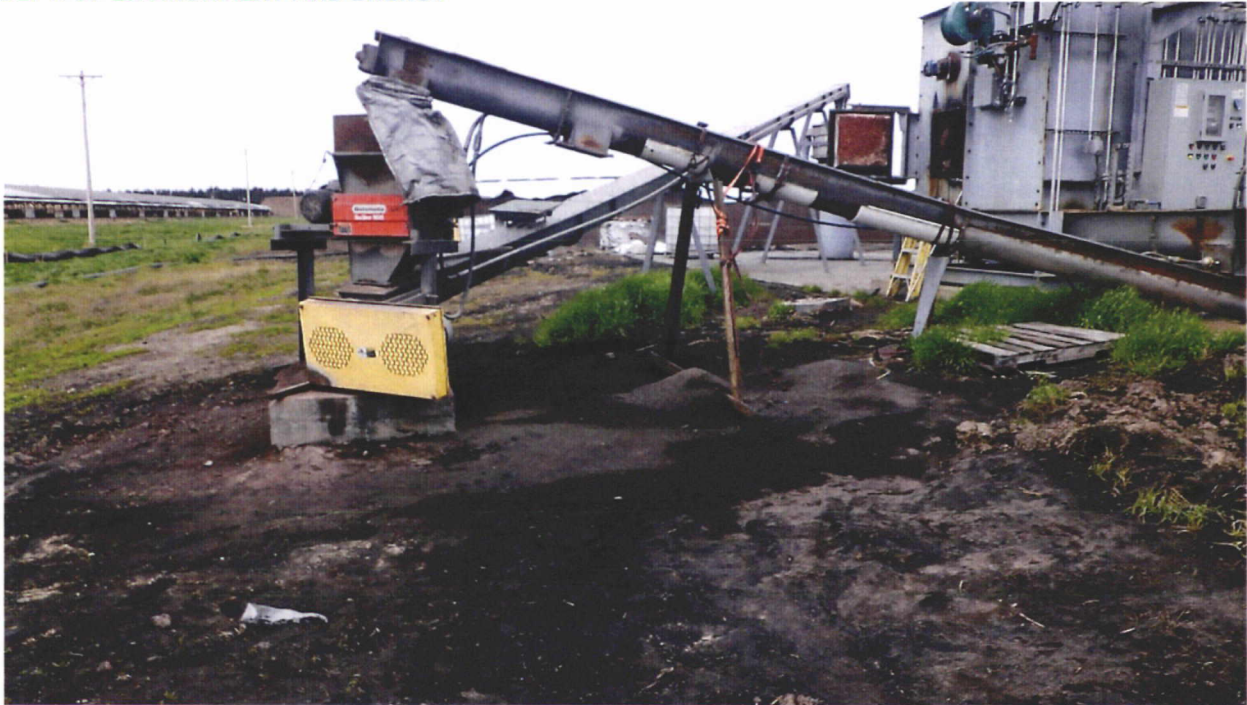
Photo: 32

Description: This photo depicts spilled biochar south of the biochar unit.

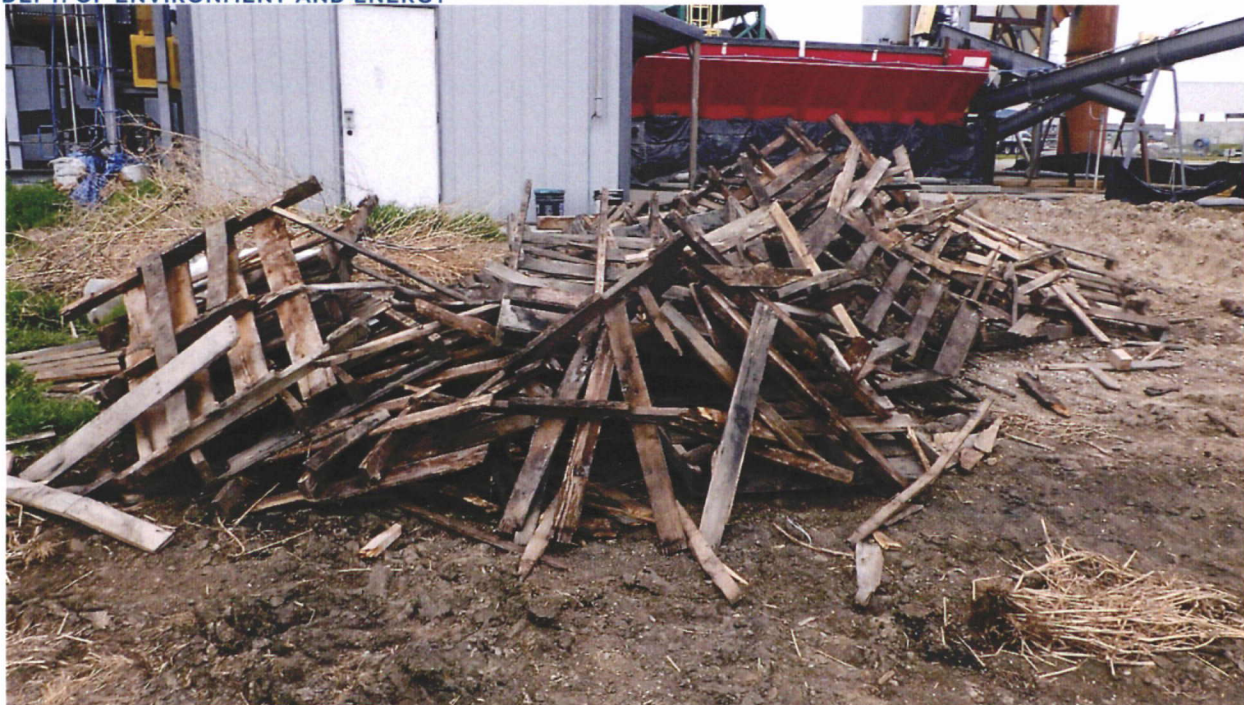
Photo: 32

Description: This photo depicts trashed pallets.

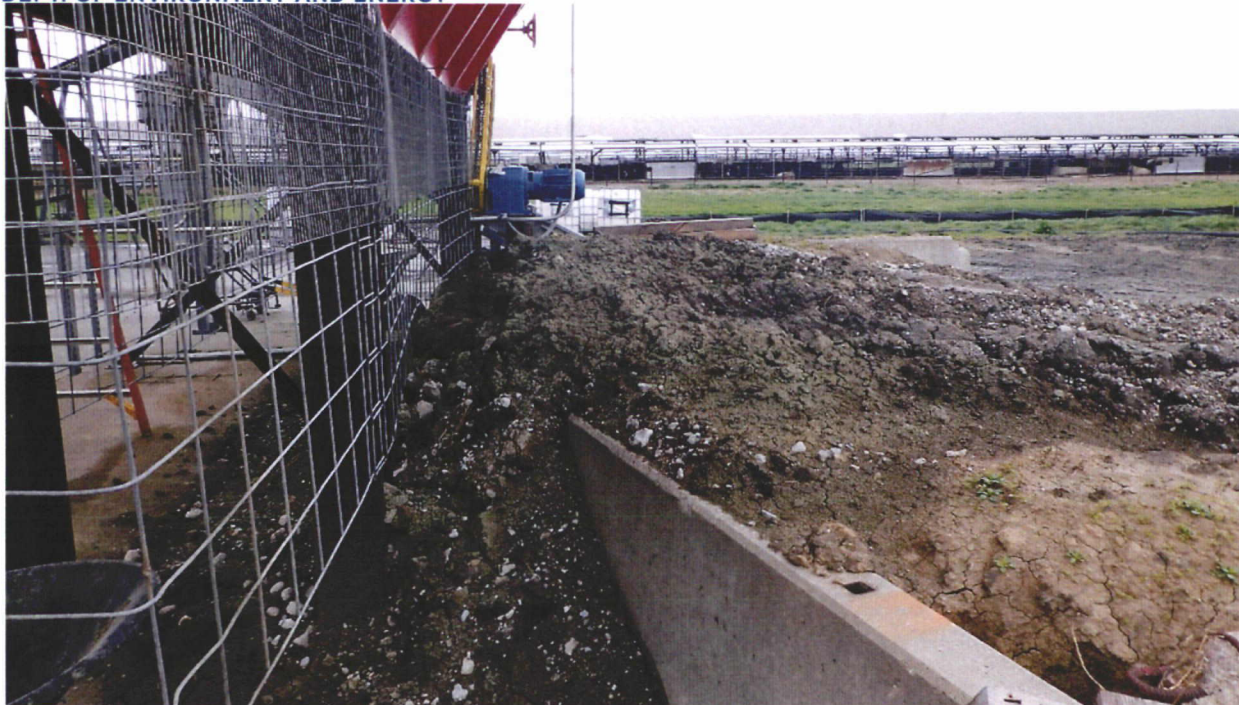
Photo: 33

Description: This photo depicts old wet cake. The wet cake is not in containment and would wash out south of the biochar during rain events.

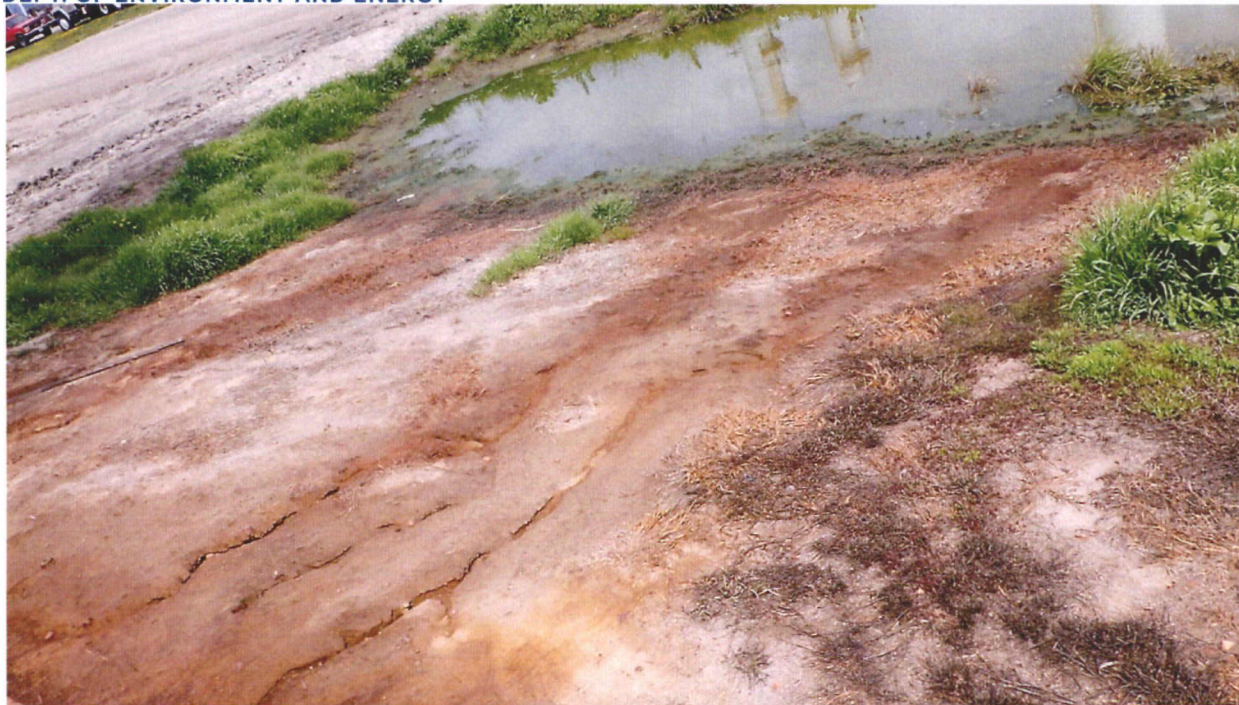
Photo: 34

Description: This photo depicts an orange discharge that had killed vegetation and accumulated in the drainage ditch.

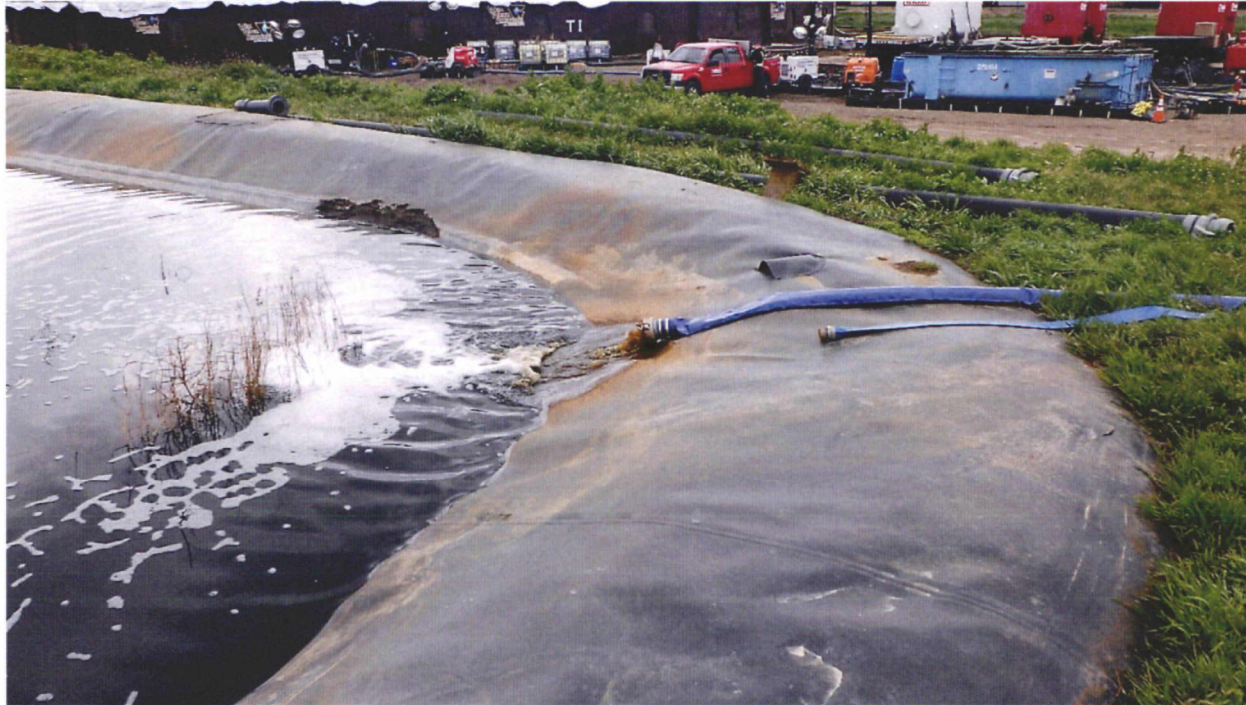
Photo: 35

Description: This photo depicts a discharge from Clean Harbors. Clean Harbor staff stated this discharge is sludge from the bottom of the Poseidon tanks.

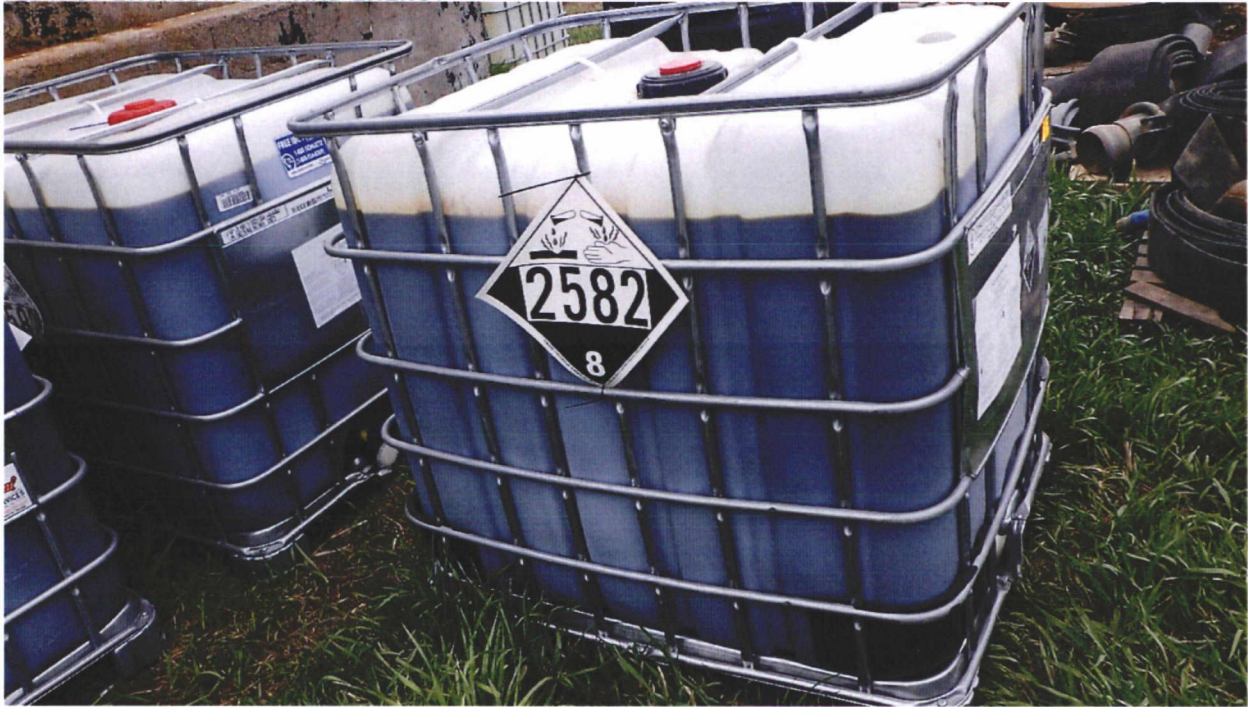
Photo: 36

Description: This photo depicts caustic chemicals stored without containment.

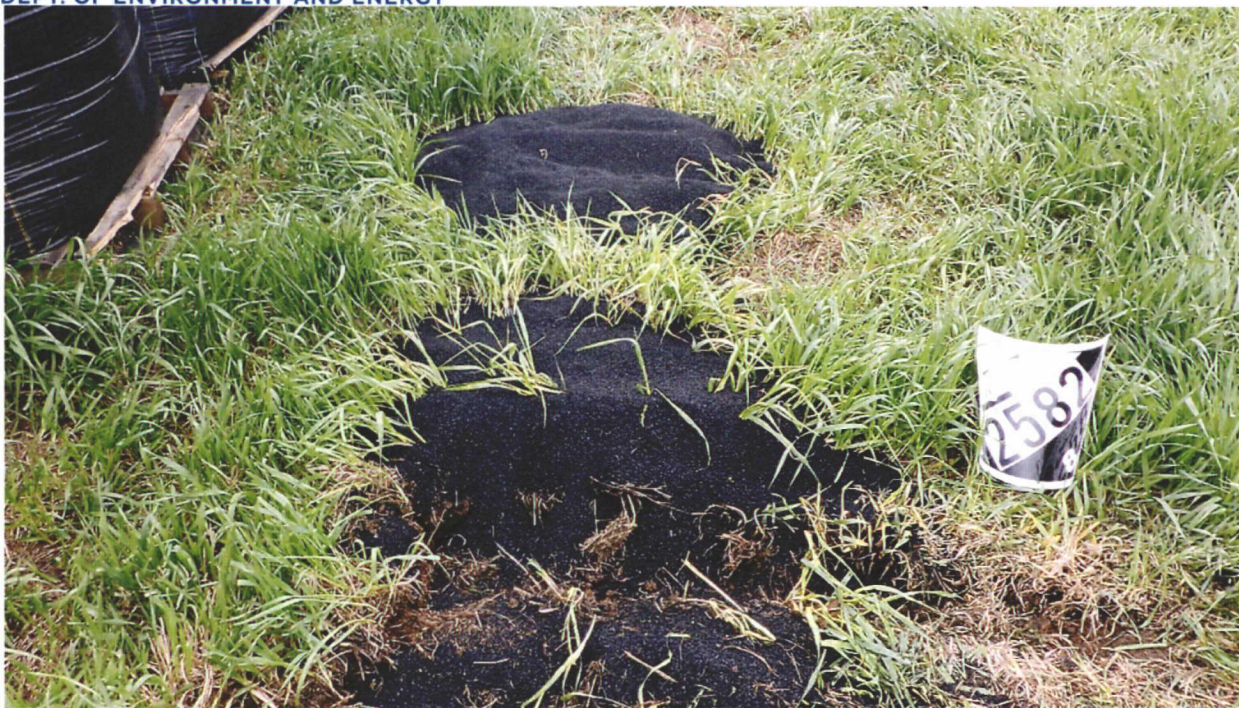
Photo: 37

Description: This photo depicts a carbon chemical used for treatment spilled on the ground.

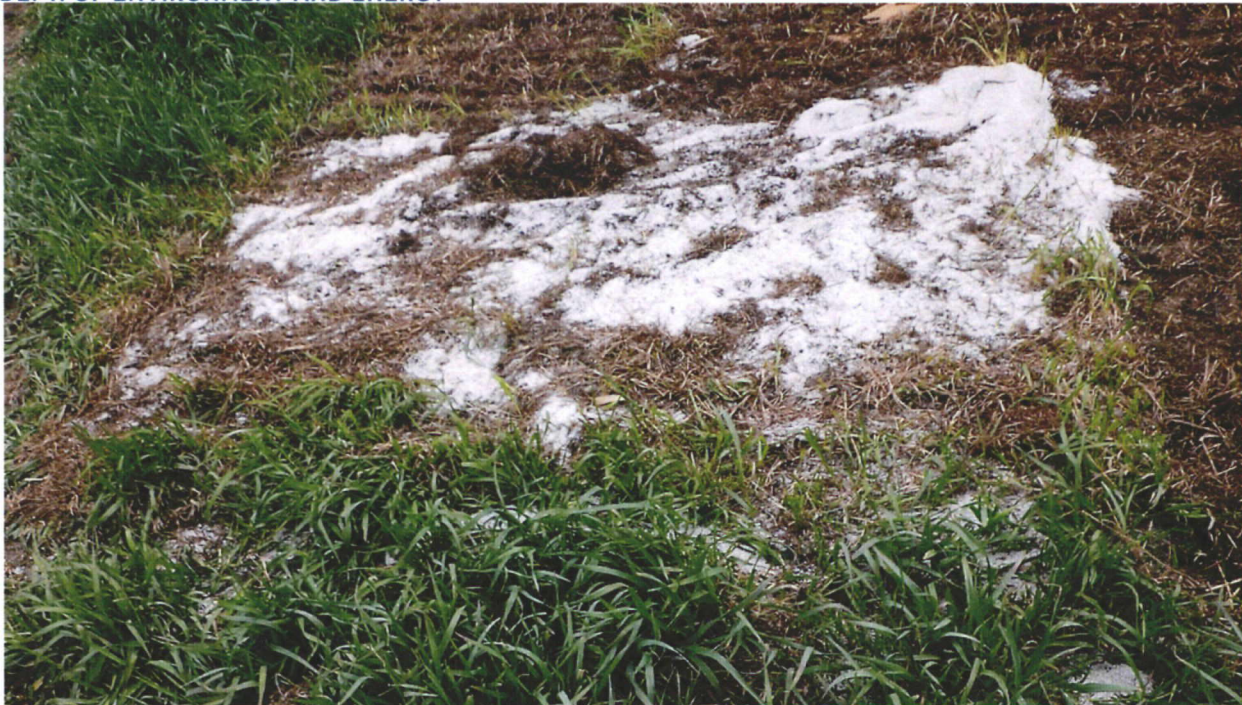
Photo: 38

Description: This photo depicts a granular chemical used for treatment spilled on the ground. None of the chemicals are stored in containment.

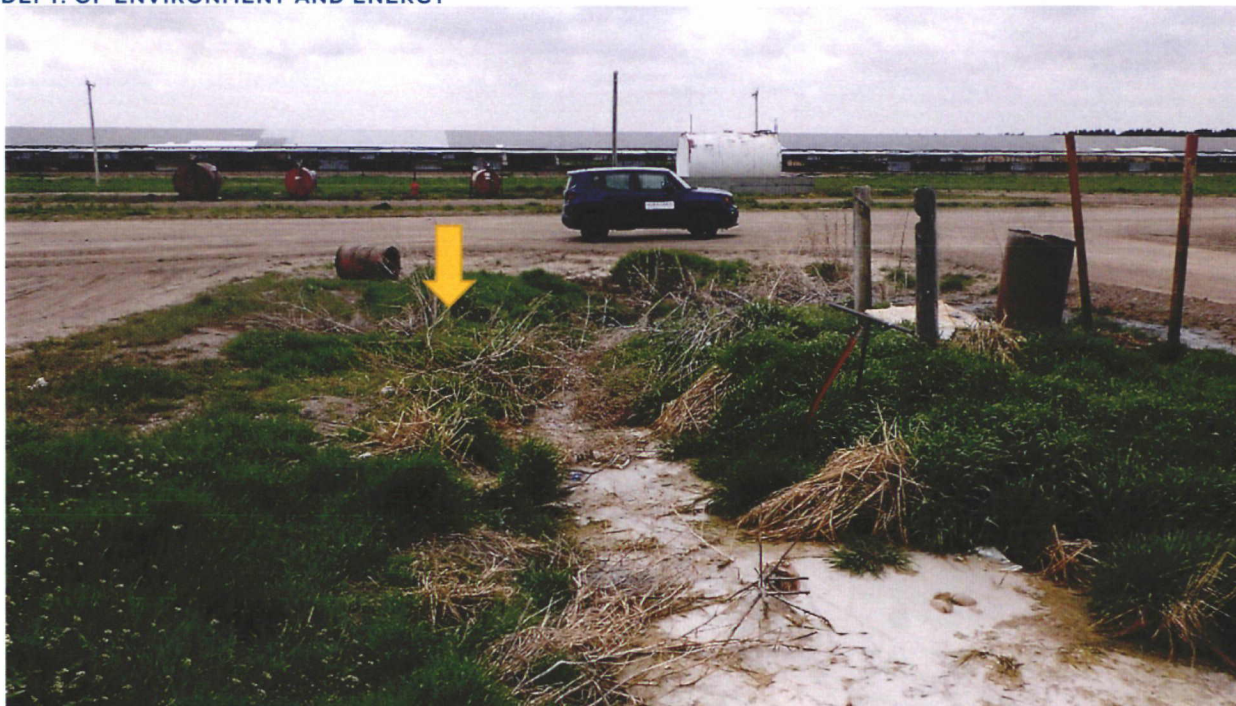
Photo: 41

- I observed a truck washout (Mead Cattle) discharging into the storm water ditch (see photo log).
- There is lots of trash and debris between the hoop buildings.

Description: This photo depicts the discharge from the truck washout. The discharge enters the drainage ditch and culvert (arrow).
