Facility: AltEn  
IIS: 84069  
PCS: NE0137634

Jason Windhorst  
3-23-2021

## Site Visit Check list

AltEn LLC - Storm Water Temporary BMP Check Map

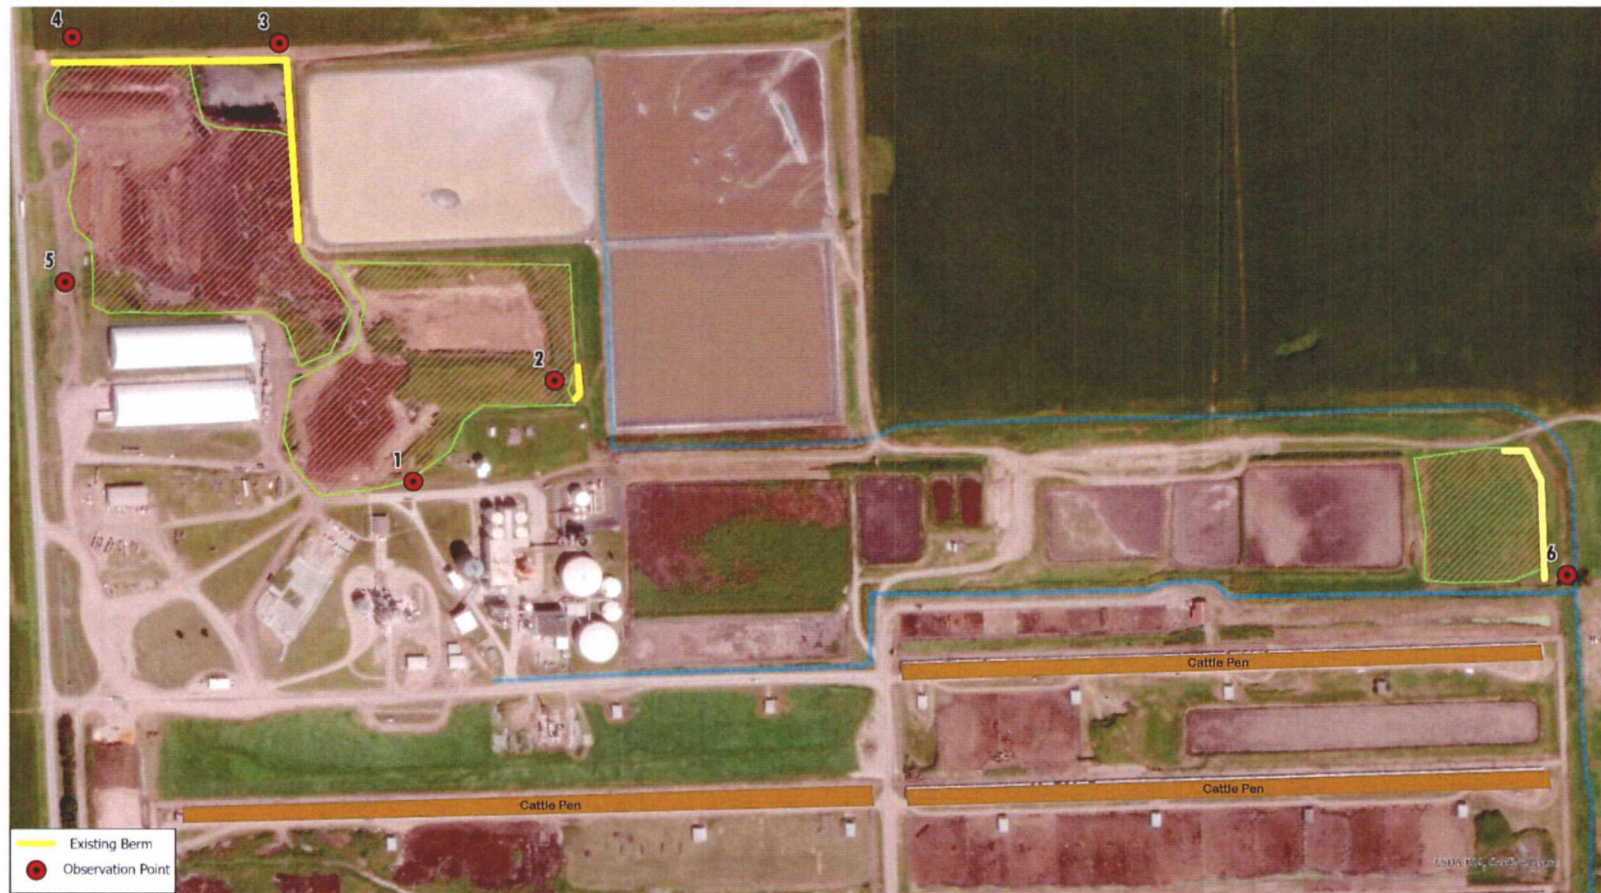
- Area 1 and 2 had overflowed and water was bypassing the berm containment. Both areas were discharging to the ditch on the south side of the southeast lagoon.

- The berm at area 3 west of the northwest lagoon was intact and was holding at the time of the inspection. Water was pooling on the north side of the berm between area 3 and 4 from runoff from the adjacent field.

- The berm along the access road at area 5 west of the hoop buildings was intact and had not overflowed or breached at the time of the inspection. The pooled runoff had backup to point that it was flowing to the east of the north hoop building.

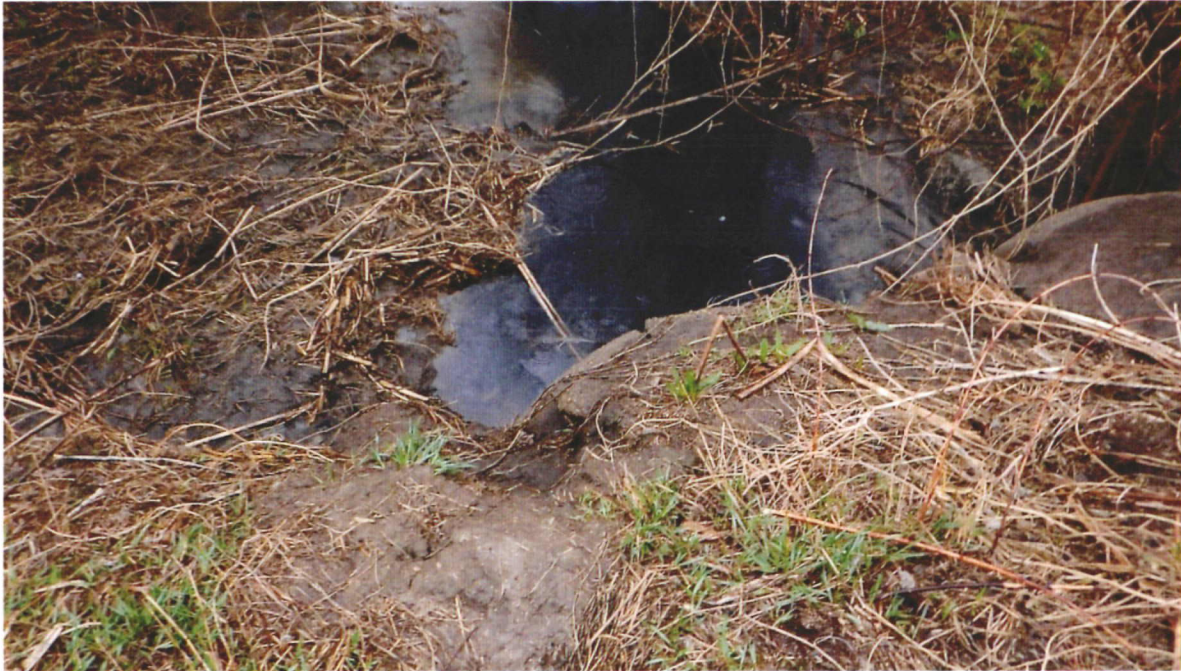
Photo: 1

- Upon arriving I stopped by the SW Outfall 001 area to check flow conditions. The area continued to have dark water with a sheen and was flowing through the culvert. (I checked this area before leaving and it did not indicate that water that had breached the two containment areas had reached it at that time.)

Description: Discharge point for most of the storm water discharging from AltEn. There was still a sheen visible on the water and continued to appear very dark in color with a strong odor.

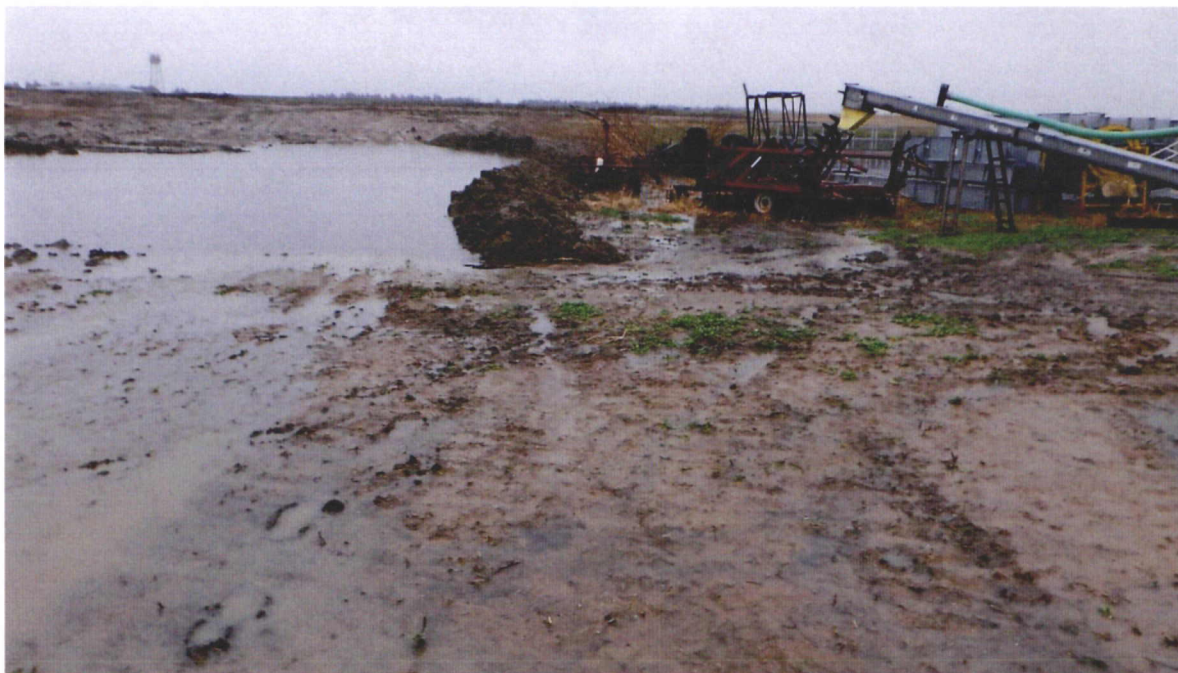
Photo: 2

Description: Storm water from wetcake area is bypassing the berm in this area and flowing through the equipment storage area.

Bypassed North side of main office - Pump out as soon as possible + repair berm

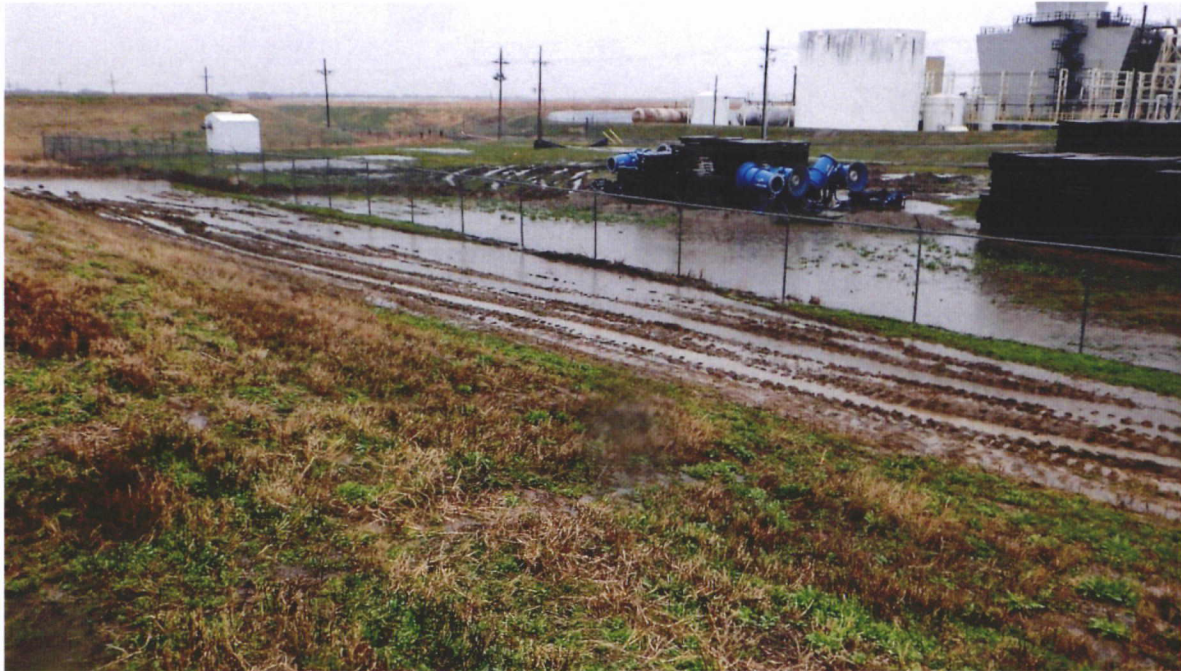
Photo: 3

Description: Storm water and wetcake runoff pooled after overflowing berm at area 1 on the map.

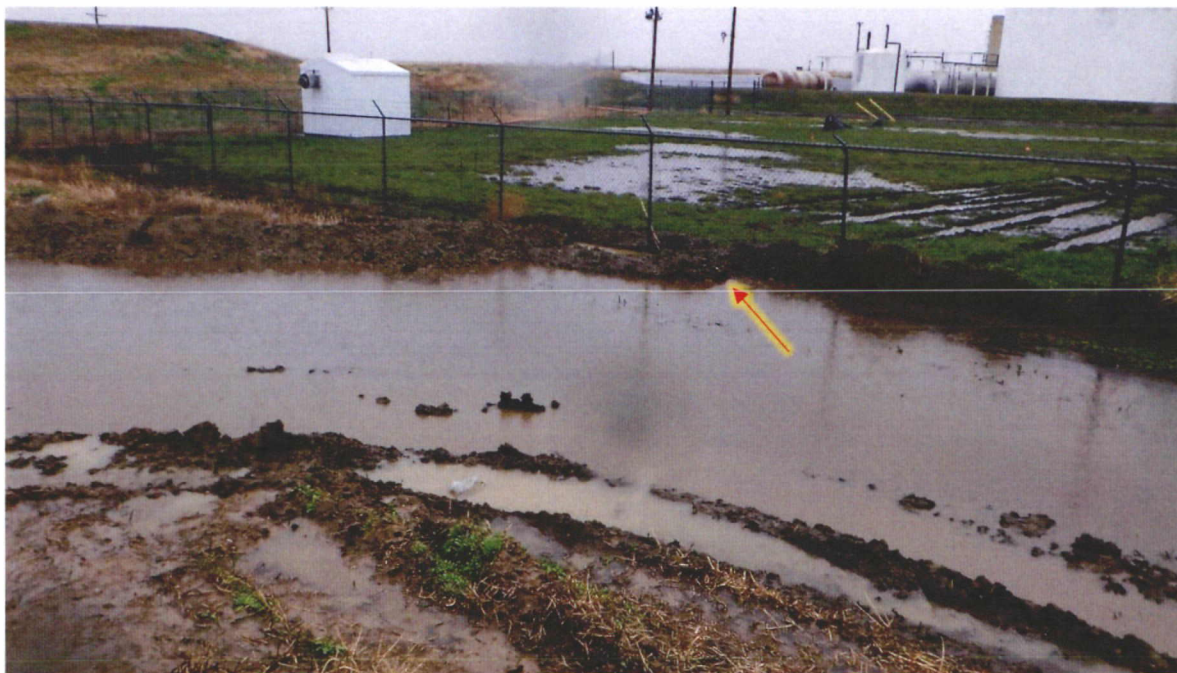
Photo: 4

Description: Berm overflow at area 2 on the map.

Bypassed SW side of Southeast Lagoon - Pump out as possible

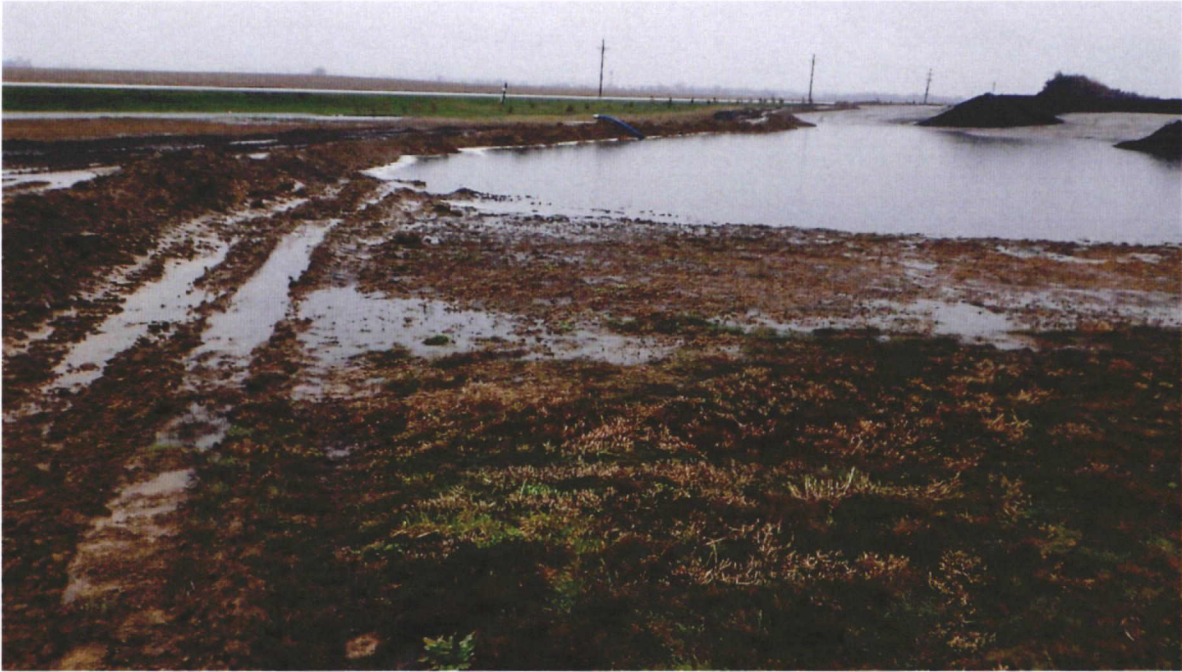
Photo: 5

Description: Bermed area west of the hoop buildings in area 5 of the map. The berm is retaining runoff and has no visible signs of failure. The runoff is backing up and discharging to the east on the north side of the hoop buildings.

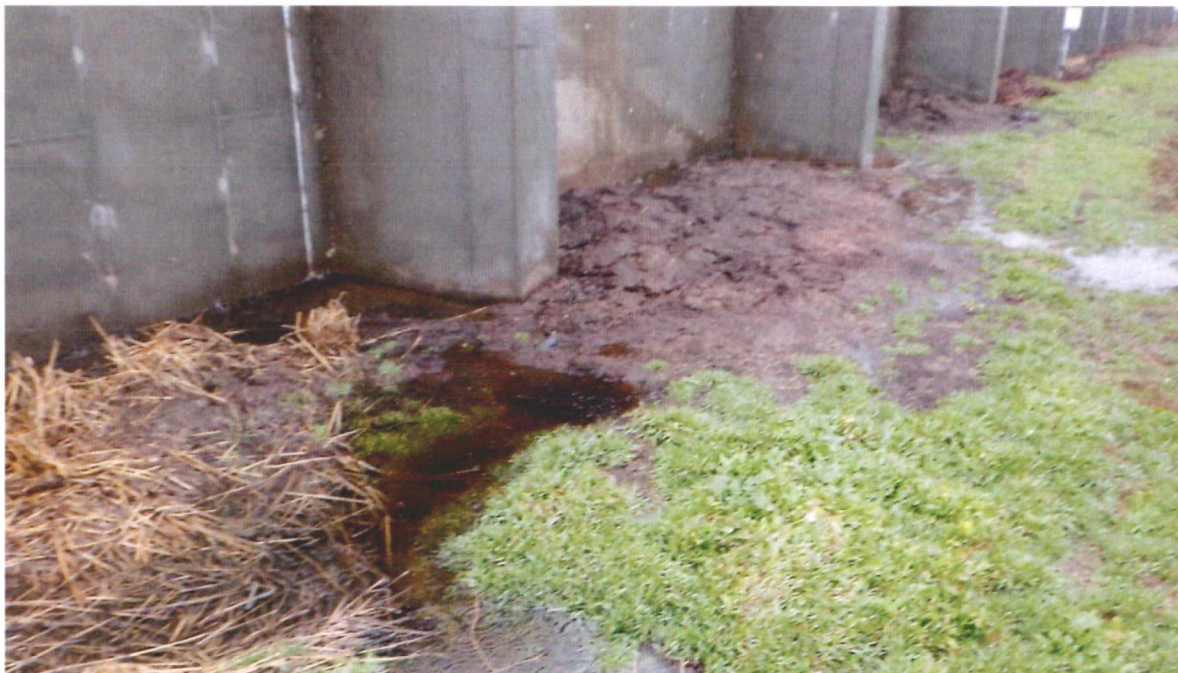
Photo: 6

Description: Rotting piles of seed dumped along the south side of the north hoop building.

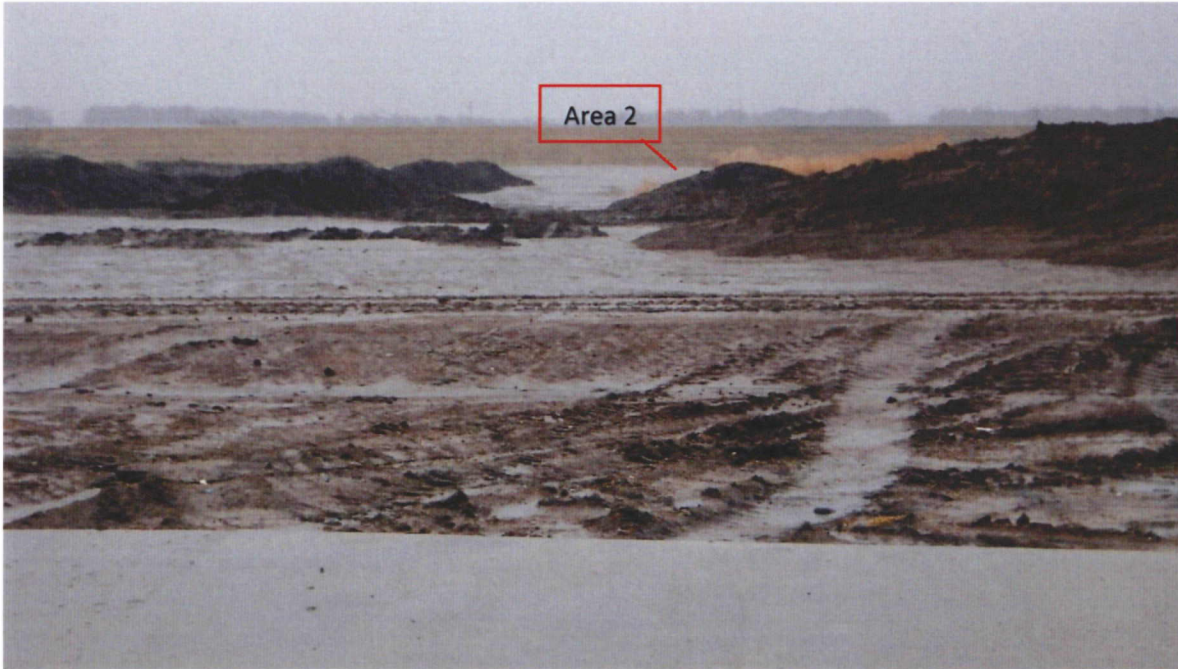
Photo: 7

Description: Runoff from the hoop building area combines with runoff from wetcake storage can be seen accumulating in area 2 on the map.

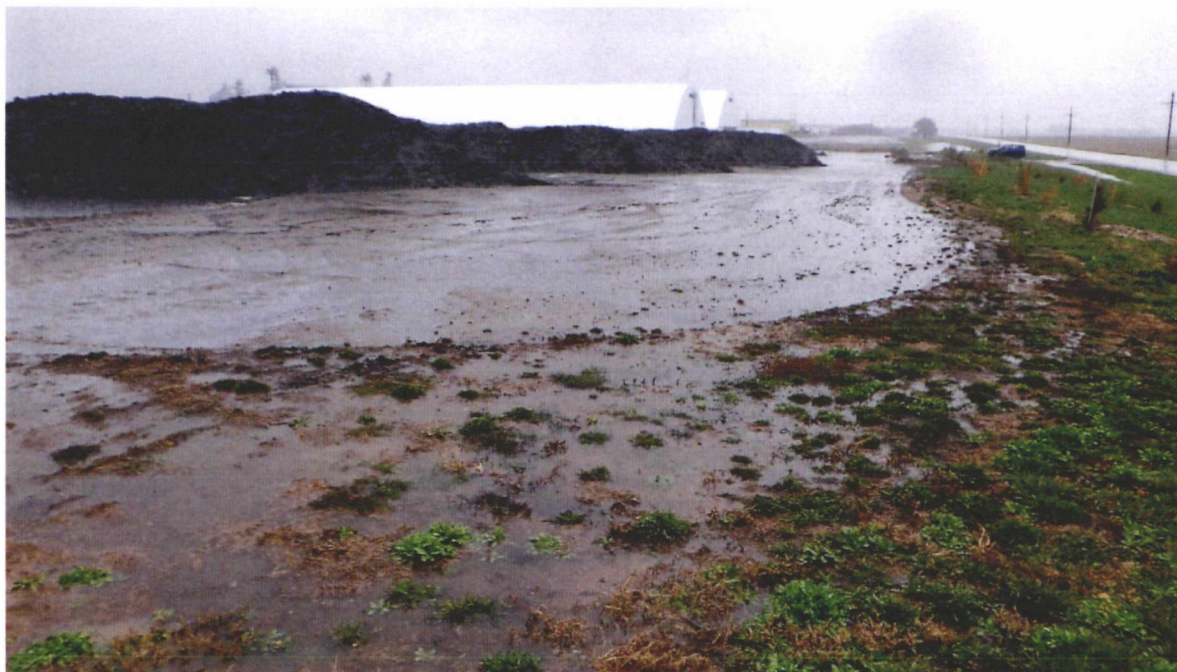
Photo: 8

Description: Runoff from the windrowed wetcake in west storage area. Storm water and wetcake runoff collects behind berm west of hoop buildings.

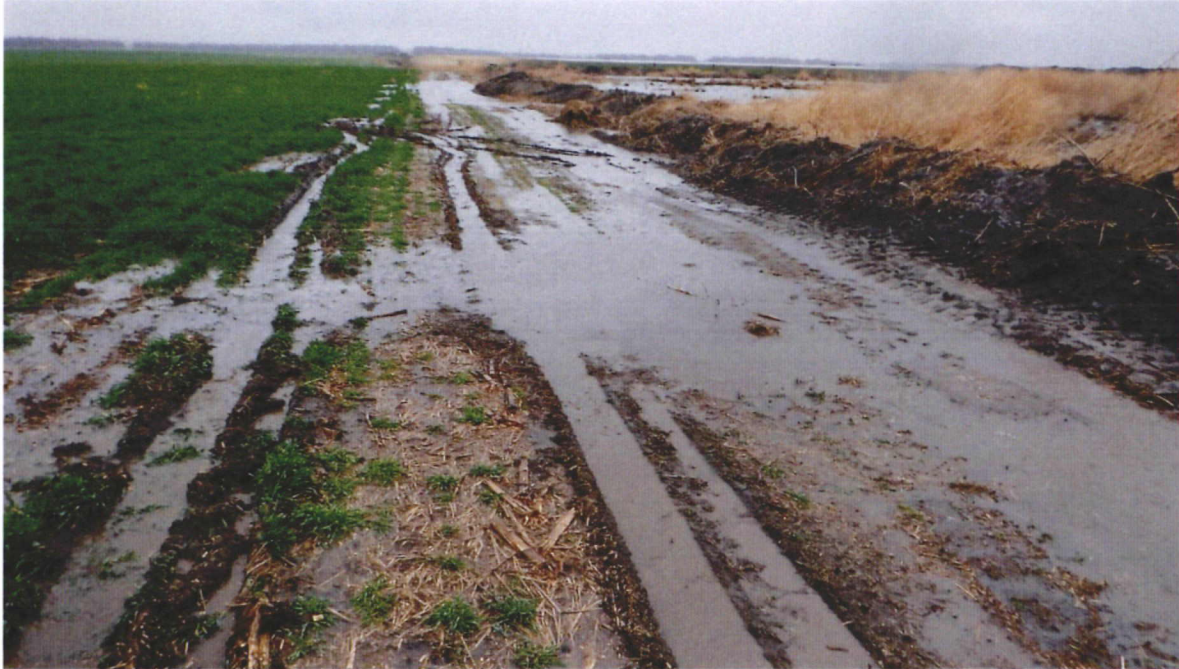
Photo: 9

Description: Runoff from adjacent field pooling behind the berm on the north side of the wetcake storage area. The berm is holding and does not indicate any point of failure along the north side at area 4 on the map.

OK - West side of NW wet cake pile - monitor & pump as needed

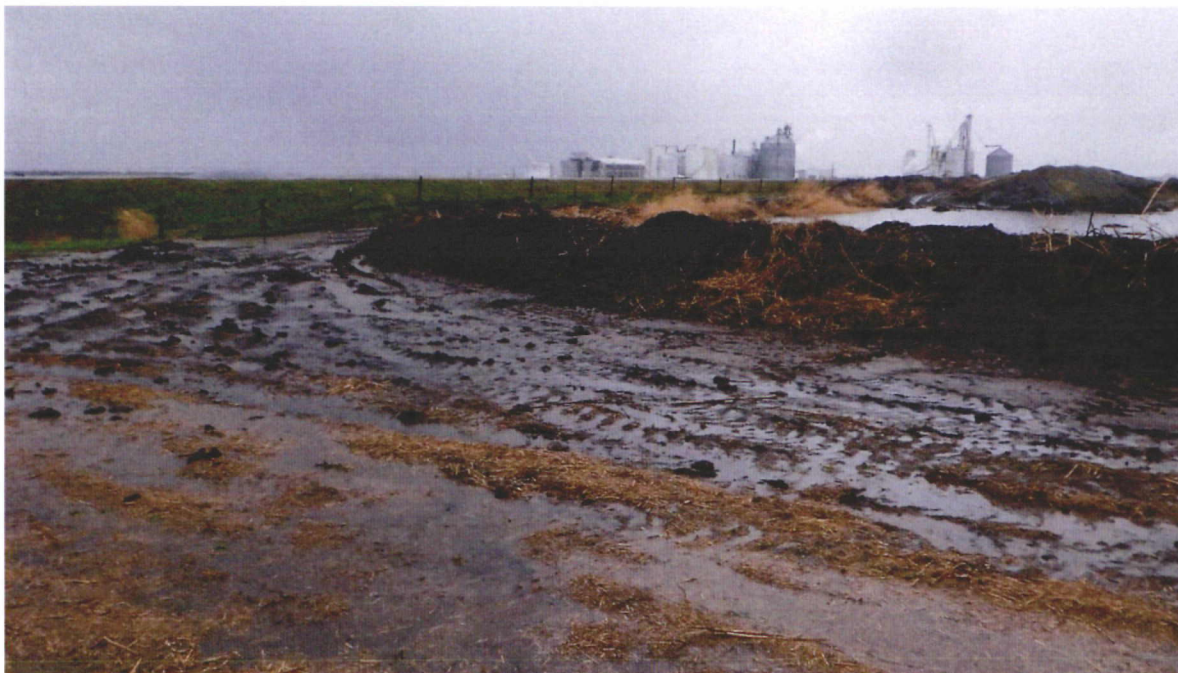
Photo: 10

Description: Berm in area 3 on the map is intact and there is no indication of overflow or breach.

OK - West side of NW lagoon - monitor & pump as needed

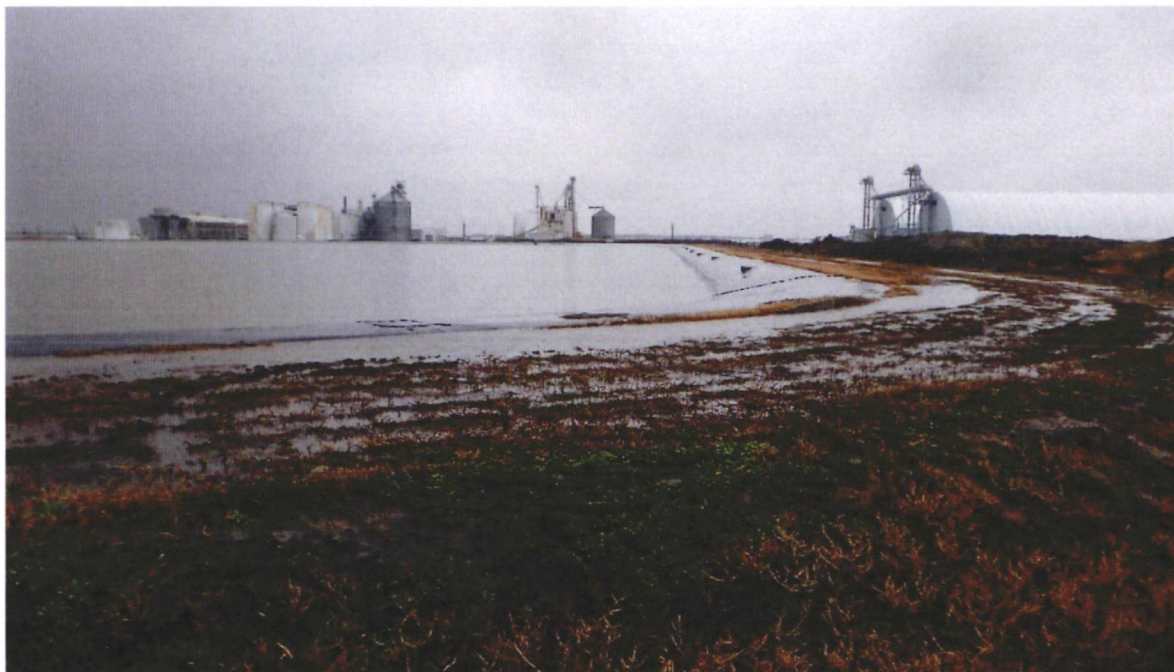
Photo: 11

Description: Lagoon appears to be below freeboard.

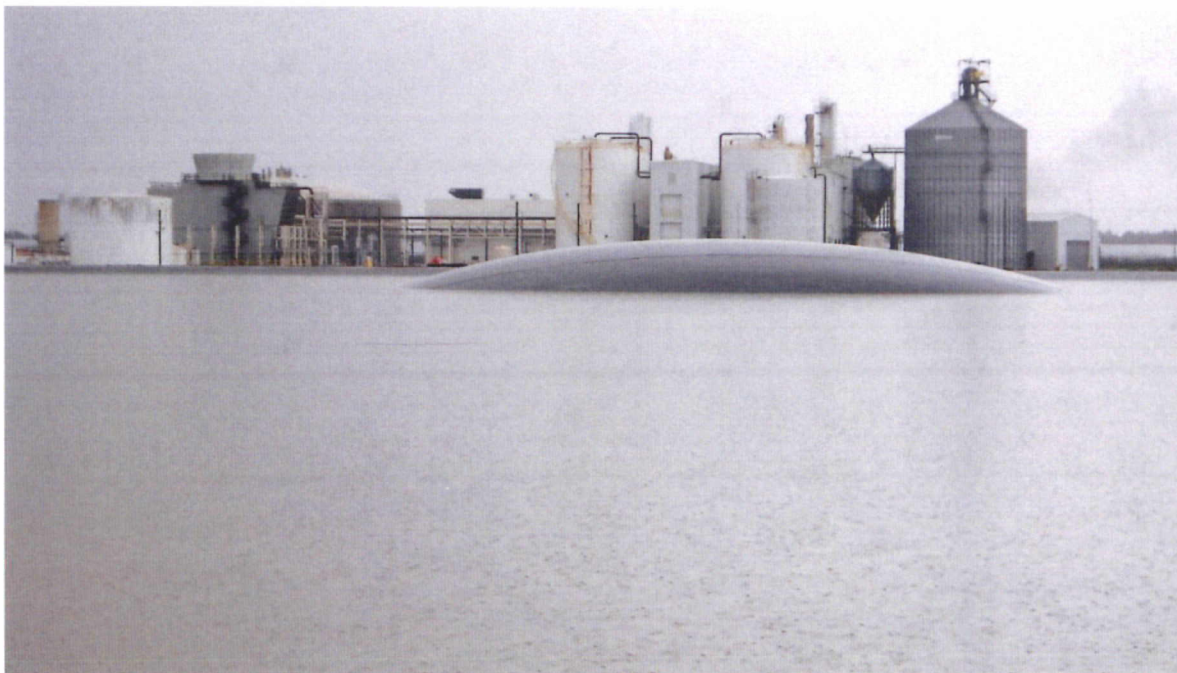
Photo: 12

Description: Large whale in northwest lagoon.

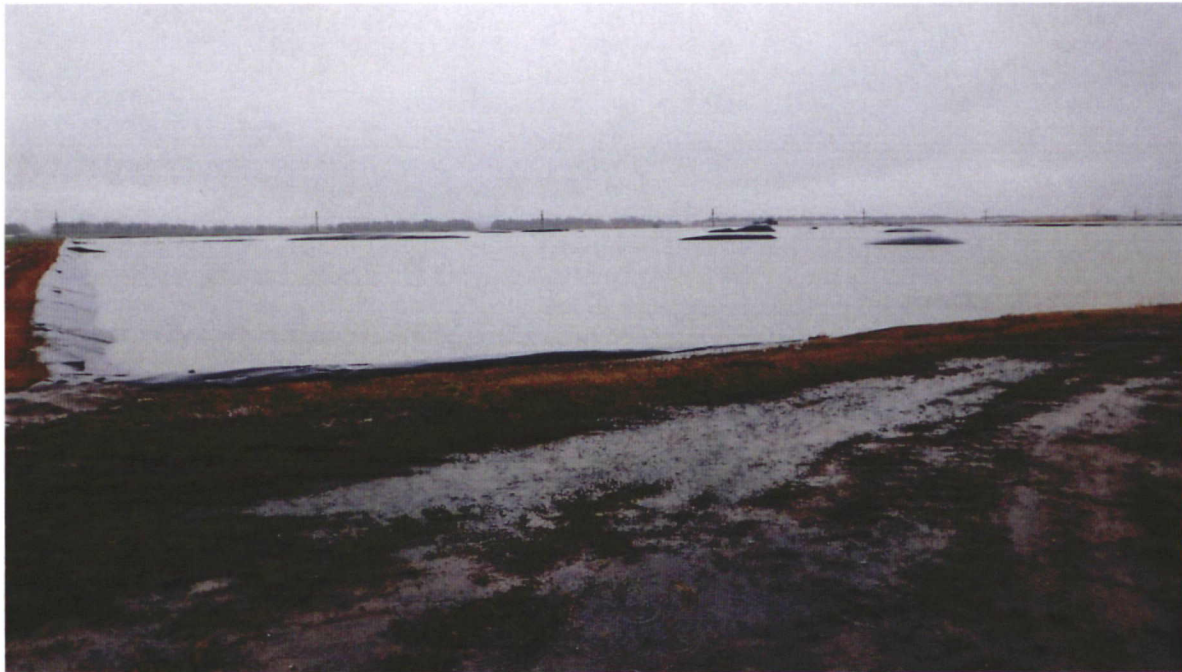
Photo: 13

Description: No change in the status of the northeast lagoon.

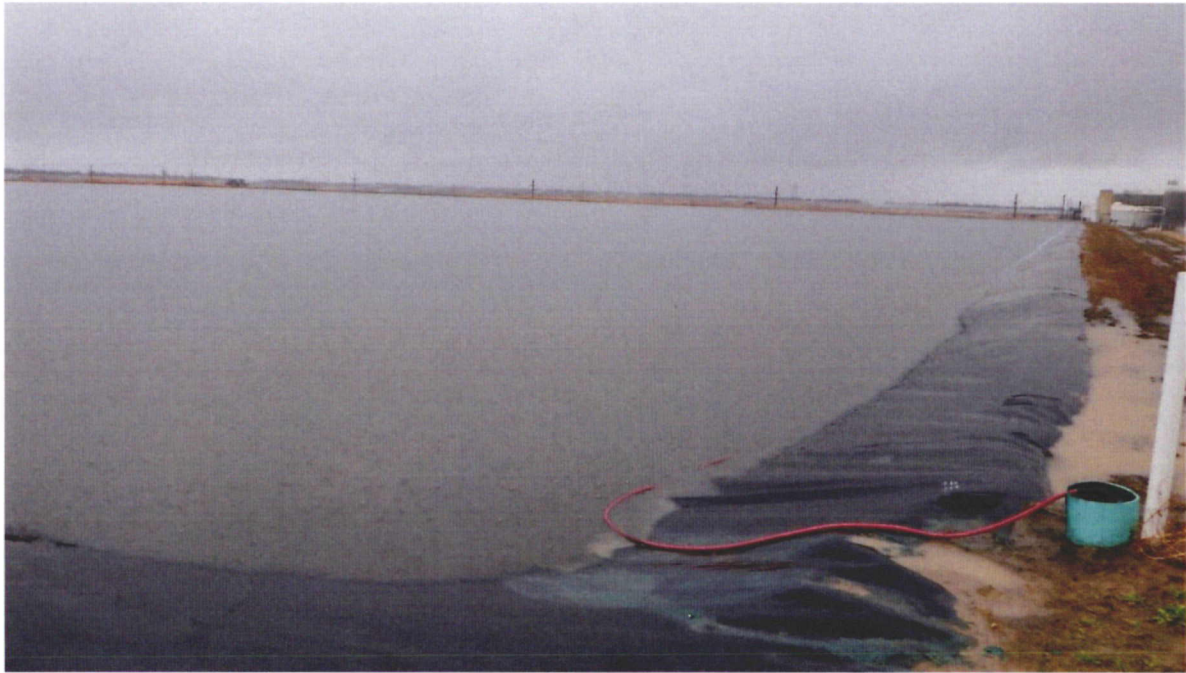
Photo: 14

Description: Vent for conveyance line for wastewater to the northwest lagoon. Wastewater was moving from the southeast to the northeast lagoon while onsite.

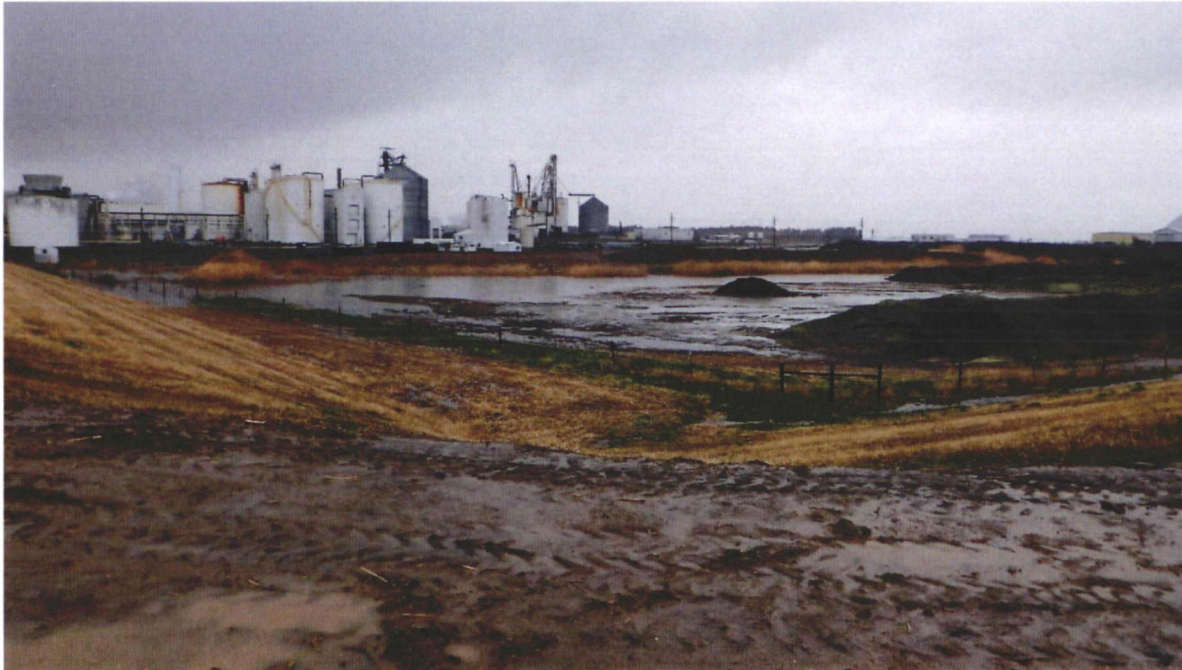
Photo: 15

Description: Area collecting stormwater and wetcake runoff near the southwest corner of the southeast lagoon. Area 2 on the map was inundated at the time the photo taken due to periodic heavy precipitation.

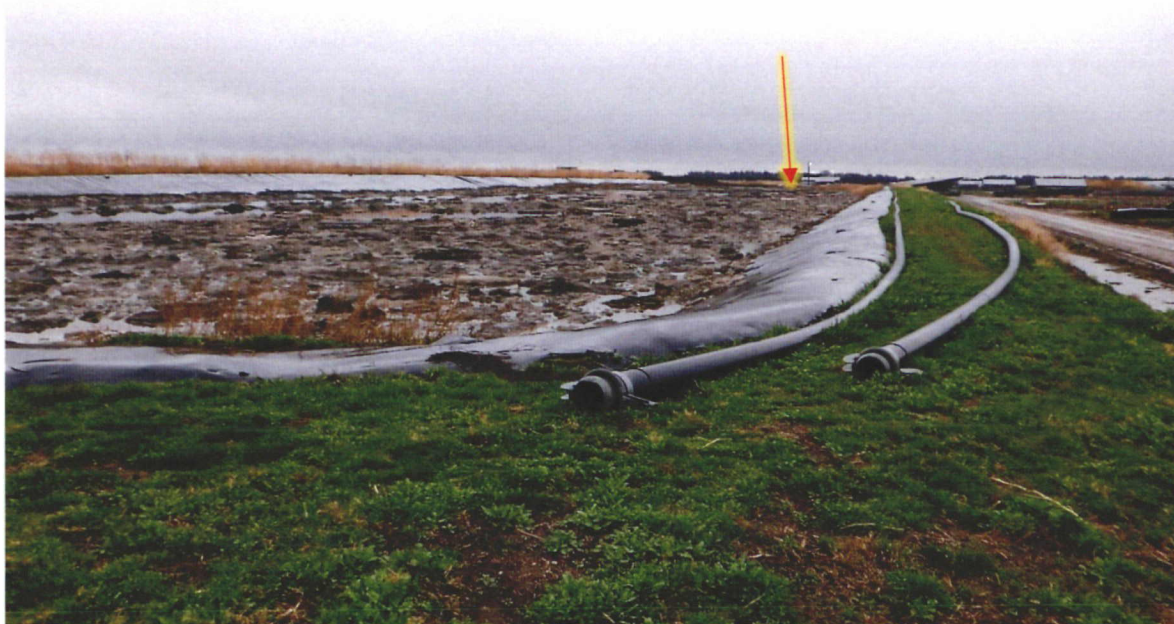
Photo: 16

Description: Lagoon is very full and was within 2.5' of the top of the east side.

- emergency lagoon is reaching low on capacity, east side is close to freeboard

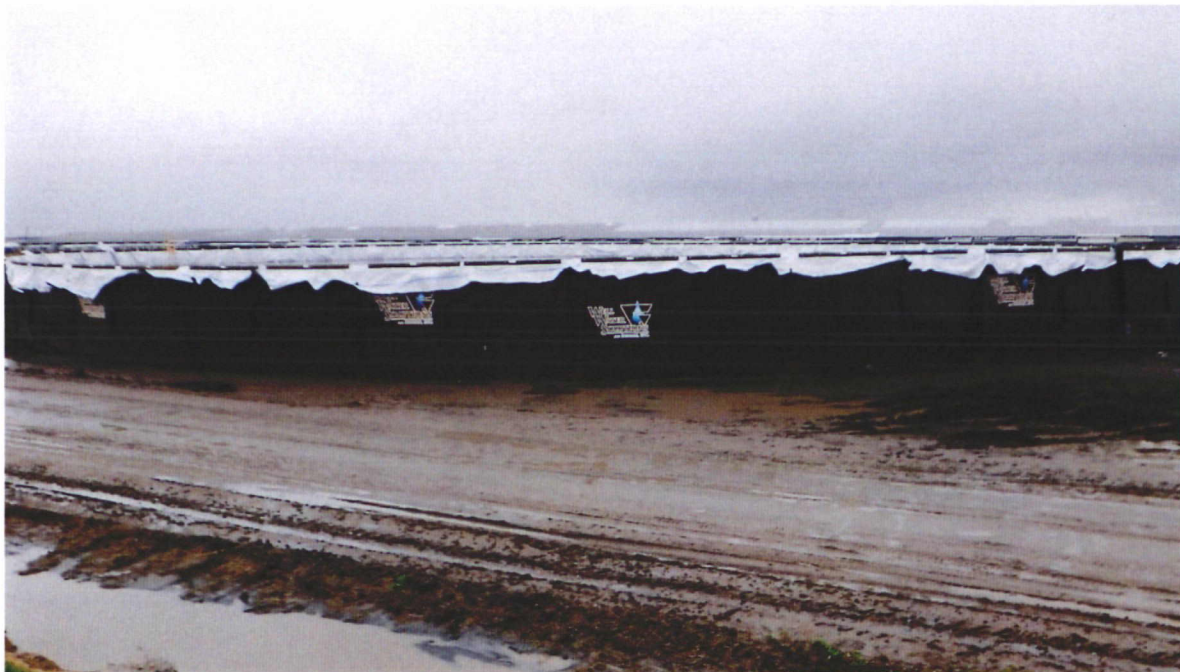
Photo: 17

Description: Tank contents appeared to be within 3' of the top of the tank.

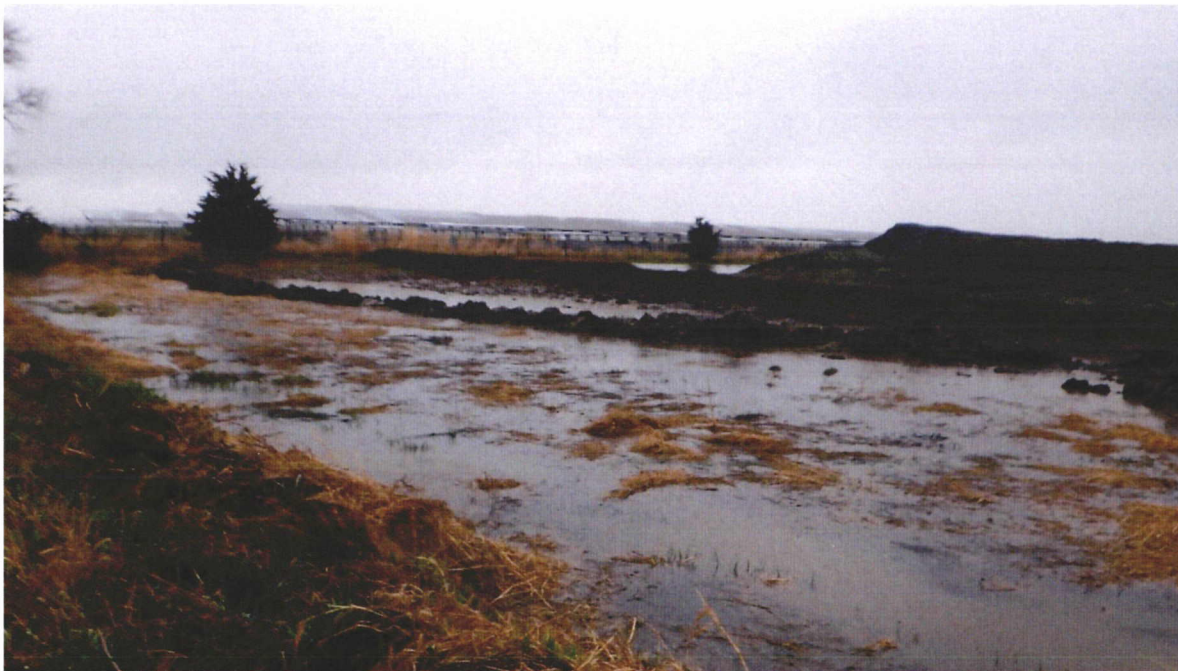
Photo: 18

Description: Ditch bank full and beginning to back up to containment berm for east side of east wetcake storage area.

OK - East wet cake area East berm - Pump as soon as possible
