Facility: AltEn
IIS: 84069
PCS: NE0137634

Jason Windhorst
3-19-2021

Site Visit Check list

AltEn LLC - Storm Water Temporary BMP Check Map

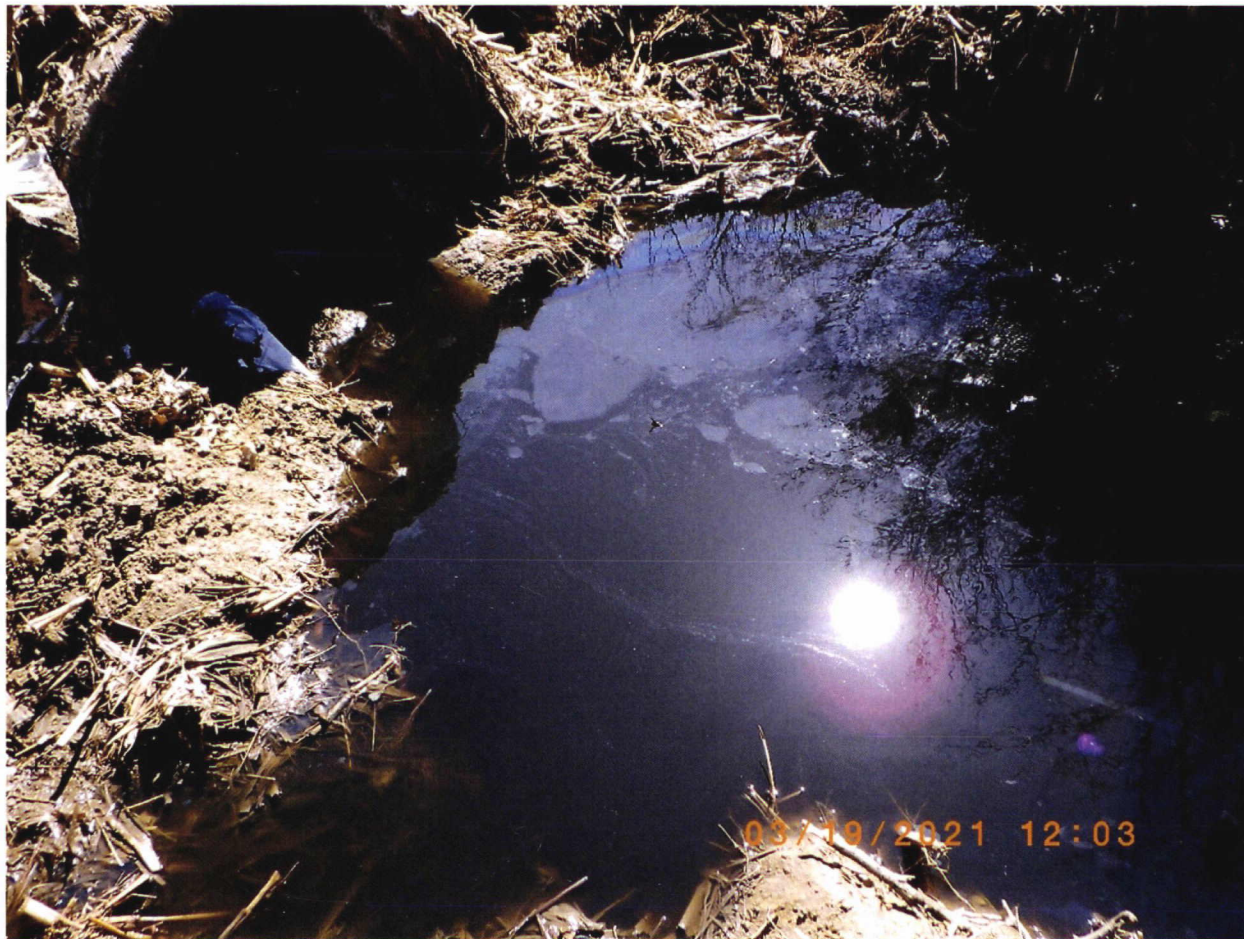
Photo: 1

Location: Culvert north of CR 9 & CR J

Description: Stagnant water with a sheen visible. There did not appear to be any flow through the culvert at the time of the visit.

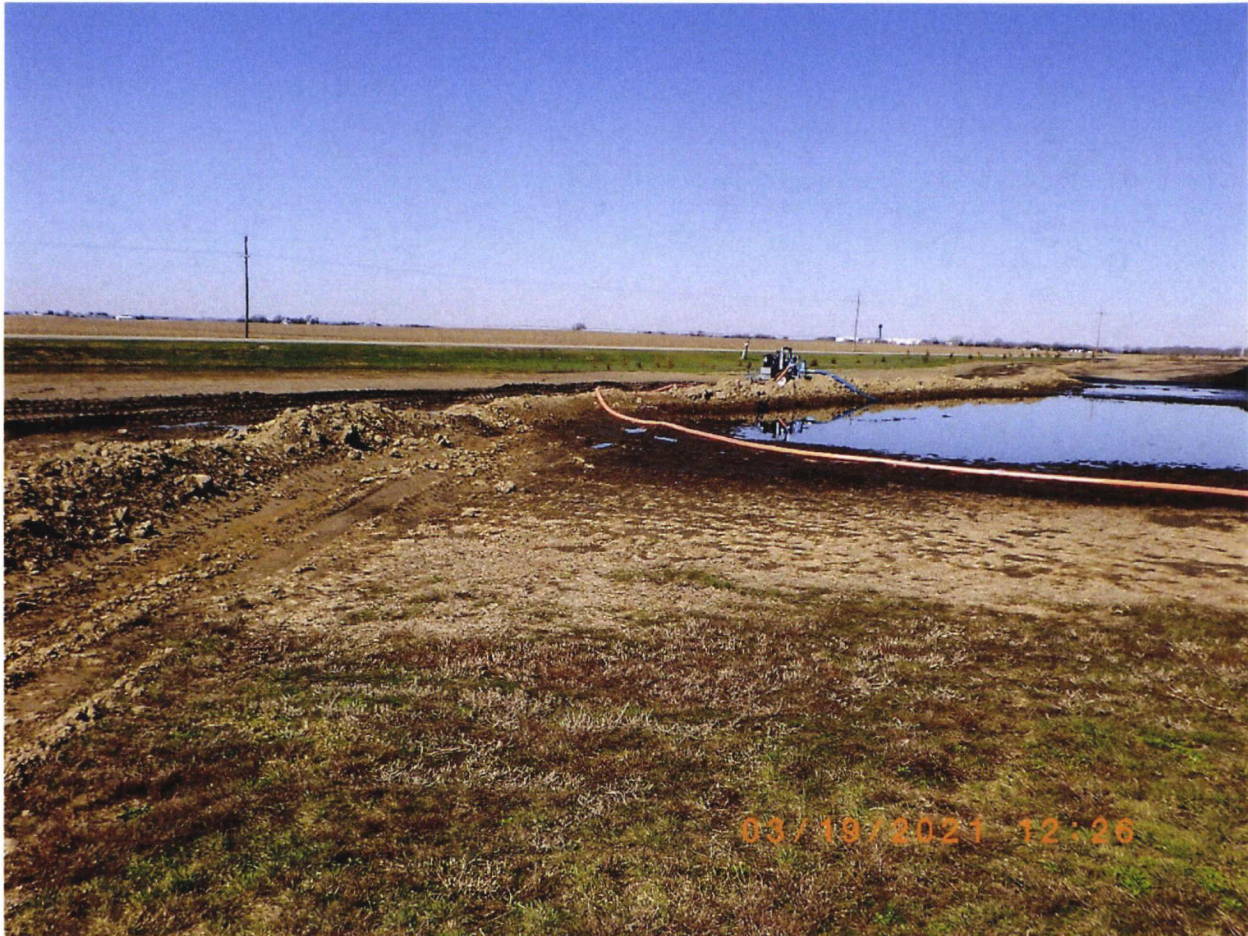
Photo: 2

Location: Area 5 on map

Description: Pumps set up to finish pumping runoff from the west wetcake storage area. This area is being pumped to area 2.

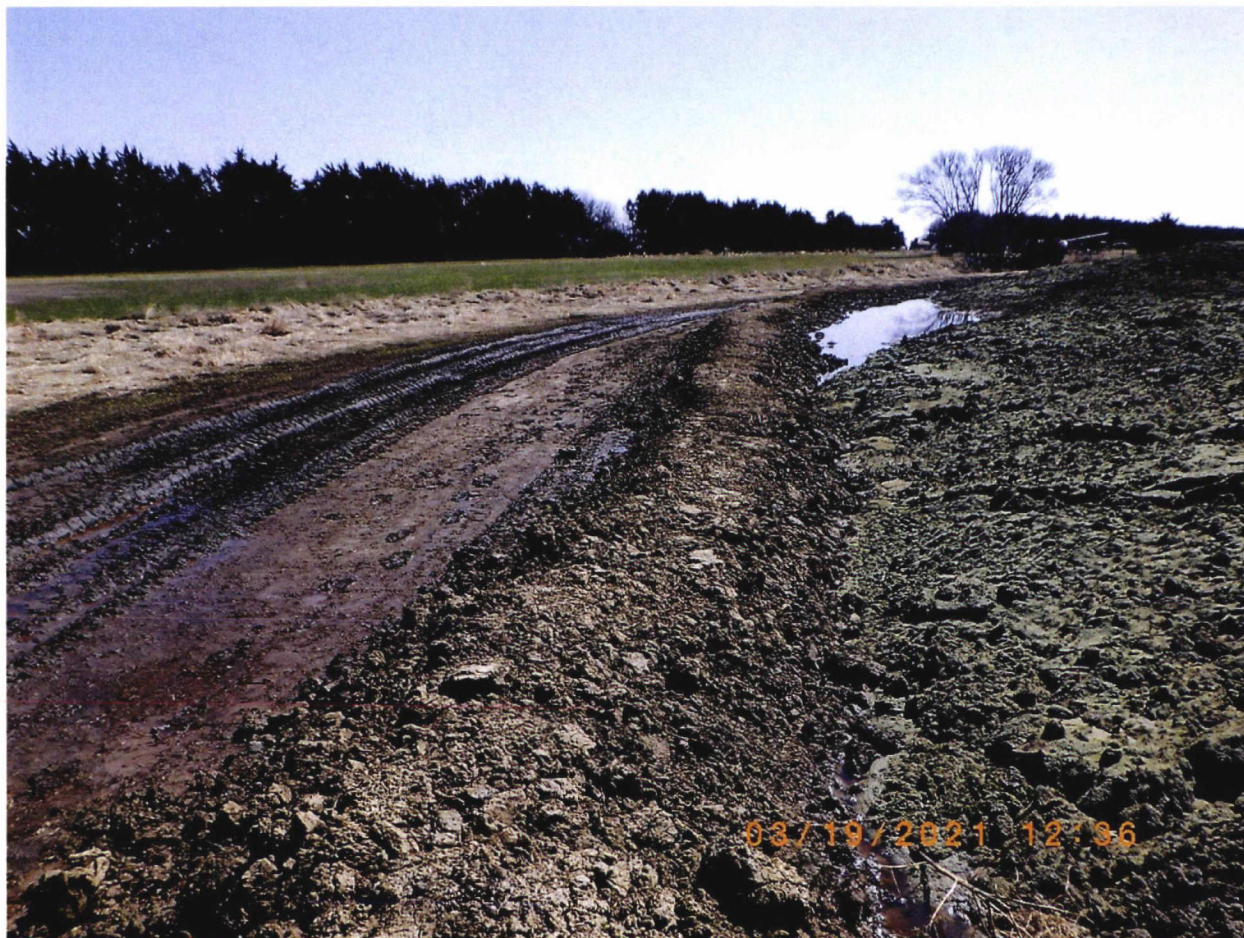
Photo: 3

Location: Area 6 – East wetcake storage area

Description: Berm along the east edge of the storage area with runoff collecting inside berm. There was no indication that runoff was seeping through the berm at the time of the site visit.

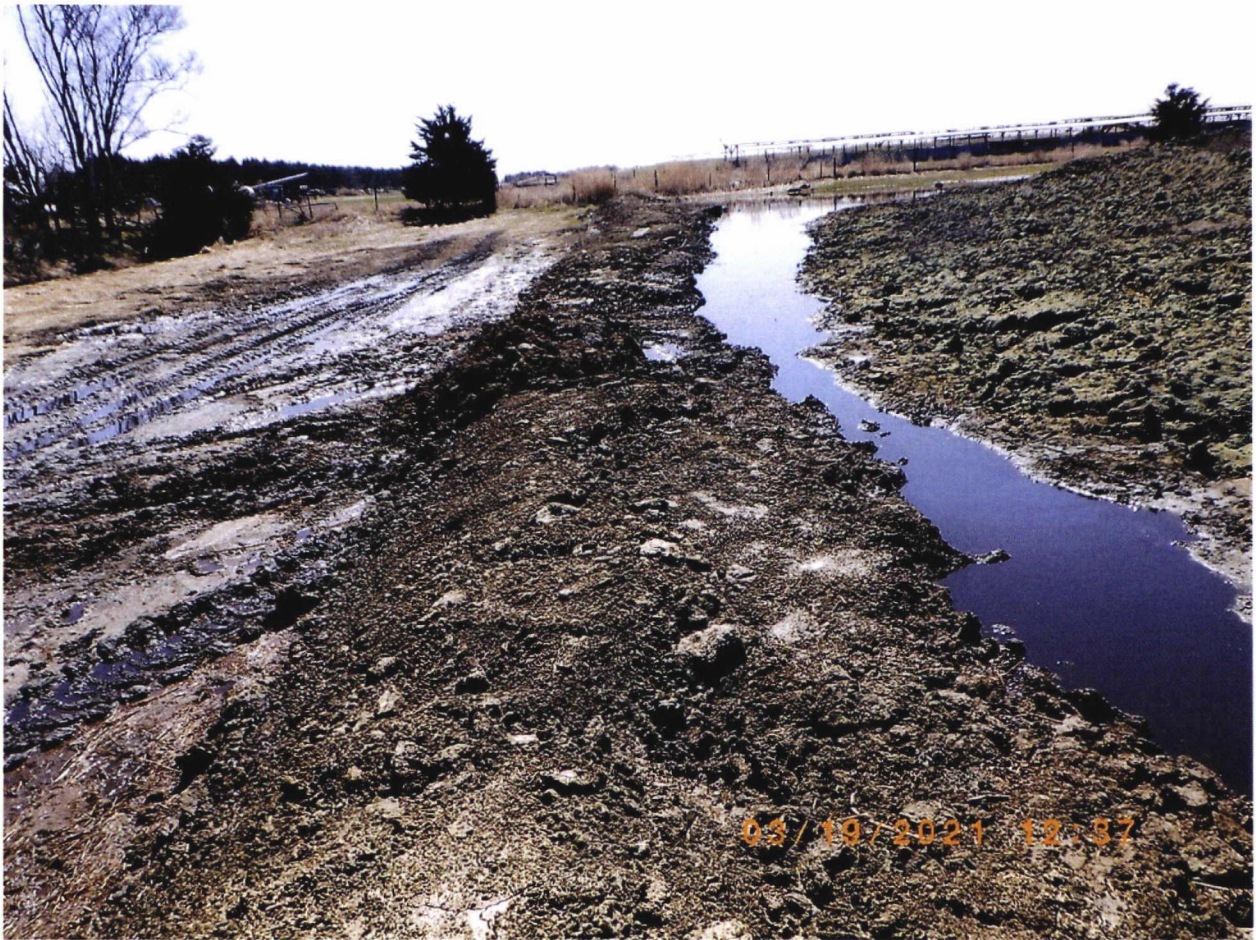
Photo: 4

Location: Midway along the east wetcake stockpile east berm.

Description: Repaired section of berm along east side requested on 3-17-2021 site visit.

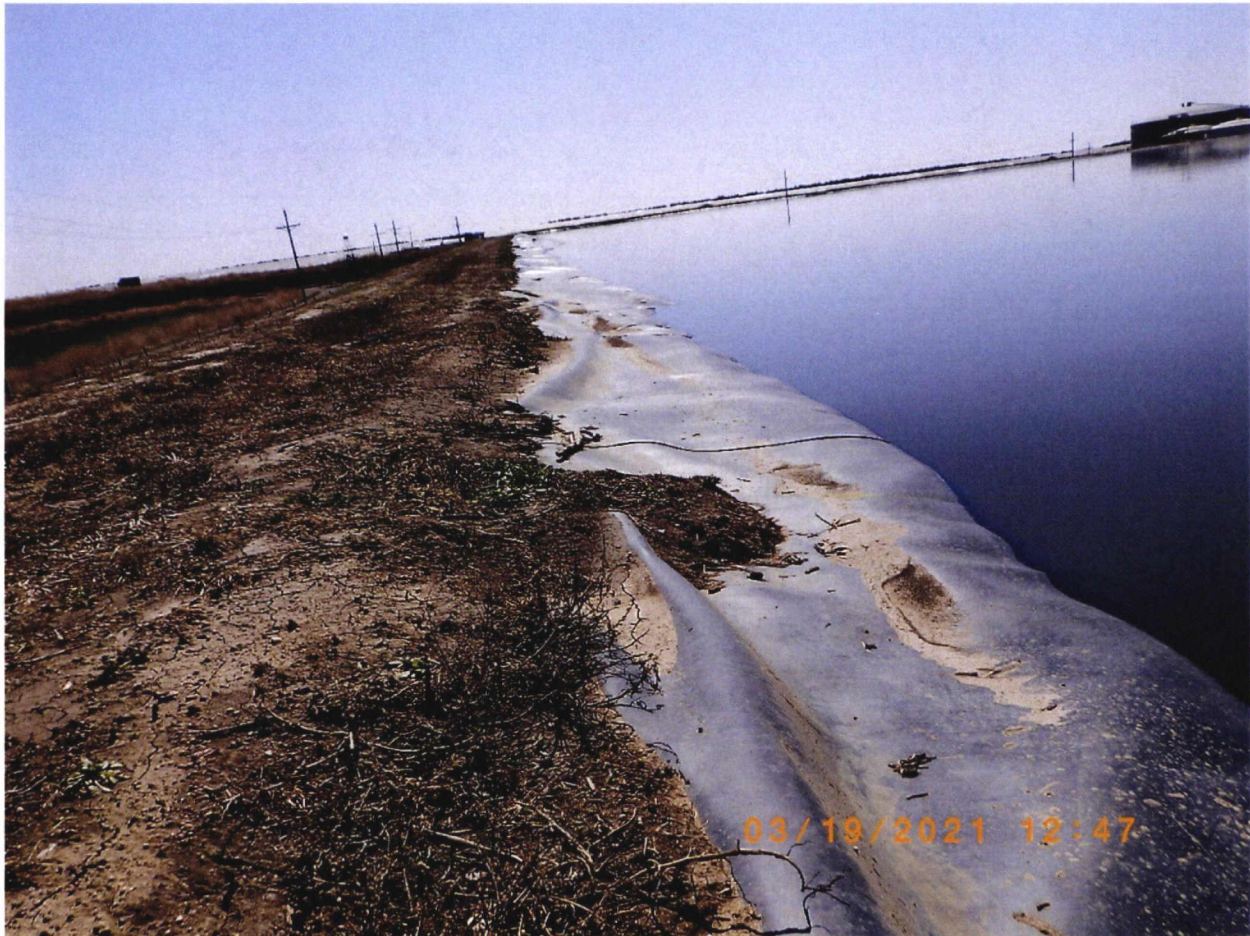
Photo: 5

Location: Northeast corner of the southeast lagoon

Description: The SE lagoon at this location appears to be within freeboard and liner is intact.

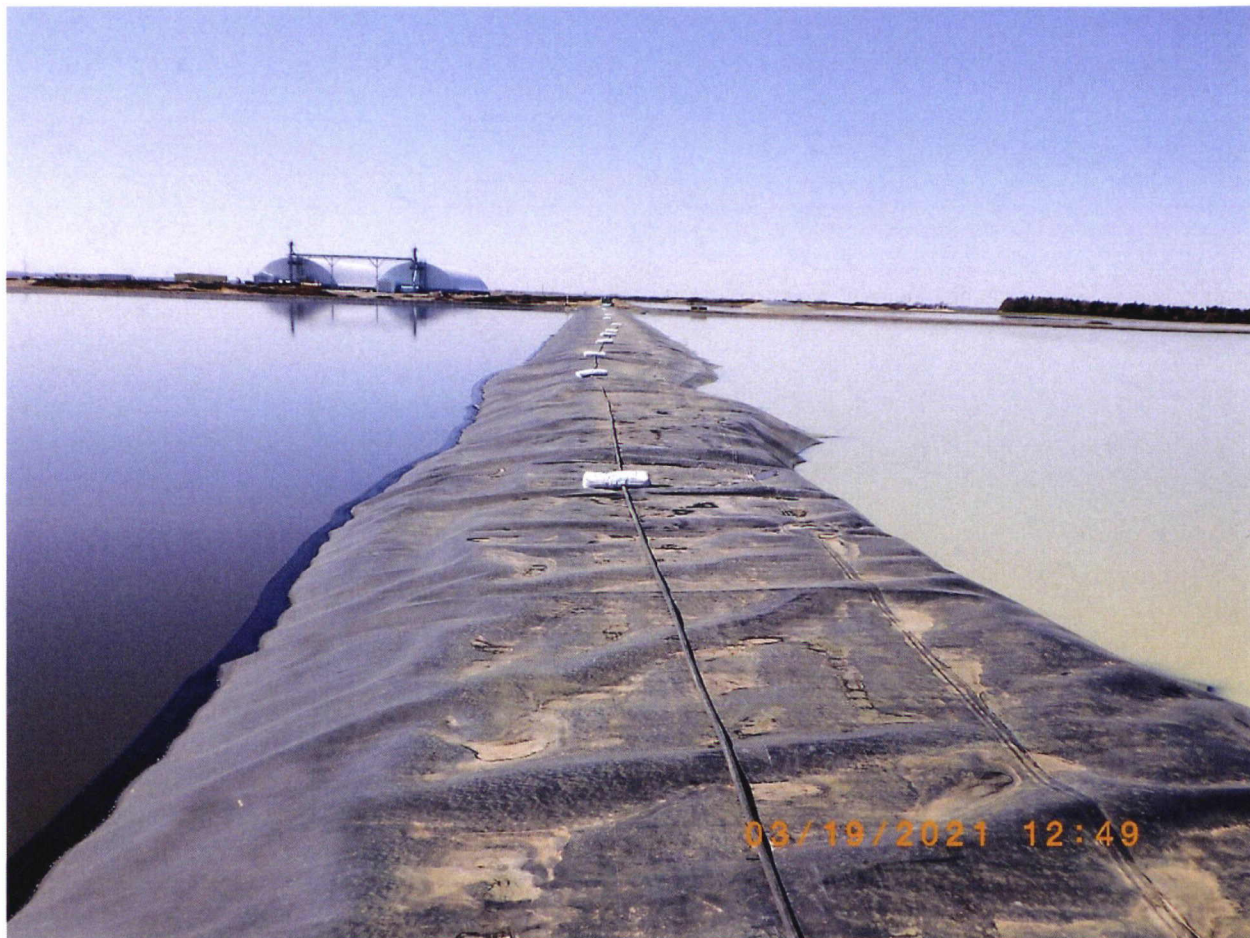
Photo: 6

Location: Approximately 220' West of the NE corner of the SE lagoon

Description: SE lagoon on the left and NE lagoon on the right side of the photo. The SE lagoon had black viscous material collection along the edge of the lagoon and flow between the lagoons reversed from NE -> SE to SE -> NE. A whale degassing in the NE lagoon also took place which coincide with the reversal.

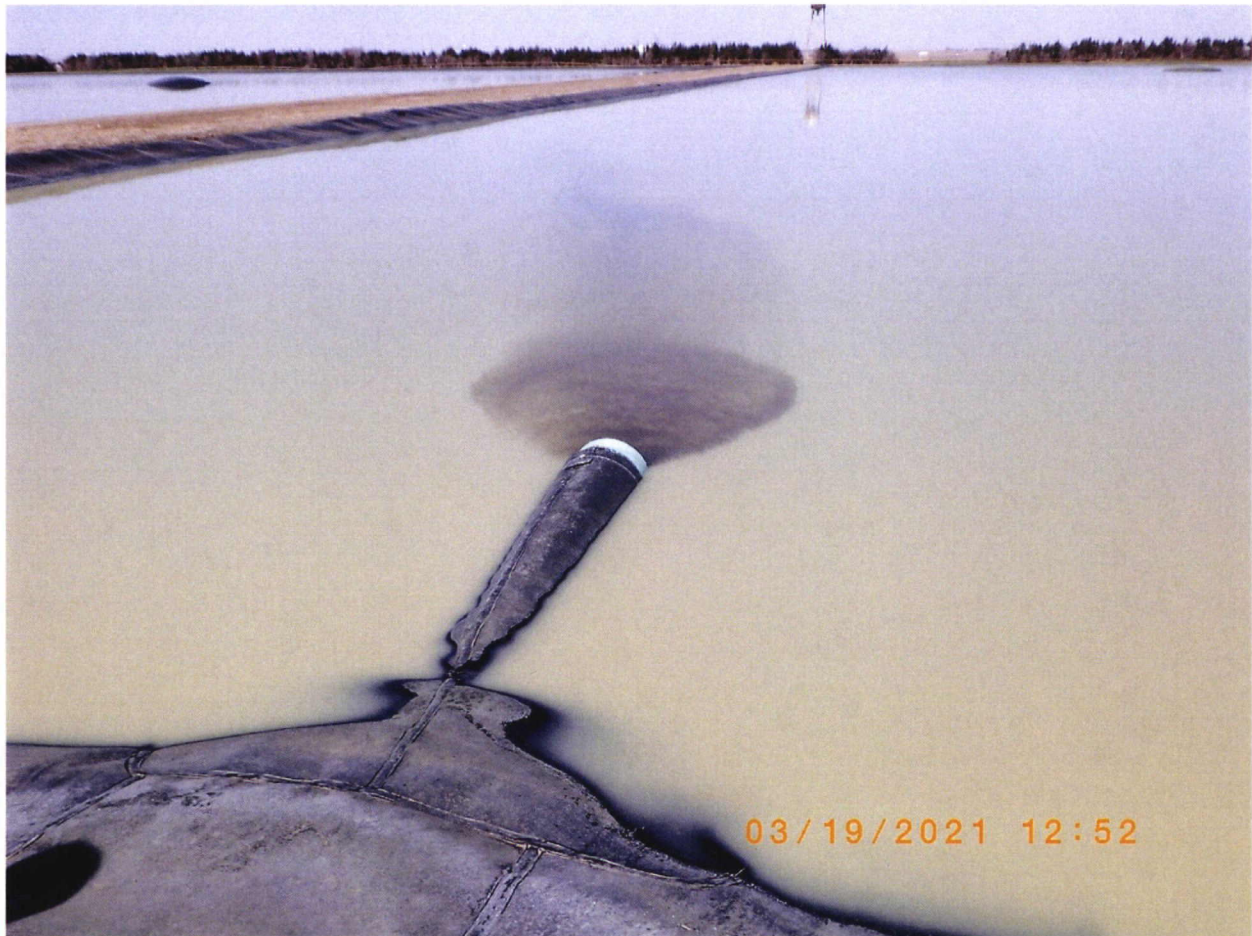
Photo: 7

Location: Near the SW corner of the NE lagoon.

Description: Pipe between the SE and NE lagoon showing the flow reversal.

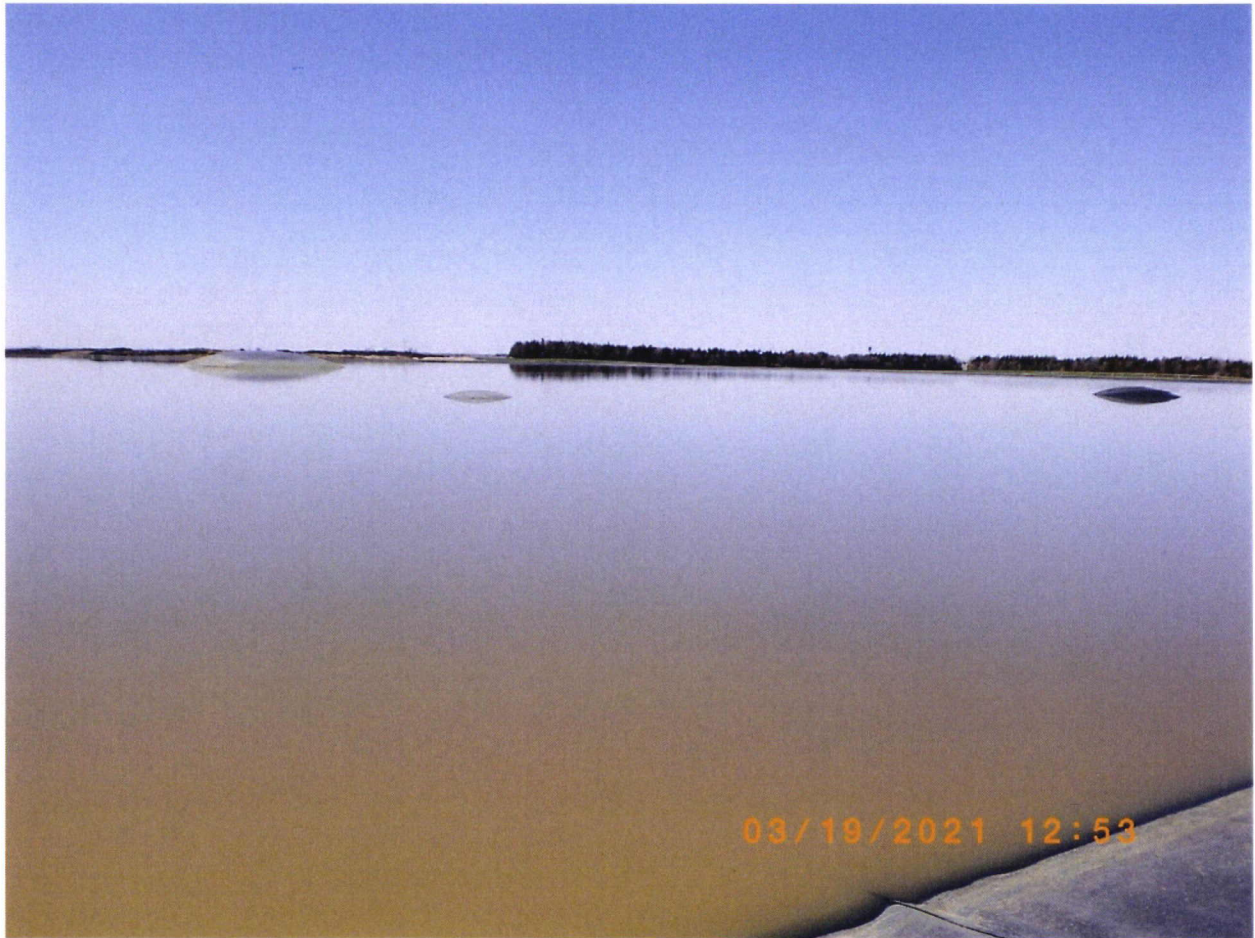
Photo: 8

2. Northwest lagoon – The NW lagoon also had flow into the NE lagoon and there were three whales were visible. The largest was increasing in size during the time onsite potentially displacing the lagoon water.
3. South lagoon – The South lagoon was close to or at freeboard and was very dark brown with oily black material clumping along the north edge.

Location: Southeast corner of the NW lagoon

Description: Three whales are visible at the time of the site visit. There was no flow observed between the NE and NW lagoon.

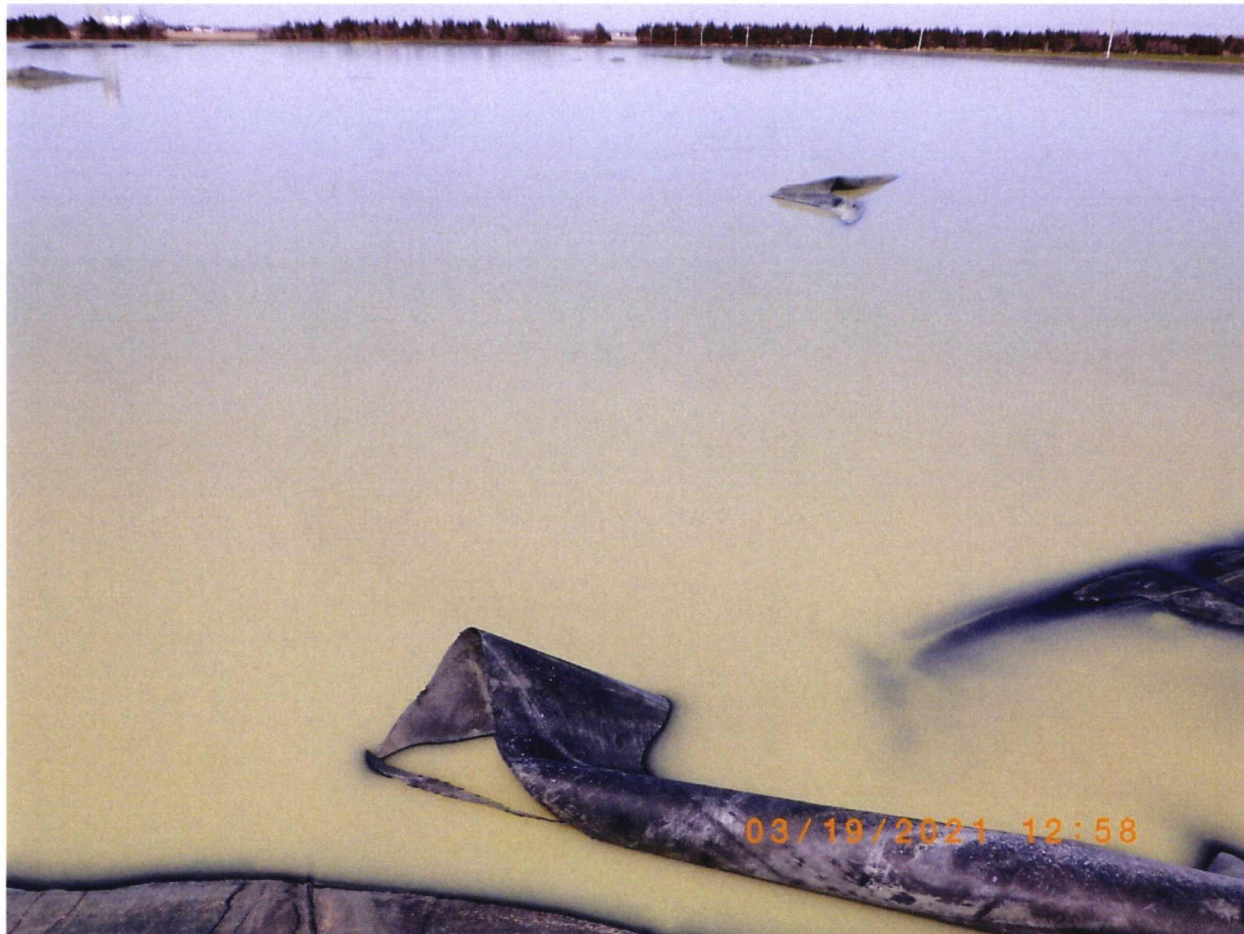
Photo: 9

1. Northeast lagoon – The NE lagoon was at or close to freeboard and had flow from the SE lagoon flowing into it. A whale had actively degassed while onsite creating volume for the SE to flow in to at the pipe connecting the two lagoons.

Location: Approximately 170' west of the NE lagoon SE corner.

Description: Location of degassed whale in the NE lagoon. Liner sections are visibly moving with gas buildup.

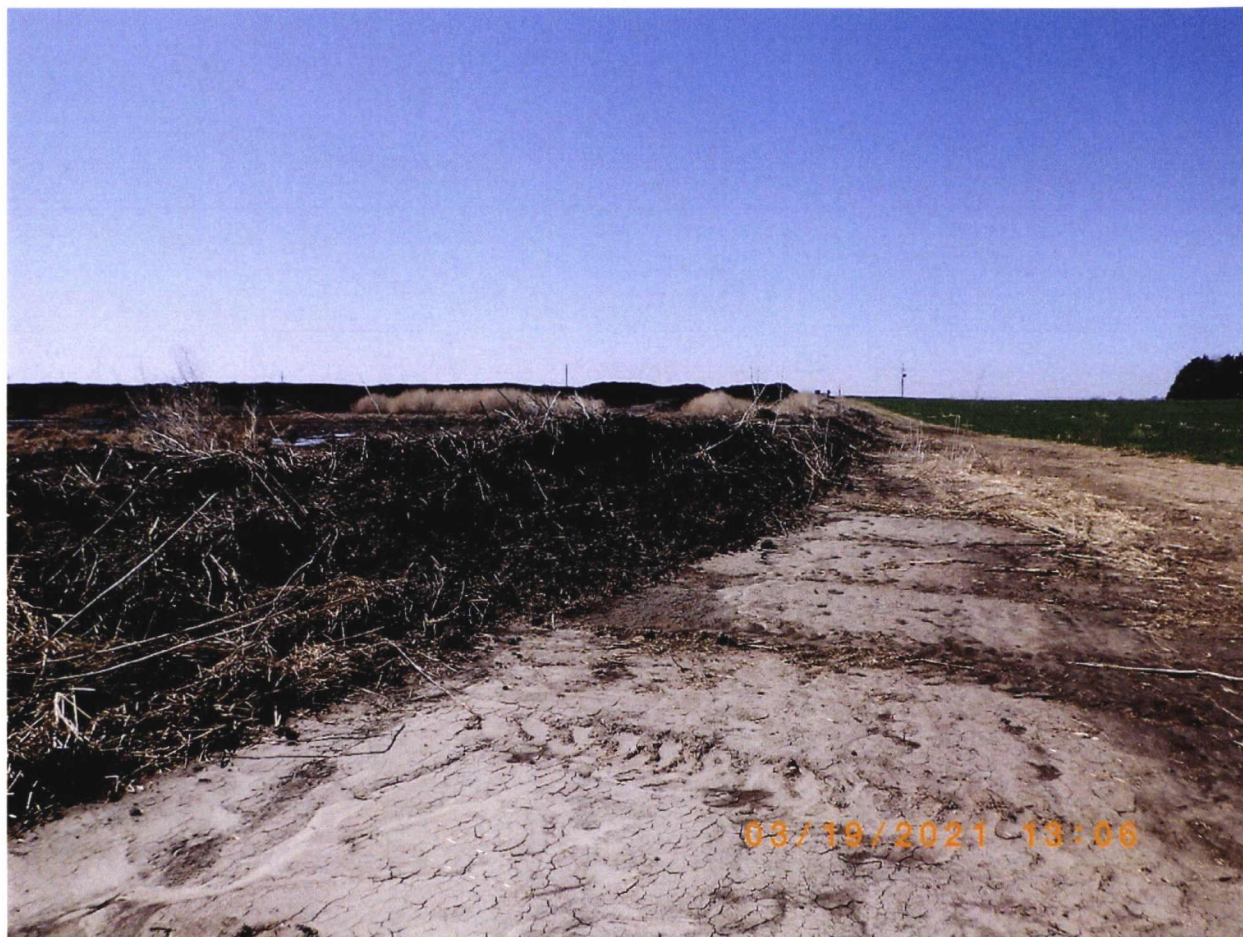
Photo: 10

Location: Between area 3 and 4 on the site map along the north side of the wet north wetcake storage.

Description: Berm repaired along the north side showing additional soil added to the berm.

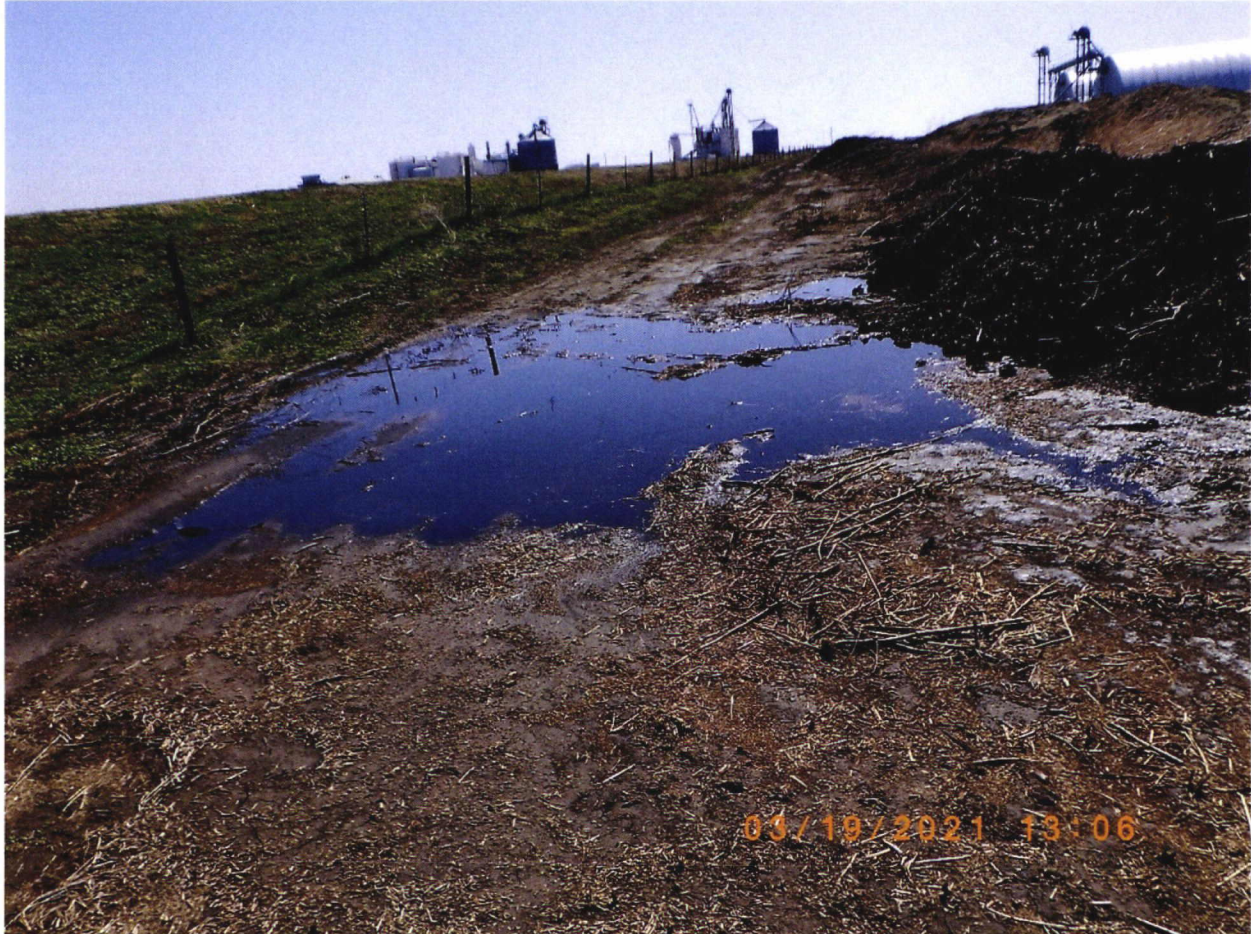
Photo: 11

- The bermed area at location 3 appeared to have liquid seeping through the berm and was pooling outside of the containment. I requested that they repair this area as soon as possible.

Location: Area 3 on the site map.

Description: The northeast corner of the bermed area to contain wetcake runoff showing active seep through the berm. I requested additional measures to be taken to repair or reinforce this section of the berm.

- Please add more soil to the berm at the NE corner of the North Wetake Storage area (Adjacent to the NW corner of the West Lagoon).
- The rise of the bermed areas appear to be holding but must be monitored daily.

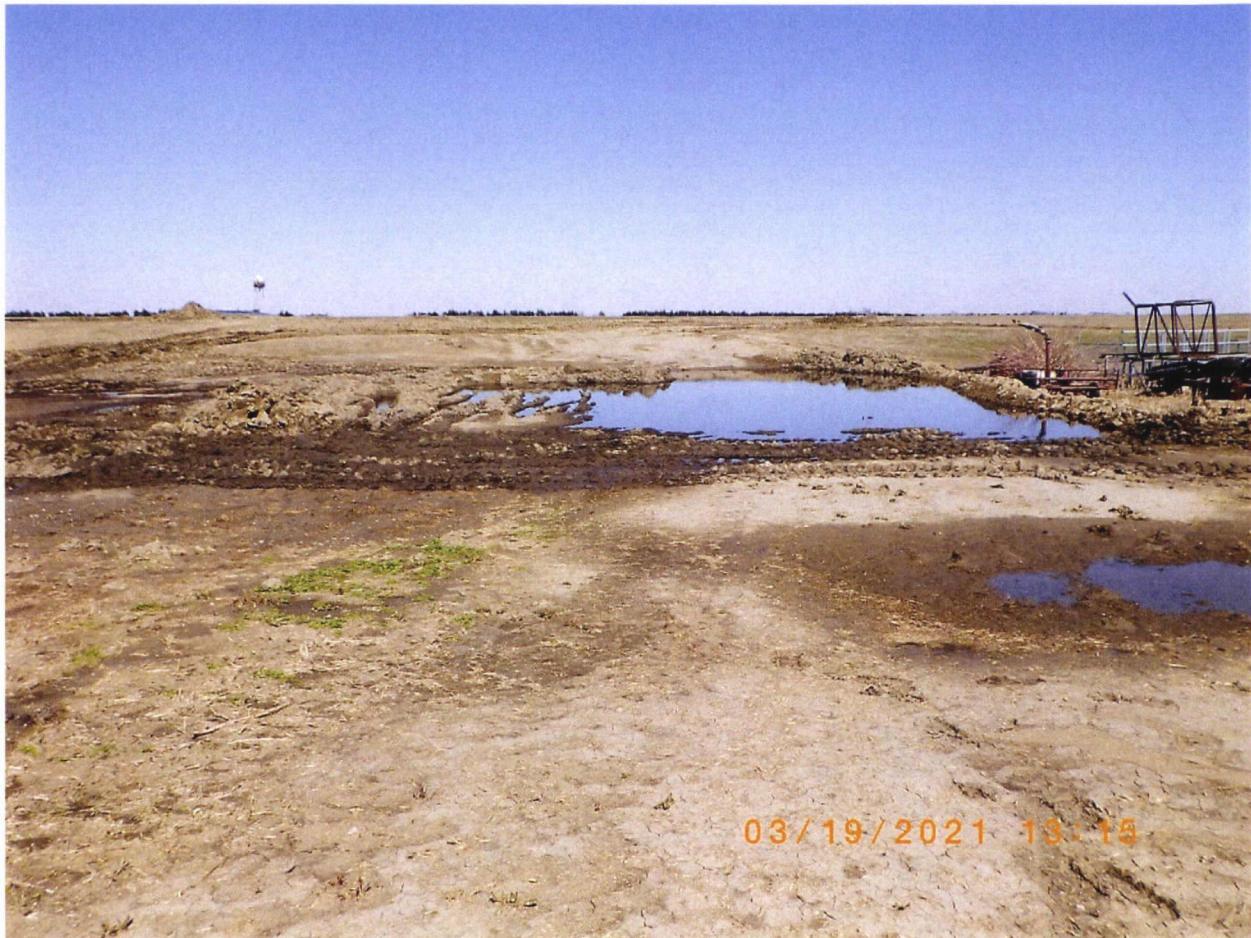
Photo: 12

Location: Area 1 on the site map north of the office building

Description: Bermed area used to contain runoff from the wetcake storage area southeast of the hoop buildings. The berms in this area appear to be stable.

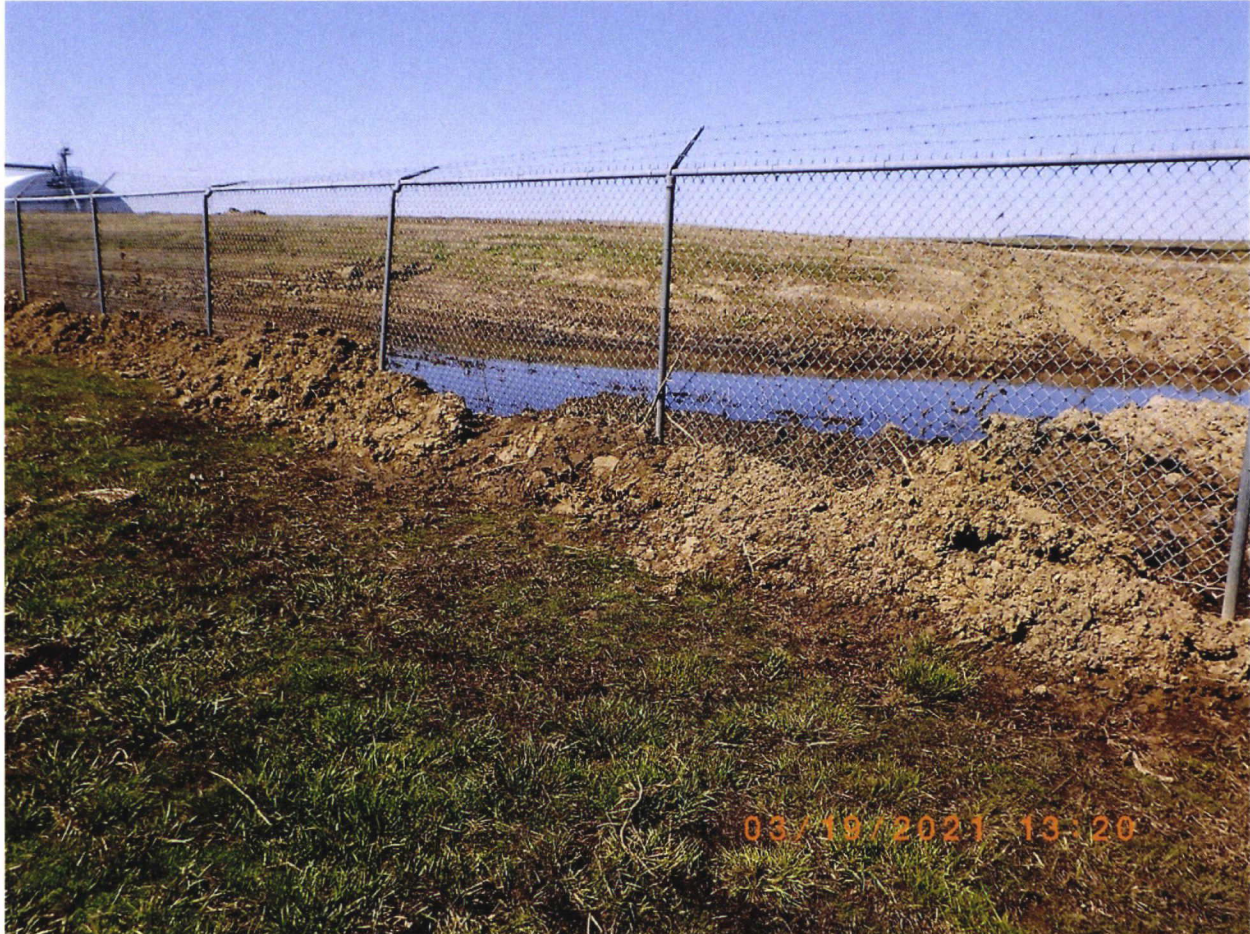
Photo: 13

Location: Area 2 on the site map

Description: Bermed area along the fence line used to contain additional runoff from area 1.

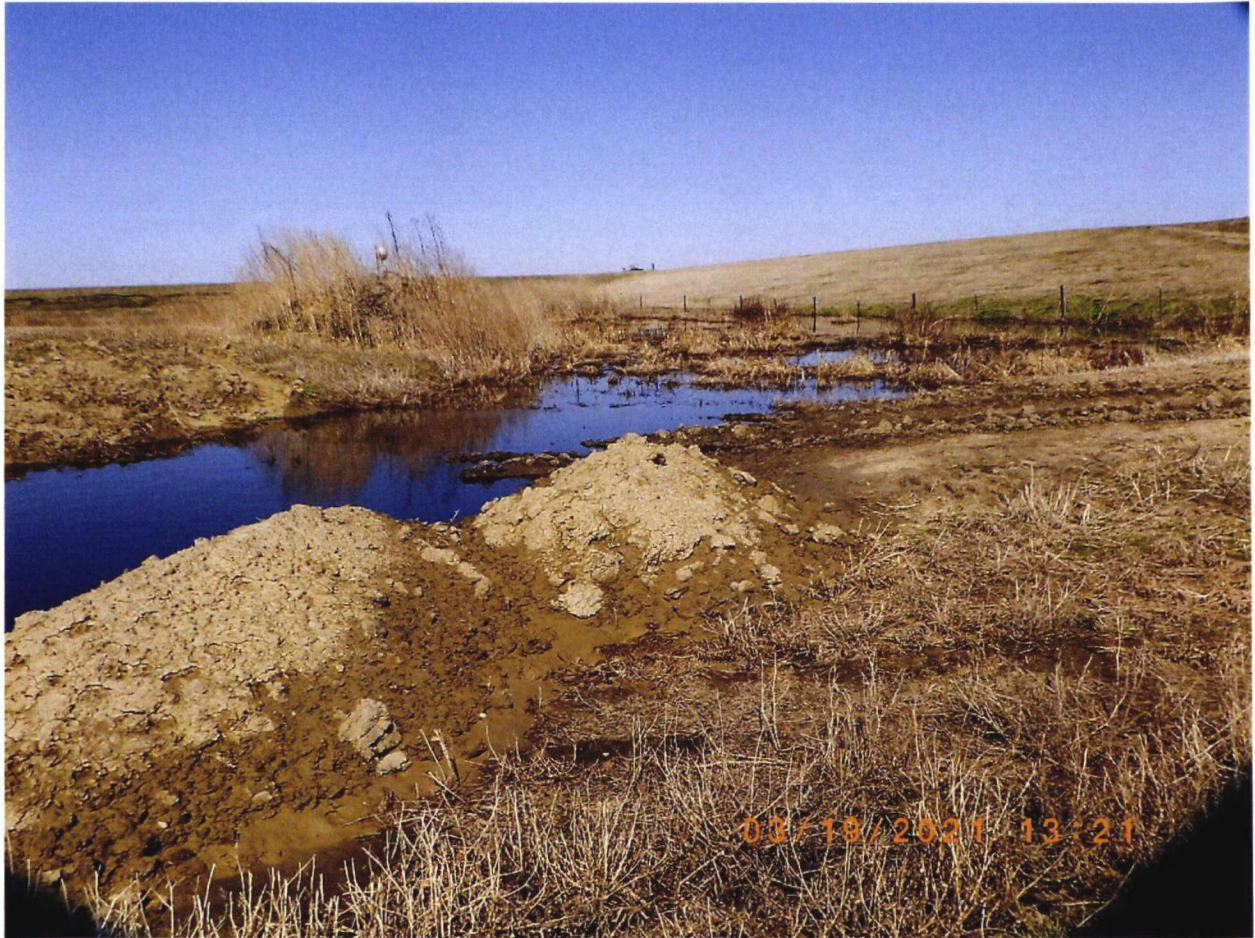
Photo: 14

Location: Area 2 on the site map.

Description: Pooled runoff from area 5 and area 1 along with runoff captured from the area north of area 1.
