Facility: AltEn
IIS: 84069
PCS: NE0137634

Jason Windhorst
3-31-2021

Site Visit Check list

AltEn LLC - Storm Water Temporary BMP Check Map

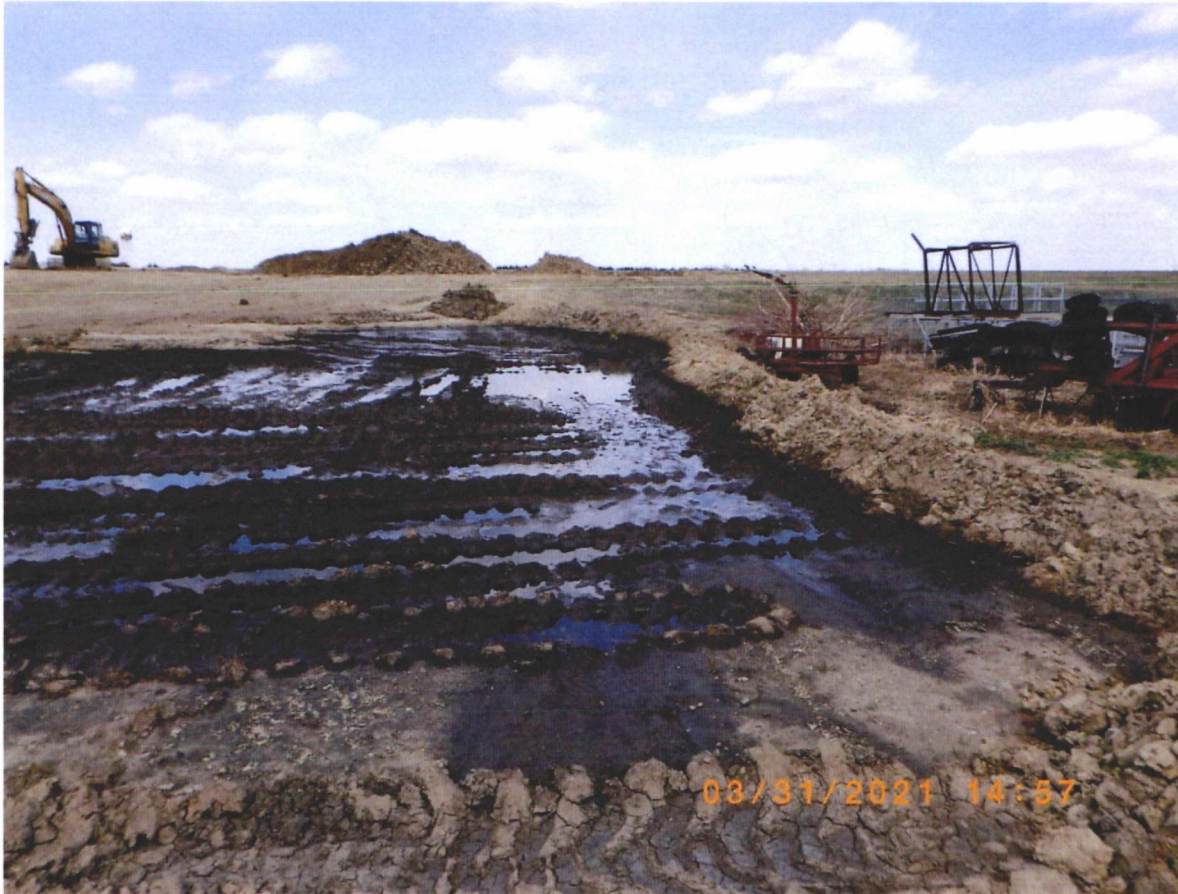
Photos: 1

- The facility is requesting to remove the berm for area. They have removed the wetcake upslope from this area and will no longer have runoff from the storage areas. They have bermed the wetcake further to the north of this area and are working on a plan to divert drainage to area 2. (See photos # 1&2)

Location: Area 1 on the site map

Description: The majority of runoff was pumped and is now being allowed to dry out. The facility has requested approval to remove this berm and use the newly constructed berm to the west as a replacement.

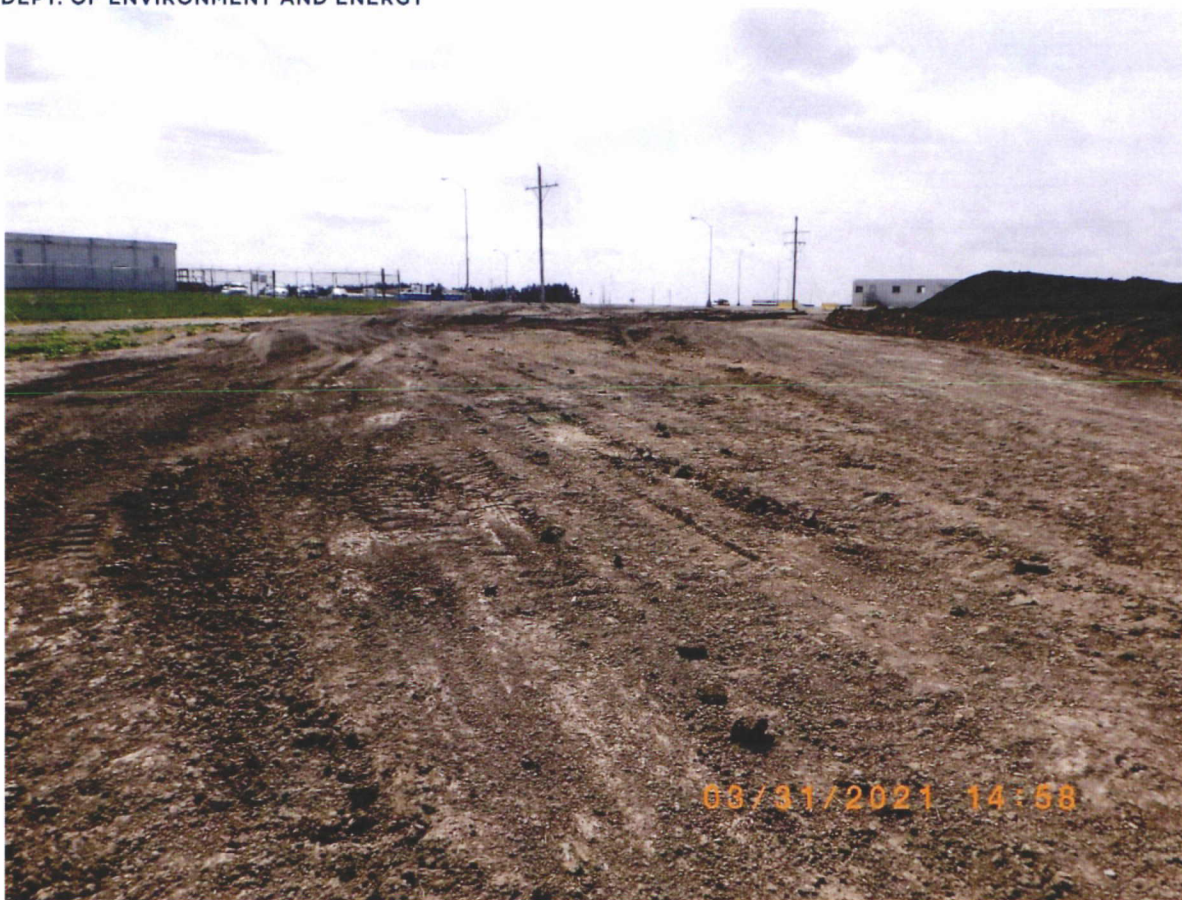
Photos: 2

Location: Area 1 on the site map

Description: The photo shows that the area above the berm AltEn is requesting to remove is clear of wetcake and any other stockpiled material. The area is not stabilized and will require additional measures such as silt-fence to reduce soil runoff in the bare areas.

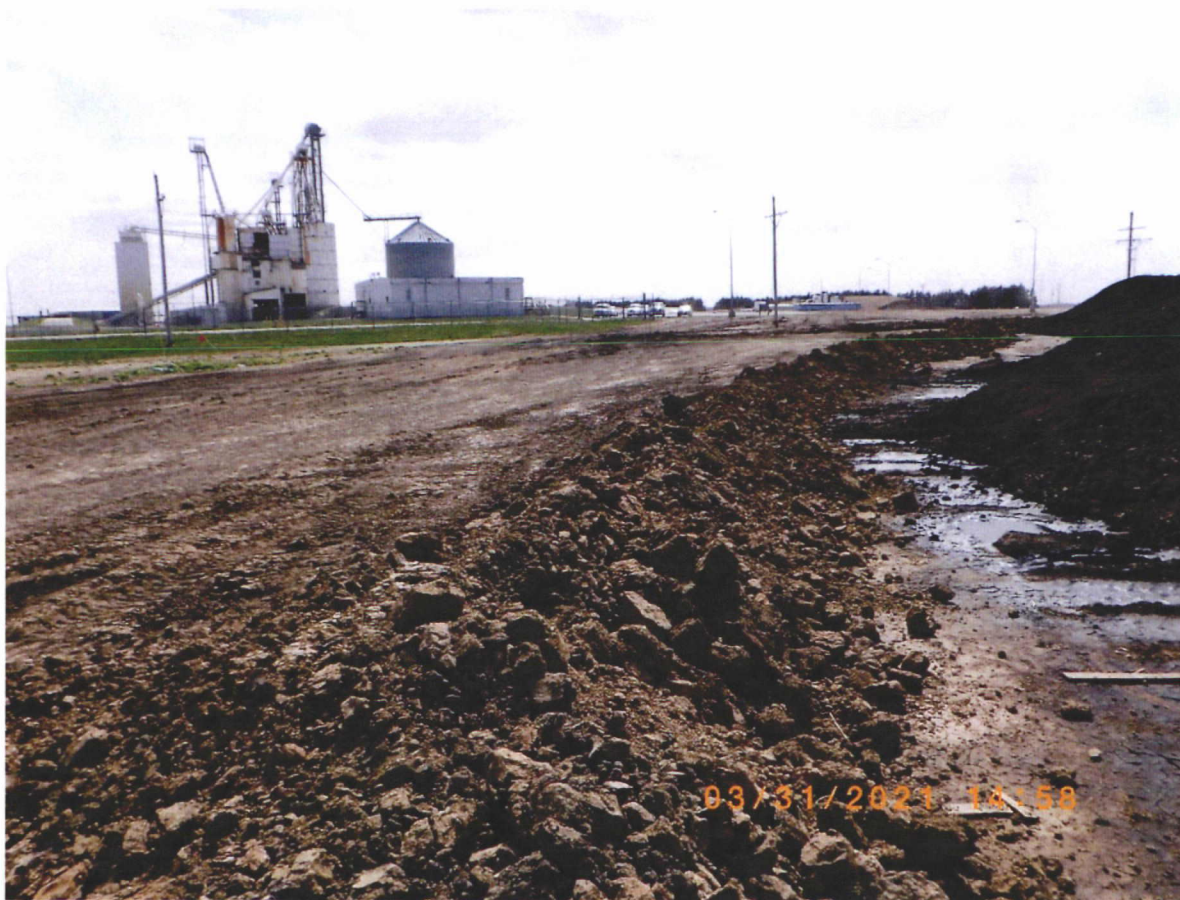
Photo: 3

Location: Area 1 on the site map

Description: The facility has created a septate berm to replace the berm downslope to contain runoff directly from the wetcake. The area to the south of this area has had wetcake moved further north and place behind the berm in the photo. The berm does not appear compacted/consolidated and may be susceptible to seep if fluid levels build up behind the berm.

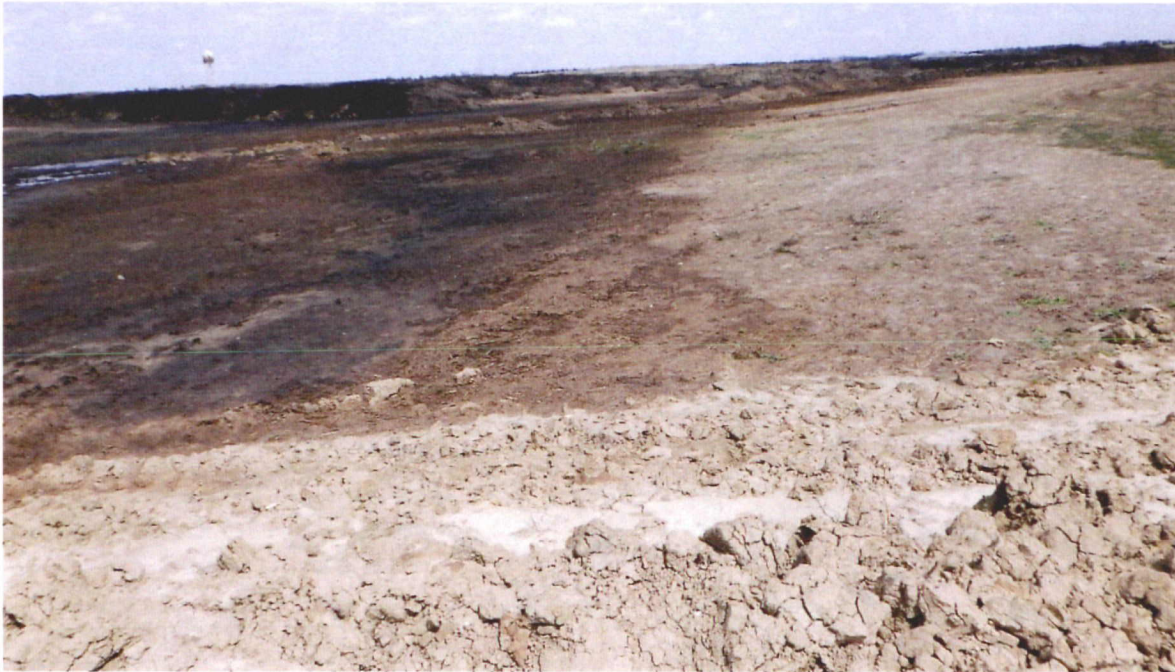
Photo: 4

Location: Area 5 on the site map

Description: This area was pumped earlier this week and has been graded to allow runoff to flow to the east now with minimal runoff collection behind the berm. AltEn indicated that majority of the runoff in this area should flow to area 2 on the site map. The berms will be maintained until further notice.

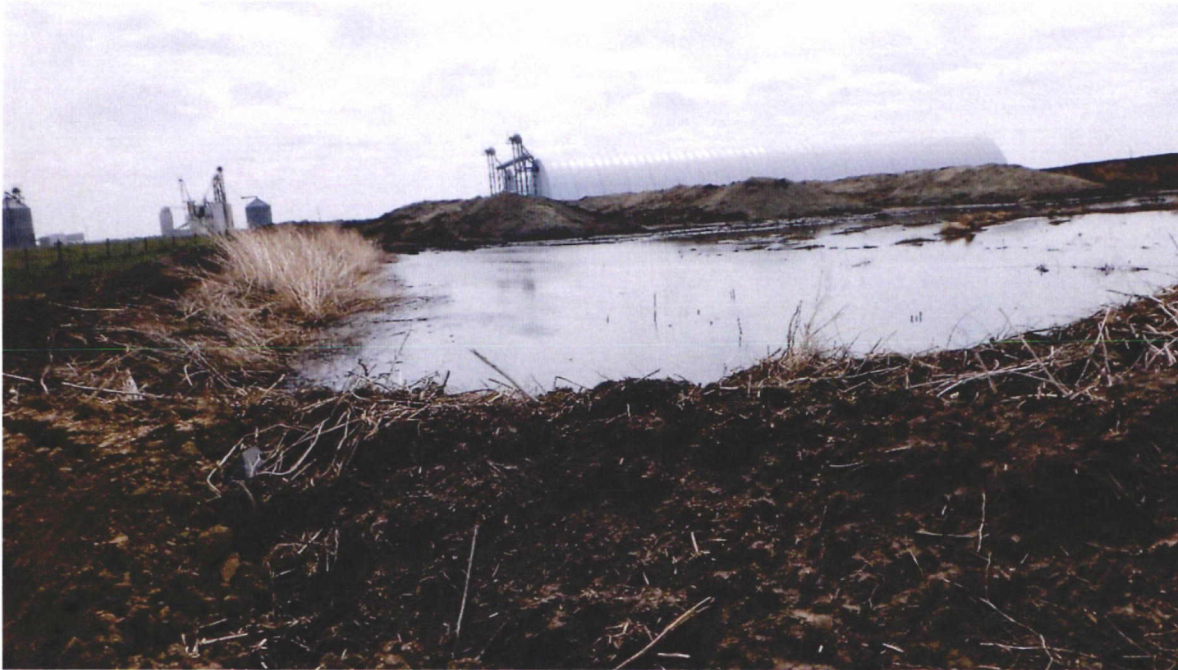
Photo: 5

- Area 3 will need to be pumped after they finish stabilizing the berm and area outside the berm.
- The second Poseidon tank frame has been constructed but not in use currently. The wind is problematic and unsafe currently to install the inside liner and will be completed late this week depending upon the weather. The third Poseidon tank area is being graded to the west of the Biochar area and should be completed this week. Assembly of the third tank is likely to begin in early April.

Location: Area 3 on the site map

Description: Runoff to the northeast in the north wetcake storage area should be pumped before the next precipitation event but is currently stable with no seepage.

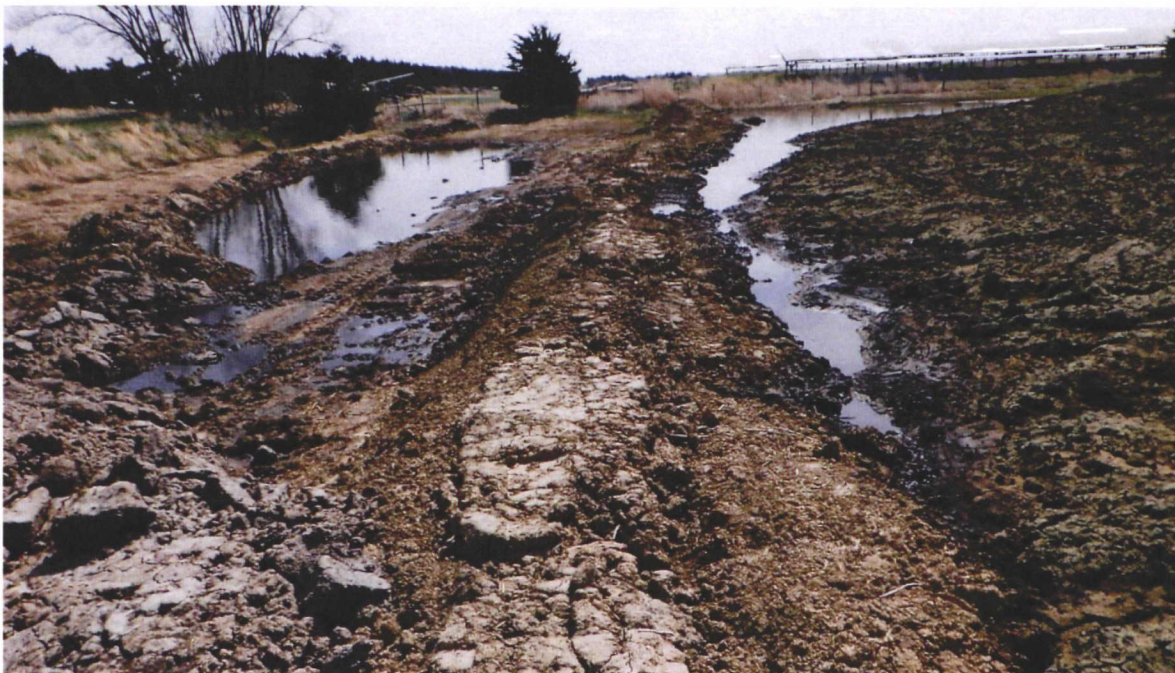
Photo: 6

- Area 6 continues to seep through the primary berm and appears to be holding at the lower berm. Mr. Peterson plans to pump out the berm once they gain access to more hose.

Location: Area 6 on the site map

Description: The containment berm adjacent to the wetcake shows some indication that there is seepage, but the second berm constructed below is currently holding with no obvious seepage. The area will be pumped according to AltEn once they acquire more hose or find another way to remove the liquid behind the berms.

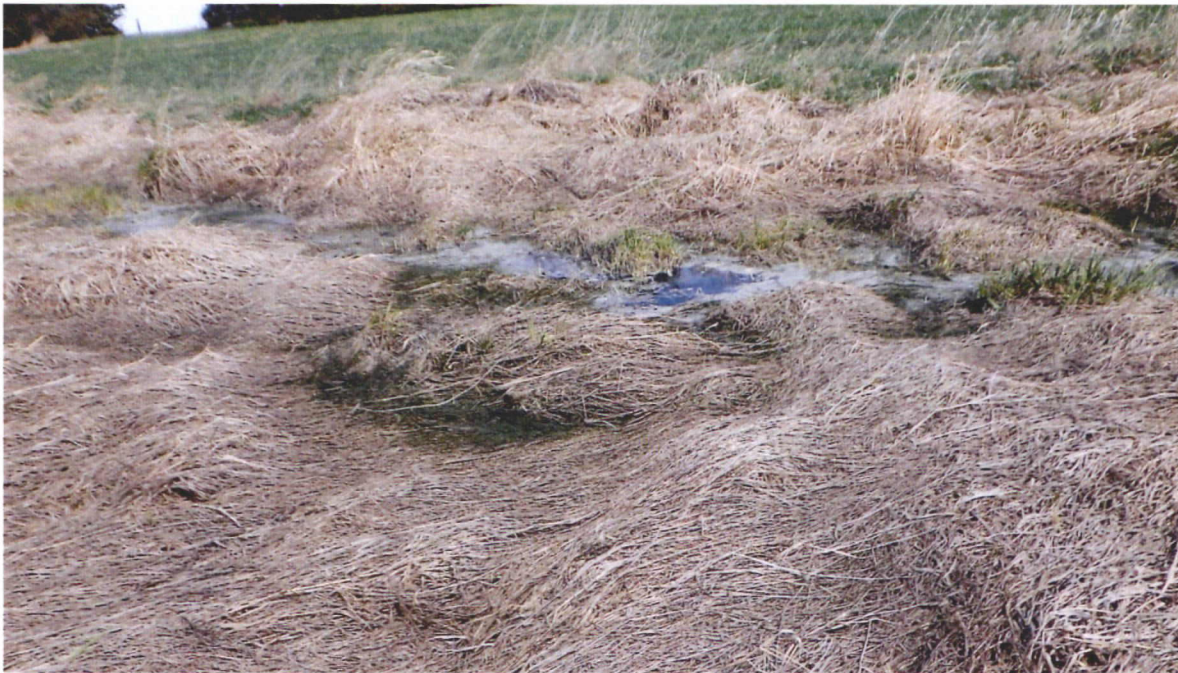
Photo: 6

Location: Area 6 on the site map

Description: The wet area is the ditch that conveys runoff from AltEn and a small portion of Mead Cattle. This area was impacted by the digester spill in February and shows evidence of filamentous bacteria (white masses). The area along the ditch has a strong acrid odor where liquid is present.

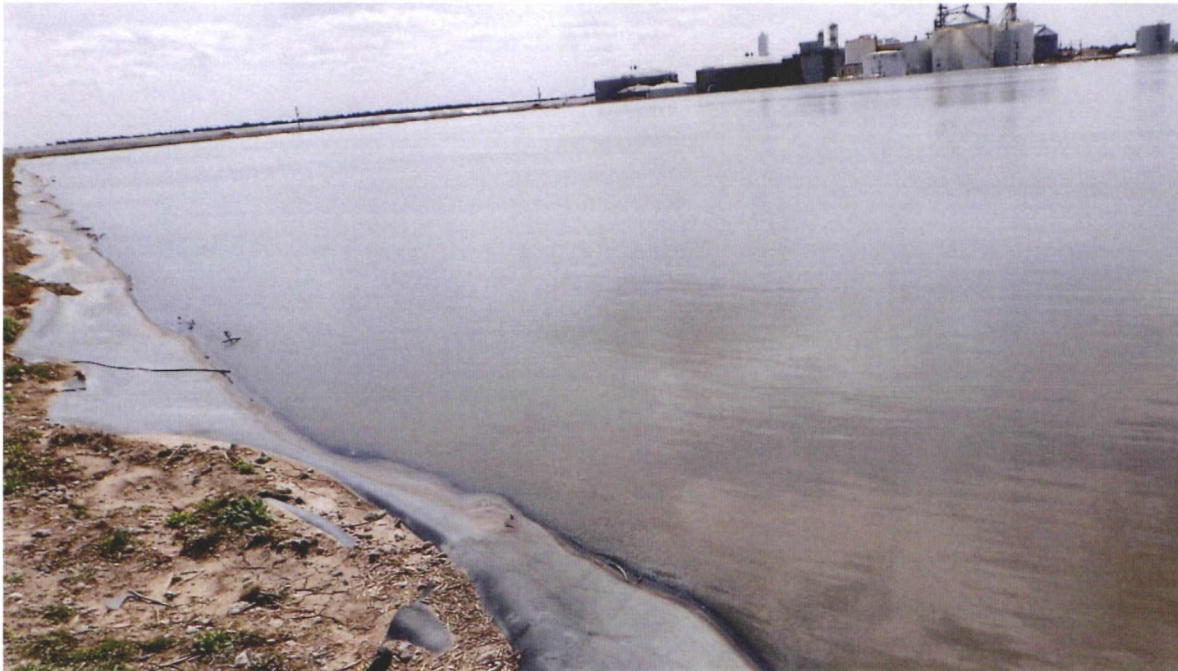
Photo: 7

Location: Northeast corner of the southeast lagoon

Description: The southeast lagoon does not appear to have any significant changes since that last inspection.

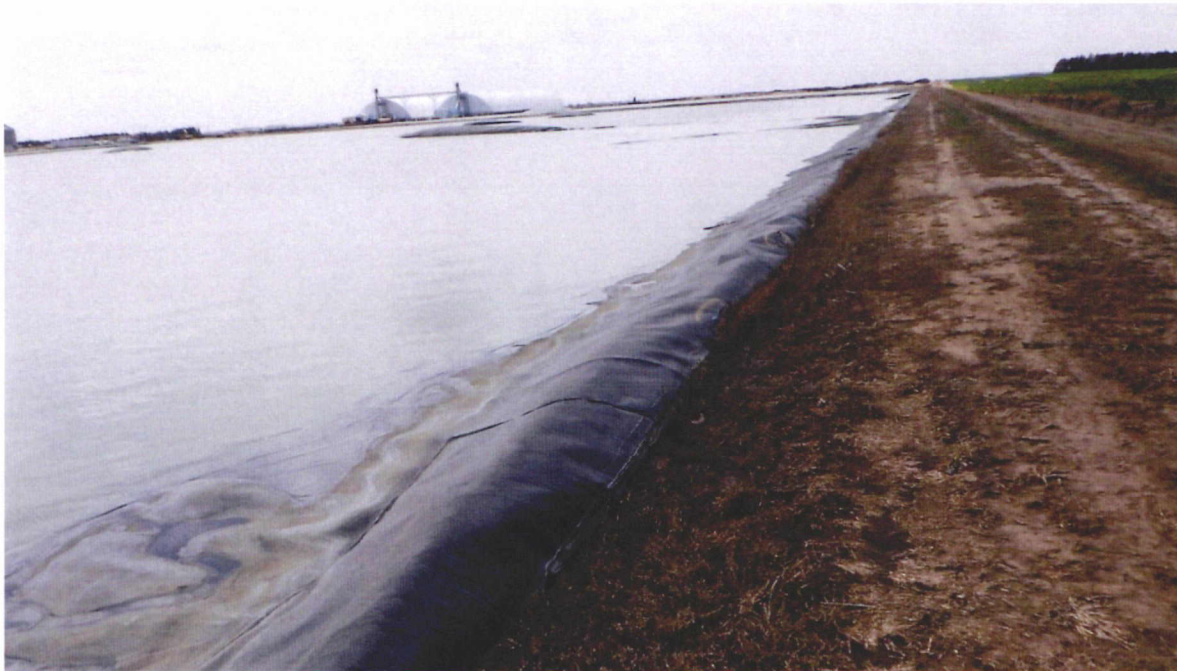
Photo: 8

Location: Northeast corner of the northeast lagoon

Description: The Northeast lagoon does not appear to have any significant changes since that last inspection.

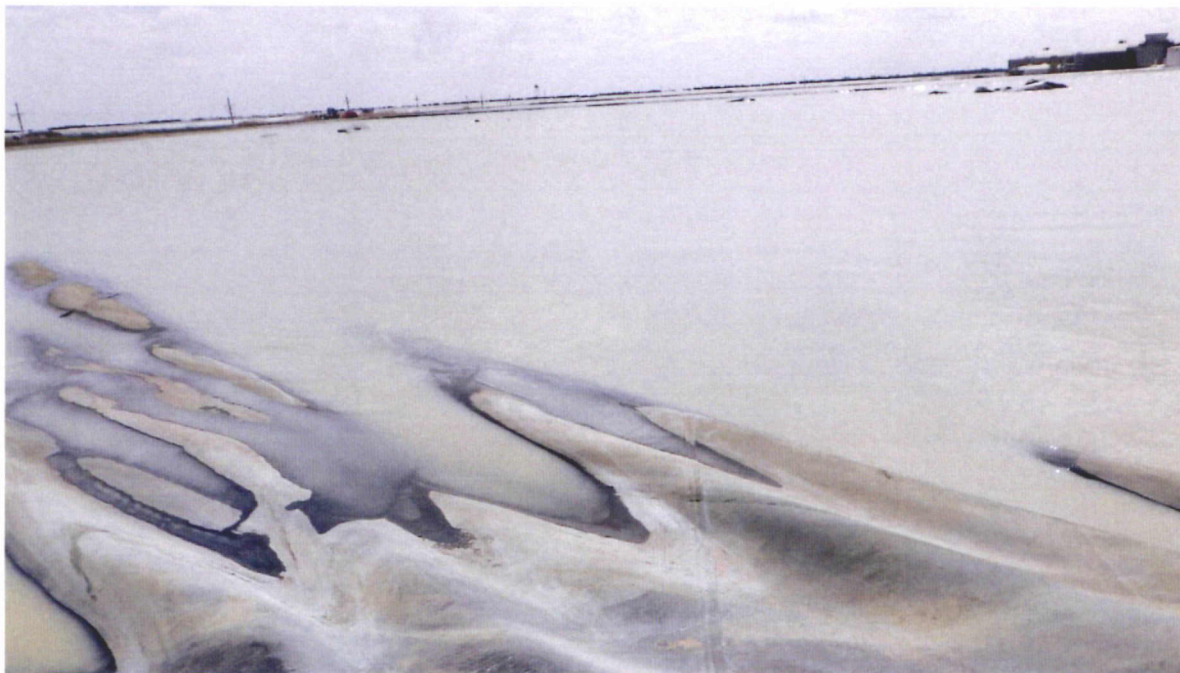
Photo: 8

- High wind gusts are causing large waves to splash up and partly over the east edge.
- Portions of the liner (whales and floating sections) were observed moving.

Location: Approximately 400' west of the NE corner of the northeast lagoon

Description: Portions of the liner was moving up and down with the wind during high gusts (40 mph).

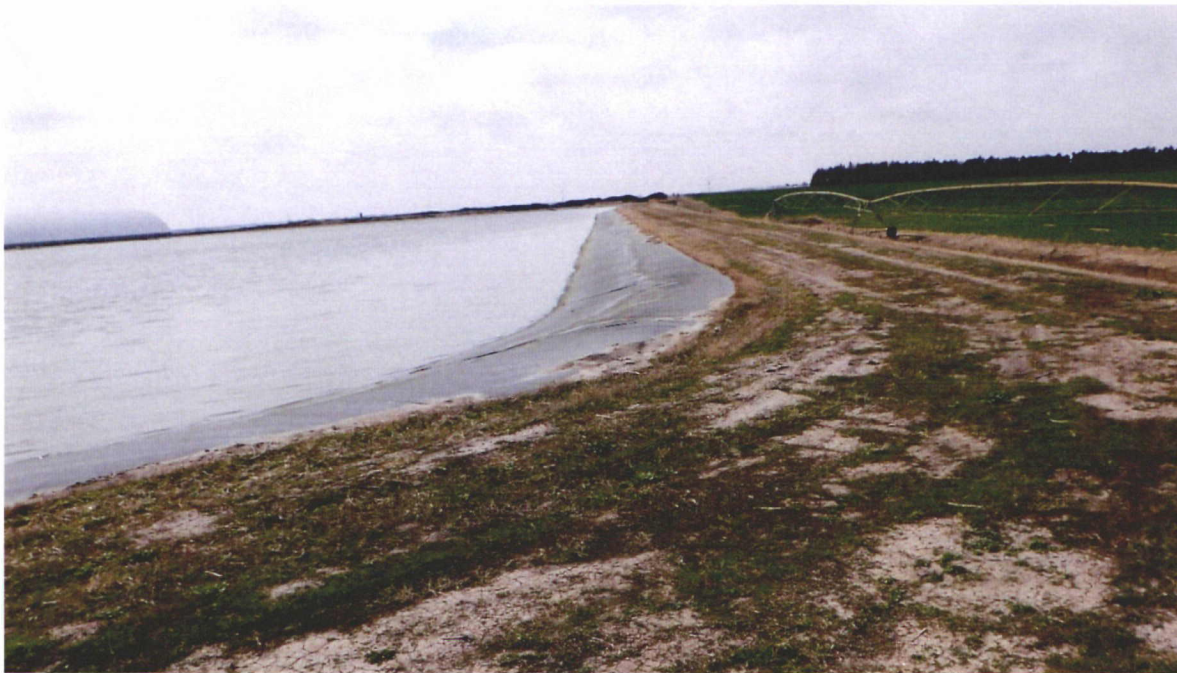
Photo: 9

Location: Northeast corner of the northwest lagoon

Description: The lagoon appears lower since the last site visit.

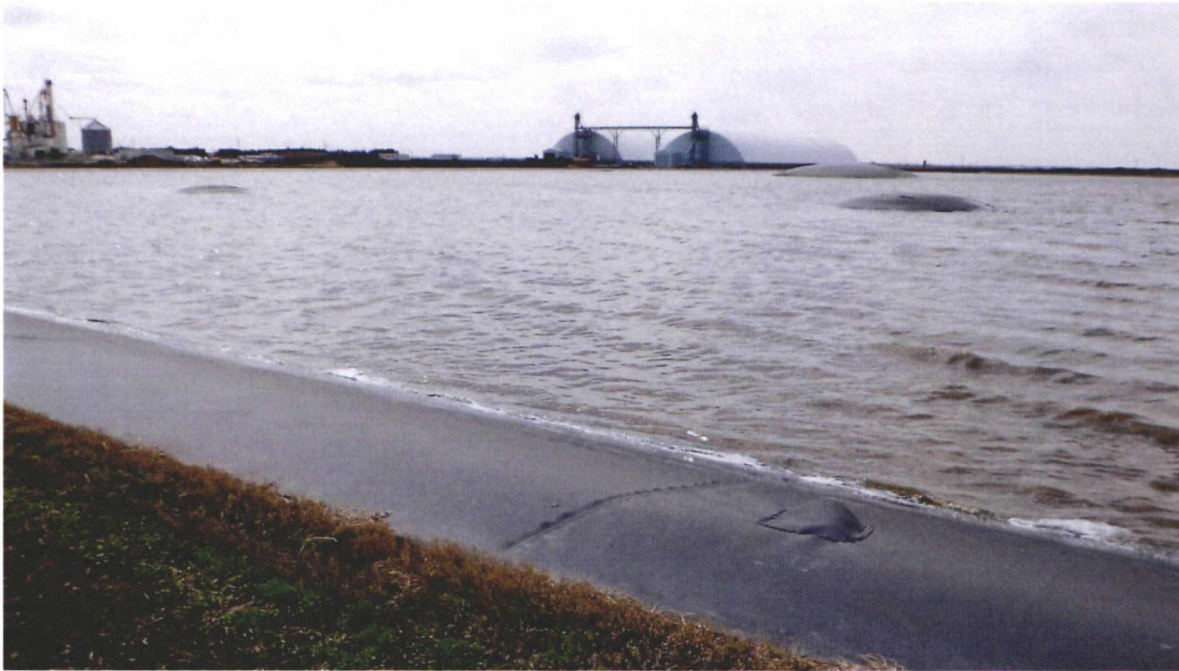
Photo: 10

Location: Approximately 250' south of the NE corner of the northwest lagoon

Description: Whales present in northwest lagoon.

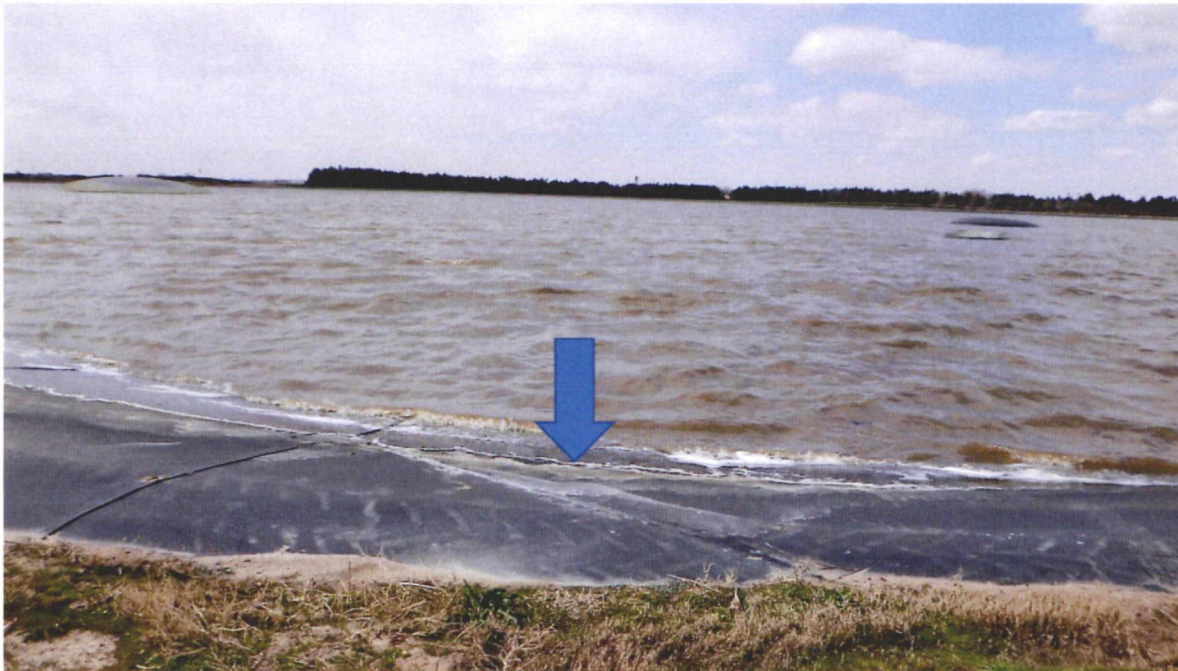
Photo: 11

- The southeast corner showed indications of movement under high gusts.

Location: Southeast corner of the northwest lagoon

Description: The liner was visibly moving up and down during strong gusts. (arrow).

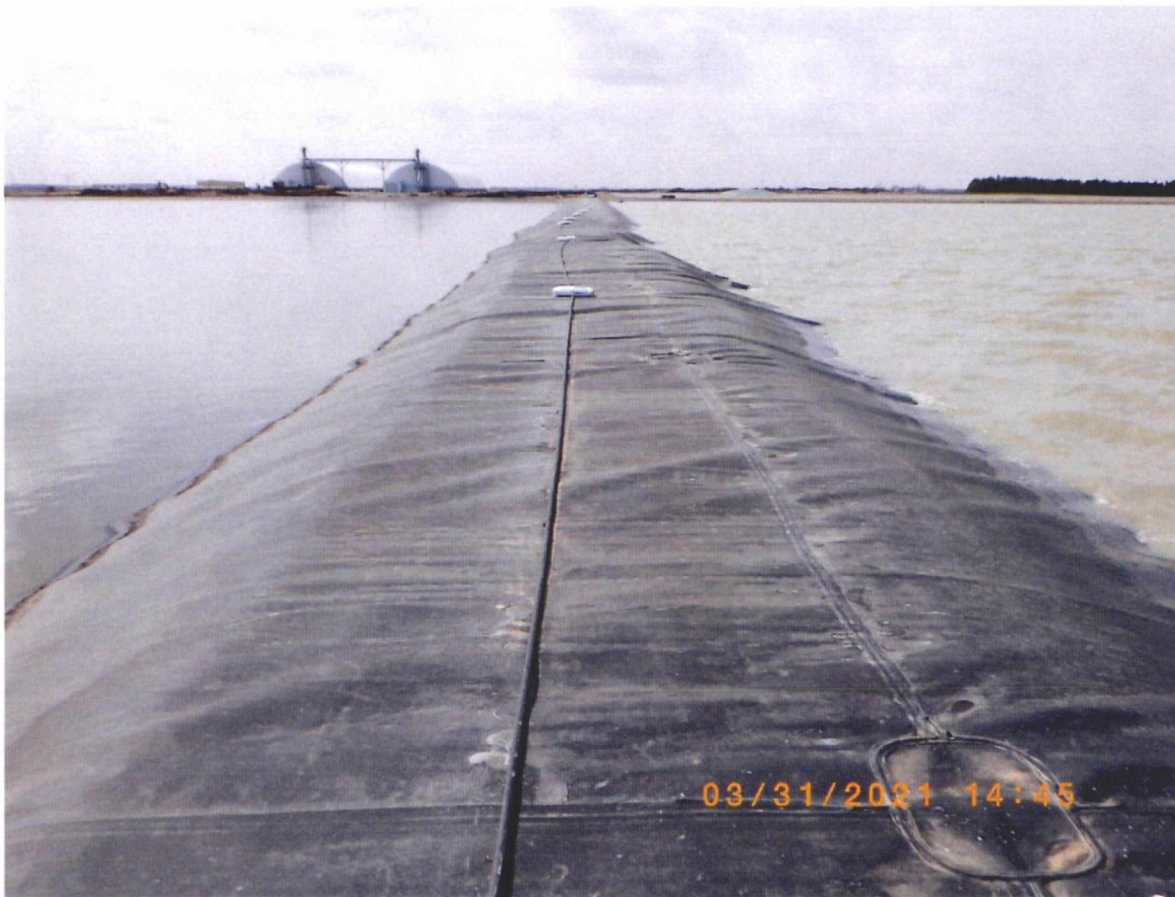
Photo: 13

Location: Approximately 275' west of the northeast corner of the southeast lagoon.

Description: Note the density change between both lagoons. The lagoon on the right had periodic whitecaps while the lagoon on the left appears calm.

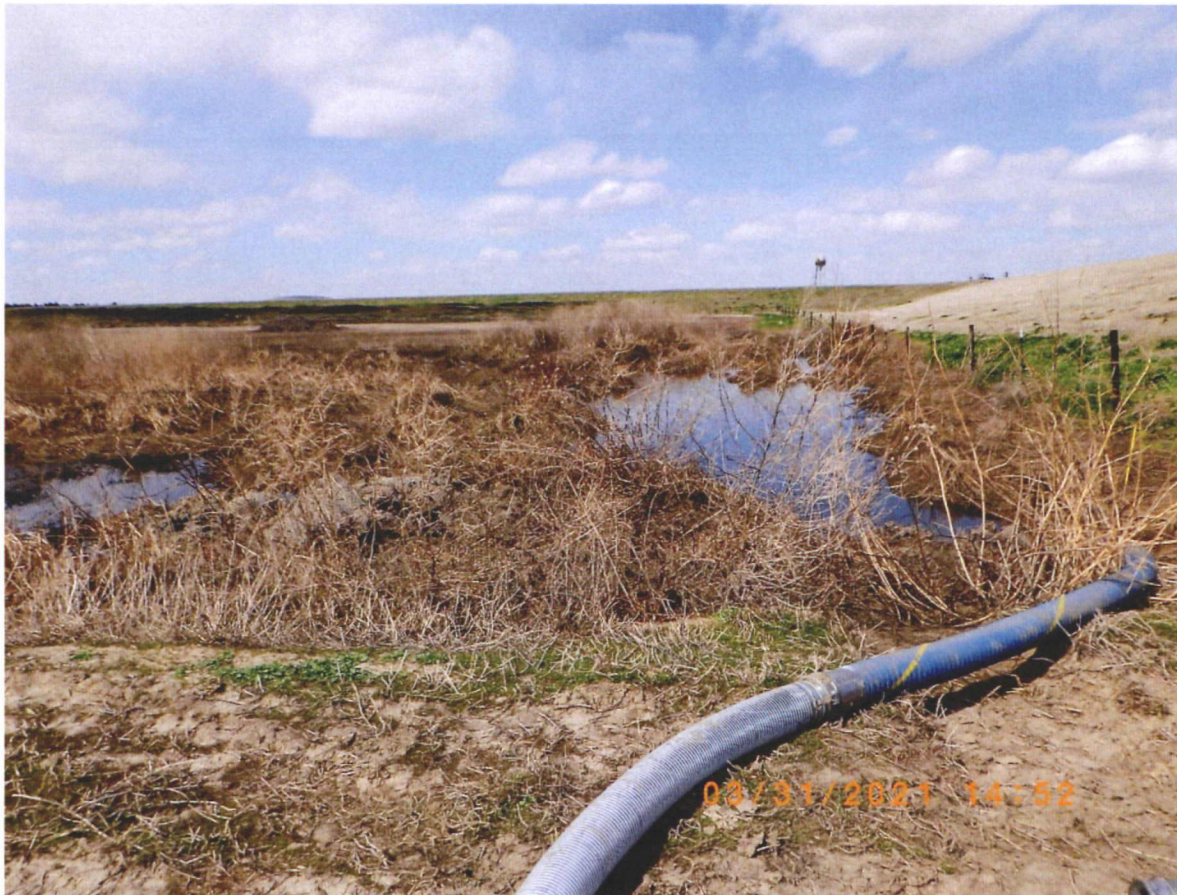
Photo: 14

Location: Area 2 on the site map

Description: Recently pumped down containment area.

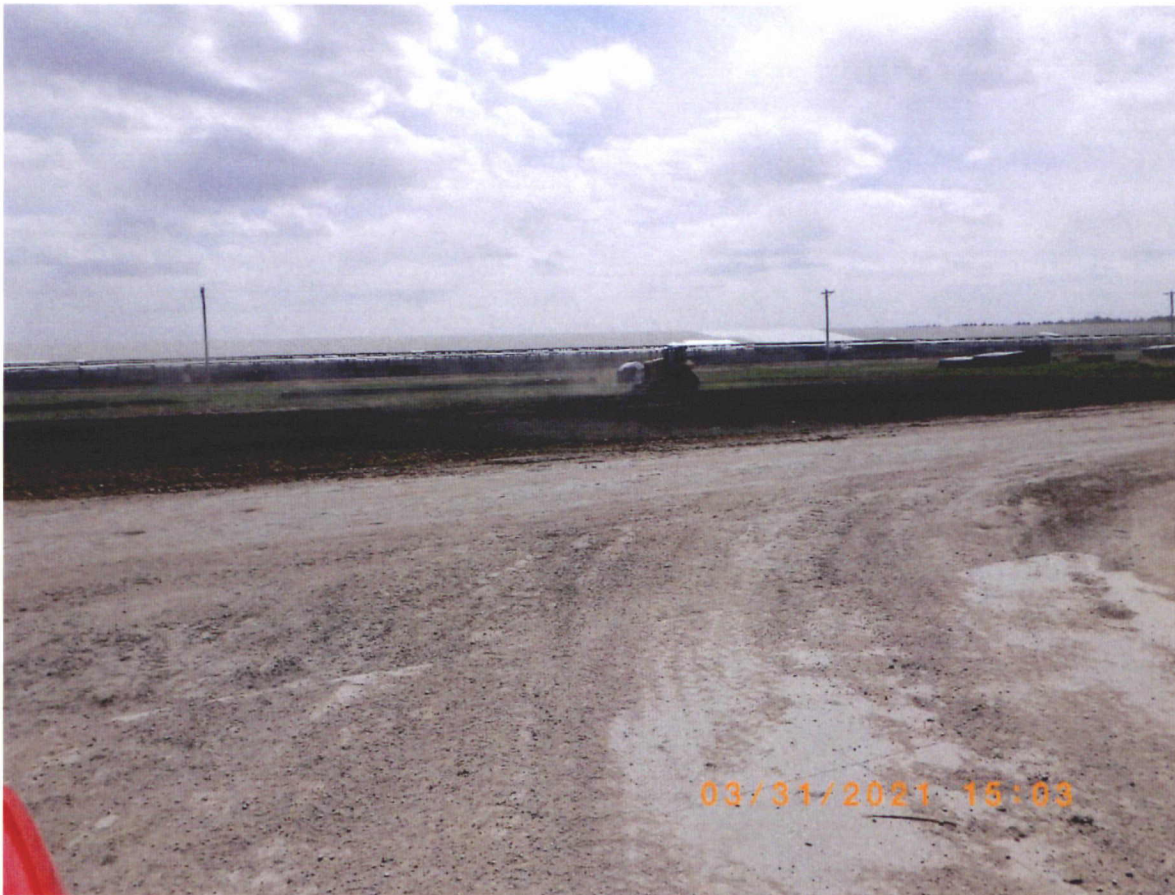
Photo: 15

Location: North of Biochar unit

Description: Area being prepped and graded for assembly of the third Poseidon tank directly west of the Biochar area.

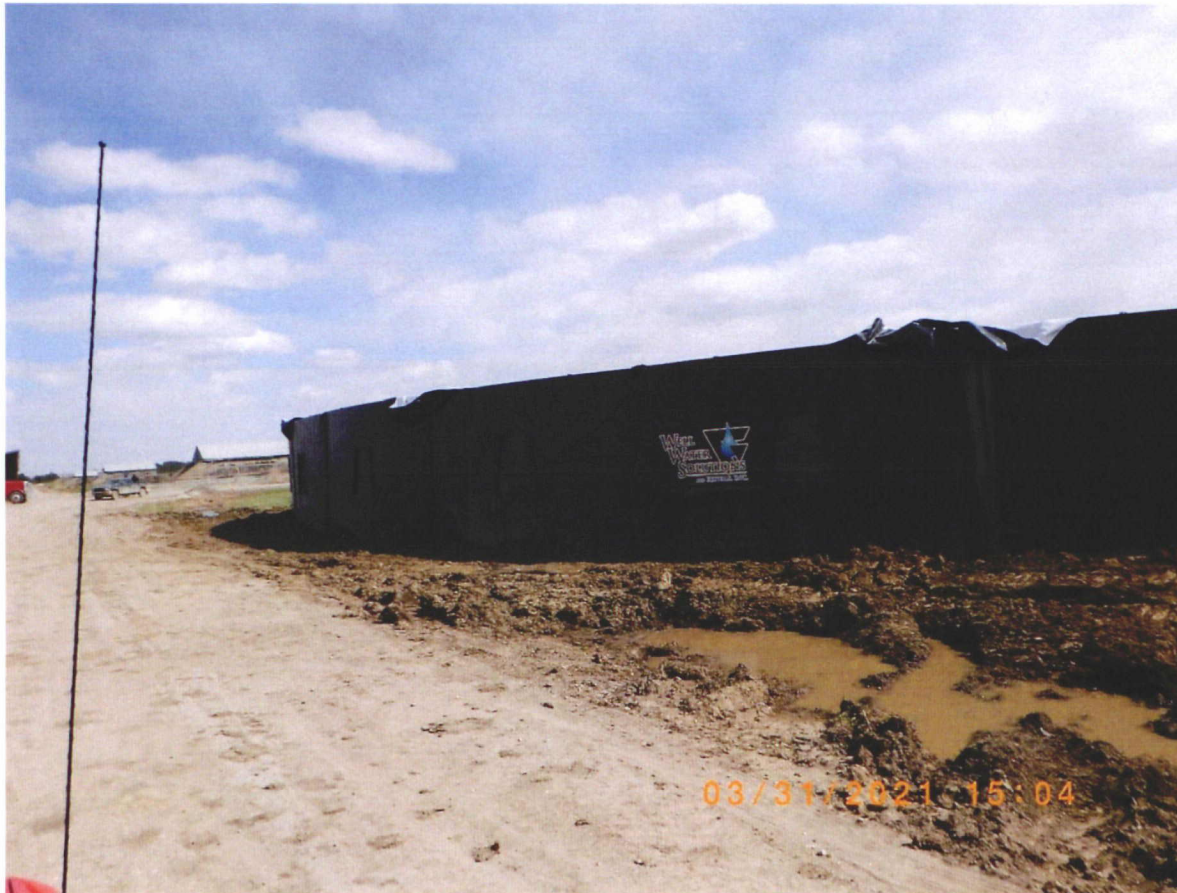
Photo: 16

Location: South of the emergency 6 mil lagoon.

Description: Partial assemble of the second Poseidon tank. High winds were blowing the inside liner around and installation could not be completed.
