## Site Visit Inspection Form

Facility Name AltEn, LLC					
Industrial Storm Water (ISW) NER910444				NDEQ ID / Program ID 84069	
INSPECTOR (s) Mark Pomajzl, Reuel Anderson and Jason Windhorst					
ADDRESS 1344 County Road 10		CITY Mead	COUNTY Saunders	STATE NE	ZIP CODE 68041
INSPECTION DATE 3-11-21	TIME/ARRIVAL 10:00am	TIME DEPARTURE 1:40pm	WEATHER Clear, cool		TEMP 50F

Site Visit Report

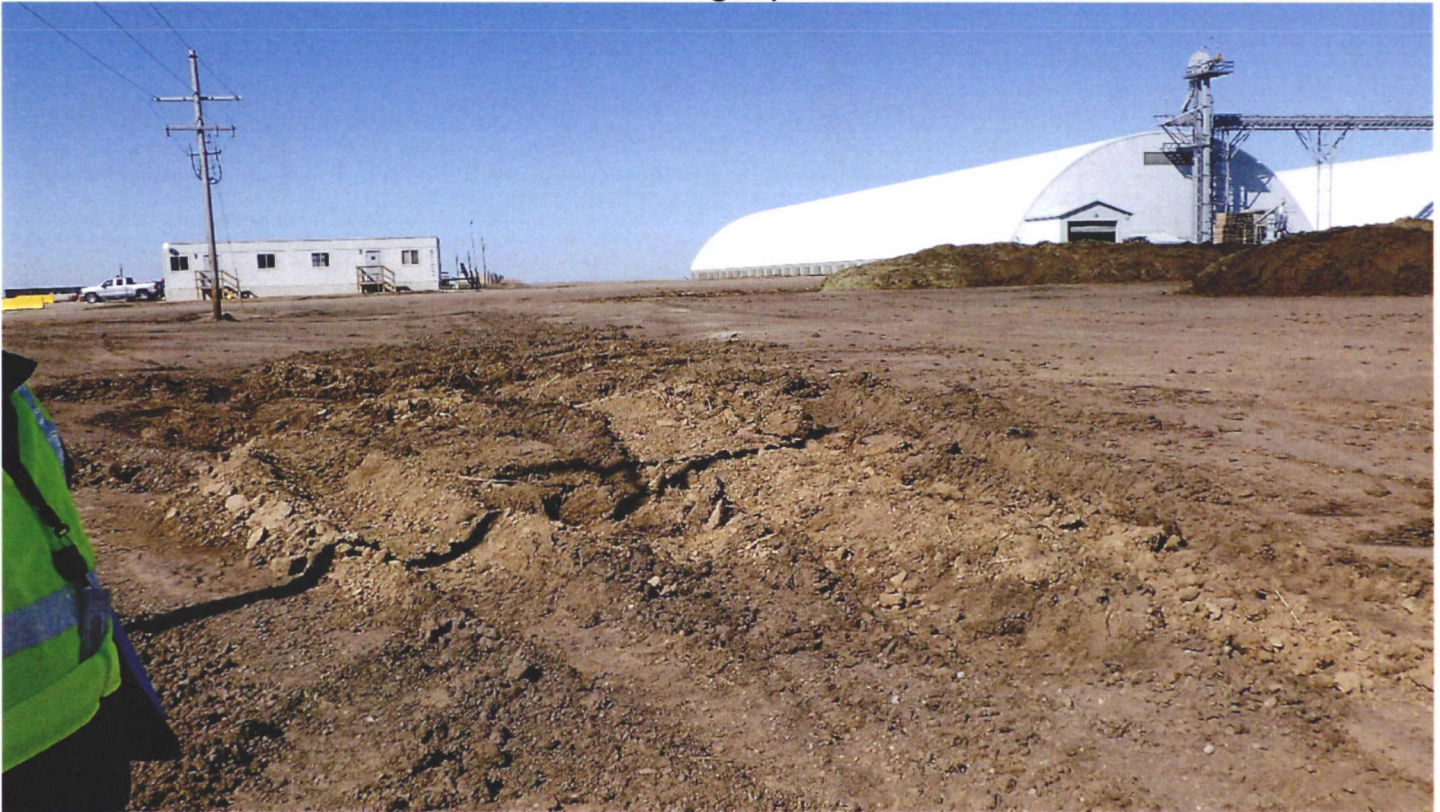
Photo: 1

Location: North of office building

Description: Saturated soils where wet cake had been removed. We instructed Mr. Egr that they need to install a berm along this area to prevent storm water from entering/exiting the wet cake area. We also discussed the distance between the berm and pile. This distance could be up to 12 feet to allow equipment to pass between the pile and berm. The berm will also need to be 2 feet high with a 3 to 1 side slope.

OP1 is north of the main office building, photos 1, 2, 3 and 4. We instructed Mr. Egr to construct berms along the southwest side of the pile. We informed Mr. Egr that the berms need to be worked at a height of two feet high and a three to one slope.

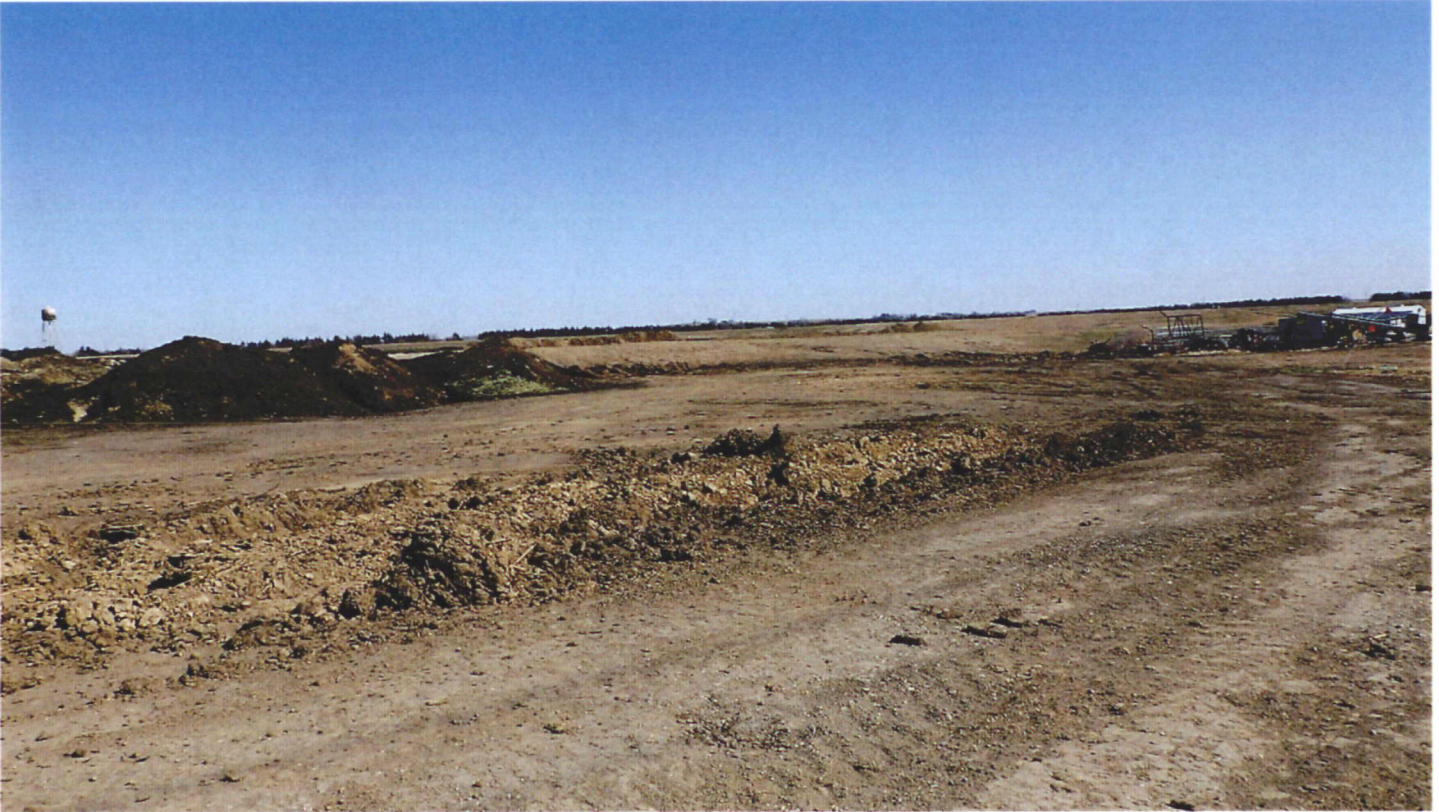
Photo: 2

Description: Area of windrowed wet cake. The constructed berm would be to the right of the area depicted in the photo.

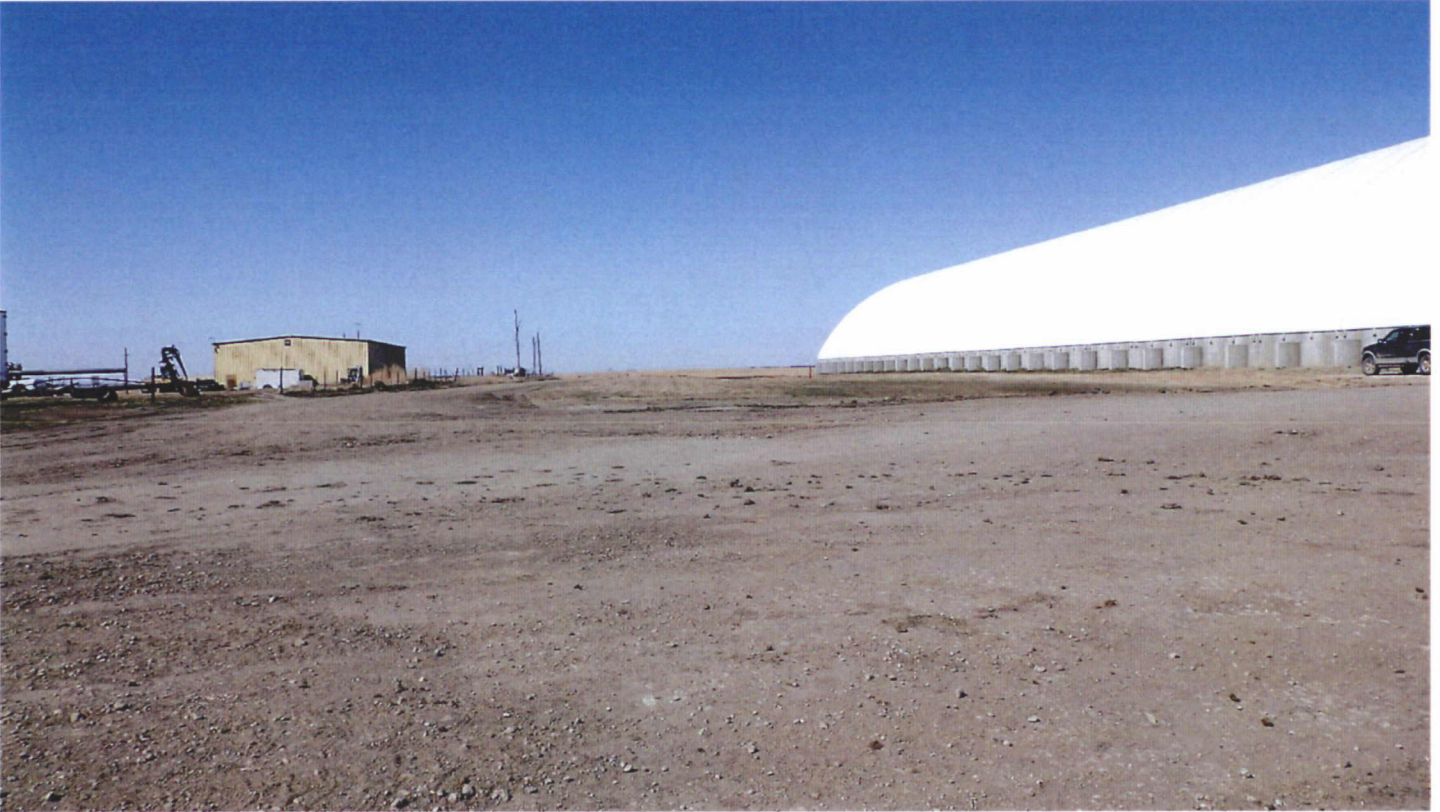
Photo: 4

Description: Open area showing available surface that could potentially sheet flow to the wet cake area east of the hoop buildings. A constructed berm would redirect this sheet flow from the wet cake windrows.

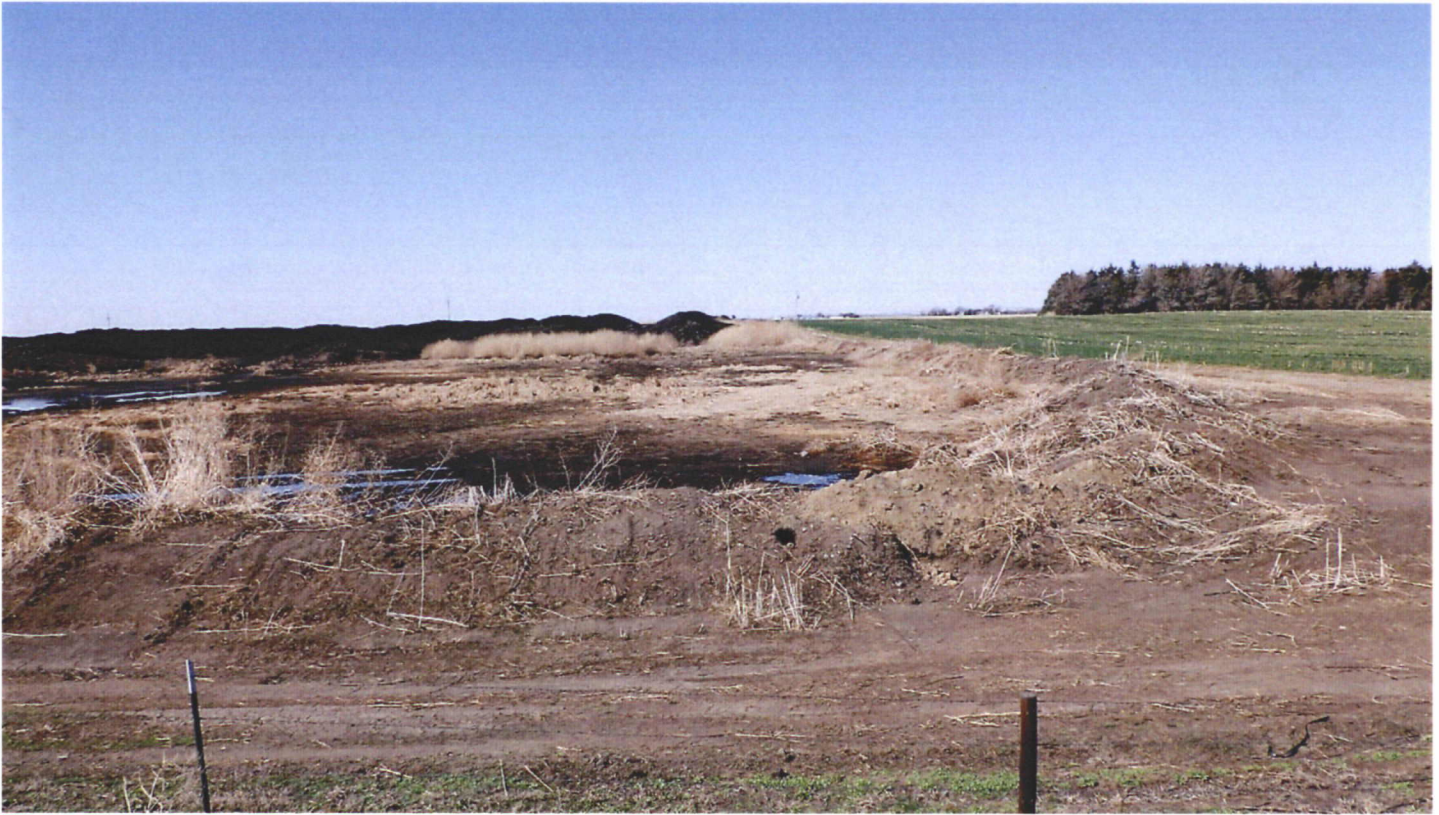
Photo: 5

Location: Northeast side of the new lagoon

Description: Berm showing unconsolidated fill and animal burrow. We instructed Mr. Egr to reinforce this area and repair the burrow. The reinforcement is to provide stability so storm water pressure would not breach the system.

OP2 is the northeast corner of the northwest lagoon, photo 5. We informed Mr. Egr that they will need to reinforce this corner. We also stated for long term this berm and all berms will need to be stabilized with temporary erosion controls, single net blankets, or hydroseeded with tackifier.

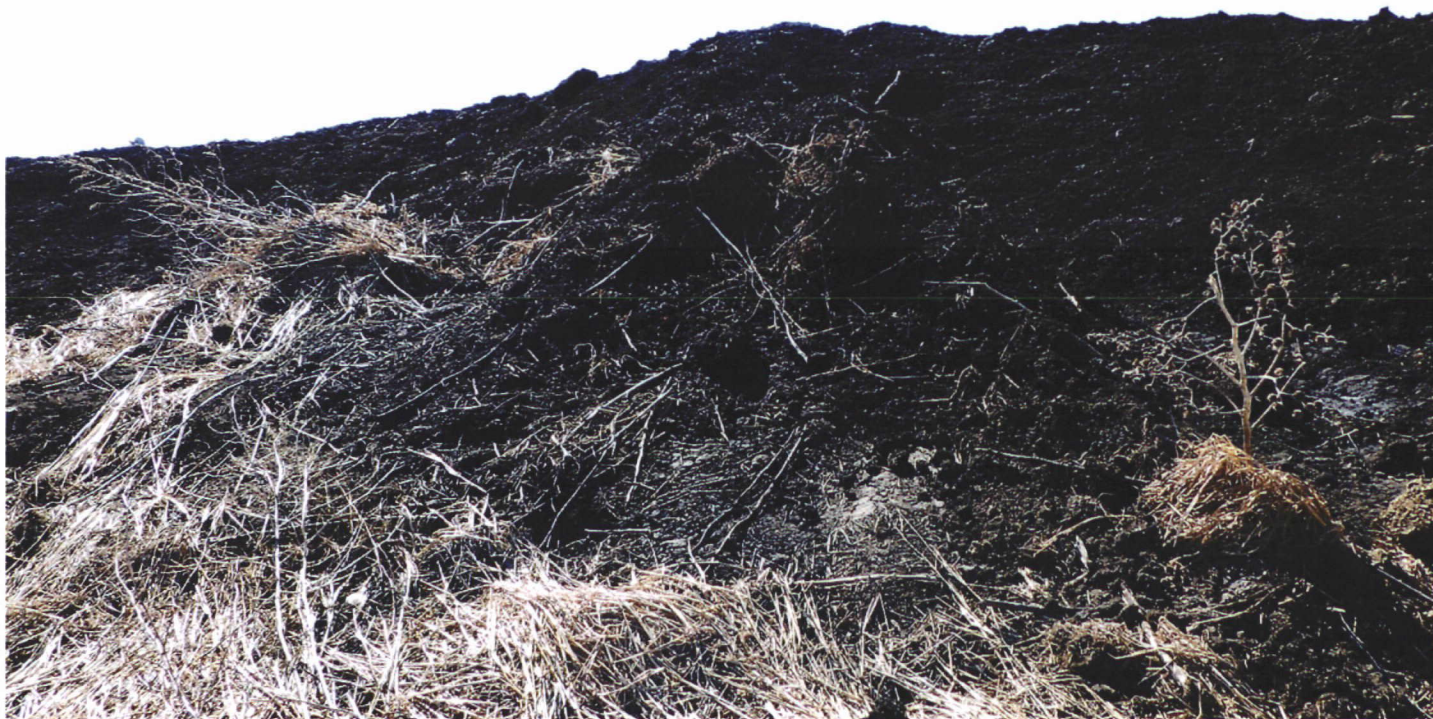
Photo: 6

We then inspected the berm on the northeast pile. There is an area of wet cake pushed up against the berm, photo 6. We explained that due to potential exposure this wet cake needed to be pushed back behind the berm.

Location: Northeast side of the north wet cake pile.

Description: This photo depicts wet cake piled over the containment berm and into the adjacent field. We instructed Mr. Egr to push this pile back behind berm.

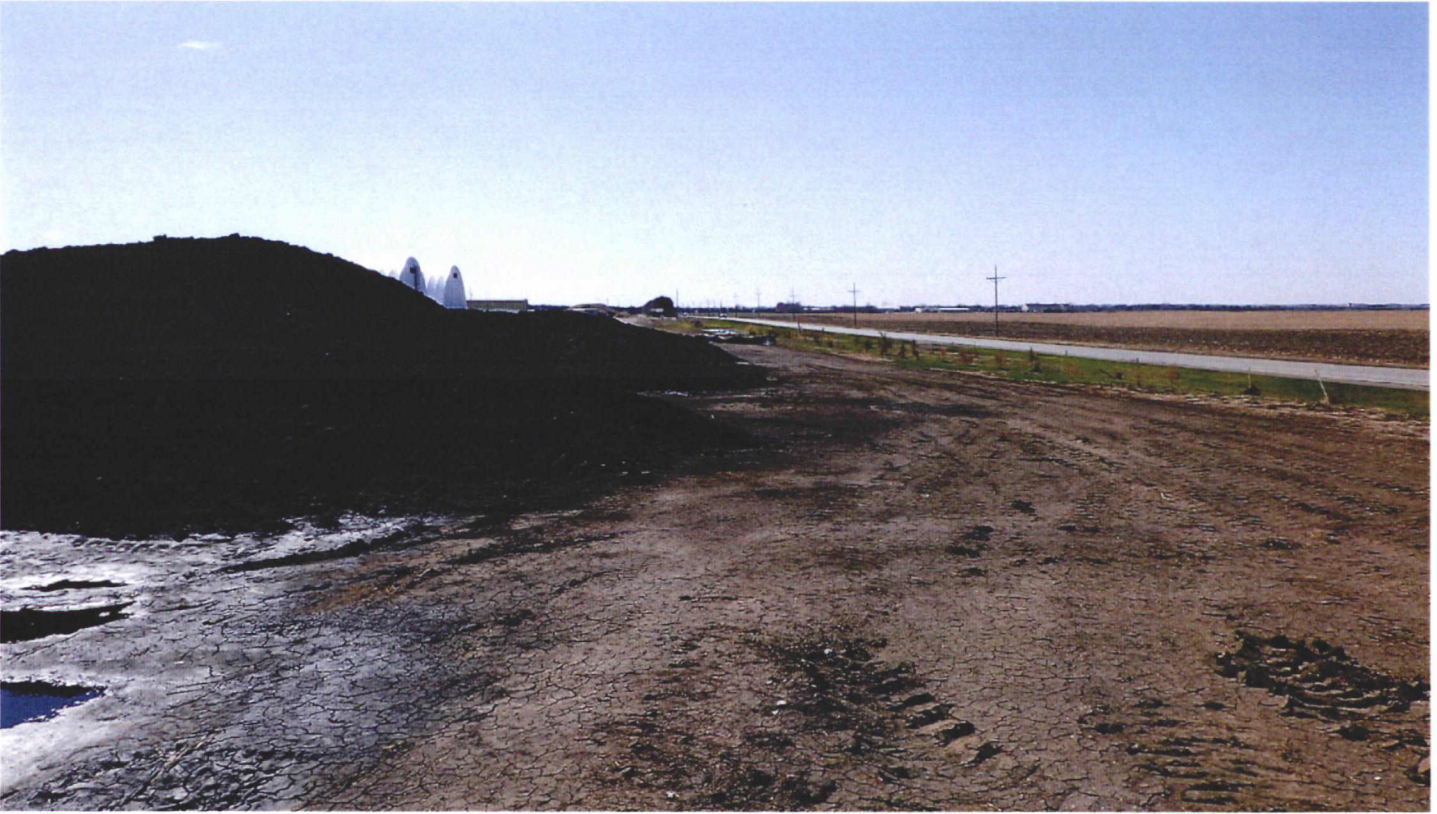
Photo: 7

We continued to inspect the west side of northeast wet cake pile. We observed the slope in this area can potentially discharge in the adjacent drainage ditch, photo 7. We told Mr. Egr that a berm will need to be installed around the west side of the pile. On the south side near the hoop building we observed pooled water, photo 8. This is a truck entry road. This area acts like a berm due to the observed pooled water. This road previously contained a culvert. Mr. Egr stated that they removed the culvert to prevent water from exiting the wet cake pile. We instructed Mr. Egr to raise the berm/road to prevent possible overflows.

Location: At northwest corner of the north wetcake storage area near the irrigation well at NW corner of facility

Description: Windrowed wet cake and stockpiles along the west edge of the storage area. County road 10 is adjacent to the storage area visible the photo. Due to topography of the area, we instructed Mr. Egr to construct a berm along the ditch and county road 10.

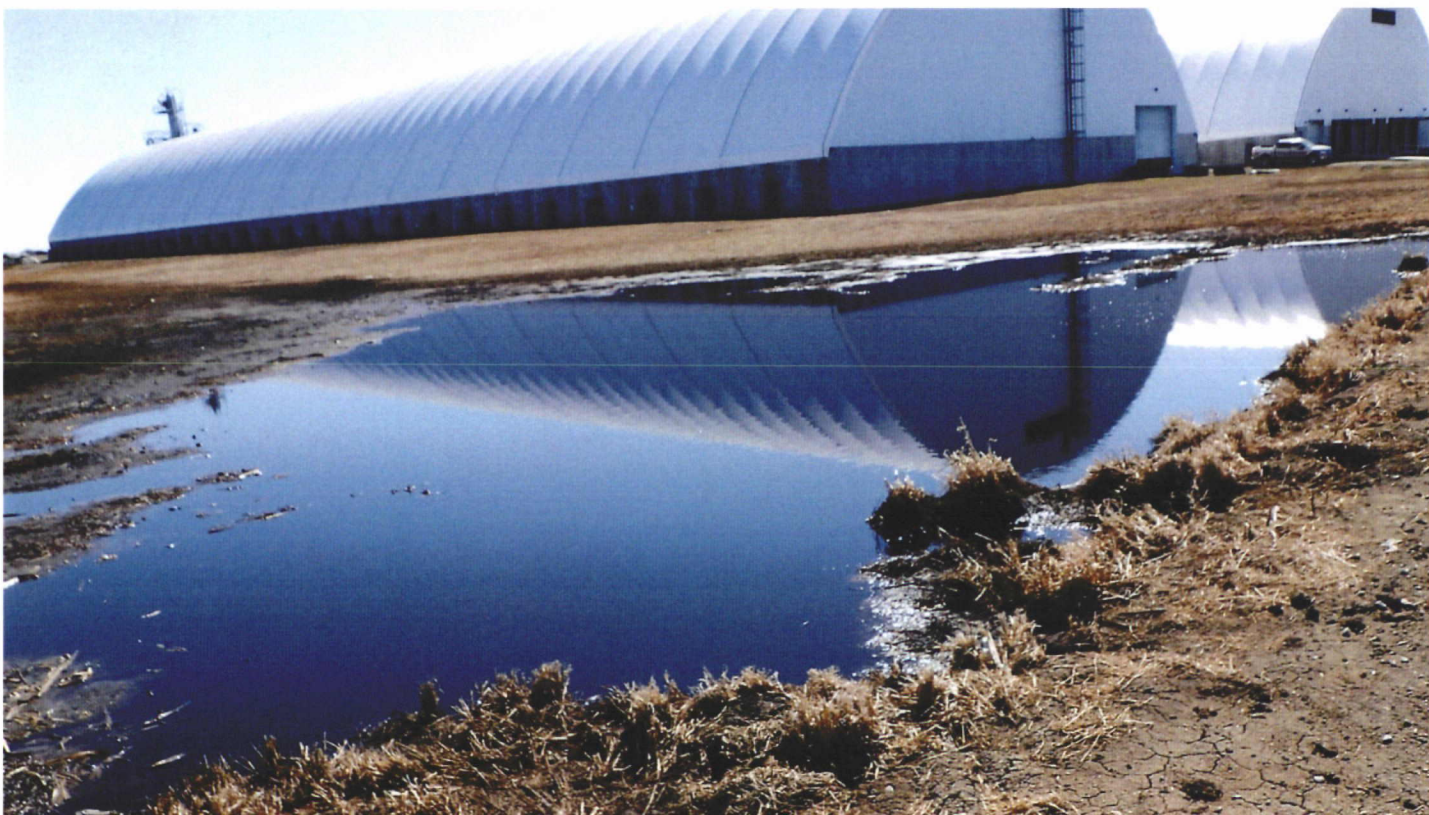
Photo: 8

Location: Approximately 120' northwest of the north hoop building

Description: Storm water and wetcake runoff area collection area. Runoff is collected and diverted east from this location or pumped out and sent to treatment system. The area is a truck entry road. The facility uses this road to load and unloading wet cake. We instructed Mr. Egr to build up this area to prevent possible runoff from this containment.

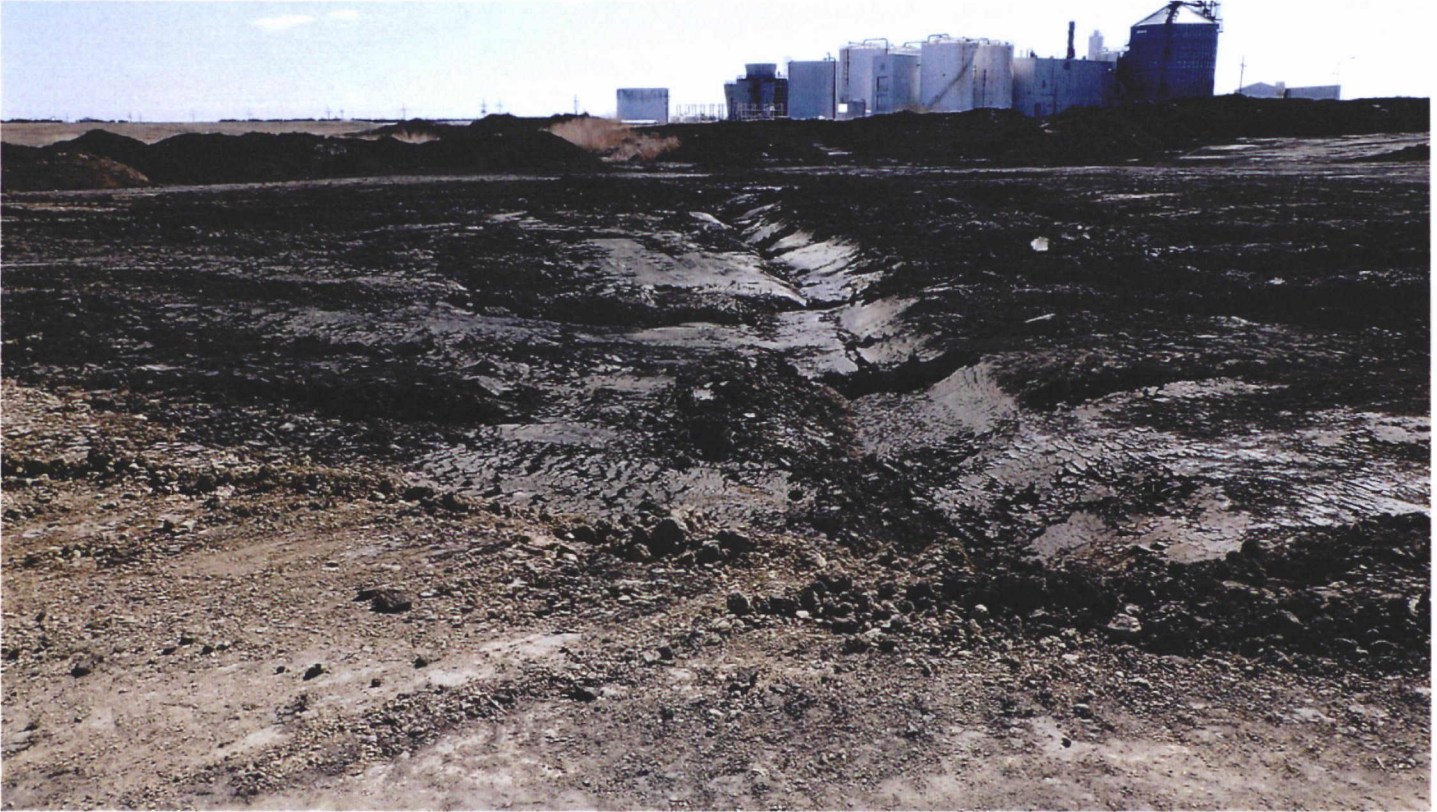
Photo: 9

Location: Approximately 300' east of the north hoop building

Description: Temporary access road with 4" pvc pipe used as culvert. We instructed Mr. Egr to install a berm area inside this general area to reduce velocity flow.

We then inspected the area between the north wet cake pile and southeast pile. This area is adjacent the north hoop building, photos 9. We instructed Mr. Egr to construct a berm between the two piles. This berm will help slow flow velocity.

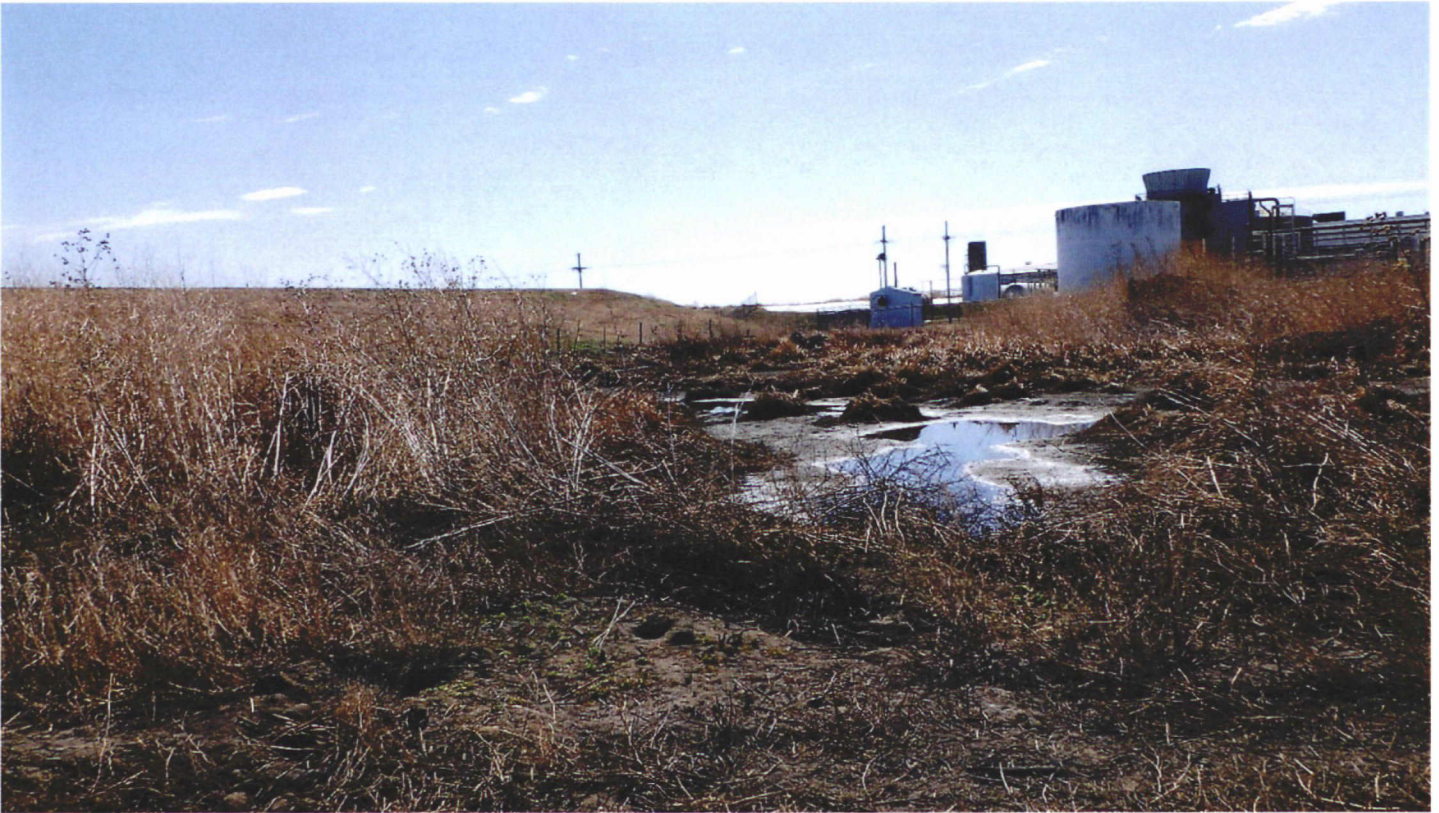
Photo: 10

Location: Approximately 300' northwest of the southwest corner of the southeast lagoon.

Description: Area used to retain storm water and wet cake runoff. The facility had recently pumped this containment into the south lagoon.

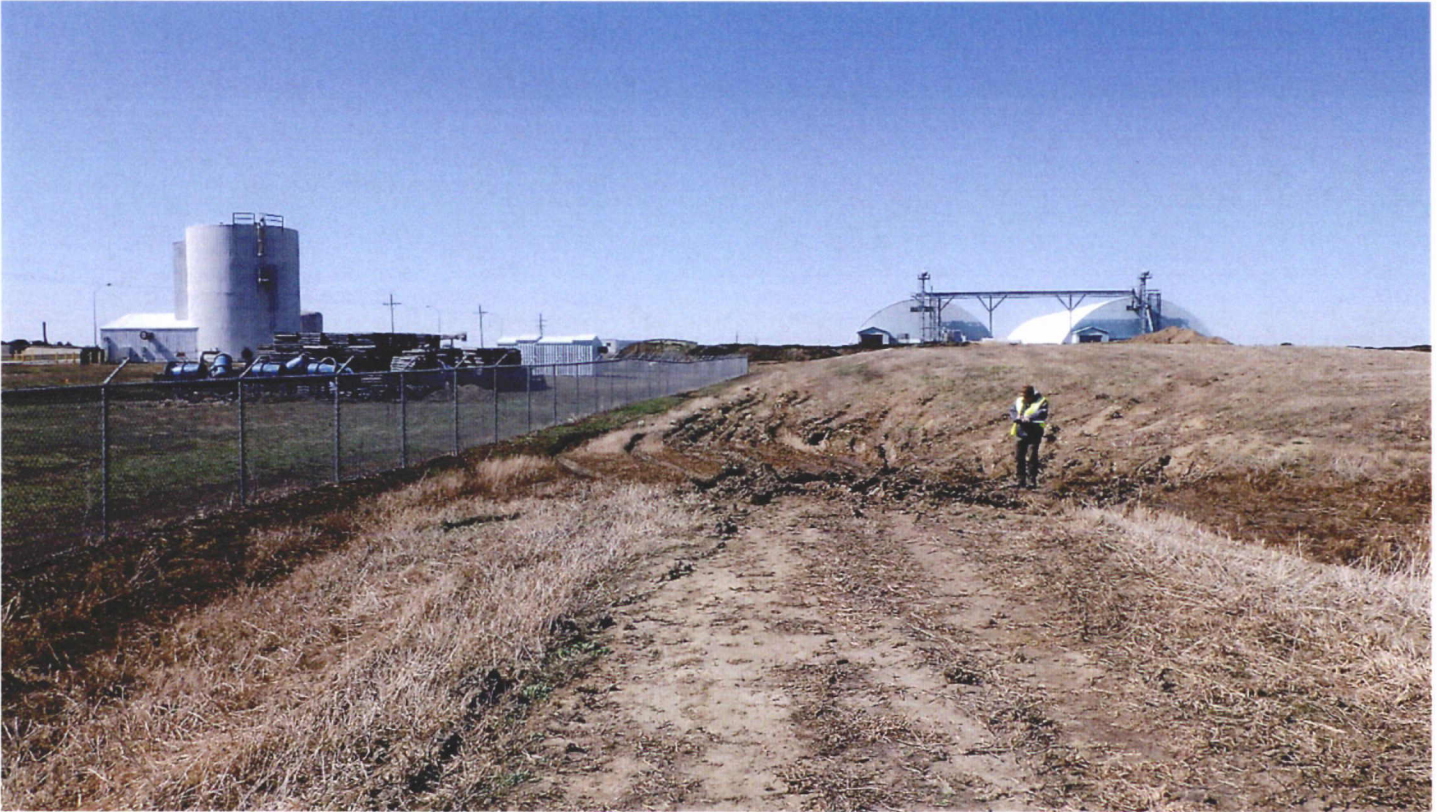
Photo: 11

Mr. Egr then escorted us to the southeast side of the south lagoon, photo 10. This area contains a berm which collects storm water from area west and northwest. There is a low area observed on the south side of the berm, photo 11. We explained to Mr. Egr that the conveyance appears to direct water away from the berm. We instructed Mr. Egr to redirect flow by raising and extending the berm to the southwest.

Location: Approximately 150' northwest of the southwest corner of the southeast lagoon.

Description: Runoff from the south edge of the west wet cake storage follows the fence line to the area used to retain storm water and wet cake runoff noted in previous photo. There is a low area in the middle of the photo. This area appears to direct water away from containment. We directed Mr. Egr to extend and raise the berm to ensure that all storm water enters the containment.

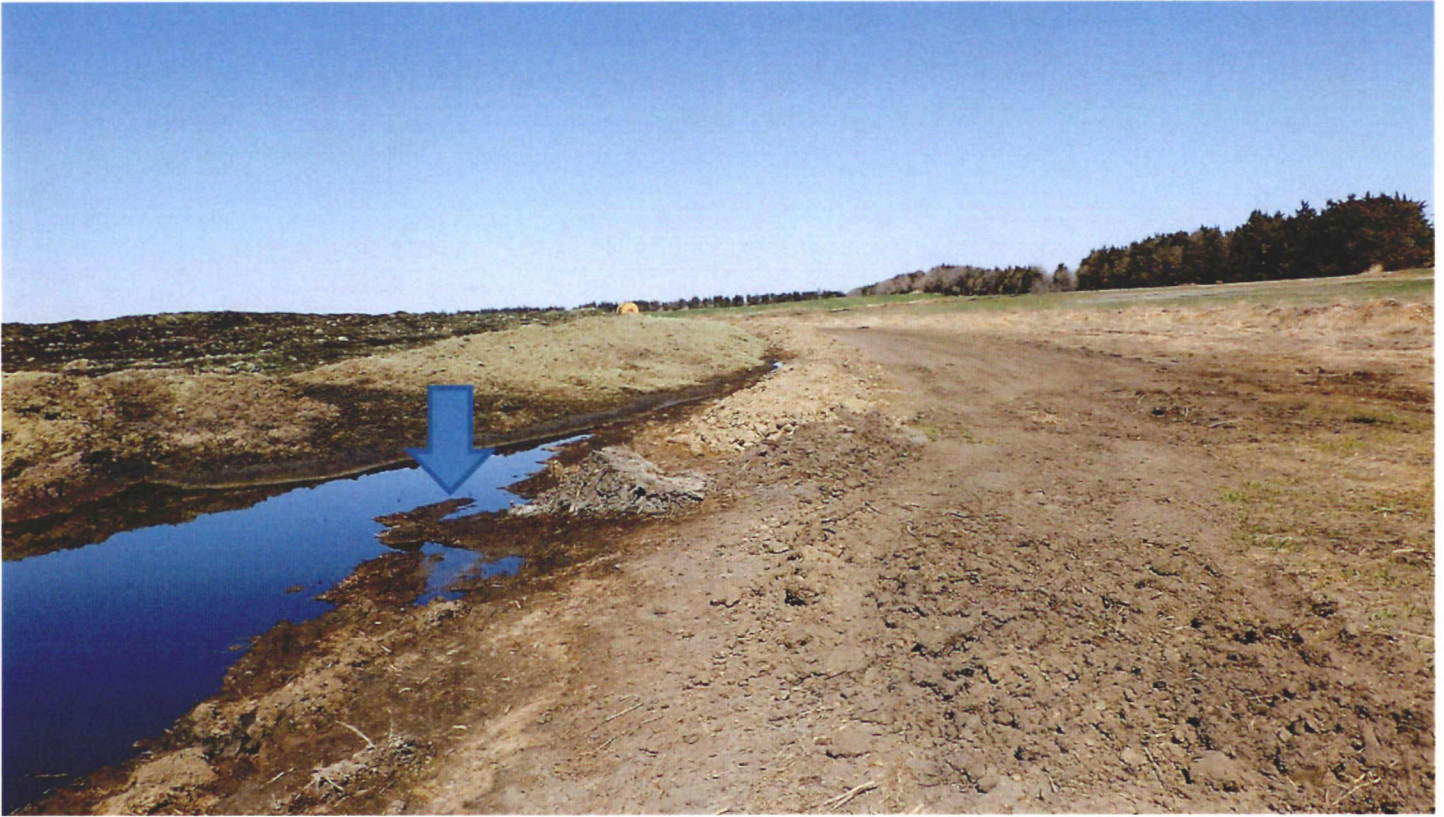
Photo: 12

We then drove to the east wet cake pile. We observed the recently constructed berm, photo 12. There are areas of pooled water. I asked if they had pumped from this berm. Mr. Egr stated no they had not. To prevent seepage, we explained they needed to reinforce the south half of the berm. We also instructed Mr. Egr to install a berm around the entire pile.

Location: East wet cake pile

Description: This photo depicts the east wet cake pile. There is some pooled water (arrow). We instructed Mr. Egr that they construct a berm around the entire pile.

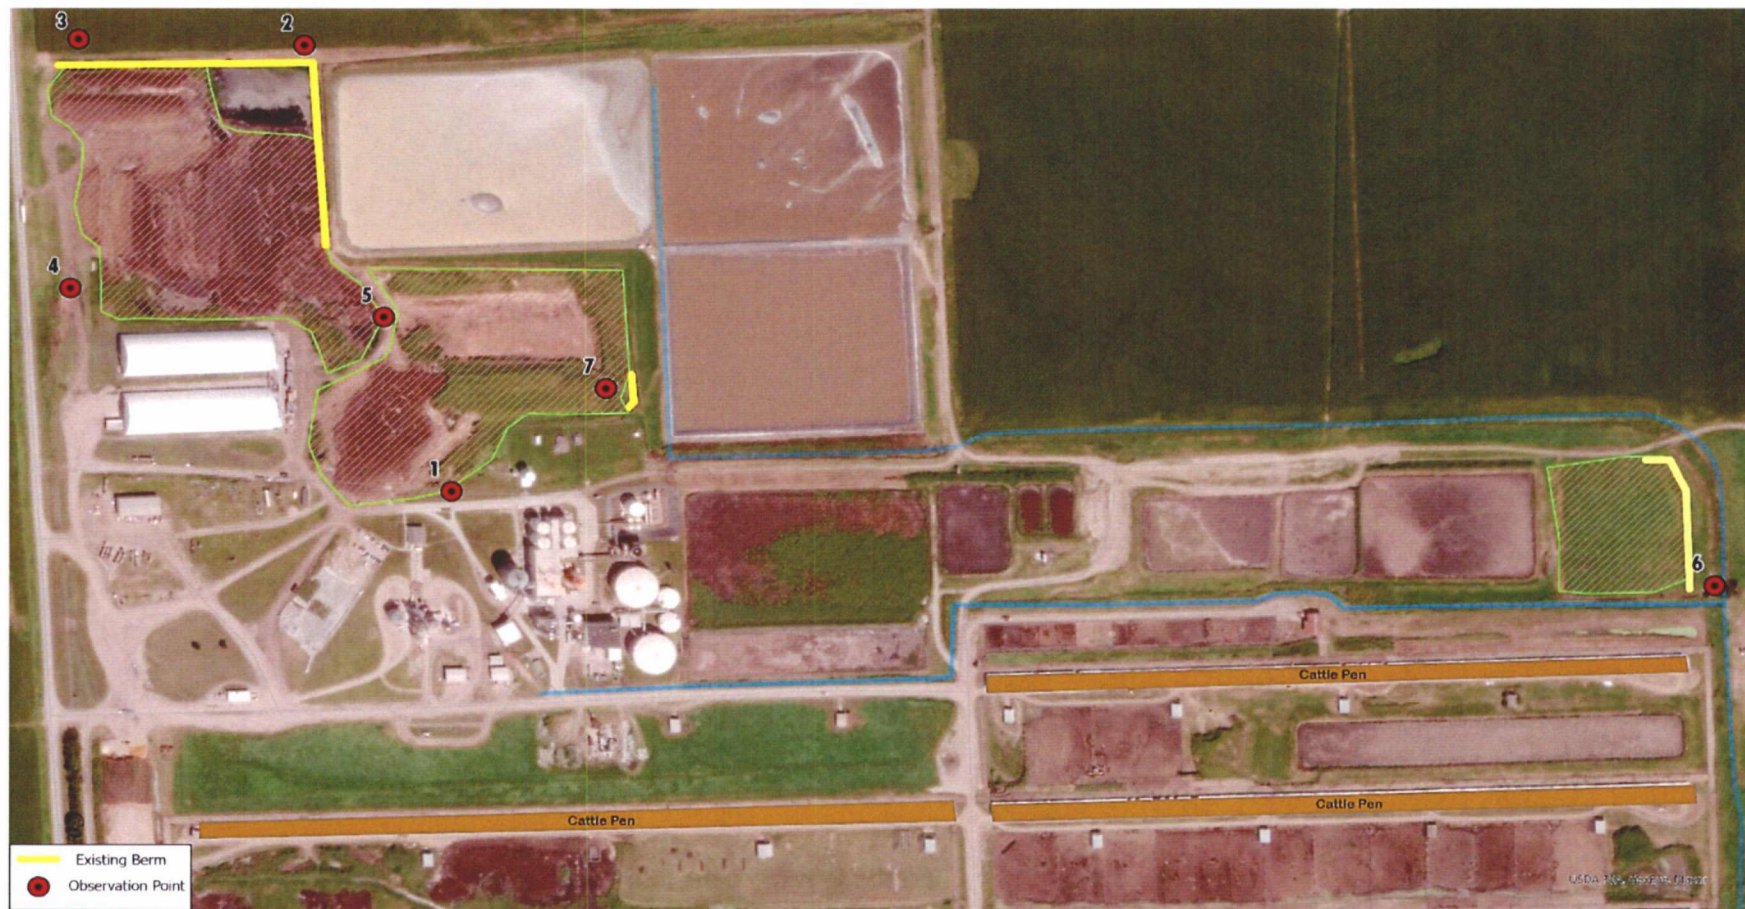
## Map 1

AltEn LLC - Storm Water Existing Berms  
March 11, 2021

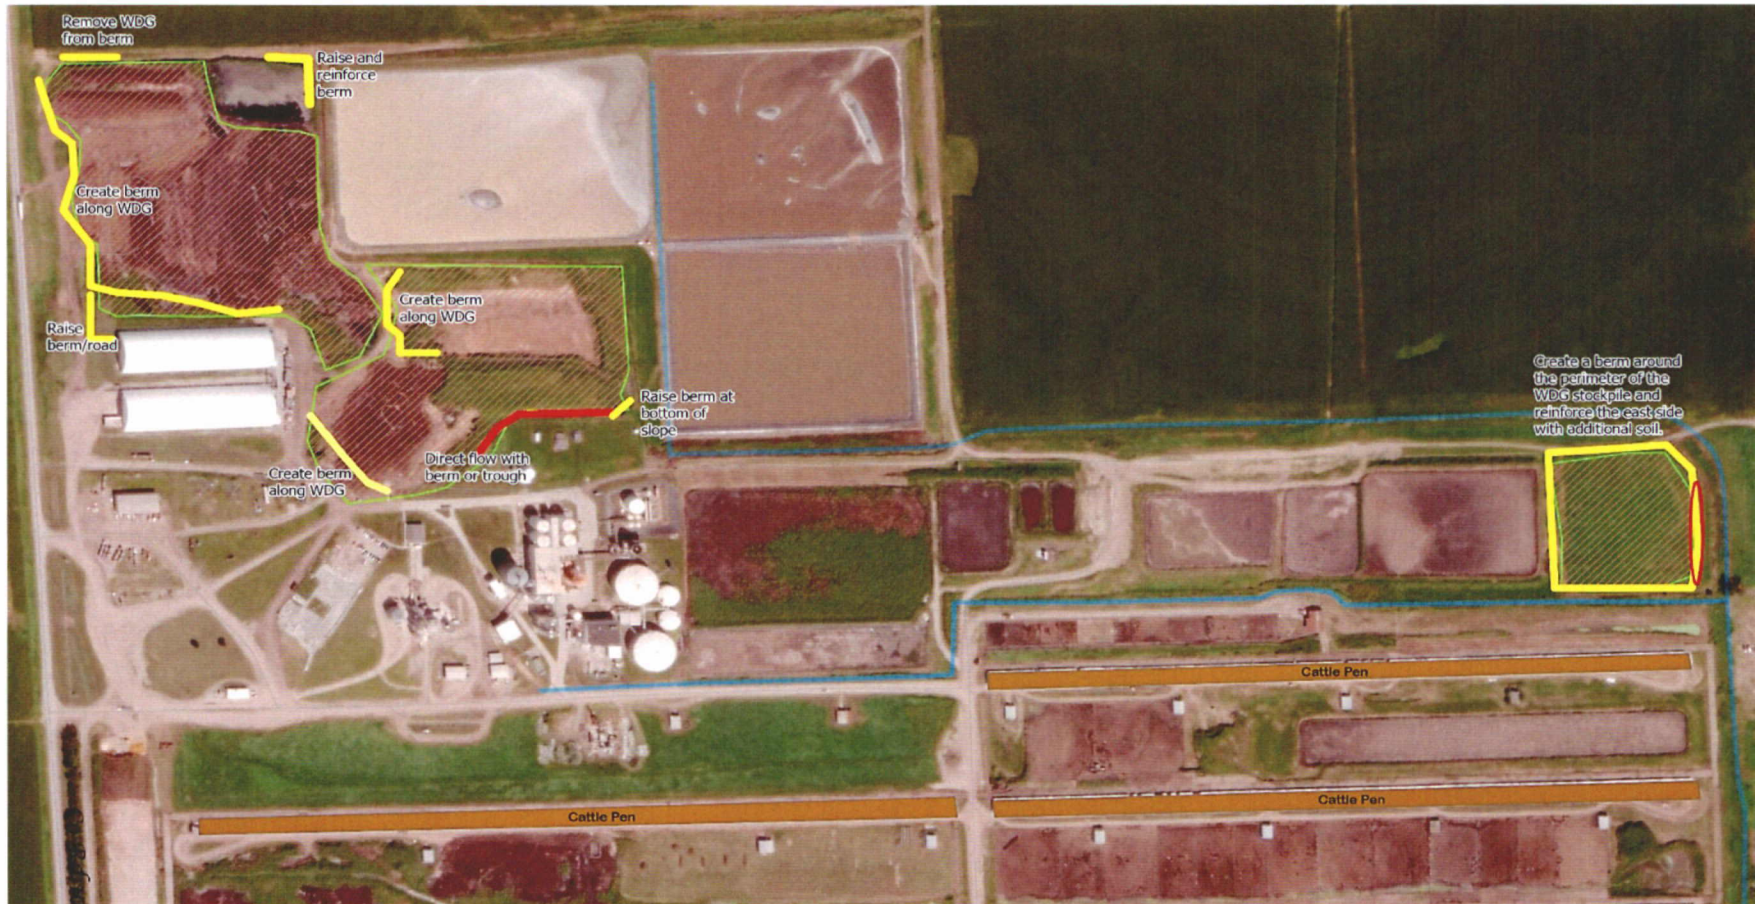
## Map 2

AltEn LLC - Storm Water Requests  
March 11, 2021
