Facility: AltEn
IIS: 84069
PCS: NE0137634

Mark Pomajzl
3-29-2021

Site Visit Check list

Site Visit Report

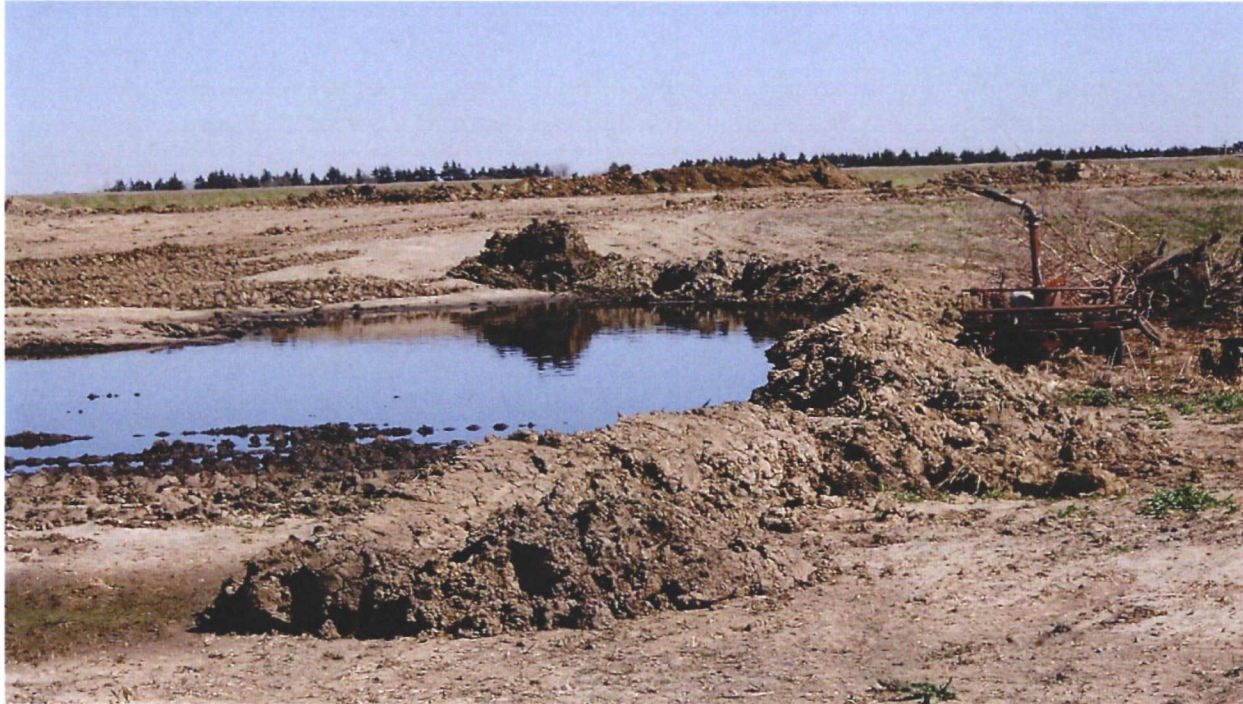
Photos: 1

Description: The 1 photo depicts storm water accumulation. I did not observe leaking at this time.

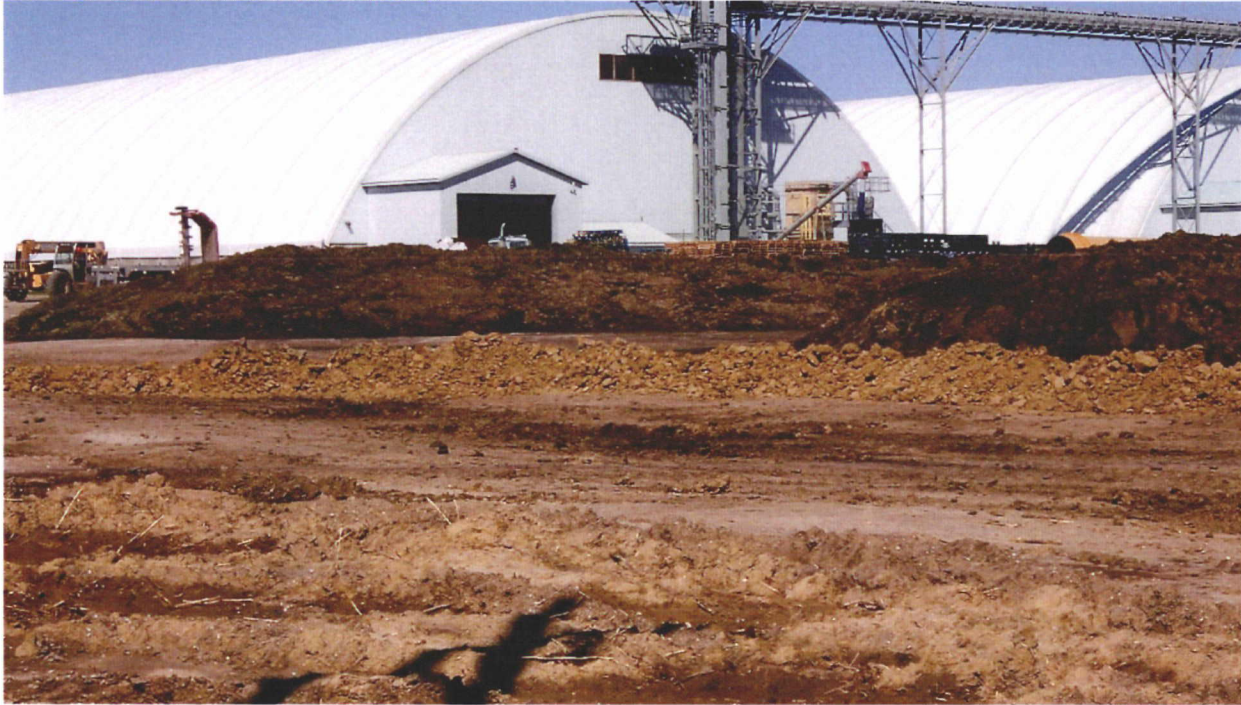
Photos: 2

Description: The left photo depicts some of the new berm construction. This berm spans the entire south wet cake pile.

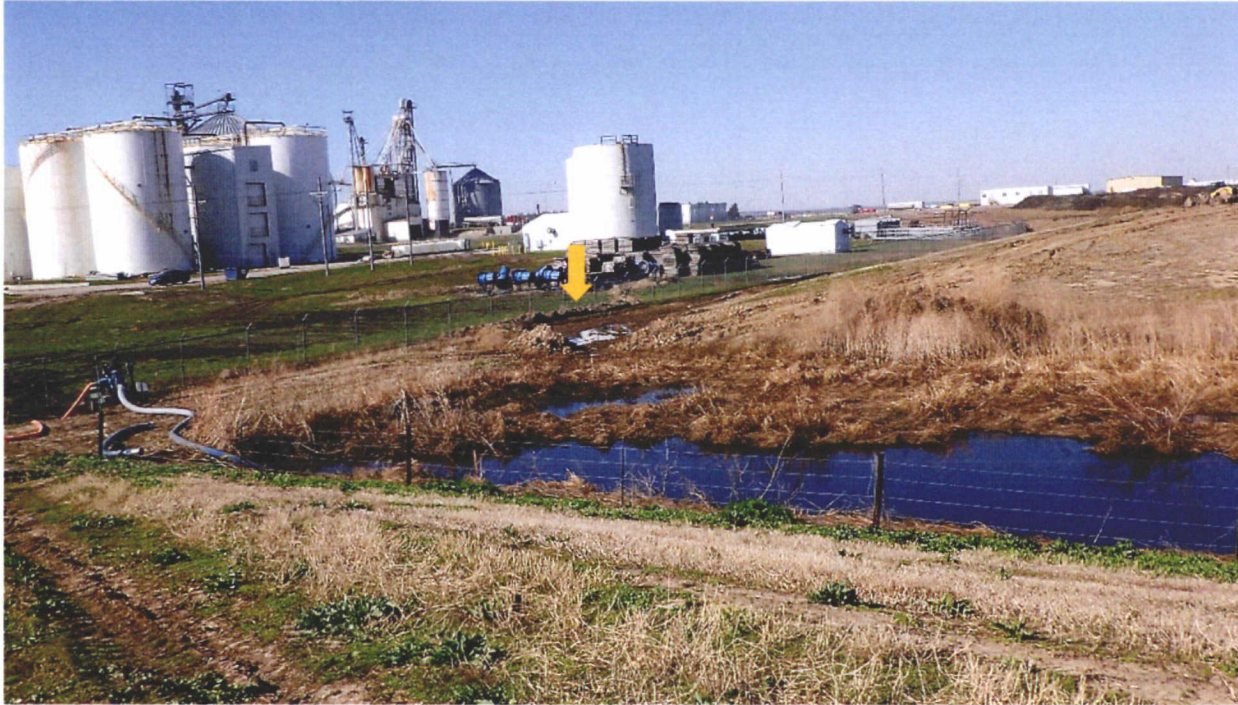
Photo: 3

Description: This photo depicts the Area 2. The facility has pumped out most of the contained water. The berm meanders along the south fence as depicted by the arrow.

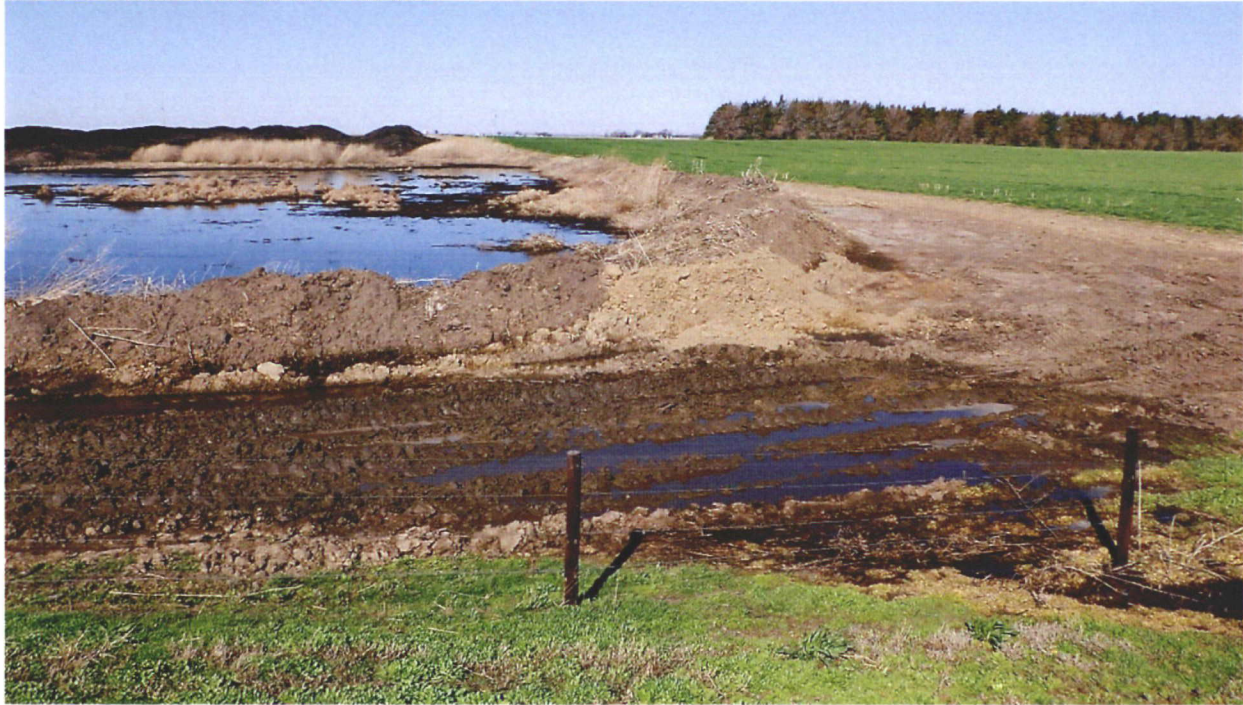
Photo: 4

- The facility is constructing berms north of the administrative building.
- Area 6 is seeping. The facility is in process of adding material. To control seepage, I instructed Mr. Peterson to pump out the berm.
- Area 3 is seeping. Prior to my departure, I observed the facility adding additional material.

Description: This photo depicts seepage from the northeast berm. The facility was repairing and adding material prior to my departure.

* Northwest corner of North West Lagoon Beam Seeping - Facility is fixing it

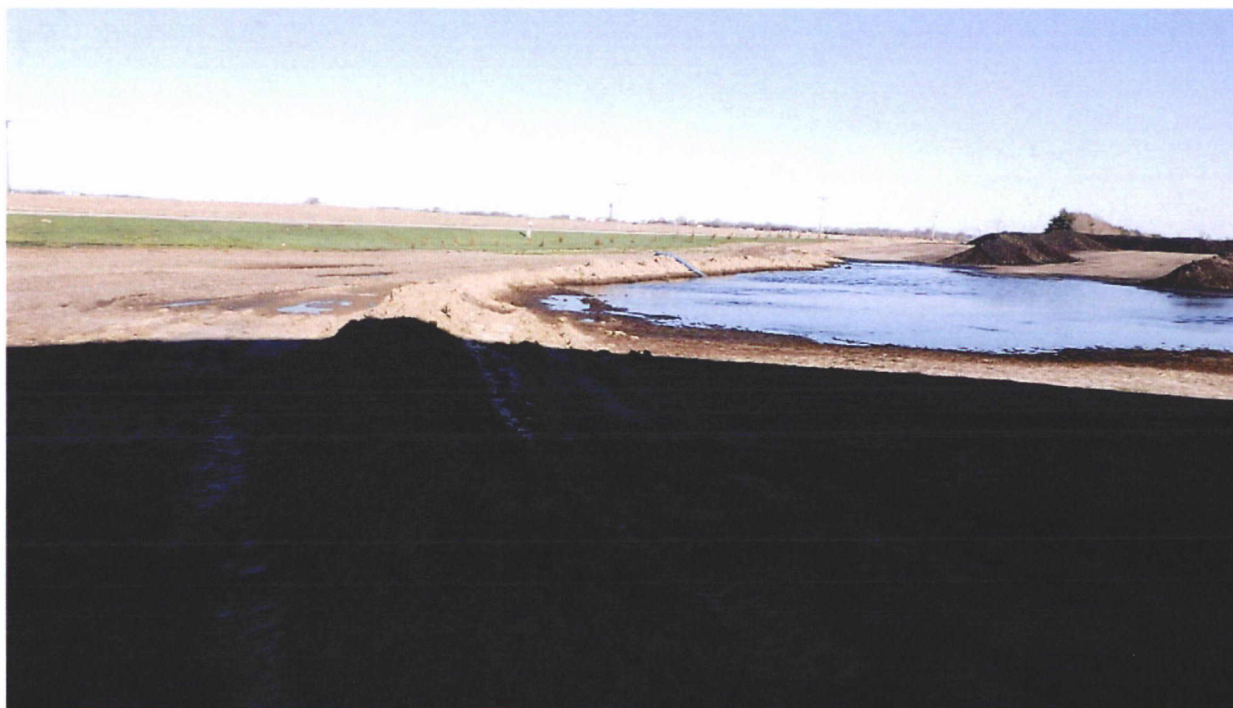
Photo: 5

Description: This photo depicts the connection hose used to transfer runoff from the west cake pile to area 2 before being transferred to the emergency lagoon.

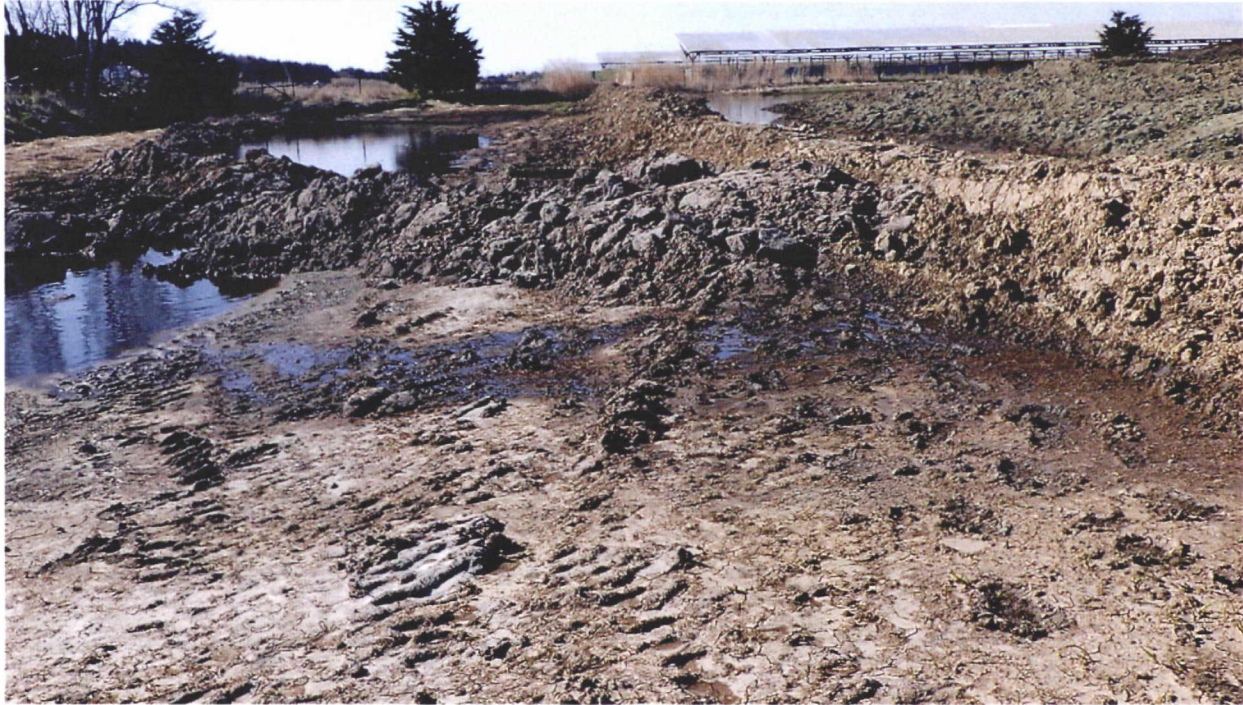
Photo: 6

Description: This photo depicts seeping from the east wet cake pile. I informed Mr. Peterson about the seepage. Mr. Peterson stated that they are going to fix the issue today. The secondary berm continues to hold water.

* Fix EAST Beam, Pump out Best you can.

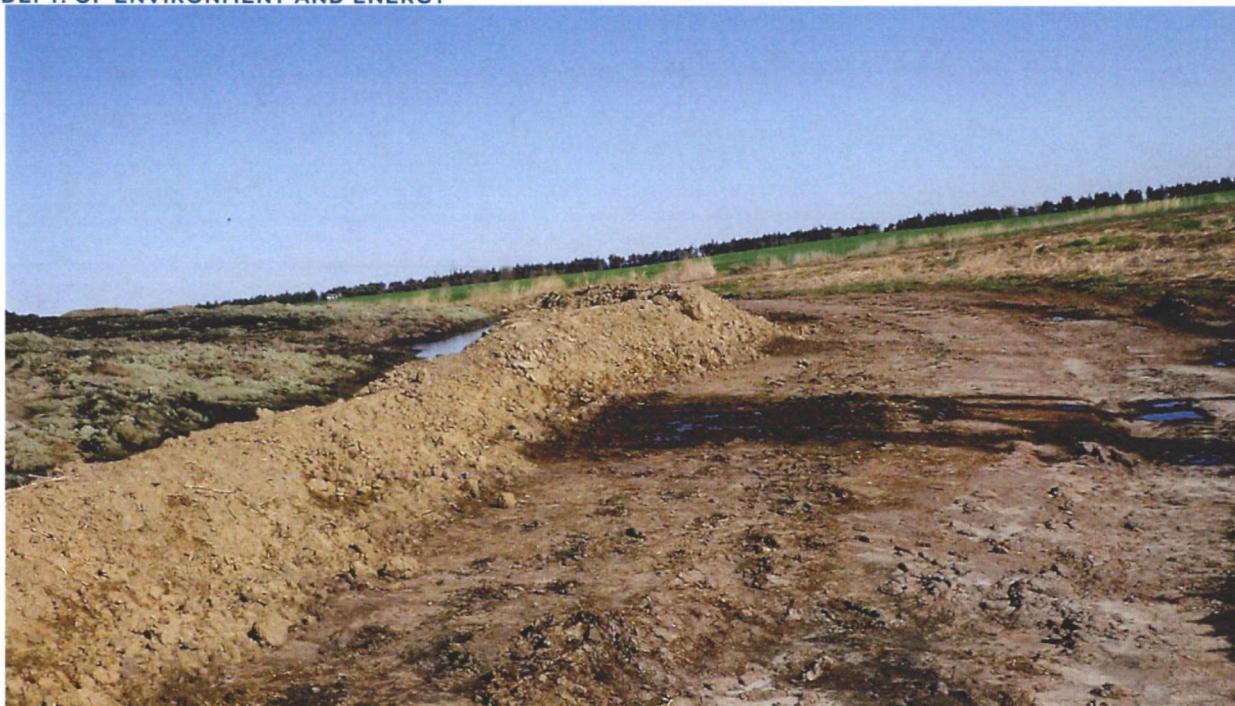
Photo: 6

Description: This photo depicts seeping from the east wet cake pile.

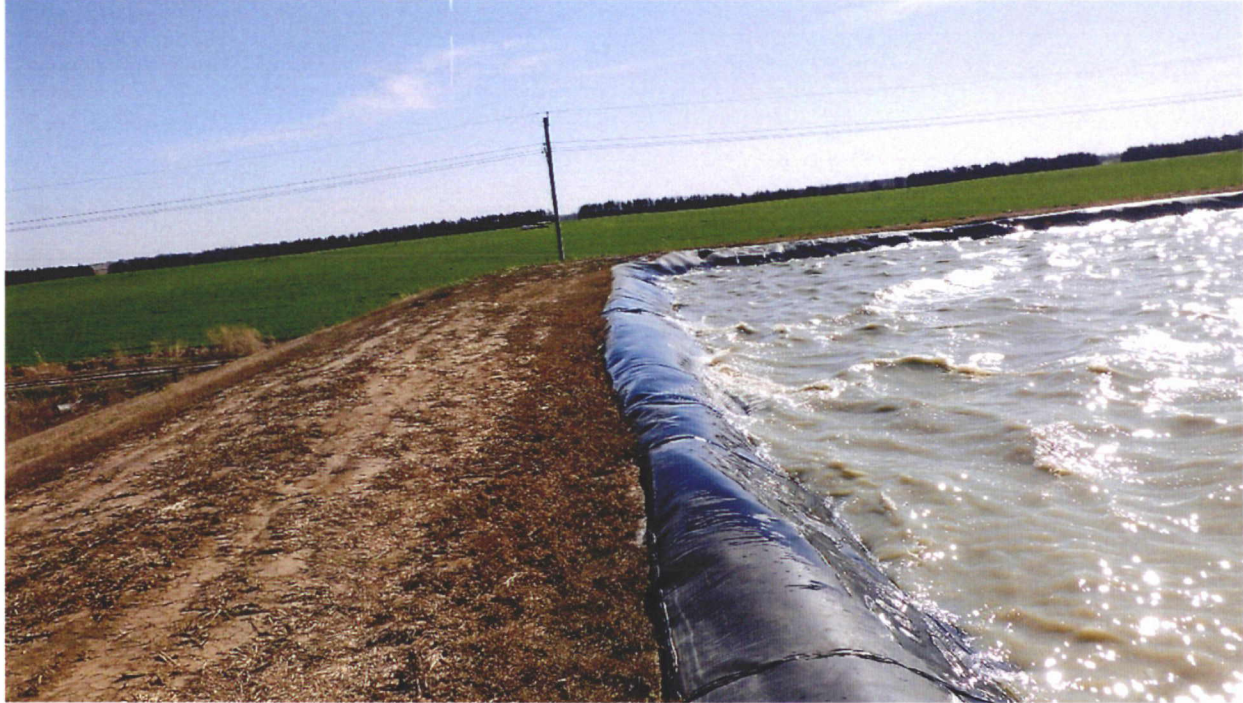
Photo: 7

- High wind gusts are causing large waves to splash over the northeast dike.
- I informed Mr. Peterson that they need to sandbag the northeast corner. Mr. Peterson stated they only have twenty sandbags. Mr. Peterson also stated they don't have any purchasing power.

Description: High winds causing large waves to splash over the liner.

* Sand Bag the ~~North~~ EAST corner of Northeast Lagoon

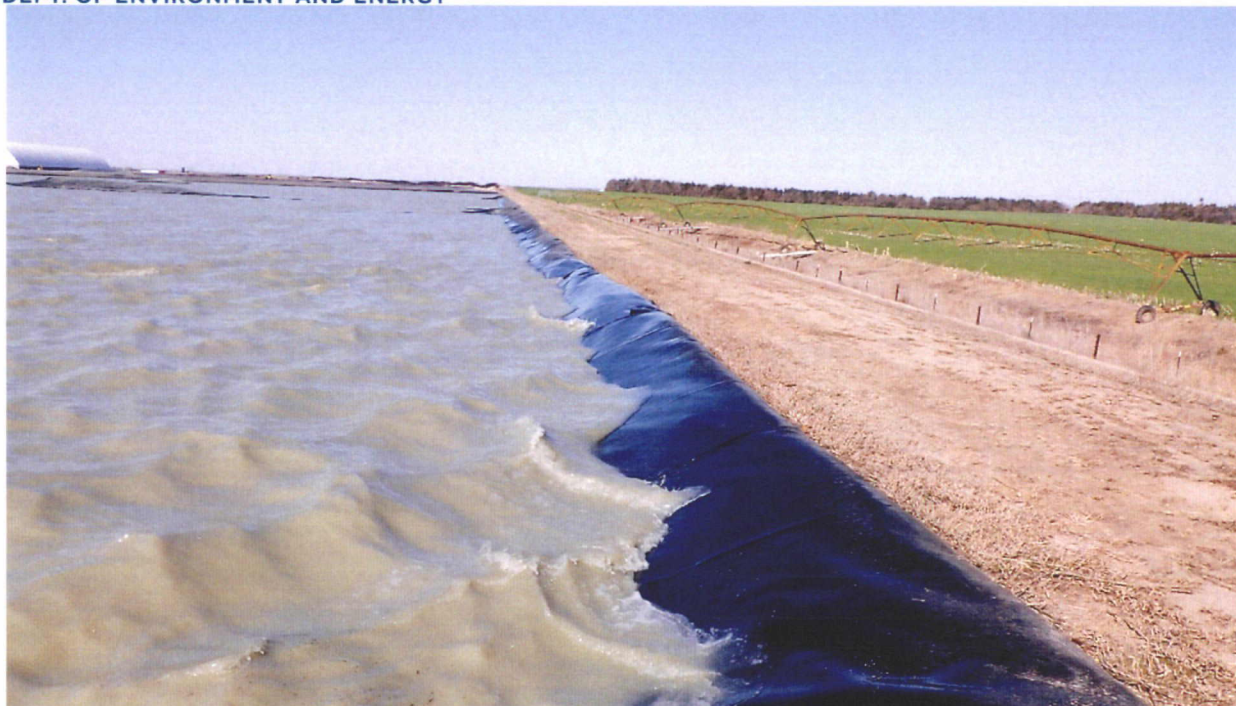
Photo: 8

Description: High winds causing large waves to splash over the liner.

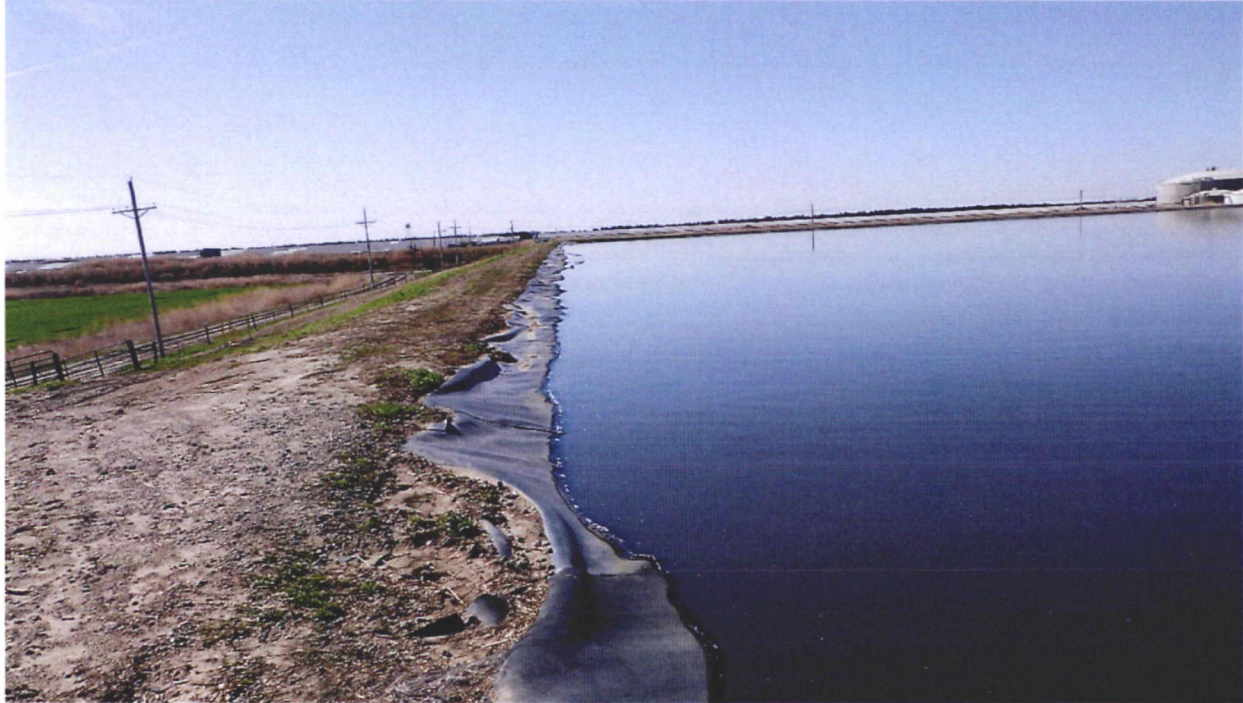
Photo: 8

Description: The south lagoon water surface is calm.

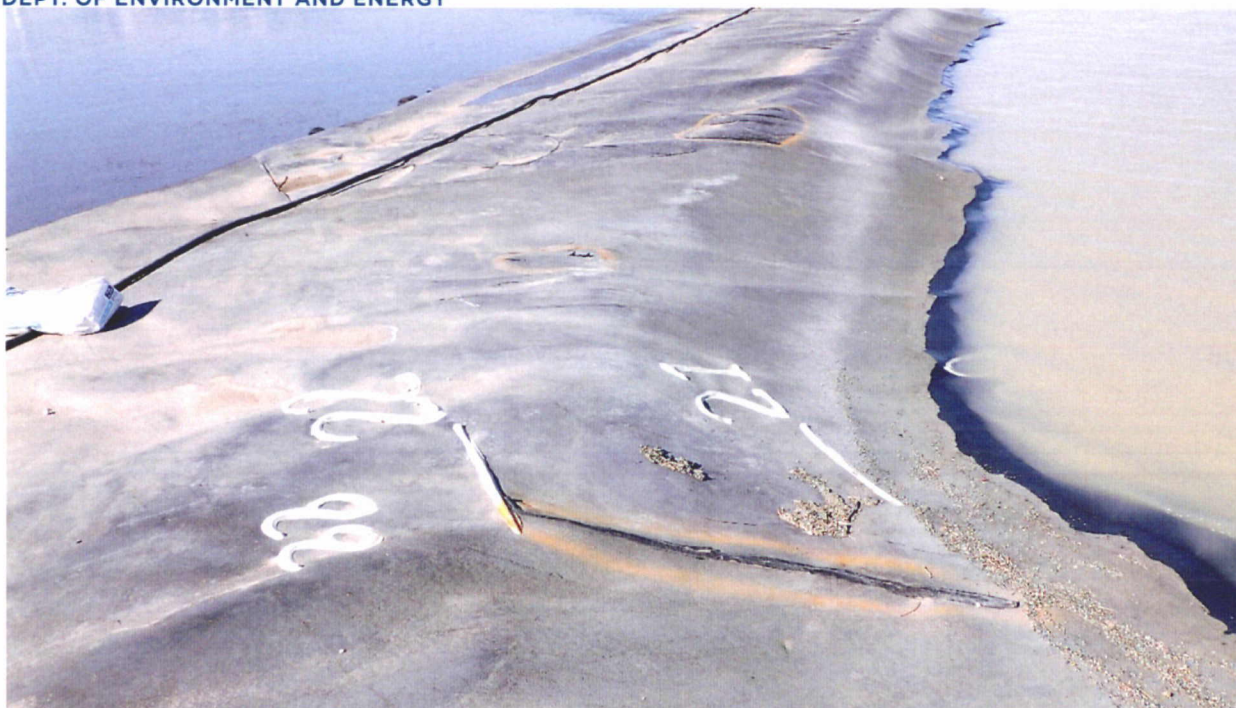
Photo: 9

Description: This the northeast lagoon depth marker.

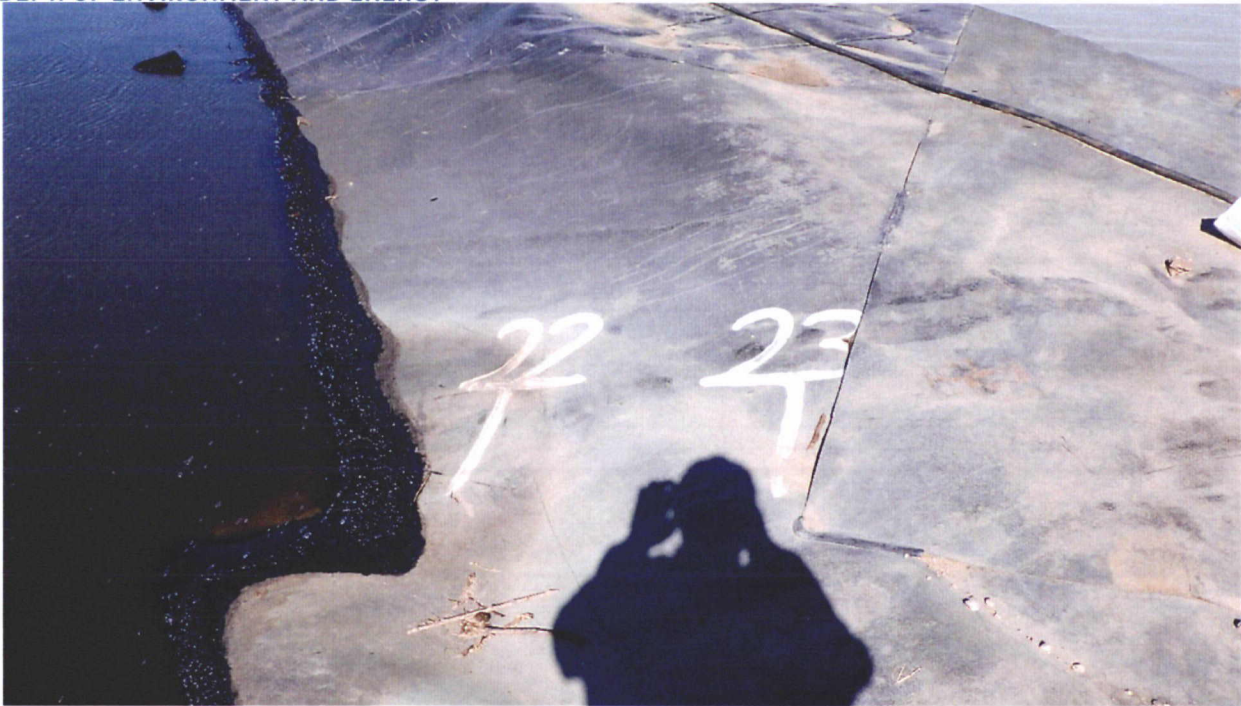
Photo: 10

Description: This the south lagoon depth marker.

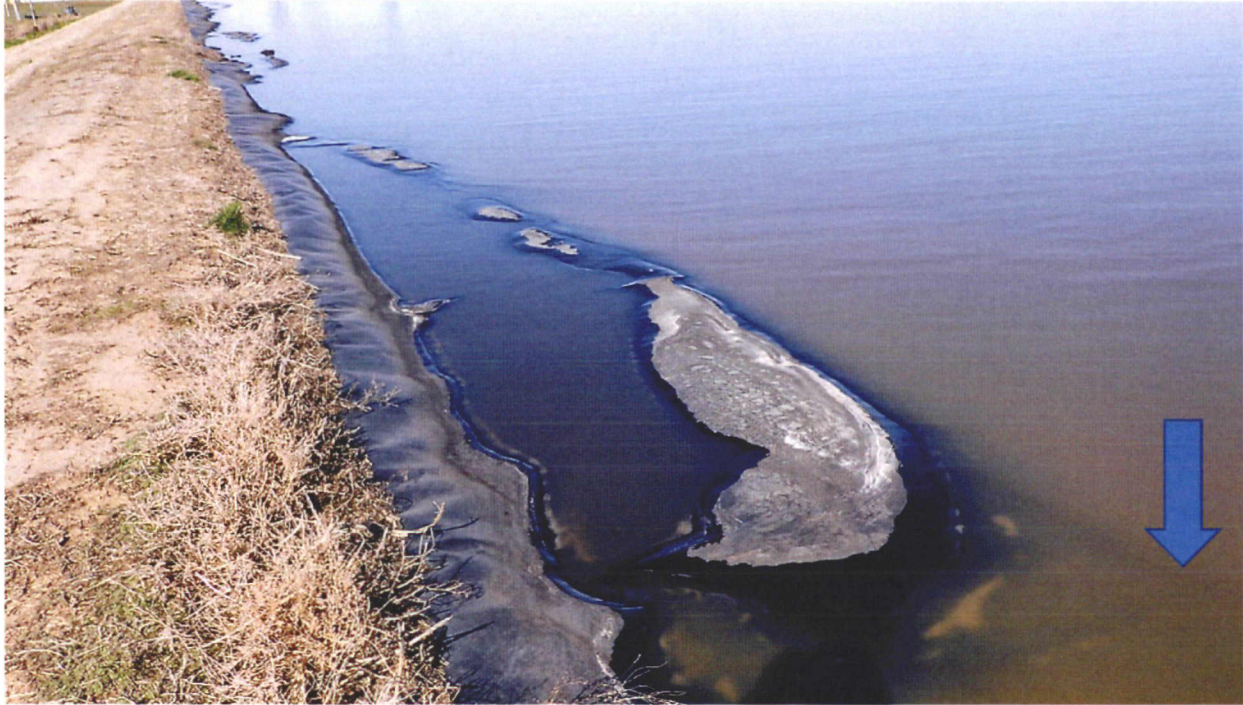
Photo: 11

Description: The liner appears to be breaking free (arrow).

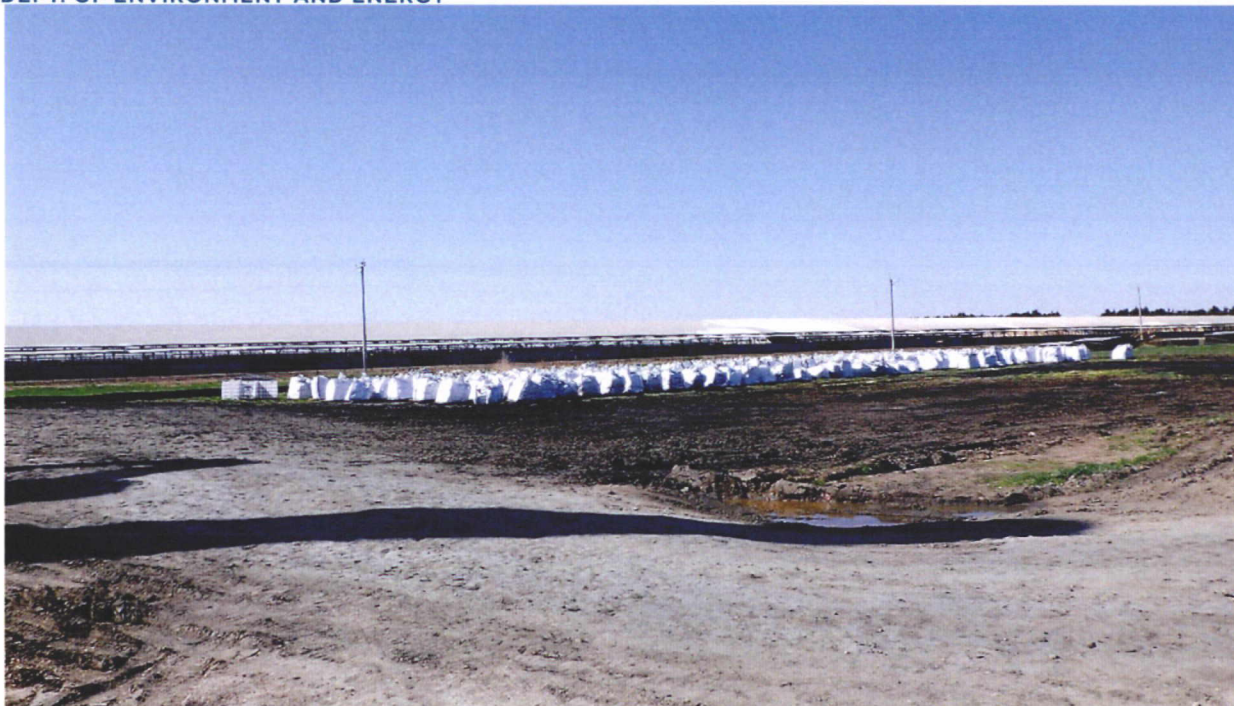
Photo: 13

Description: The facility has hauled approximately half of the biochar supersacks in the south hoop building.

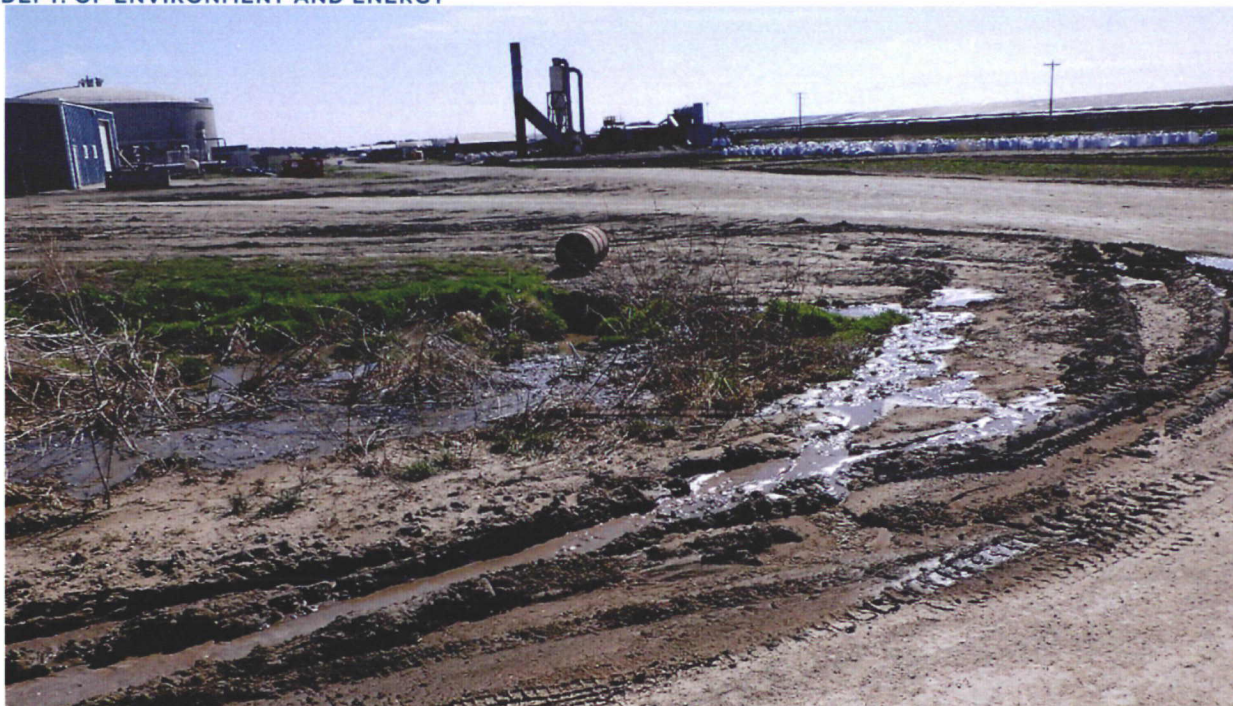
Photo: 14

Description: While walking near the biochar I observed water in the storm water ditch. I traced it to the area in the photo (Feed Mill). I observed a worker wash their feed trailer into a containment area (next photo).

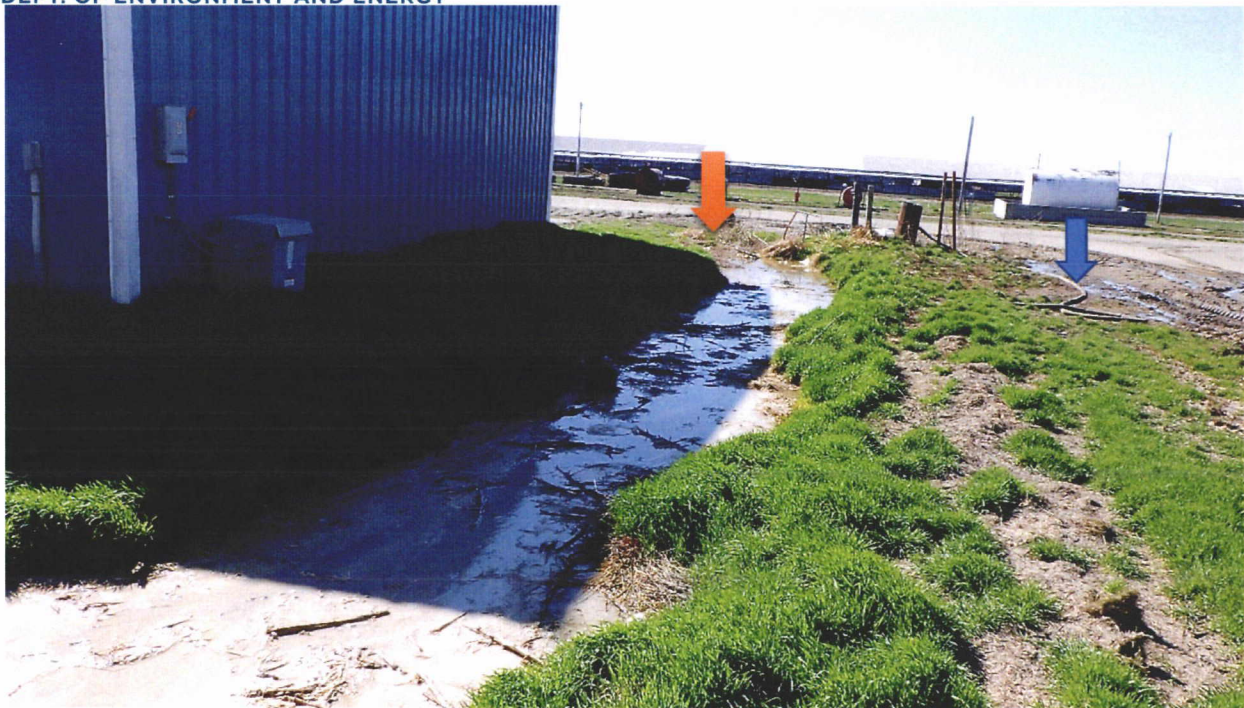
Photo: 15

- The facility continues to transfer biochar supersacks into the south hoop building. The facility has transferred about half.
- Mead Cattle truck wash out is leaking into the storm water drainage system.

Description: This photo depicts the washout area for the observed feed truck. The hose in the forefront was used to washout the backend of the feed truck (arrow). The slurry observed here is not contained and is exiting the culvert (orange arrow) onto AltEn property.

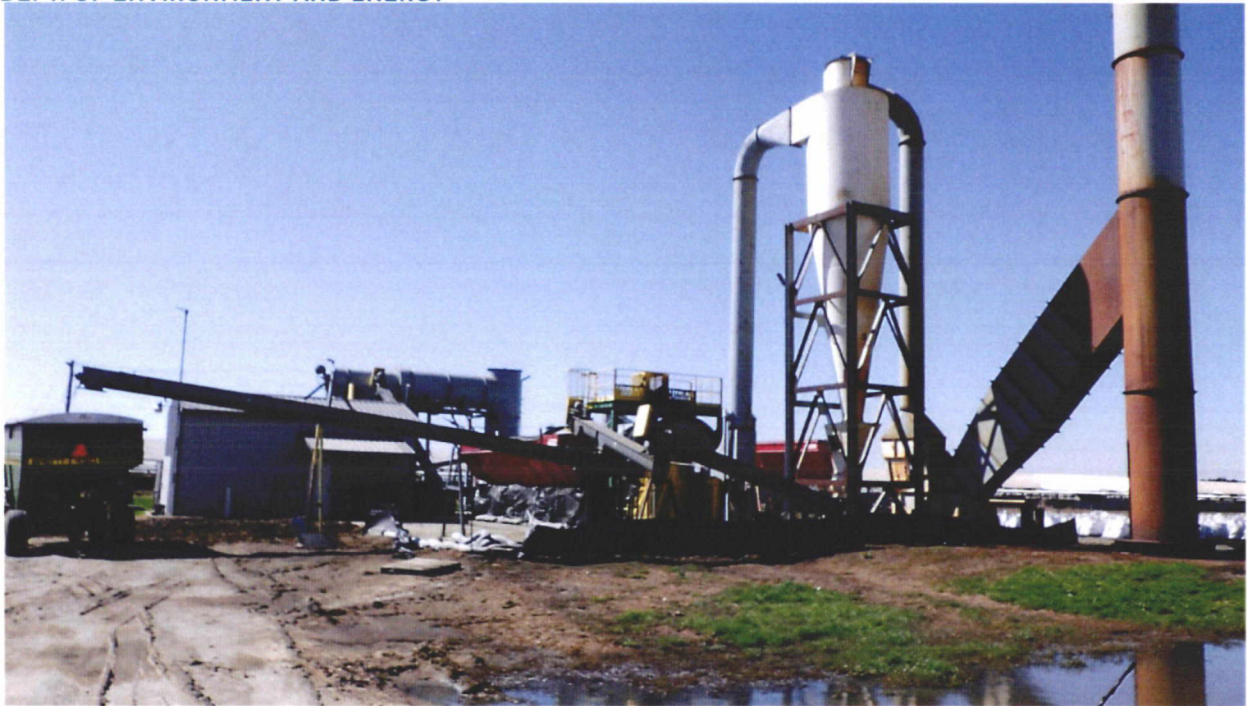
Photo: 16

Description: This photo depicts the biochar. The system is currently not operational and is being repaired.

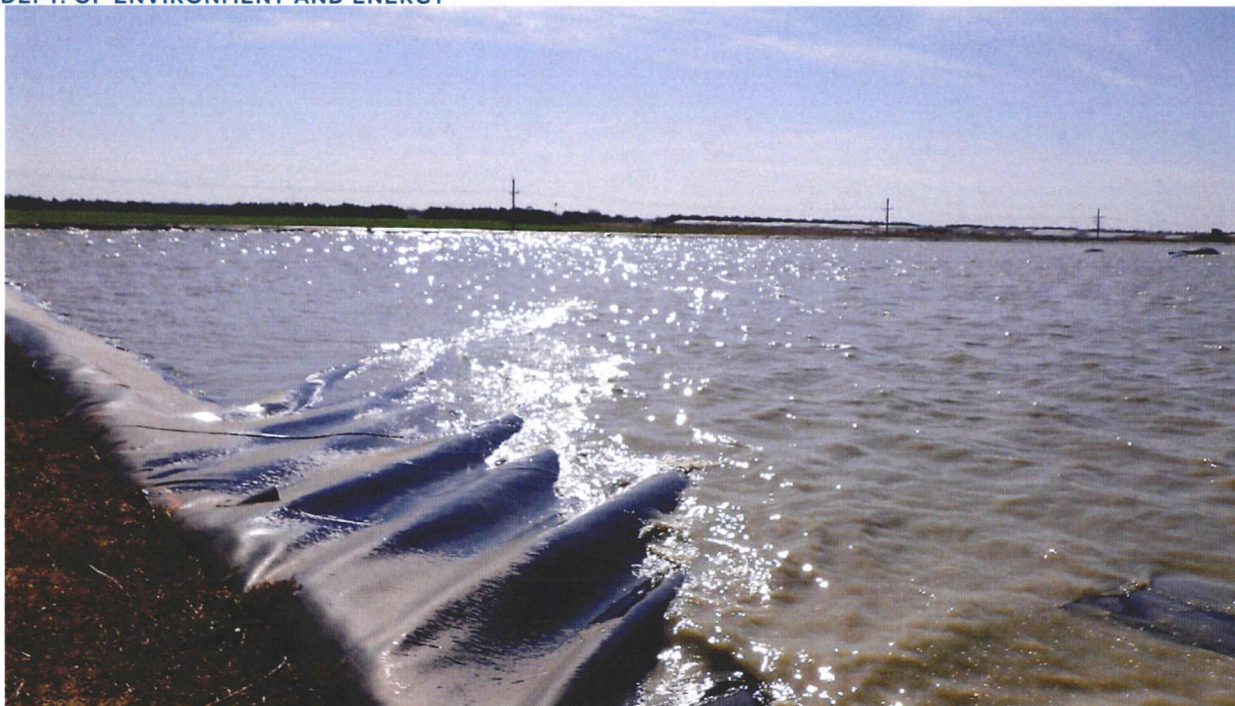
Photo: 17

Description: This photo depicts floating liner in the northeast lagoon.

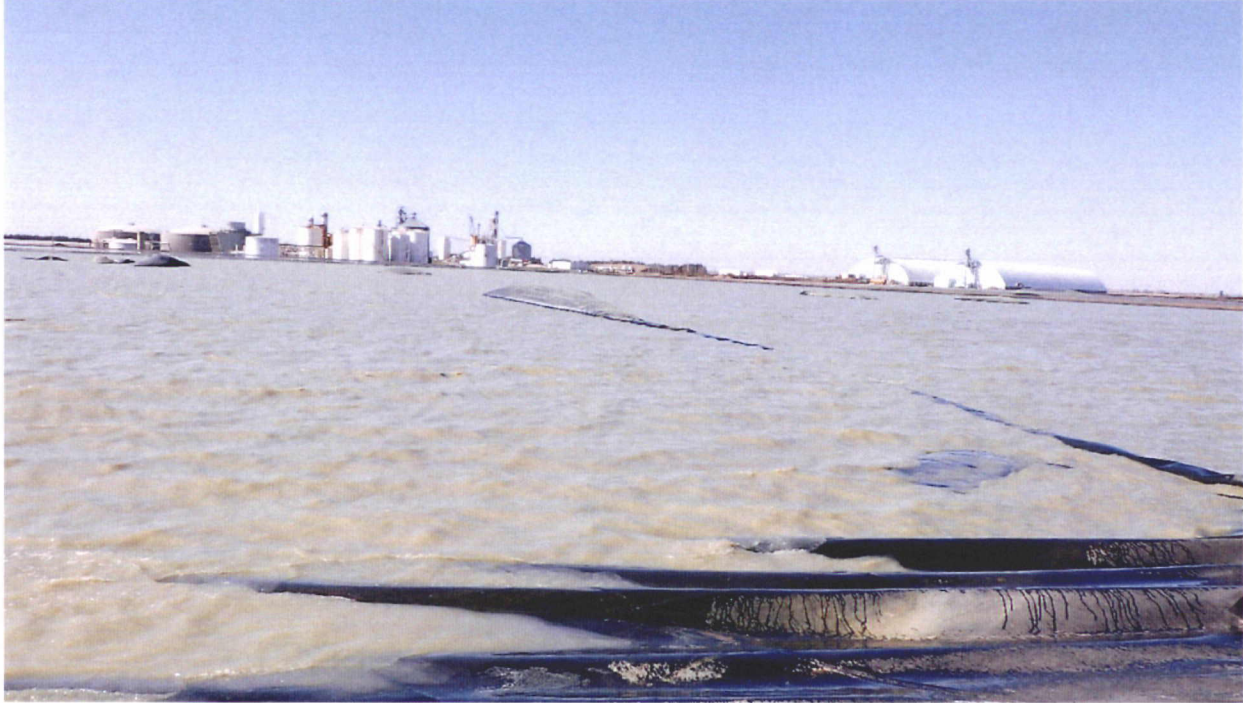
Photo: 18

Description: This photo depicts floating liner in the northeast lagoon.

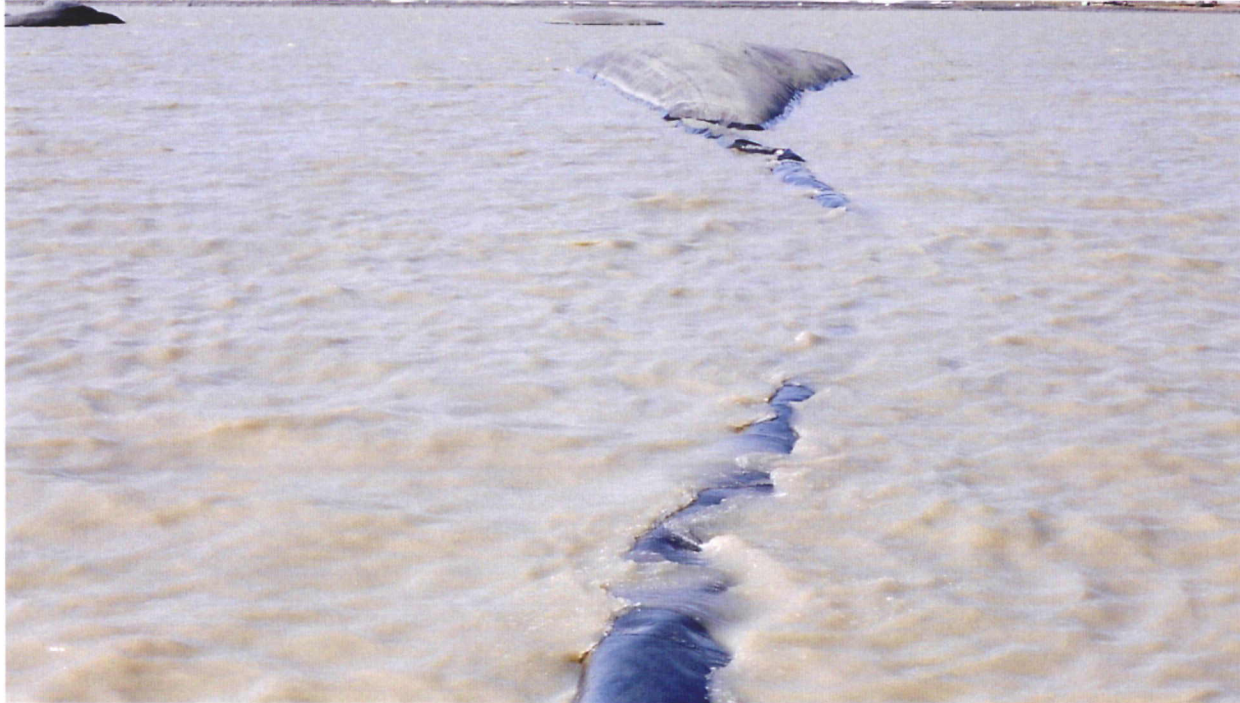
Photo: 19

Description: This photo depicts floating liner in the northeast lagoon.
