Facility: AltEn
IIS: 84069
PCS: NE0137634

Site Visit Check list

Site Visit Report

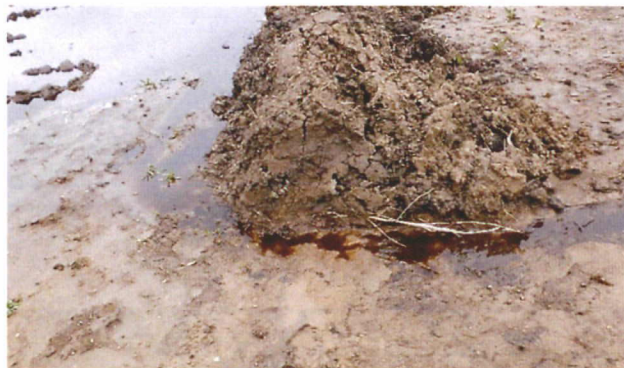
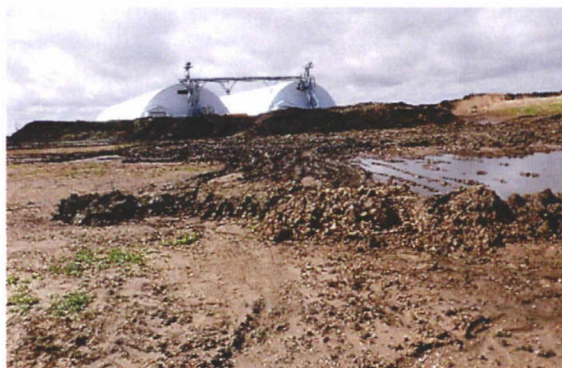
Photos: 1/2

- The berm northeast of the administration building is leaking around the south side, photo 1.
- The facility will be pumping berms down on March 25, 2021

Description: The left photo depicts storm water discharging around the south side of the berm. The right photo is after repairs. The repair occurred before I left the facility.

- 1) North berm fixed before I left for the day
- 2) Pump water from berms into the emergency lagoon
- 3) Place biochar bags into containment area. (Mr. Peterson stated they are going to put them into the Hoop building)

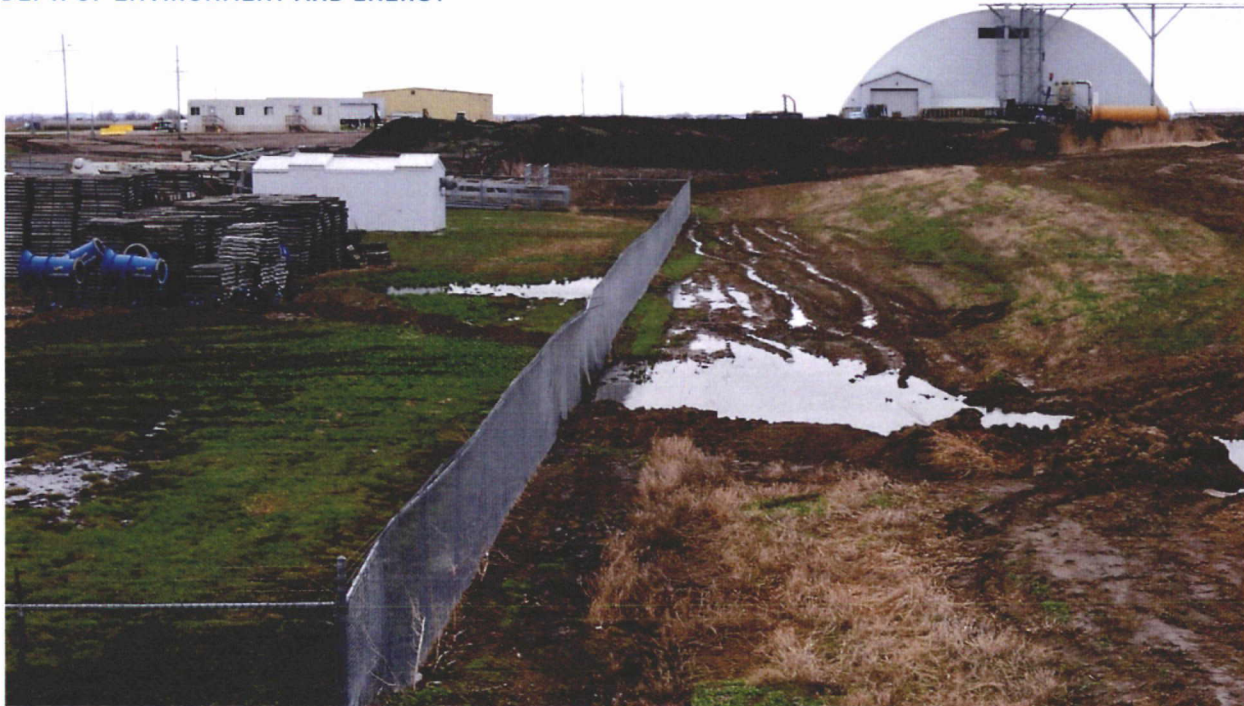
Photo: 3

Description: Bermed area along the southeast corner of the wet cake pile. The berm appears to holding water at this time.

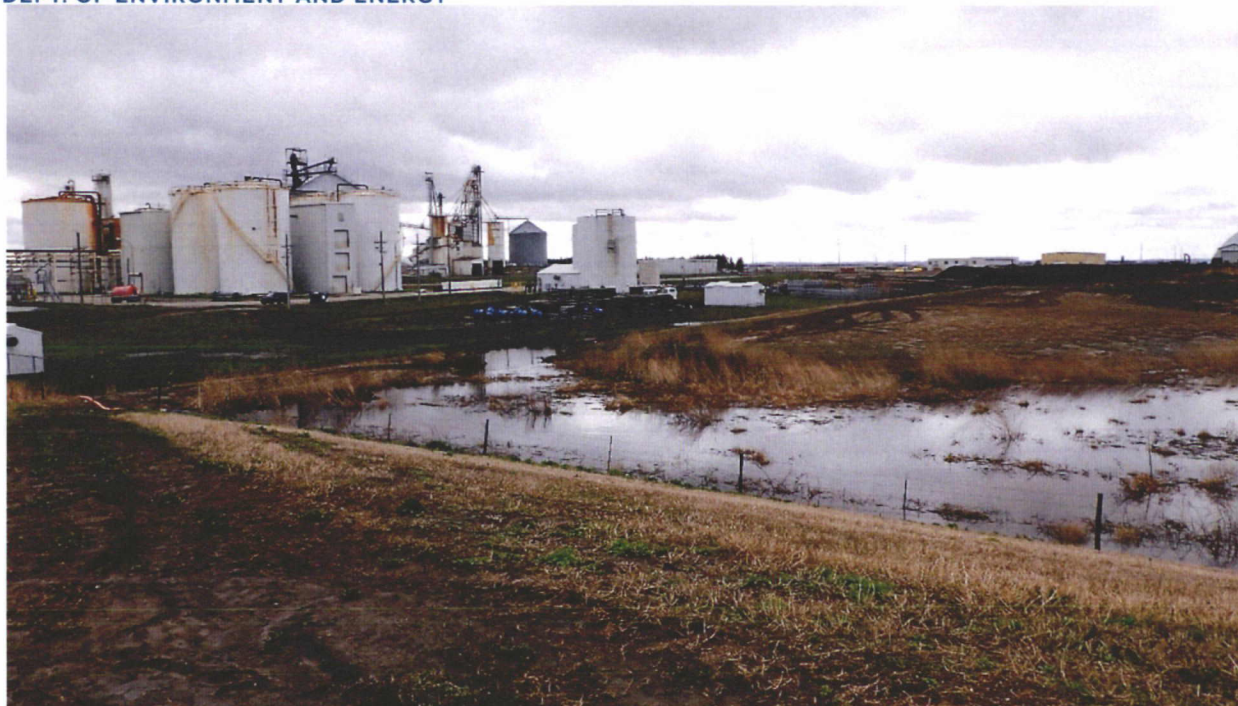
Photo: 4

Description: Contained storm water

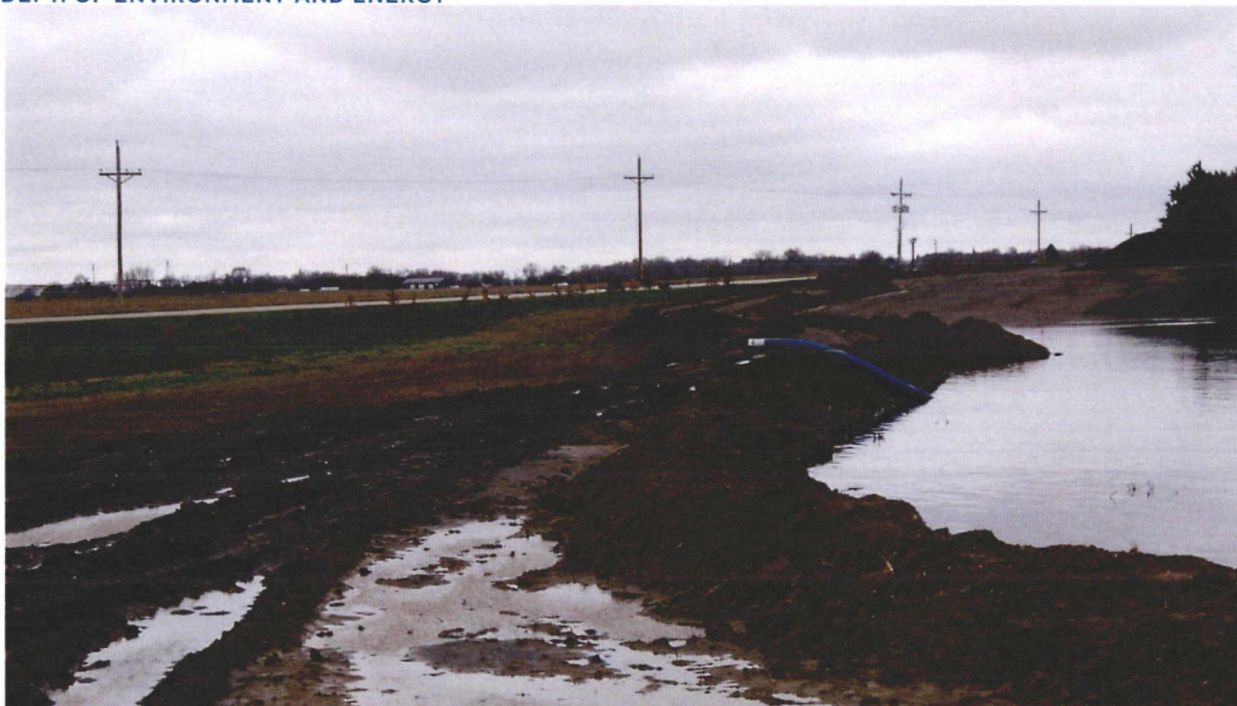
Photo: 4

Description: This photo depicts a connection hose use to pump out runoff from the west wet cake storage area. This is pumped to area 2.

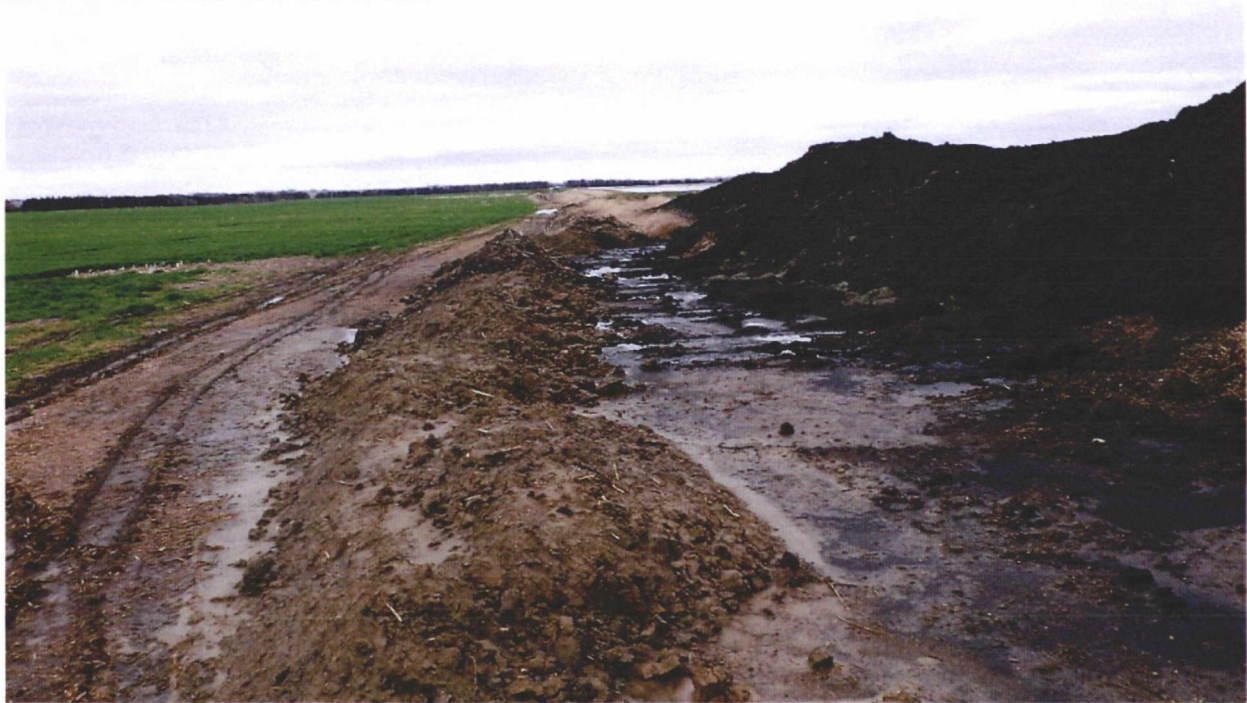
Photo: 5

Description: Wet cake has been pushed back into storage area.

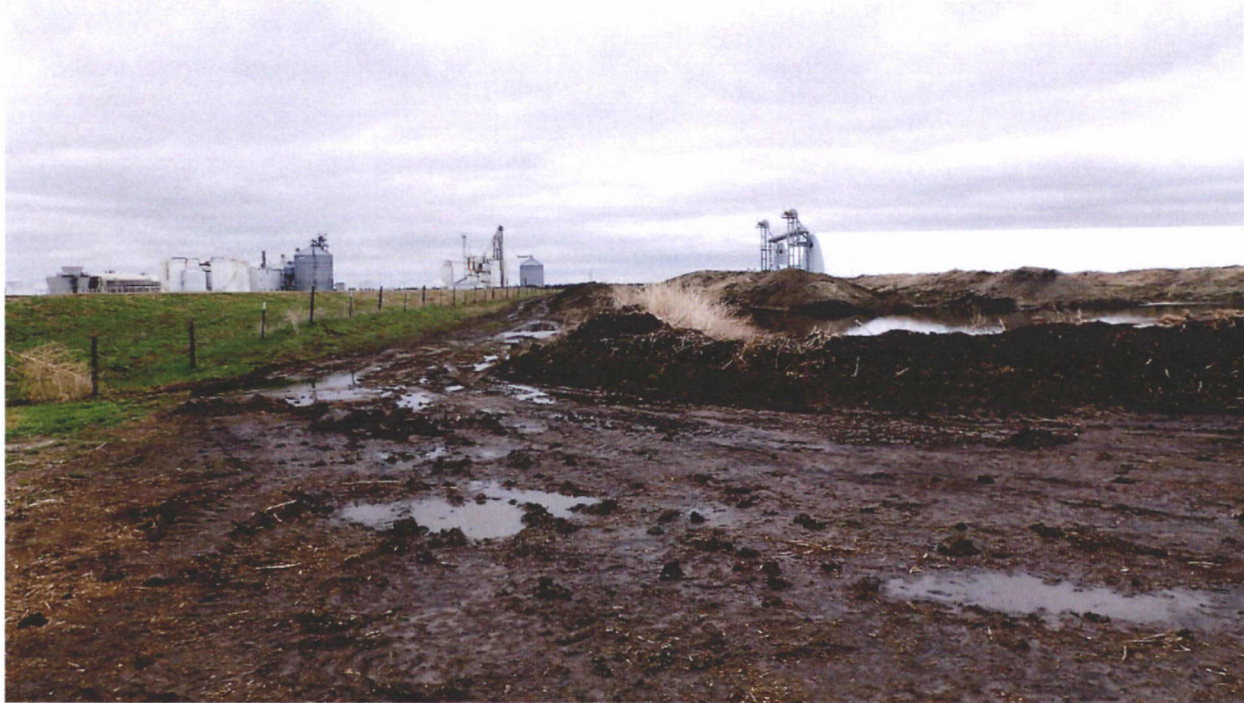
Photo: 6

Description: Water accumulation from the recent rain event.

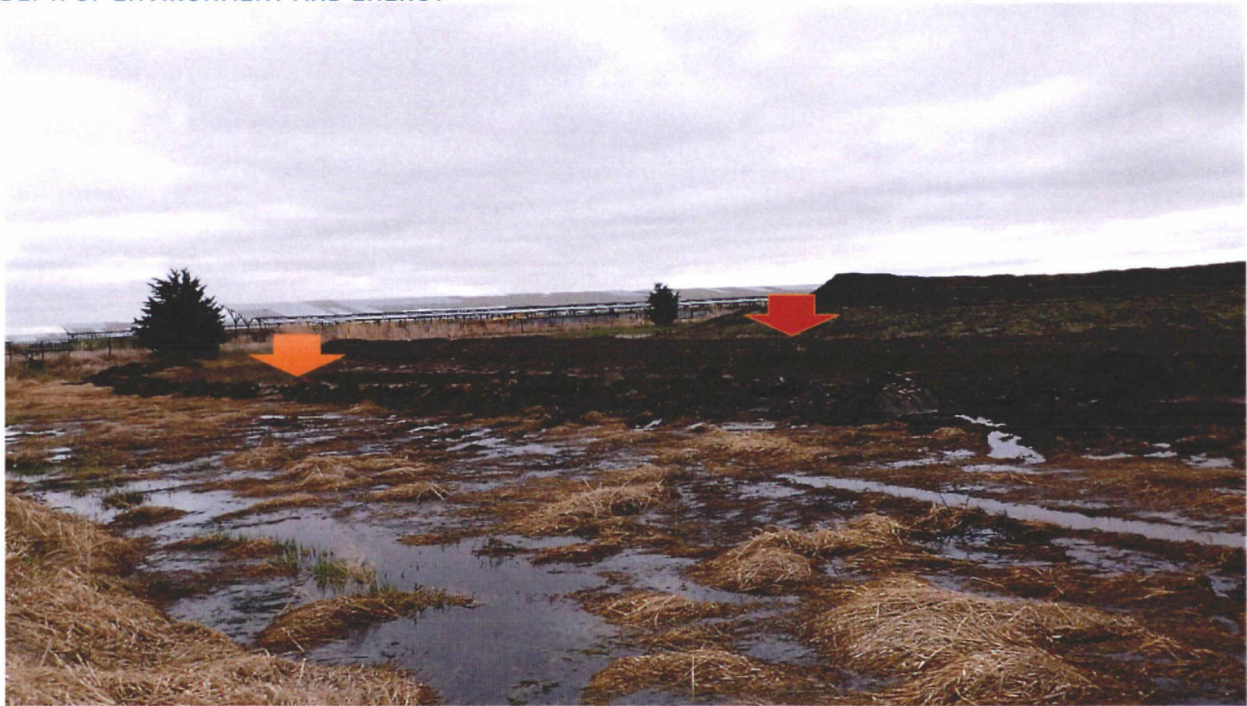
Photo: 6

Description: This photo depicts the east wet cake pile. The original berm appears to be in good condition, red arrow. To help protect the waterway the facility installed an additional berm, orange arrow.

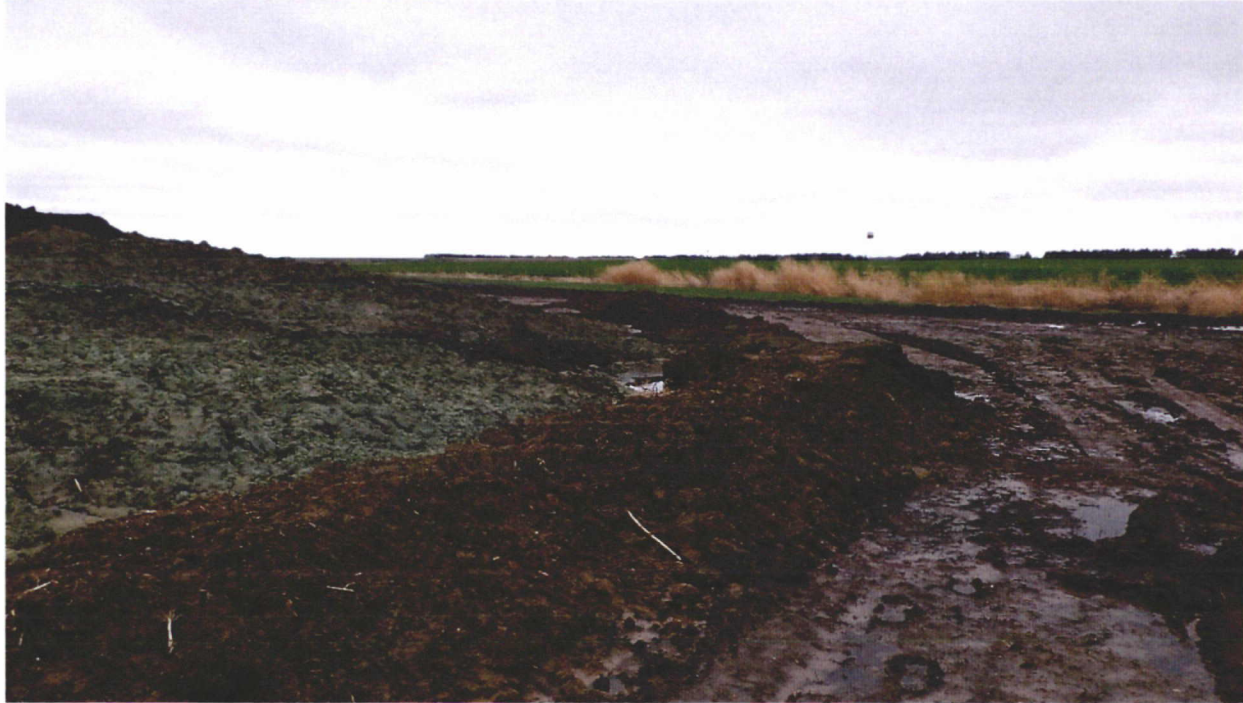
Photo: 7

Description: This photo depicts the east wet cake pile. This is the north side of the berm. This is no evidence of seepage or overflows.

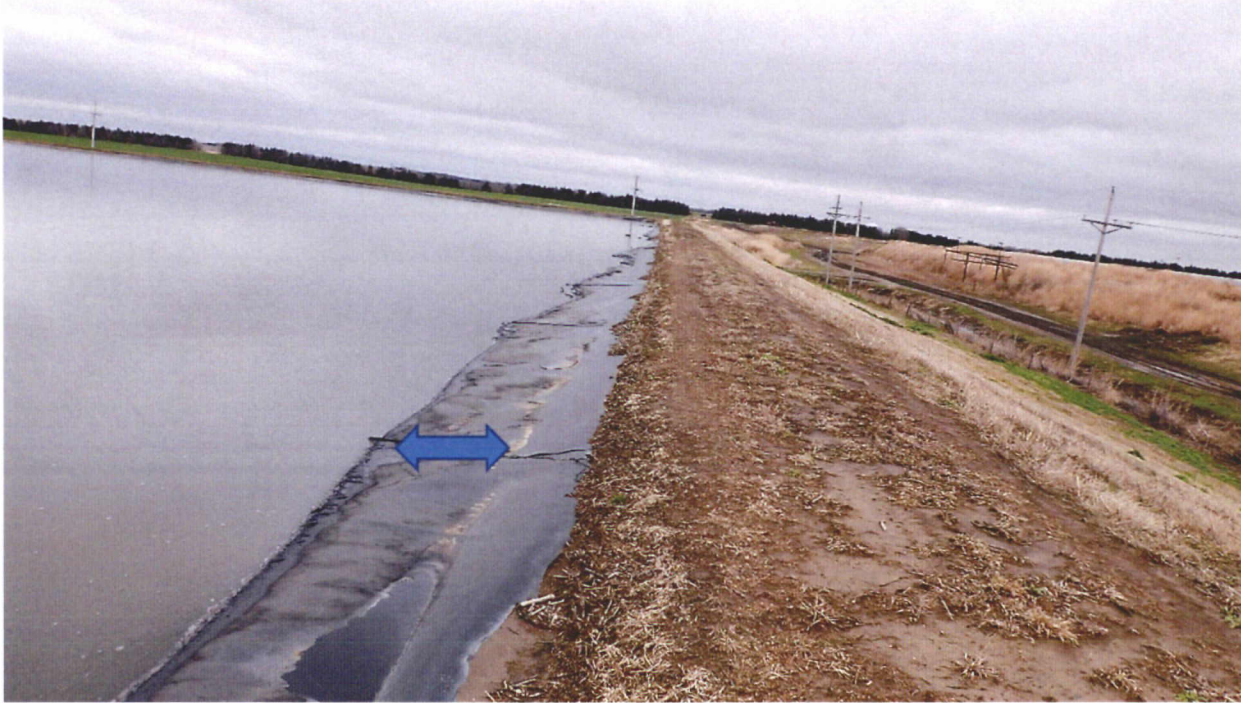
Photo: 8

Description: It appears water level has lowered some, arrow.

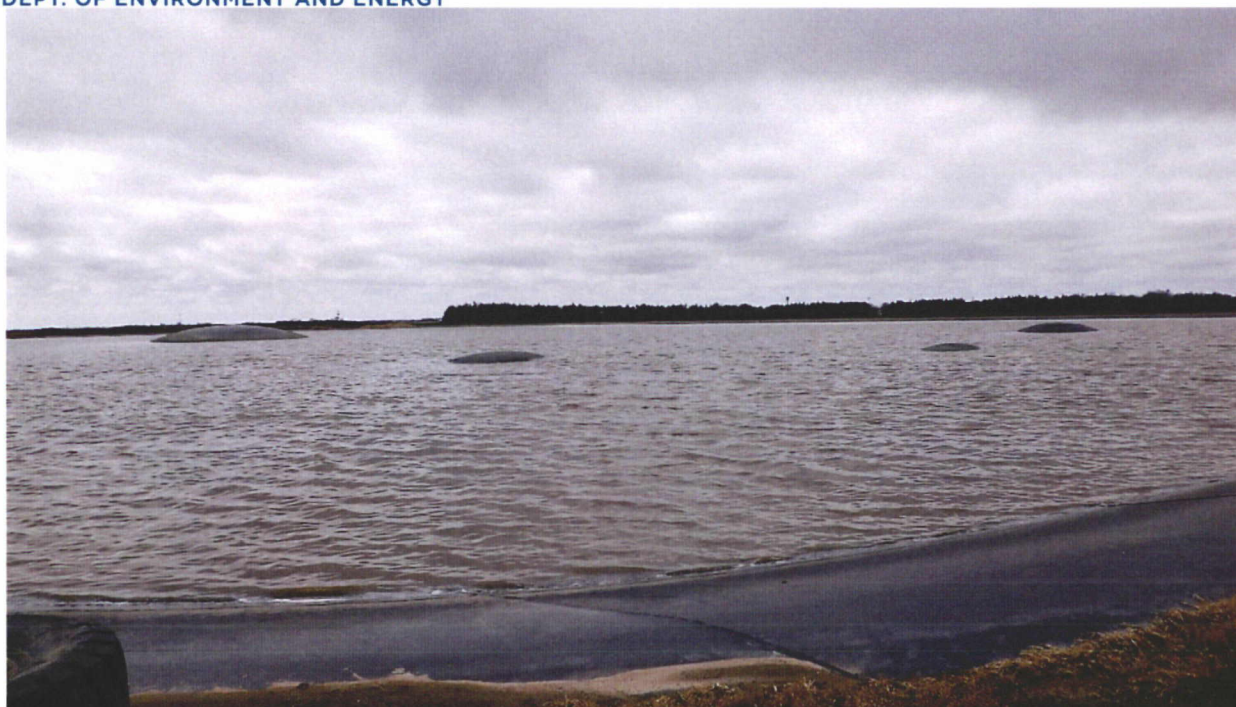
Photo: 8

Description: This photo depicts the whales in the northwest lagoon.

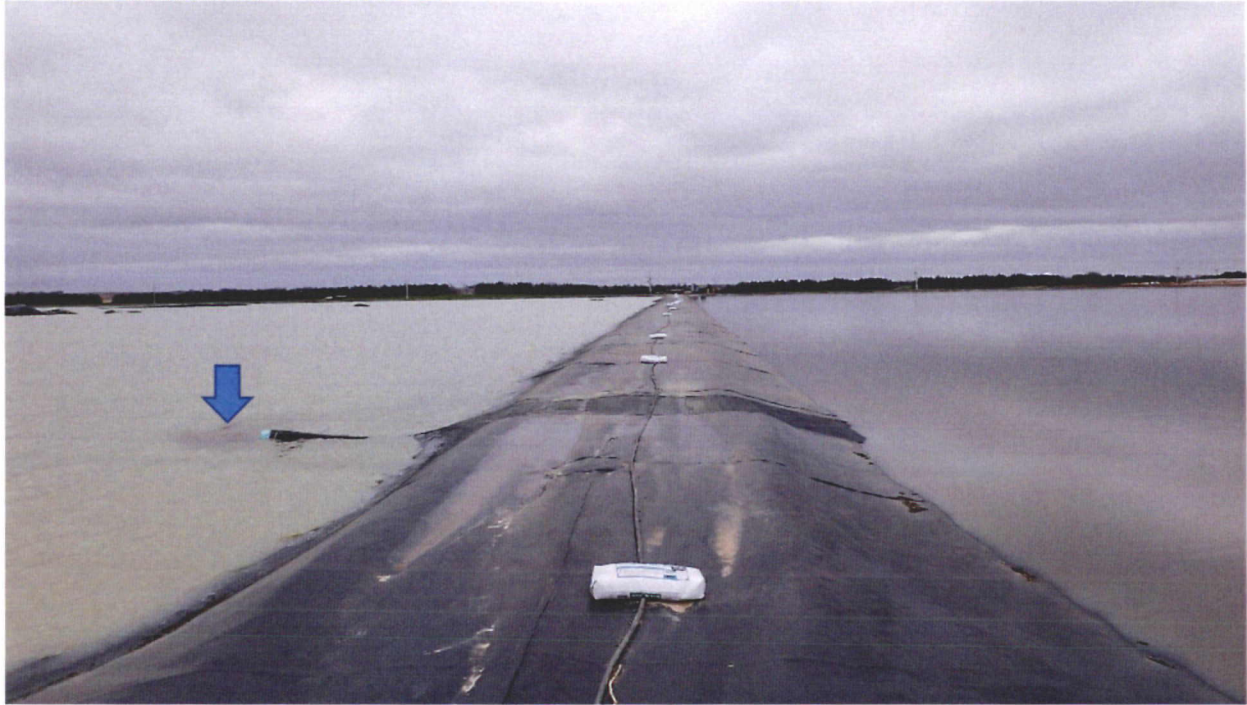
Photo: 9

- Northeast lagoon
 - No change
- Northwest lagoon
 - no change
- South lagoon
 - The south lagoon continues to equalize into the northeast lagoon.

Description: This photo depicts the dike between the northeast and south lagoon. Notice the plume from the south lagoon into the northeast lagoon, arrow.

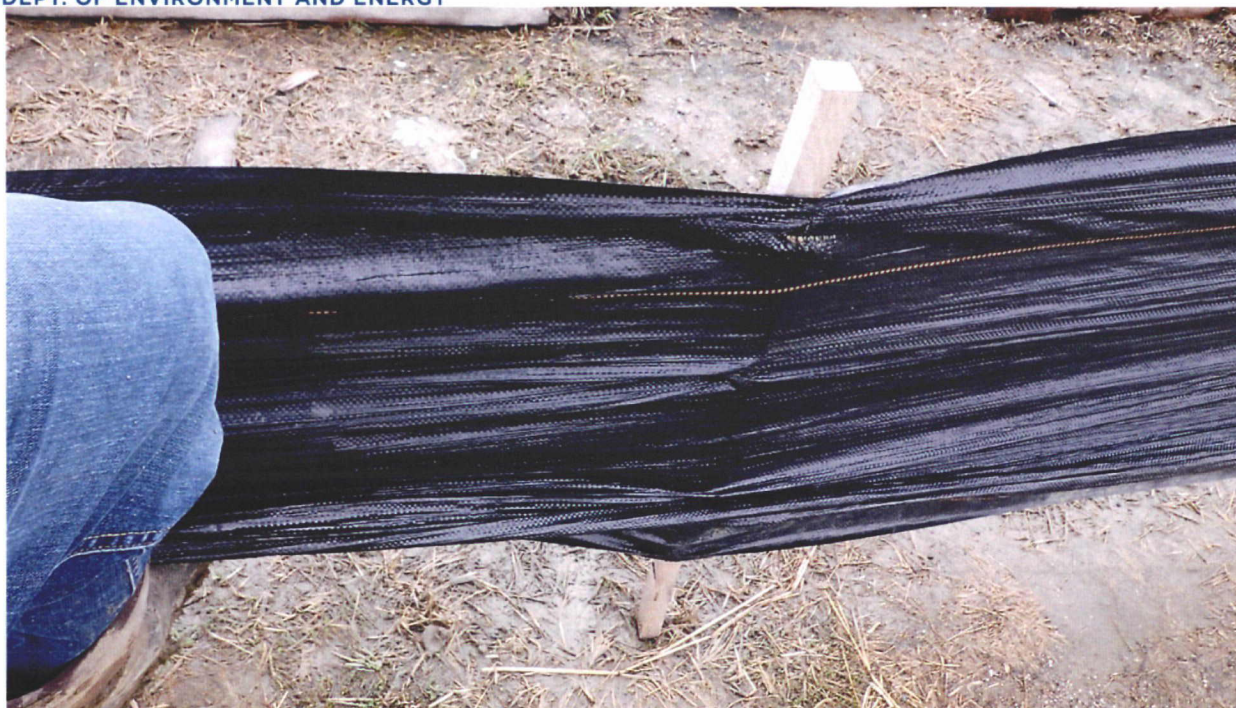
Photo: 10

Description: This is the silt fence used to contain supersacks. The silt fence is not installed correctly.

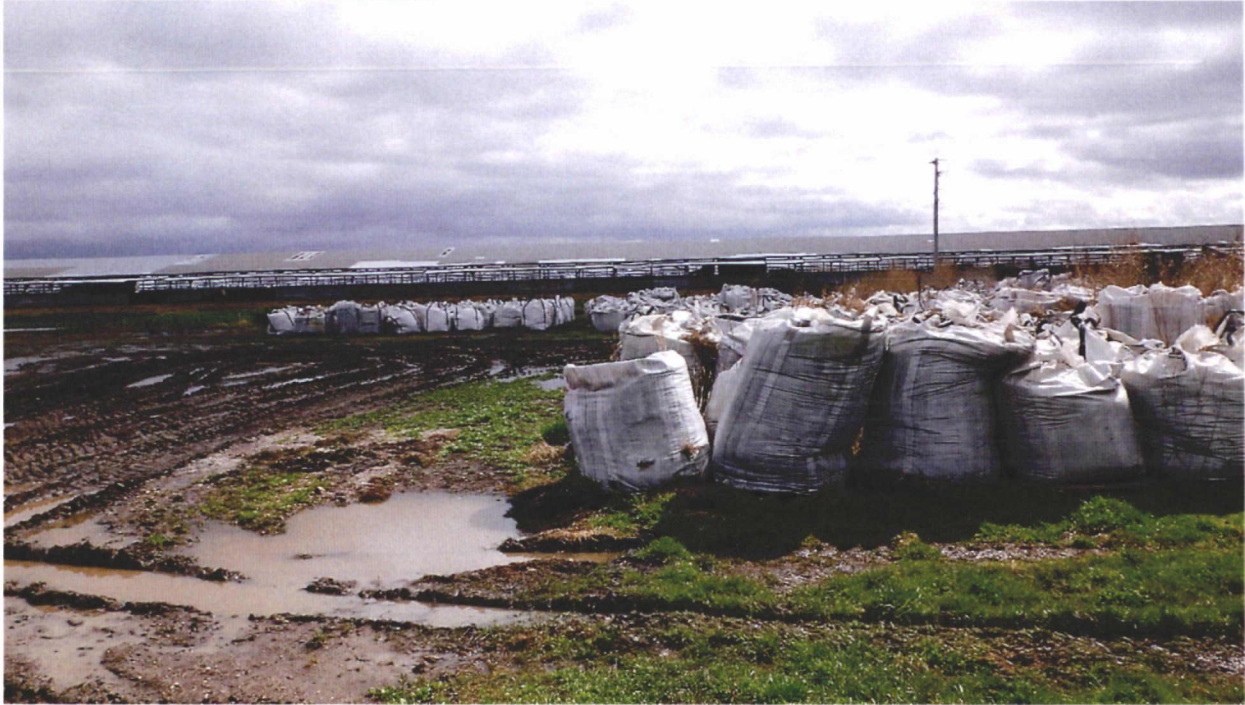
Photo: 11

- There are approximately 40 bags of Biochar Supersacks stored north of the Biochar production area. I asked Mr. Peterson why supersacks are stored in that location. Mr. Peterson stated they had originally been sold but the buyer cancelled the order. Mr. Peterson stated to solve the stormwater issue, the supersacks are going to be moved into the Hoop building.
- The silt fence surrounding the biochar storage is not knifed in.
- There are approximately 25 totes of recycled beer and pop stored in the production area.

Description: Bags of supersacks stored on the east side of the biochar unit. These supersacks are not surround by silt fence as described in the facility storm water pollution prevention plan (SWPPP).

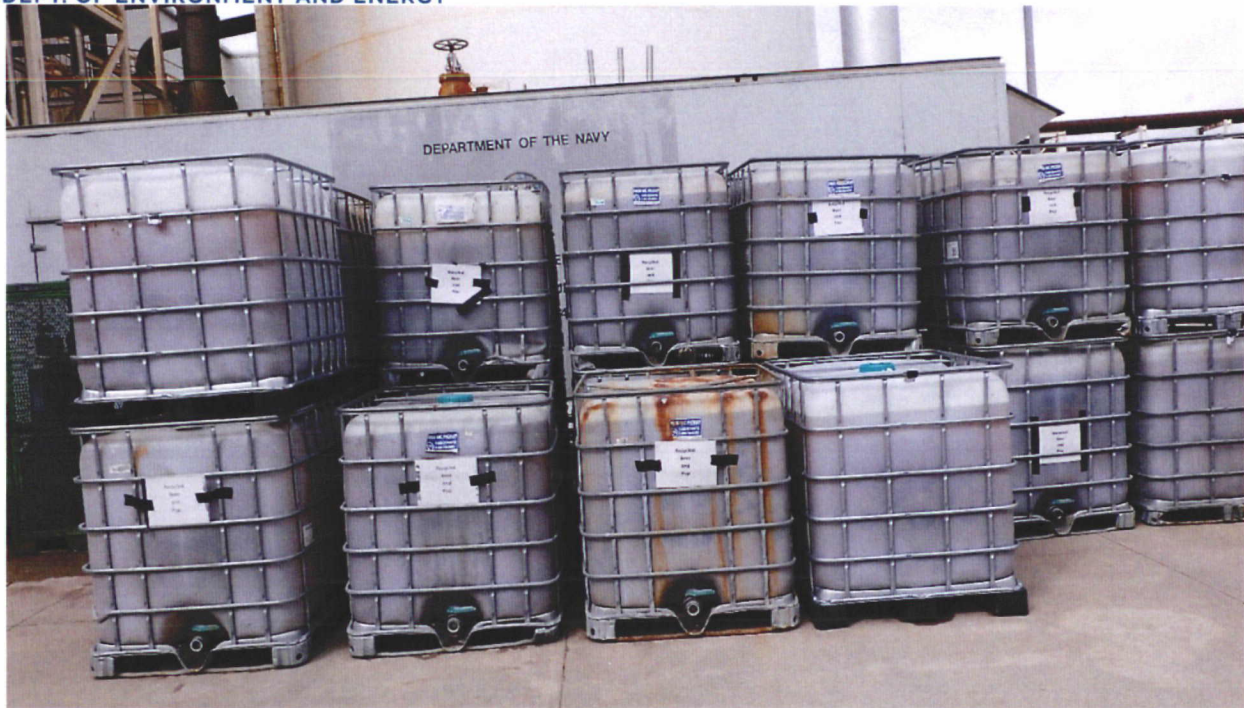
Photo: 12

Description: These are totes of beer and pop. There are approximately 25 totes onsite.

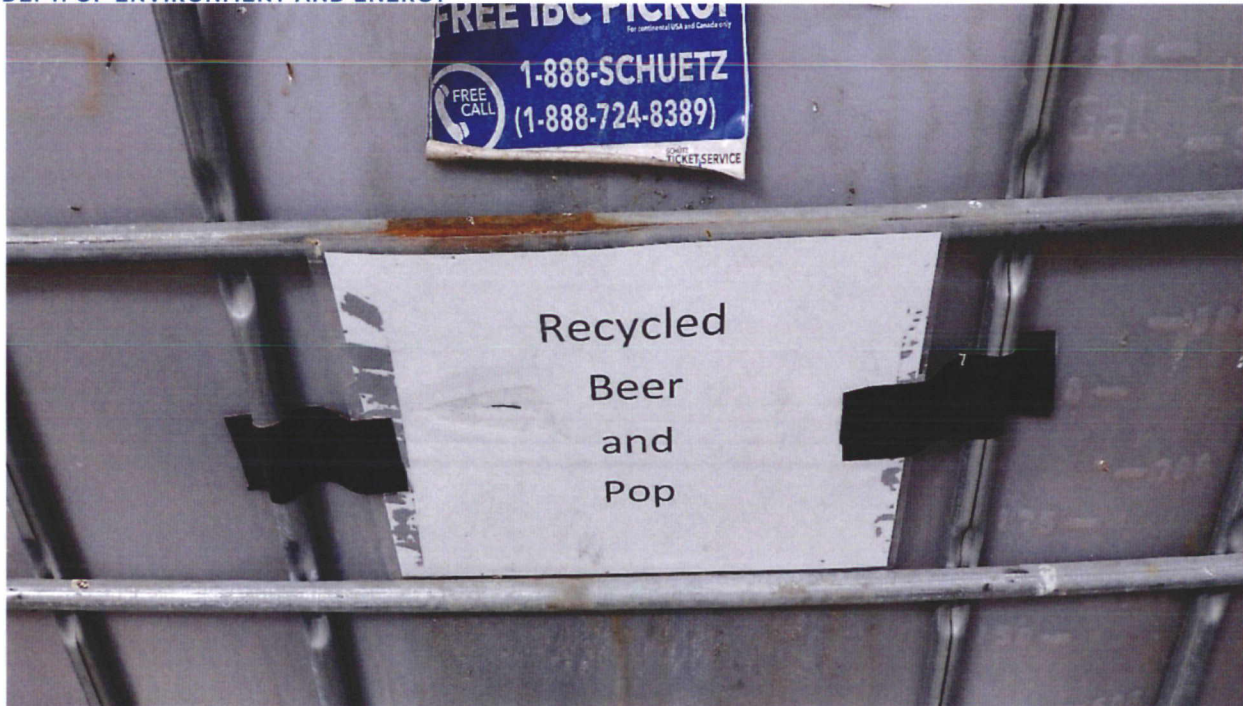
Photo: 13

Description: This is the label for one of the totes.

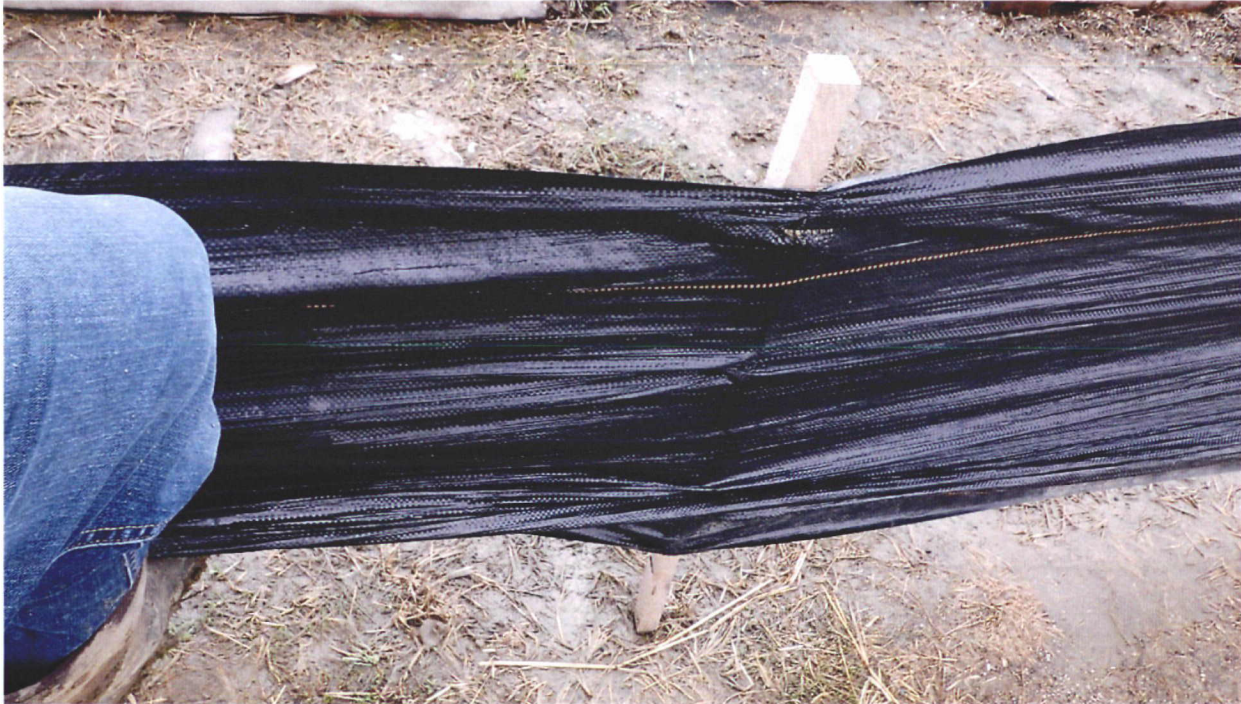
Photo: 13

Description: This photo depicts improper installation of silt fencing.
