Facility: AltEn  
IIS: 84069  
PCS: NE0137634

### Site Visit Check list

Site Visit Report

Facility Name/ Project Name: AltEn LLC

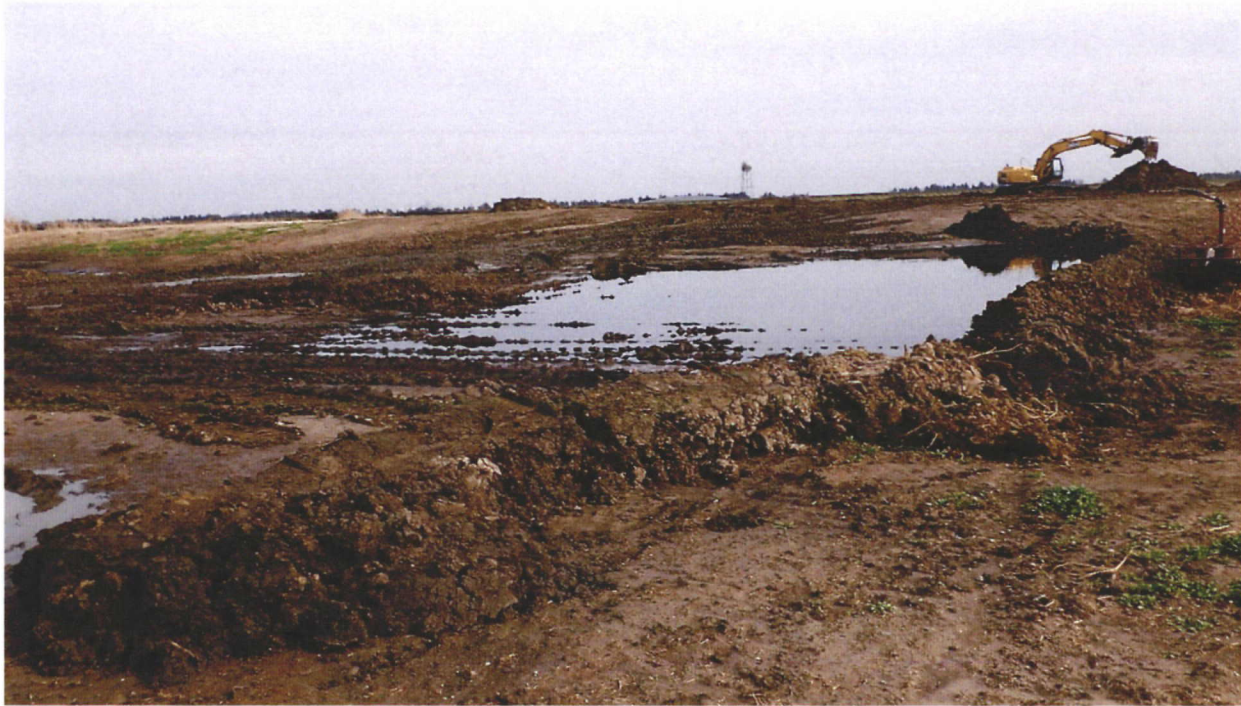
Photos: 1

Location: Area 1 on the site map

Description: The left photo depicts storm water accumulation. I did not observe leaking at this time.

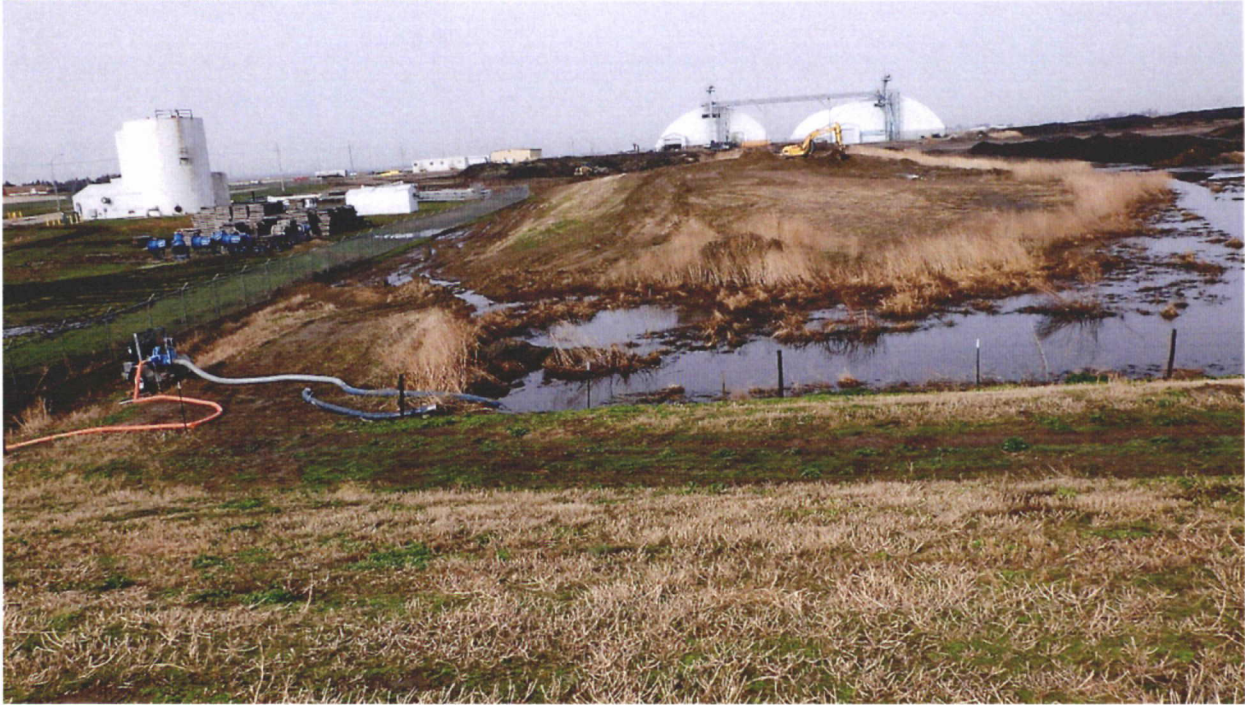
Photos: 2

Location: Area 2 on the site map

Description: Storm water accumulation and pumping equipment at Area 2.

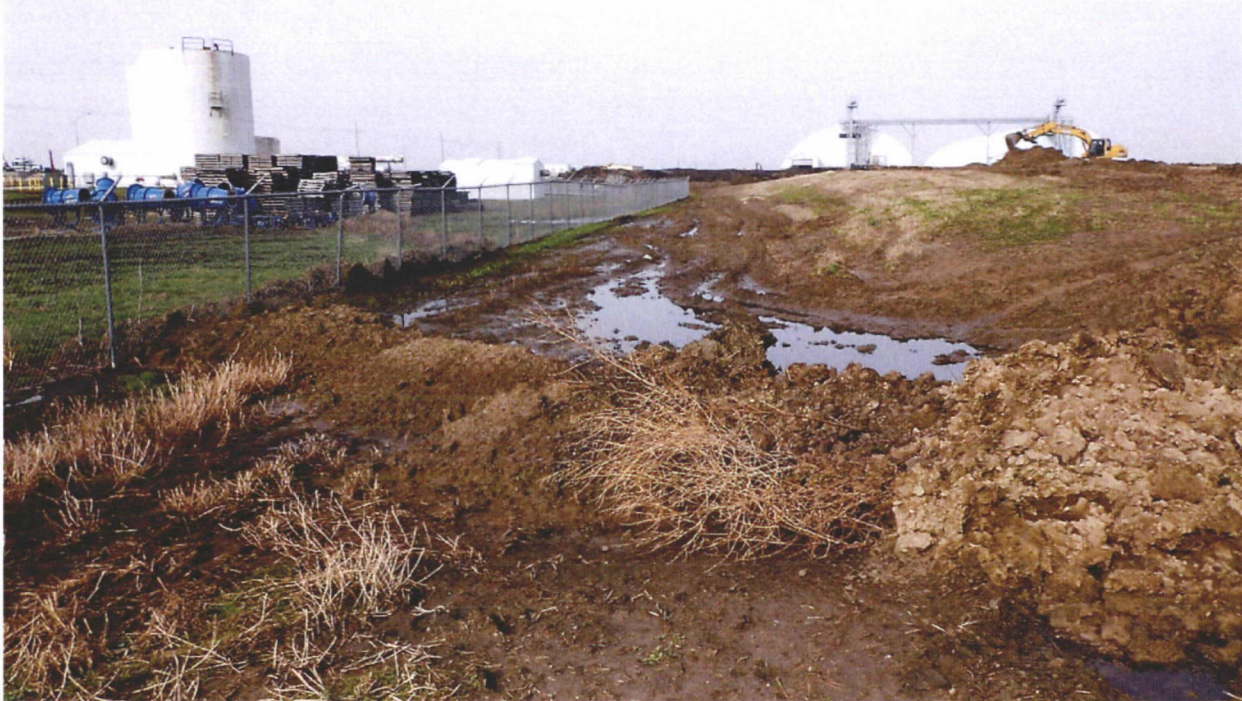
Photo: 3

Location: Area 2 on the site map

Description: Bermed area along the southeast corner of the wet cake pile. The facility has recently added material.

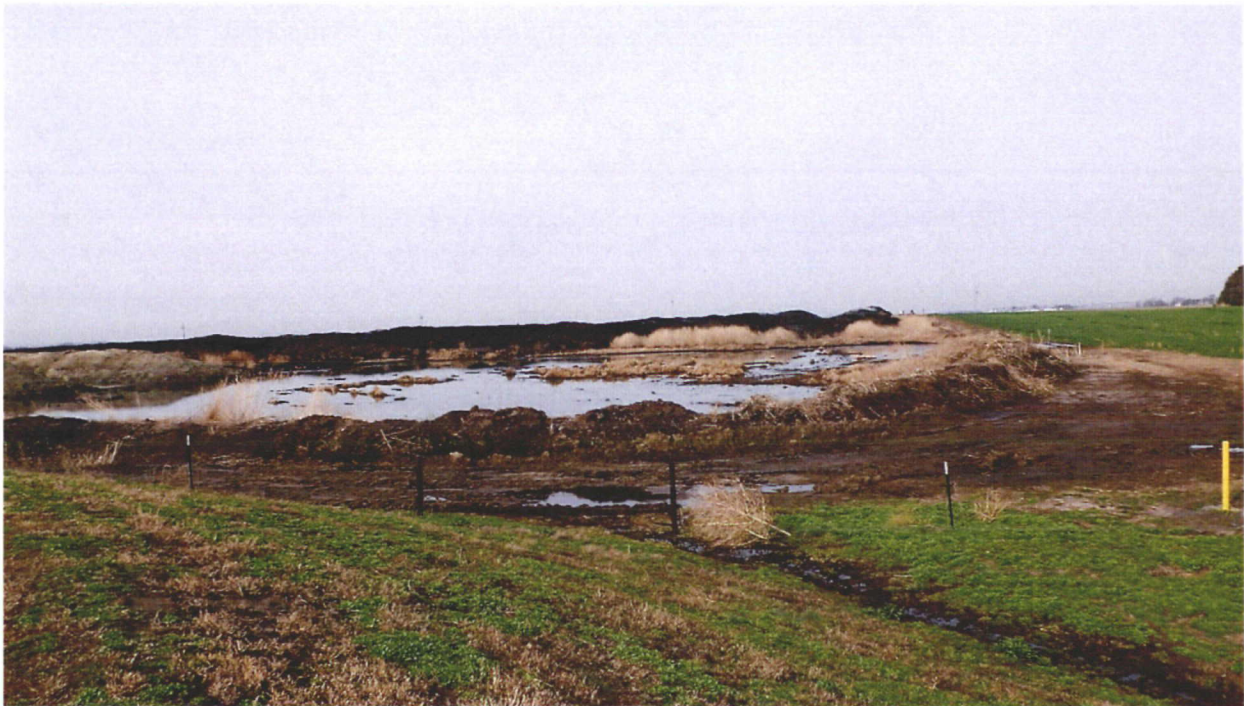
Photo: 4

- Mr. Peterson stated they are actively pumping from berms. Mr. Peterson also stated they only have two general laborers and it is becoming difficult to get all the work completed.
- The facility is constructing more berms north of the administrative building (Area 1) on the map.
- Area 3 berm appears to be seeping. The facility will be adding material today.

Location: Area 3 on the site map

Description: This photo depicts the berm on the north side of the wet cake pile. There appears to be some seepage behind the berm.

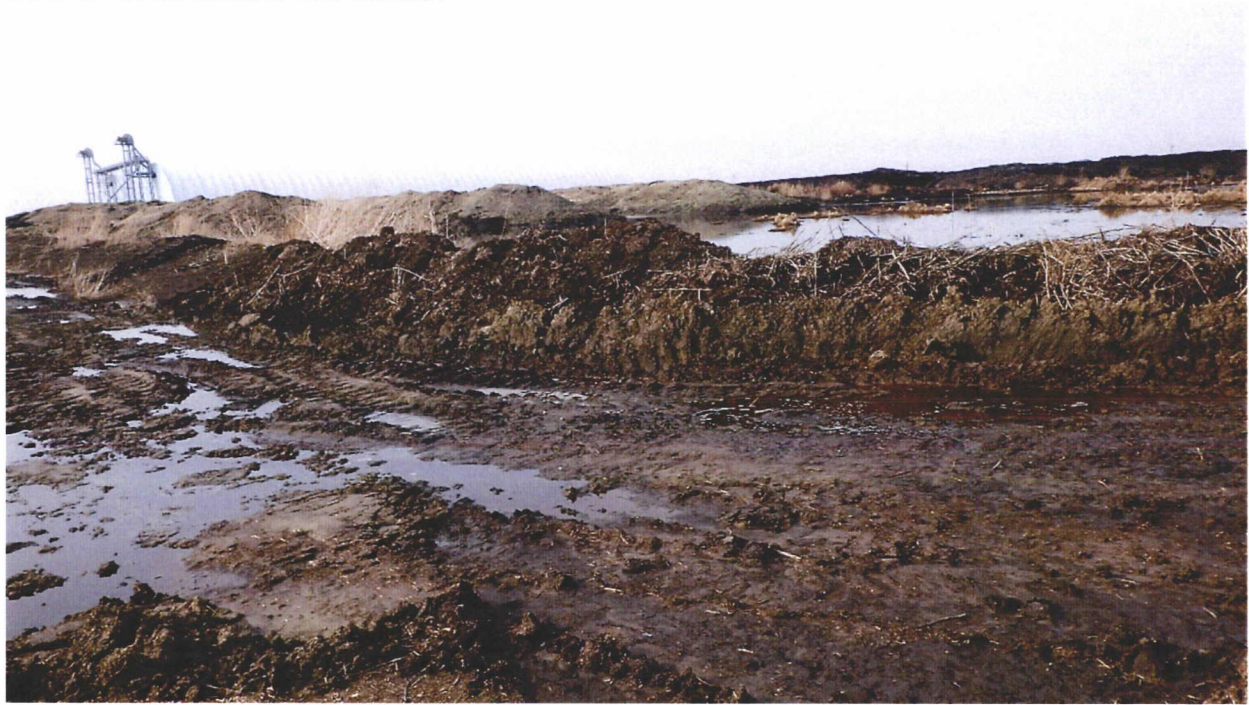
Photo: 5

Location: Area 3 on the site map

Description: This photo depicts the berm on the north side of the wet cake pile. There appears to be some seepage behind the berm.

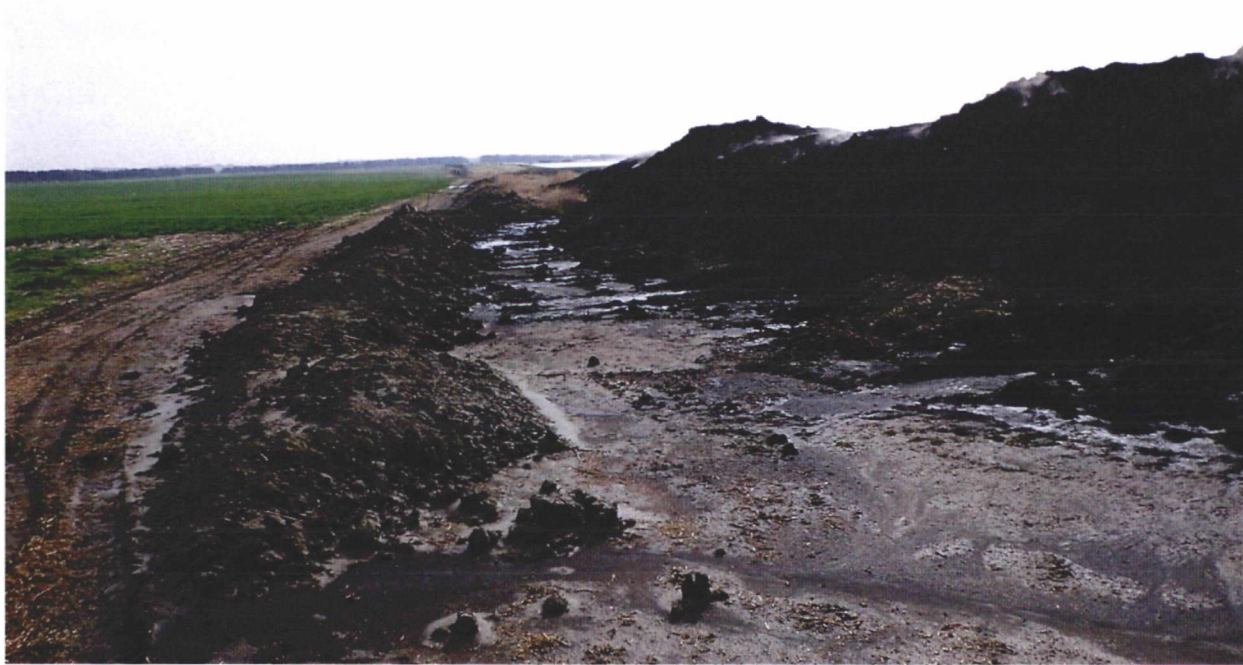
Photo: 6

Location: Area 4 on the site map

Description: This photo depicts that the facility separated the wet cake from the berm.

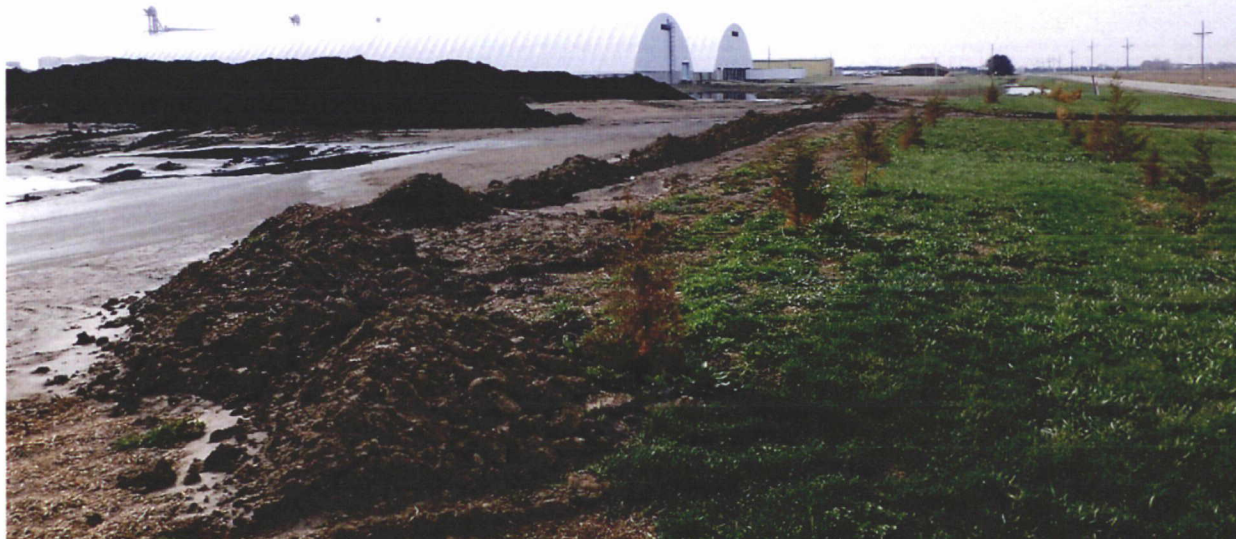
Photo: 6

Location: Area 5 on the site map

Description: This photo depicts the berm spans the length of the west side of the property.

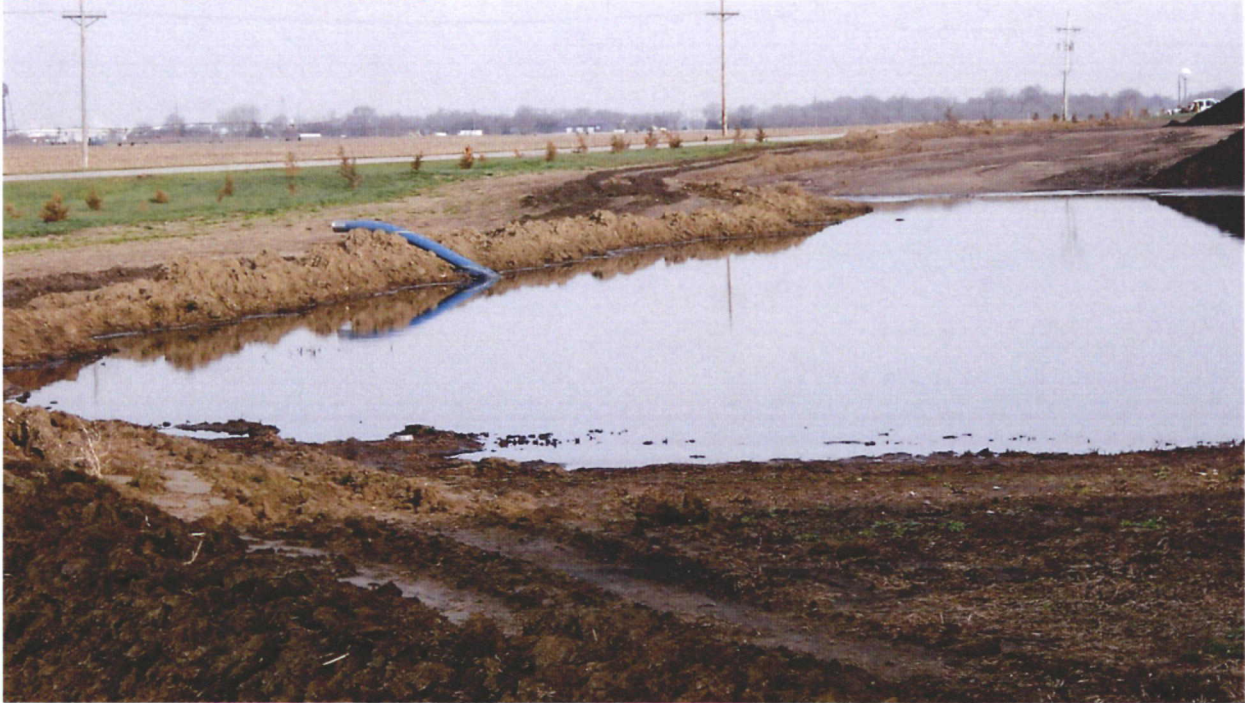
Photo: 7

Location: Area 5 on the site map

Description: This photo depicts the connection hose used to transfer runoff from the west wet cake pile to area 2 before being transferred to the emergency lagoon.

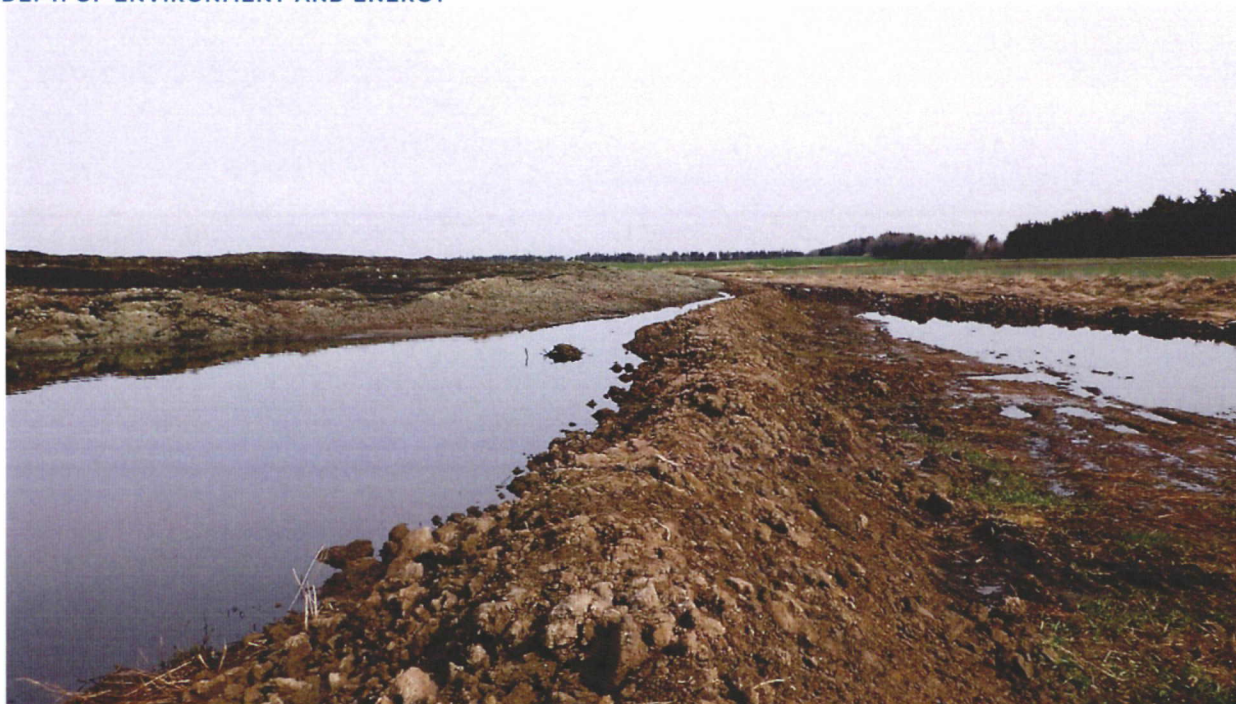
Photo: 8

Location: Area 6 on the site map

Description: This photo depicts the berm that surrounds the east wet cake pile.

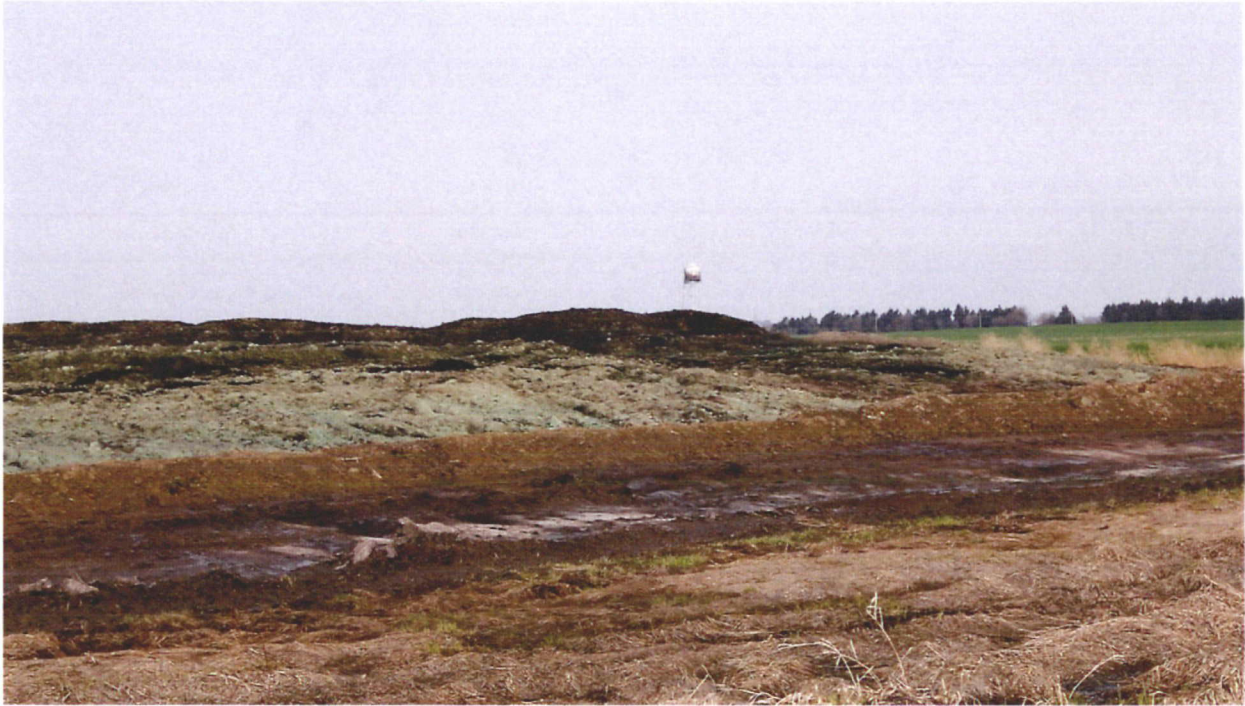
Photo: 9

Location: Area 6 on the site map

Description: This photo depicts the berm that surrounds the east wet cake pile.

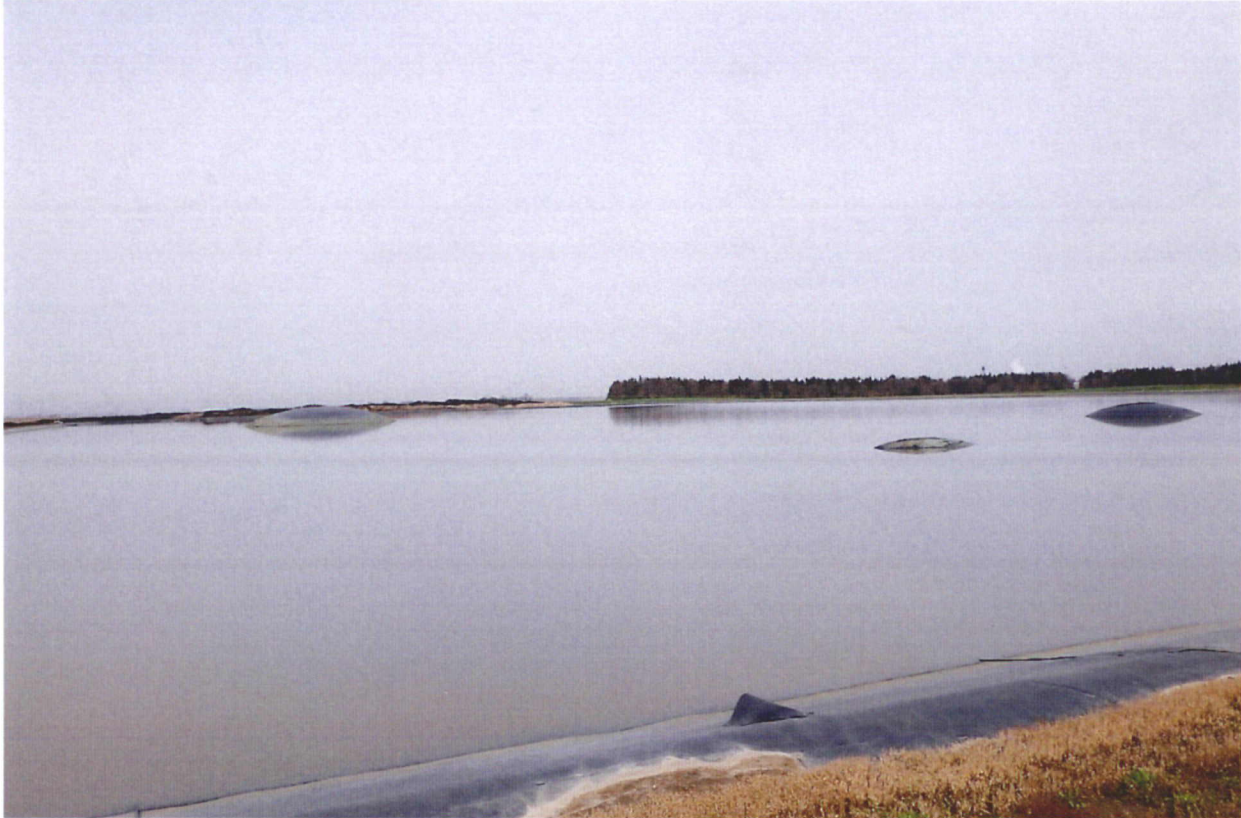
Photo: 10

Location: Northwest lagoon

Description: This photo depicts that one of the whales has dissipated.

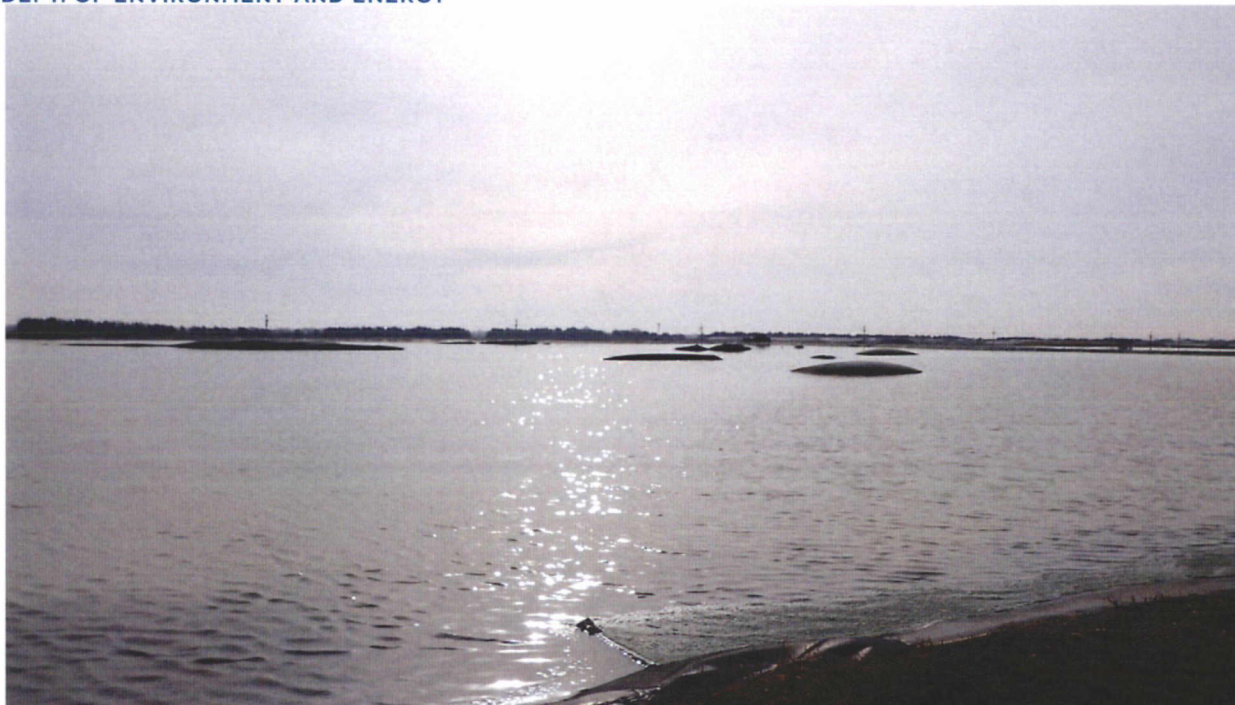
Photo: 11

Location: Northeast lagoon

Description: This photo depicts floating liner.

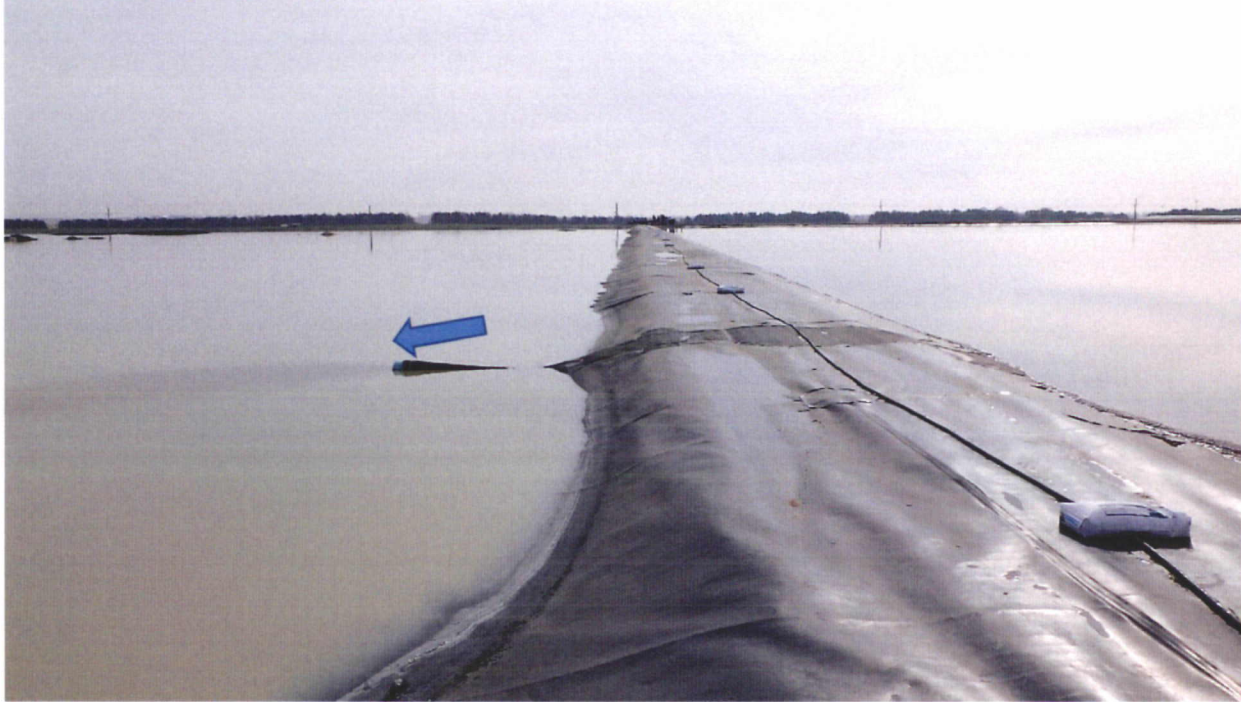
Photo: 12

Location: Dike separating the northeast and south lagoon

Description: The south lagoon continues to equalize into the northeast lagoon (arrow).

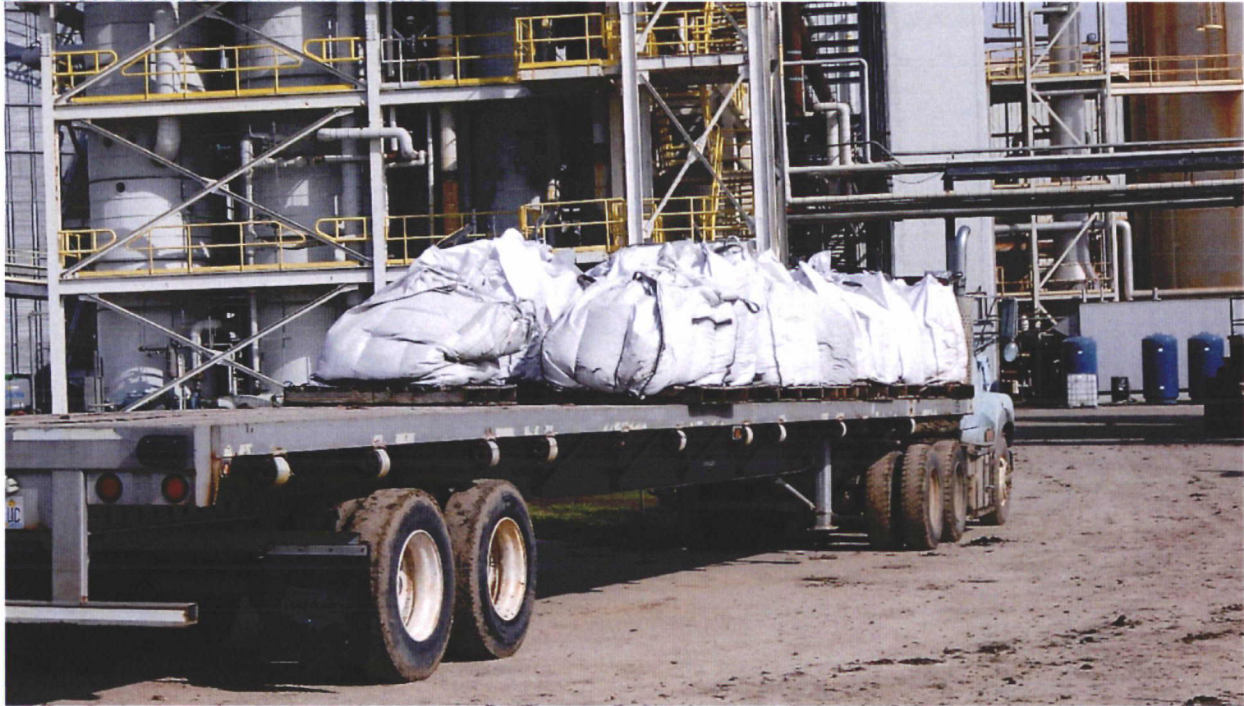
Photo: 13

Location: Supersacks to be hauled to the south hoop building.

Description: The facility continues to transfer supersacks to the hoop building.

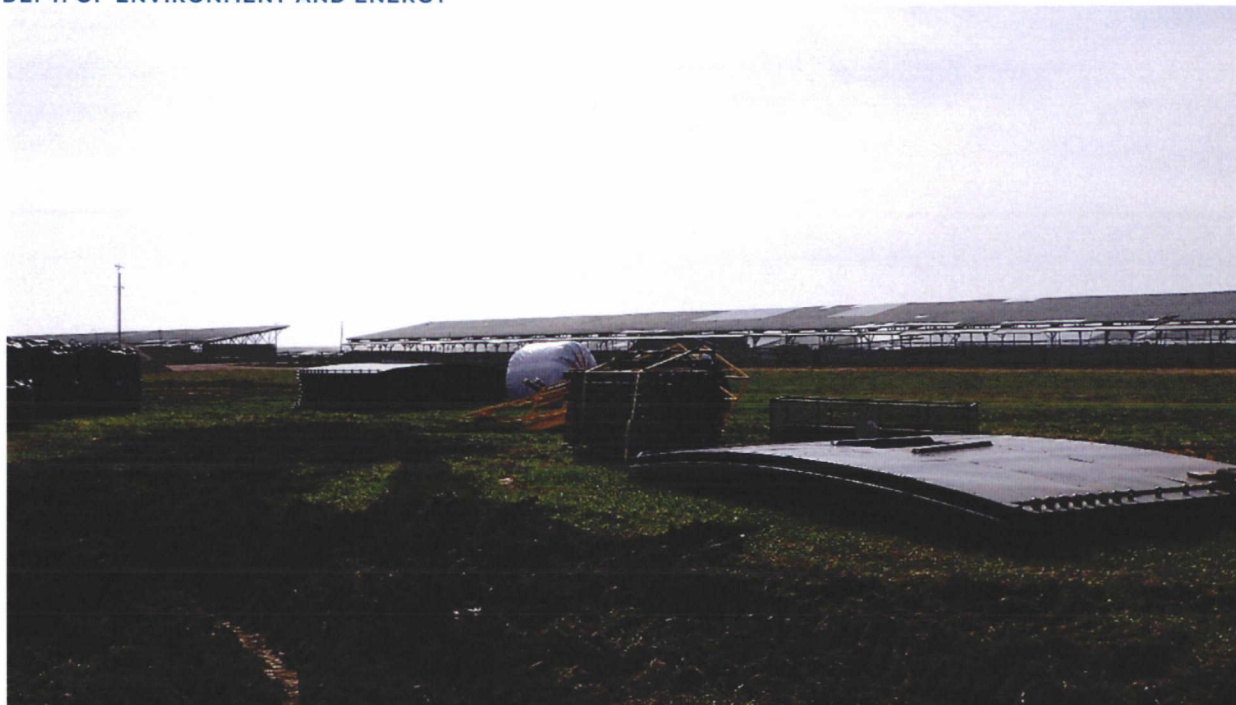
Photo: 14

Location: South of the emergency lagoon

Description: This photo depicts parts for the new hurricane tank.

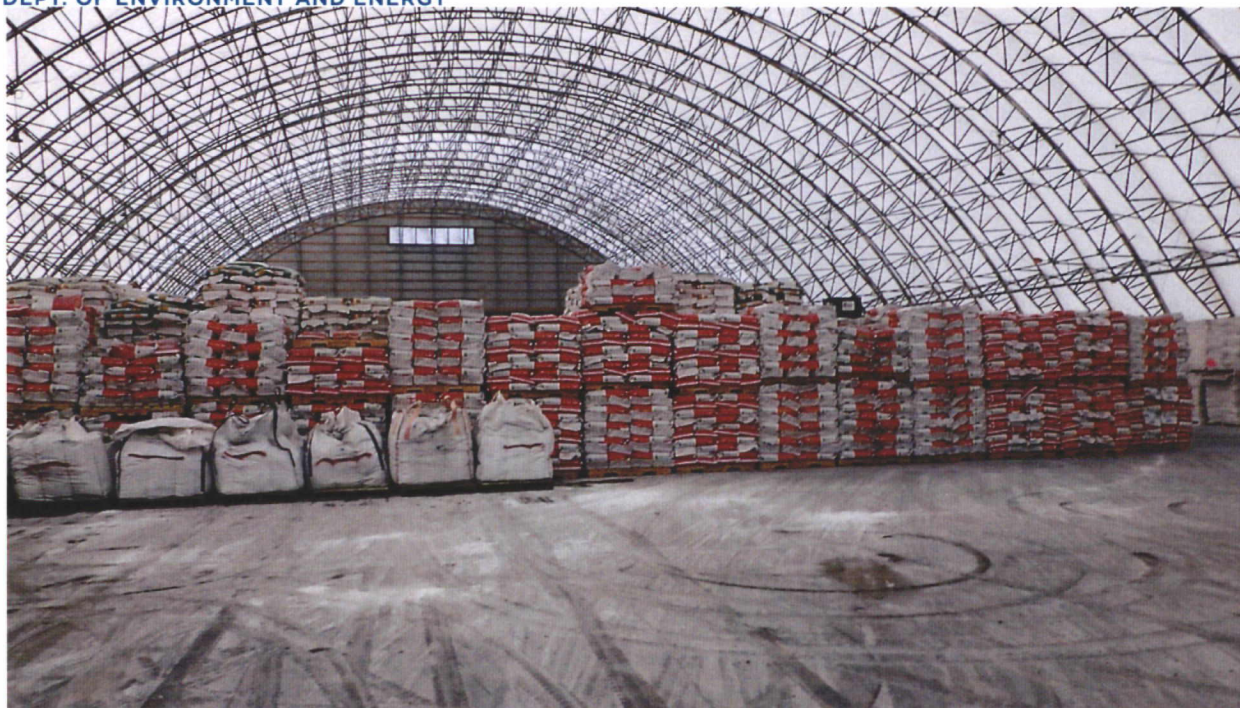
Photo: 15

Location: South hoop building

Description: This photo depicts treated seed corn and supersack storage.

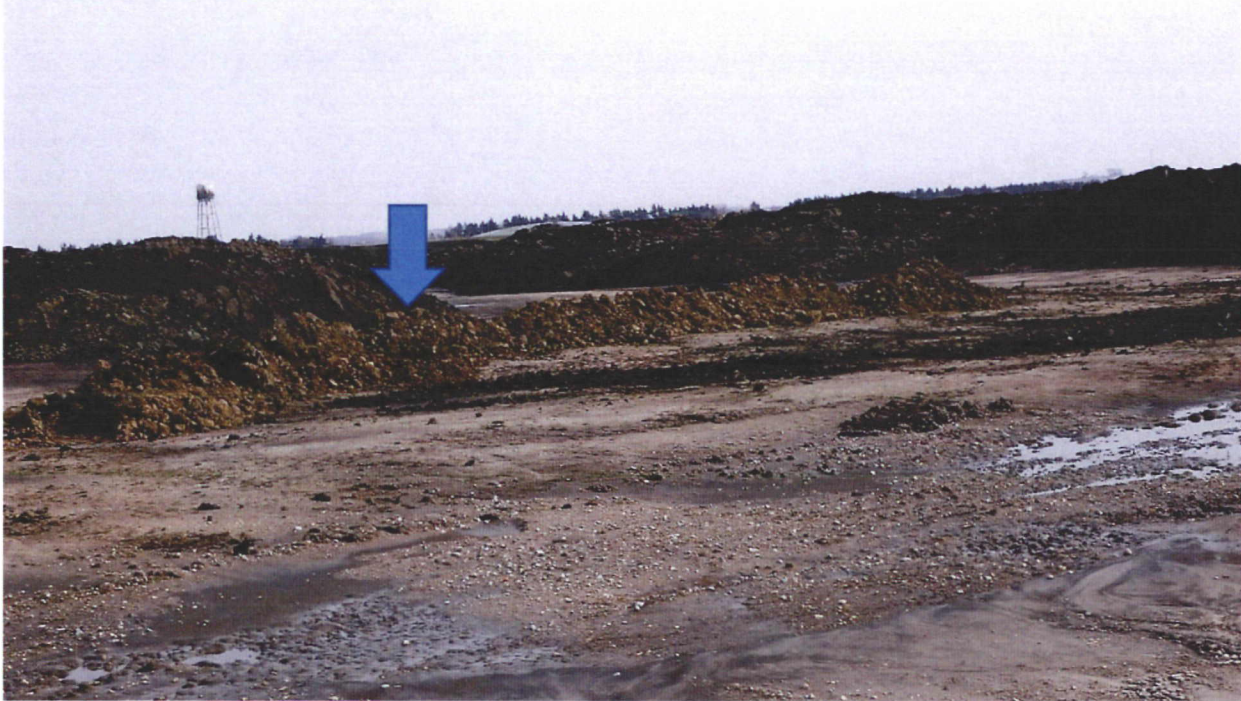
Photo: 16

Location: Area 1 on the map

Description: The facility is constructing additional berms depicted by the arrow.
