Site Visit Inspection Form

Facility Name AltEn, LLC					
Industrial Storm Water (ISW) NER910444				NDEQ ID / Program ID 84069	
INSPECTOR (s) Mark Pomajzl					
ADDRESS 1344 County Road 10		CITY Mead	COUNTY Saunders	STATE NE	ZIP CODE 68041
INSPECTION DATE 3-15-21	TIME/ARRIVAL 10:00am	TIME DEPARTURE 1:40pm	WEATHER Clear, cool		TEMP 50F

AltEn LLC - Storm Water Temporary BMP Check Map

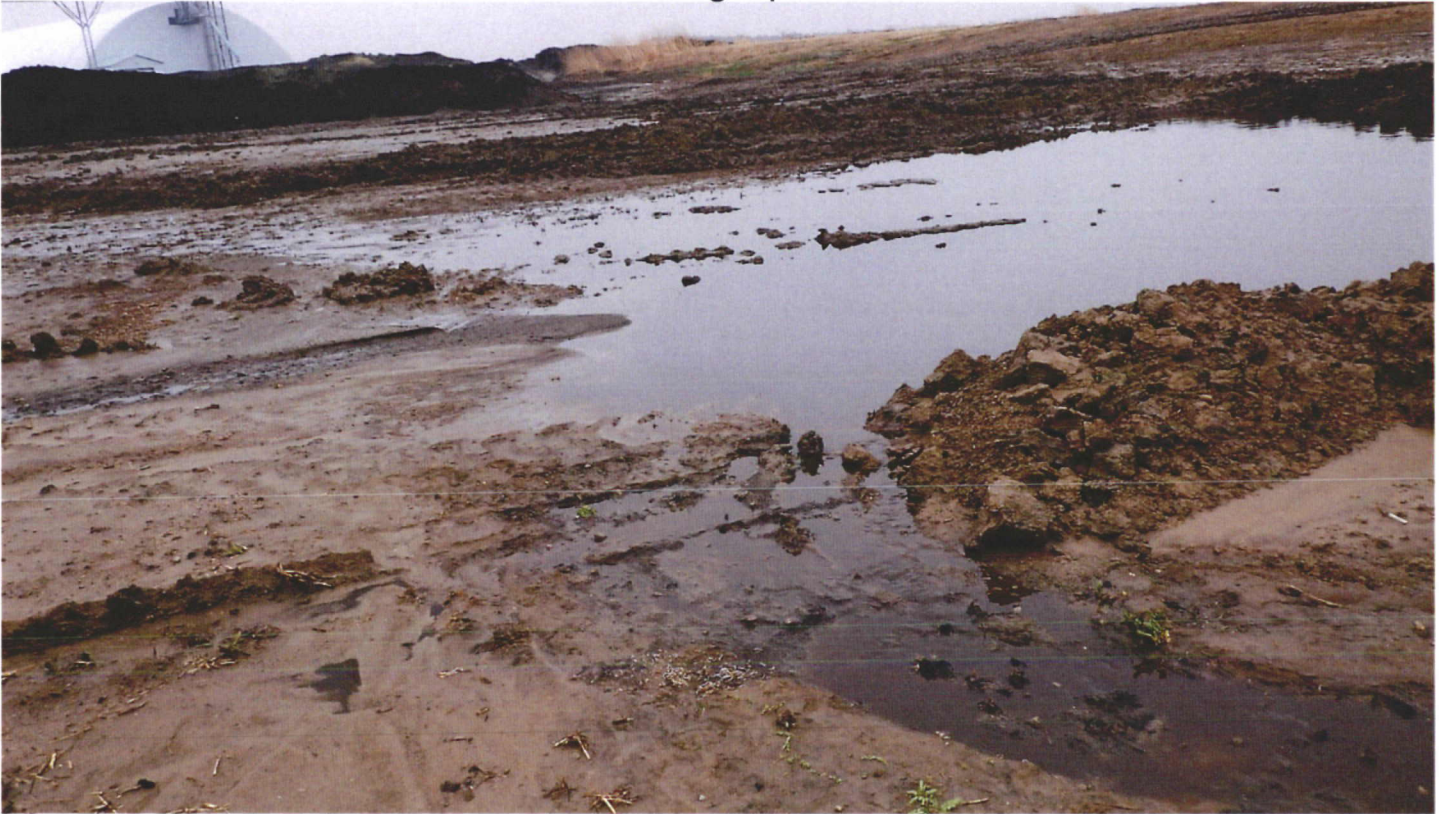
Photo: 1

OP1 is northeast of the main office building. The berm is overloaded with storm water and discharging around the south side, photo 1.

Description: This photo depicts the area northeast of the administration building. Water is overflowing the south side of the berm.

(3) SOUTH North of Administrative Building Dike BREACH NEEDS DIRT (ASAP) -

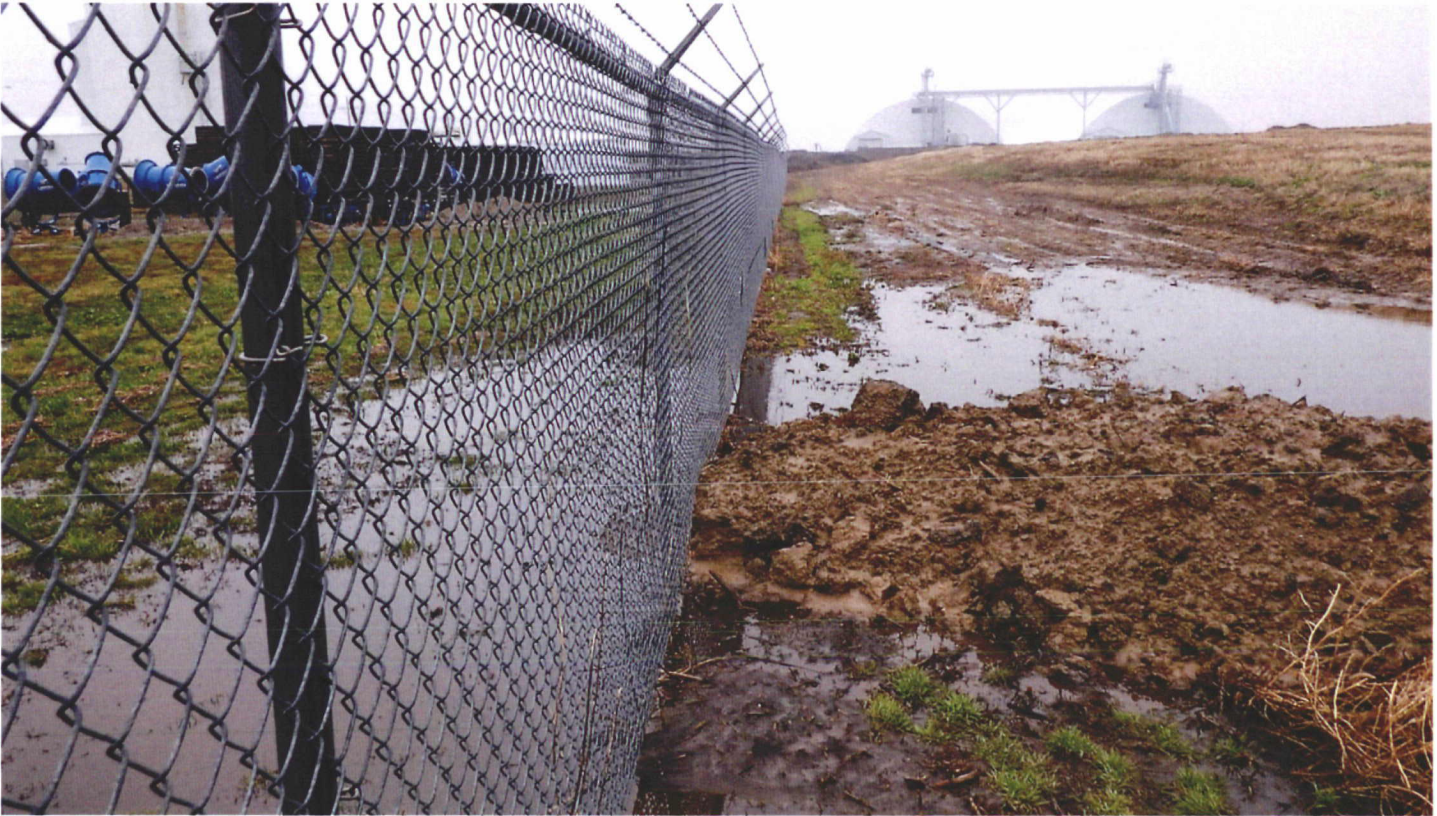
Photo: 2

OP2 is the berm southwest of the south lagoon. The facility extended the berm to the southwest to the chain link fence. Storm water had overloaded the berm discharging along the south side, photo 2.

Description: This photo depicts the area northeast of the administration building. The berm is overflowing the south side.

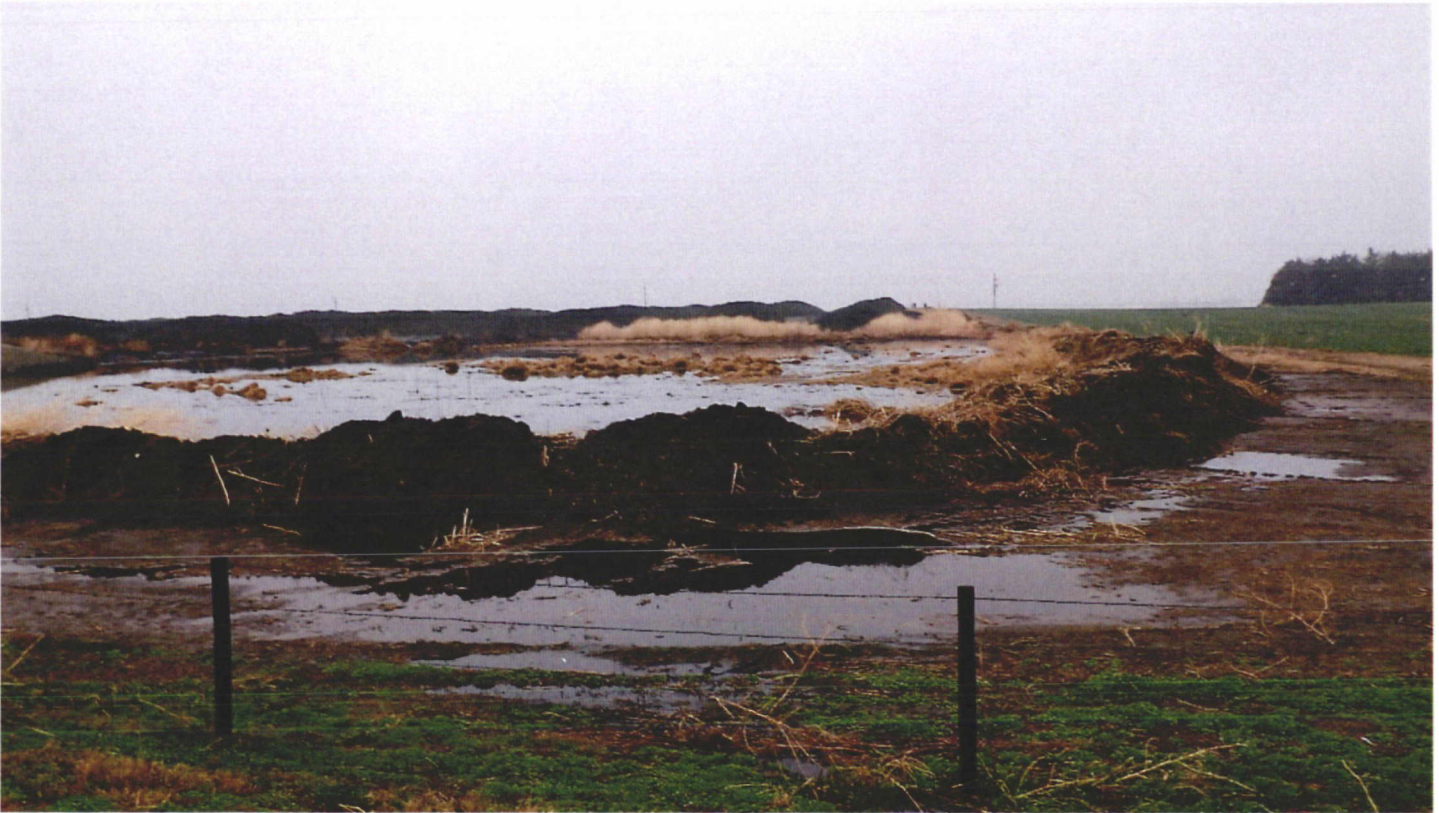
Photo: 3

The facility added dirt along the berm west of the northwest corner of the northwest lagoon. There is some water accumulation behind the berm. This water appears to be accumulated storm water in front of the berm. The berm does not appear to be leaking, photo 3. There is also water accumulation along the north side of the berm. There appears to be drop in elevation creating a ponding area, photo 4.

Description: This photo depicts accumulated water along the berm located on the northeast corner of the northwest lagoon. There is some accumulation of water which appears to be from outside the berm. There is a large quantity of water inside the berm area.

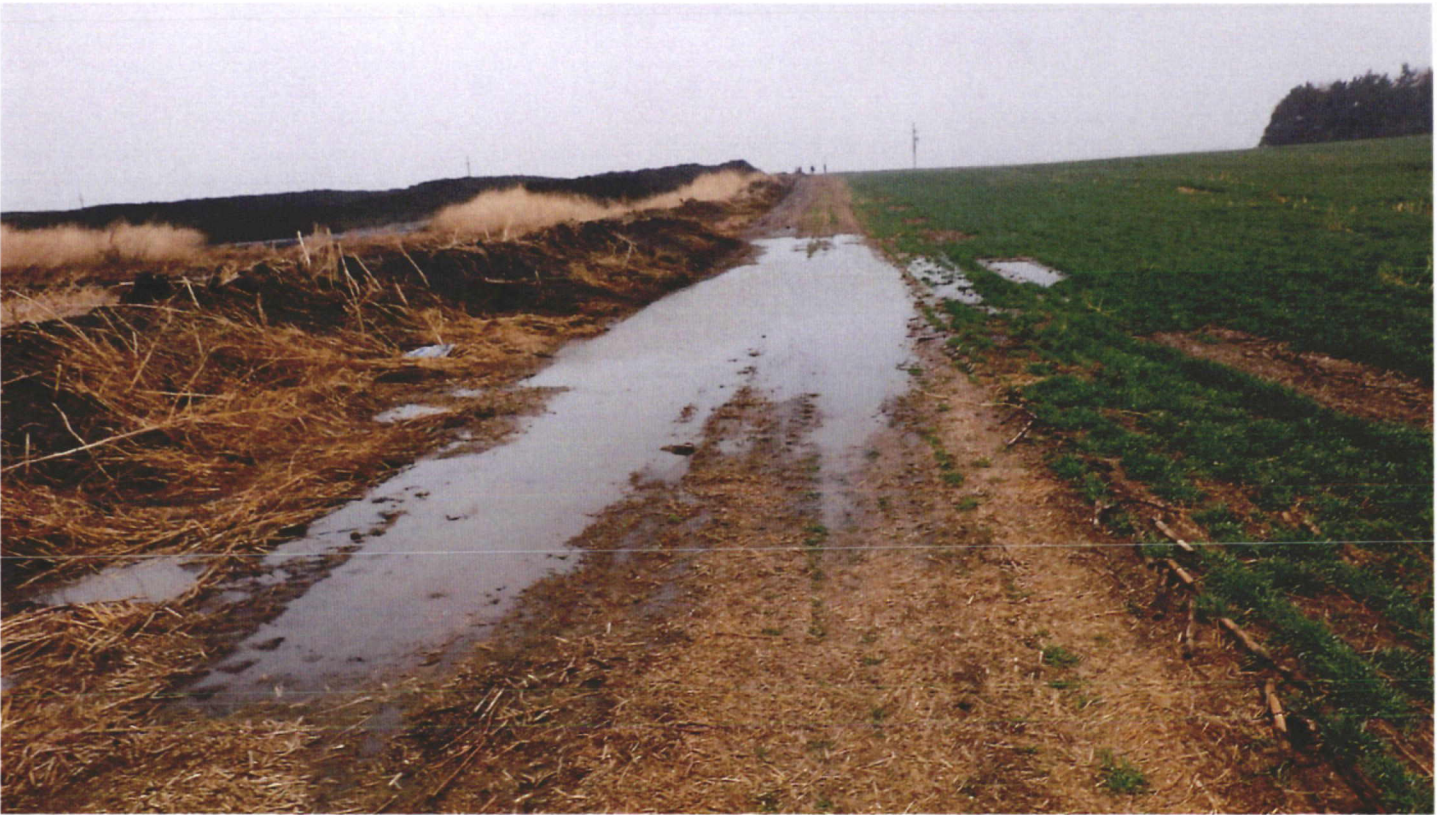
Photo: 4

Description: This photo depicts accumulated water along the north berm. There appears to be an drop in elevation creating a ponding area. The berm does not appear to be leaking.

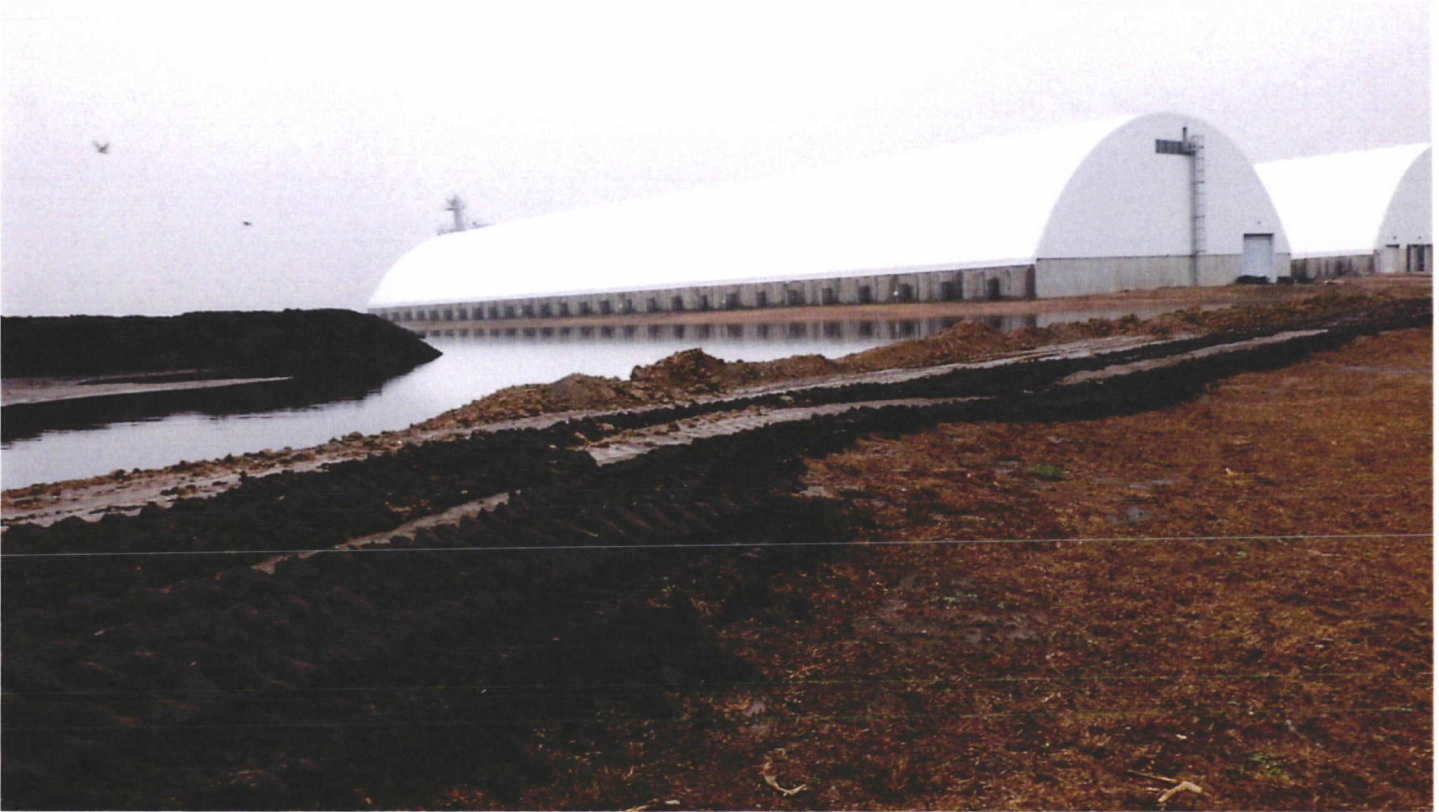
Photo: 5

I then inspected the west side near the hoop building, photo 5. The facility reported that the berm had overflowed and pooled water along county road 10. The facility had pumped some water back into the berm. The facility also added material to raise the berm height. There is no indication that the berm is leaking.

Description: This photo depicts accumulated water along the west berm. The facility had added material to raise the berm on Friday March 12, 2021. Water escaped the berm during the weekend rain event. The facility has added additional material and pumped water back into the berm prior to today's visit.

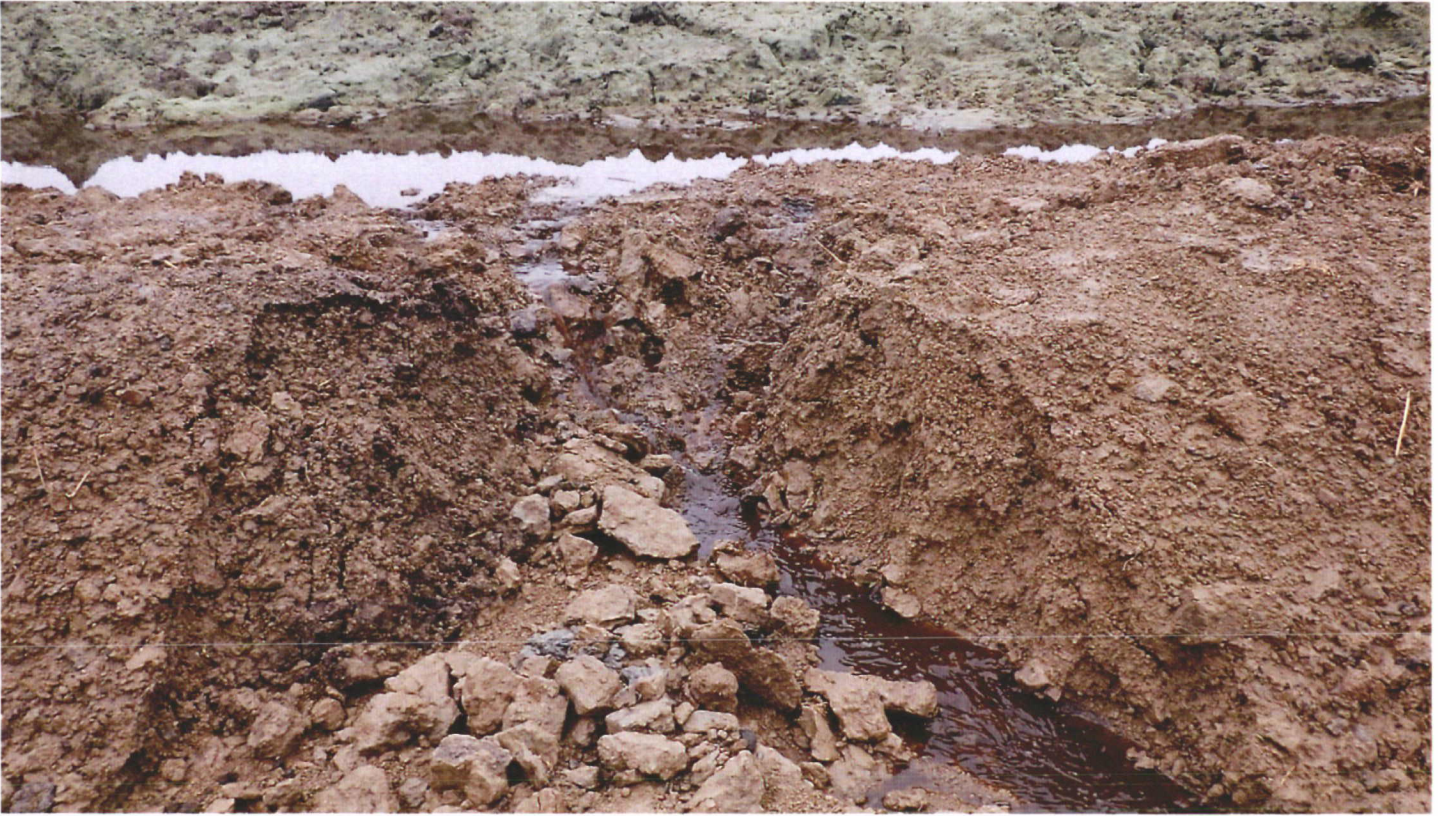
Photo: 6

I then drove to inspect the east wet cake pile. The berm failed on the east side near the south line fence, photo 6 and 7. It appears that the leak had begun shortly before arriving. There is lots of accumulated water on the southwest corner of the berm, photo 8.

Description: This photo depicts berm failure along the east wet cake pile berm.

(1) EAST PILE BREACH Along South On Dike (EAST side near Culvert). NEED TO fix ASAP.

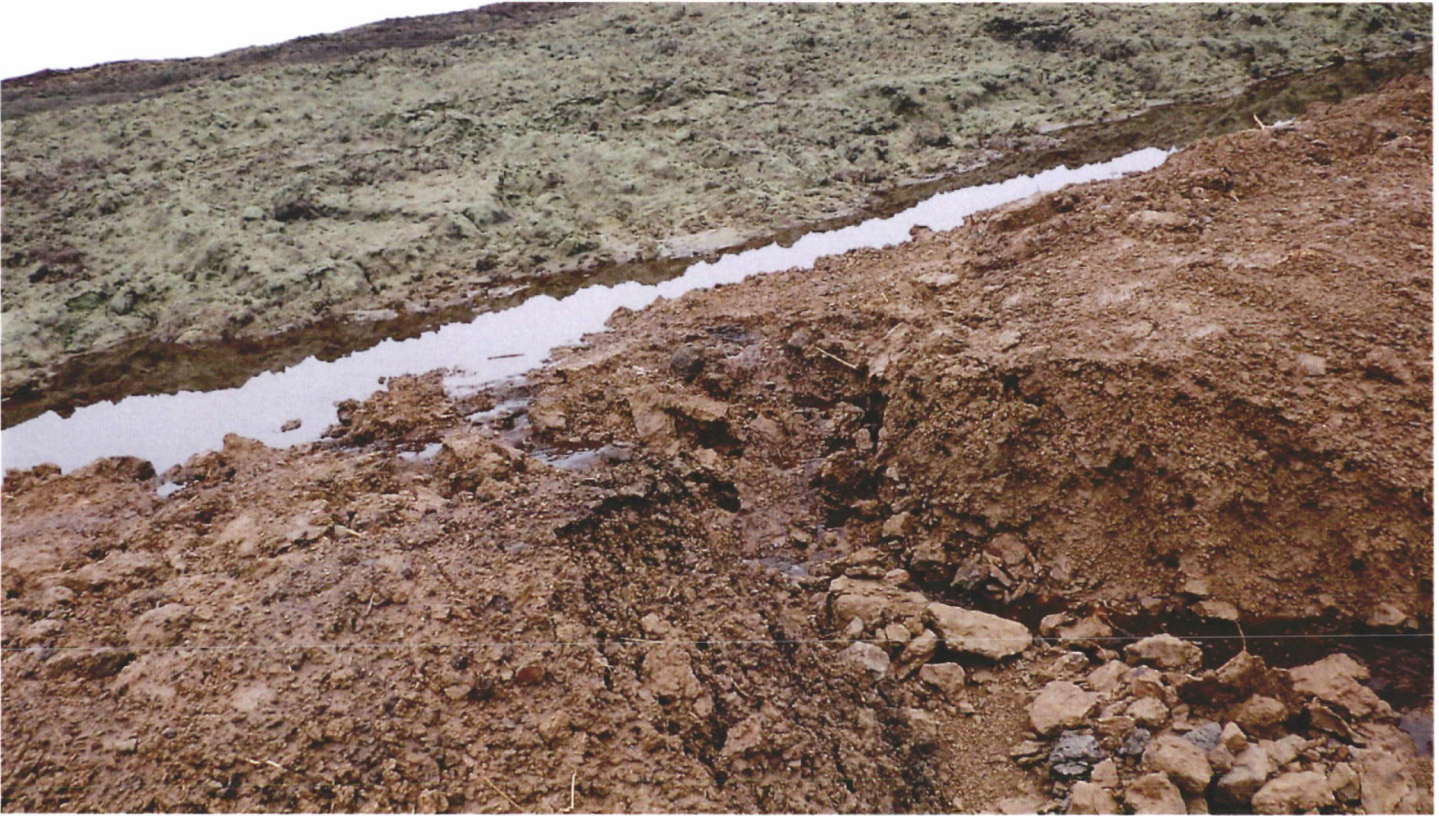
Photo: 7

Description: This photo depicts berm failure along the east wet cake pile berm. This photo is from the same location as the above photo.

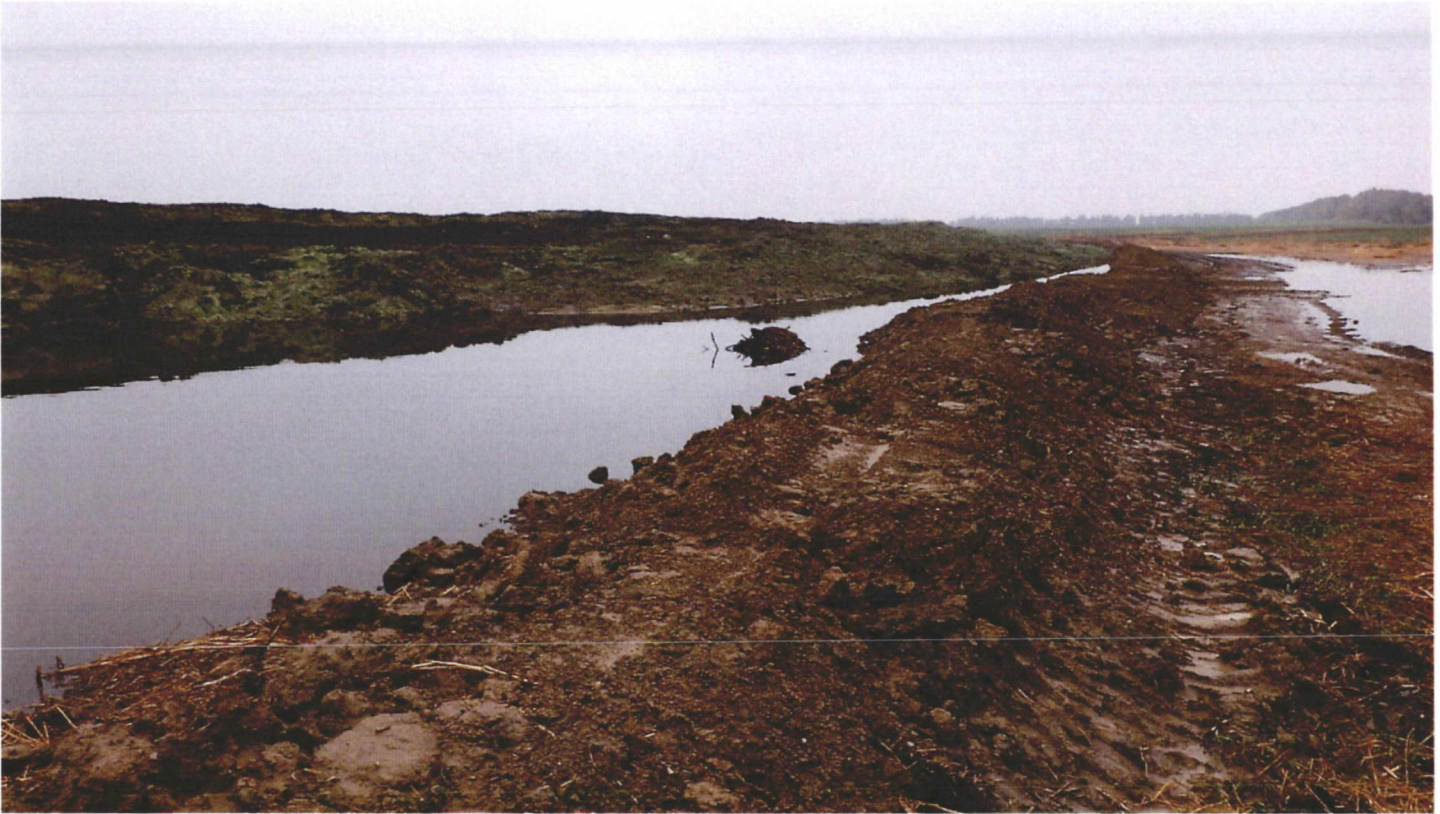
Photo: 8

Description: This photo depicts water accumulation behind the east cake pile berm.

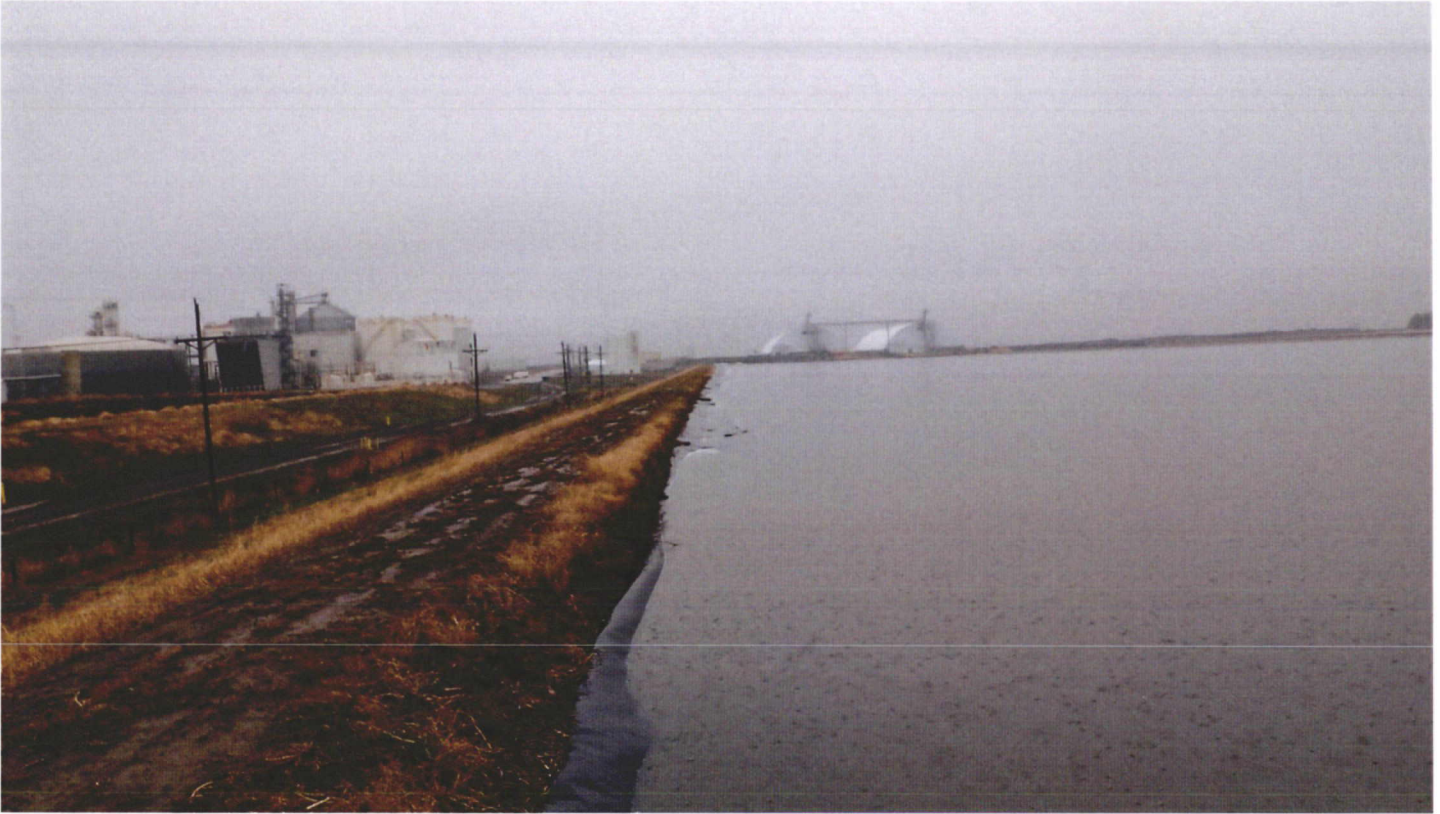
Photo: 9

Lagoon observation: The south lagoon is observed to be very high today. The southeast corner is operating in the area designated for freeboard, photos 9 and 10. The northwest and northeast lagoons are not in danger of overtopping at this time, photos 11, 12 and 13.

Description: This photo depicts high water along the south dike of the south lagoon.

(2) SOUTH EAST side of South Lagoon (NEEDS Additional DIRT)

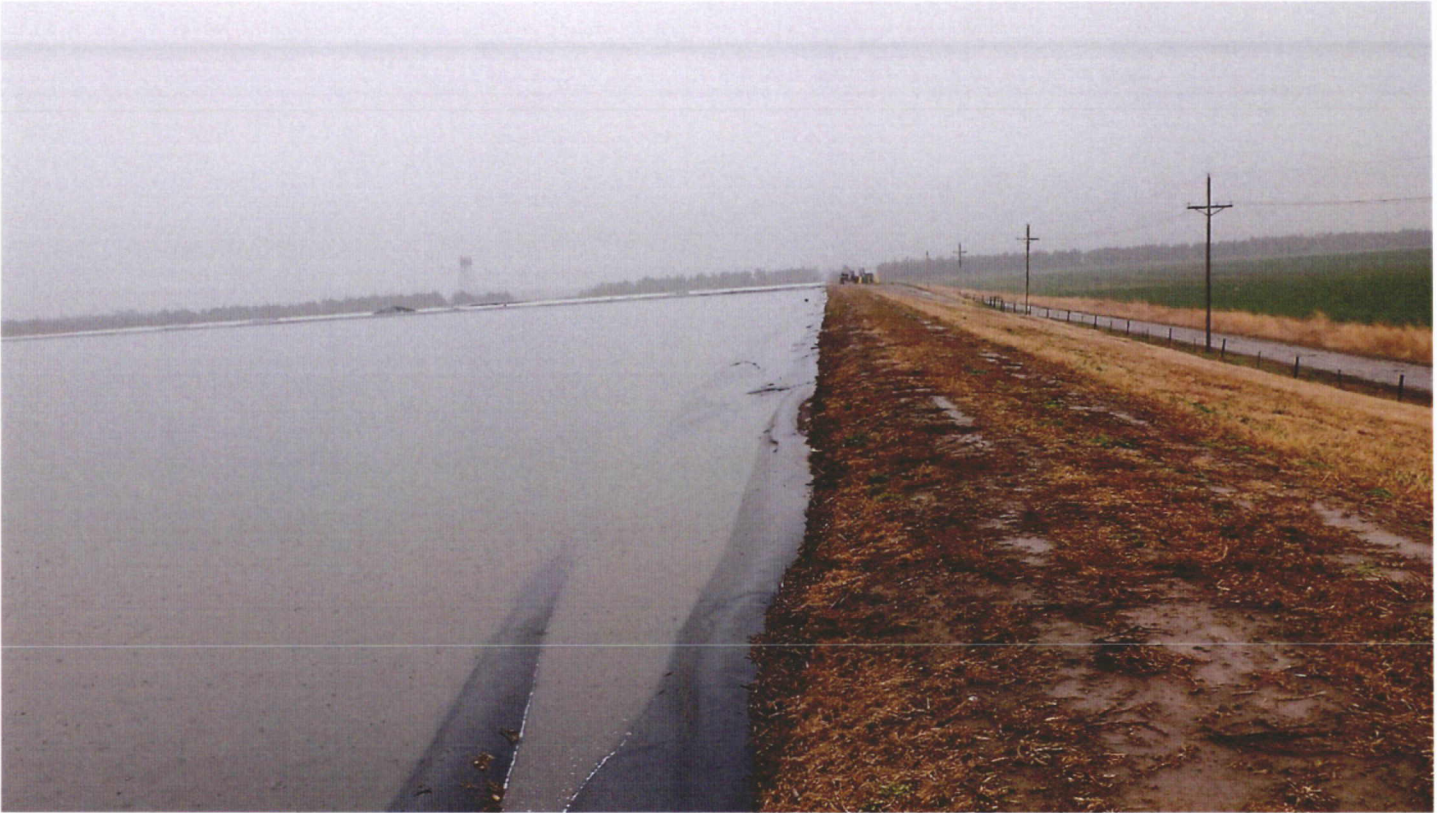
Photo: 10

Description: This photo depicts high water along the east dike of the south lagoon.

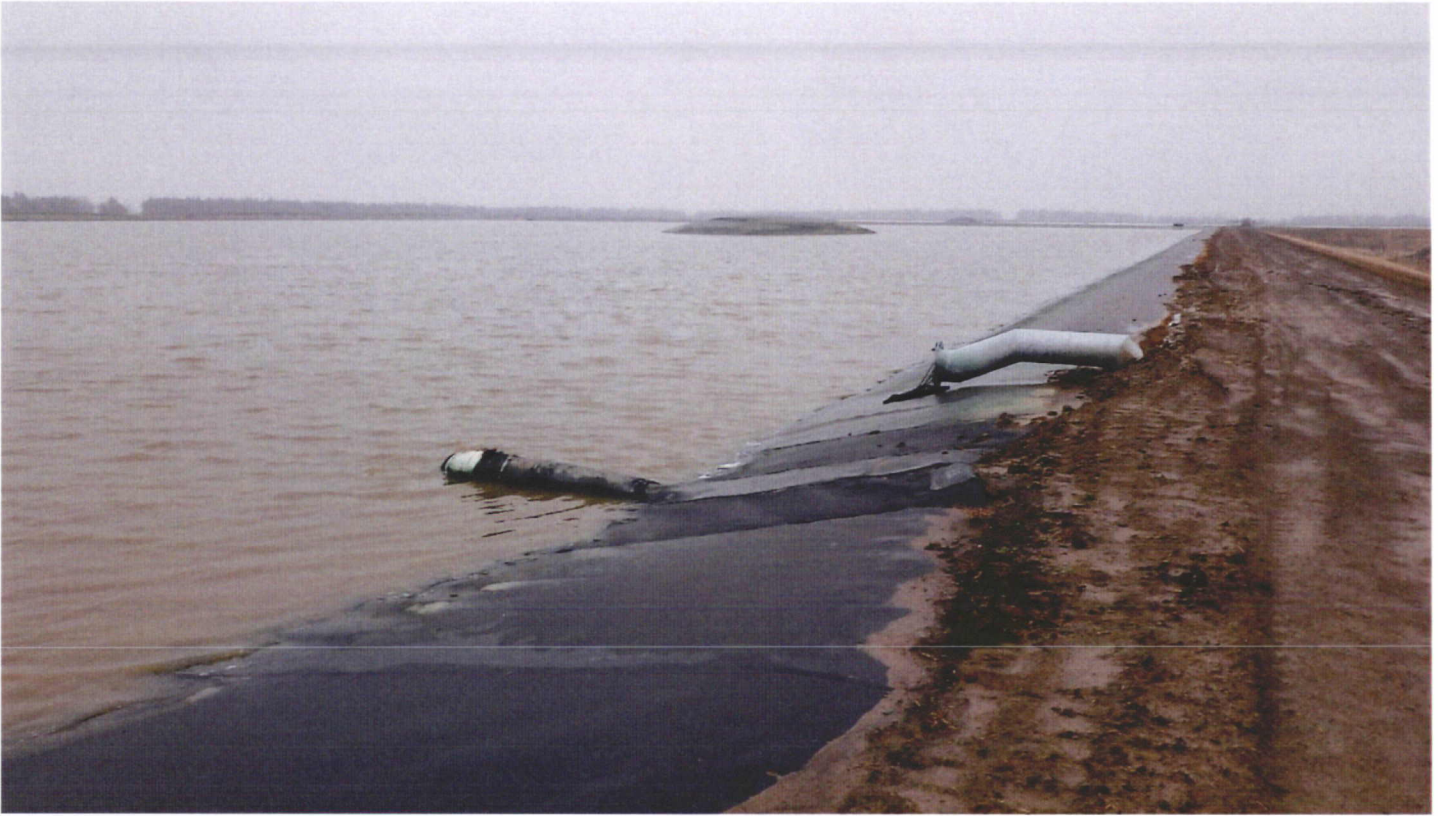
Photo: 11

Description: This photo depicts the influent pipe and whale in the background.

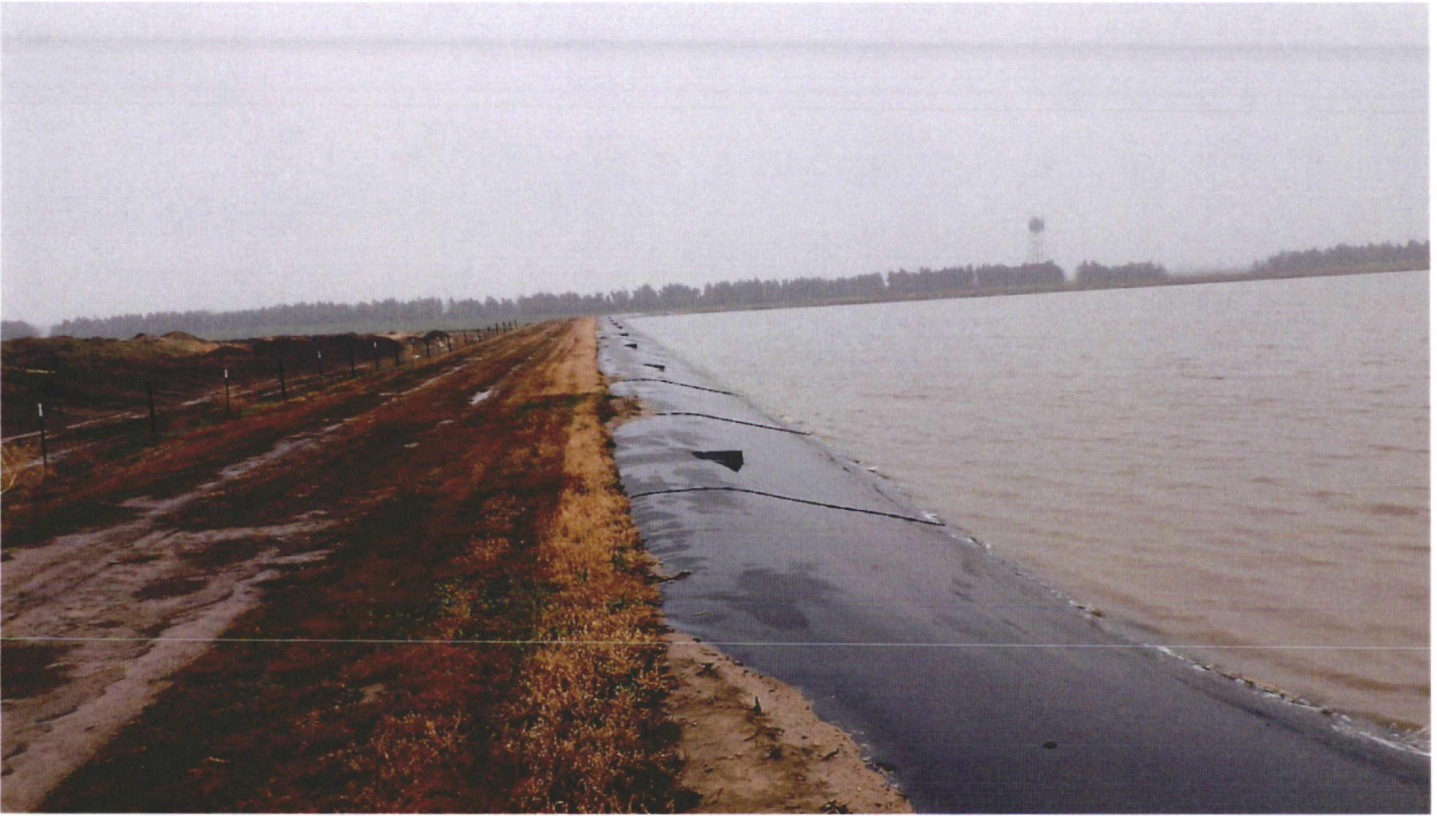
Photo: 12
Site Visit Report
Date Taken: 3-15-2021
Photographer: Mark Pomajzl
Facility Name/ Project Name: AltEn LLC
Facility IIS number / Project identifier: IIS: 84069 / NE0137634
Location: Northwest lagoon
Direction Facing: North
Description: This photo depicts the west dike of the northwest lagoon.

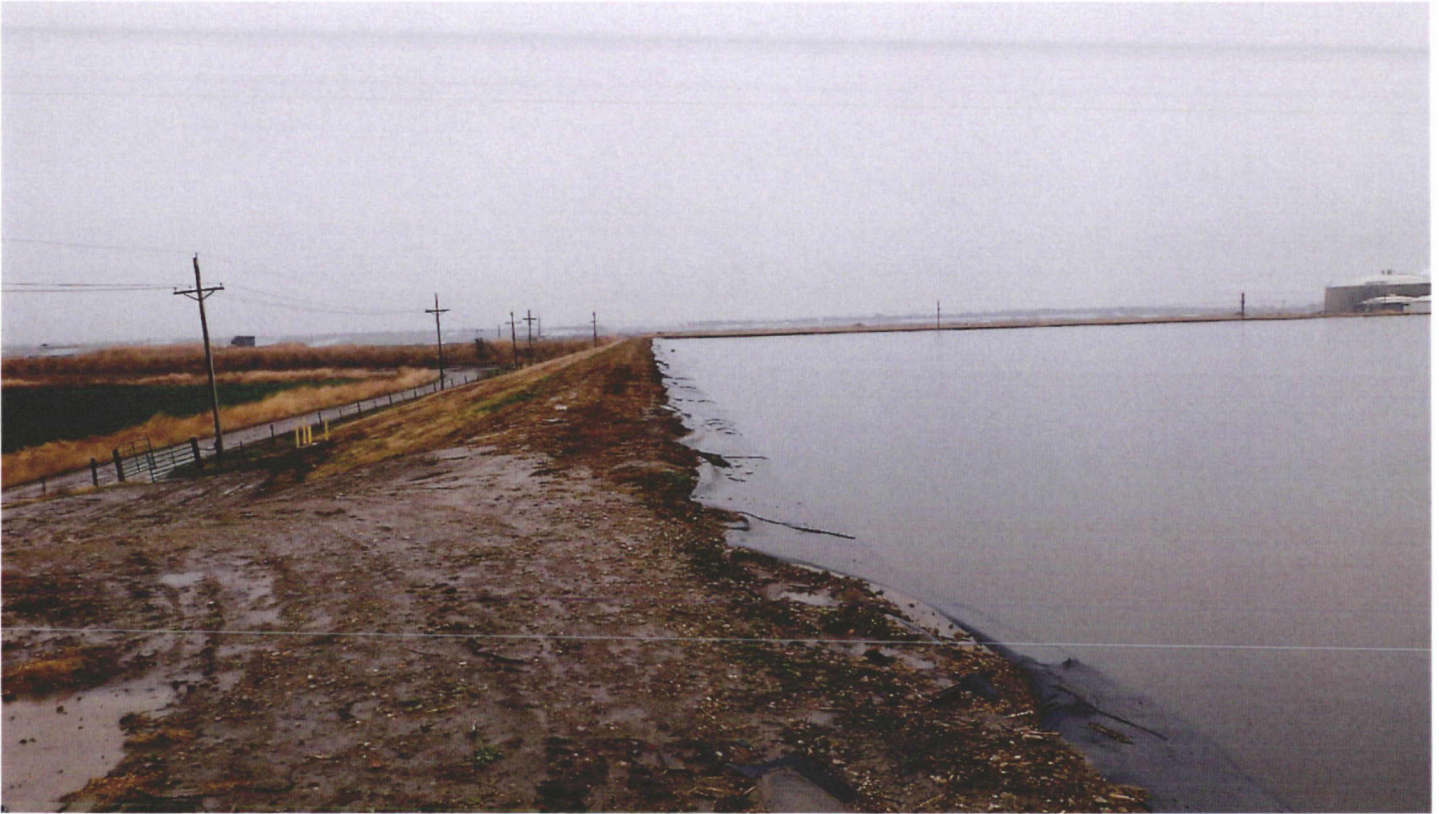
Photo: 13
Site Visit Report
Date Taken: 3-15-2021
Photographer: Mark Pomajzl
Facility Name/ Project Name: AltEn LLC
Facility IIS number / Project identifier: IIS: 84069 / NE0137634
Location: South lagoon
Direction Facing: South
Description: This photo depicts the east dike of the south lagoon.

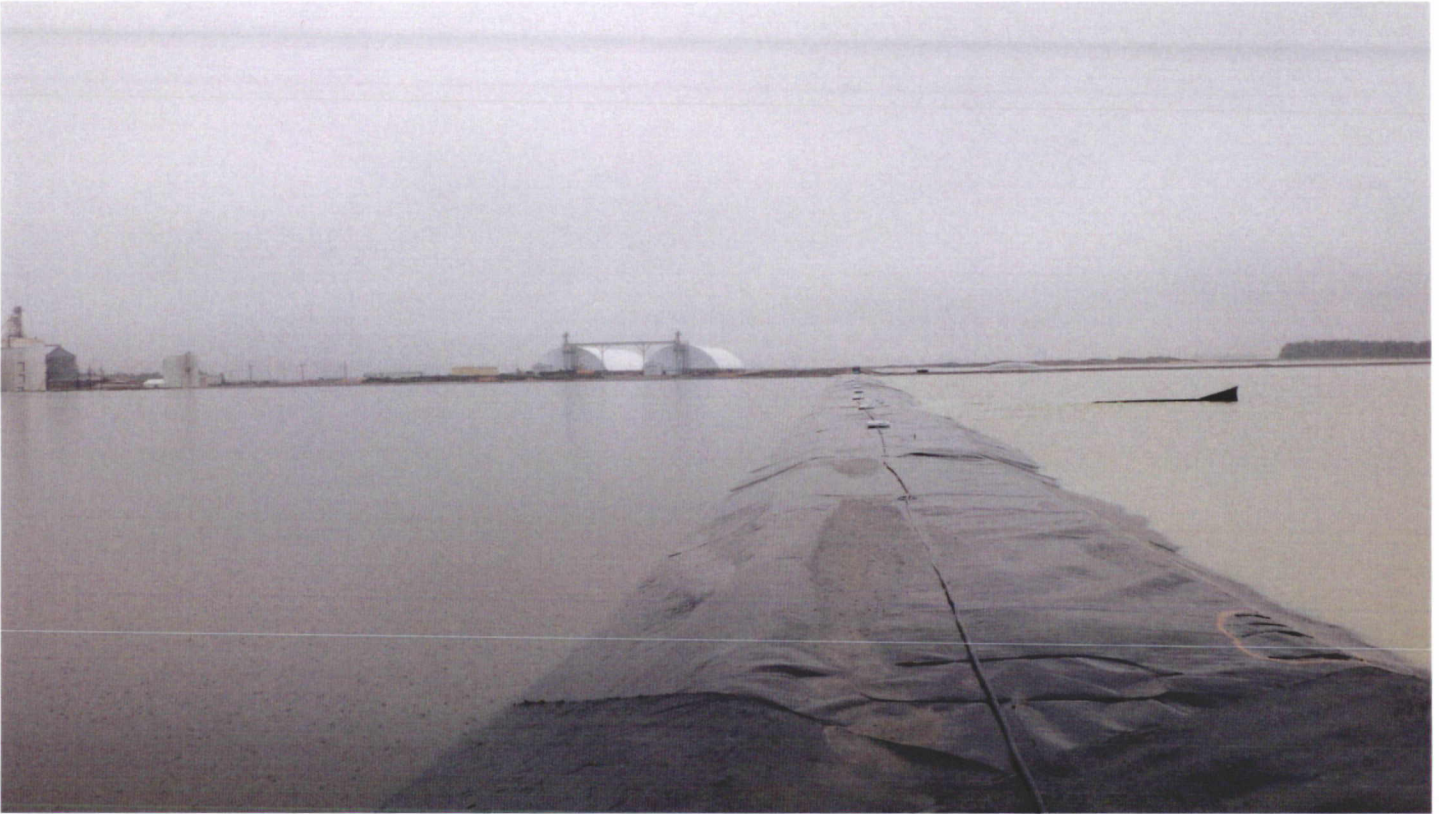
Photo: 14

Description: This photo depicts the area between the south and northeast lagoon.
