## CLOSURE CHECKLIST FOR SOLID WASTE PROCESSING FACILITIES

FACILITY AltEn, LLC		FACILITY ID # 84069	PERMIT # NE020447	
ADDRESS 1344 County Road 10		CITY Mead	COUNTY Saunders	STATE NE
			ZIP CODE 68041	
OWNER/ADDRESS Mead Cattle Company, LLC 1344 County Rd 10			TELEPHONE NUMBER	
OPERATOR/CONTACT Scott Tingelhoff, General Manager			TELEPHONE NUMBER (402) 624-2000, ext. 108	
			EMAIL stingelhoff@mrgkc.com	
DATE 12/11/20	TIME/ARRIVAL 0935	TIME/DEPARTURE 1200	WEATHER Cloudy, north wind 18 mph	
TEMP 36°F				
INSPECTOR Jason Holsten accompanied by Blayne Glissman				
PREVIOUS INSPECTION DATE/VIOLATIONS 10/23/18 - No violations.

**ATTACHMENT I**  
Site Drawing w/ Hand Written Notes

### **Photographs**

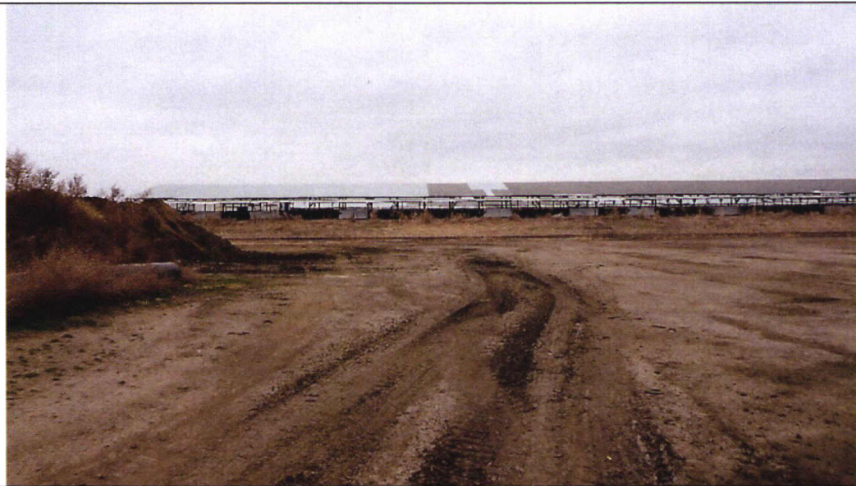
Photograph 1  
Date: December 11, 2020  
Photographer: Jason Holsten  
Camera: Ricoh WG-50  
NDEE ID: 84069  
Program ID: NE0204447  
Subject: AltEn, LLC Compost Facility

Looking south, photograph showing the eastern edge of the compost area.

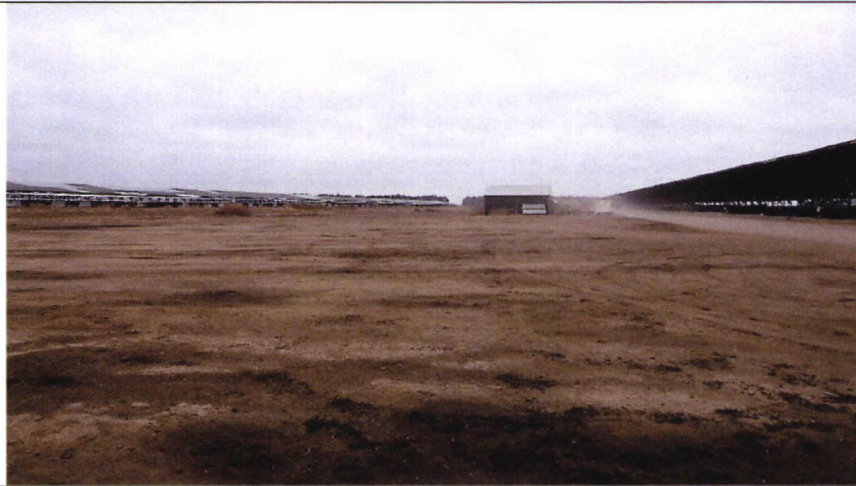
Photograph 2  
Date: December 11, 2020  
Photographer: Jason Holsten  
Camera: Ricoh WG-50  
NDEE ID: 84069  
Program ID: NE0204447  
Subject: AltEn, LLC Compost Facility

From the eastern edge of the compost area, photograph looking west across the compost area along the northern edge.

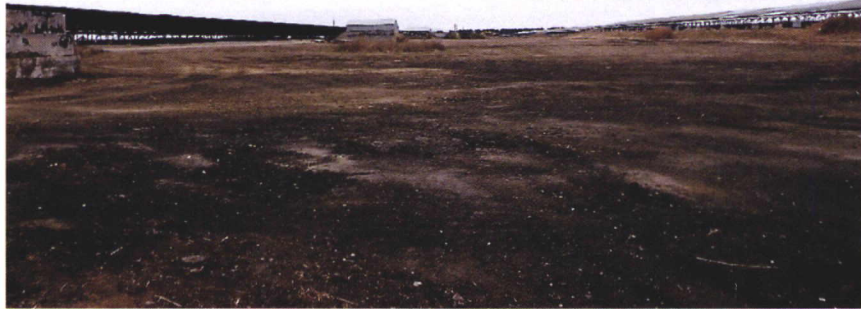
Photograph 3  
Date: December 11, 2020  
Photographer: Jason Holsten  
Camera: Ricoh WG-50  
NDEE ID: 84069  
Program ID: NE0204447  
Subject: AltEn, LLC Compost Facility

From the western edge of the compost area, photograph looking east across the composting area.

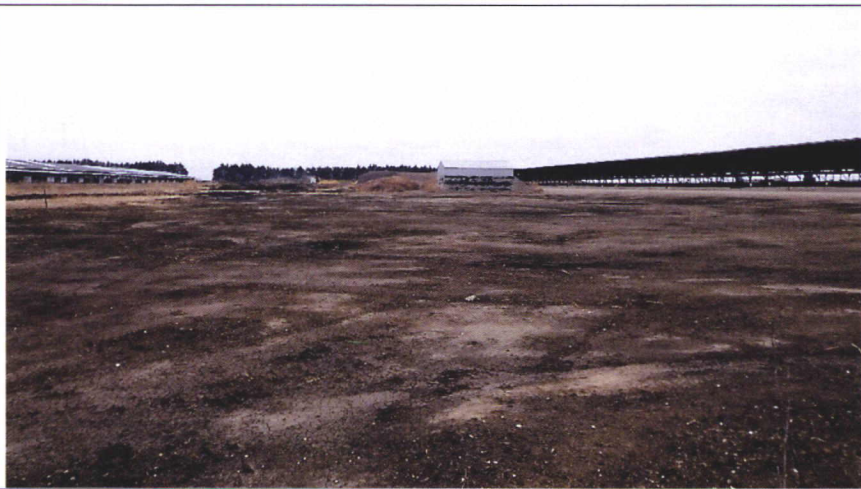
Photograph 4  
Date: December 11, 2020  
Photographer: Jason Holsten  
Camera: Ricoh WG-50  
NDEE ID: 84069  
Program ID: NE0204447  
Subject: AltEn, LLC Compost Facility

Looking west, photograph showing the area that is considered compost pad 3.

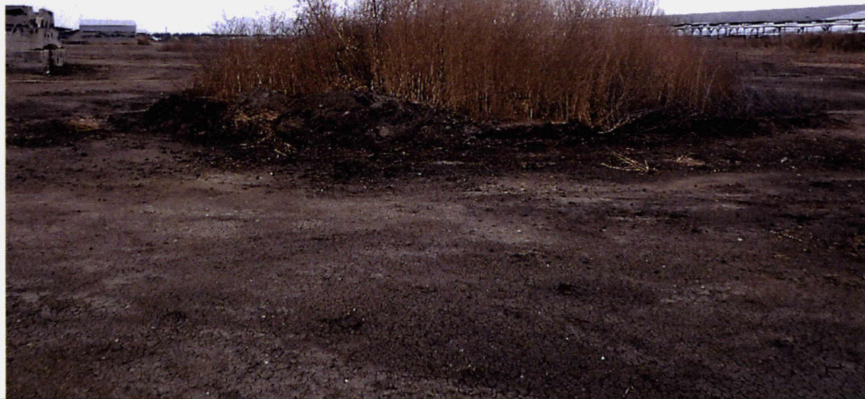
Photograph 5  
Date: December 11, 2020  
Photographer: Jason Holsten  
Camera: Ricoh WG-50  
NDEE ID: 84069  
Program ID: NE0204447  
Subject: AltEn, LLC Compost Facility

Looking east, photograph showing material observed around a pre-existing concrete structure.

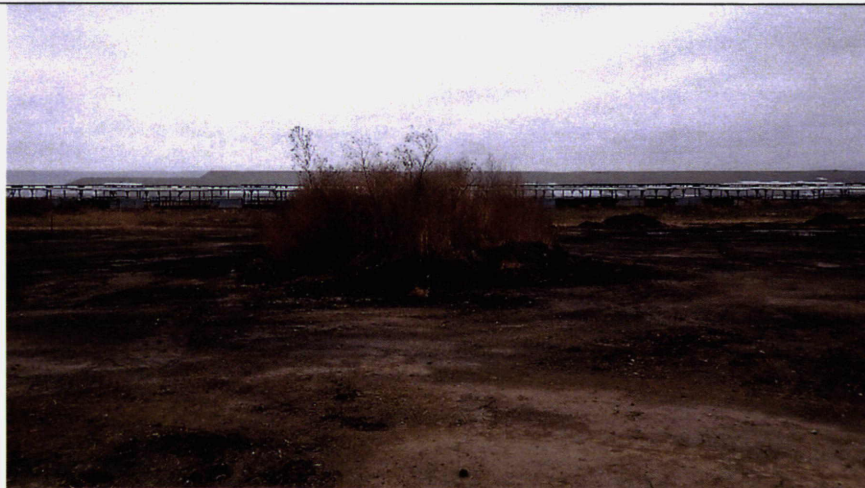
Photograph 6  
Date: December 11, 2020  
Photographer: Jason Holsten  
Camera: Ricoh WG-50  
NDEE ID: 84069  
Program ID: NE0204447  
Subject: AltEn, LLC Compost Facility

Looking south, photograph showing the material mentioned in photograph 5.

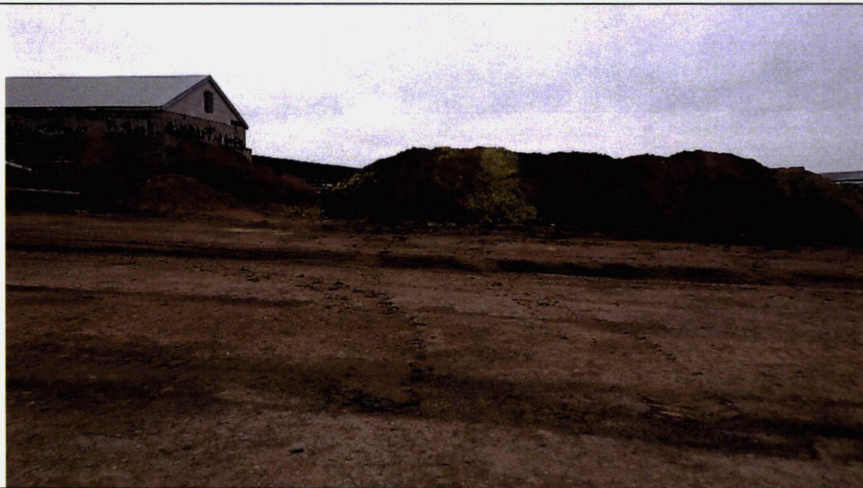
Photograph 7  
Date: December 11, 2020  
Photographer: Jason Holsten  
Camera: Ricoh WG-50  
NDEE ID: 84069  
Program ID: NE0204447  
Subject: AltEn, LLC Compost Facility

Looking east, photograph showing distiller's grain piled off and to the east of the compost area.

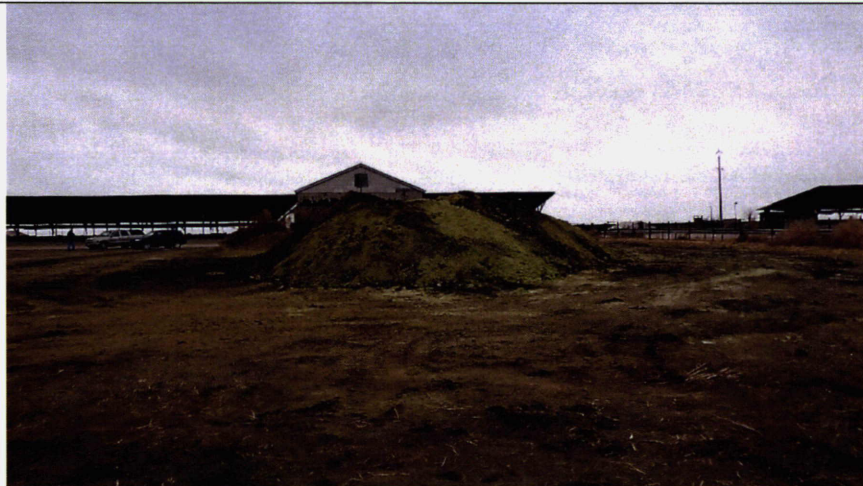
Photograph 8  
Date: December 11, 2020  
Photographer: Jason Holsten  
Camera: Ricoh WG-50  
NDEE ID: 84069  
Program ID: NE0204447  
Subject: AltEn, LLC Compost Facility

Looking north, photograph showing the pile of distiller's grain mentioned in photograph 7.

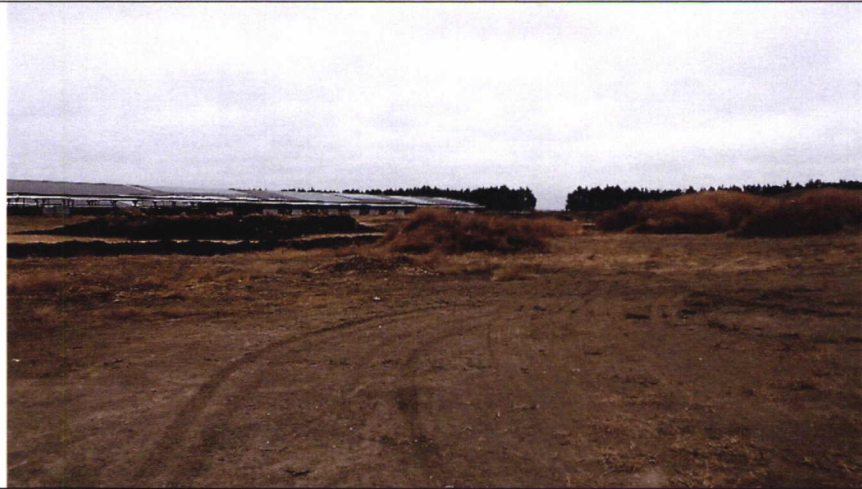
Photograph 9  
Date: December 11, 2020  
Photographer: Jason Holsten  
Camera: Ricoh WG-50  
NDEE ID: 84069  
Program ID: NE0204447  
Subject: AltEn, LLC Compost Facility

Looking west southwest, photograph showing material piled off and to the west of the compost area.

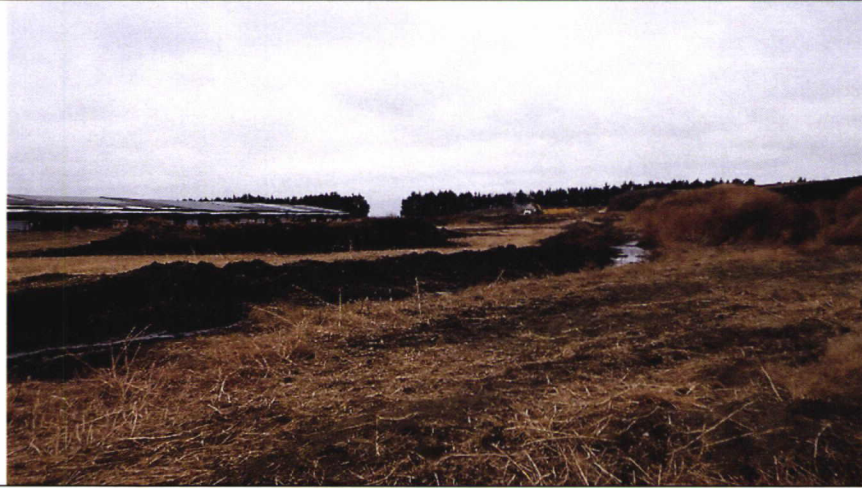
Photograph 10  
Date: December 11, 2020  
Photographer: Jason Holsten  
Camera: Ricoh WG-50  
NDEE ID: 84069  
Program ID: NE0204447  
Subject: AltEn, LLC Compost Facility

Photograph showing a closer view of the material mentioned in photograph 9. Photograph also shows the work being done to promote drainage in the area. This drainage area flows into the area mentioned in photographs 11-14.

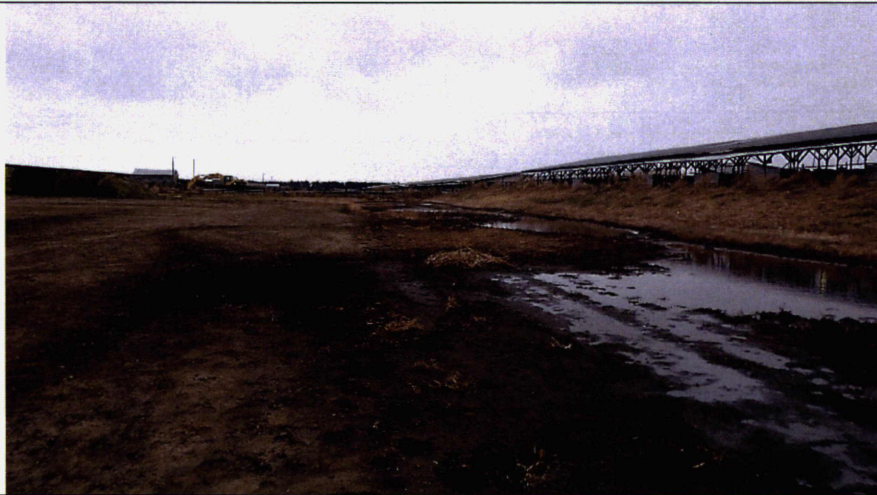
Photograph 11  
Date: December 11, 2020  
Photographer: Jason Holsten  
Camera: Ricoh WG-50  
NDEE ID: 84069  
Program ID: NE0204447  
Subject: AltEn, LLC Compost Facility

Looking east, photograph showing standing liquid observed along the southern edge of the compost area.

- Provide dates for receipt of final volume of waste, date of initiation of closure and date of the completion of closure
- Mr. Tingelhoff was requested to review the last soil analysis records and share with the Dept. the most recent records results to determine if additional sampling would be required.
- Address liquid in ditch on south end of compost pads

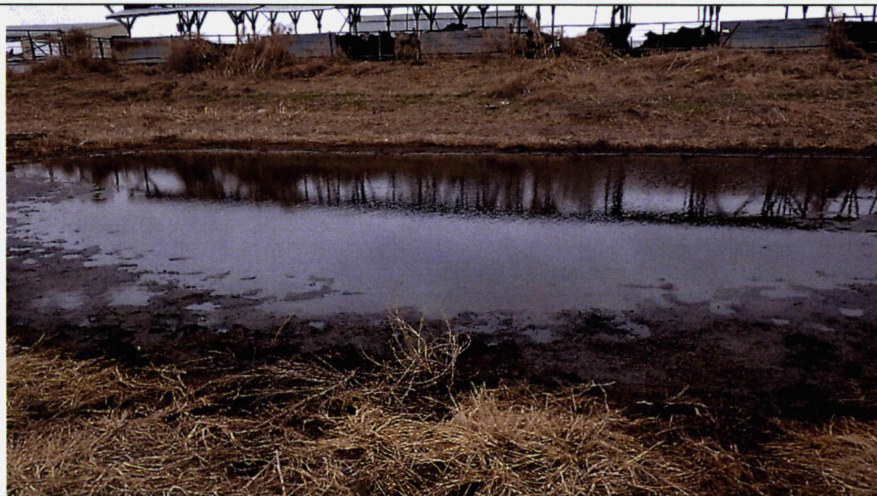
Photograph 12  
Date: December 11, 2020  
Photographer: Jason Holsten  
Camera: Ricoh WG-50  
NDEE ID: 84069  
Program ID: NE0204447  
Subject: AltEn, LLC Compost Facility

Photograph showing a closer view of standing liquid observed along the southern edge of the compost area.

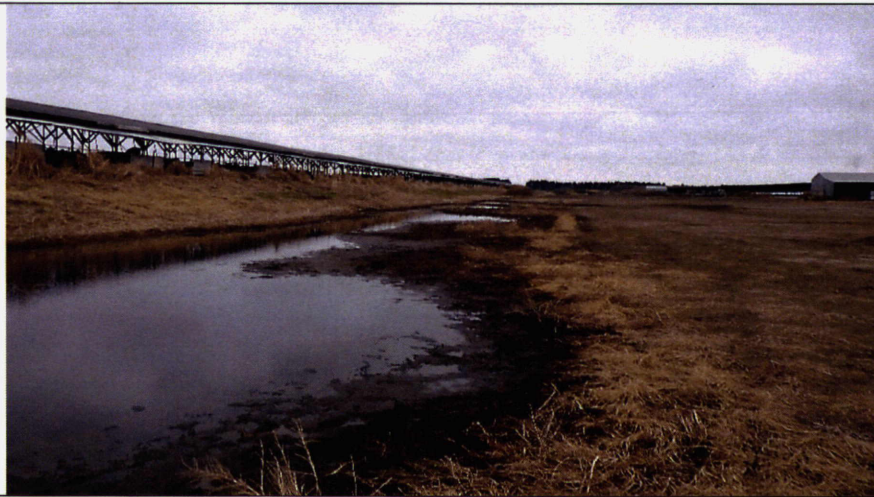
Photograph 13  
Date: December 11, 2020  
Photographer: Jason Holsten  
Camera: Ricoh WG-50  
NDEE ID: 84069  
Program ID: NE0204447  
Subject: AltEn, LLC Compost Facility

Looking west, photograph showing standing liquid observed along the southern edge of the compost area.

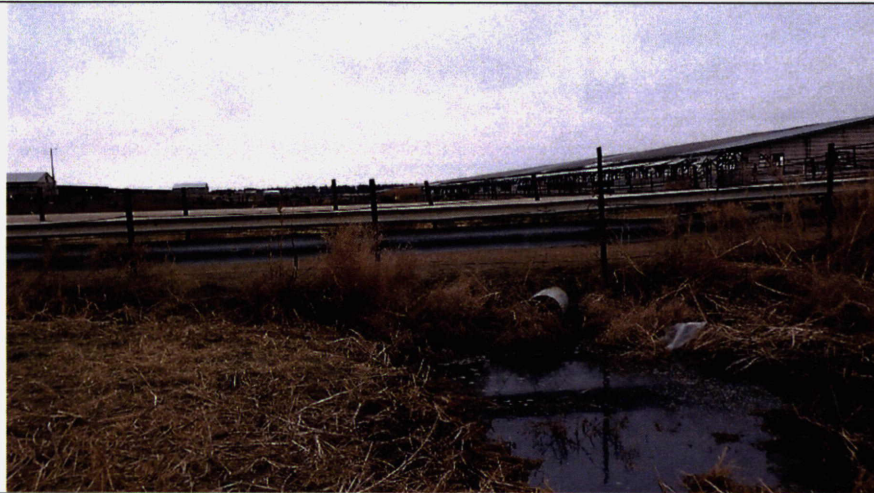
Photograph 14  
Date: December 11, 2020  
Photographer: Jason Holsten  
Camera: Ricoh WG-50  
NDEE ID: 84069  
Program ID: NE0204447  
Subject: AltEn, LLC Compost Facility

Looking east, photograph showing a culvert located southeast of the compost area. The culvert runs under a road and drains into an adjoining cattle yard. Standing liquid observed and mentioned in photographs 10-13 flows towards this culvert.

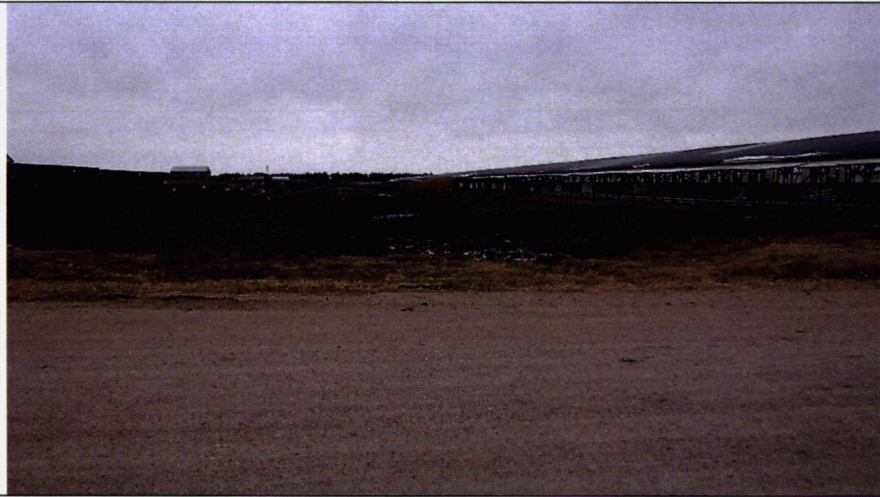
Photograph 15  
Date: December 11, 2020  
Photographer: Jason Holsten  
Camera: Ricoh WG-50  
NDEE ID: 84069  
Program ID: NE0204447  
Subject: AltEn, LLC Compost Facility

Looking east from the road, photograph showing where liquid drains through the culvert mentioned in photograph 14 and into this adjoining cattle yard.

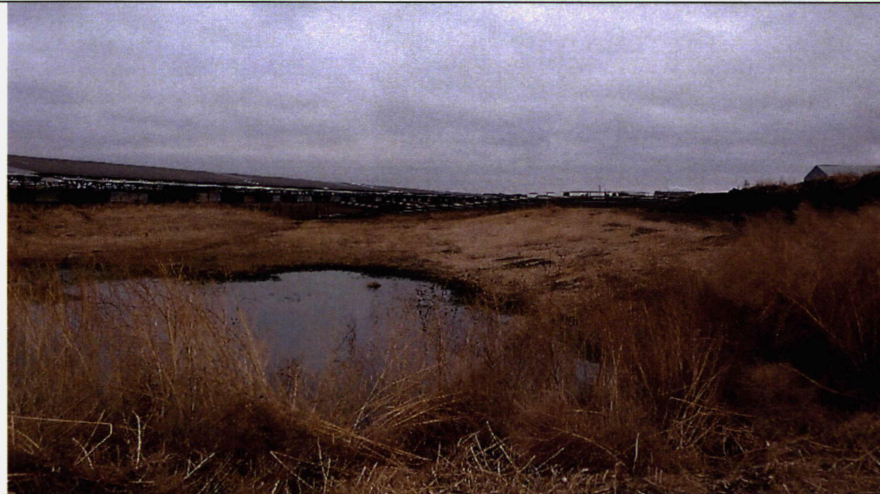
Photograph 16  
Date: December 11, 2020  
Photographer: Jason Holsten  
Camera: Ricoh WG-50  
NDEE ID: 84069  
Program ID: NE0204447  
Subject: AltEn, LLC Compost Facility

Looking west, photograph showing a holding pond. Site drainage from areas mentioned in photographs 10-15 drain to this pond. It is unknown if liquid from this pond is pumped to the ponds shown in photographs 17 and/or 18.

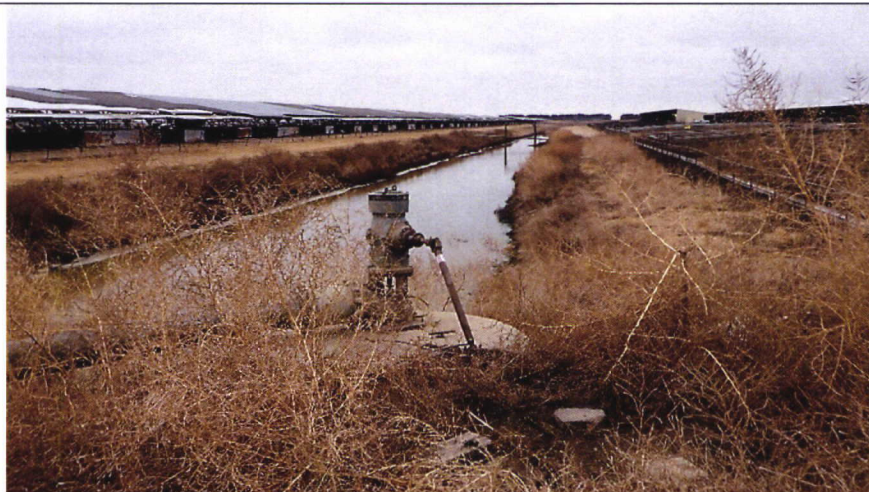
Photograph 17  
Date: December 11, 2020  
Photographer: Jason Holsten  
Camera: Ricoh WG-50  
NDEE ID: 84069  
Program ID: NE0204447  
Subject: AltEn, LLC Compost Facility

Looking west, photograph showing another holding pond that was located south of the pond mentioned in photograph 16.

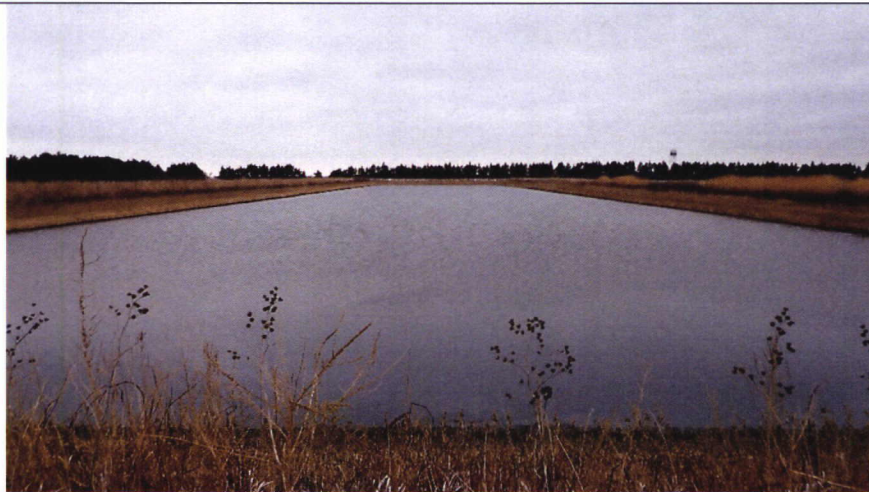
Photograph 18  
Date: December 11, 2020  
Photographer: Jason Holsten  
Camera: Ricoh WG-50  
NDEE ID: 84069  
Program ID: NE0204447  
Subject: AltEn, LLC Compost Facility

Looking south, photograph showing what is presumed to be the livestock waste control holding pond for Mead Cattle.
