Facility: AltEn
IIS: 84069
PCS: NE0137634

Site Visit Check list

Site Visit Report

Facility Name/ Project Name: AltEn LLC

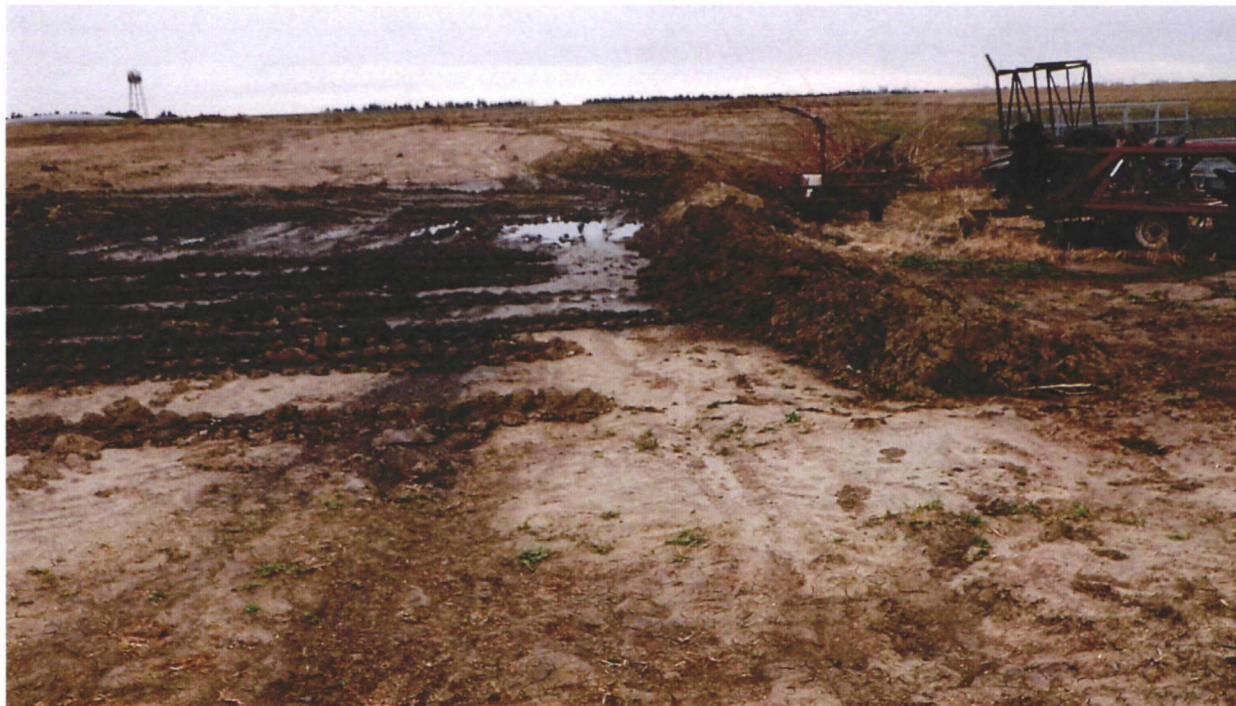
Photo: 1

Description: This photo depicts the area northwest of the administration building. The facility installed a berm along a low area which conveys to the southwest side of the south lagoon. The facility has recently pumped the berm into the emergency lagoon.

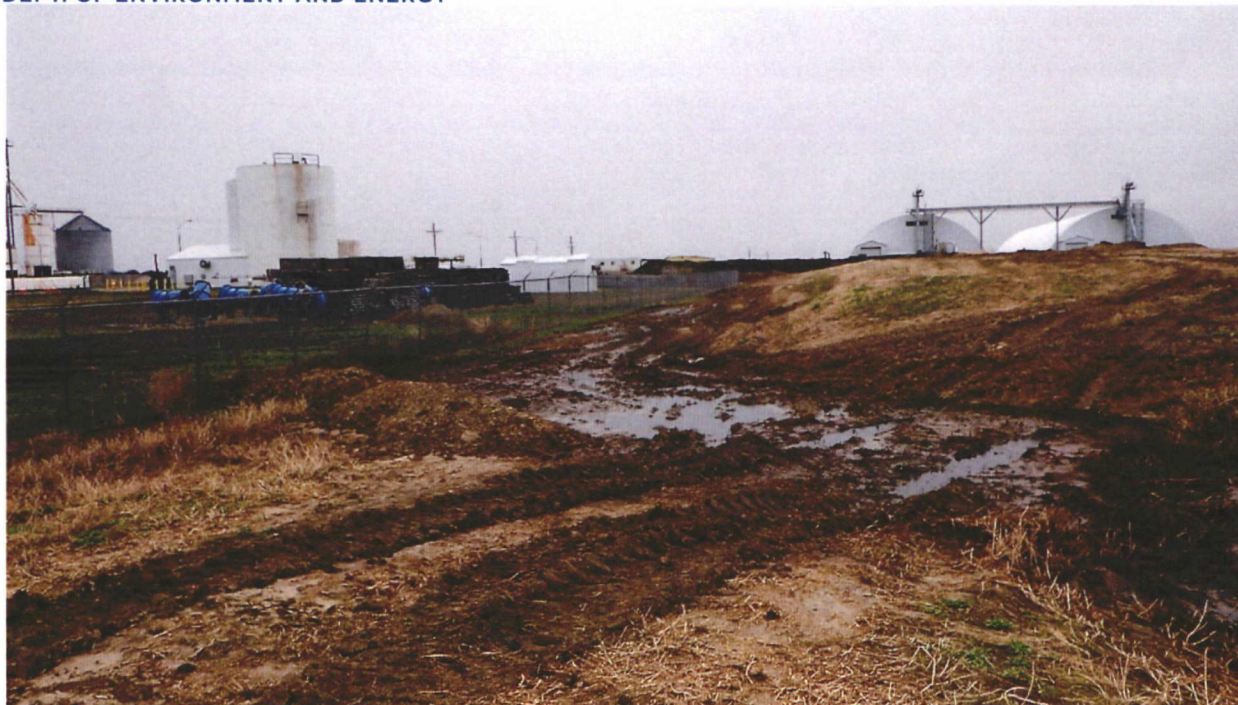
Photo: 2

Description: This is the berm on the southwest corner of the south lagoon. The facility has recently pumped stored water into the emergency lagoon.

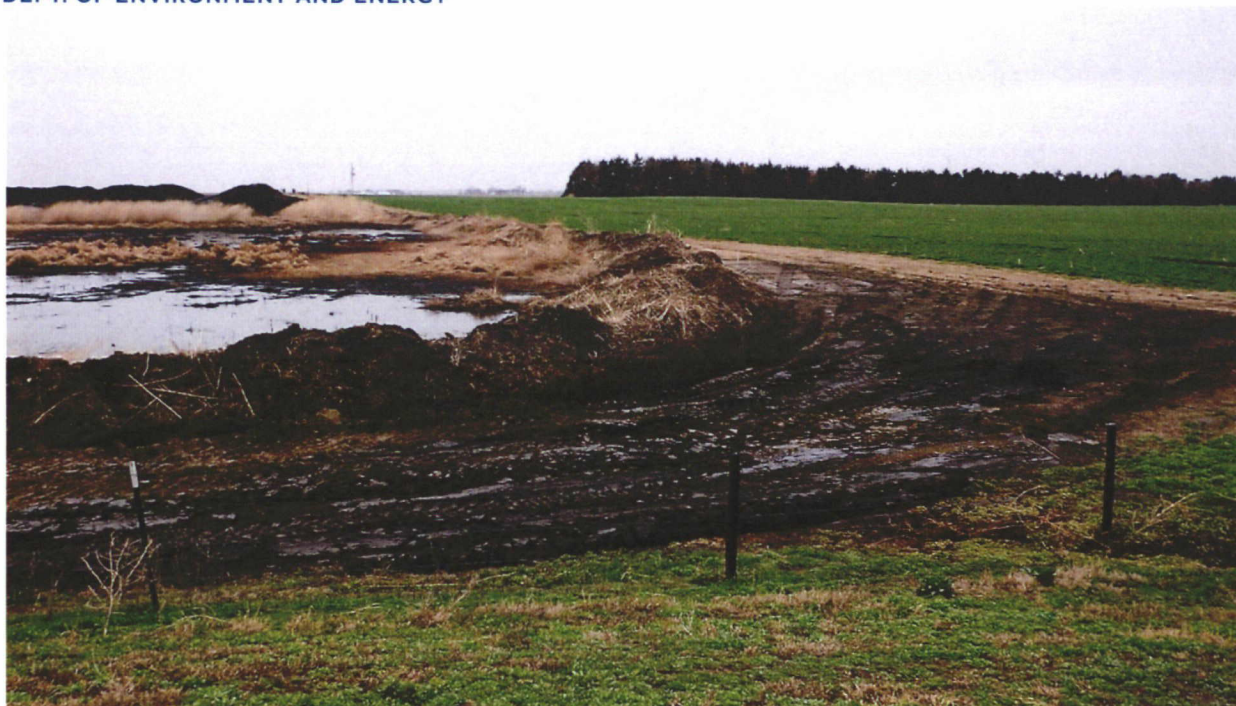
Photo: 3

Description: This is the berm on the northwest corner of the north pile. The berm was observed seeping during the March 19, 2021 visit and has been repaired.

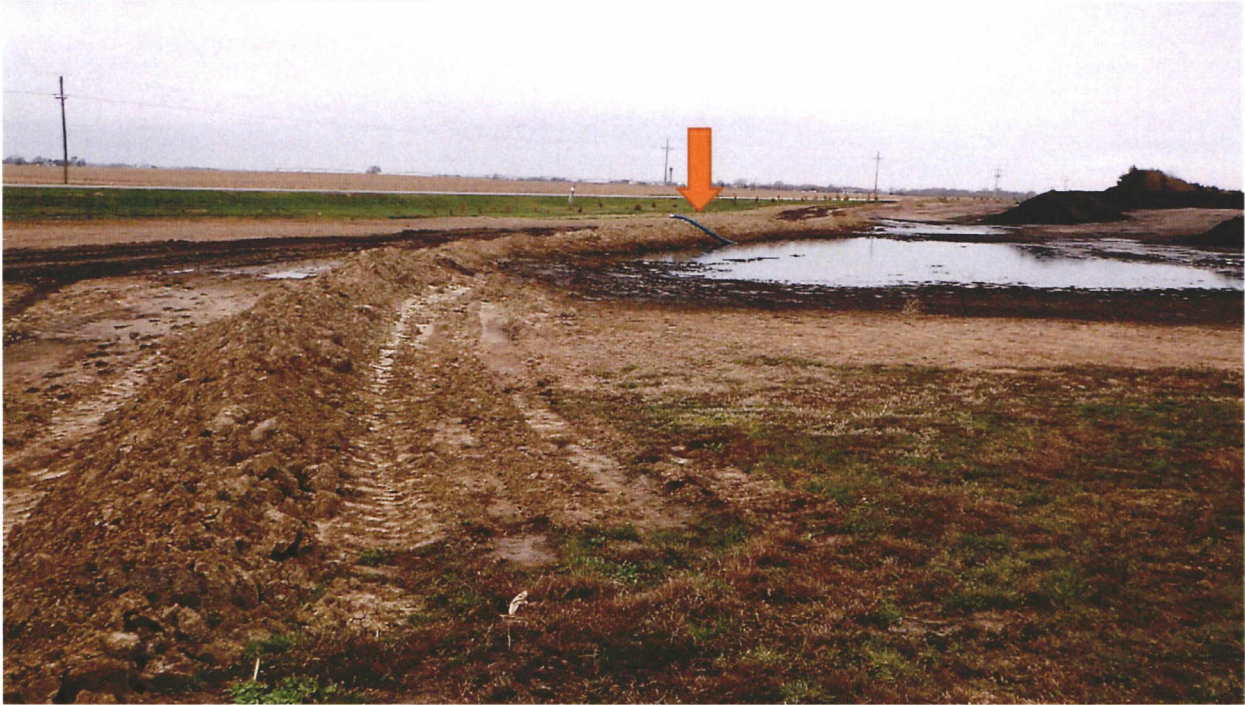
Photo: 4

Description: This is the berm located west of the Hoop buildings. The blue hose (arrow) was used to convey water to the emergency lagoon.

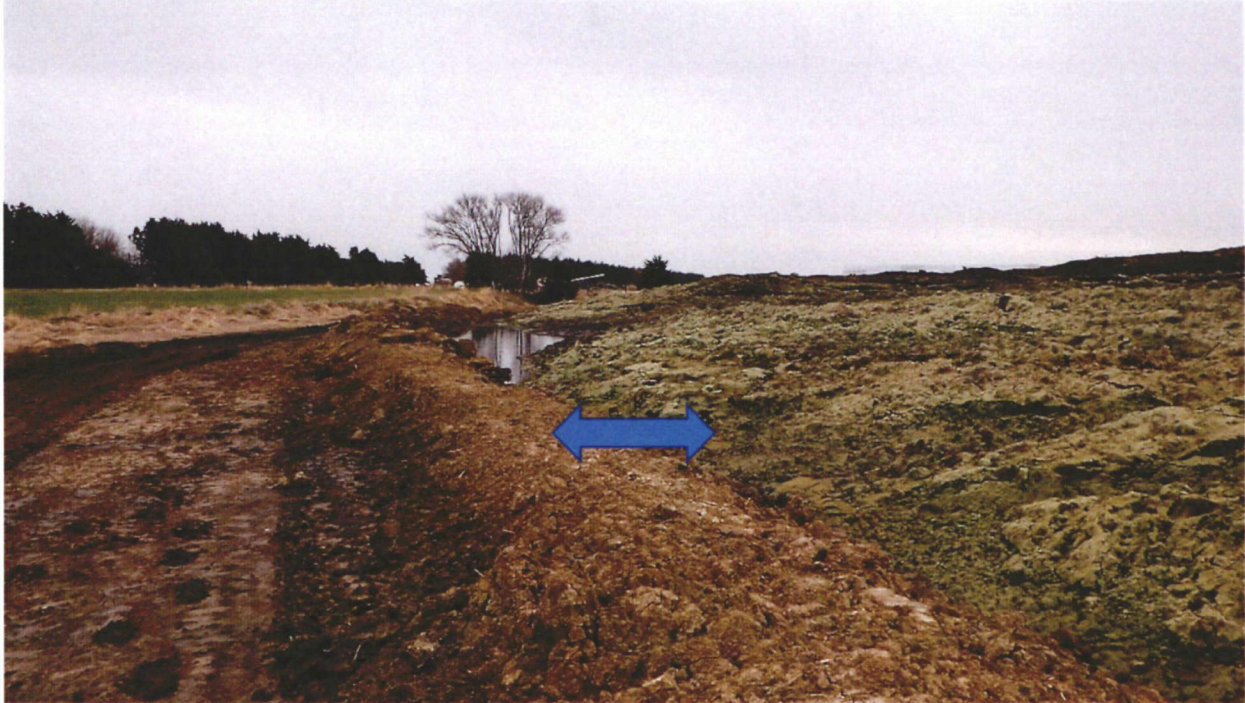
Photo: 5

- Wet cake has shifted at the east pile and is now pushing against the berm. I instructed AltEn to install an additional berm to contain potential breaches. Mr. Peterson will provide the Department updates of its installation.
- The facility agreed to continue monitoring the berms and provide daily emails of changes and repairs.
- The facility reinforced the northeast corner of the north cake pile berm. This was requested on Friday March 19, 2021.

Description: This photo depicts the east berm. The wet cake has shifted against the berm (arrow).

East beam pile needs to be expanded to contain wet cake

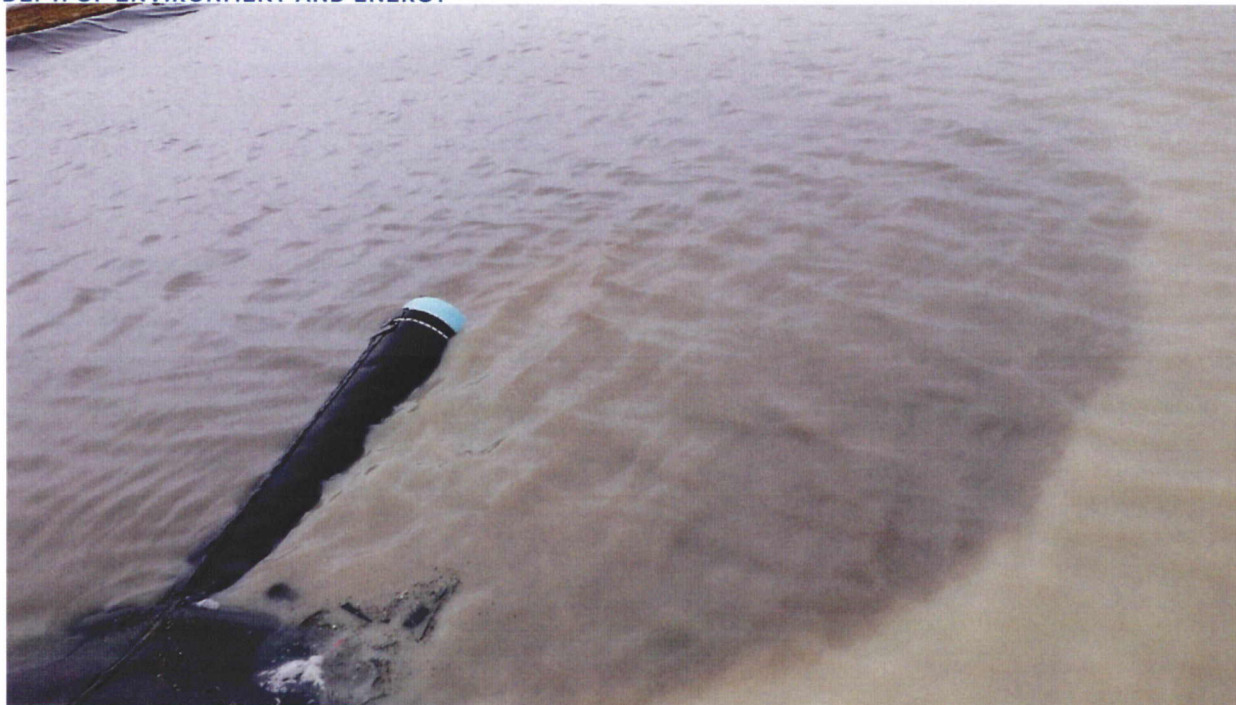
Photo: 6

- Northeast lagoon
 - The south lagoon appears to be equalizing back into the northeast lagoon, photo 6.
 - Teal colored water
 - Appears to be operating at 20 feet, photo 7
- Northwest lagoon
 - Appears to be additional whales, photo 8.
 - Teal colored water
 - Appears to be operating at 18.5 feet, photo 9.

Description: This photo depicts the equalization pipe between the south lagoon and northeast lagoon. There is a plume of dark water from the south lagoon.

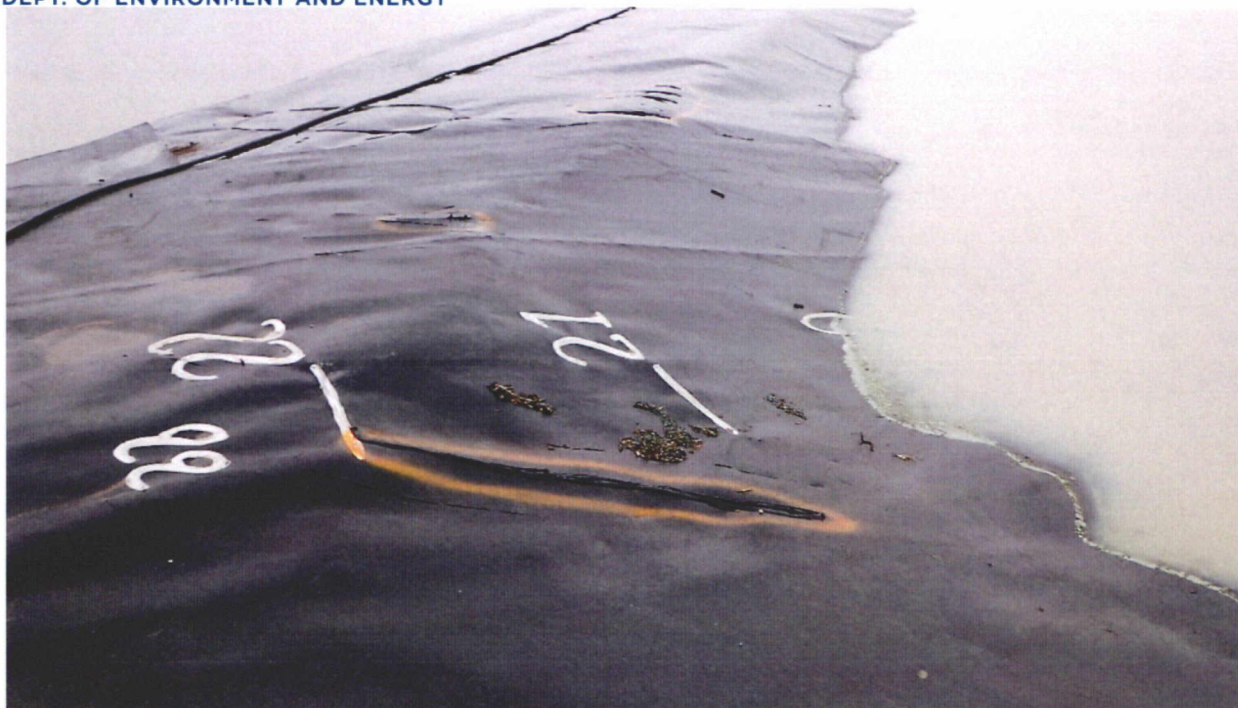
Photo: 7

Description: This photo depicts the northeast lagoon depth marker.

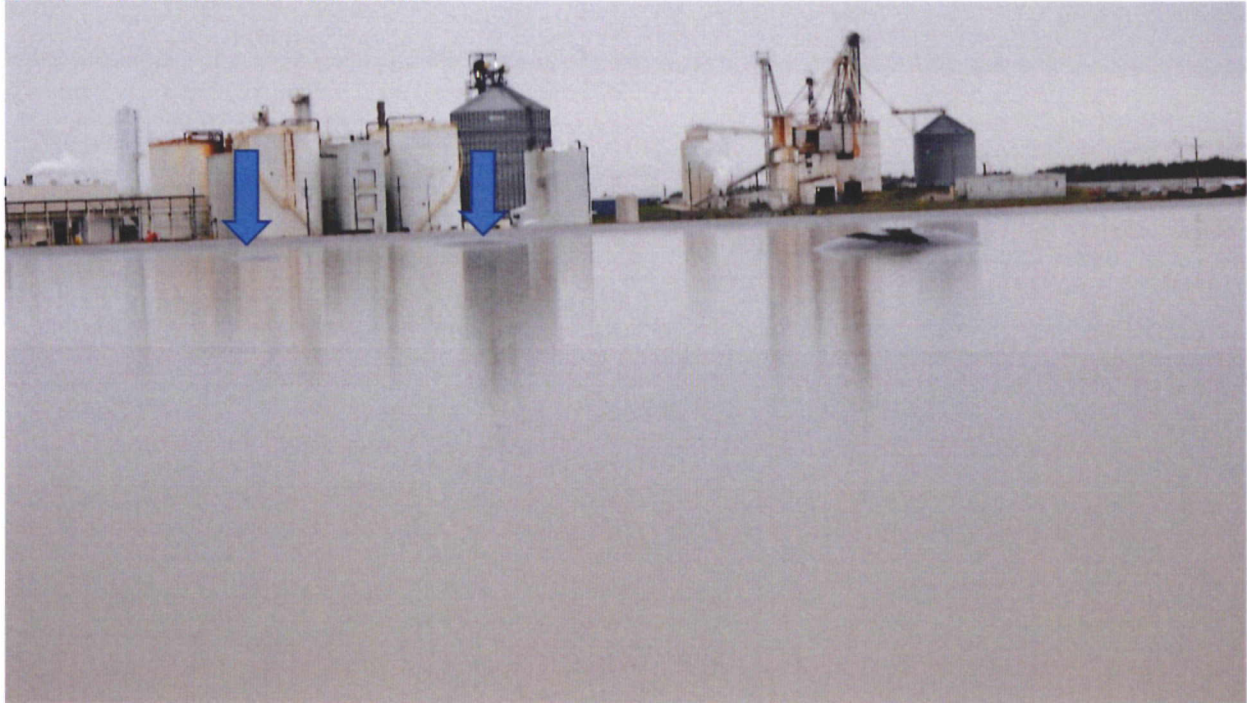
Photo: 8

Description: This photo depicts possible new whales on the northwest lagoon (arrows).

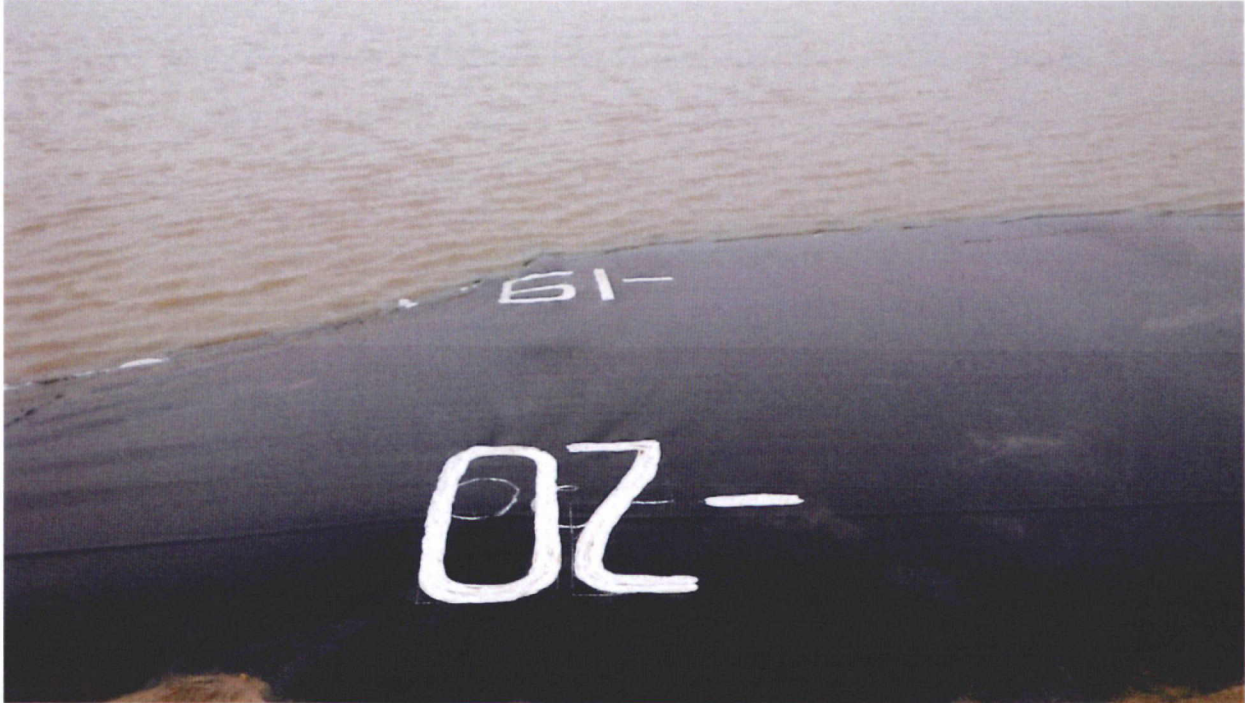
Photo: 9

Description: This photo depicts the northwest lagoon depth marker.

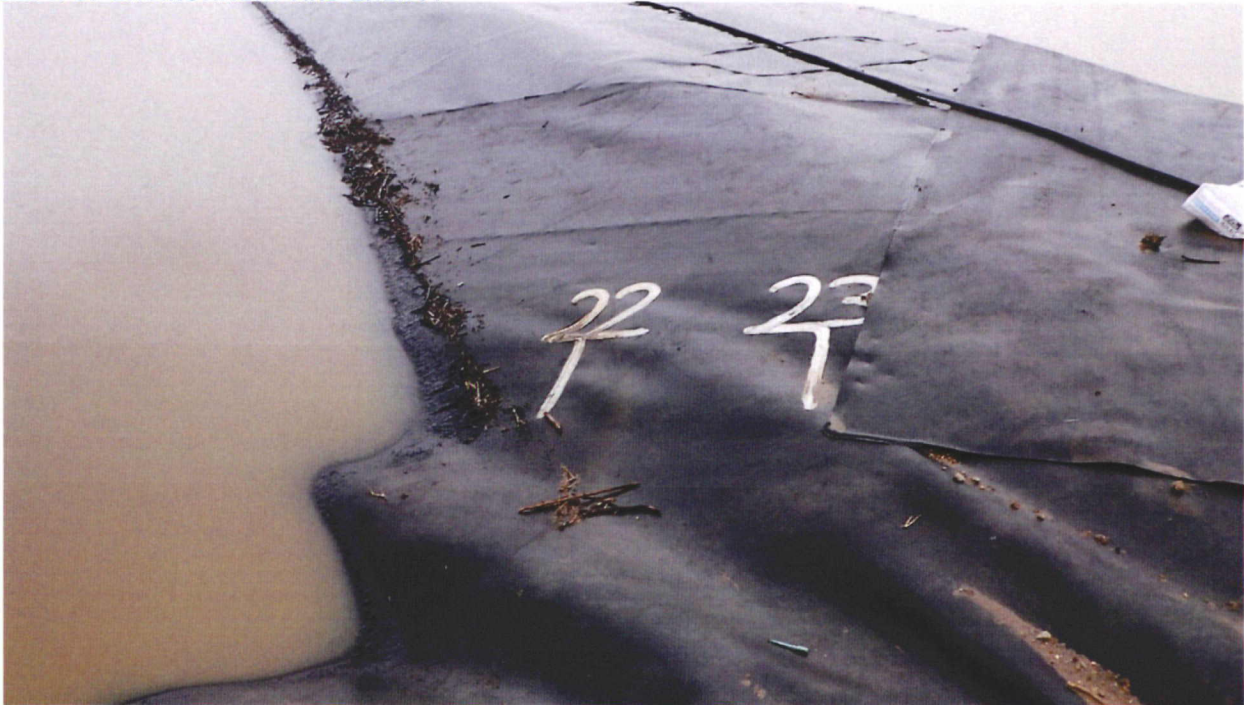
Photo: 10

- The lagoon appears to be Equalization back into the northeast lagoon.
- Appears to be operating at approximately 21.5 feet, photo 10.

Description: This photo depicts the south lagoon depth marker.

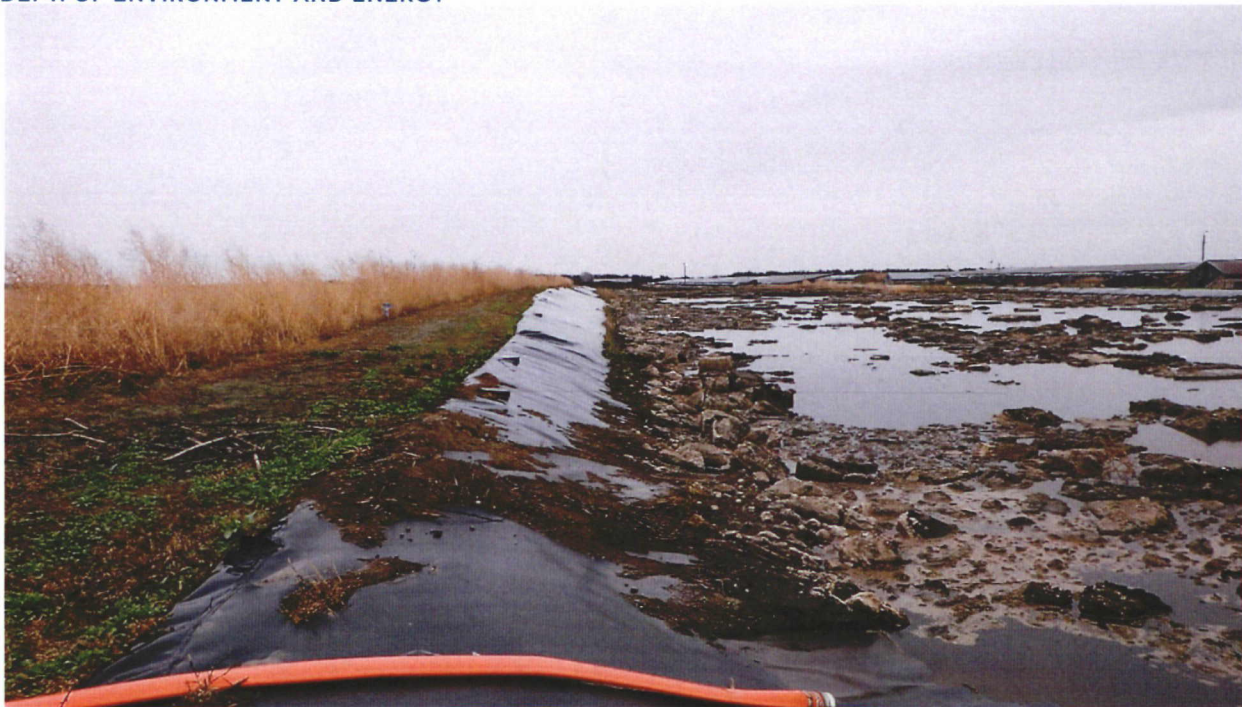
Photo: 11

Notes: • I also inspected the emergency lagoon, photo 11. The facility is pumping the berms into this lagoon. The lagoon appears to have enough capacity for additional discharges, photo 11.

Description: This photo depicts the west side of the emergency lagoon. The orange hose is used to pump from storm water berms.

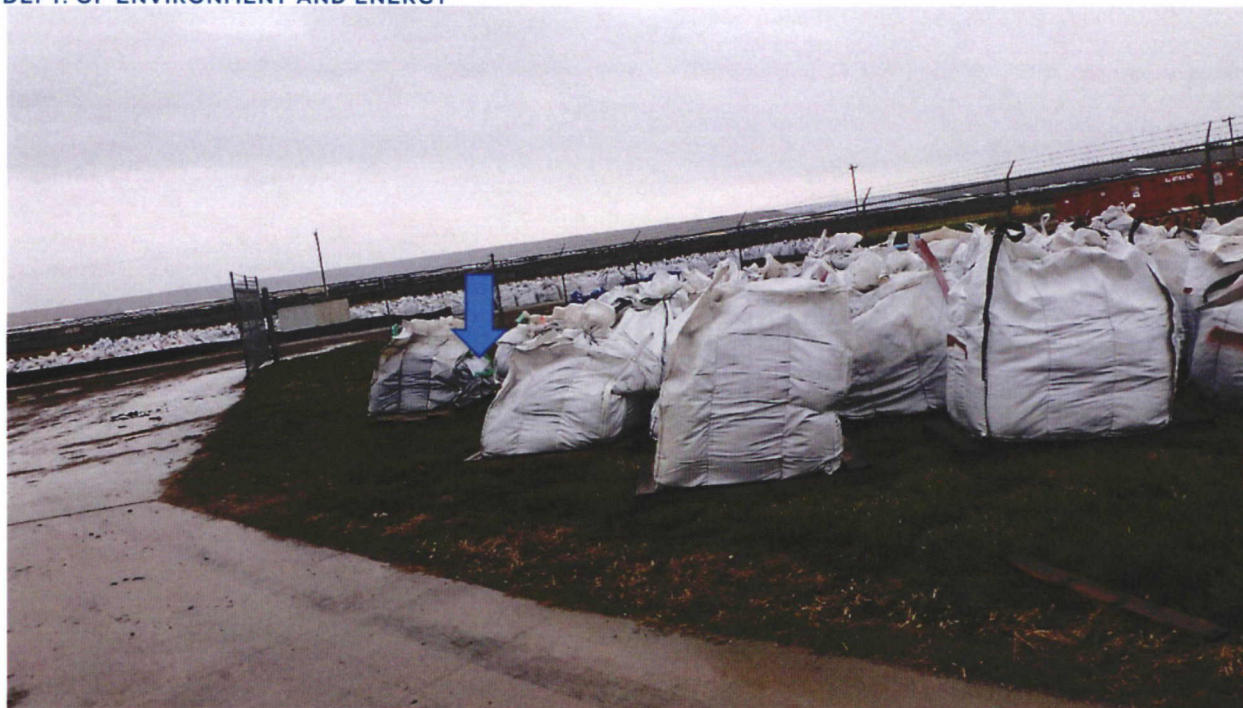
Photo: 13

- I then walked to the Biochar and supersack storage area. There are supersacks being stored across the road. There are some damaged supersacks and spillage, photo 12 and 13. The supersacks are not in containment.

Description: This photo depicts supersacks stored out of the contained area. There is a broken sack on the left side (arrow).

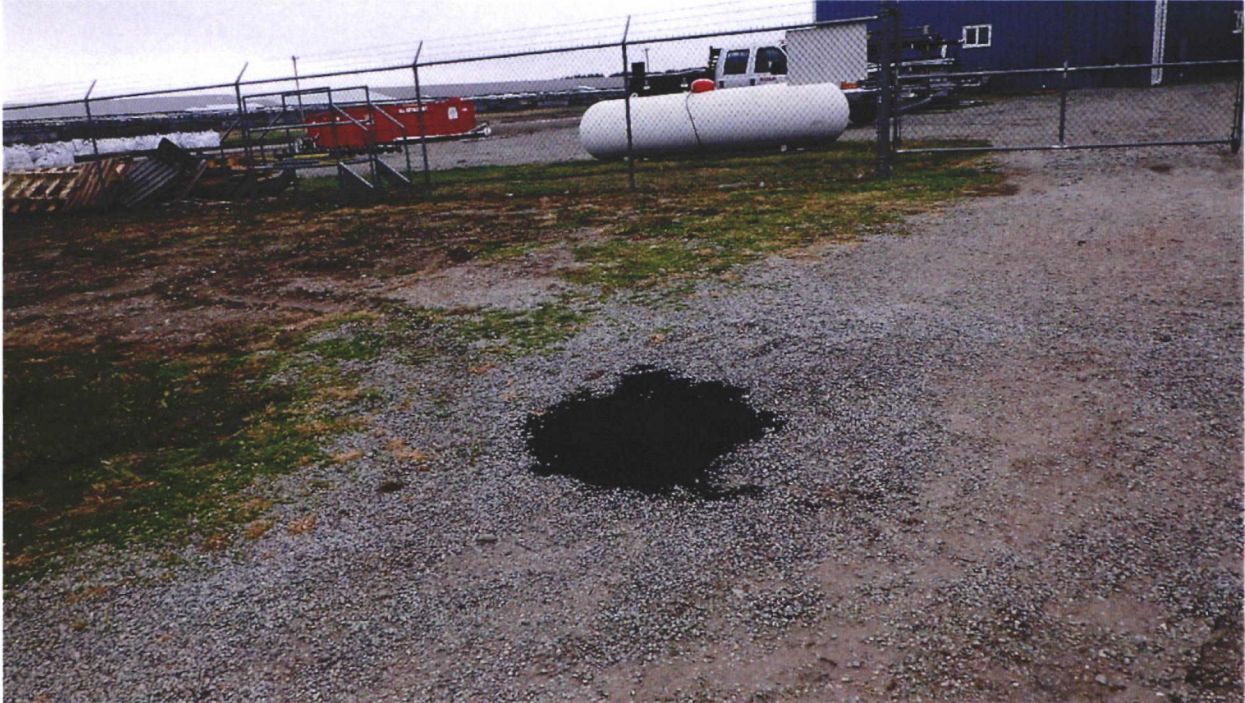
Photo: 14

Description: This photo depicts spilled biochar. There is no containment in the area. A rain event could wash piles like this into the storm water conveyance system.
