Facility: AltEn, LLC
IIS: 84069
PCS: NE0137634

Jason Windhorst
6/4/2021

Site Visit Check list

Site Visit Report

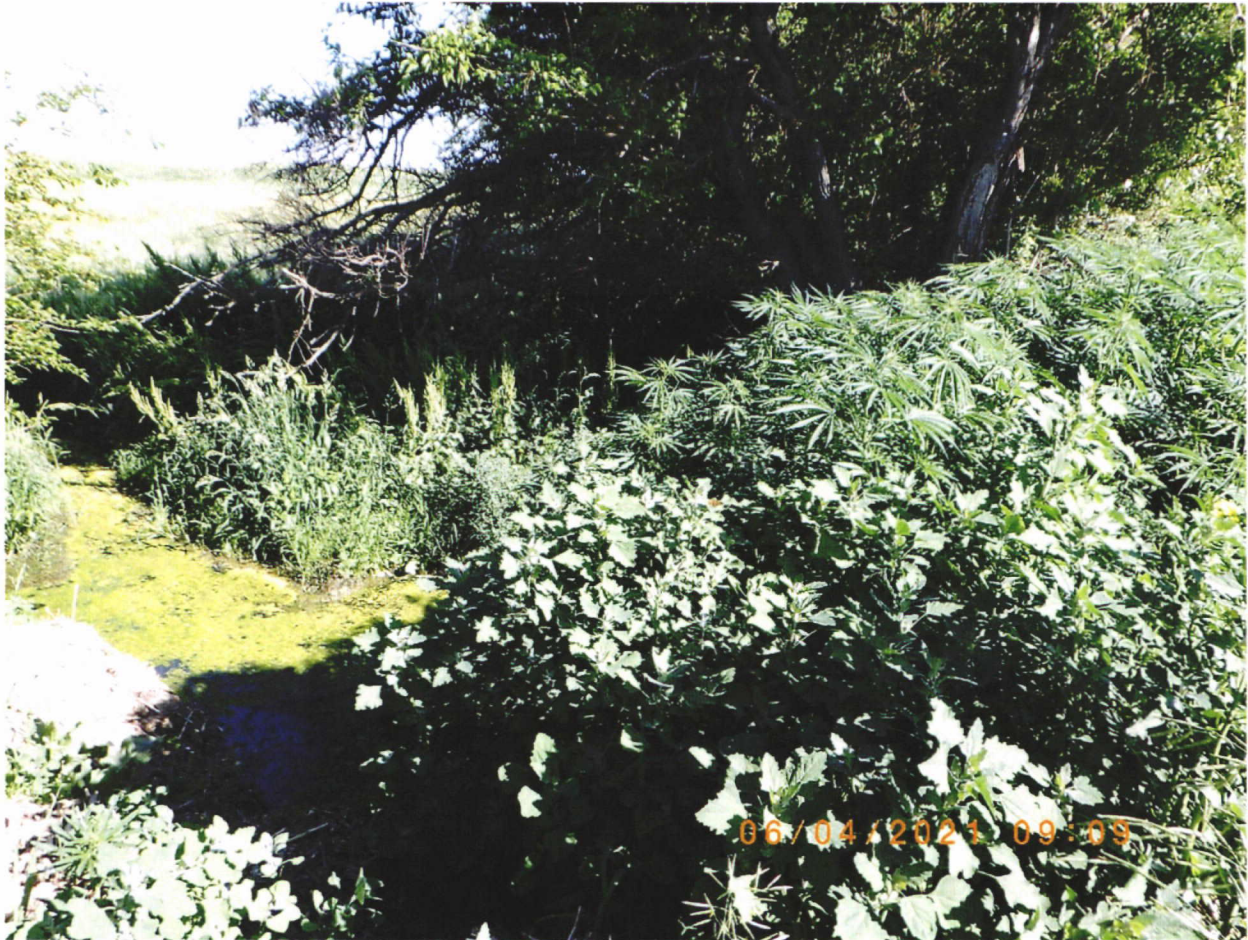
Photos: 1

Description: Very little flow through the culverts at this time has allowed growth in the waterway and weed growth around the area is beginning to limit access to the area.

- Continue mowing operations. If possible, speak with county regarding culvert cleanout north of CR 9 & J for "Inflatable Pipe Plugs" to be used in spill protection.

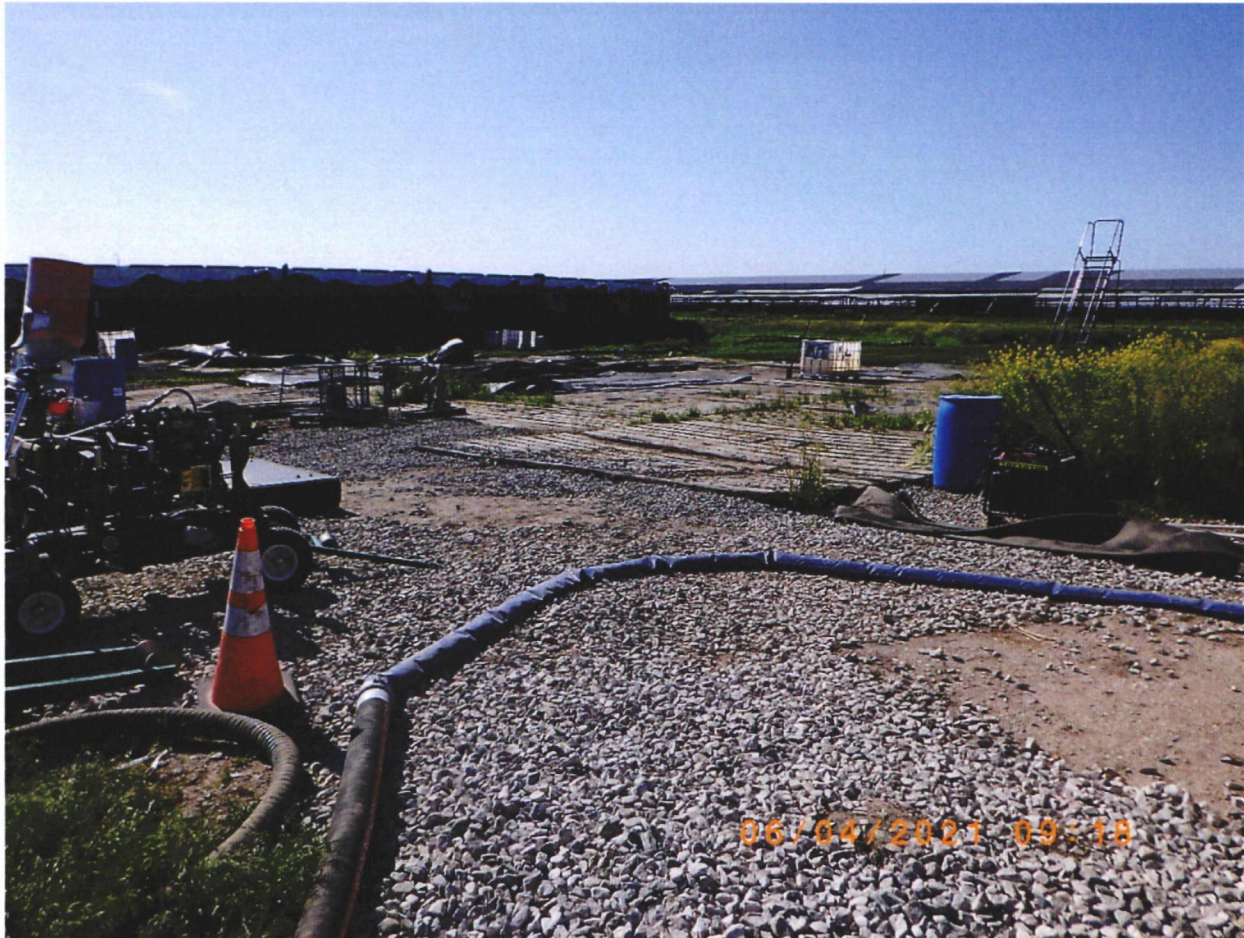
Photos: 2

Description: Clean Harbors continues to move treatment equipment to the area north of the ethanol plant.

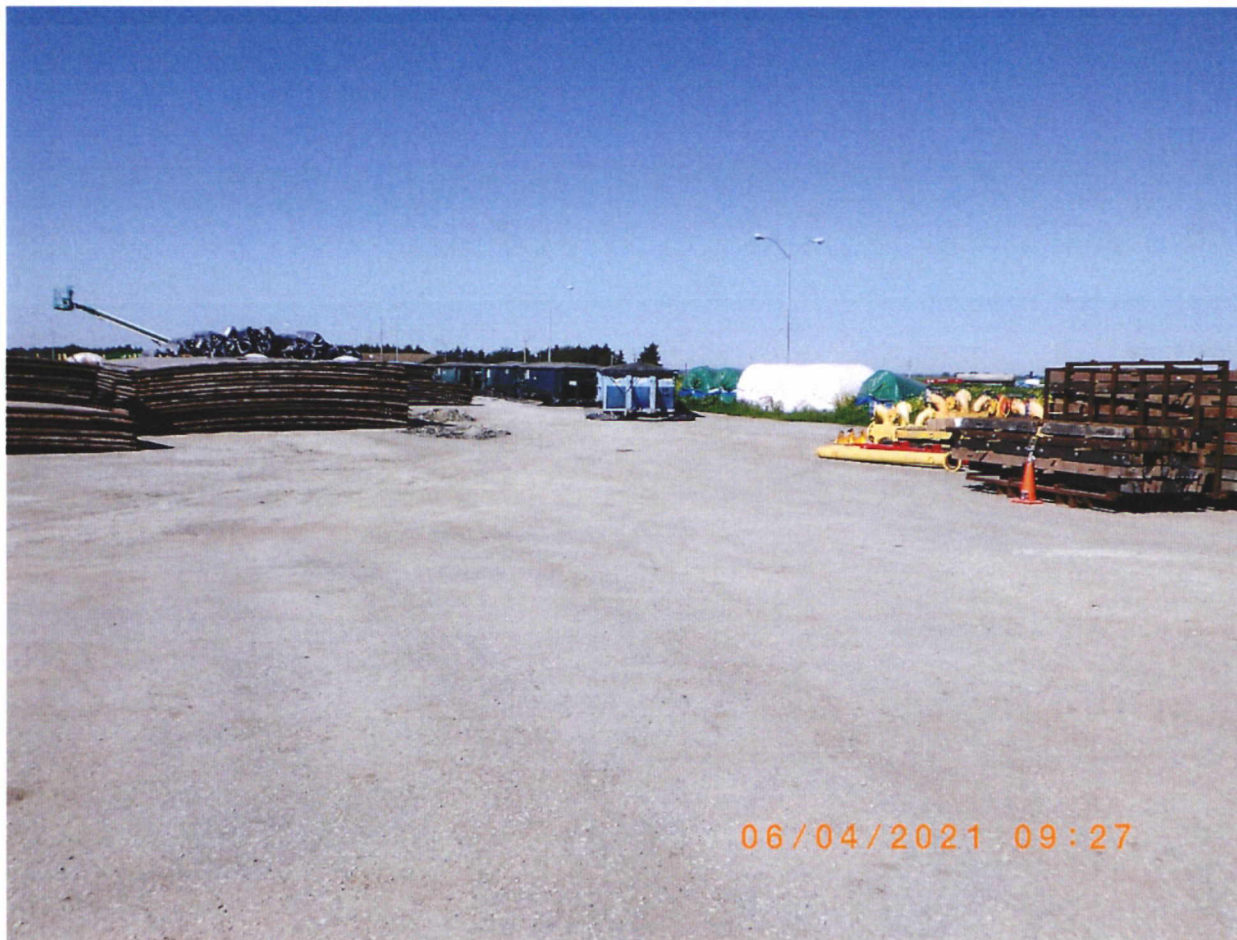
Photos: 3

Description: Parking lot used as delivery area for new tank farm and waste carbon storage.

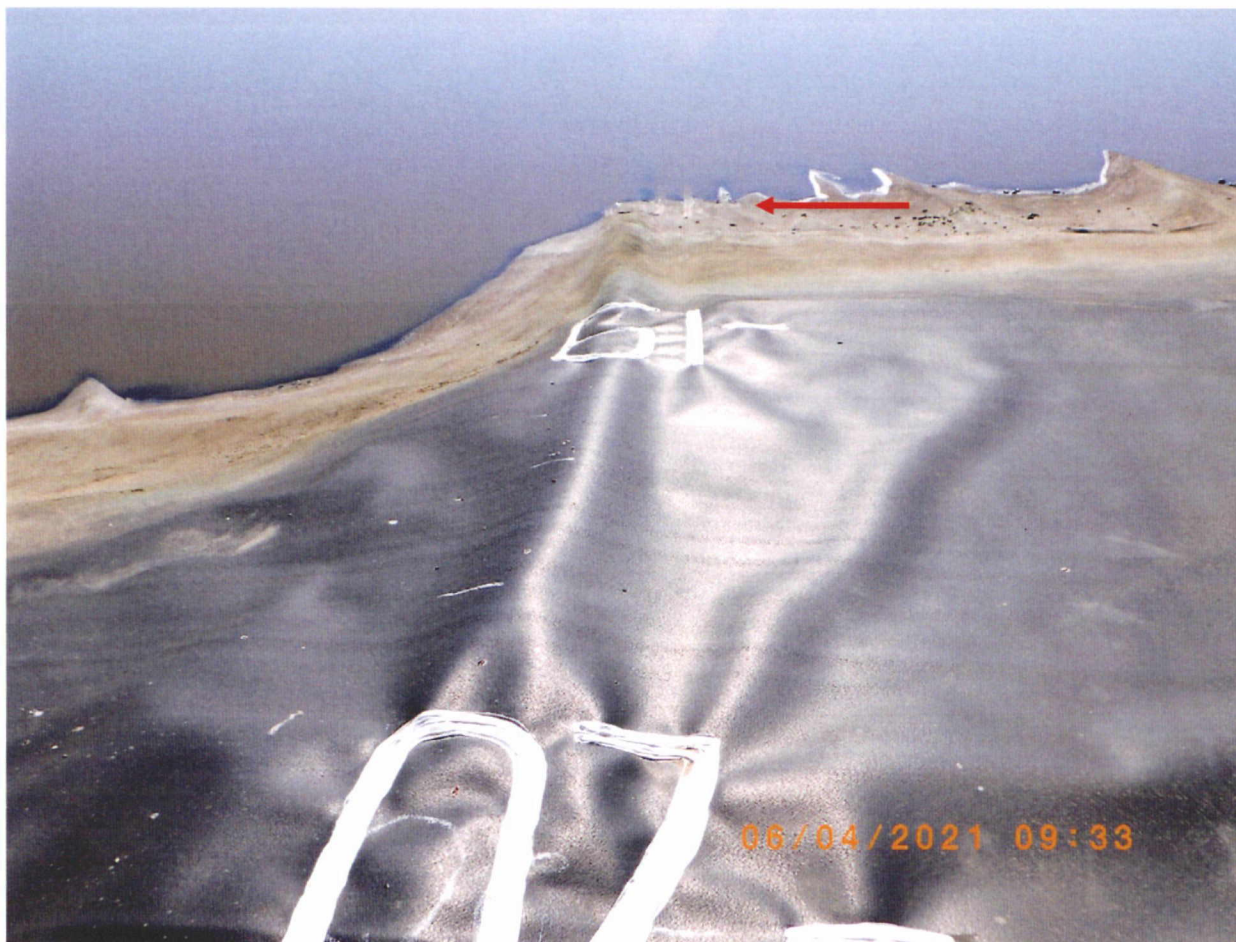
Photos: 4

Description: Depth marker indicates that this lagoon is at the 18' marker line.

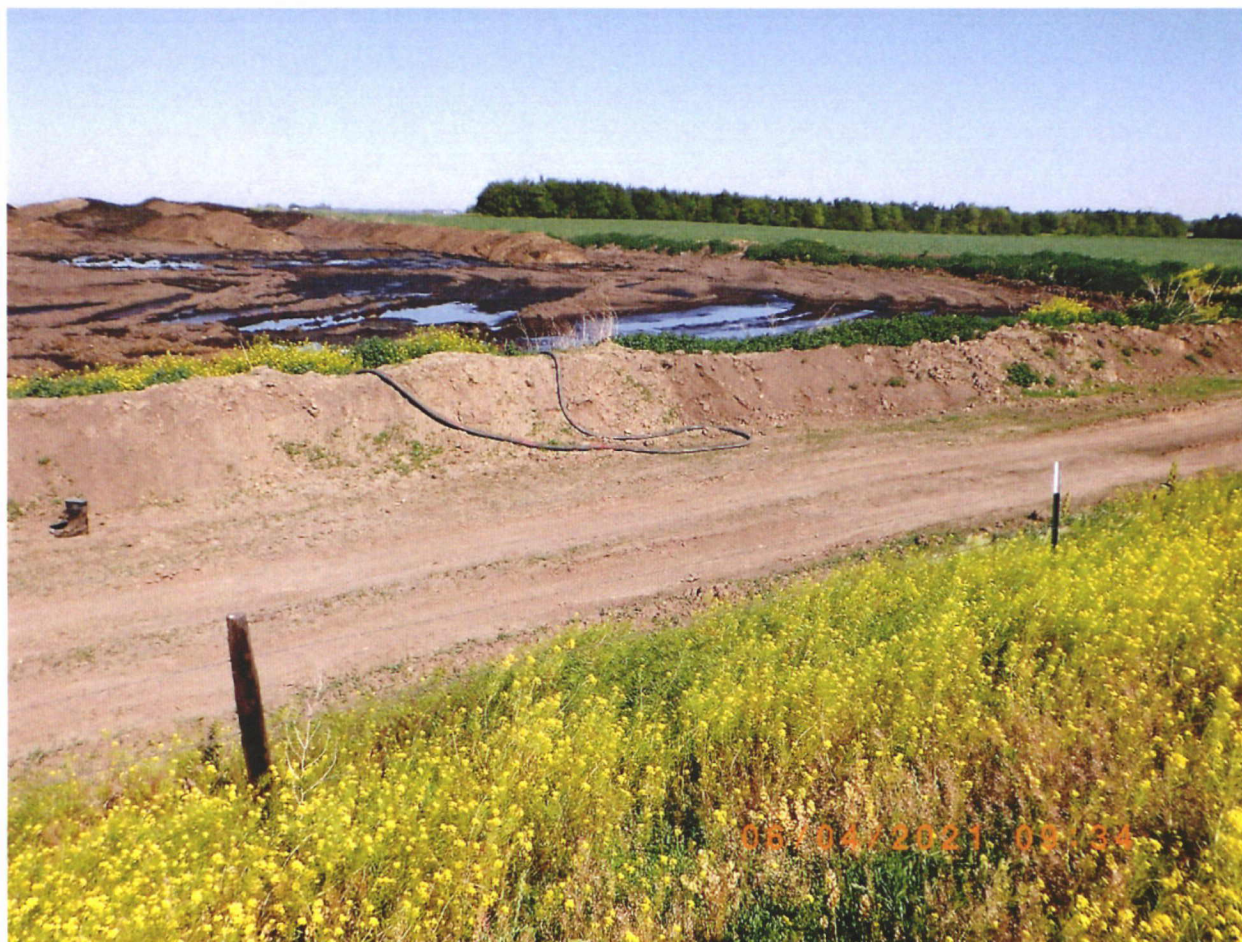
Photos: 5

Description: Very little runoff left in this area and the berms are holding with no seepage. Area 4 has wetcake moved back to the south of the berm and has no potential for seepage.

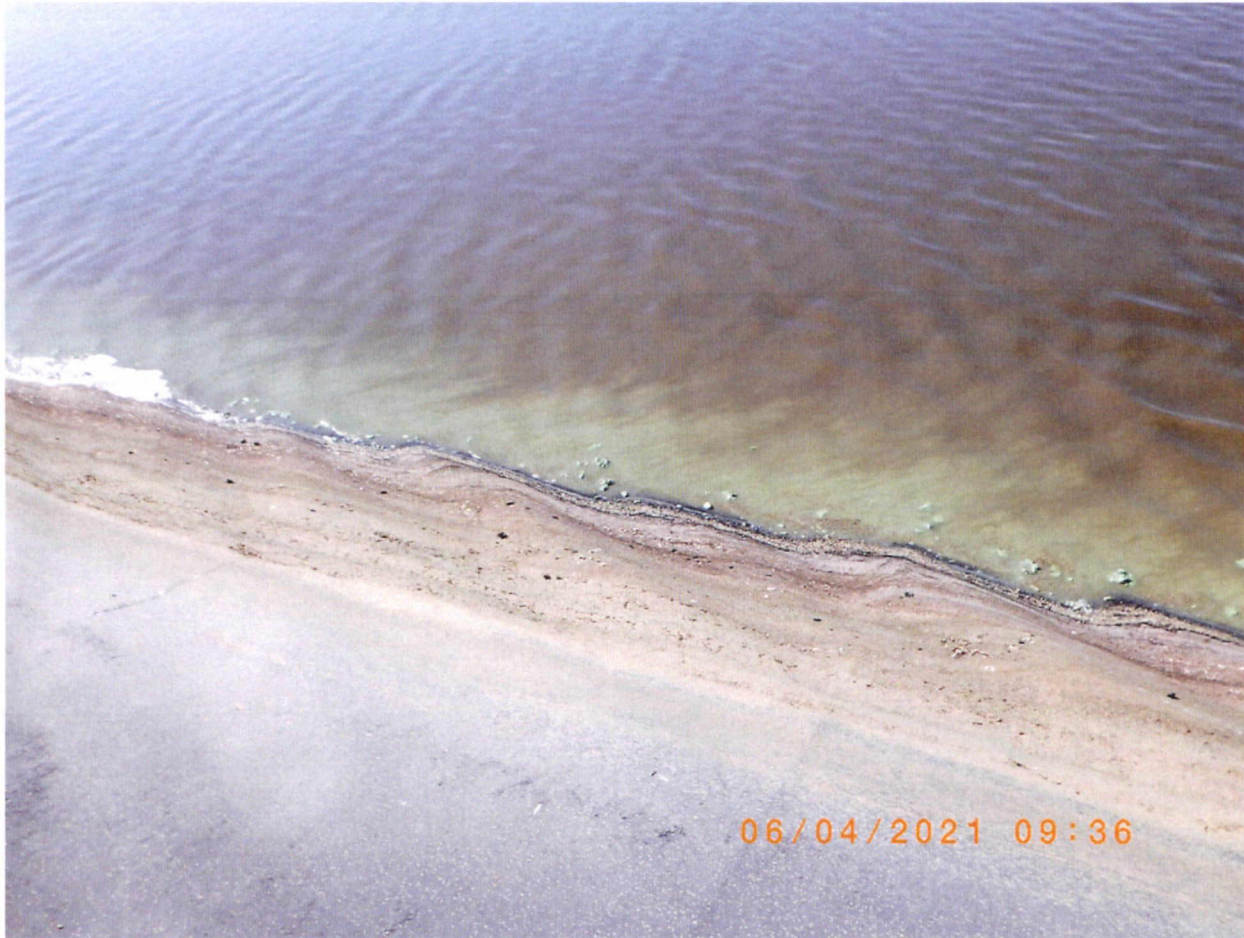
Photos: 6

Description: Green sludge is accumulating along the north edge of the lagoon with debris.

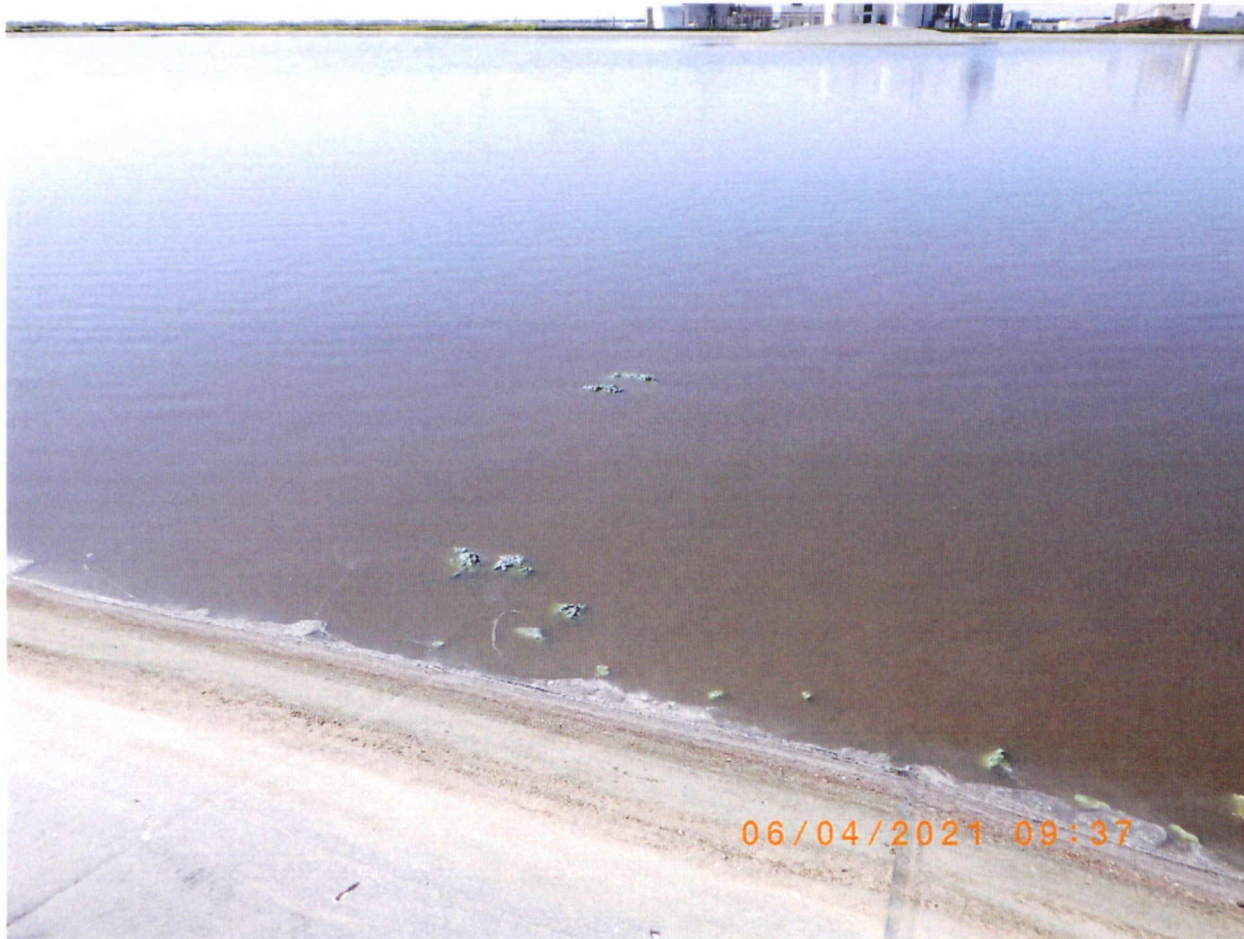
Photos: 7
Site Visit Report
Date Taken: 6-4-2021
Photographer: Jason Windhorst
Facility Name/ Project Name: AltEn LLC
Facility IIS number / Project identifier: IIS: 84069 / NE0137634
Location: Same as photo 6
Direction Facing: South
Description: Larger masses of sludge floating to the surface.

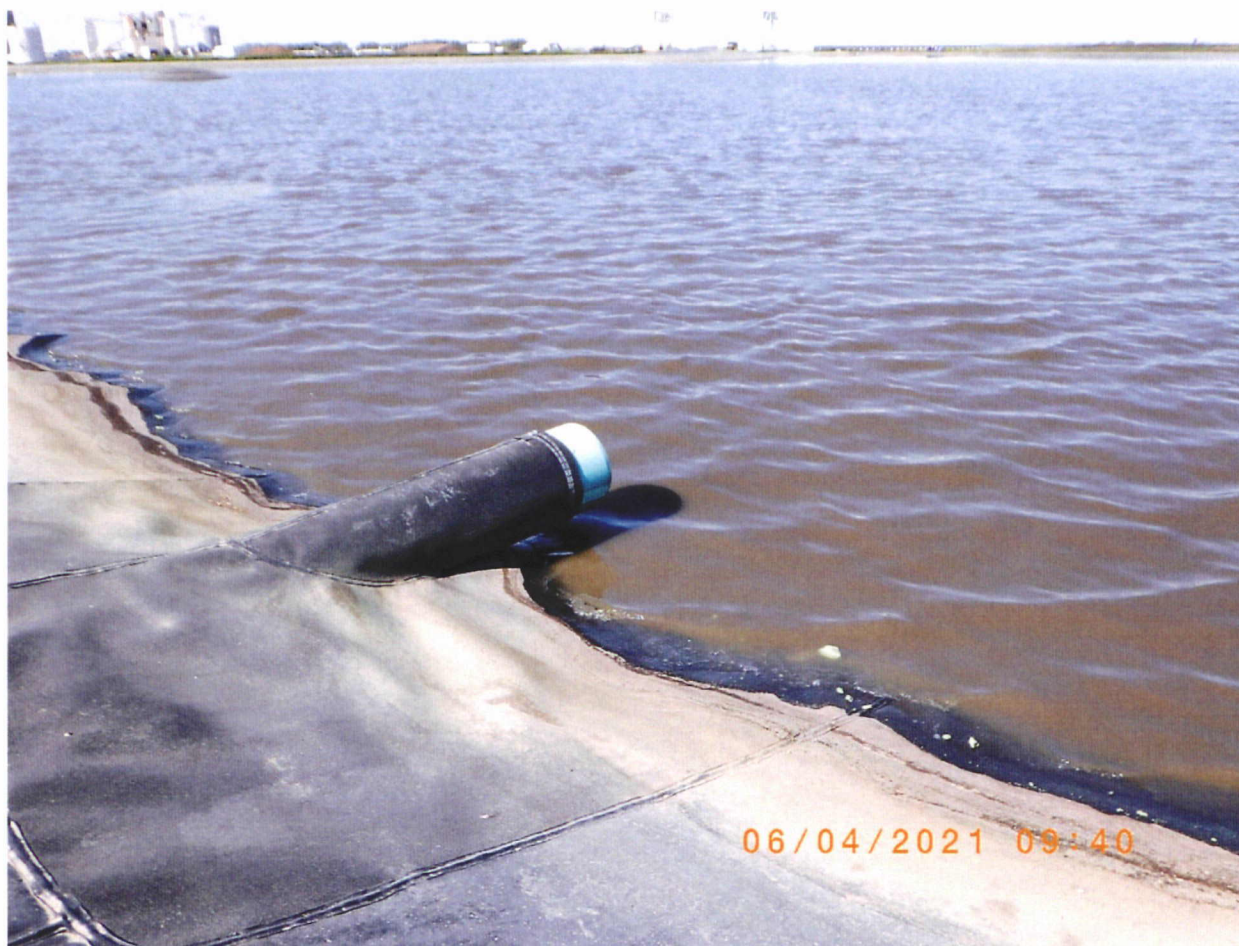
Photos: 8

Description: Equalization pipe over 3" out of the lagoon water. Photo also two small whales with the persistent large whale in the background.

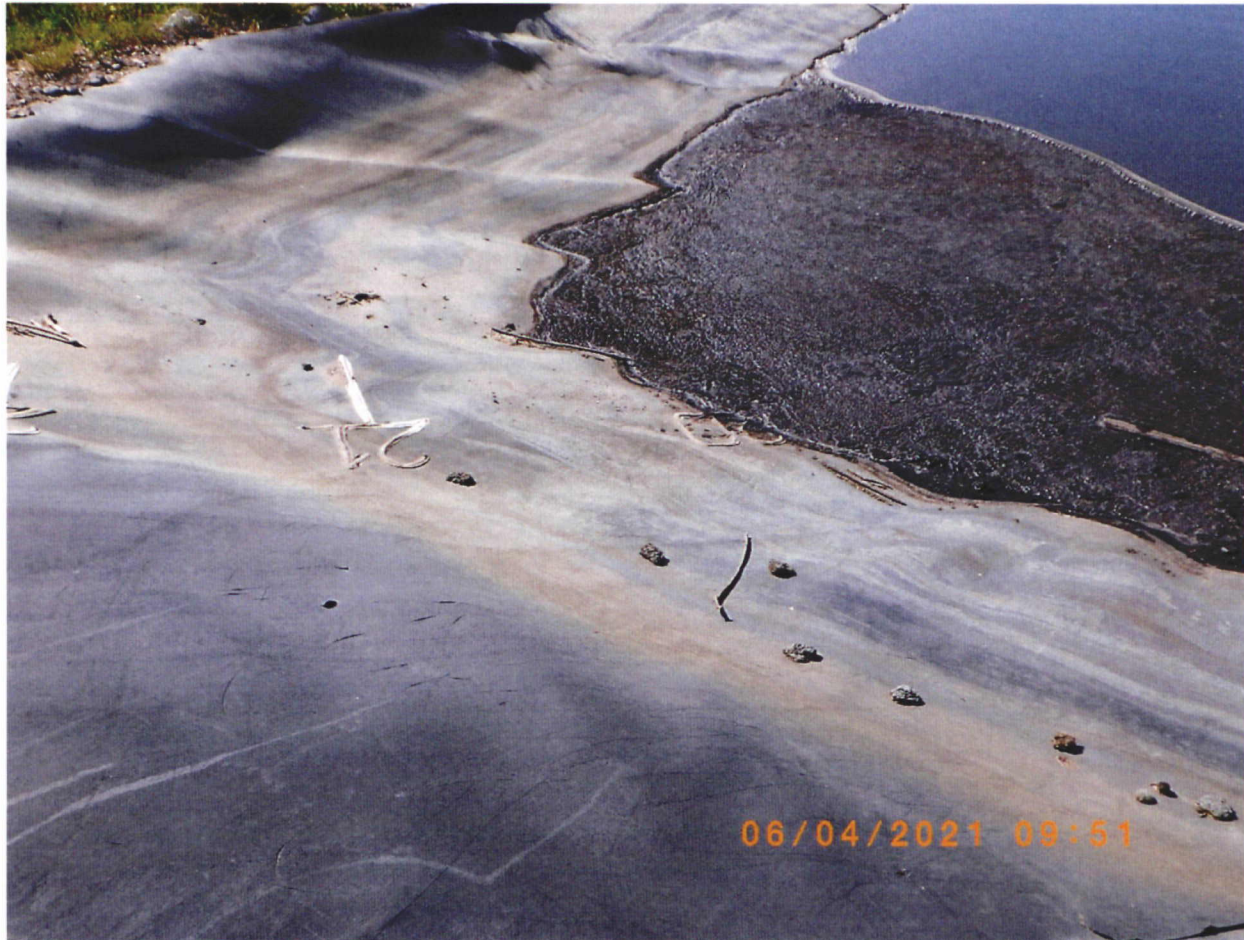
Photos: 9

Description: No change in the lagoon status. Lagoon depth marker indicates the lagoon is at 20'.

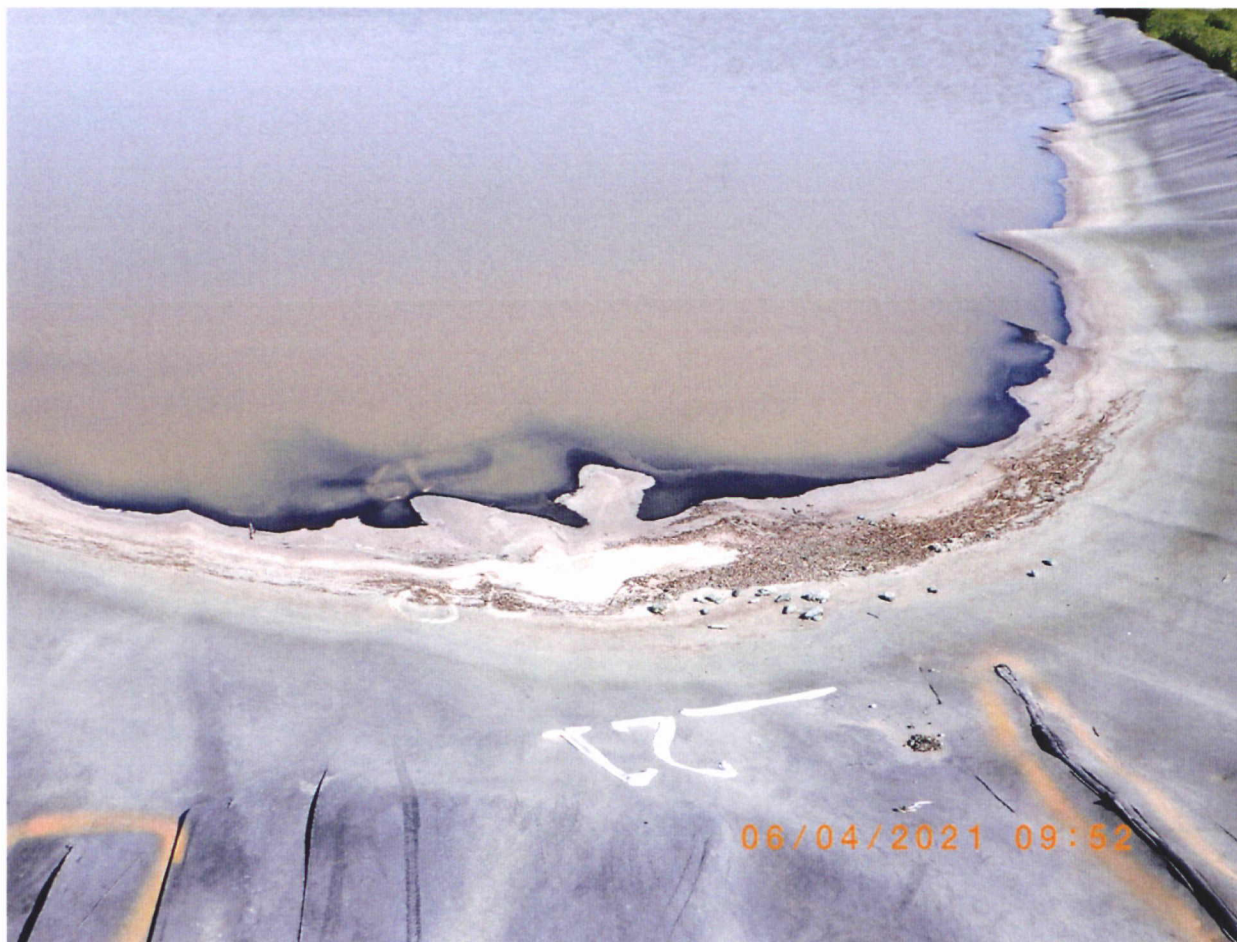
Photos: 10

Description: This lagoon has no significant changes beyond the occasional gas releases. Lagoon depth marker indicates the lagoon is at 19.5'.

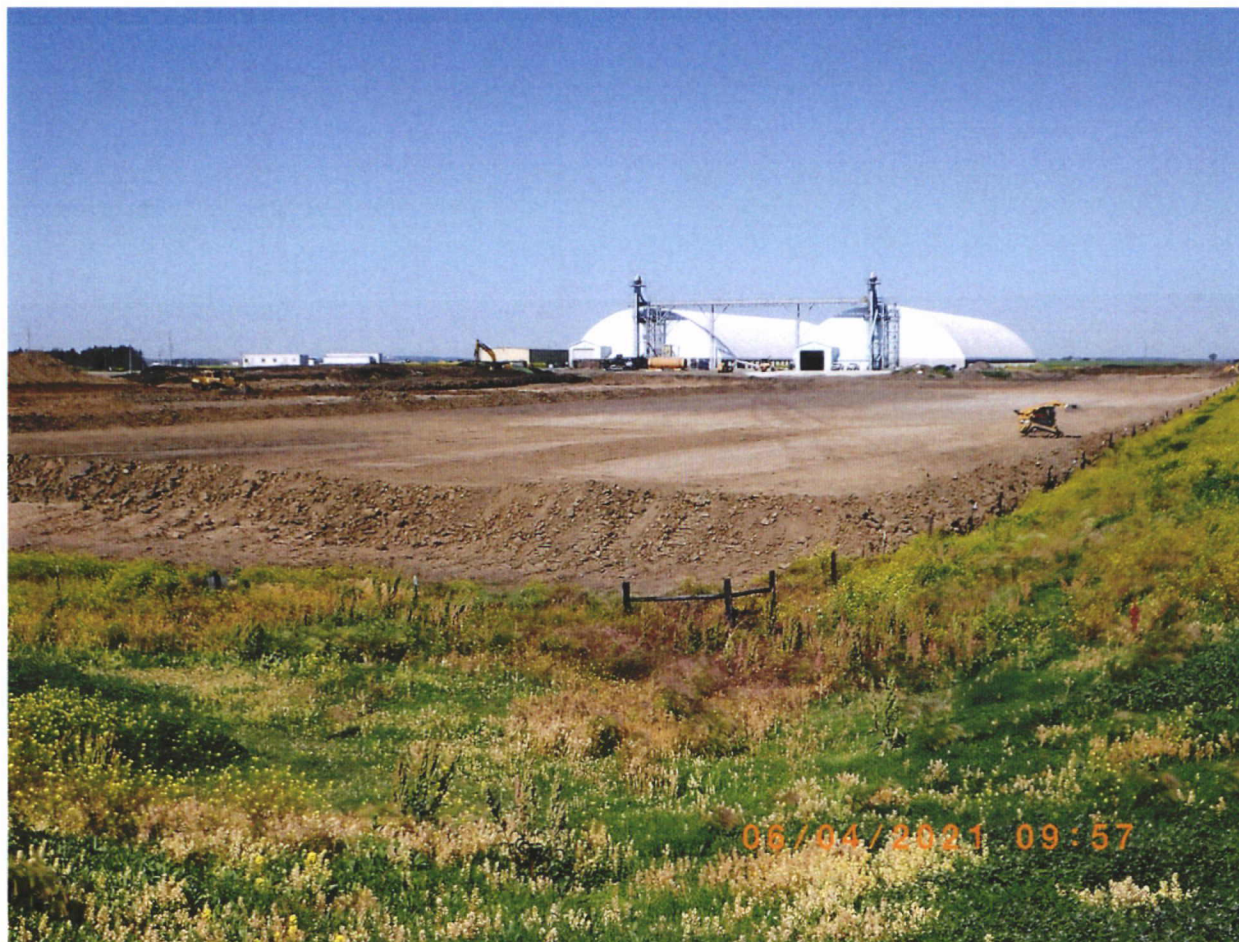
Photos: 11

Description: Area being stabilized south of the northwest lagoon. They will likely begin placing the geotextile fabric after June 7, 2021.

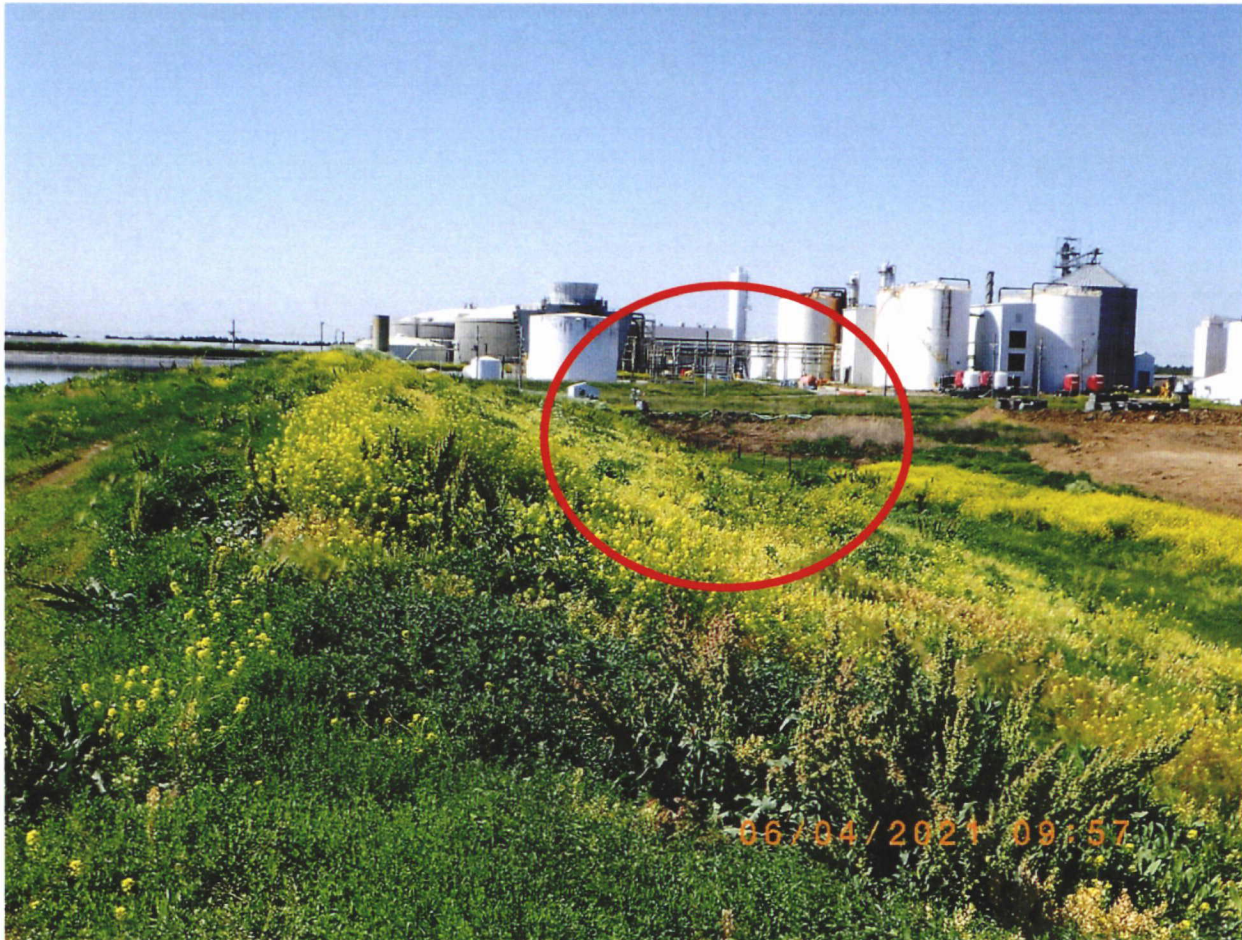
Photos: 12
Site Visit Report
Date Taken: 6-4-2021
Photographer: Jason Windhorst
Facility Name/ Project Name: AltEn LLC
Facility IIS number / Project identifier: IIS: 84069 / NE0137634
Location: Same as photo 11.
Direction Facing: South
Description: Area 2 on the site map pumped dry.

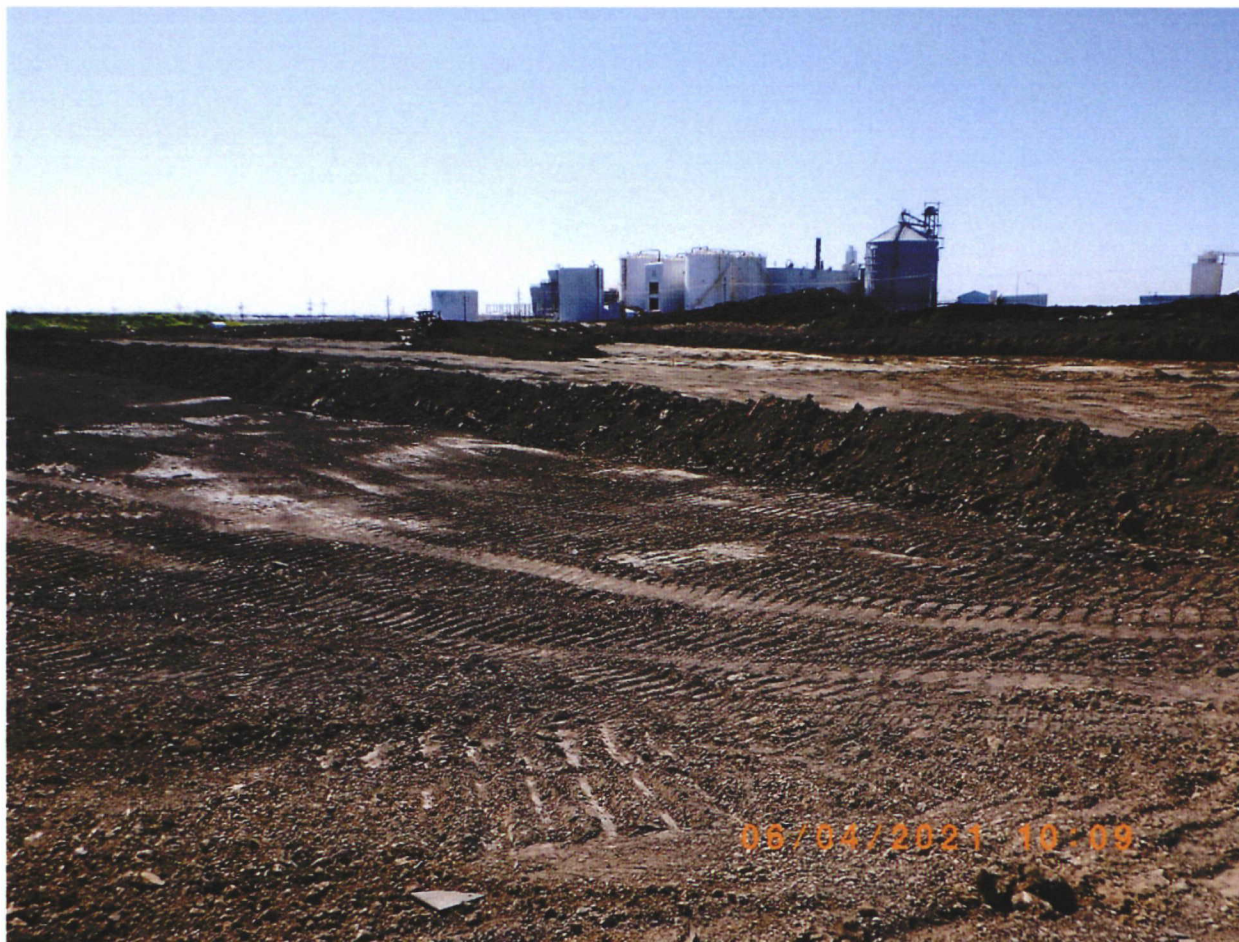
Photos: 13

Description: Pad preparation for Poseidon tank farm.

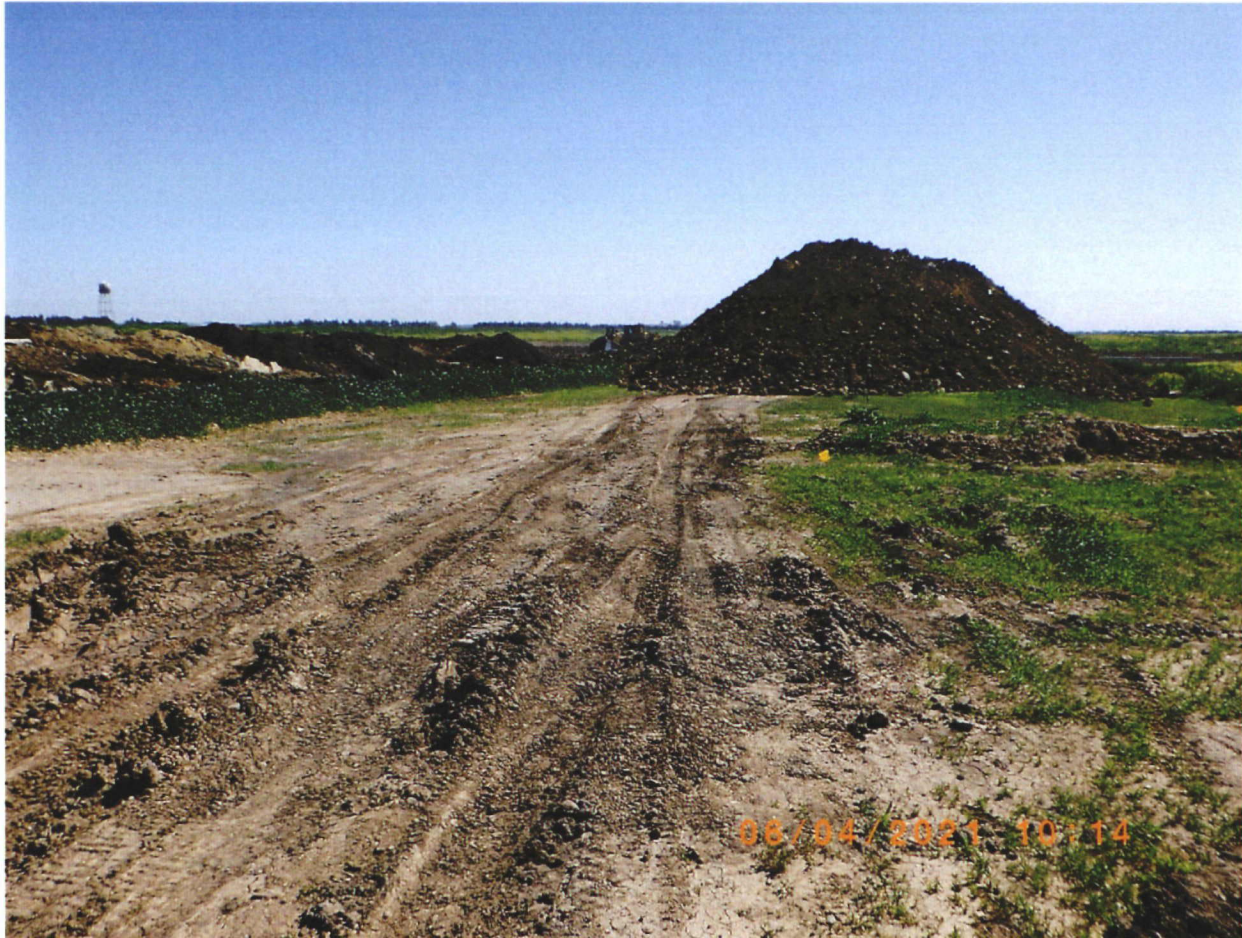
Photos: 14

- Clean Harbors continues to work on grading and stabilizing the area south of the northwest lagoon for the six pack - Poseidon tank farm.
- NDEE drone crew onsite today.
- Clean Harbors expressed concern regarding chemicals left inside the Process Building.
- Large pile of soil has been placed adjacent to the facility sanitary onsite system and may be covering part of the leach field.

Description: Bermed area for area 1 is now covered in large soil stockpile and possibly covering part of the sanitary onsite system. It is unknown if the runoff was pumped out after being comingled with wetcake seepage.

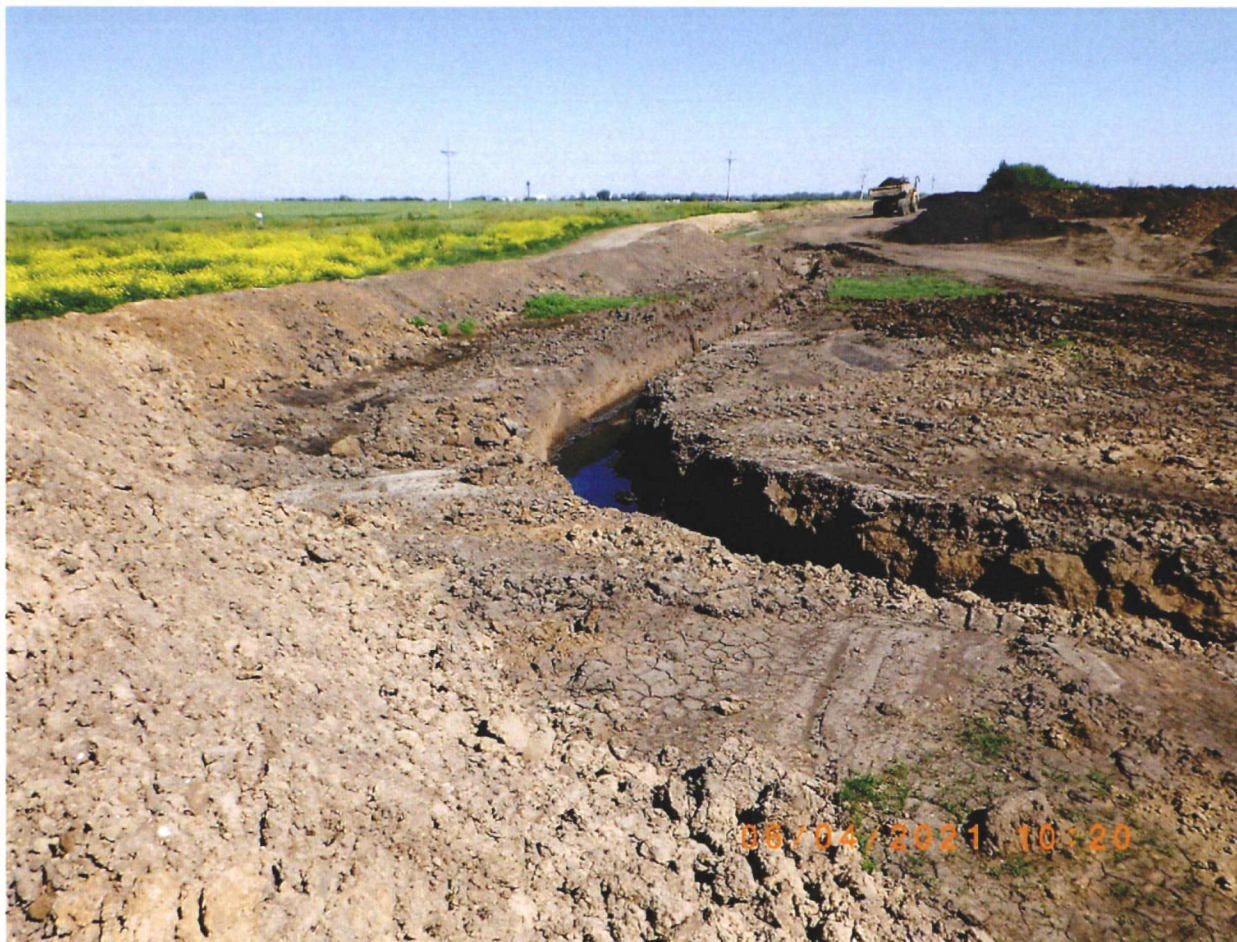
Photos: 15

Description: Ditch cut along berm to drain area 5 on the site map.

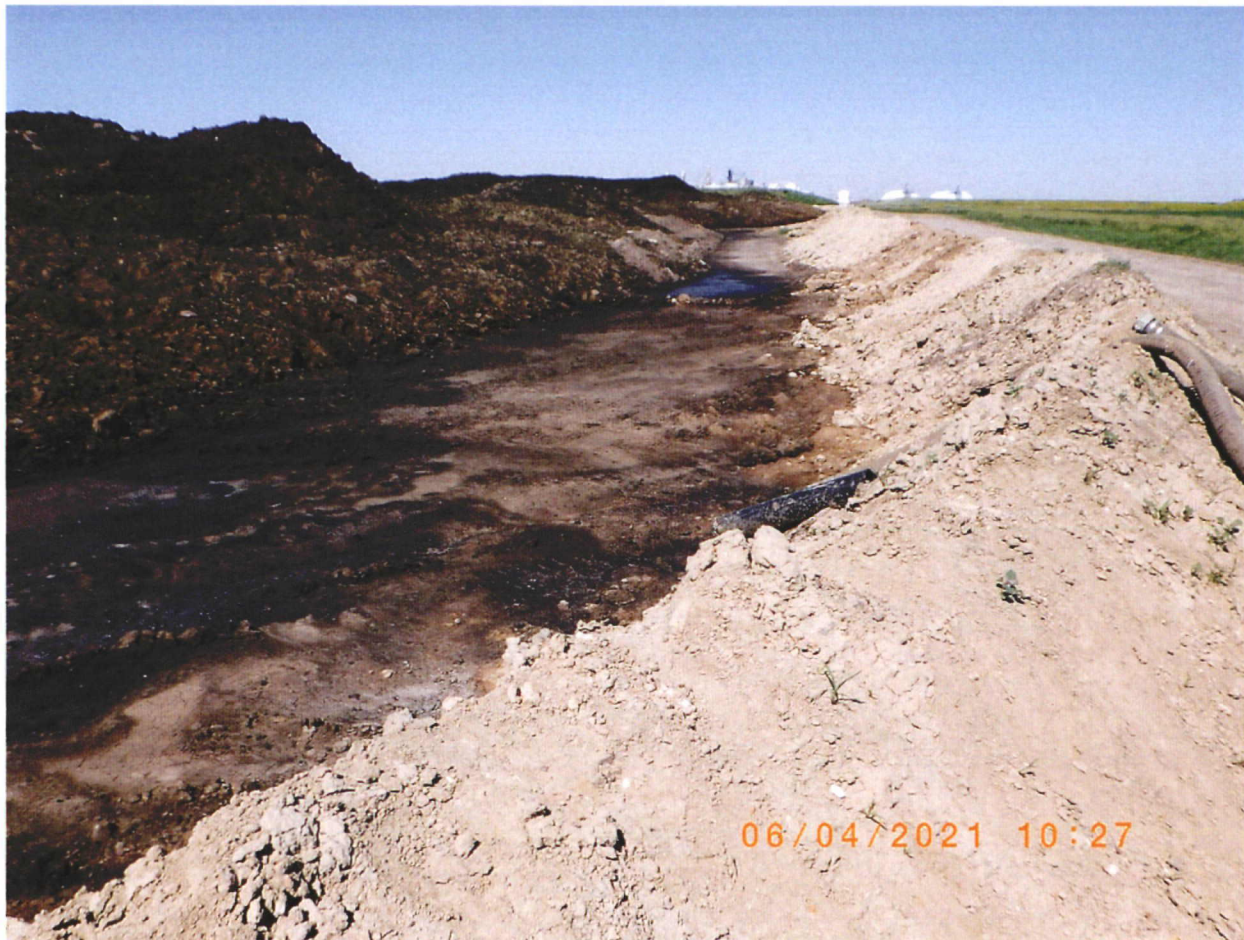
Photos: 16

Description: Photo showing runoff storage along the north side of the wetcake pile.

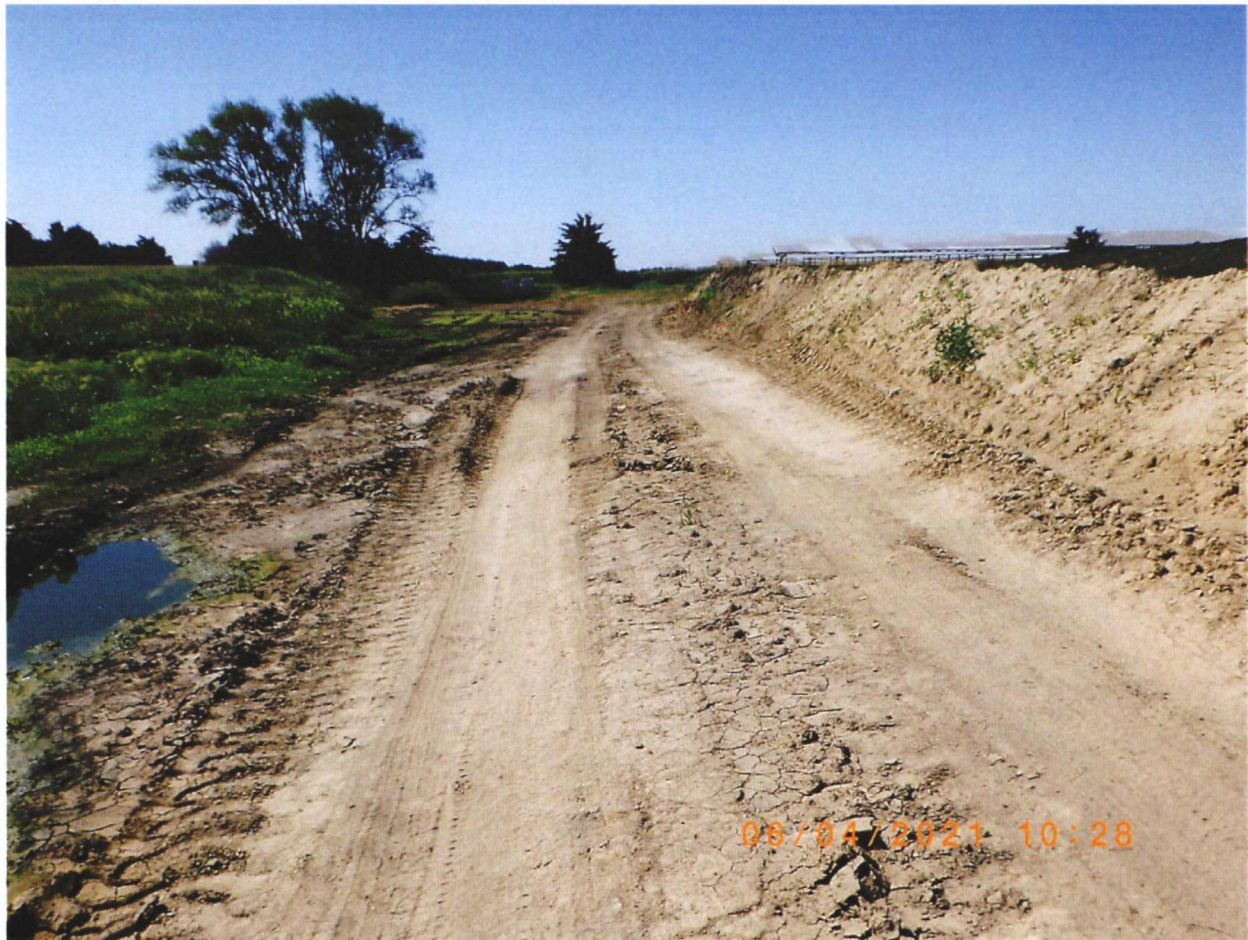
Photos: 17

Description: Partially recompacted berm area where seepage was present. The berm appears to be wheel rolled in the area there was seepage.

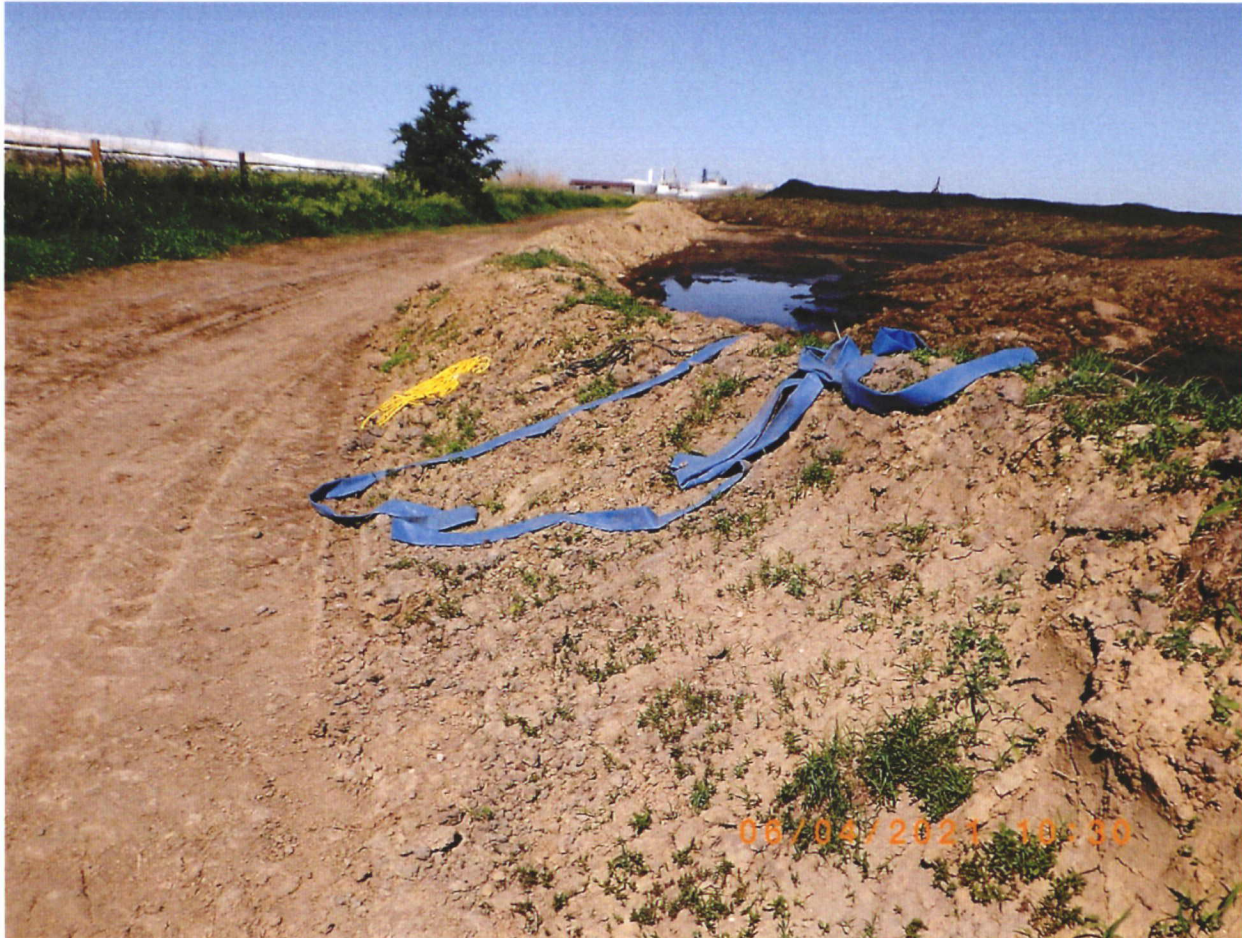
Photos: 18
Site Visit Report
Date Taken: 6-4-2021
Photographer: Jason Windhorst
Facility Name/ Project Name: AltEn LLC
Facility IIS number / Project identifier: IIS: 84069 / NE0137634
Location: Area 6 on the site map.
Direction Facing: West
Description: South edge of the wetcake storage area.

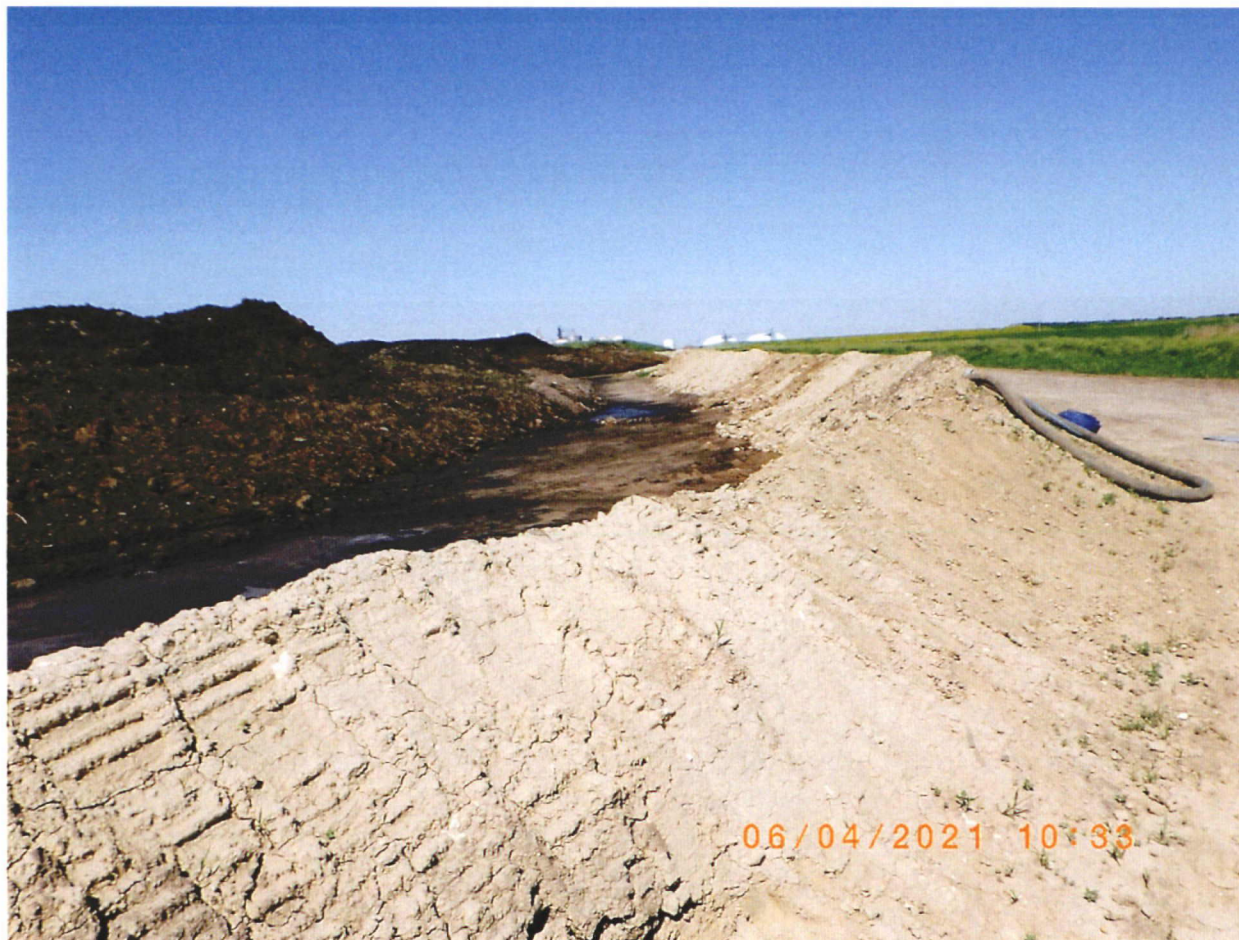
Photos: 19

Description: Southeast corner of the storage area showing storage space available.
