Facility: AltEn, LLC
IIS: 84069
PCS: NE0137634

Jason Windhorst
6/4/2021

Site Visit Check list

Site Visit Report

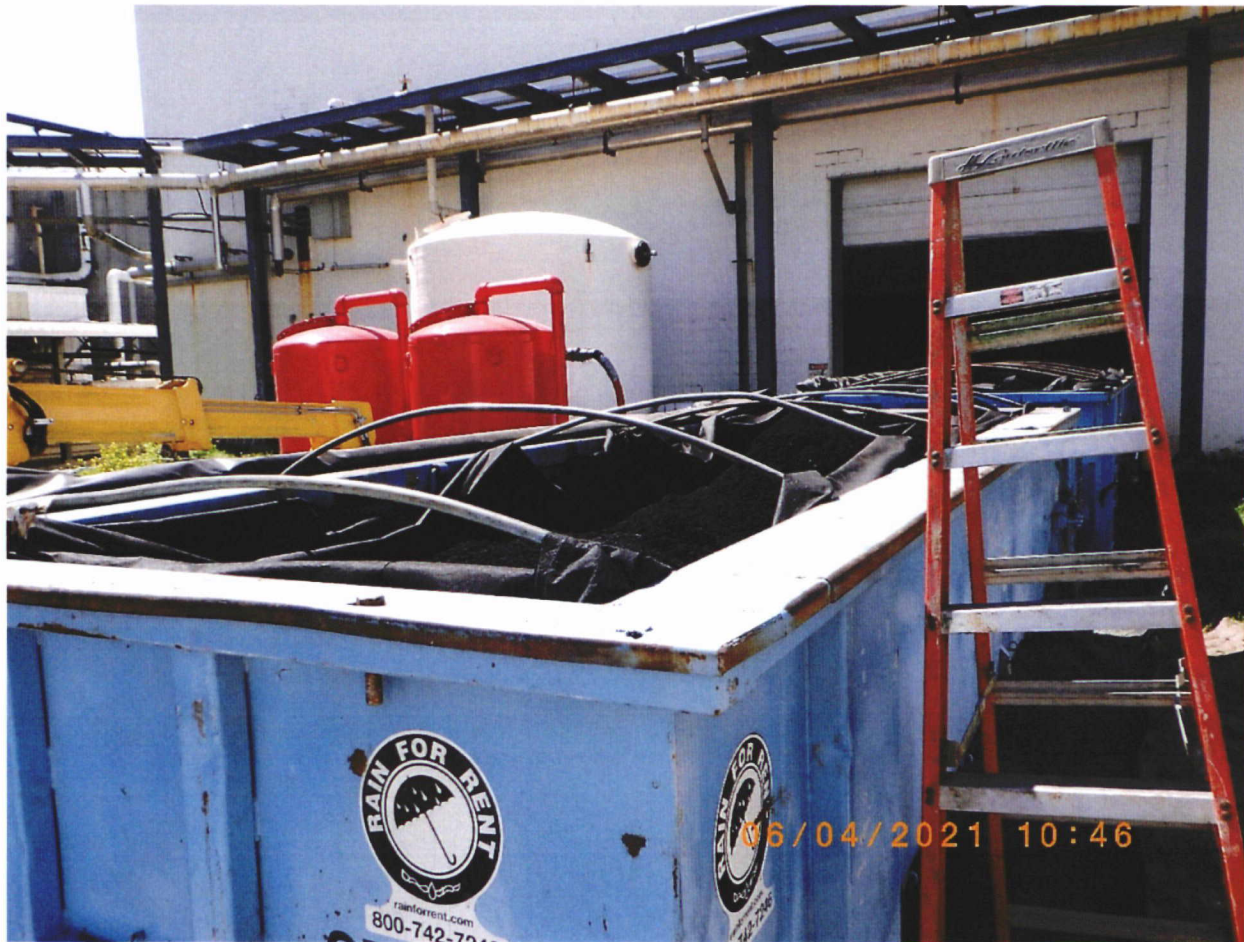
Photos: 20
Site Visit Report
Date Taken: 6-4-2021
Photographer: Jason Windhorst
Facility Name/ Project Name: AltEn LLC
Facility IIS number / Project identifier: IIS: 84069 / NE0137634
Location: North side of the resource recovery building
Direction Facing: South
Description: Roll-off used for spent carbon removed from AltEn's carbon filter system.

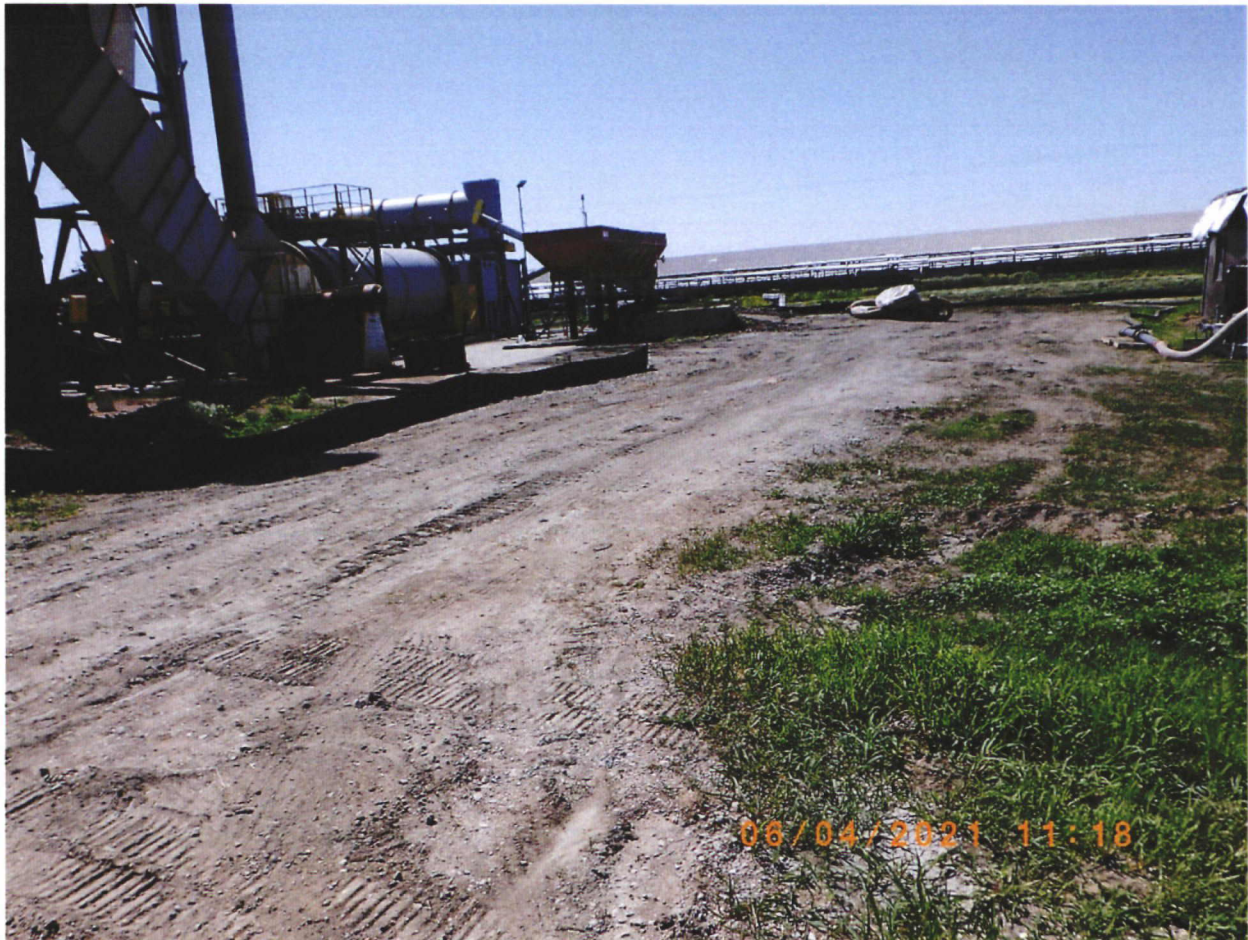
Photos: 21

Description: Containment (silt fence) in place around the entire area except for loading area where Clean Harbors will place wattles.

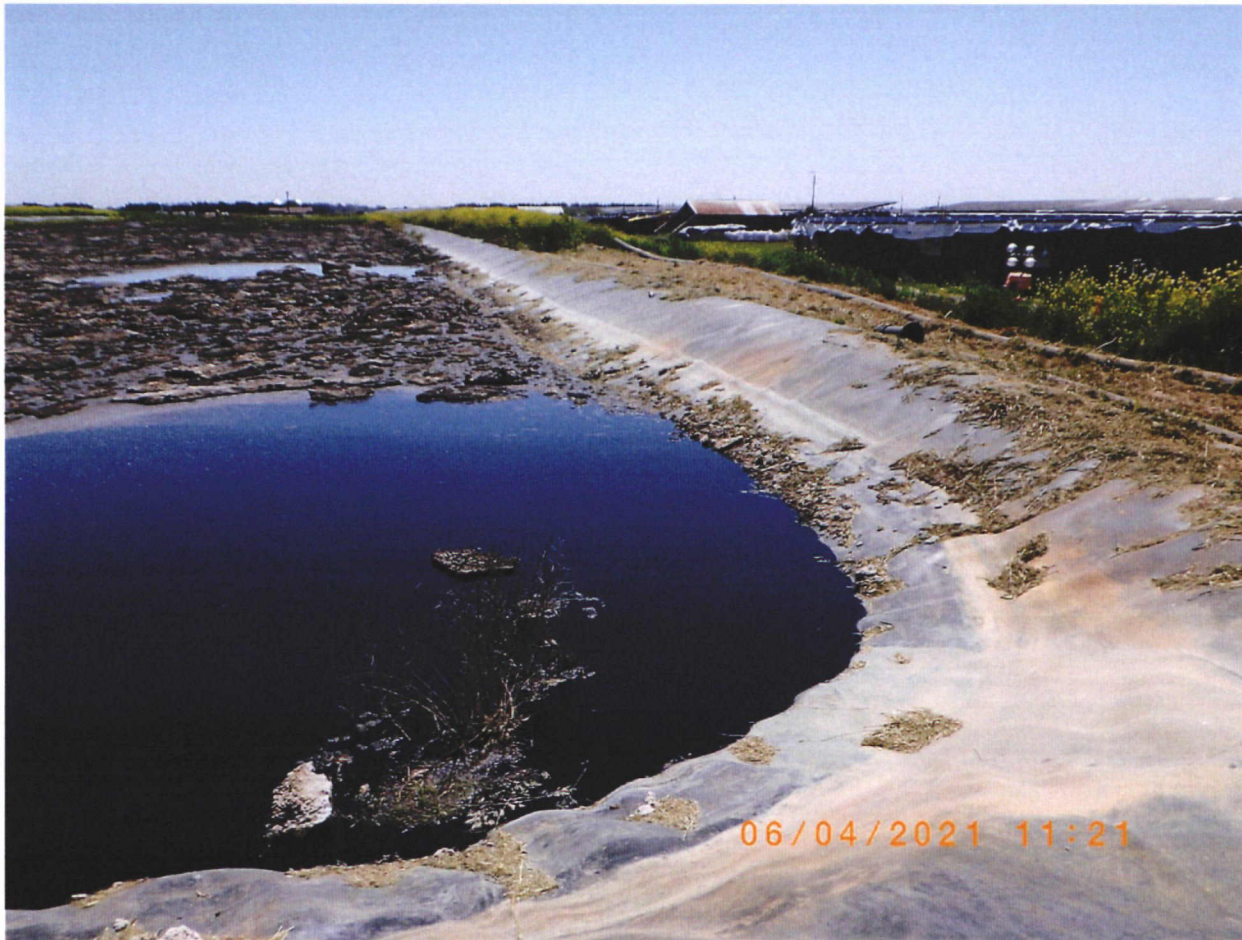
Photos: 22

Description: Photo depicts lowered lagoon level and partial vegetation removal along the south side of the lagoon.

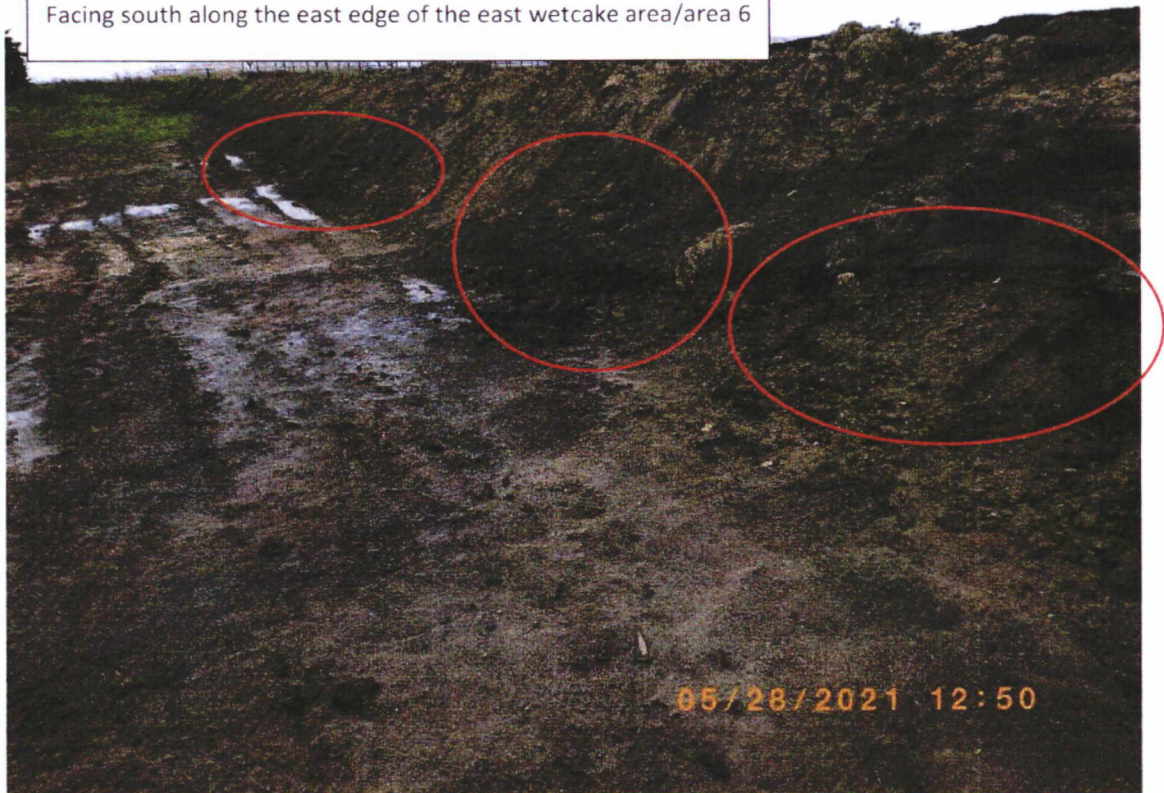
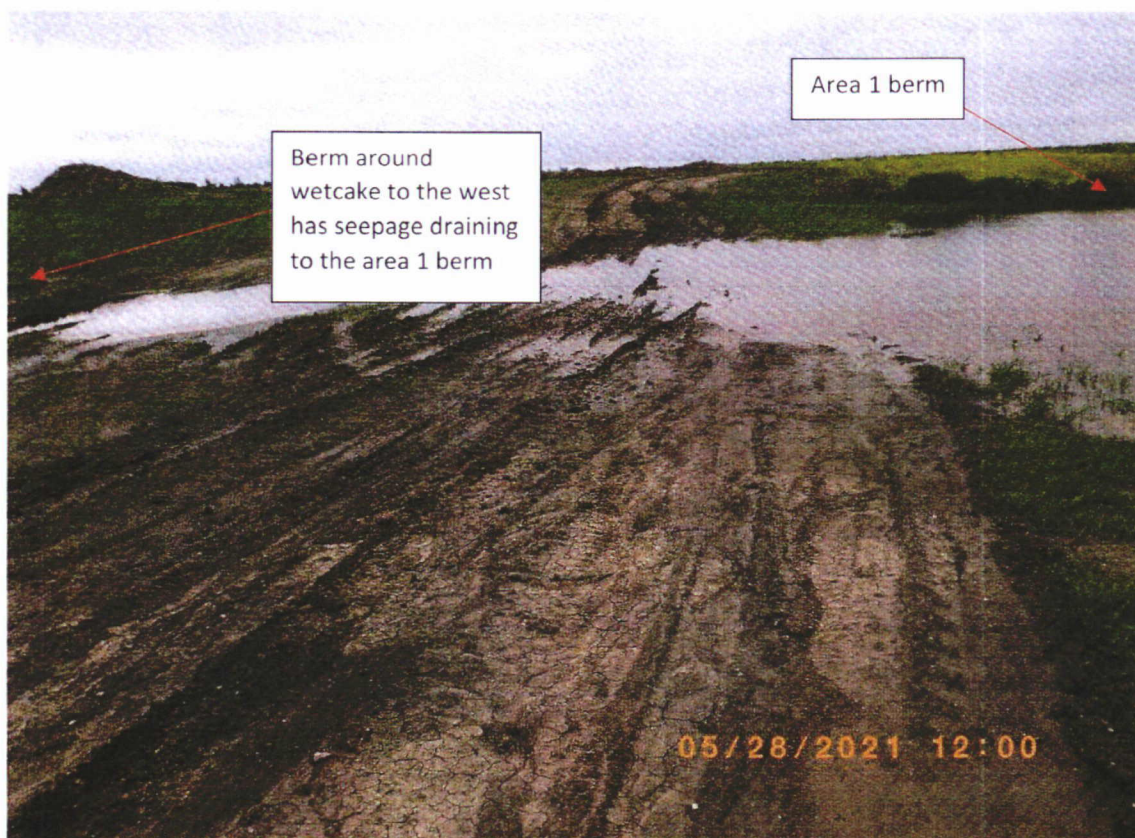
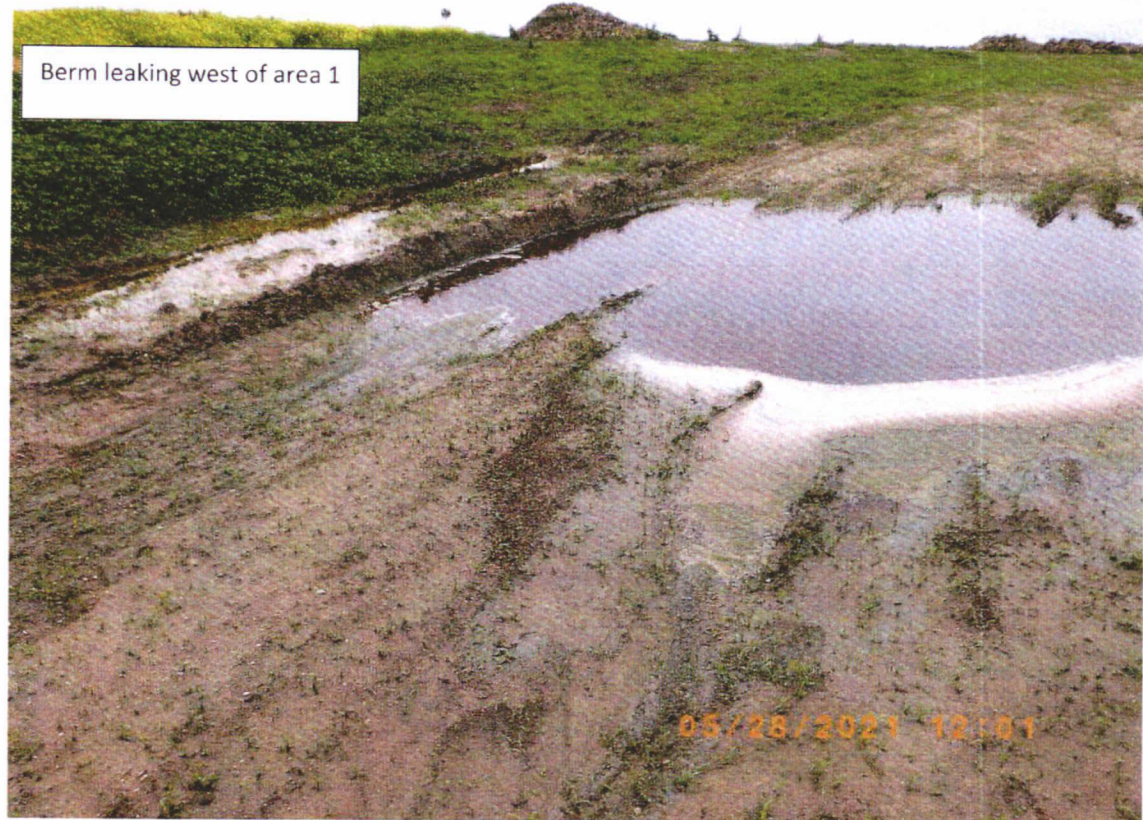
Area 1 - Getting seepage from water tank the west it should be pumped
2 - Berm good & runoff being pumped
3 - Berm good & no concerns
4 - Berm good & no concerns
5 - Berm good & no concerns
6 - multiple areas of seepage collecting down
gradient towards drainage ditch.

Facing south along the east edge of the east wetcake area/area 6

- repair berms along east side of area 6
seepage is collecting in pools & can potentially
be discharge in next rain event.
