Facility: AltEn, LLC
IIS: 84069
PCS: NE0137634

Mark Pomajzl
6/1/2021

Site Visit Report

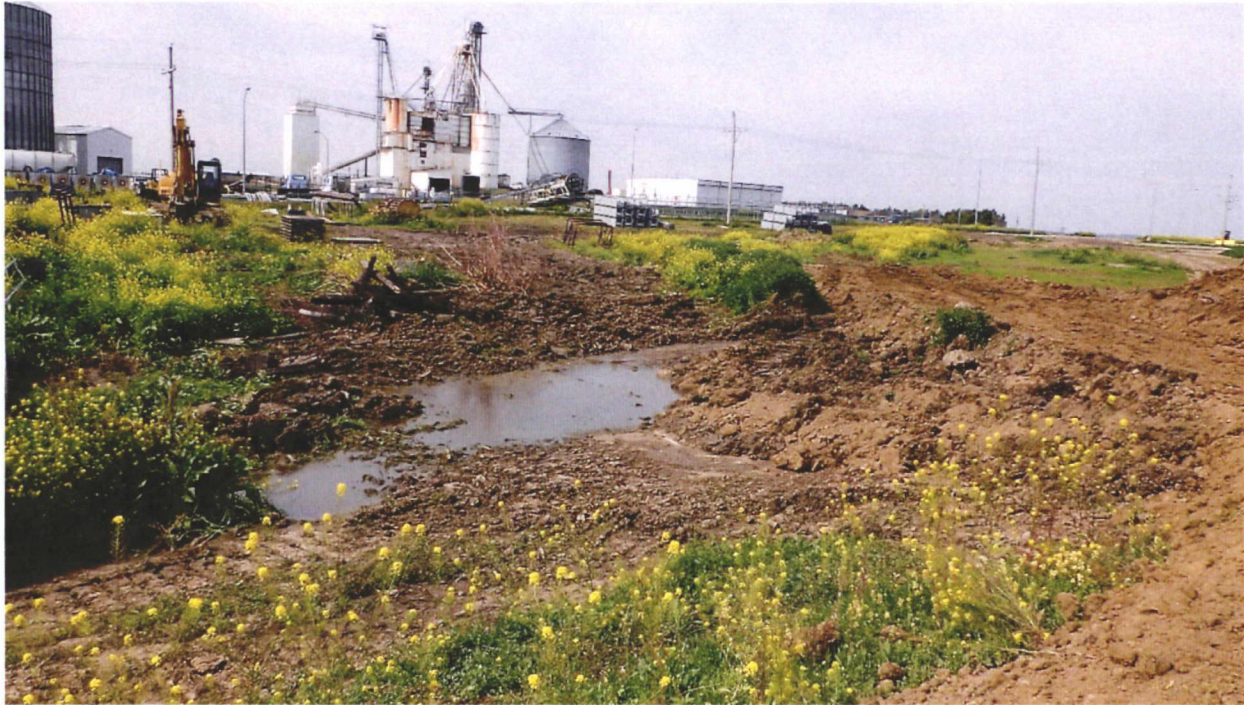
Photo: 1

- Area 1 contains two berms. The original berm is being taken out. There is slurry water on the east side of the berm. It appears that some of the water has exited the area along the chain link fence which drains east of the facility, photos 1, 2 and 3.
- Areas 2: minor water accumulation.
- Area 3: seepage observed.
- Area 4 is in good condition. No seepage observed.
- Area 5 is in good condition. No seepage observed.
- Area 6: The 5-28-21 site visit observed seepage. Clean Harbors pumped 12,000 gallons from this berm. There is still minor seepage observed.

Description: This is the original east berm. The previous site visit requested that this area be pumped. Photo 2 depicts green water along the fence leading to area 2.

Area 1 – It appears that the Clean Harbors did not remove water from Area 1. Clean Harbors has added some material but by doing this has pushed water on the east side. (Mr. Windhorst request that the area be pumped (5-28-21)).

- Pump water from the area 1 berm.
- Mow vegetation around the lagoon system and around the facility, it is becoming a safety concern.
- Install additional silt fence around the biochar to control spilled biochar product.

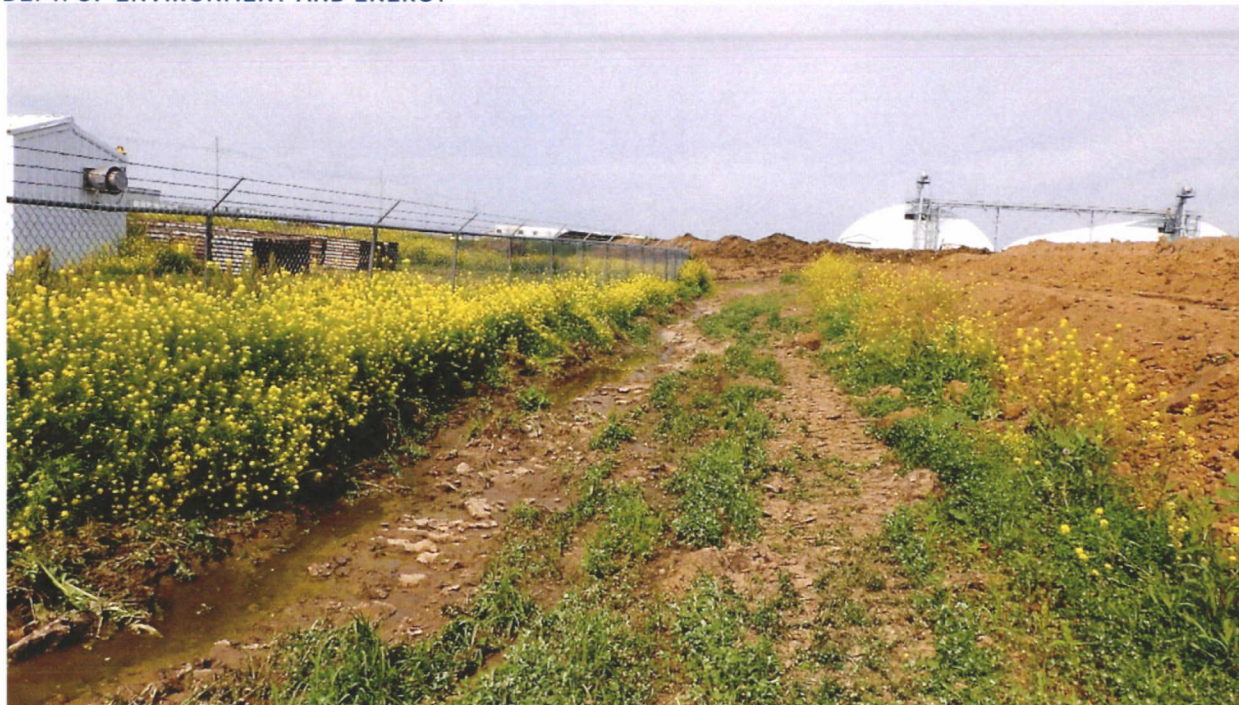
Photo: 2

Description: This photo depicts green water along the fence heading toward area 2. I am standing on the east side of fence which is better depicted in photo 3.

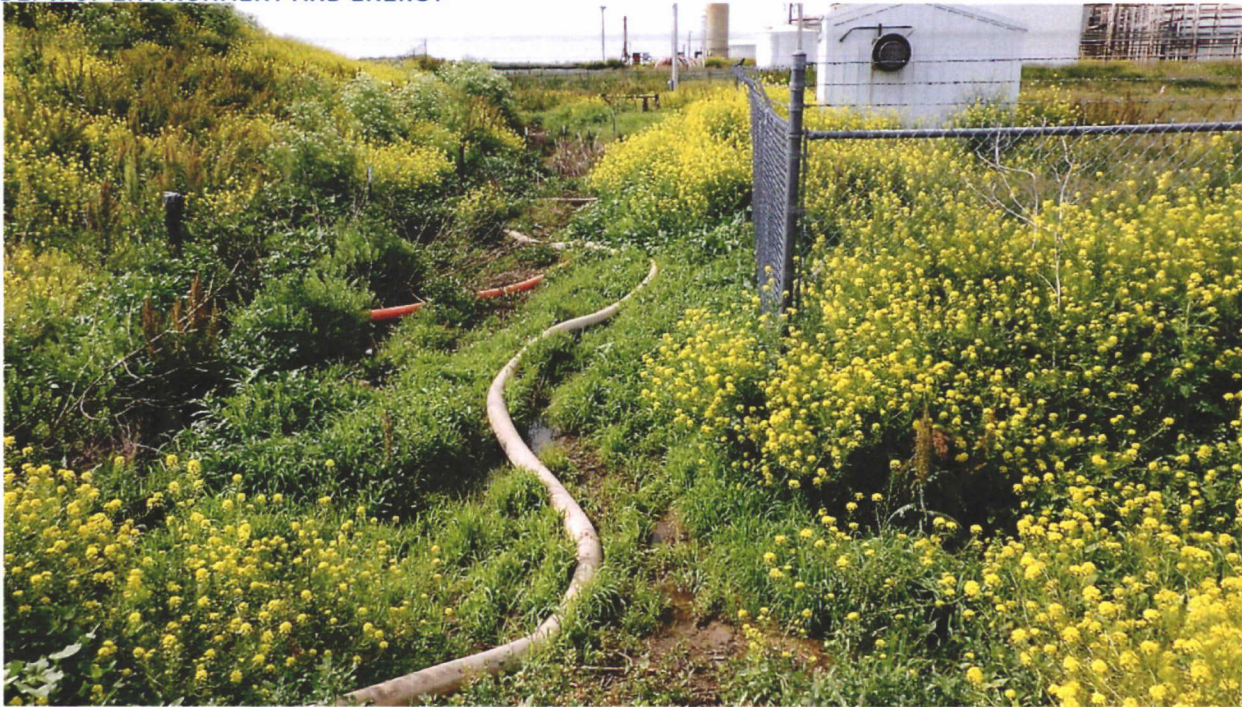
Photo: 3

Description: This photo depicts that the water from photos 1 and 2 drain to this area. There is no berm to collect this water. The facility will need to collect this water.

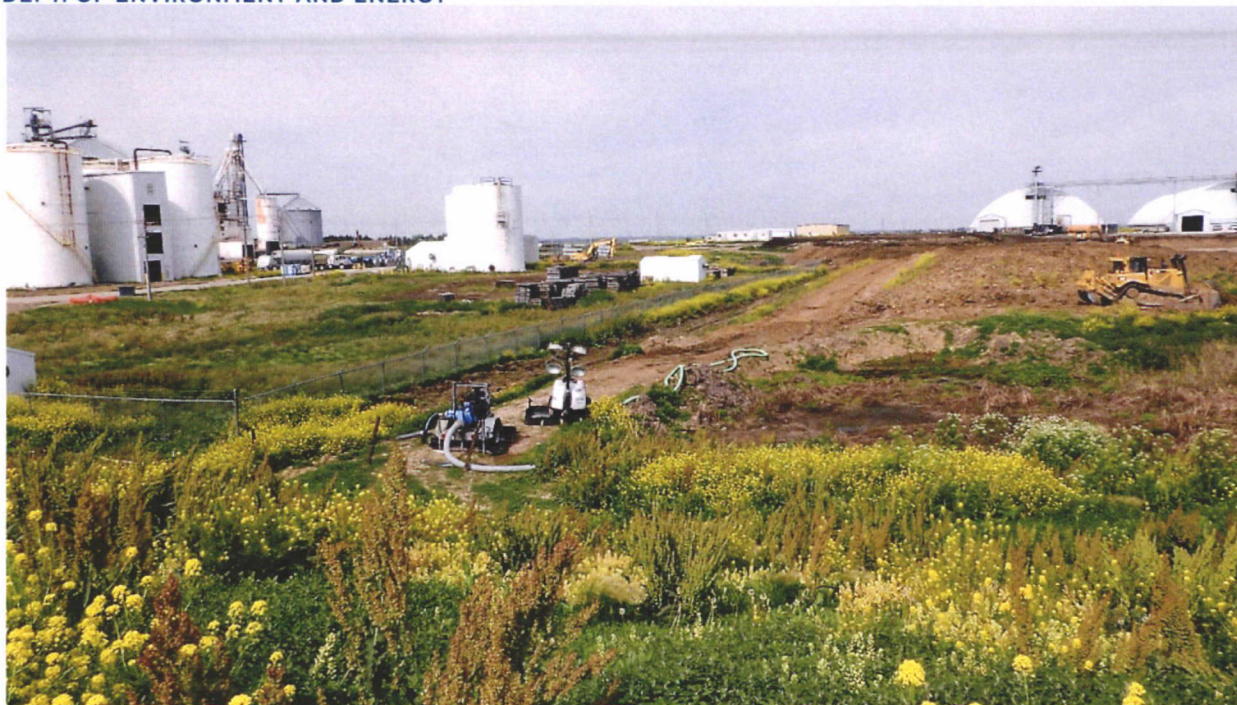
Photo: 4

Description: This photo depicts the pumping station for area 2

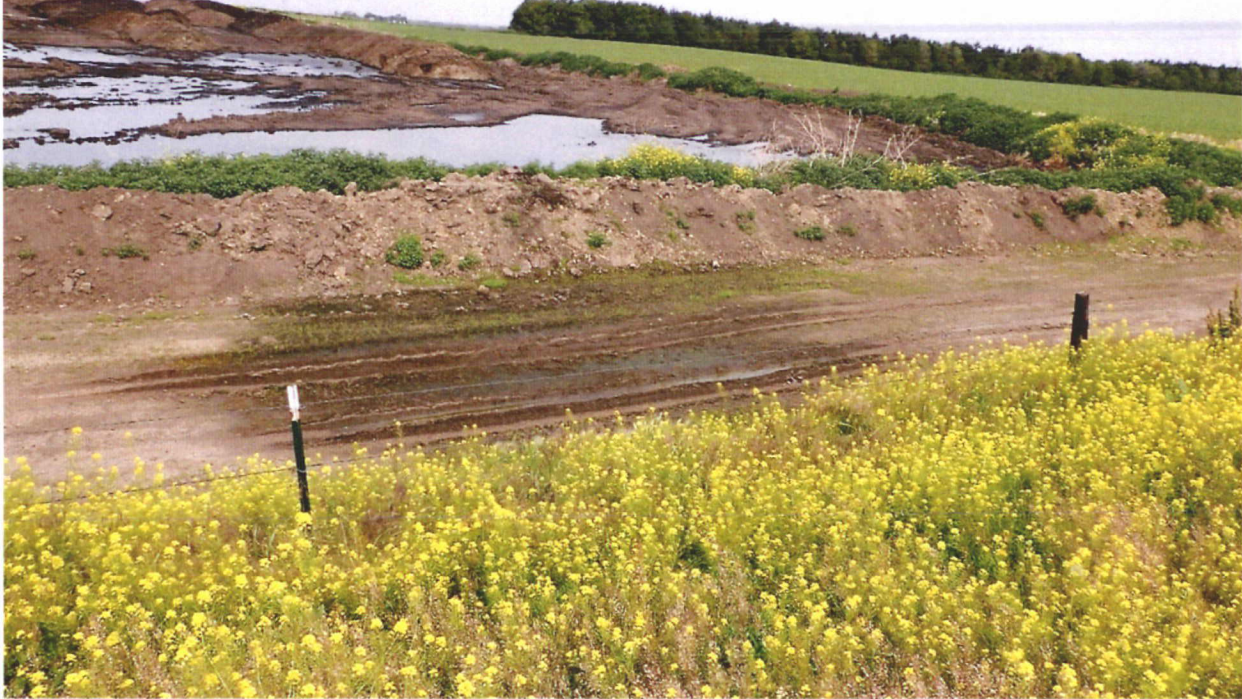
Photo: 5

Description: This photo depicts seepage on area 3.

Area 3 – seepage observed

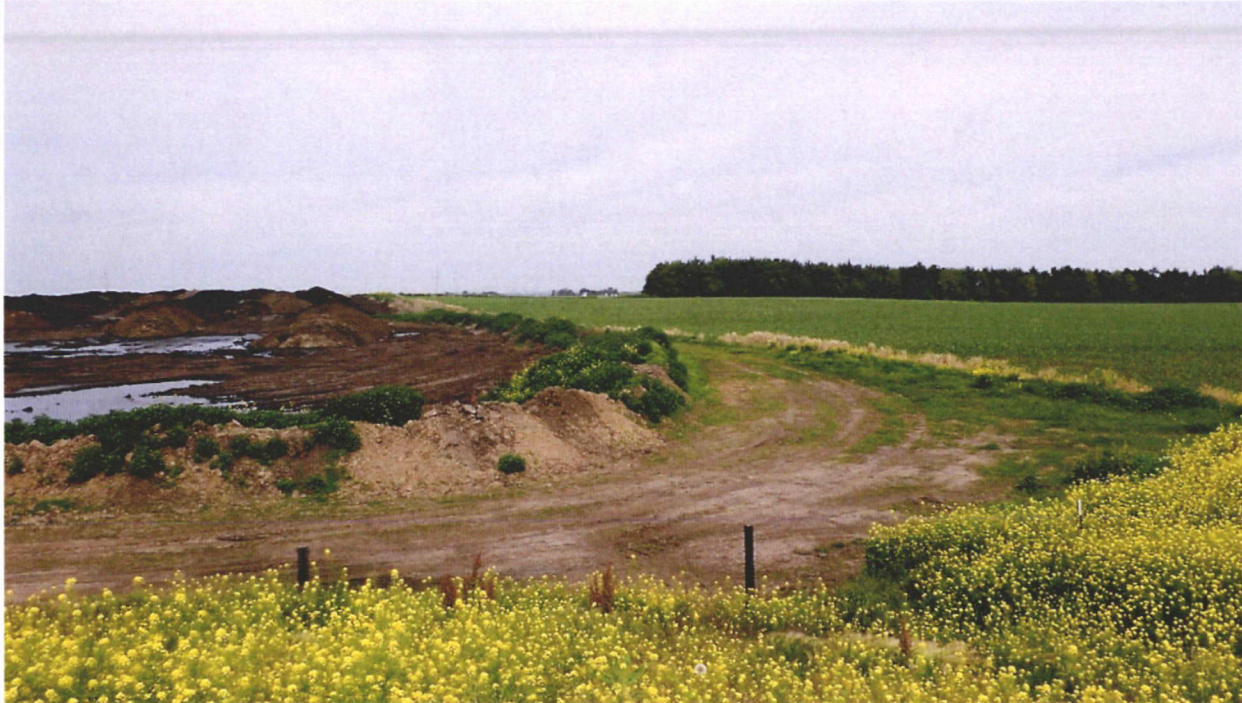
Photo: 6

Description: This photo depicts back side of area 3.

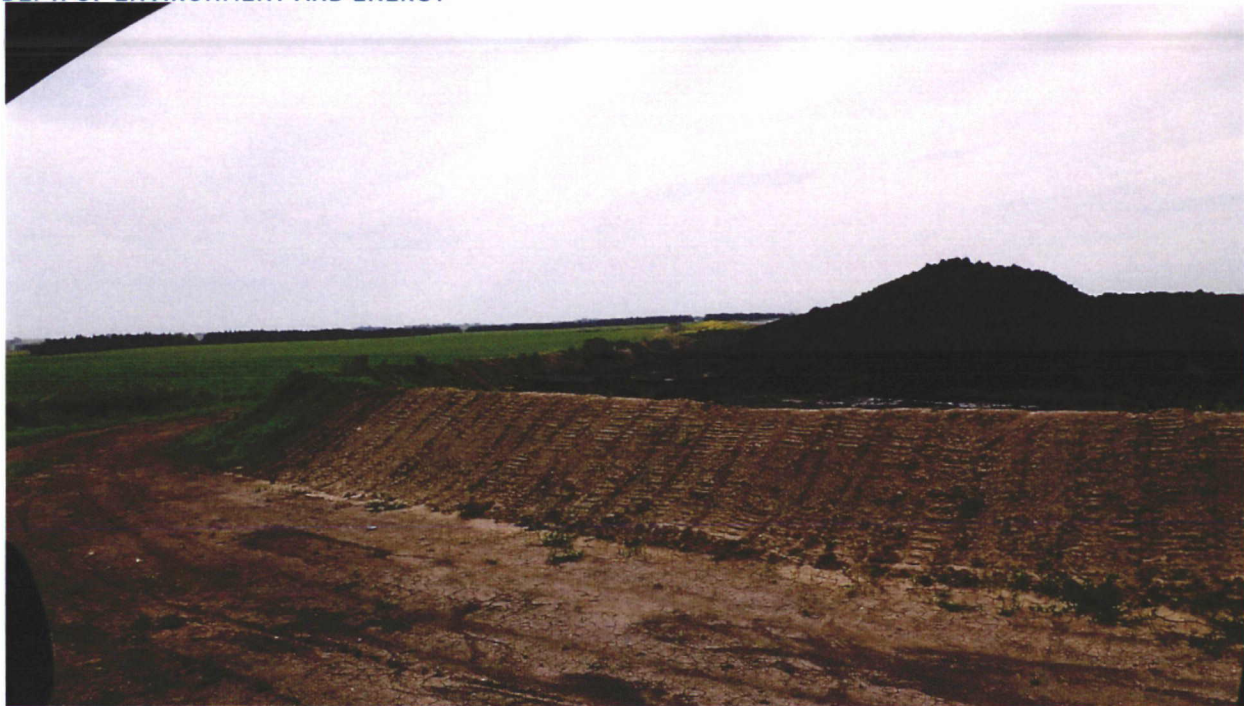
Photo: 7

Description: This photo depicts the berm along area 4. There is no seepage observed.

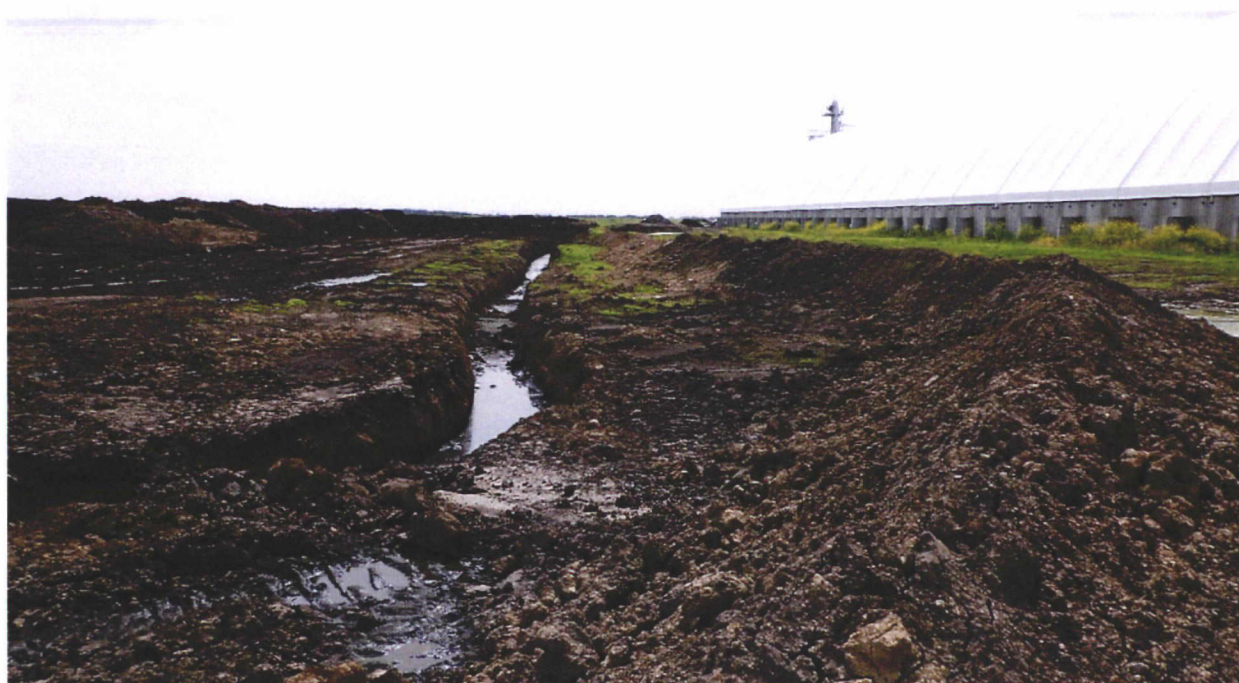
Photo: 8

Description: This photo depicts the trench used to convey water from area 5 to area 2.

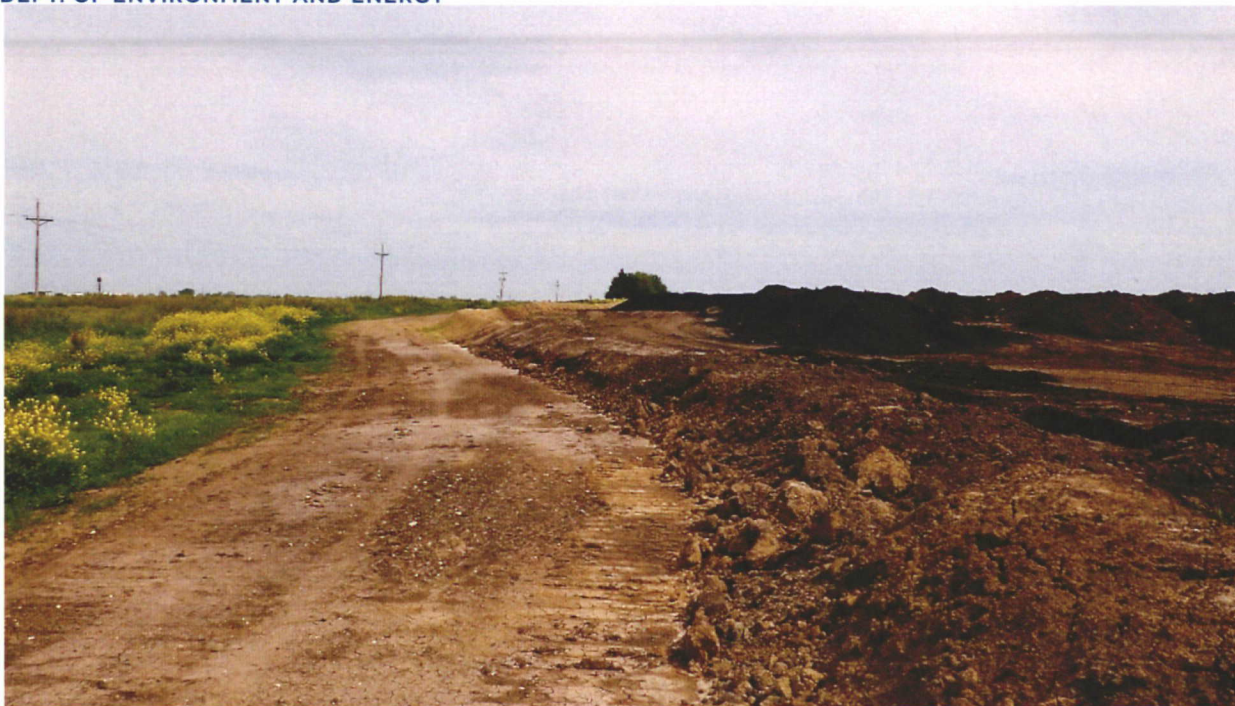
Photo: 9

Description: Area 4 and 5 are now connected.

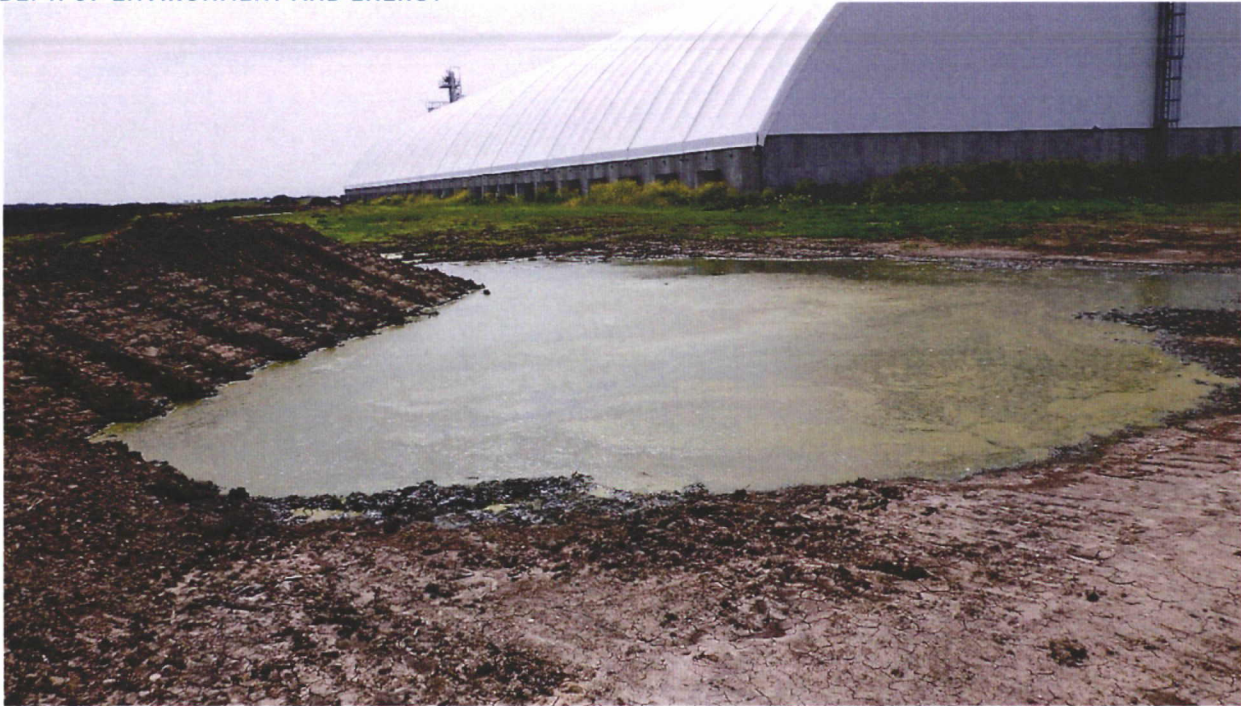
Photo: 10

Description: This photo depicts green water on the outside of the area 5 berm. This water is accumulated from runoff which includes the hoop building.

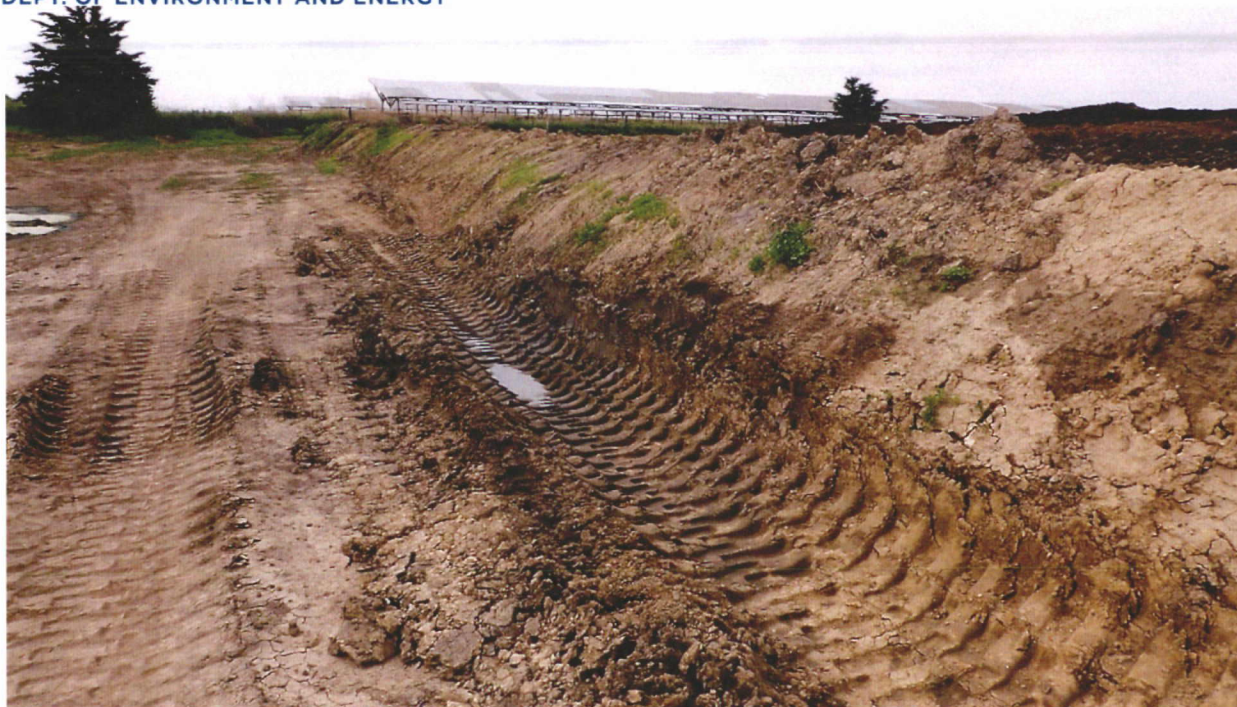
Photo: 11

Description: This photo depicts seepage from the south side of area 6.

Area 6 – seepage observed

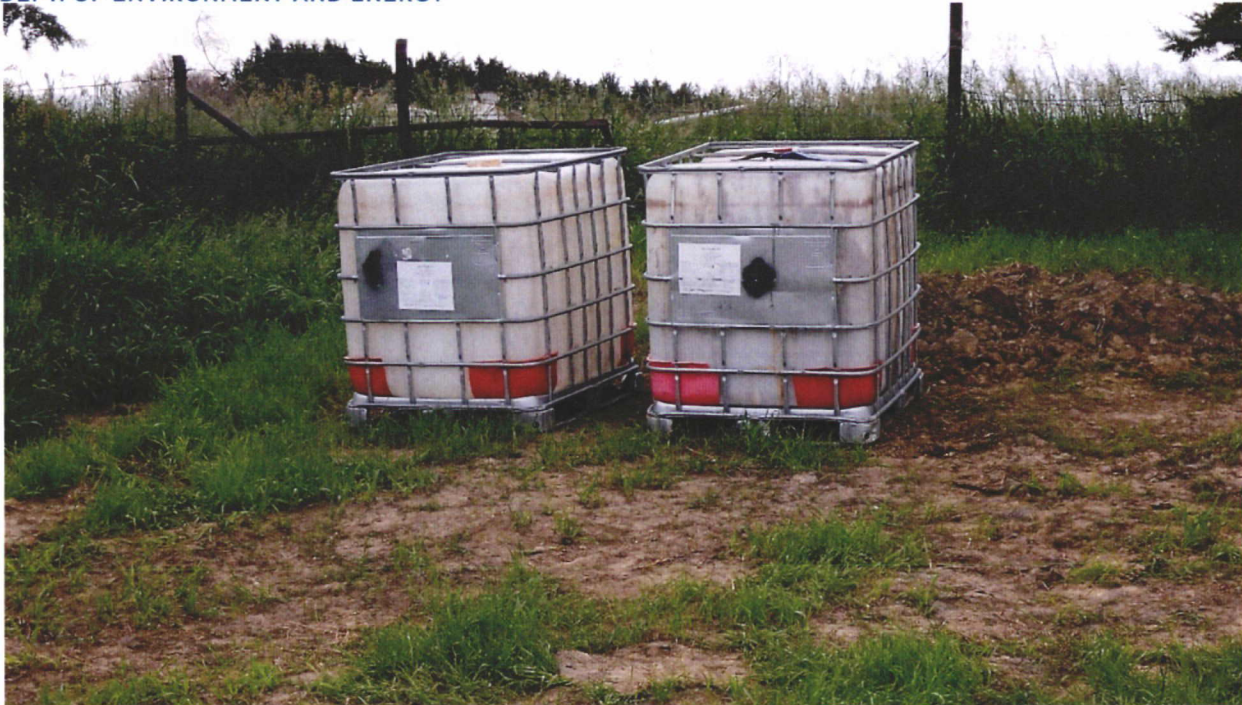
Photo: 12

Description: These are totes used to transfer water from area 6 to the emergency lagoon.

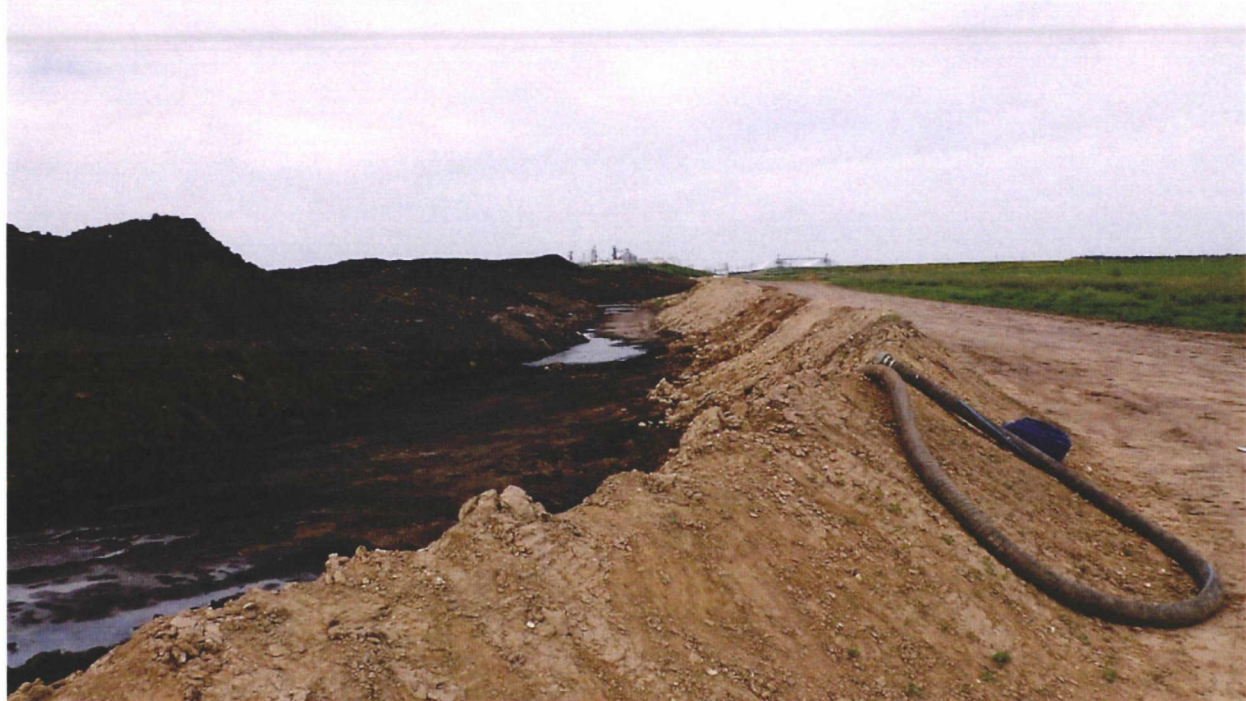
Photo: 13

Description: Hose used to transfer water from the area 6 berm. Staff stated they removed 12, 000 gallons from the area recently.

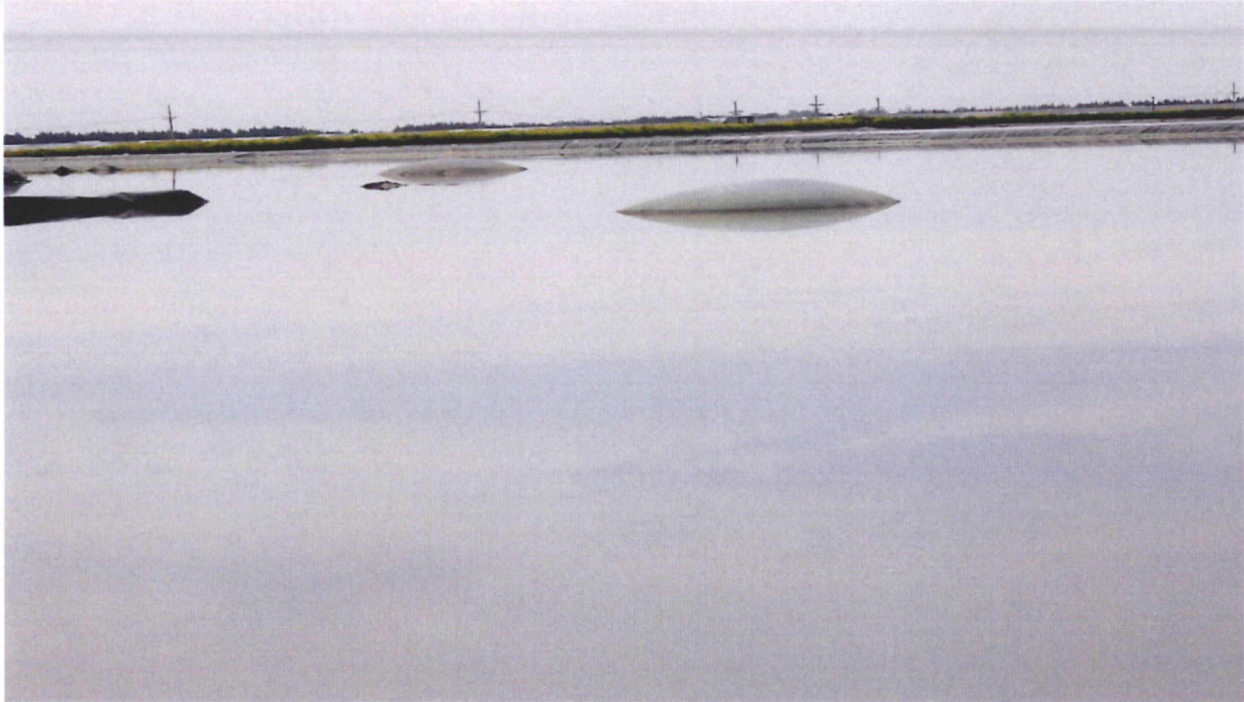
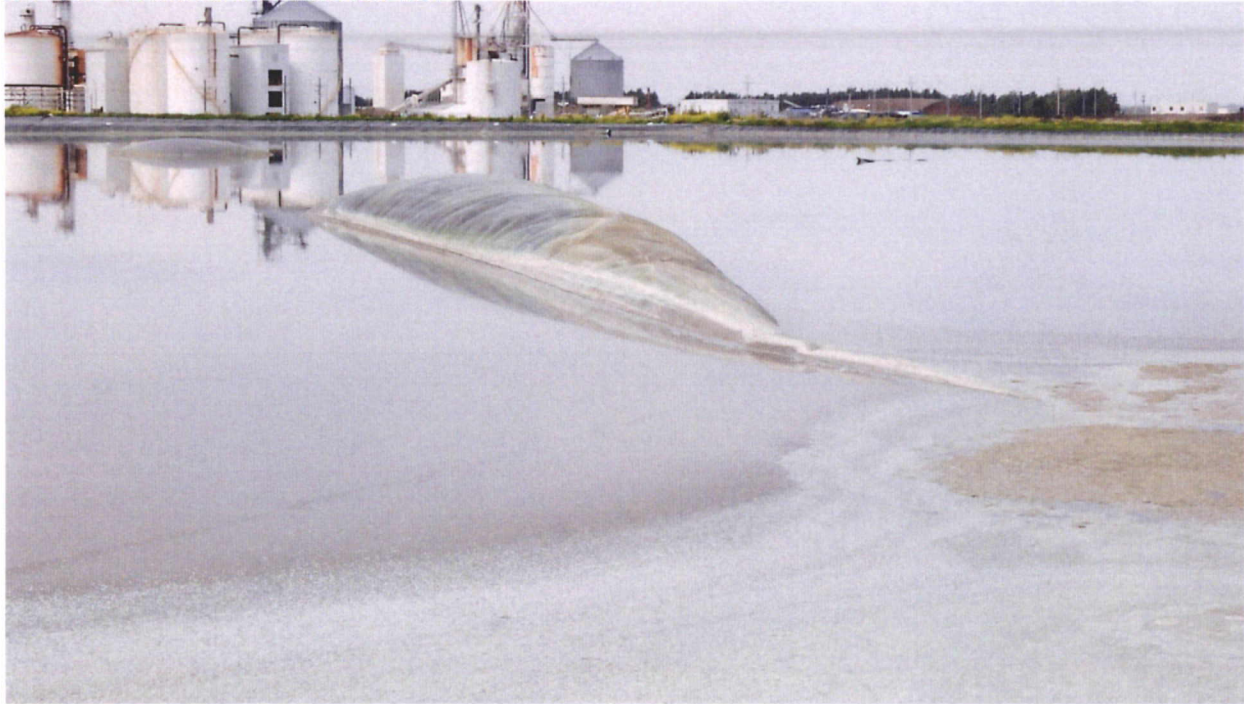
1. Northeast lagoon
 - No change with the liners. The lagoon is releasing gas in multiple locations.
 - Vegetation is growing fast around the lagoon. Vegetation is becoming a tripping and falling hazard
2. Northwest lagoon
 - Vegetation is growing fast.
 - No change in the liners.

Description: This photo depicts floating liners in the northeast lagoon.

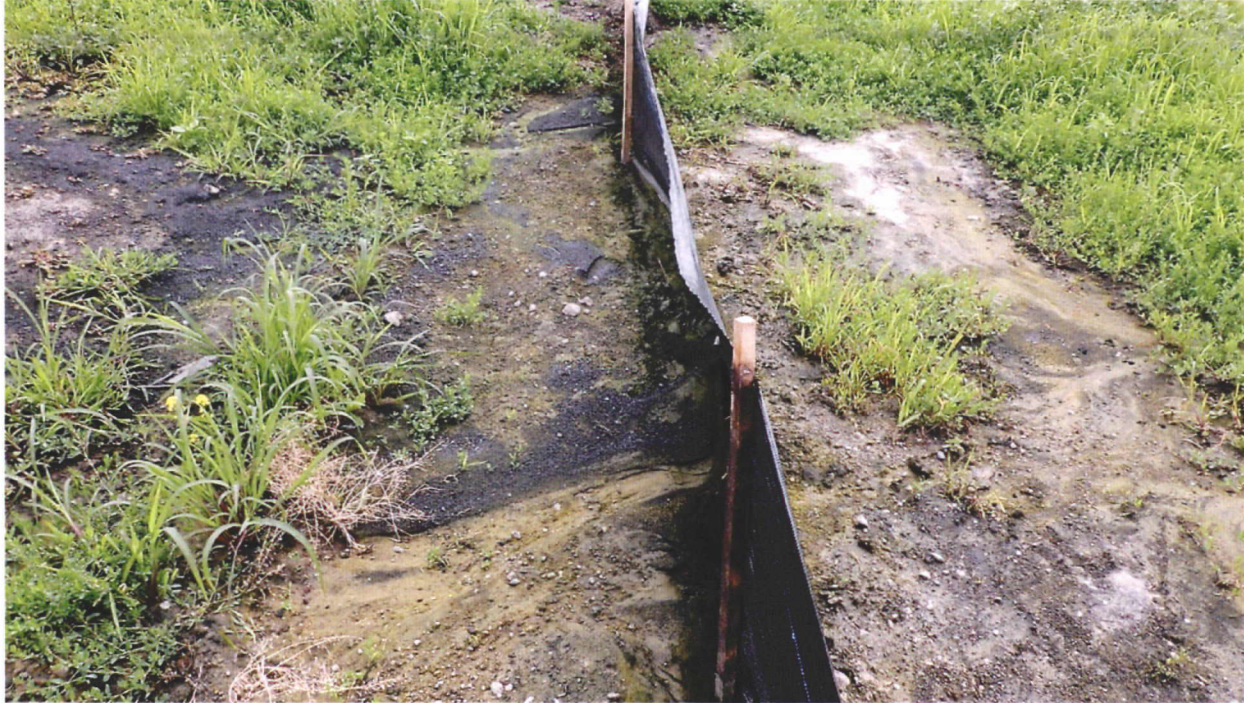
Photo: 20

Description: Newly installed silt fence. The recent rain event washed into the silt fence. The fence held some debris but now needs to be maintained.

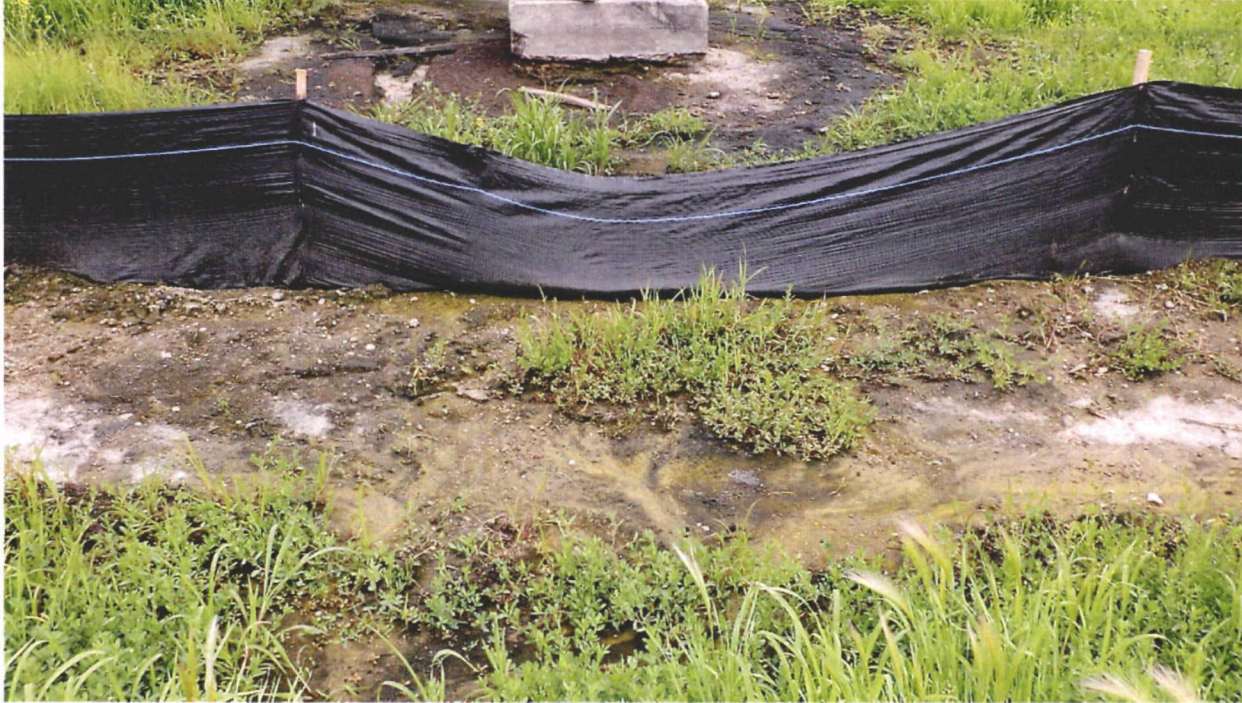
Photo: 21

Description: Newly installed silt fence. The recent rain event washed into the silt fence. This photo depicts silt pushing on the front side. This indicates the fence is working but will need to be cleaned

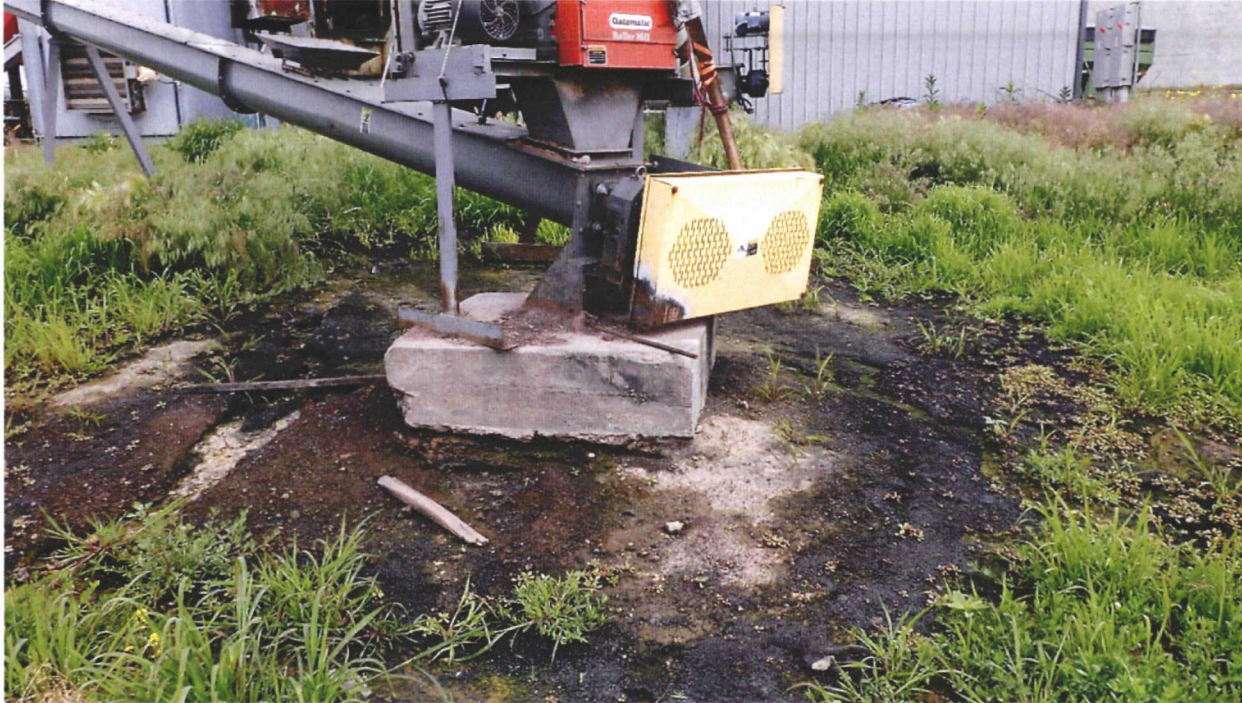
Photo: 22

Description: This is the auger used to transport biochar to bagging area. The auger would spill product causing these piles. Rain causes this product to wash into the silt fence depicted in photo 21.

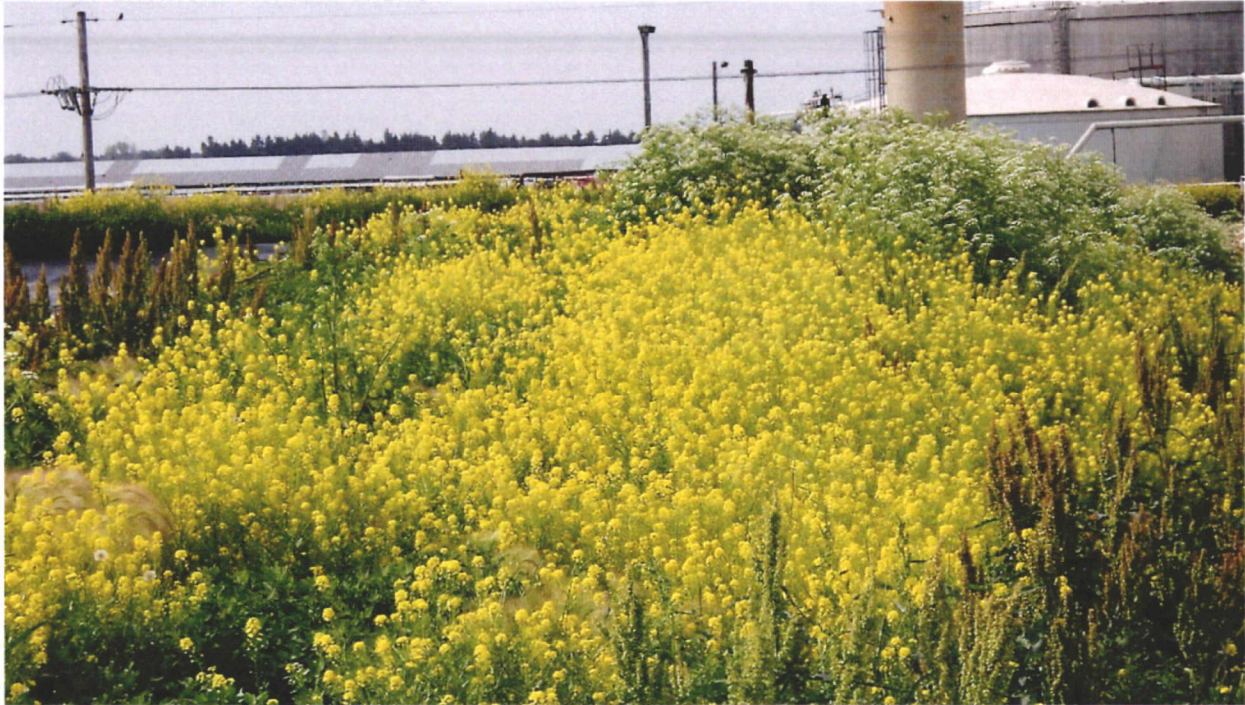
Photo: 24

Description: This is vegetation along the west dike of the south lagoon. The vegetation is above chest level in places.

• **Vegetation** is growing fast around the lagoon system. The inspector tripped this morning over the orange hose use to transfer water. This is along the west side of the south lagoon. (not injured)

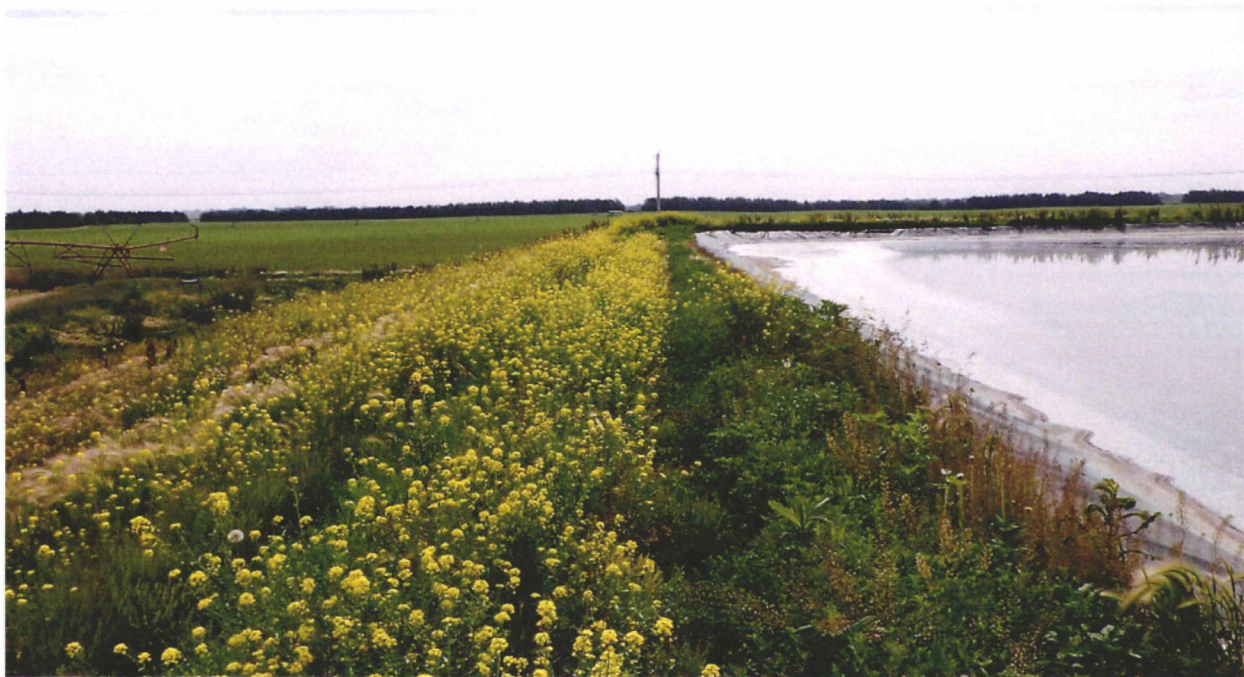
Photo: 25

Description: This photo depicts vegetation along the north dike.

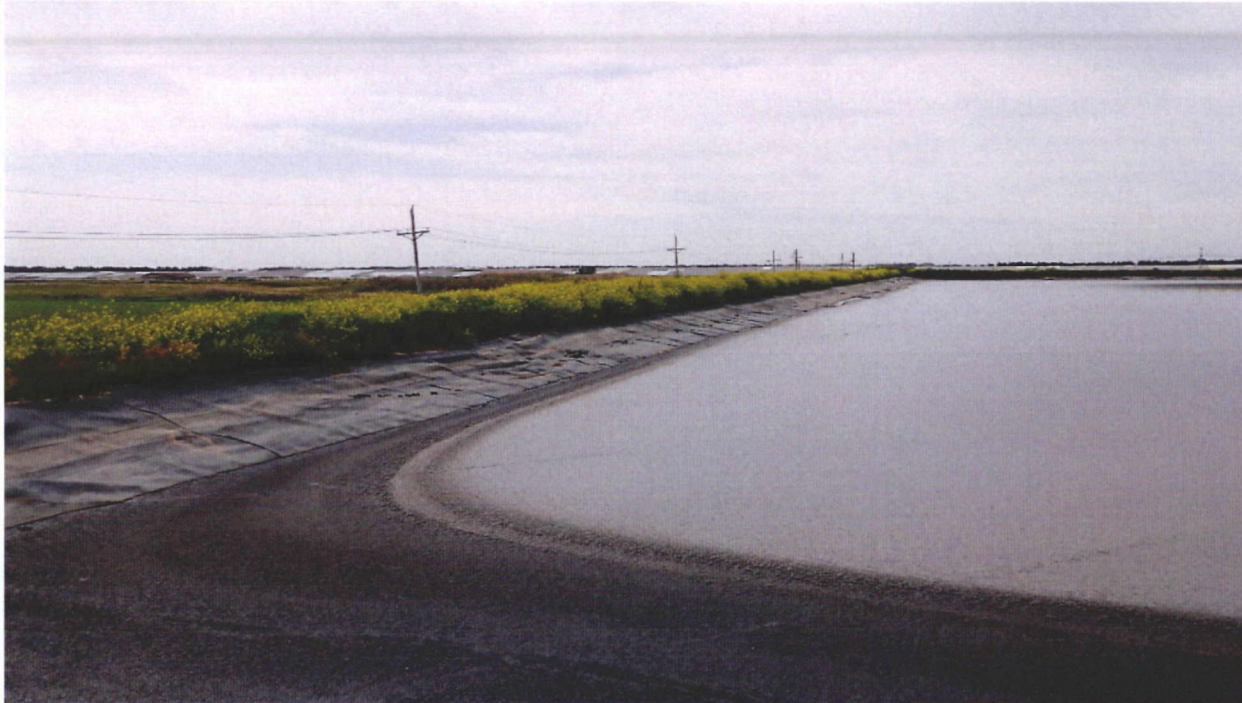
Photo: 26

- Vegetation is beginning to take over the south and east dike. The inspector tripped over the orange hose used to transport water from the south lagoon to treatment. (not injured).

Description: This photo depicts vegetation along the east dike.

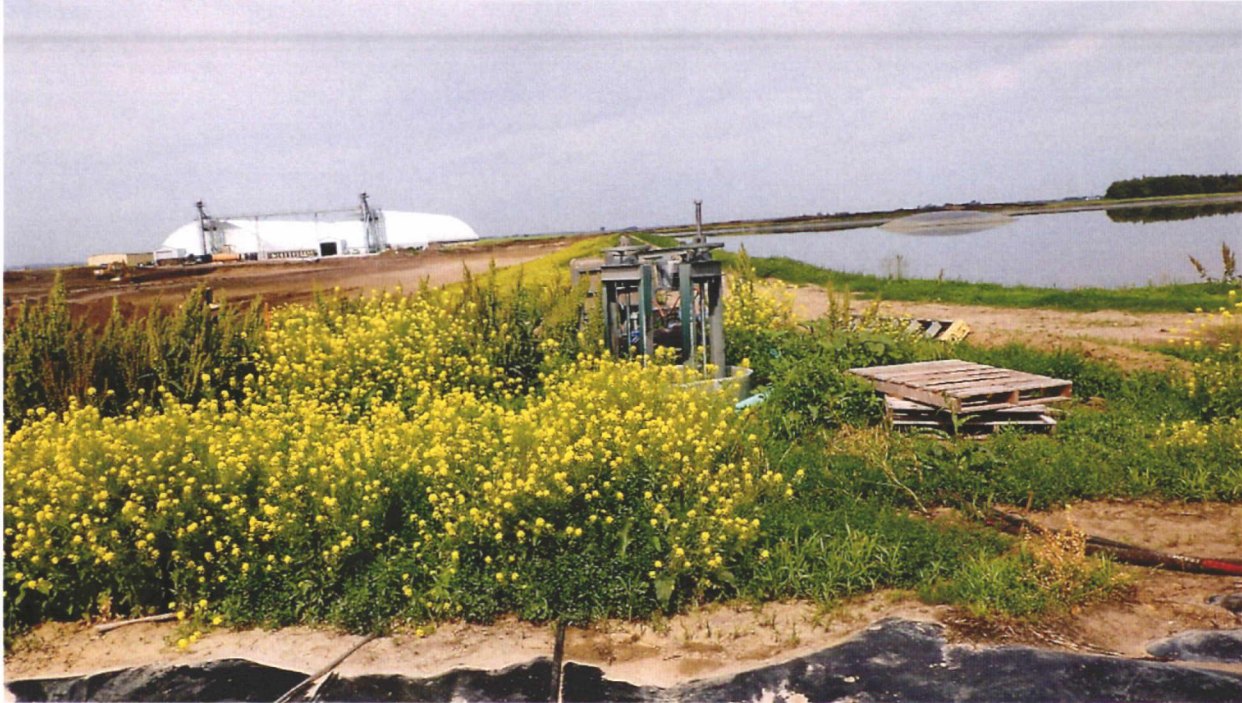
Photo: 27

Description: This photo depicts vegetation east of the transfer station.

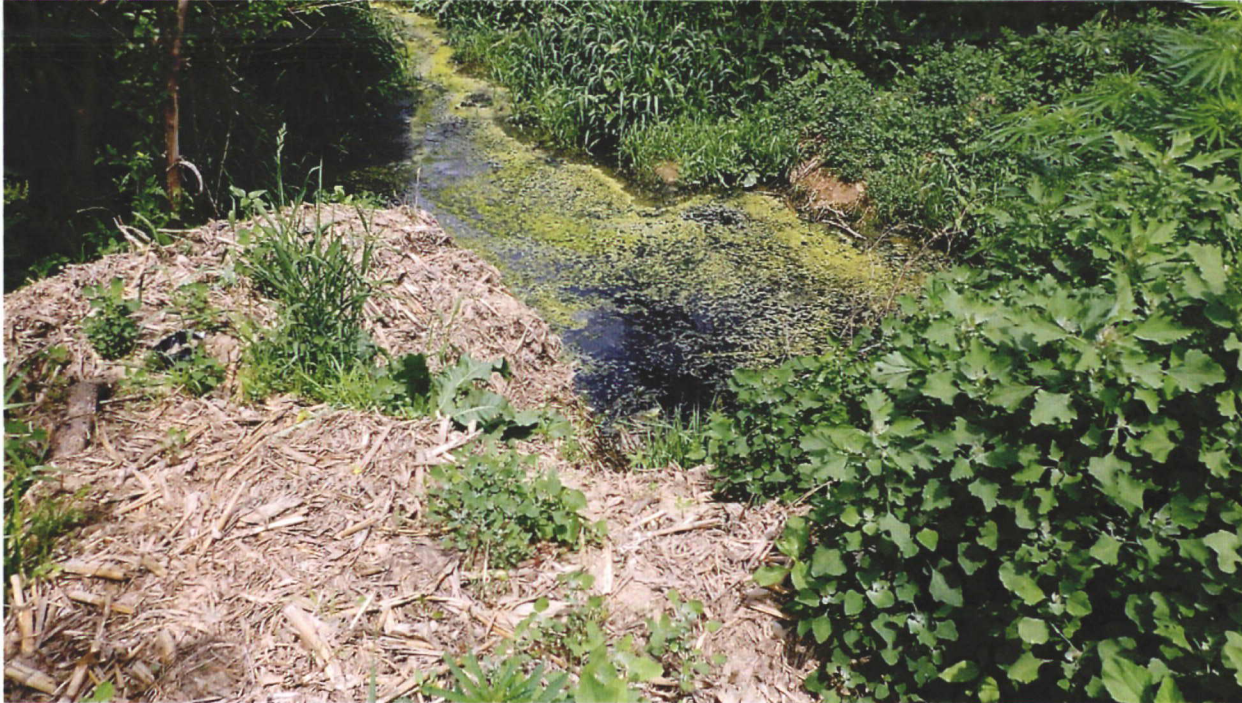
Photo: 38

Description: This photo depicts stagnant water along the culvert at County Road 9 and J. There is no water flow at this time.
