Facility: AltEn, LLC  
 IIS: 84069  
 PCS: NE0137634

### Site Visit Check list

Site Visit Report

### Inspection and Assistance Exit Summary

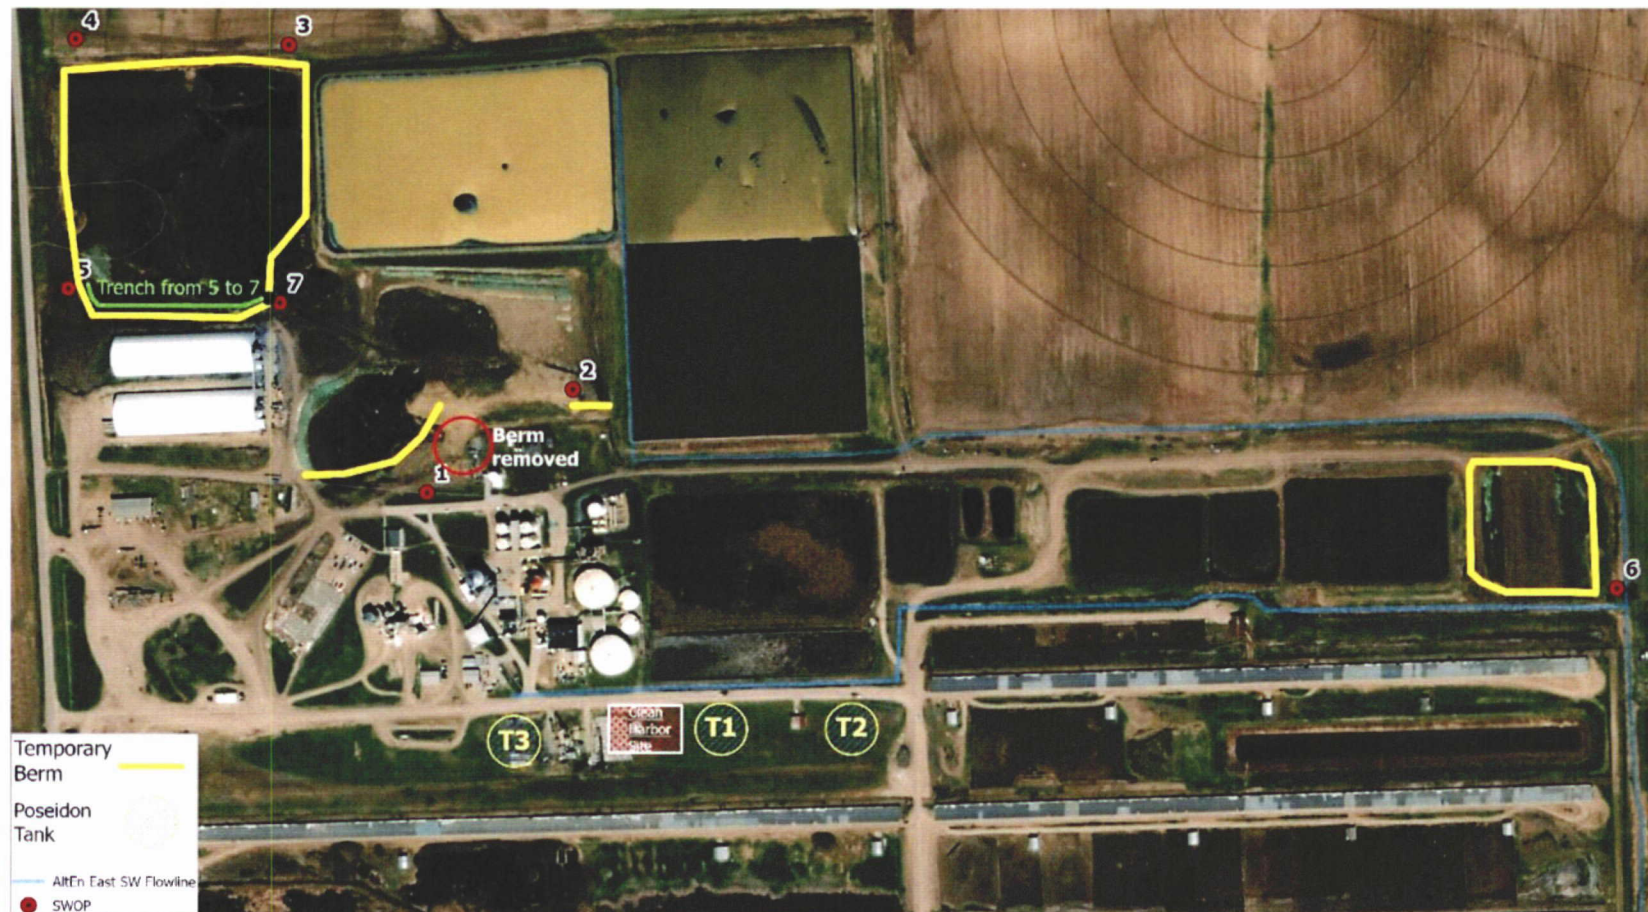
## AltEn LLC - Storm Water Temporary BMP Check Map

Location	Inspected		Area Description	
	Yes	No		
1. Northeast side of the administration building	<input checked="" type="checkbox"/>	<input type="checkbox"/>	<i>Berm removed</i>

2. Southwest side of the south lagoon	<input checked="" type="checkbox"/>	<input type="checkbox"/>	pumped <input checked="" type="checkbox"/>	not pumped <input type="checkbox"/>

3. West side of the northwest lagoon	<input checked="" type="checkbox"/>	<input type="checkbox"/>	pumped <input checked="" type="checkbox"/>	not pumped <input type="checkbox"/>

4. North side of the north wet cake pile	<input checked="" type="checkbox"/>	<input type="checkbox"/>	<i>Does not accumulate runoff</i>	
5. County Road 10 (Hoop building)	<input checked="" type="checkbox"/>	<input type="checkbox"/>	<i>Area trenched-no ponding</i>

6. East wet cake pile	<input checked="" type="checkbox"/>	<input type="checkbox"/>	pumped <input checked="" type="checkbox"/>	not pumped <input type="checkbox"/>

7. Berm northeast of hoop buildings	<input checked="" type="checkbox"/>	<input type="checkbox"/>	pumped <input checked="" type="checkbox"/>	not pumped <input type="checkbox"/>

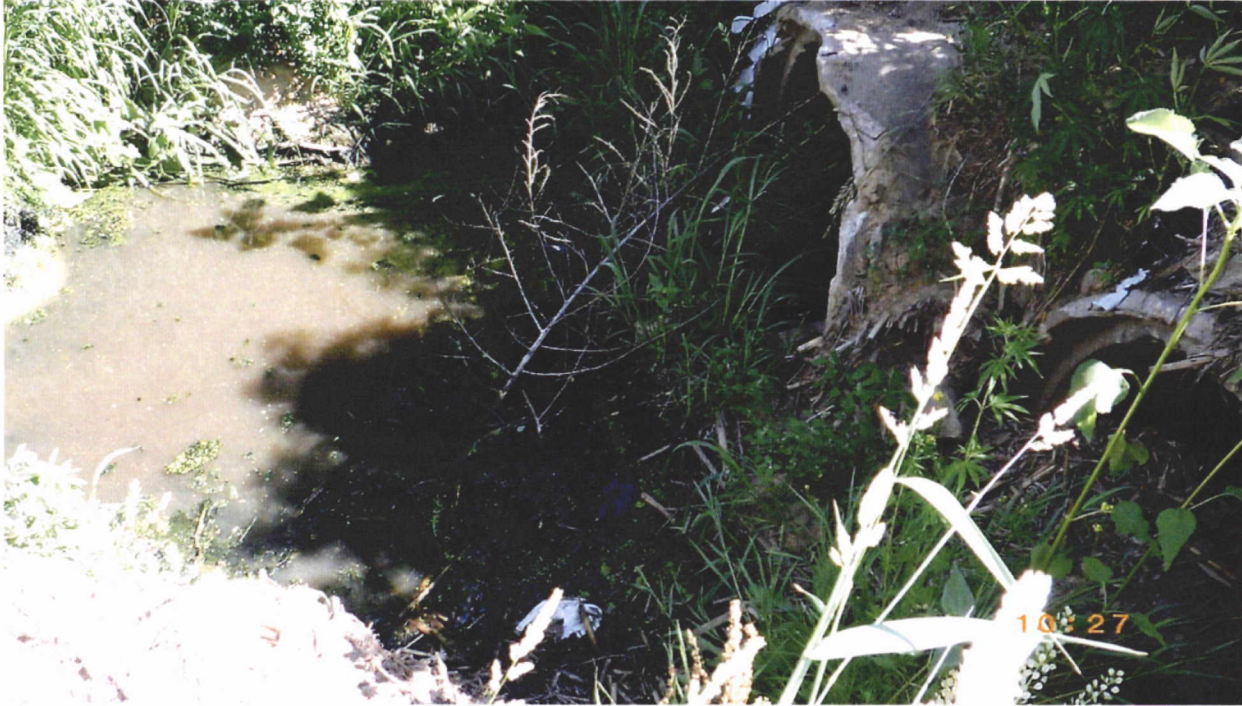
Photos: 1

Location: Culverts at CR 9 & J

Description: Stagnant water with vegetation starting to grow in sections of partially plugged culvert.

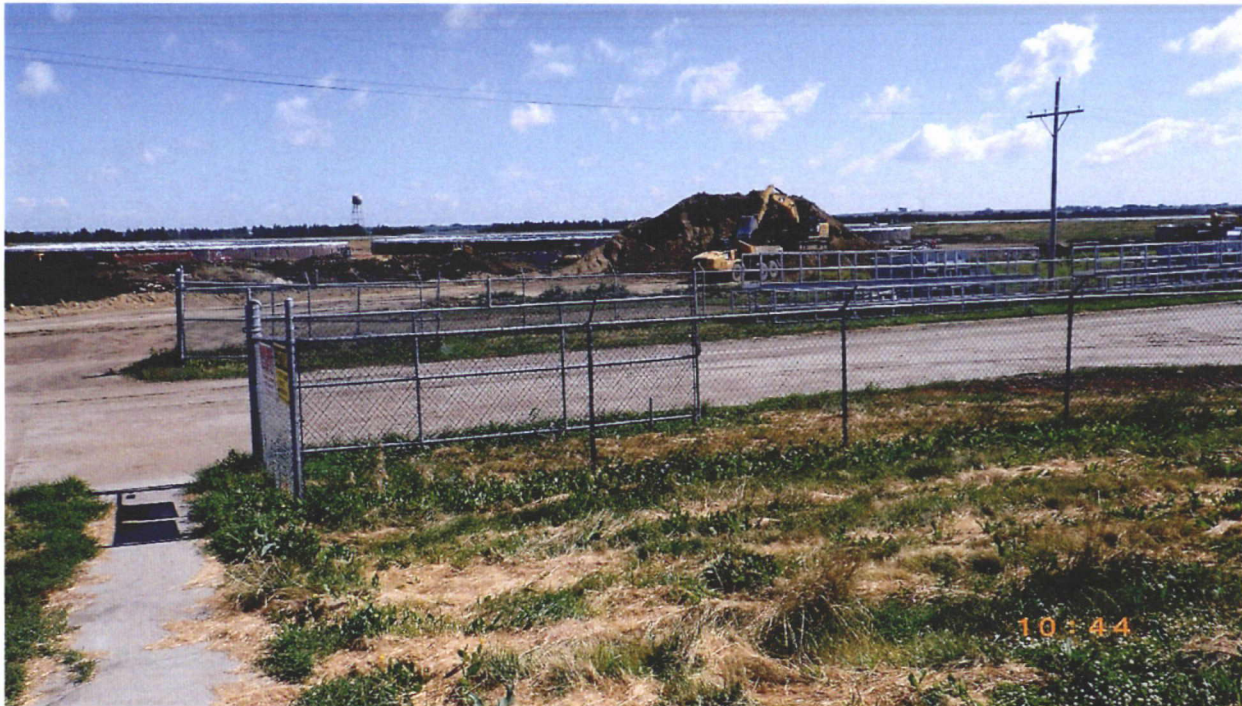
Photos: 2

Location: North of admin building.

Description: Grading crew removing large pile of soil borrow material from area 1 on the site map.

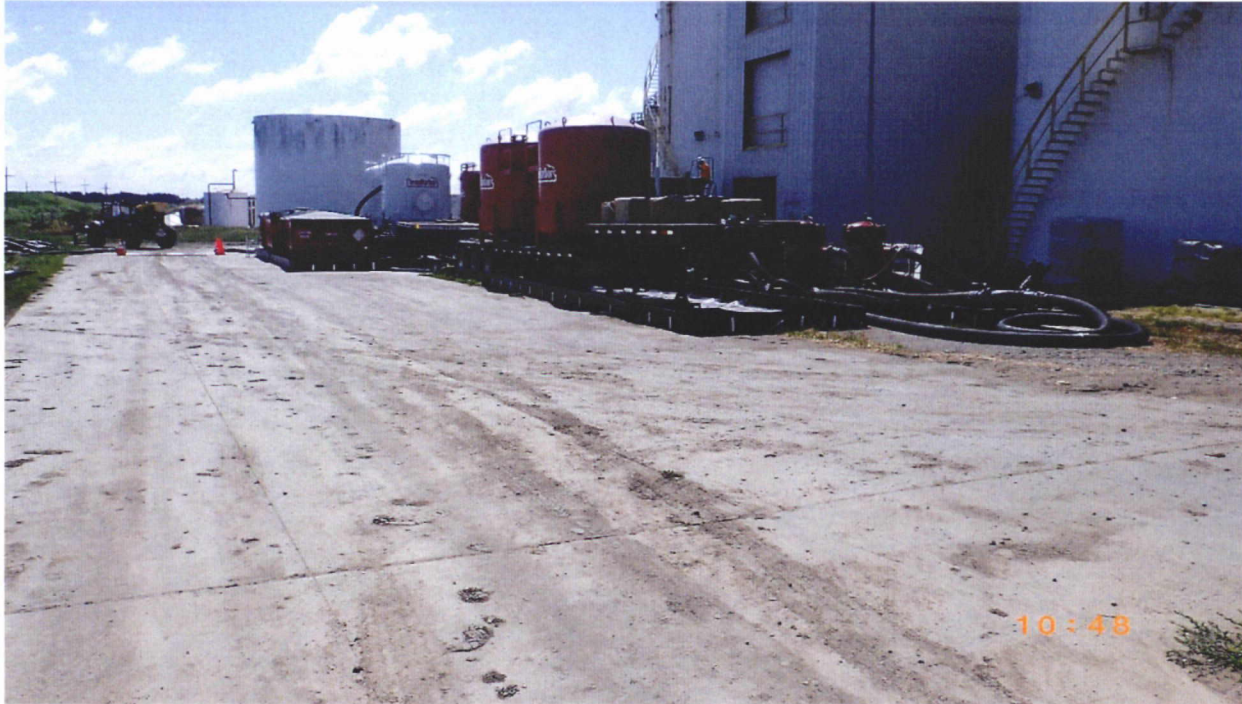
Photos: 3

Location: Northwest of the process building.

Description: Clean Harbors wastewater treatment area.

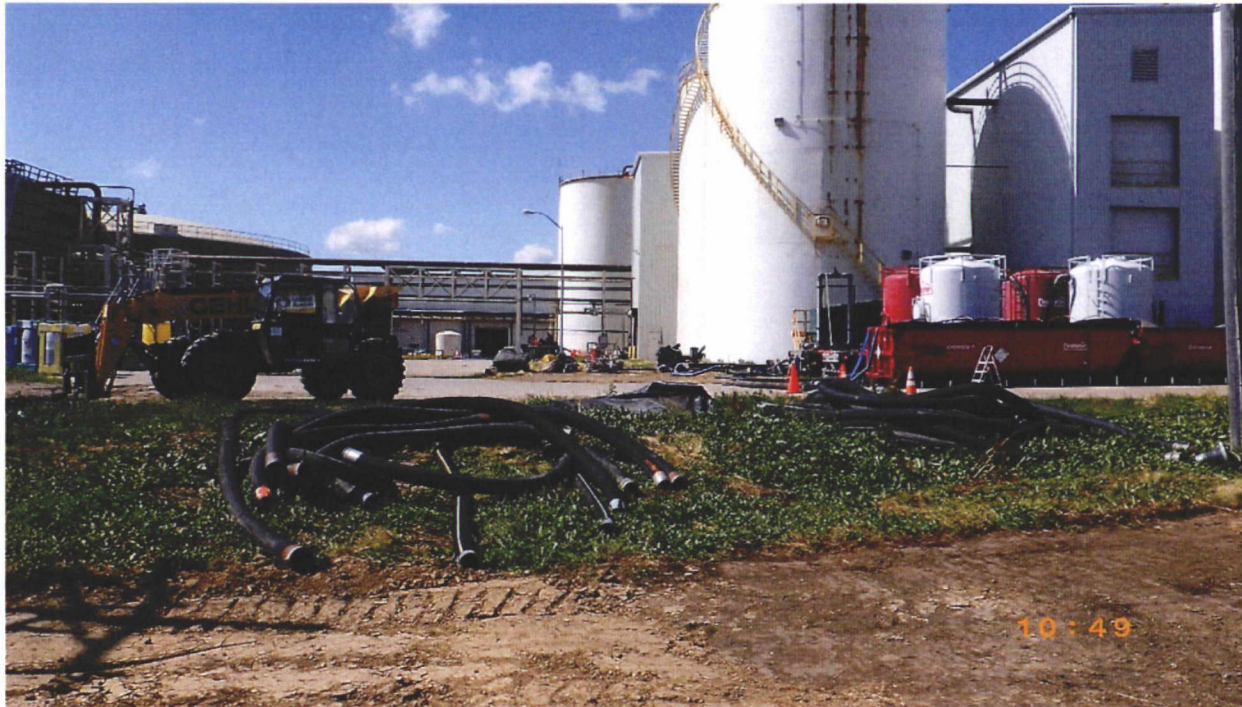
Photos: 4

Location: Northeast of the process building and north of the nutrient recovery building.

Description: Material used for transferring water is being centralized in this area for use in the tank farm under construction.

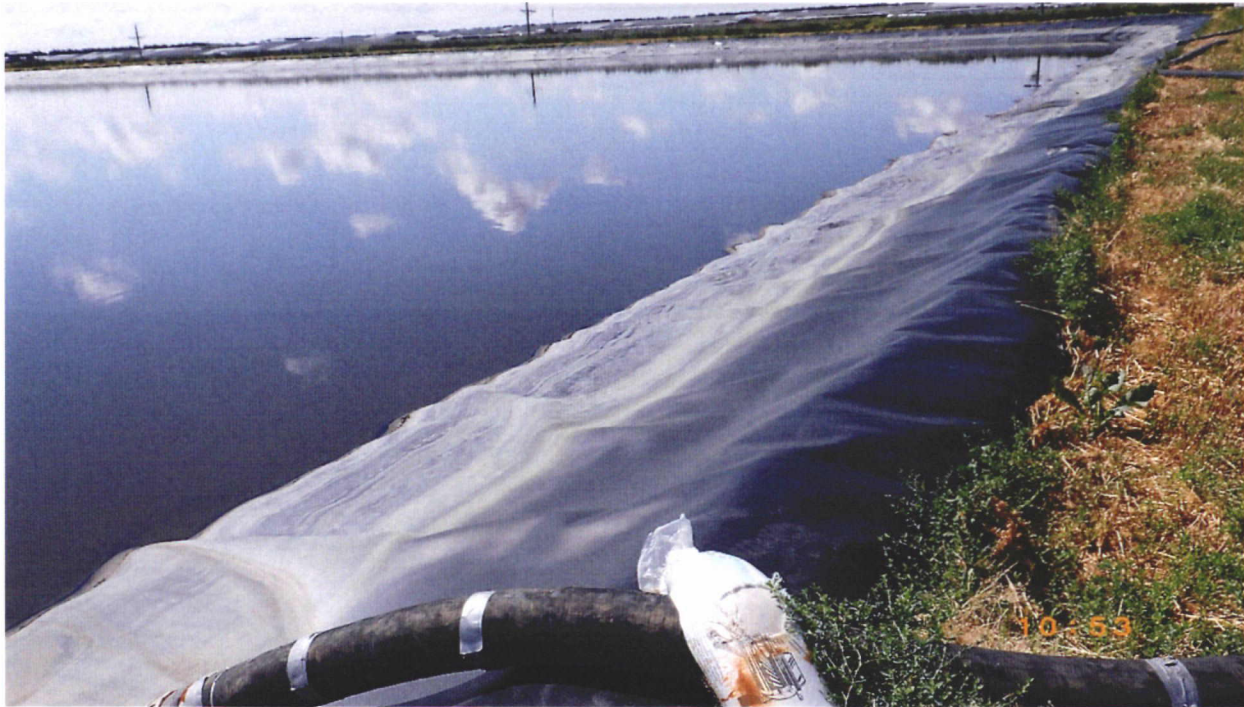
Photos: 5

Location: North of the southwest corner of the southeast lagoon

Description: Very little change in lagoon water level and liner. The odor from this lagoon is very strong.

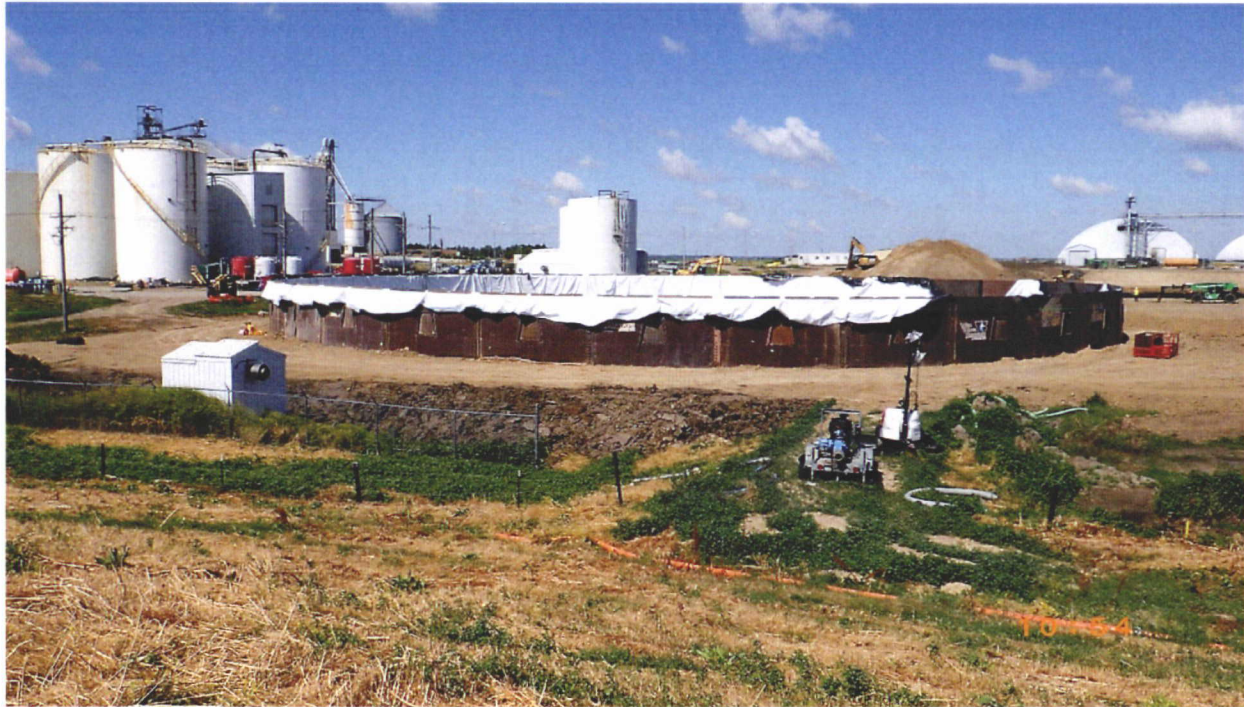
Photos: 6

Location: Same as photo 5.

Description: Poseidon tank 10 being filled with process water from the treatment system. Area 2 on the site map is to the right of the pump and portable lighting.

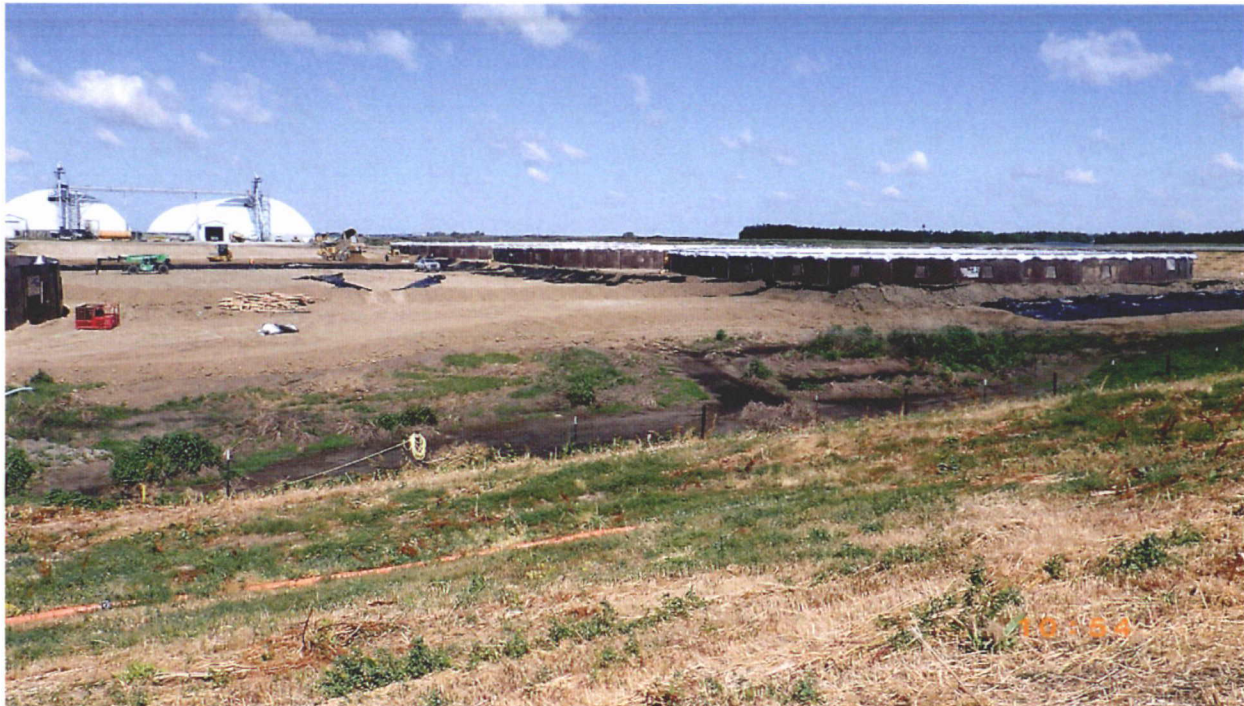
Photos: 7

Location: Same as photo 5.

Description: Photo shows Poseidon tanks 4-6 and tank 10 on the left edge of the photo. The area in the center of the photo is close to completion for setup of tanks 7-9.

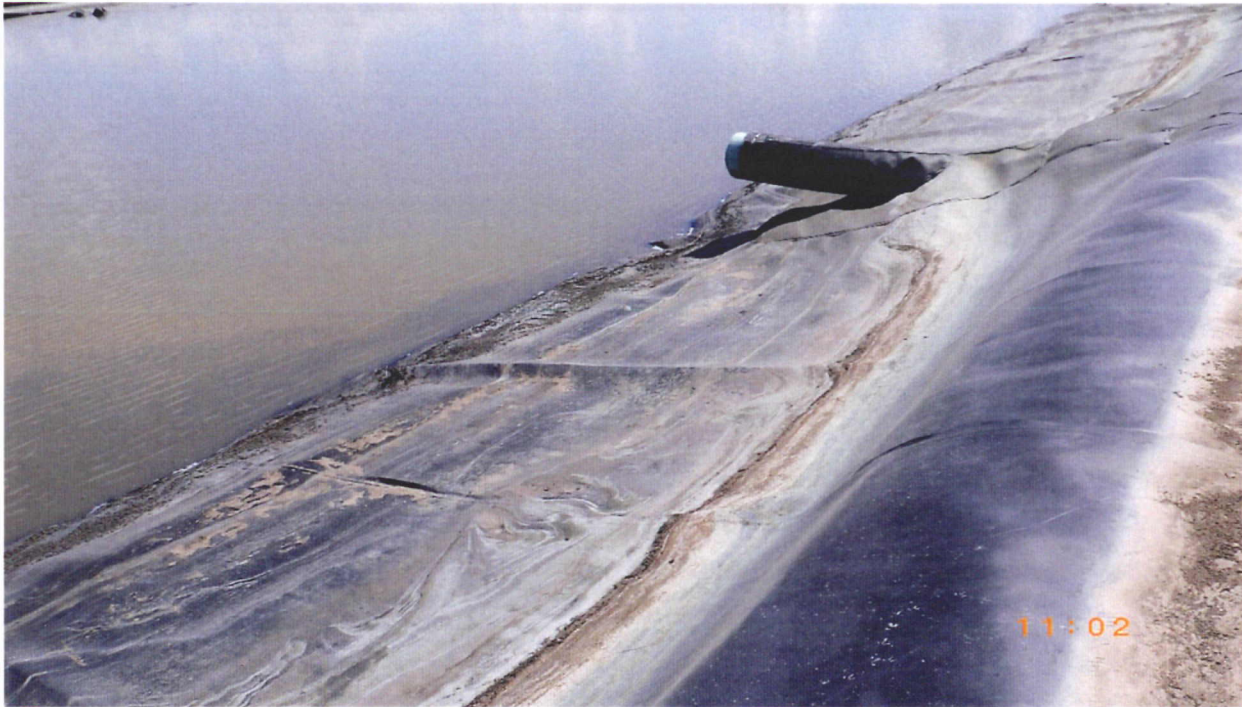
Photos: 8

Location: Southwest corner of the northeast lagoon.

Description: Equalization pipe between the northeast and southeast lagoon aerial above the lagoon water.

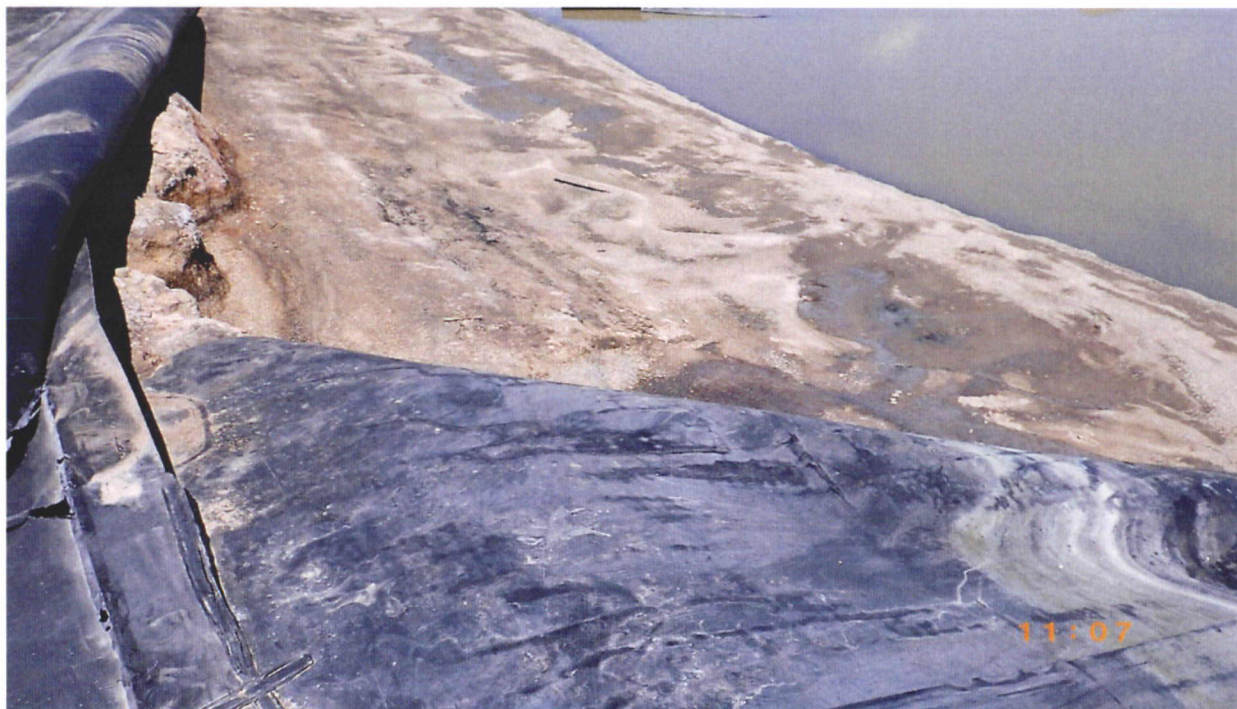
Photos: 9

- Clean Harbors continues work on placing geofabric in the area south of the northwest lagoon for the six pack - Poseidon tank farm.
- Poseidon tanks 4, 5, 6, & 10 have been erected and tank 10 is being filled with process water from the remediation process.
- Poseidon tanks 4-6 have been filled with water from the northeast lagoon.
- A section of liner has become detached and blown over the berm between the northeast and southeast lagoon.

Location: East of the southwest corner of the northeast lagoon.

Description: Section of liner torn and laying over the berm between the northeast and southeast lagoon.

- Section of lagoon liner has torn loose and is laying across the berm between the northeast and southeast lagoon exposing soil to wastewater.

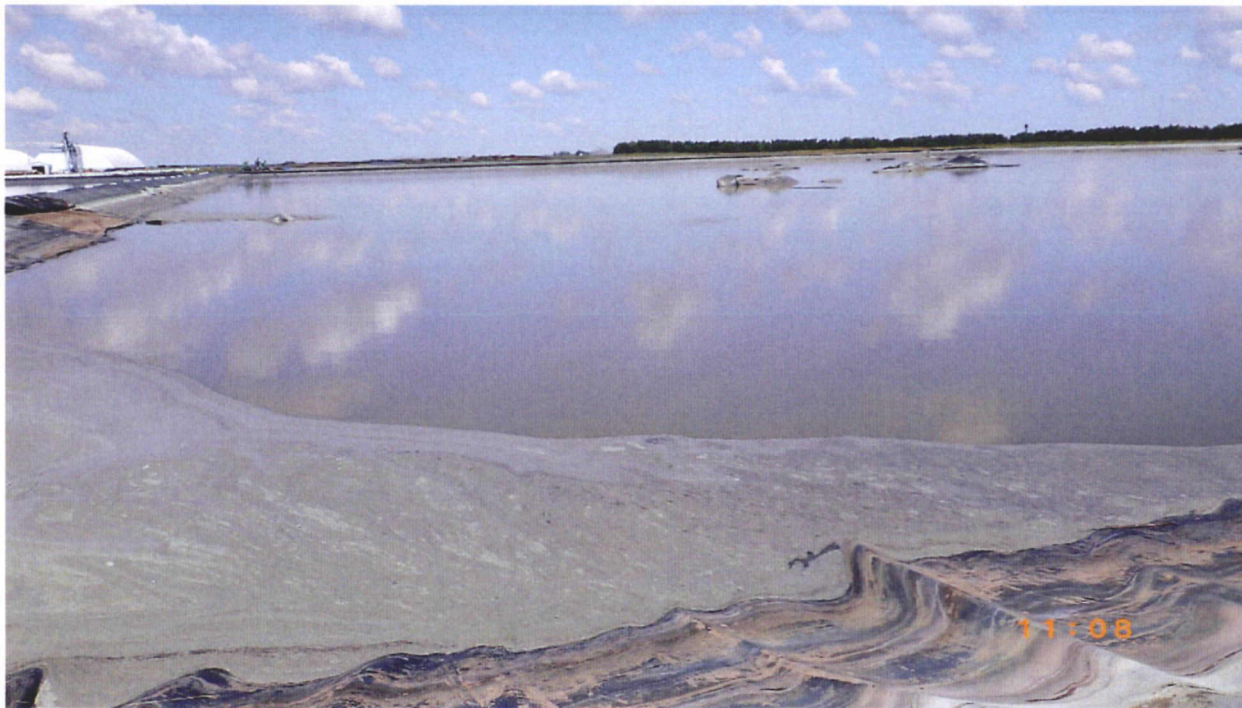
Photos: 10

Location: Southeast corner of the northeast lagoon.

Description: Photo shows thick sludge accumulating in the corner and the torn section on the left side of the photo.

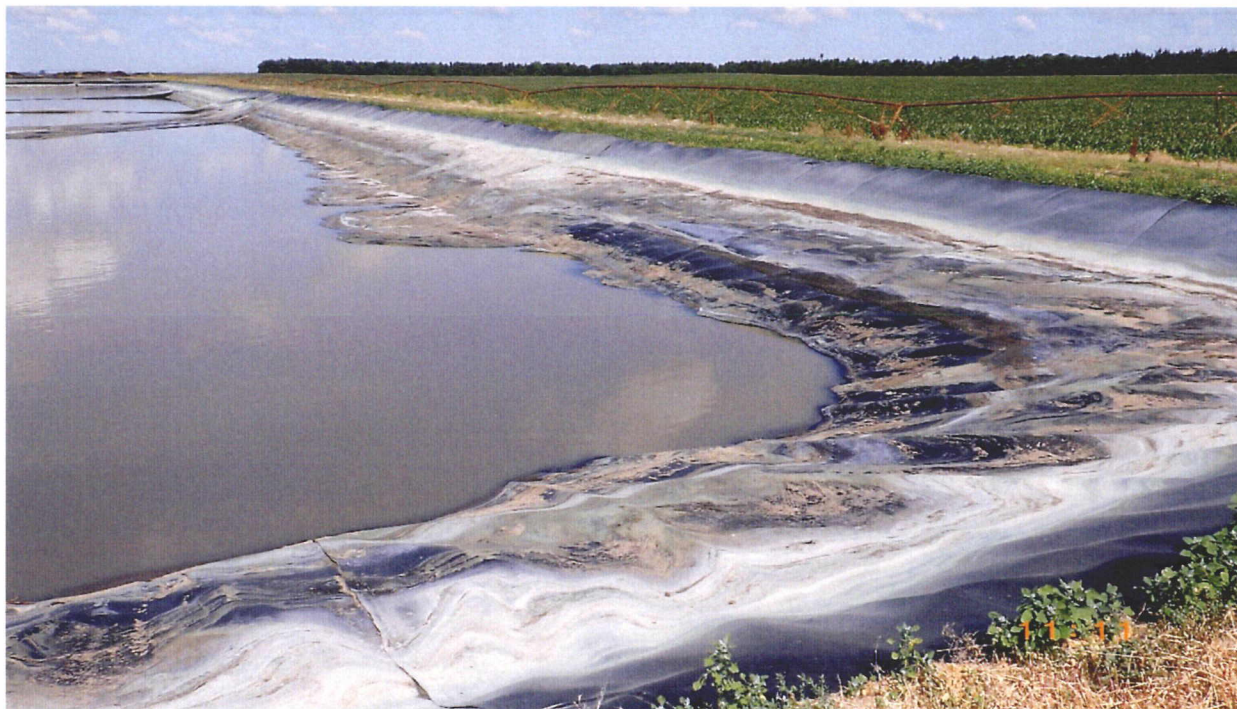
Photos: 11

1. Northeast lagoon
  - Liner condition is changing as more torn sections become exposed as the lagoon is drawn down.
2. Northwest lagoon
  - No change in liner condition or lagoon water observed. 2 whales present now.
3. South lagoon
  - No change in liner condition or lagoon water observed.

Location: Northeast corner of the northeast lagoon.

Description: Exposed liner section after partial draw down of the lagoon.

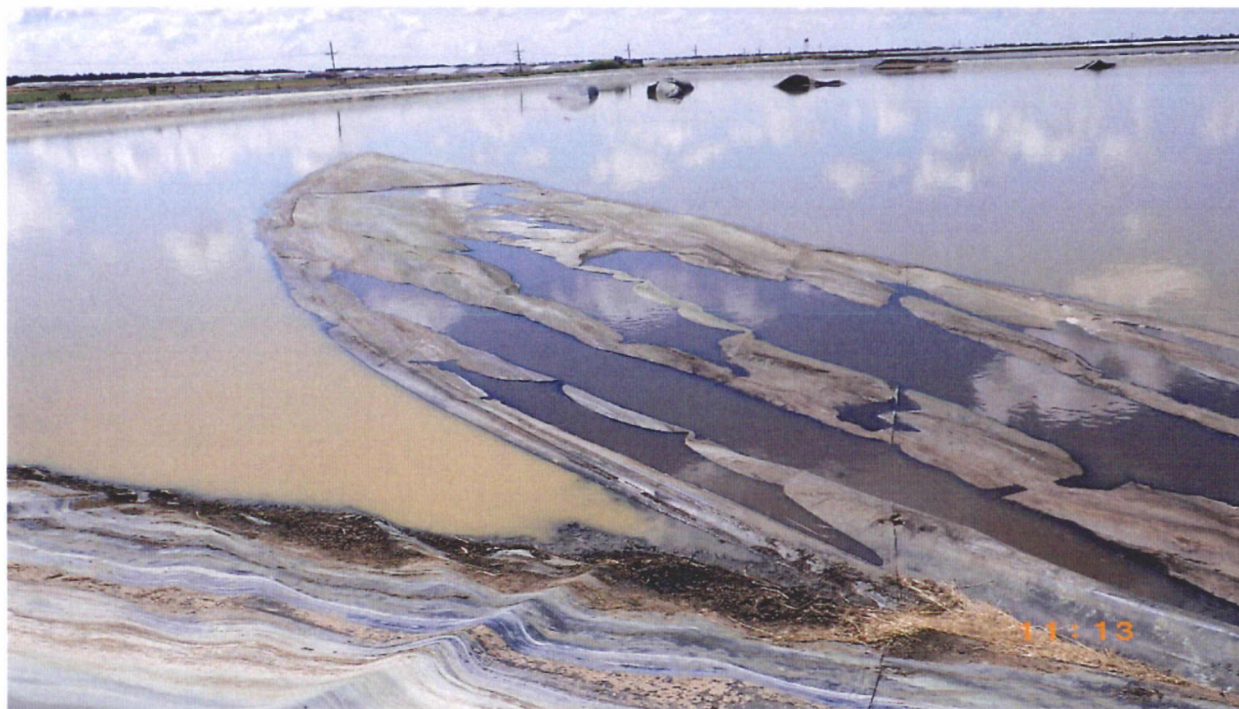
Photos: 12

Location: West of the northeast corner of the northeast lagoon.

Description: Additional section of this area of the liner now exposed and torn section is visible in the background.

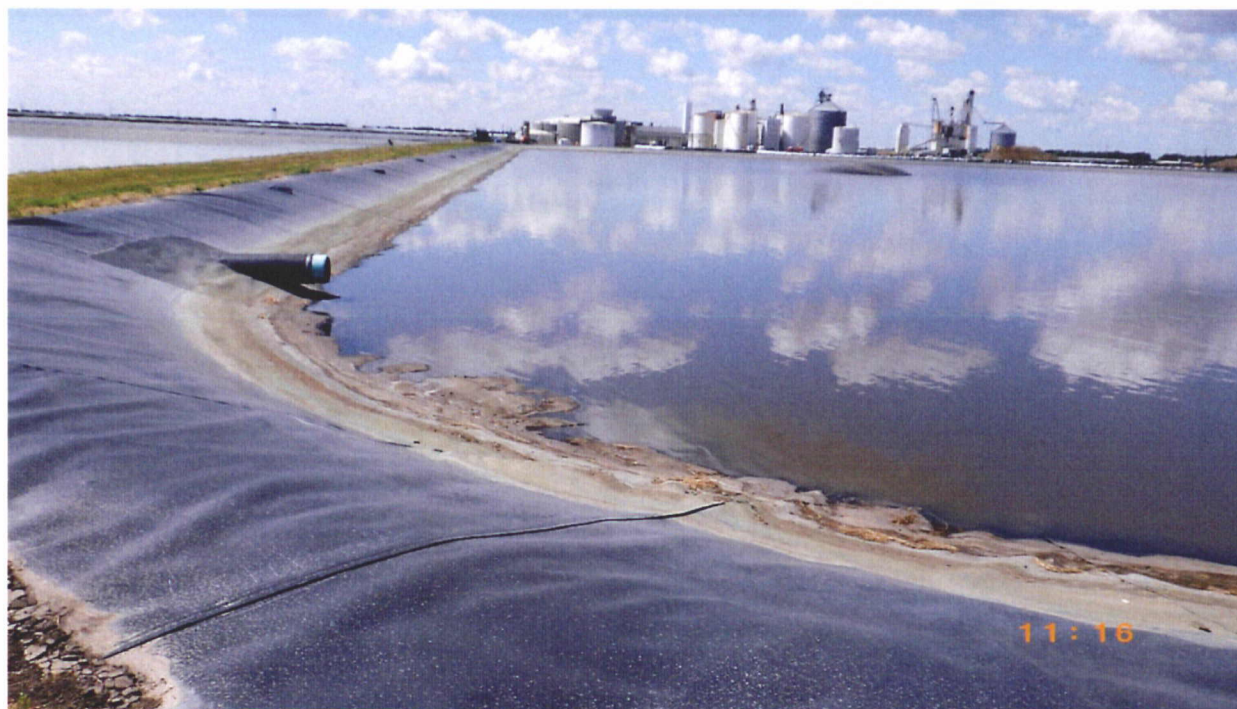
Photos: 13

Location: Northeast corner of the northwest lagoon.

Description: Photo shows the lagoon water level drop with one of the two current whales visible.

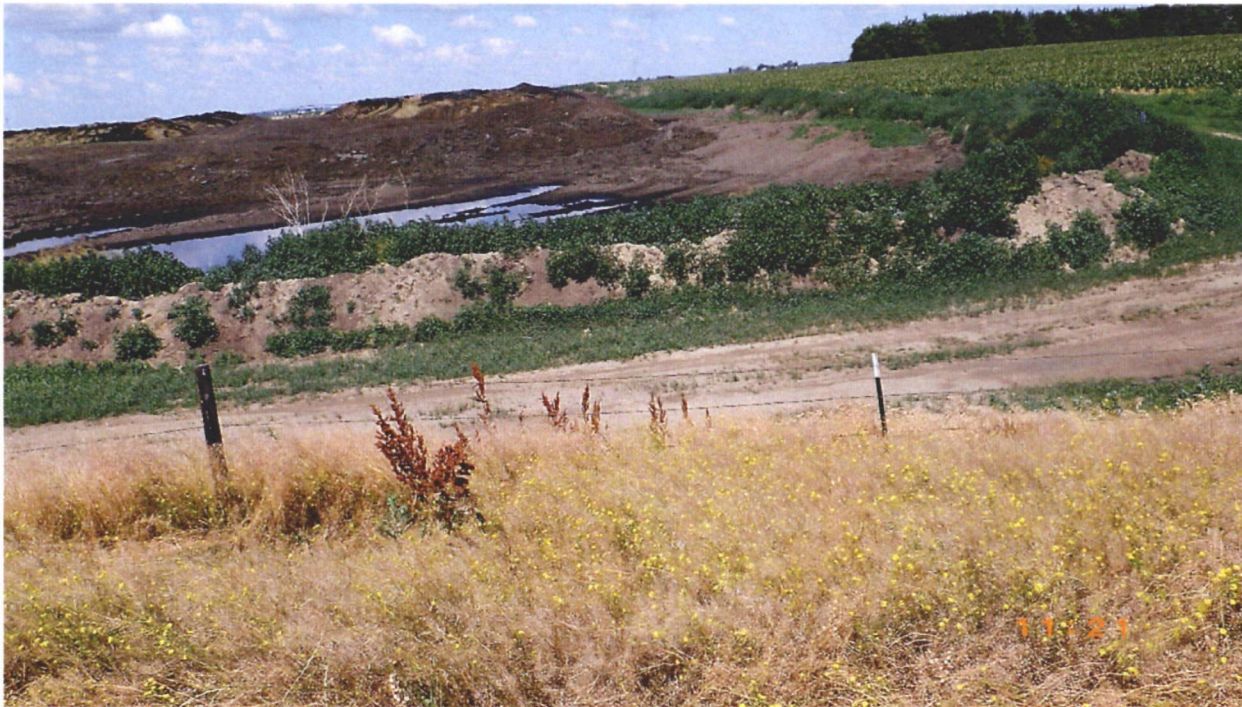
Photos: 14

Location: Area 3 on the site map.

Description: Berm is intact and currently showing no indication of seepage.

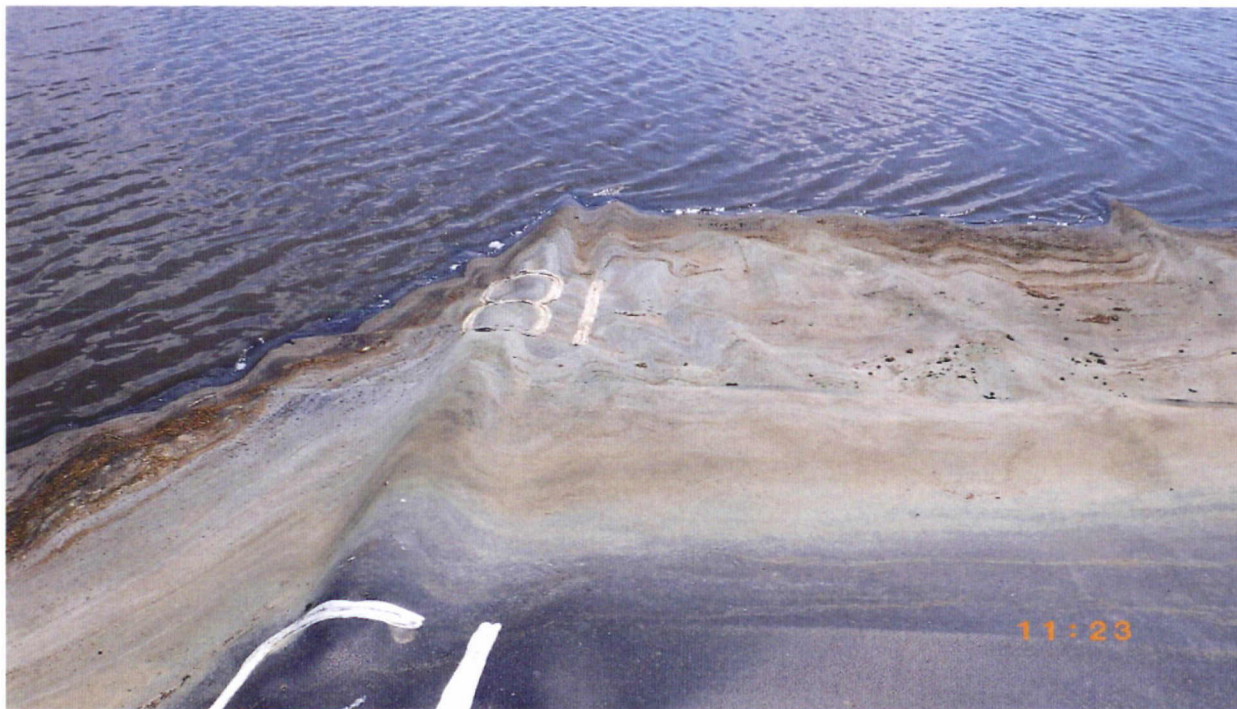
Photos: 15

Location: Southwest corner of the northwest lagoon.

Description: Photo shows current water level of the lagoon.

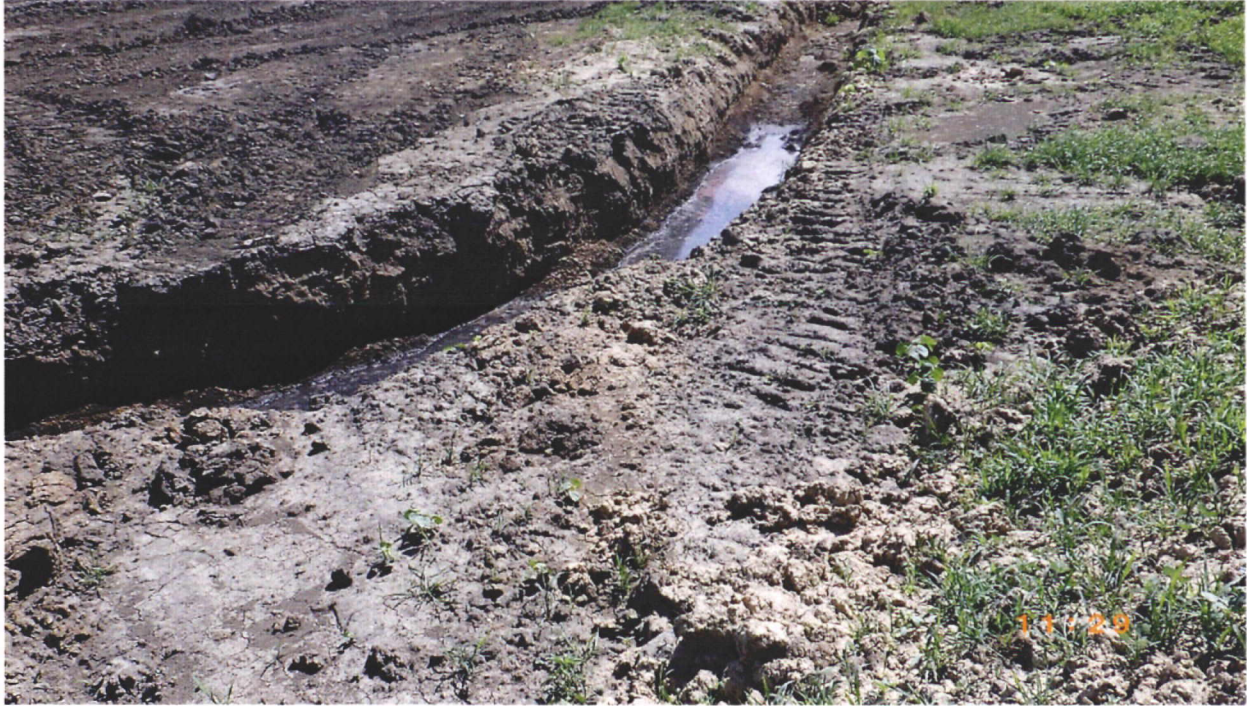
Photos: 16

Location: Area 5 on the site map.

Description: Trench has a small amount of runoff in this section of the trench. The area drains to the east (area 7 on the site map) where it is pumped as needed.

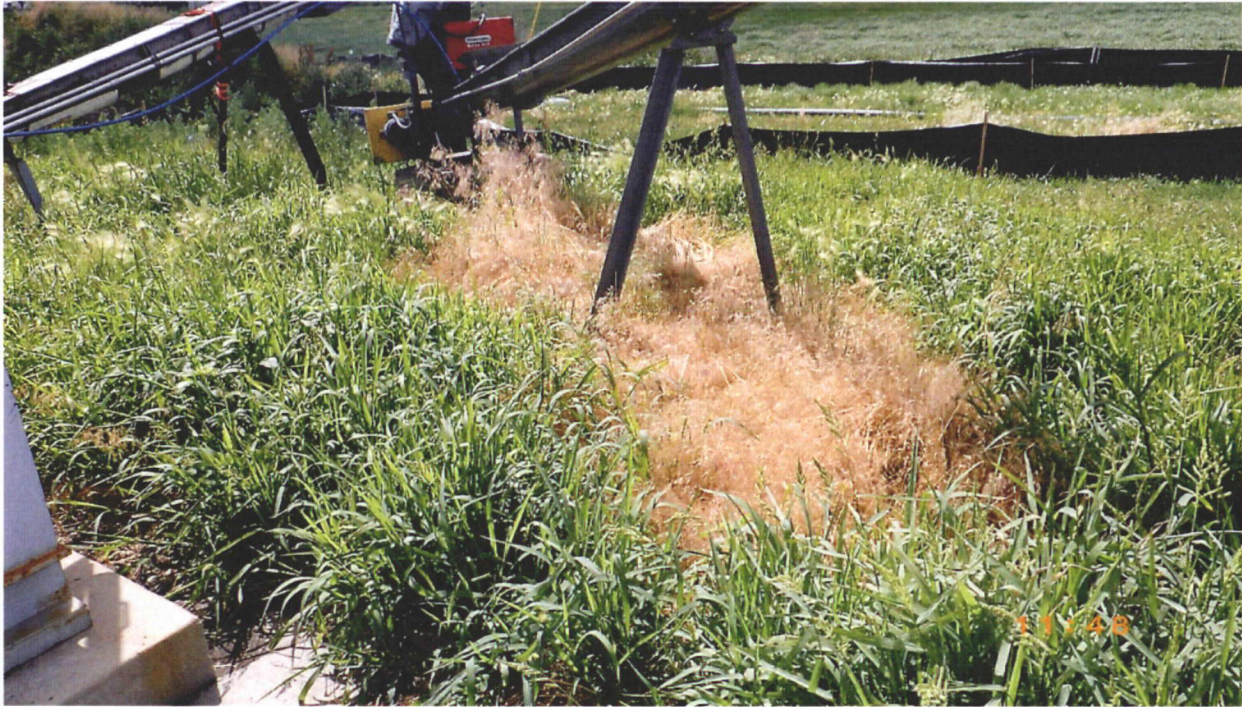
Photos: 17

Location: South side of Biochar area.

Description: Photo shows two rows of silt-fence around Biochar area with unknown vegetation die off under auger system.

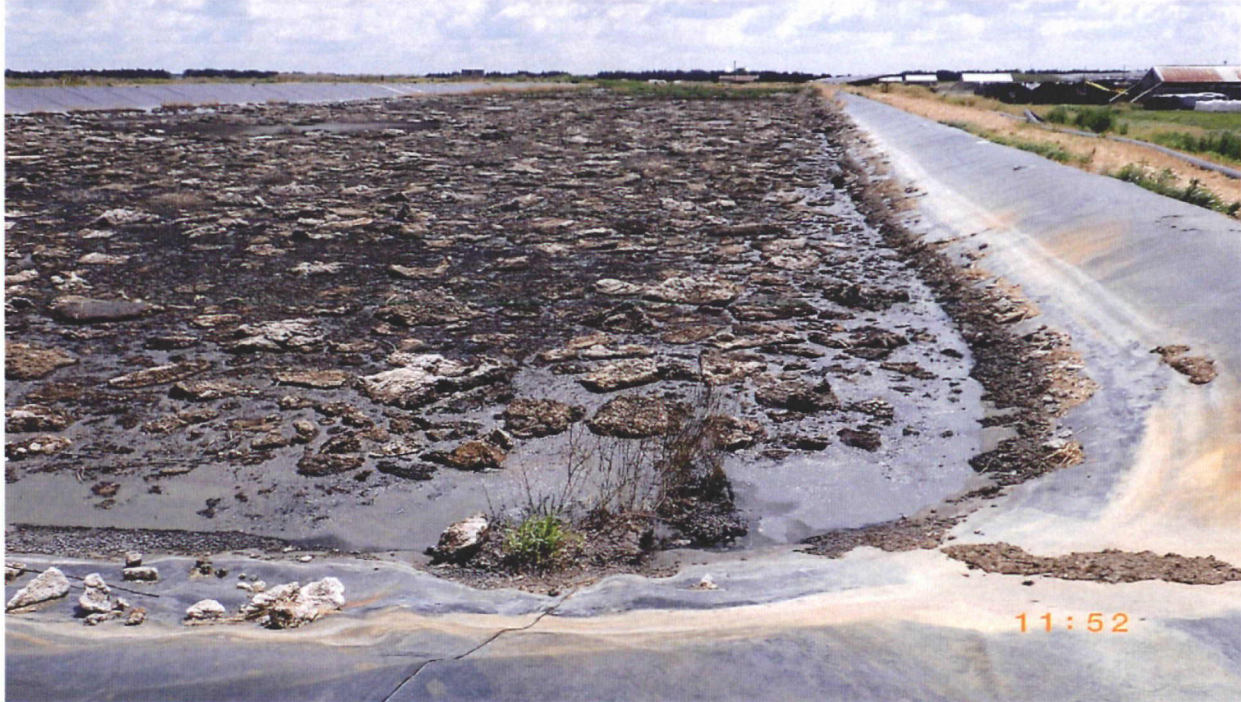
Photos: 18

Location: Southwest corner of the emergency lagoon.

Description: Thick solids continue to persist across the lagoon making extraction of lagoon water very difficult.

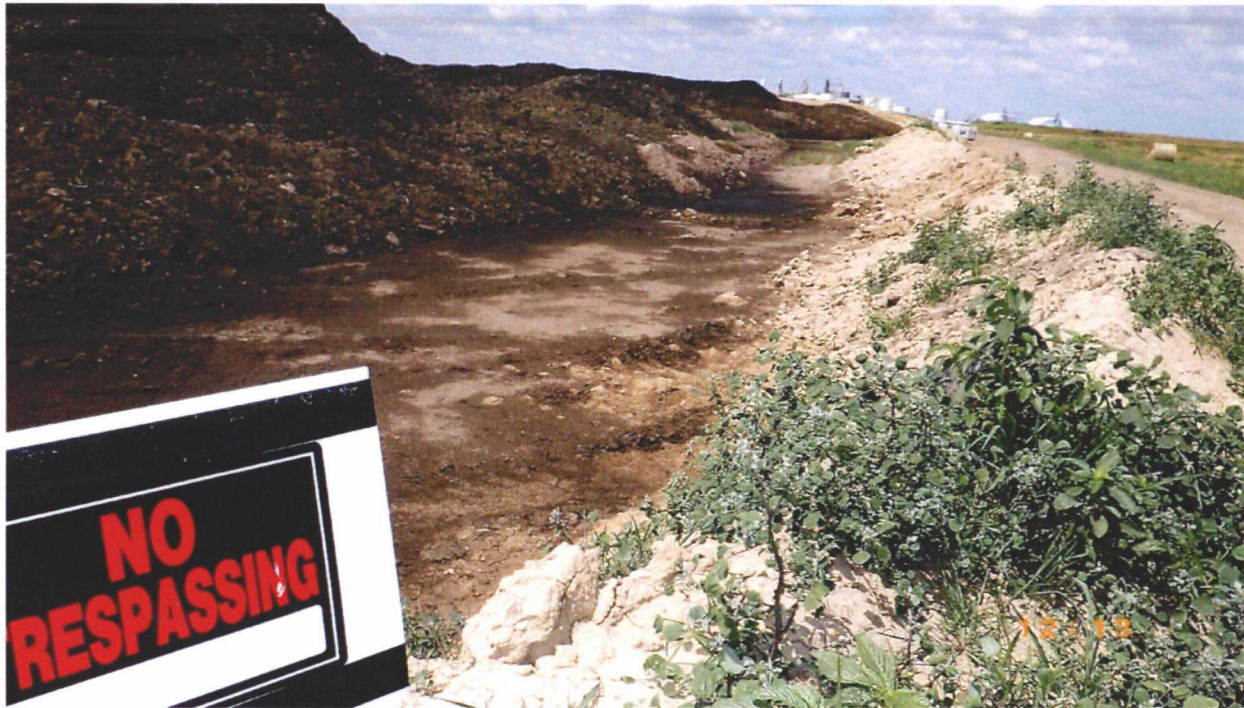
Photos: 19

Location: Area 6 on the site map

Description: Northeast corner of the east wetcake storage area showing little accumulation of runoff.

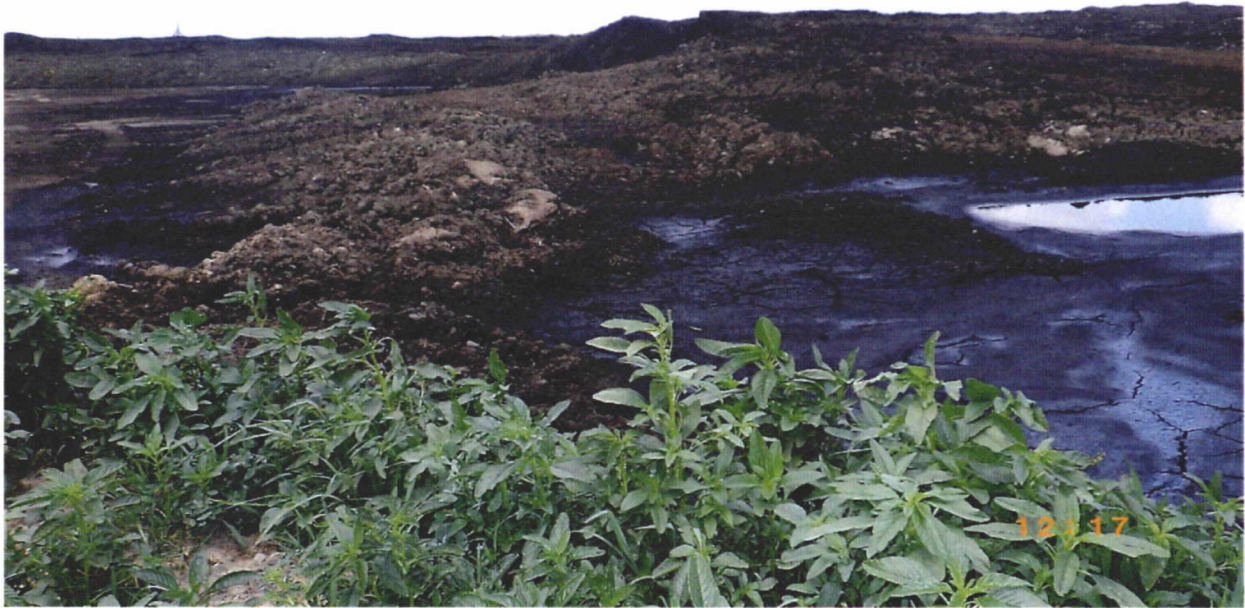
Photos: 20

Location: Area 6 on the site map.

Description: Very little accumulation of runoff from wetcake at the southeast corner of the east wetcake area. The wetcake does continue to slump further spreading closer to the berms surrounding the area.

At the time of the inspection there was no sign of seepage from the berms.
