Facility: AltEn, LLC

IIS: 84069

PCS: NE0137634

Site Visit Report

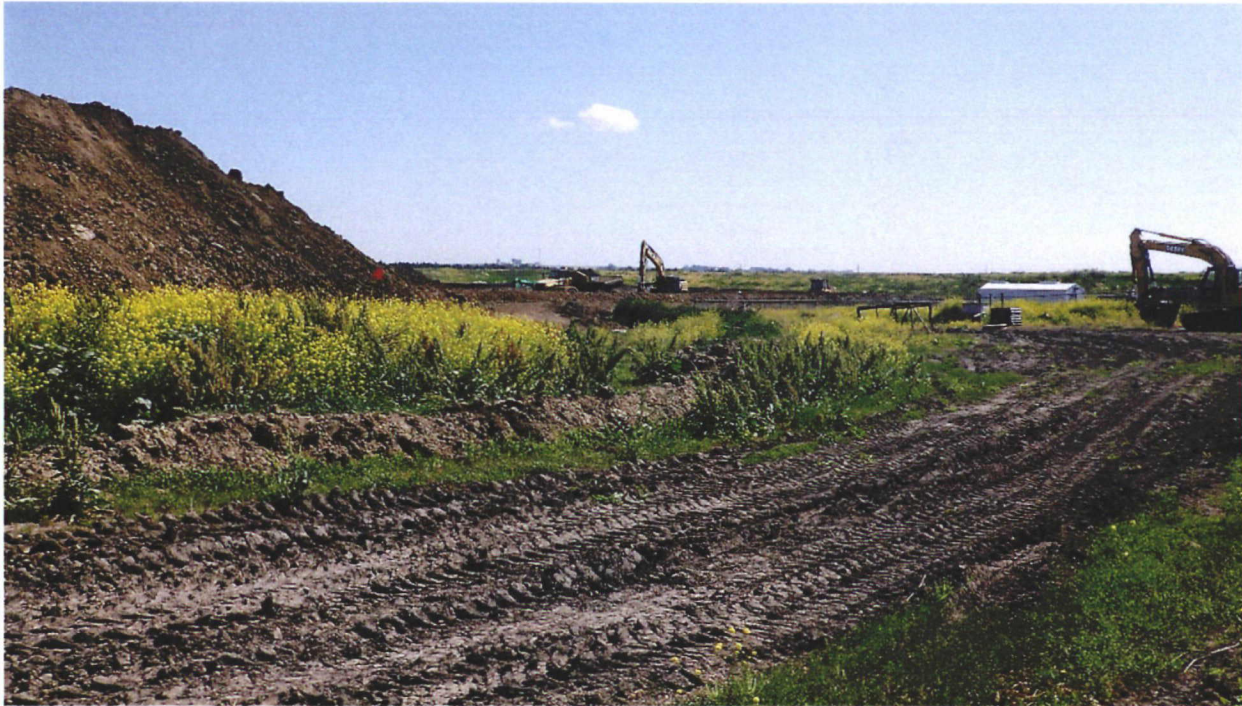
Photo: 1

Description: The original berm is gone only this ruminant remains. This berm prevents water from the parking lot from entering the berm area.

Area 1 - the original berm has been removed. A large pile of earth is in its place.

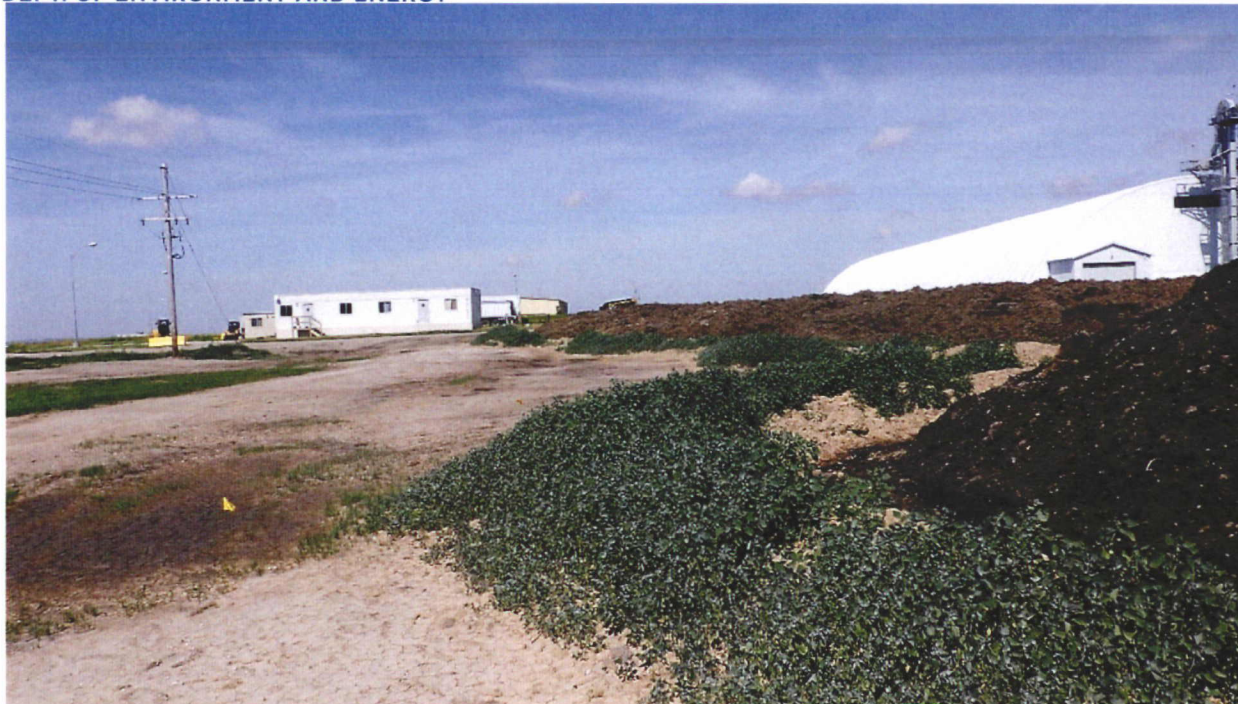
Photo: 2

Description: This is the west berm of area 1. There is only minor water accumulation observed.

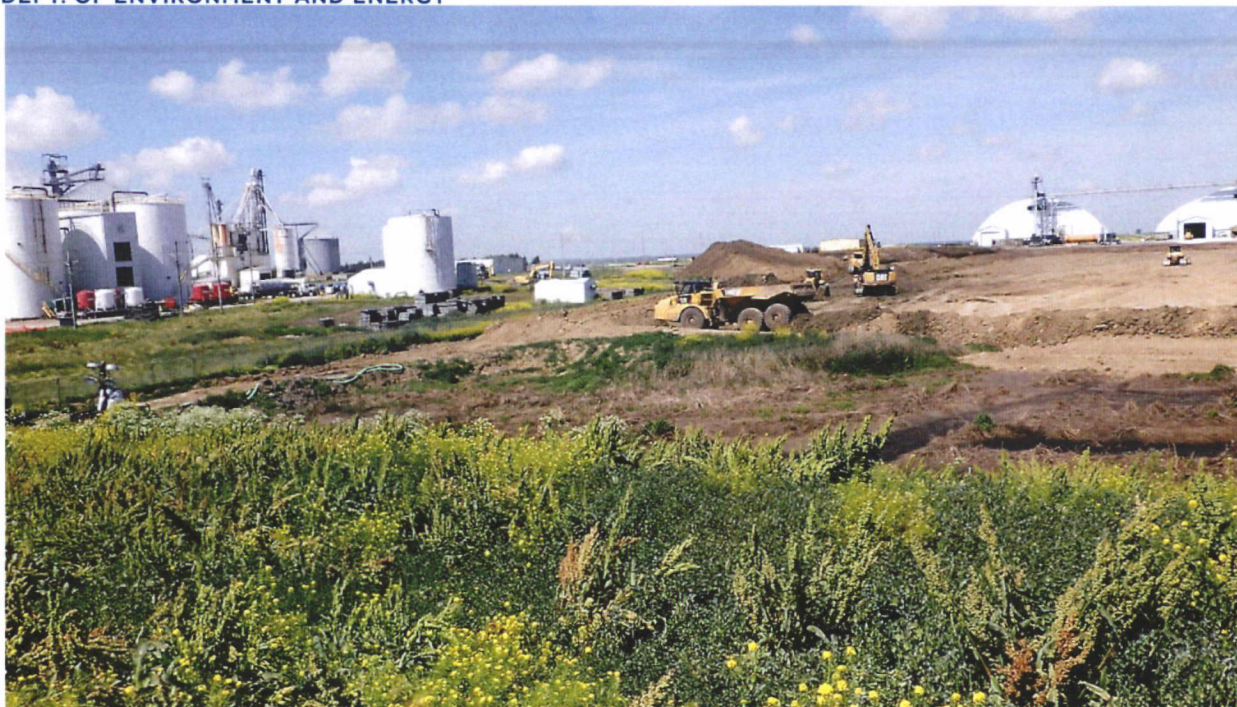
Photo: 3

Description: This is area 2. There is no water accumulation observed.

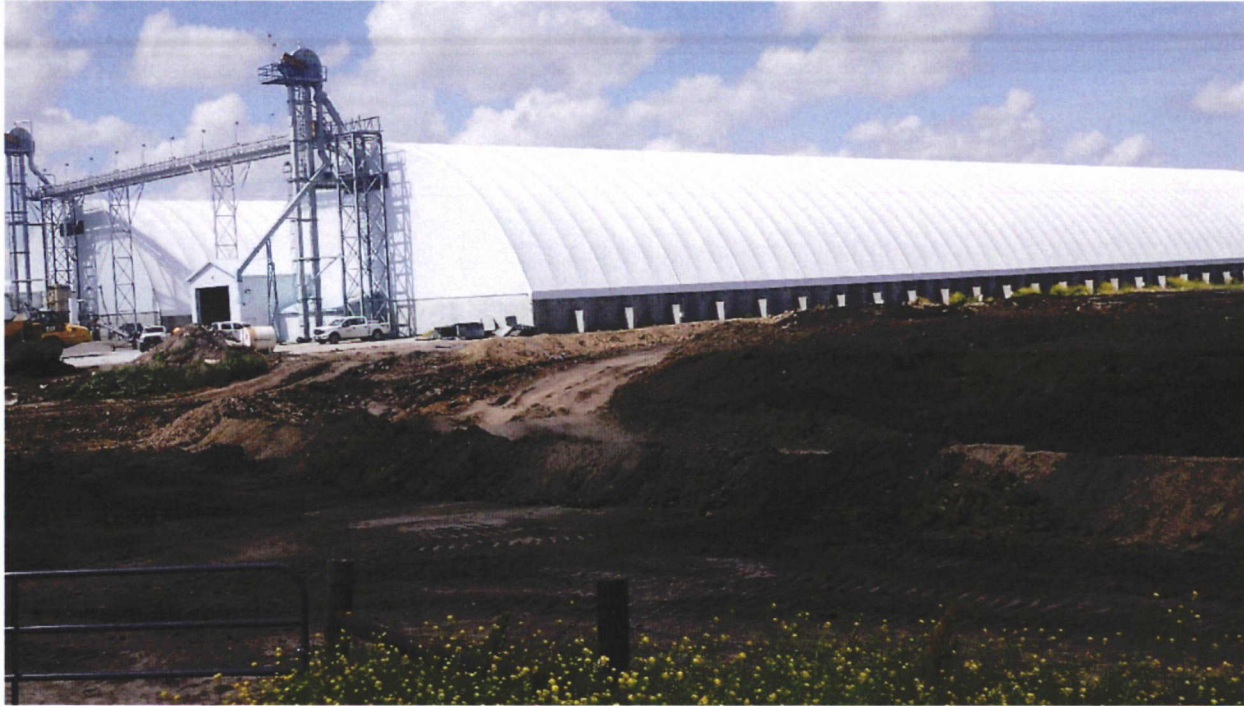
Photo: 4

Description: Clean Harbors has completed the wet cake transfer from the south location to the north location. The berm is closed to prevent water from entering the Poseidon tank farm.

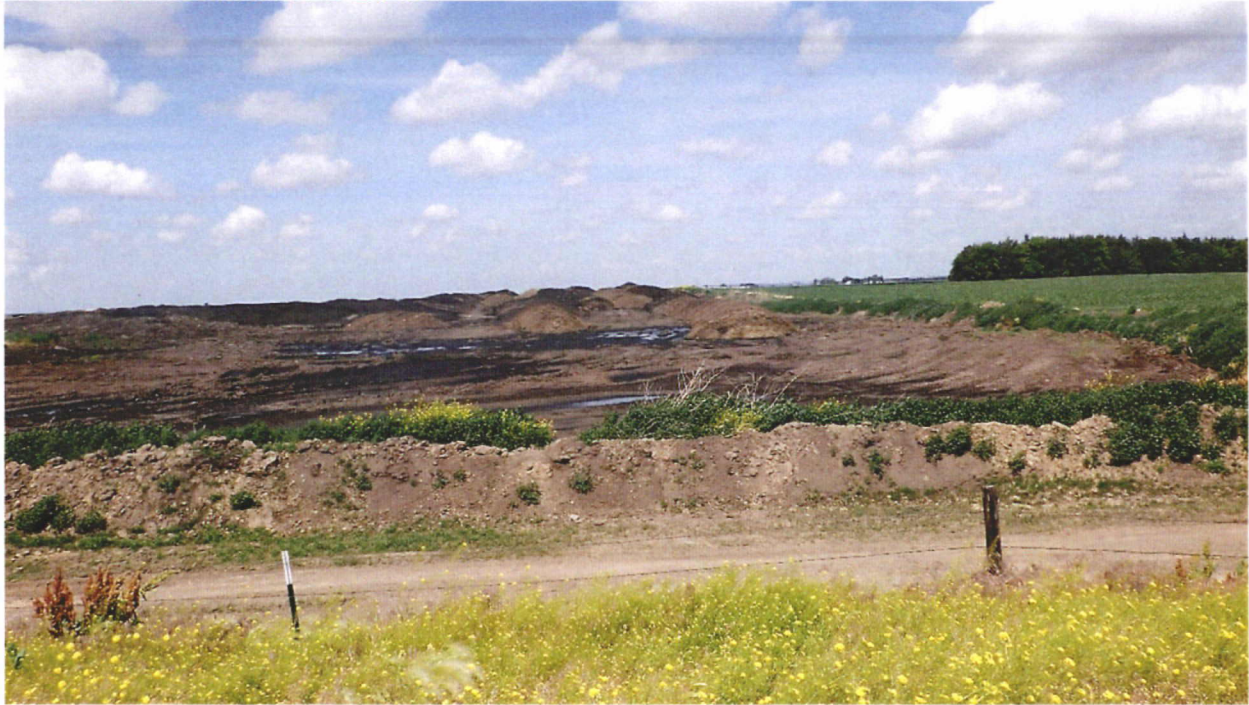
Photo: 5

Description: No seepage observed.

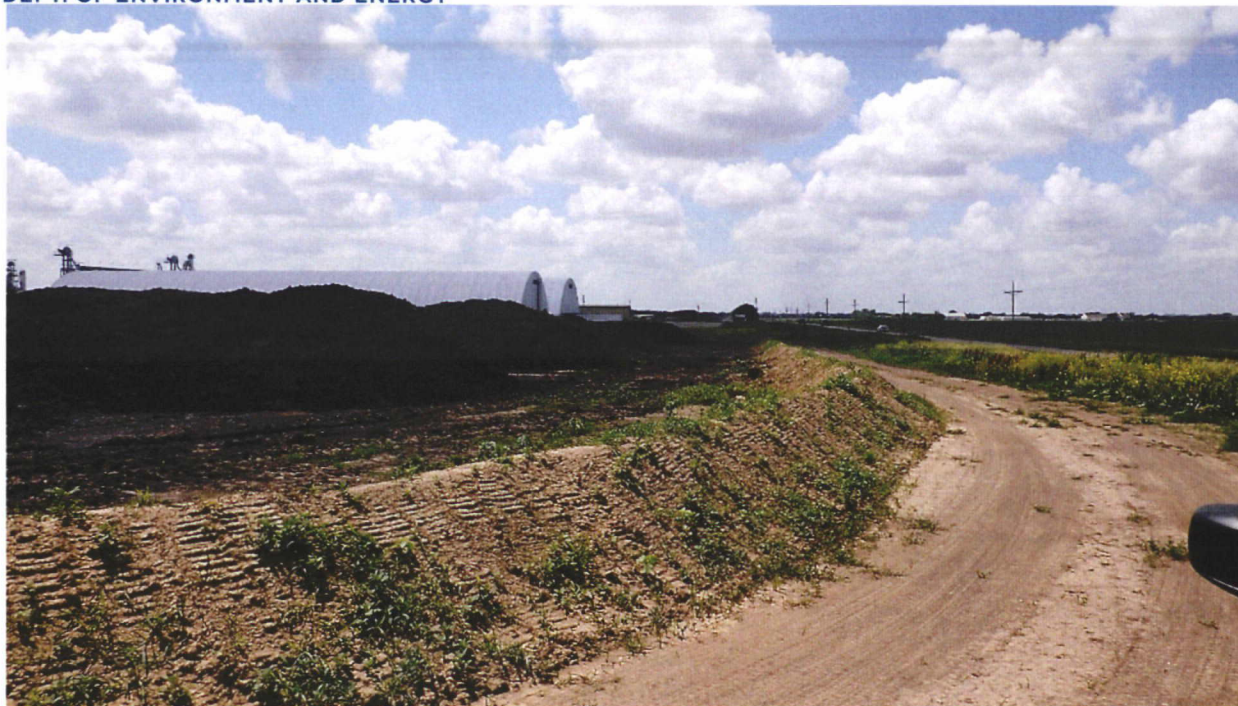
Photo: 6

Description: Area 4 is now connected to area 5. No seepage observed.

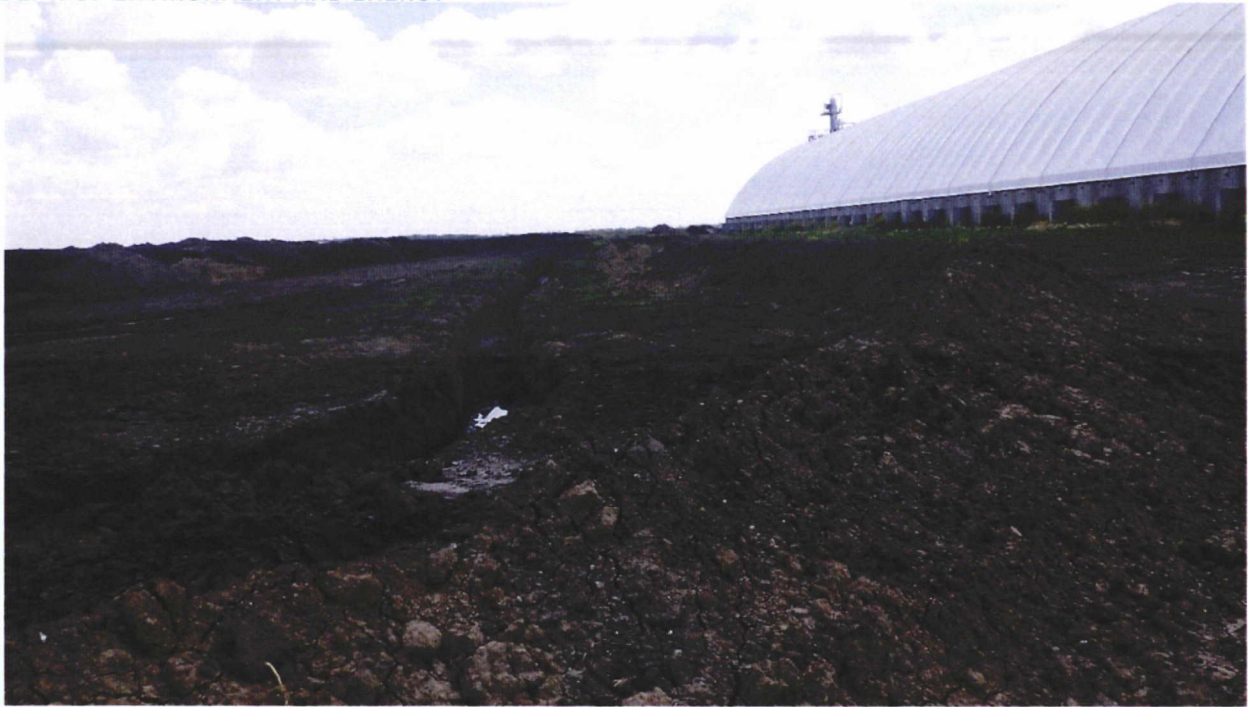
Photo: 7

Description: This is the area 4 and 5 trench. This trench discharges north of the north hoop building which is depicted better in photo 8.

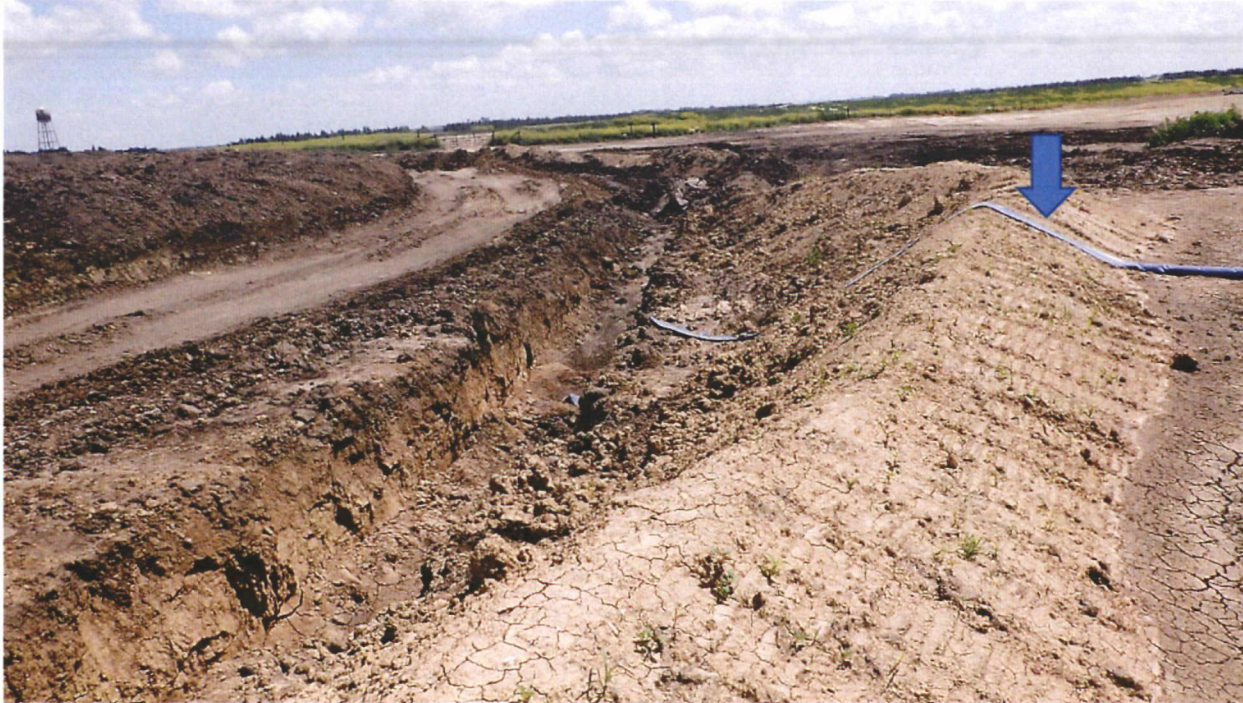
Photo: 8

Description: This is the area 4 and 5 trench. This photo depicts the end of the trench. The trench ends directly north of the north hoop building. The blue hose (arrow) is used to transfer water to the emergency lagoon.

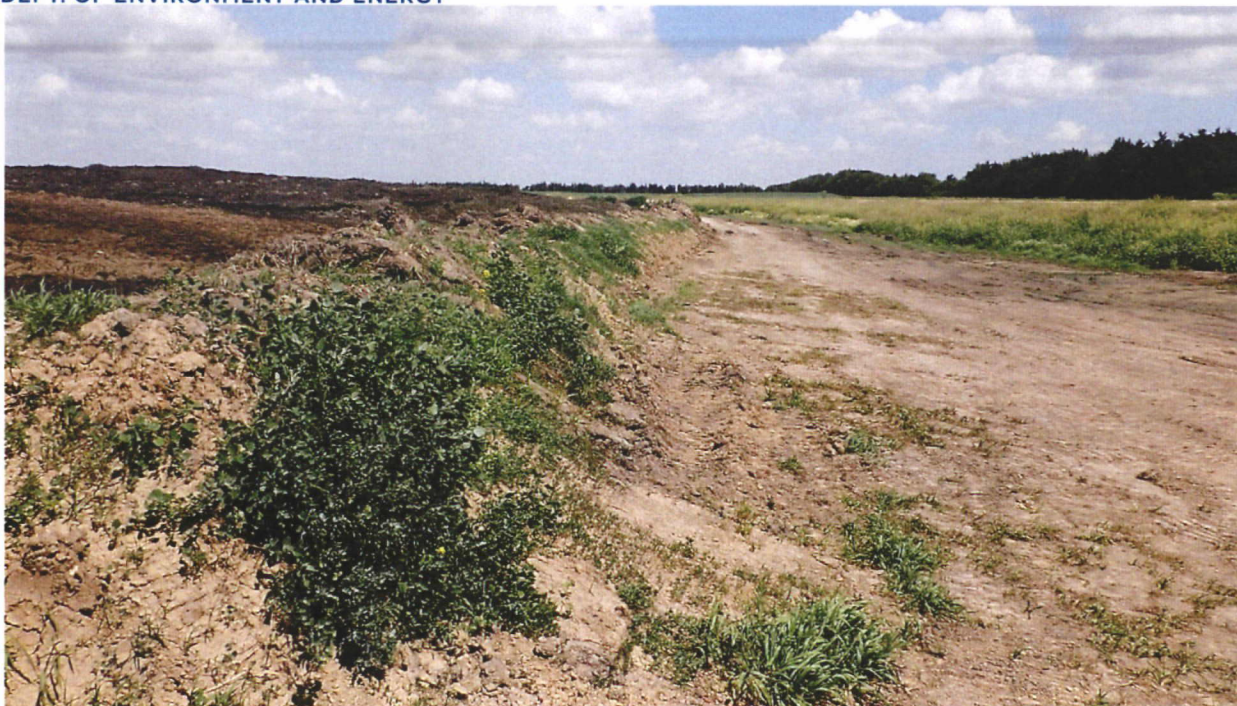
Photo: 9

Description: This is the east dike of area 6.

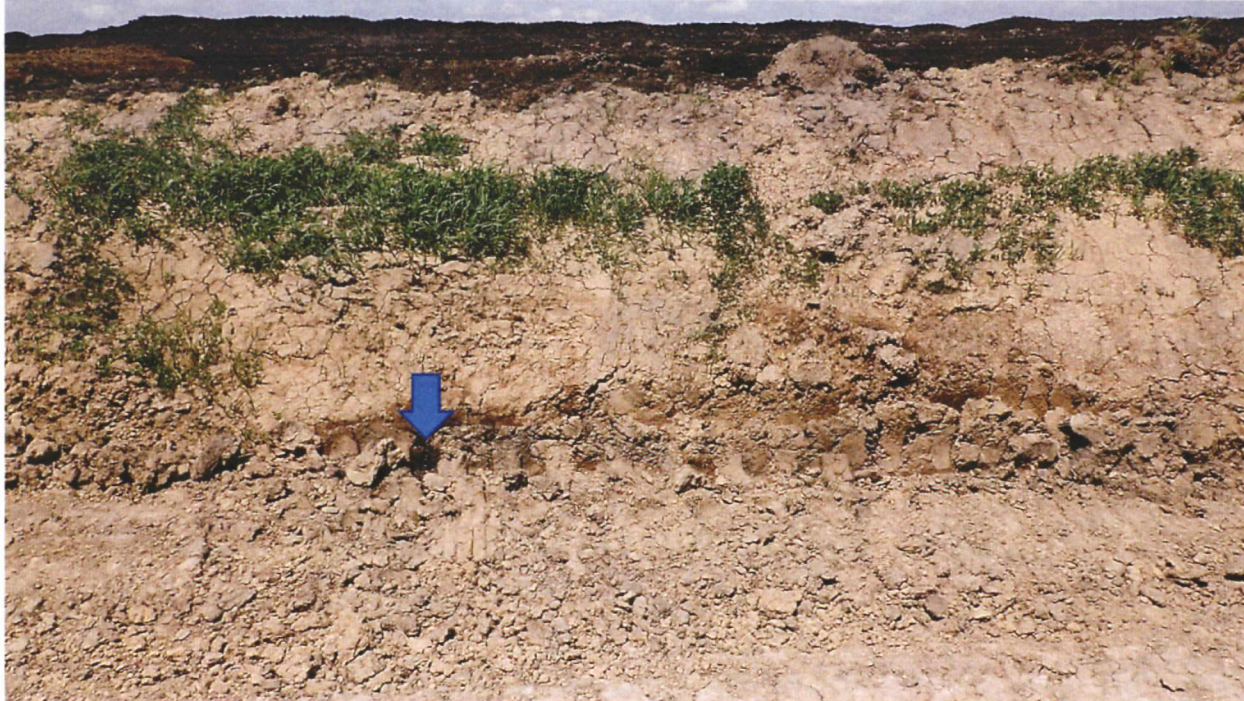
Photo: 10

Description: This photo depicts minor seepage on the east berm.

Area 6 - minor seepage observed

- Investigate/fix area 6 east dike for minor seepage.
- Mow vegetation around the lagoon system, it is becoming a safety concern.
- Discuss lagoon freeboard with NDEE engineering staff. (1-402-471-4252)

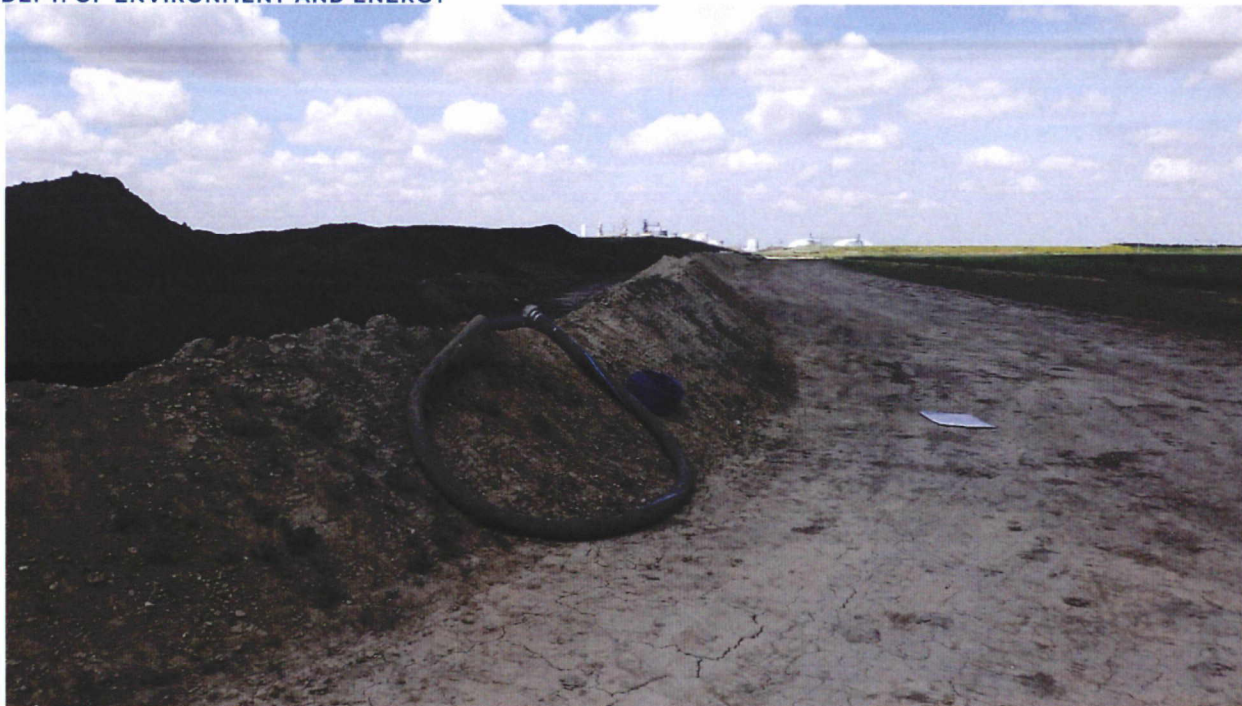
Photo: 11

Description: This photo depicts the hose used to transfer water to totes and then the emergency lagoon.

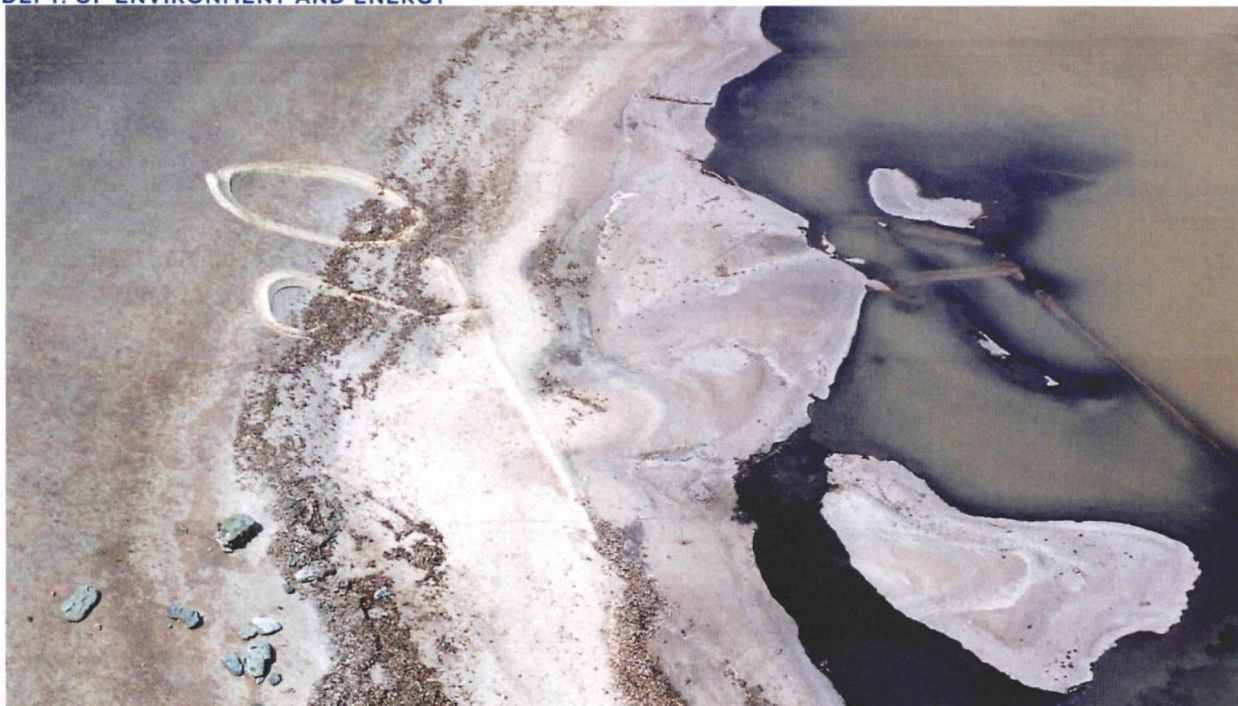
Photo: 12

Description: This photo depicts the depth marker for the northeast lagoon.

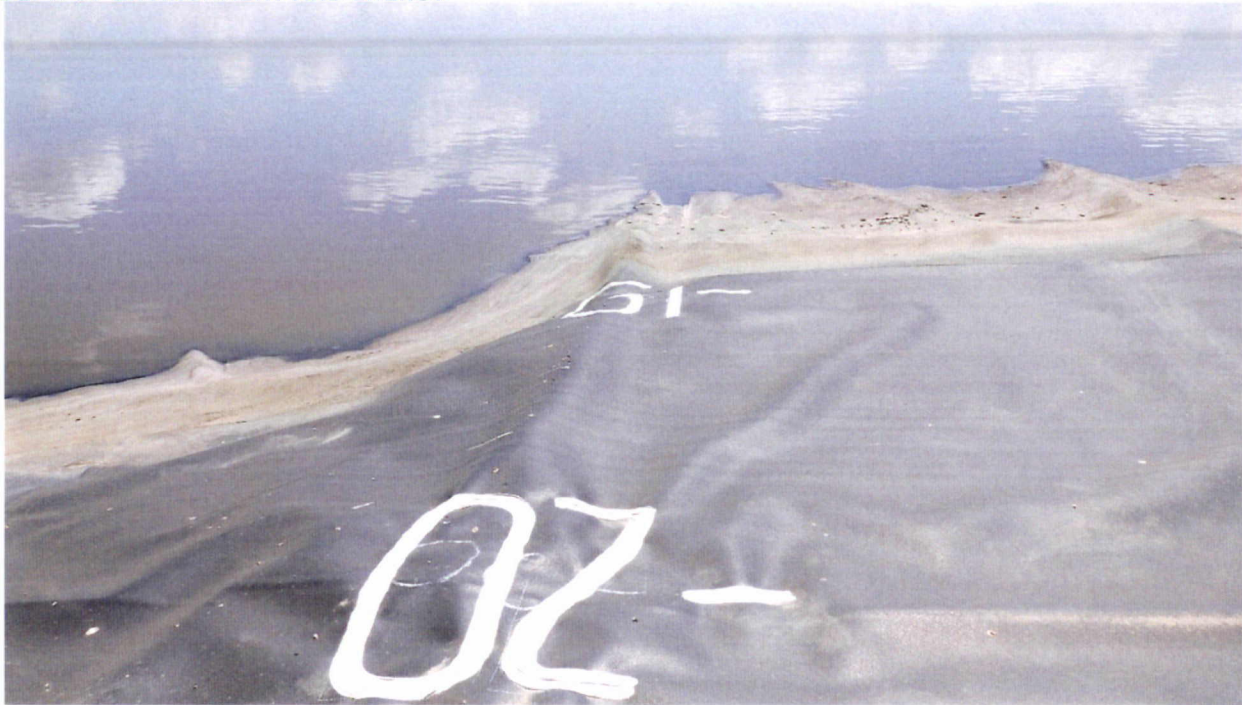
Photo: 13

Description: Depth gauge for the northwest lagoon.

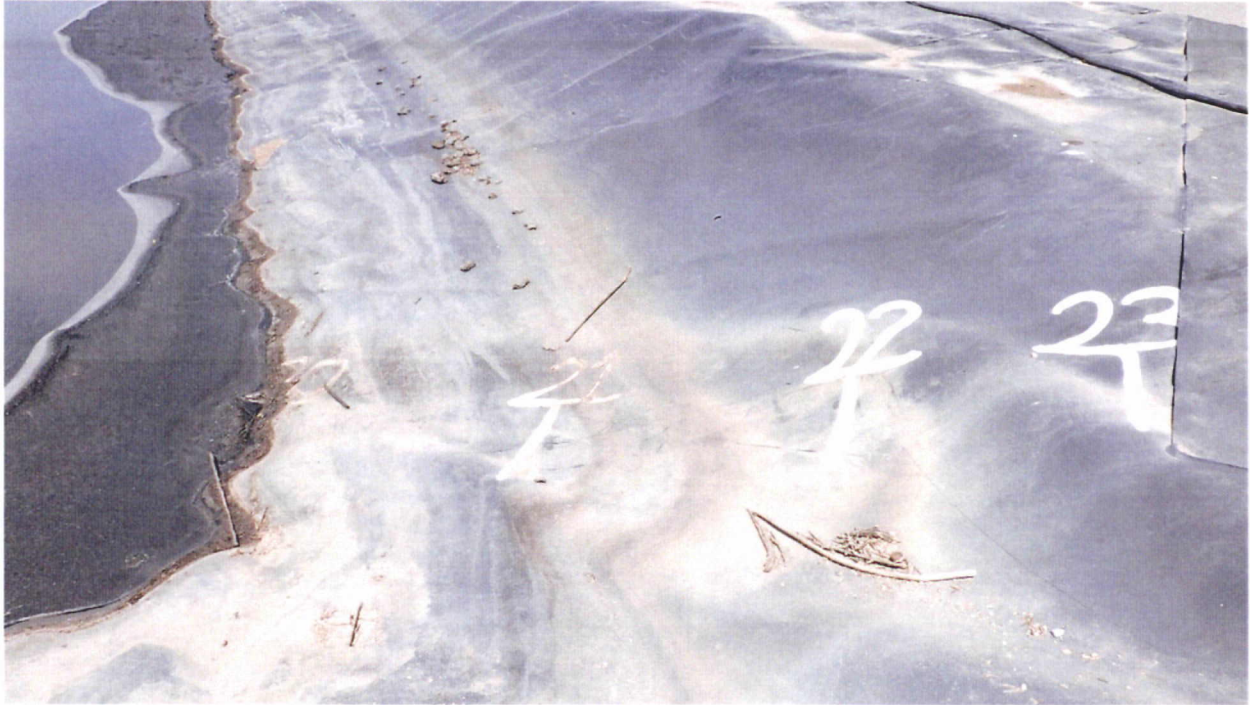
Photo: 14

Description: Depth gauge for the south lagoon.

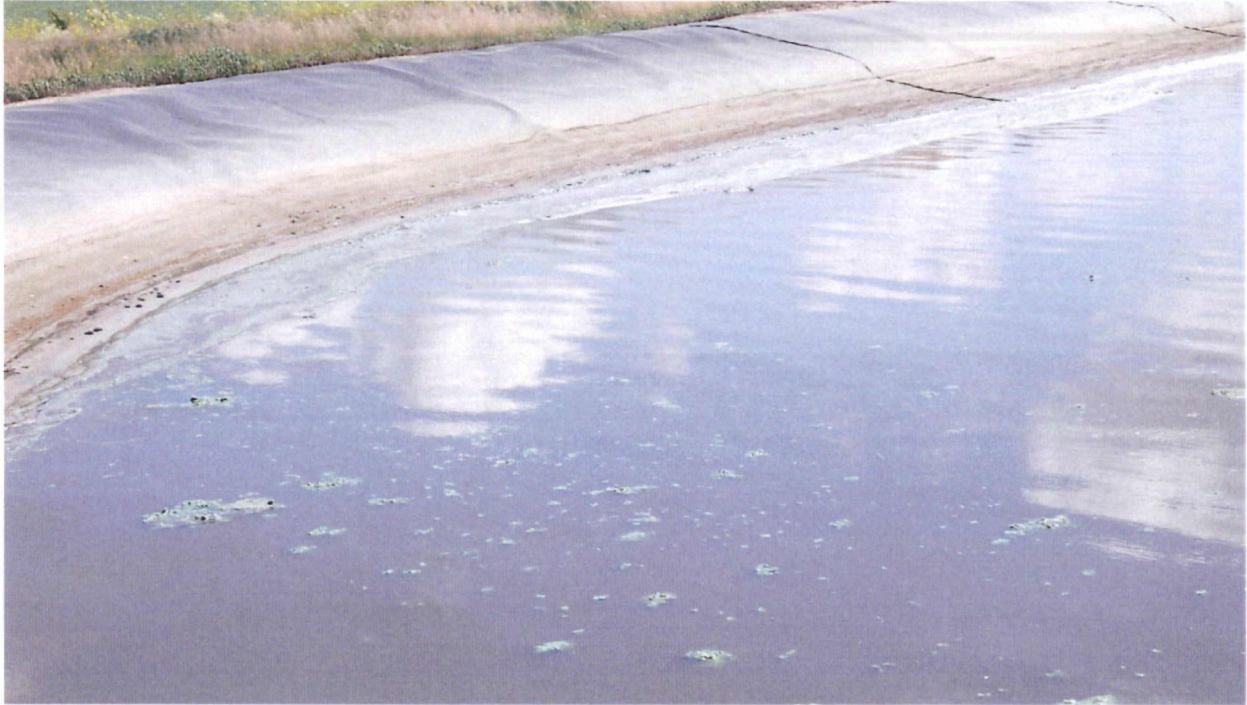
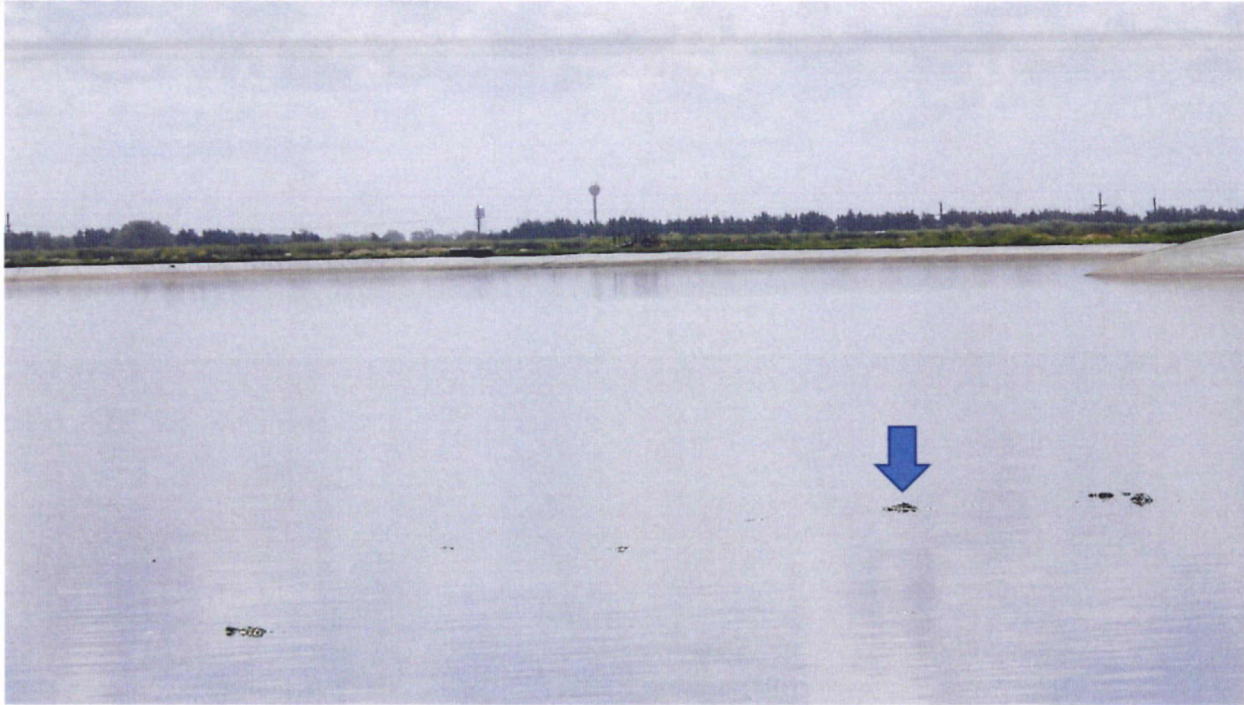
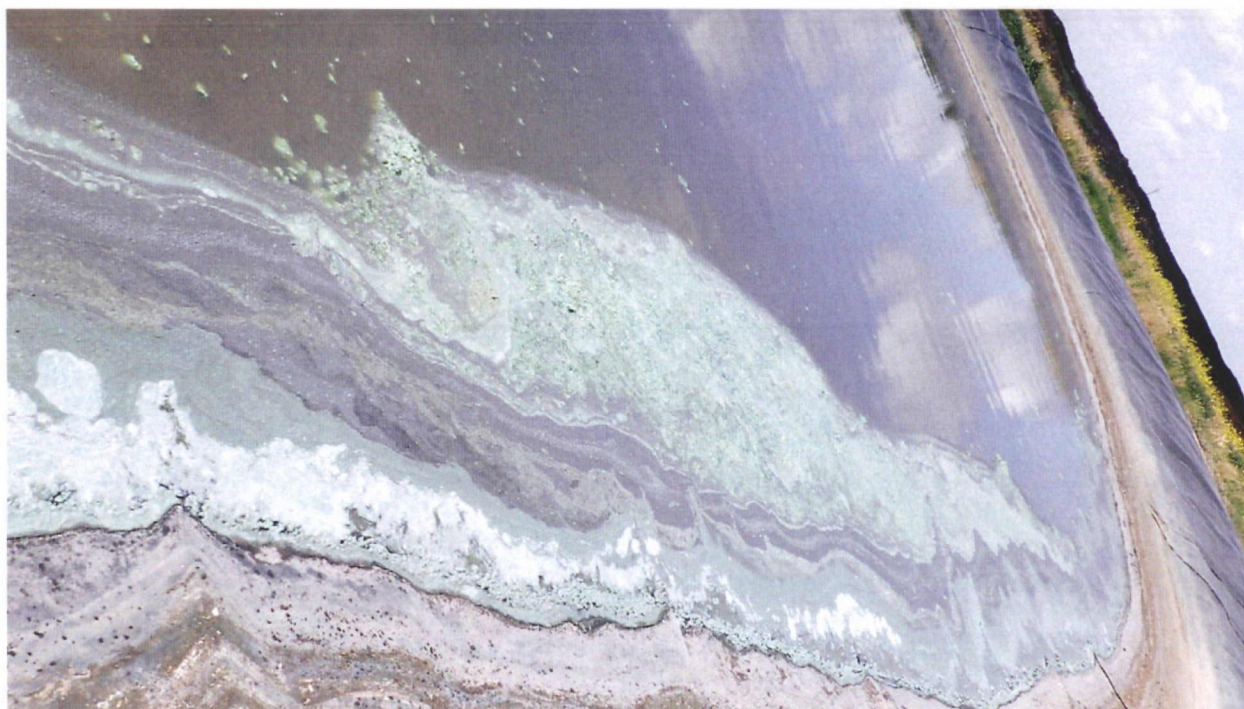
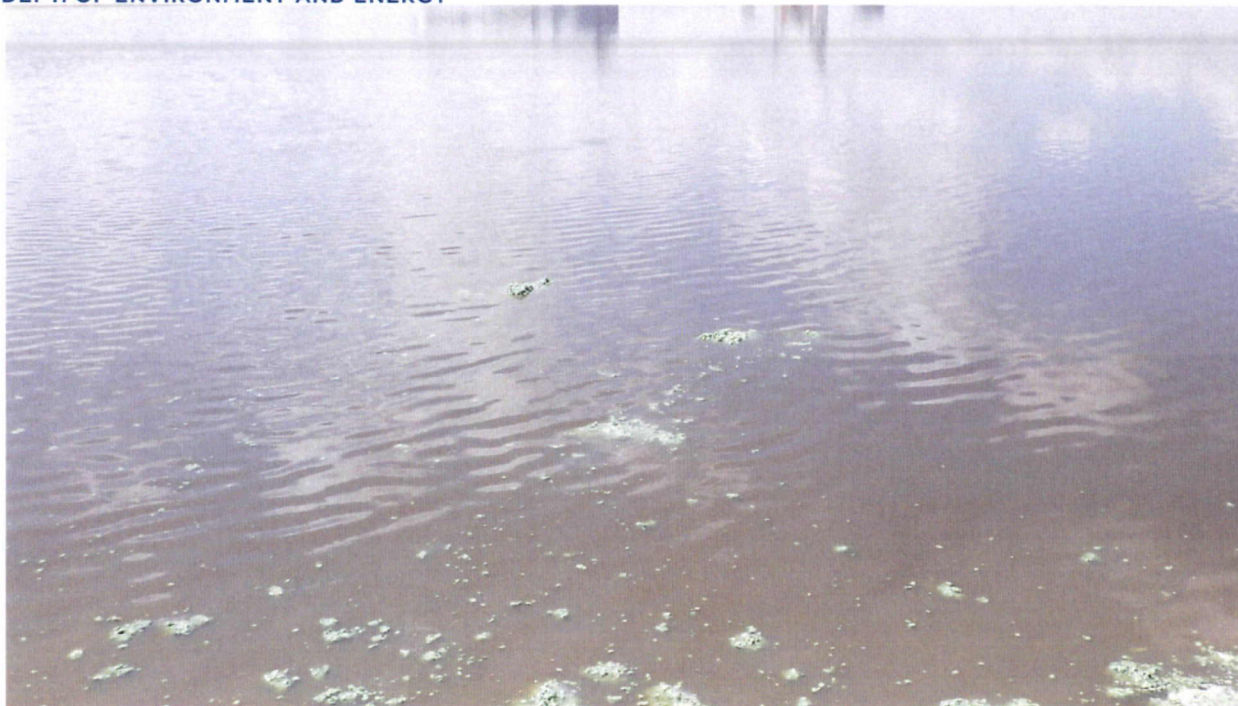
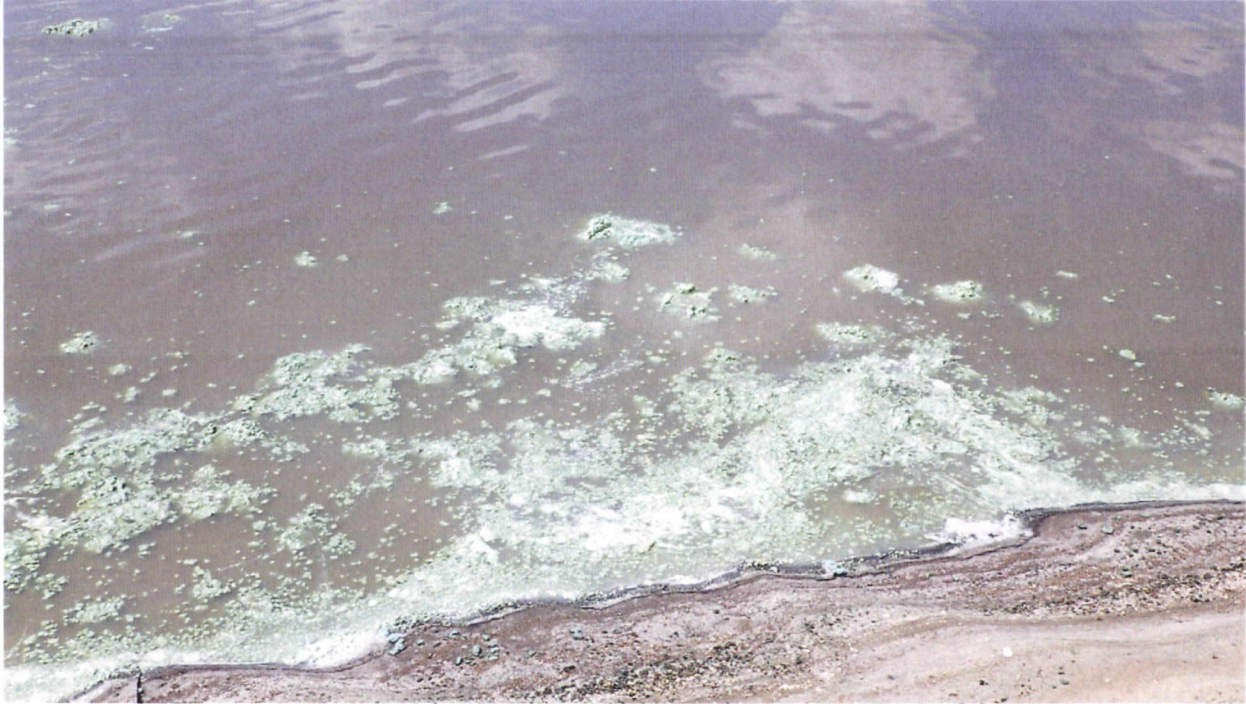
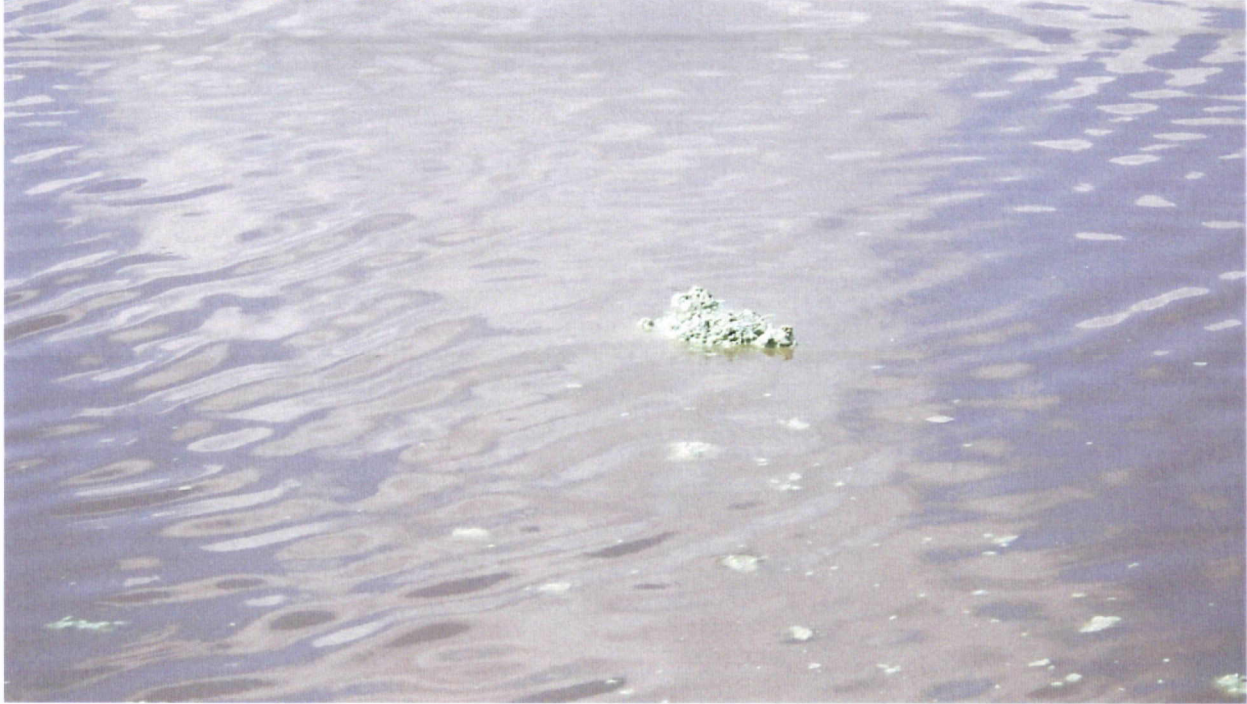
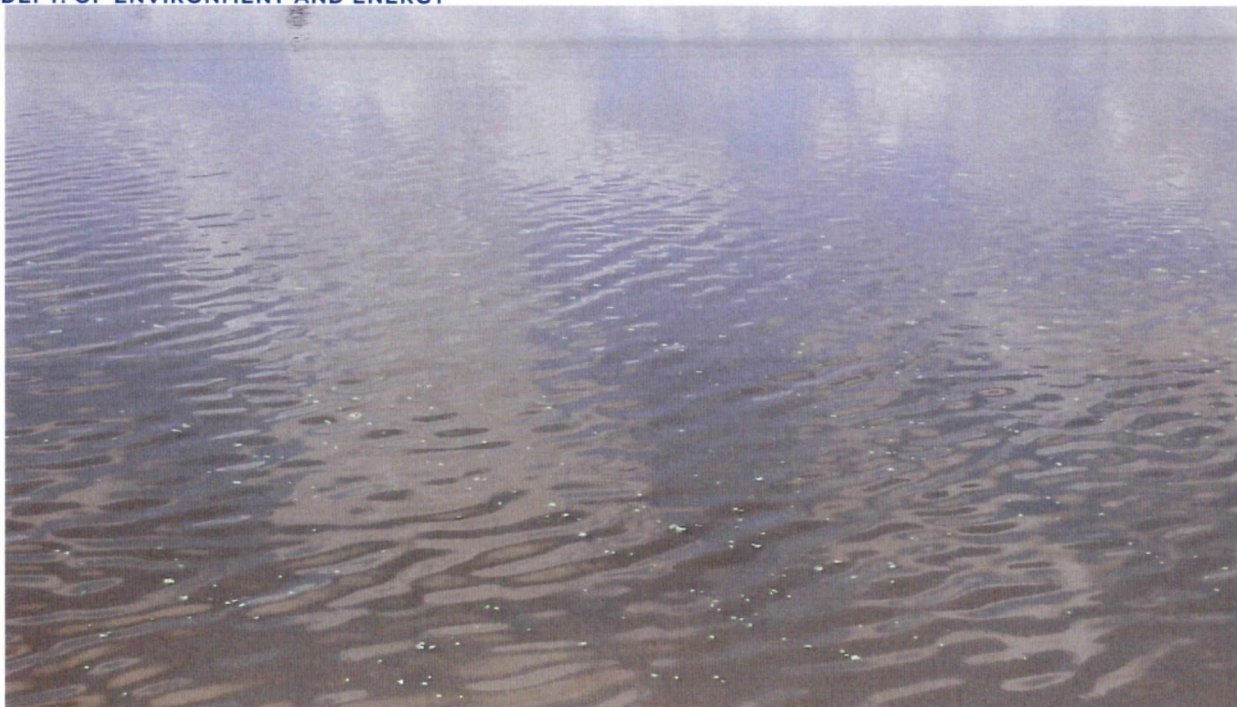
Description: This photo depicts bright green floating sludge.

Description: This photo depicts bright green floating sludge (arrow).

Northwest Lagoon: There is some bright green sludge floating on the north dike. Clean Harbors personal did not know its origin.

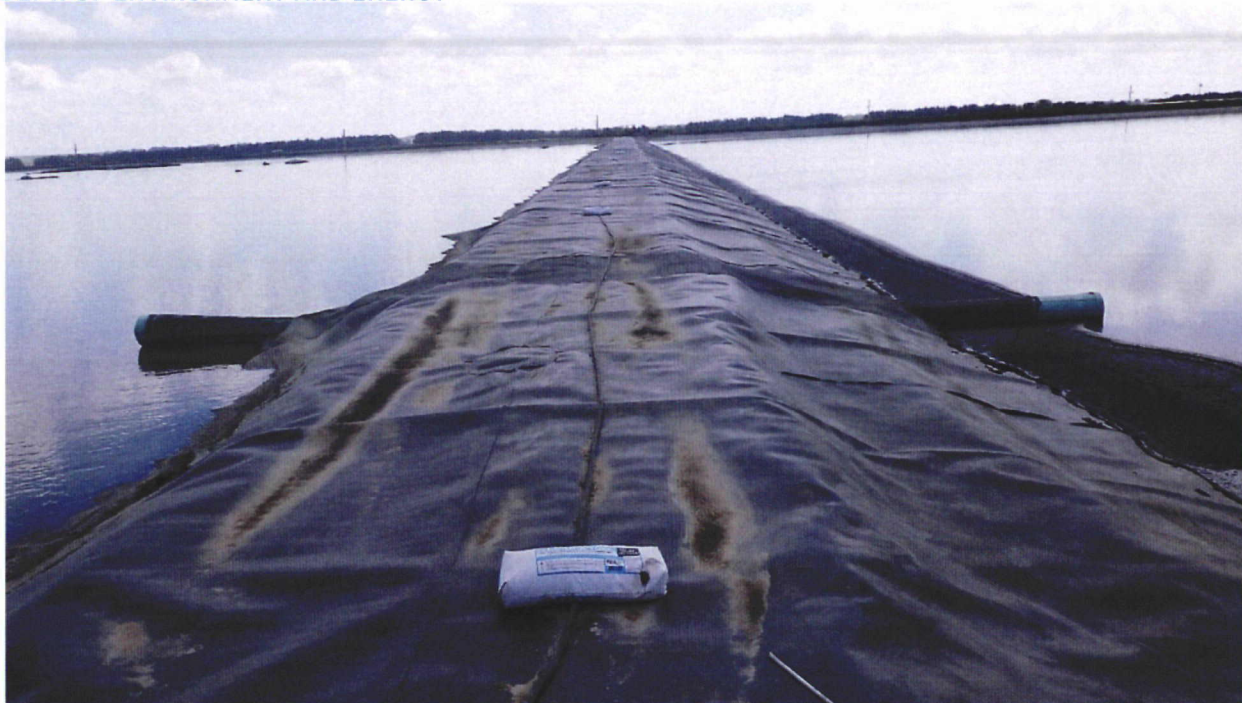
Photo: 22

Description: This photo depicts the equalization pipe between the northeast and south lagoon.

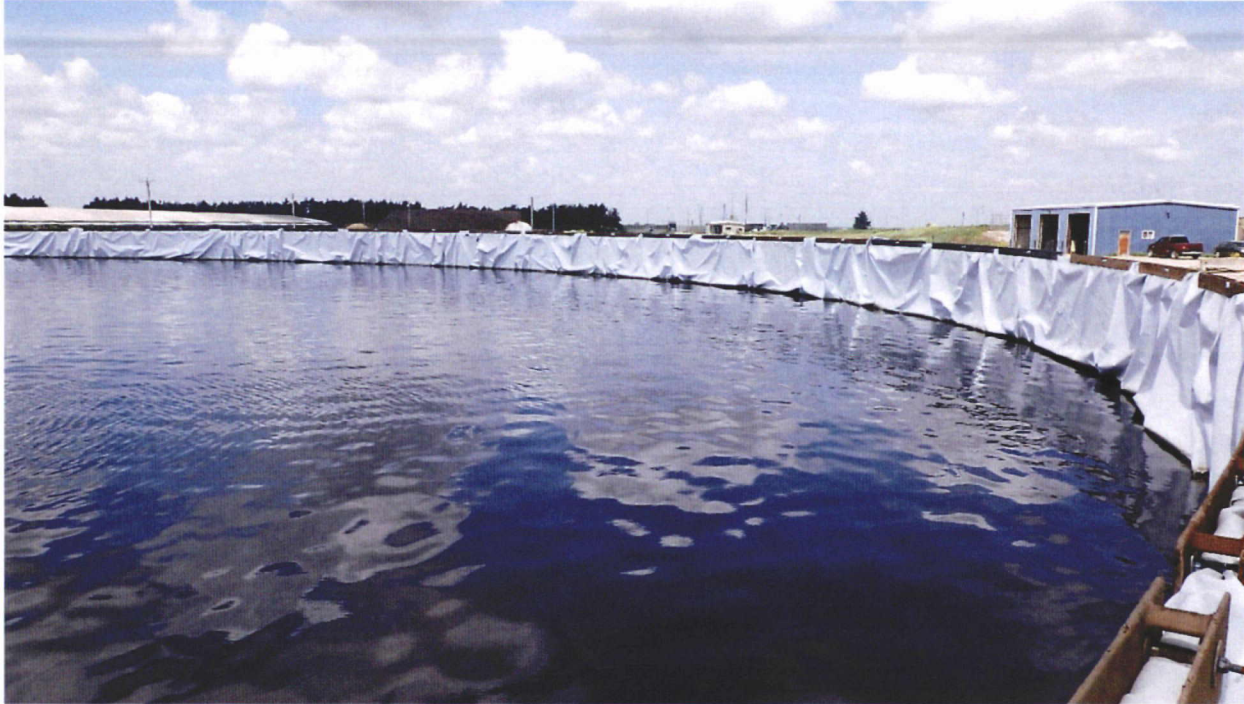
Photo: 25

Description: This photo depicts that the water color is beginning to turn pink.

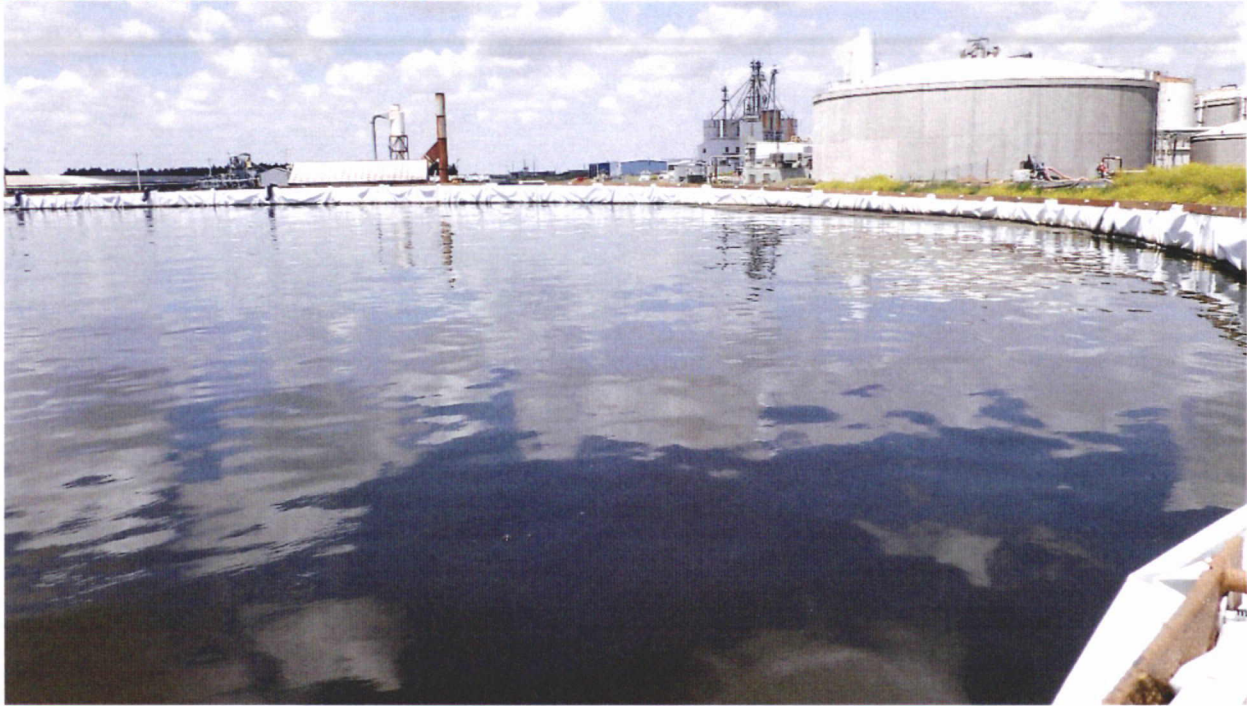
Photo: 25

Description: This photo depicts black water color.

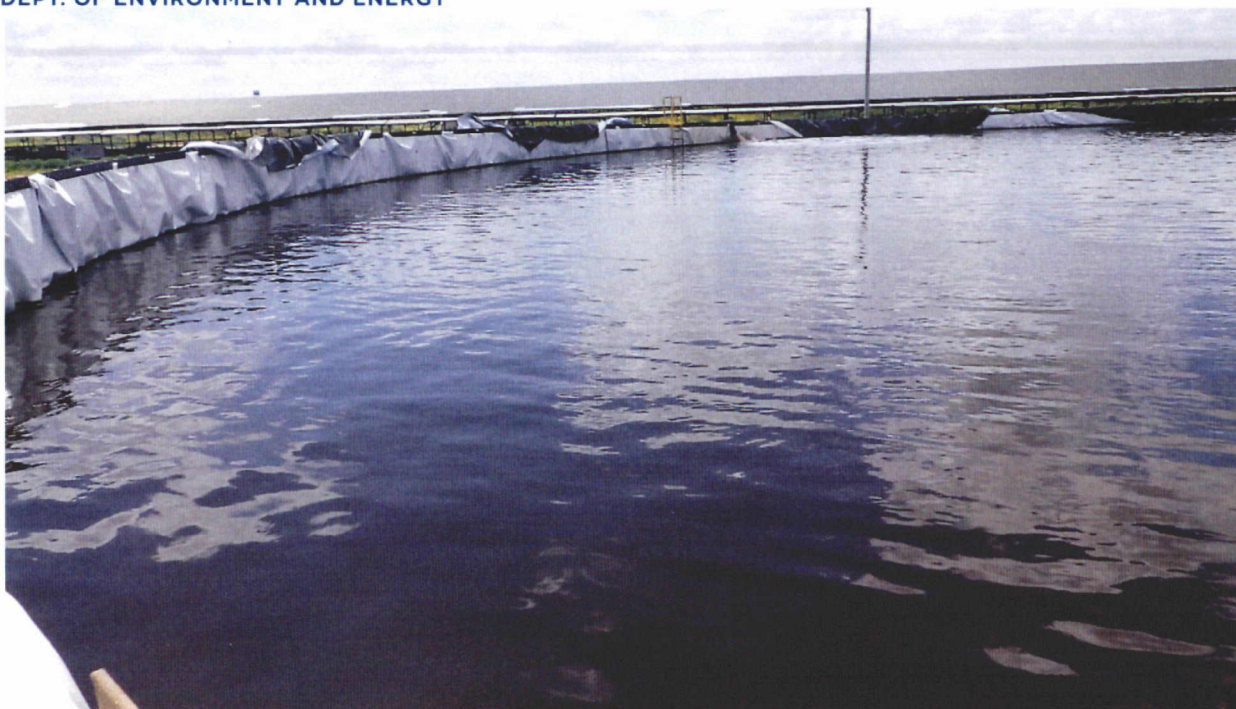
Photo: 26

Description: This photo depicts a dark pink/magenta color.
