Facility: AltEn, LLC

IIS: 84069

PCS: NE0137634

Site Visit Report

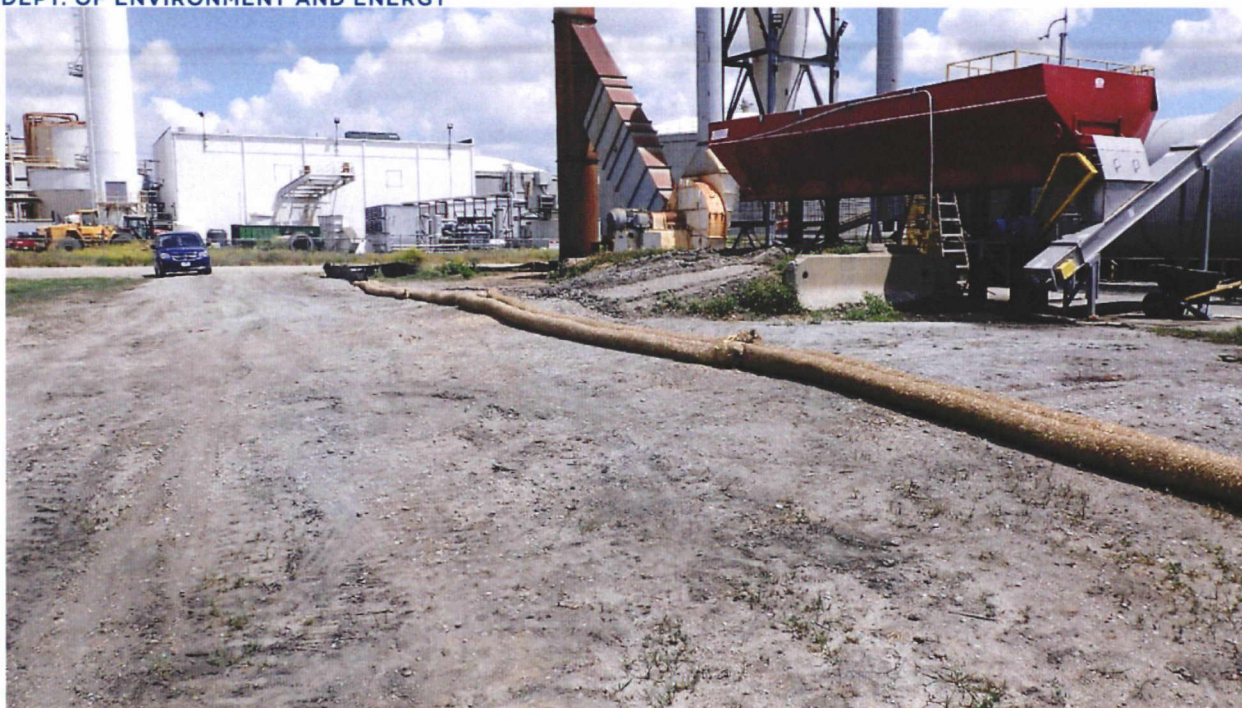
Photo: 27

Description: This photo depicts that Clean Harbors has added straw socks to prevent biochar product runoff.

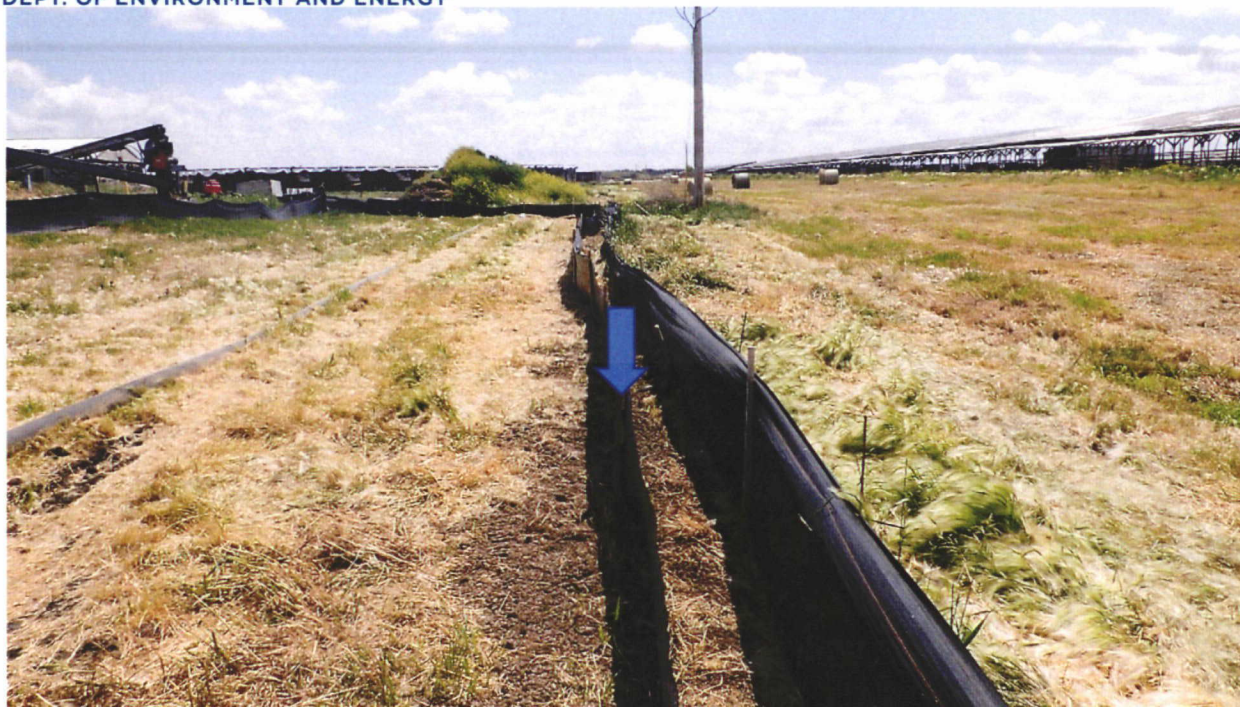
Photo: 28

Description: This photo depicts the new silt fence which is trenched in (arrow).

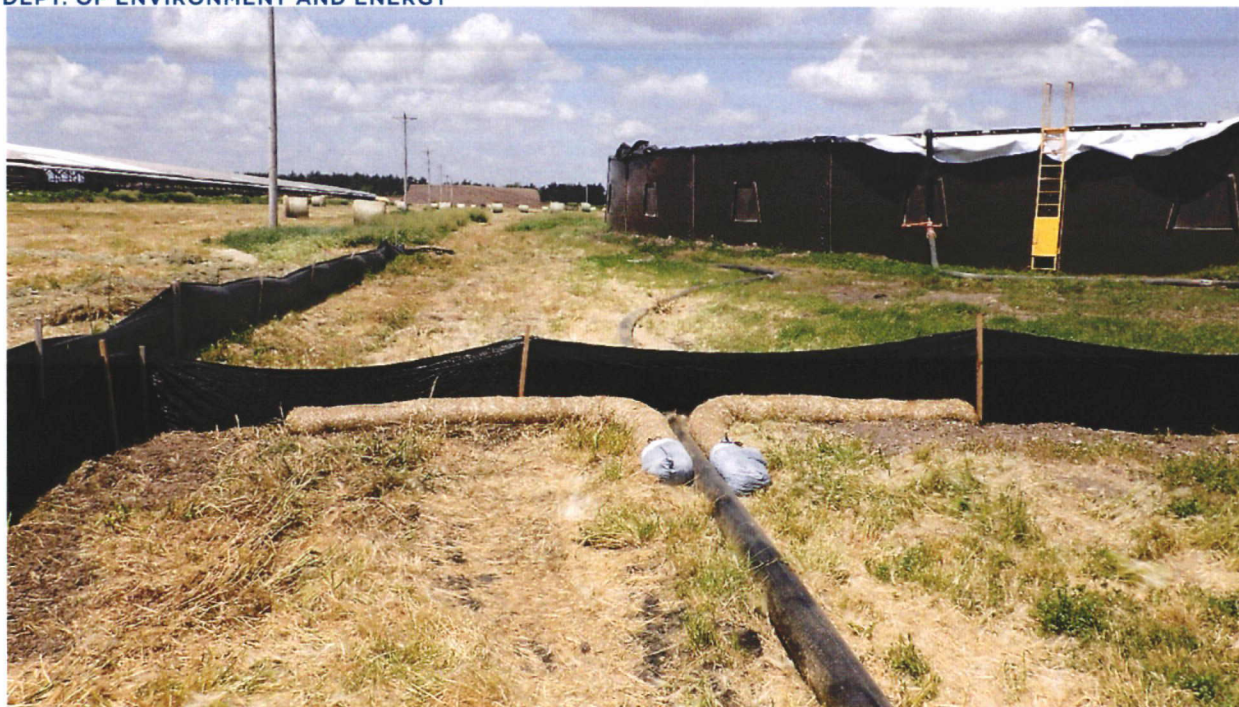
Photo: 29

Description: This photo depicts the new silt fence and straw socks to prevent runoff from the biochar product.

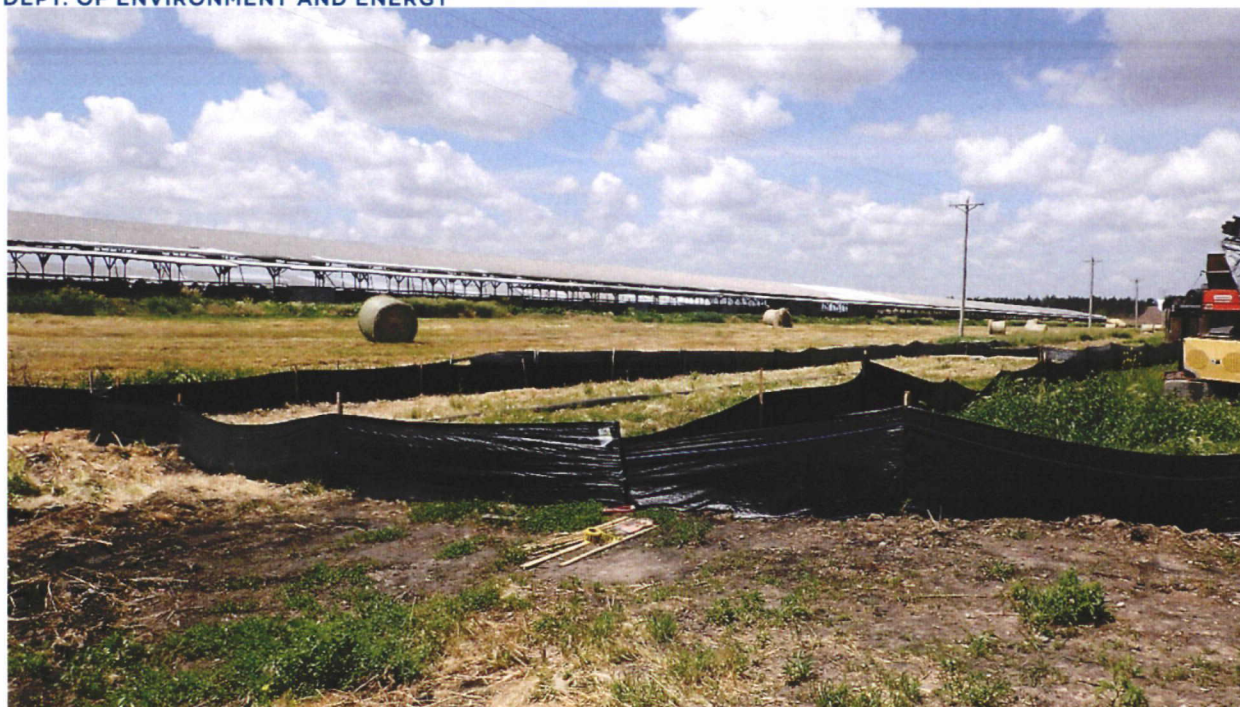
Photo: 30

Description: The new silt fencing appears to contain all the spilled product.

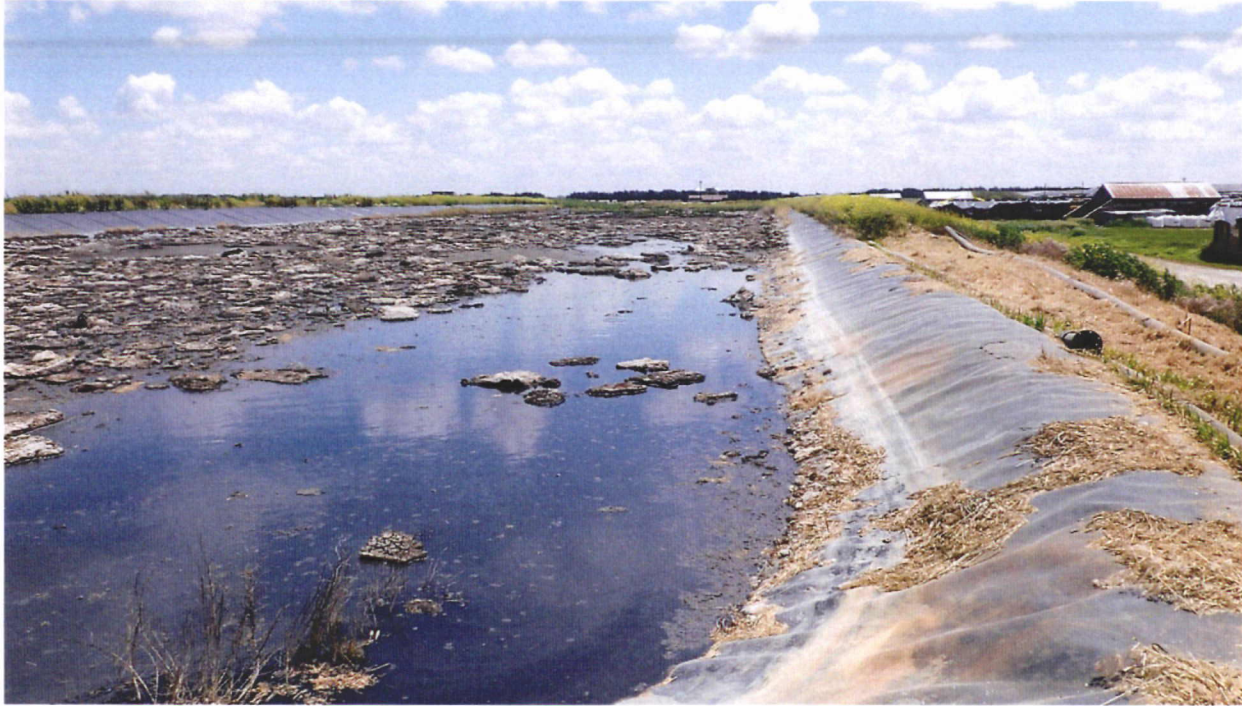
Photo: 31

Description: This photo depicts the lagoon depth.
