Facility: AltEn, LLC

IIS: 84069

PCS: NE0137634

**Site Visit Check list**

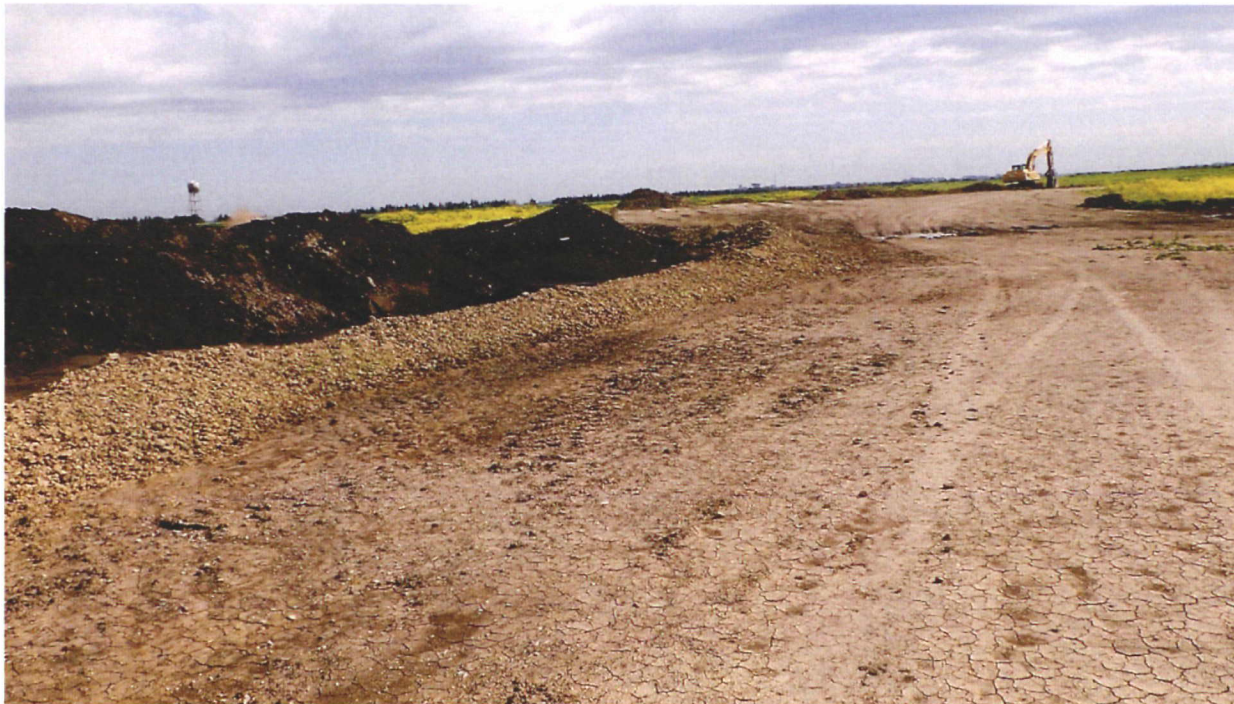
Photo: 1

Description: This is the west berm. There is no water accumulation.

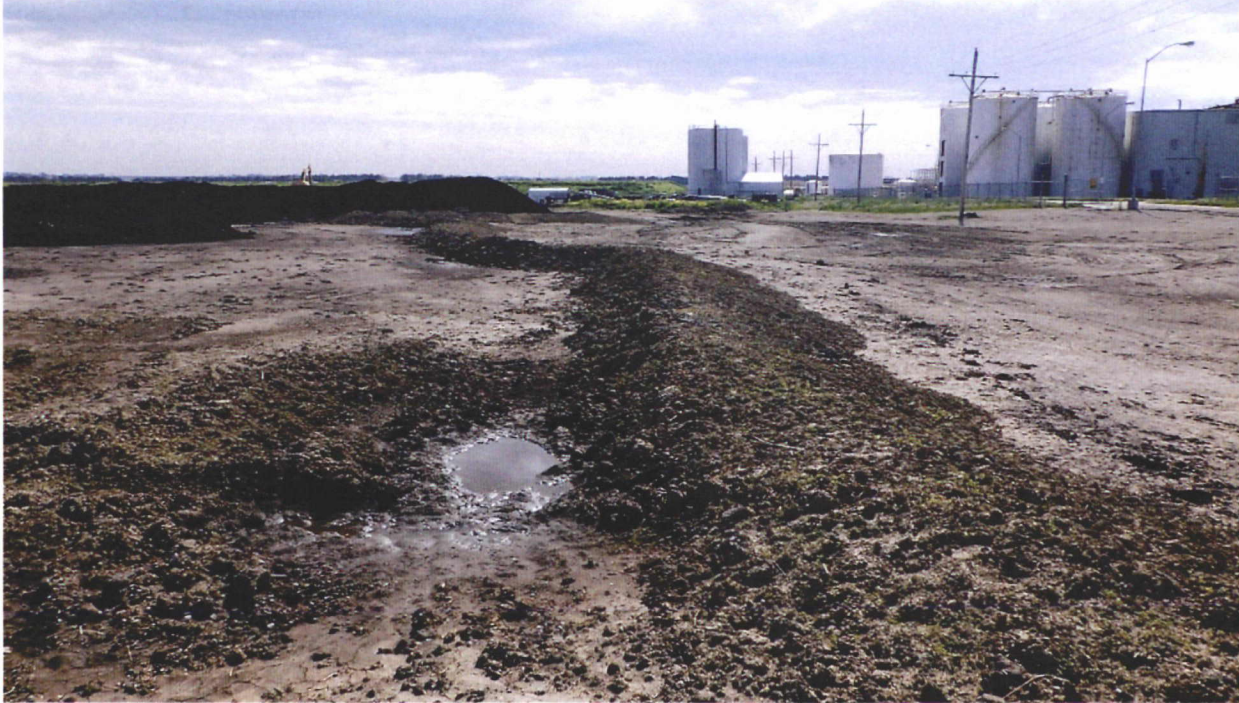
Photo: 2

Description: This is the west berm. This part of the berm expands to west side of the south wet cake pile. There is minor water accumulation and no signs of seepage.

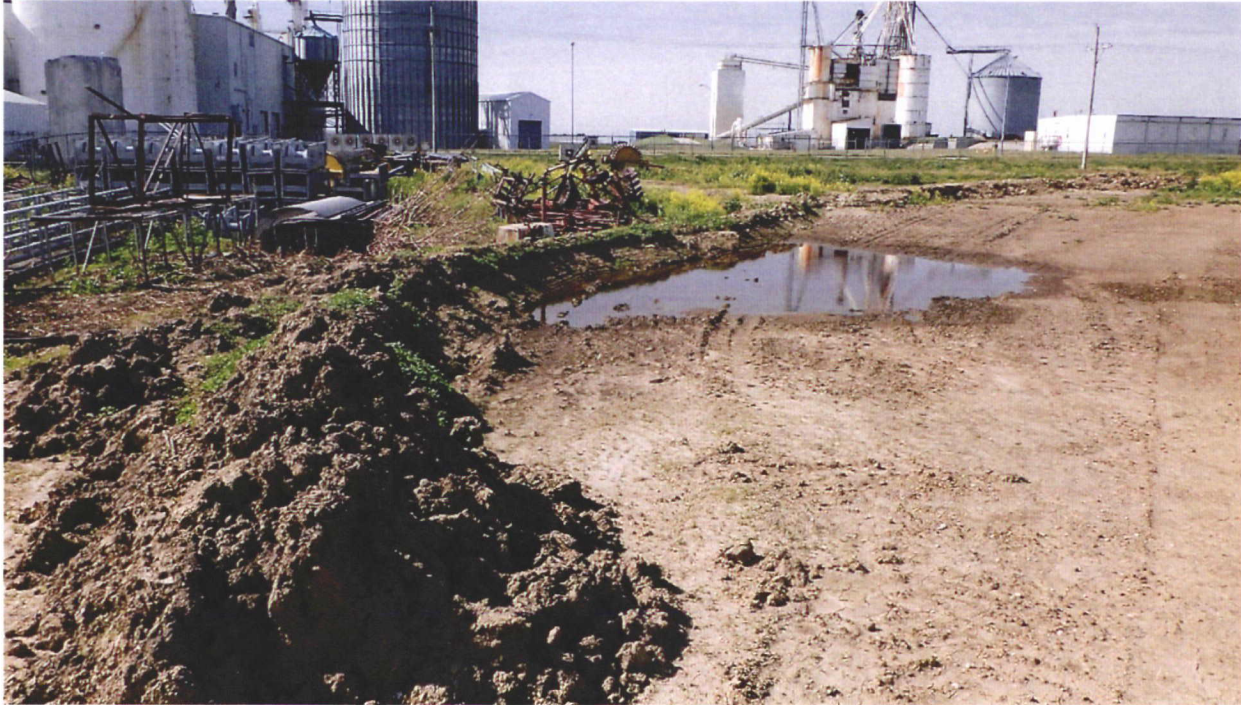
Photo: 3

Description: This is the original east berm. There is only minor water accumulation and no signs of seepage.

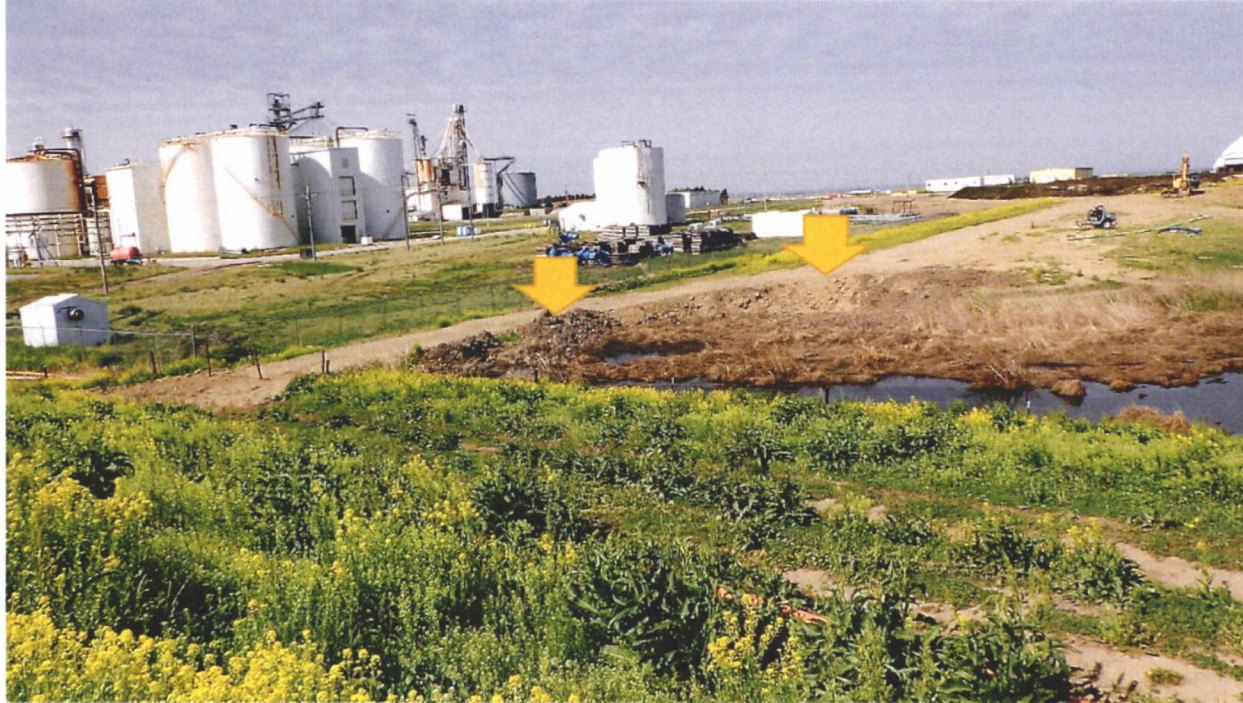
Photo: 4

Description: The facility is adding addition dirt (arrow). There is some water accumulation and no signs of seepage.

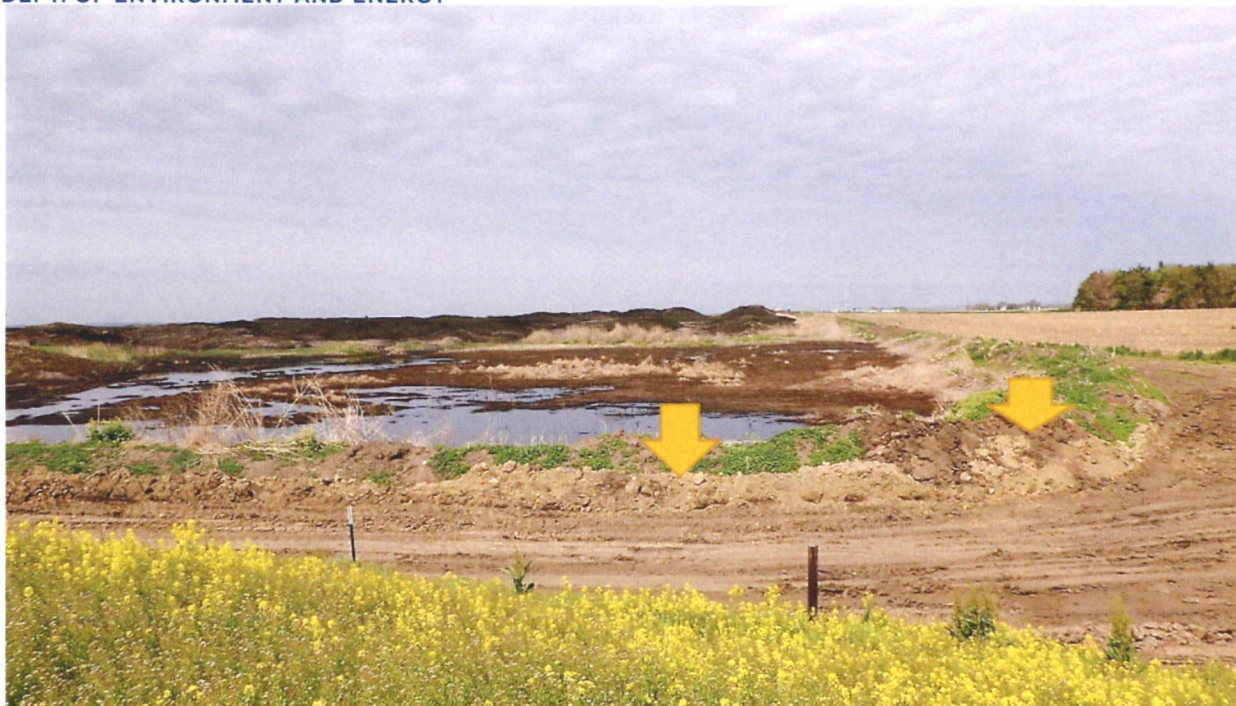
Photo: 5

Description: The facility has added additional dirt (arrow). There are no signs of seepage.

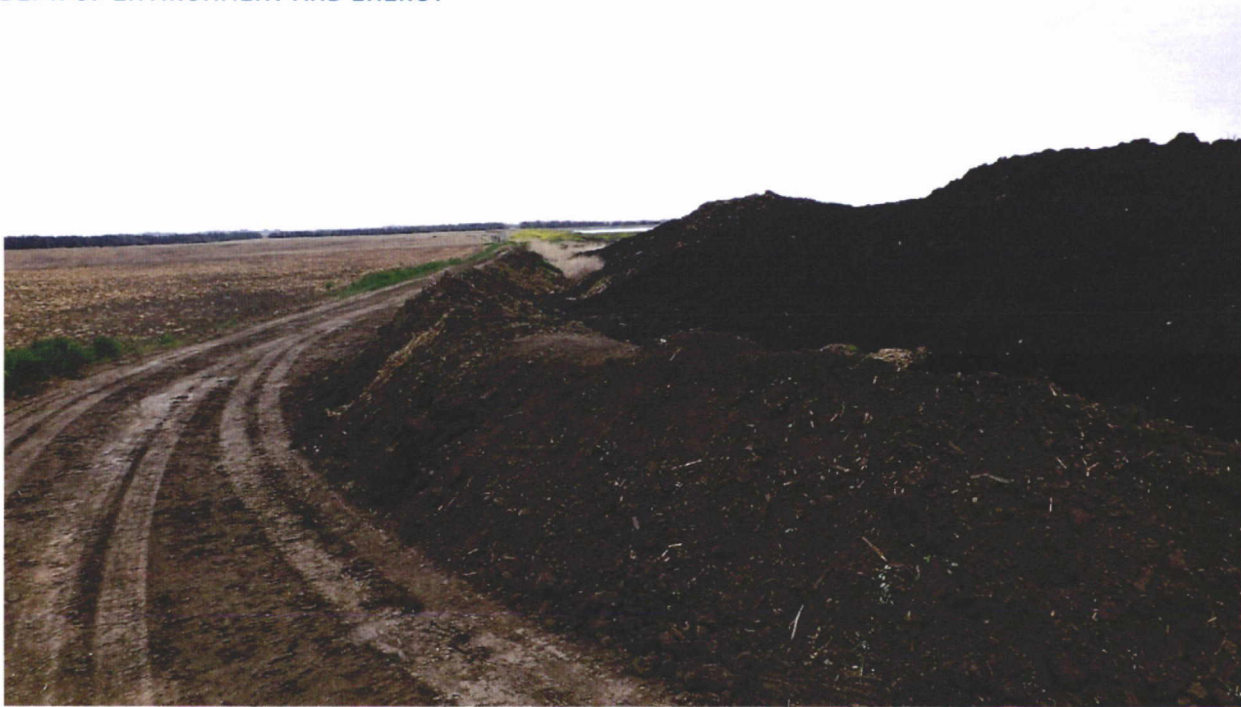
Photo: 6

Description: The facility has added dirt. There is no water accumulation.

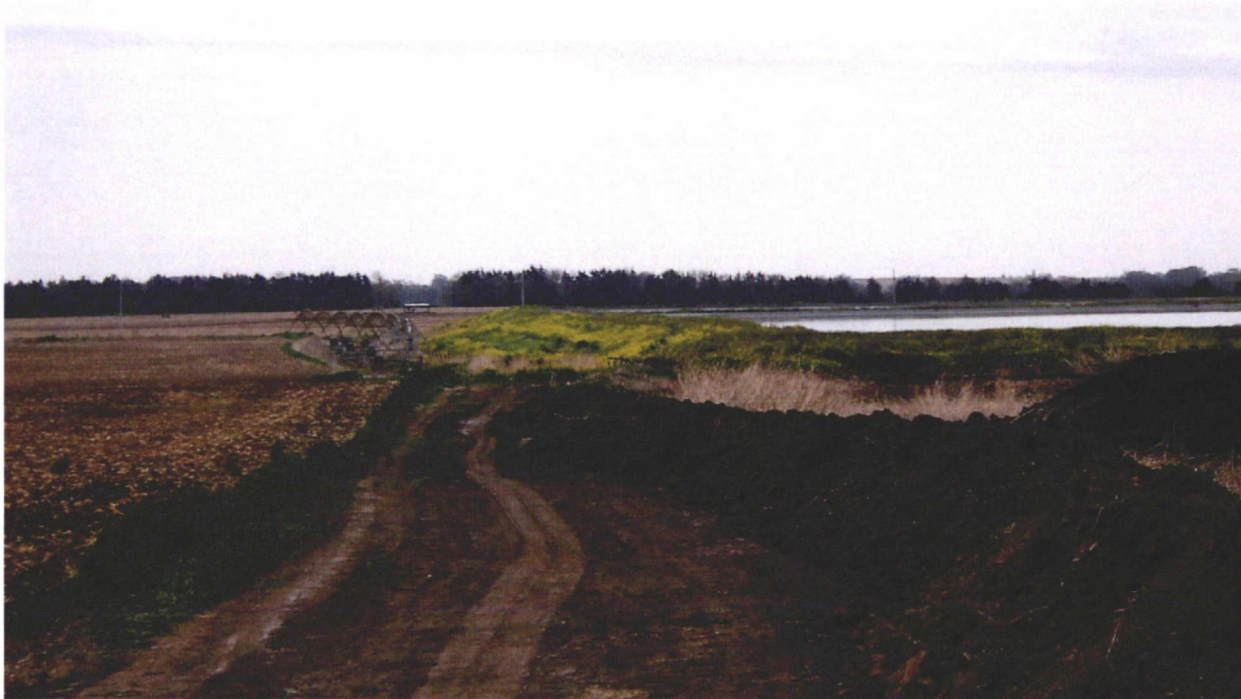
Photo: 7

Description: The facility has added dirt along the north side of the north wet cake pile. This photo depicts that the berm is not compacted.

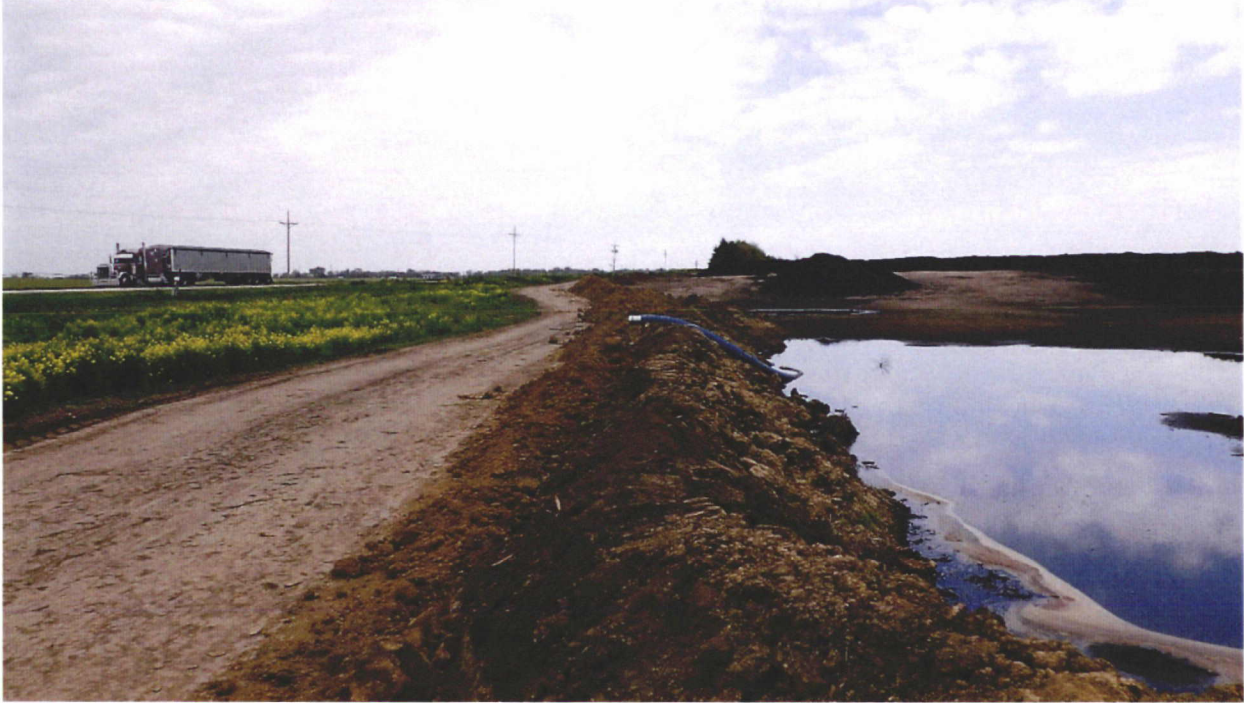
Photo: 8

Description: This photo depicts the area 5 berm. Clean Harbors had added additional dirt. The berm is not compacted. There is no seepage observed.

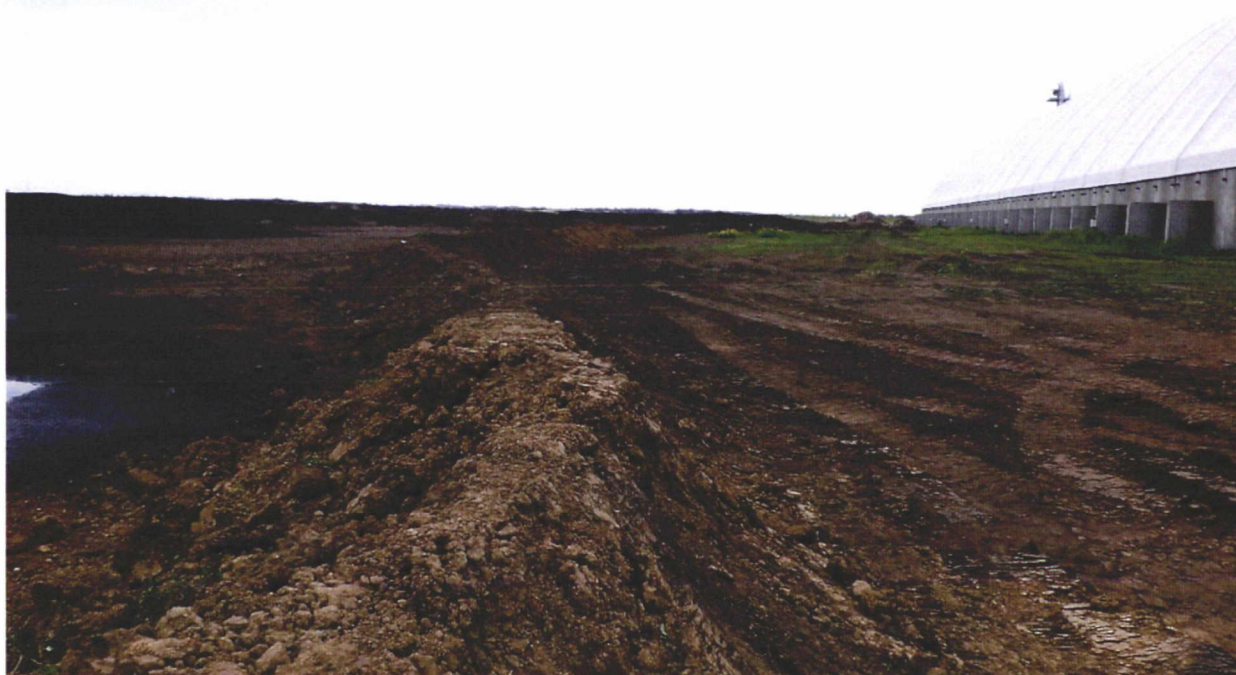
Photo: 9

Description: This photo depicts the area 5 berm. Clean Harbors has added additional berm on the south side of Area 5.

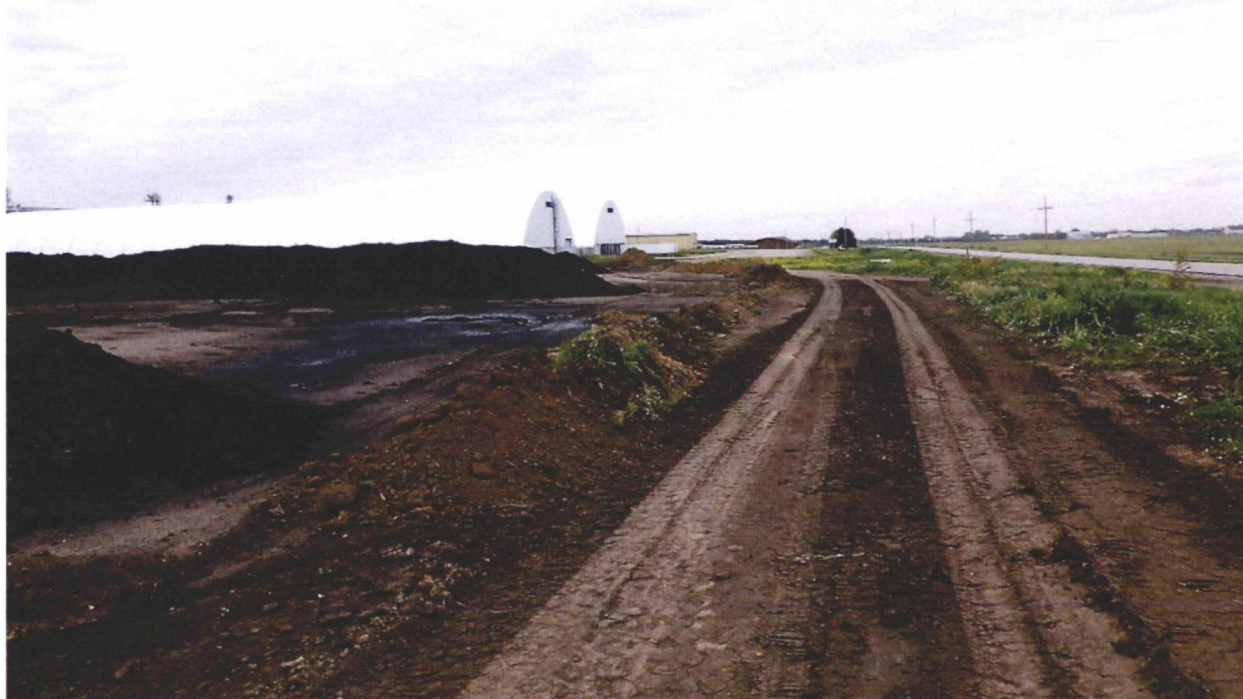
Photo: 11

Description: This photo depicts addition soil added on the north side of Area 5. The berm is not compacted.

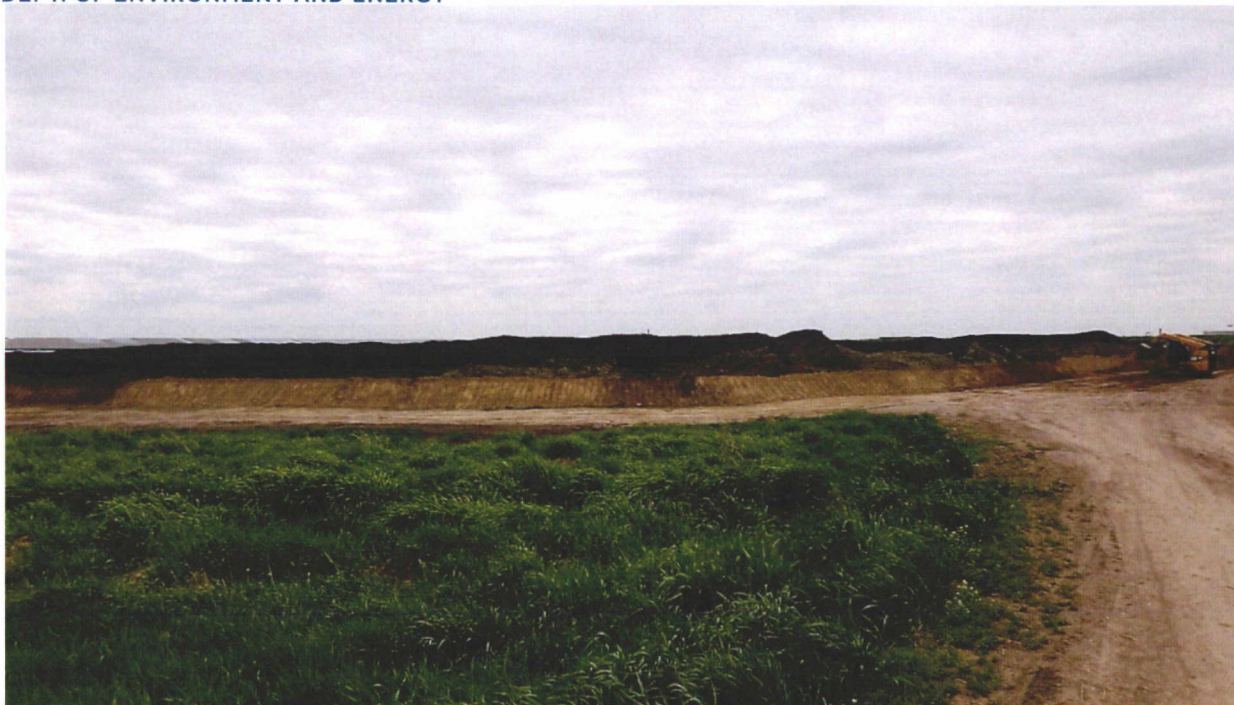
Photo: 12

- Area 1 contains two berms. The east berm has been expanded to prevent parking lot water from entering the berm area.
- Areas 2, 3, 4 and 5 has some water accumulation. Clean Harbors has added dirt around areas 2, 4 and 5.
- Clean Harbors is constructing berms around Area 6. The berm will surround the pile, see photos 12 through 19.

Description: This photo depicts the new compacted berm along Area 6.

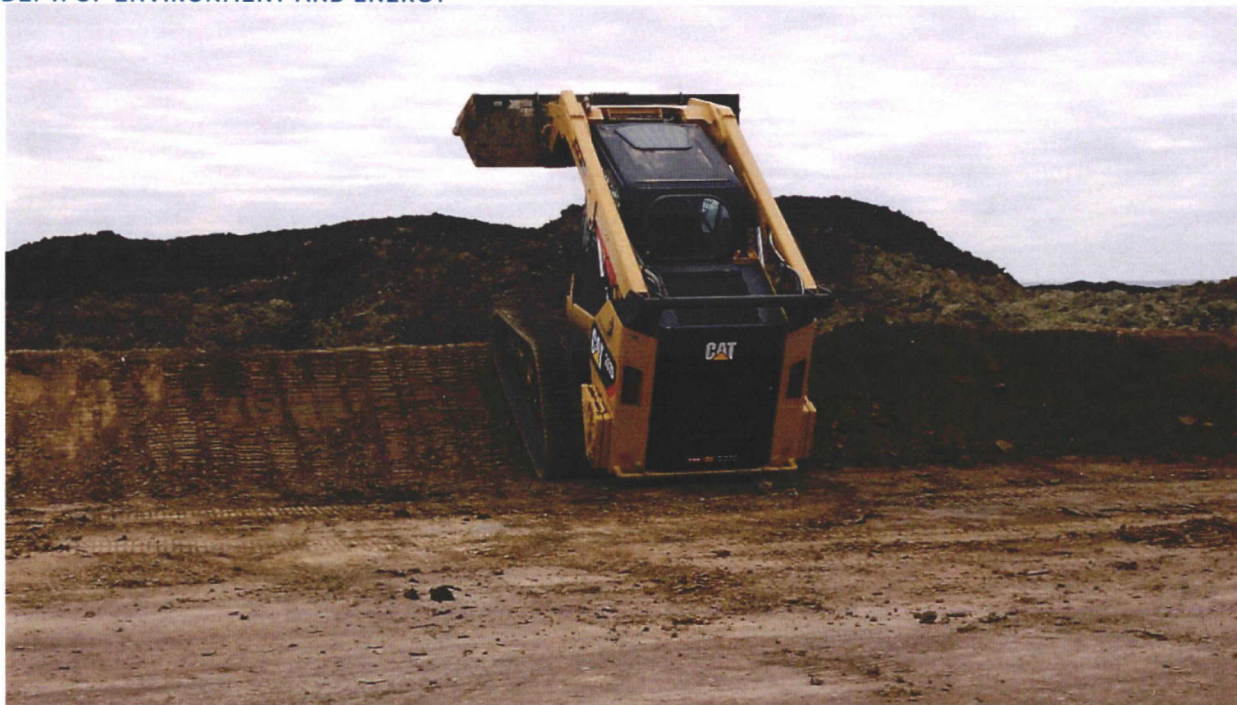
Photo: 13

Description: This photo depicts a heavy equipment operator compacting the berm on the north side.

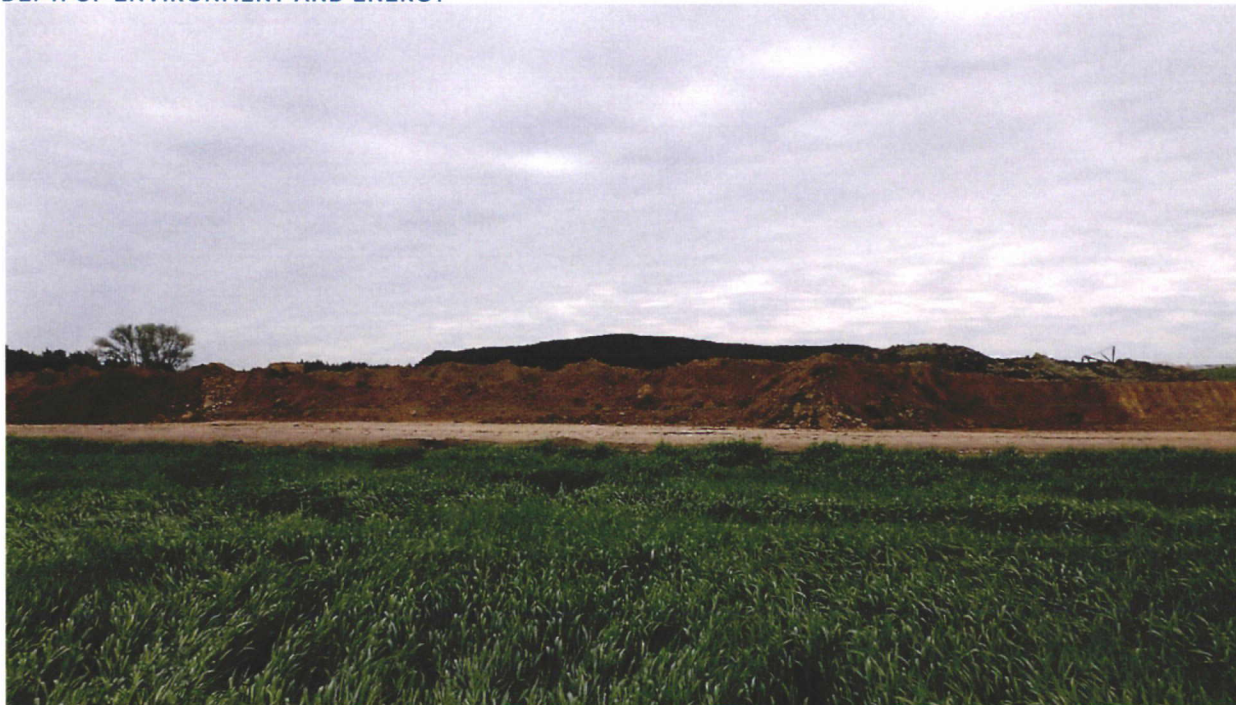
Photo: 14

Description: This photo depicts the north side of the berm. This area was not compacted during the inspection. I took this photo while standing in the waterway north of Area 6.

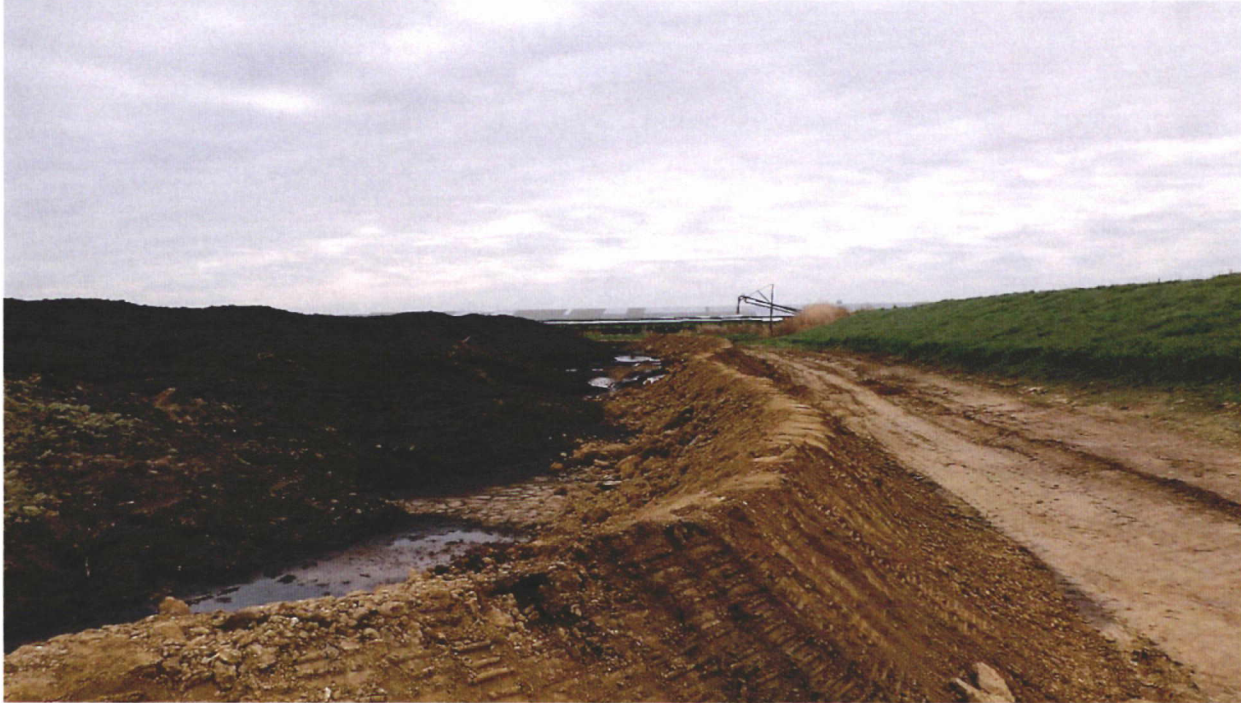
Photo: 15

Description: This photo depicts the west side. Clean Harbors is expanding the berm around the pile.

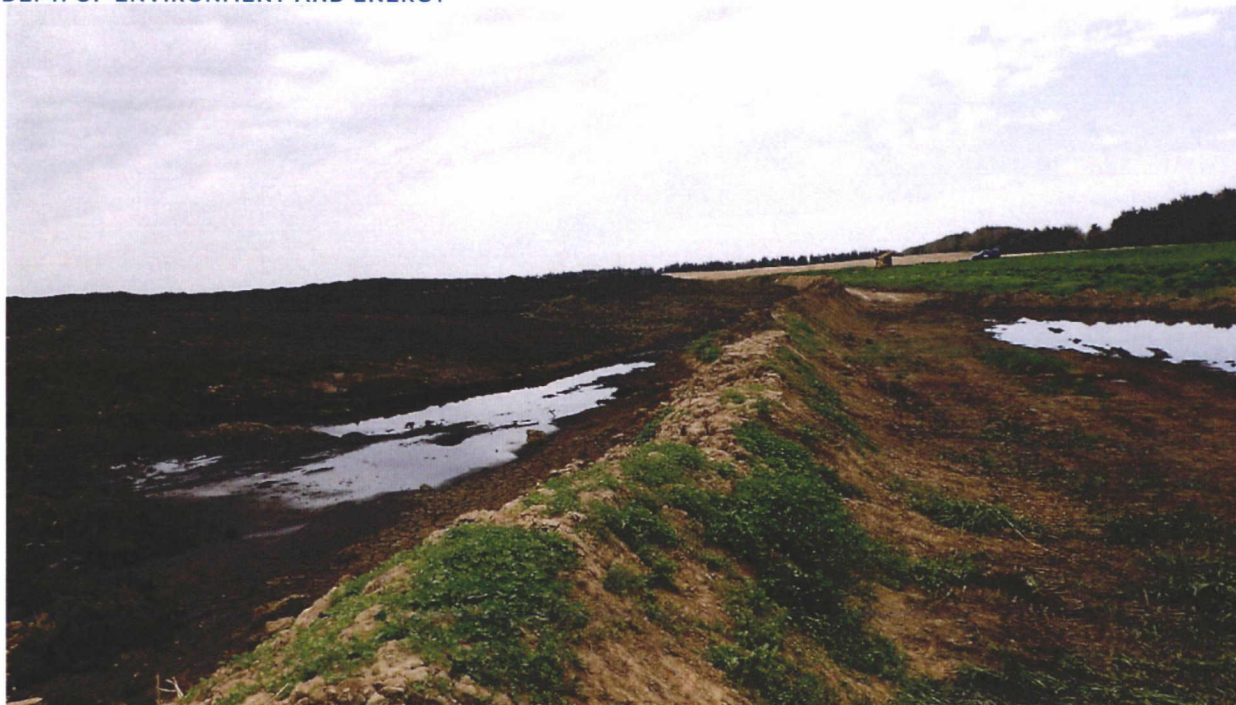
Photo: 16

Description: This photo depicts the southside near the fence. There is some water accumulation and no signs of seepage.

Area 6 - Seepage noted

- Fix seepage problem at the east berm.

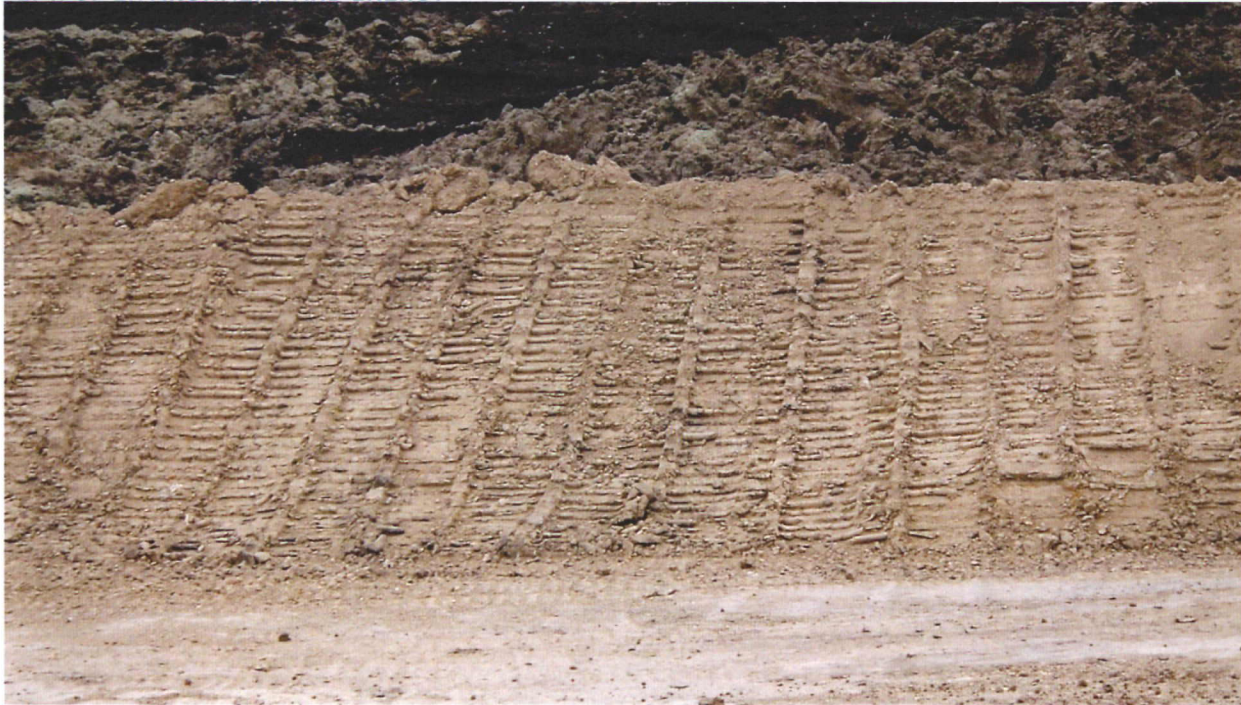
Photo: 17

Description: This photo depicts tracks from a small skid-steer loader. Clean Harbors is using a skid-steer to compact the berm.

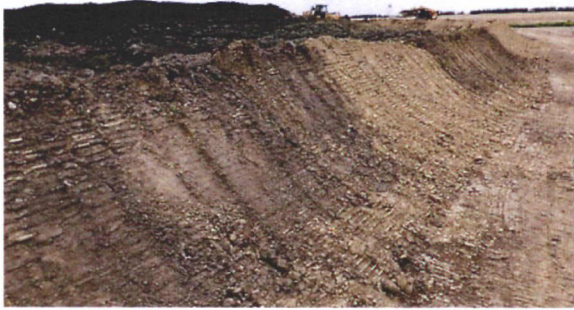
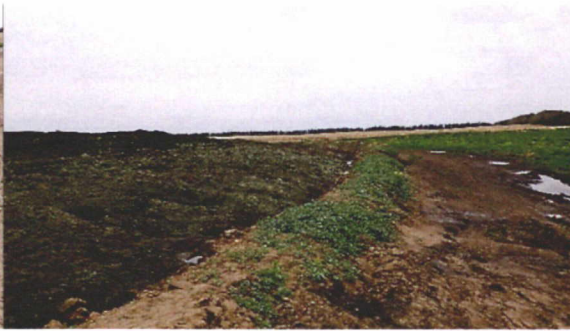
Photo: 18

Description: This photo depicts the difference the berms from 5-3 to 5-7 2021.

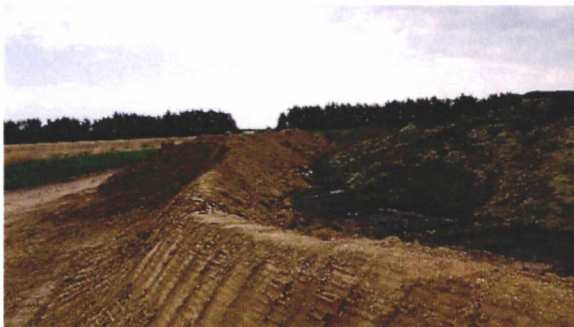
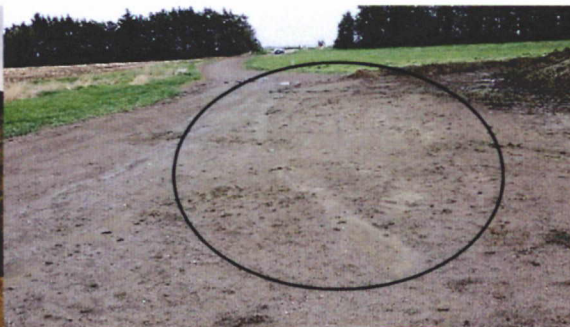
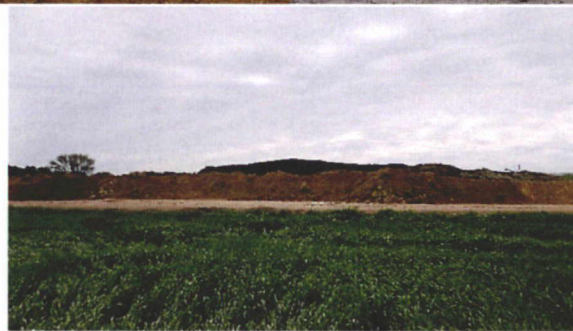
Photo 19

The left and bottom photo depicts the new berm. The berm is not completed but will cover the north side. The top right photo was taken on May 3, 2021 and depicts no berm and residual wet cake.

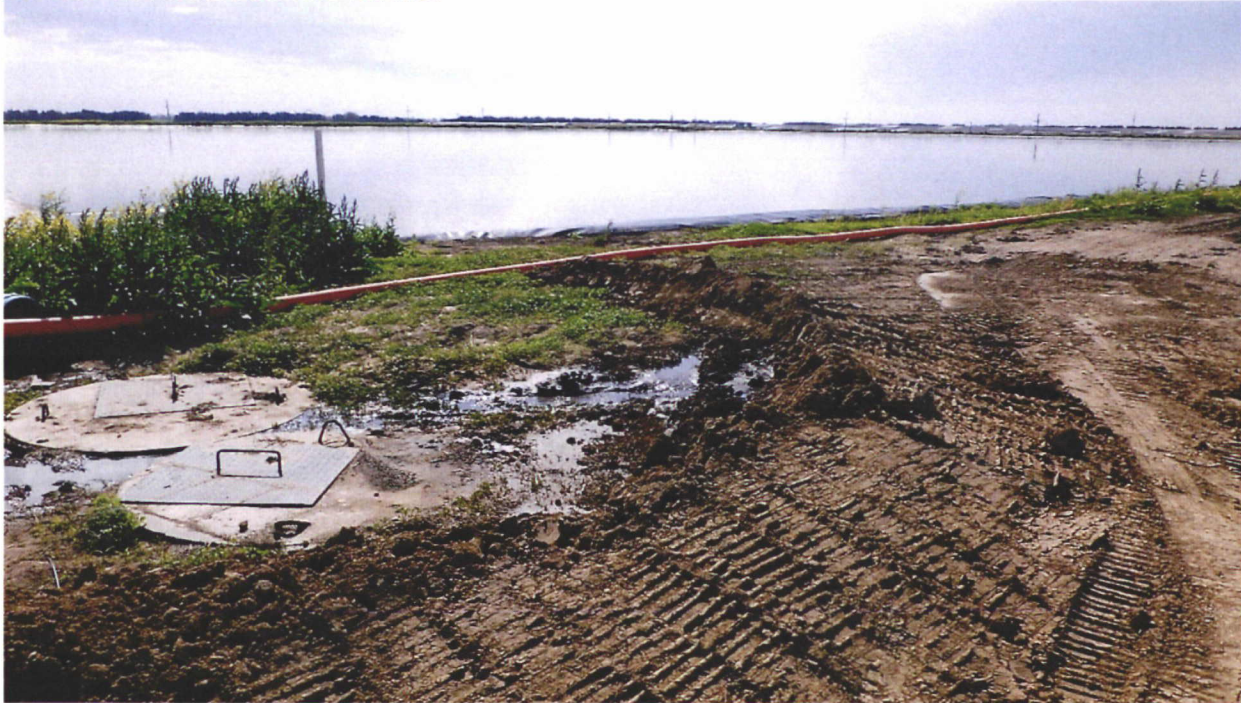
Photo: 22

\* The facility is pumping from the emergency lagoon into the Industrial northwest lagoon. Mr. Matt O'Brien stated that the emergency lagoon is near freeboard and they need to free up room. Mr. O'Brien stated they had started pumping three days ago and that they are pumping approximately .060 MGD. I also observed pooled water near the pumping station. I asked Mr. O'Brien about the pooled water. Mr. O'Brien stated the industrial line is leaking underground. Mr. O'Brien stated the leak should be fixed today. Clean Harbors has installed a berm to contain the leak, see photos 22 through 24.

Description: This photo depicts a recently constructed berm. The berm is used to control a leak from the force main. The facility is pumping from the emergency lagoon into the Industrial lagoons.

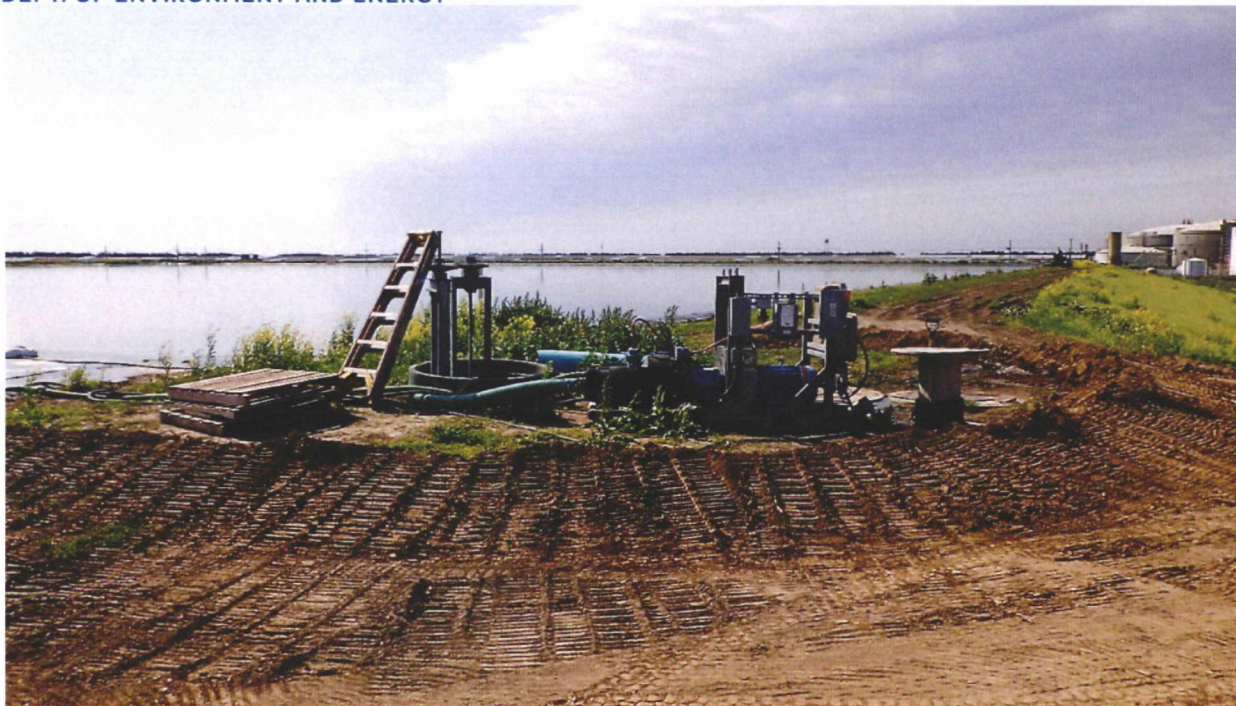
Photo: 23

Description: This photo depicts a recently constructed berm. The berm is used to control a leak from the force main. This photo depicts the size of the constructed berm.

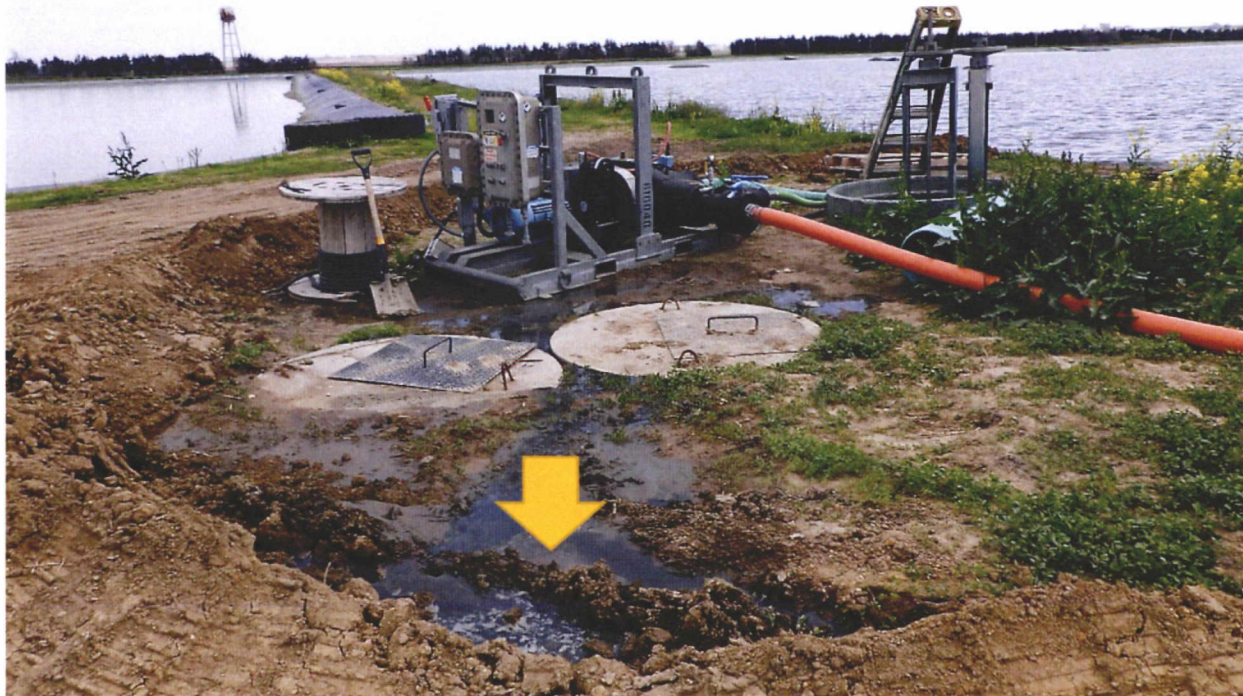
Photo: 24

Description: This photo depicts an underground leak. I observed water rising and flowing in this area (arrow)

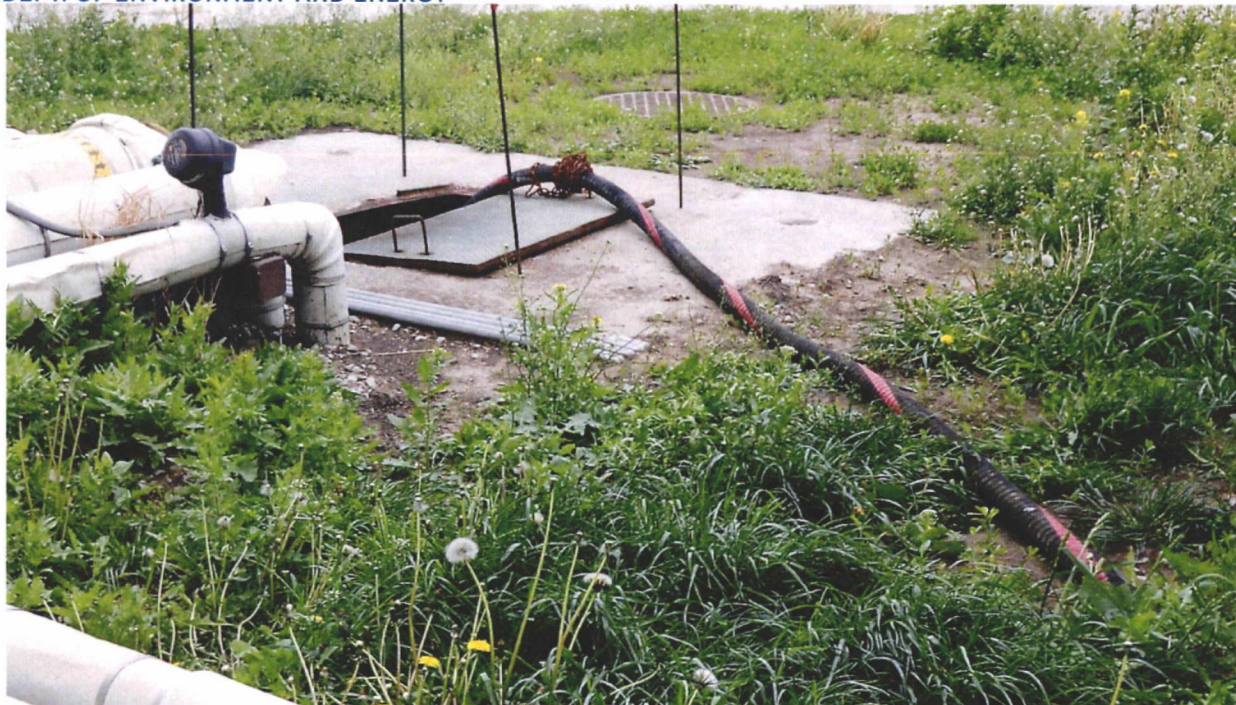
Photo: 29

Description: This photo depicts a hose that is connected from the Beer Well tank. The hose is not discharging.

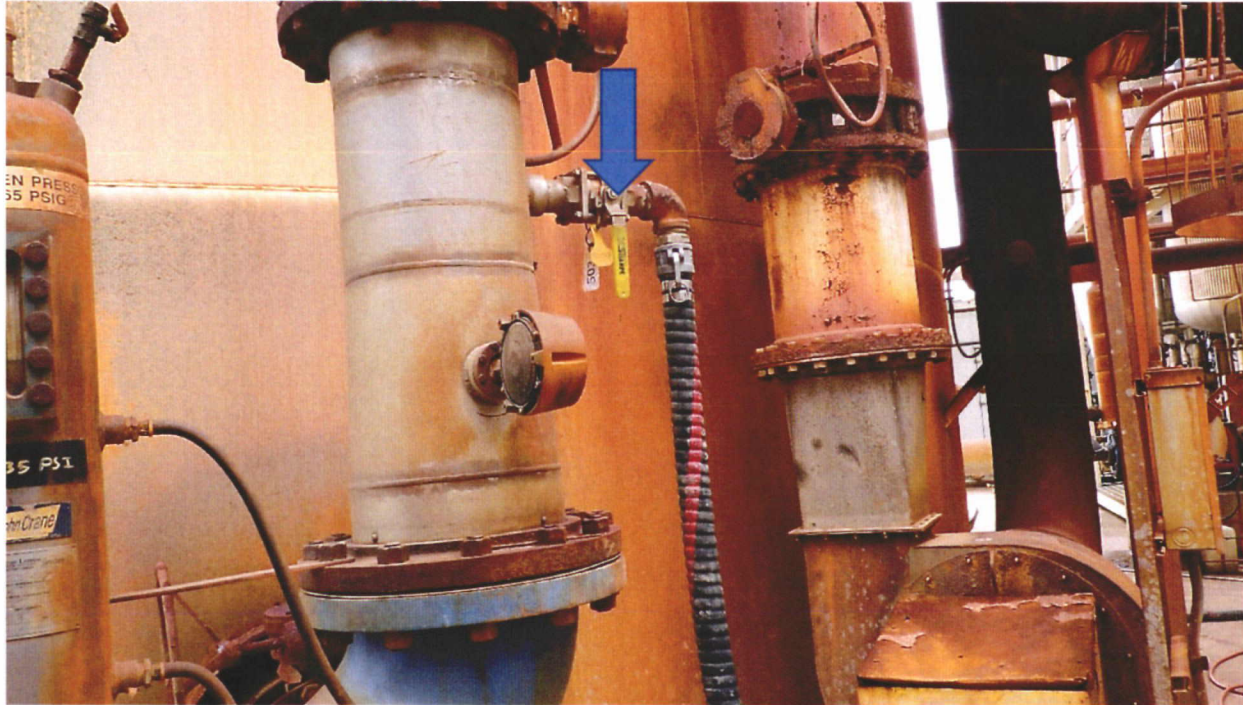
Photo: 30

Description: This photo depicts a hose that is connected from the Beer Well tank. The valve is off (arrow).

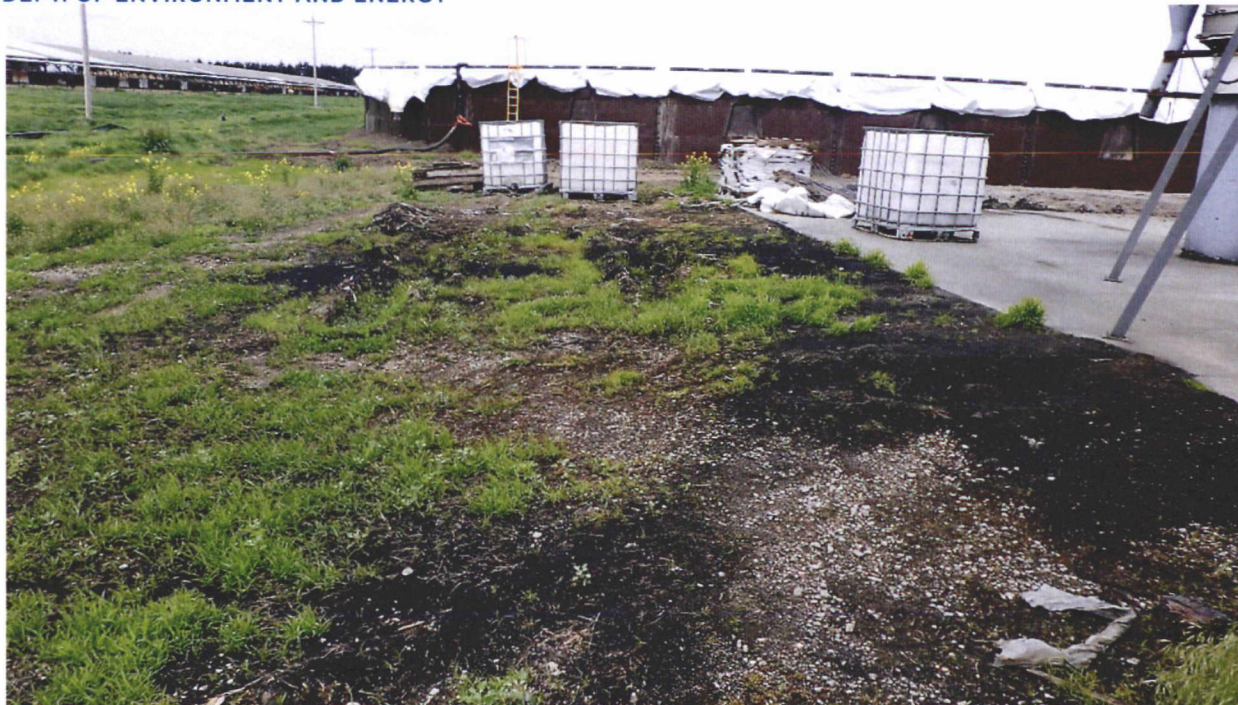
Photo: 31

- Spilled biochar product.
- Trash and debris observed.

Description: This photo depicts spilled biochar.

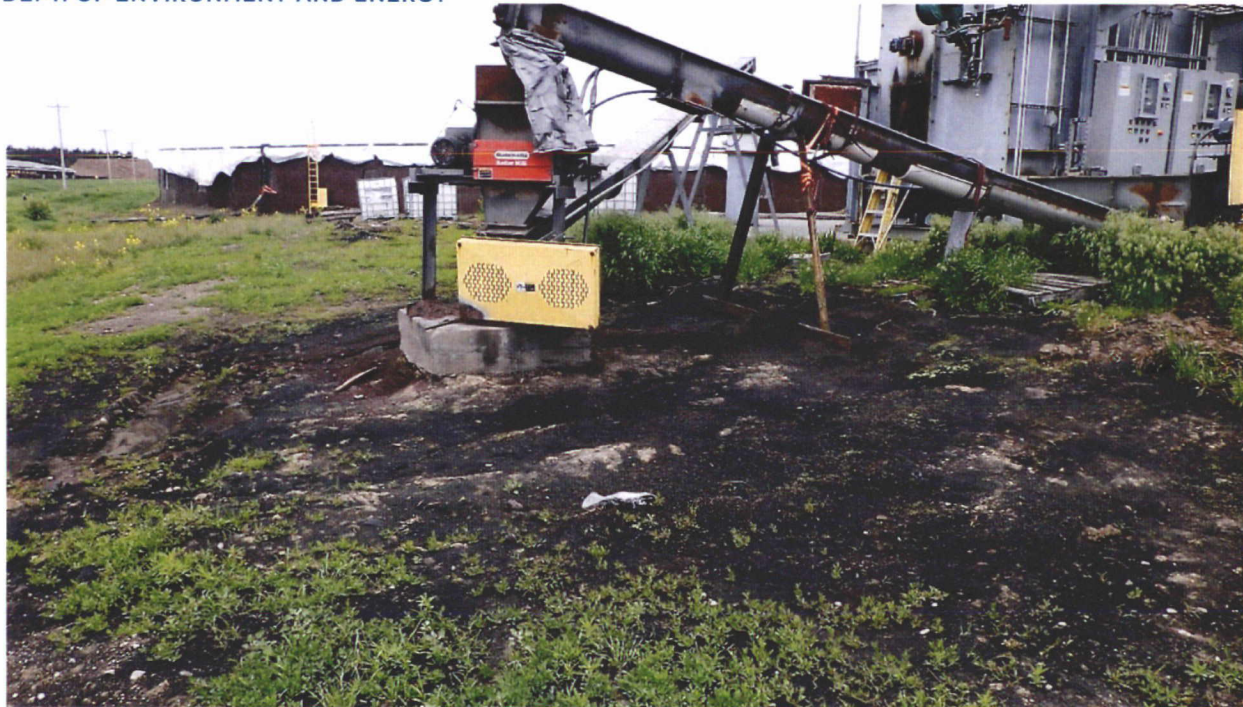
Photo: 32

Description: This photo depicts spilled biochar.

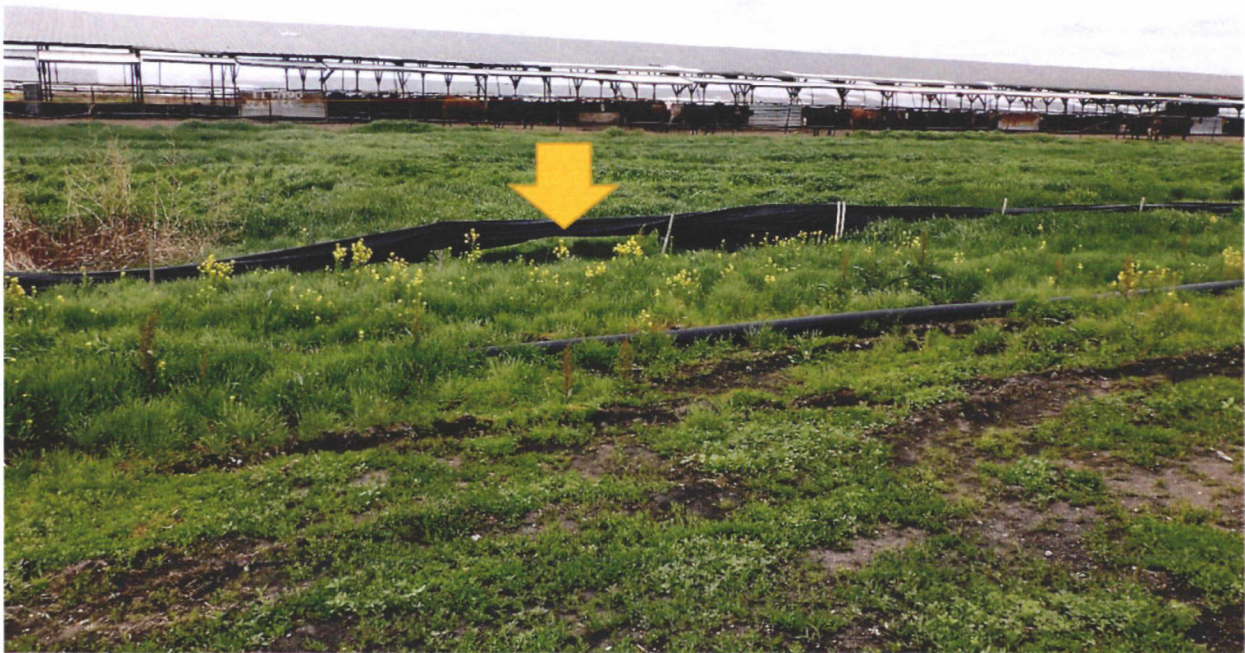
Photo: 33

Description: This photo depicts the silt fence installed to control biochar spillage.
