Facility: AltEn, LLC

IIS: 84069

PCS: NE0137634

**Site Visit Check list**

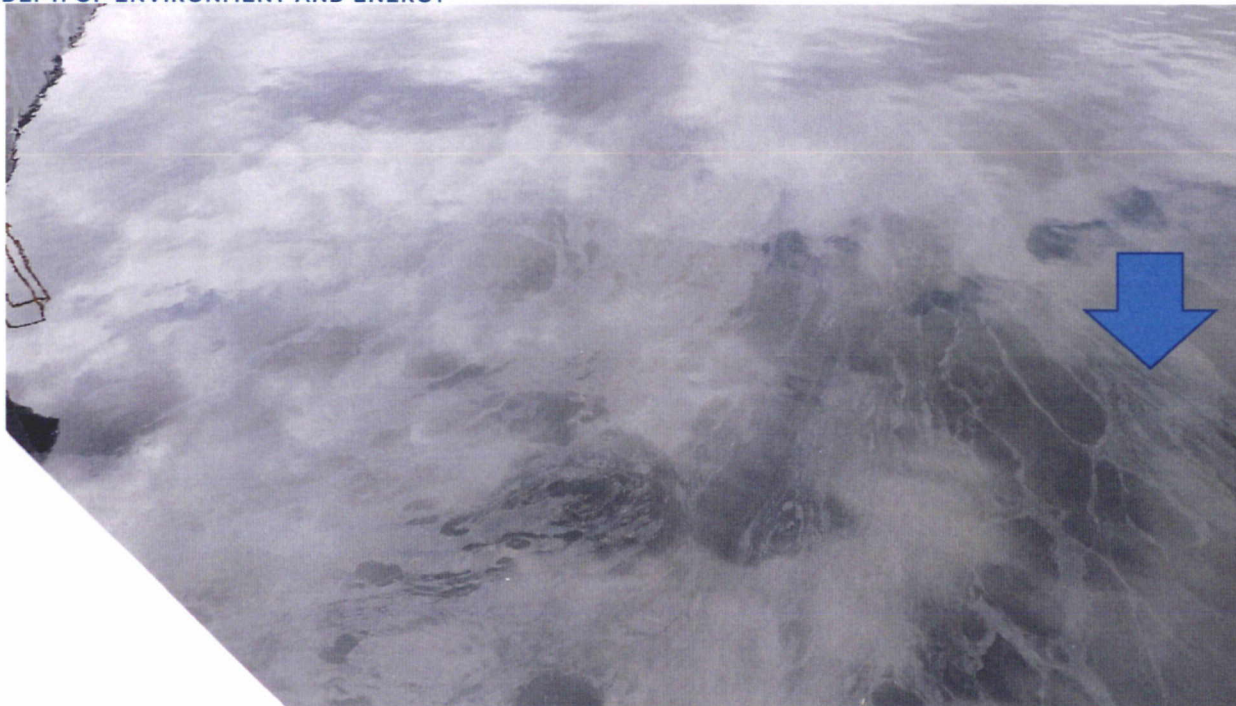
Photo: 35

Description: This photo depicts an oil sheen.

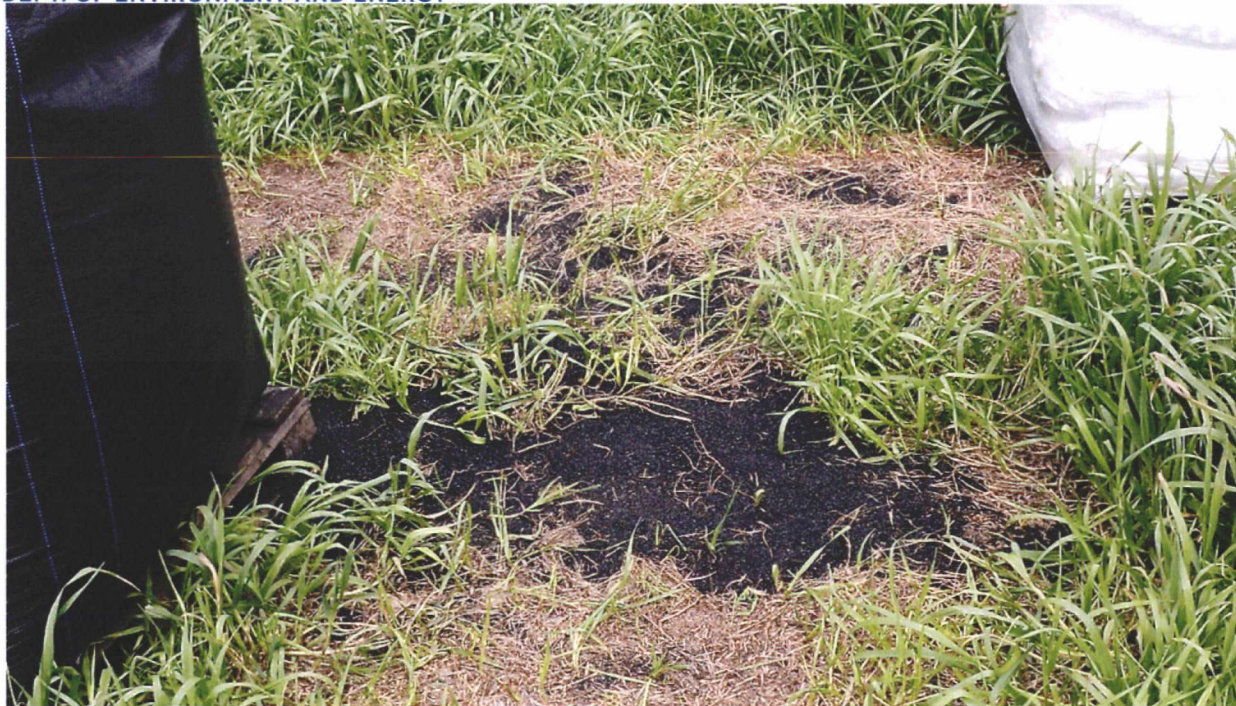
Photo: 36

Description: This photo depicts spilled carbon source used for treatment.

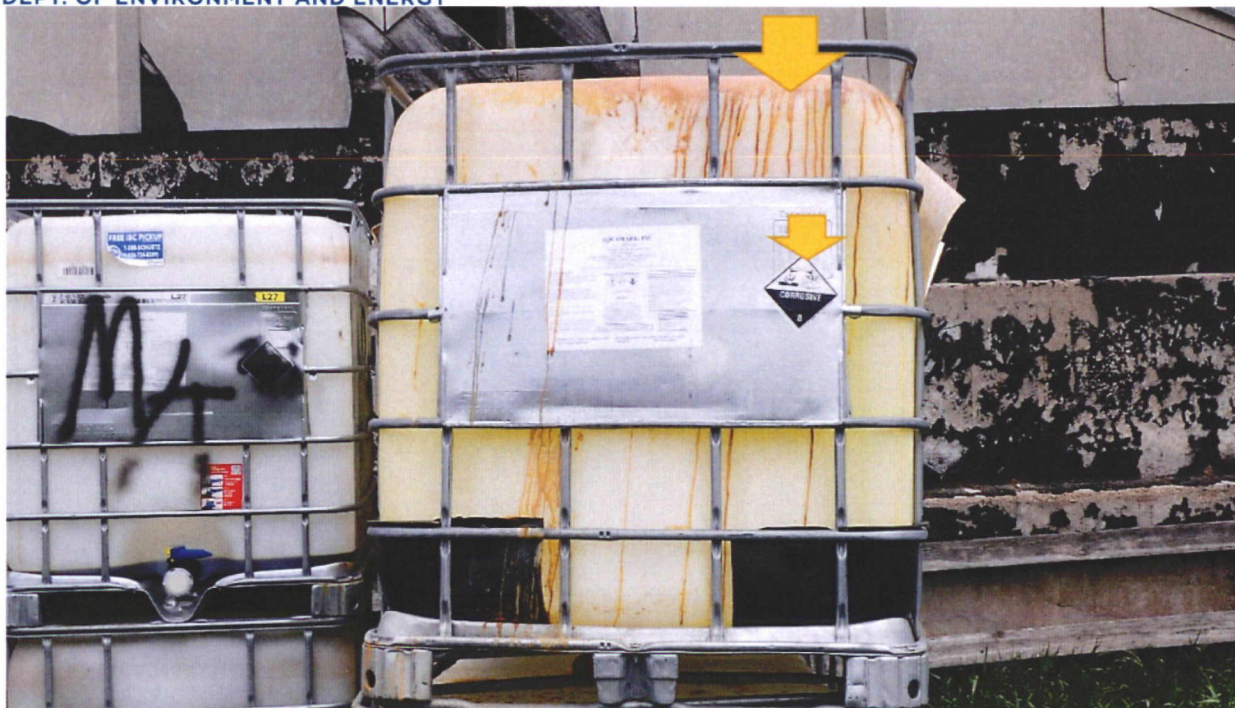
Photo: 37

Description: This photo depicts empty chemical totes. There is spilled chemical exposed to the environment (arrow). The placard states the chemical is corrosive (arrow).

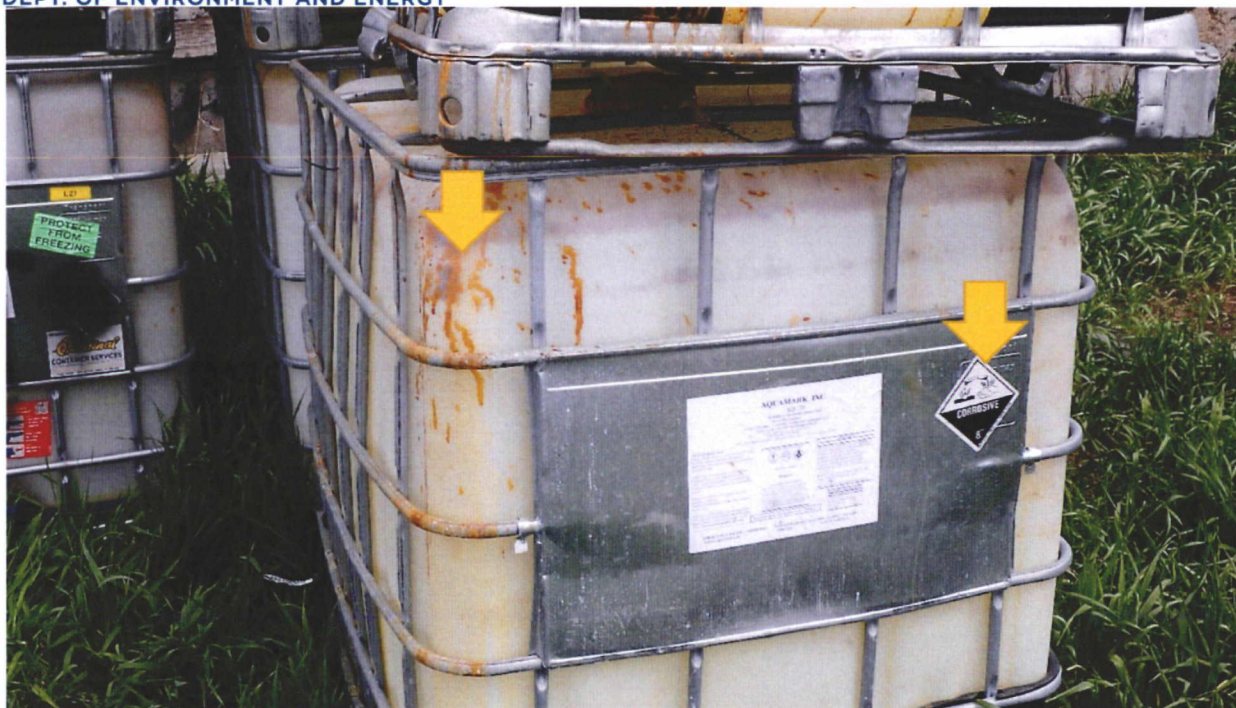
Photo: 38

Description: This photo depicts empty chemical totes. There is spilled chemical exposed to the environment (arrow). The placard states the chemical is corrosive (arrow).

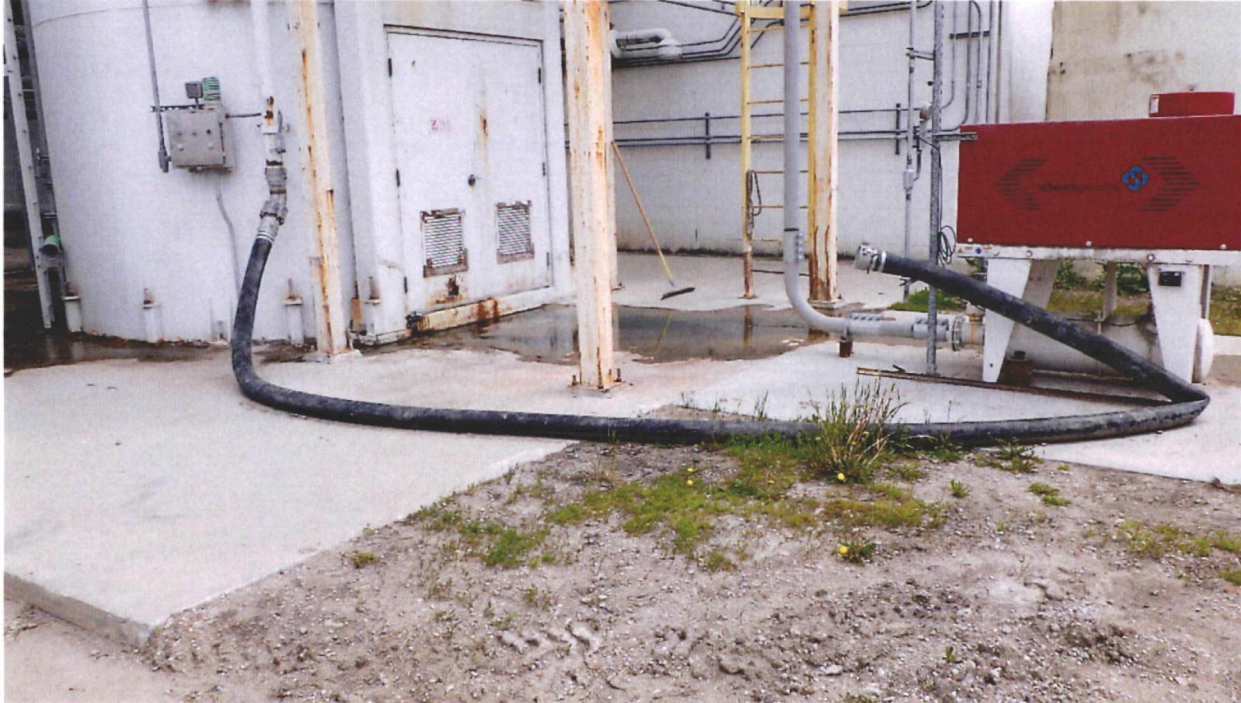
Photo: 40

Description: This photo depicts an attached hose without containment.

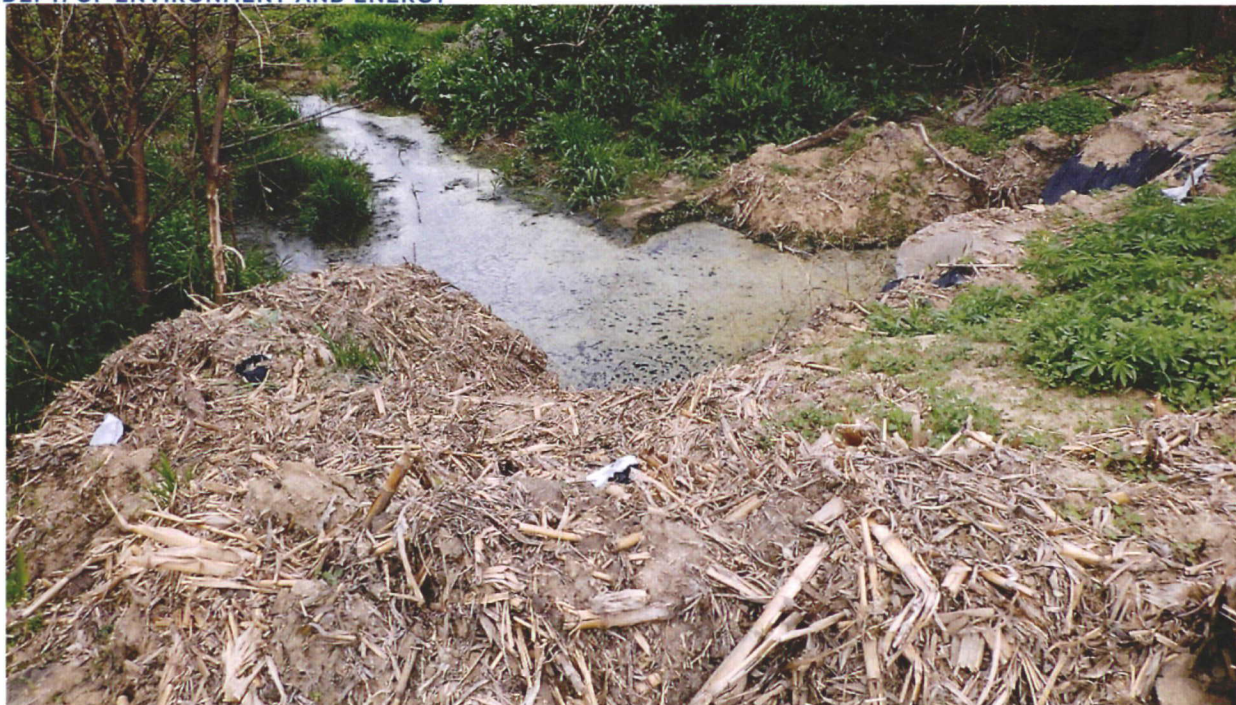
Photo: 41

Description: This photo depicts the culvert at County Road 9 and J. The water is stationary today and no odor observed.
