Facility: AltEn  
IIS: 84069  
PCS: NE0137634

Jason Windhorst  
5-10-2021

## Site Visit Check list

AltEn LLC - Storm Water Temporary BMP Check Map

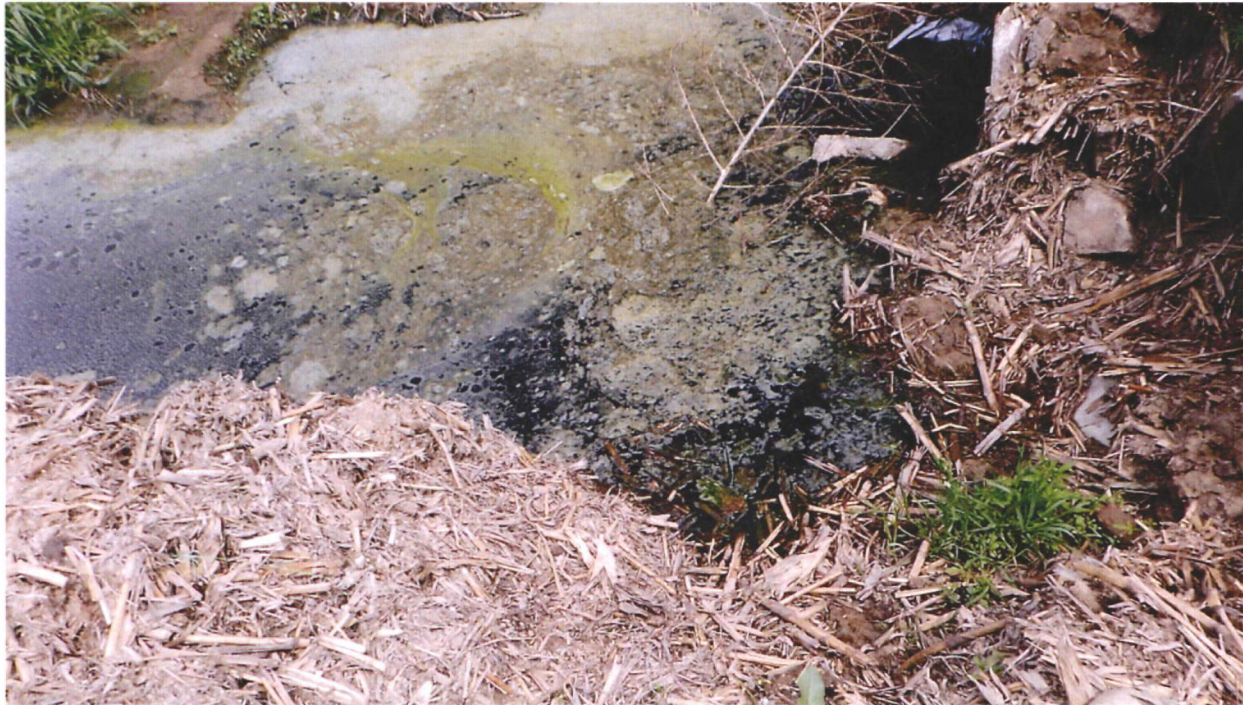
Photos: 1

Location: Culverts at CR 9 & J

Description: The water in the ditch has little flow and appears stagnant. There is algae covering most of the water on the west side of the culvert.

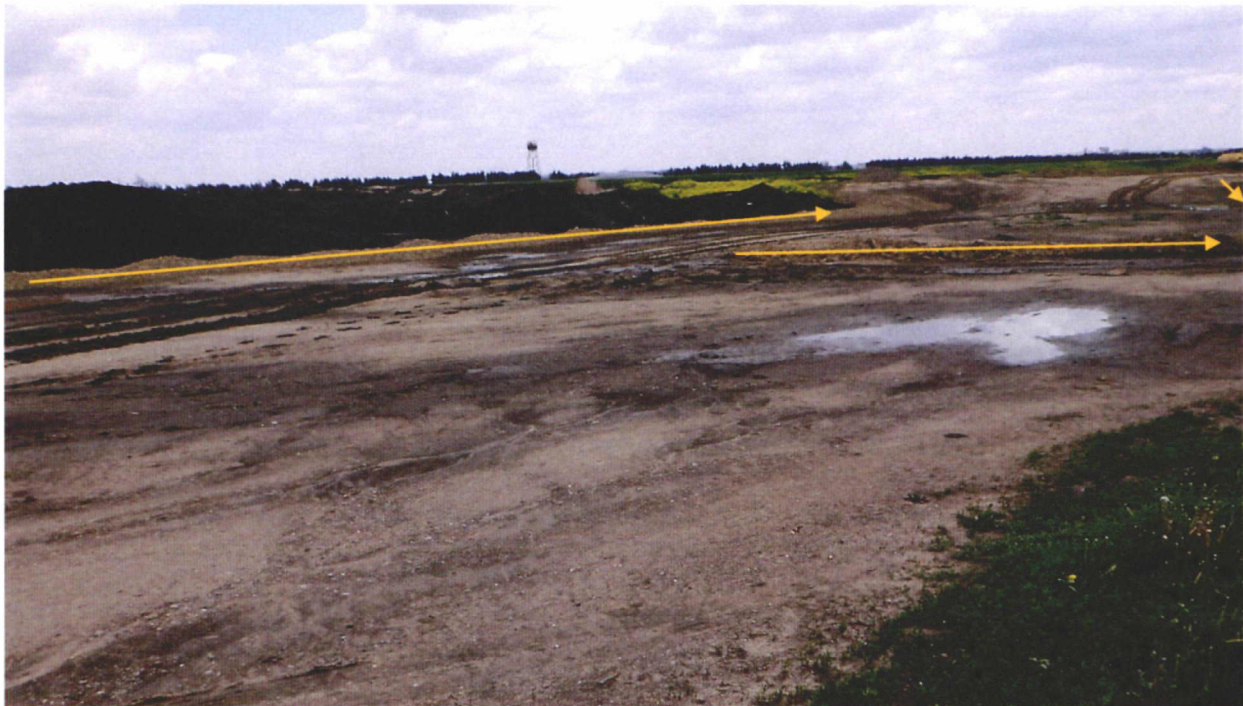
Photos: 2

Location: Area 1 on the site map

Description: Small berm around the wetcake and additional berms to capture runoff are in good condition and do not exhibit signs seepage.

Area 1 - Berm holding w/no seepage but should be pumped  
2 - Berm holding w/no seepage was pumped earlier  
3 - Berm reinforced & holding w/no seepage  
4 - no concerns, berm also reinforced  
5 - Berm holding w/no seepage & has been reinforced  
6 - Berm holding w/no seepage on upper berm  
but lower berm has seepage & should be pumped

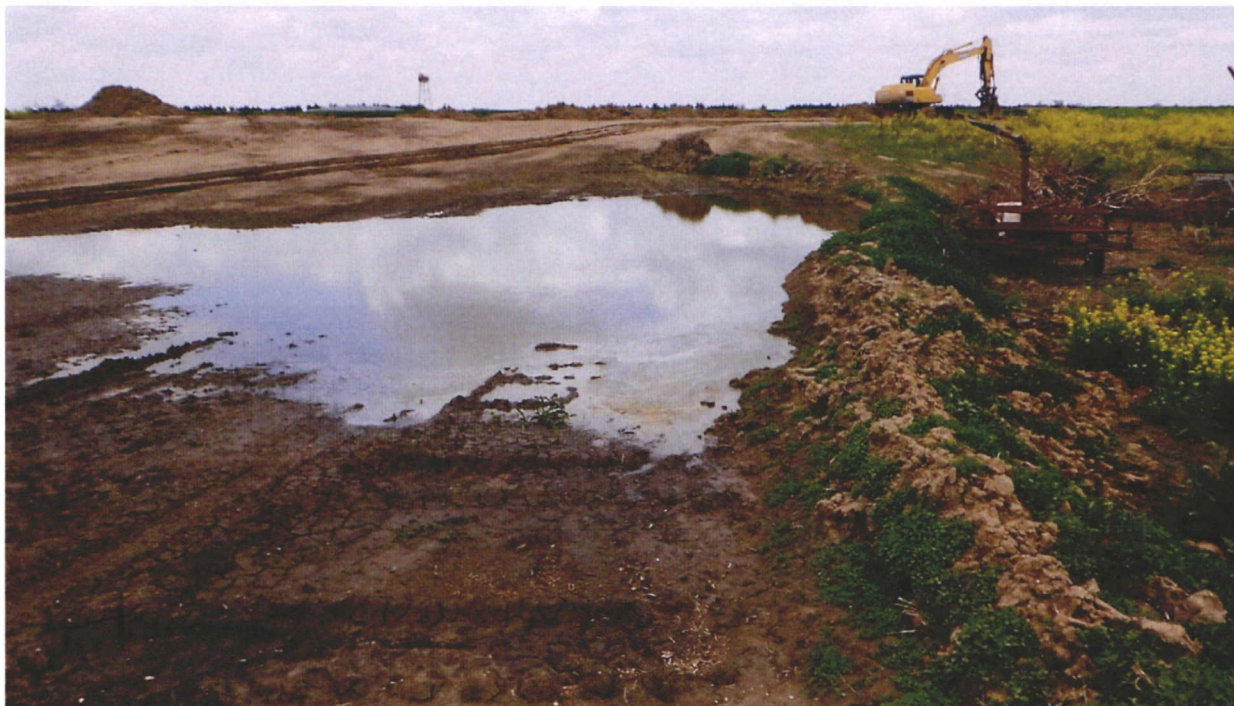
Photos: 3

Location: Area 1 on the site map.

Description: First berm constructed to capture runoff continues to function properly.

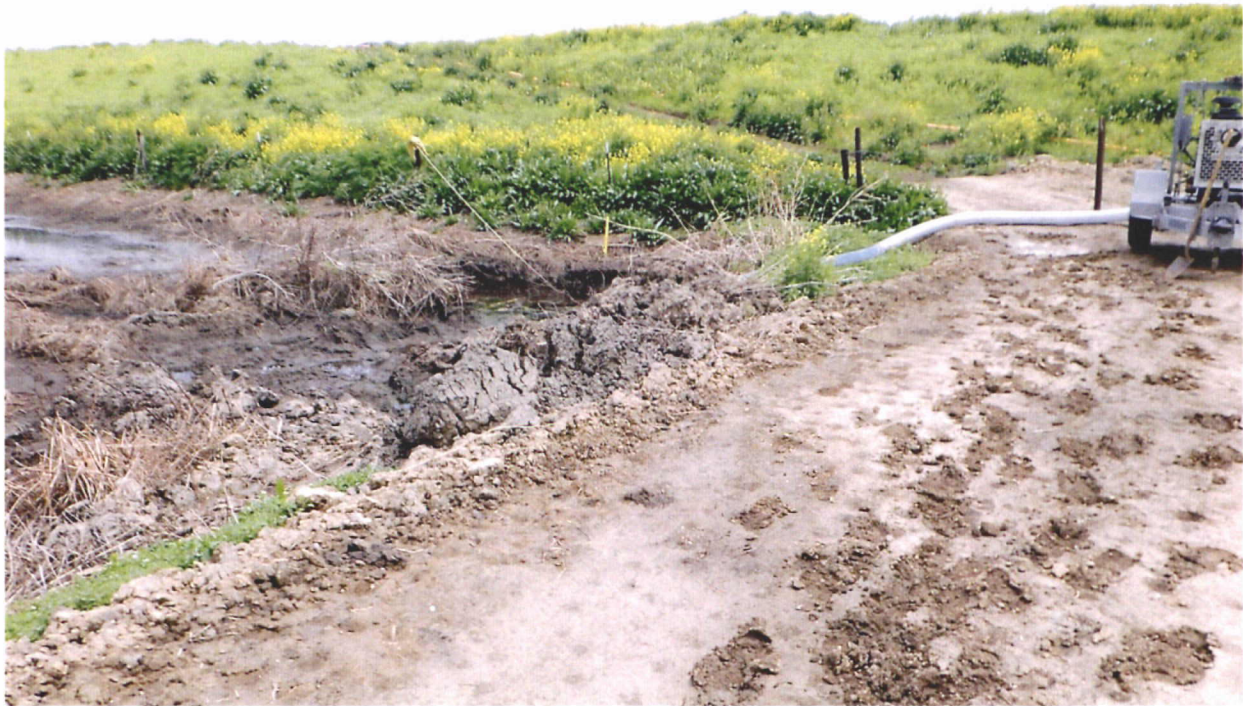
Photos: 4

Location: Area 2 on the site map.

Description: Berm is holding and does not indicate any sign of seepage. This area was recently pumped.

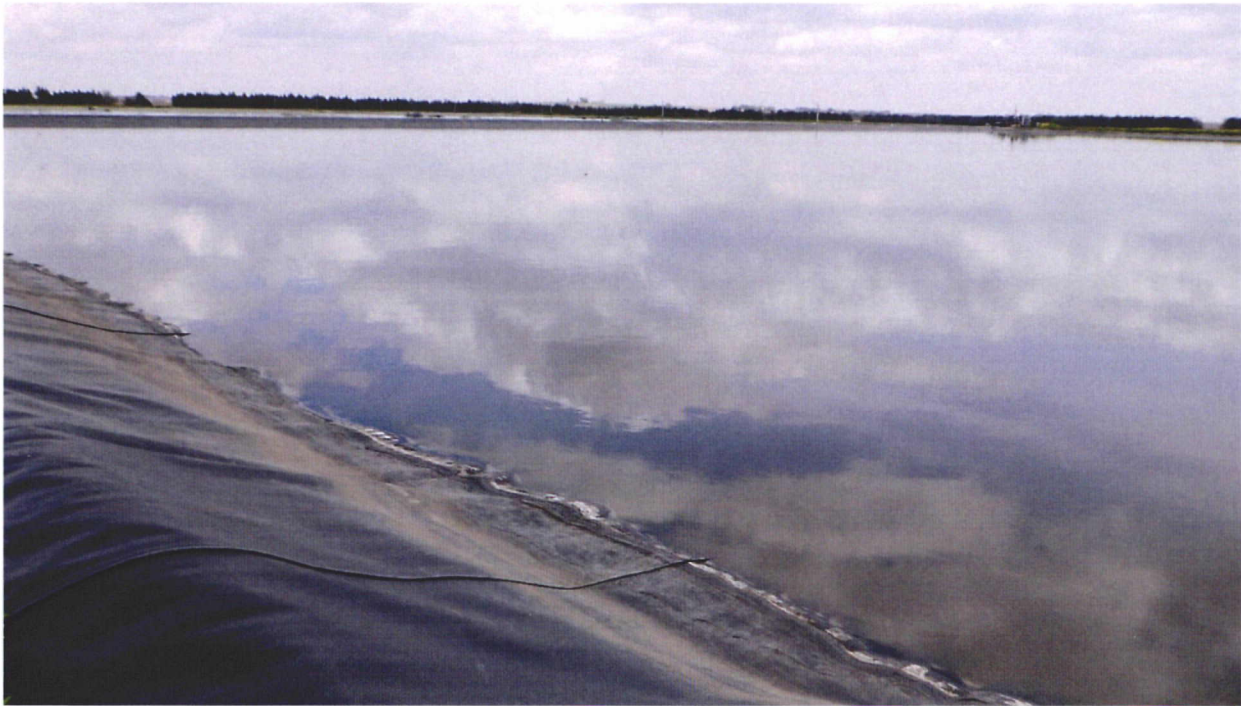
Photos: 5

Location: South of the northwest corner of the southeast lagoon.

Description: Nothing new observed in this lagoon except the floating black sludge is no longer visible at the surface.

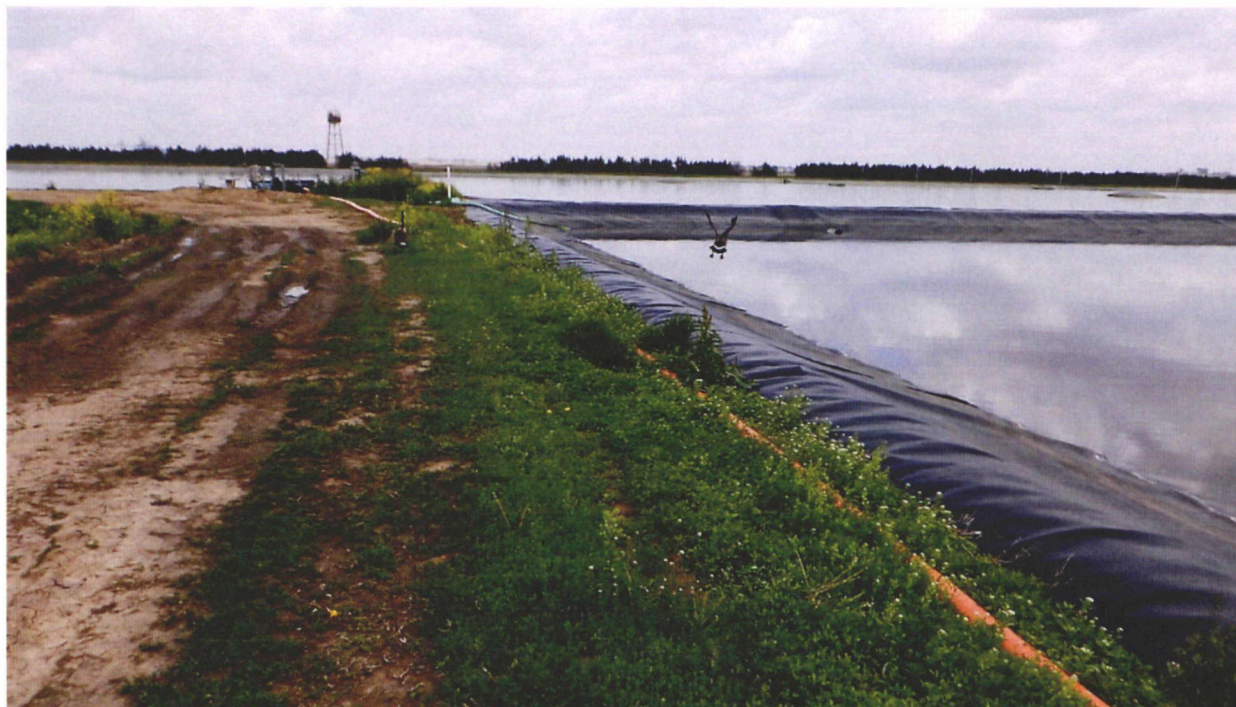
Photos: 6

Location: Northwest corner of the southeast lagoon.

Description: Water is slowly flowing into the southeast lagoon from the northeast lagoon.

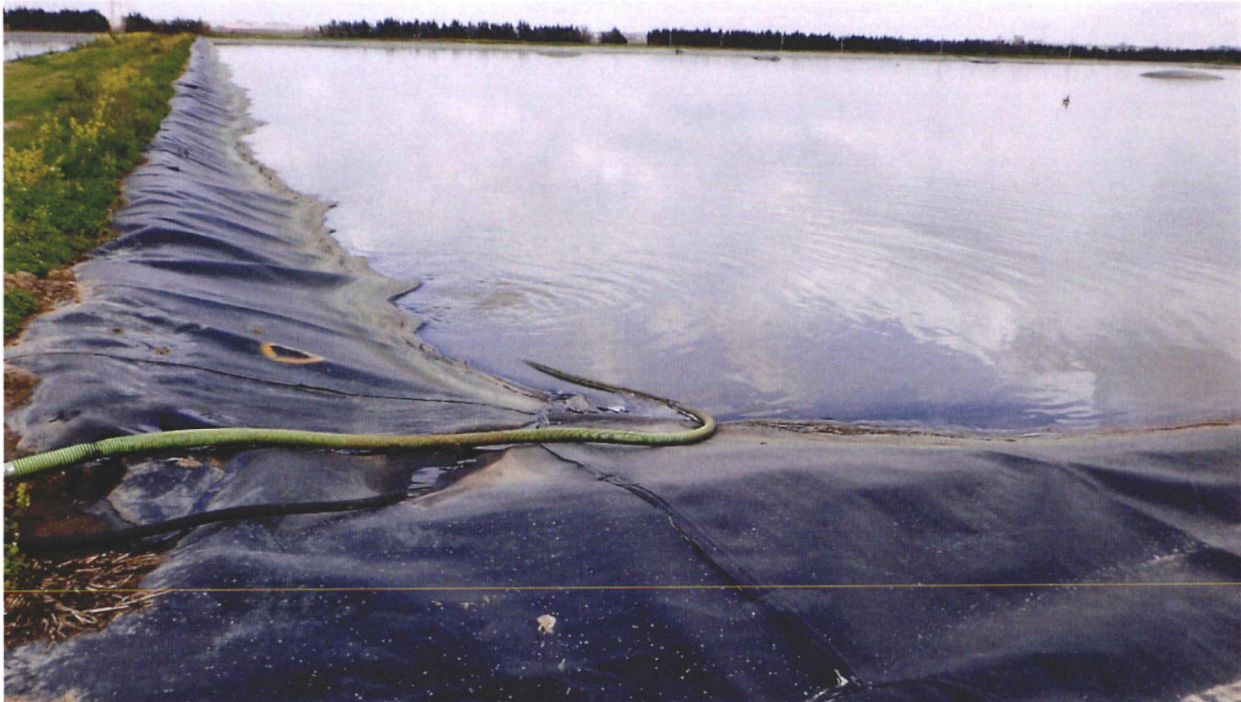
Photos: 7

Location: Southwest corner of the northeast lagoon.

Description: Clean Harbors pumping water from the emergency to this lagoon.

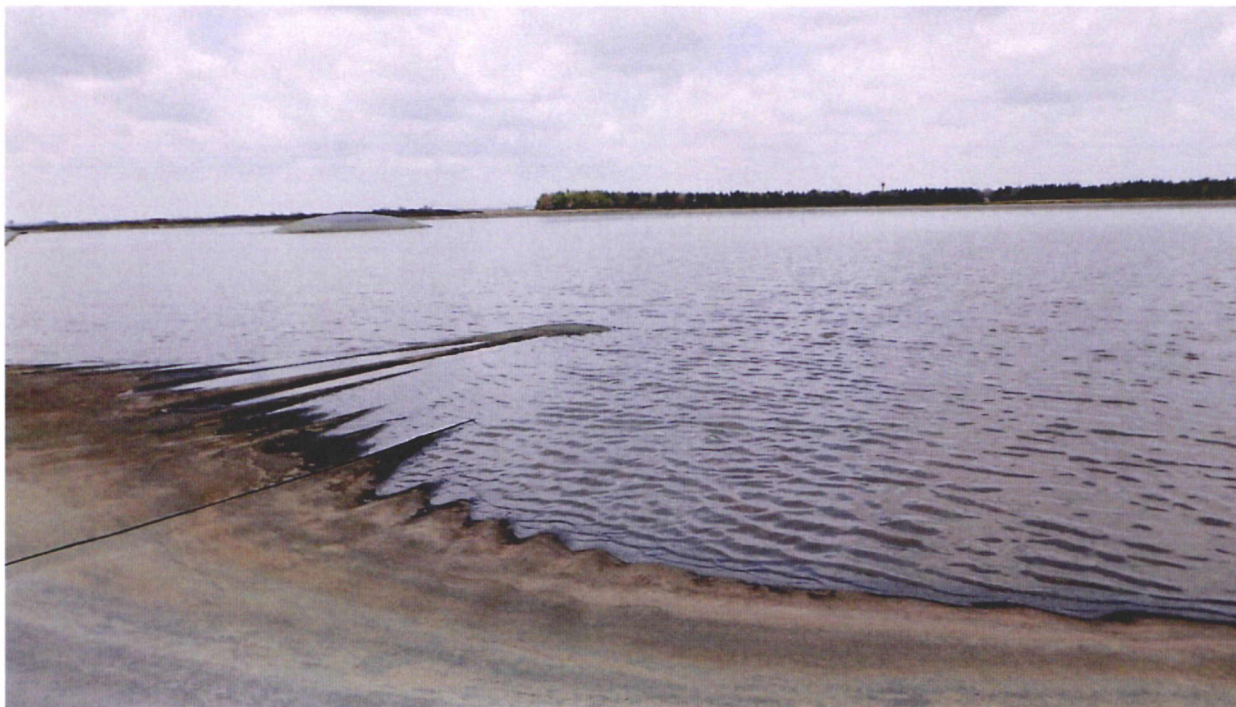
Photos: 8

Location: Southeast corner of the northwest lagoon.

Description: Section of the liner that becomes more exposed weekly.

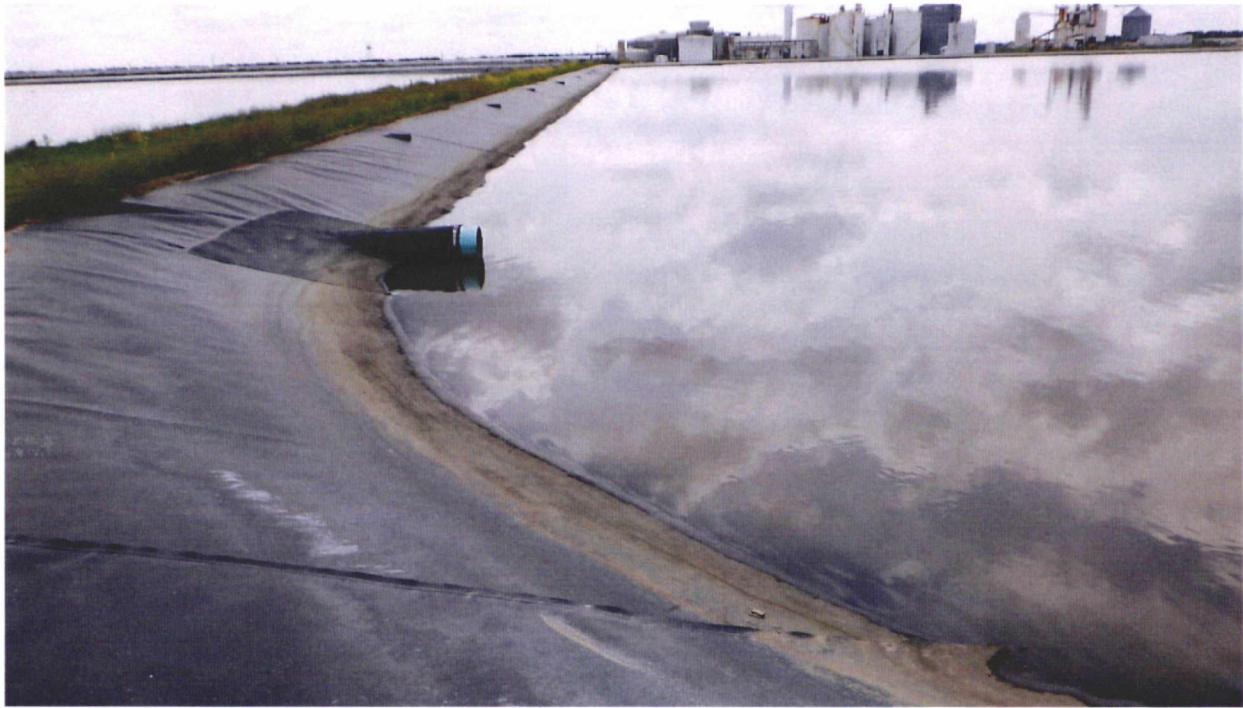
Photos: 9

Location: Northeast corner of the northwest lagoon

Description: Equalization pipe flowing west into the lagoon from the northeast lagoon.

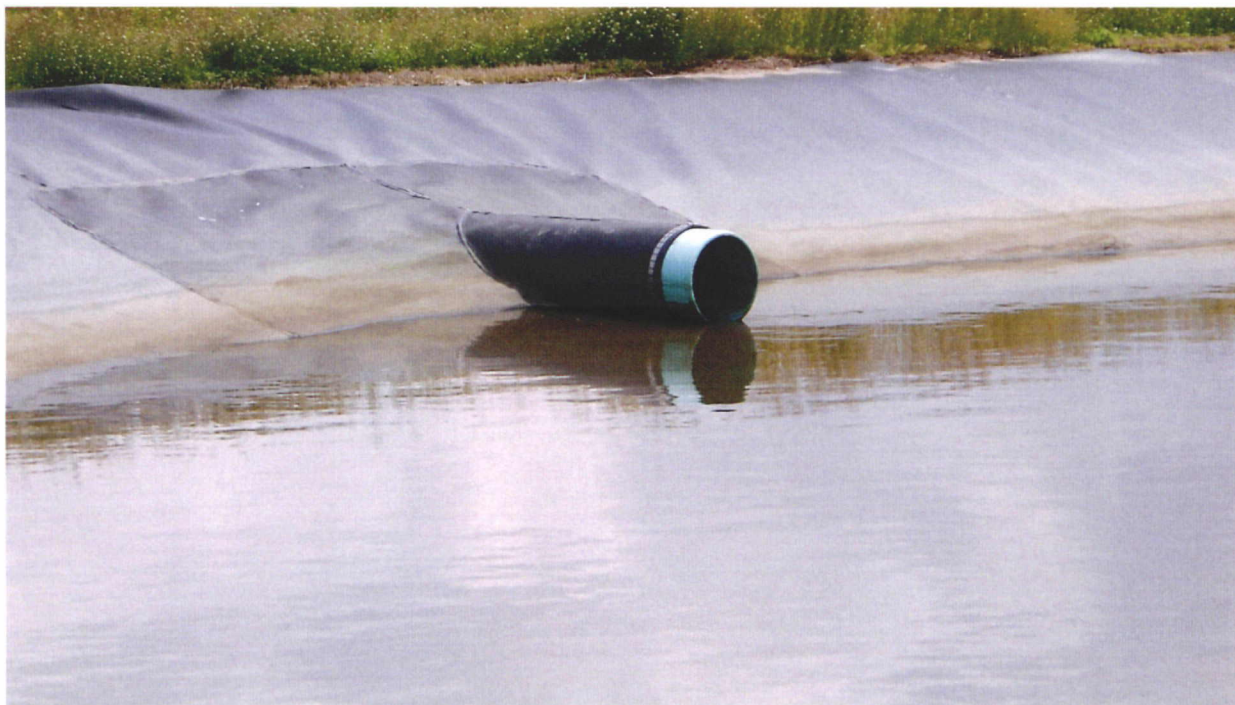
Photos: 10

Location: Same as photo 9

Description: Closeup of equalization pipe showing the current level of the lagoon.

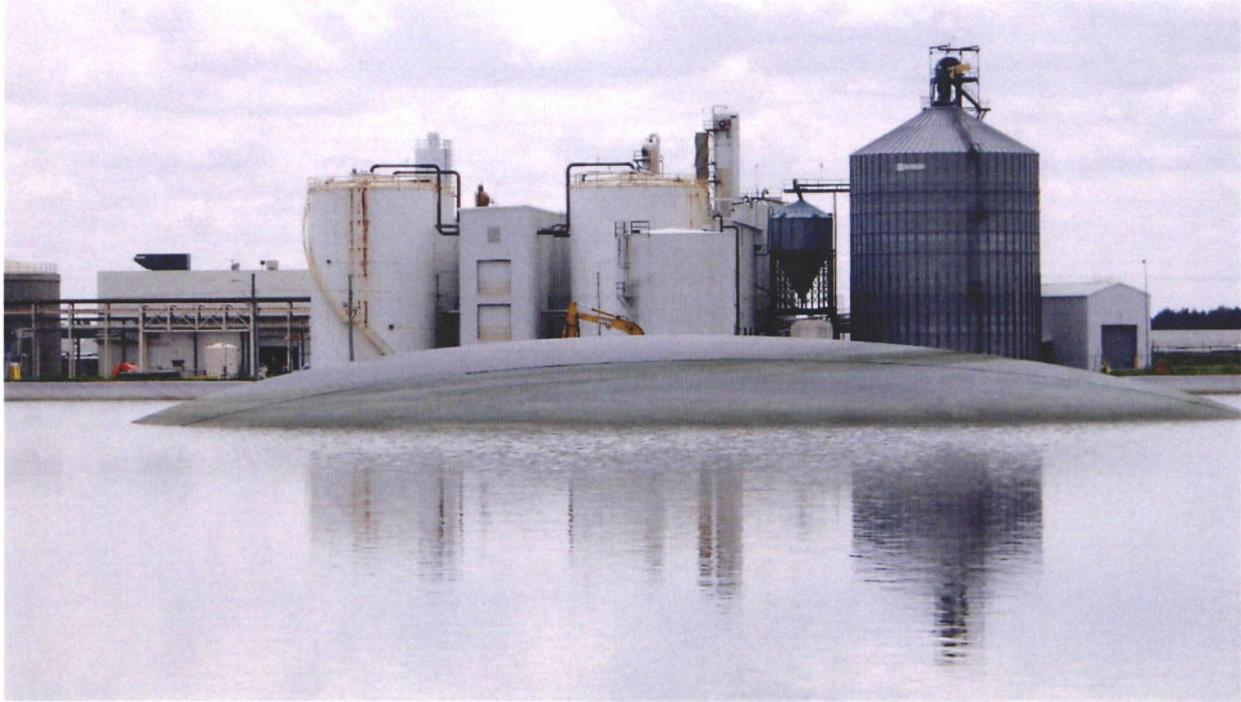
Photos: 11

Location: Middle of the north side of the northwest lagoon.

Description: Persistent whale stationary along the south side of the lagoon.

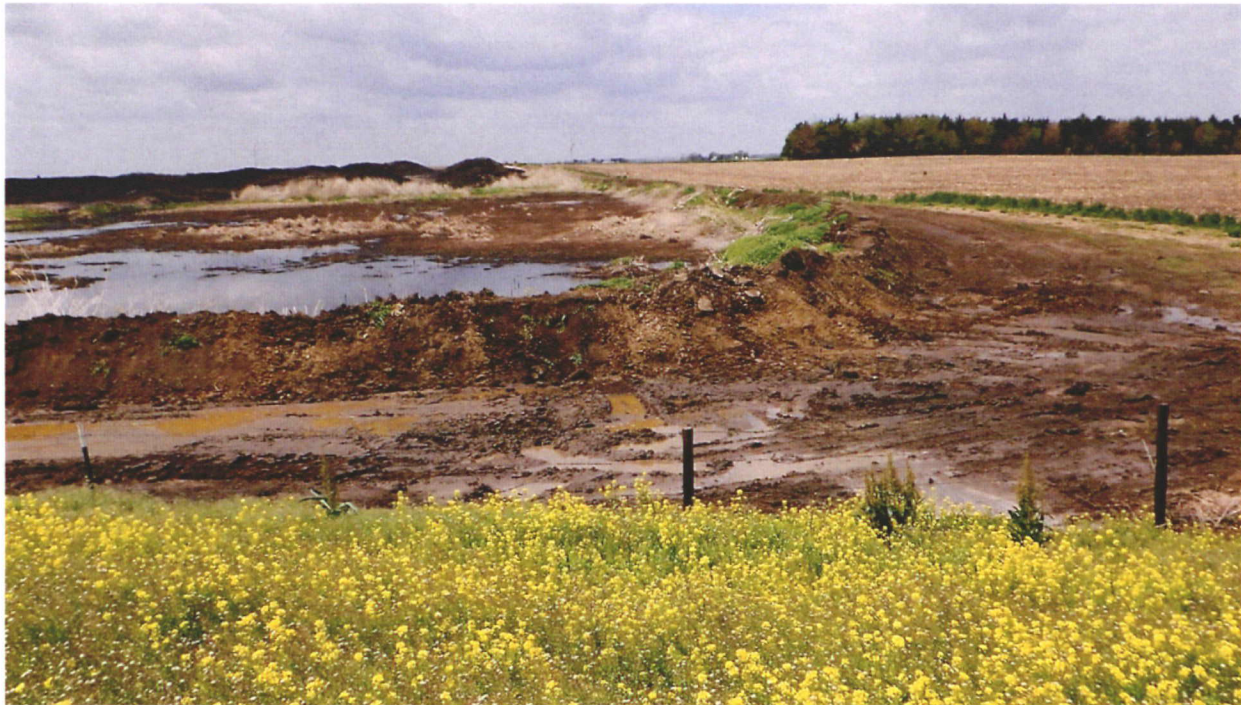
Photos: 12

Location: Area 3 on the site map.

Description: Berms are in good condition and have no evidence of seepage. Mud on the outside of the berm is from the recent rain and Clean Harbor traffic.

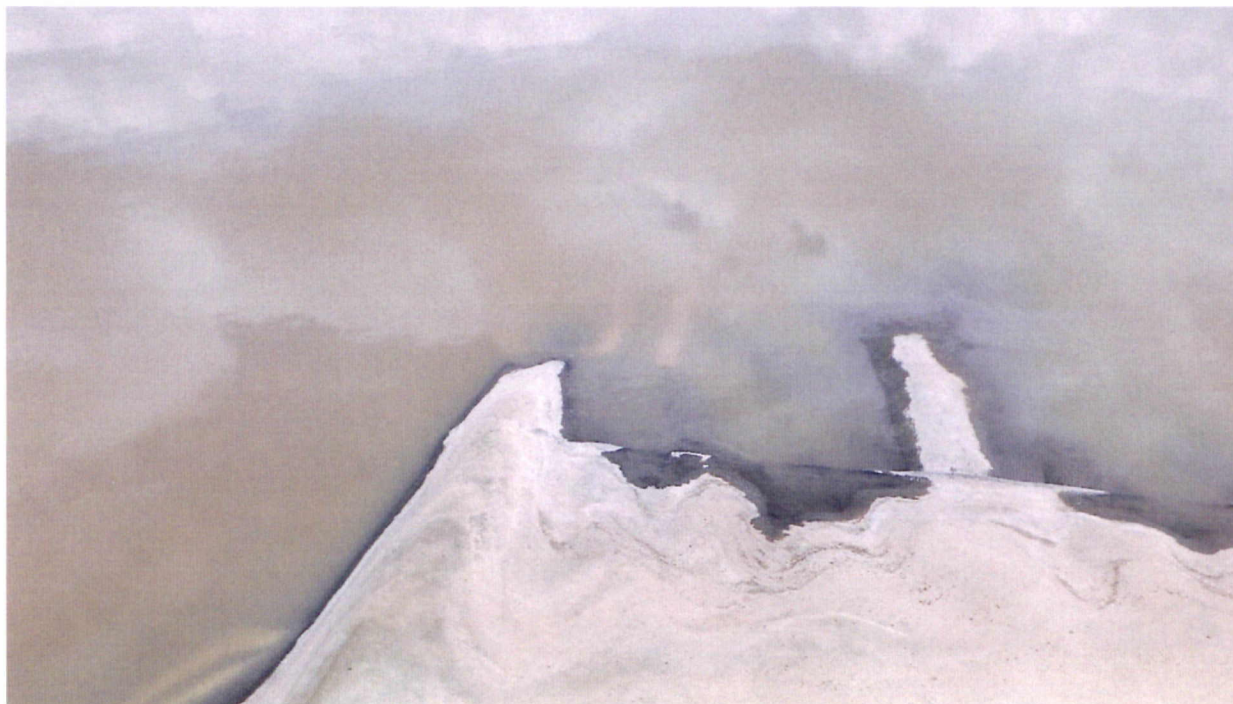
Photos: 13

Location: Southwest corner of the northwest lagoon.

Description: Depth indicator is visible showing the 18' marker still submerged.

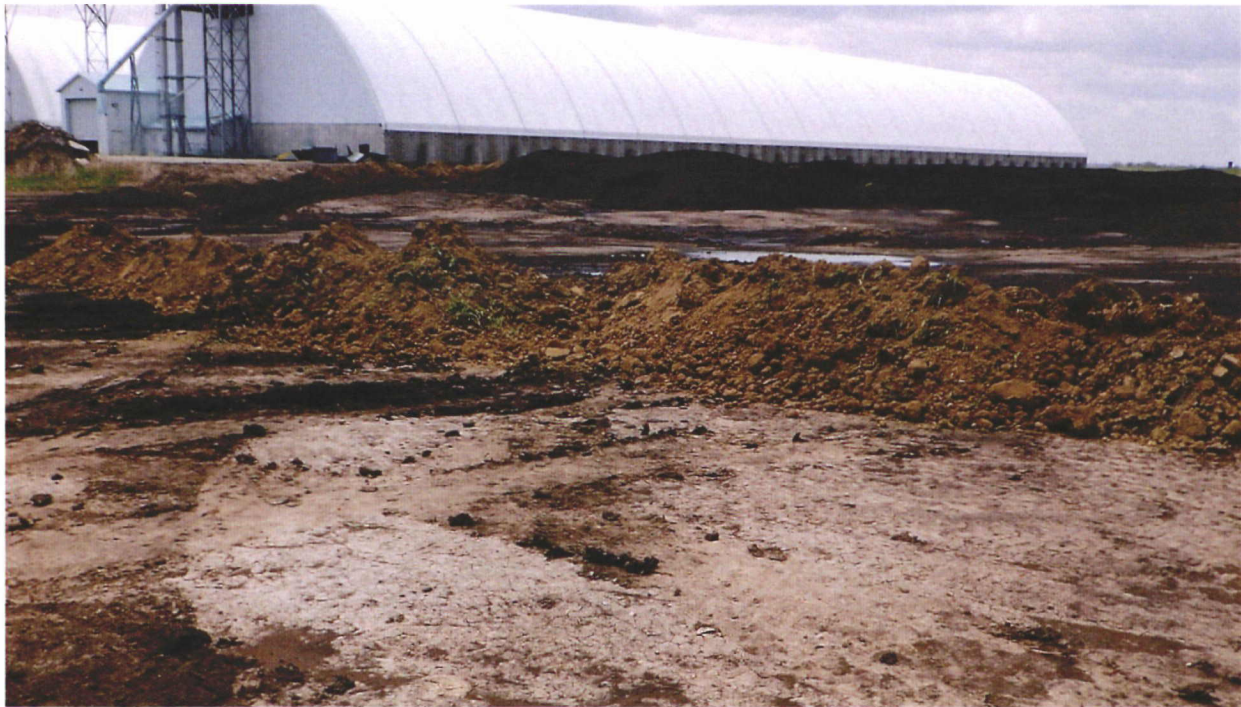
Photos: 14

Location: Northeast of the north hoop building.

Description: New berm being constructed/extended from the existing berm west of the northwest lagoon.

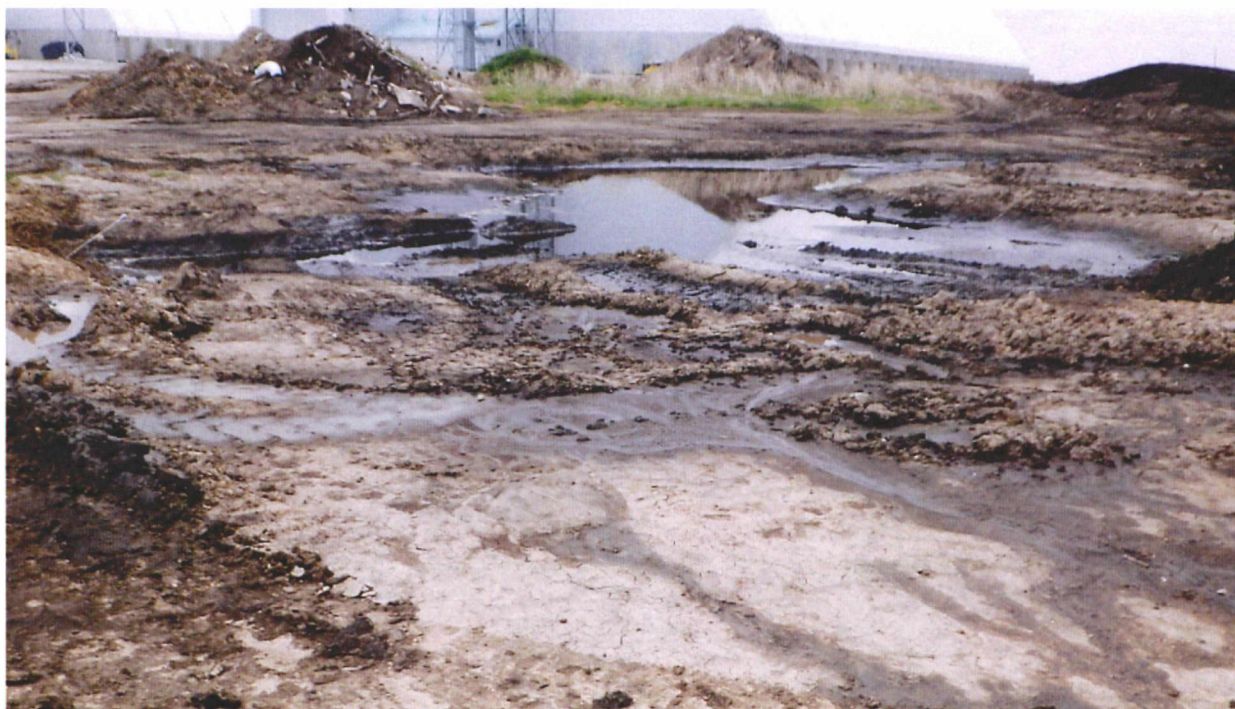
Photos: 15

Location: West of photo 14

Description: Ponded runoff from wetcake stored north of the hoop buildings.

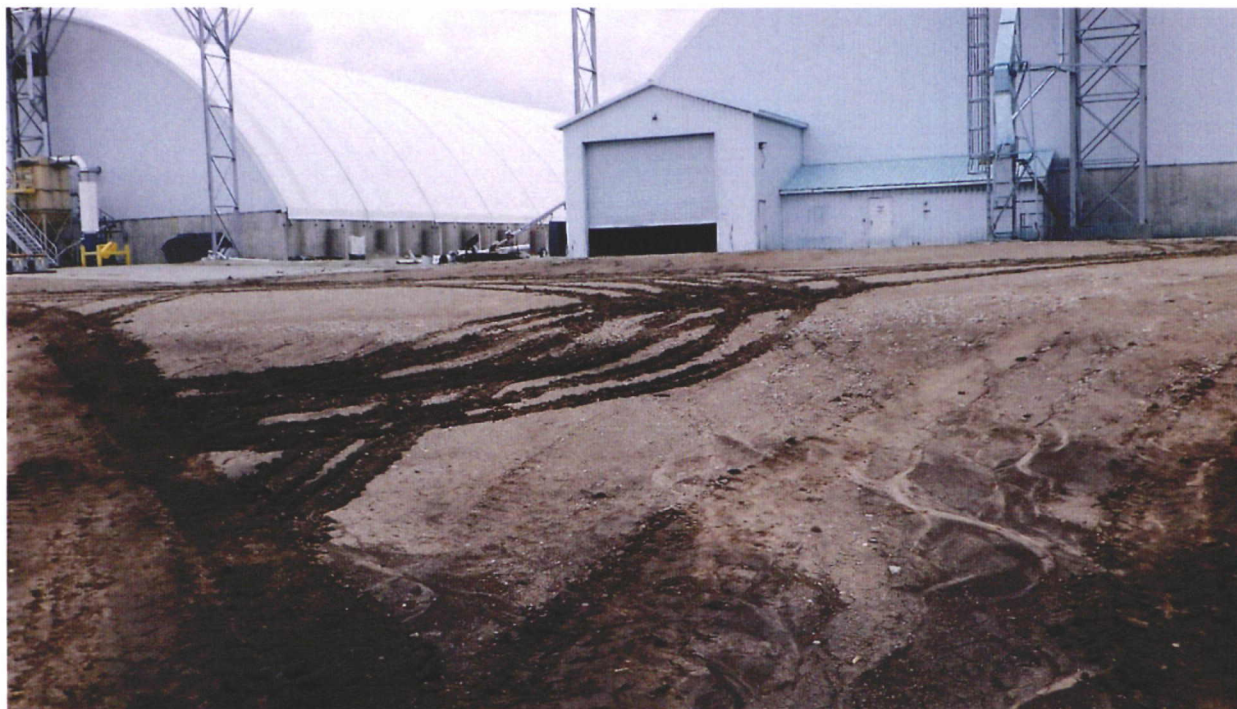
Photos: 16

Location: Approximately 120' East of the north hoop building

Description: Bay door left open again on north hoop building.

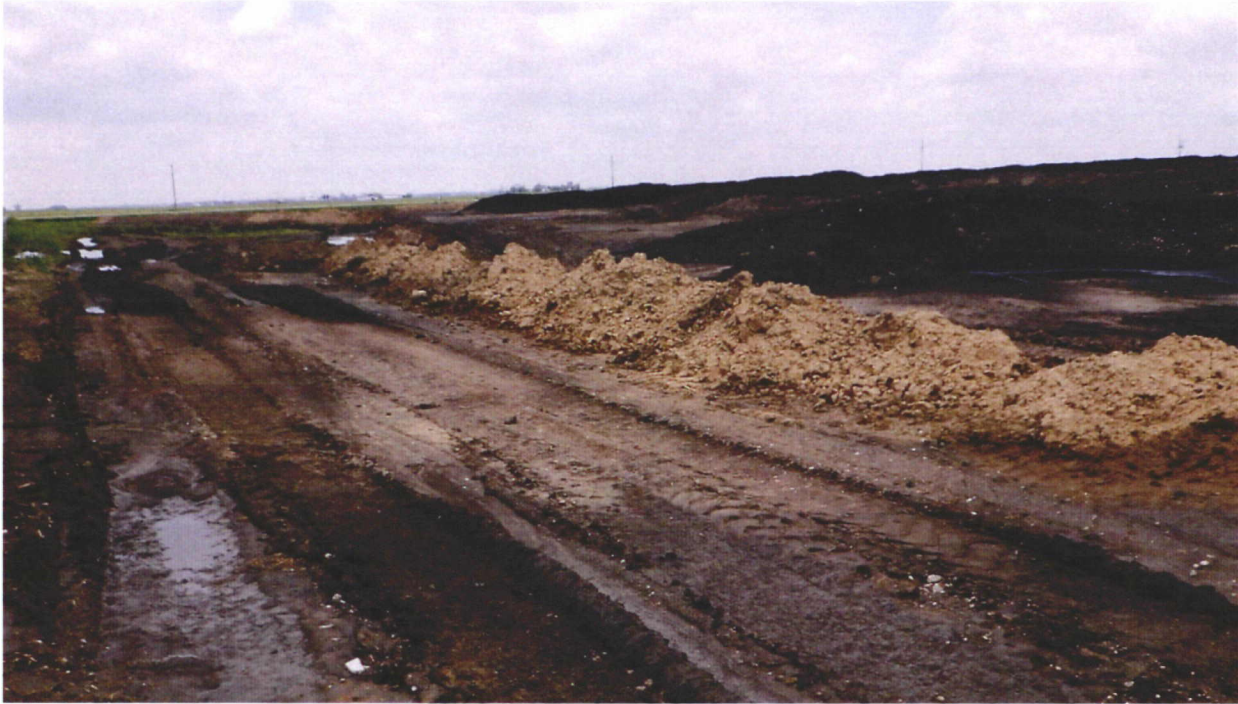
Photos: 17

Location: North of the north hoop building.

Description: Clean Harbors is constructing additional berms on the south side of the ditch excavated by AltEn.

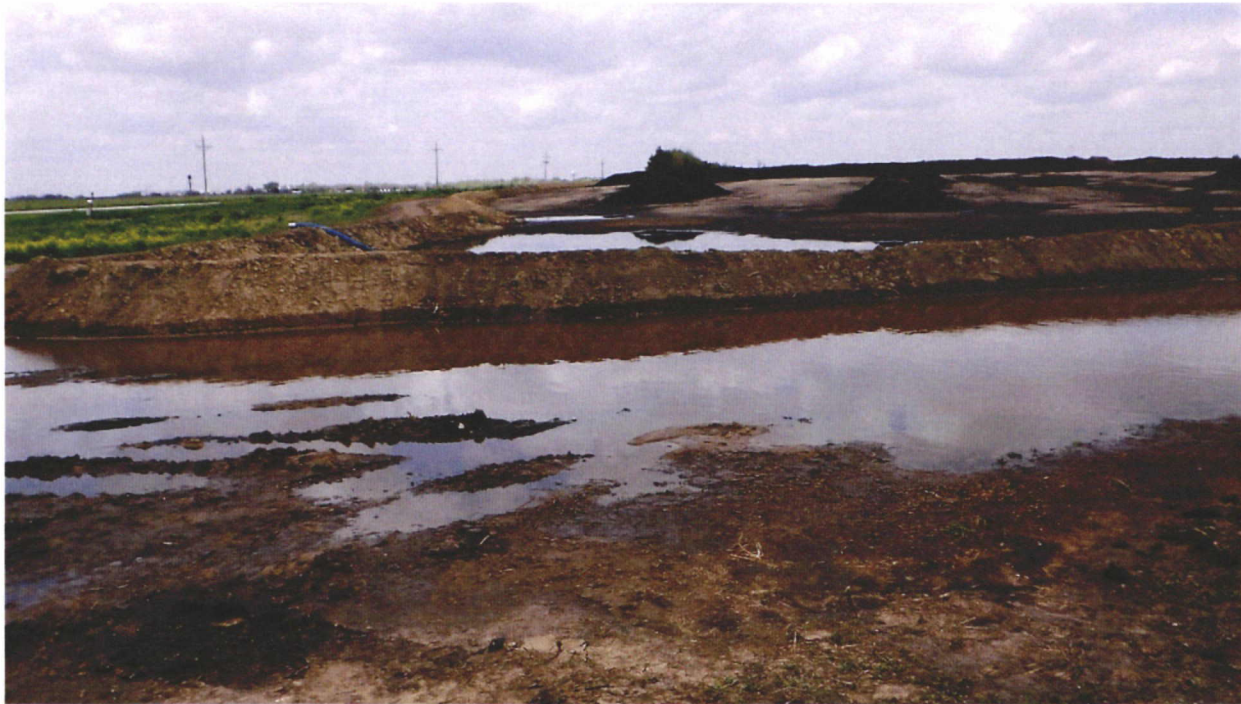
Photos: 18

Location: Area 5 on the site map.

Description: Reinforced berm separating wetcake runoff from uncontaminated runoff.

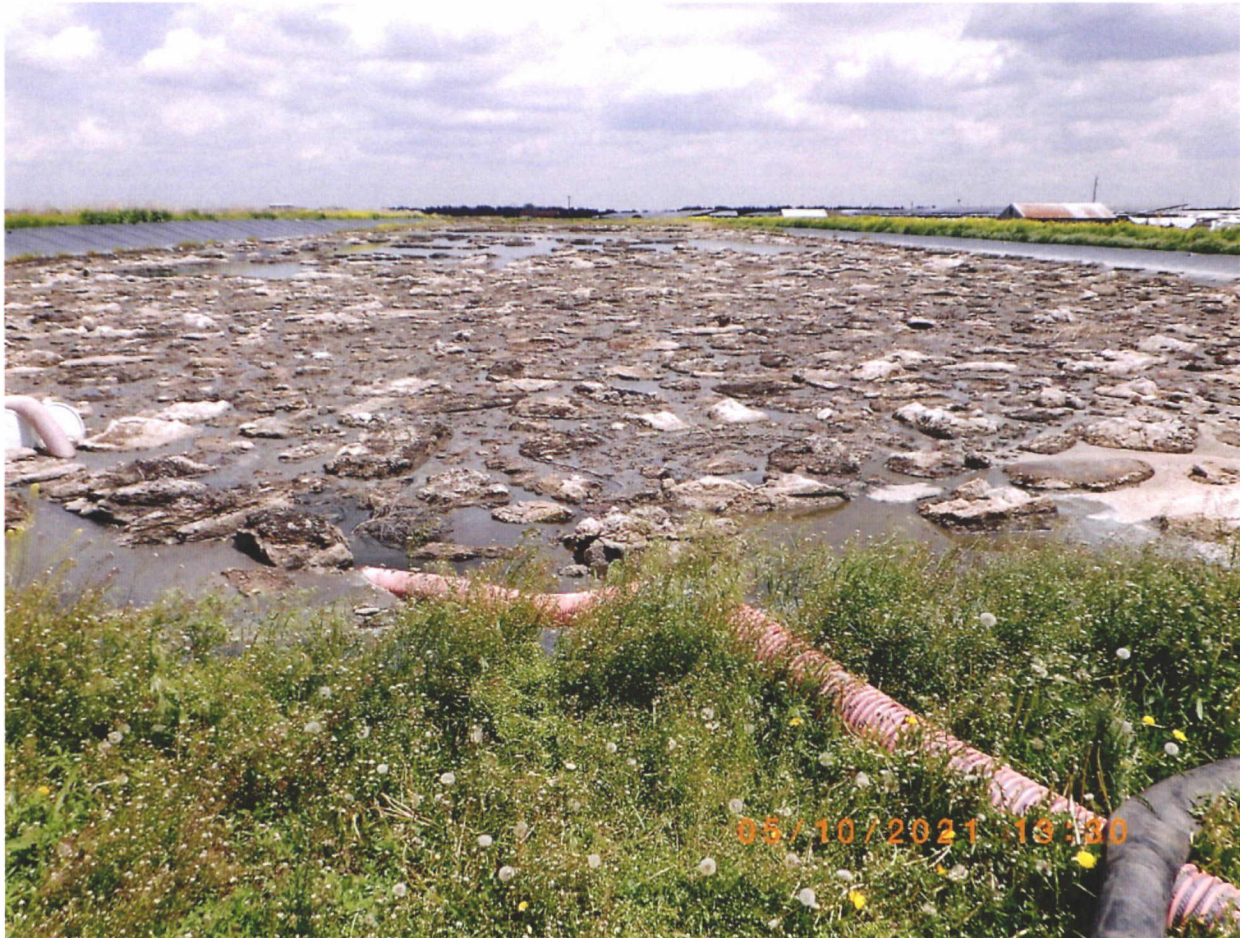
Photos: 19

Location: West side of the emergency lagoon.

Description: Clean Harbors pumping from the emergency lagoon to the northeast lagoon.

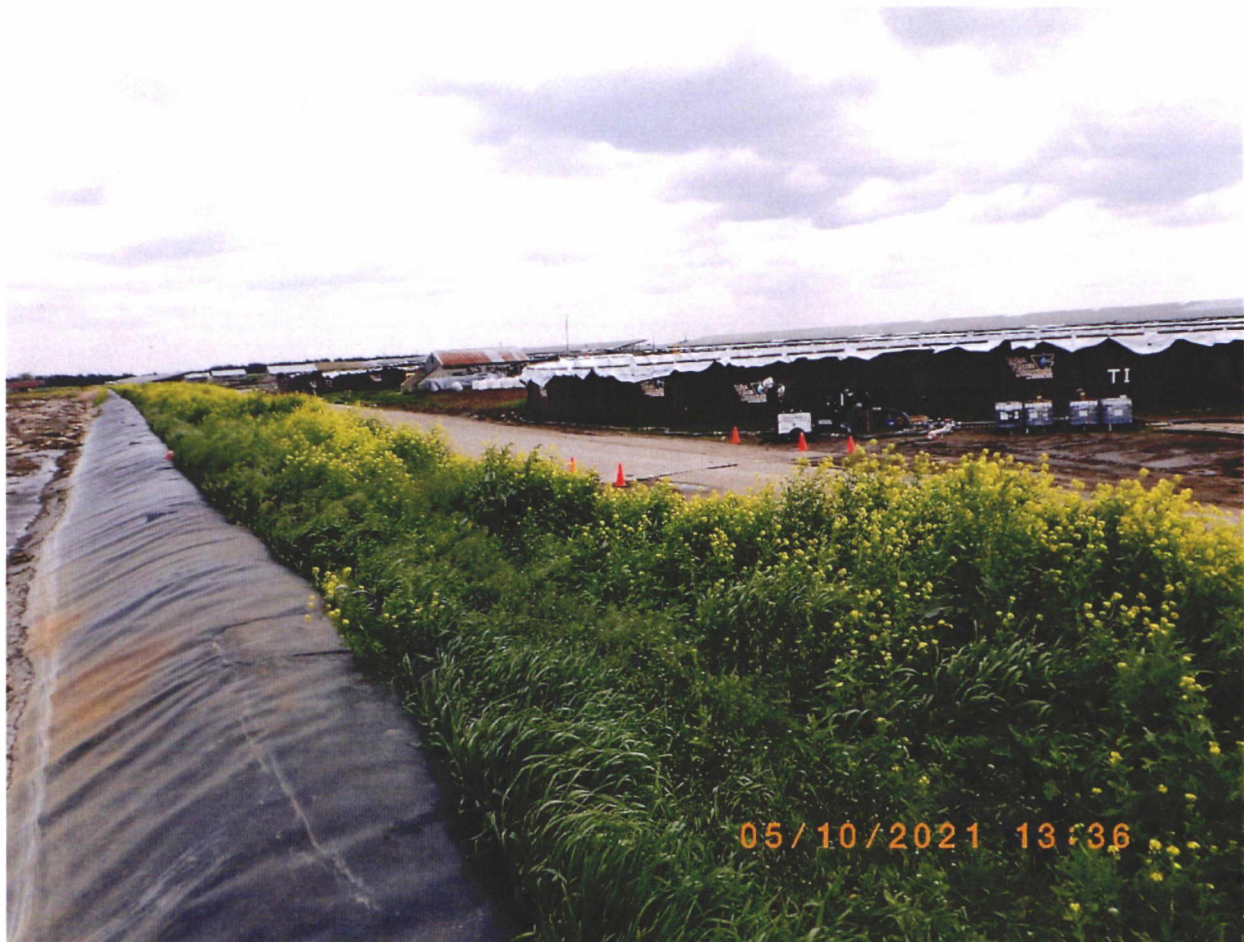
Photos: 20

Location: North of the north hoop building.

Description: Poseidon tank 1 in the center of the photo and tank 2 in the background.

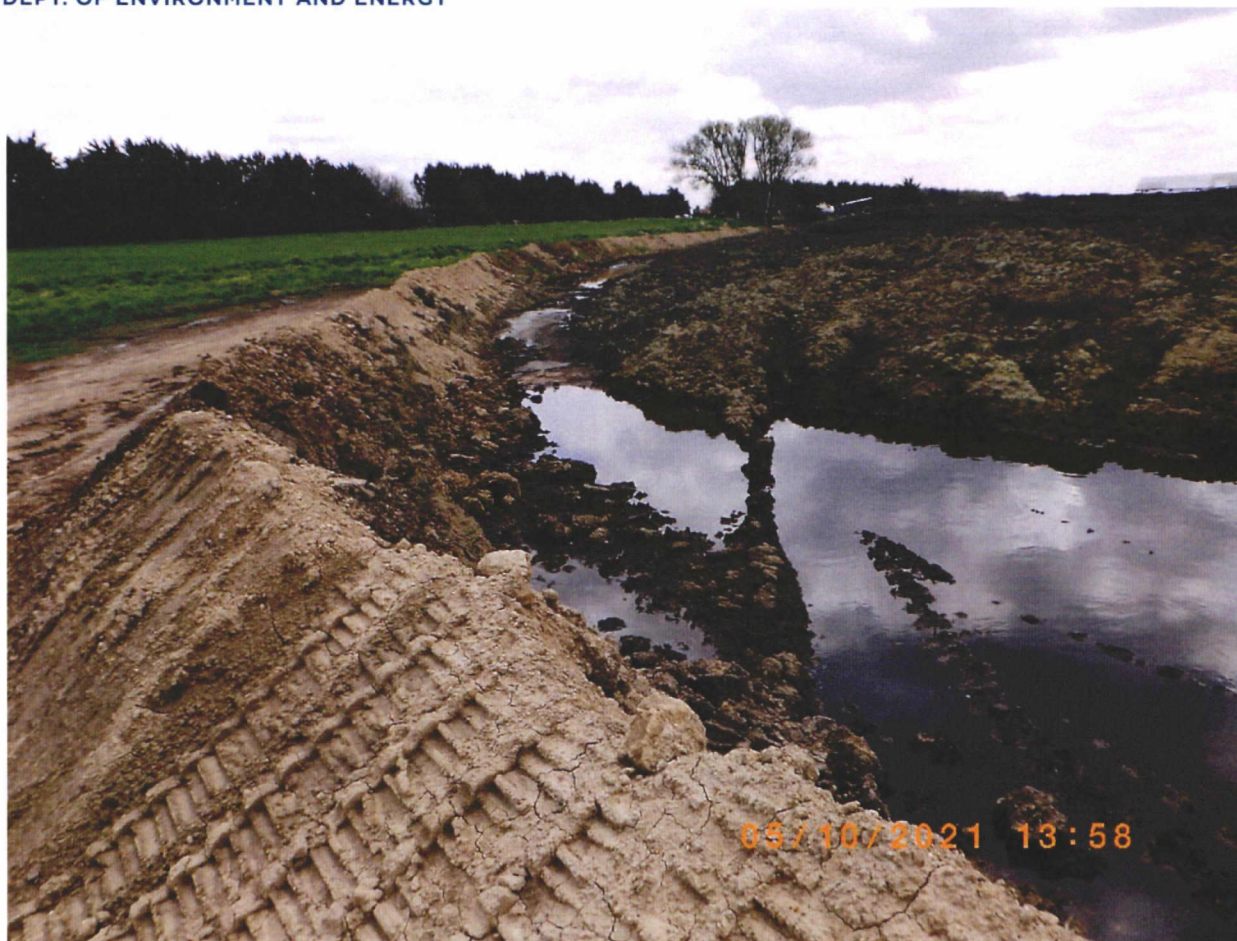
Photos: 21

Location: Area 6 on the site map.

Description: Reinforced berm at the northwest corner of the east wetcake storage area.

- Address lower berm in Area 6

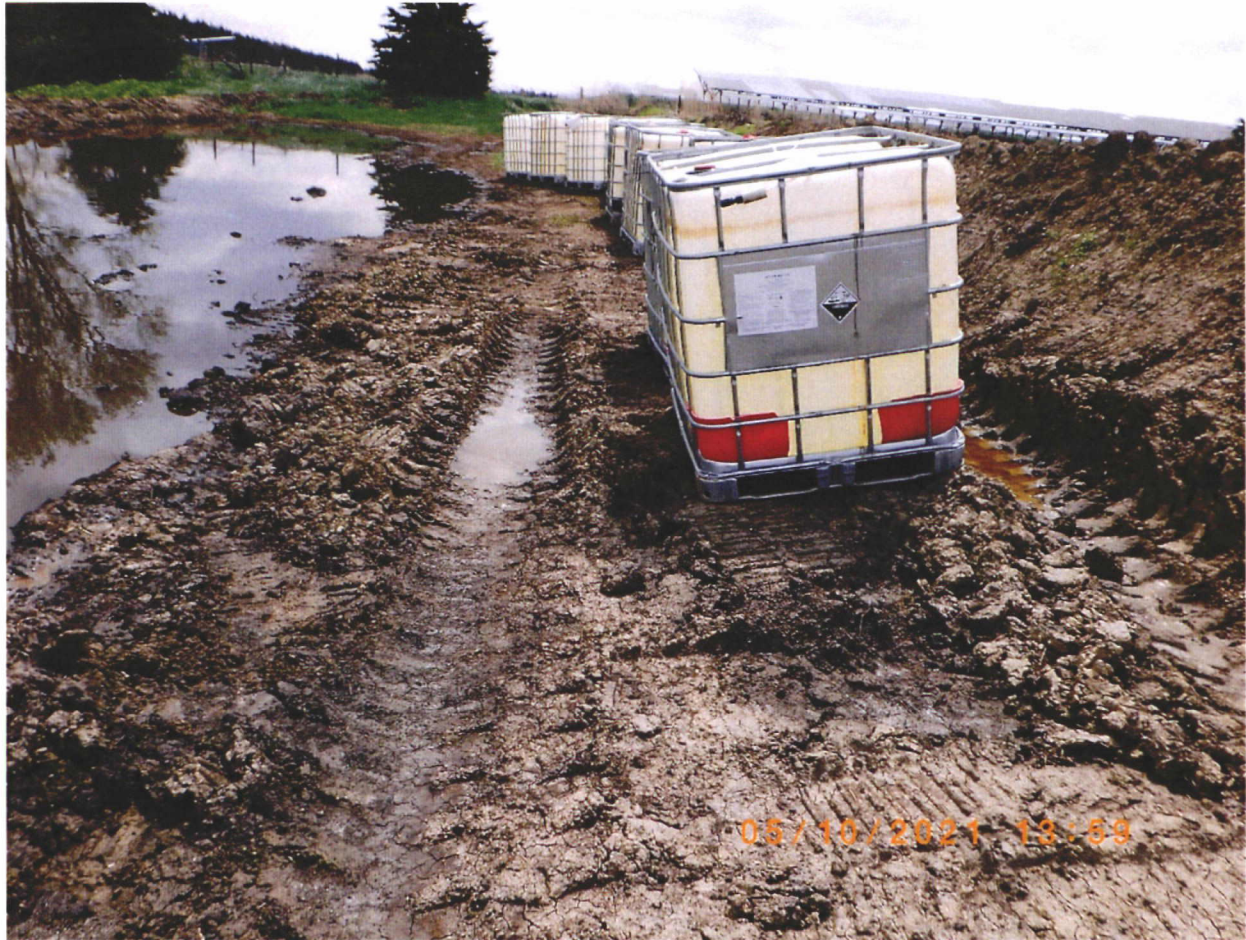
Photos: 22

Location: Area 6 on the site map.

Description: Totes moved to this area to be used to pump runoff and transport to the emergency lagoon. I requested that Clean Harbors work on pumping this area as soon as staff was available before forecasted rain arrived.
