Facility: AltEn, LLC
IIS: 84069
PCS: NE0137634

Mark Pomajzl
5/21/2021

Site Visit Check list

Inspection and Assistance Exit Summary

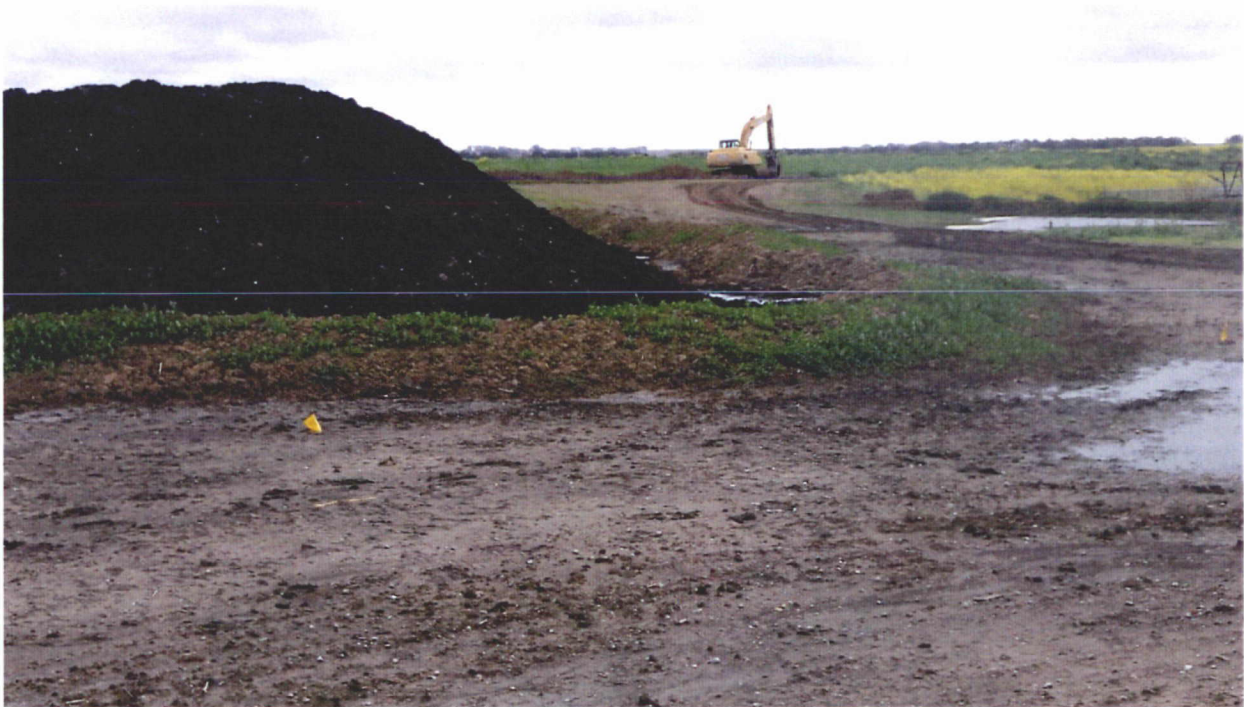
Photo: 1

Description: This is the newest of the berms in area 1.

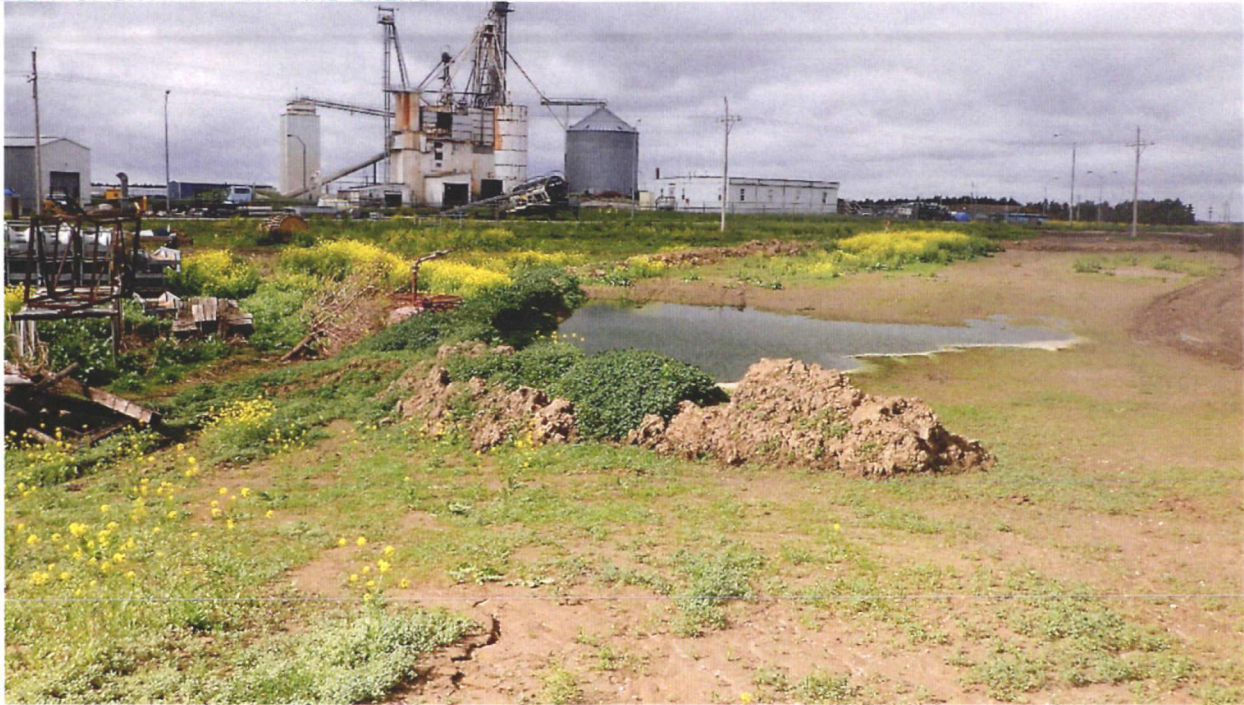
Description: Green water observed in the area 1 dike.

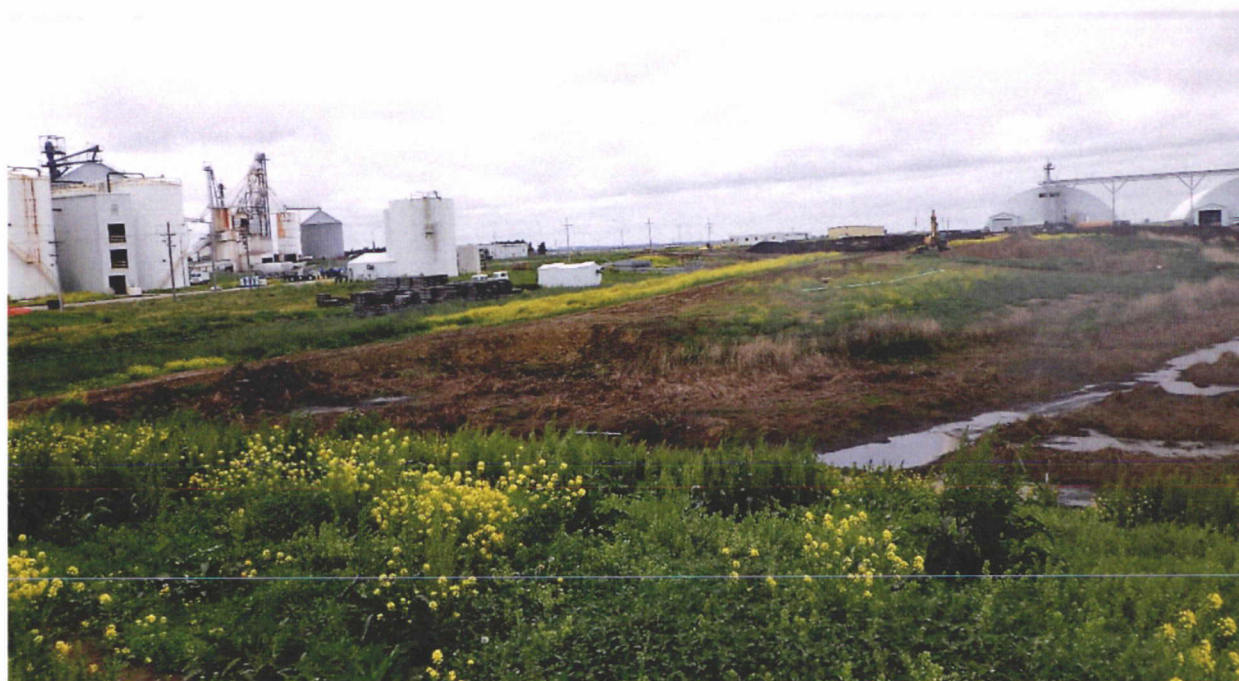
Photo: 3

Description: There is some minor water accumulation.

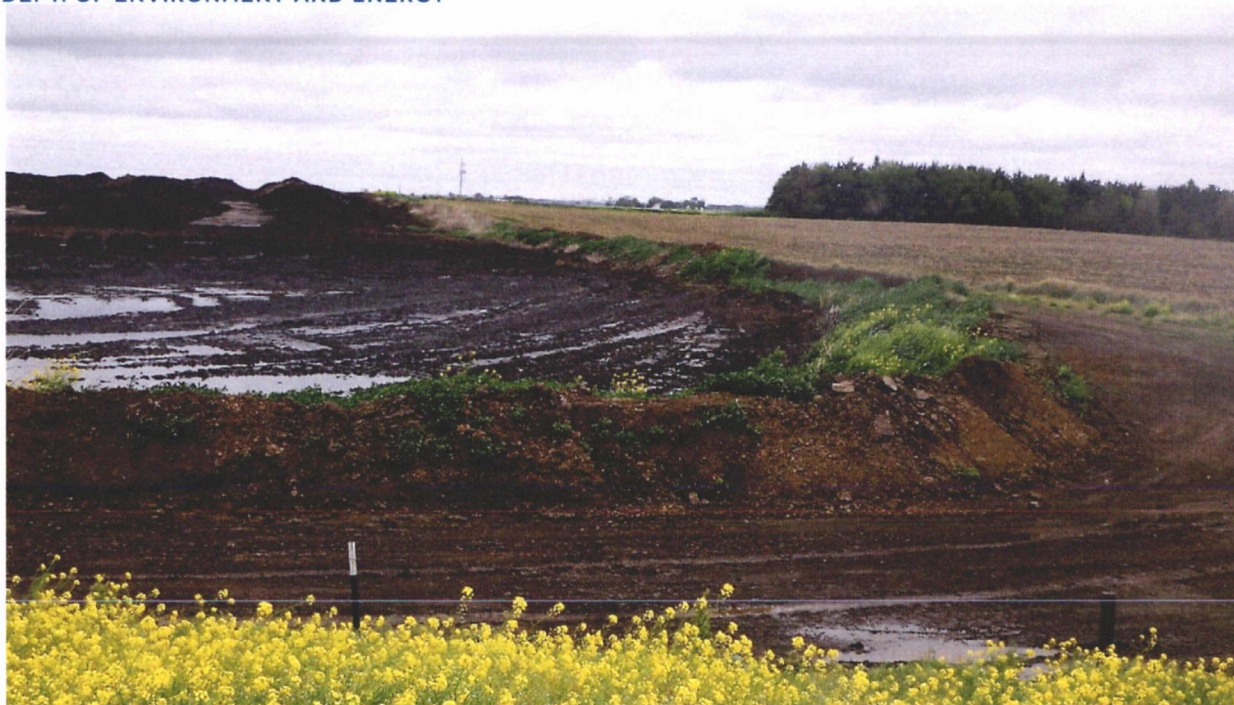
Photo: 4

Description: There is some minor water accumulation.

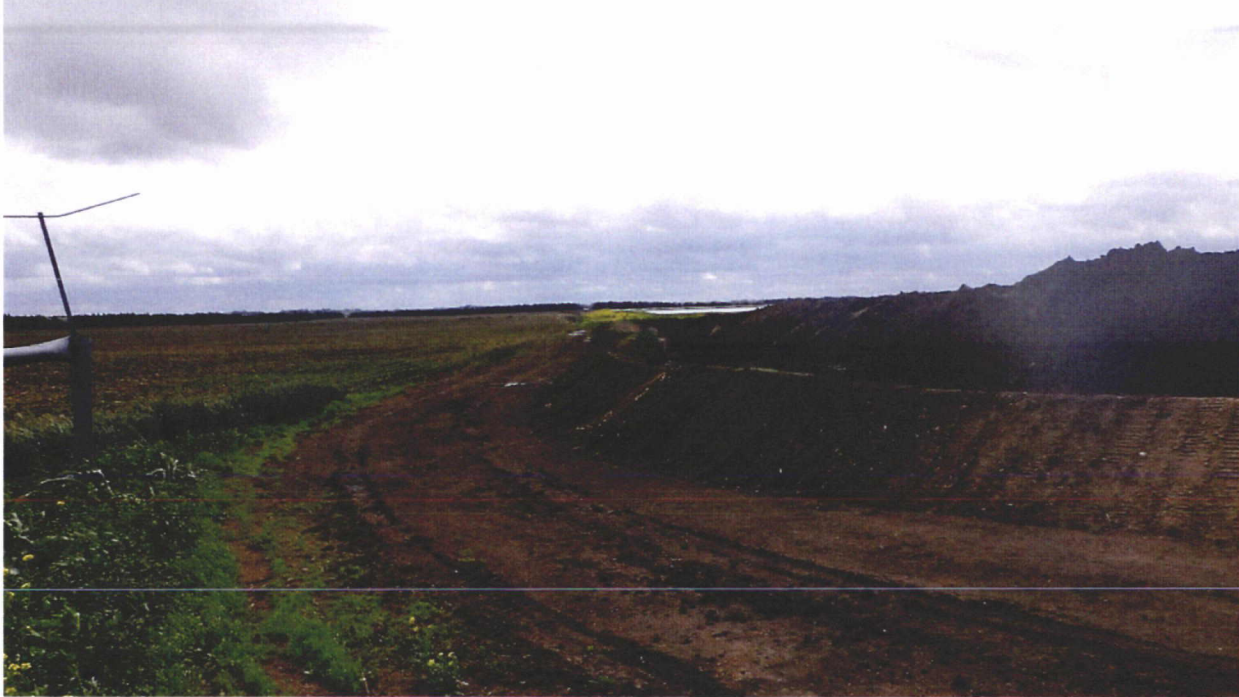
Photo: 5

Description: Area 4 and 5 are interconnected.

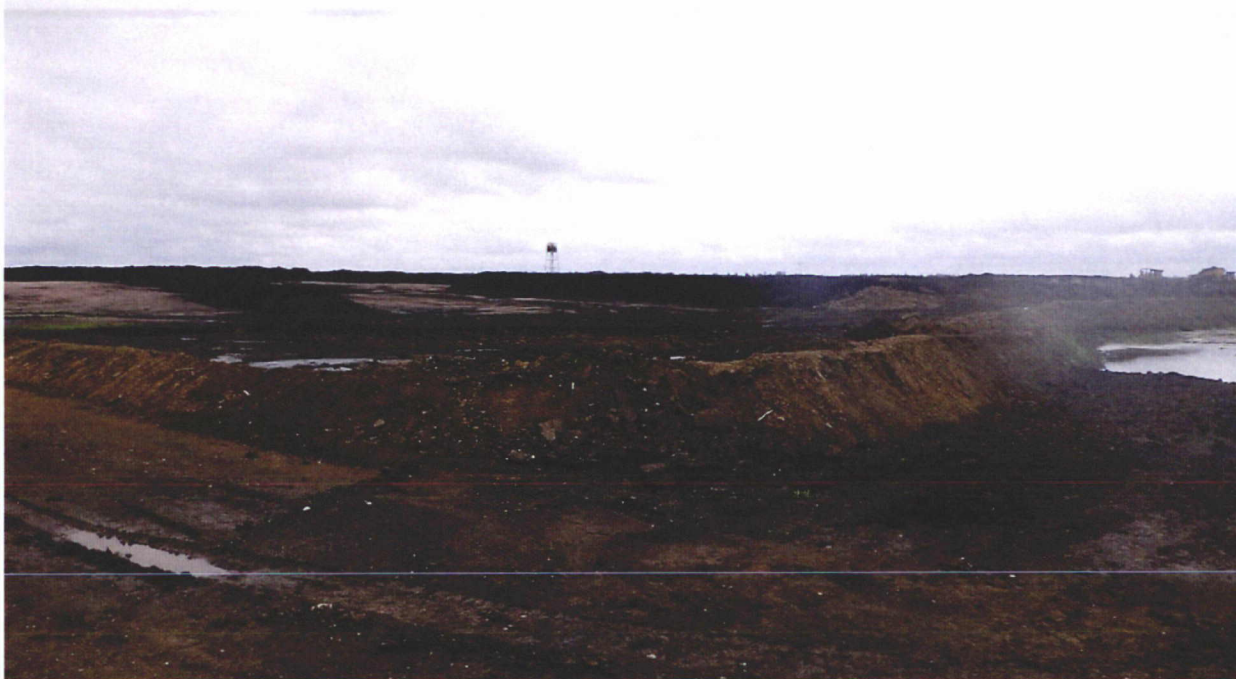
Photo: 6

Description: There is no seepage observed.

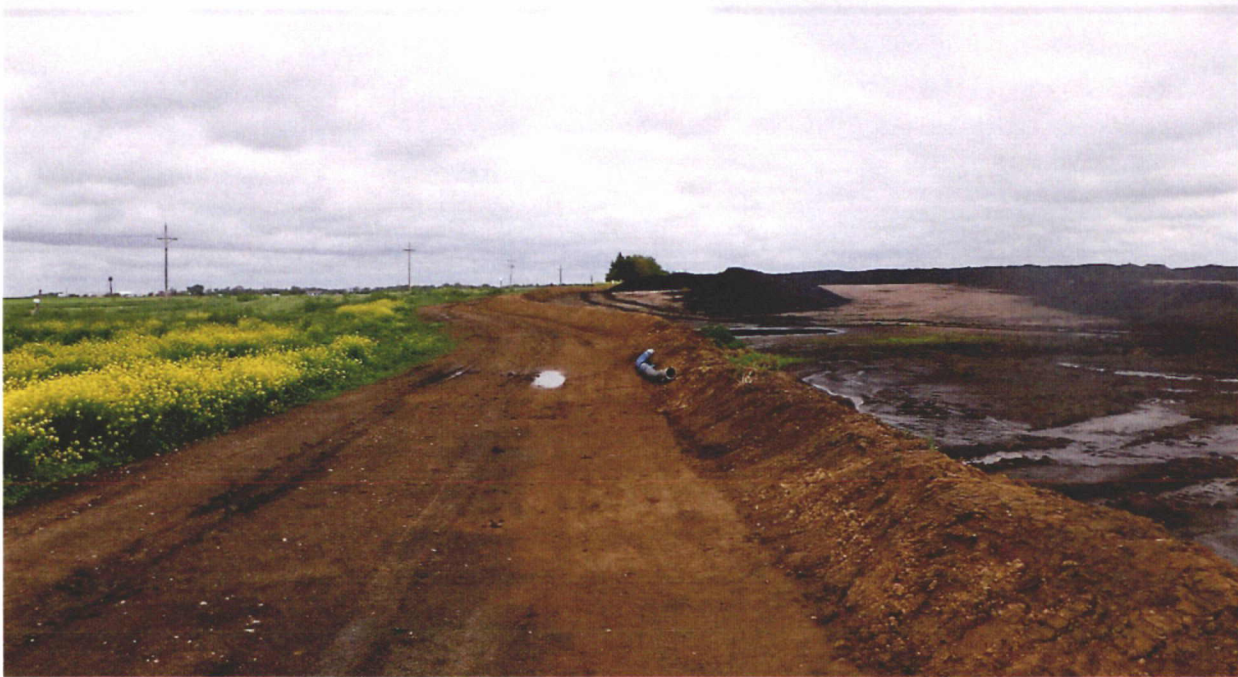
Photo: 7

Description: Clean Harbors has removed the piping for draining area 5. They had trenched drainage to area 2.

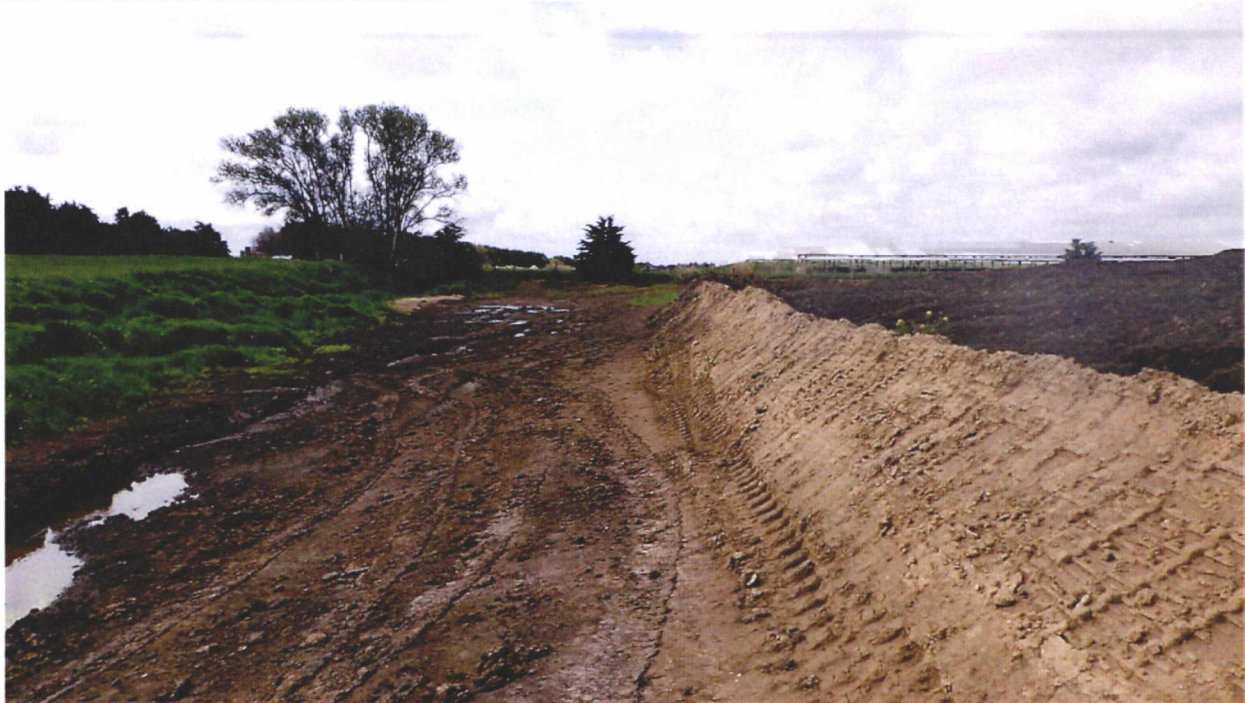
Photo: 8

Description: This photo depicts the south side of area 6. There is no seepage observed.

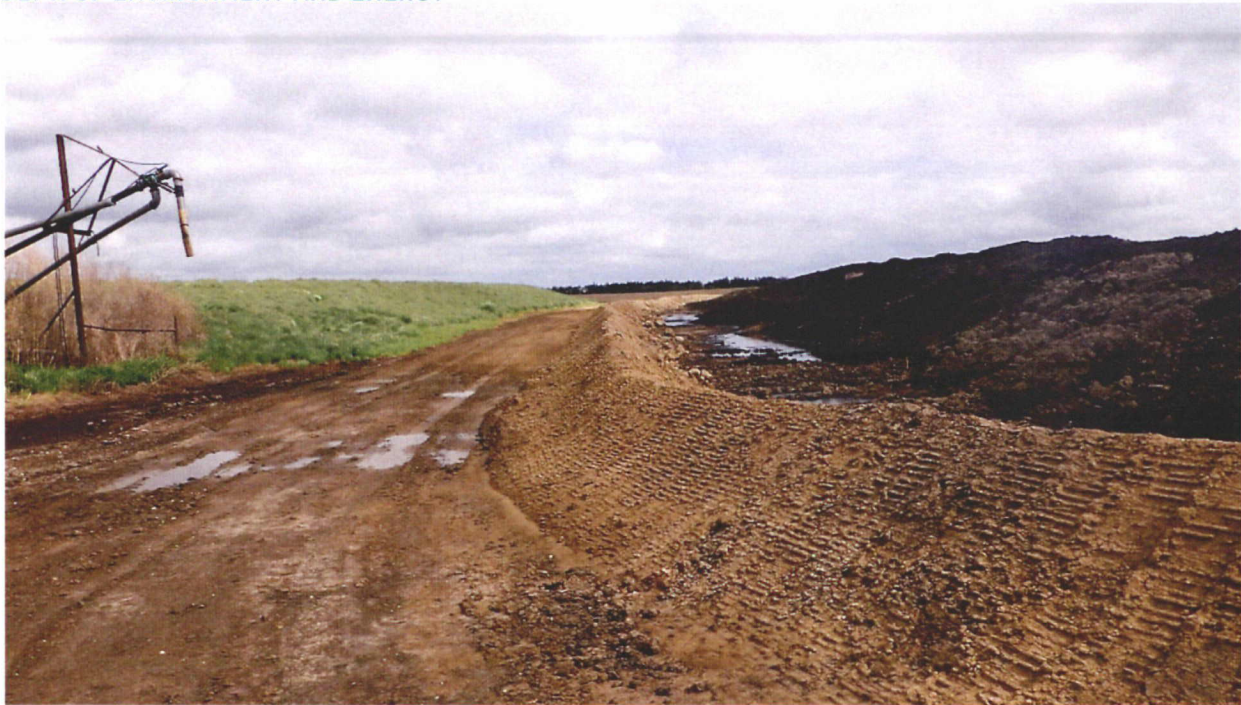
Photo: 9

Description: This photo depicts the west side of area 6. There is no seepage observed.

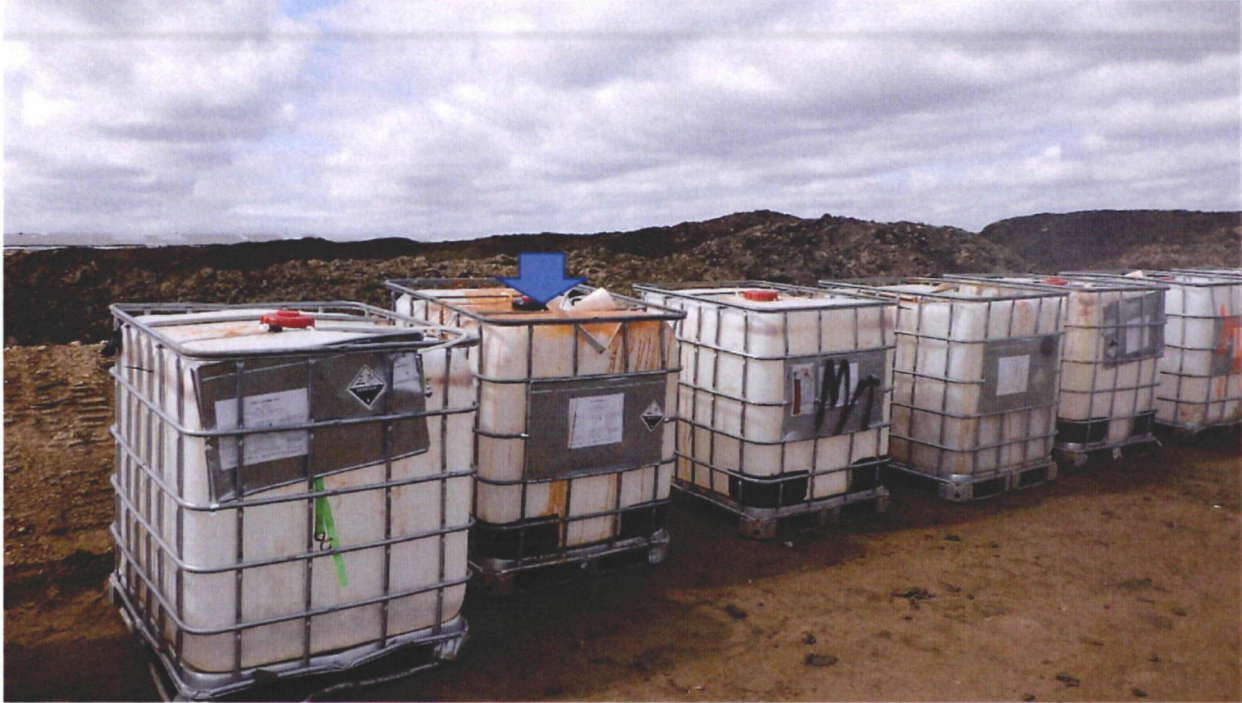
Photo: 11

Description: This photo depicts the north side of area 6. These are empty totes used to transport water to the emergency lagoons when needed. This photo also depicts residual chemical on one of the totes (arrow). Photo 12 depicts the residual chemical.

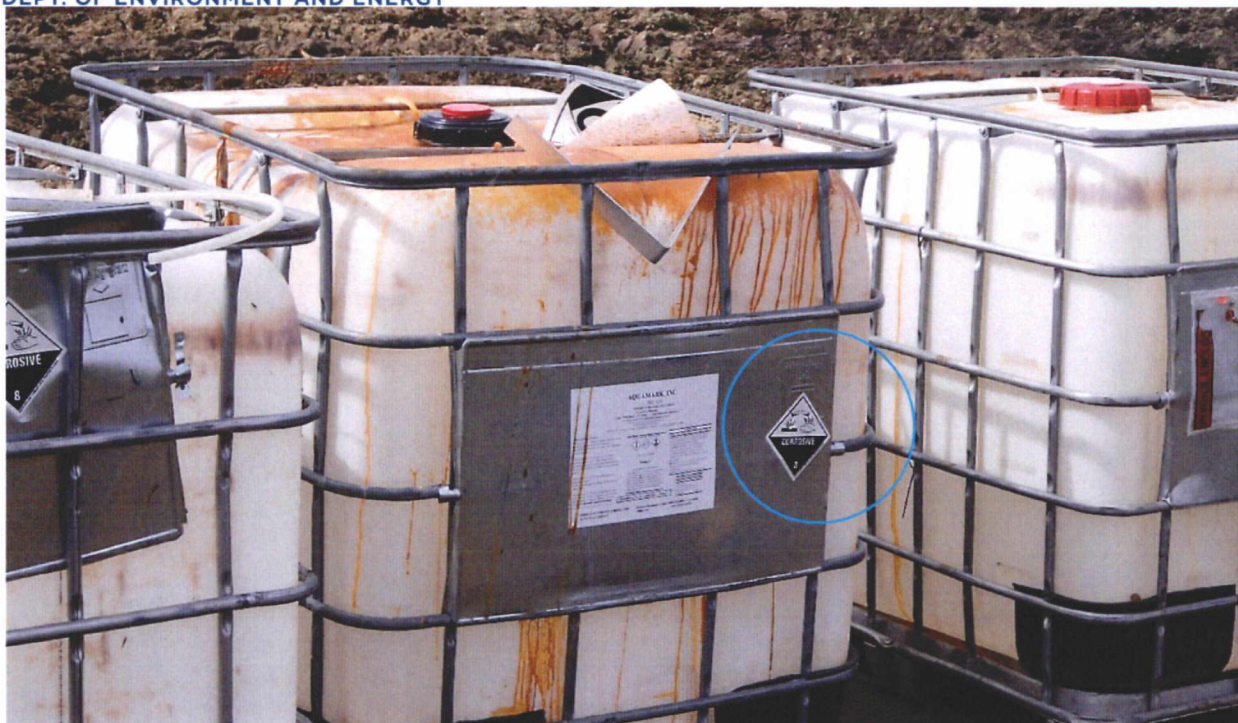
Photo: 12

- Area 1 contains two berms. The east berm has been expanded to prevent parking lot water from entering the berm area. The east berm contains older water which is green.
- Areas 2 has minor water accumulation.
- Area 3 is in good condition. No seepage observed.
- Area 4 is in good condition. No seepage observed.
- Area 5 is in good condition. No seepage observed.
- Clean Harbors has finished the berm around the Area 6 pile. One of the totes used to transfer water has residual corrosive chemical dried on the tote. The chemical is actively flaking off, see photo log.

Description: This photo depicts the north side of area 6. This photo depicts residual chemical. The tote is stained with flaking off chemical. The chemical is a corrosive (circle).

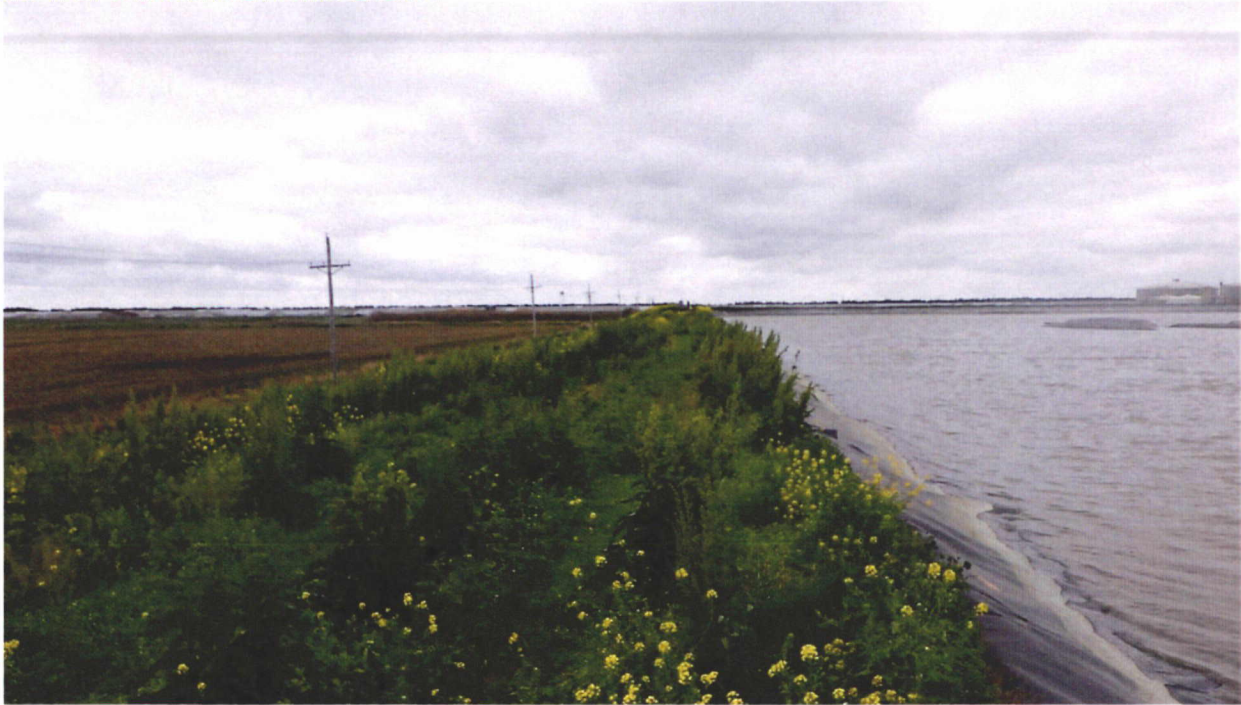
Photo: 14

- Northeast lagoon
 - No change with the liners.
 - The water level continues to lower.
 - The facility is recirculating water from the pumping station into the northeast lagoon.
 - Vegetation is growing fast around the lagoon.

Description: This photo depicts excessive vegetation along the east dike.

× Manage vegetation around lagoons

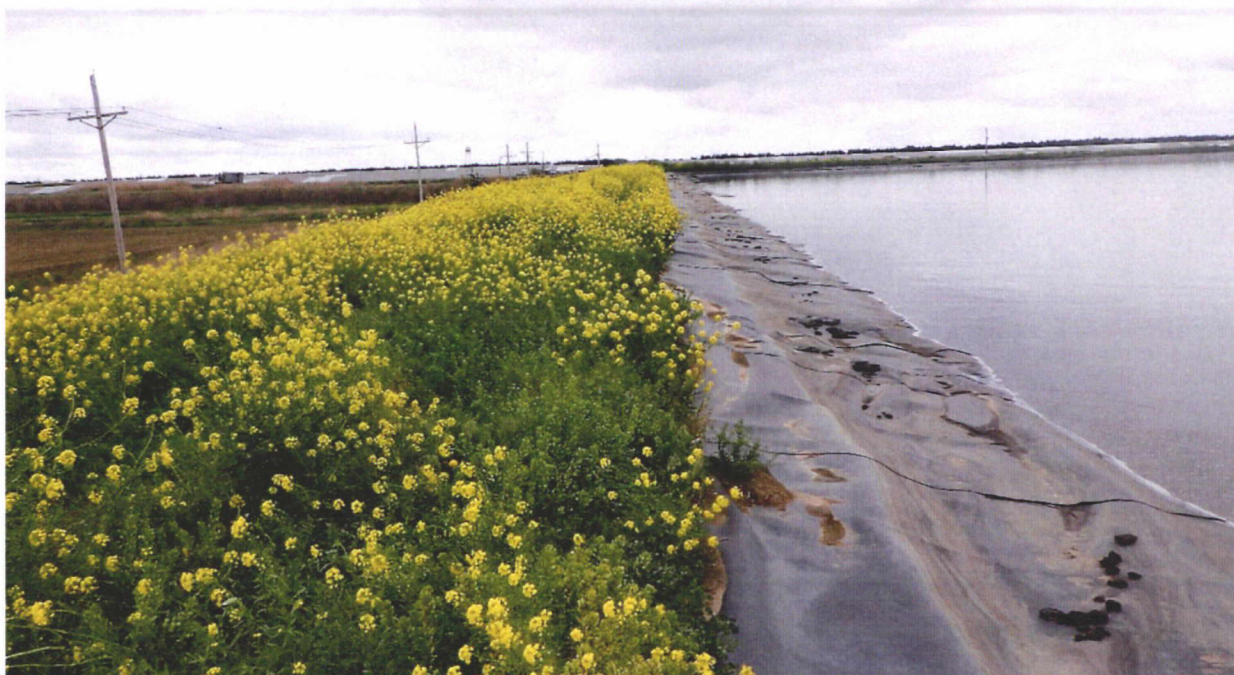
Photo: 15

- Vegetation is beginning to take over the south and east dike. These areas are becoming a hazard for tripping and falling.

Description: This photo depicts excessive vegetation along the east dike.

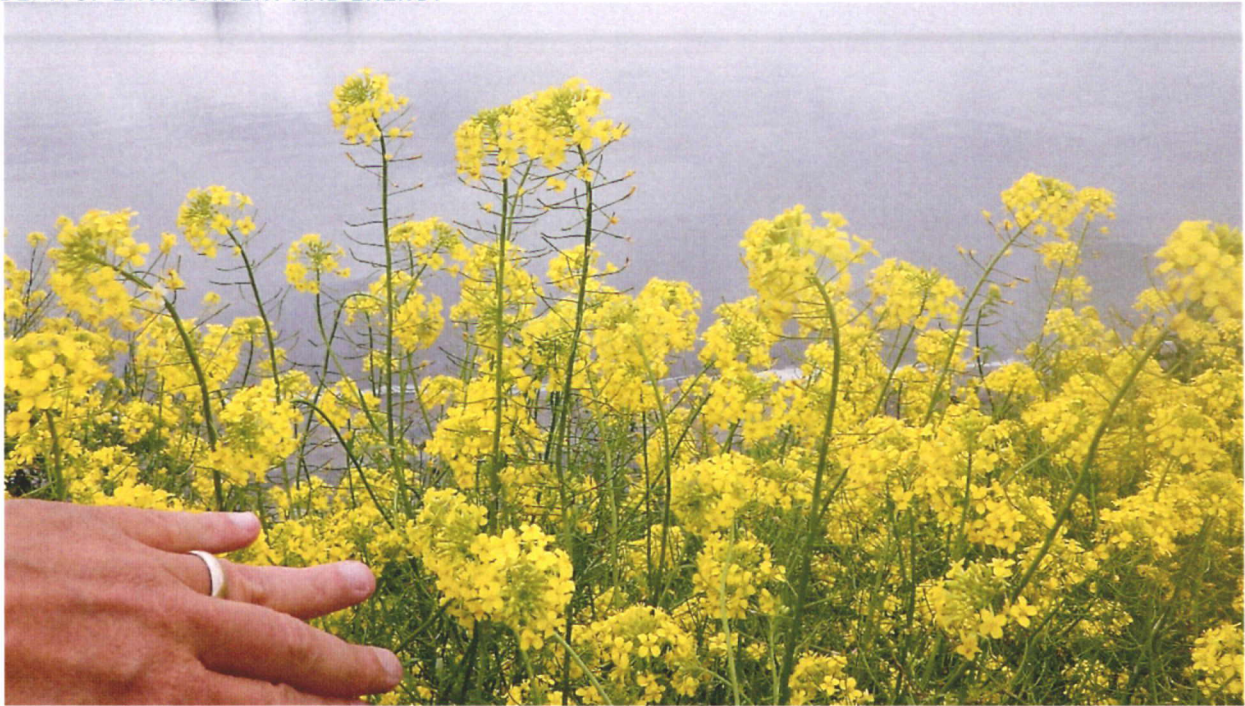
Photo: 16

Description: This photo depicts excessive vegetation along the east dike. The vegetation is about chest high in places.

× Vegetation is up to the inspector's chest on the east and south dikes of the south lagoon. Vegetation is growing fast along all the lagoon dikes.

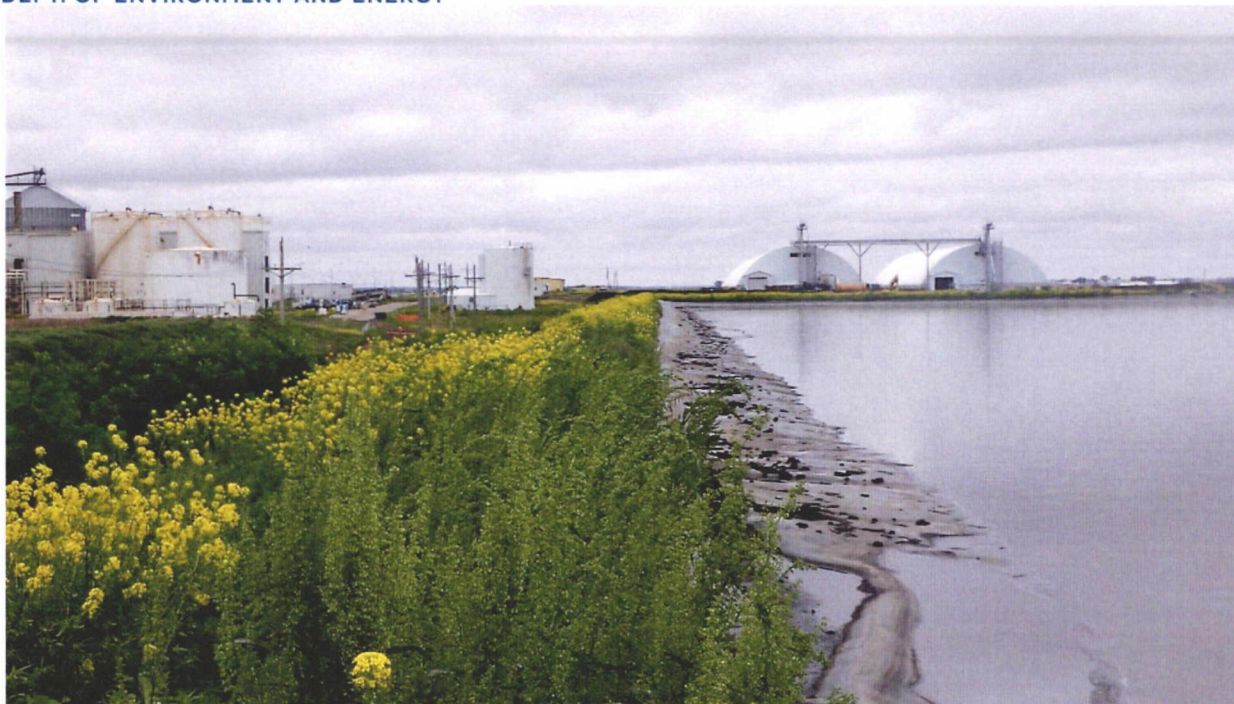
Photo: 17

Description: This photo depicts excessive vegetation along the south dike. The vegetation is about chest high in places.

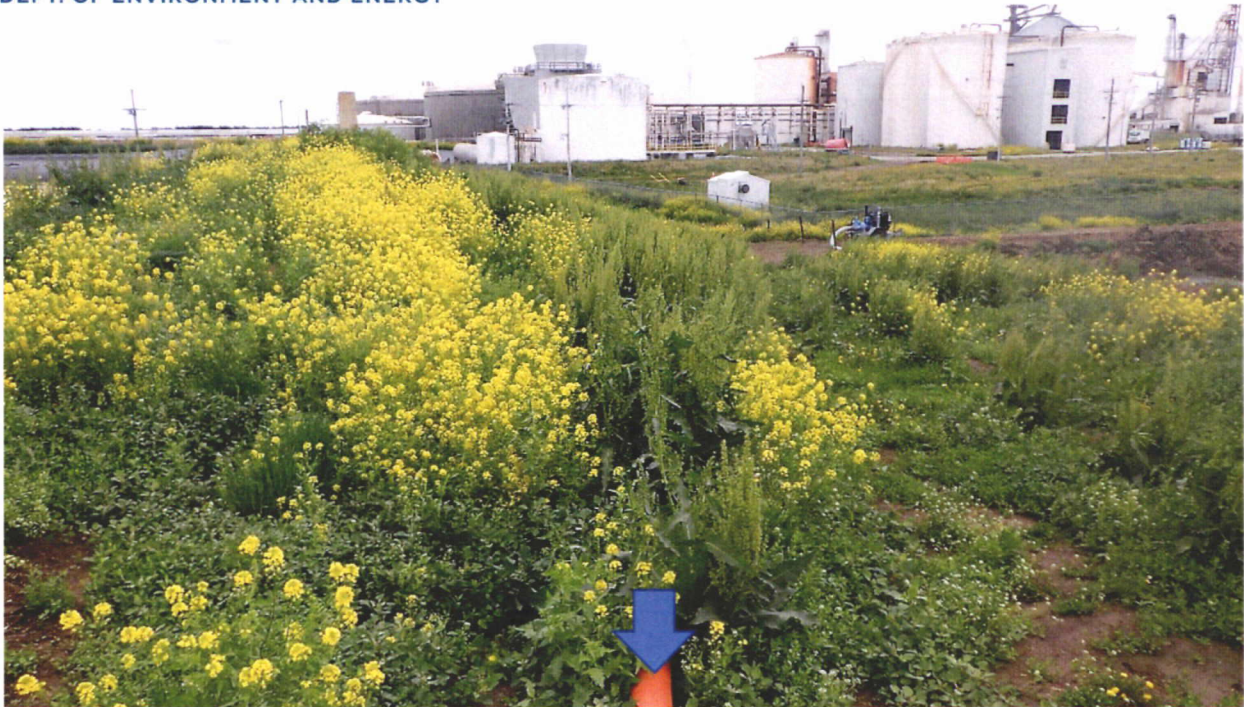
Photo: 18

Description: The orange hose in the forefront (arrow) is the used to transport water from the lagoon to the treatment system. It is becoming difficult to inspect due to weed coverage.

× The orange hose used to pump water from the lagoon system is hard to see due to vegetation. It is difficult to inspect the hose for leaks.

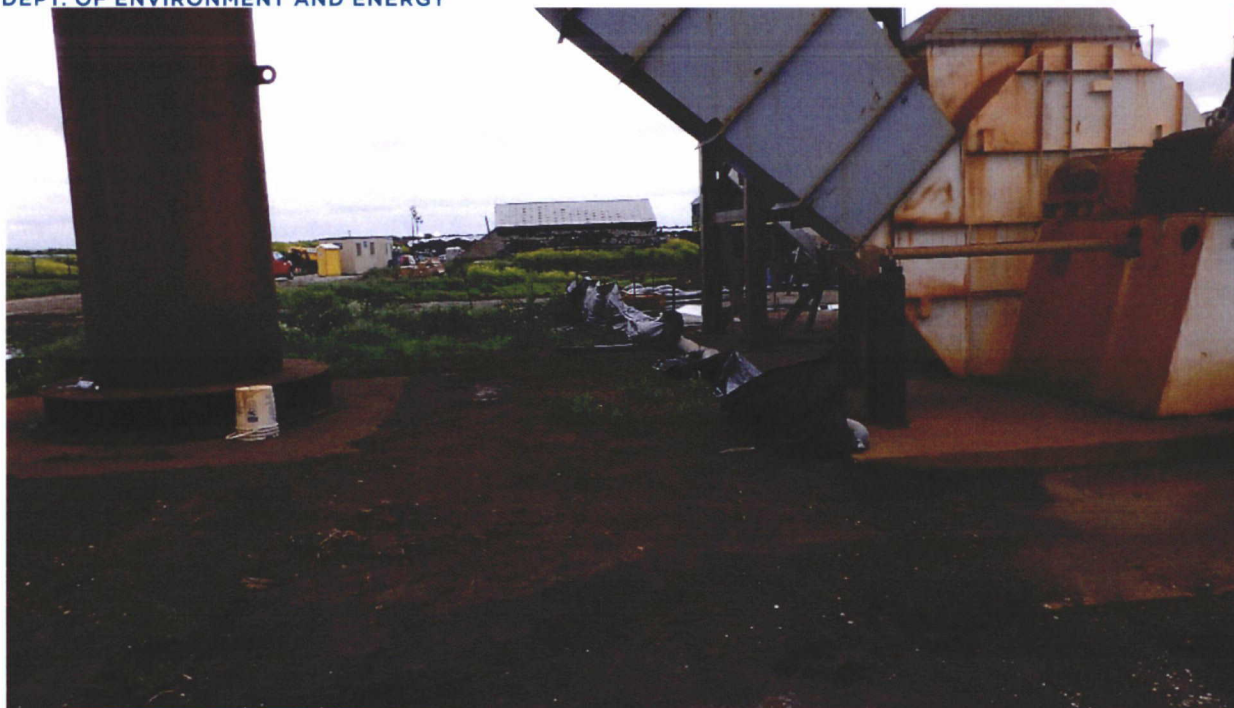
Photo: 19

Description: This photo depicts the Biochar Process. The BMPs that are installed have failed.

× The Biochar does not contain BMP's. (Clean Harbors stated that the area had been too muddy to install BMPs. They will be using a Ditch Witch for trenching and have the BMP installed they believe today or this weekend)

× Install BMP's around the Biochar.

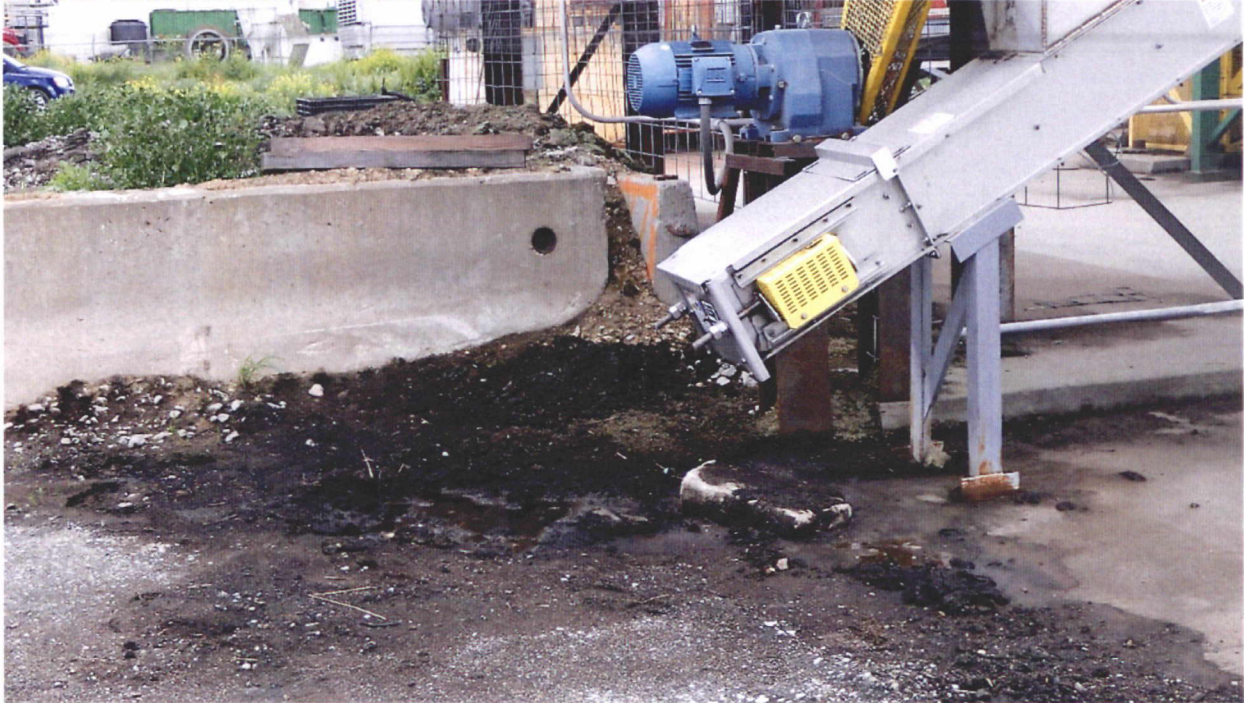
Photo: 20

- Spilled biochar product.
- The area continues to contain trash and debris.

Description: This photo depicts the south side of the Biochar Process. There is old residual biochar spilled on the pad. There is no BMP installed to control runoff from this.

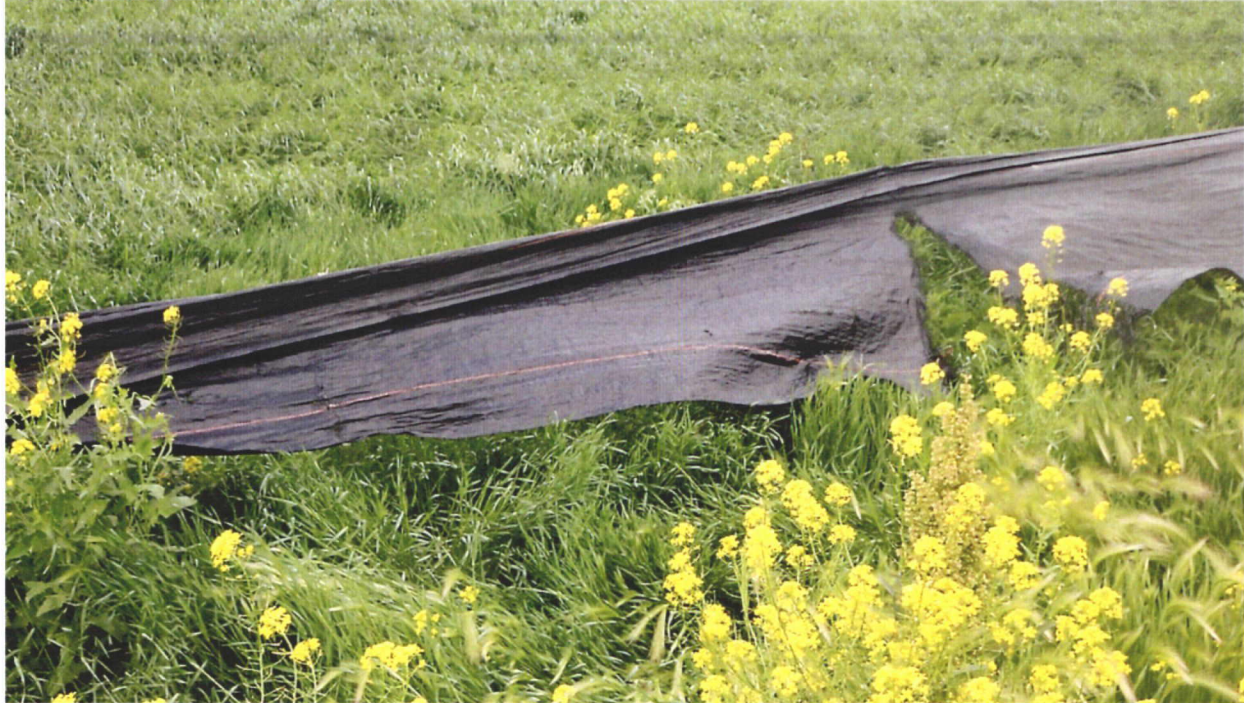
Photo: 21

Description: This photo depicts the south side of the Biochar Process. This is the old silt fence.

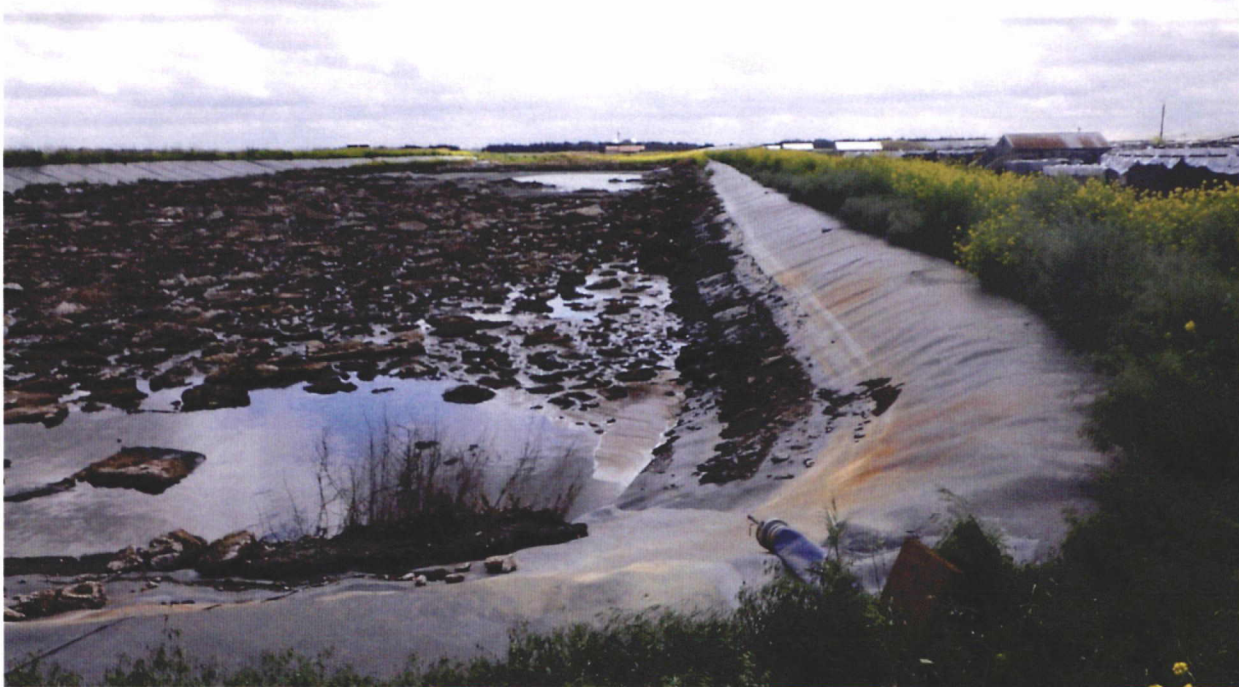
Photo: 22

Description: This photo depicts that the levels have been dropped.
