Facility: AltEn, LLC
IIS: 84069
PCS: NE0137634

Mark Pomajzl / Amanda Woita
5/12/2021

Site Visit Check list

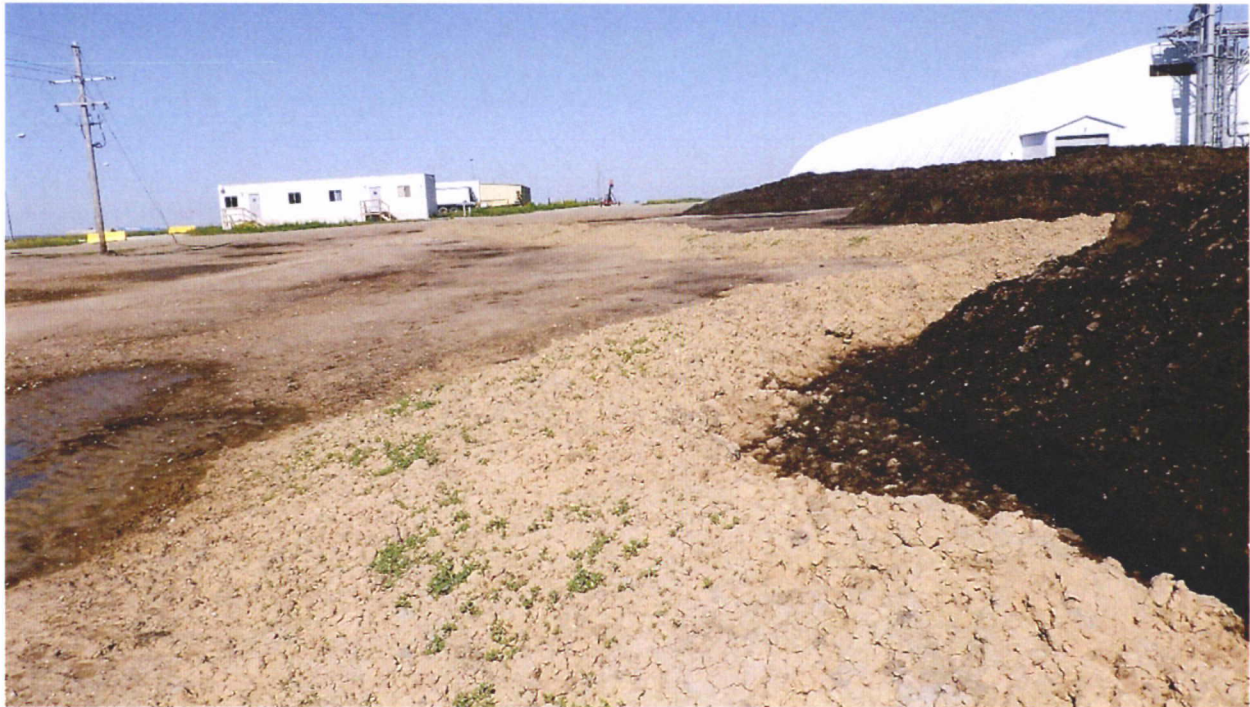
Photo: 1

Description: This is the west berm. There is no water accumulation.

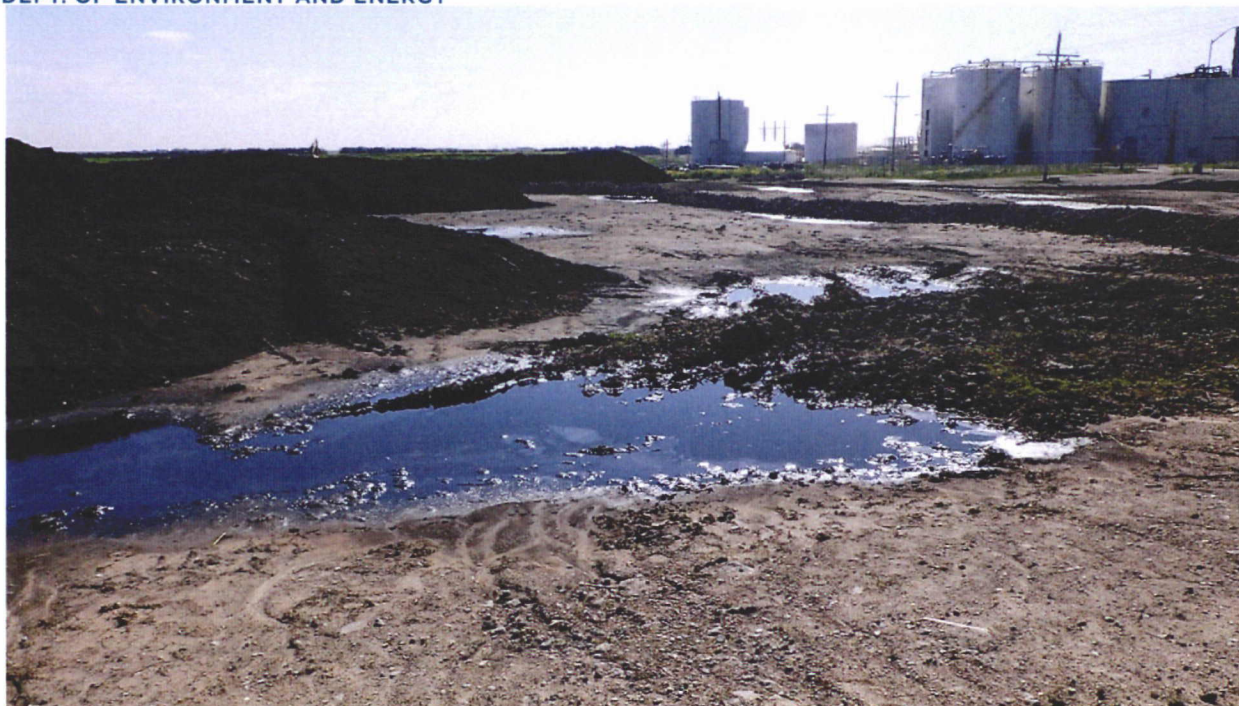
Photo: 2

Description: This is the west berm. There is minor water accumulation.

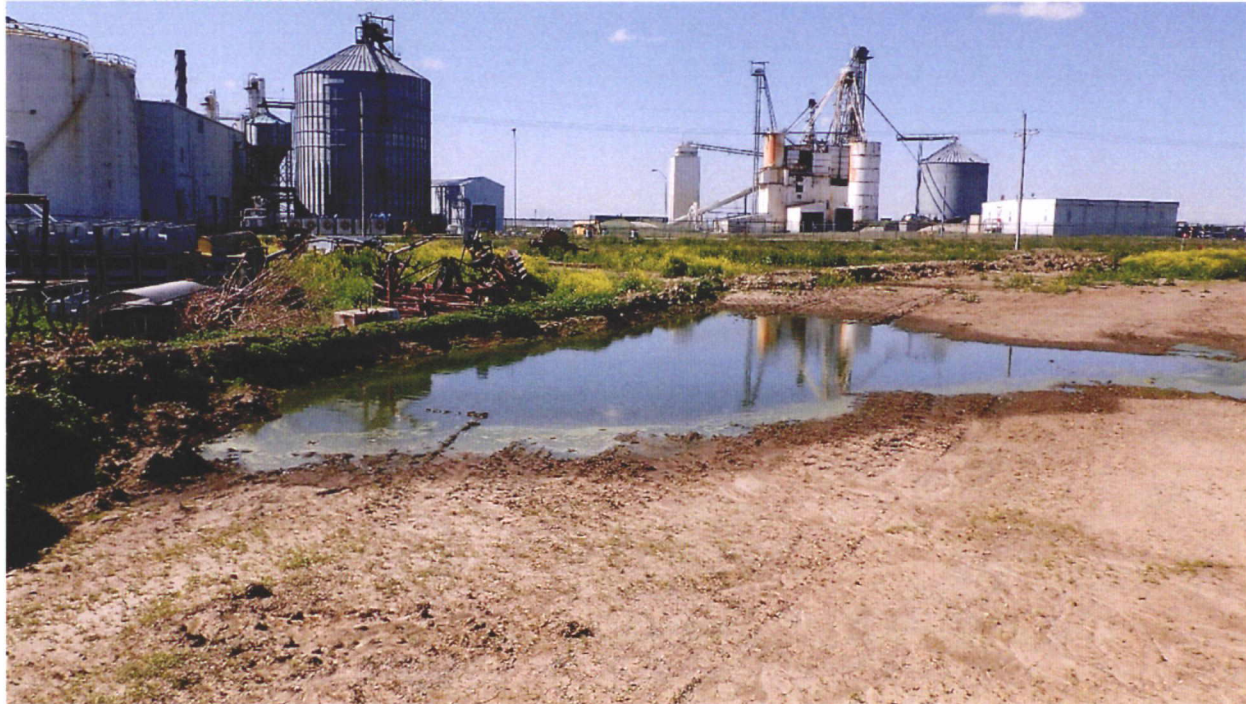
Photo: 3

Description: This is the original Area 1 berm. There is some water accumulation. There is no signs of seepage.

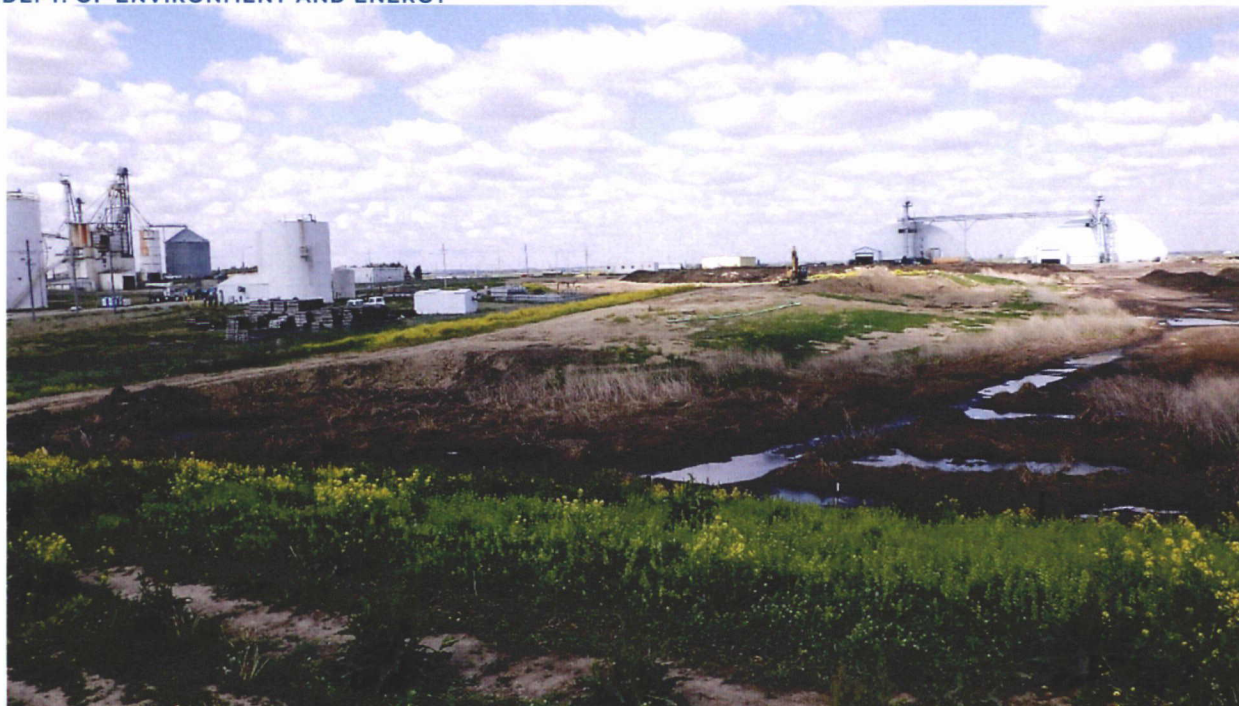
Photo: 4

Description: The facility has recently pumped Area 2 to the emergency lagoon.

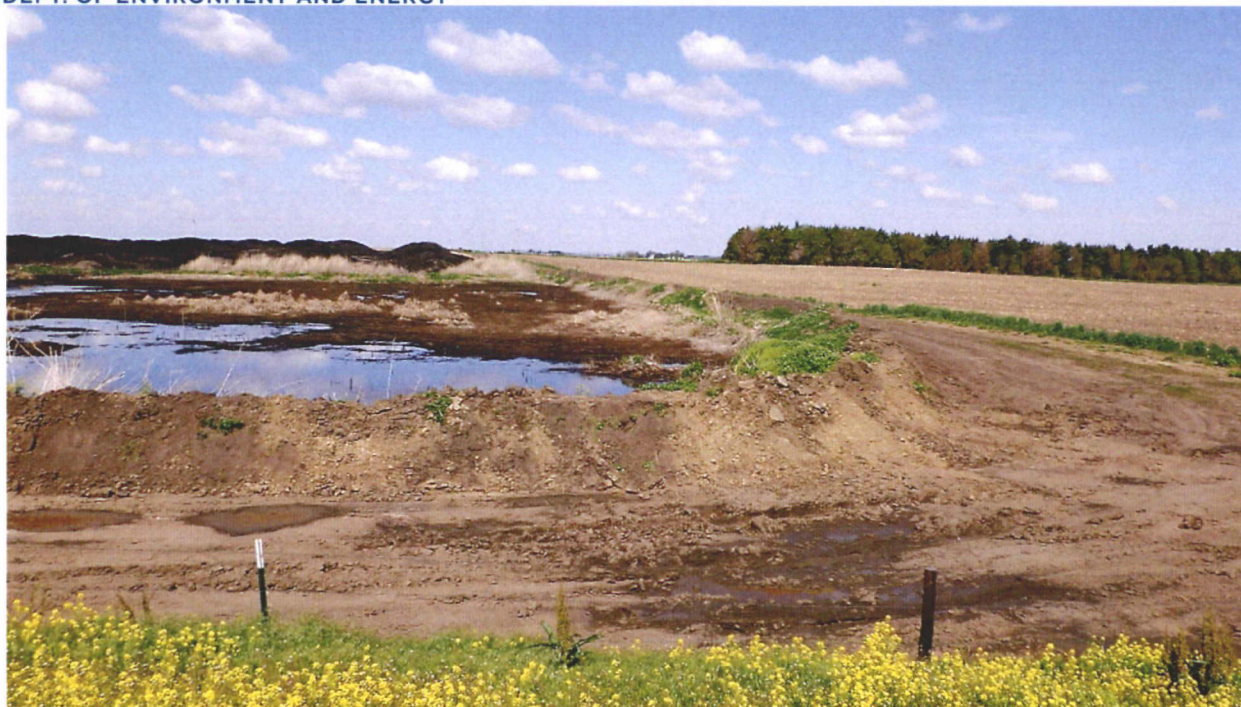
Photo: 7

Description: This photo depicts Area 3.

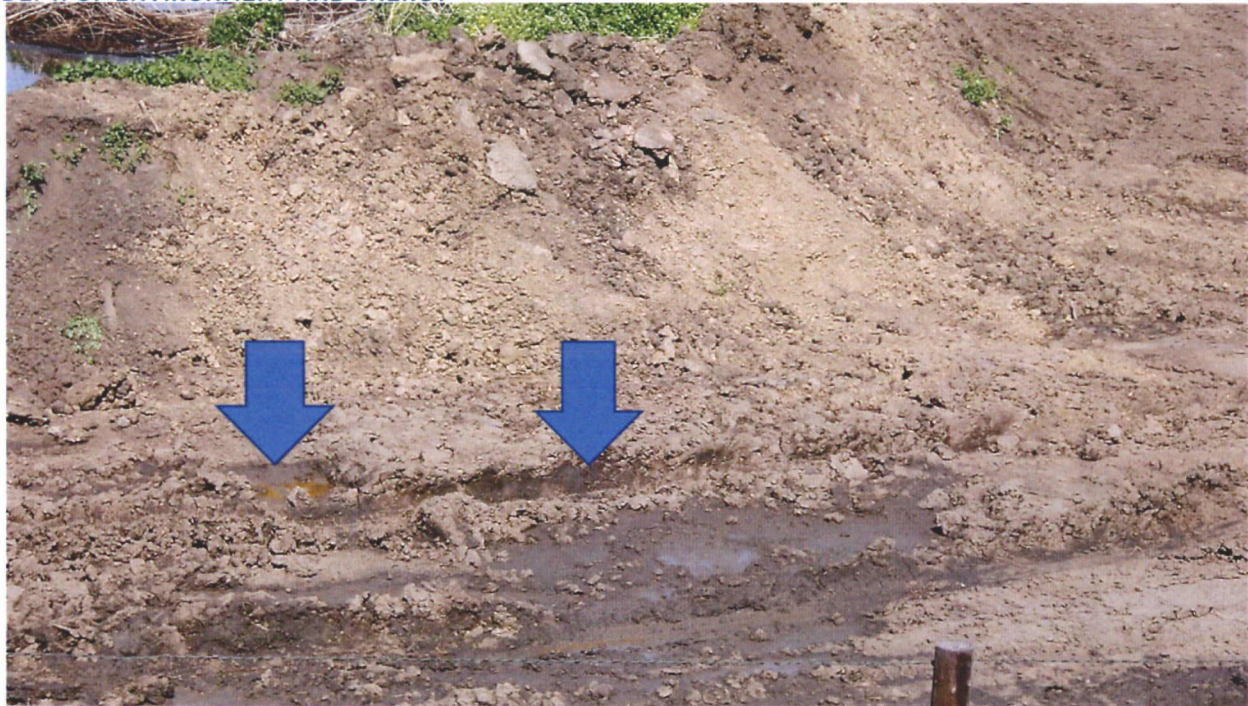
Photo: 8

Description: This photo depicts possible seepage (arrow).

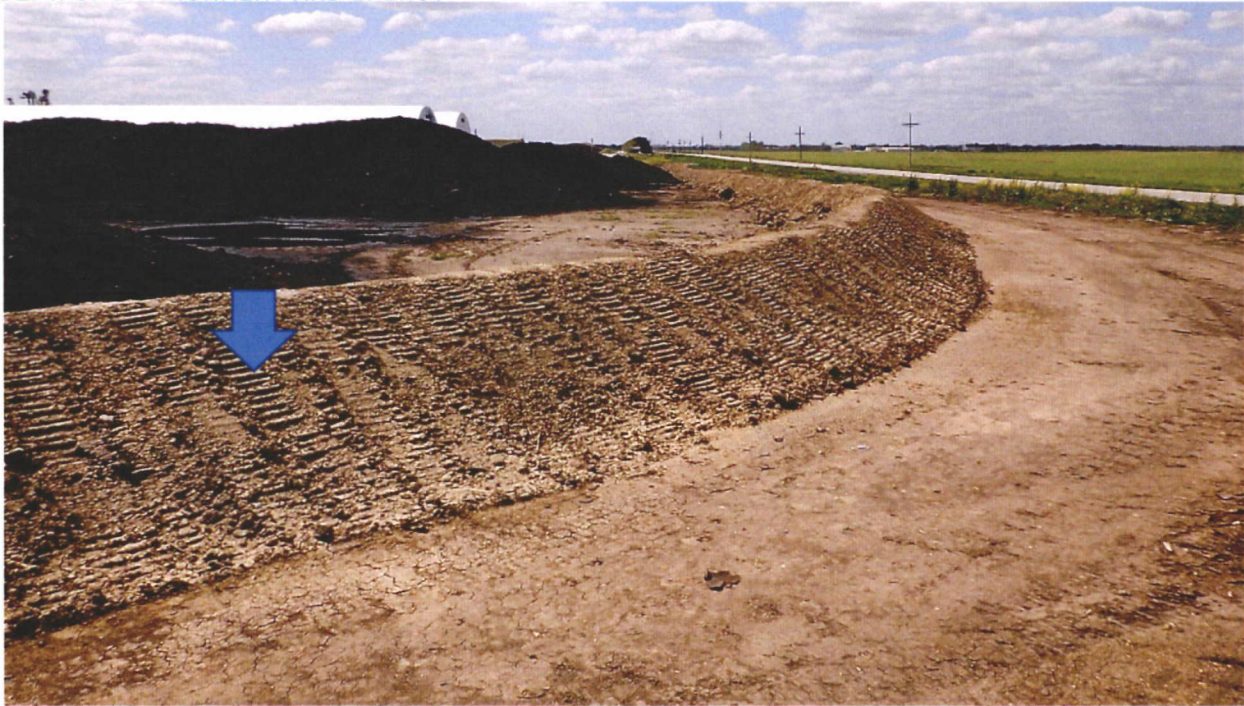
Photo: 9

Description: This photo depicts the near berm along Area 4. The berm in this area is compacted (arrow).

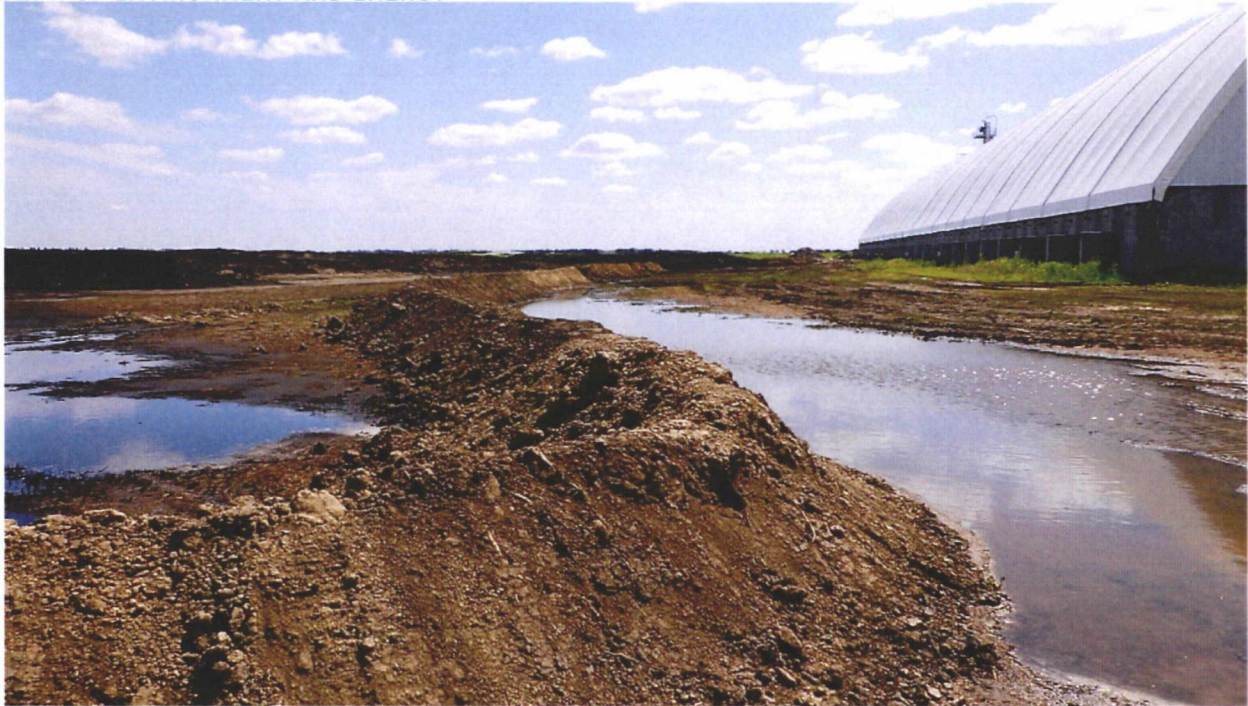
Photo: 11

Description: This photo is a new berm east of the original Area 5 berm. The berm surrounds the south side of the north wet cake pile to the east side of the north hoop building. There is accumulated rainwater on the south side of the berm.

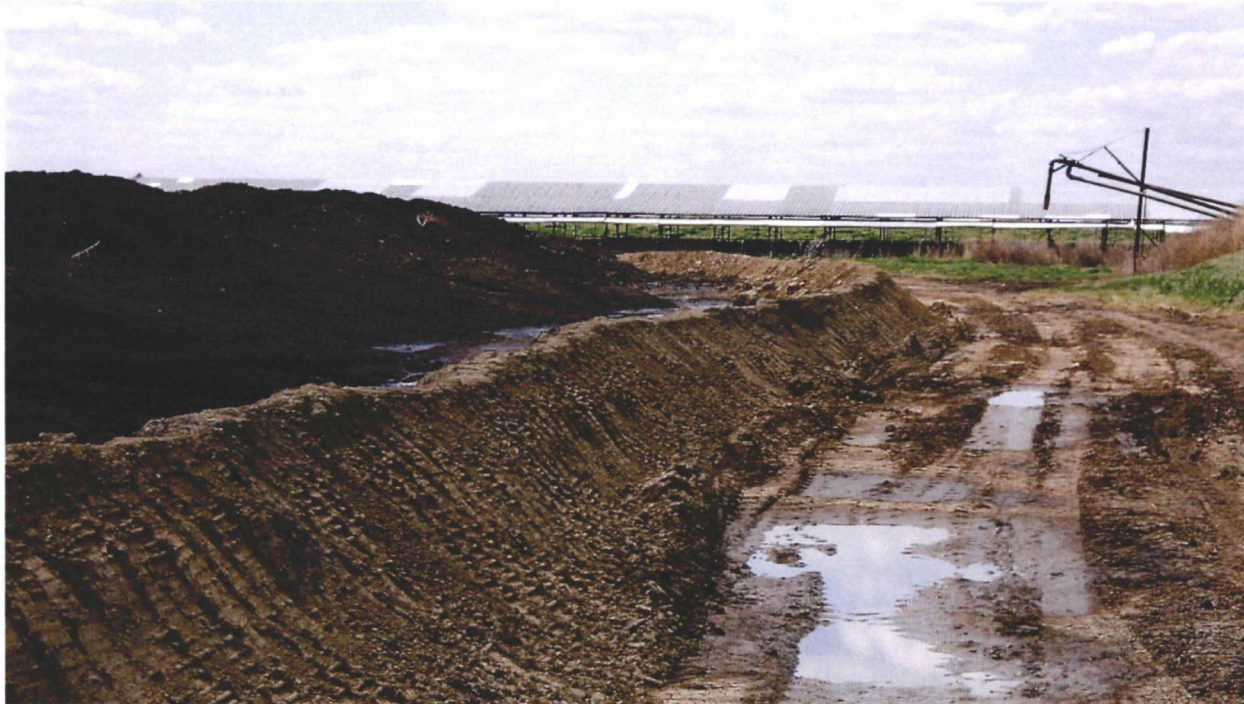
Photo: 13

Description: This photo depicts the west side of Area 6. The new berm is compacted and surrounds the wet cake pile. The water observed is believed to be residual rainwater from the recent rain event.

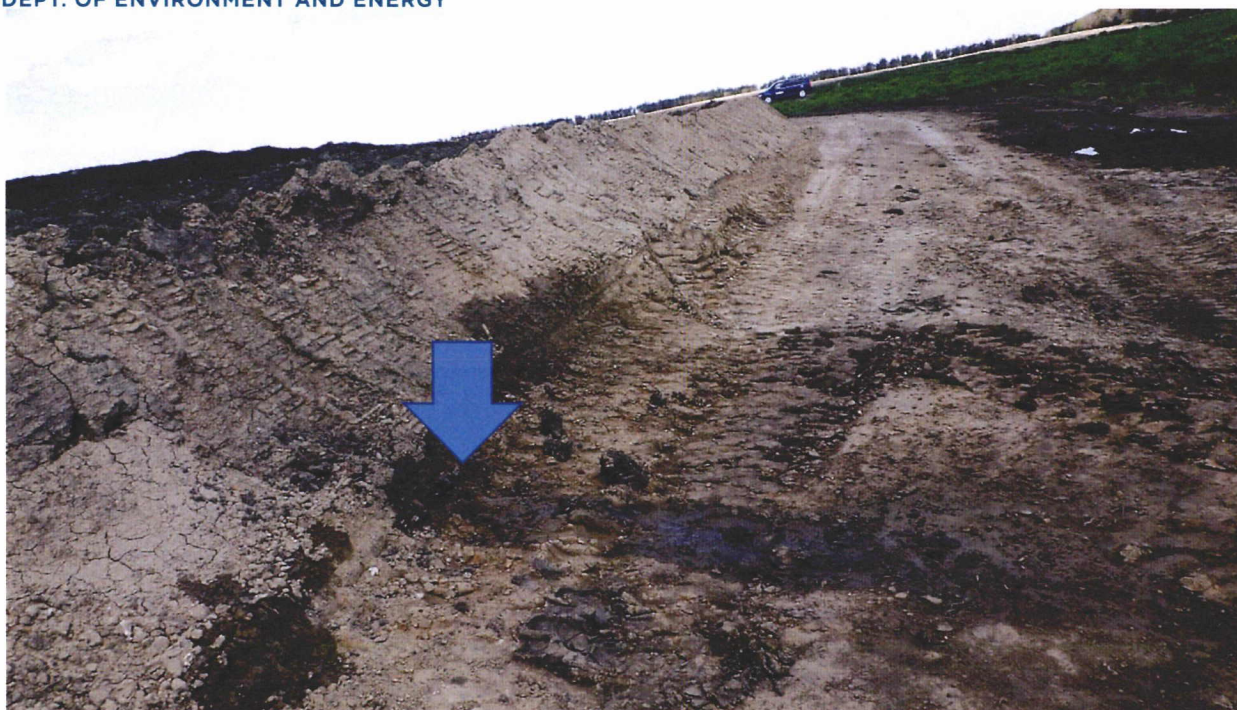
Photo: 15

Description: This photo depicts possible seepage on the east side of Area 6 (arrow).

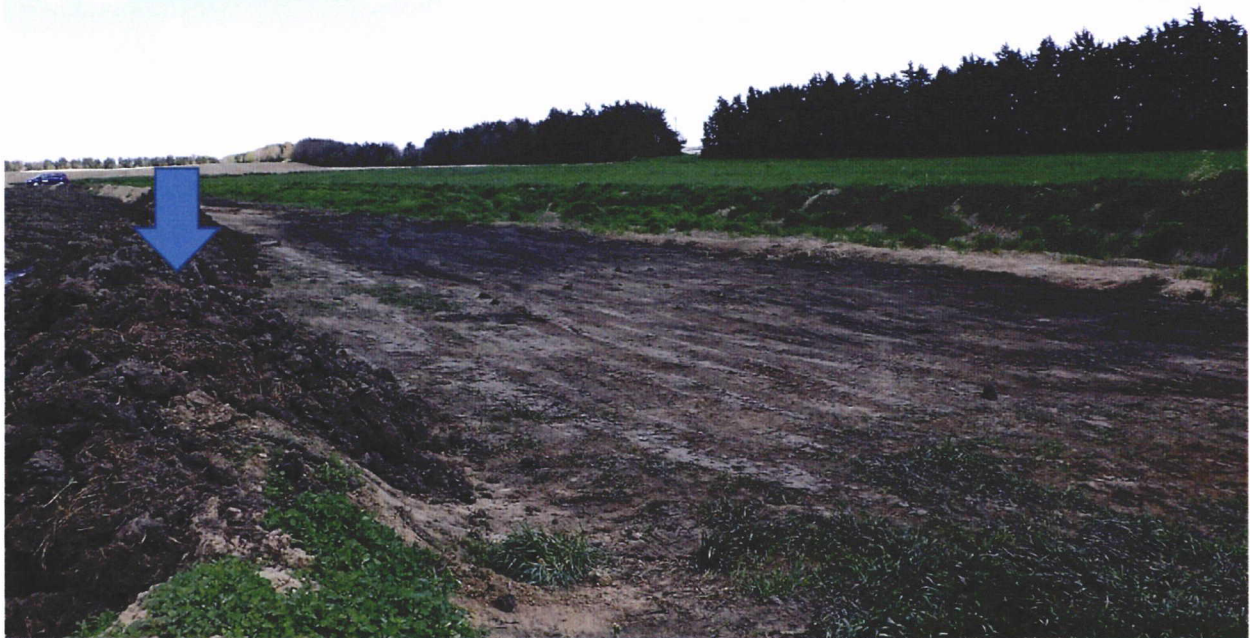
Photo: 16

Description: The facility has recently pumped out the secondary berm. The facility then added the material to reinforce the primary berm (arrow). There is some residual moisture observed. Clean Harbors stated that the area is in process of drying out.

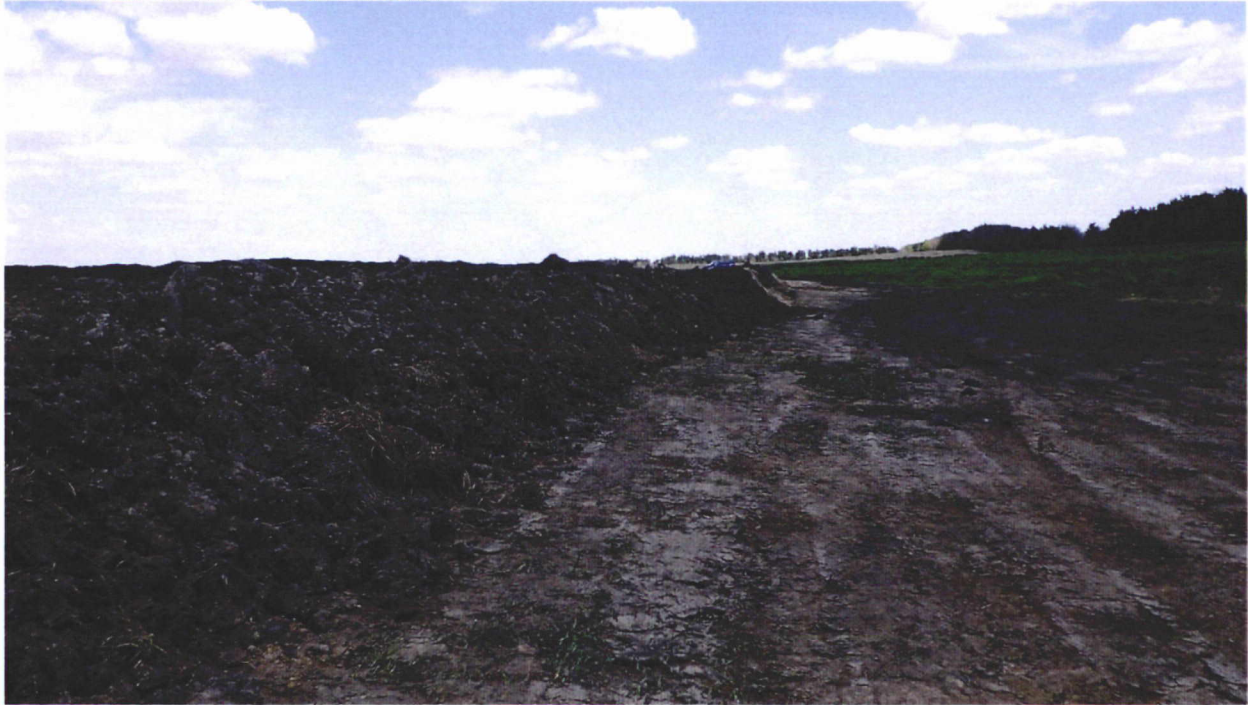
Photo: 17

Description: This photo depicts the southern part of the Area 6 berm. The berm is above six feet in height.

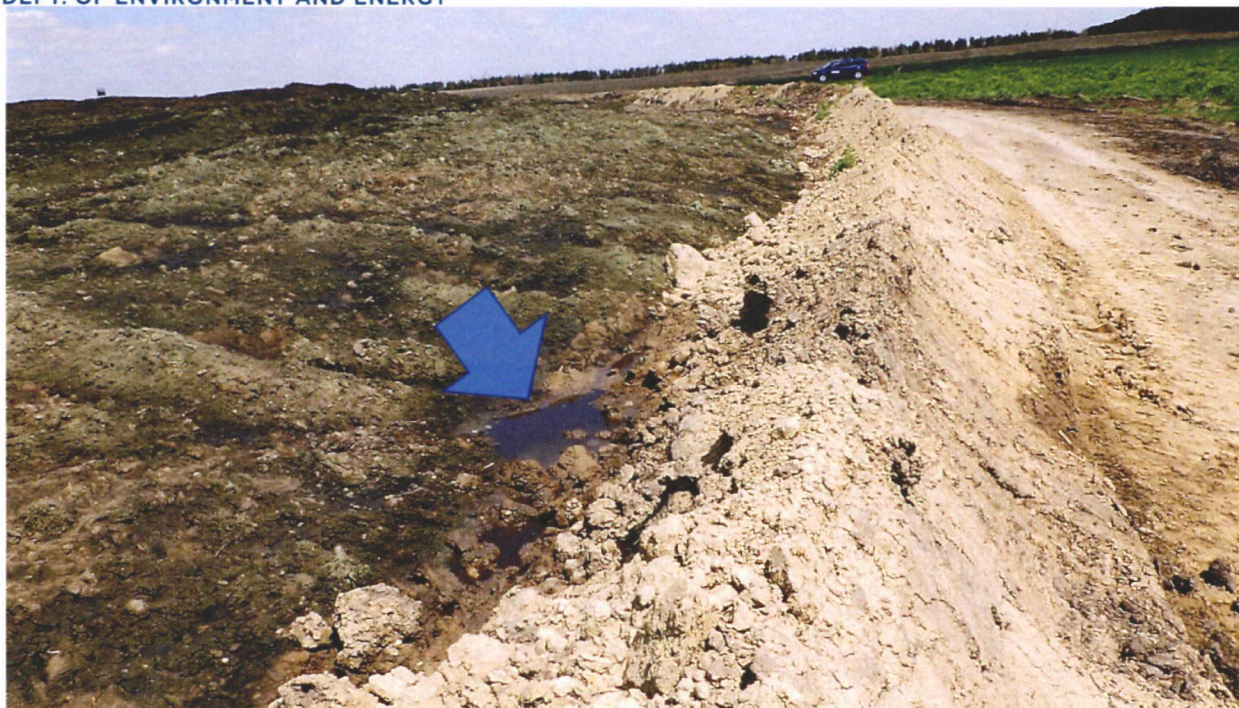
Photo: 18

Description: This photo depicts that wet cake is pushing up against the berm. The berm is compacted on the outside but appears to still have possible seepage.

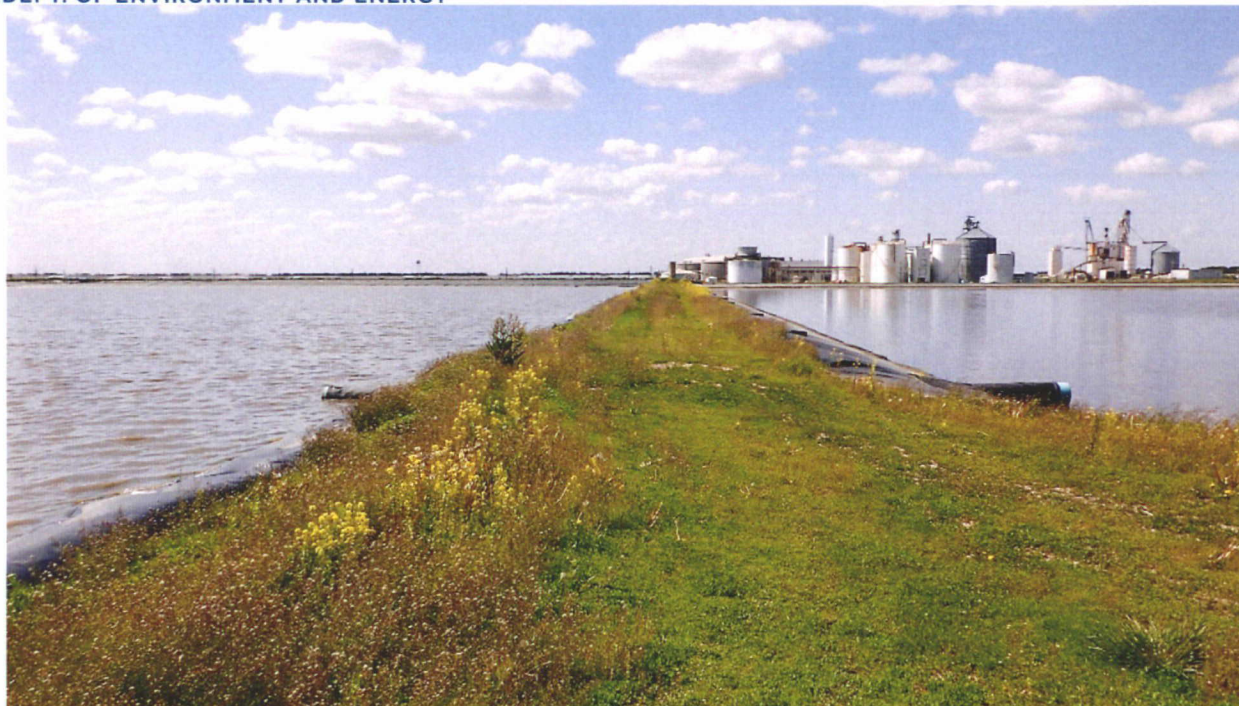
Photo: 20

Description: This photo depicts that the lagoons are continuing to lower.

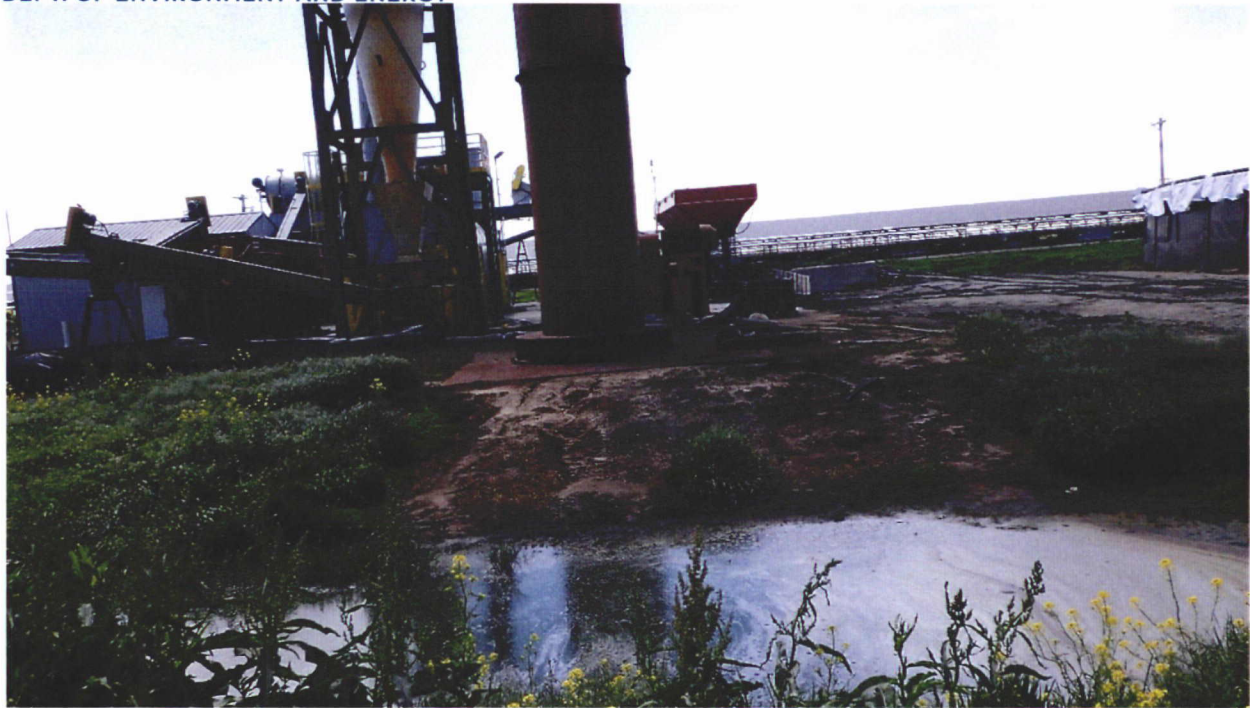
Photo: 23

Description: This photo depicts dead vegetation north of the biochar. The water in the forefront is contained.

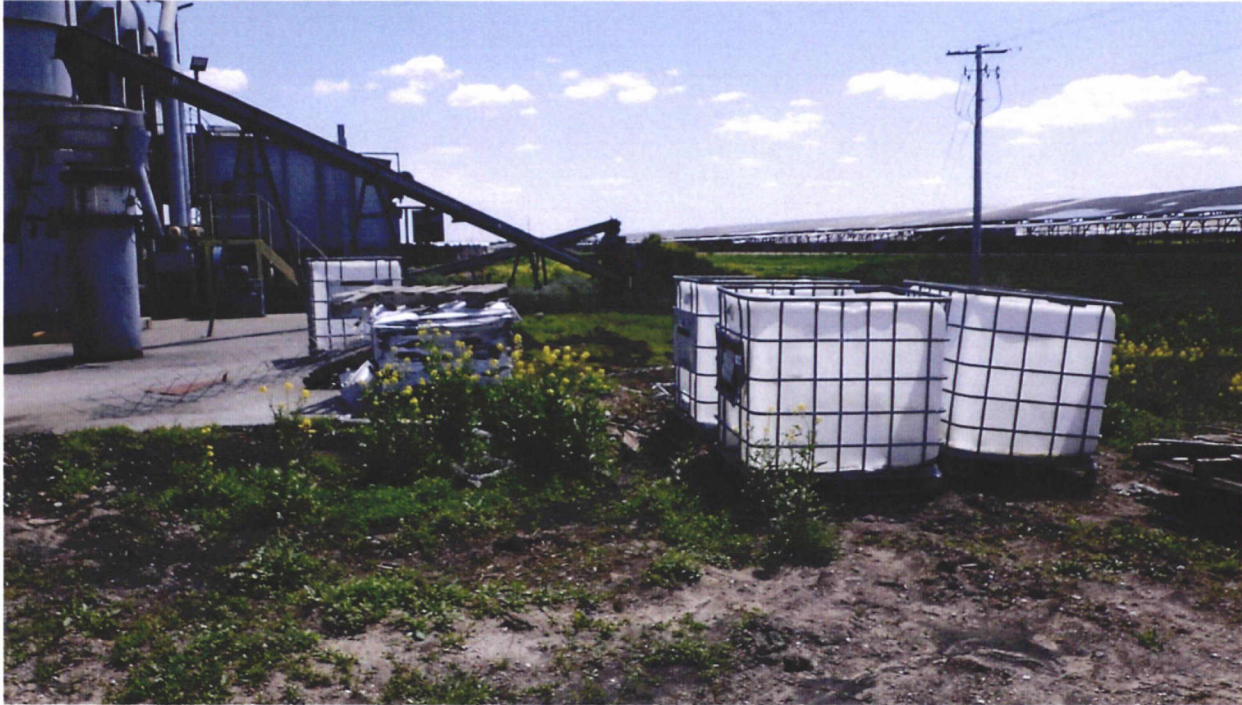
Photo: 24

Description: This photo depicts empty chemical totes, trash and debris on the south side of the Biochar unit.

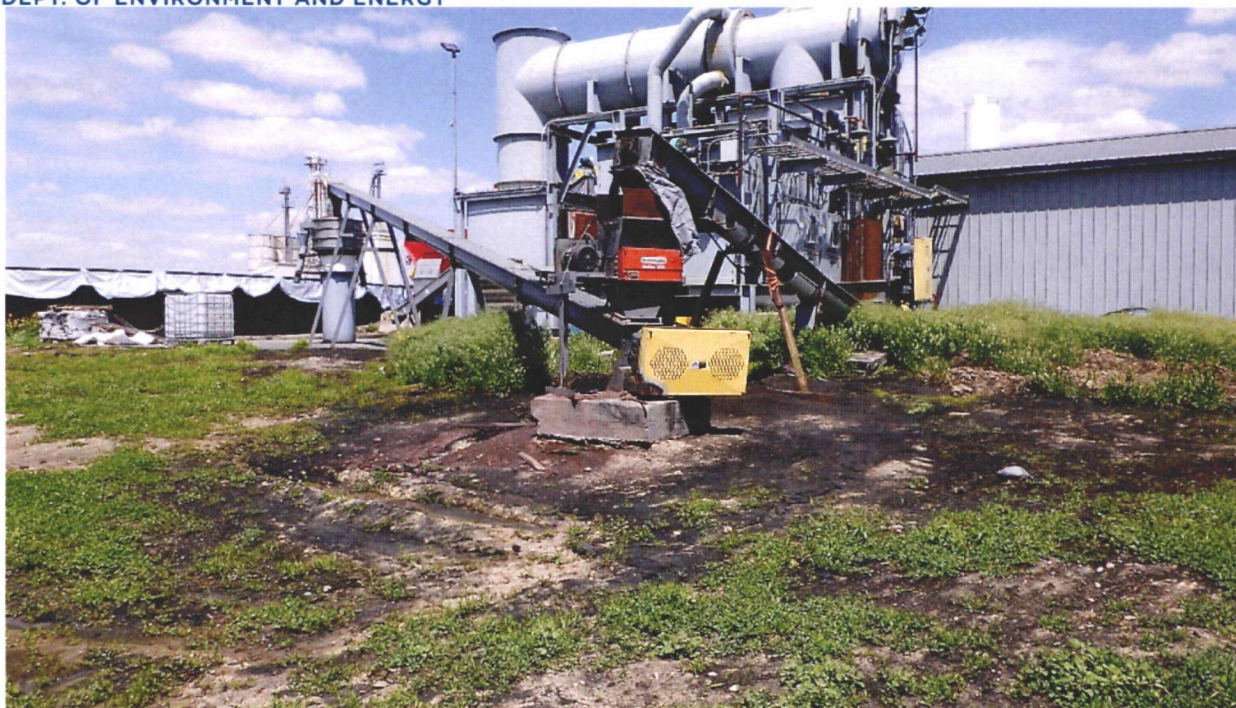
Photo: 25

Description: This photo depicts spilled biochar on the south side of the unit.

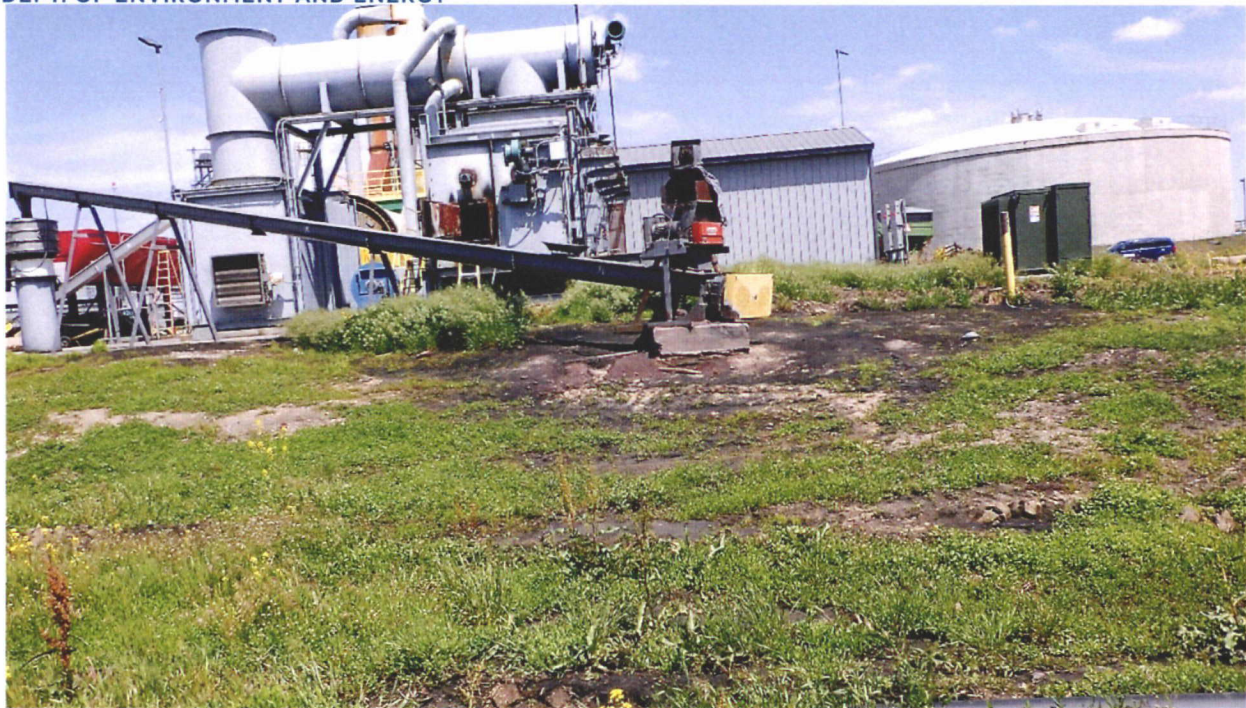
Photo: 26

Description: This photo depicts spilled biochar. I observed biochar near the silt fence depicted in the next photo.

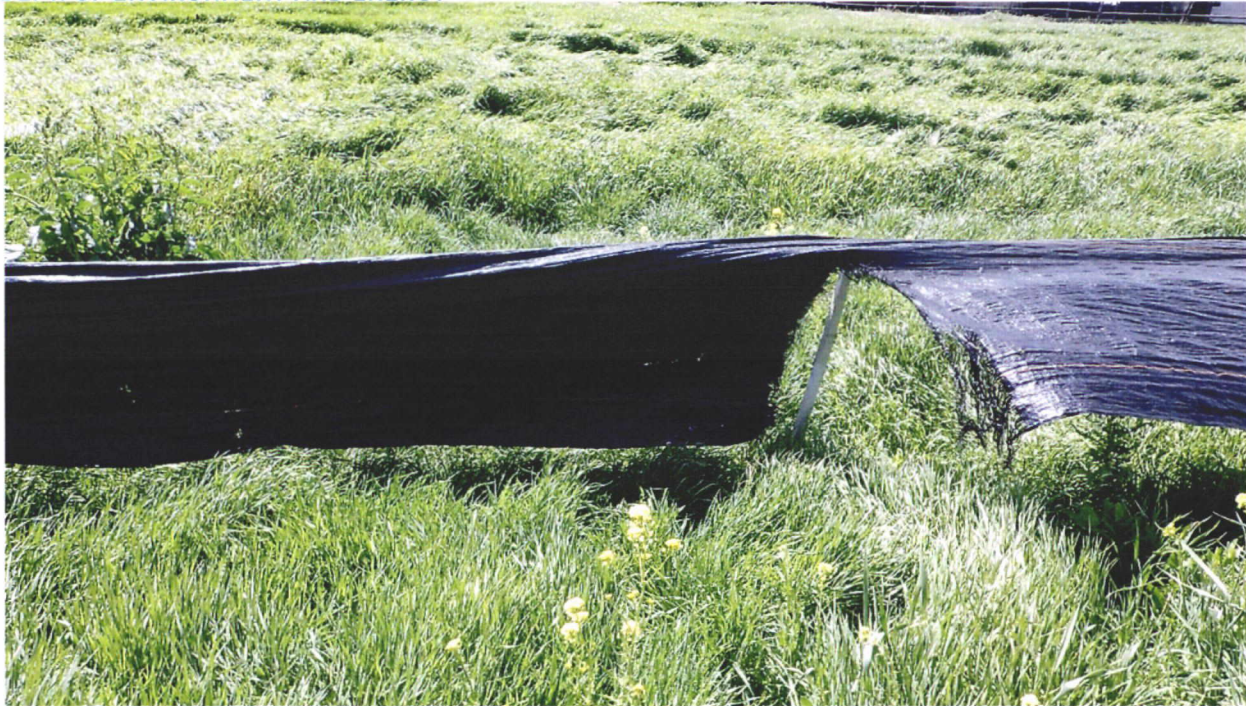
Photo: 27

Description: This photo depicts the silt fence used as a storm water control. The silt fence is not knifed in or controlling runoff.

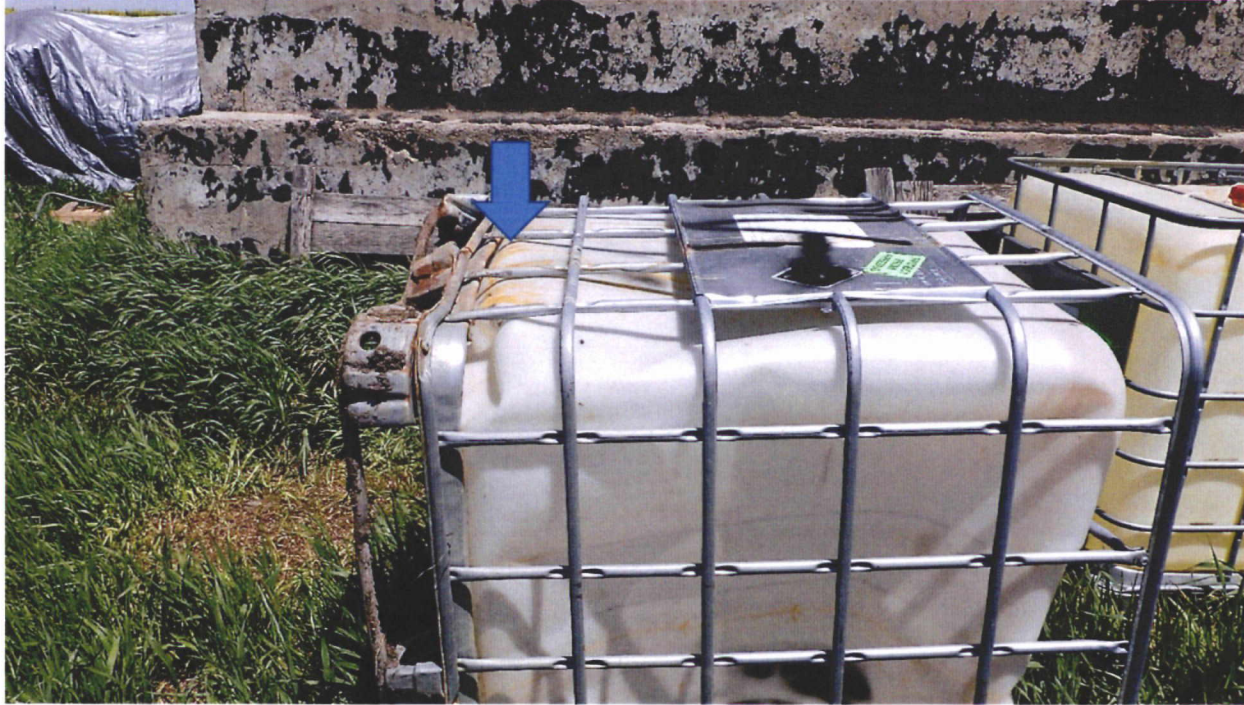
Photo: 28

Description: This photo depicts residual chemical on an empty chemical tote.

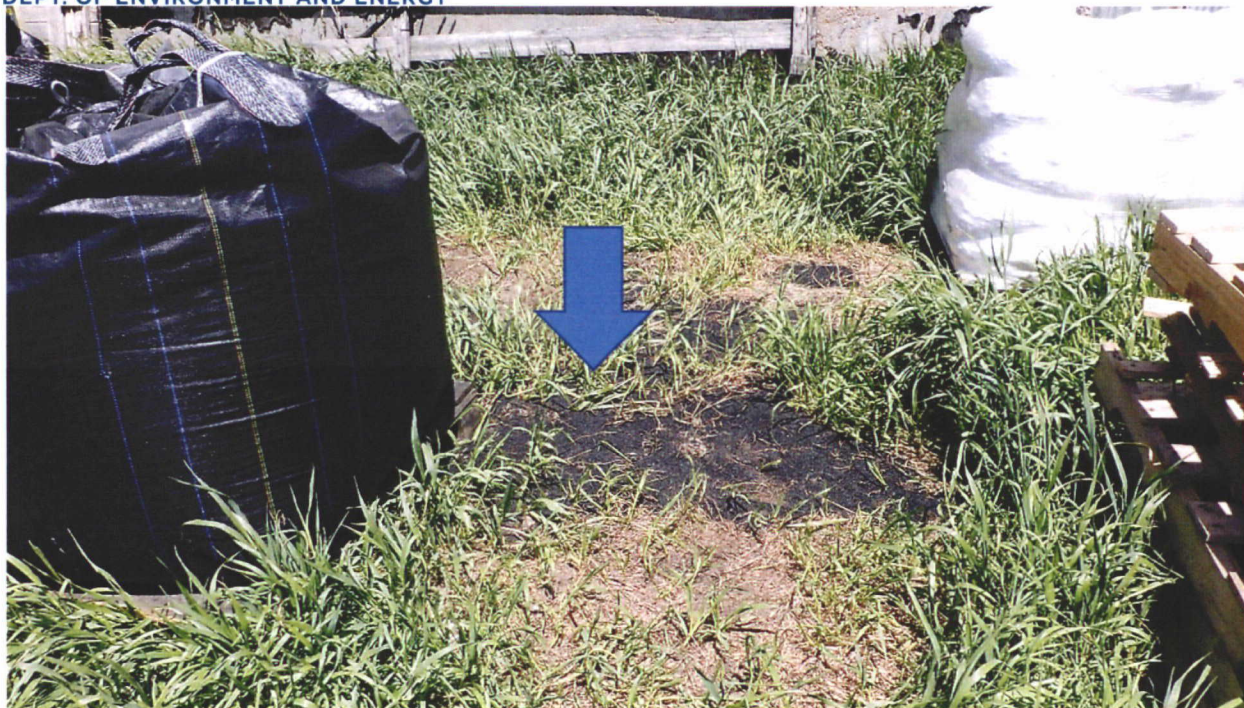
Photo: 29

Description: This photo depicts spilled dry chemical.

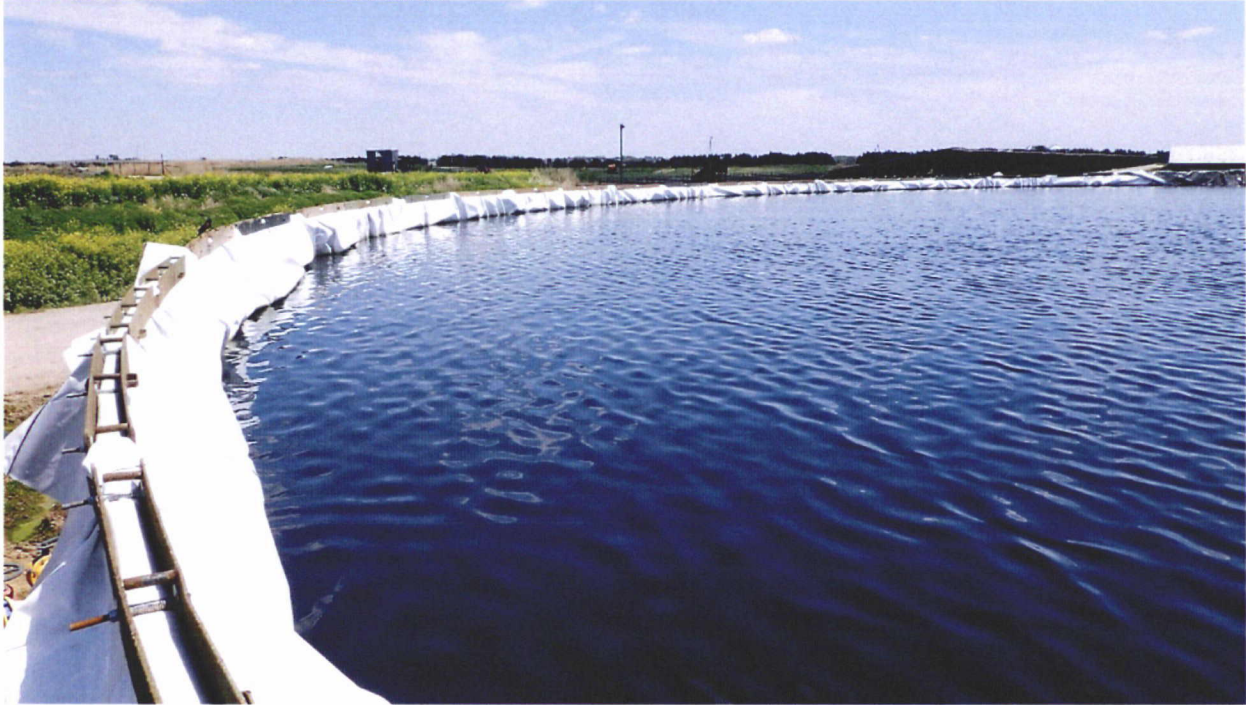
Photo: 30

Description: The east Poseidon tank is near capacity.

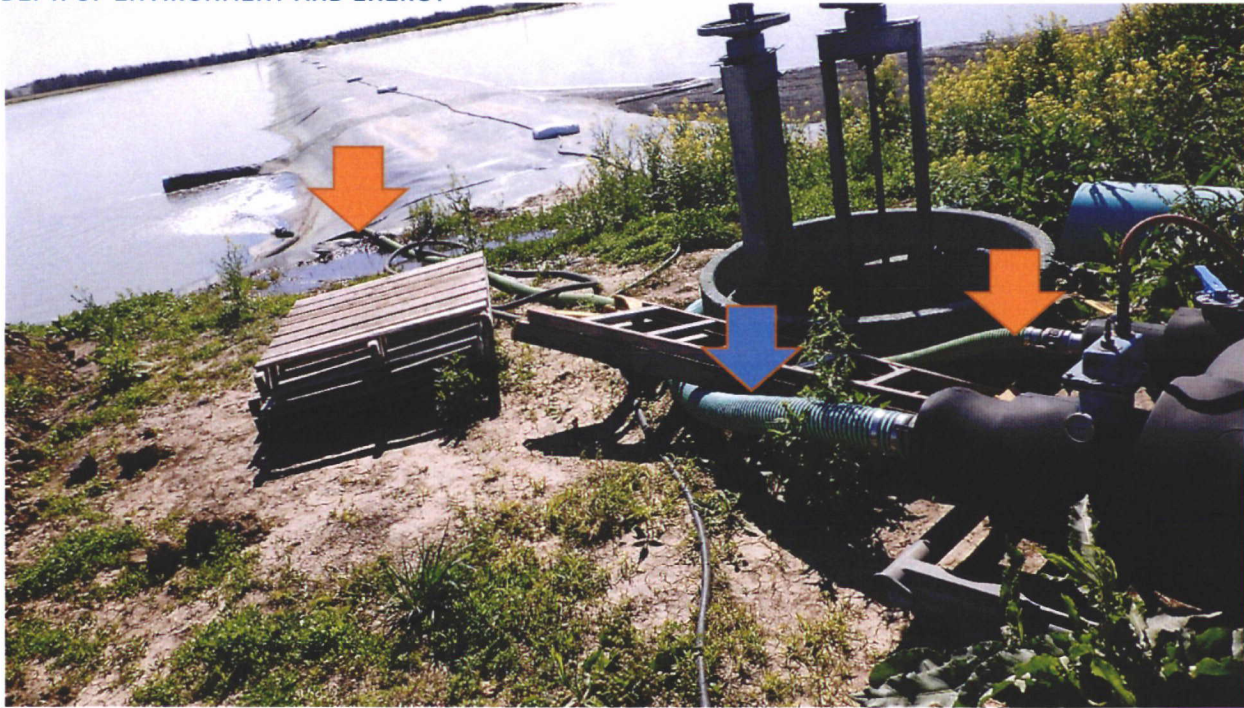
Photo: 34

Description: This photo depicts a discharge into the northeast lagoon. After investigation the line depicted here (orange arrow) is a recirculation hose. Mr. O'Brien stated that this hose is just allowing some water back into the lagoon to help with pressure. Mr. O'Brien confirmed that the line is not pumping from the emergency lagoon. The larger hose (blue arrow) is pumping from the south lagoon.
