Facility: AltEn, LLC

5/17/2021

## Site Visit Check list

## Inspection and Assistance Exit Summary

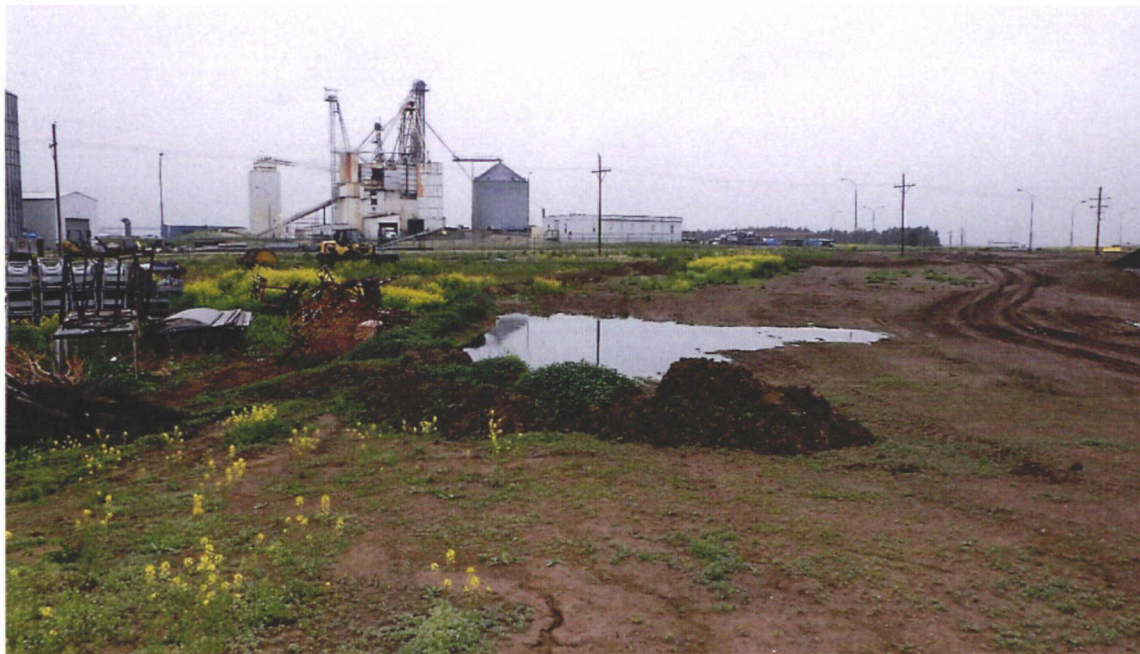
Photo: 1

Description: This is the original east berm. There is minor water accumulation but no seepage observed.

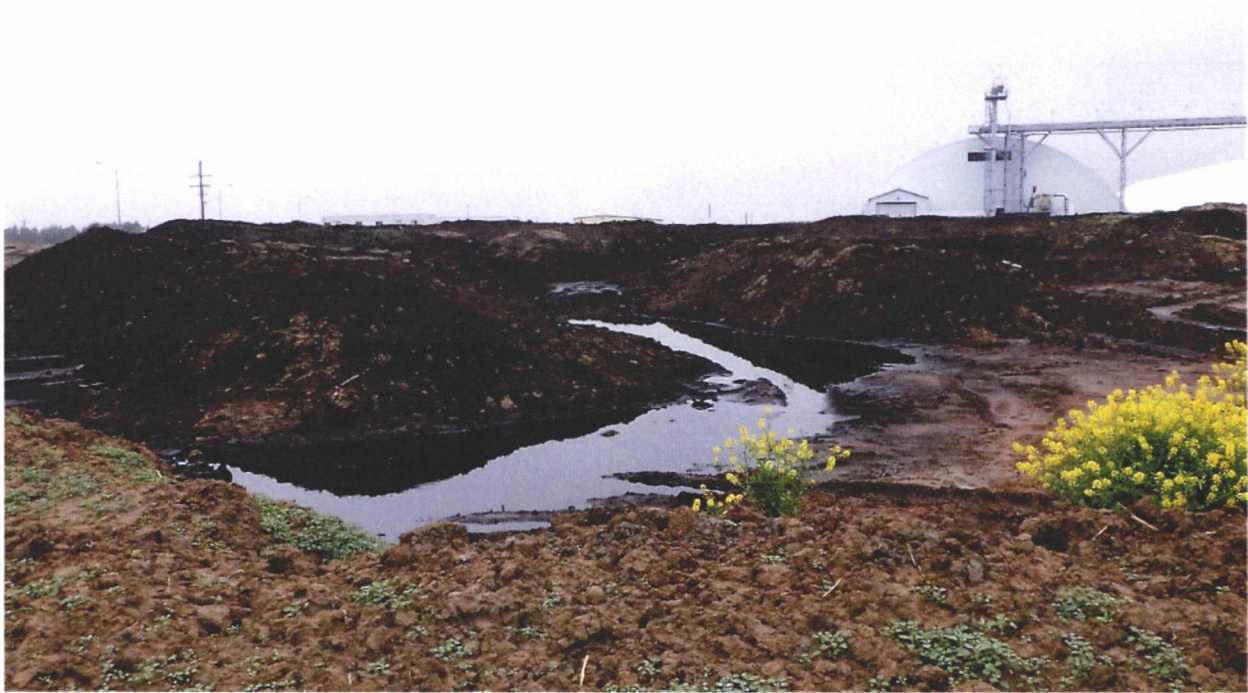
Photo: 2

Description: This is the west berm. There is minor water accumulation and depicted here. There are no signs of seepage.

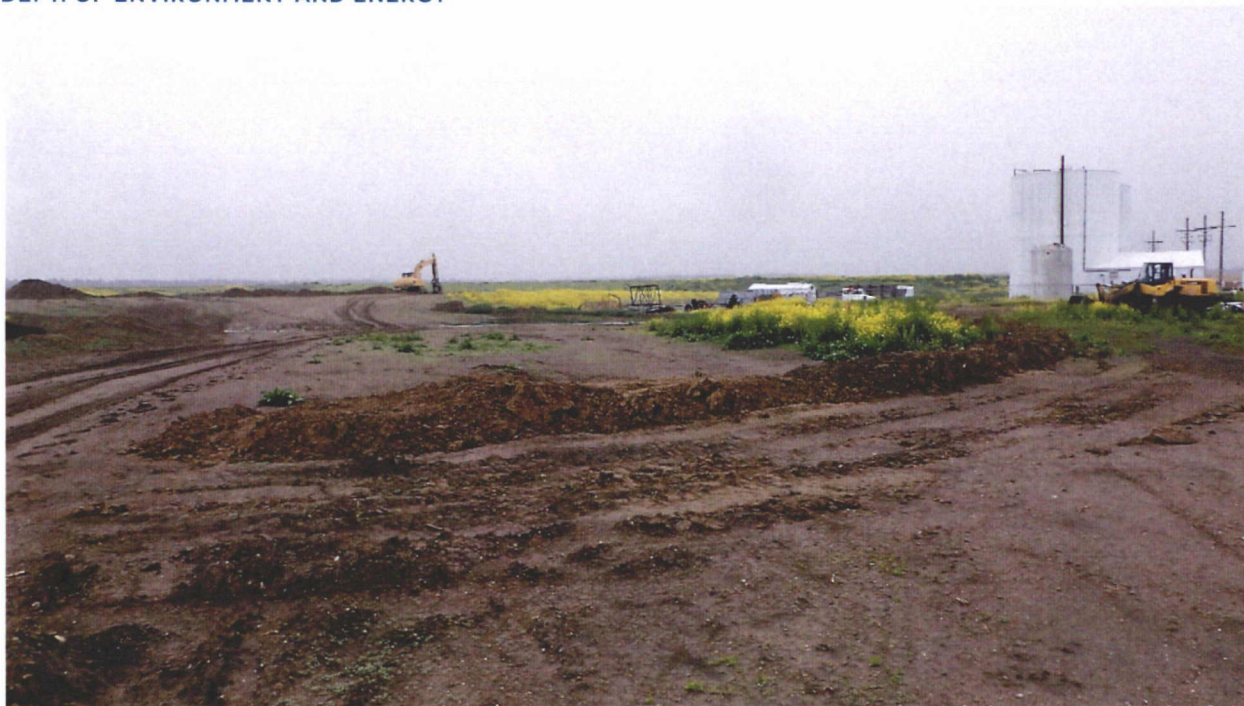
Photo: 3

Description: This is the south portion of the east berm. This J hook shaped berm is designed to prevent parking lot water from entering the berm area.

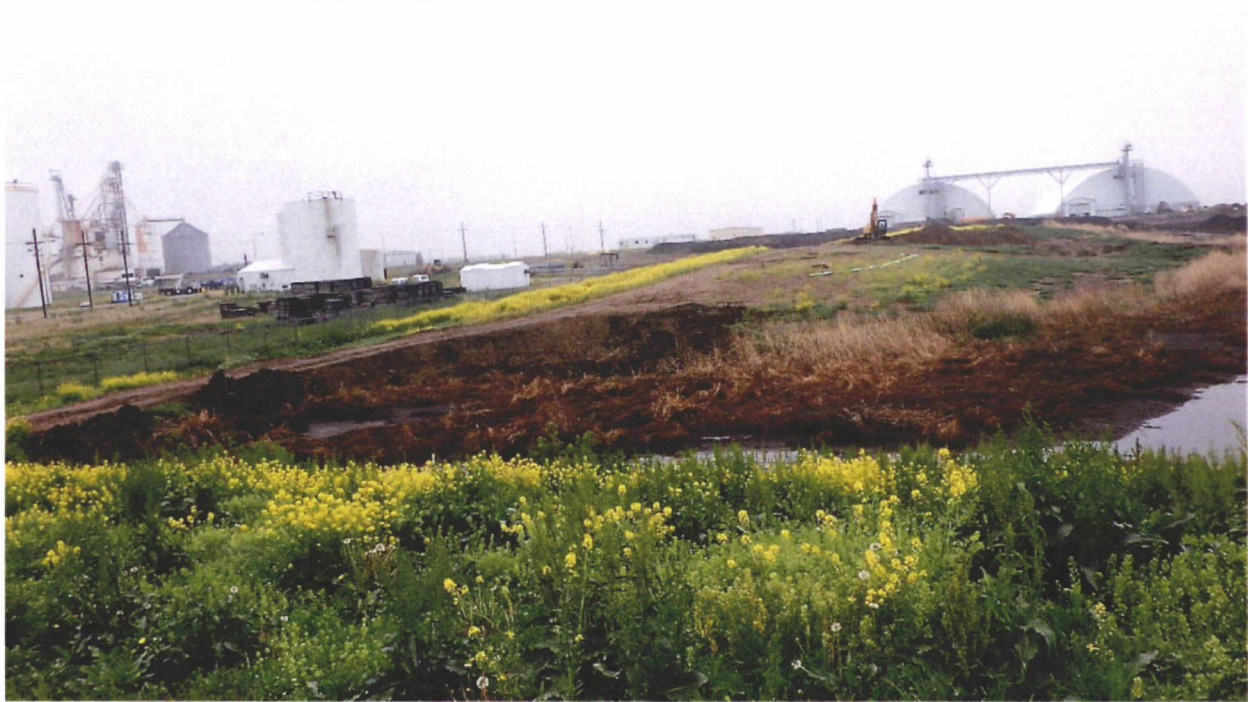
Photo: 4

Description: This photo depicts minor water accumulation.

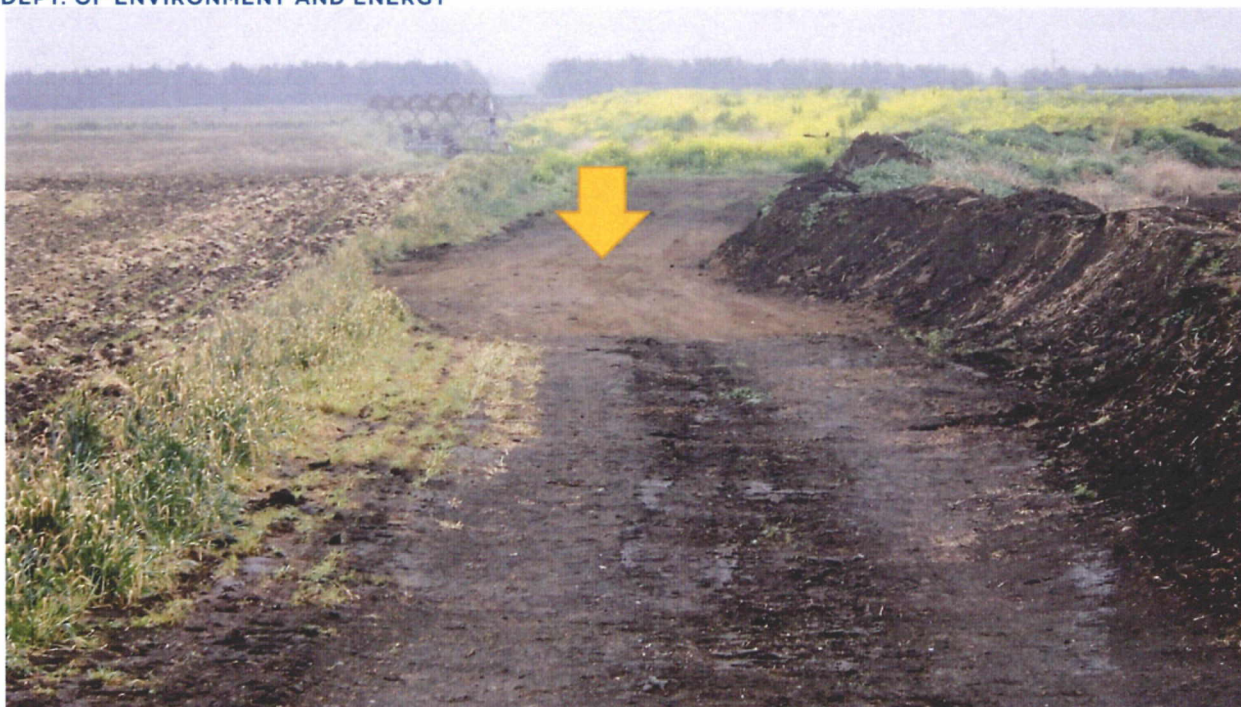
Photo: 5

Description: This photo depicts that Clean Harbors has added clay and leveled off a low area north of area 3 (arrow). Clean Harbors has also reinforced the north side of area 3.

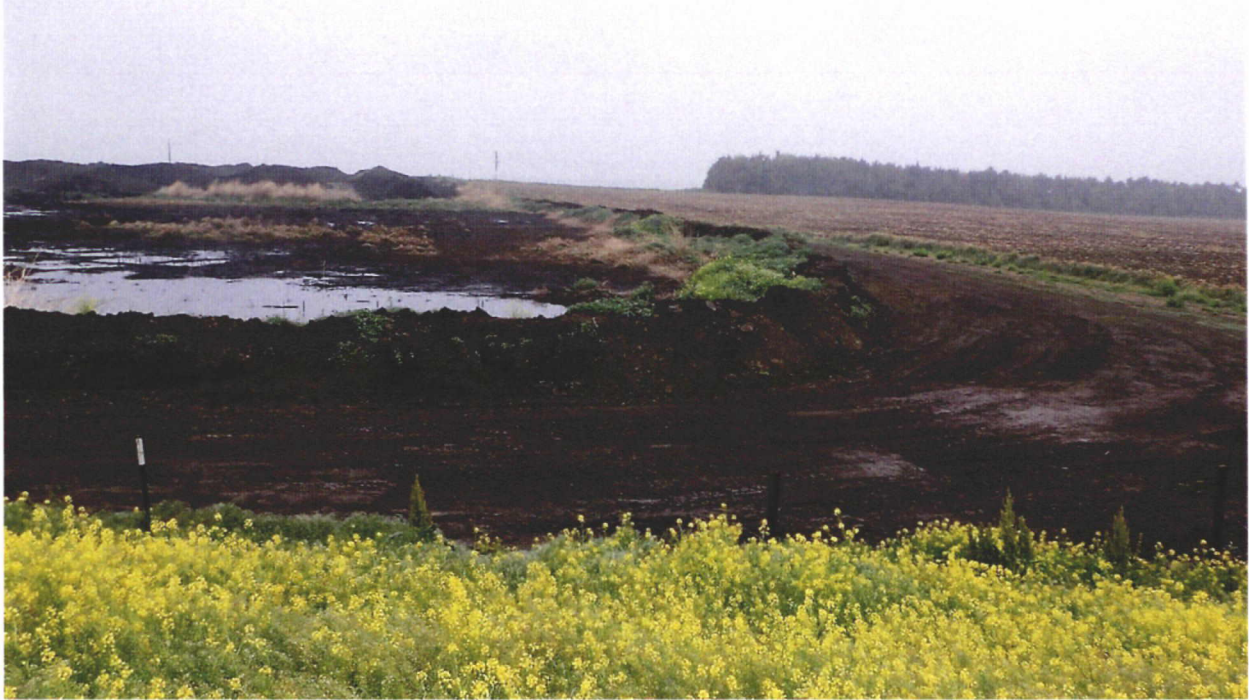
Photo: 6

Description: This photo depicts water accumulation behind area 3. Clean Harbors has reinforced the berm. There is no seepage observed.

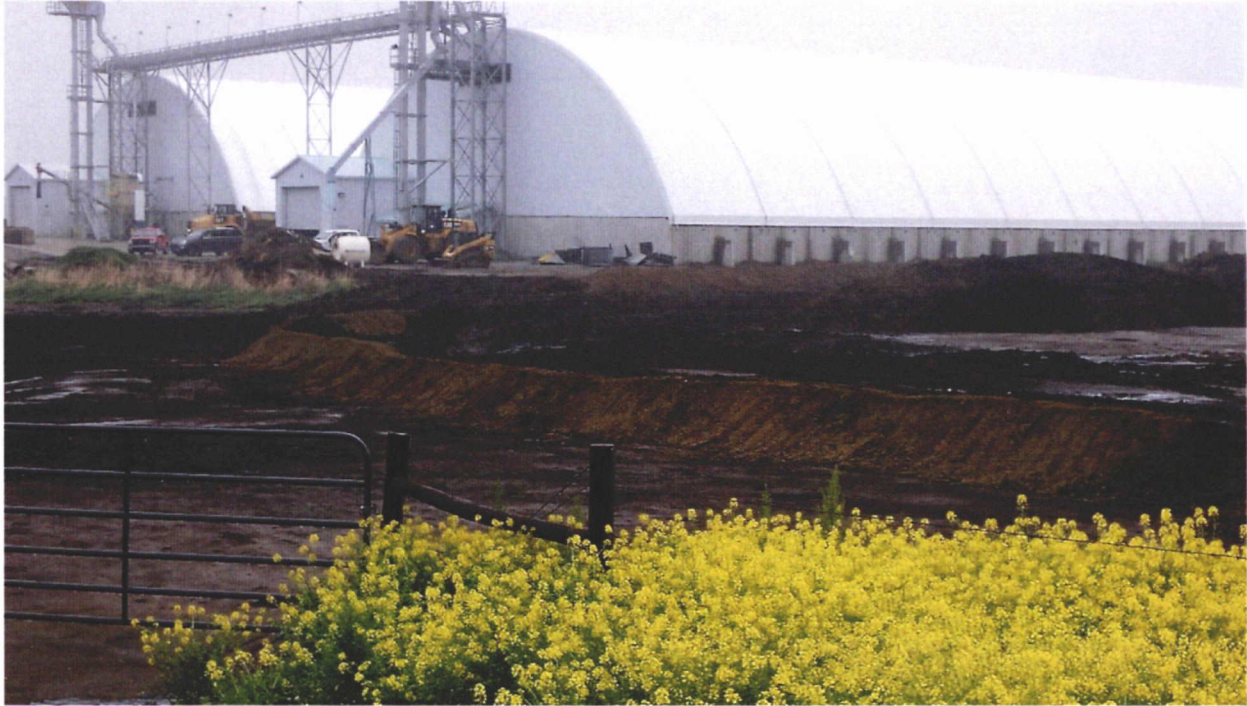
Photo: 7

Description: This photo depicts a newly constructed berm that connects area 3 and area 5.

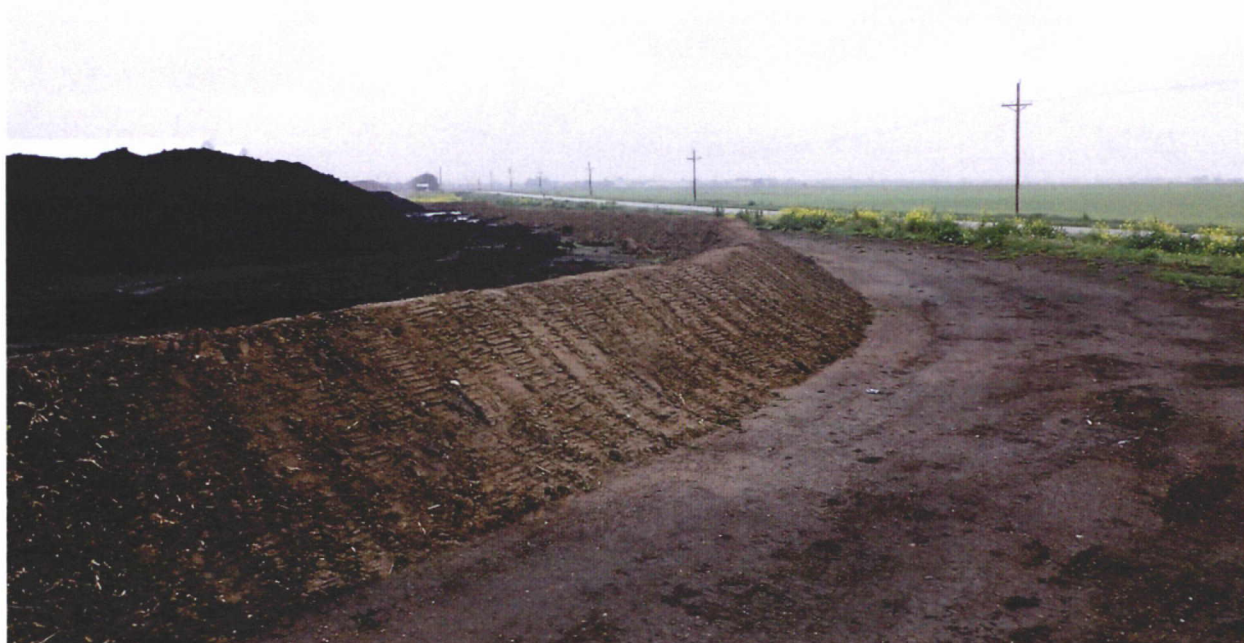
Photo: 9

Description: This photo depicts a newly constructed berm at area 4. There are no signs of seepage.

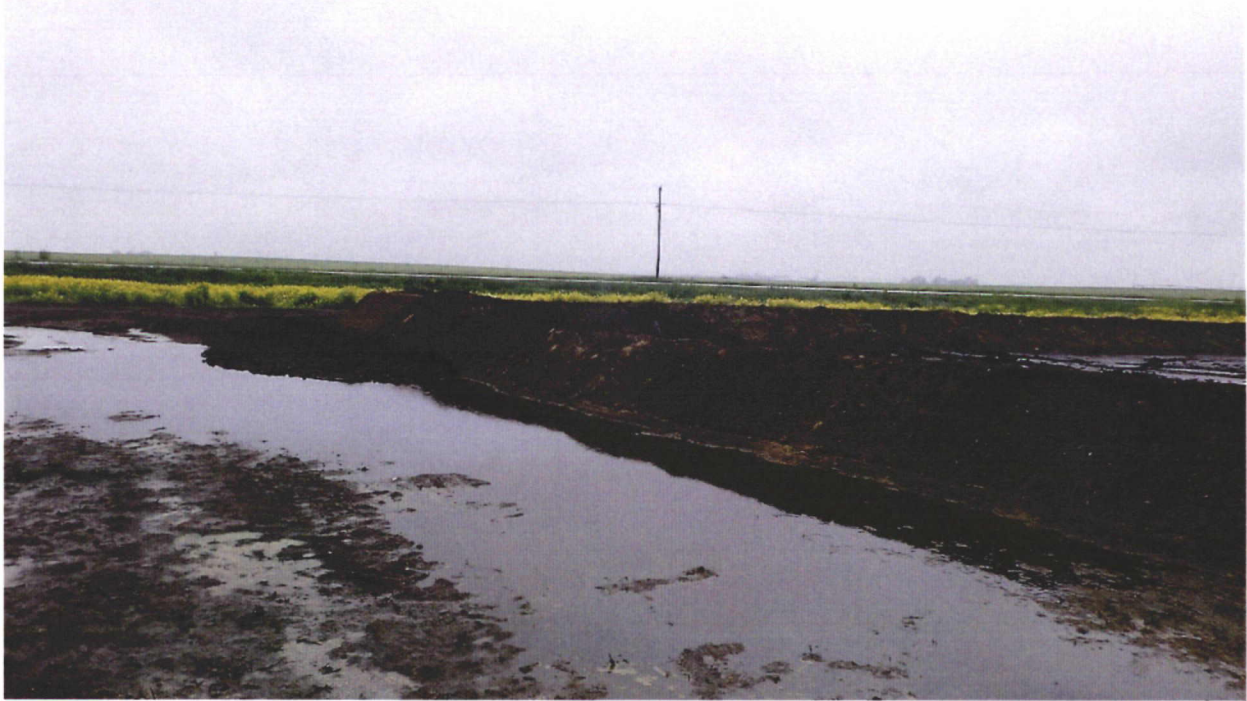
Photo: 10

Description: This photo depicts water accumulation from outside the berm. This water is not leaking from the berm but is runoff from northside of the hoop building depicted in photo 11.

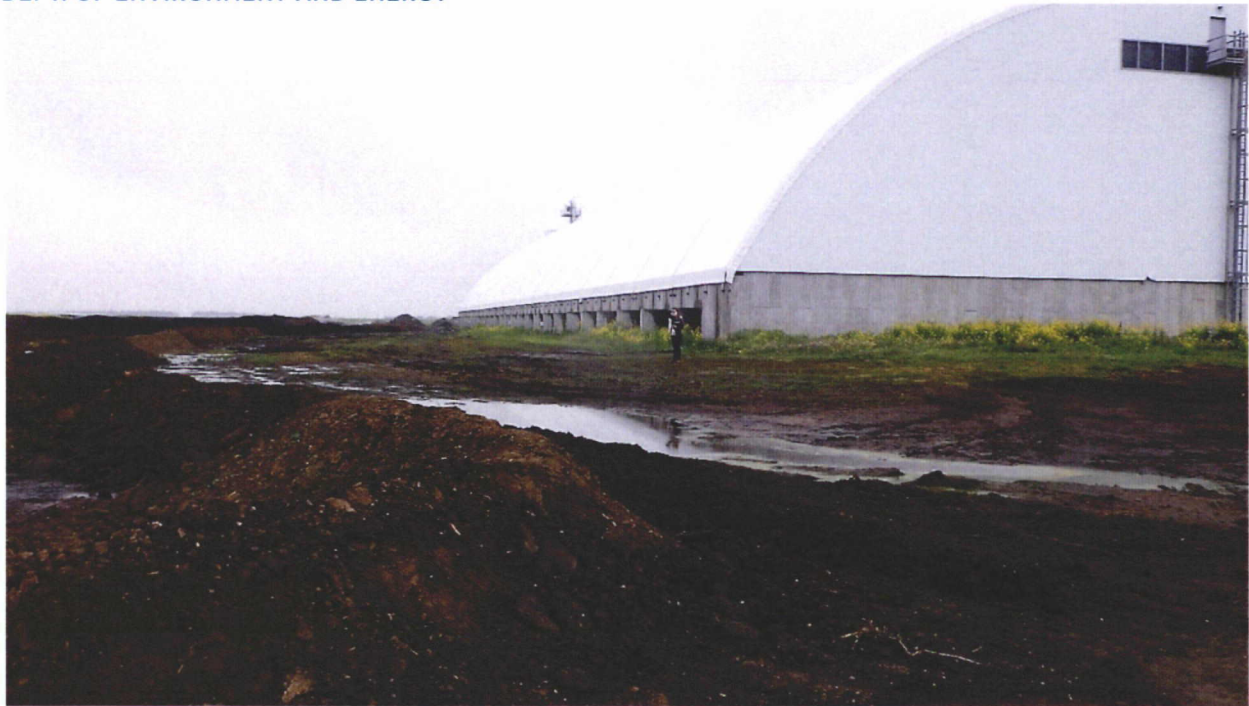
Photo: 11

Description: This photo depicts runoff water from outside the berm. The water in this area is from the north side of the hoop building.

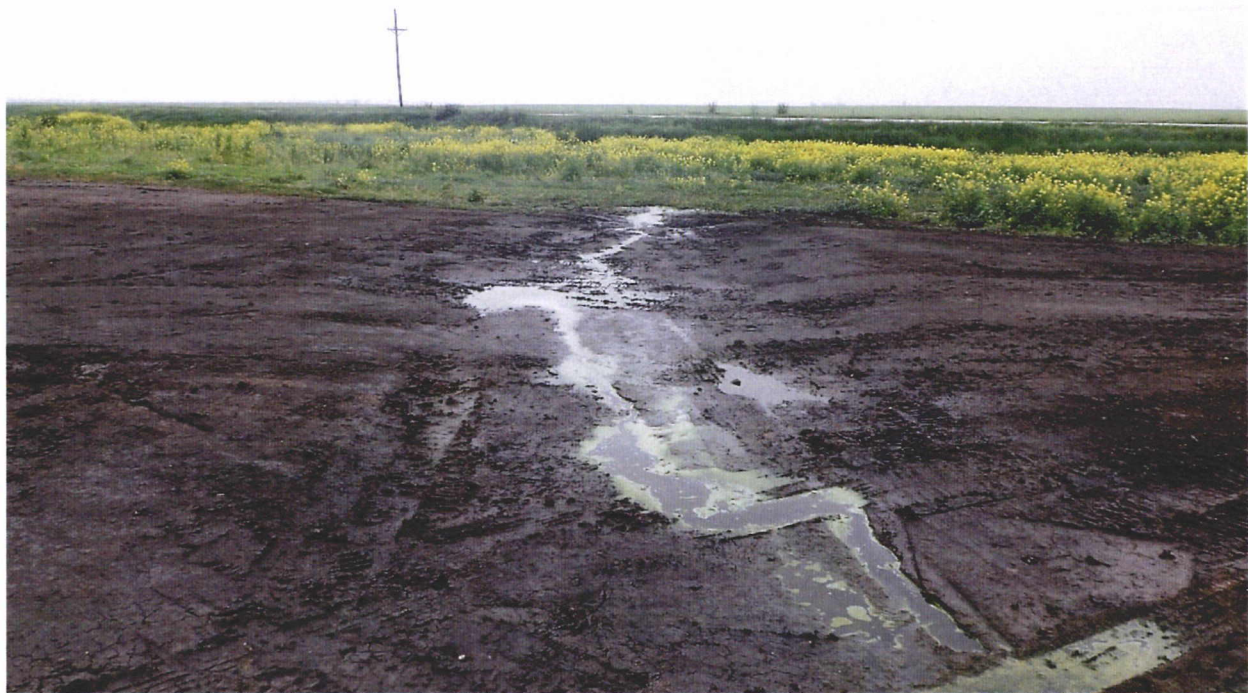
Photo: 12

Description: This photo depicts runoff from the accumulated water depicted in photos 10 and 11.

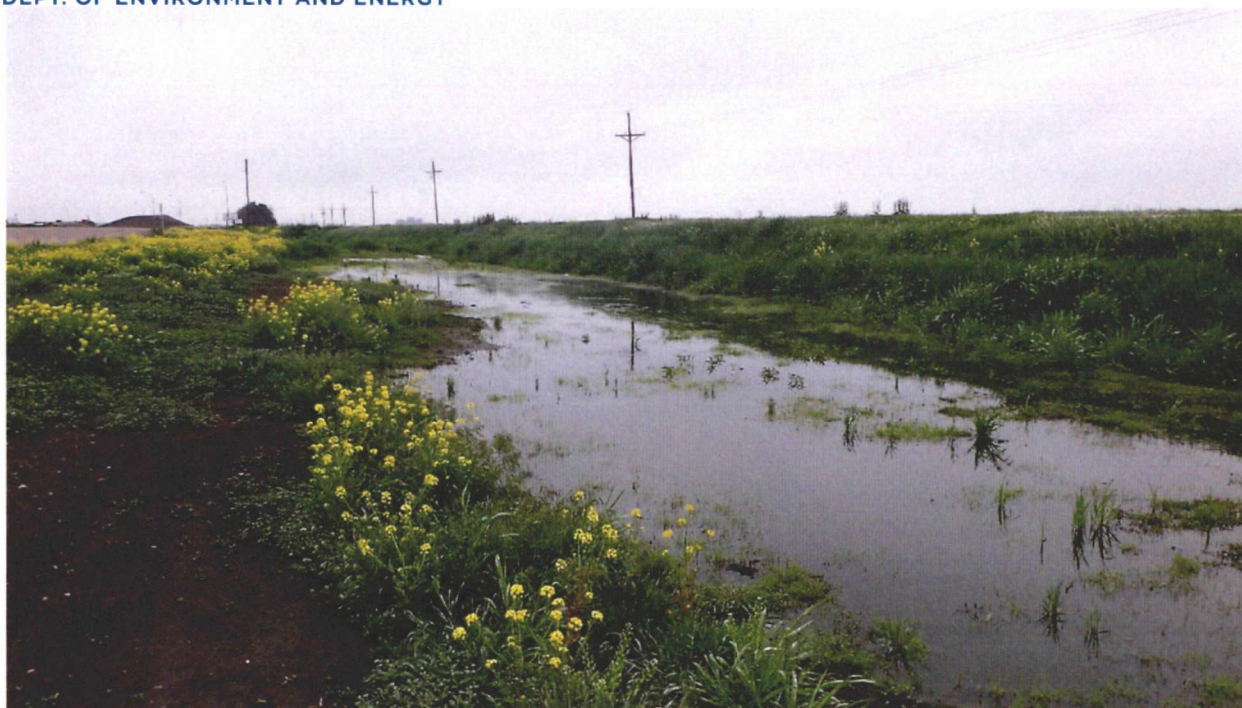
Photo: 13

Description: This photo depicts runoff from area 5. Water is accumulating in the west ditch. The ditch culvert drains south but does not drain.

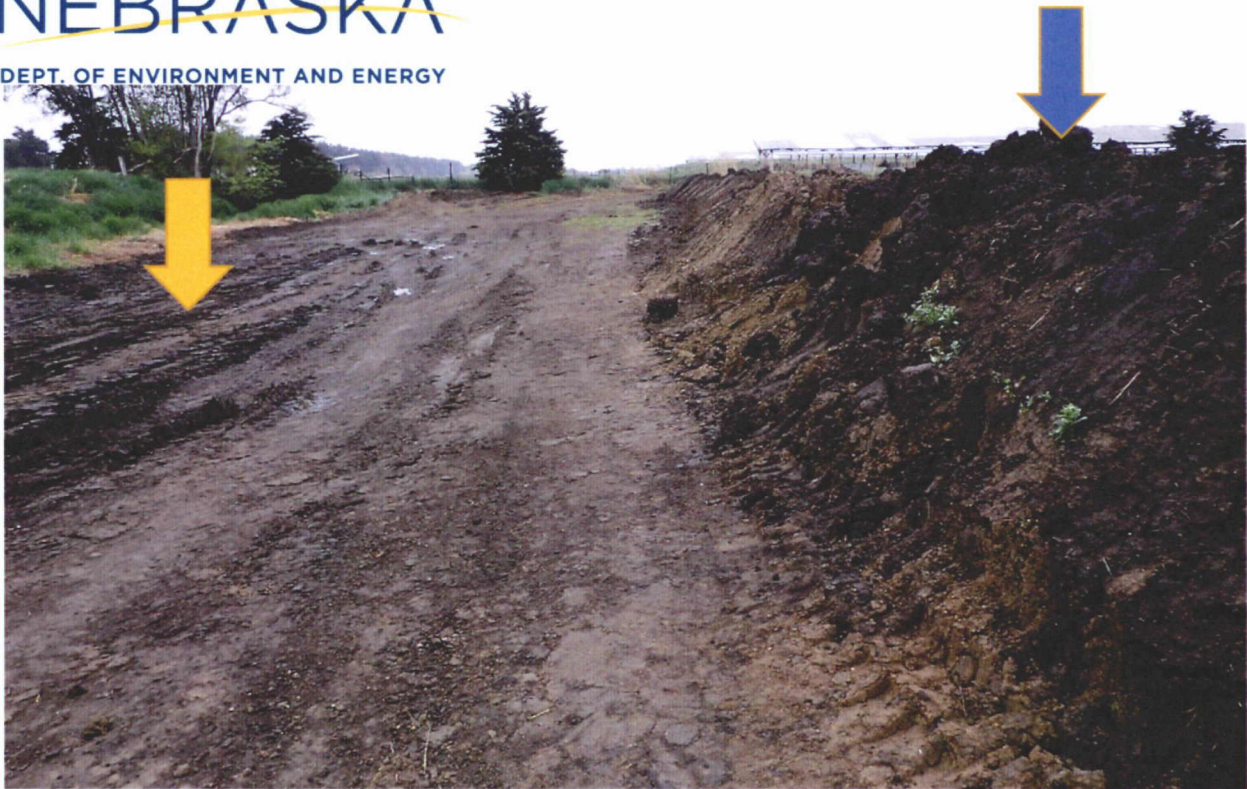
Photo: 14

Description: This photo depicts the berm on the east side of area 6. Clean Harbors has removed the secondary berm (yellow arrow). The primary berm has been reinforced (blue arrow)

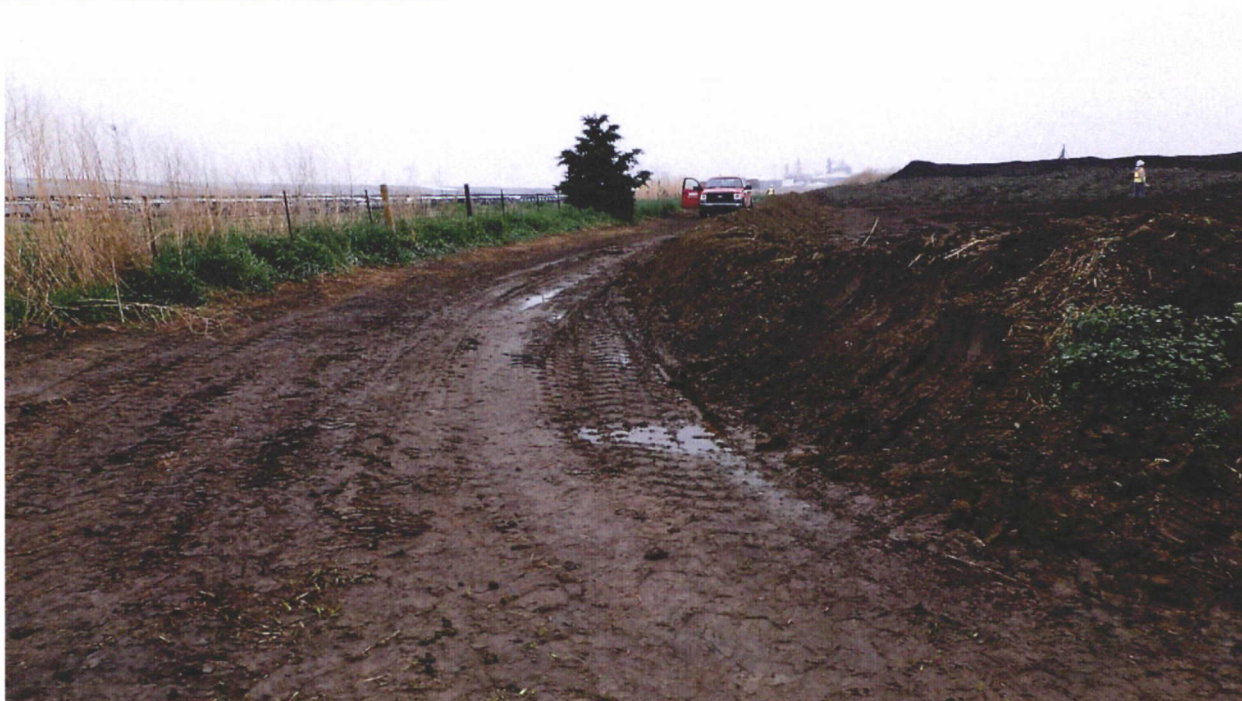
Photo: 15

Description: This photo depicts the south side of area 6. Clean Harbors has removed the south portion of the berm. The berm now surrounds the south side. Area 6 can be driven around for inspection.

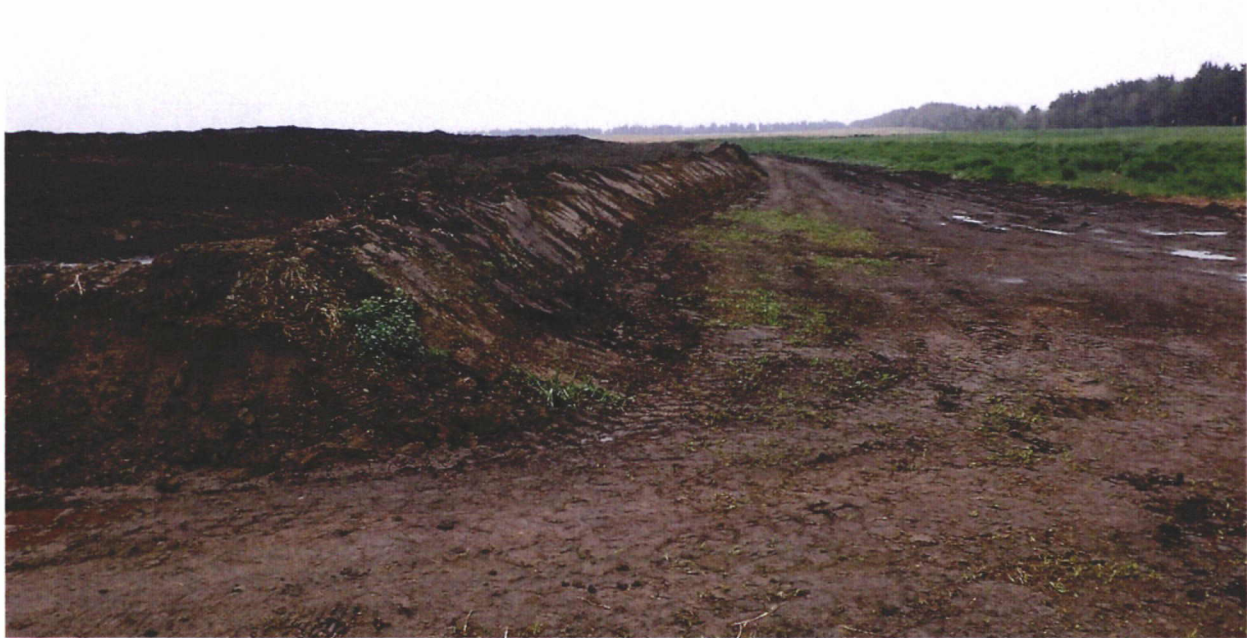
Photo: 16

Description: This photo depicts the south side of area 6. This photo is from the same position as photo 15 just looking north. Clean Harbors has reinforced the berm since the previous site visit. There are no signs of seepage.

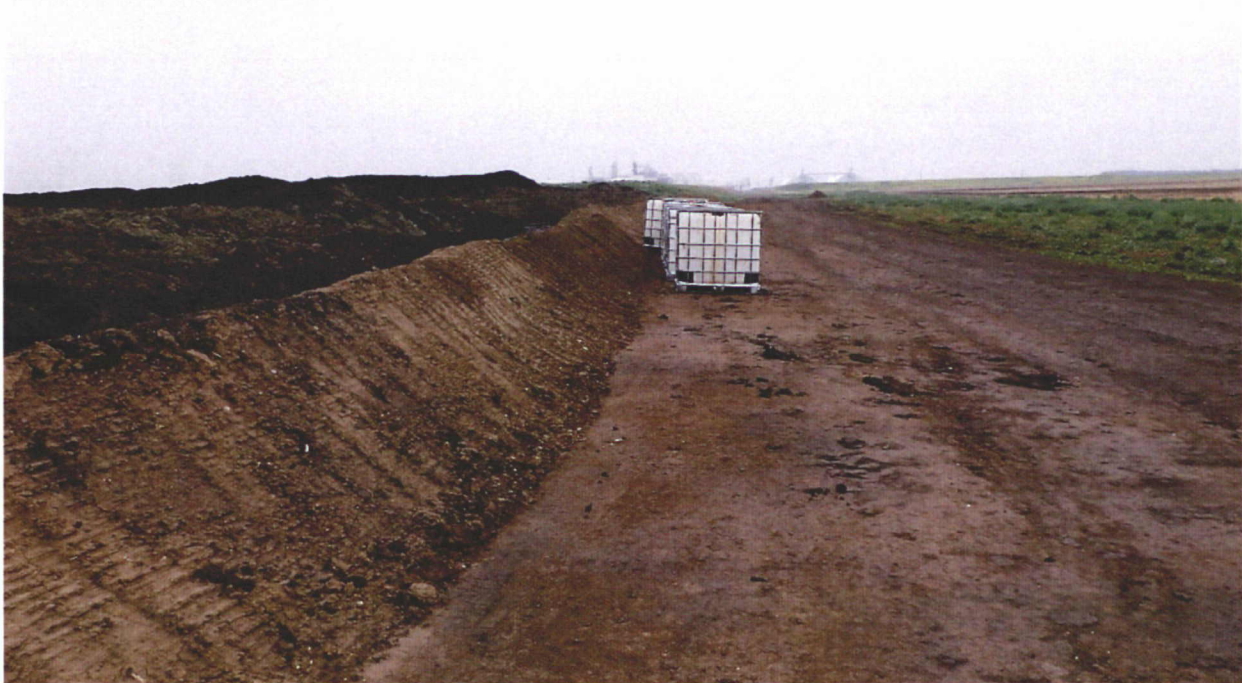
Photo: 17

Description: This photo depicts the north side of area 6. The berm is compacted on the outside. The totes are used to transfer water when needed.

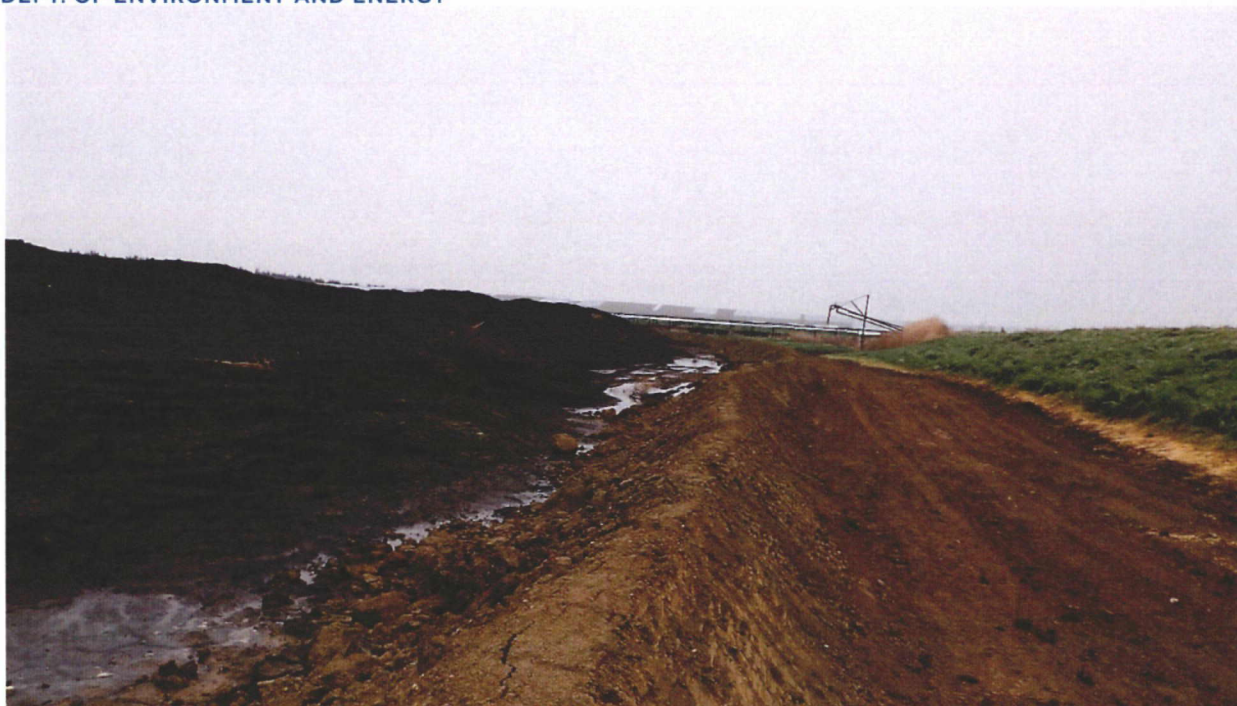
Photo: 18

Description: This photo depicts the west side of area 6. This is the newest berm construction.

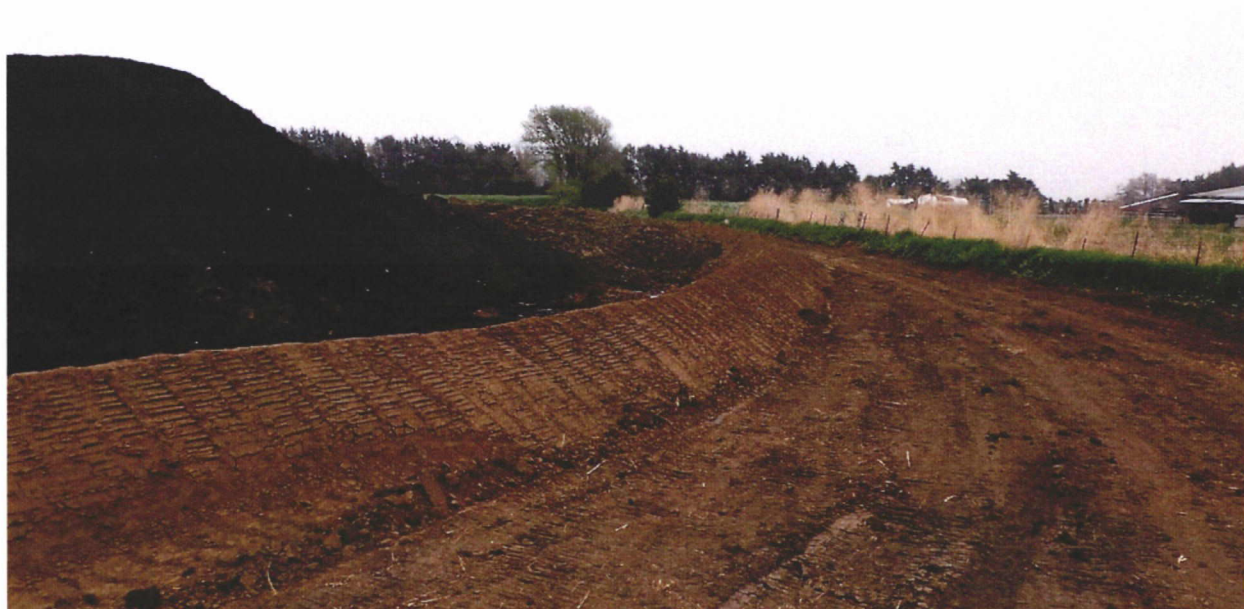
Photo: 19

Description: This photo depicts the southwest side of area 6. The berm is compacted on the outside.

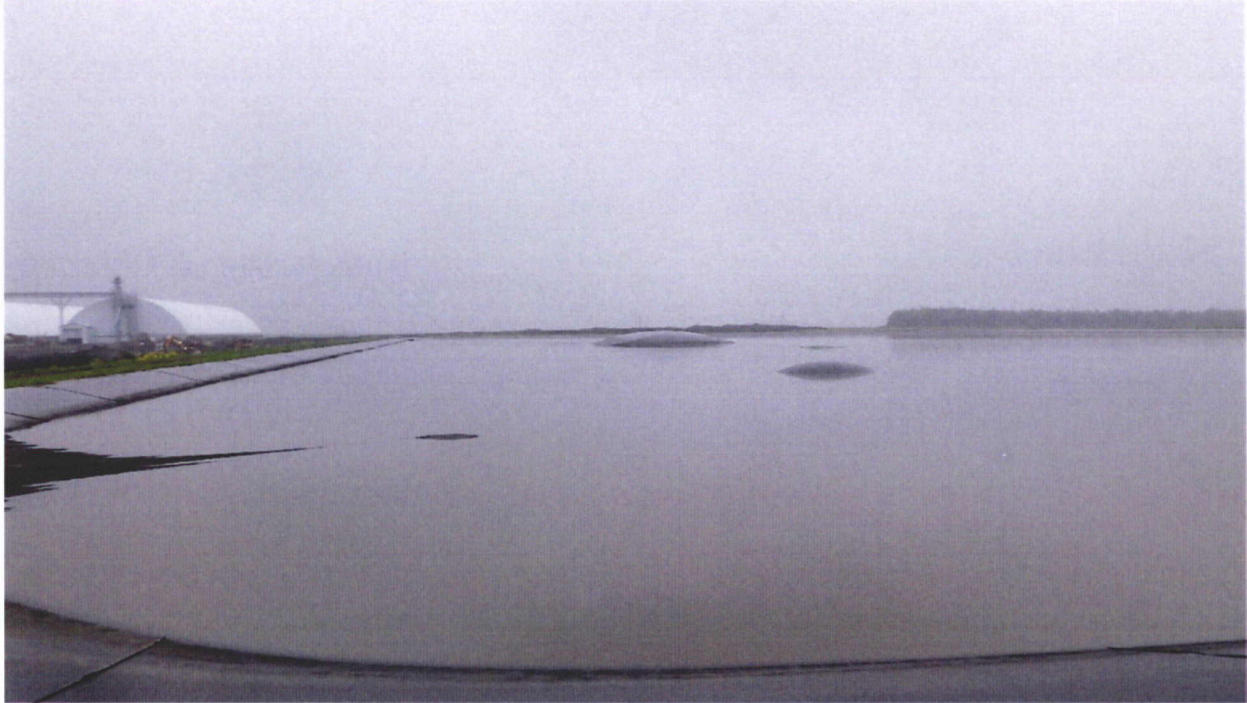
Photo: 20

Description: This photo depicts the northwest lagoon. Today there are multiple floating liners.

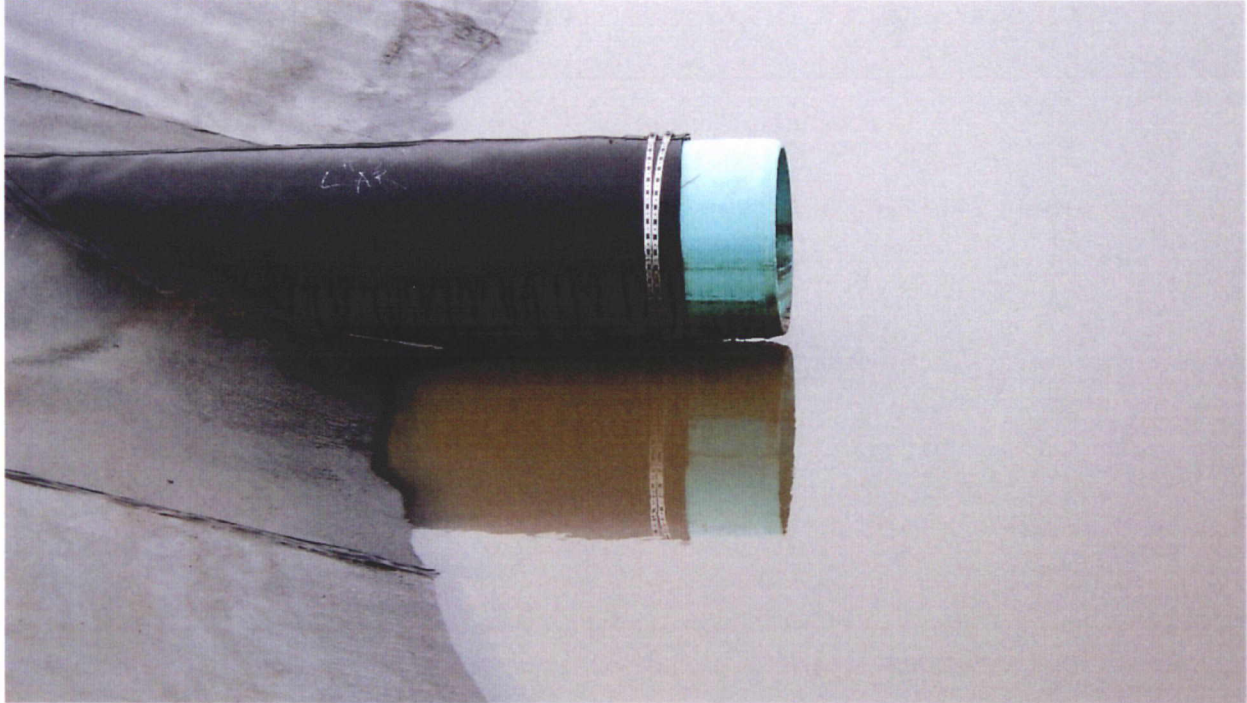
Photo: 22

Description: This photo depicts the equalization pipe between the northwest and northeast lagoon. The water level is now below the pipe.

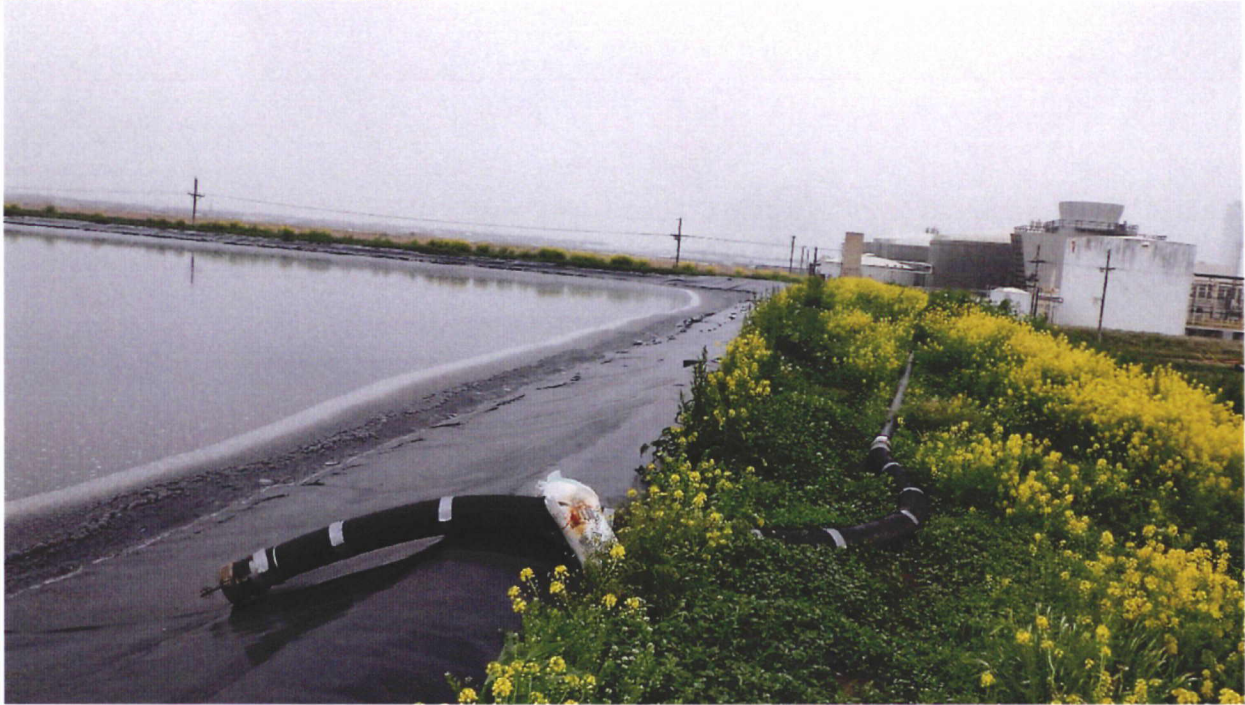
Photo: 26

- × Vegetation is becoming a problem. I observed an increasing amount of vegetation along the south lagoon dikes.
- × Vegetation is also growing fast along the storm water ditch south of the digester.
- × The facility is moving wet cake and dirt south of the northwest lagoon. The facility is preparing an area for additional Poseidon tanks.
- × Areas 3, 4 and 5 are interconnected by berms.
- Today I brought two additional Department employees: Dane Pauley and Lindsey Hollman. Their task was to record video and take photos of the berms and lagoons. The video and photos were taken with the Drone.

Description: This photo depicts the hose used to transfer water from the emergency lagoon to the south lagoon. The system is off. Also notice the vegetation.

- Clean the biochar area
- Manage vegetation around the lagoons and the main facility.

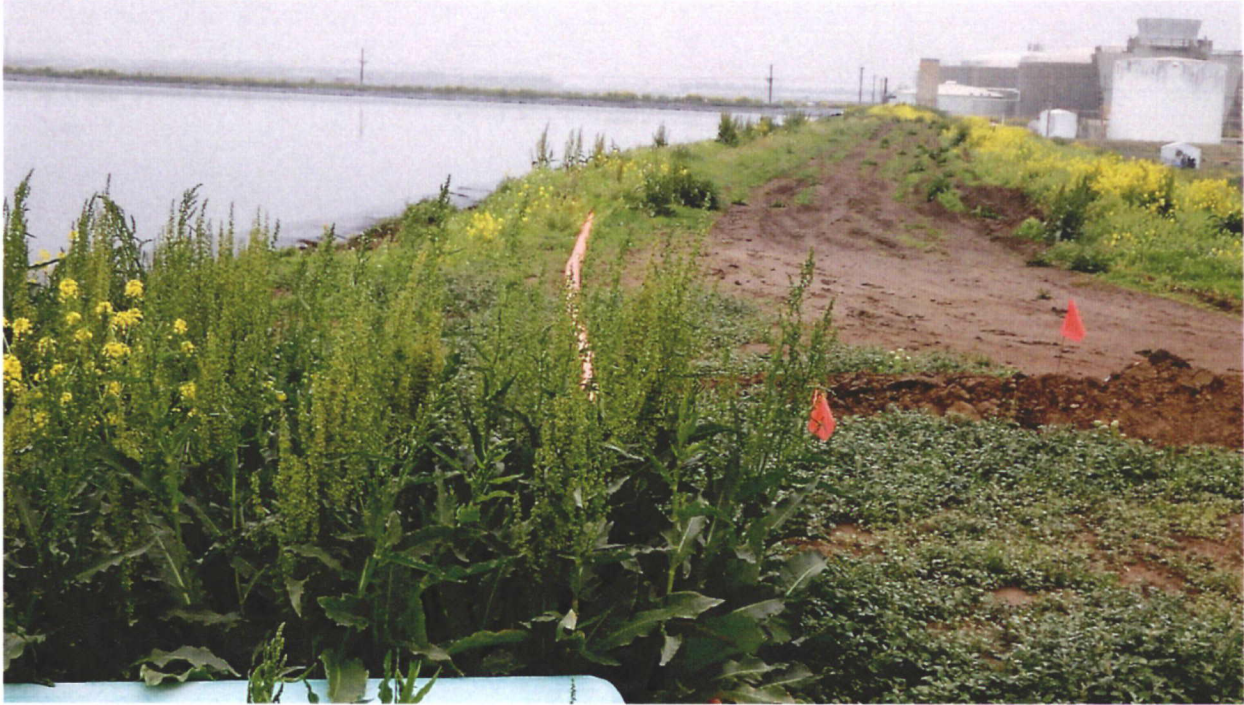
Photo: 27

Description: This photo also depicts tall vegetation.

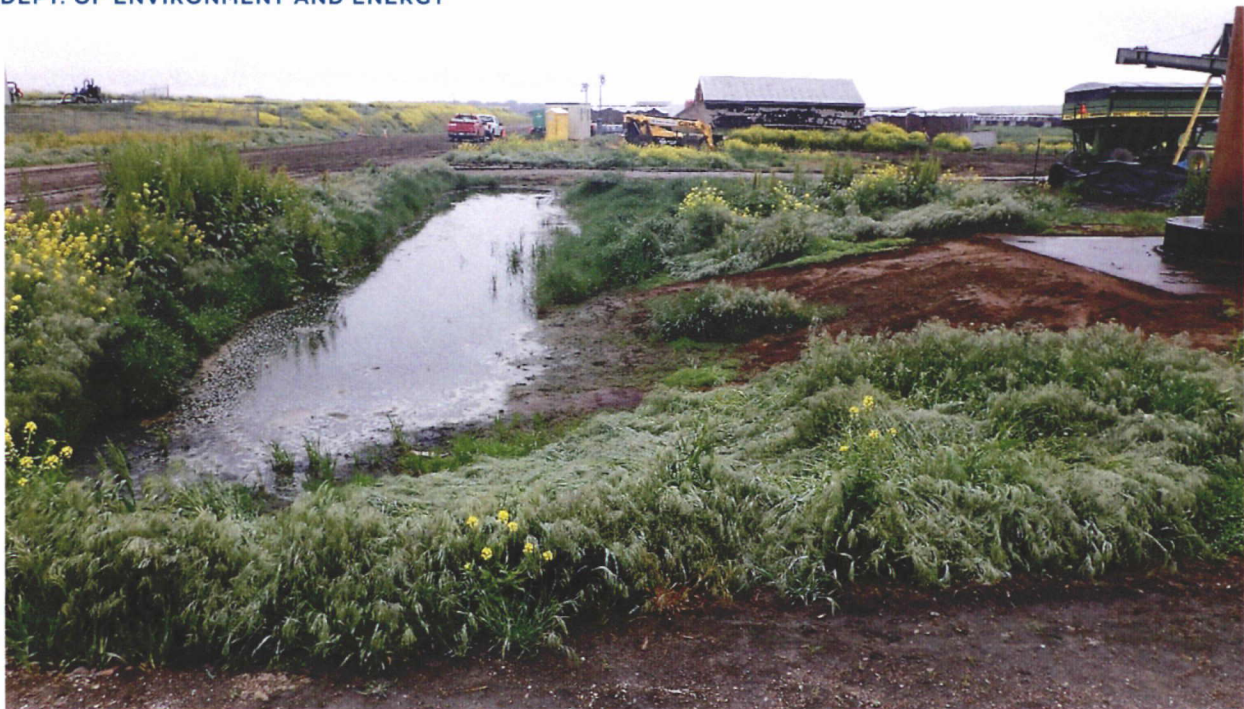
Photo: 28

Description: This photo depicts accumulated runoff water from the Biochar unit. The photo also depicts uncontrolled vegetation.

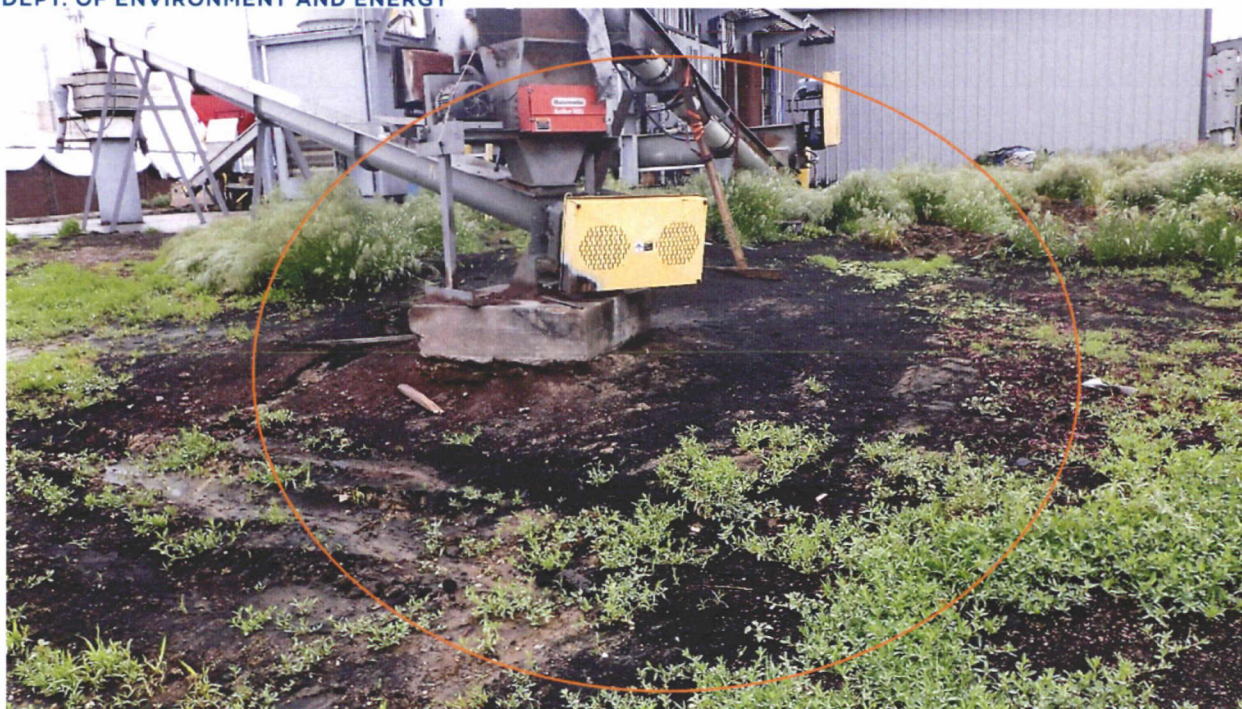
Photo: 29

Description: This photo depicts spilled biochar.

- × Vegetation is growing fast and is need of control (Lagoons and main plant)
- × The Biochar area continues to have spilled product, trash and debris.

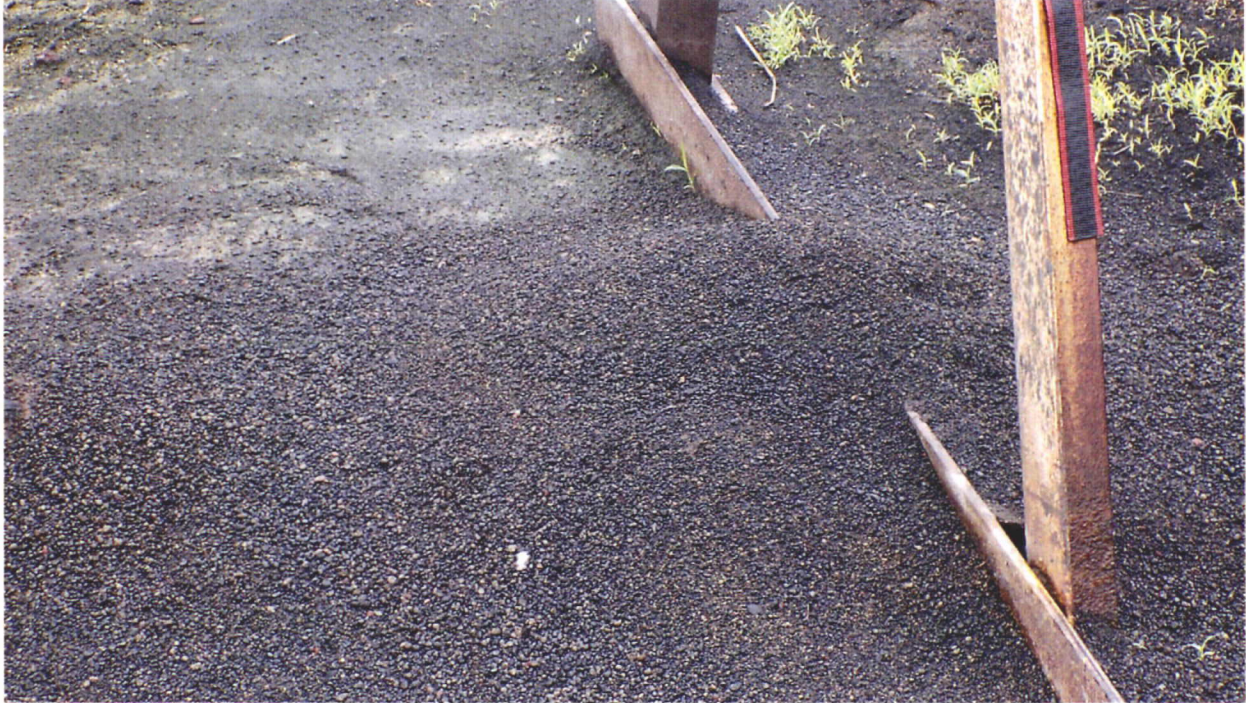
Photo: 30

Description: This is a close up of spilled biochar product.
