Facility: AltEn, LLC

5/17/2021

## Site Visit Check list

## Inspection and Assistance Exit Summary

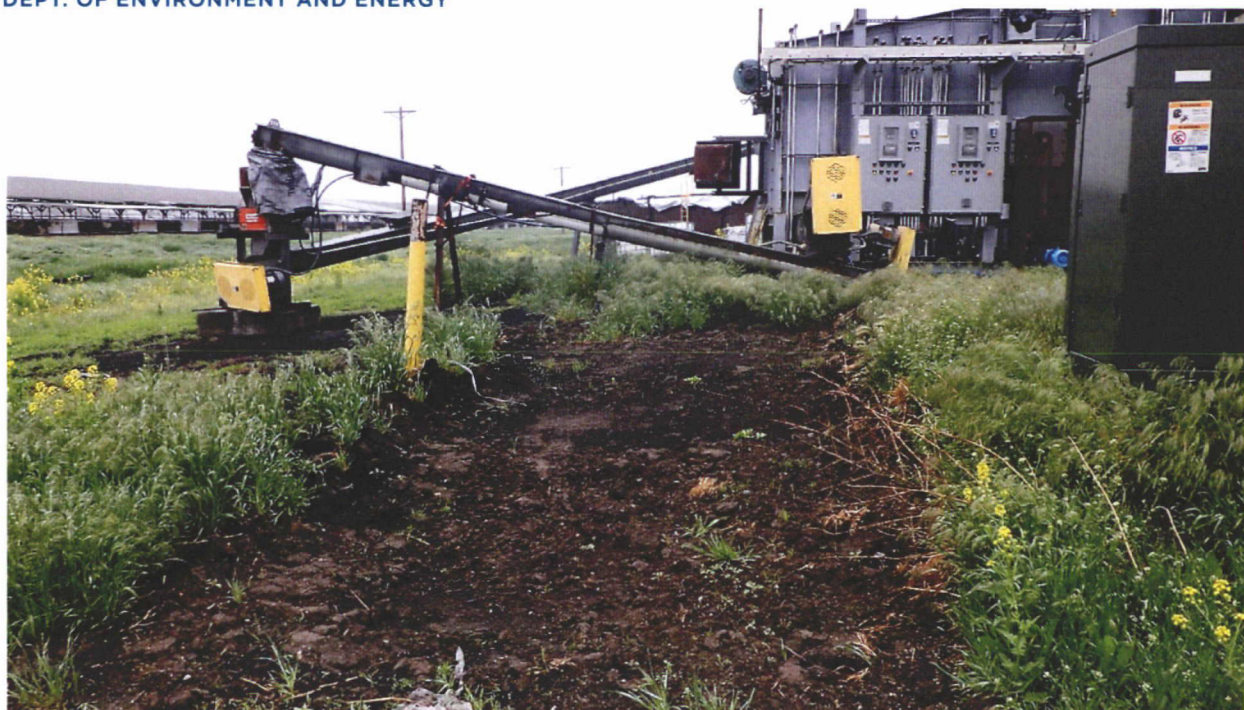
Photo: 31

Description: This photo depicts spilled biochar product. Also note that the vegetation is becoming more prevalent.

- × Vegetation is growing fast and is need of control (Lagoons and main plant)
- × The Biochar area continues to have spilled product, trash and debris.

- Clean the biochar area
- Manage vegetation around the lagoons and the main facility.

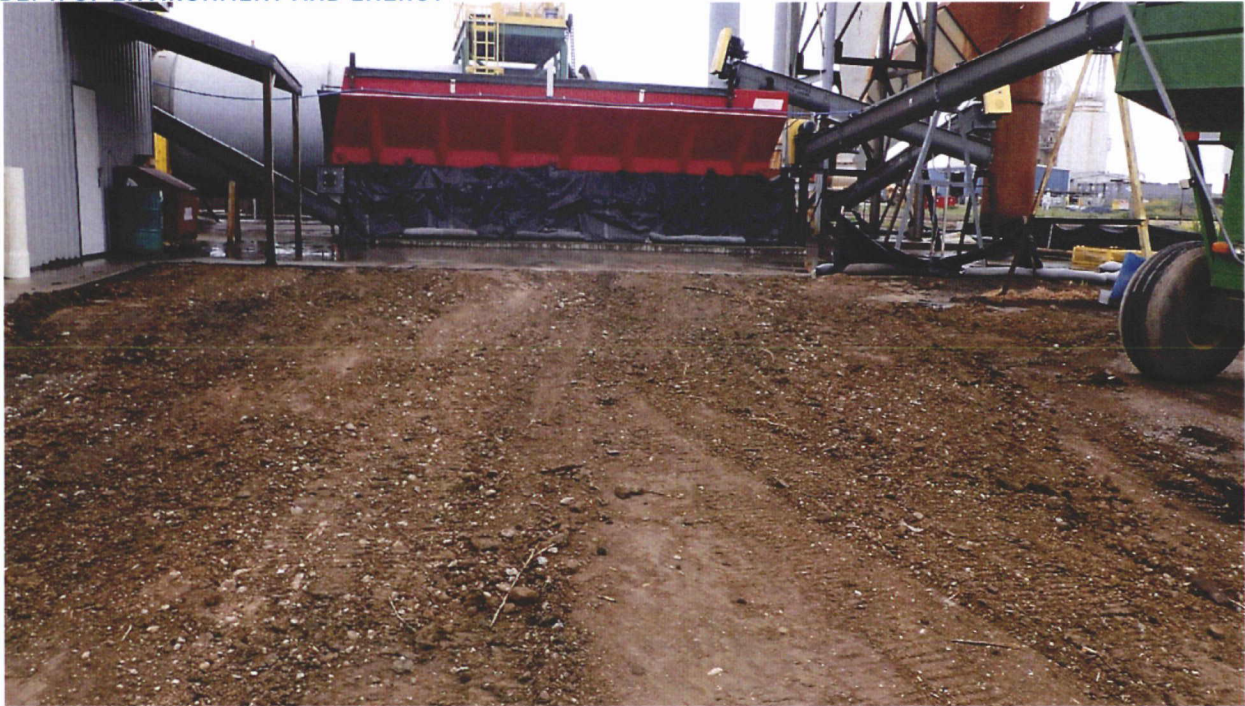
Photo: 32

Description: Clean Harbors has cleaned the biochar east side.

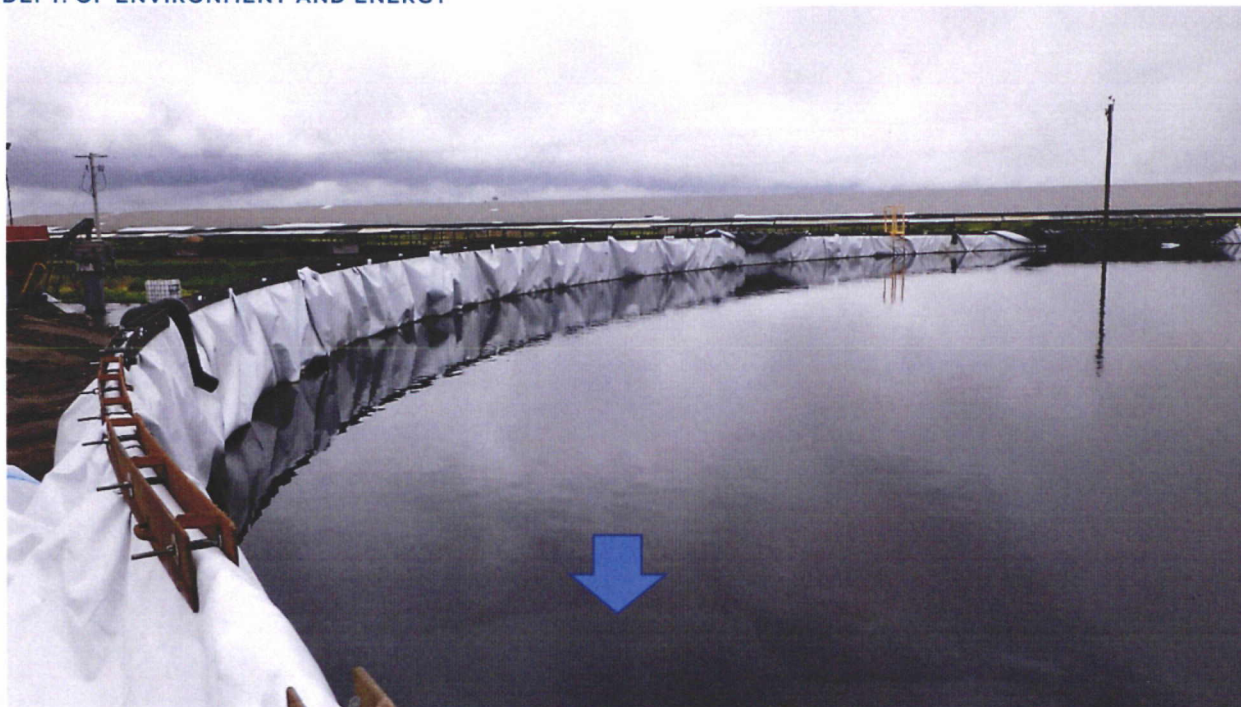
Photo: 34

Description: This photo depicts an oily sheen (arrow)

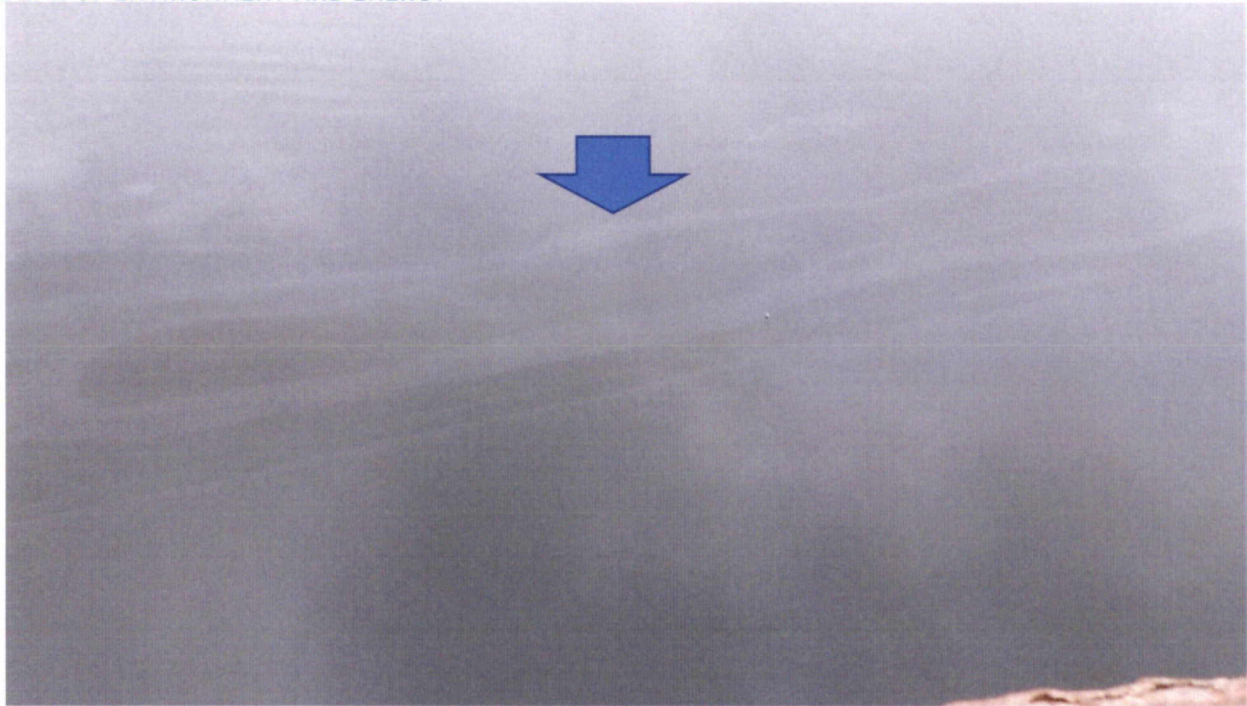
Photo: 35

Description: This photo depicts an oily sheen (arrow)
