Facility: AltEn, LLC

Site Visit Check list

Site Visit Report

Inspection and Assistance Exit Summary

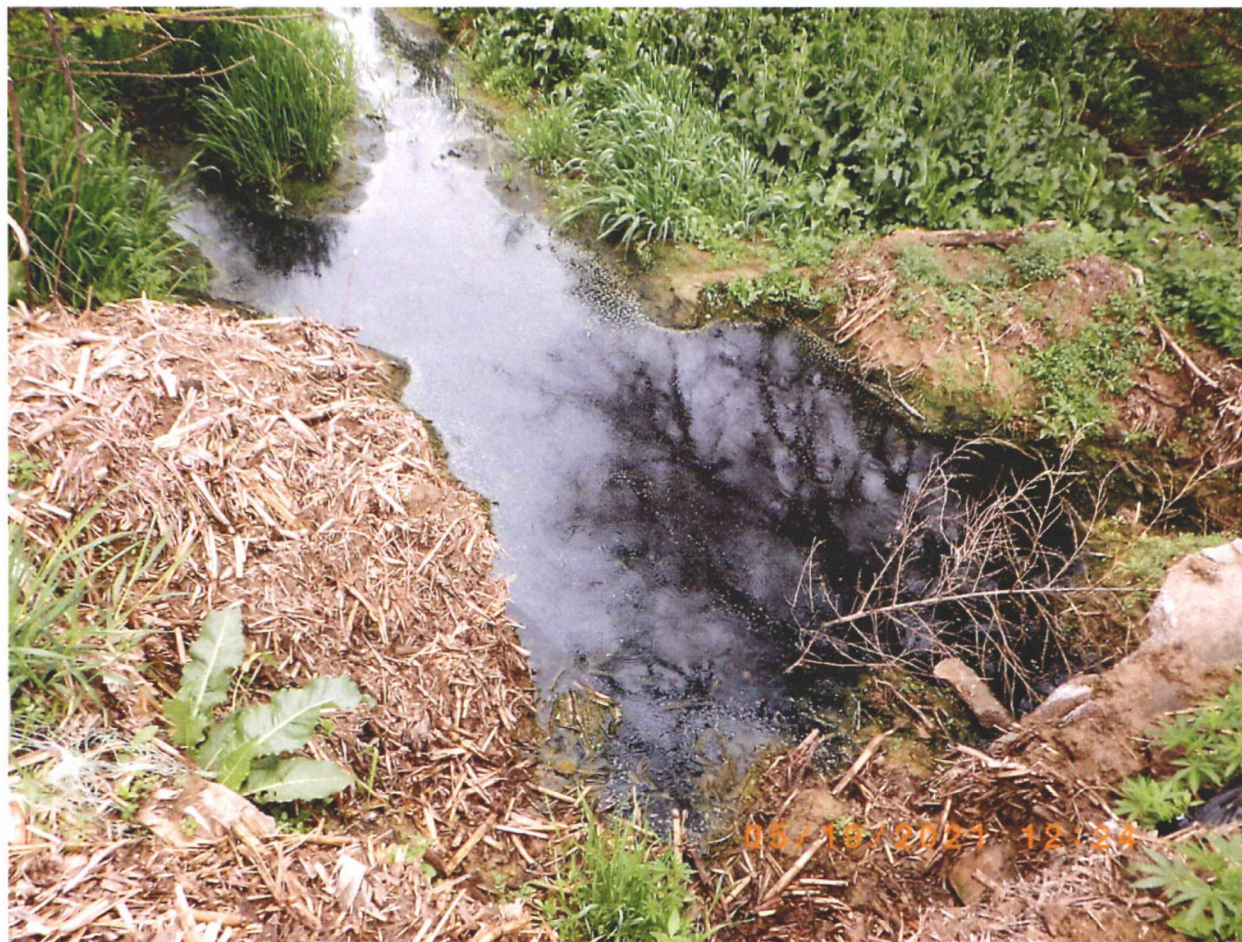
Photos: 1

Location: Culverts at CR 9 & J

Description: The water appears to be somewhat clearer, but has white-green foam on the surface.

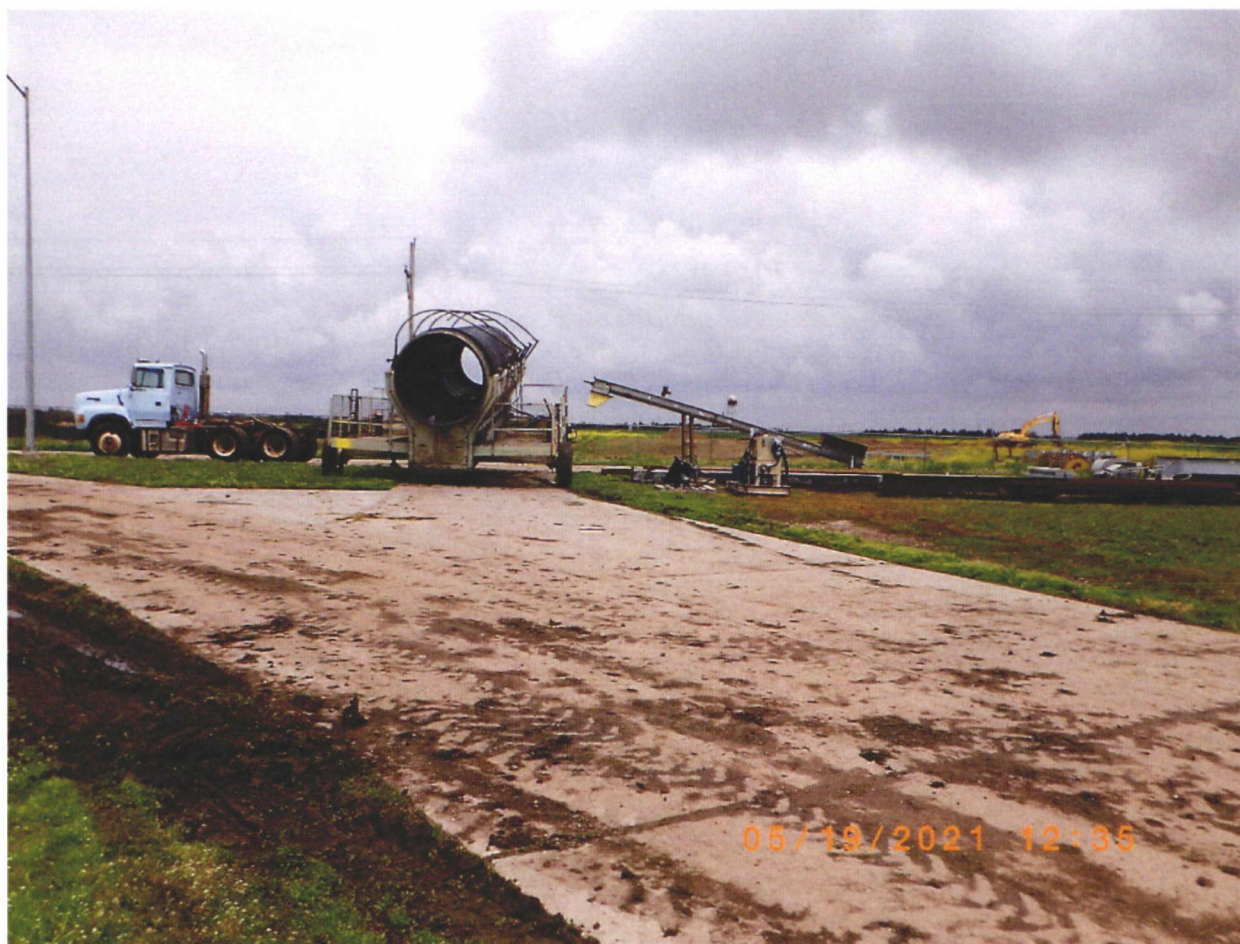
Photos: 2

Description: Equipment removed from the south hoop building for auction.

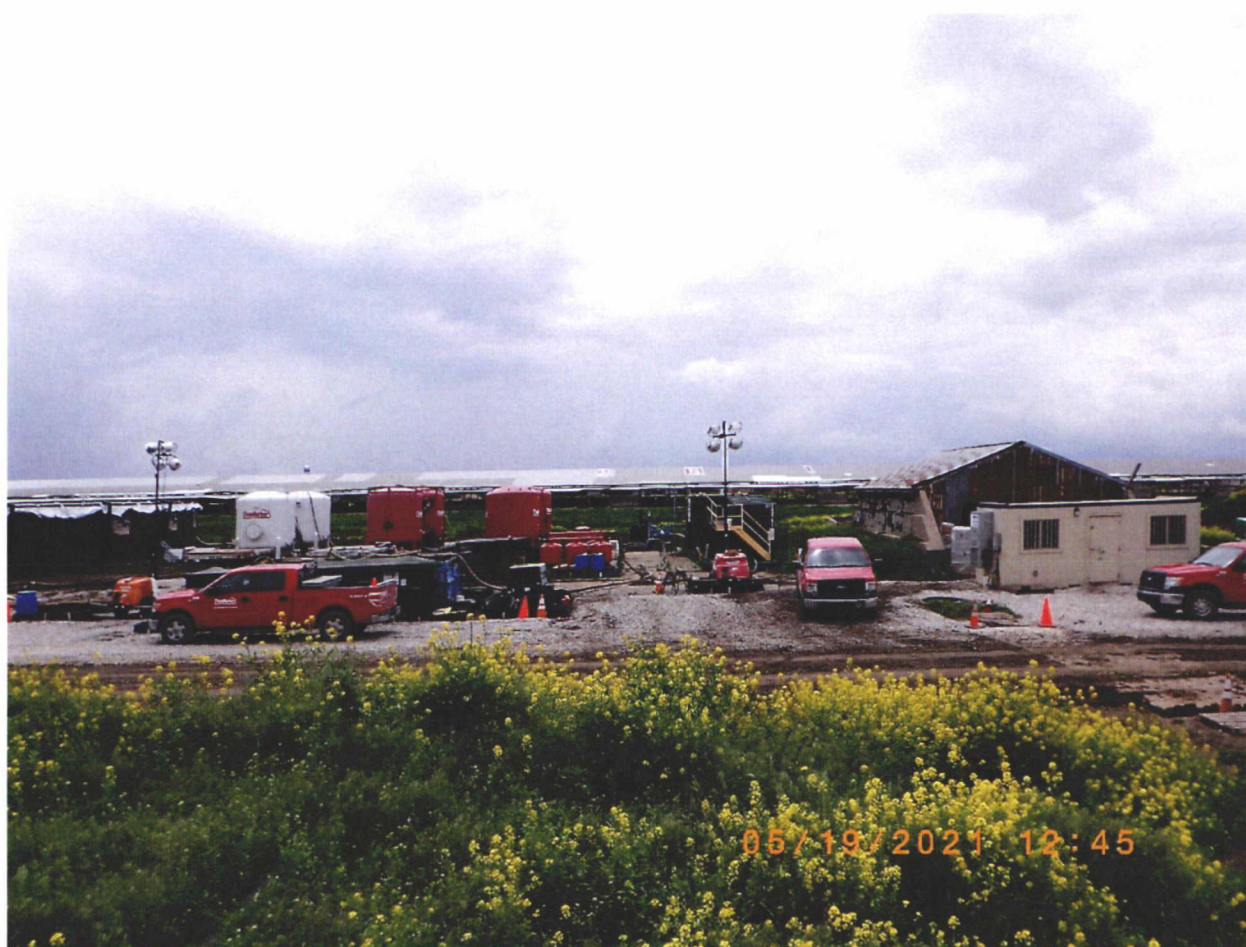
Photos: 3

Description: Clean Harbors wastewater treatment area. The main field office onsite for Clean Harbors is located on the north side of the treatment area.

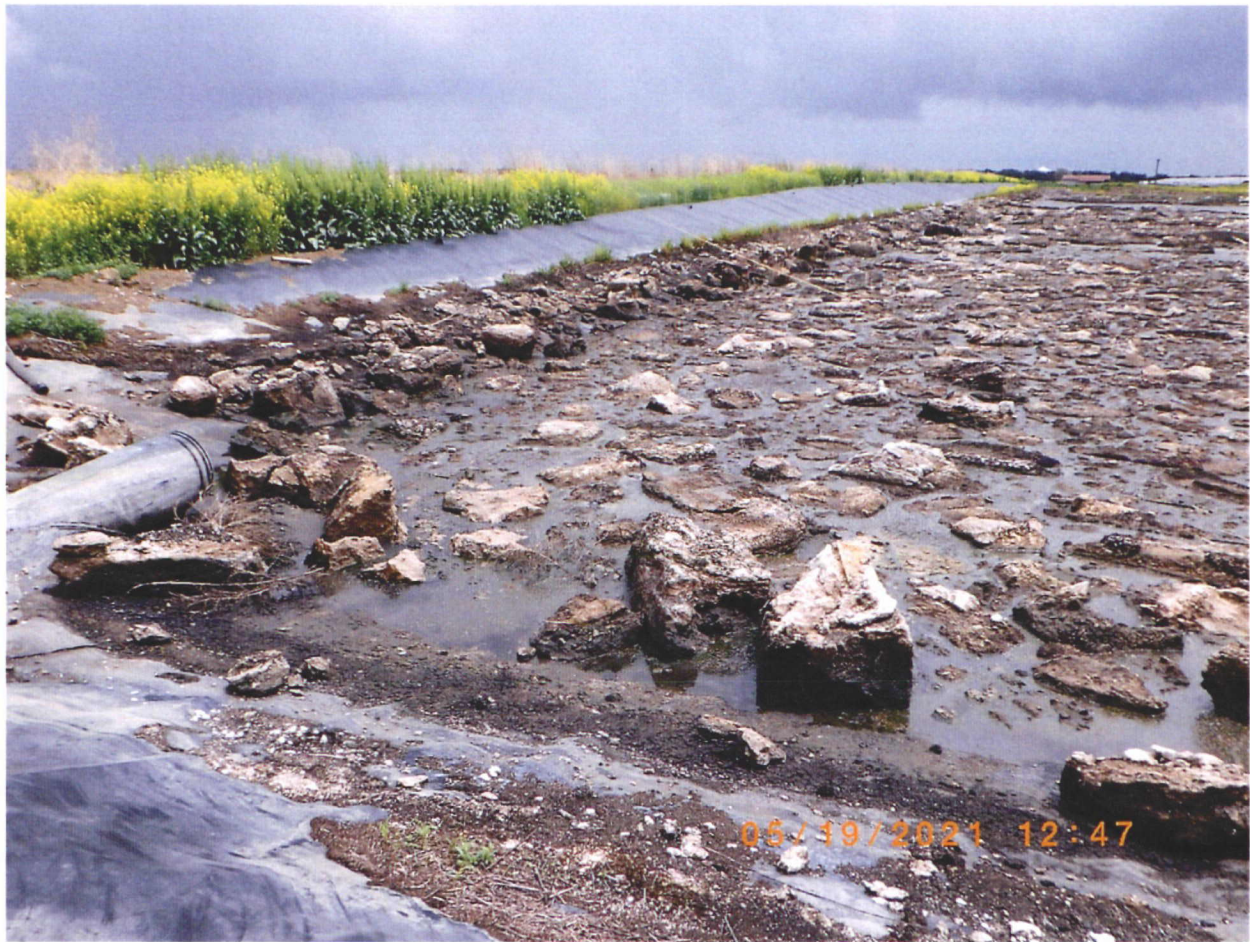
Photos: 4

Description: The lagoon has been drawn down to the point where influent pipe is above the lagoon water and solids.

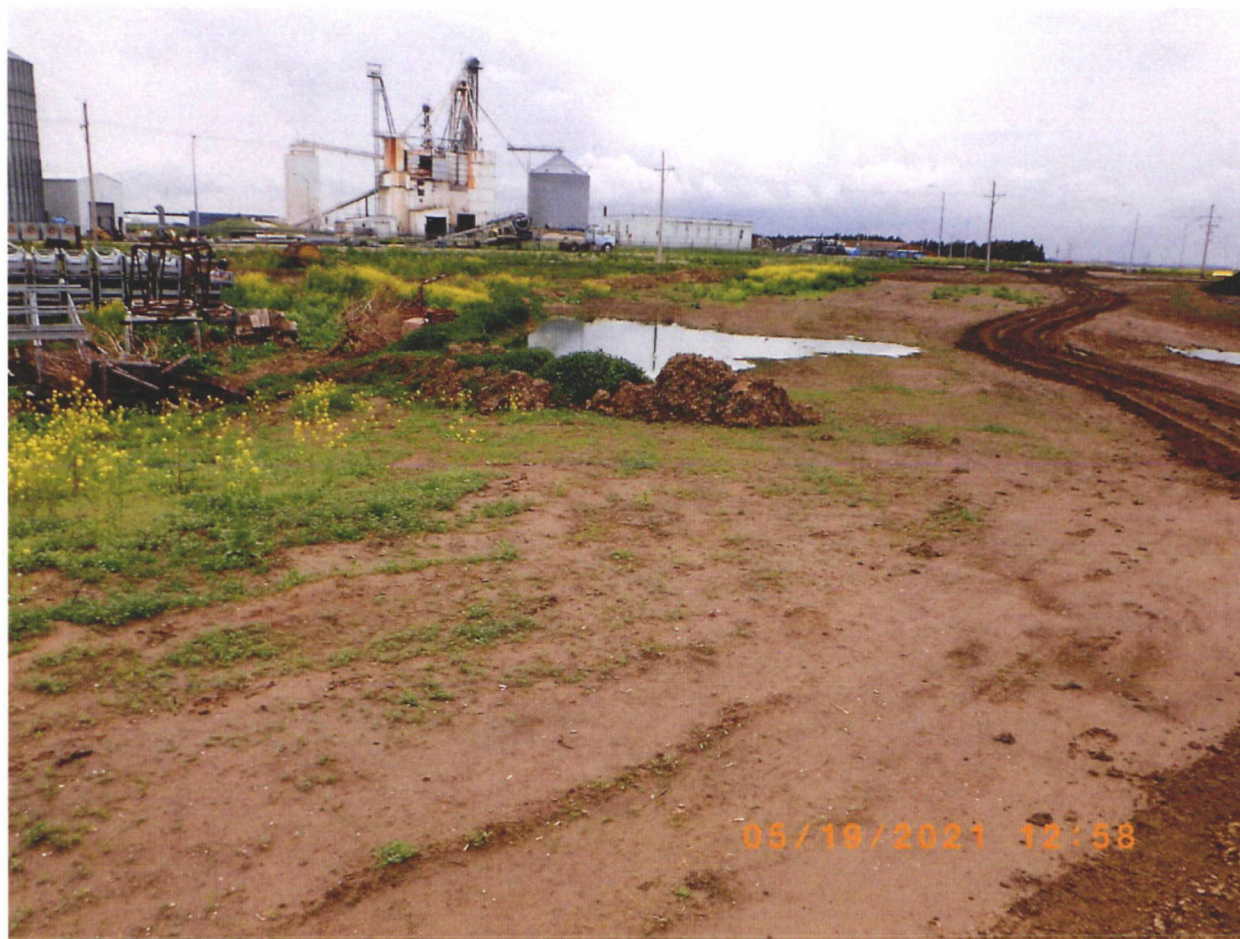
Photos: 5

Description: Access road through area 1 to area 2 on the site map.

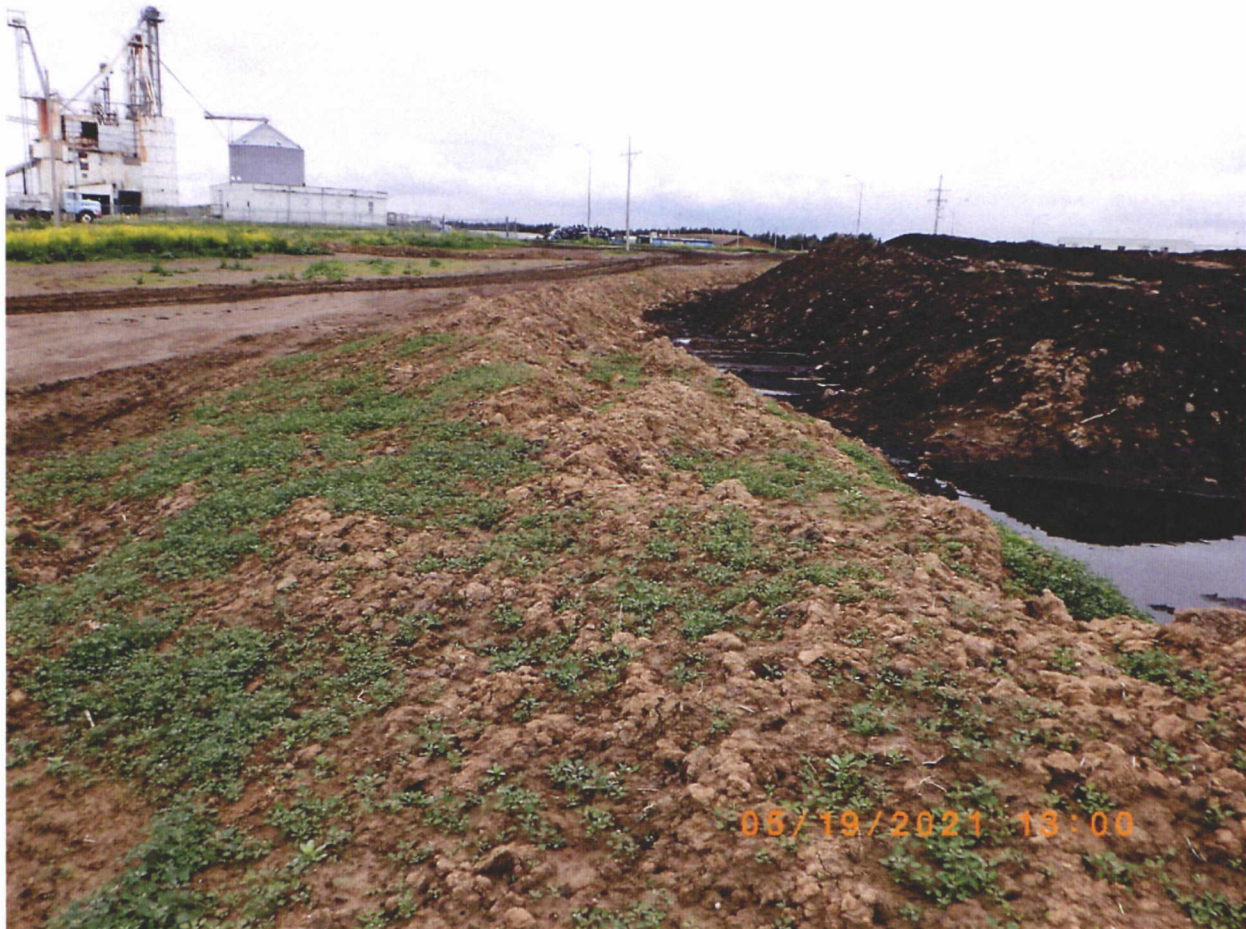
Photos: 6

Description: Bermed area around wetcake north of the administration building.

Area 1 - Berms holding no sign of seepage. may need to be pumped if more rain: 15 min

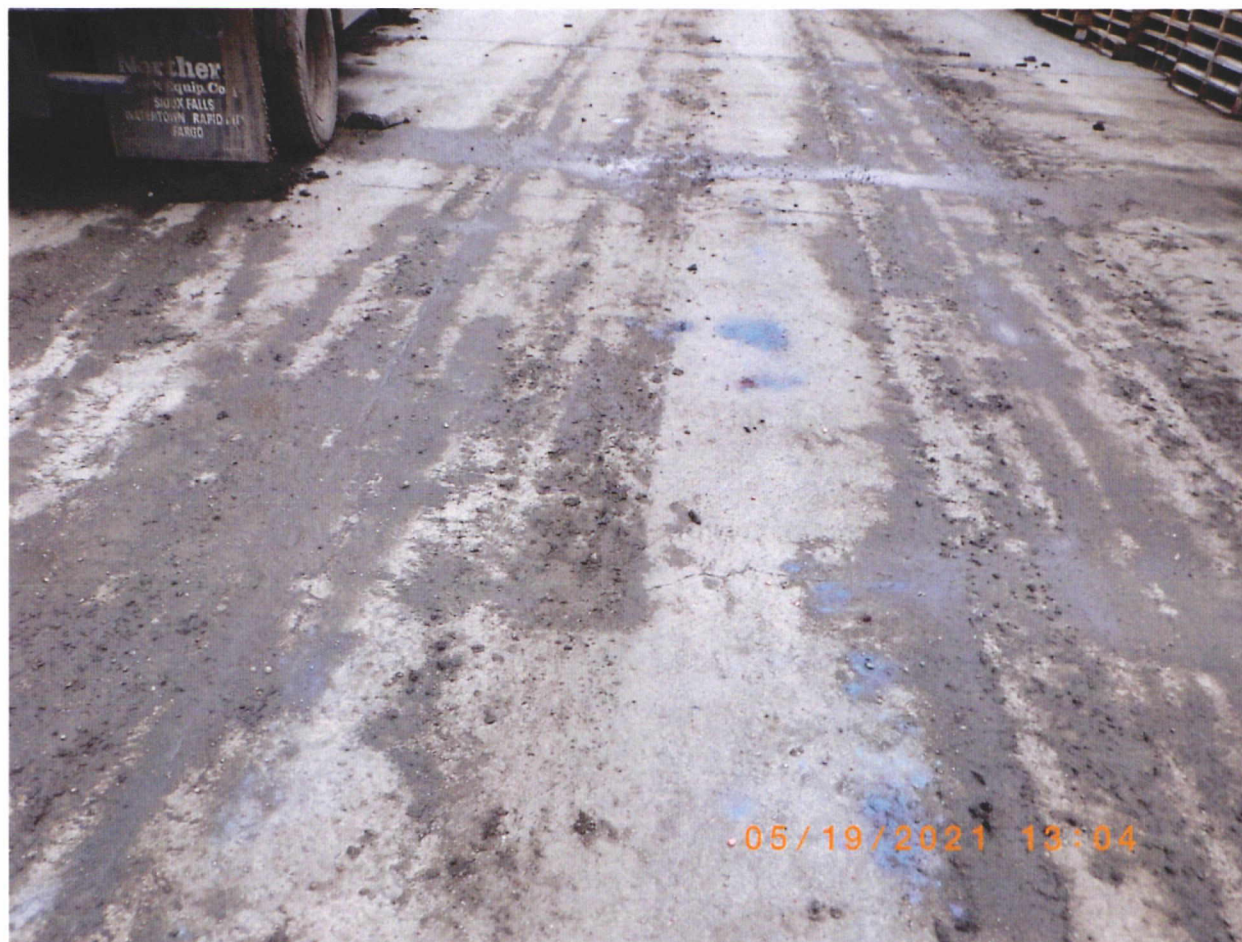
Photos: 7

Description: Seed coating residue tracked out of hoop buildings onto access roads from equipment relocation.

- Seed coating dust is being tracked out of hoop buildings & should be cleaned up.

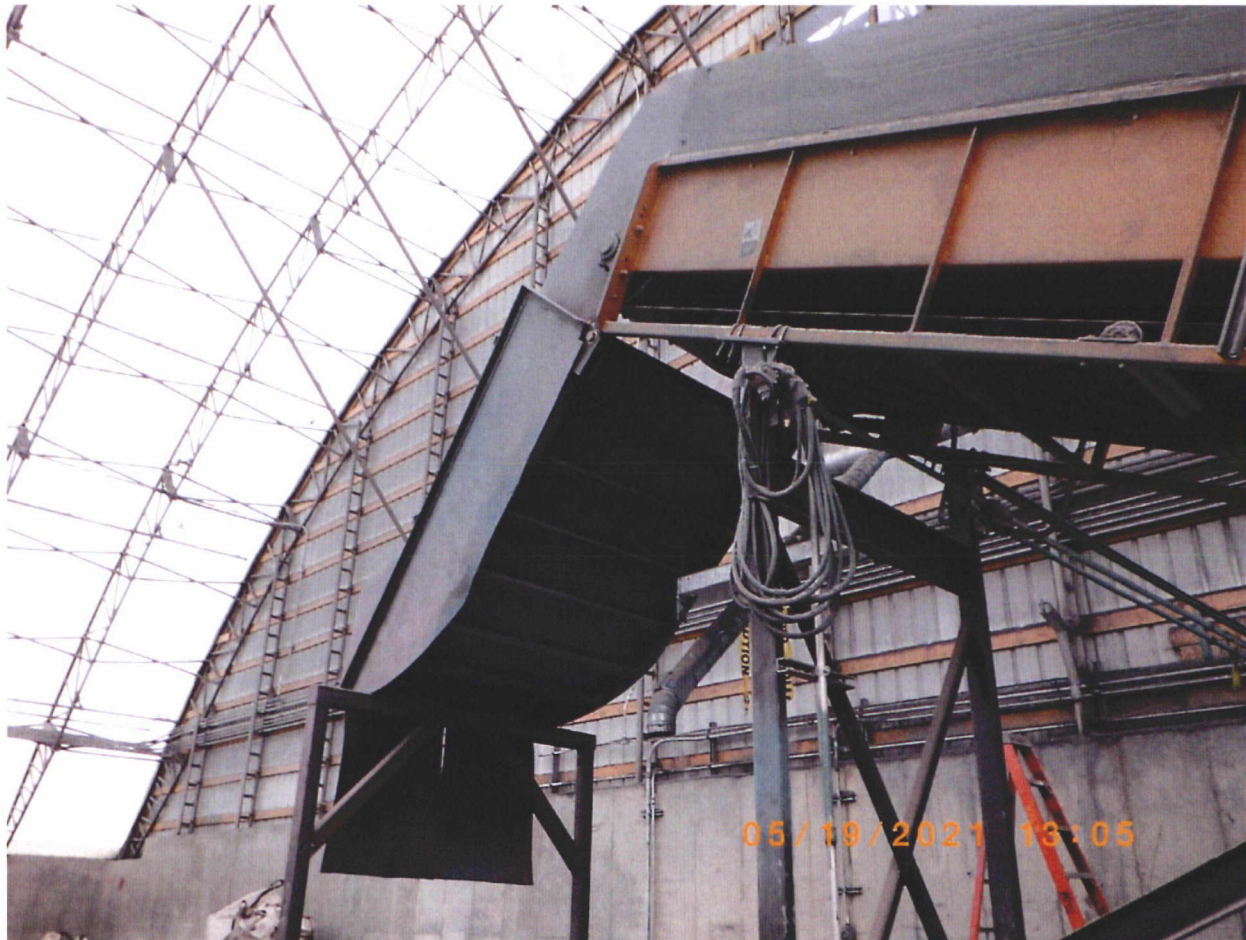
Photos: 8

Description: Component of the depackaging equipment used to open and extract seed bags.

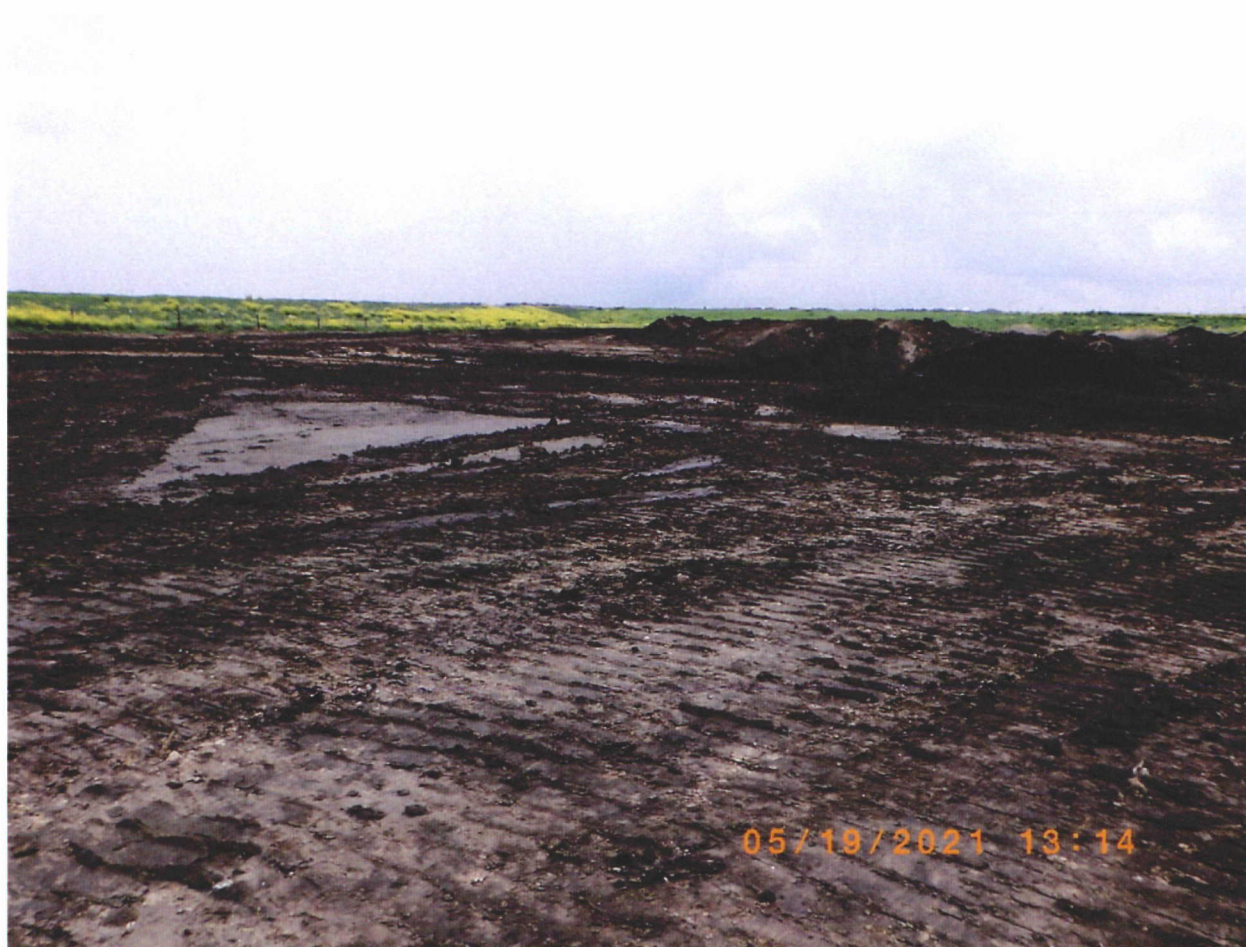
Photos: 9

Description: Area cleared of wetcake relocated to the area west of the northwest lagoon.

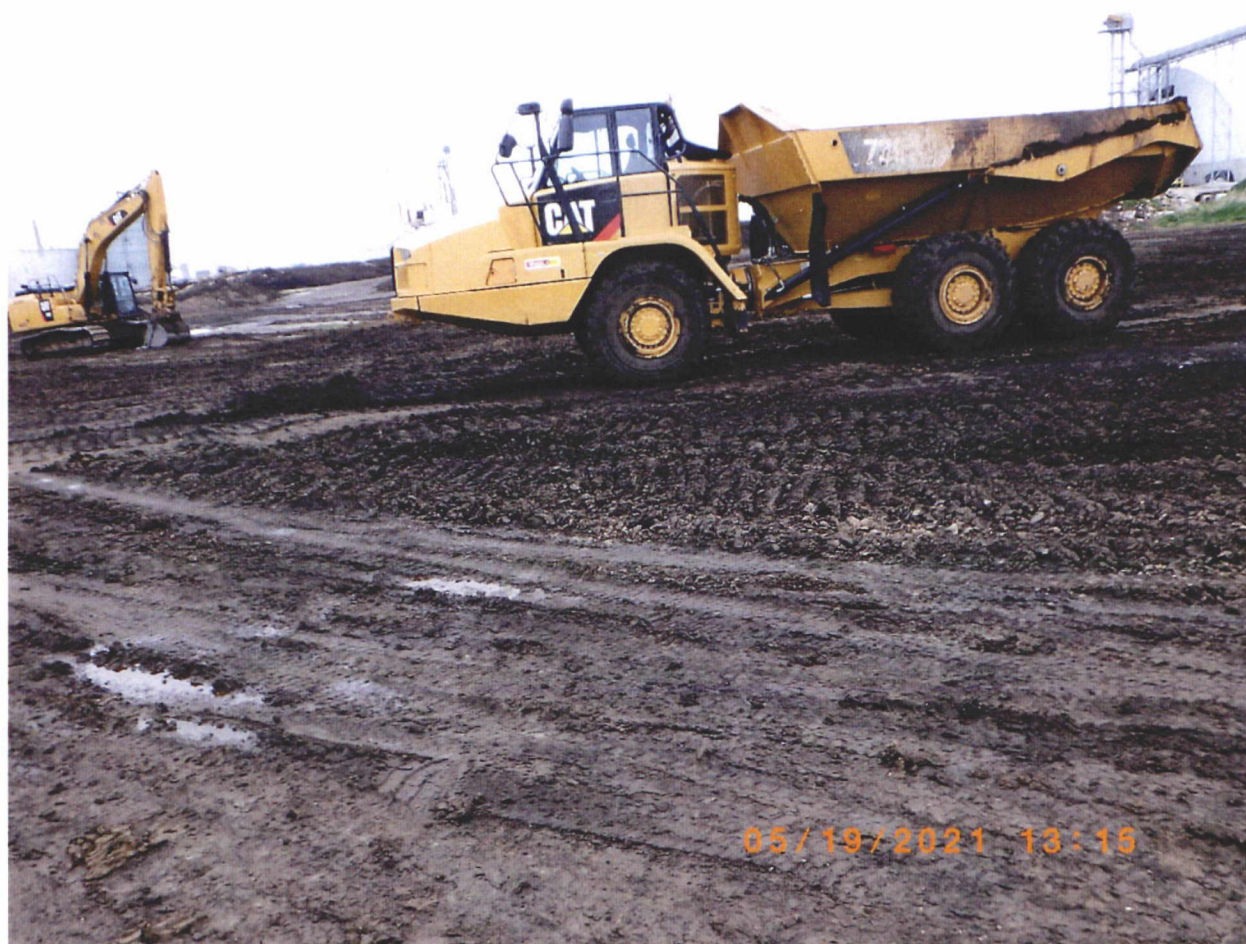
Photos: 10

Description: Articulating dump truck and backhoe used to move the wetcake.

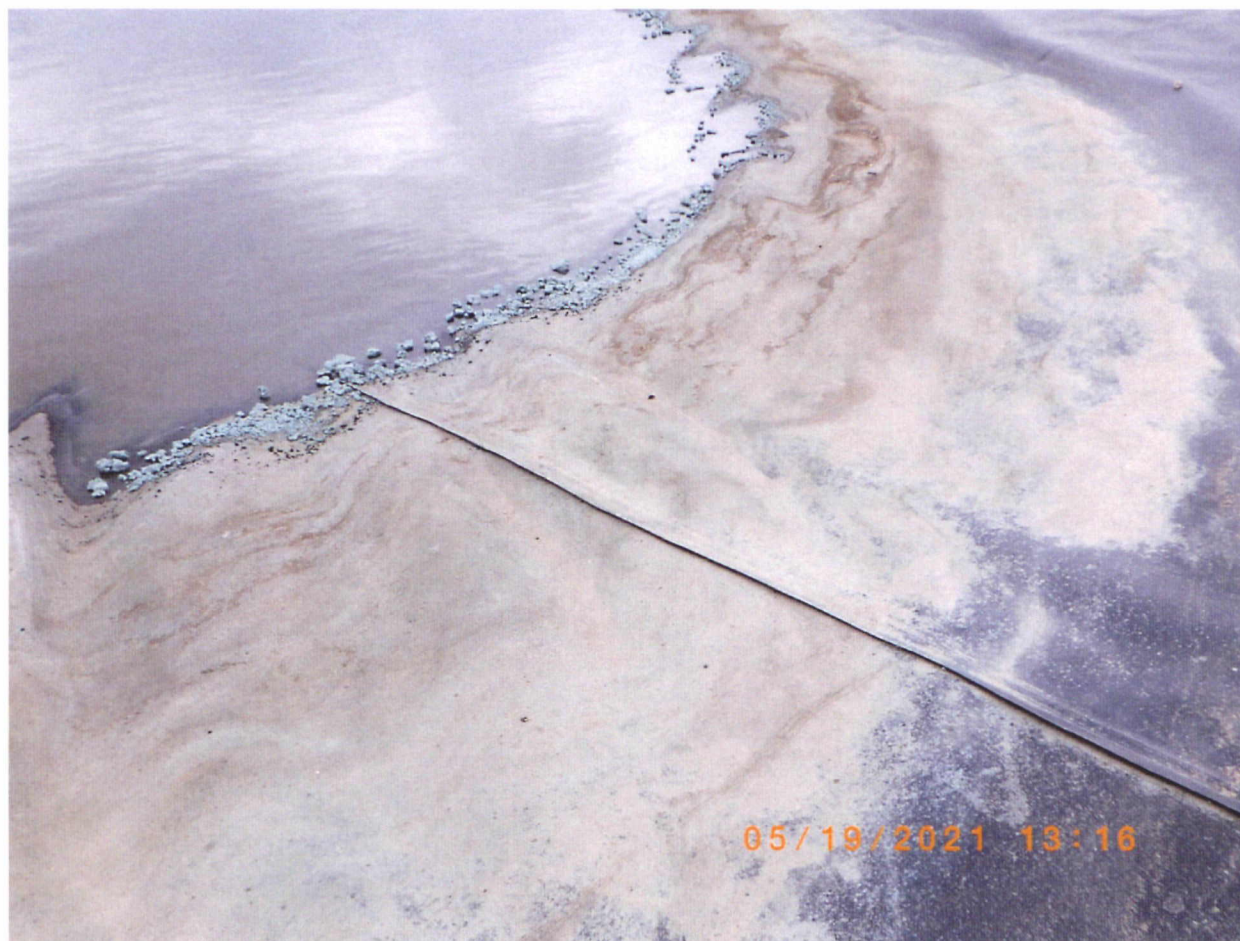
Photos: 11

Description: Residue and sludge accumulating along the edge of the lagoon.

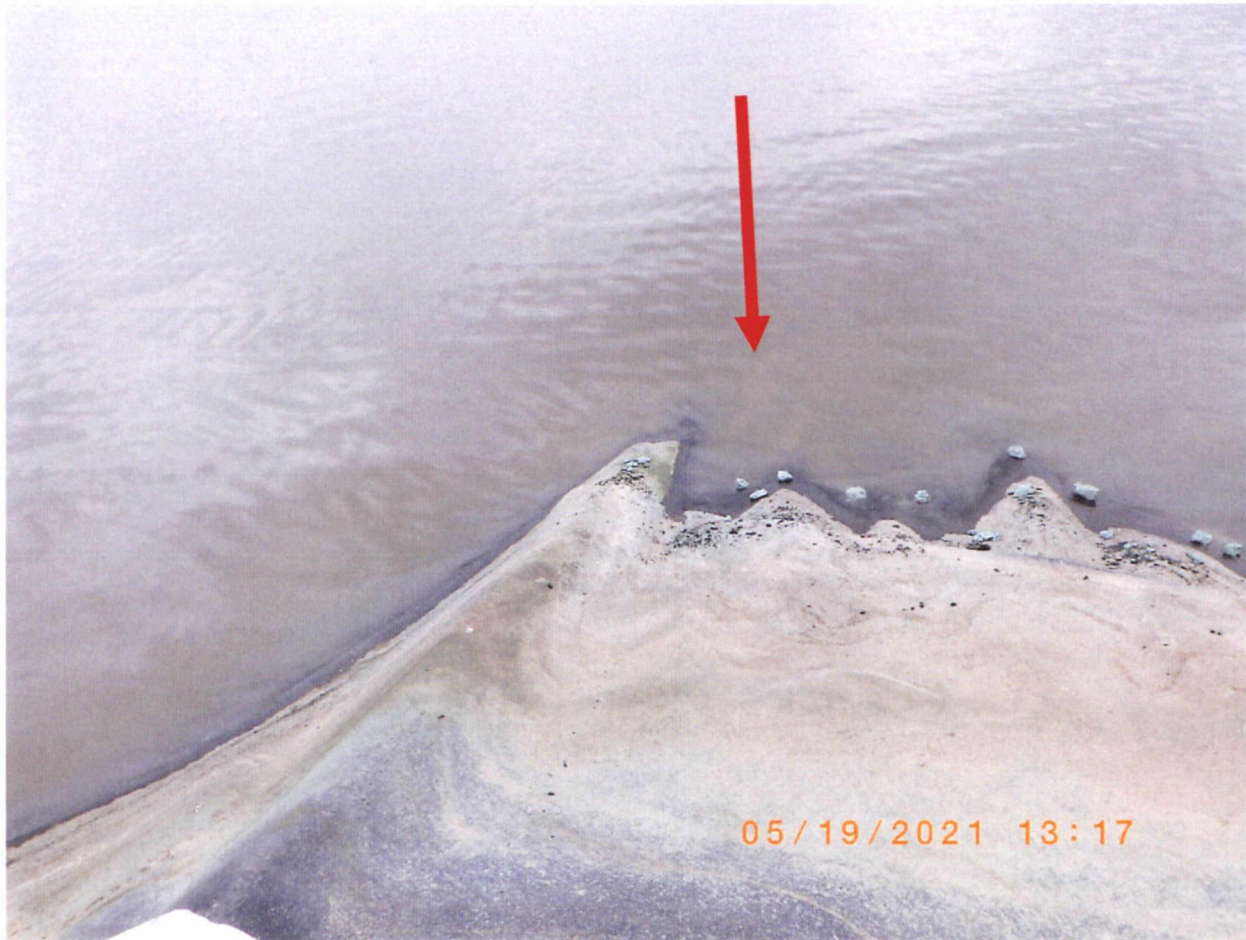
Photos: 12

Description: Depth indicator marking 18' becoming more visible daily.

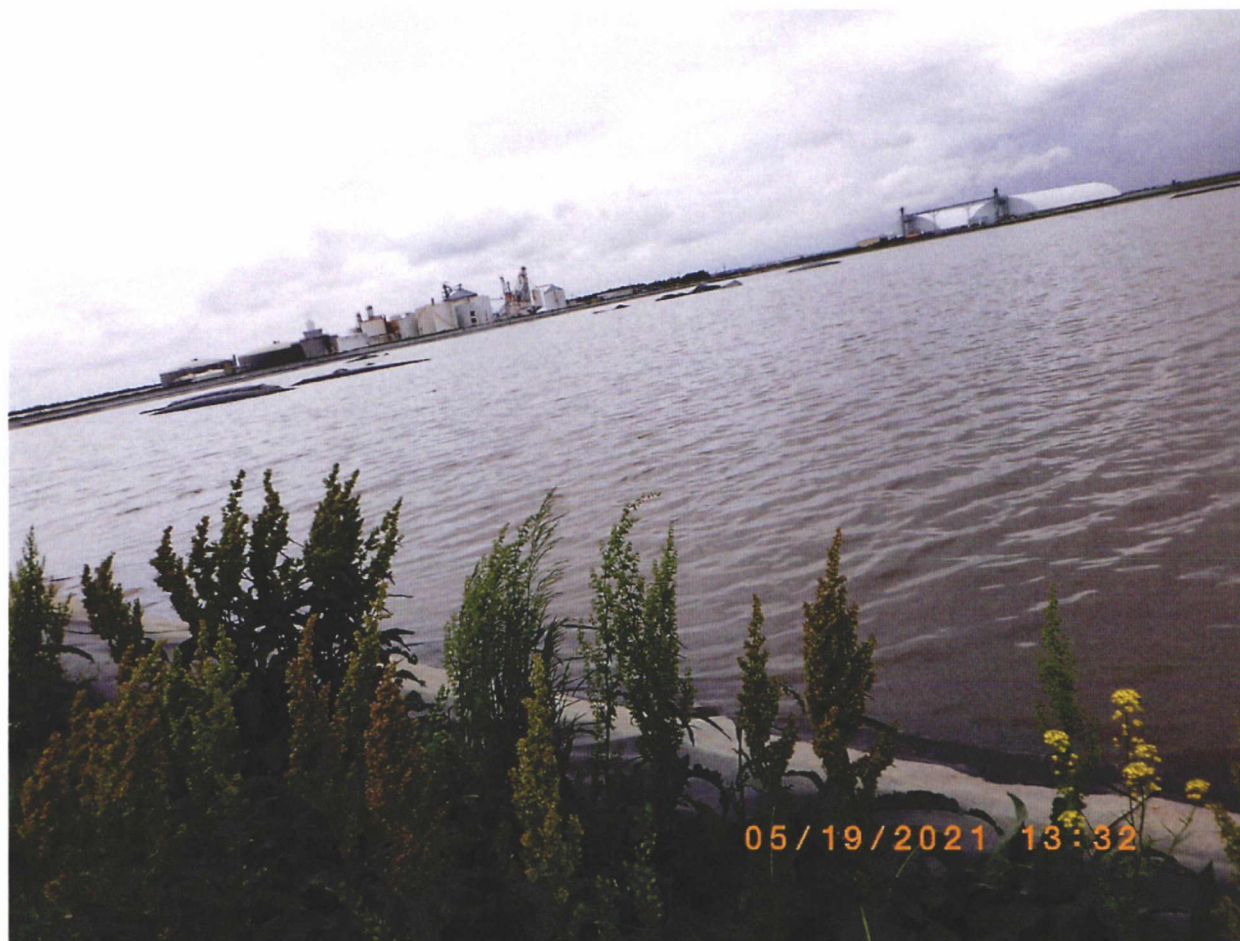
Photos: 13

Description: View of the northeast lagoon showing the liner tears and whales.

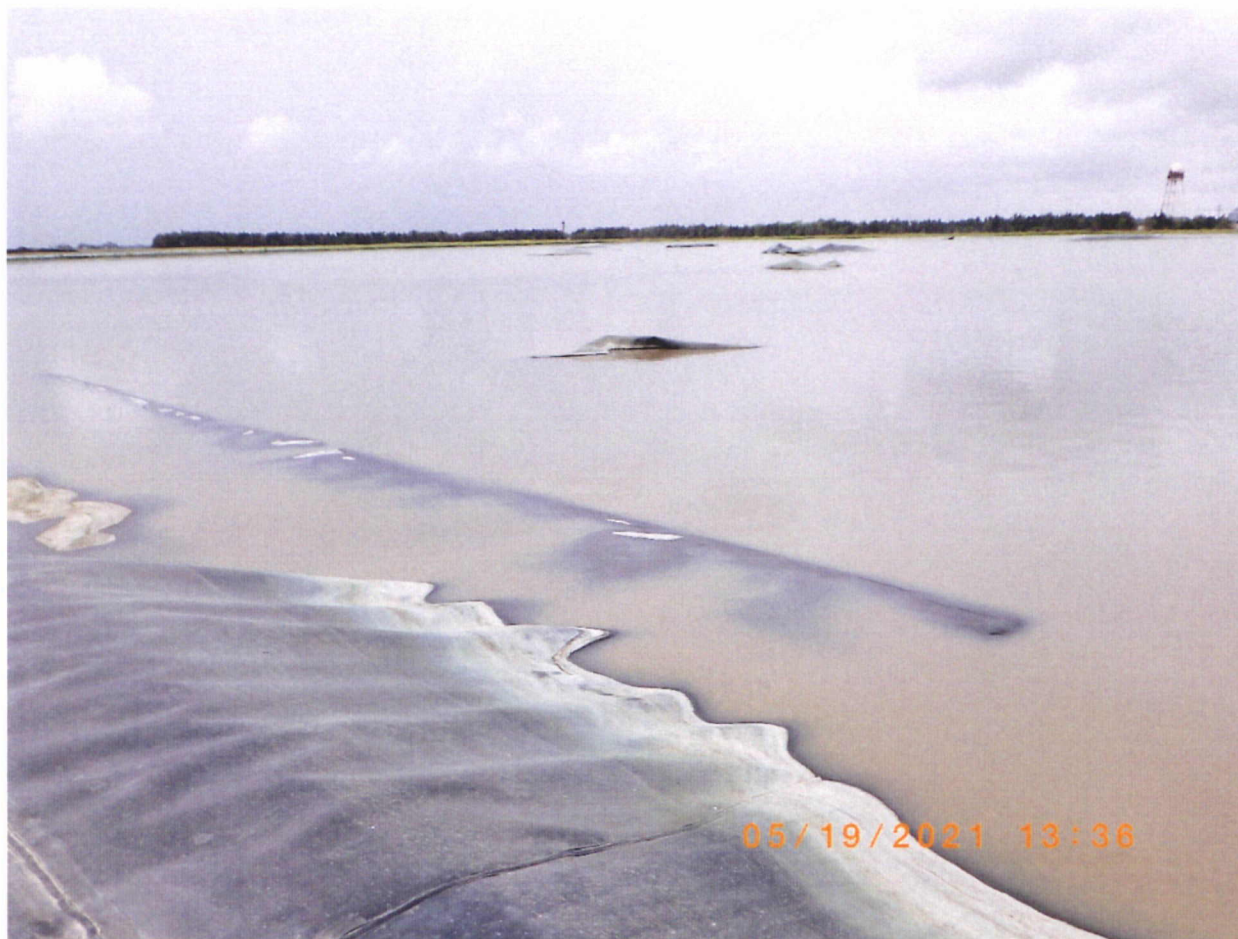
Photos: 14

Description: View of the northeast lagoon showing the liner tears and whales. More sections of torn liner appear as the lagoon is drawn down.

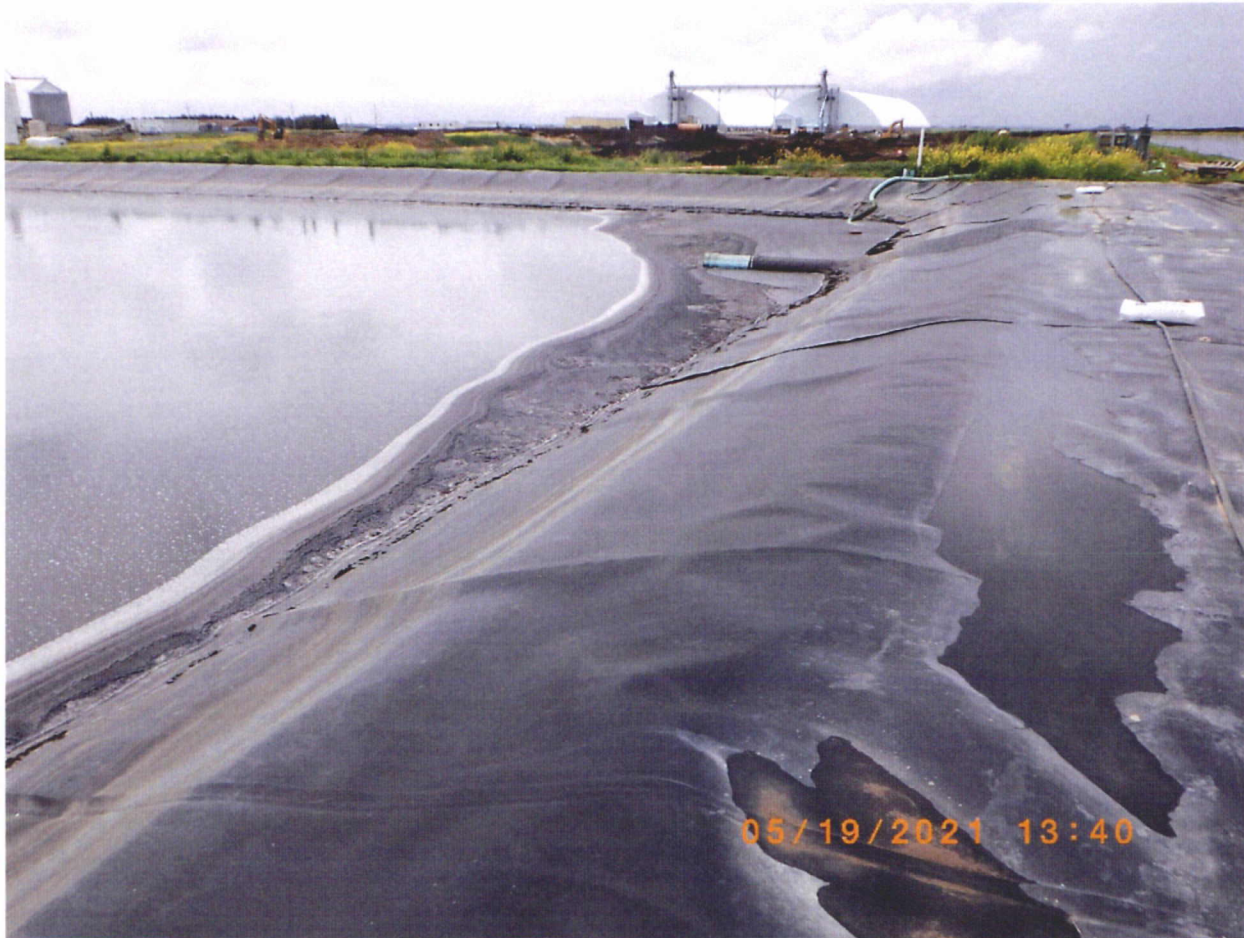
Photos: 15

Description: Sludge and foam accumulated at the pumping location of the lagoon to the treatment system.

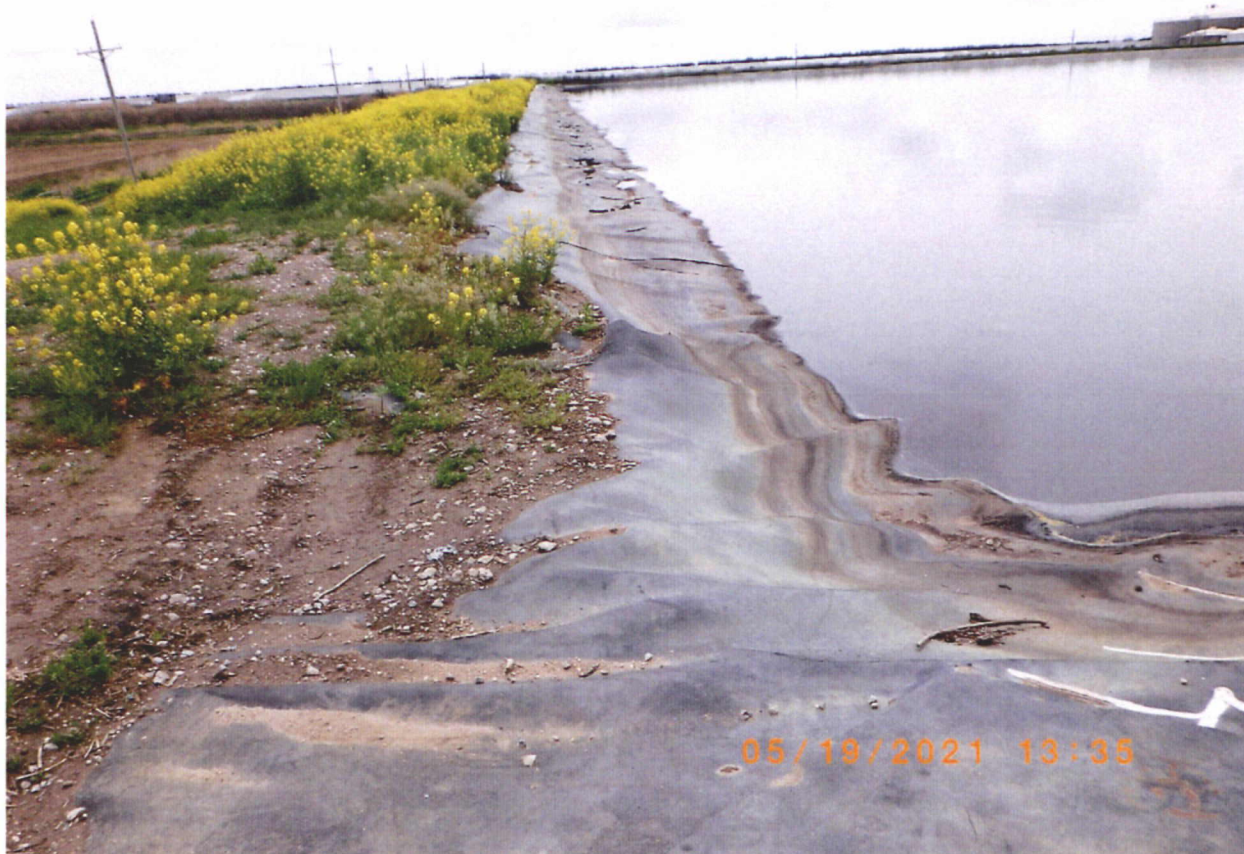
Photos: 16

Description: Residue and solids accumulated along the edge of the lagoon during draw down.

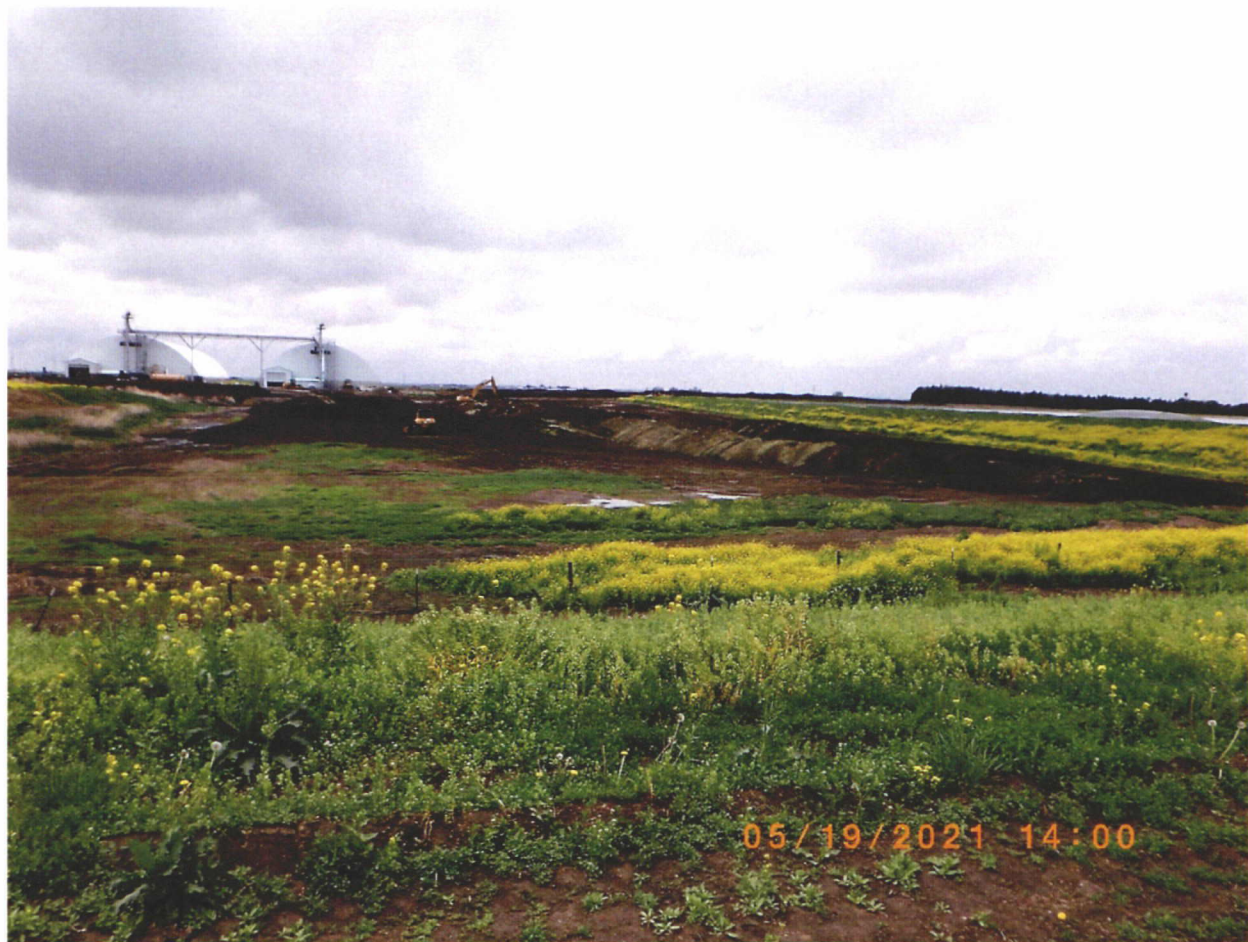
Photos: 17

Description: Area south of the west lagoon where Clean Harbors is moving wetcake.

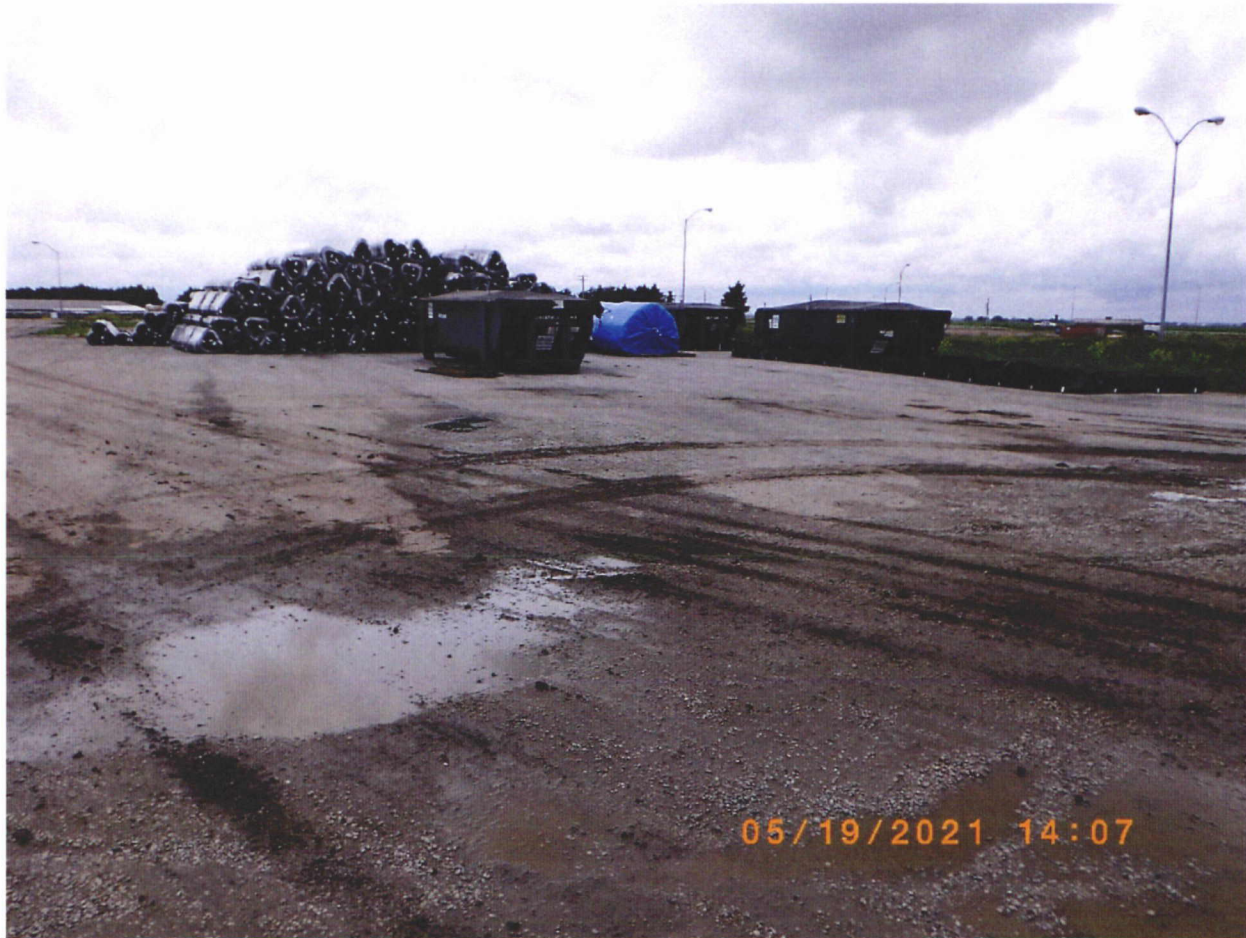
Photos: 18

Description: Geotextile fabric storage and spent carbon storage. There is 6 storage containers of spent carbon stored in this area.

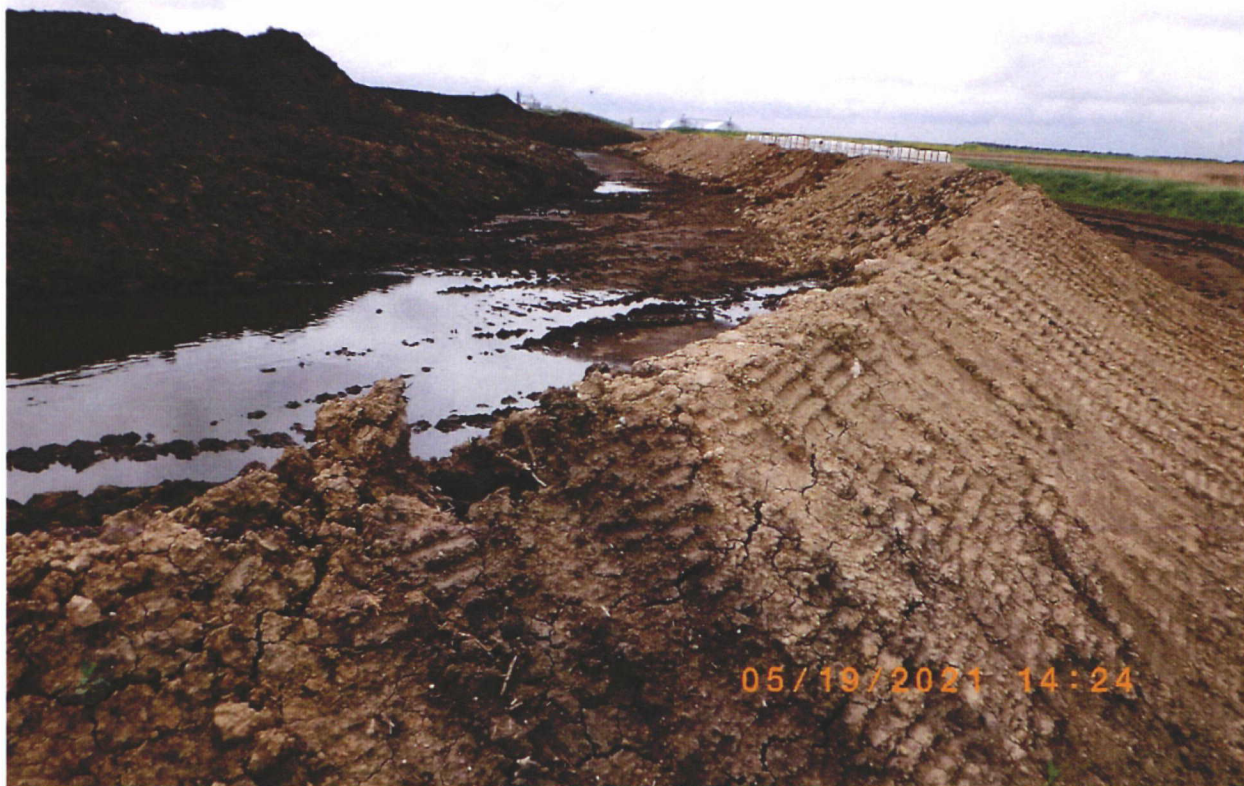
Photos: 19

Description: Berm holding and not showing signs of seepage.

6 - berms are raised on the east side & show no sign of seepage. may be pumped soon if more runoff accumulates along east side
