Facility: AltEn, LLC

Site Visit Check list

Site Visit Report

Inspection and Assistance Exit Summary

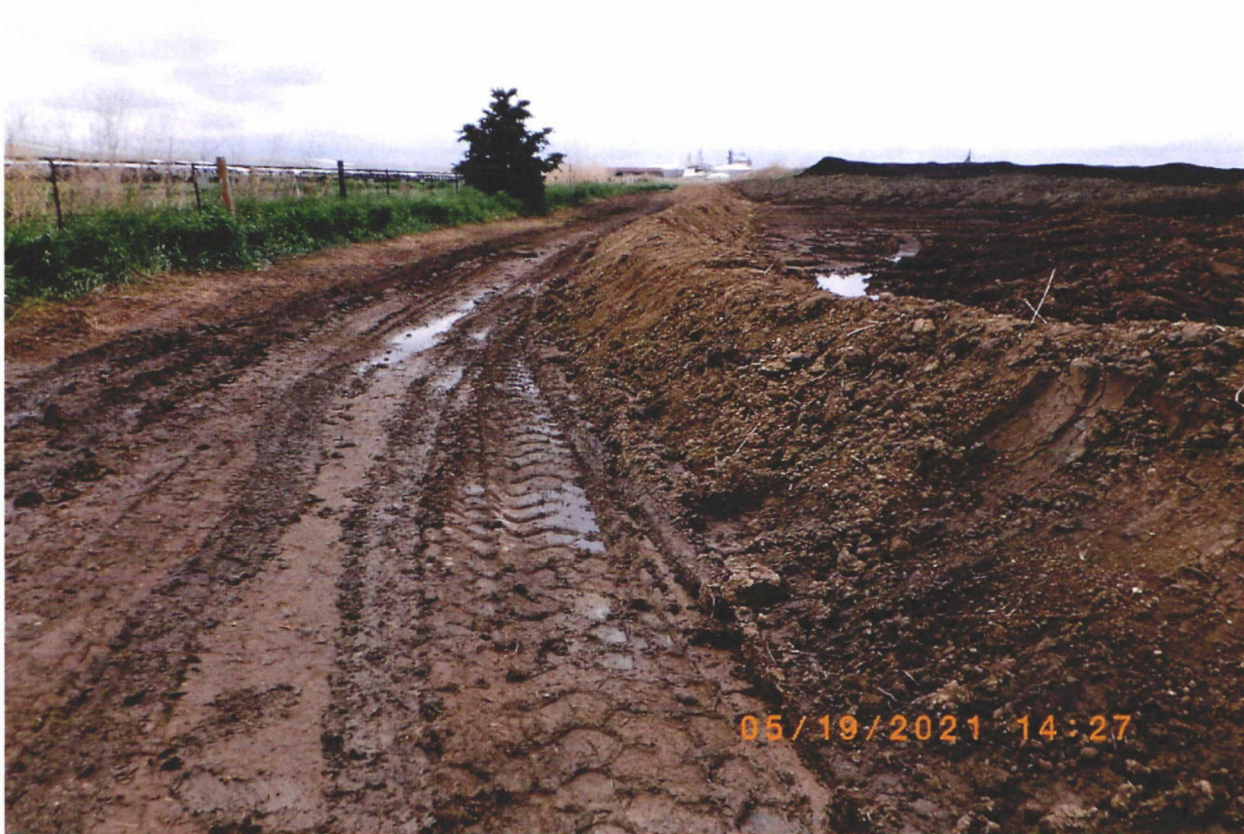
Photos: 20
Site Visit Report
Date Taken: 5-19-2021
Photographer: Jason Windhorst
Facility Name/ Project Name: AltEn LLC
Facility IIS number / Project identifier: IIS: 84069 / NE0137634
Location: Area 6 on the site map. (Southeast corner)
Direction Facing: West.
Description: Berm holding and not showing signs of seepage.

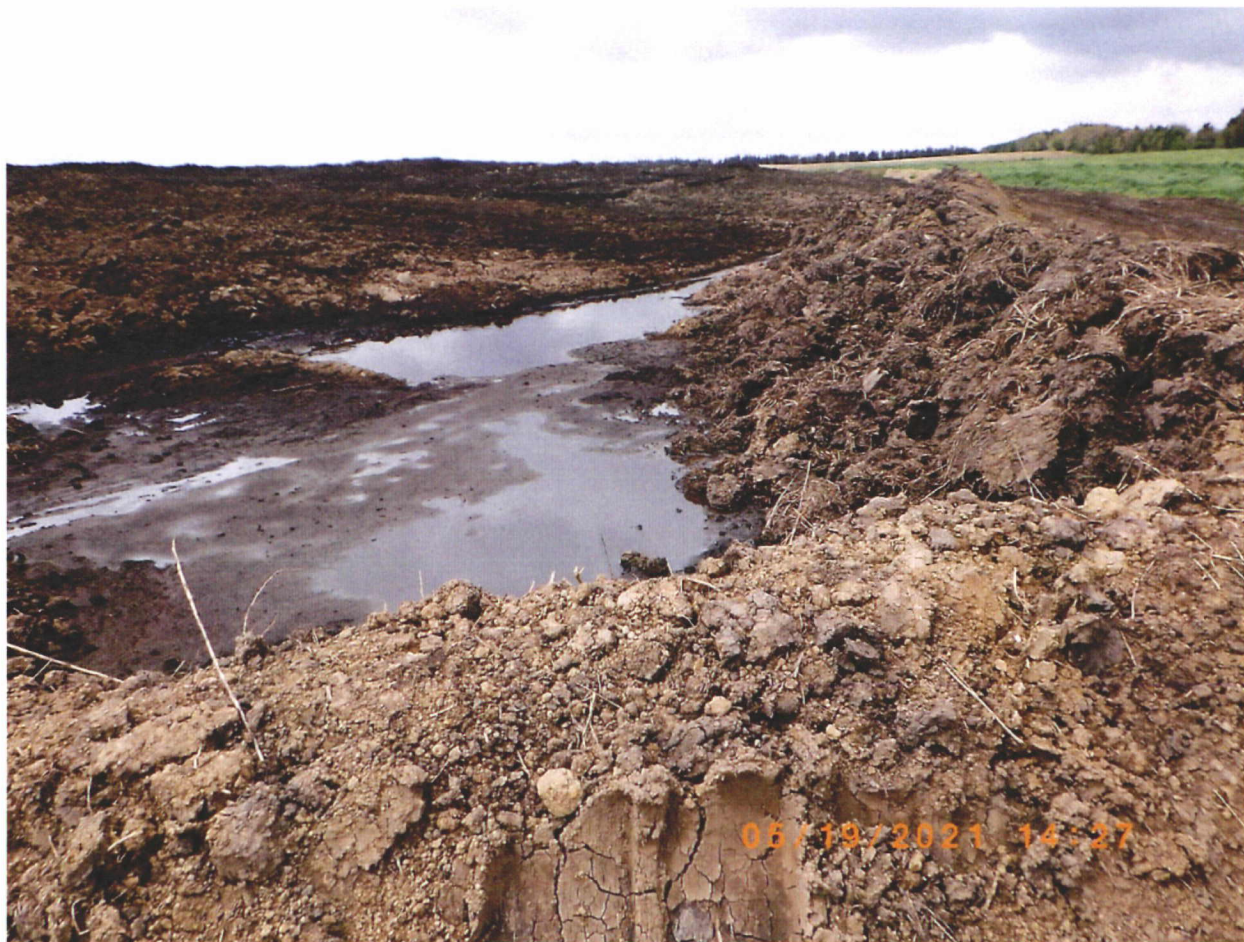
Photos: 21
Site Visit Report
Date Taken: 5-19-2021
Photographer: Jason Windhorst
Facility Name/ Project Name: AltEn LLC
Facility IIS number / Project identifier: IIS: 84069 / NE0137634
Location: Area 6 on the site map. (southeast corner)
Direction Facing: North
Description: Runoff beginning to pond behind the berm.

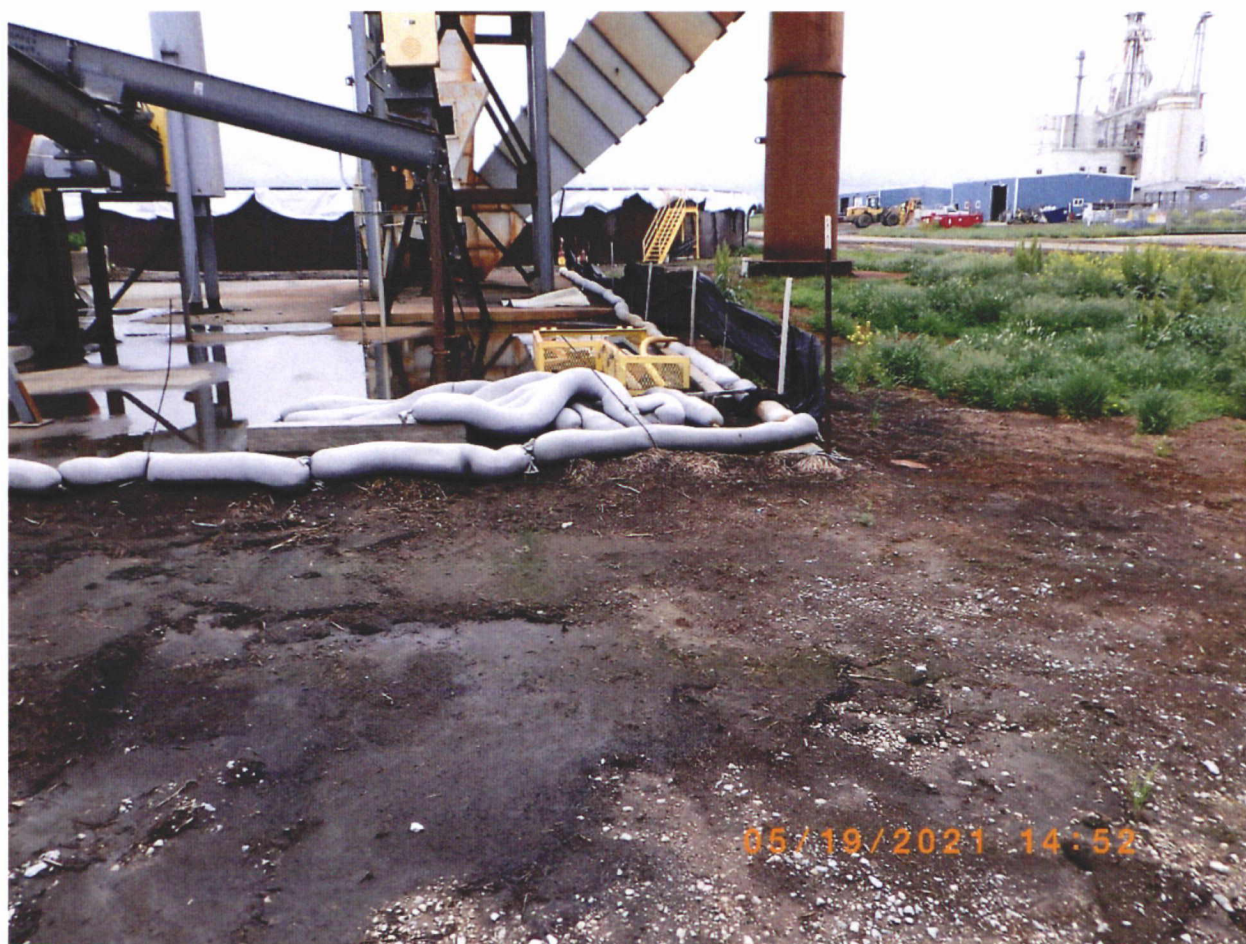
Photos: 22

Description: Runoff from pad accumulating on the ground around the pad and ditch to the north.

- Continue cleaning Biochar from ground at & around the Biochar manufacturing area.

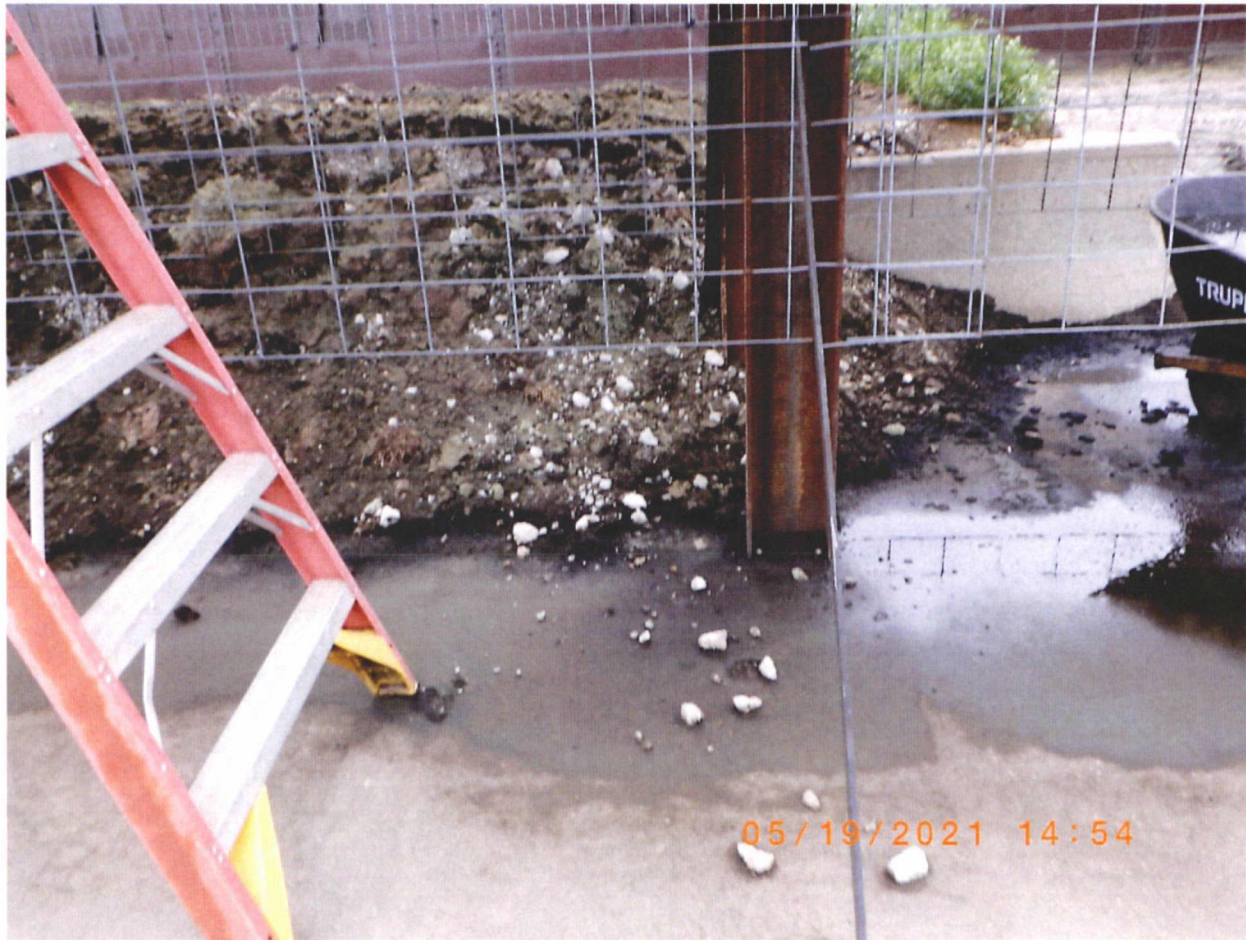
Photos: 23

Description: Wetcake loading area showing wetcake and Biochar on the ground.
