Facility: AltEn, LLC

5/3/2021

Site Visit Check list

Site Visit Report

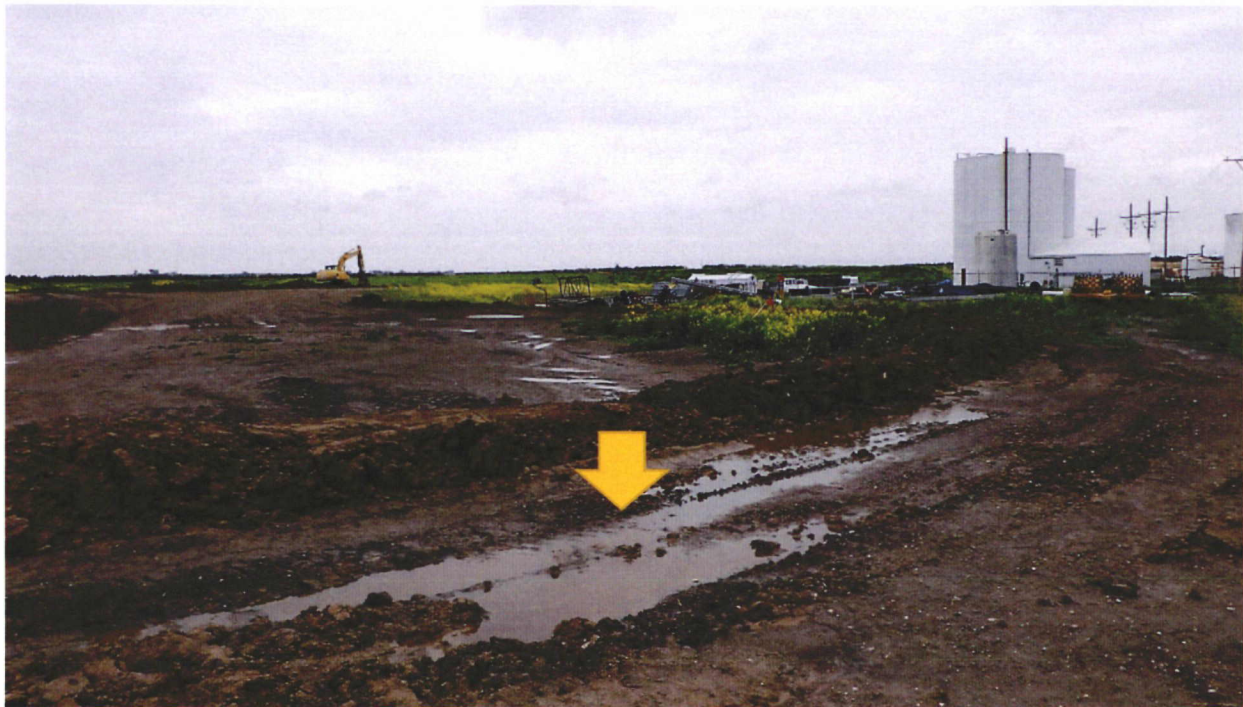
Photo: 1

- Area 1 contains two berms. The east berm has been expanded to prevent parking lot water from entering the berm area. There is minimal water accumulation.
- Areas 2, 3, 4 and 5 has some water accumulation. No seepage observed.
- Area 6 is containing water. There is some seepage observed.

Description: This is the east berm. The berm has been extended and is keeping excess water from entering the berm area (arrow).

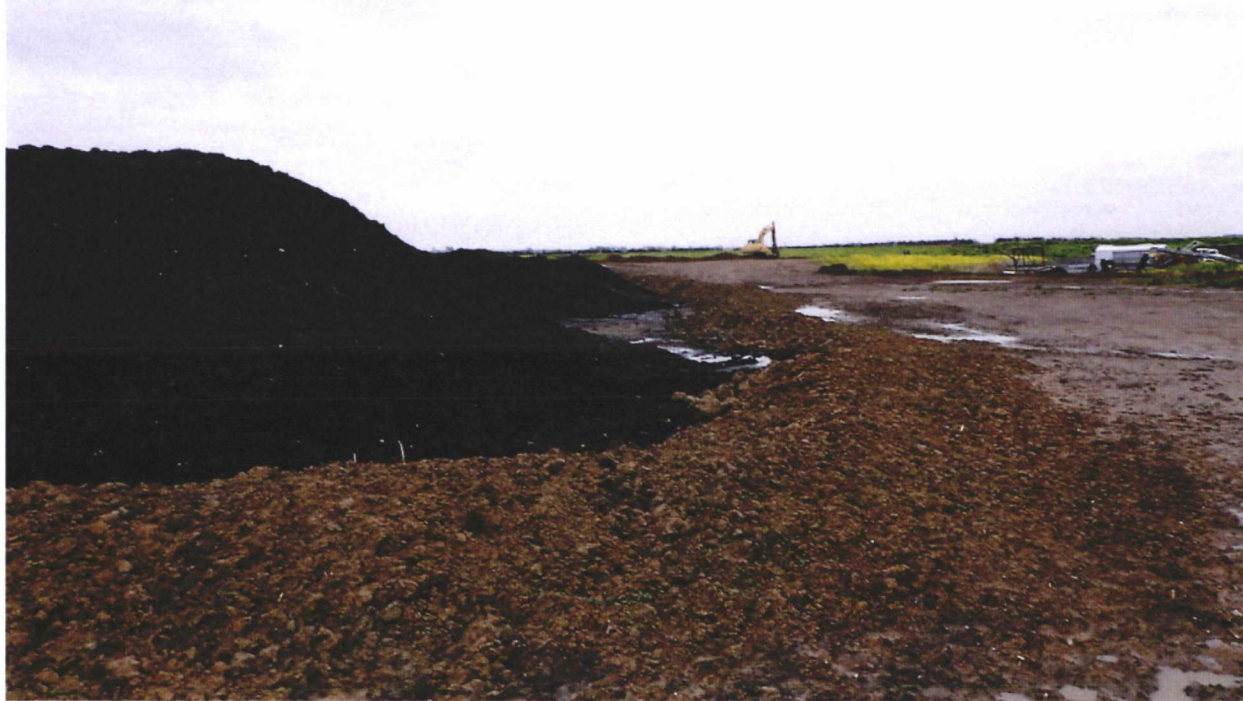
Photo: 2

Description: This is the west berm. The berm is surrounding the south wet cake pile. There are no signs of seepage and is containing water.

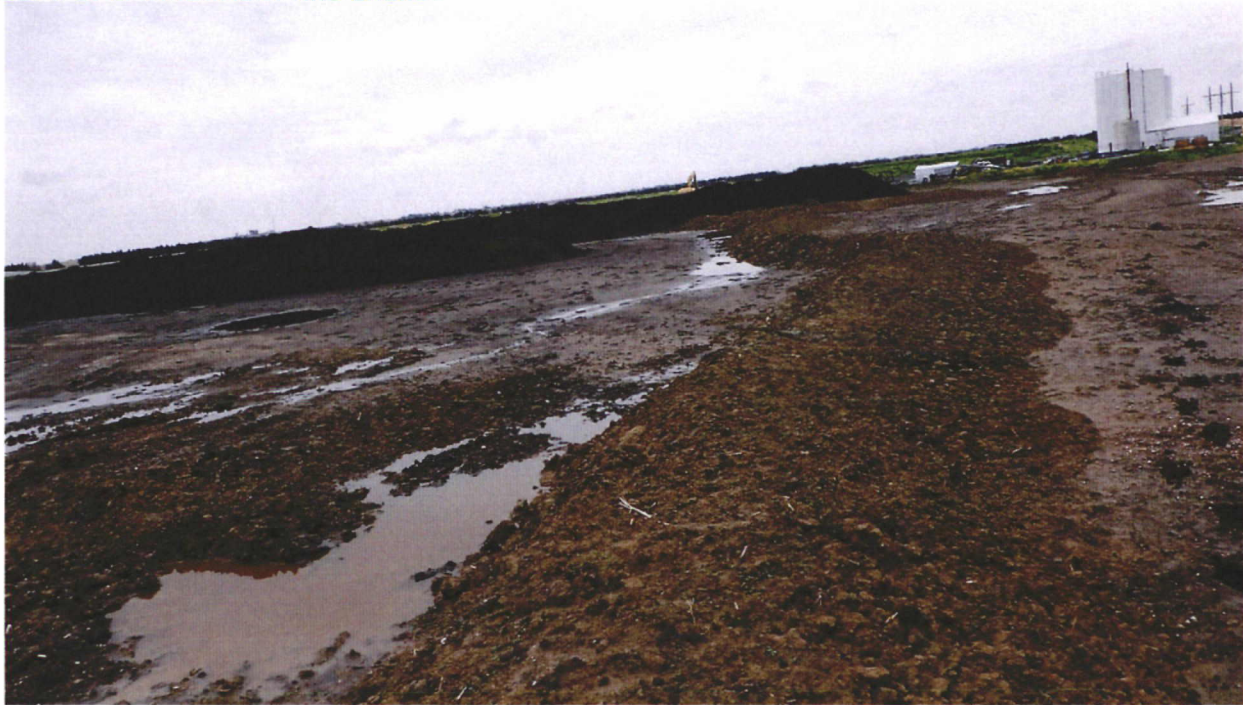
Photo: 3

Description: This is the west berm. The berm is surrounding the south wet cake pile. There are no signs of seepage and the berm is containing water.

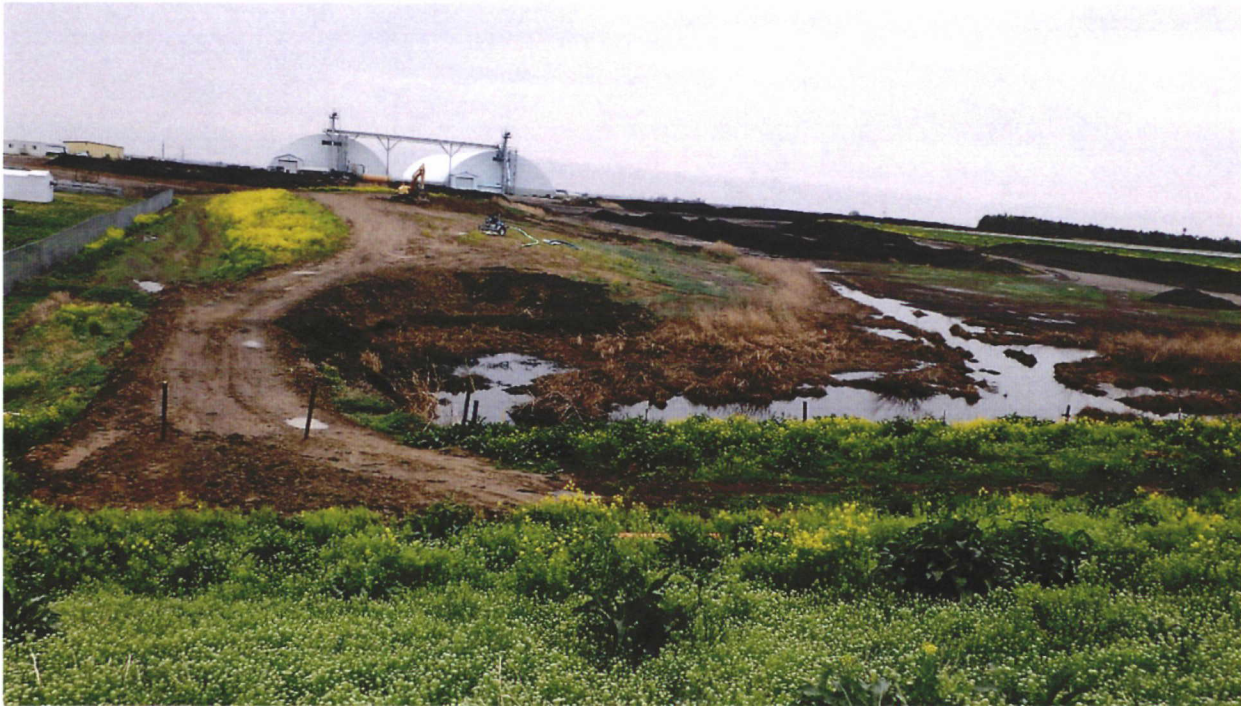
Photo: 4

Description: The facility has created a berm that is also an entrance to the south lagoon. The berm is holding water. There are no signs of seepage.

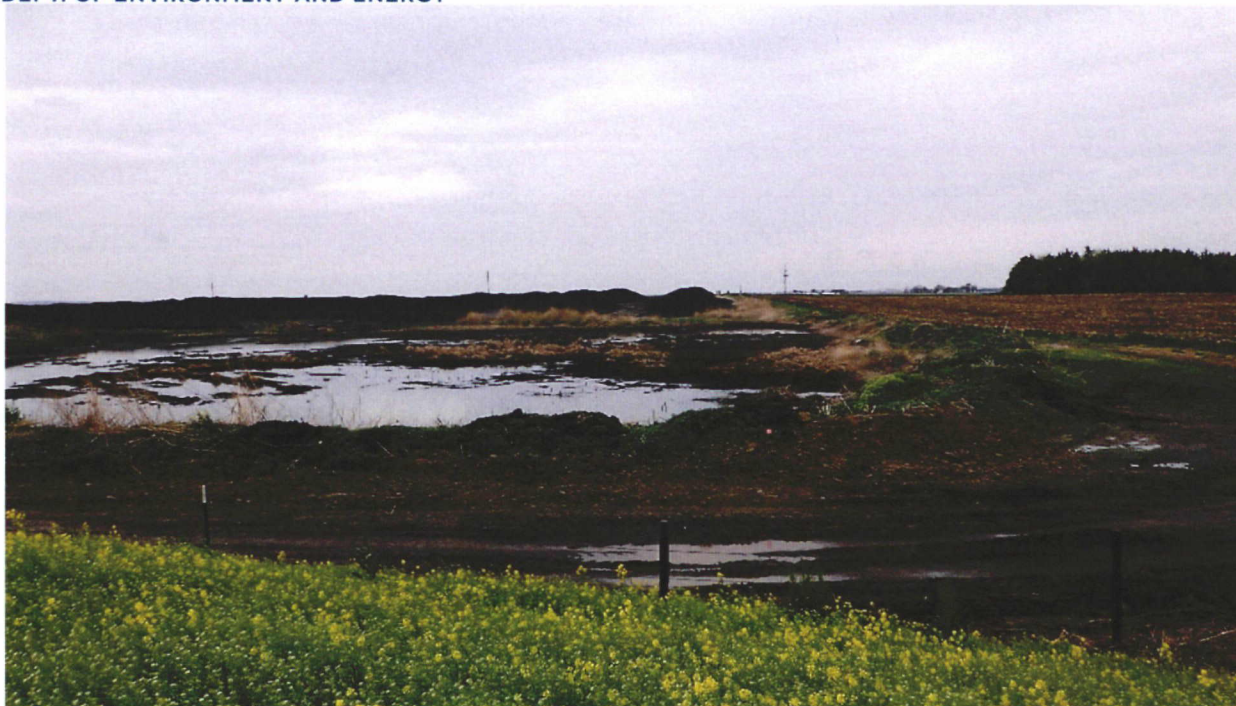
Photo: 5

Description: The facility has added additional soil to prevent seepage. The pooled water appears to be from the rain event and not from seepage.

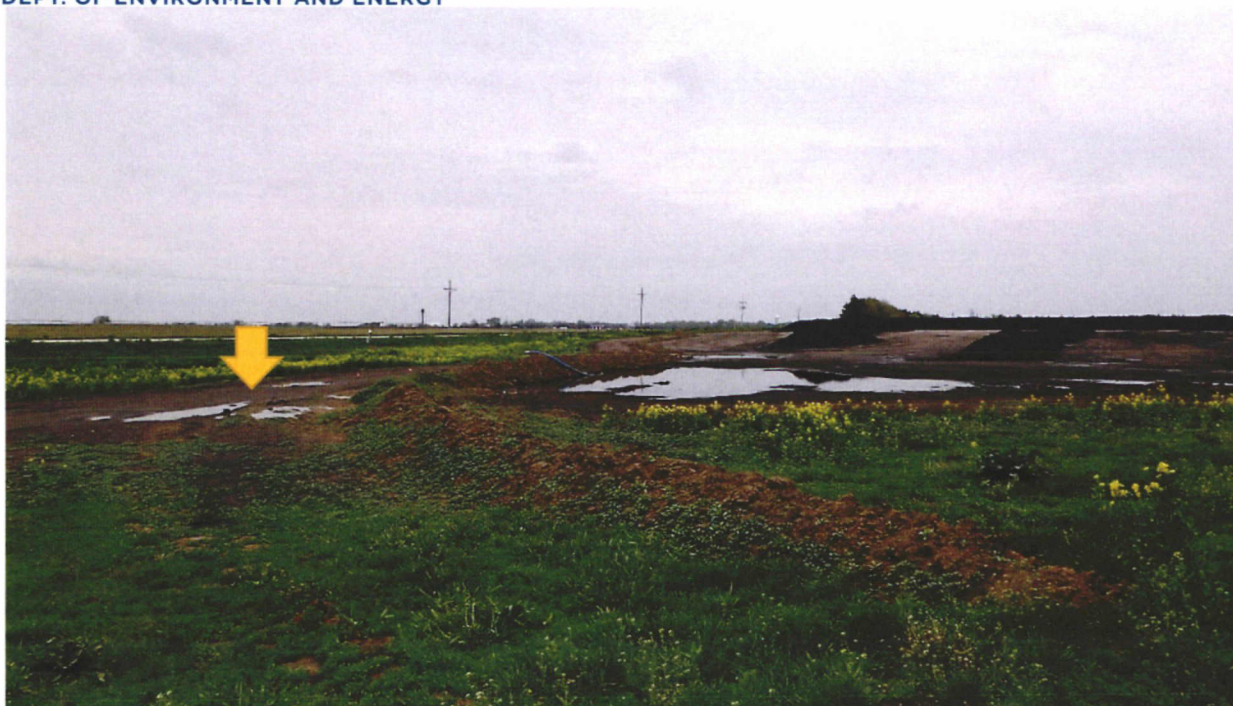
Photo: 6

Description: There are no signs of seepage. The water to the left of the berm appears to be pooled rain water (arrow).

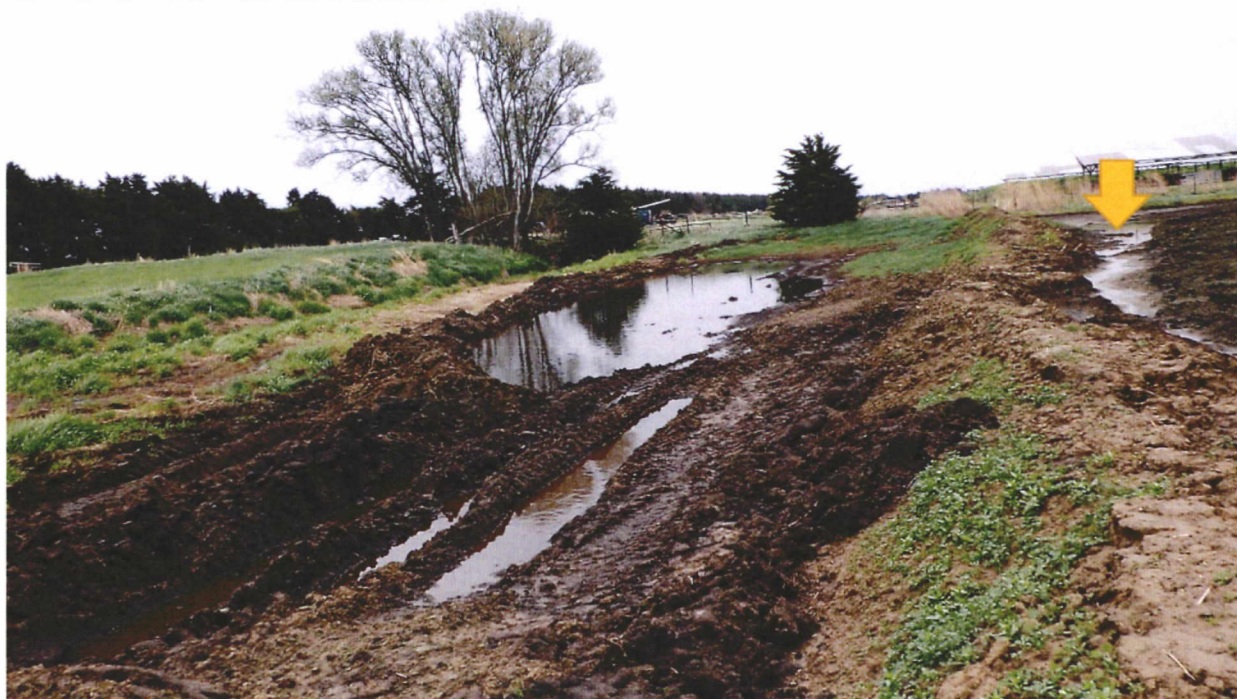
Photo: 7

Description: This photo depicts the berm along the east wet cake pile. There is water accumulation behind the secondary berm and only minimal water accumulation behind the main berm (arrow).

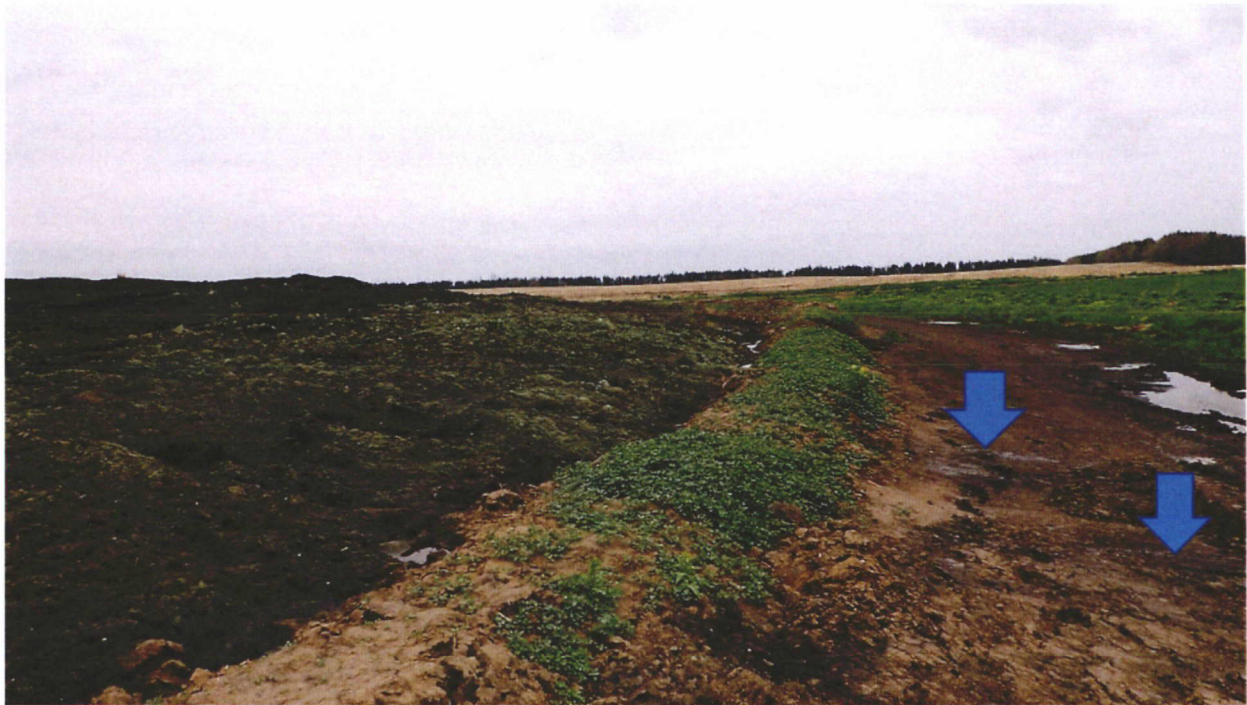
Photo: 8

Description: This photo depicts the berm along the east wet cake pile. Wet cake is up against the berm. There is signs of seepage (arrow).

- Area 1 - ok
- Area 2 - ok
- Area 3 - ok
- Area 4 - ok
- Area 5 - ok
- Area 6 - Some Rungs observed on the north side of the pile
- Hoop Building has a Cont. nr (Cement Waste pile)
- Biochan - Housekeeping Concerns

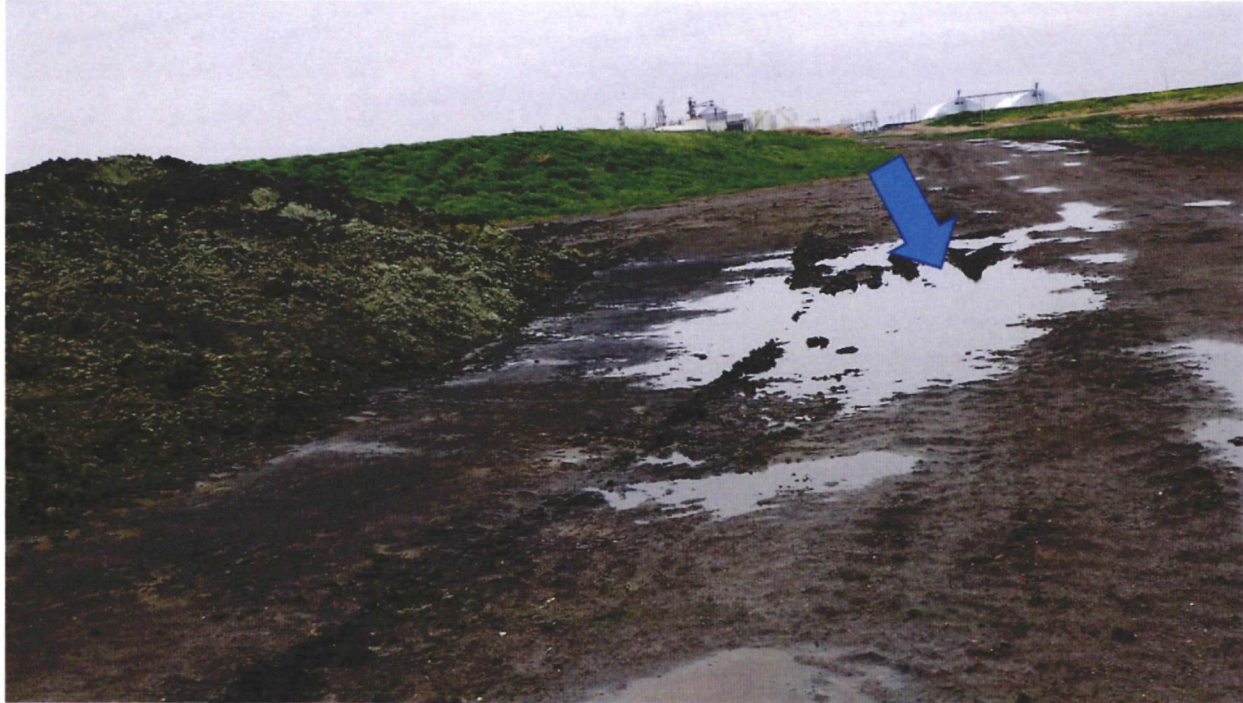
Photo: 9

Description: This photo depicts the northwest corner of the east wet cake pile. There is no berm and there is water accumulation north of the pile.

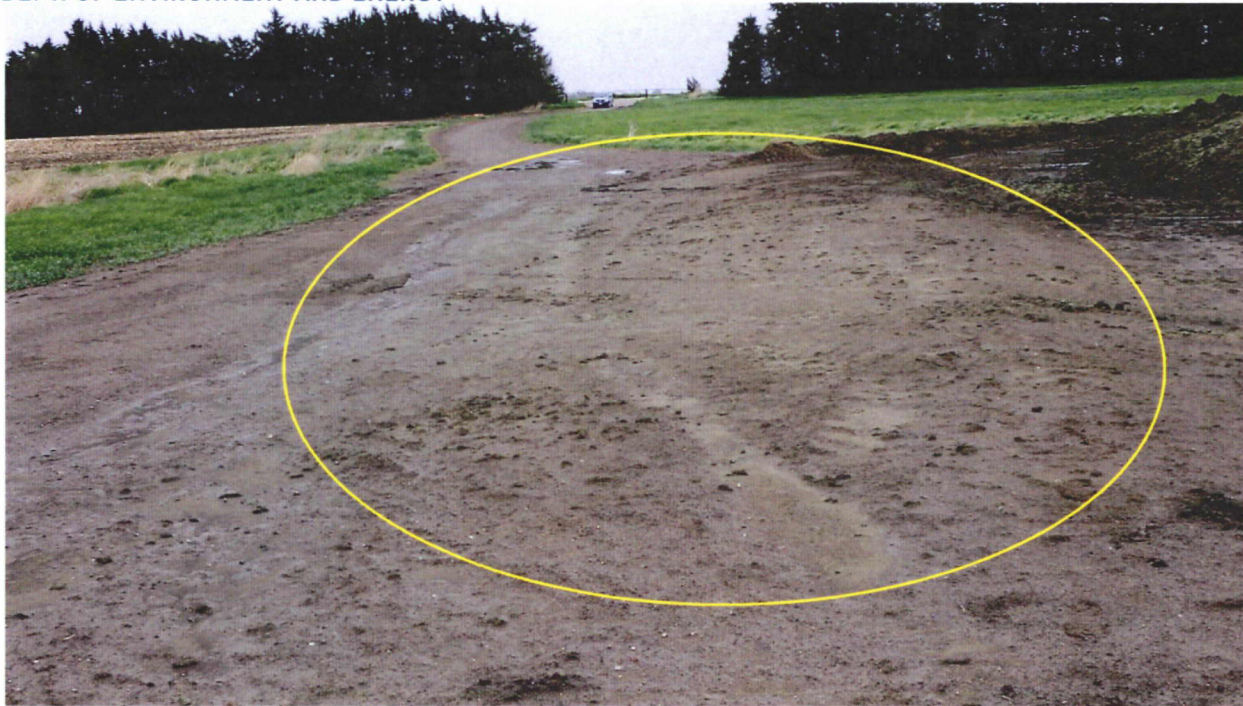
Photo: 10

Description: This photo depicts wet cake residue. The facility has recently moved some wet cake to the west storage area. The operation left residue on the roadway (circle).

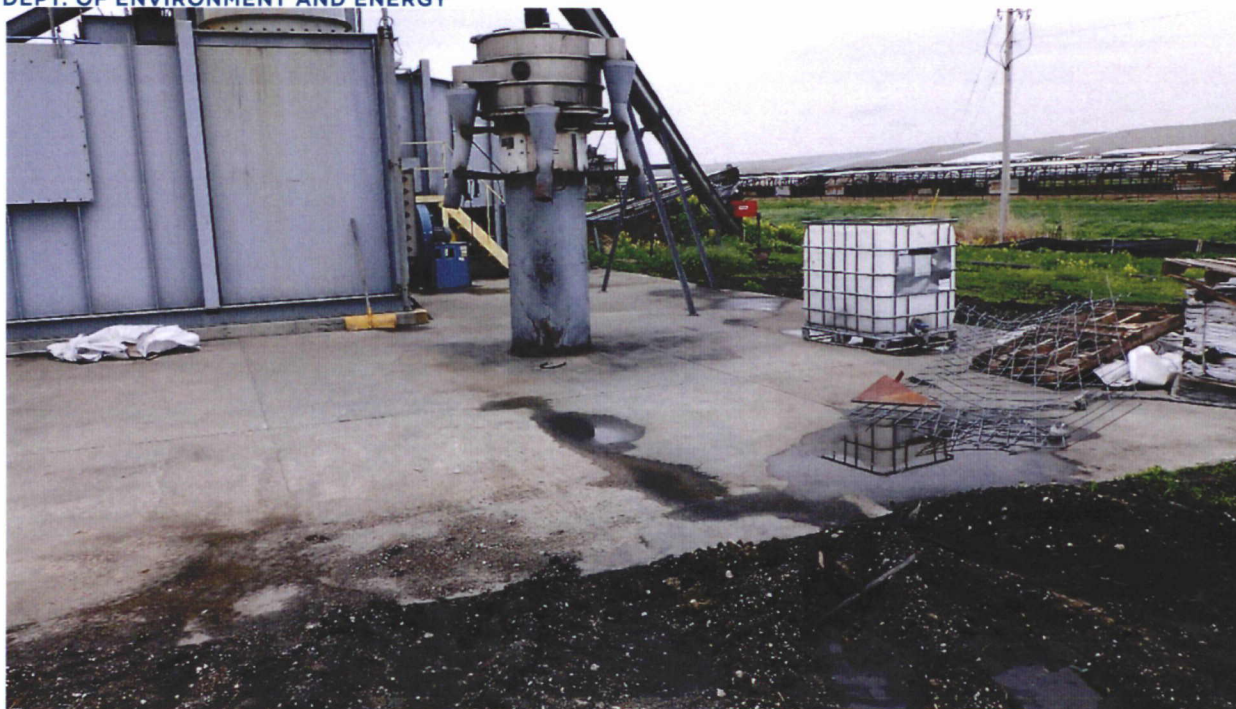
Photo: 11

- Spilled biochar product.
- Trash and debris observed.

Description: This photo depicts spilled biochar, empty tote and trash.

- Remove Cont. pile
- Work on Housekeeping (Biochan)

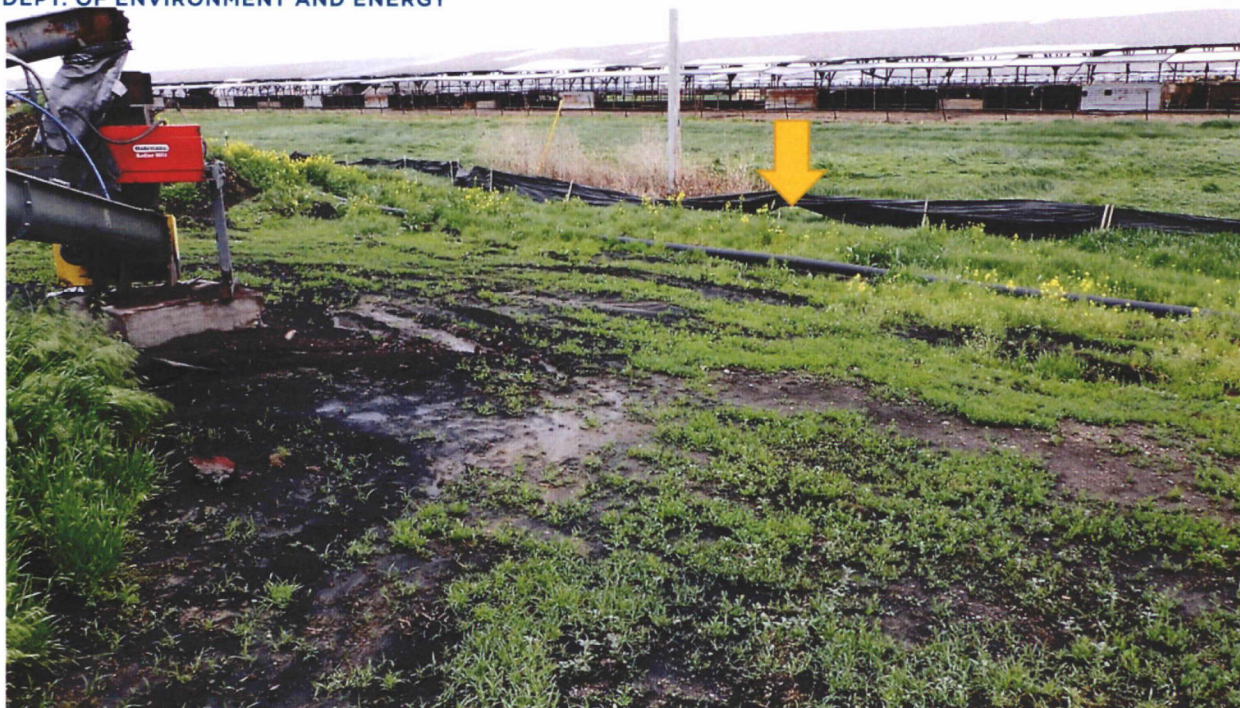
Photo: 12

Description: This photo depicts spilled biochar. Notice the silt fence (arrow).

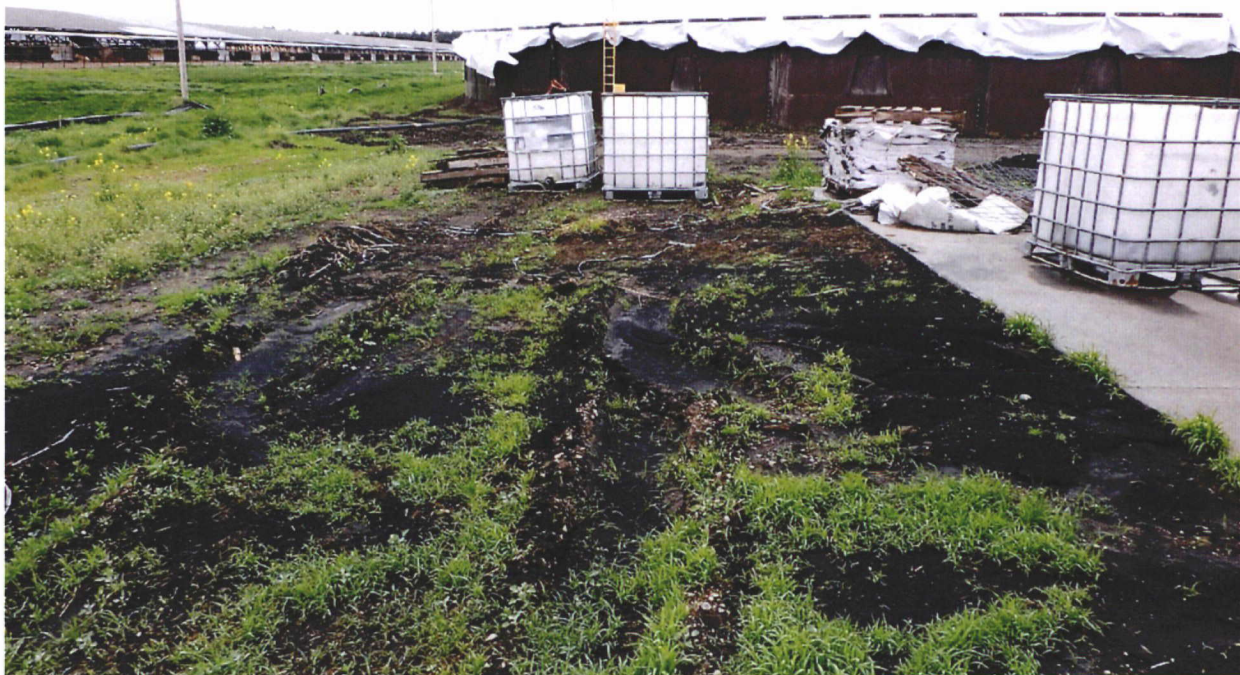
Photo: 13

Description: This photo depicts spilled biochar from the south pad. There is spilled biochar, empty totes and trash observed.

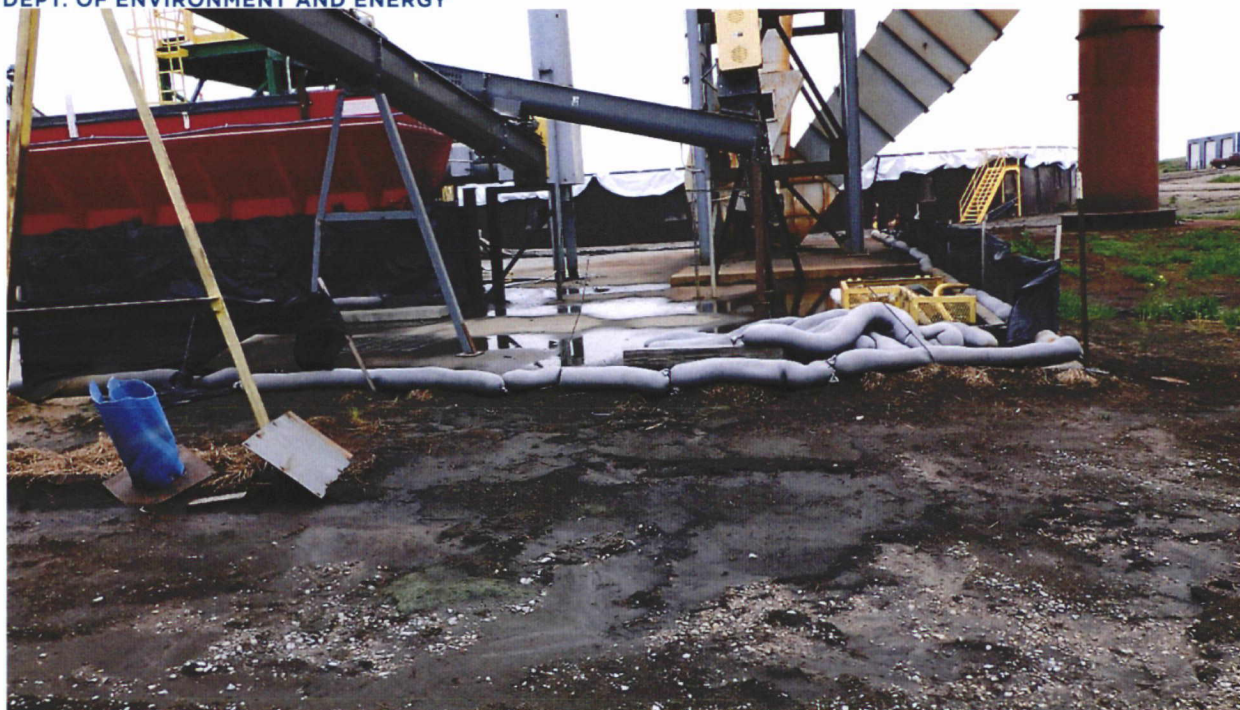
Photo: 14

Description: This photo depicts spilled biochar from the east pad.

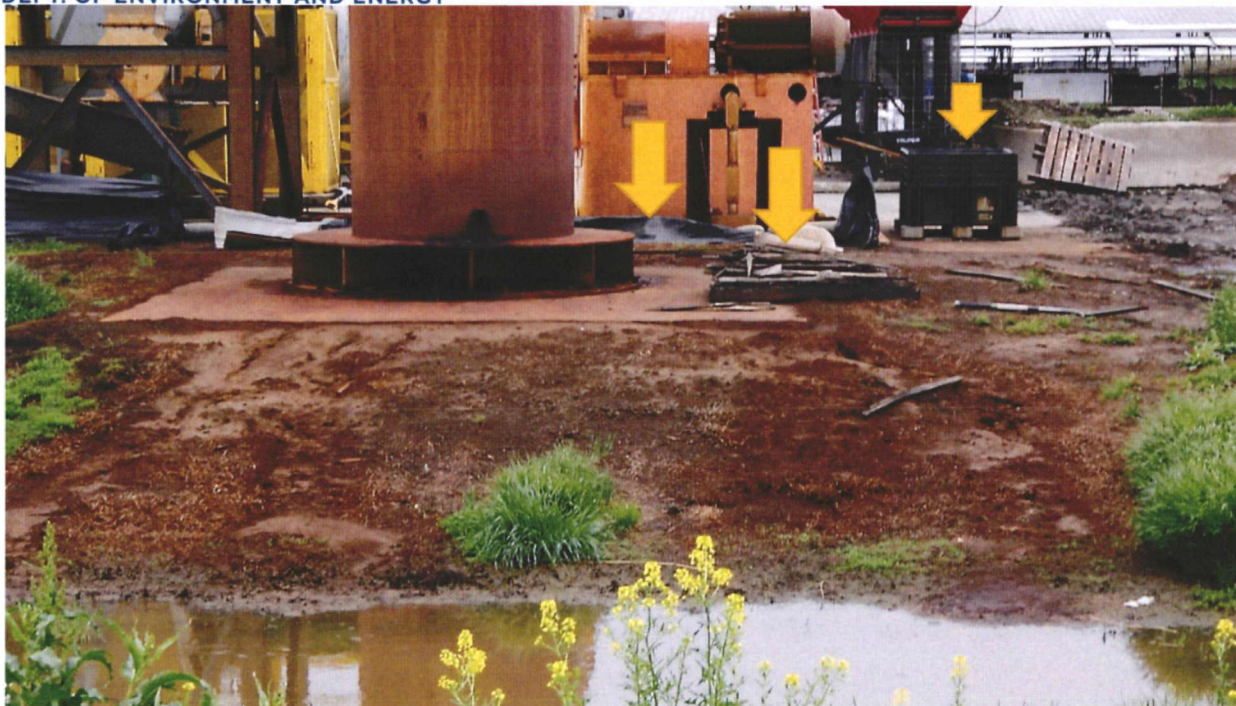
Photo: 15

Description: This photo depicts red staining from the biochar system into the drainage ditch. The runoff has killed vegetation. The photo also depicts pallets, totes and plastic debris (arrows).

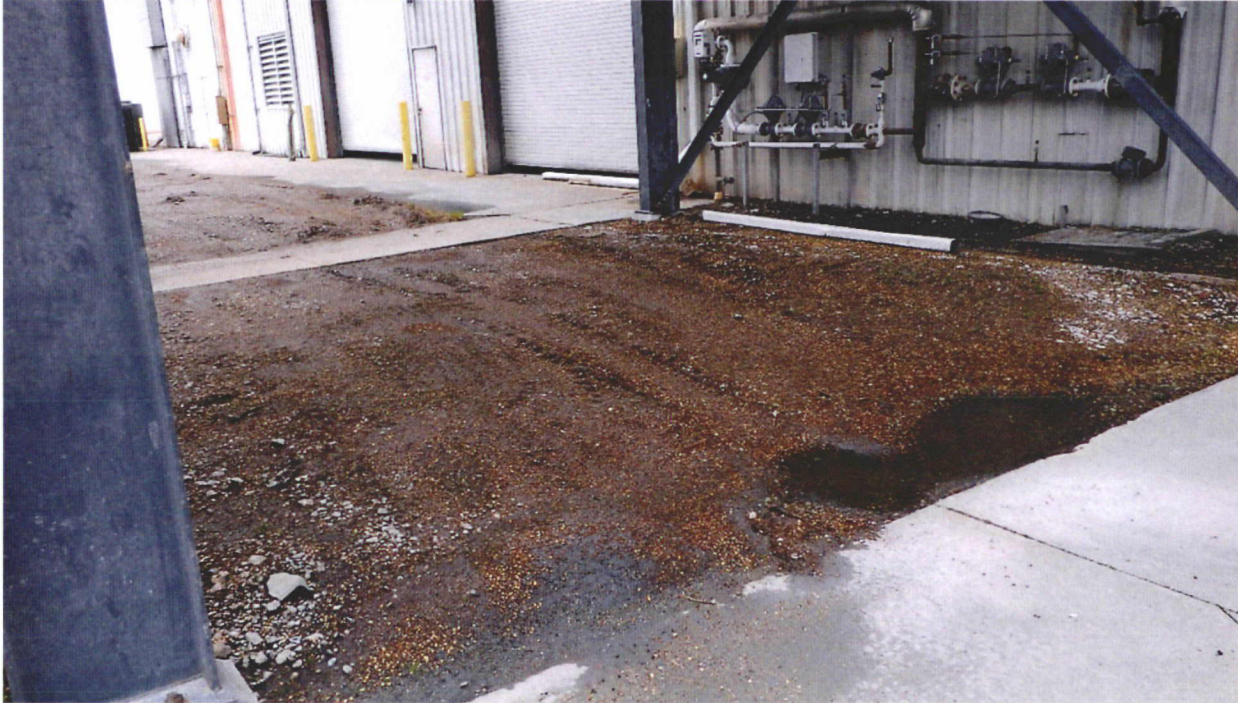
Photo: 16

- There is trash and debris observed north of the hoop building, including a pile of cement, plastic and wood.
- There is residual seed on the ground near the grain storage area, see photos 16 through 19.

Description: This photo depicts residual grain. This grain has potential to wash into the conveyance depicted in the next photo.

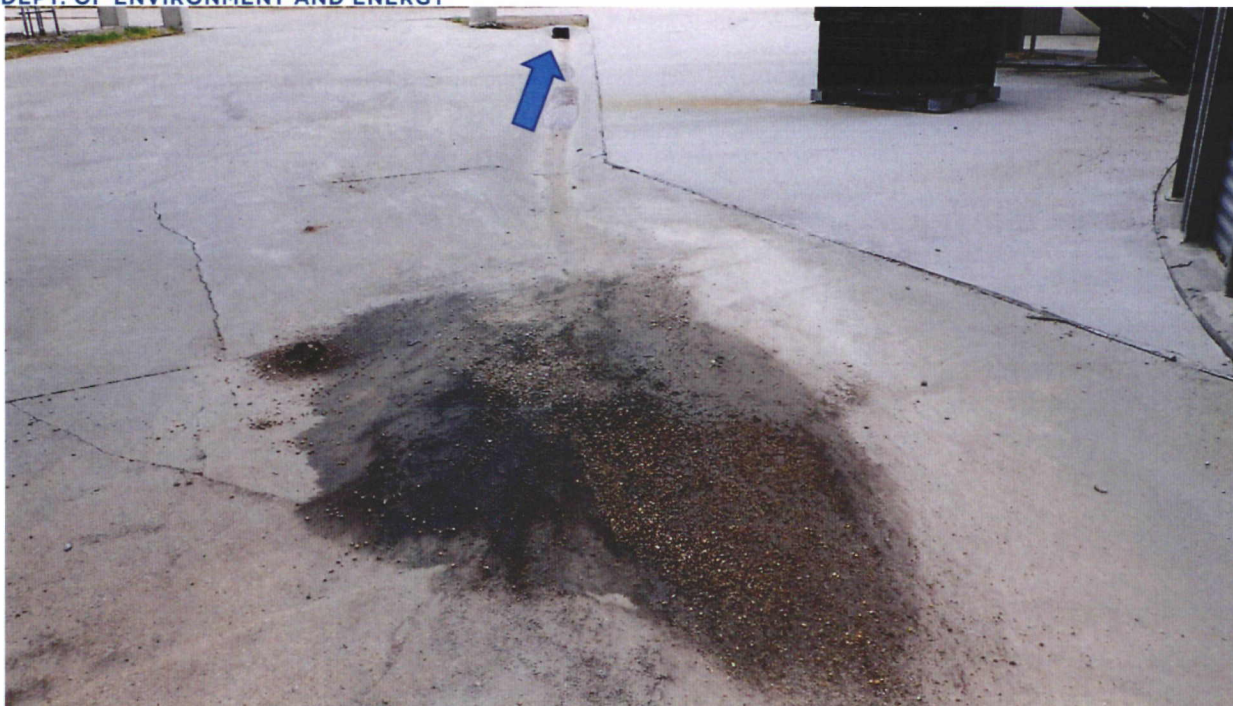
Photo: 17

Description: This photo depicts the conveyance discussed in photo 16. Runoff conveys through this drainage and into the south ditch (arrow).

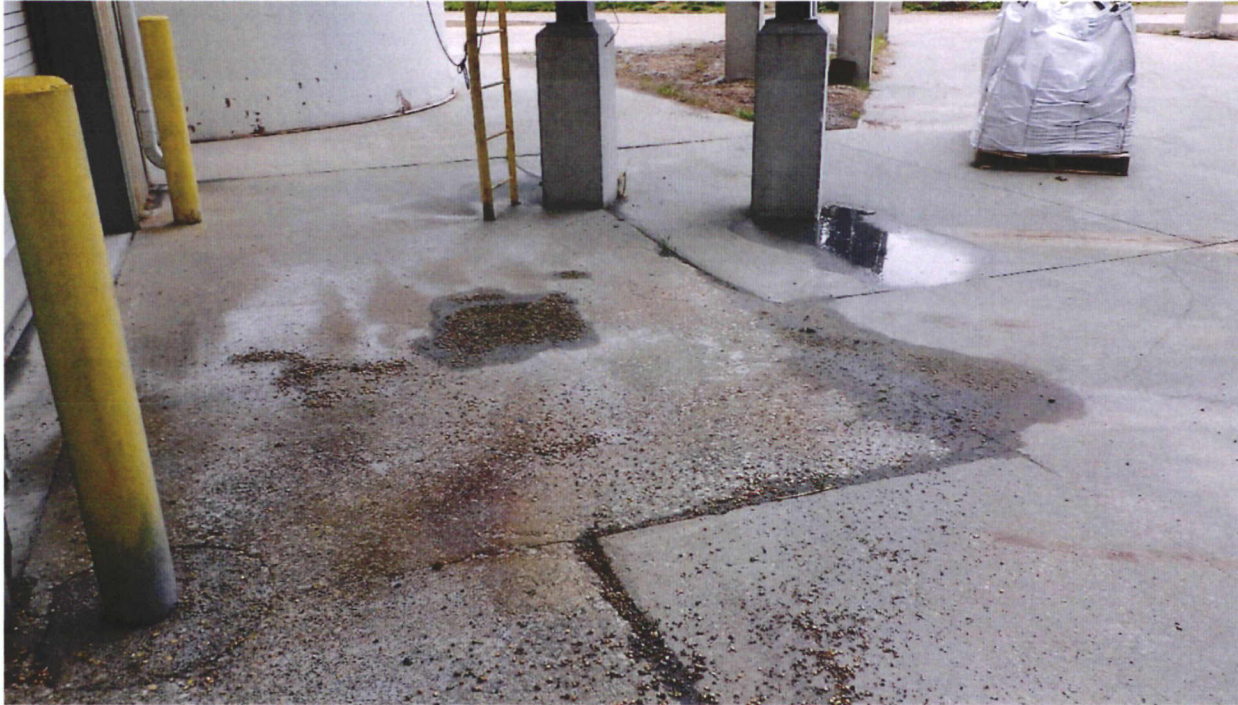
Photo: 18

Description: This photo depicts residual seed. This seed also drains into the conveyance discussed in photos 17 and 18.

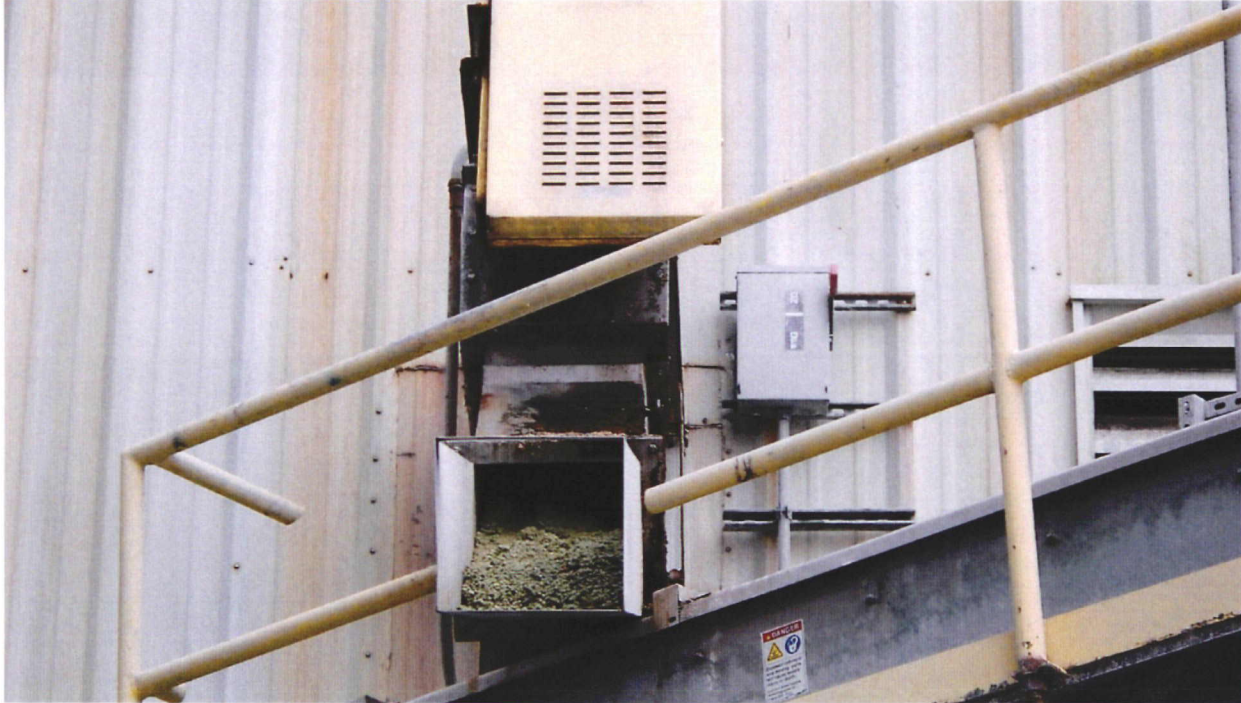
Photo: 19

Description: This photo depicts wet cake inside a shoot. This shoot was used to transfer wetcake to the staging area before being hauled to storage.

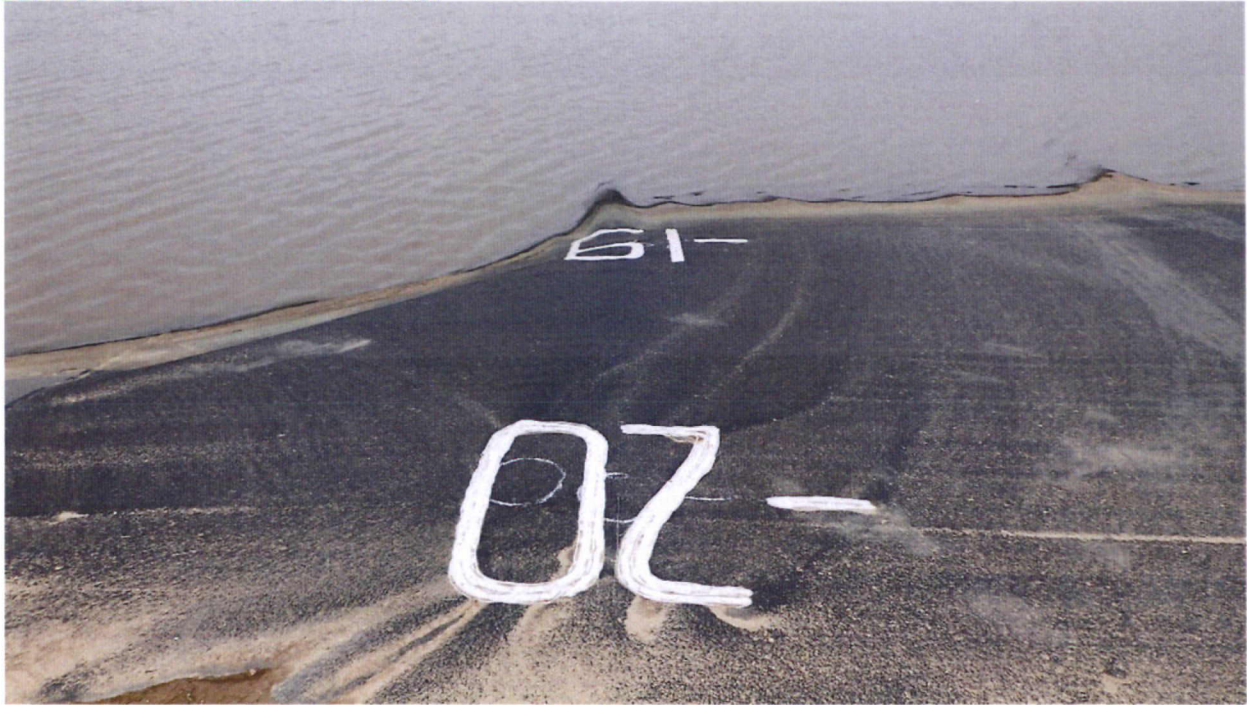
Photo: 20

- The water level is starting to drop below the equalization pipe. The lagoon continues to lower.

Description: This photo depicts the northwest lagoon depth gauge.

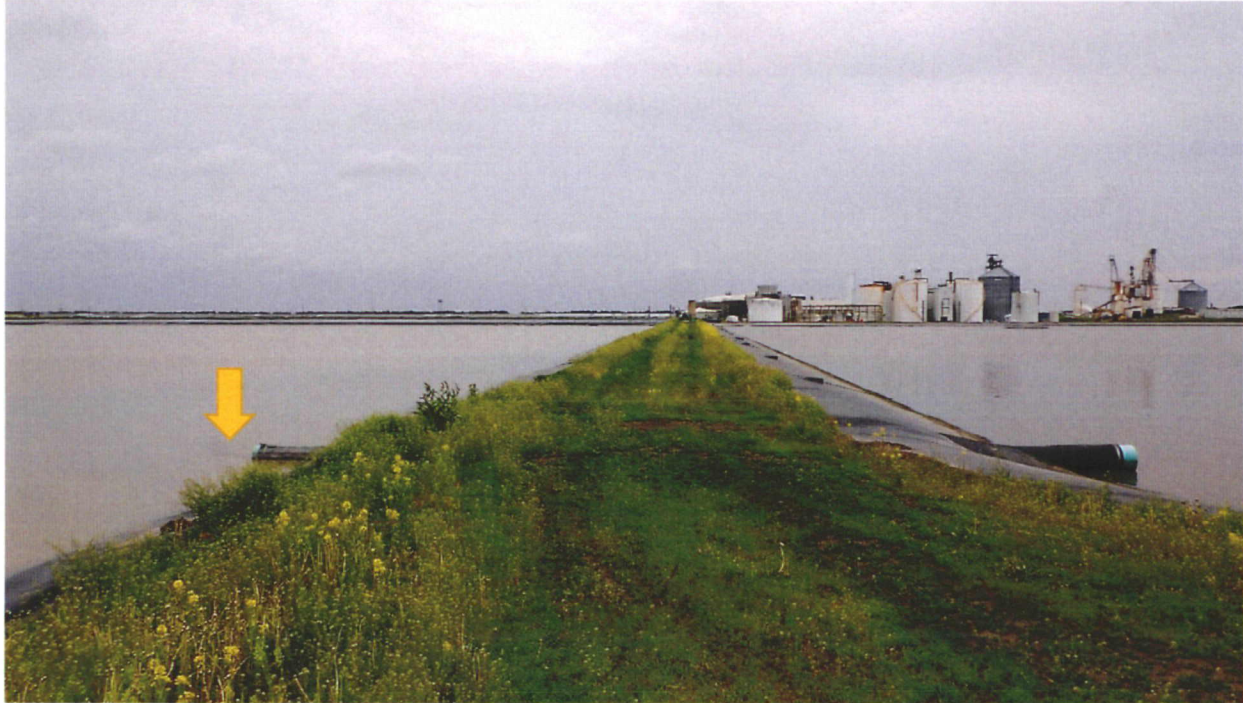
Photo: 21

Description: This photo depicts the equalization pipe. Water is observed flowing into the northeast lagoon (arrow).

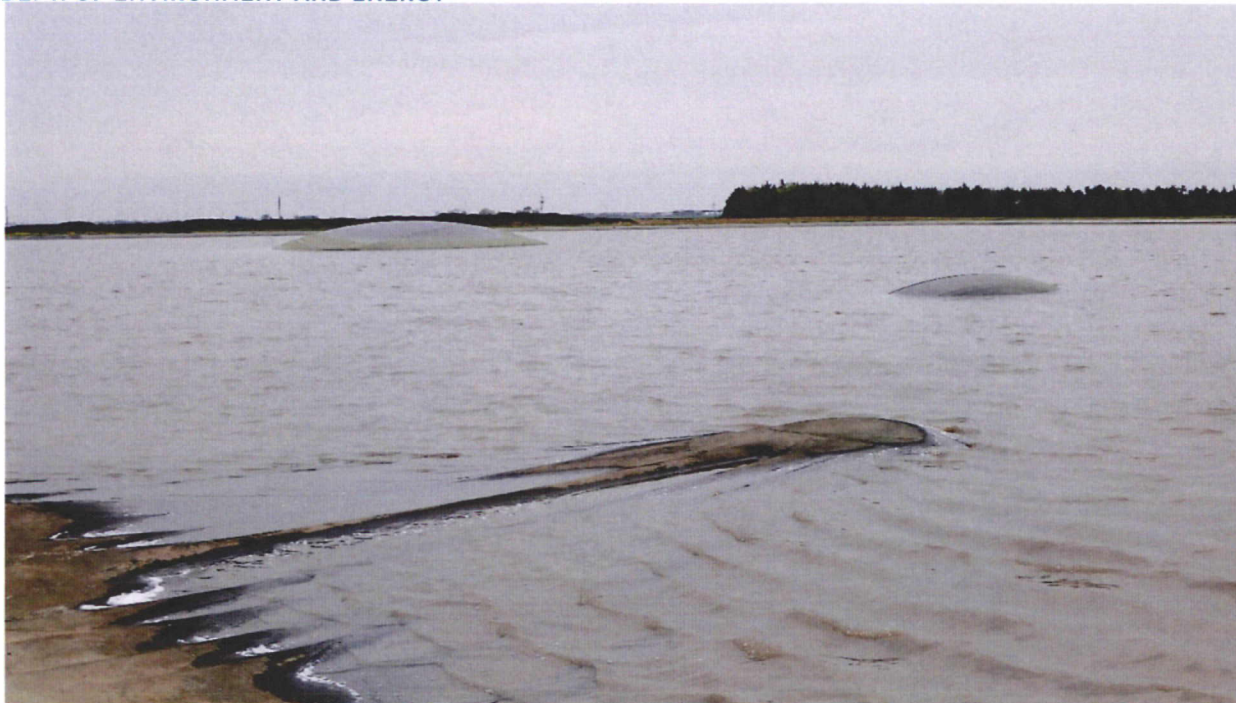
Photo: 22

Description: This photo depicts three areas of floating liners.

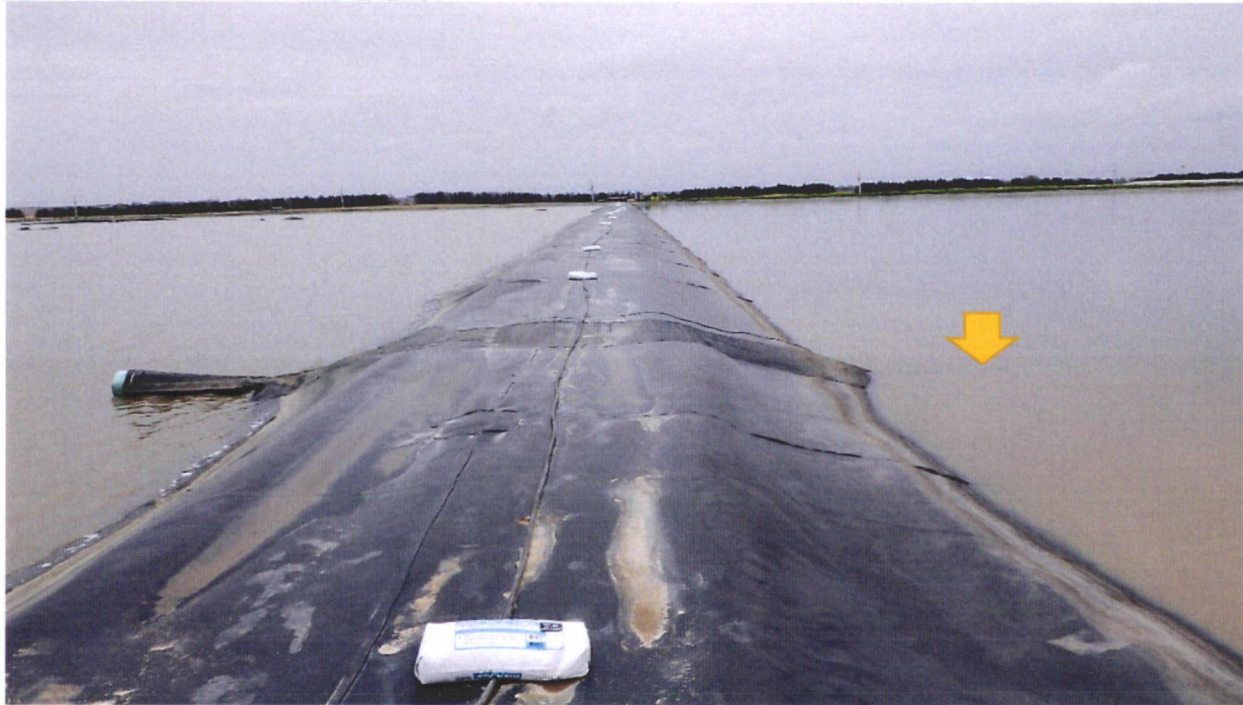
Photo: 23

- The water level continues to lower. The equalization pipe is visible.

Description: This photo depicts the equalization tube between the south and northeast lagoon. The south pipe is now visible (arrow).

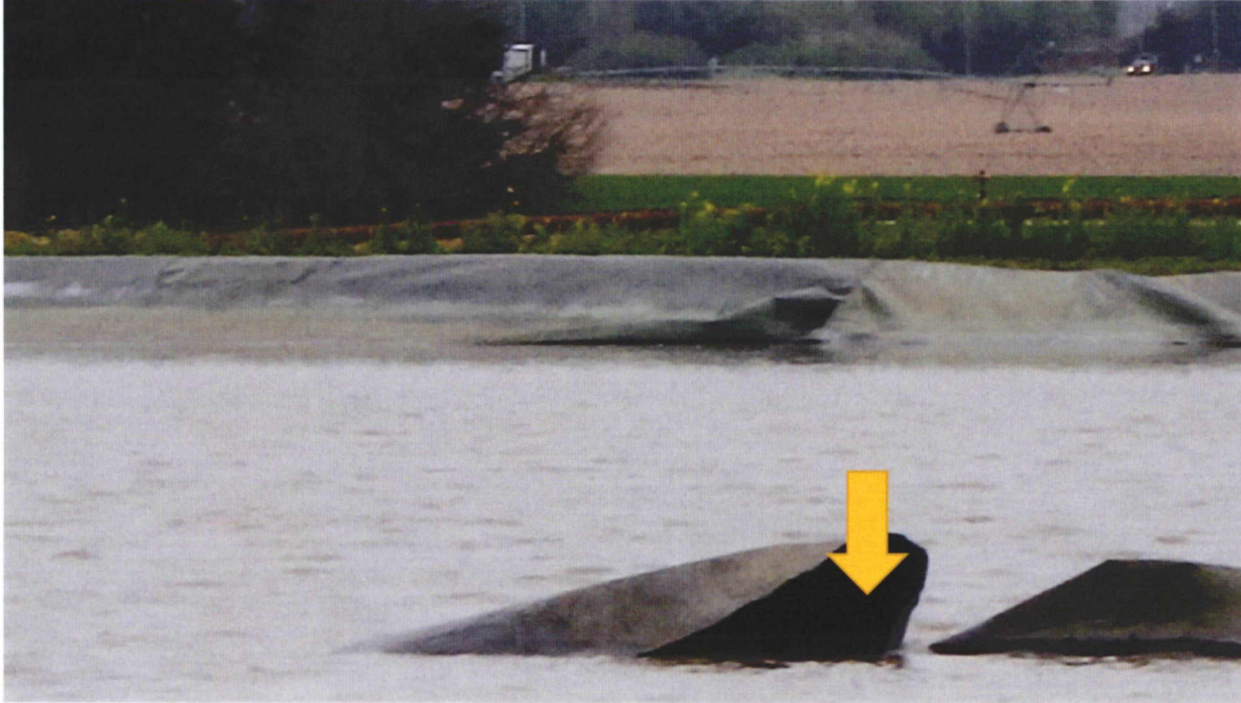
Photo: 24

Description: This photo depicts a torn liner in the middle of the northeast lagoon.

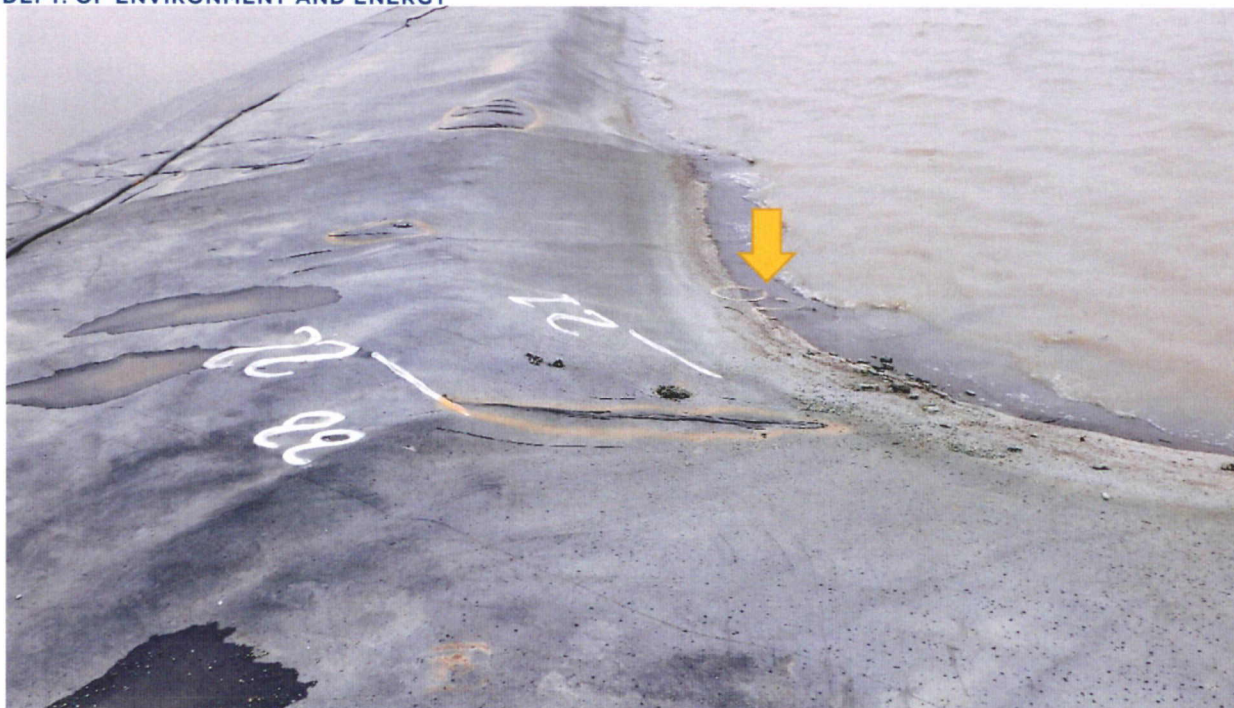
Photo: 25

Description: This is the depth gauge of the northeast lagoon. This photo depicts the water level about 20 ft.
